CCKV Maitai Dev Co LP
7 Ralphine Way,
Nelson

Addendum Contamination Assessment – Maitahi Subdivision – V4

Envirolink Ltd has been engaged by CCKV Maitai Dev Co LP to undertake additional investigation and assessment of ground conditions around the former sheep treatment area and former homestead at 7 Ralphine Way, Nelson (the site). The objective of the assessment is to provide additional detail to further inform a remediation methodology, including possible dewatering requirements.

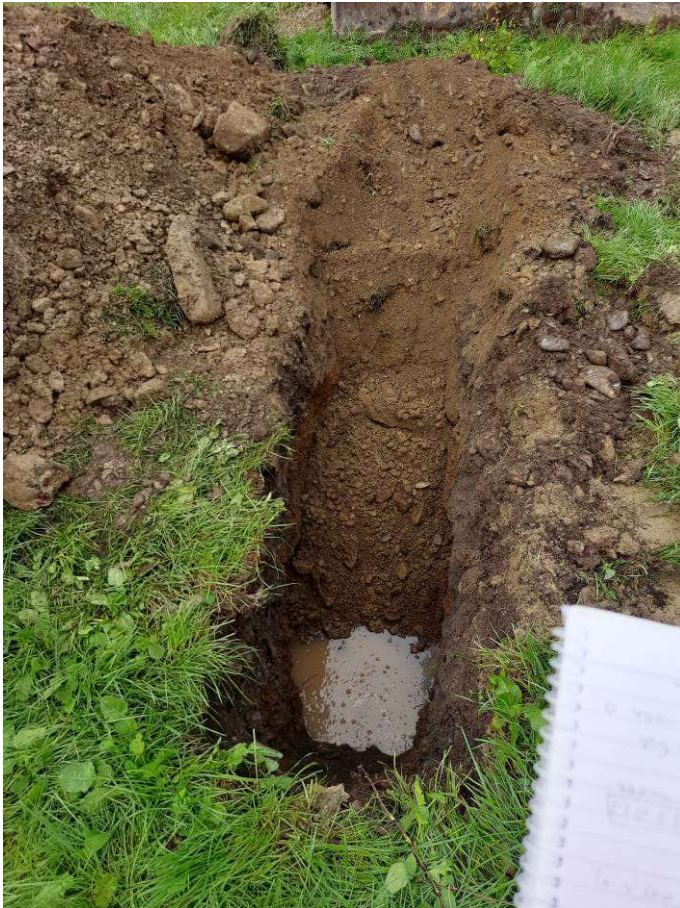
Photograph 6 – TP 5

TP05 and TP07 were located downgradient of the treatment infrastructure, in the run-out zone. At these locations, elevated concentrations of arsenic and dieldrin above NES recreational SCS were reported to 0.5 m bgl. Elevated arsenic concentrations, when compared to residential SCS, were still being reported at 0.9 m and 1.2 m depth but are much reduced compared to shallower samples.

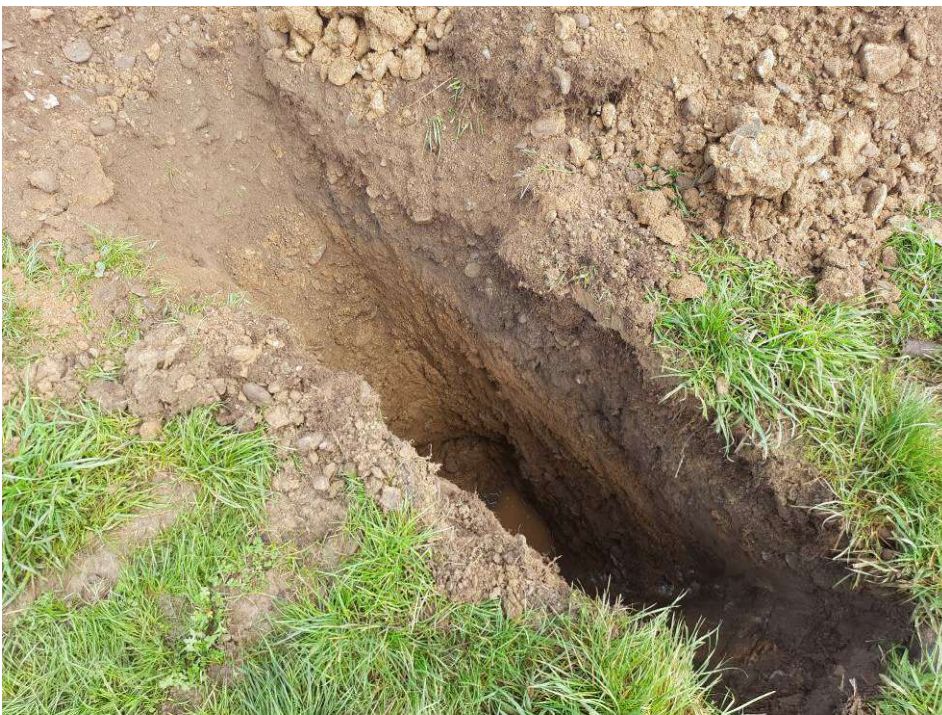
Photograph 7: TP6

TP06 was located downgradient of the footpath. At 0.5 m bgl concentrations of arsenic were above the residential SCS, but below recreational SCS. Copper was also reported above the Eco-SGV.

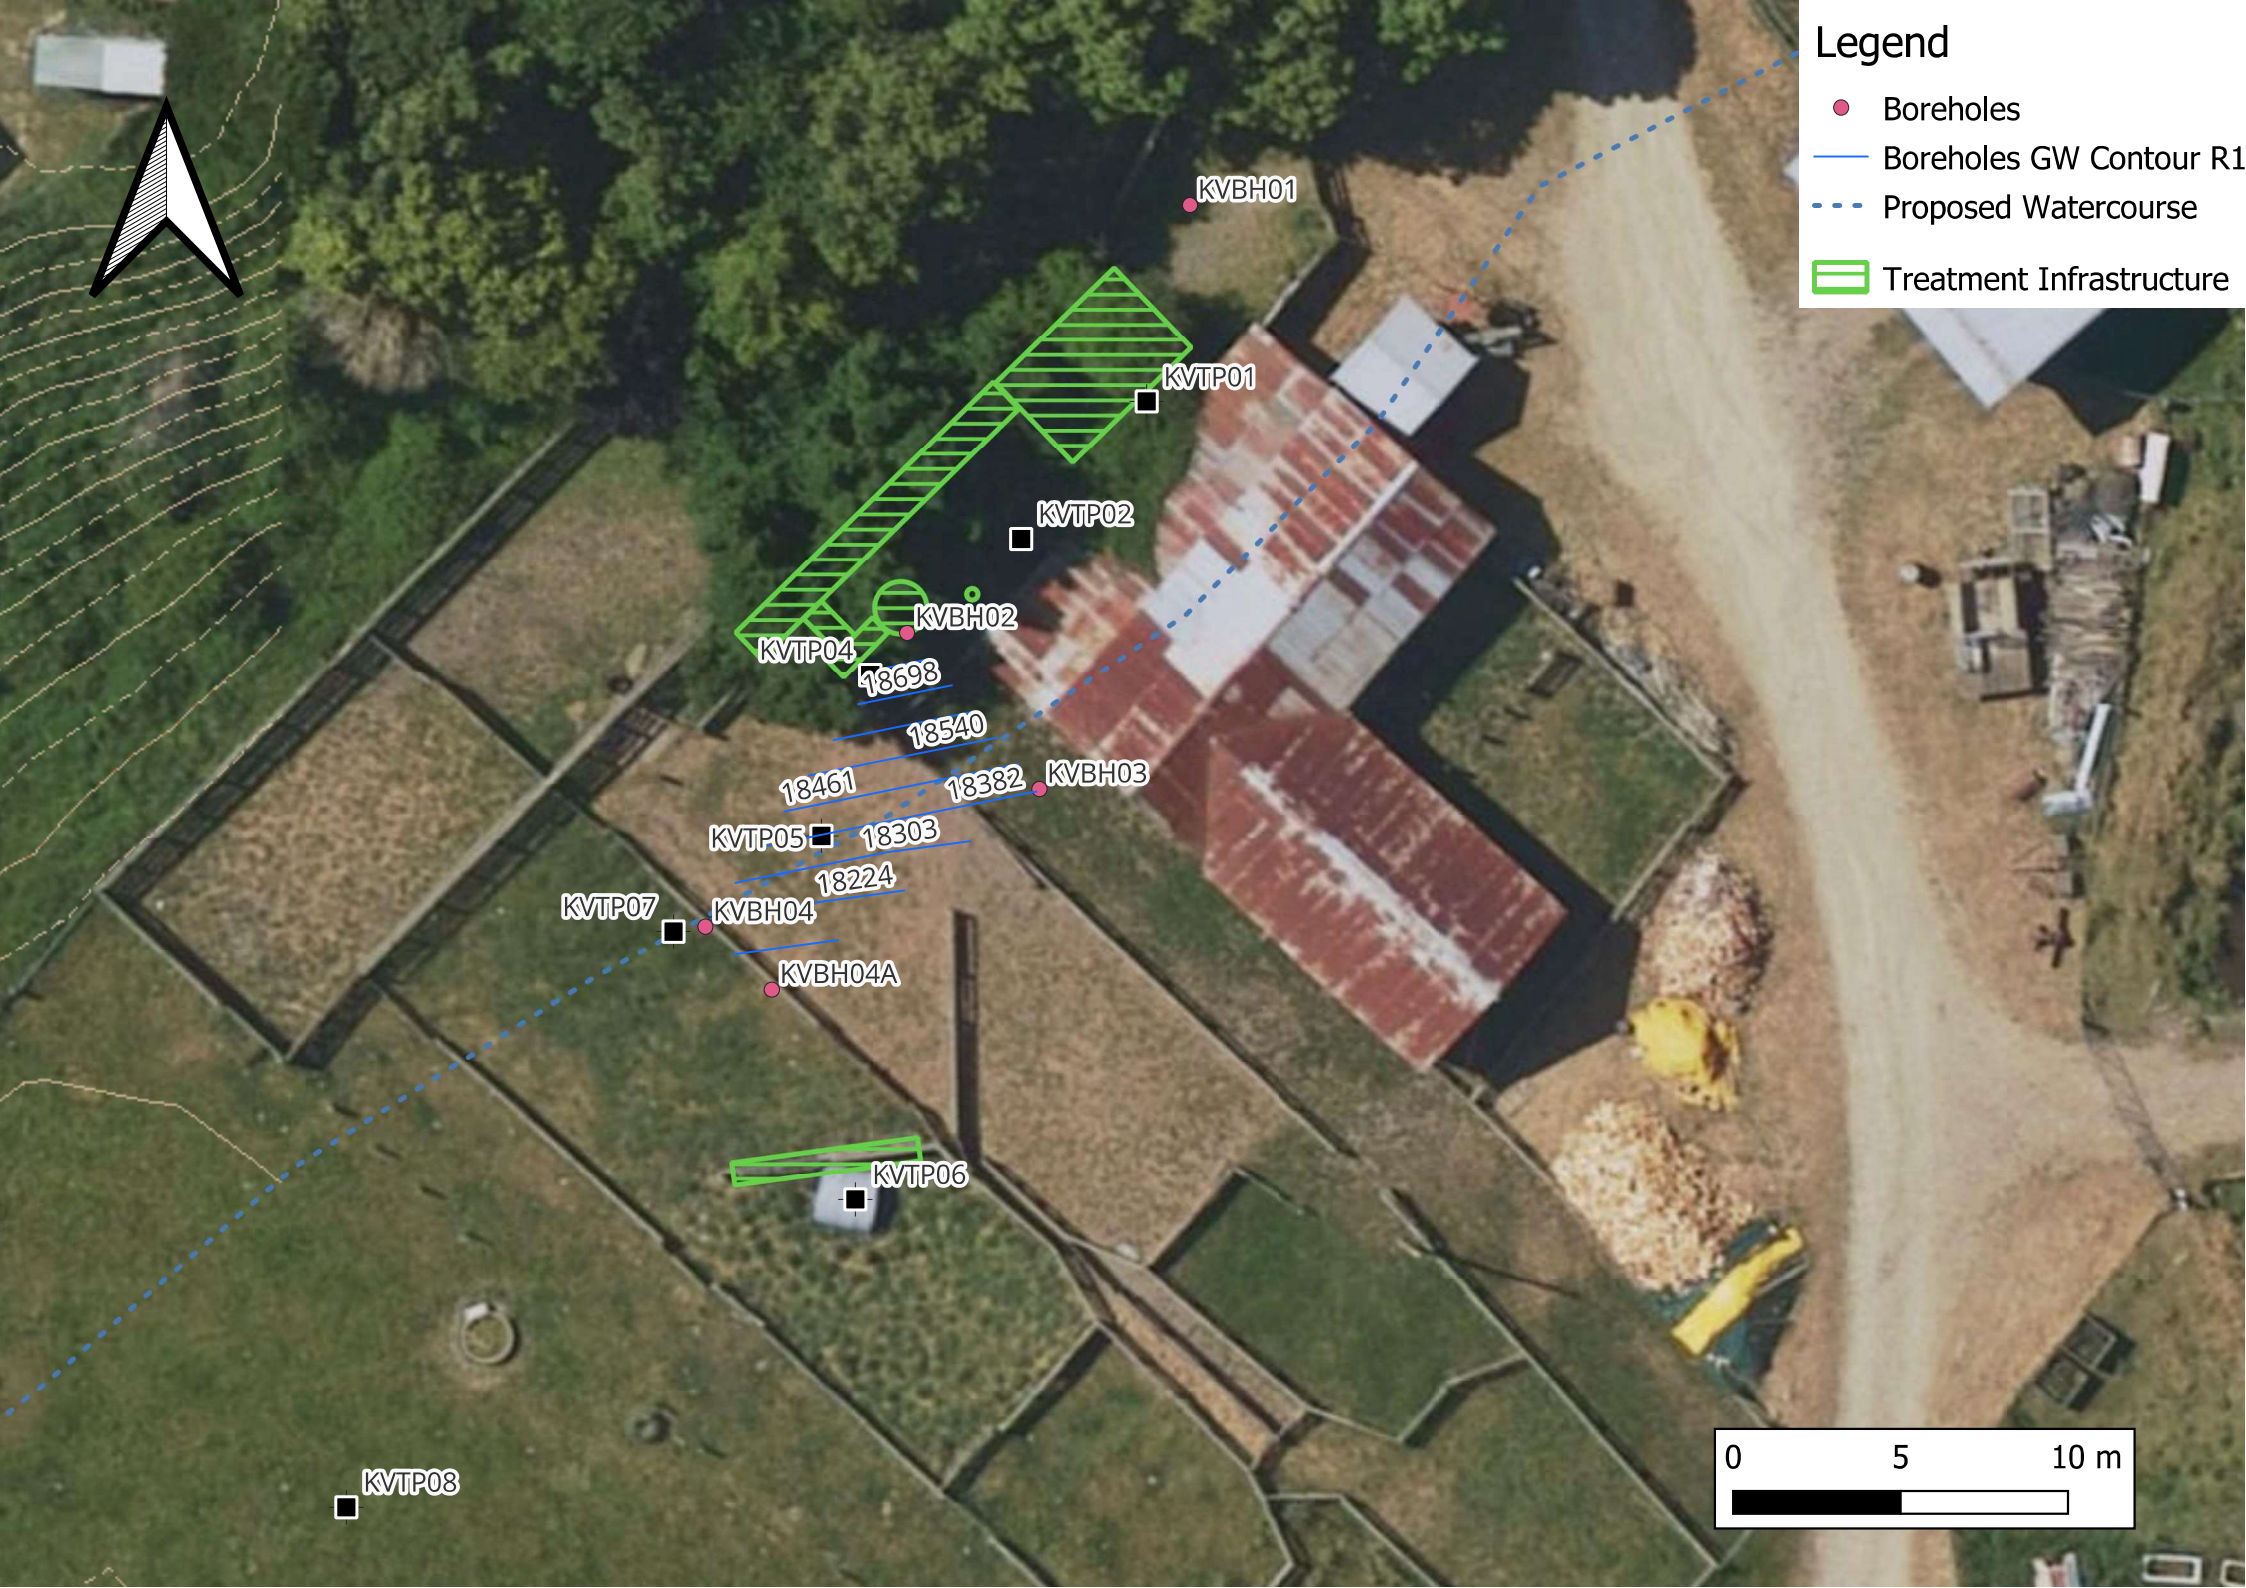
Appendix E – Groundwater Monitoring Data

The piezometers have been monitored to confirm water flow direction. A summary of the monitoring data is presented in Appendix E. The data was collected by Tonkin and Taylor. Given the topography, and water sampling results from the control location, it is considered likely that flow direction is towards the south-southeast. Groundwater contours have been provided and indicate shallow water moves in a southerly/south easterly direction. Groundwater contours are presented in Appendix E.
