## **APPENDIX 3:** Investigation Location Plan

Title: 2025 Test Pit Investigation Plan

| Project:<br>Mt Welcome | Drawn: TV | Appendix No.:<br>3 |

Mt Welcome Development  
422 State Highway 59  
Pukerua Bay, Porirua  
19796.000.002

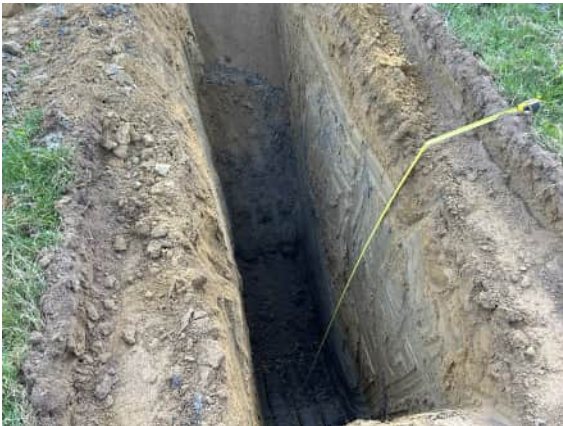
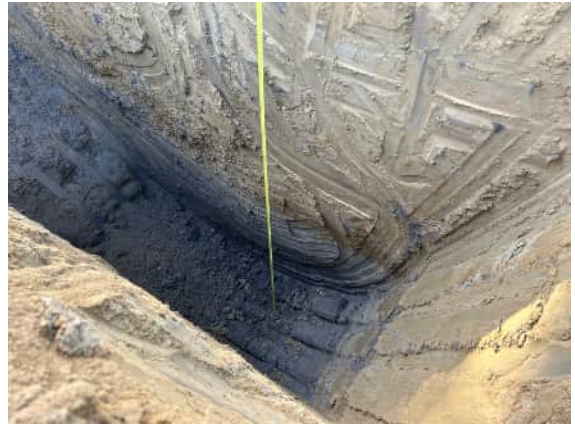
Bucket excavator met target depth at 4.2 m.  
Scala Penetrometer met practical refusal at 2.7 m depth.  
Standing groundwater was not encountered.  
T = Topsoil, M = Moist, W = Wet

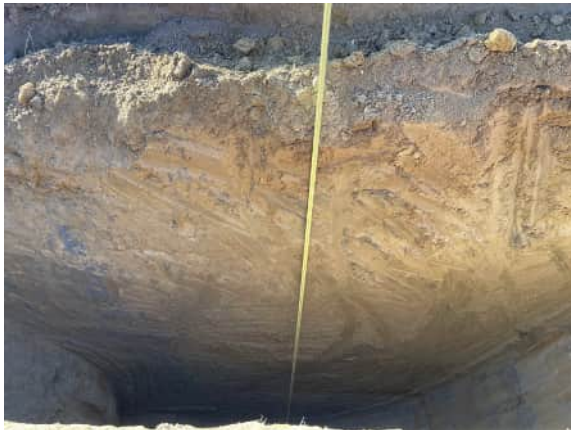
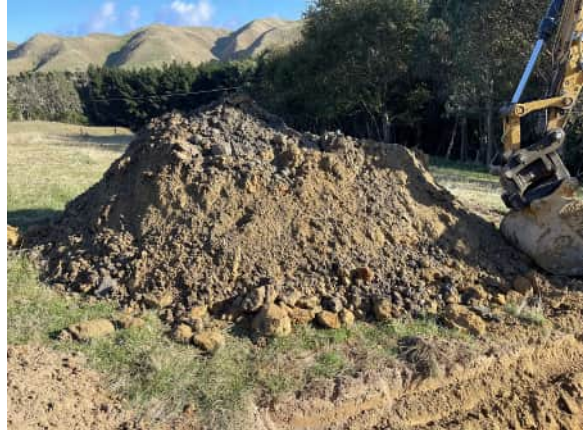
Bucket excavator met target depth at 5.1 m.  
Scala Penetrometer met practical refusal at 3.5 m depth.  
Standing groundwater was not encountered.

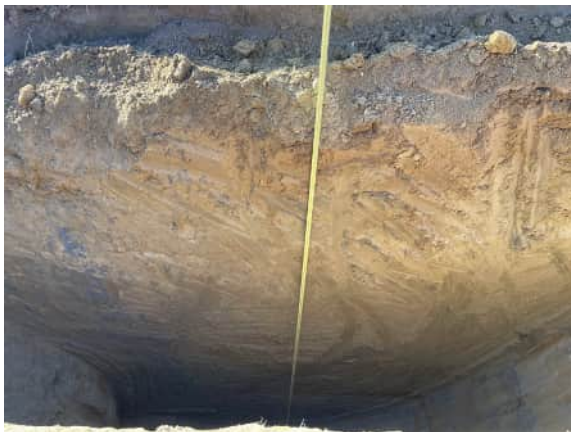
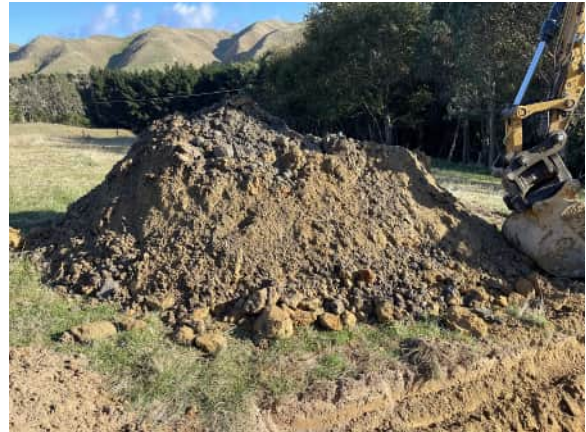
Bucket excavator met target depth at 5.1 m.  
Scala Penetrometer met practical refusal at 3.5 m depth.  
Standing groundwater was not encountered.

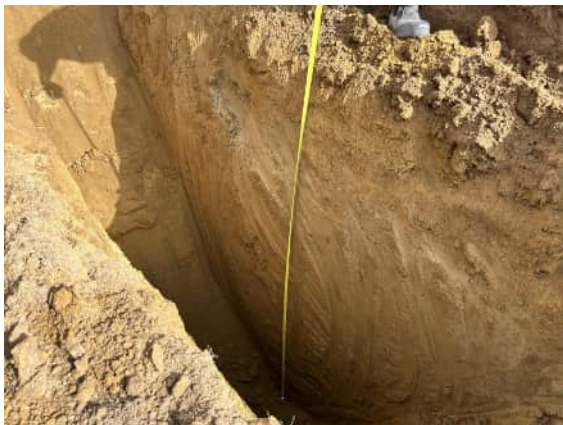
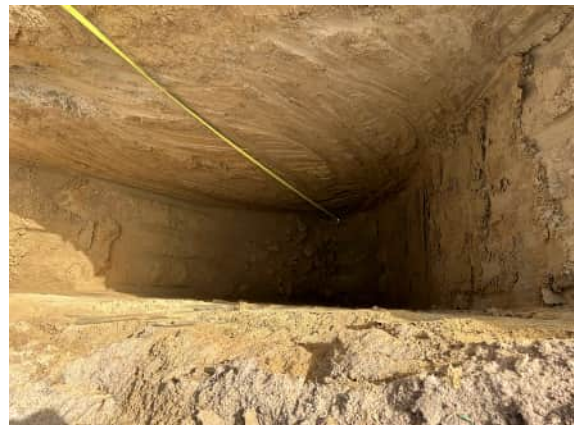
Bucket excavator met target depth at 4 m.  
Scala Penetrometer met practical refusal at 3.3 m depth.  
Standing groundwater was not encountered.  
T = Topsoil, M = Moist

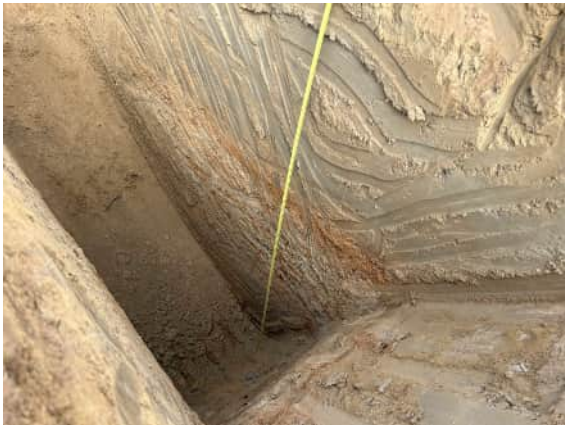
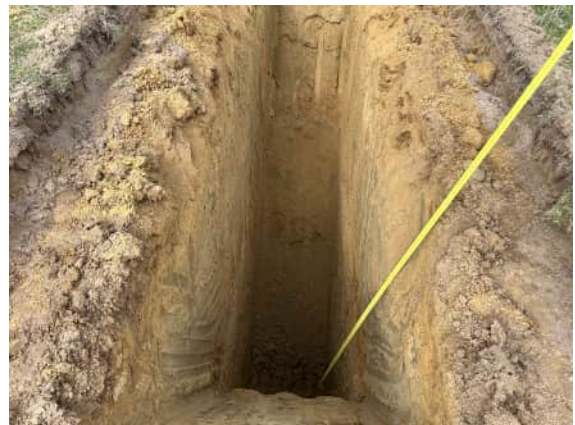
Bucket excavator met target depth at 4.3 m.  
Scala Penetrometer met practical refusal at 2.8 m depth.  
Standing groundwater was not encountered.  
T = Topsoil, M = Moist, W = Wet

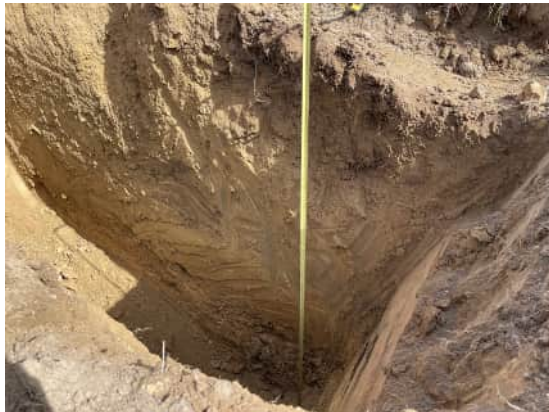
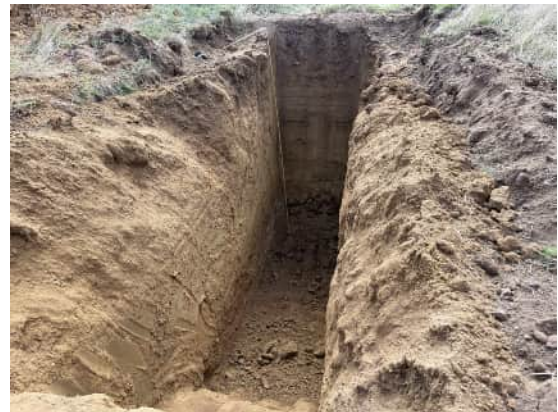
Bucket excavator met target depth at 4 m.  
Scala Penetrometer met practical refusal at 2.5 m depth.  
Standing groundwater was not encountered.  
TS = Topsoil, M = Moist, D = Dry

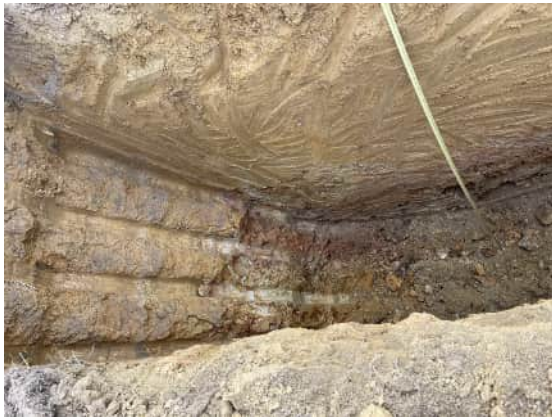
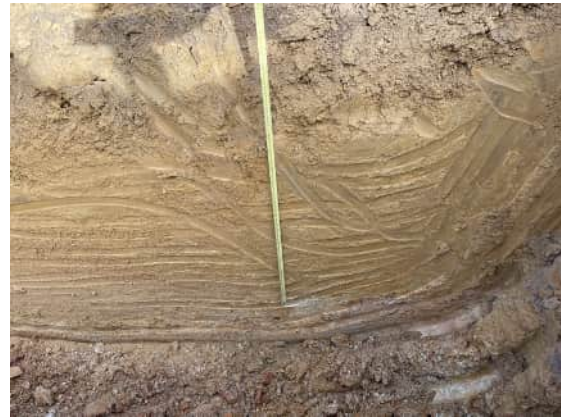
Bucket excavator met target depth at 4 m.  
Scala Penetrometer met practical refusal at 1.8 m depth.  
Standing groundwater was not encountered.  
TS = Topsoil, M = Moist

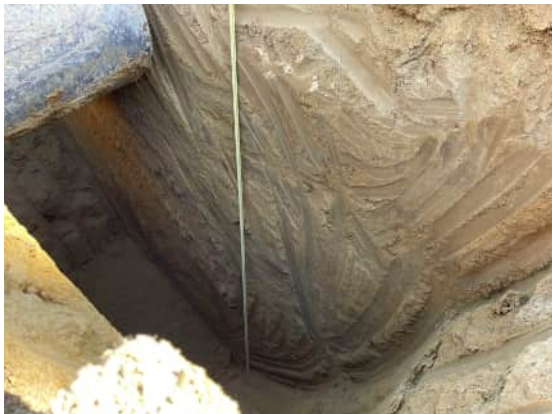
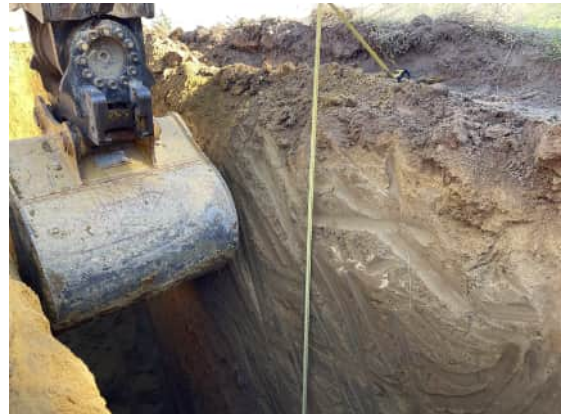
Bucket excavator met target depth at 4.5 m.  
Scala Penetrometer met practical refusal at 2.5 m depth.  
Standing groundwater was not encountered.  
TS = Topsoil, D = Dry, M = Moist

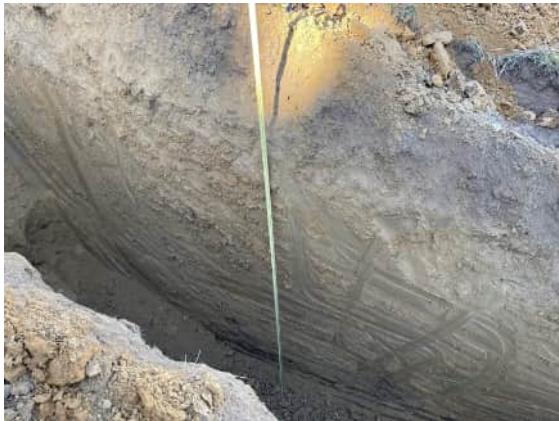
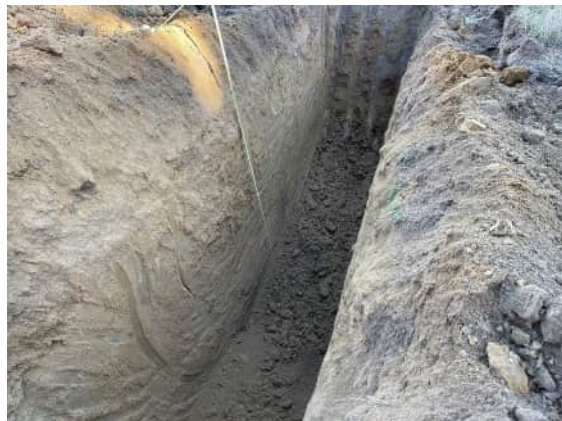
Bucket excavator met target depth at 2.6 m depth on rock.  
Scala Penetrometer met practical refusal at 2.6 m depth.  
Standing groundwater was not encountered.

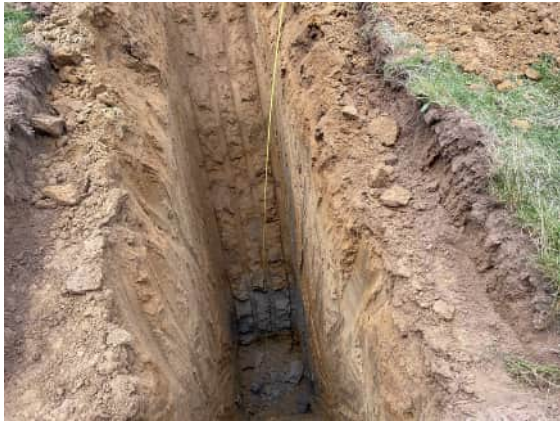
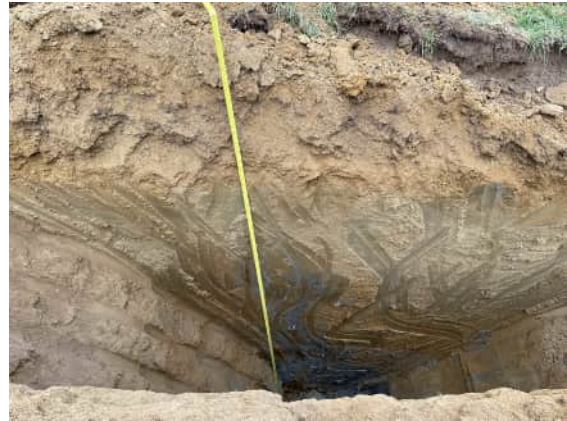
Bucket excavator met target depth at 5.1 m.  
Scala Penetrometer met practical refusal at 3.9 m depth.  
Standing groundwater was not encountered.  
TS = Topsoil, GWS = Greywacke Sandstone, L/A = Lacustrine/Alluvium, C = Colluvium D = Dry, M = Moist, W = Wet

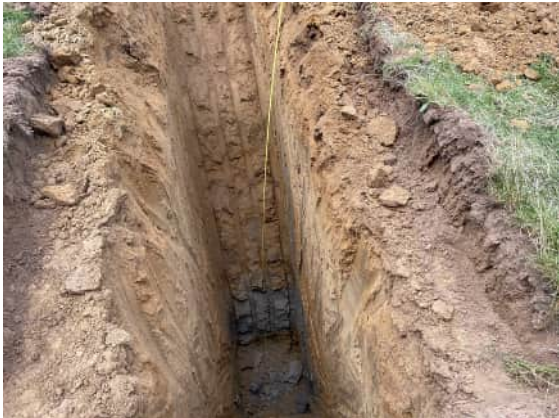
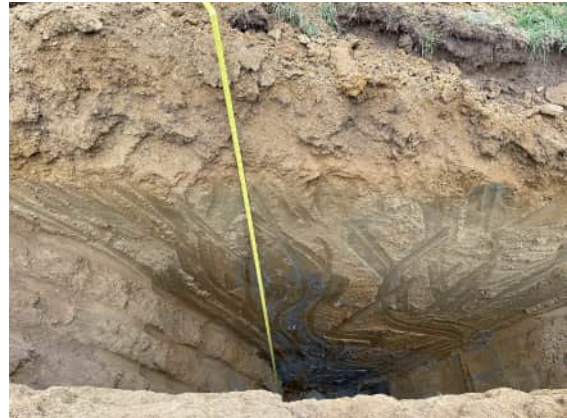
Bucket excavator met target depth at 5.1 m.  
Scala Penetrometer met practical refusal at 3.9 m depth.  
Standing groundwater was not encountered.  
TS = Topsoil, GWS = Greywacke Sandstone, L/A = Lacustrine/Alluvium, C = Colluvium D = Dry, M = Moist, W = Wet

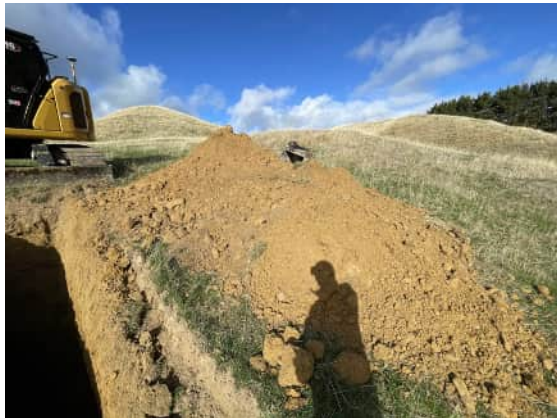
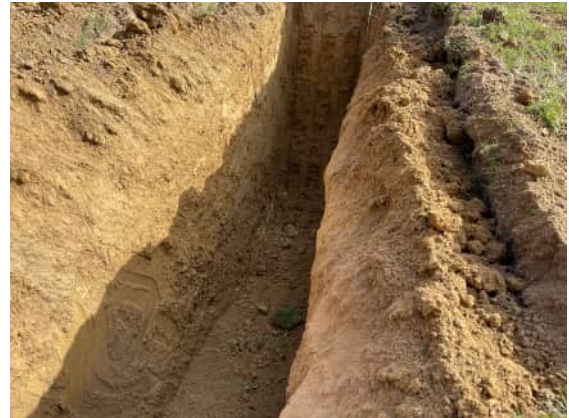
Bucket excavator met target depth at 2.9 m depth on rock.  
Scala Penetrometer met practical refusal at 1.6 m depth.  
Standing groundwater was not encountered.

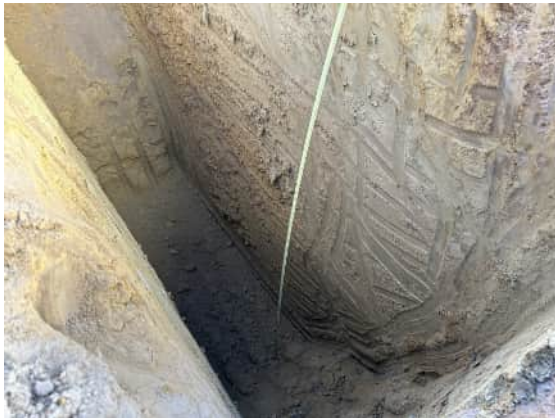
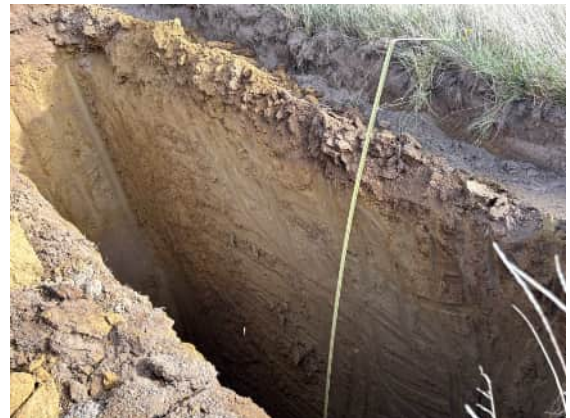
Bucket excavator met target depth at 4.3 m.  
Scala Penetrometer met practical refusal at 2.7 m depth.  
Standing groundwater was not encountered.

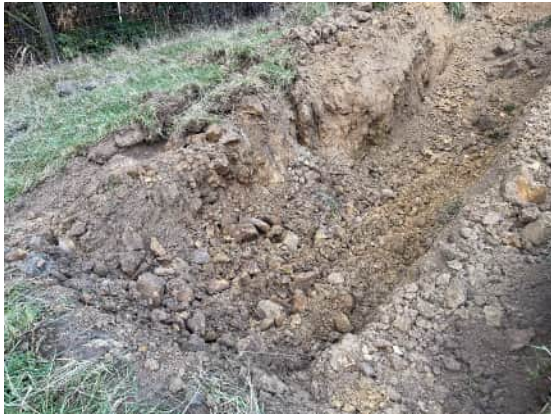
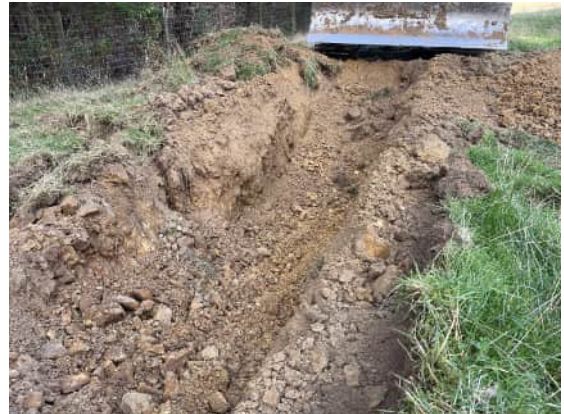
Bucket excavator met target depth at 0.3 m depth on rock.

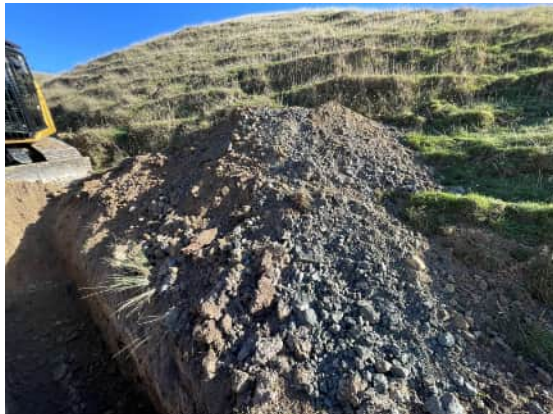
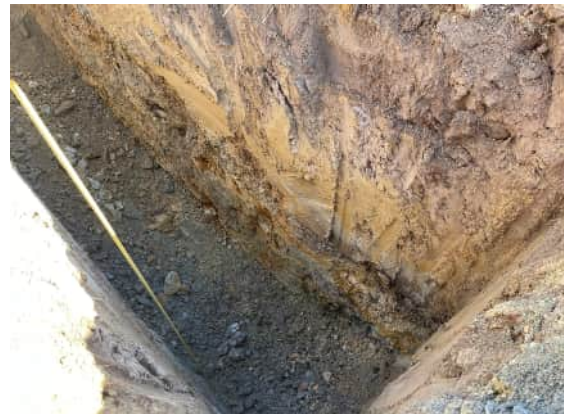
Bucket excavator met target depth at 2.8 m depth on rock.  
Scala Penetrometer met practical refusal at 1.7 m depth.  
Standing groundwater was not encountered.

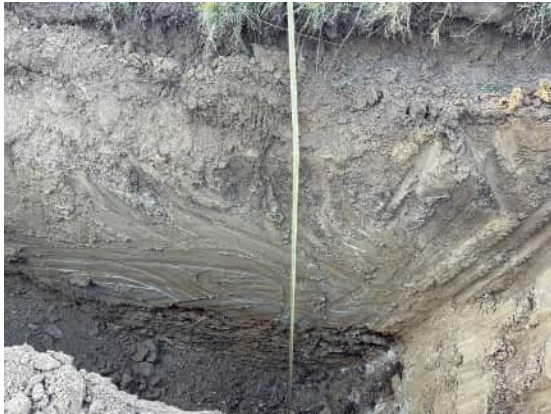
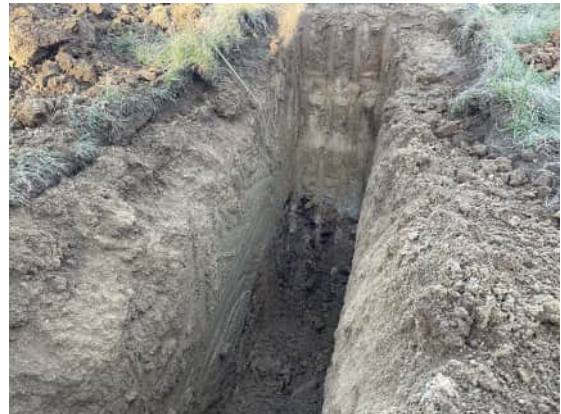
Bucket excavator met target depth at 2.8 m depth on rock.  
Scala Penetrometer met practical refusal at 2.5 m depth.  
Standing groundwater was not encountered.

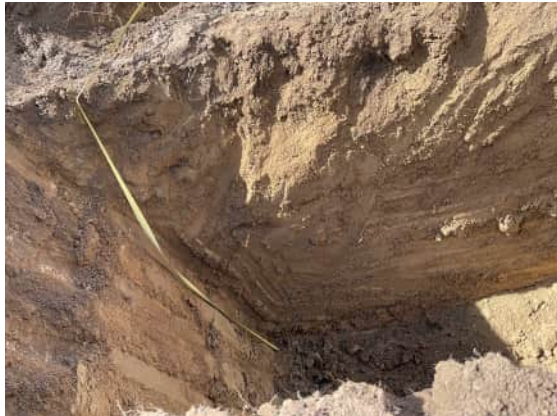
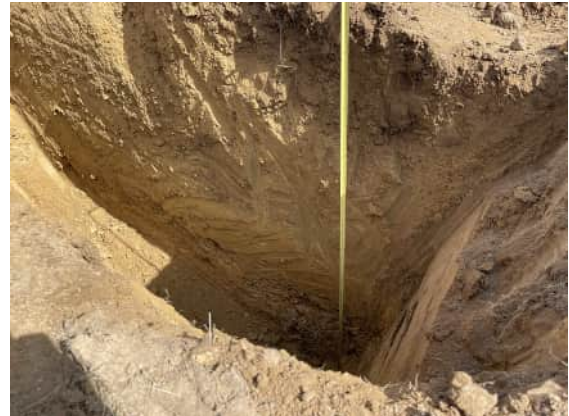
Bucket excavator met target depth at 2.9 m depth on rock.  
Scala Penetrometer met practical refusal at 2.7 m depth.  
Standing groundwater was not encountered.

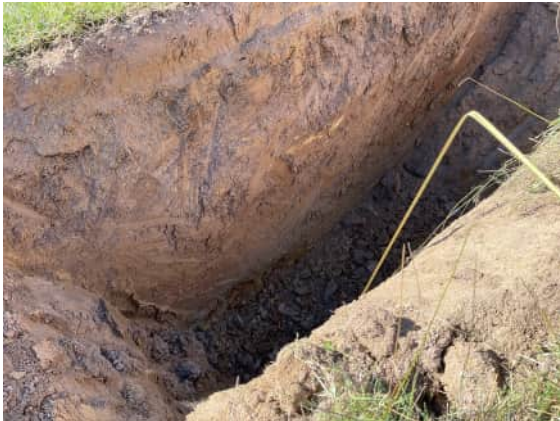
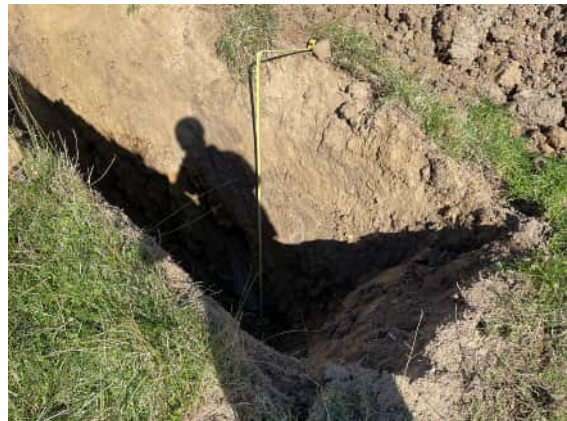
Bucket excavator met target depth at 2.5 m depth on rock.  
Scala Penetrometer met practical refusal at 2.8 m depth.  
Standing groundwater was not encountered.

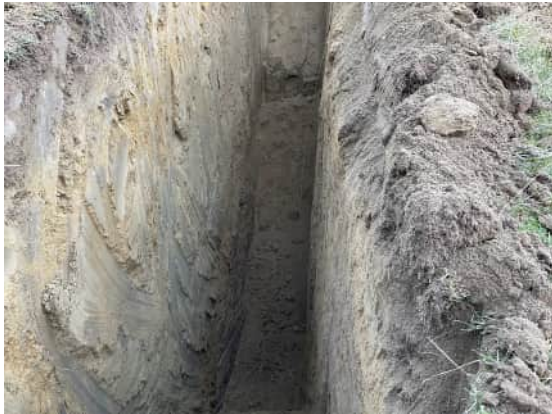
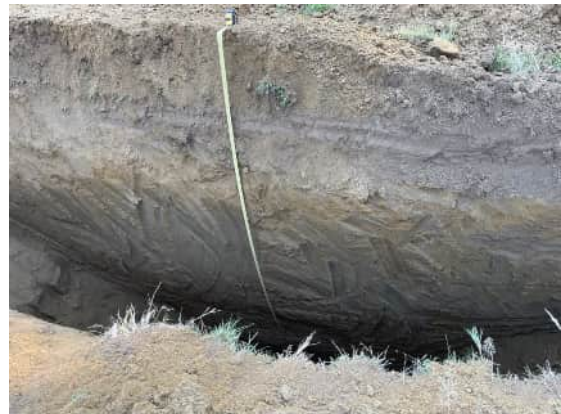
Bucket excavator met target depth at 4.7 m.  
Scala Penetrometer met practical refusal at 2.8 m depth.  
Standing groundwater was not encountered.  
TS = Topsoil, GWS = Greywacke Sandstone, D = Dry, M = Moist

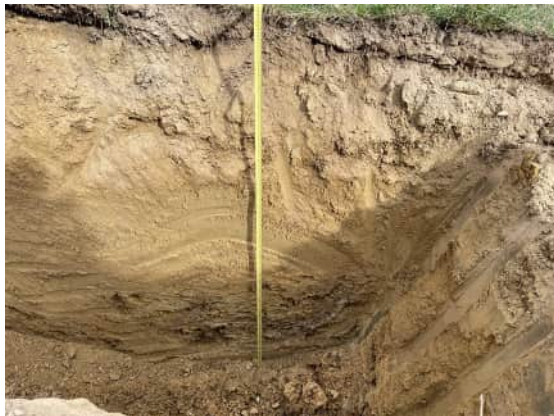
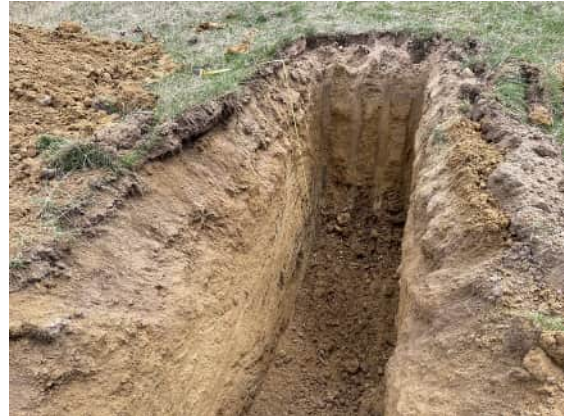
Bucket excavator met target depth at 2 m depth on rock.  
Scala Penetrometer met practical refusal at 2.1 m depth.  
Standing groundwater was not encountered.  
TS = Topsoil, GWS = Greywacke Sandstone, D = Dry

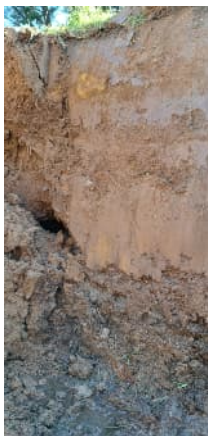
Testpit met target depth at 2.4 m.  
Scala Penetrometer met practical refusal at 1.9 m depth.  
GS - Greywacke sandstone  
West most side of TP

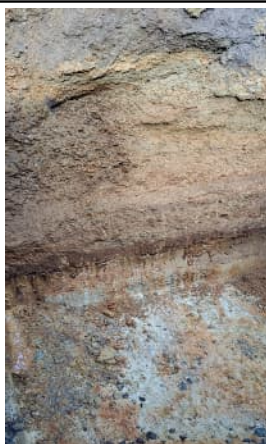
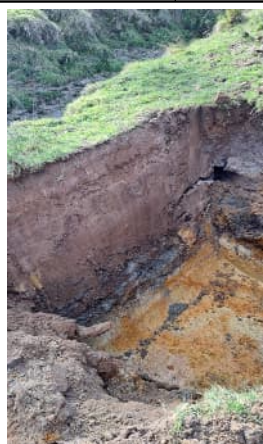
Testpit met target depth at 2.4 m.  
Scala Penetrometer met practical refusal at 1.9 m depth.  
GS - Greywacke sandstone  
East most side of TP

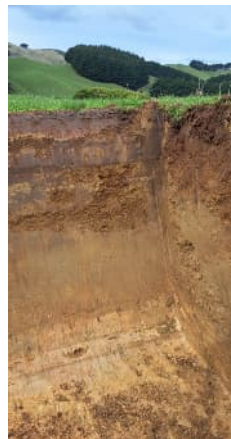
Testpit met target depth at 1.4 m.  
Scala Penetrometer met practical refusal at 1.2 m depth.  
GS - Greywacke sandstone

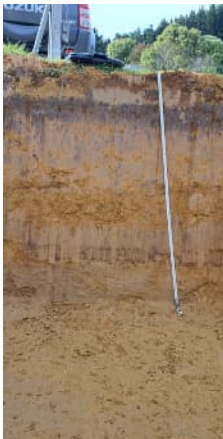
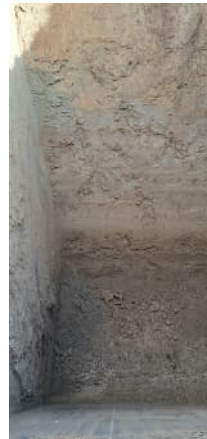
Testpit met target depth at 4 m.  
Scala Penetrometer met practical refusal at 3.5 m depth.

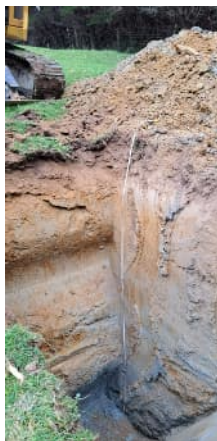
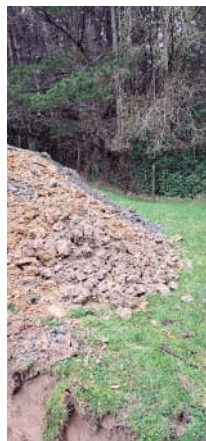
Testpit met target depth at 4 m.  
Scala Penetrometer met target depth at 3.9 m.  
TS = Topsoil, DS = Dune sands

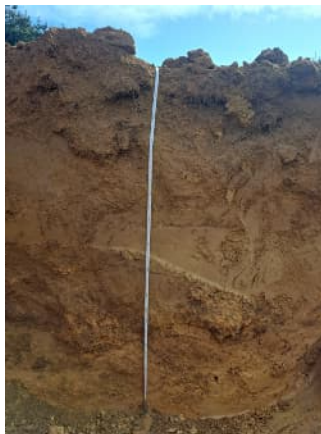
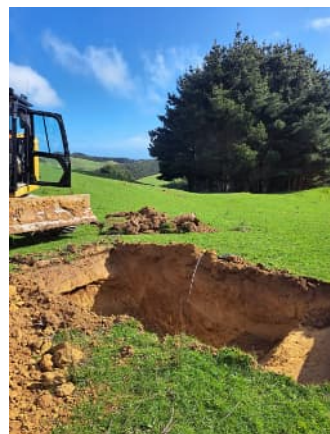
## LOG OF TEST PIT TP25

Testpit met target depth at 1.4 m.  
Scala Penetrometer met practical refusal at 1.1 m depth.  
GS - Greywacke sandstone

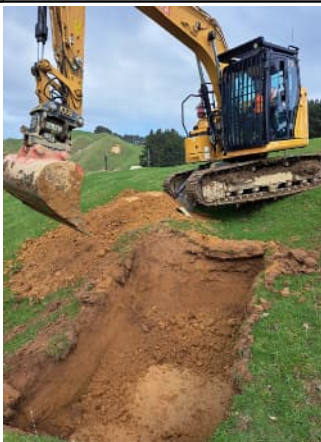
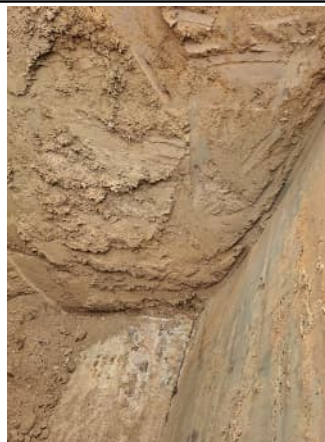
Testpit met target depth at 3.4 m.  
Scala Penetrometer met practical refusal at 3.2 m depth.  
GS - Greywacke sandstone

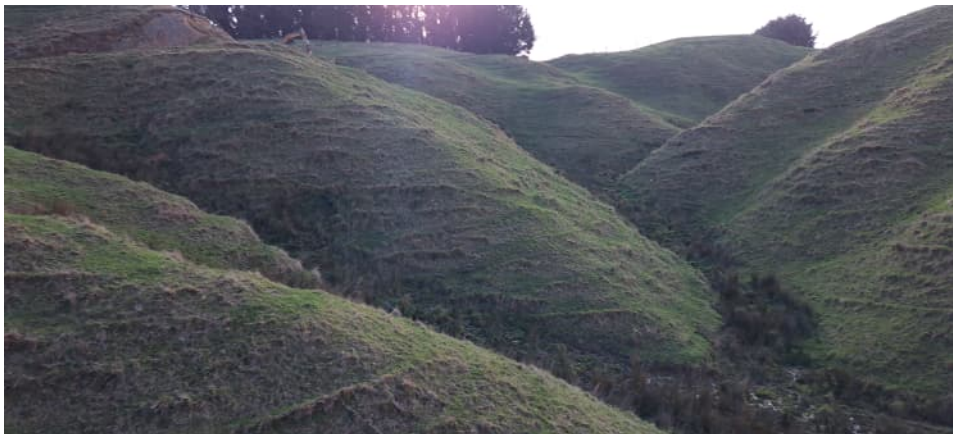
Scala Penetrometer met practical refusal at 2.5 m depth.

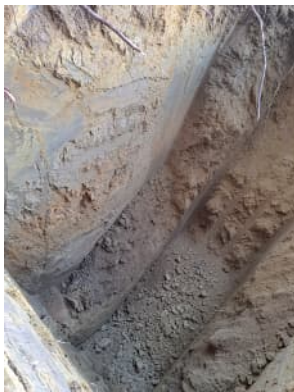
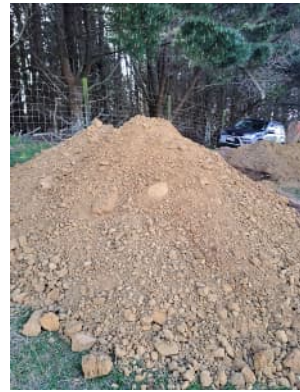
Testpit met target depth at 4 m.  
Scala Penetrometer met practical refusal at 3.2 m depth.  
RS = Residual soil

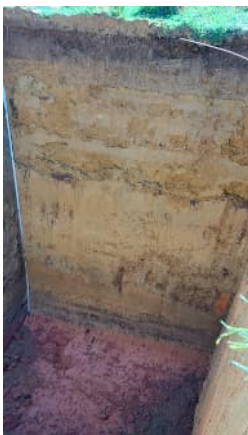
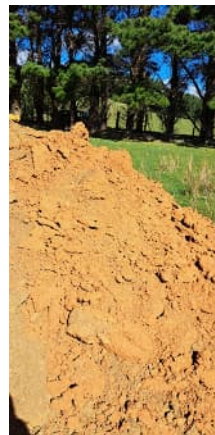
Testpit met target depth at 4 m.  
Scala Penetrometer met practical refusal at 3.7 m depth.  
TS = Topsoil

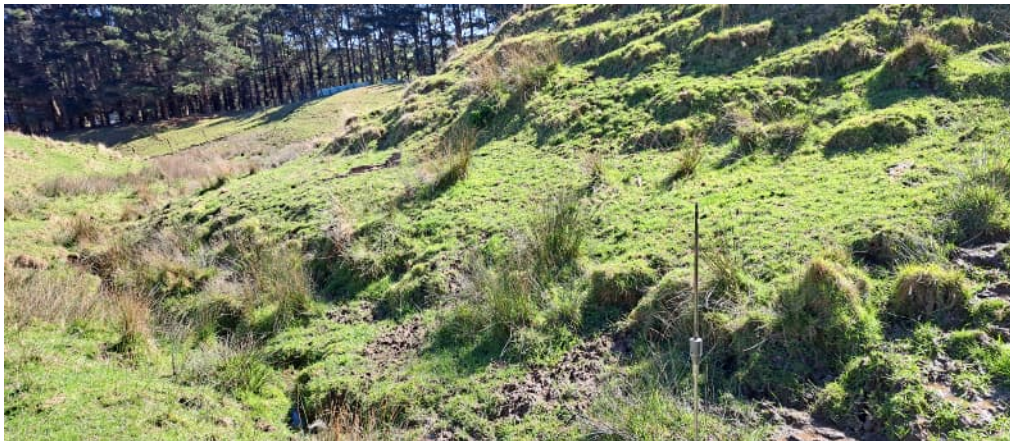
Scala Penetrometer met practical refusal at 1.2 m depth.

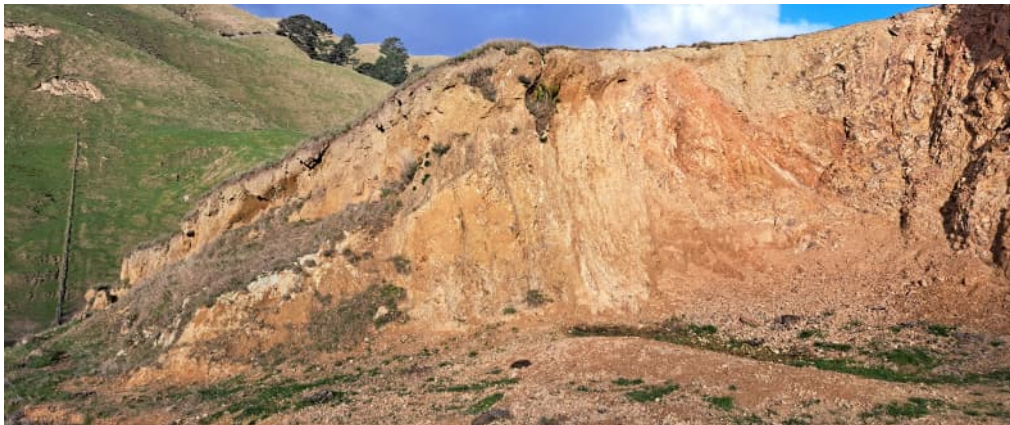
Scala Penetrometer met practical refusal at 2.9 m depth.

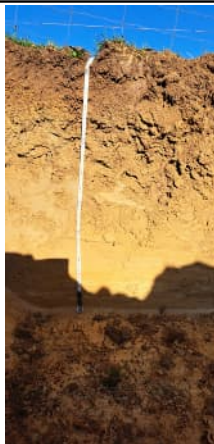
# LOG OF TEST PIT TP32

Testpit met target depth at 0.9 m.  
 Scala Penetrometer met practical refusal at 1.8 m depth.  
 TS = Topsoil, RS = Residual Soil, GS = Greywacke sandstone

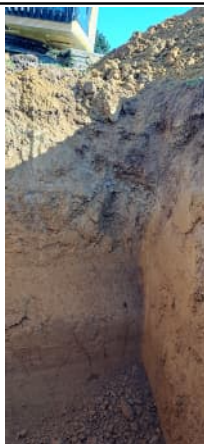
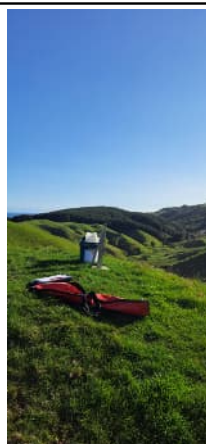
Testpit met target depth at 2.5 m.  
Scala Penetrometer met practical refusal at 2.5 m depth.  
GS - Greywacke sandstone

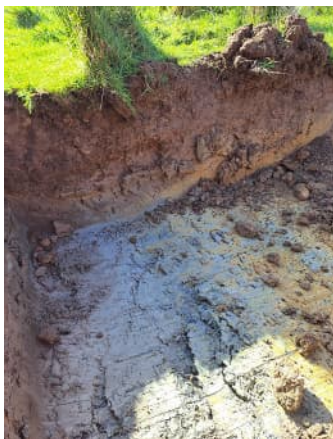
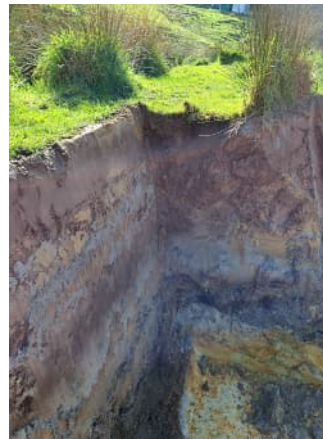
Hand auger met practical refusal at 2.5 m.  
Scala Penetrometer met practical refusal at 1.6 m depth.  
GS - Greywacke sandstone

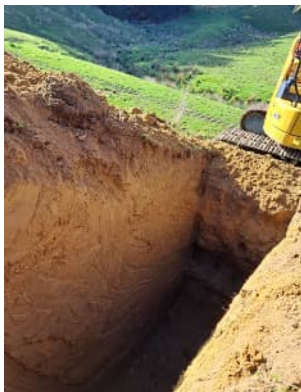
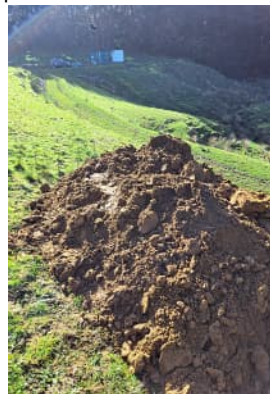
Testpit met target depth at 4 m.  
Scala Penetrometer met target depth at 3.9 m.

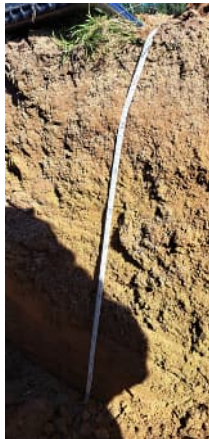
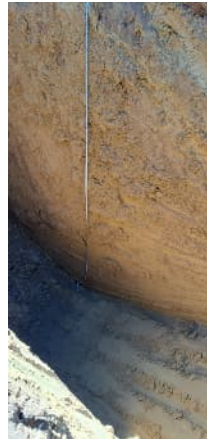
Hand auger met target depth at 4 m.  
Scala Penetrometer met practical refusal at 3.8 m depth.  
GS - Greywacke sandstone

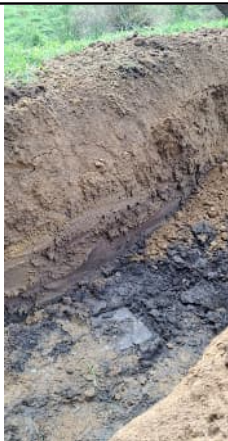
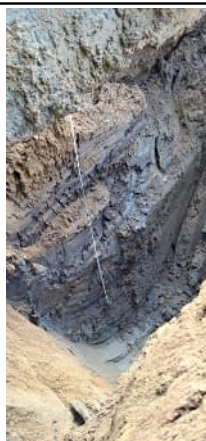
Testpit met target depth at 4.2 m.  
Scala Penetrometer met target depth at 3.9 m.  
BTS = Buried topsoil

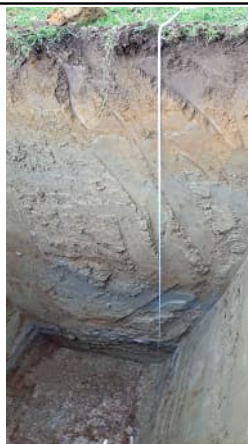
Testpit met target depth at 4 m.  
Scala Penetrometer met practical refusal at 2.8 m depth.

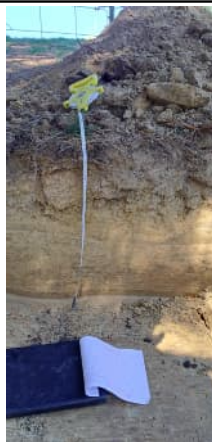
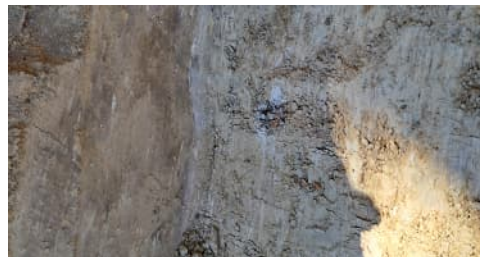
Testpit met target depth at 0.8 m.  
Scala Penetrometer met practical refusal at 0.6 m depth.  
TS = Topsoil, L/C = Loess/colluvium. GS - Greywacke sandstone
