## Geological Cross-Section & Slope Stability Analysis

122 Morven Ferry Road,  
Arrow Junction

**SLOPE STABILITY TRANSECT LINES  
LOCATION PLAN**

## SLOPE STABILITY SETBACK ANALYSIS

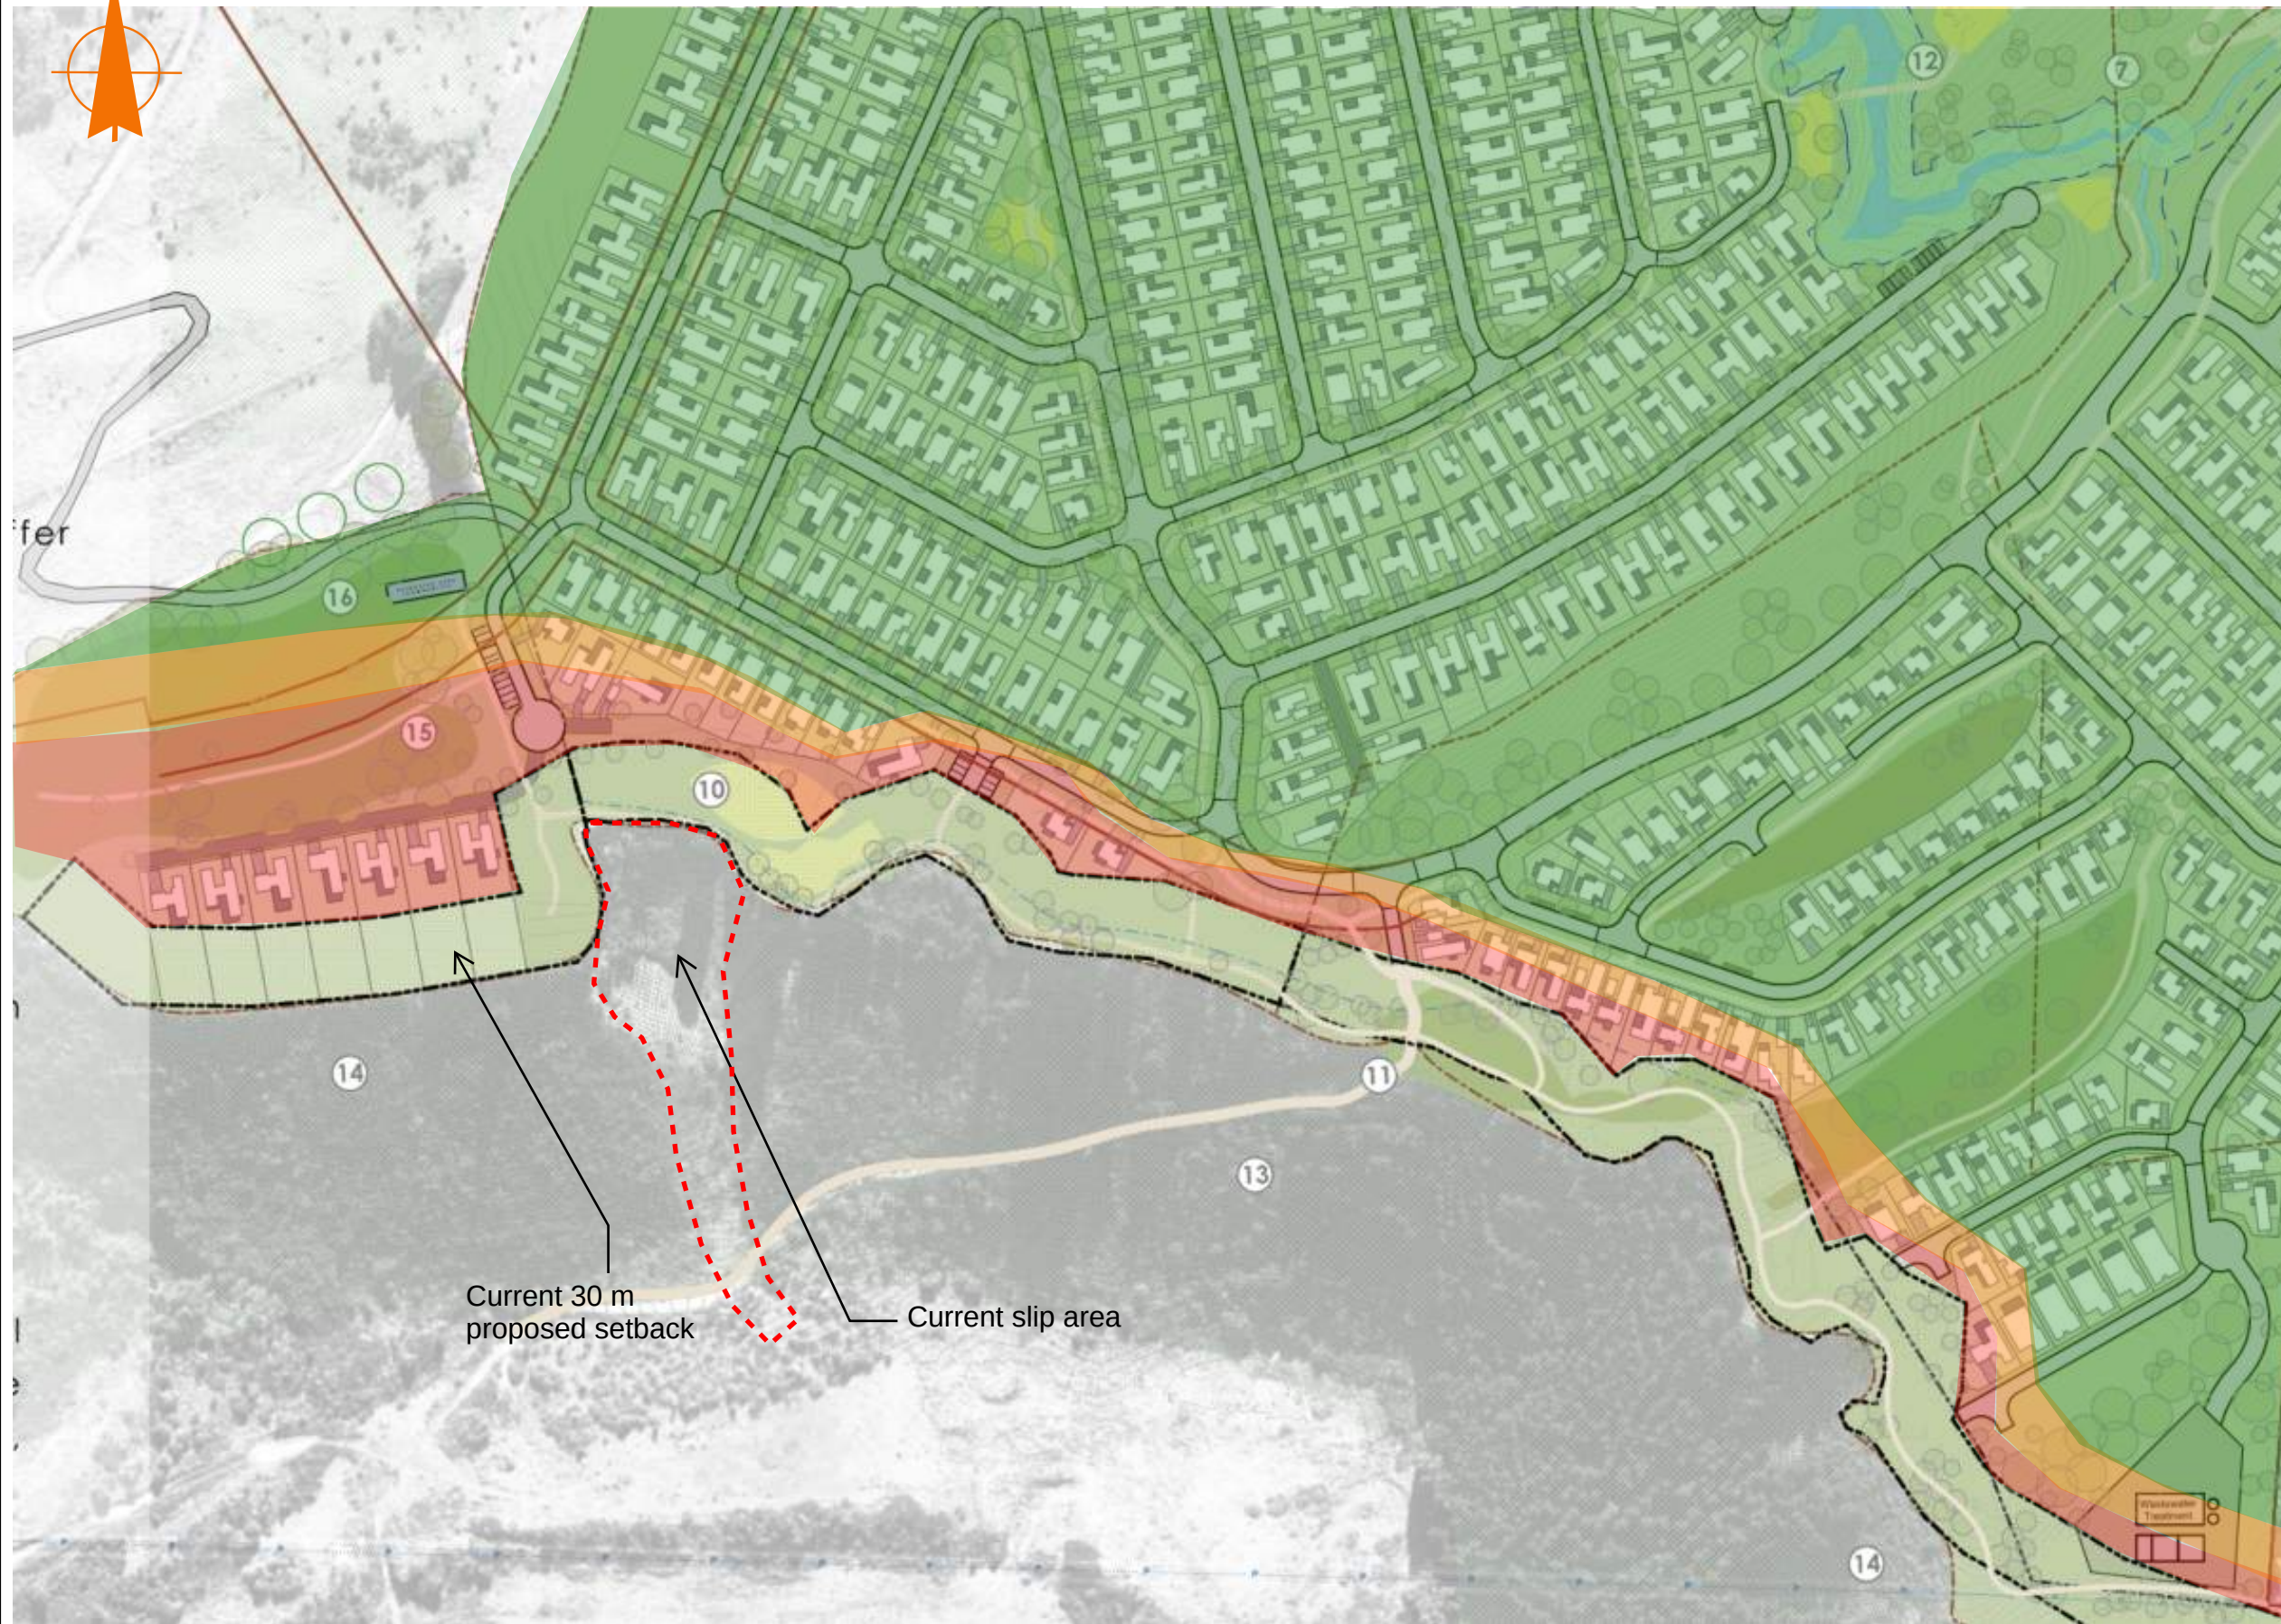
- Areas Meeting Minimum Factor of Safety (ULS)
- Areas that may meet Minimum Factor of Safety with Additional Investigation
- Areas that may meet Minimum Factor of Safety with Additional Investigation and In-ground Slope Remediation (ULS)

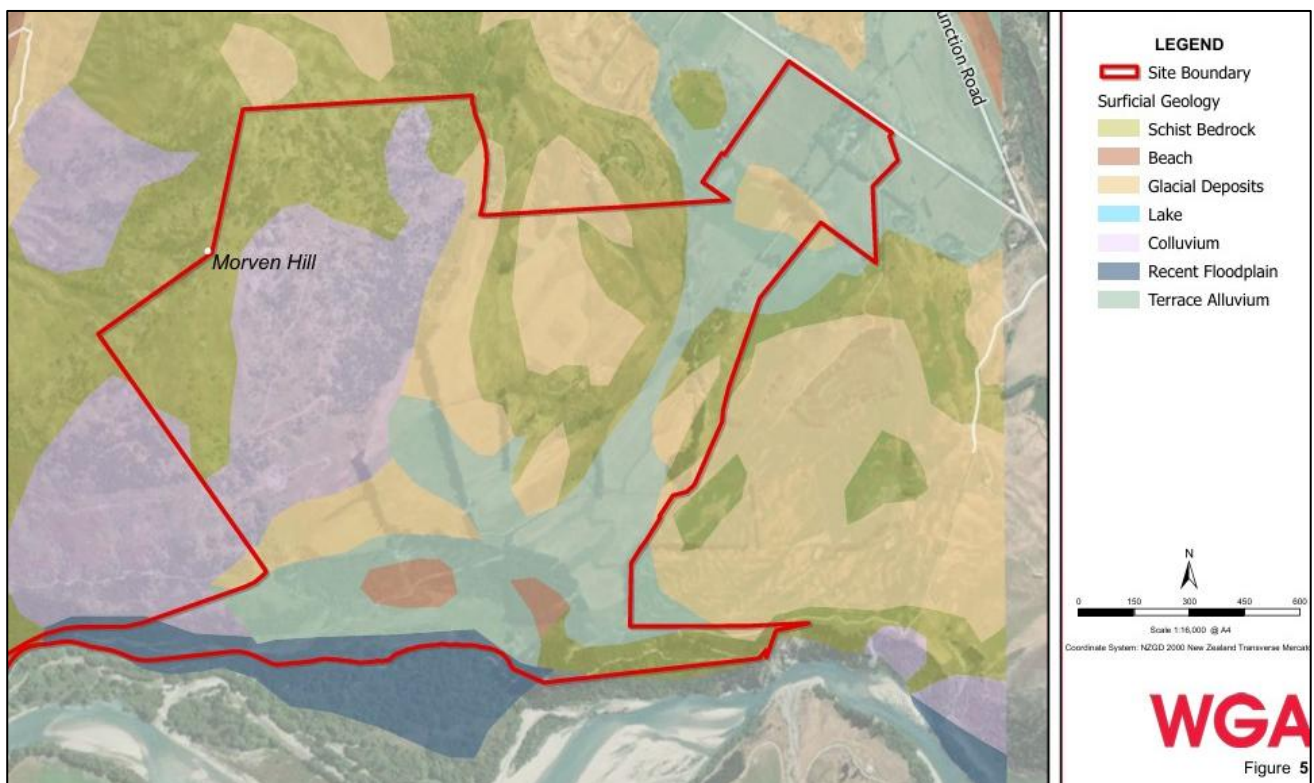
The email mentioned above, included a map of inferred superficial soil profile (Figure 1). This was reviewed prior to the site investigation. The map estimated a thin colluvium soil profile overlying the basement schist bedrock on the disposal site, with exposed schist areas at the top of the ridgeline of Morven Hill, and colluvium layers down near the toe areas.

**Figure 1: WGA inferred superficial geology map (Source: WGA, 2026 – provided via email)**

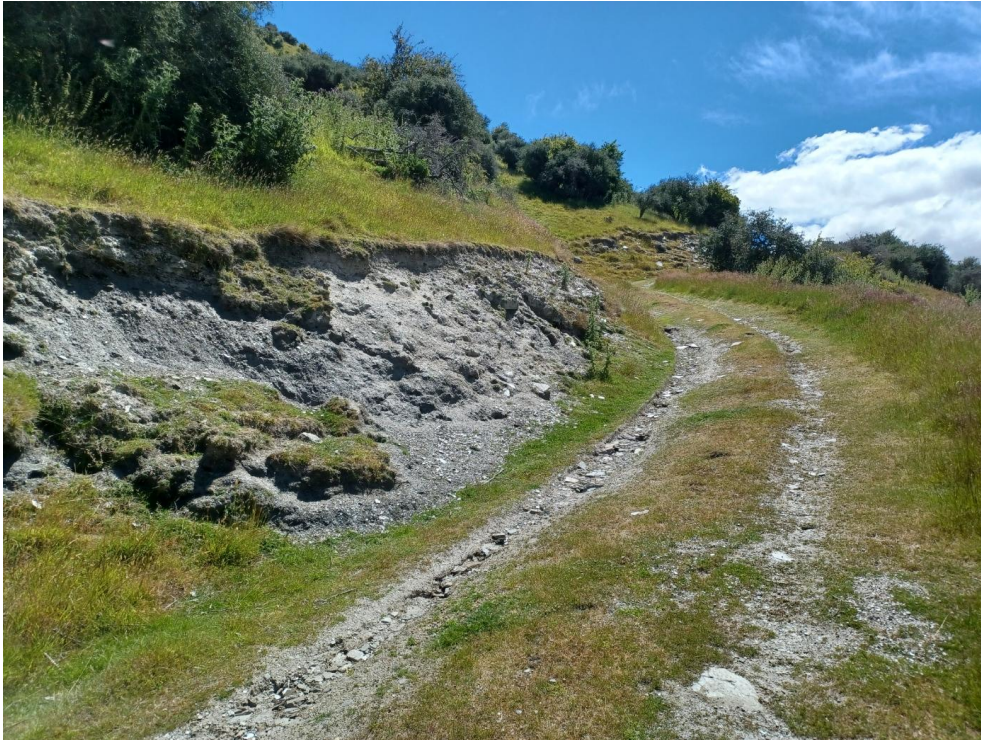
*Photograph 2: Overburden soil profiles exposed within the road batters.*

Photographs and a visual investigation of exposed cuts along the road as well as shallow slip scarps, indicated that the soil profile may be up to 1.0 m in certain areas on the lower half of Morven Hill consisting of silt-natured material overlying completely to highly weathered schist rock. The top 0.5 m was sighted to consist of silt material in these exposed scarp areas. The slips were prominent in areas of steep road batters and some other weathered cliff areas, but no evidence was noted to indicate this was a prominent occurrence.

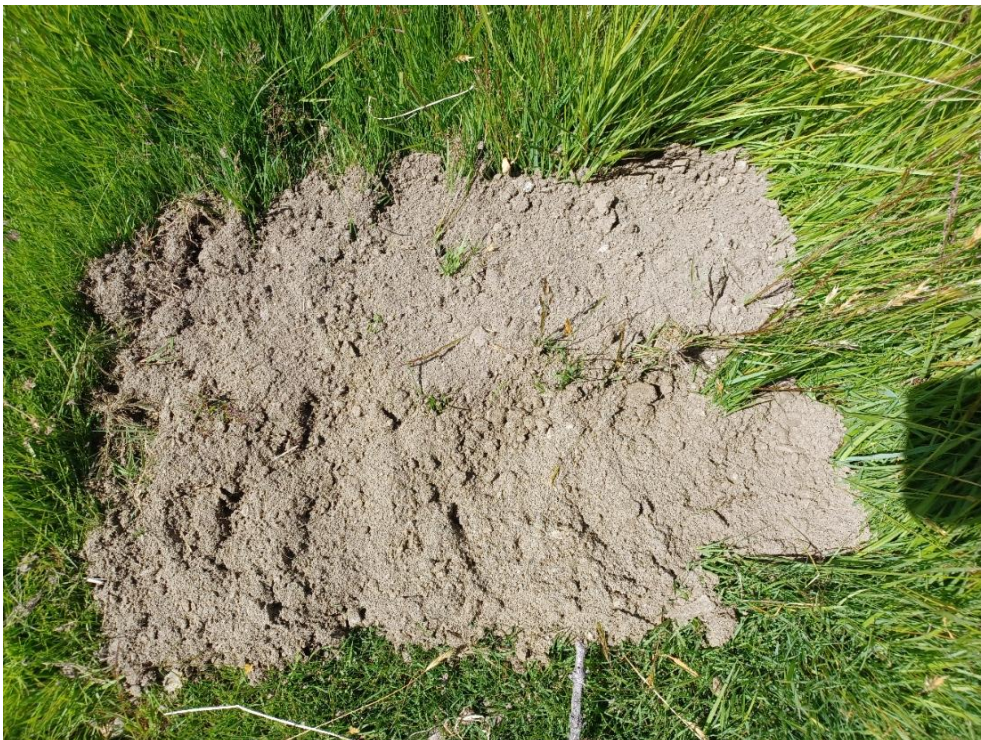
*Photograph 3: Soil recovered from the wastewater hand augers.*
