# Beachlands South Fast-Track Application

## Desktop Ground Contamination Investigation

**Prepared by:** Tonkin & Taylor Ltd

**Job Number:** 1014358.3200 v3

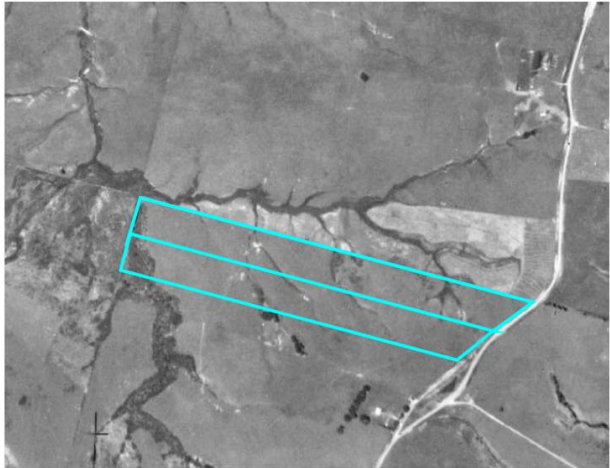
| Aerial photograph<br>(date and source) | Key points identified | Photograph |
|---|---|---|
| 1940s<br>(Auckland Council Geomaps) | <p>The Site and surrounding land is largely pastoral. Some overland flow paths are observed within the Site and appear to be within natural gullies on Site.</p> <p>A watercourse is present immediately to the north and what appears to be an unsealed road is present along the eastern boundary of the Site.</p> | |

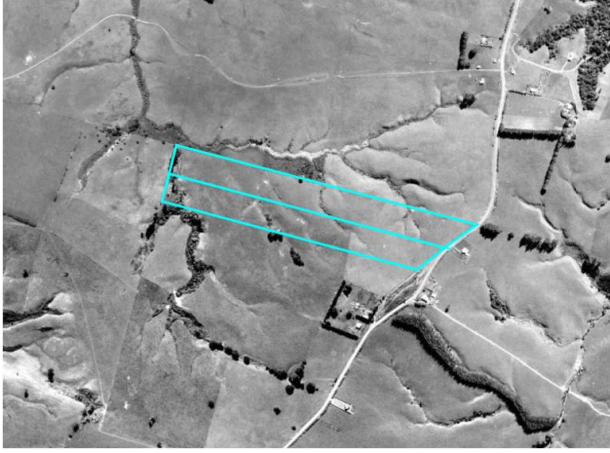
| Aerial photograph<br>(date and source) | Key points identified | Photograph |
|---|---|---|
| 1950s<br>(Auckland Council Geomaps) | <p>The Site appears to be relatively unchanged.</p> <p>Some rural residential properties appear on land to the north, south and east of the Site.</p> | |

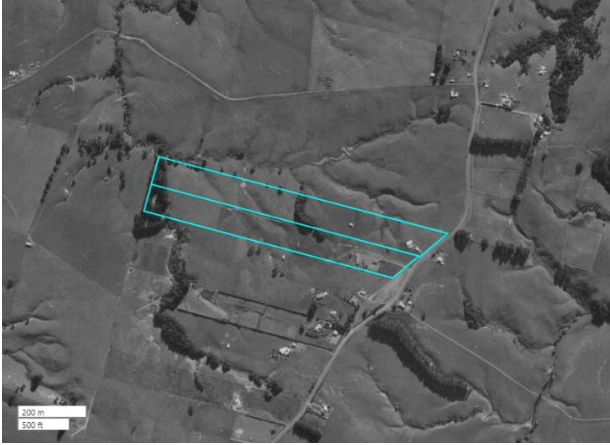
| Aerial photograph<br>(date and source) | Key points identified | Photograph |
|---|---|---|
| 1975<br>(Retrolens) | <p>The Site is currently used for rural residential purposes and residential-style dwellings are present in the eastern portion of the Site, with access to the road.</p> <p>The surrounding land use appears to be relatively unchanged since the 1950s aerial. Some additional rural residential-style properties have been added to the north and south and some properties to the north appear to contain fenced paddocks.</p> | |

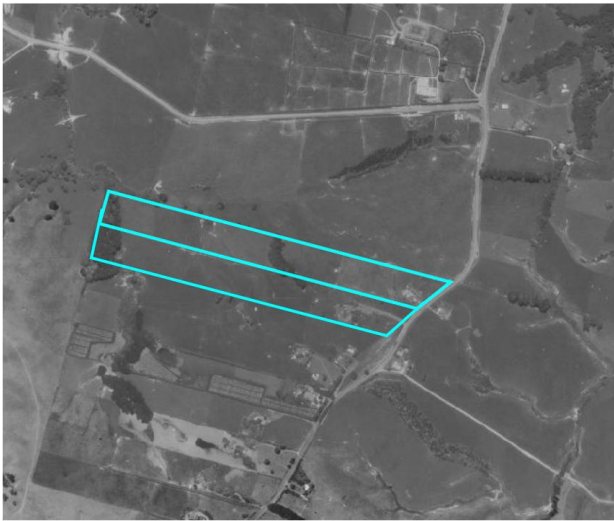
| Aerial photograph<br>(date and source) | Key points identified | Photograph |
|---|---|---|
| 1980s<br>(Auckland Council Geomaps) | <p>Some areas of ground disturbance are visible within the Site.</p> <p>Additional rural residential-style properties to the south have been established.</p> <p>One property to the south appears to have market gardens / orchards established. Subdivision of land further north appears to be underway.</p> | |

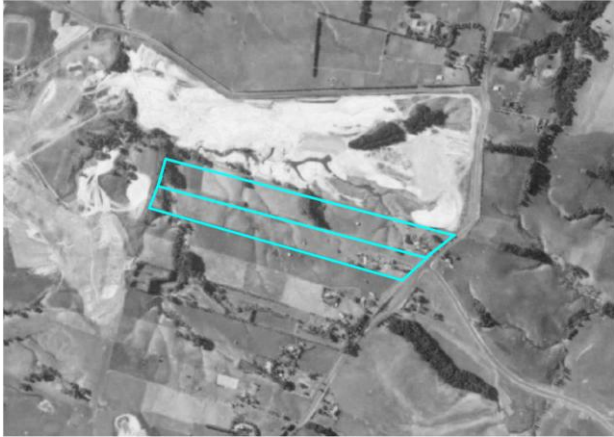
| Aerial photograph<br>(date and source) | Key points identified | Photograph |
|---|---|---|
| 1990s<br>(Auckland Council Geomaps) | <p>The Site appears to be unchanged.</p> <p>Market gardens / orchard activities on a property to the south appear to have ceased.</p> <p>The land immediately north of the Site is undergoing earthwork.</p> | |

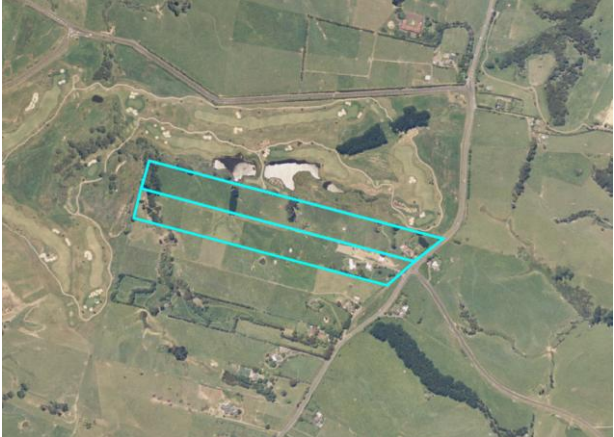
| Aerial photograph<br>(date and source) | Key points identified | Photograph |
|---|---|---|
| 2000<br>(Auckland Council Geomaps) | <p>The Site appears to be relatively unchanged.</p> <p>The property immediately to the north has been developed into a golf course.</p> <p>Land to the west is under development.</p> | |

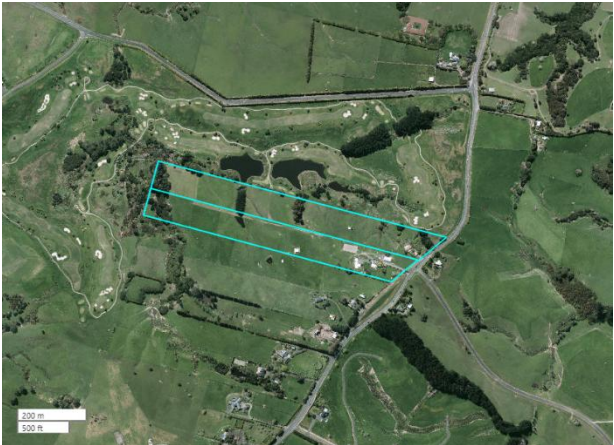
| Aerial photograph<br>(date and source) | Key points identified | Photograph |
|---|---|---|
| 2010-2011<br>(Auckland Council Geomaps) | The Site appears to be relatively unchanged.<br>The surrounding area also appears to be relatively unchanged. | |

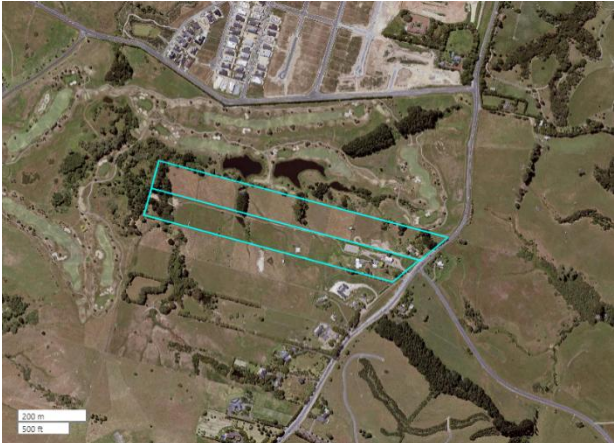
| Aerial photograph<br>(date and source) | Key points identified | Photograph |
|---|---|---|
| 2015-2016<br>(Auckland Council Geomaps) | The Site appears to be relatively unchanged.<br>Land to the north of the golf course is under residential development. | |

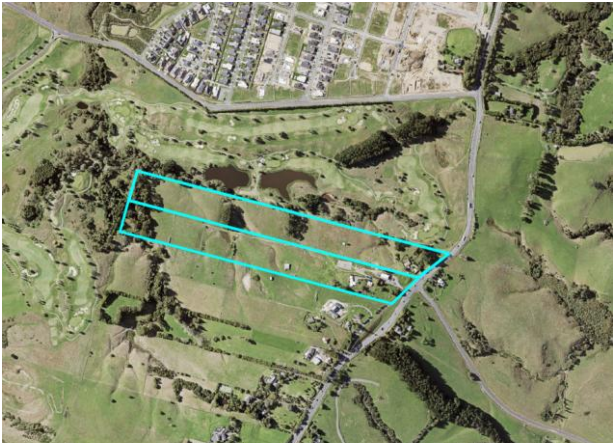
| Aerial photograph<br>(date and source) | Key points identified | Photograph |
|---|---|---|
| 2019-2020<br>(Auckland Council Geomaps) | Additional hardstand areas (inferred driveways) have been added to the property at No. 758. Some surface water appears to be ponded on this property.<br>The surrounding land use appears to be relatively unchanged. | |

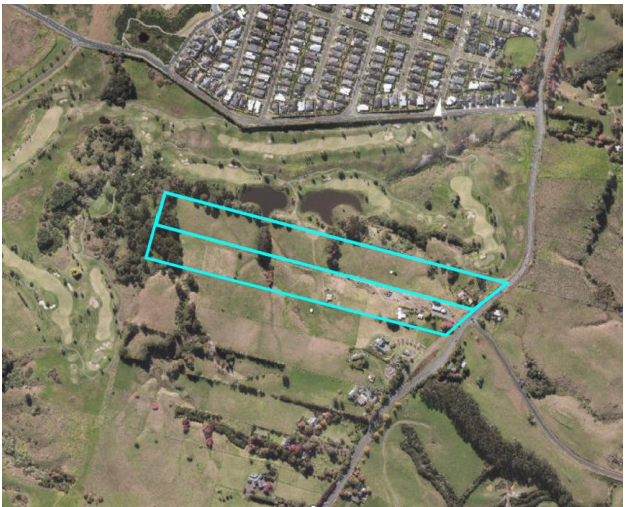
| Aerial photograph (date and source) | Key points identified | Photograph |
|---|---|---|
| 2024-2025<br>(Auckland Council Geomaps) | <p>Some ancillary buildings (likely sheds) have been added to both No. 758 and No. 770.</p> <p>The immediately surrounding land appears to be unchanged.</p> <p>The residential development further north (noted in the 2015-2016 aerial) has intensified.</p> <p>Land to the west that was under development, noted in the 2000 aerial, appears to have been developed into retirement-style living.</p> | |
