## **Remediation Action Plan for the Parkburn Quarry at 922 Luggate- Cromwell Road (SH6), Cromwell**

**Prepared for:** Fulton Hogan Land  
Development

**Date:** 16/07/2026

**Our Reference Number:** 24019\_RAP

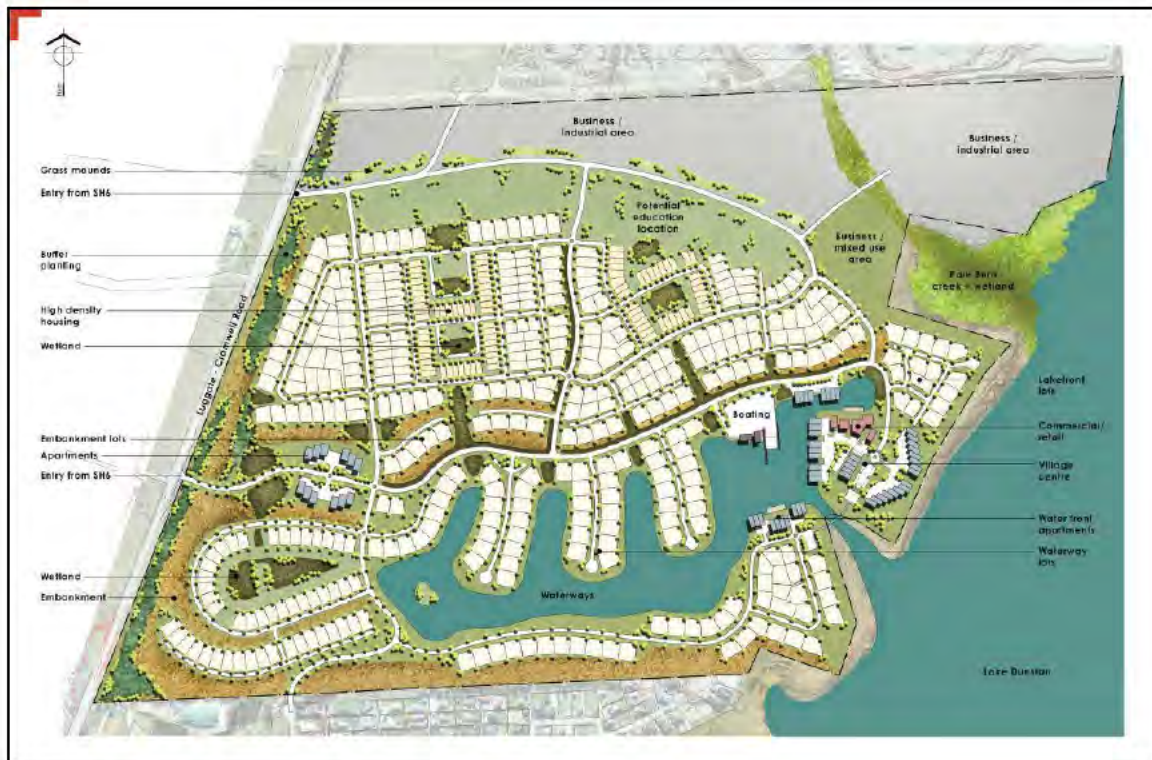
**Figure 1: Draft concept plans**

Fulton Hogan are proposing to rezone the quarry through a private plan change. Draft concept plans provided by Fulton Hogan indicate that the site could potentially accommodate a wide range of uses, including residential (standard and high density), commercial, retail commercial, childcare / education, green space, and industrial (Figure 1).

The residential areas will be located towards the south of the property, where the current quarry operations are located, adjacent to the existing Pisa Moorings development. The residential areas could be located around man-made waterways and inlets, as found in the southern area of Pisa Moorings. The commercial and industrial areas will be located towards the northern boundary of the site, where these types of activities currently take place.

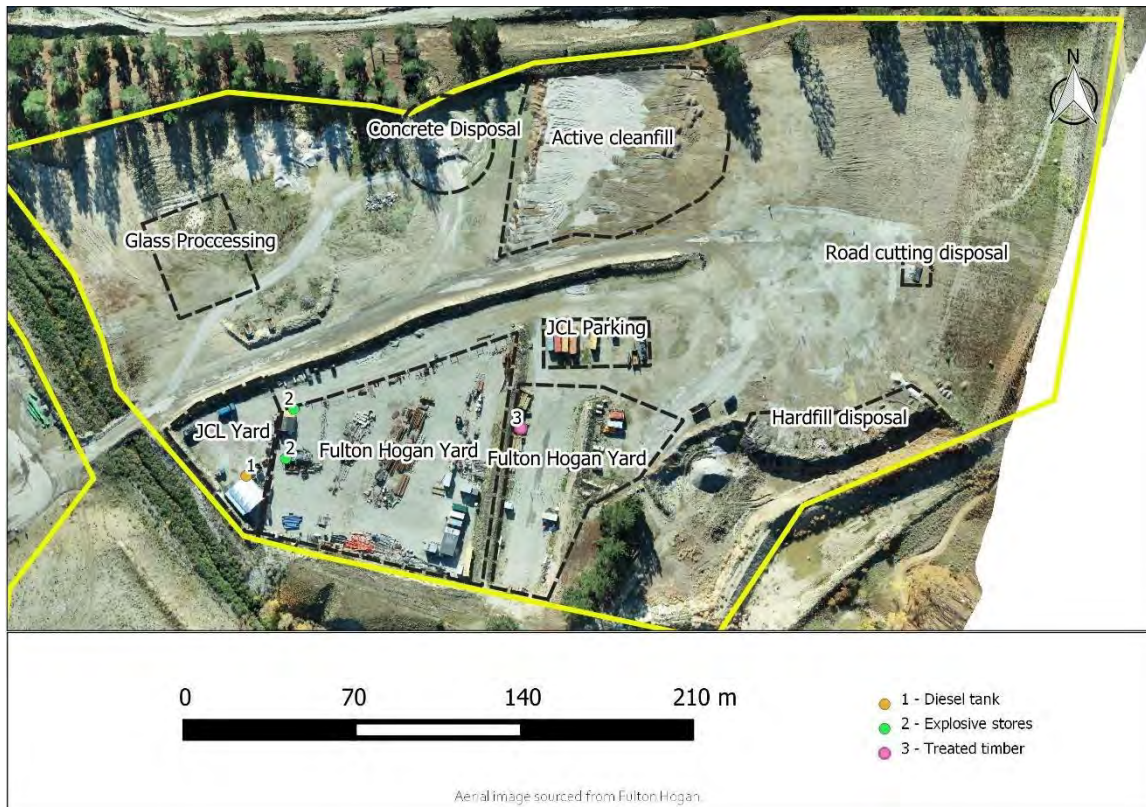
**Figure 8: Cleanfill and yards area**

A new shed, which will be used for crushing and storage of recycled glass, has been constructed. This building was consented under RC210112. During the site inspection, drainage work was being completed, but storage and crushing of glass had not yet commenced.

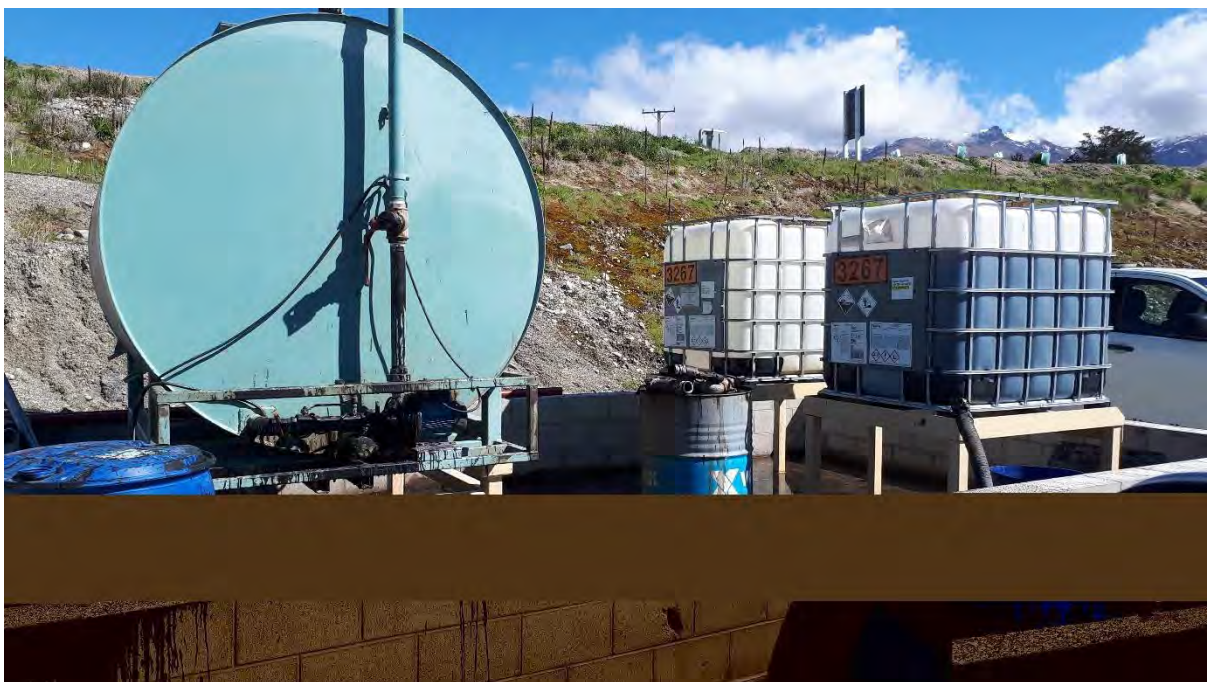
**Figure 10: Bitumen storage at the asphalt plant.**

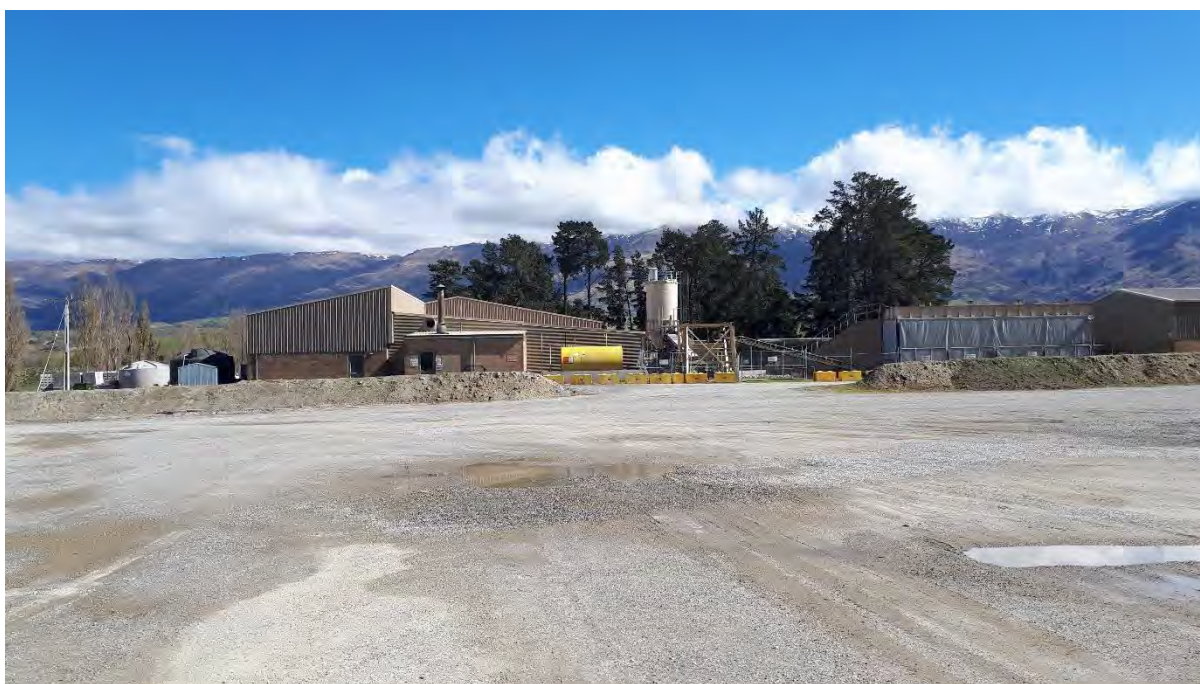
**Figure 12: Firth concrete block plant, with concrete silo (white) and diesel tank (yellow) in background.**
