## **Appendix C      Cross-Sections and Bund Profiles**

**CLIENT** WM NEW ZEALAND  
**PROJECT** ARL TP

**TITLE** CROSS SECTIONS N1, N2 AND N2a

**Redvale Landfill  
ARL - TP**

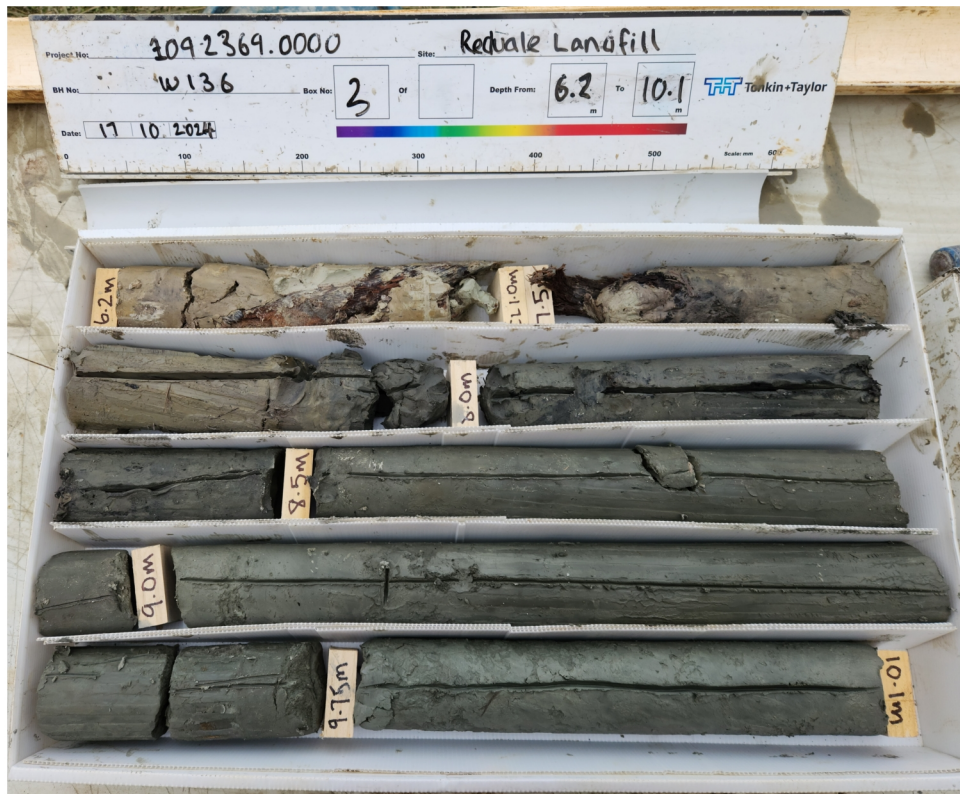
6.20-10.10m

| GEOLOGICAL UNIT | MATERIAL DESCRIPTION | Rock Weathering | Rock Strength | Sampling Method | Core Recovery (%) | Testing | RL (m) | Depth (m) | Graphic Log | ROCK MASS DISCONTINUITIES | | | | Water Level (Ref #) / Fluid Loss (%) | Casing | Installation | Core Box No |
|---|---|---|---|---|---|---|---|---|---|---|---|---|---|---|---|---|---|
| | 6.14m: Organic CLAY, some silt; grey with banded orange. Very stiff, moist, high plasticity wood fragments (partially decomposed) (Alluvium - Pleistocene). | | | | | | | 72 | | | | | | | | | |
| | 7.50m: Organic CLAY; bluish grey and banded orange. Stiff to very stiff, moist to wet, high plasticity wood fragments (partially decomposed) wood and roots (Alluvium - Pleistocene). | | | | | | | 71 | | | | | | | | | |
| | 7.88m: CLAY, trace organic; dark bluish grey. Stiff to very stiff, moist, high plasticity carbonaceous flecks and rootlets (Alluvium - Pleistocene). | | | | | | | 8 | | | | | | | | | |
| | 8.44m: CLAY; dark bluish grey. Very stiff, moist, high plasticity (Alluvium - Pleistocene). | | | | | | | 70 | | | | | | | | | |
| | 8.65m: Silty CLAY, trace organic; dark bluish grey. Very stiff to hard, moist, medium to high plasticity; organics, rootlets rootlets (partially decomposed) (Alluvium - Pleistocene). | | | | | | | 9 | | | | | | | | | |

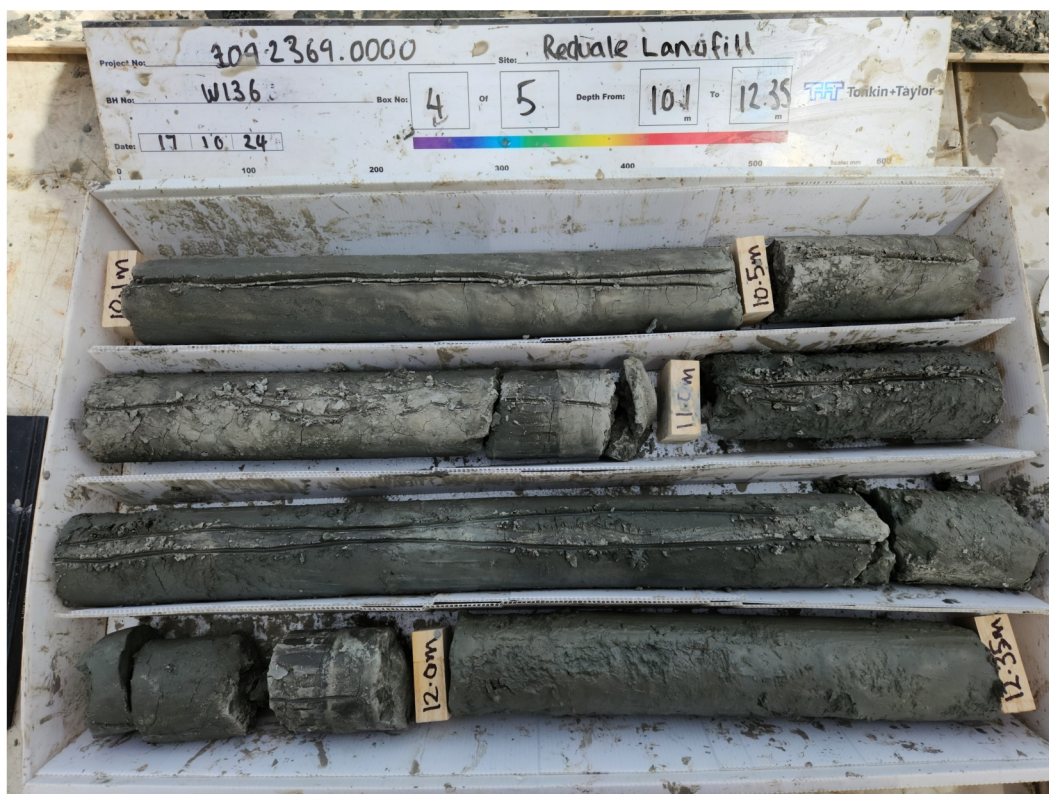
10.10-12.35m

| GEOLOGICAL UNIT | MATERIAL DESCRIPTION | Rock Weathering | Rock Strength | Sampling Method | Core Recovery (%) | Testing | RL (m) | Depth (m) | Graphic Log | ROCK MASS DISCONTINUITIES | | | | Water Level (Ref #) / Fluid Loss (%) | Casing | Installation | Core Box No |
|---|---|---|---|---|---|---|---|---|---|---|---|---|---|---|---|---|---|
| | 12.00m: Unweathered, Dark Bluish Grey, broken, Shelly, MUDSTONE, Extremely weak to very weak. | UW | VS | SW | 100 | | 12 | | | | 200 | 100 | | 50 | | | |

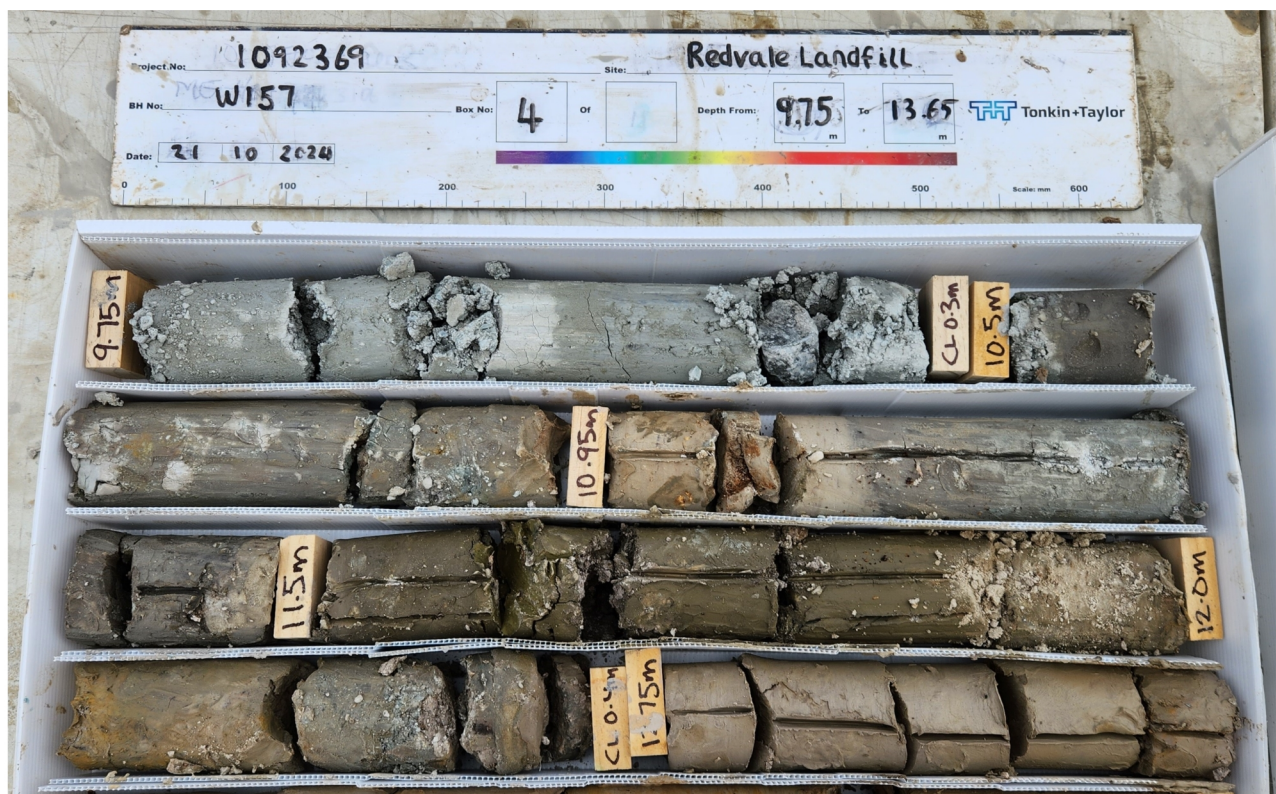
9.75-13.65m

| GEOLOGICAL UNIT | MATERIAL DESCRIPTION<br><br>SOIL: Classification, colour, consistency / density, moisture, plasticity<br>ROCK: Weathering, colour, fabric, name, strength, cementation | Rock Weathering<br><br>USW<br>SW<br>MSW<br>HSW<br>CWS<br>VWS<br>WS<br>SWS<br>VWS<br>WS | Rock Strength<br><br>USW<br>SW<br>MSW<br>HSW<br>CWS<br>VWS<br>WS<br>SWS<br>VWS<br>WS | Sampling Method<br><br>Core Recovery (%) | Testing | RL (m) | Depth (m) | Graphic Log | Defect Log | Fracture Spacing (mm)<br><br>2000<br>1000<br>500<br>200<br>100<br>50<br>20 | ROCK MASS DISCONTINUITIES | | Description<br>& Additional Observations | Water Level (Ref #) /<br>Fluid Loss (%)<br><br>25<br>50<br>75 | Casing | Installation | Core Box No |
|---|---|---|---|---|---|---|---|---|---|---|---|--|---|---|---|---|---|
| | 10.90m: CLAY, trace wood and trace gravel; light brownish grey. Stiff to very stiff, moist to wet, high plasticity; gravel, fine to medium. (Alluvium - Pleistocene). | | | | | | | | | | | | | | | | |
| | 11.08m: CLAY, minor organics; grey with streaked orange. Stiff, moist to wet, medium to high plasticity; organics, wood fragments (partially decomposed). (Alluvium - Pleistocene). | | | | | | | | | | | | | | | | |
| | 11.90m: Fine SAND; light greyish brown. Medium dense, moist, well graded. (Alluvium - Pleistocene). | | | | | | | | | | | | | | | | |
| | 12.00m: CLAY, minor organics, trace gravel; orange mottled light grey. Stiff to very stiff, moist, medium to high plasticity; organics, wood fragments (partially decomposed). (Alluvium - Pleistocene). | | | | | | | | | | | | | | | | |
| | 12.75m: CLAY; orange streaked light grey. Stiff to very stiff, moist, high plasticity. (Alluvium - Pleistocene). | | | | | | | | | | | | | | | | |
| | 13.28m: CLAY, trace organic flecks; orange streaked light grey. Firm to stiff, moist, high plasticity; organics, carbonaceous flecks. (Alluvium - Pleistocene). | | | | | | | | | | | | | | | | |
| | 13.50m: Silty CLAY, some organics; orange mottled light greyish brown. Stiff to very stiff, moist, medium to high plasticity; organics, timber fragments (partially decomposed). (Alluvium - Pleistocene). | | | | | | | | | | | | | | | | |

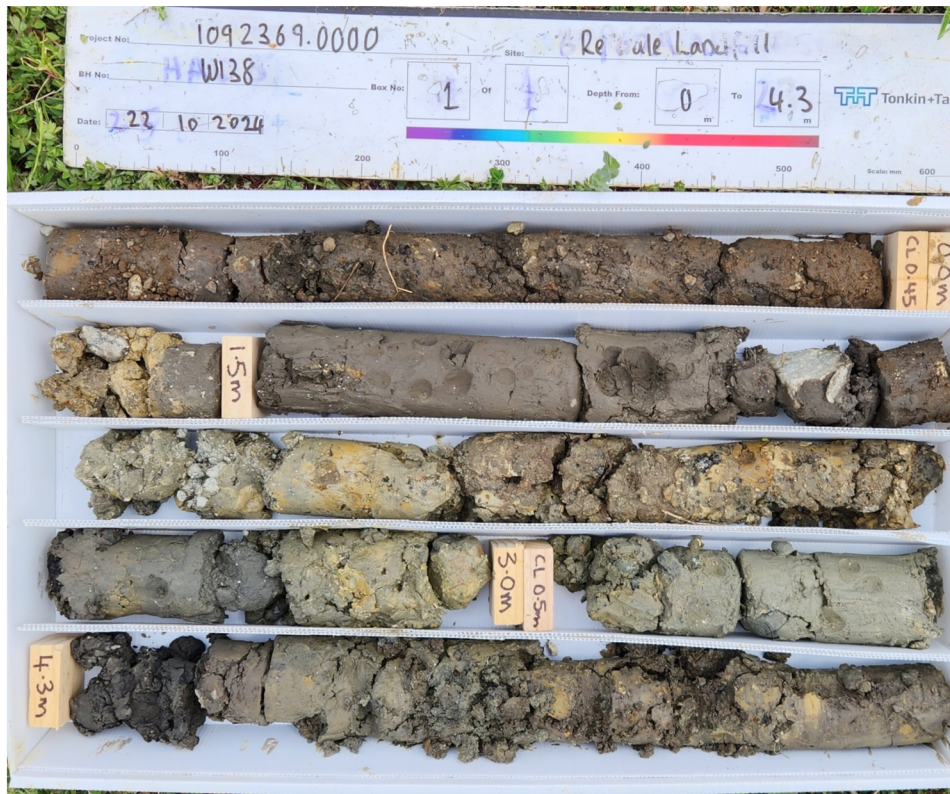
0.00-4.30m

| GEOLOGICAL UNIT | MATERIAL DESCRIPTION | Rock Weathering | Rock Strength | Sampling Method | Core Recovery (%) | Testing | RL (m) | Depth (m) | Graphic Log | ROCK MASS DISCONTINUITIES | | | | Water Level (Ref #) / Fluid Loss (%) | Casing | Installation | Core Box No |
|---|---|---|---|---|---|---|---|---|---|---|---|---|---|---|---|---|---|
| Fill | 0.00m: CORE LOSS - Suspect loose granular material dropped out of barrel | | | | | | | 78 | | | | | | | | | |
| | 0.45m: Gravelly CLAY, some silt; orange and yellow mottled dark brown. Soft to firm, moist, well graded; gravel, medium to coarse, up to 40 mm sub-angular to angular (fill) | | | | | | | | | | | | | | | | |
| | 0.80m: Gravelly CLAY, minor cobbles; orange speckled dark grey. Very stiff, moist; gravel, medium to coarse; cobbles, up to 70 mm sub-angular limestone (fill) | | | | | | | 1 | | | | | | | | | |
| | 1.55m: Gravelly CLAY, some sand; dark grey with banded yellow. Firm to stiff, moist to wet, poorly graded; gravel, medium to coarse, up to 10 mm sub-angular limestone (fill) | | | | | | | 2 | | | | | | | | | |
| | 2.50m: CORE LOSS - Suspect loose granular material dropped out of barrel | | | | | | | 3 | | | | | | | | | |
| | 3.00m: Gravelly SILT, some clay; grey with mixed yellow. Soft, moist to wet, medium plasticity; gravel, medium to coarse, up to 40 mm sub-angular to angular limestone (fill) | | | | | | | | | | | | | | | | |
| | 3.15m: Gravelly SILT, some clay; dark grey with speckled green and yellow. Firm, moist, poorly graded; gravel, medium to coarse, up to 20 mm sub-angular to angular limestone (fill) | | | | | | | 4 | | | | | | | | | |

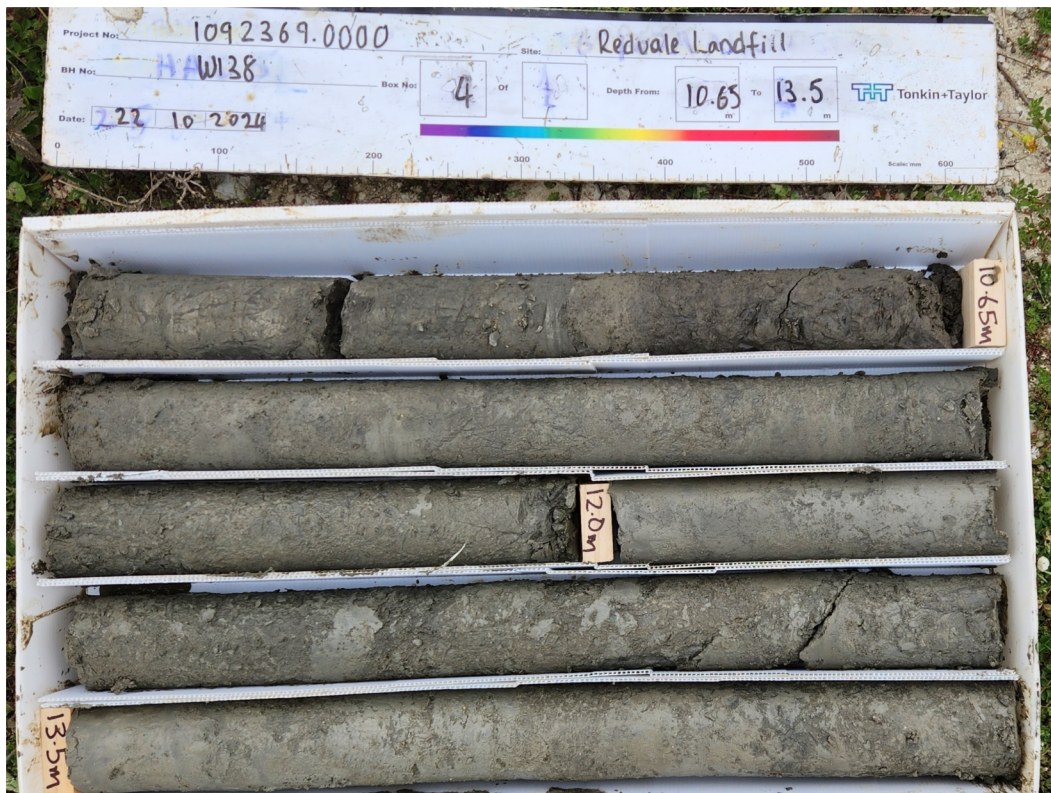
10.65-13.50m

| GEOLOGICAL UNIT | MATERIAL DESCRIPTION | | Rock Weathering | Rock Strength | Sampling Method | Core Recovery (%) | Testing | RL (m) | Depth (m) | Graphic Log | ROCK MASS DISCONTINUITIES | | | | Water Level (Ref #) /<br>Fluid Loss (%) | Casing | Installation | Core Box No |
|---|---|--|---|---|---|---|---|---|---|---|---|--|---|---|---|---|---|---|
| Northland Allochthon (Mangakahia Complex) | [CONT] 8.70m: Unweathered, Bluish Grey, broken and sheared with polished surfaces, MUDSTONE, Extremely weak. | | UW<br>SW<br>PW<br>CW<br>VW | VS<br>S<br>MS<br>WS<br>VWS | Q<br>S<br>W<br>VW | | | 67 | | | 2000<br>1000<br>500<br>200<br>100<br>60<br>20 | | 10.53-12.00m: DD, 5°, UNST, R | 25<br>50<br>75 | | | | |
