**BULLER PLATEAUX CONTINUATION PROJECT,  
WESTPORT, SOUTH ISLAND:  
ARCHAEOLOGICAL AND HISTORIC HERITAGE  
ASSESSMENT  
(APPENDIX: HISTORICAL AND ARCHAEOLOGICAL  
BACKGROUND)**

Prepared for Bathurst Resource Ltd

March 2026

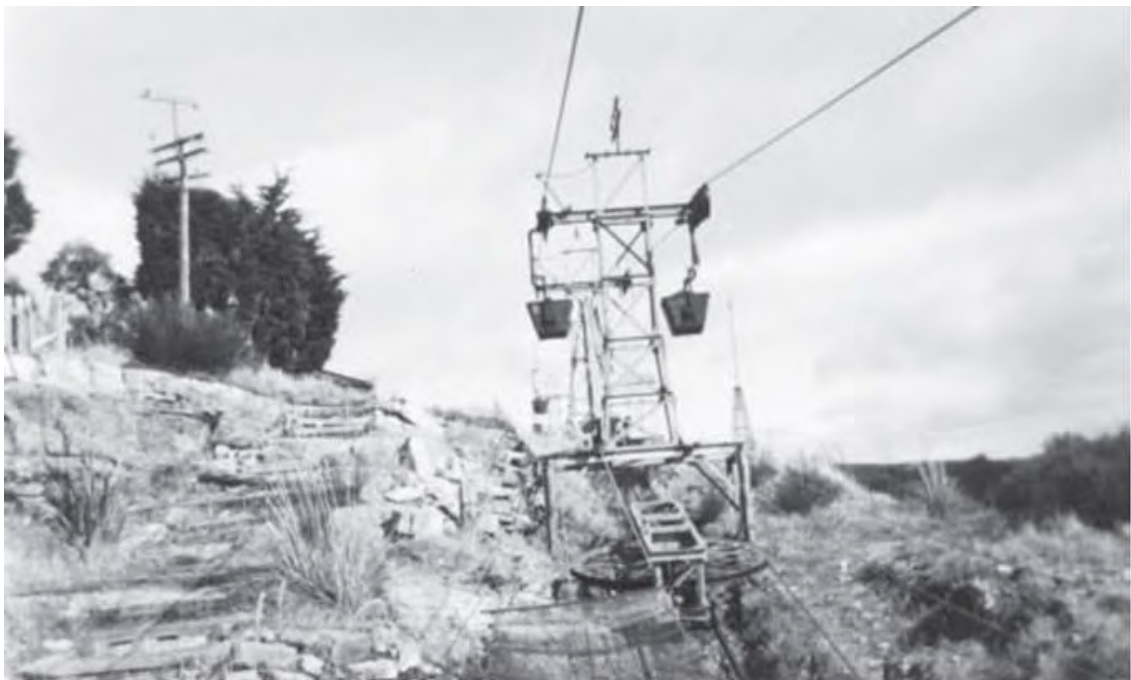
**Figure 8.** At the brakehead end of the aerial, a complex system kept the cable taut. Many elements of the tensioner (Feature A40) remain, including the large wheel (inset lower right) visible in front of the tower. (Photo courtesy of Brian Kerr. In Watson and Wright May 2004:88)

The Monocable Aerial Cableway was an electrically powered monocable aerial system designed by the British Ropeway Engineering Co. Ltd of London and built in 1950-1953 by the Public Works Department, Westport, and the State Mines Denniston engineers to transport coal from the distant Whareatea and Sullivan Mines to the Denniston Brakehead (Figure 7 and Figure 8). It replaced the surface rope road. The aerial ropeway was itself replaced by road transport in 1968.

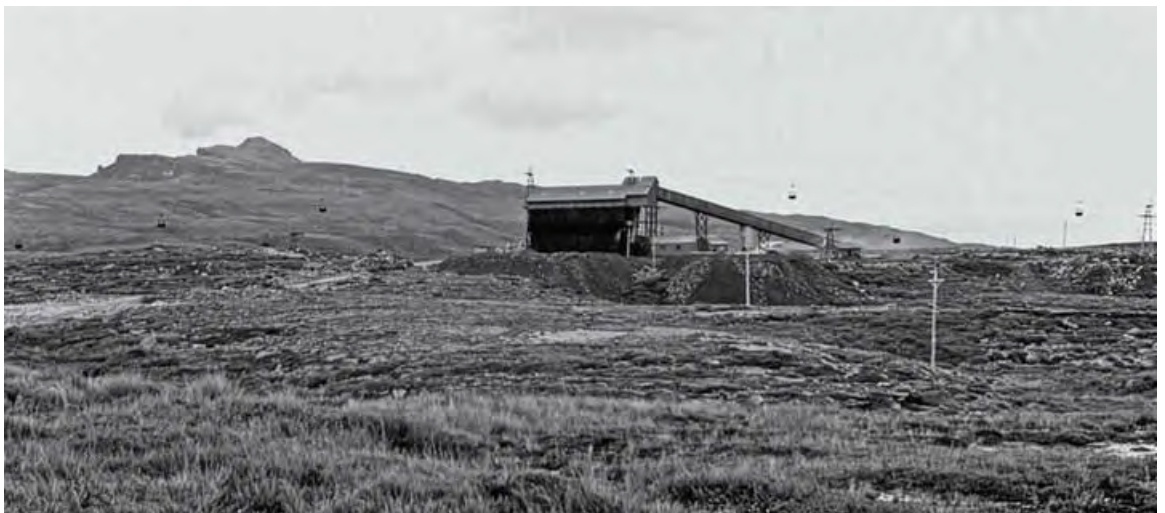
**Figure 10. The Sullivan Mine Loading Station with the aerial cableway towers in the background**  
(<https://www.doc.govt.nz/globalassets/documents/conservation/historic/by-region/west-coast/denniston/journey-through-denniston>)

History: Construction of the bins began in 1952 and they were ready for the commencement of mining the following year (AJHR 1952-53). The full (western) side of the aerial ran through the bins while the empty buckets returning to Whareatea passed over the top (Fig. 10, Plate 34). Aerial buckets sent through from the Whareatea drive station automatically detached from the moving cable and ran on their own wheels along the shunt rail for loading before being pushed to the end where they dropped onto the moving cable again (Frank Robertson, pers. comm.). Originally coal was not screened until it reached the brakehead bins, but when the aerial was abandoned the bins were partitioned and a crusher was installed to provide different-sized coal (Brian Kerr, pers. comm.). No longer needed when hydro mining began via Sullivan West in 1985, the bins were demolished free of charge in return for the material scrap value (Gary Bainbridge, pers. comm.) during the bitter winter of 1991 (Denniston Mines report, 4.6.91).

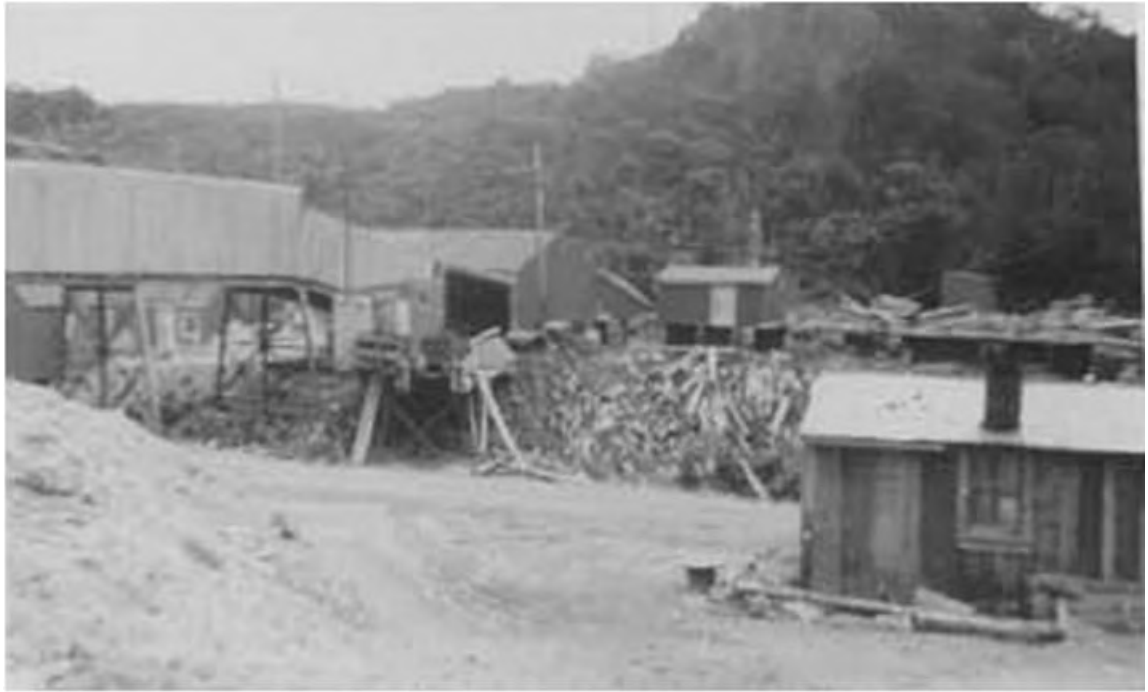
**Figure 12. Whareatea c.1960 with the mine conveyor gantry running from the building at the mine entrance in the middle background to the left. The early underviewers' office is to the right of the entrance and the early workshop is at right (Department of Conservation, Westport in Watson and Wright May 2004:65)**

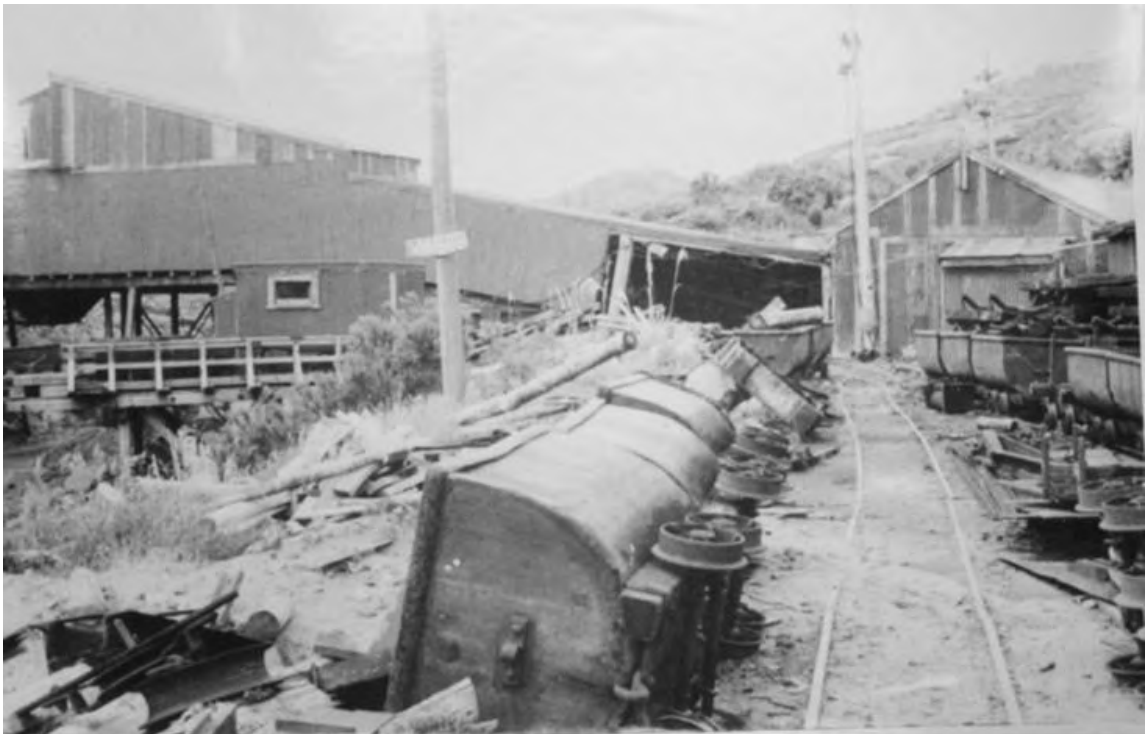
**Figure 13. Southward view at Whareatea showing the conveyor gantry with the higher roof built to accommodate the modifications of 1968 at left and the truck loading hoppers just visible below it. Left of the post carrying the 'Whareatea' sign is a footbridge spanning the creek. The mine entrance building is in the right background. (Friends of the Hill in Watson and Wright May 2004:65)**

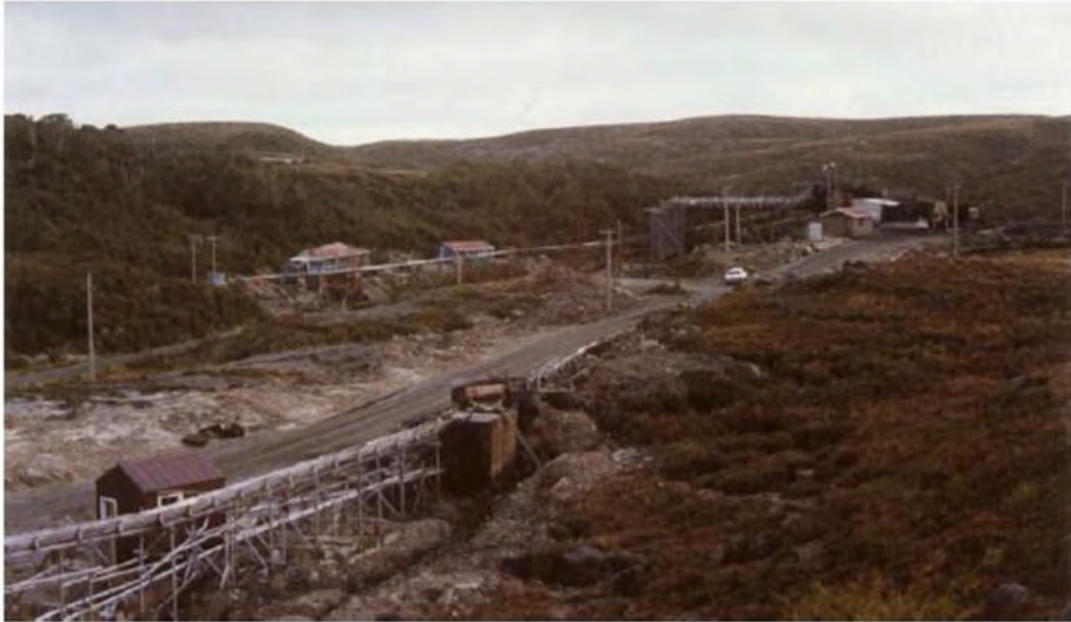
**Figure 14. A northward view of the Whareatea fines filtration tank with flumes from the Escarpment (left) and Whareatea pads visible, along with hydro pipes and the pump shed at left. The mine offices and workshop and the storeroom on the stables' foundation are farther back, left of centre beyond the hydro pipes from the mine. (Solid Energy, Westport, photo B2002 in Watson and Wright May 2004:71)**

The new Whareatea system employed a new 150 kW (200hp) Australian-made stainless steel pump capable of pumping out one tonne of coal per minute, while a 126 kW (170hp) New Zealand-built pump handled the silt-laden overflow. The pump room was a huge, hollowed-out cavern inside the mine. Coal was blasted, and then sluiced along to the dip or lowest point, from where it was pumped out. About 5 percent of the old mine was reworked, an area measuring about 800m by less than 400m. The fact that this section had been flood-prone in the past became an advantage, while places that had been too difficult and dangerous to work before, even partially collapsed areas, could be mined. Hydro mining also resulted in record outputs.

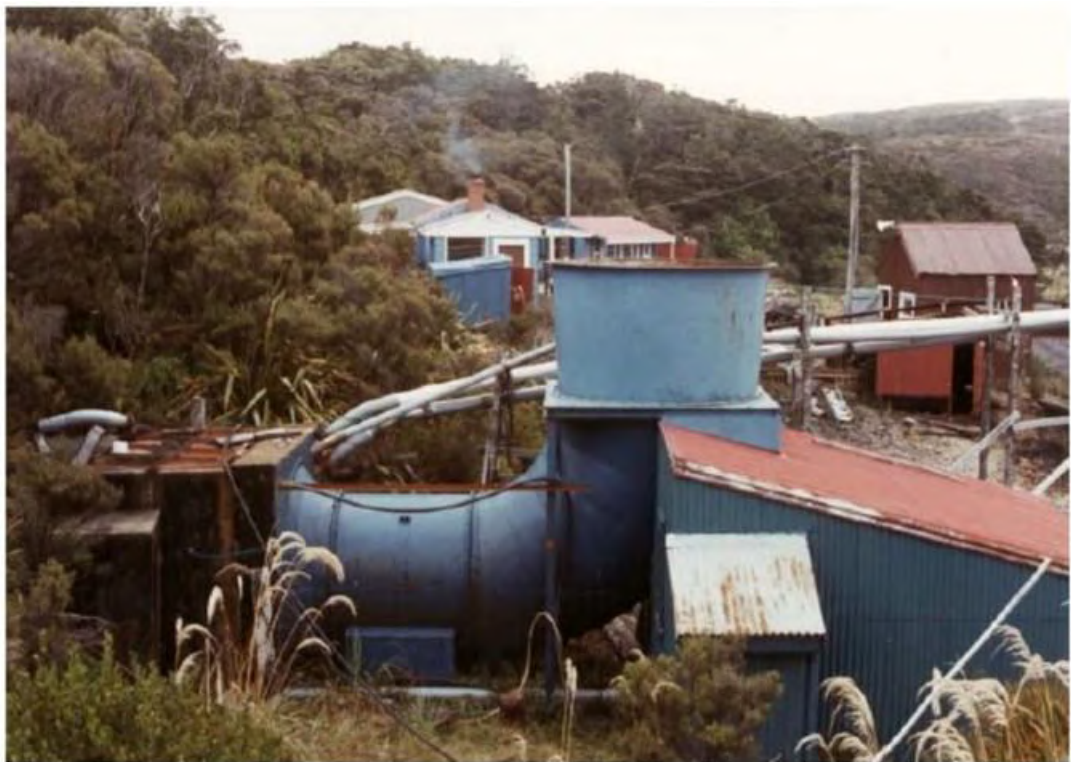
**Figure 15. Steps fanhouse during the 1980s with hydro pipes running from the fan drift. In the centre background are the office and workshop, with the store on the stables' foundation beyond and the winch shed at right. In the foreground is the small lean-to pumphouse with a pipe from the dam out of picture at left. (Solid Energy, Westport, photo B2003. in Watson and Wright May 2004:62)**

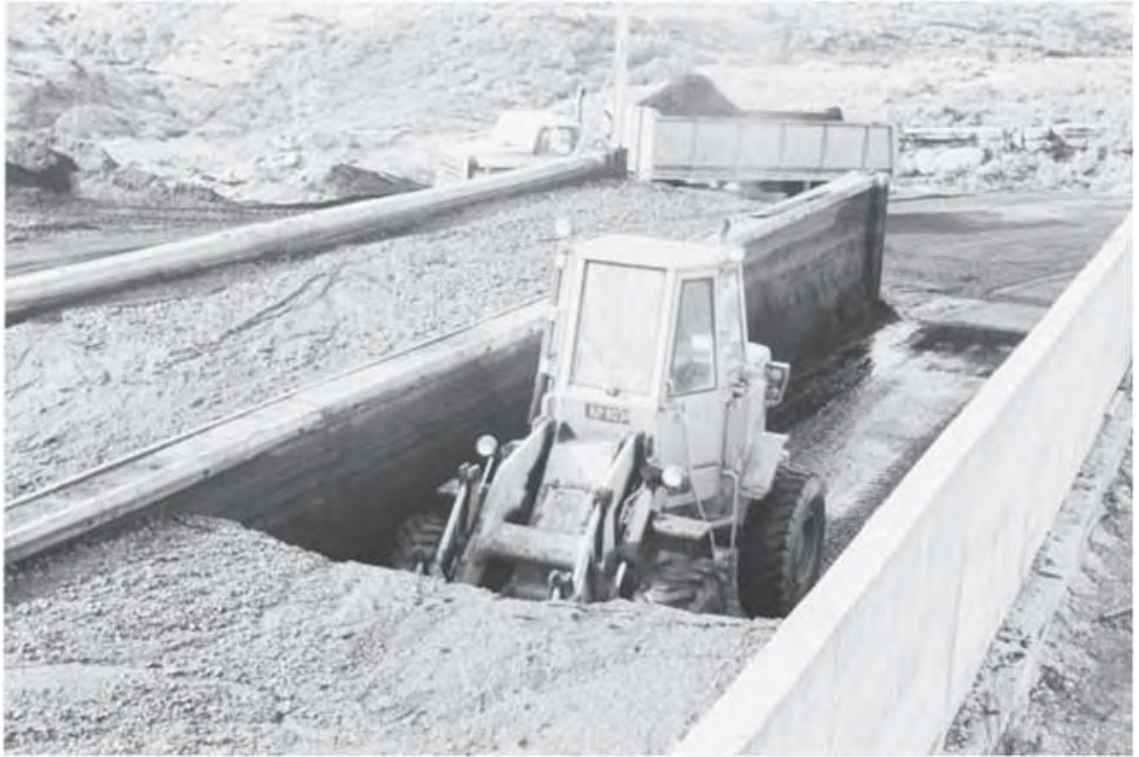
**Figure 16. Loading coal from the Whareatea pads. The truck is standing on the lower part of the apron, from where the photo above was taken. (Solid Energy, Westport, photo B2007 in Watson and Wright May 2004:69)**

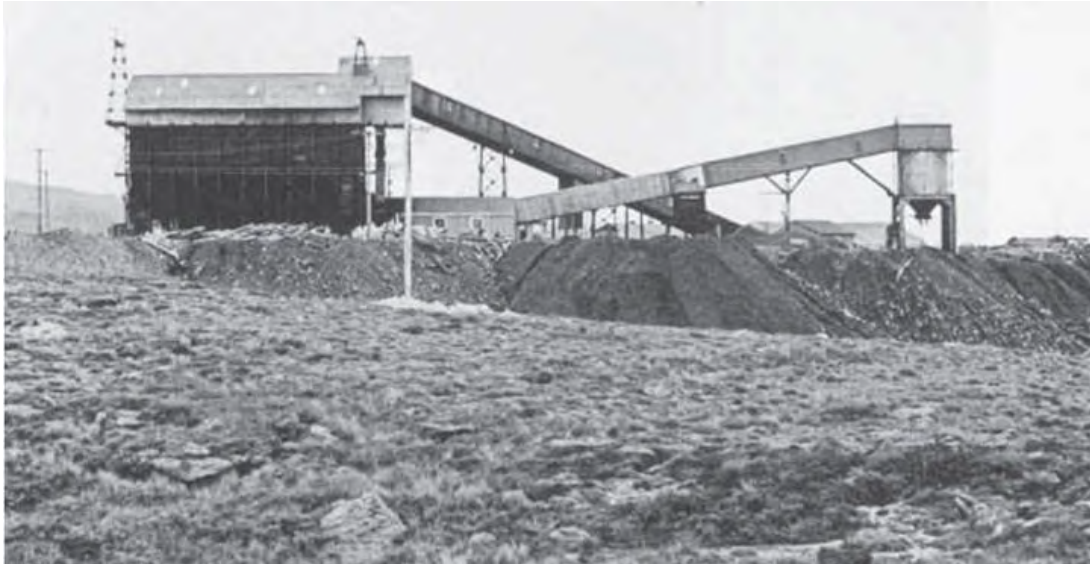
**Figure 20. Sullivan bins from the east in 1984 with conveyor gantries to the mine behind and the truck bin at right. To the right of a gantry support, about the centre the mine conveyor tensioner is visible although mostly obscured by the truck bin gantry. Aerial towers still stand on top of the bins. ('New Zealand Coal' Vol. 28: No. 1, Autumn 1984. In Watson and Wright May 2004:74)**

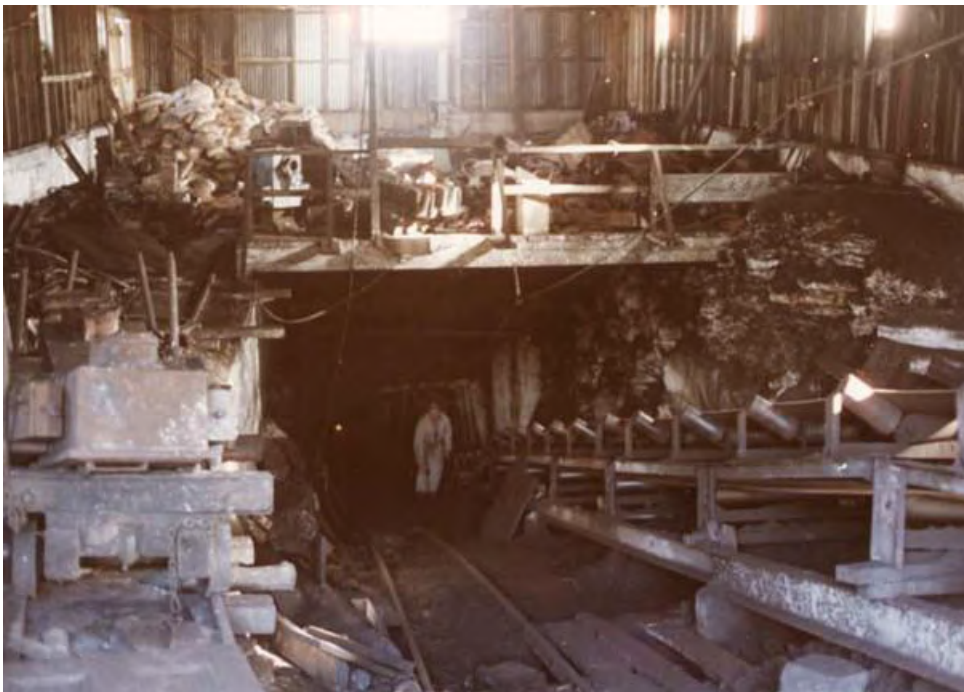
**Figure 21. A view down the Sullivan Mine entrance late in the mine's life, with the rails at centre and conveyor at right. Materials and equipment were stored in the large entrance shed (Solid Energy, Westport, photo B2020. In Watson and Wright May 2004:74)**

History: Described as a dip stone drive, the entrance was driven in the hard strata of a granite upthrust, work beginning in November 1950 (AJHR 1951). It subsequently served as the working entrance of the Sullivan mine until operations became centred at Rapid Creek in the 1980s. A large gable-roofed corrugated iron building covered the entrance (Plates 29 and 30). Materials were hauled in and out on rails along the south-western side, using an electric winch (site 29, Plate 37). Coal and stone went out along the north-east side on a belt conveyor covered by a gantry connected to the bins (Plates 30, 33 and 34). The small slabs at the eastern end were the entranceway and the start of a steel stairway that went up inside the gantry (Frank Robertson, pers. comm.). In 1998 the mine entrance was filled with unwanted mine equipment, building debris and other material, apparently including the south-eastern foundation wall. Household rubbish and other items including old cars were later added. (Plate 28) During the summer of 2003-04 the entrance was cleared to a depth of 3m at the portal end, then backfilled and compacted using locally sourced hard fill (Plate 27). Mining equipment was piled nearby (Plate 41) or taken to the Friends of the Hill museum while other rubbish was taken to a scrapper or dumped. (Michael Kingsbury, pers. comm.)

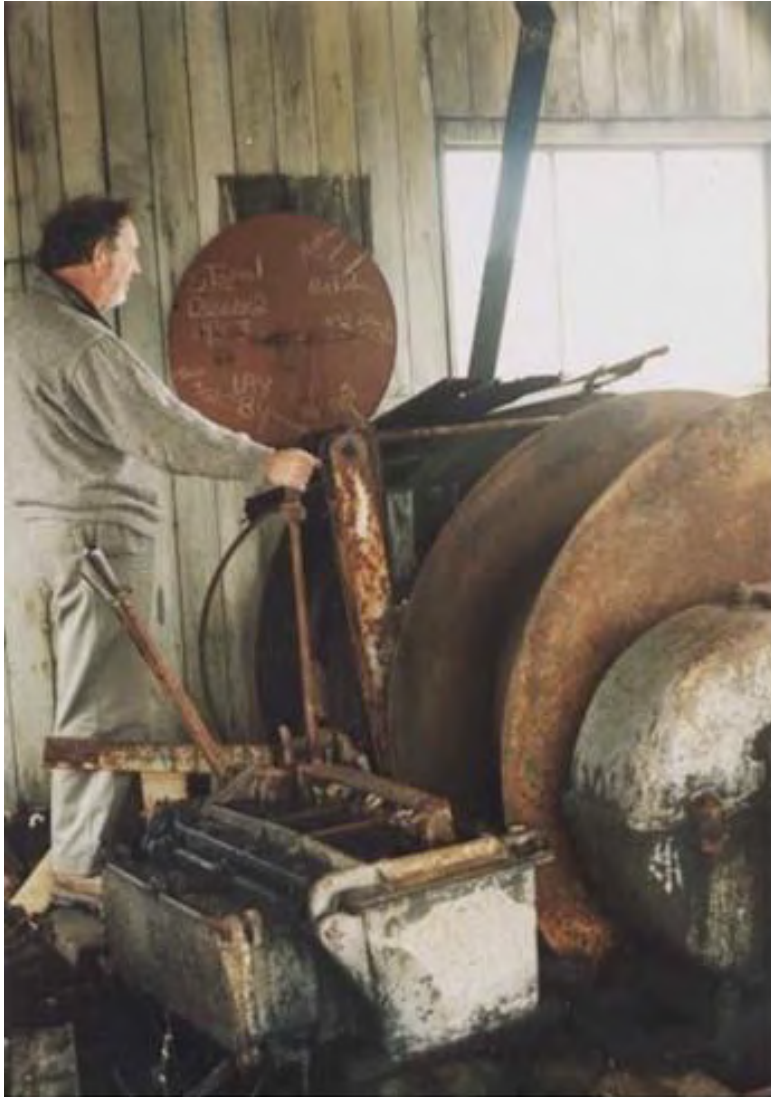
**Figure 22. The Sullivan Mine winch shortly before removal from its foundation (on site but not in situ). The winch shed has been destroyed (Watson and Wright May 2004:77)**

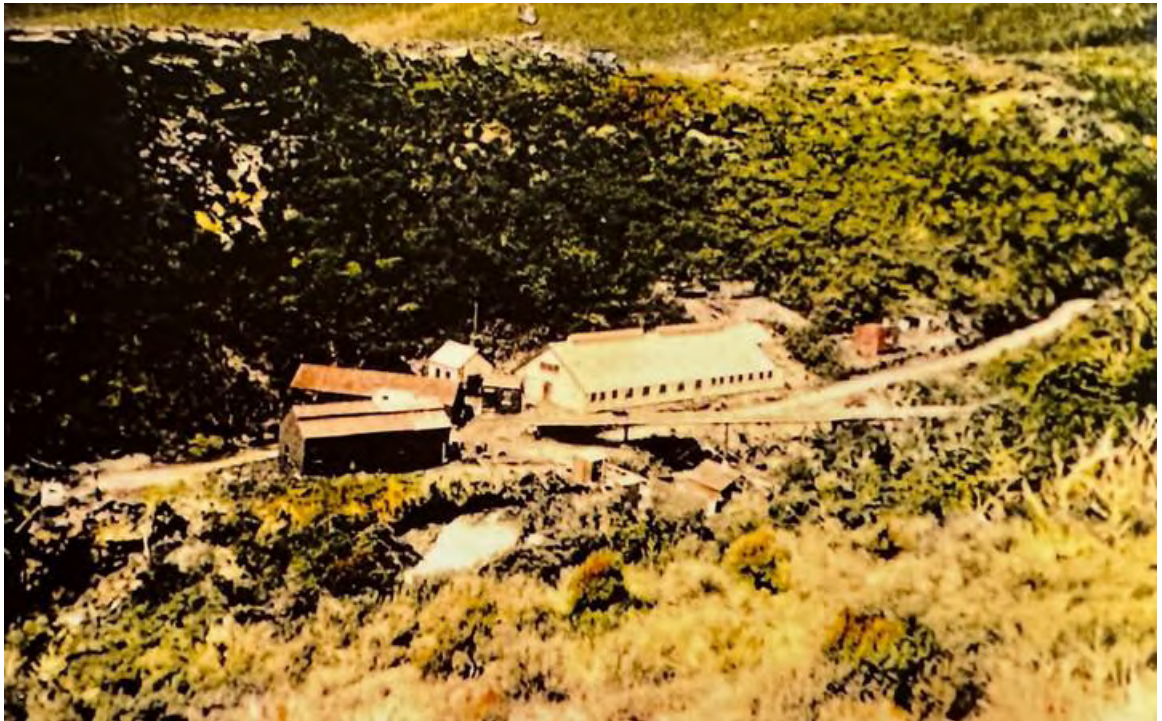
**Figure 26. Looking down on Iron Bridge Mine infrastructure. On the left is a toilet, left is the blacksmith's shop and stables, an iron-roofed mine entrance in the centre and a white bathhouse in the right. The bridge on the right goes to Burnett's Face (source: Bill Andrew Collection, Friends of the Hill)**

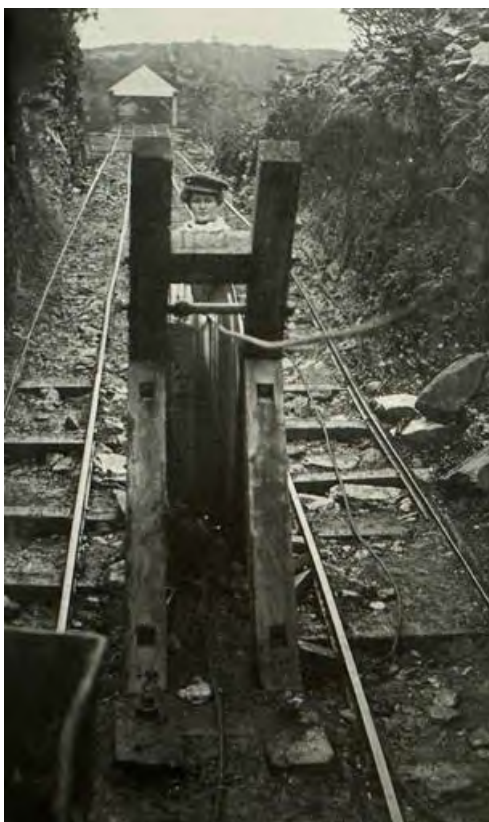
**Figure 32. Kiwi Mine jig for the rope road (source: Series PA1-o-990, #20, Alexander Turnbull Library, Wellington)**

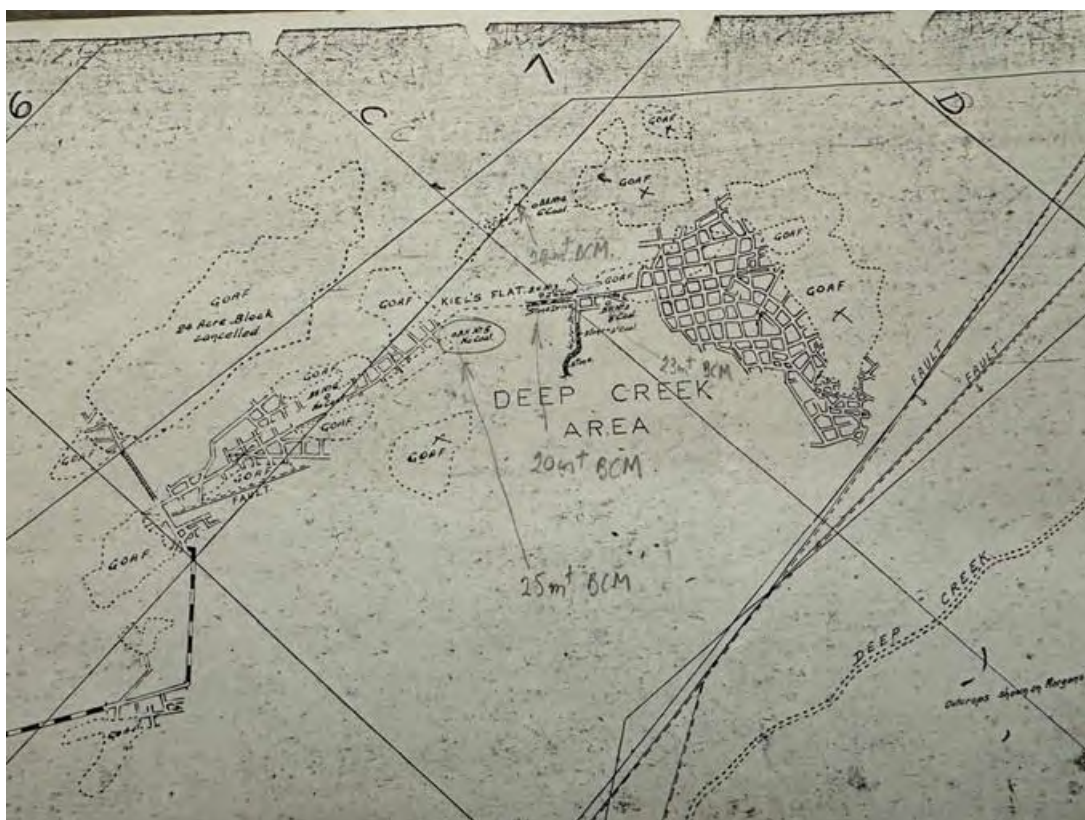
**Figure 34. Detail from plan of Main Lease Iron Bridge (Jul 1945) State Coal Mines Survey Office, Granity, showing the Taipo Mine workings in the Deep Creek area (Bathurst Archives S00014403 / 04-01-012)**

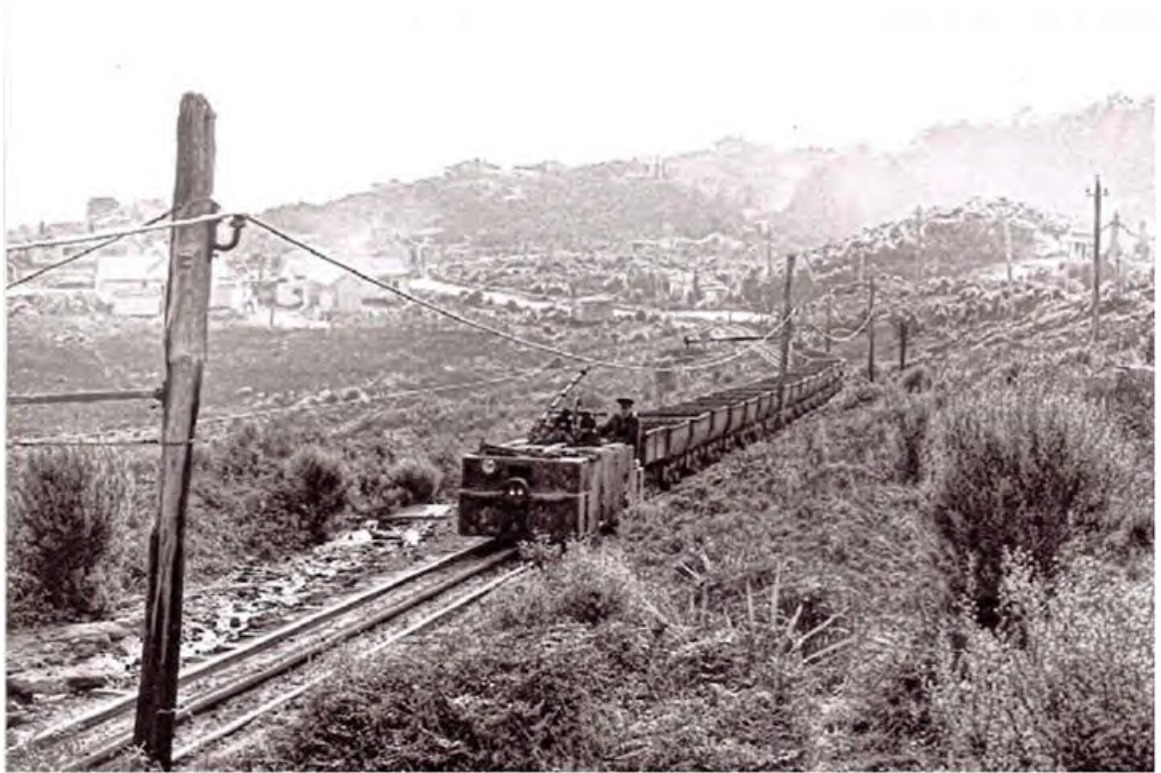
**Figure 37. The Electric Loco Line in operation (source: Harris 2008)**

Further 'extensive repairs and renewals' were carried out on the Electric Loco Line in the 1940s and 1950s when No. 4 Substation was destroyed by fire. This must have been particularly frustrating for the now State-owned colliery, with work on the aerial cableway (the new haulage system; see below) already underway. The ongoing references to the need for repairs to the loco line no doubt reflect the heavy wear and tear to which it was subjected, and must have been one of the reasons it was replaced.

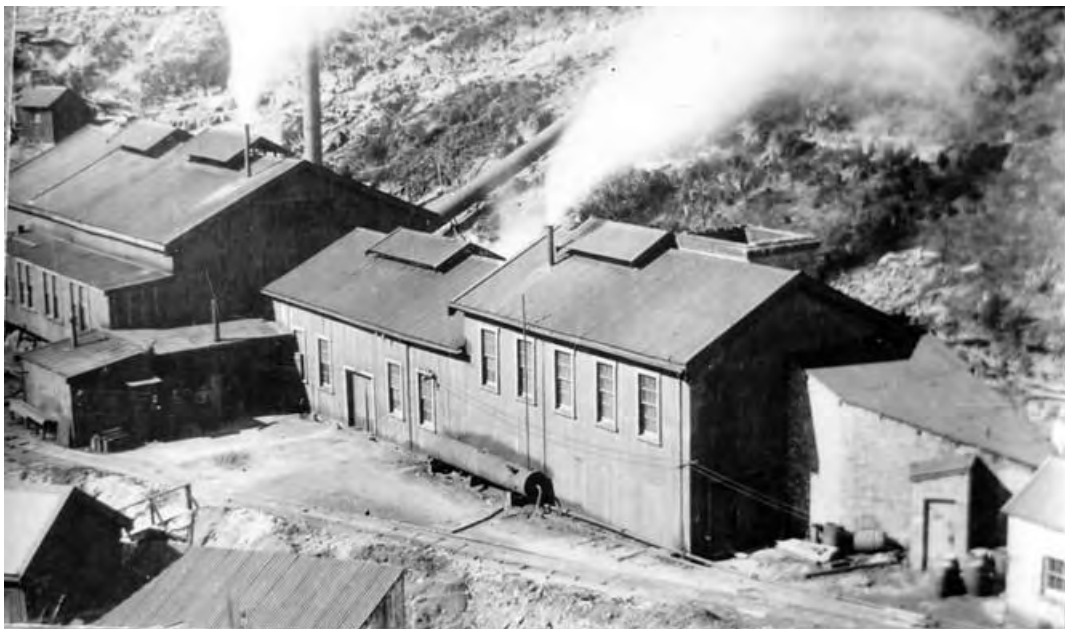
**Figure 41. The air compressor and fan drive sheds on the true right of Mine Creek. The square top of the brick ventilation flue is visible behind the fan drive shed, which was home to the Schiele fan. There is a brick or concrete structure to the south of this shed. A metal pipe leading up to the flue is visible on the hillside. There is a rail line between the sheds and Mine Creek. A metal pipe leading up to the flue is visible on the hillside. There is a rail line between the sheds and Mine Creek (source: Coaltown Museum Ref: MN56)**

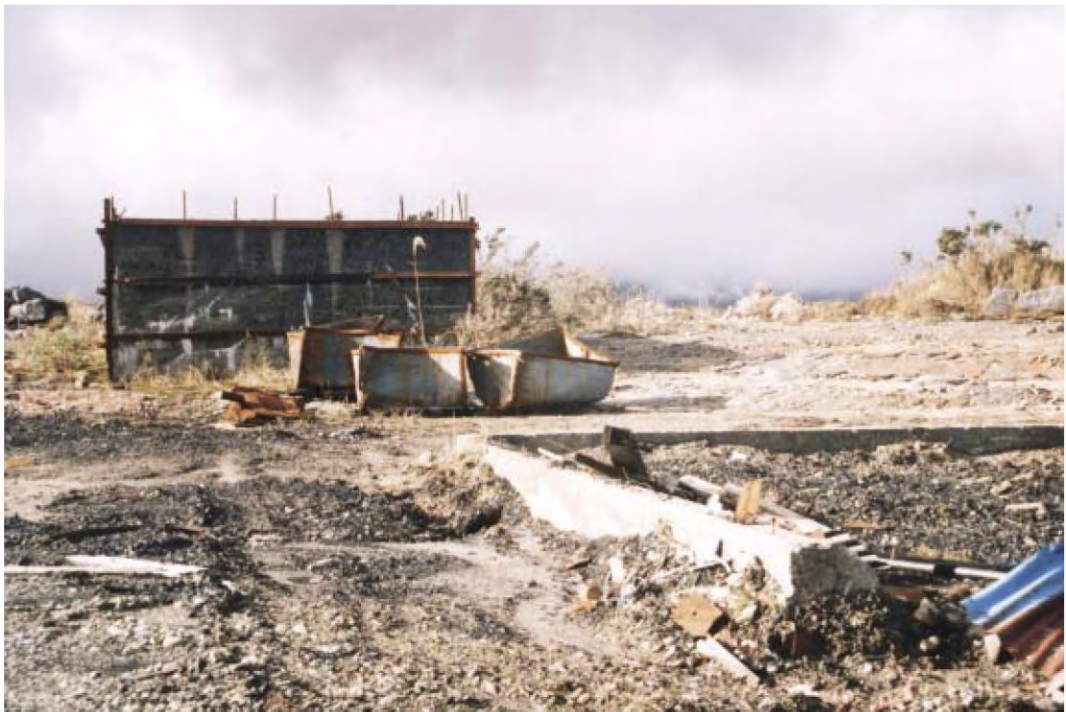
*Plate 27: Intact end and side kerbing at Sullivan mine entrance (23), showing recent backfill. The place where the other side kerb was broken off is in the right foreground. In the background, behind the bodies of some old mine boxes or tubs is the concrete water tank (34).*

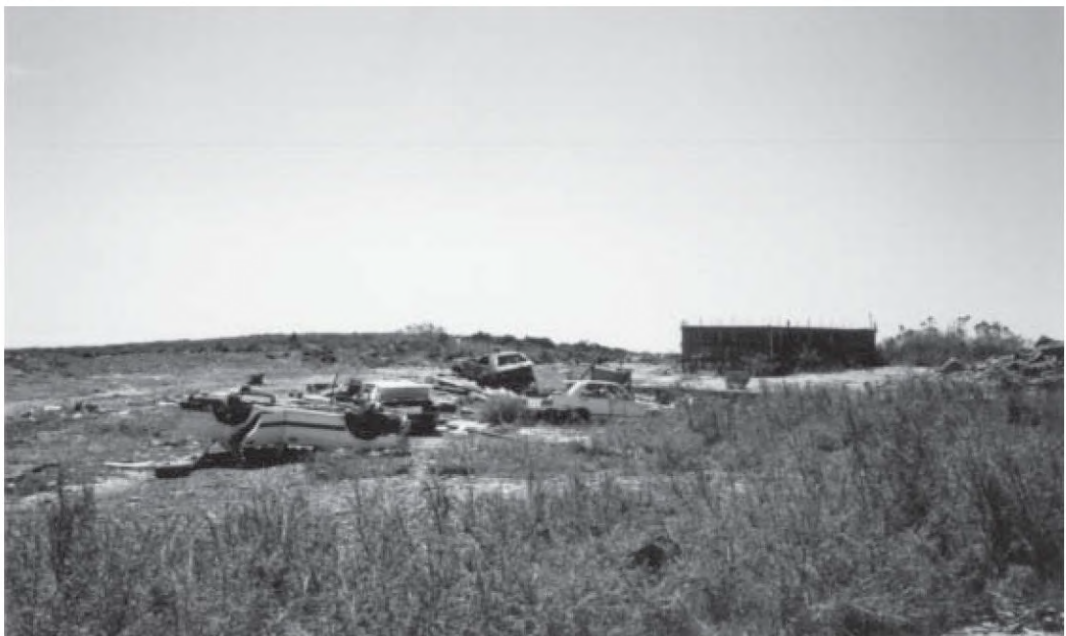
*Plate 28: The Sullivan mine entrance area (23) before a recent cleanup. The water tank (34) is in the background.*

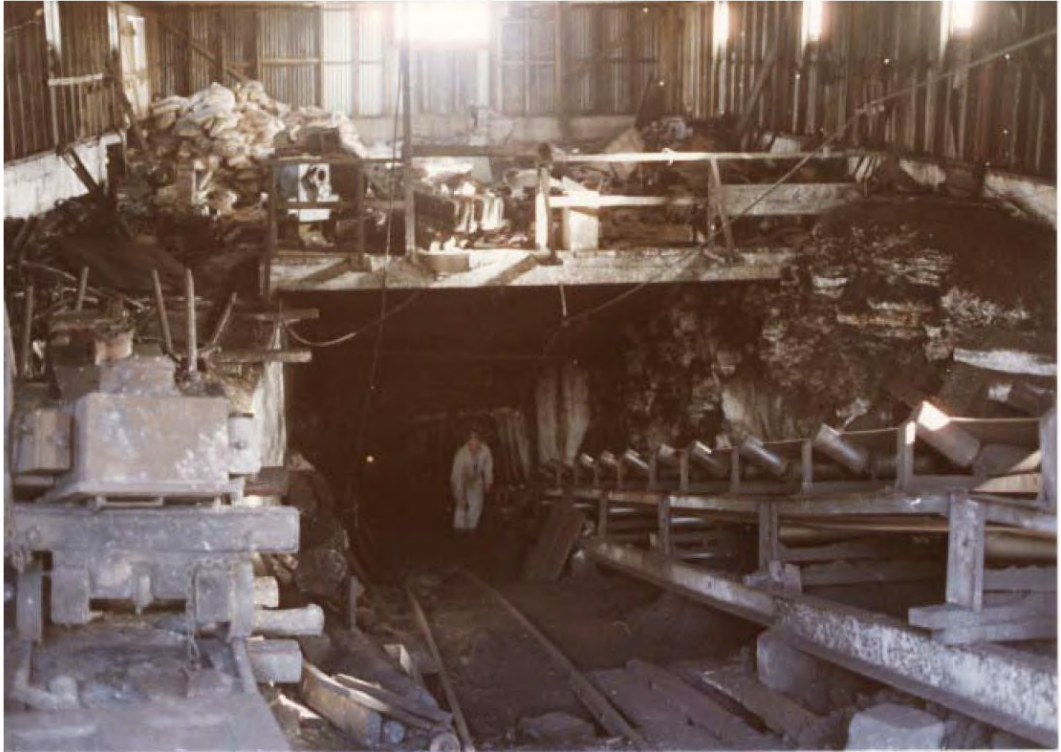
*Plate 29: A view down the Sullivan entrance (23) late in the mine's life, with the rails at centre and conveyor at right. Materials and equipment were stored in the large entrance shed. (Solid Energy, Westport, photo B2020.)*

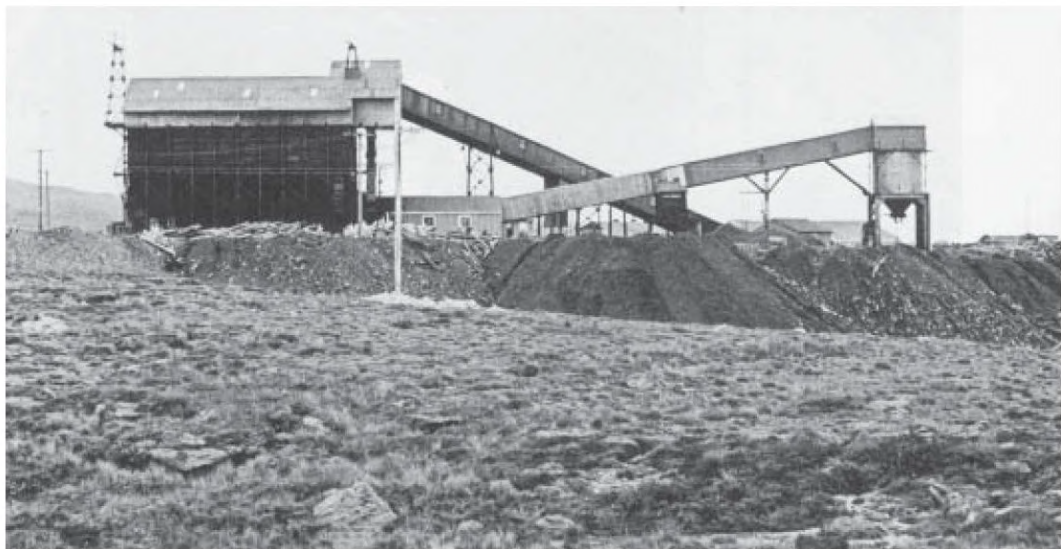
*Plate 30: Sullivan bins (26) from the east in 1984 with conveyor gantries (25 and 27) to the mine behind and the truck bin (28) at right. To the right of a gantry support, about the centre the mine conveyor tensioner is visible although mostly obscured by the truck bin gantry. Aerial towers (see Fig. 10) still stand on top of the bins. ('New Zealand Coal' Vol. 28: No. 1, Autumn 1984.)*

History: The plinths were the bases for the gantry that supported the mine-to-bins conveyor, built c.1953. The single foundation was for the conveyor belt tensioner (Plates 30, 33 and 34). Besides bringing coal up from the mine, the conveyor could handle coal from stockpiles in the vicinity via a loading chute behind the building over the mine entrance (Brian Kerr, pers. comm.). The conveyor was demolished in 1989 (Gary Bainbridge, pers. comm.).

History: These foundations supported the conveyor to the truck loading bin (28) in use from 1968 until the close (Plates 30 and 33). The northernmost foundations could also have been bases for a tower on the aerial system that preceded the bin.

History: These foundations were built to load coal into road trucks after the aerial was retired in 1968. Coal reached the bin via a conveyor (27) from the main bins (26; Plates 30 and 33).

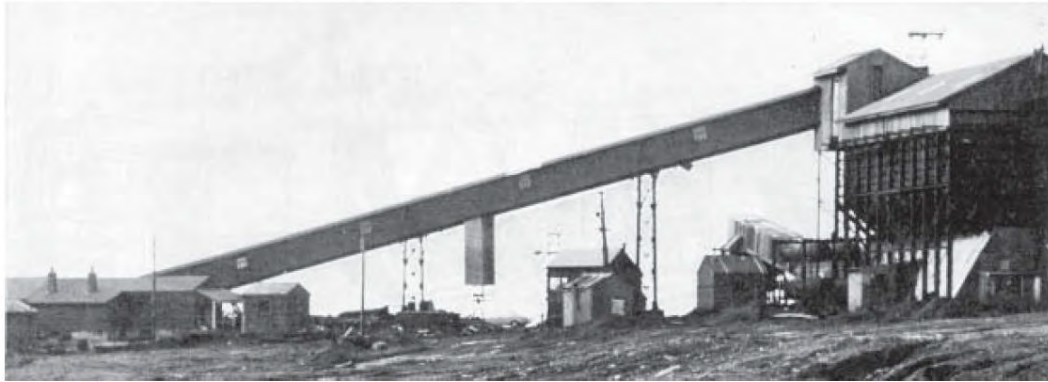
*Plate 33: The Sullivan mine from the south in 1977 with the mine conveyor gantry (25) going up to the bins (26) at right and the smaller gantry (27) connecting with the truck loading bin (28) beyond. At centre is the conveyor belt tensioner (25c) with gantry supports (25b and 25c) on either side. The winch shed (29) is right of the tensioner with the electrical substation (31) nearer the camera and the compressor shed/garage (33) farther right again, mostly obscuring the truck bin. At left are the mine offices which have disappeared entirely. (Peter Robertson photo from 'New Zealand Coal' Vol. 21: No. 4: Spring 1977.*

37). It had been used previously to haul tubs from the Cascade dip at Coalbrookdale. The winch was given to the Department of Conservation several years ago to restore on the Coalbrookdale site (Plates 33 and 34).

History: A shed containing transformer, switching gear and other electrical equipment stood here (Brian Kerr, pers. comm.). It was shown on the early mine layout (Fig. 10) and is visible in Plate 33.

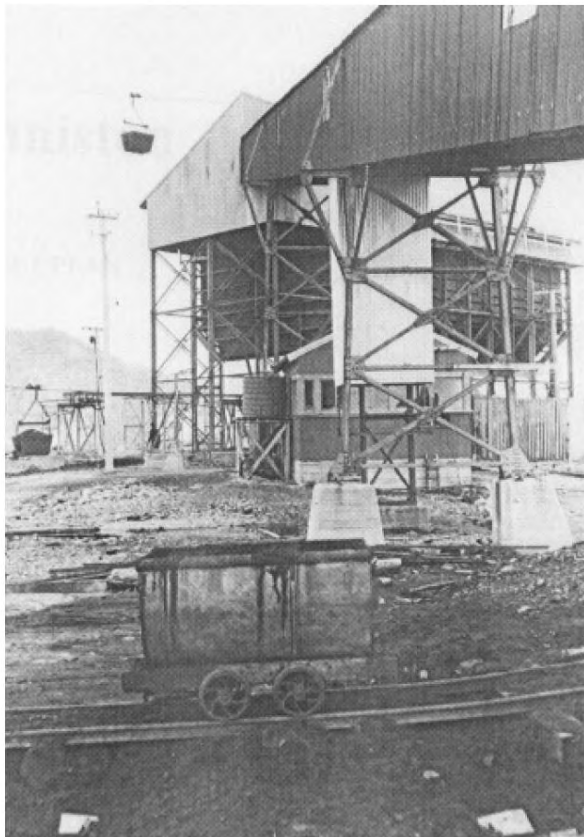
*Plate 34 (left): Sullivan conveyor gantry (25) and bins (26) during the pre-1968 period. At left a loaded bucket leaves the bins for the brakehead while an 'empty' passes over the roof of the bins, bound for the Whareatea. The space between the gantry foundations (25b) and tensioner (25c) has yet to be filled by the landing platform (30). The winch house (29) is partly visible.*

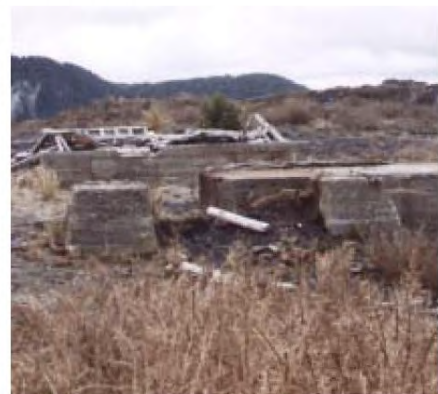
*Plate 35 (below): View from the same place today with features 25b, 29 and 30 most obvious.*

25) Conveyor gantry foundations: Three pairs of concrete plinths, (25a, b and c), 0.45 x 0.68m (Plate 35). There is also a concrete foundation (25d), 1.7 x 0.7m, in line with the space between the plinths, immediately south-east of foundation 30.

29) Winch house foundation: A concrete slab, 6 x 4.43m, with remnants of steel bolts embedded in it (Plate 35).

30) Landing platform: A concrete slab 4 x 3.3m with four threaded rods sticking out of the middle (Plate 35).

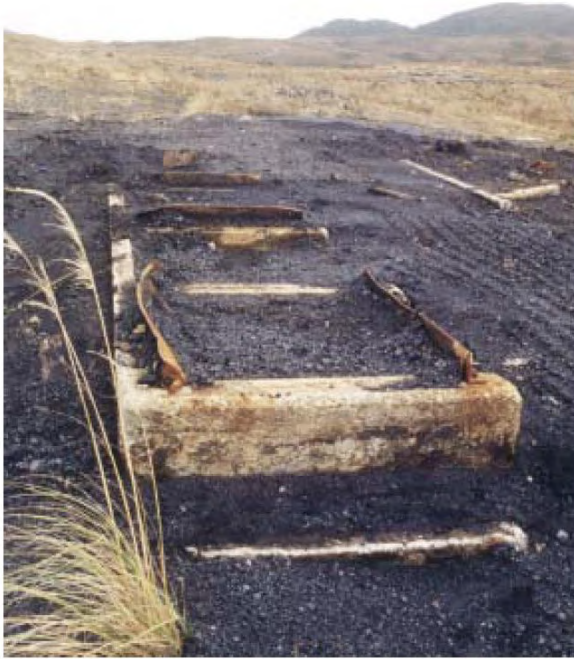
*Plate 36: Looking south along the bucket loading shunt foundations at the Sullivan bins site (26). The western perimeter of the foundation is at the far right where the angled concrete foundation ends.*

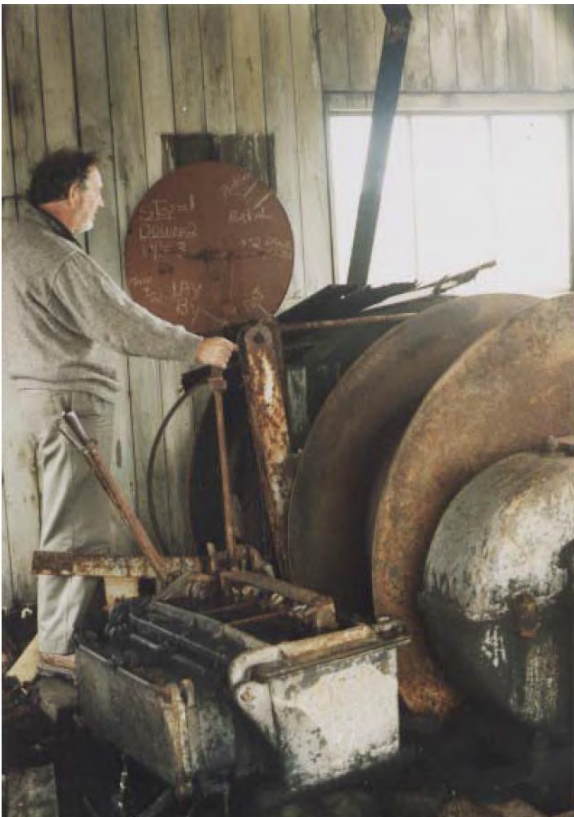
*Plate 37: The Sullivan mine winch shortly before removal from its site (29) to which it may be returned. The winch shed has been destroyed.*

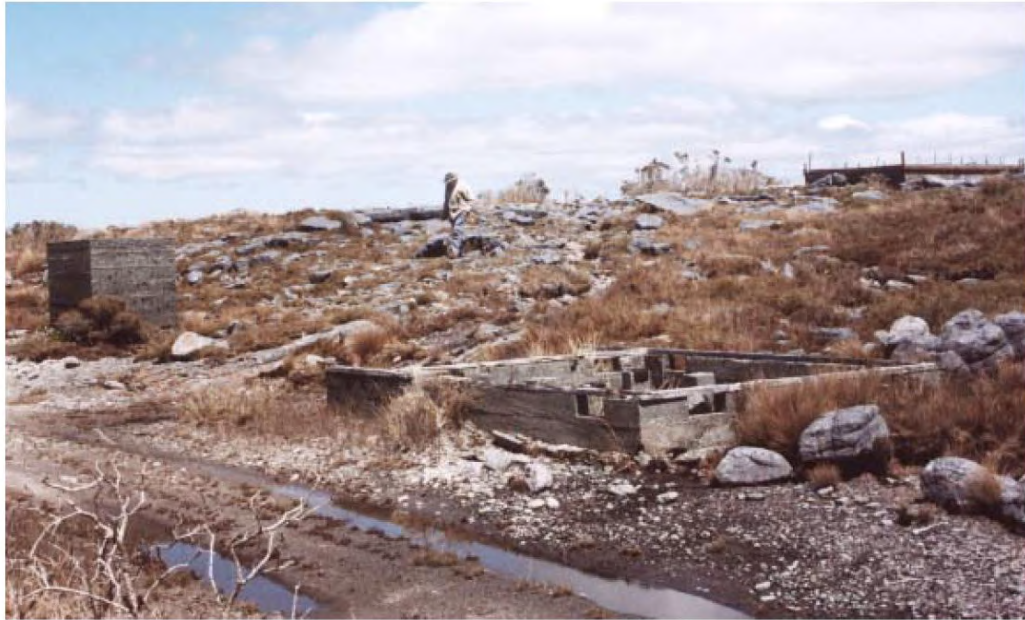
*Plate 38: The concrete shell of the Sullivan detonator magazine (36) and the foundation of the original explosives magazine (35). The concrete water tank (34) is on the sky line.*

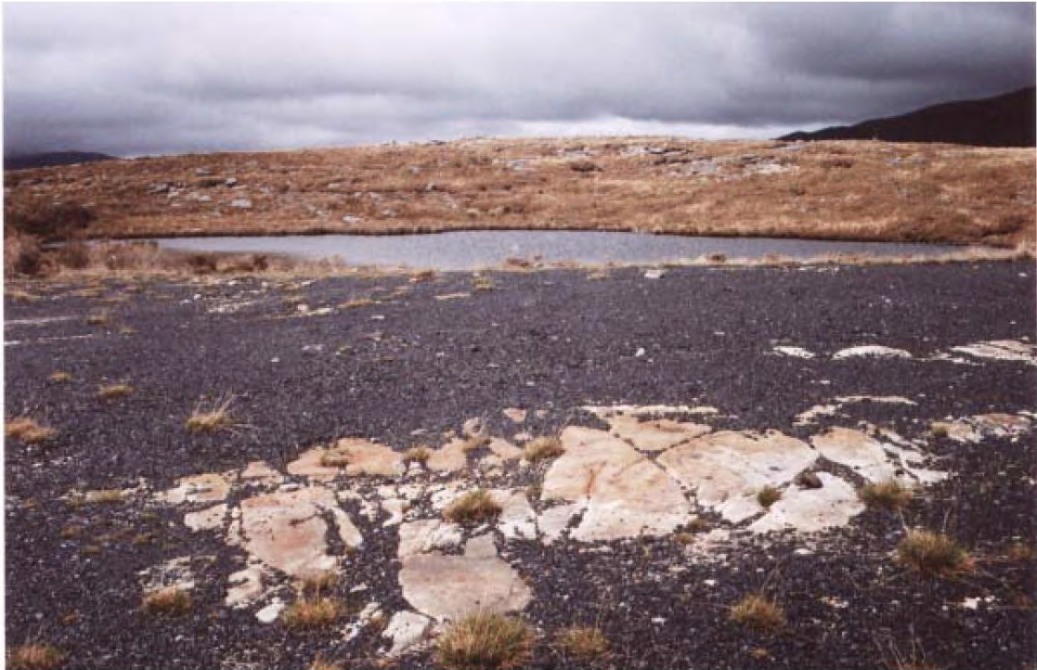
*Plate 40: Fines from one of many Sullivan coal dumps spread almost to the shore of the reservoir referred to as Lake Connew (37). A pump shed foundation (38) lies amidst the growth at left.*

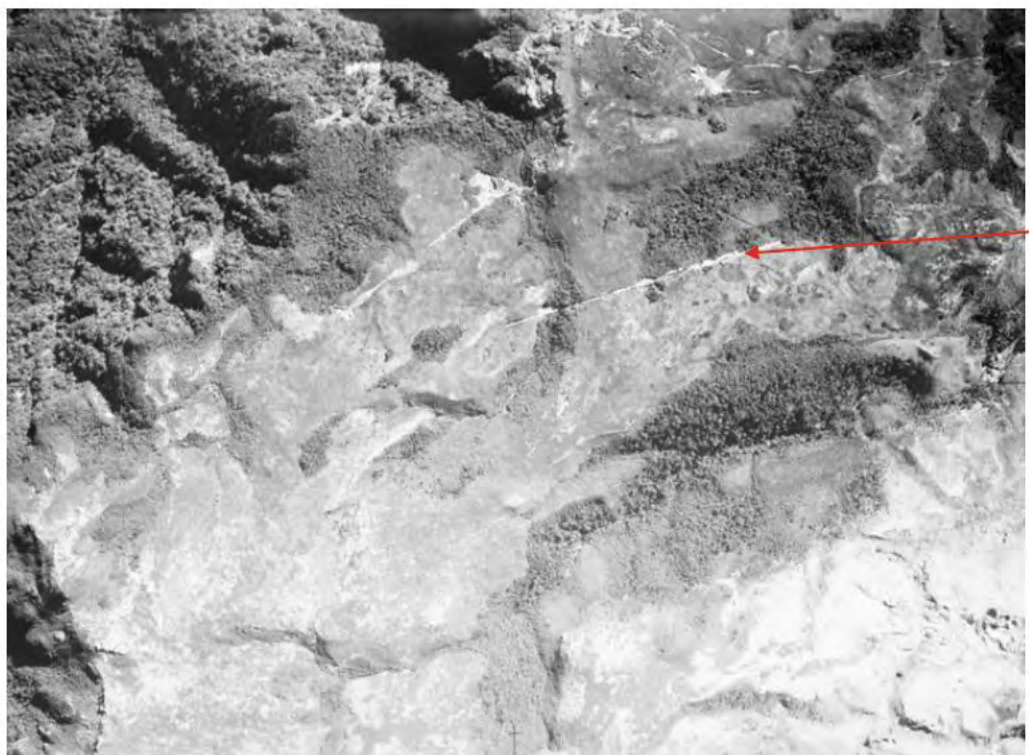
**1943 aerial photograph showing the cutting of Jorgen's Drive (arrowed) (Retrolens SN264 Run No. 778 Photo. 4)**

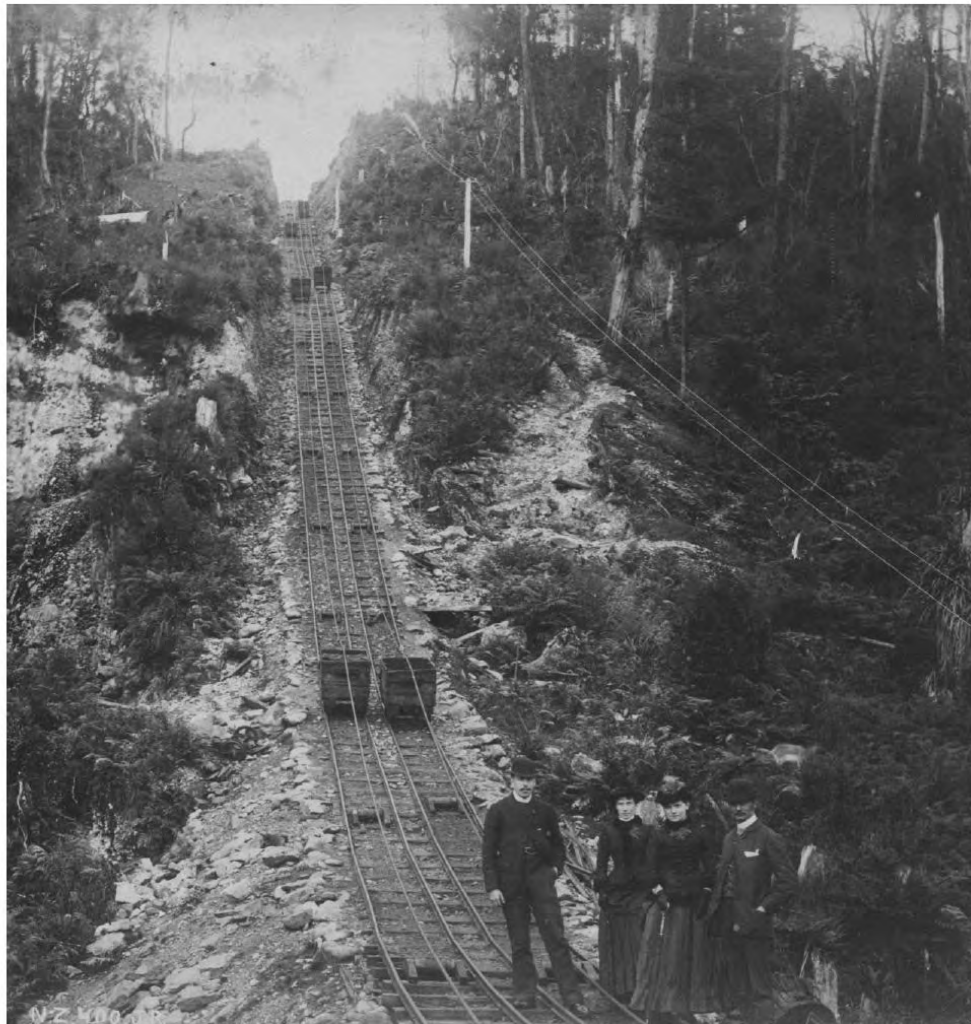
**Plate 1:** This photograph is believed to be of the Koranui incline as the Koranui incline was the only Buller incline with an overhead rope. PAColl-9487, Alexander Turnbull Library.
