**BULLER PLATEAUX CONTINUATION PROJECT,  
WESTPORT, SOUTH ISLAND:  
ARCHAEOLOGICAL AND HISTORIC HERITAGE  
ASSESSMENT  
(APPENDIX: HISTORICAL AND ARCHAEOLOGICAL  
BACKGROUND)**

Prepared for Bathurst Resource Ltd

March 2026

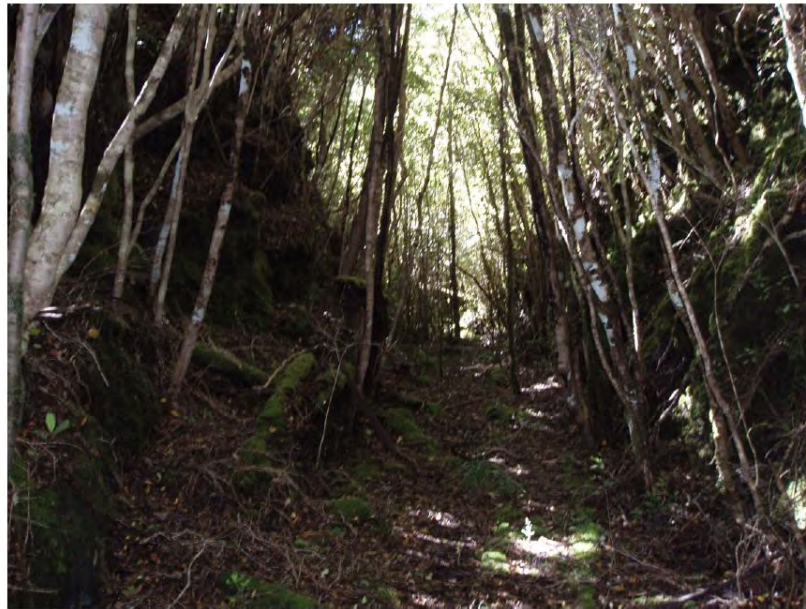
**Plate 2:** The incline running through a cutting (waypoint 922).

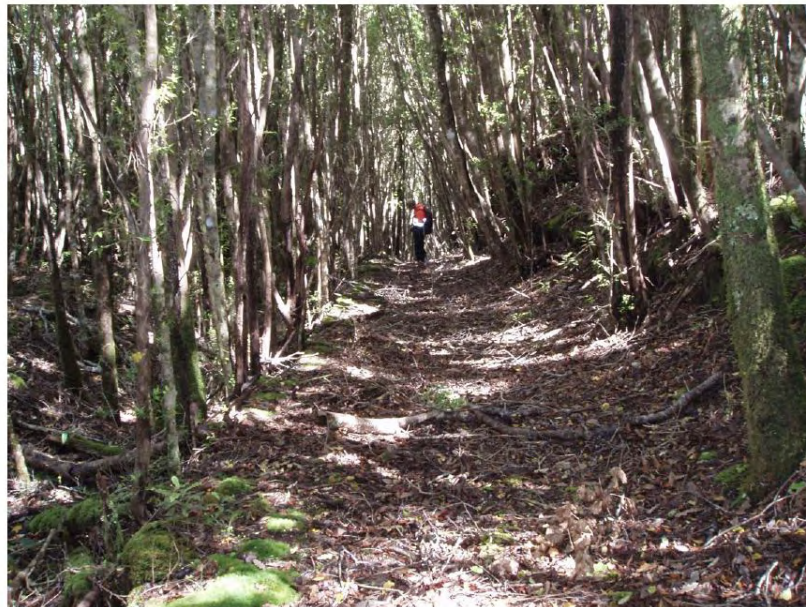
**Plate 3:** The incline on a benched formation (waypoint 936).

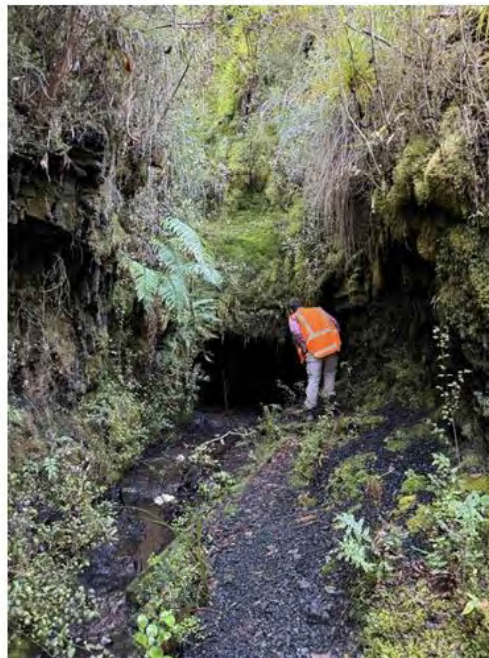
Northerly mine entrance at Beggs Outcrop

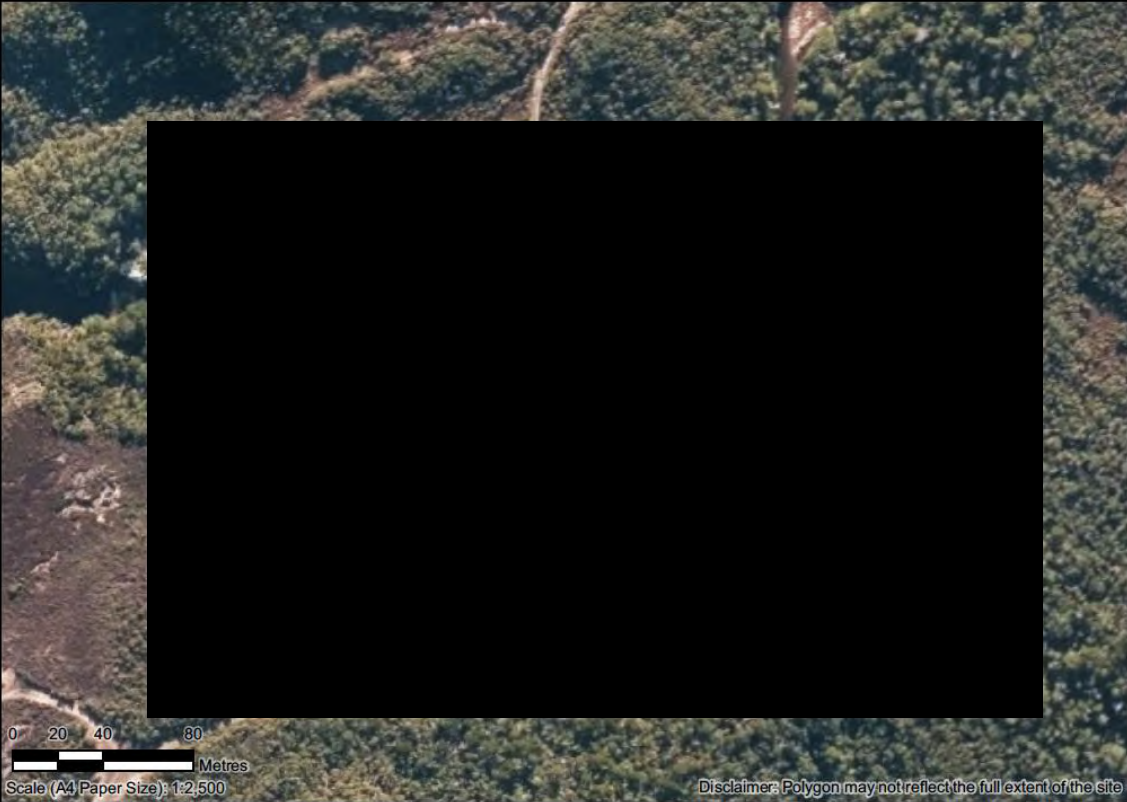
| <h2 style="margin: 0;">Site Record Form</h2> | | |
|---|---|--|
| <b>Brief Description:</b><br>Area of open cast mining: cables of swing bridge, spoil heaps, metal artefacts | | |
| <b>Condition of Site when last visited:</b><br>Poor | | |
