Re: Preliminary and Detailed Site Investigations for the Sunfield Urban Development Area, Papakura.

Job Reference FES 1804.001 (R1)

Please find a summary of the Preliminary Site Investigations and Detailed Site Investigations, conducted for the nineteen properties located within the proposed Sunfield Urban Development Area (UDA), Papakura.

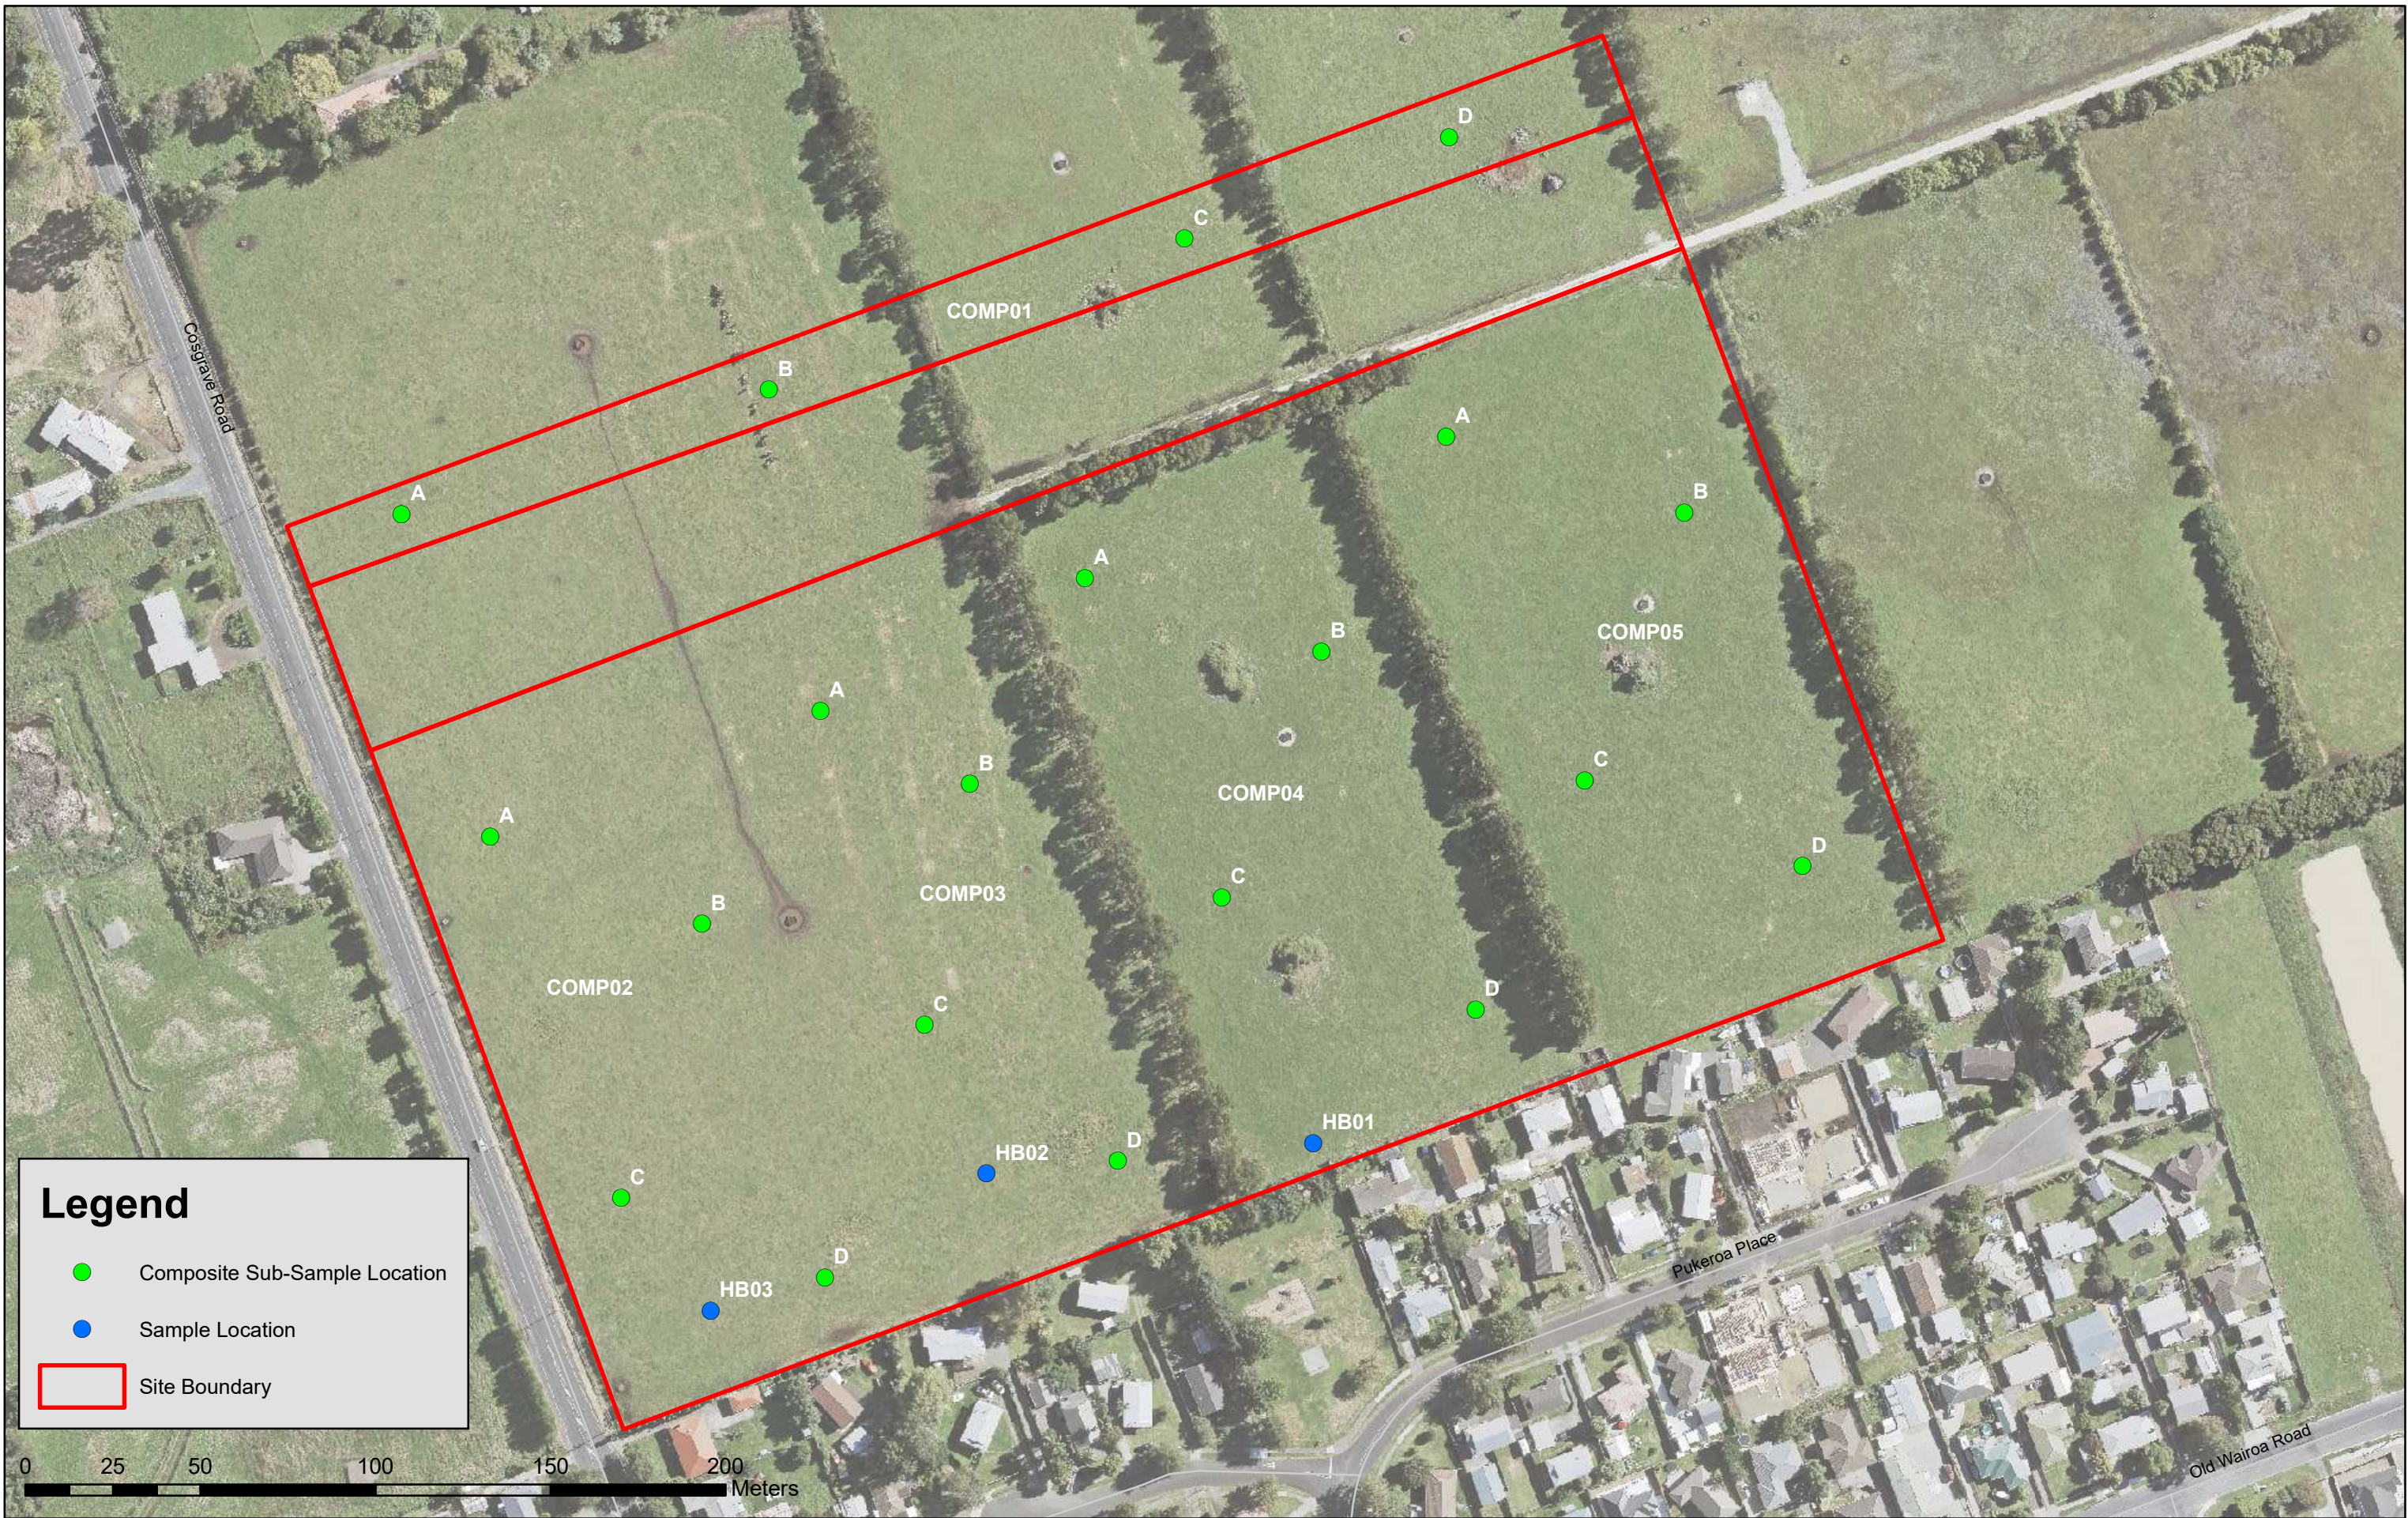
Figure 2 - Sample Location Plan

<p>Focus Environmental Services Limited PO Box 11455 Ellerslie Auckland 1542</p> <p>Ph: +64 9 579 4155 www.focusenvironmental.co.nz</p>	<p>Winton Land Limited 55 & 55A Cosgrave Road Sunfield Urban Development Area Papakura Auckland</p>	<p>Figure 2: Sample Location Plan Detailed Site Investigation</p>

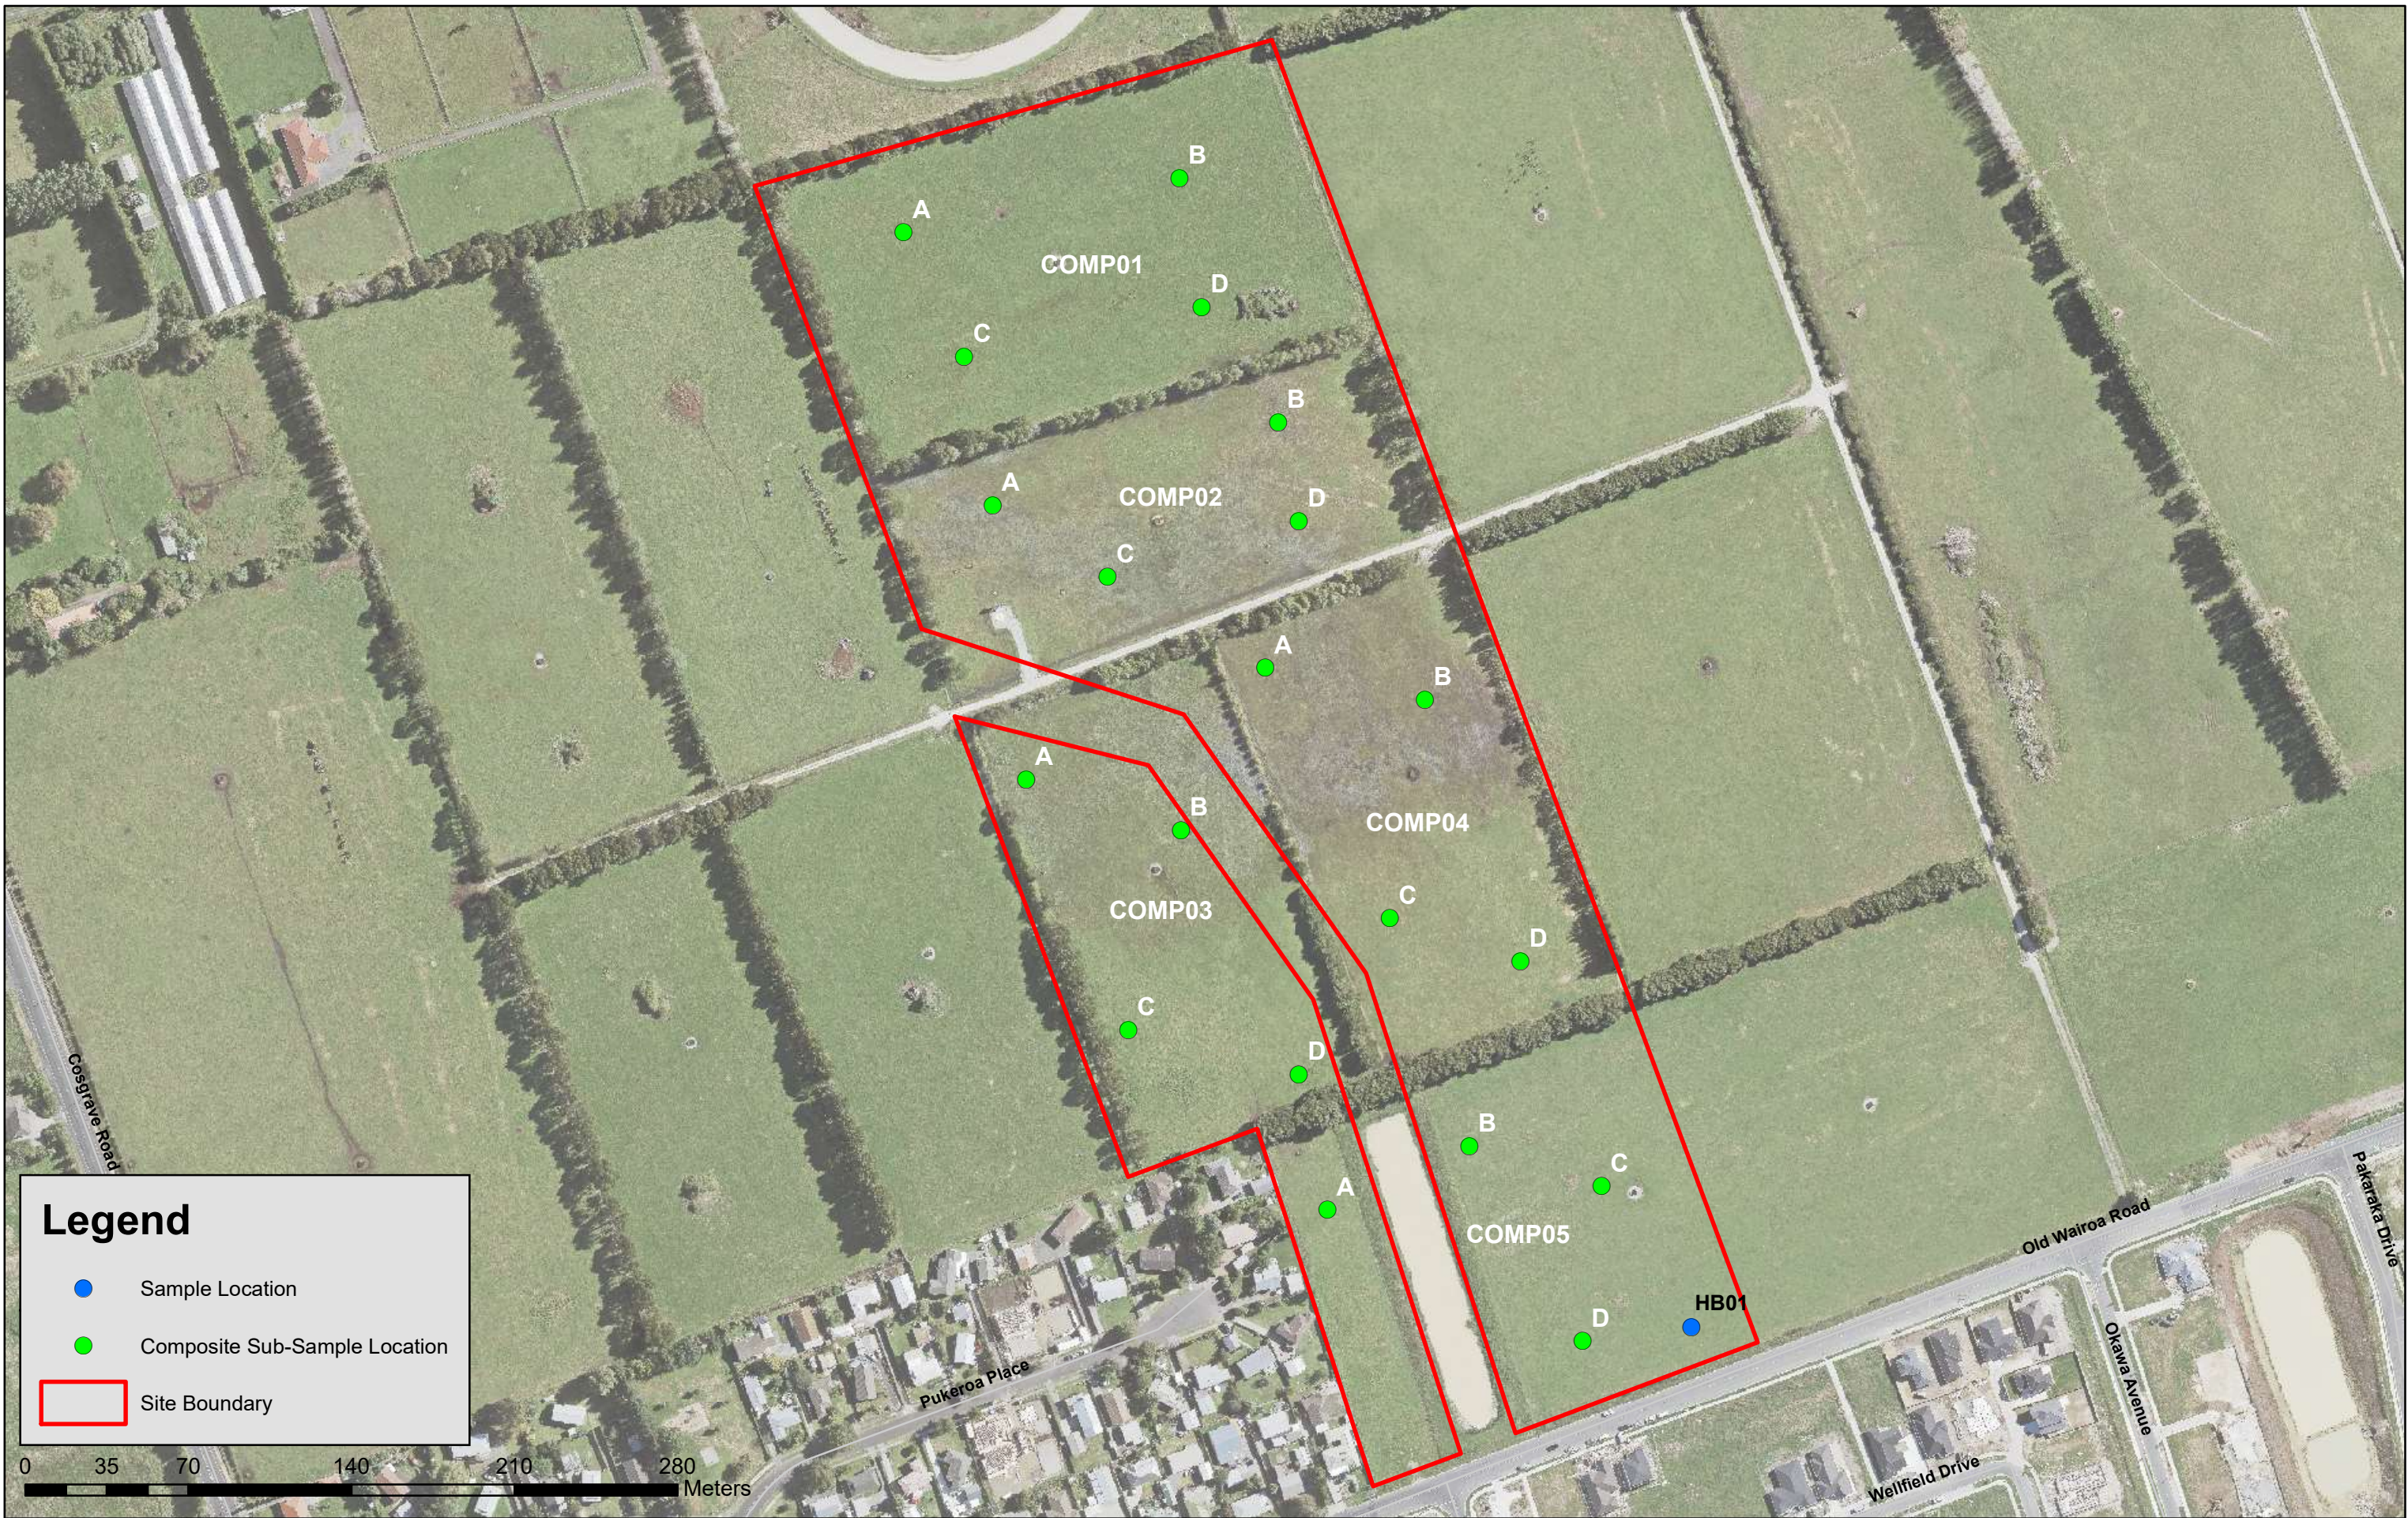
<div>Focus Environmental Services Limited PO Box 11455 Ellerslie Auckland 1542 Ph: +64 9 579 4155 www.focusenvironmental.co.nz</div>	<div>Winton Land Limited</div> <div>Sect 5 SO 495342, Sect 6 SO 495342 Old Wairoa Road Sunfield Urban Development Area Papakura Auckland</div>	<div>Figure 3: Sample Location Plan</div> <div>Detailed Site Investigation</div>

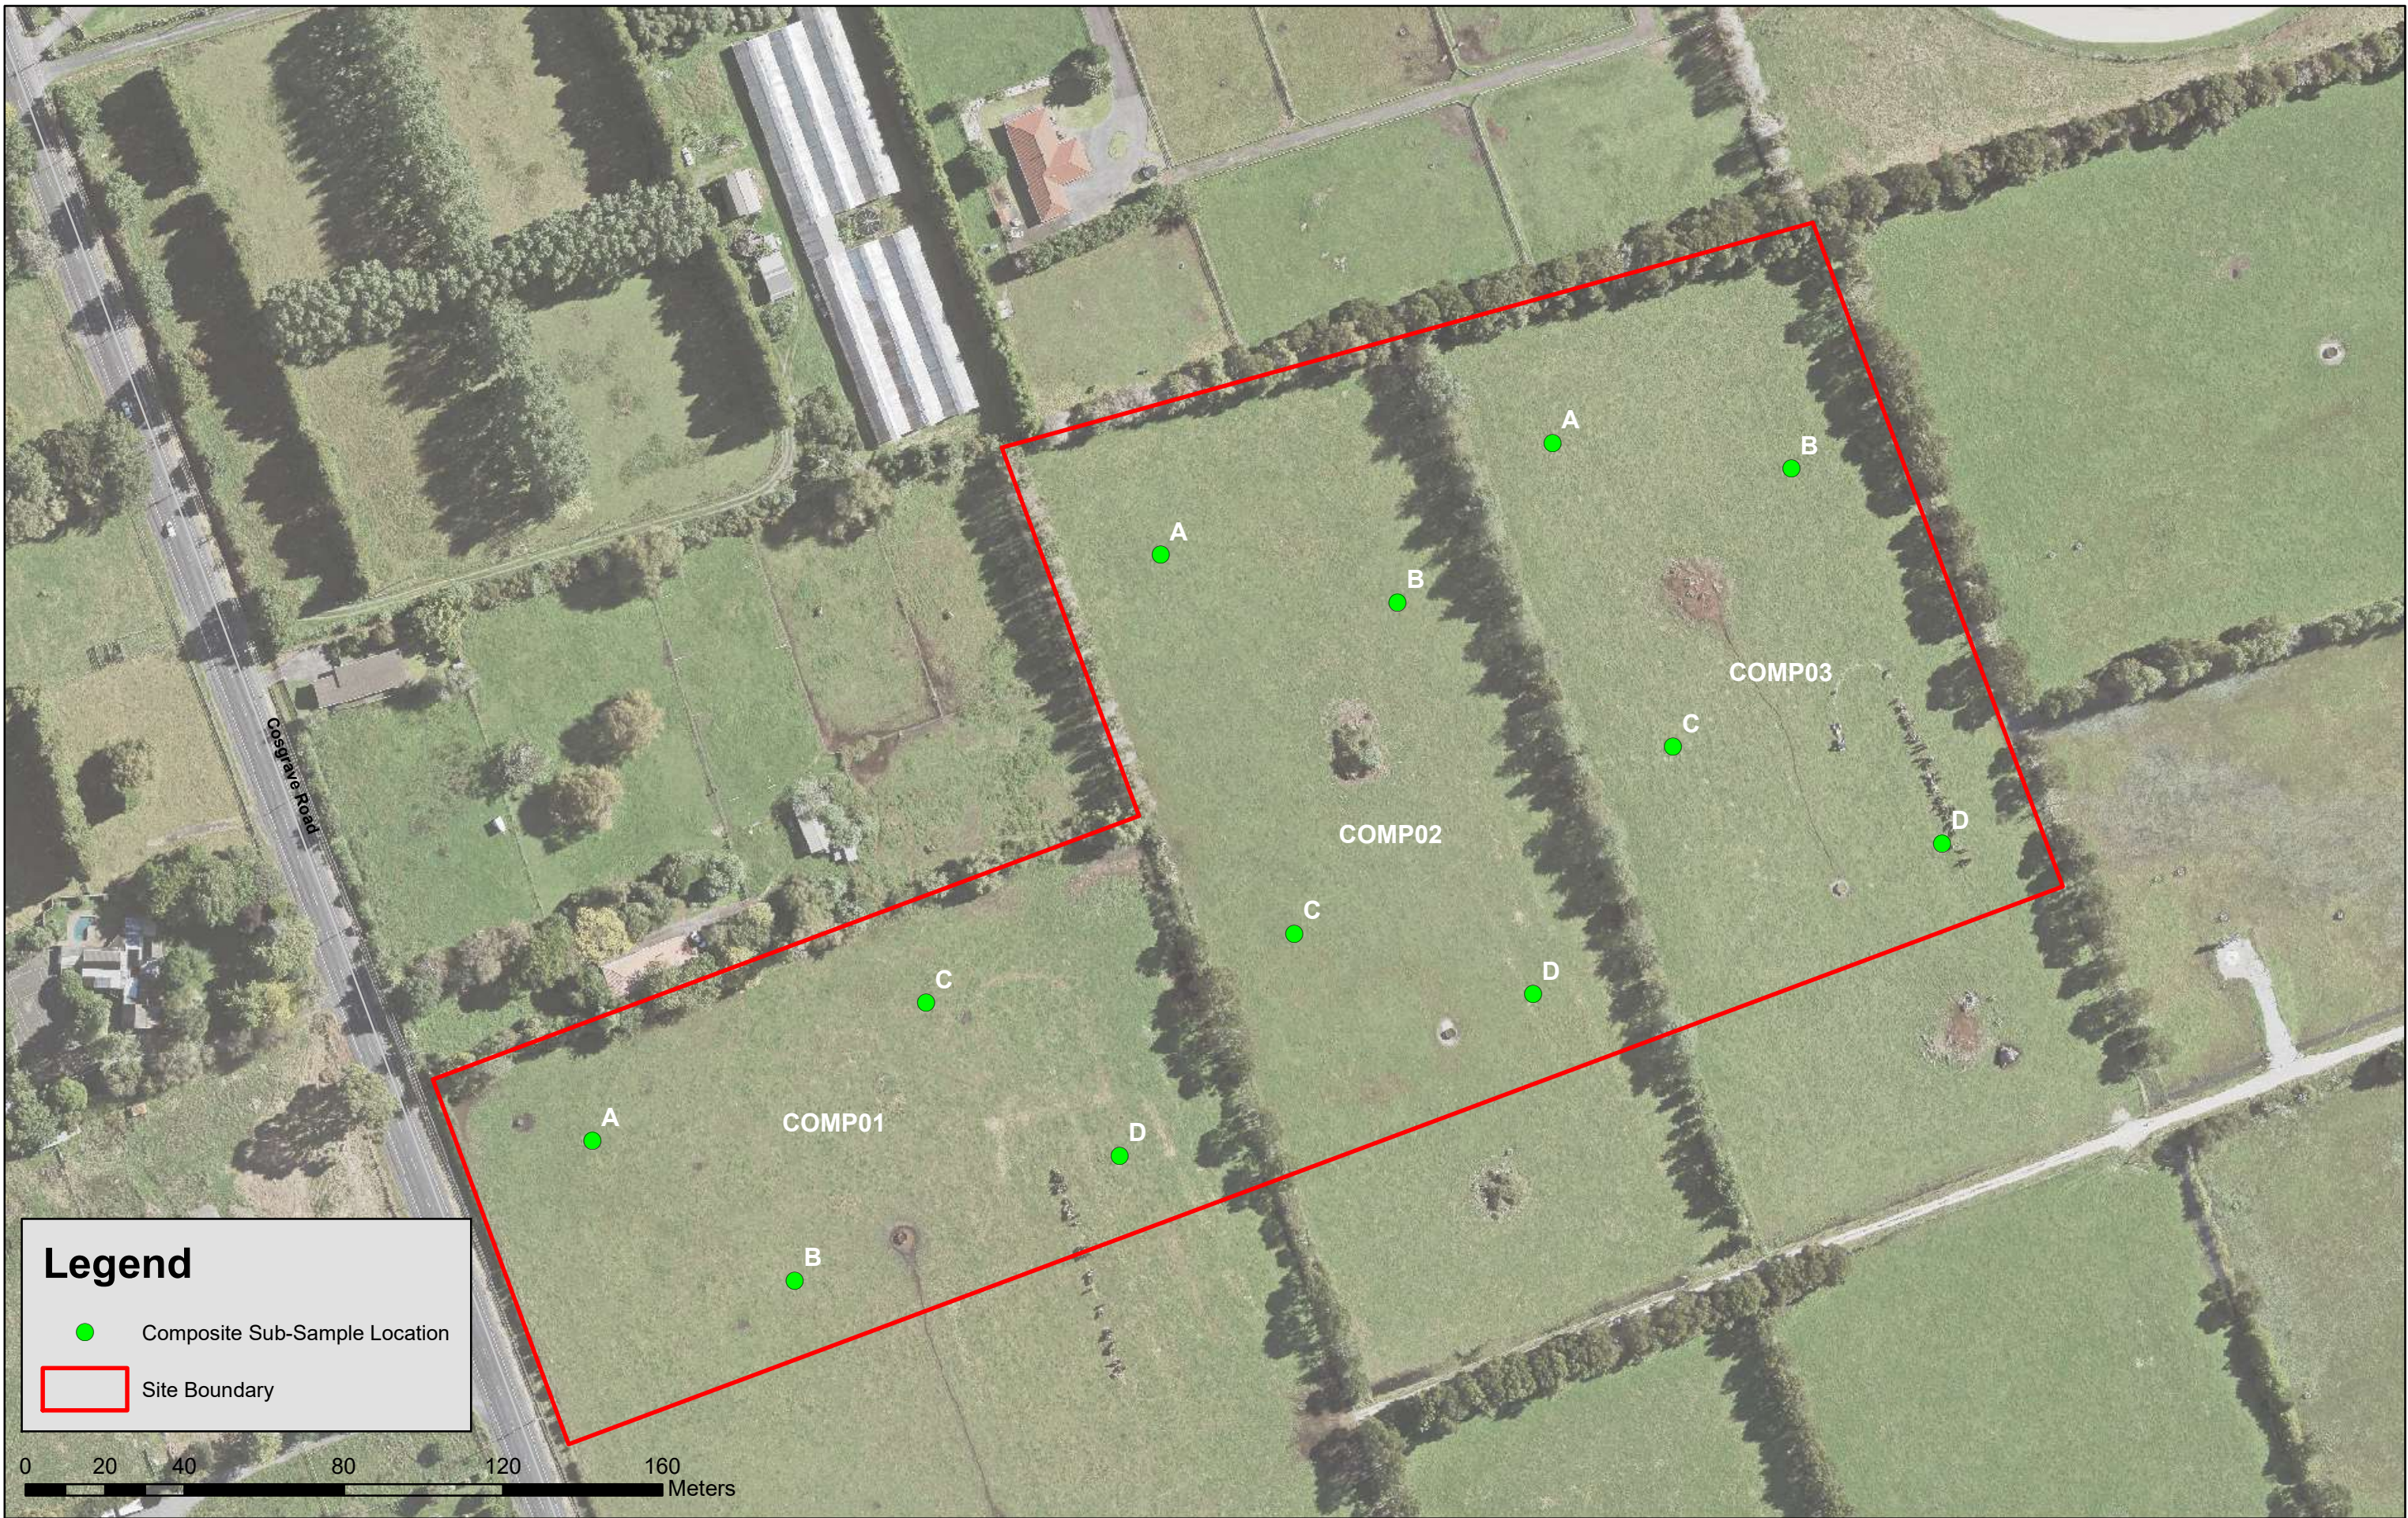
Figure 2 - Sample Location Plan

<p>Focus Environmental Services Limited PO Box 11455 Ellerslie Auckland 1542</p> <p>Ph: +64 9 579 4155 www.focusenvironmental.co.nz</p>	<p>Winton Land Limited Lot 1 DP 55480 Cosgrave Road Sunfield Urban Development Area Papakura Auckland</p>	<p>Figure 2: Sample Location Plan Detailed Site Investigation</p>

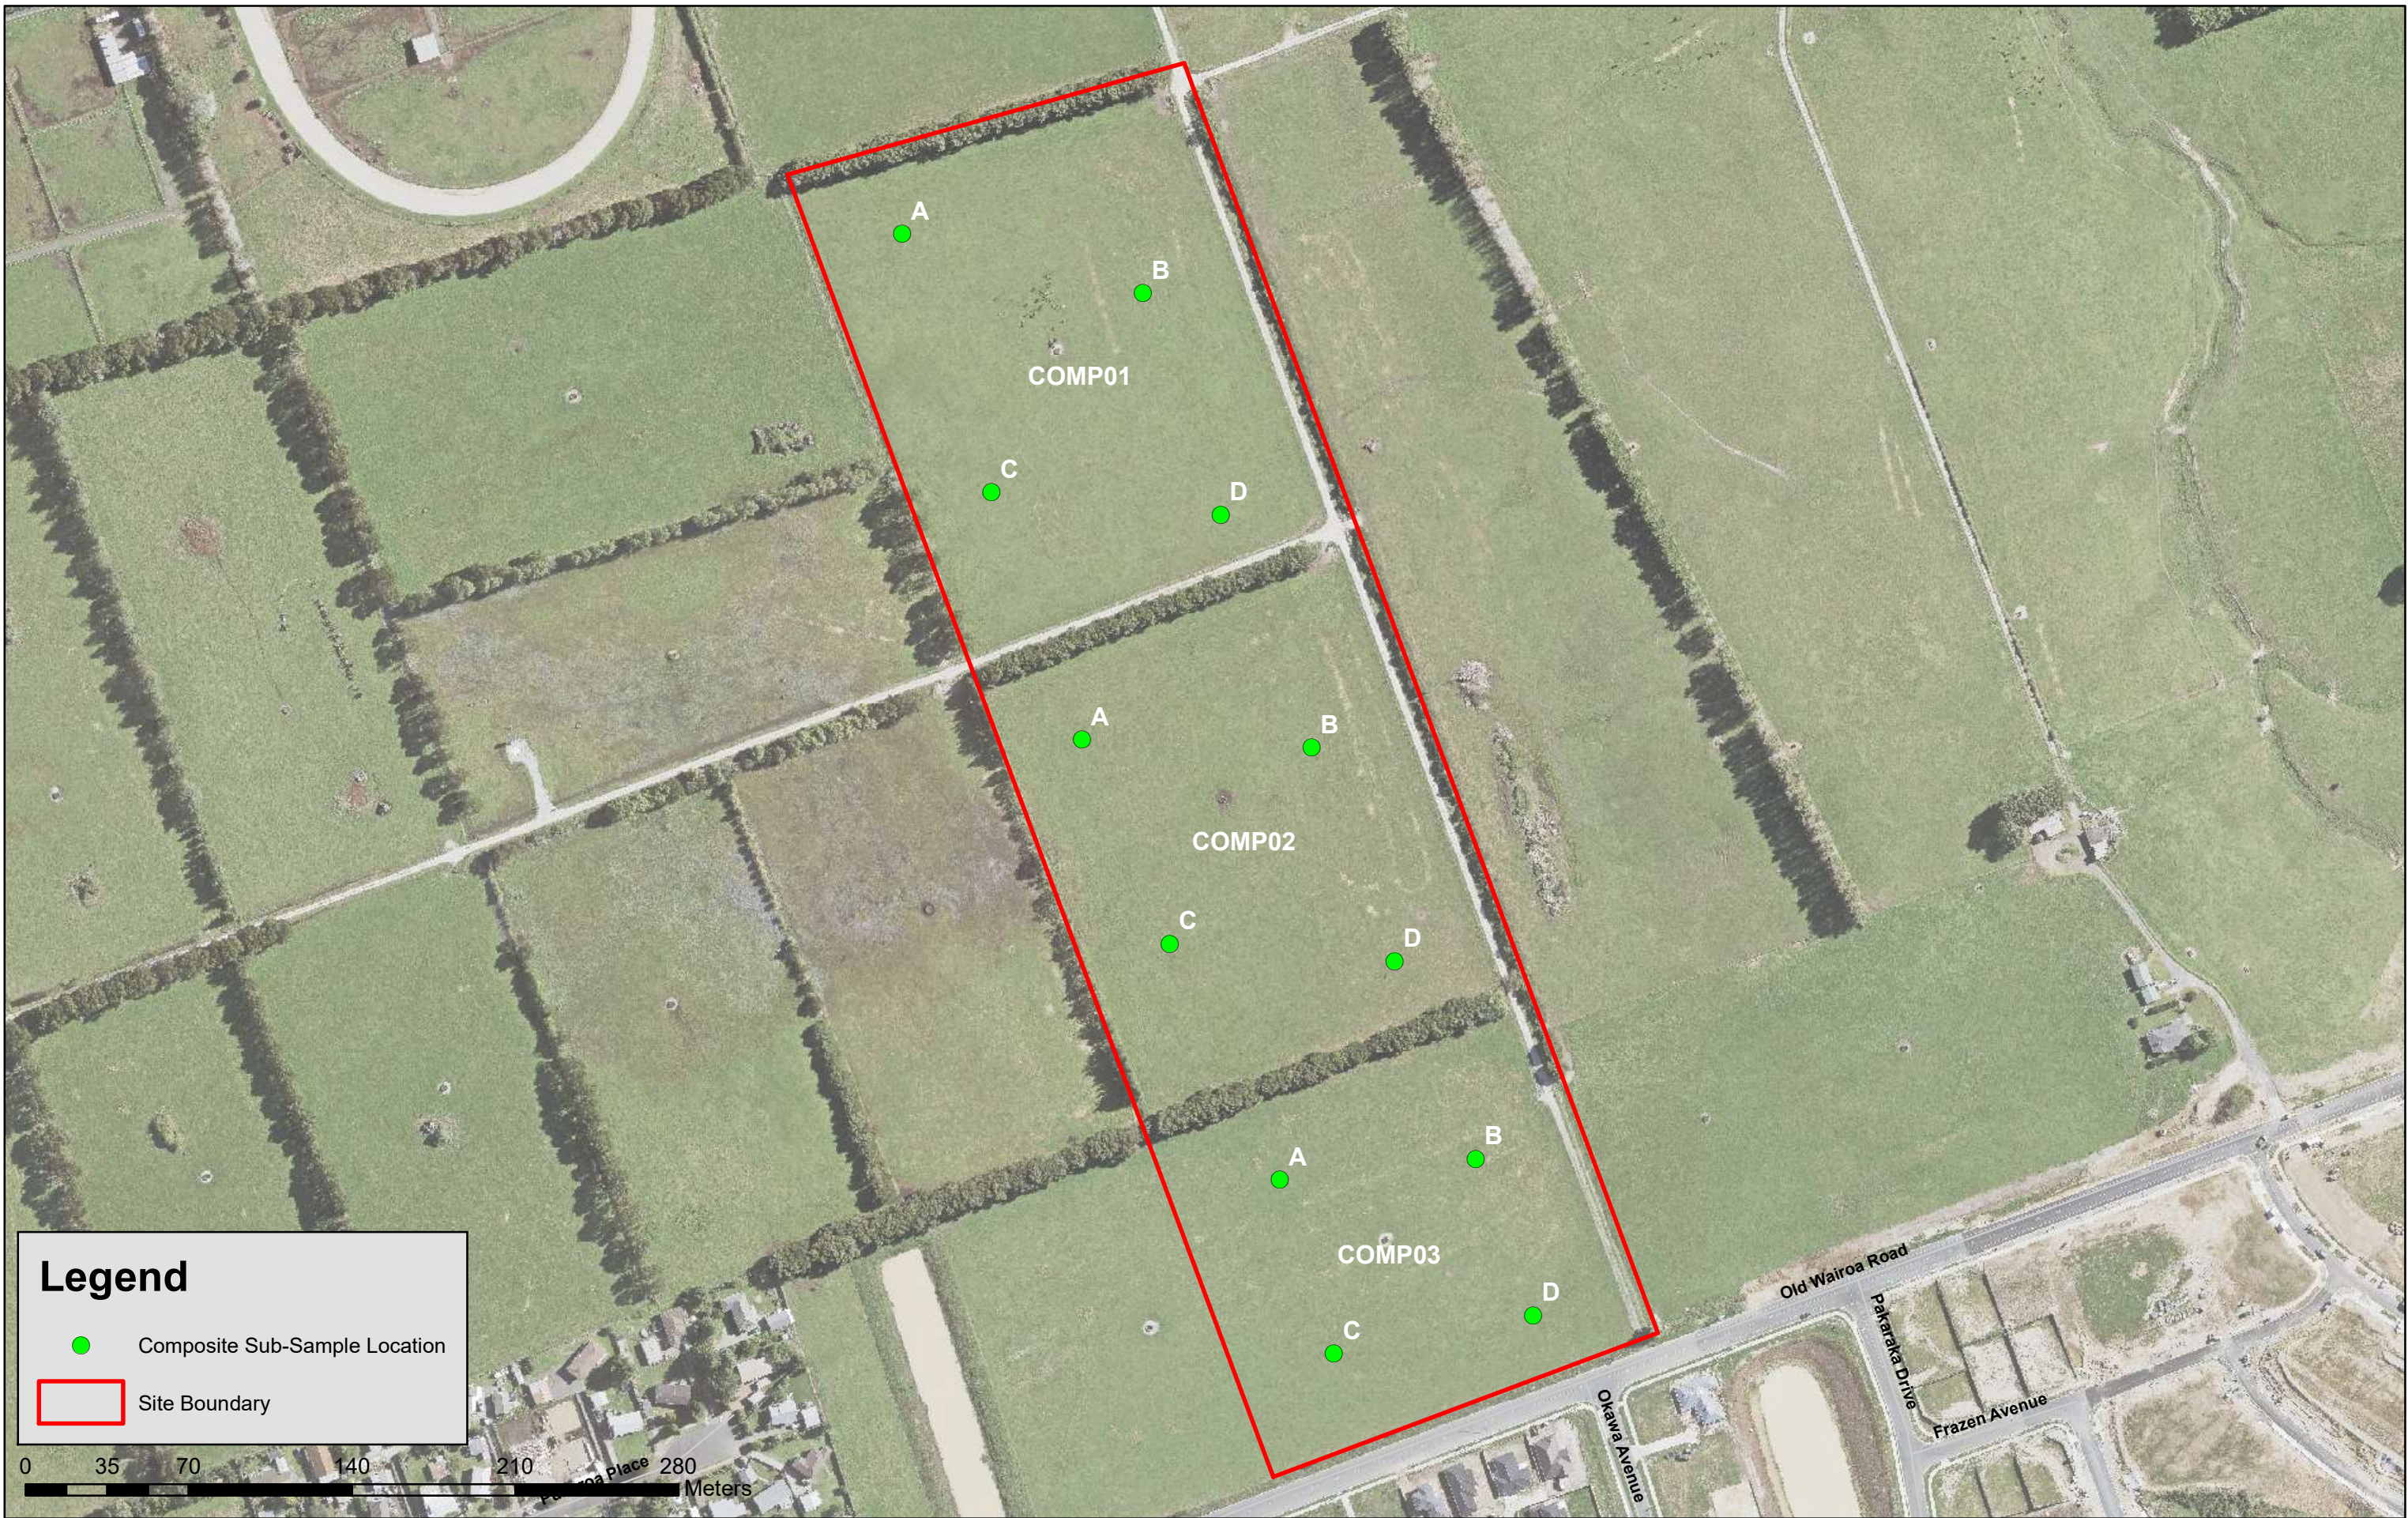
● Composite Sub-Sample Location
