# Wainui Subdivision Wetland Assessment

# Hydric Soil & Hydrology Tool Assessments

Vineway Limited

WWLA1147

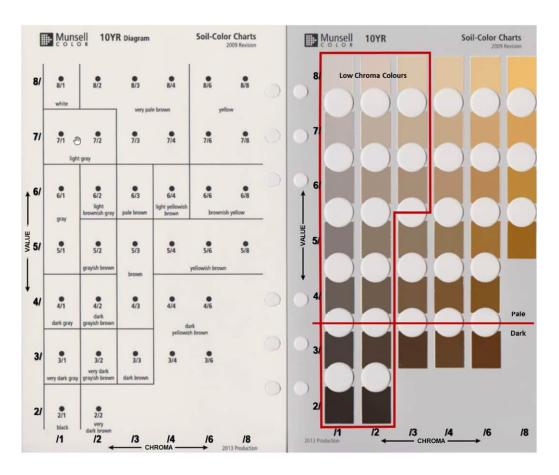
Figure 4. 10YR hue page from a soil colour chart.

Describing a colour requires three components: hue, value, and chroma. Hue refers to the colour (e.g. red, orange, yellow), value describes how light or dark the colour is, and chroma rates how bright or vibrant the colour is.

Soil colour<sup>4</sup> is one of the key defining feature for identification of hydric soils because the presence of water within the soil profile will affect the colour of soils, depending on the duration of anaerobic conditions. Soils that are subject to prolonged anaerobic conditions with the matrix iron reduced tend to have matrix with low chroma colours. The low chroma colour are typical of hydric soils, as shown in **Figure 4**. Note that dark topsoil colour values of 3 or less are not good indicators of hydric soils as many topsoils have colours in this range.

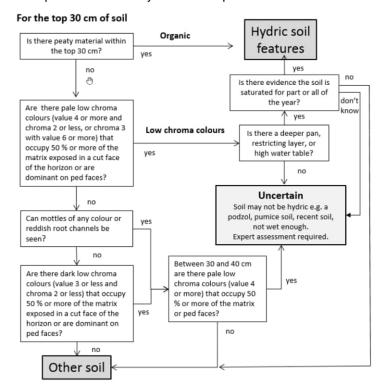
Figure 5. Simple key to identifying hydric soils.

A simple indicator for hydric soils is provided in Landcare Research (2018), which is reproduced in Figure 5.

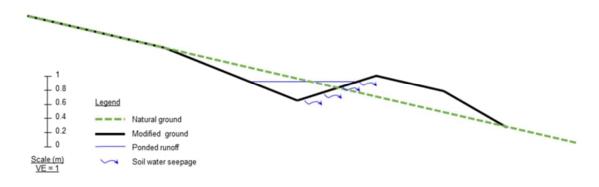
Figure 6. Cross section showing conceptual contour bund design.

To construct the bunds, it is recommended that a small swale following the natural contour of the slope will be excavated, with a maximum depth of approximately 0.3 m and swale width of up to 2 m. The material removed to create the swale would then be used to raise the ground level for the bund, minimising work involved. **Figure 6** shows a conceptual schematic of each bund, with pooled water during or after a storm.

A total of 14 bunds have been recommended within the non-hydric soil areas, at roughly 2 m change in elevation intervals. Each bund follows the natural contour of the slope with each end turned uphill to prevent water from flowing out of the bund – i.e. the only way runoff can migrate downslope is via sub-soil seepage or overtopping of the bunds during large storm events (refer to **Figure 7** to **Figure 9**). **Table 9** summarises the sites requiring drainage intervention.

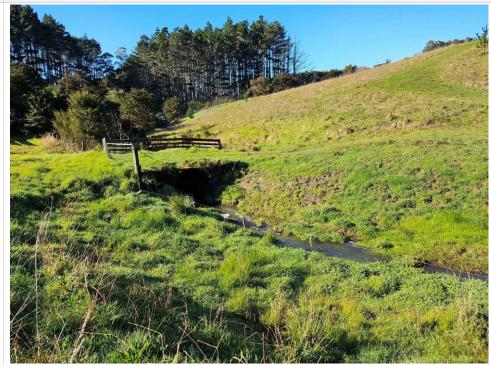
Photograph 9: Site 4 (looking towards culvert from test pit).

Silty CLAY, light grey, with light yellowishbrown streaks. Moderately moist, moderate to high plasticity.
