**Downtown Carpark Site
Development**

**Preliminary Detailed Site Investigation
Report**

Prepared for
Precinct Properties NZ Limited

Prepared by
Tonkin & Taylor Ltd

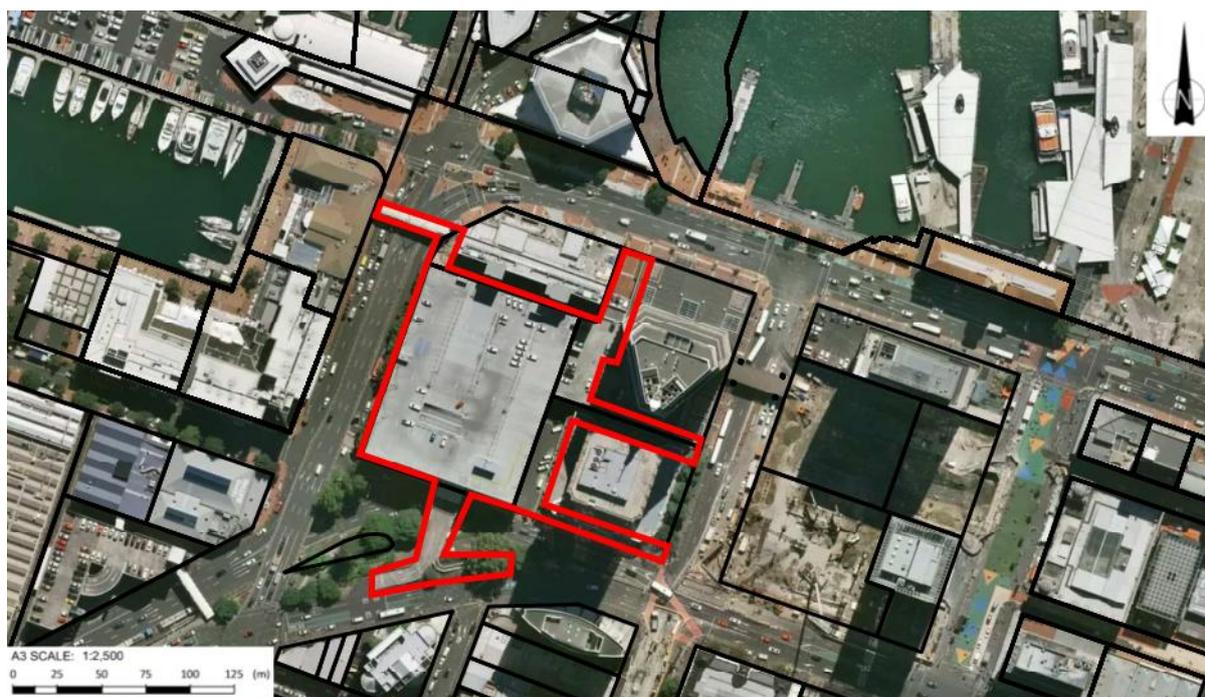
Figure 1.1: Site location shown in red outline (Basemap Source: LINZ Creative Commons Attribution 3.0 New Zealand)

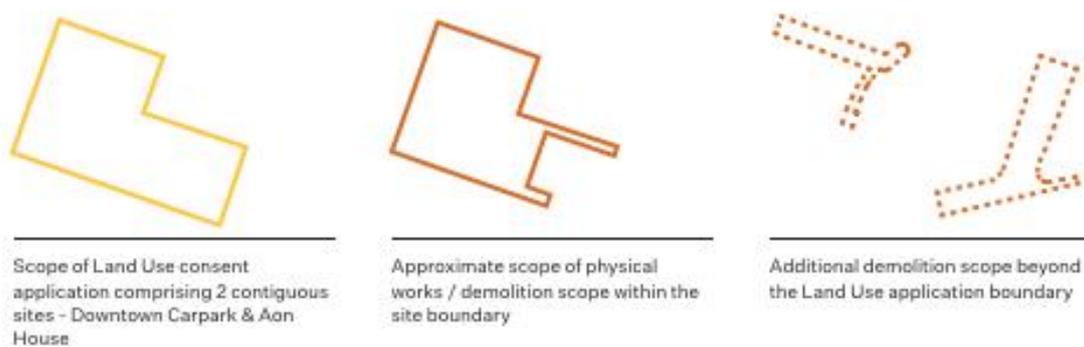
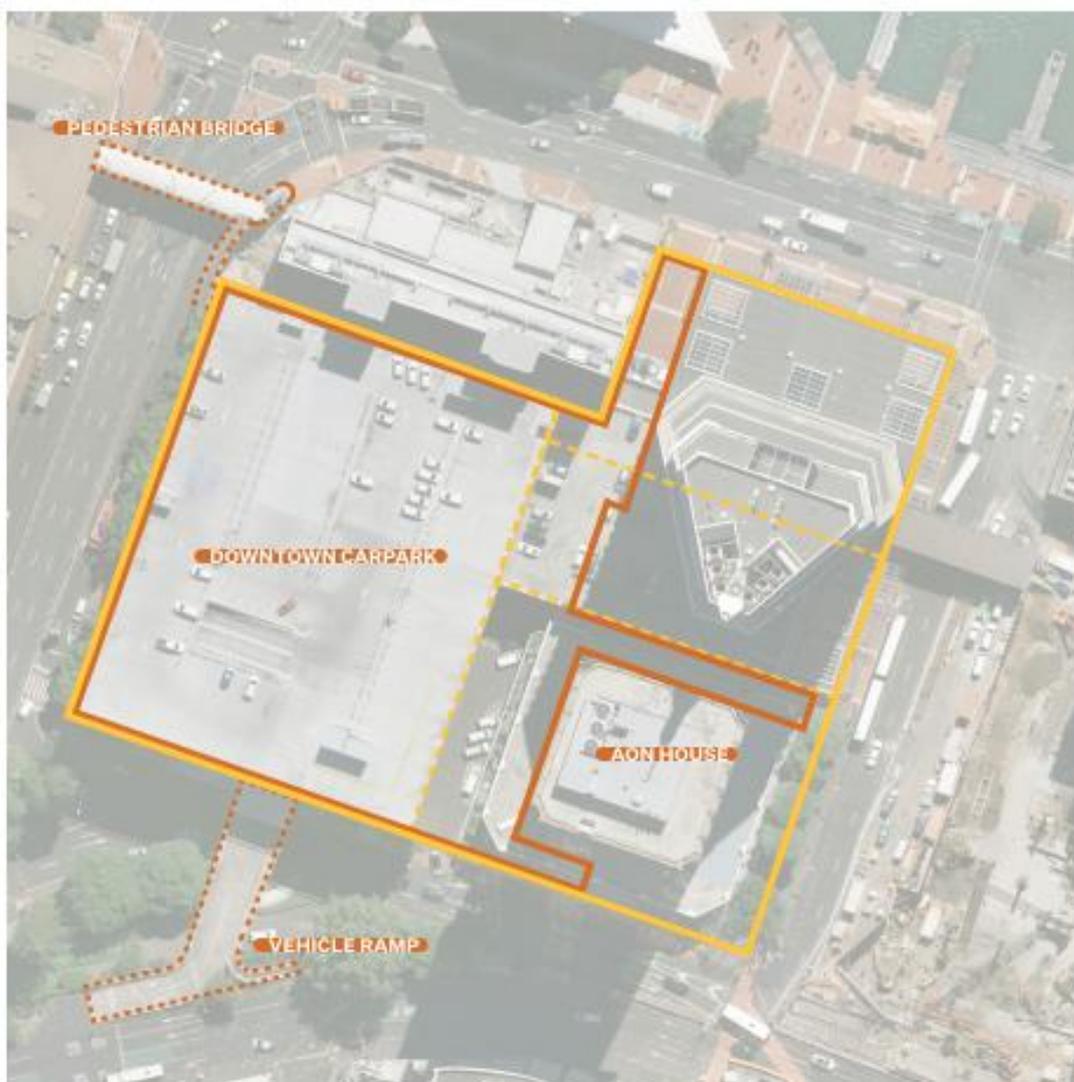
Figure 2.1: Site location and extent of physical works shown in solid orange outline (Source: Downtown Carpark Site Development Architecture & Landscape Report, 3 October 2025)

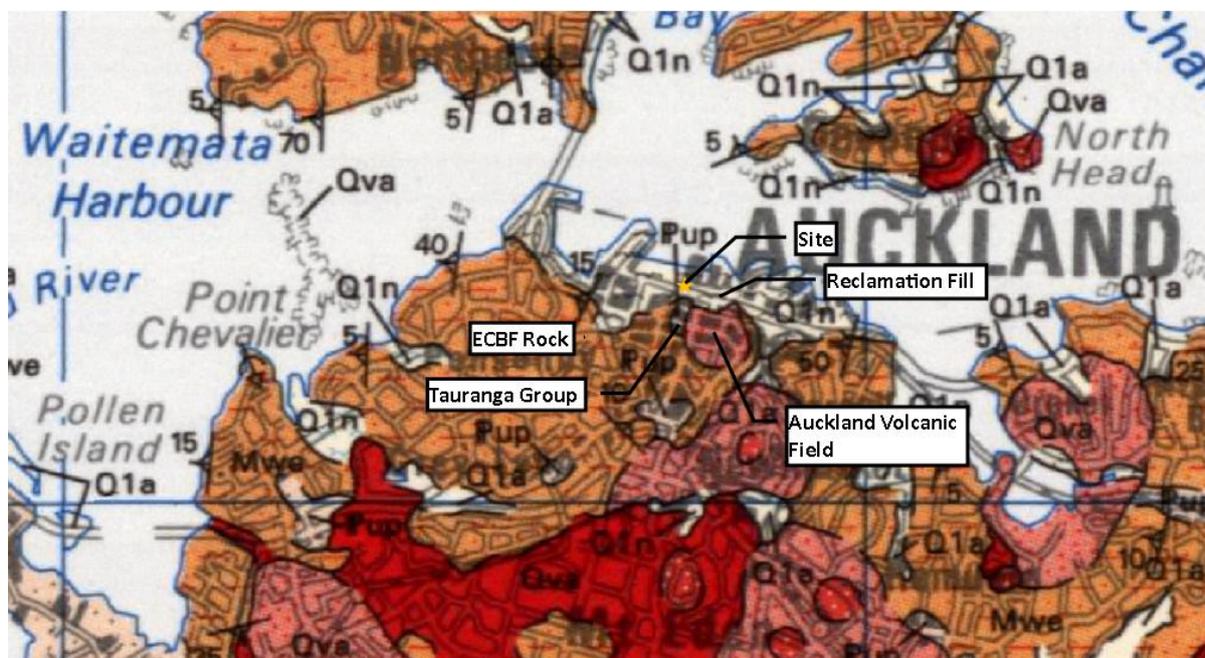
Figure 2.2: Published Geological Map (Source: Edbrooke, 2001)

The old relict sea cliffs of the Waitemata Harbour are located immediately on the south side of Custom Street West. A wave cut platform extended over much of the site and the area has been subject to reclamation in the period 1860 – 1920. The reclamation fill has multiple sources including material excavated from local ridges, dredging and demolition materials. The reclamation fill is underlain by a thin layer of recent marine sediments and Pleistocene sediments of the Tauranga Group². The recent marine sediments consist predominantly of firm to stiff sandy silt with significant amount of organic matter. The Pleistocene sediments consist predominantly of stiff silts with some organic matter.

Beneath the sediments, East Coast Bays Formation (ECBF), part of the local basement Waitemata Group rocks, underlies much of the Urban Auckland area and consists predominantly of an alternating sequence of siltstone and lithic sandstone. A relatively thin layer (< 2 m) of extremely weathered material mantles the unweathered rock. The total thickness of this group is inferred to be greater than 300 m.

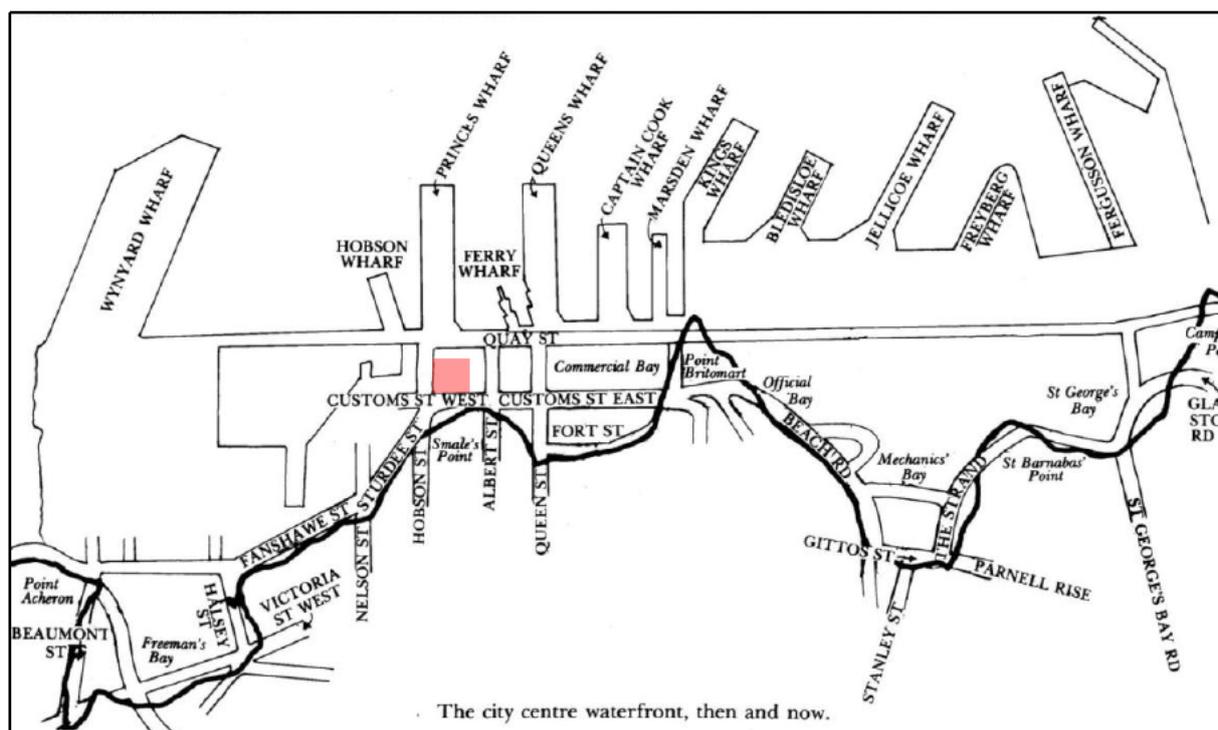
Figure 3.1: Reclamation and historic features in project area (from Barnett, 1981⁴)

Reclamation to provide additional land, in addition to deeper harbours, was a central part of the early vision for Auckland. Figure 3.1 shows the original coastline relative to the subject site.

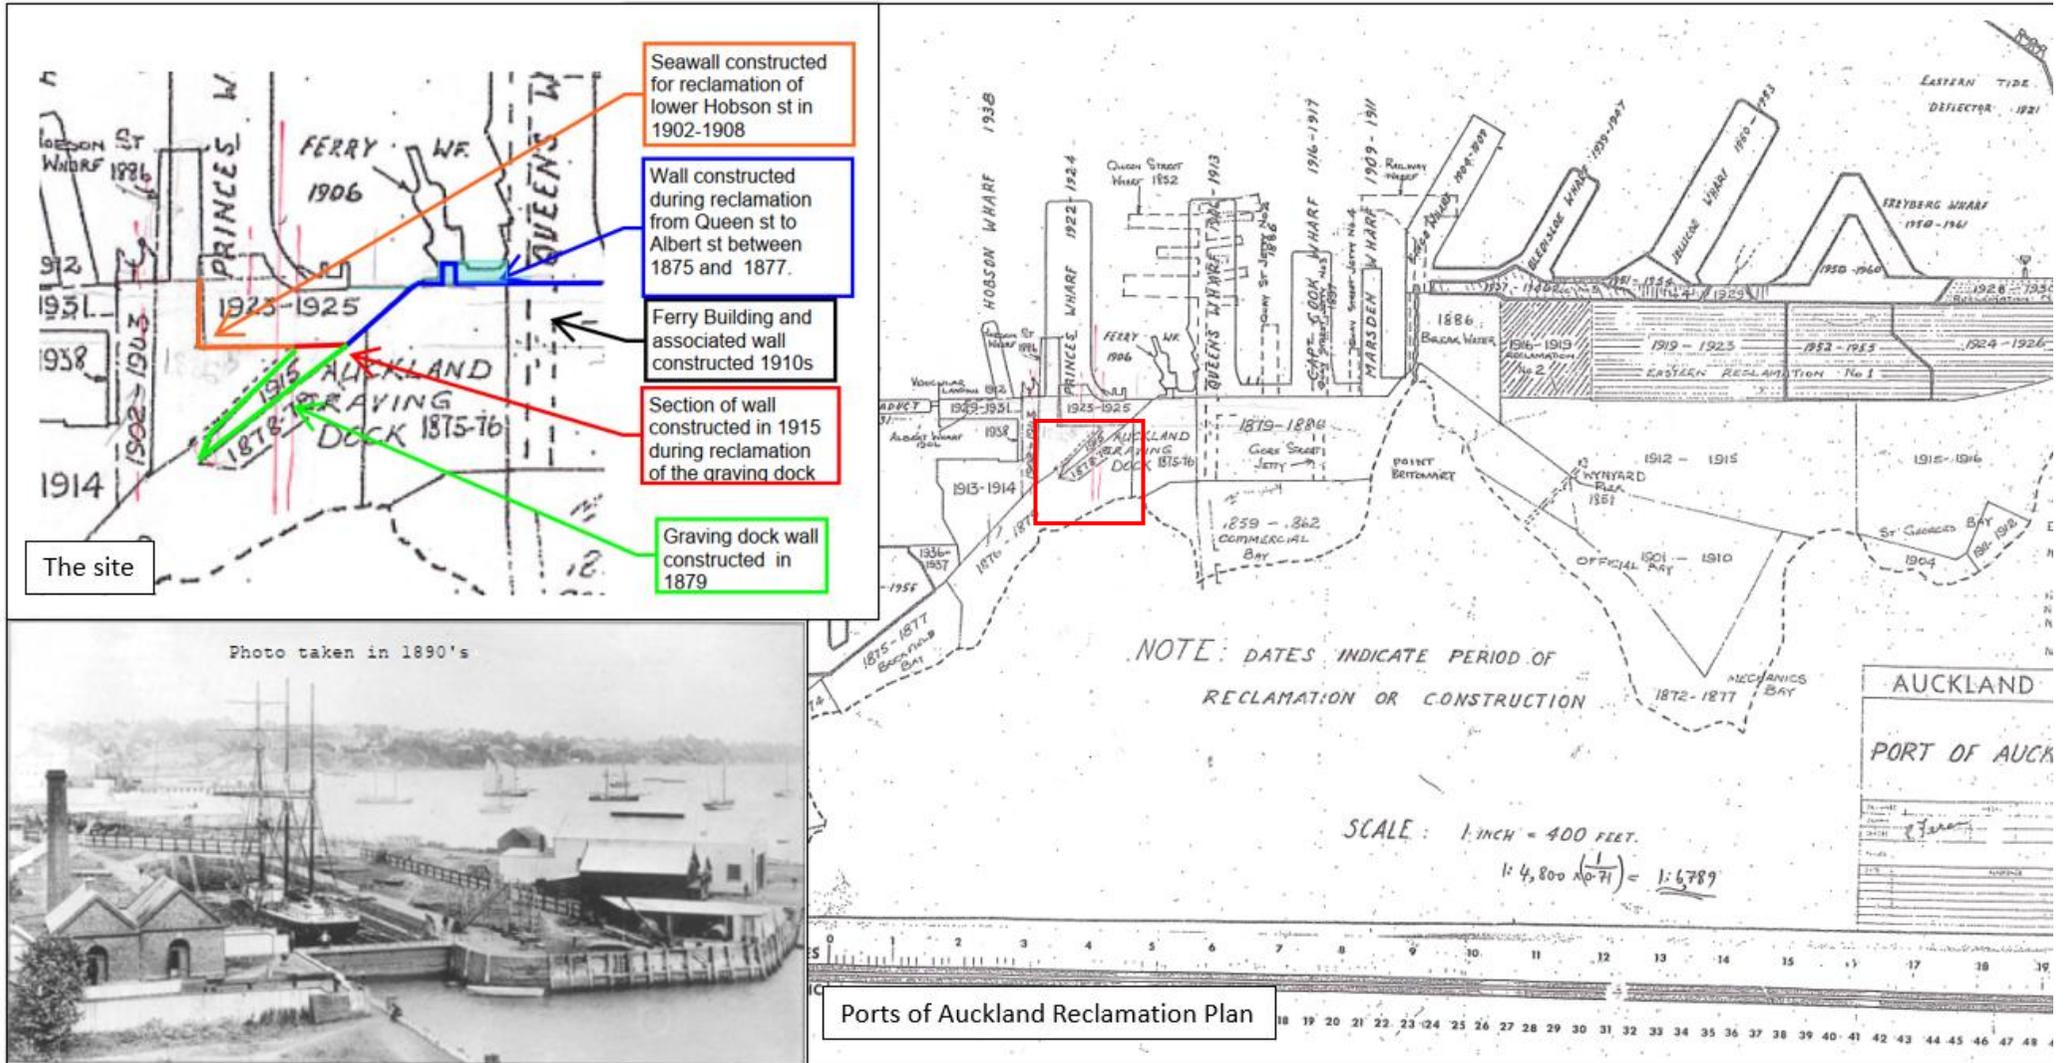
Figure 3.2: Ports of Auckland Reclamation Plan and photograph of the site in the 1890's (source: Cloughs Associates Archeological Assessment)

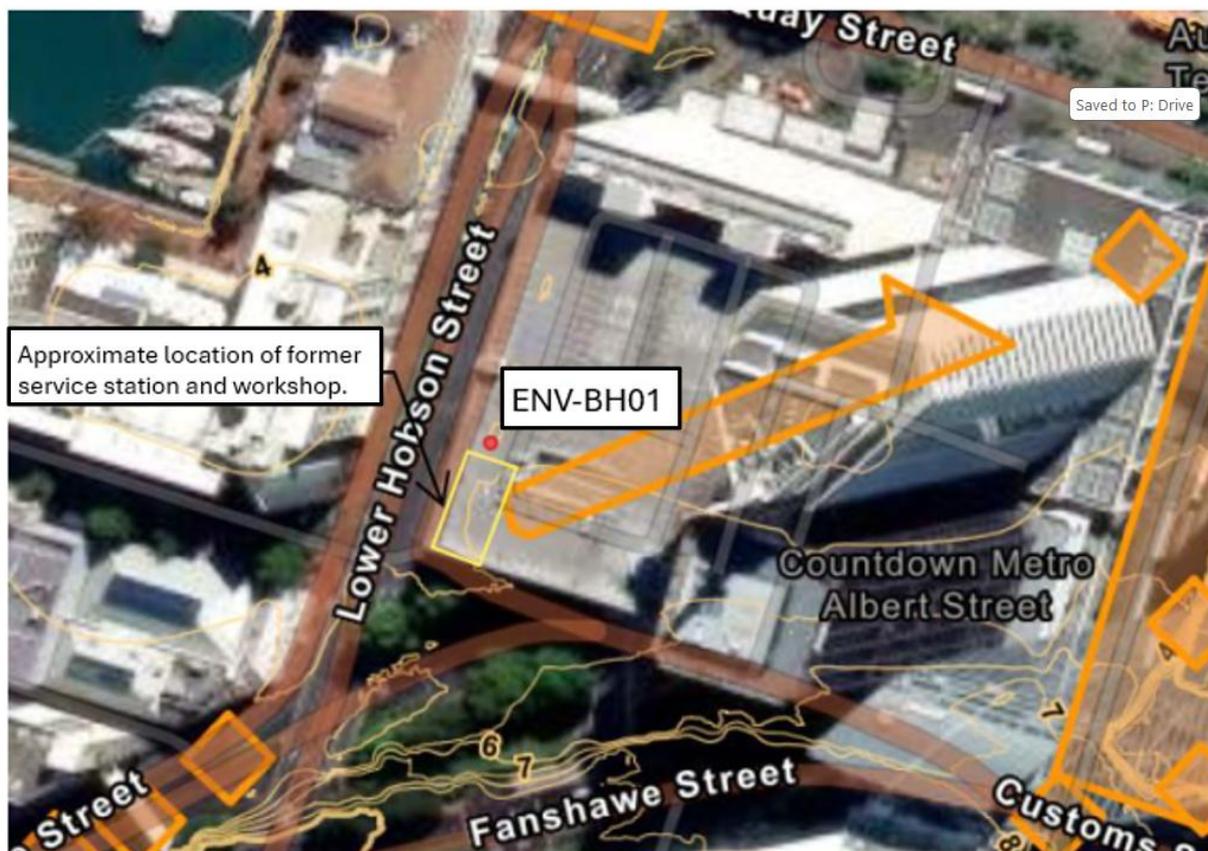
Figure 6.1: Preliminary Environmental borehole (ENV-BH01) shown as red point and approximate location of former service station outlined in yellow.

- The advancement of one environmental borehole (ENV-BH01) to a total depth of eight (8) m below ground level (bgl). The area within the former service station was not accessible by a drilling rig. The borehole was placed on the downgradient side of the service station within the carpark building (refer Figure 6.1) to establish whether activities from the former service station had caused significant hydrocarbon contamination and were impacting groundwater.. The borehole was drilled from Level 1 of the carpark building and is about 2 m above Lower Hobson Street road level.

The location of the preliminary investigation locations is presented on Figure 6.1.

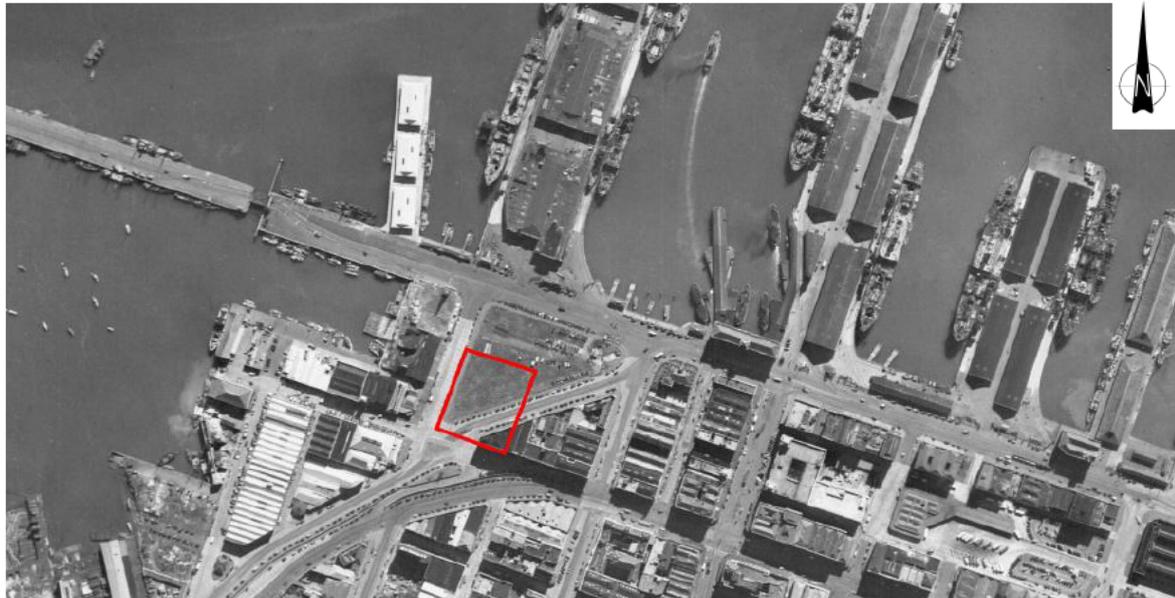
1940, Auckland Council GeoMaps

Site: Sturdee Street divides the site in a south-west to north-east alignment. The larger northern section of the site is vacant and appears to be either grass or gravel covered. Parts of it is being used for materials lay down / parking purposes. The smaller, triangular shaped southern section of the site is occupied by a single commercial building.

Surrounding land features: General port activities occupy the surrounds to the north. Commercial buildings occupy the immediate surrounds to the west, east and south.

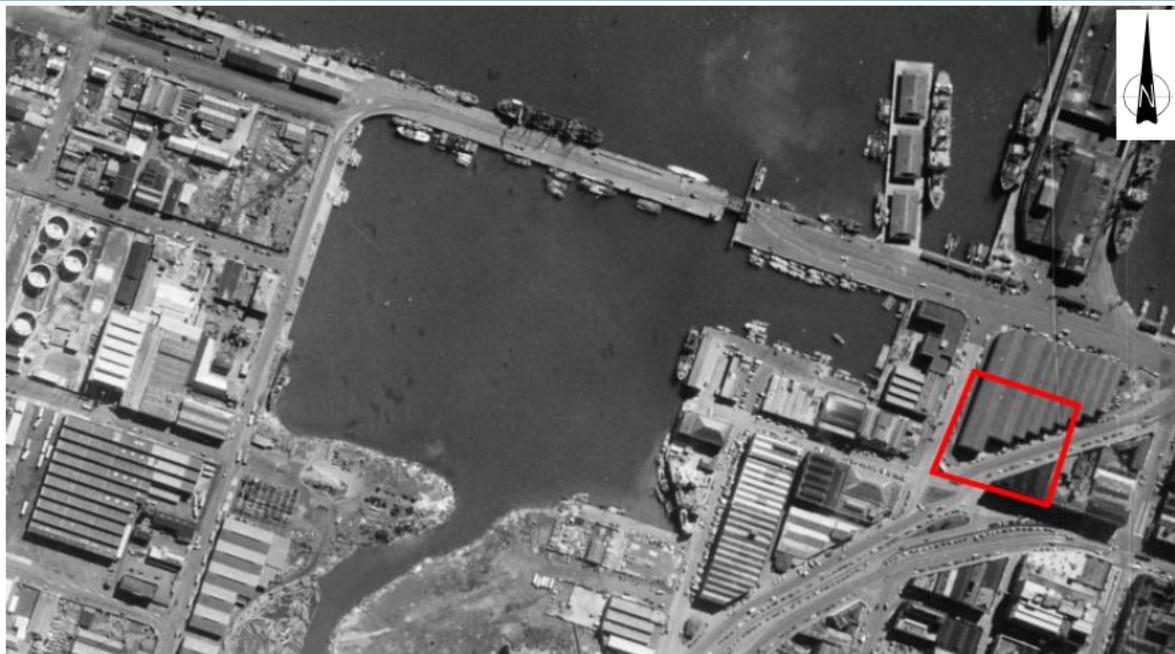
1950, Retrolens

Site: A large commercial building has been established on the northern part of site.

Surrounding land features: No significant changes are evident.

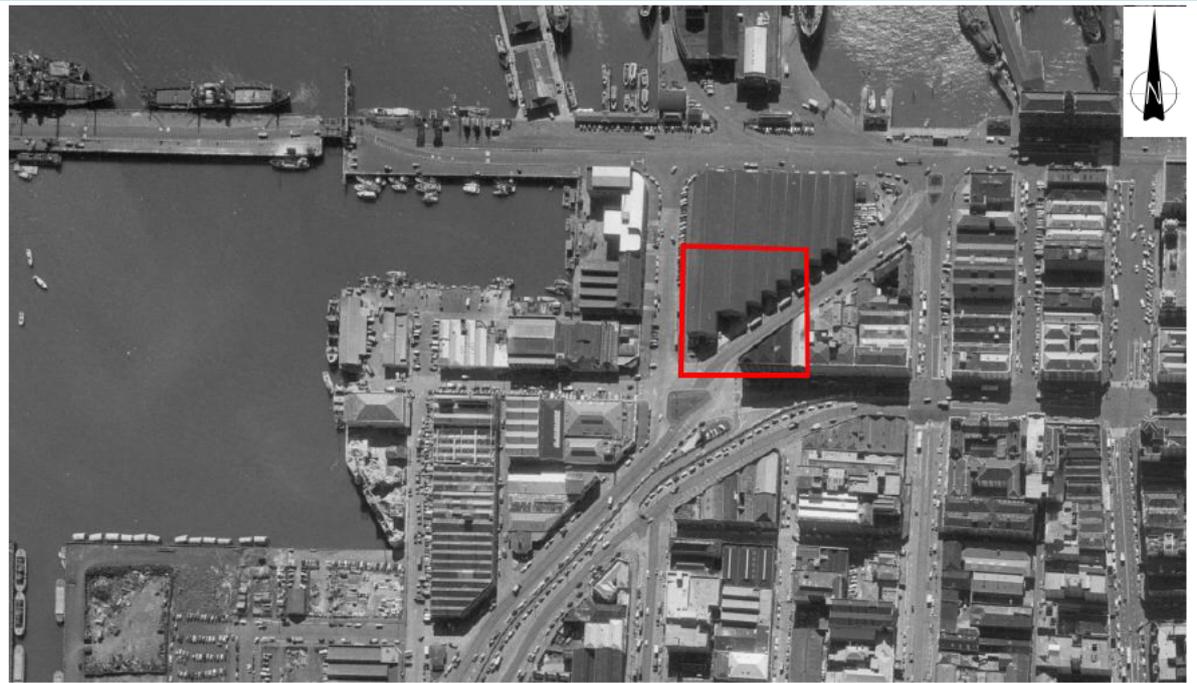
1958, Retrolens

Site: No significant changes are evident.

Surrounding land features: No significant changes are evident.

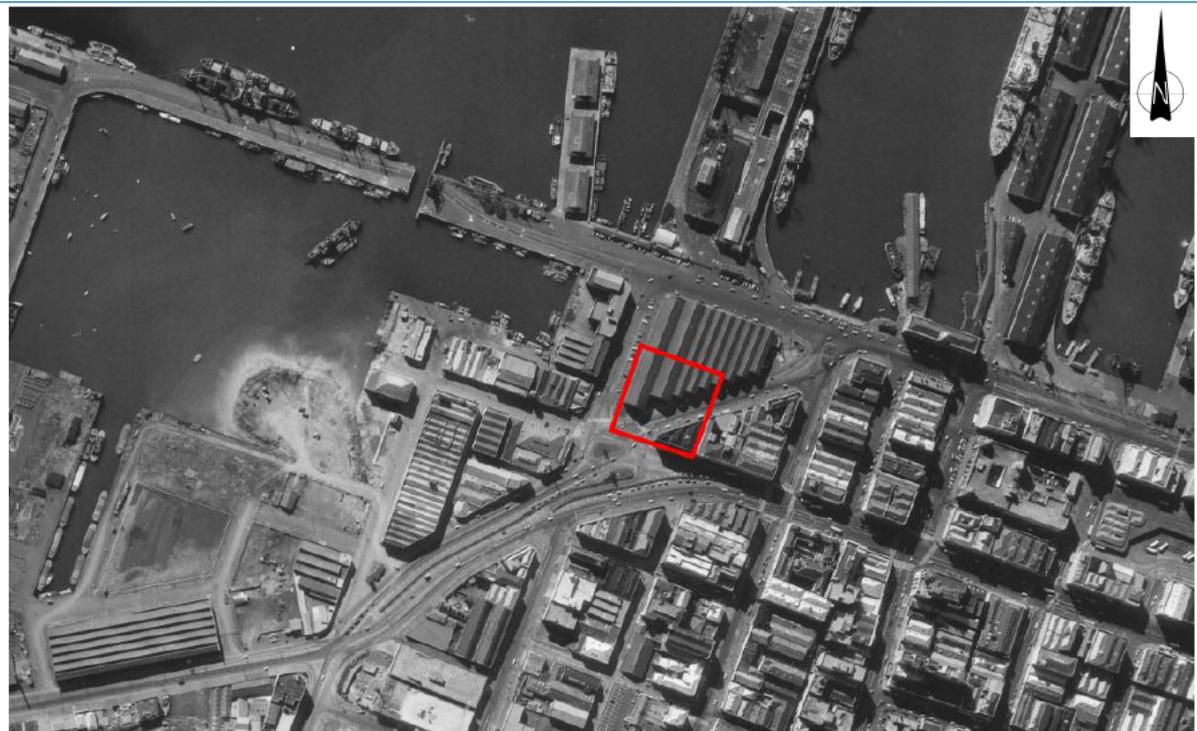
1963 to 1968, Retrolens

Site: No significant changes are evident.

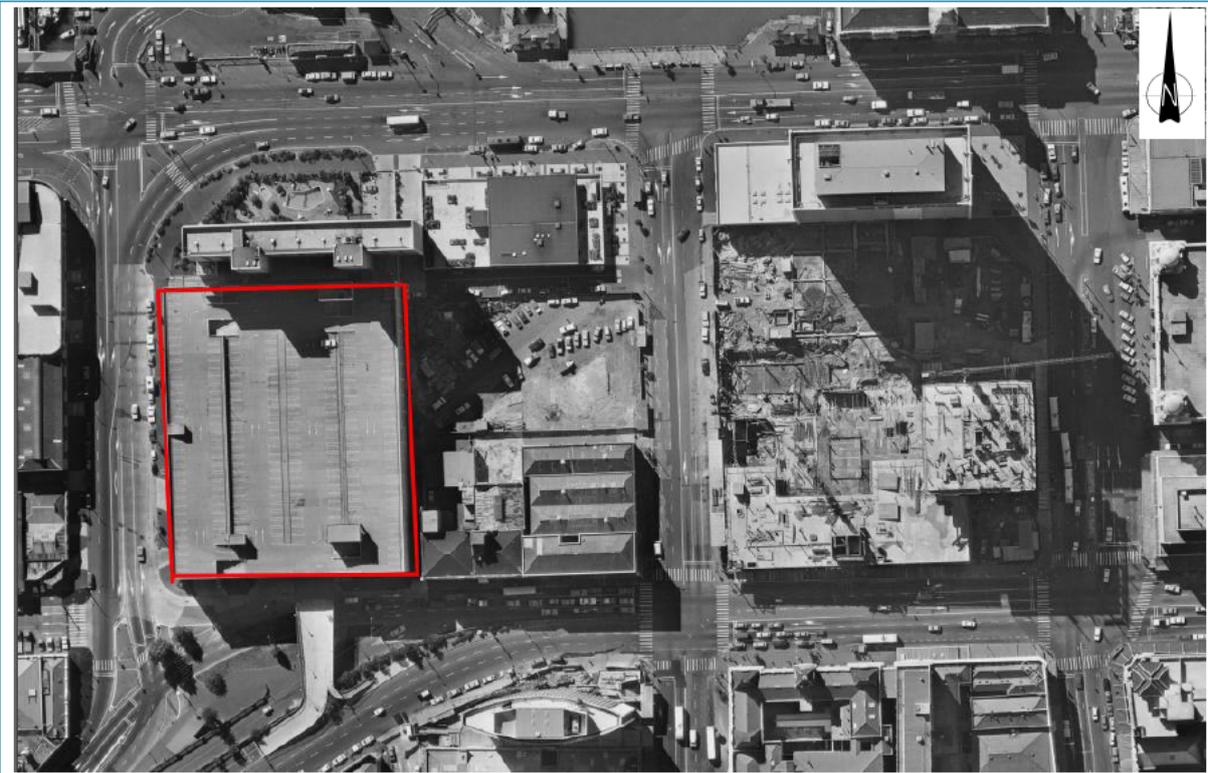
1972, Retrolens

Site: Sturdee Street no longer divides the site. The buildings that formerly occupied the northern and southern sections of the site have been removed and replaced by a single structure built over the entire site footprint including the former Sturdee Street road reserve.

Surrounding land features: A high rise building has been constructed immediately to the north between the site and Quay Street, and further development and construction of buildings has occurred in areas east of the site.

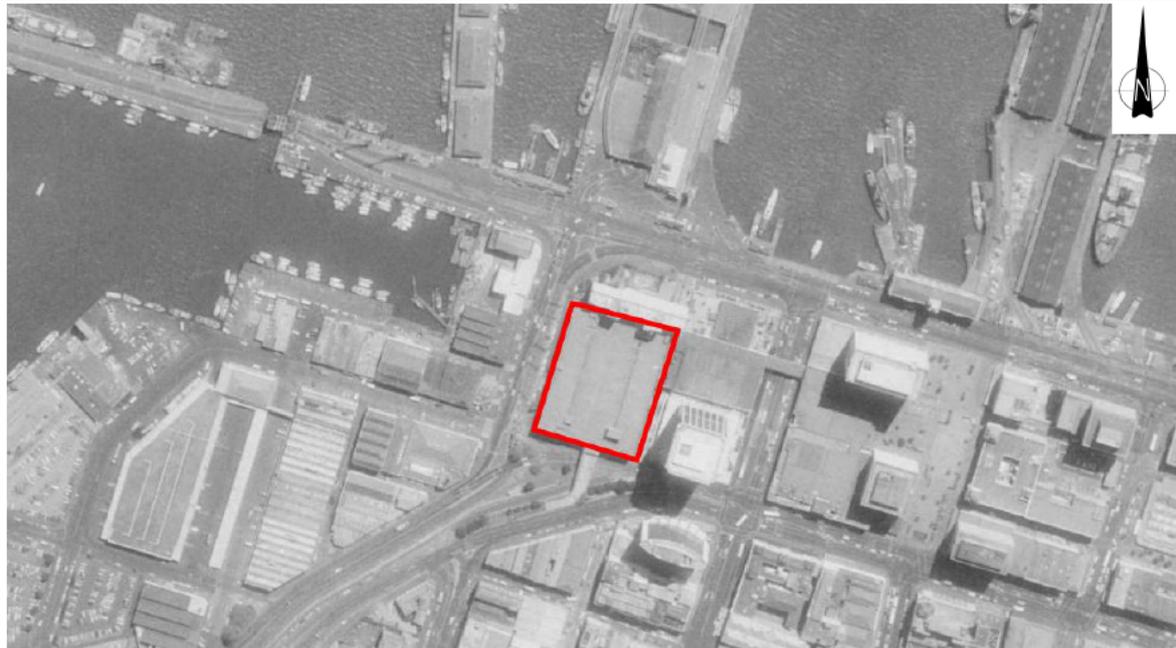
1980, Retrolens

Site: No significant changes are evident.

Surrounding land features: A large high-rise has been constructed immediately east of the site, replacing the smaller buildings that were established sometime between 1940 and 1950.

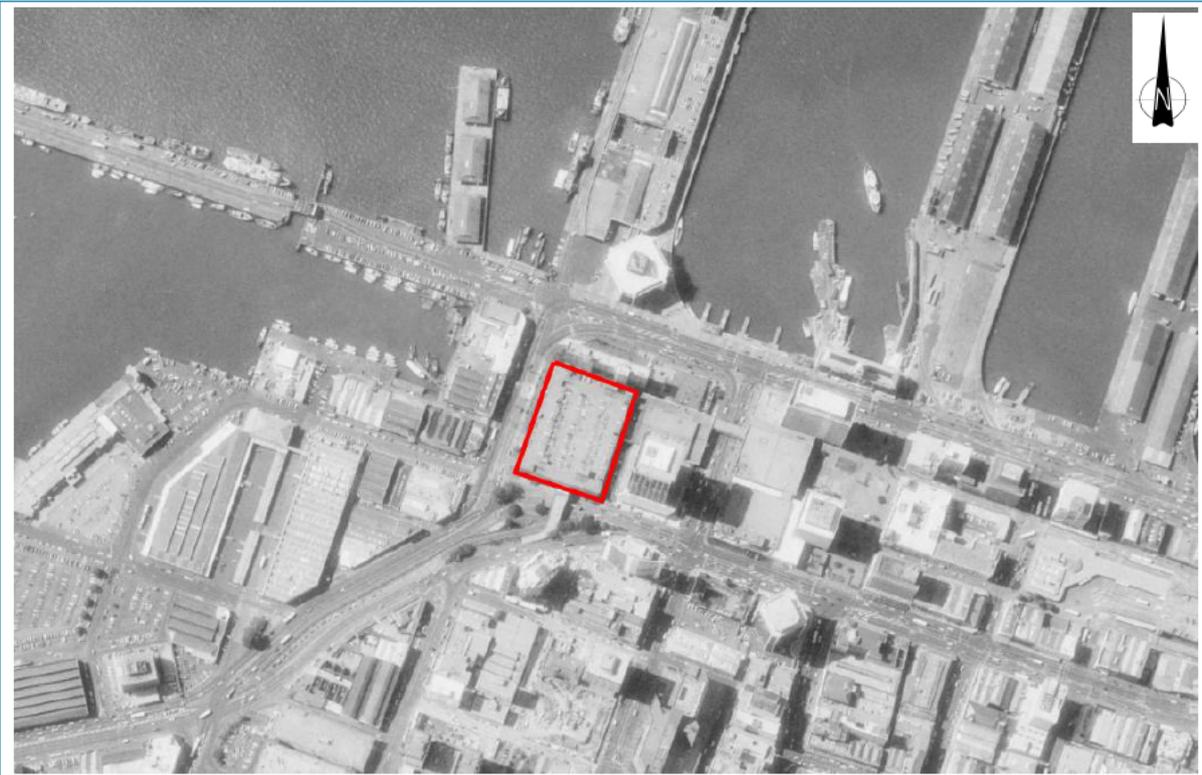
1987, Retrolens

Site: For the first time vehicles are visible parked on the roof of the building but no significant changes are evident.

Surrounding land features: Some redevelopment of buildings to the north and west, but no other significant changes are evident.

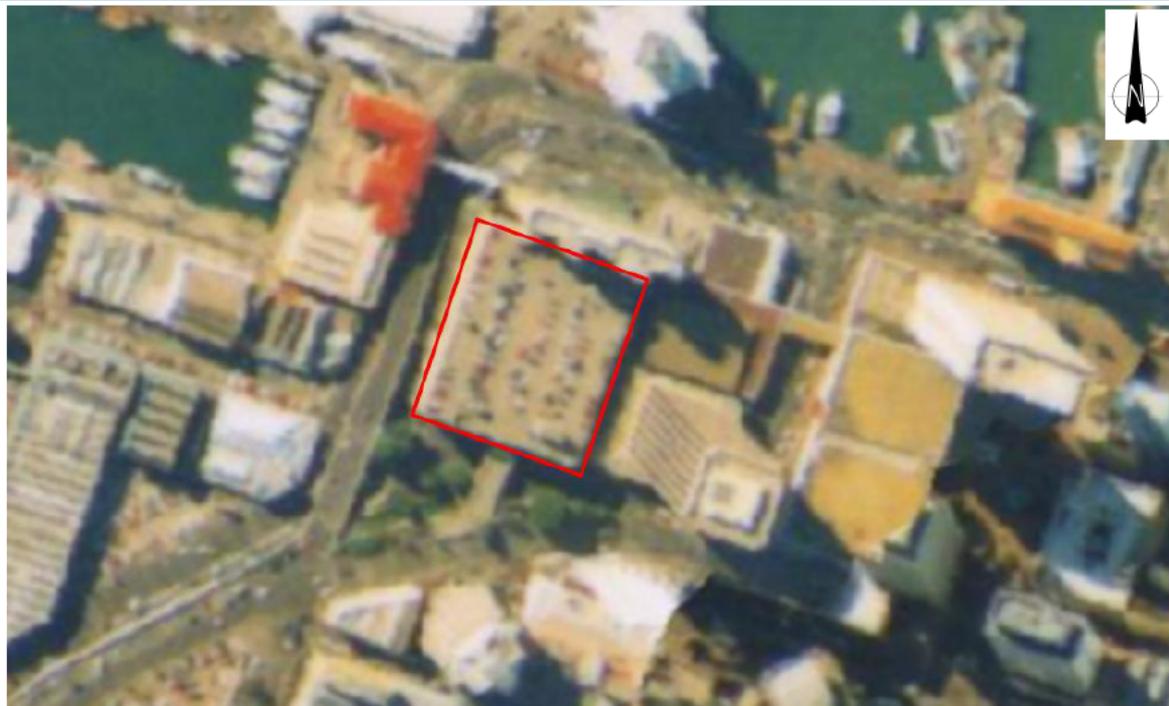
1996, Auckland Council GeoMaps

Site: No significant changes are evident.

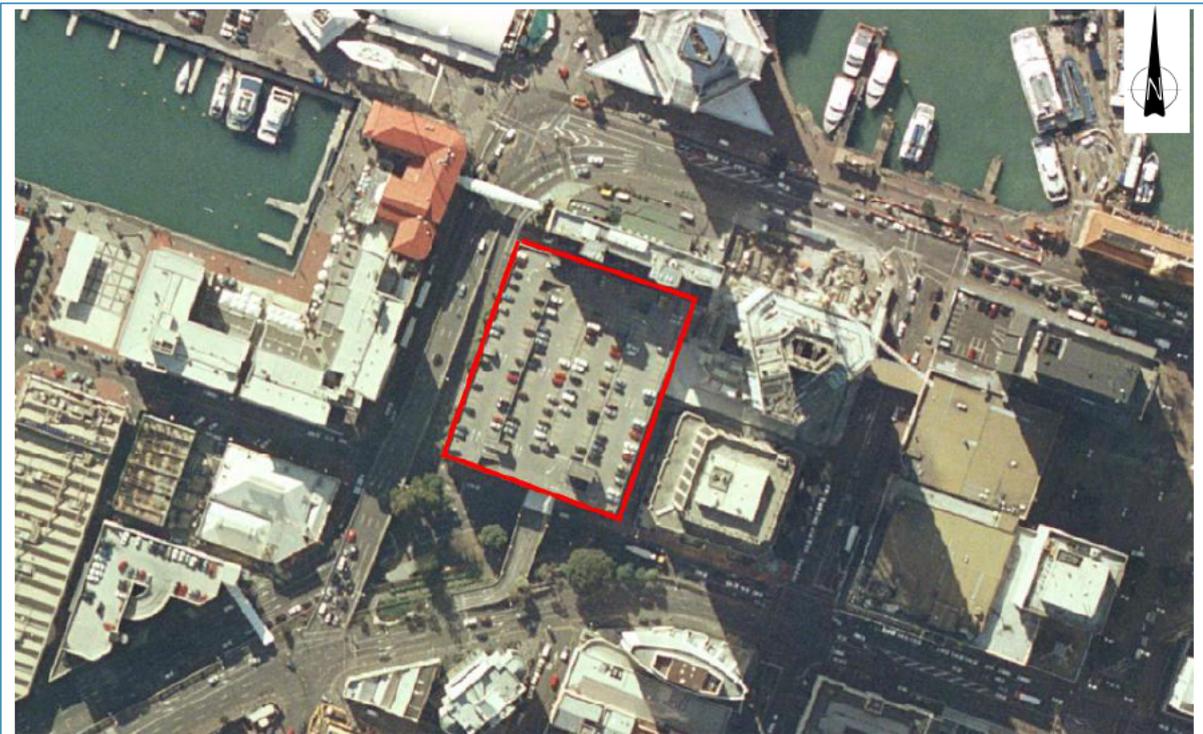
2001, Auckland Council GeoMaps

Site: No significant changes are evident.

Surrounding land features: PWC tower, adjoining the sites north-eastern corner, is under construction

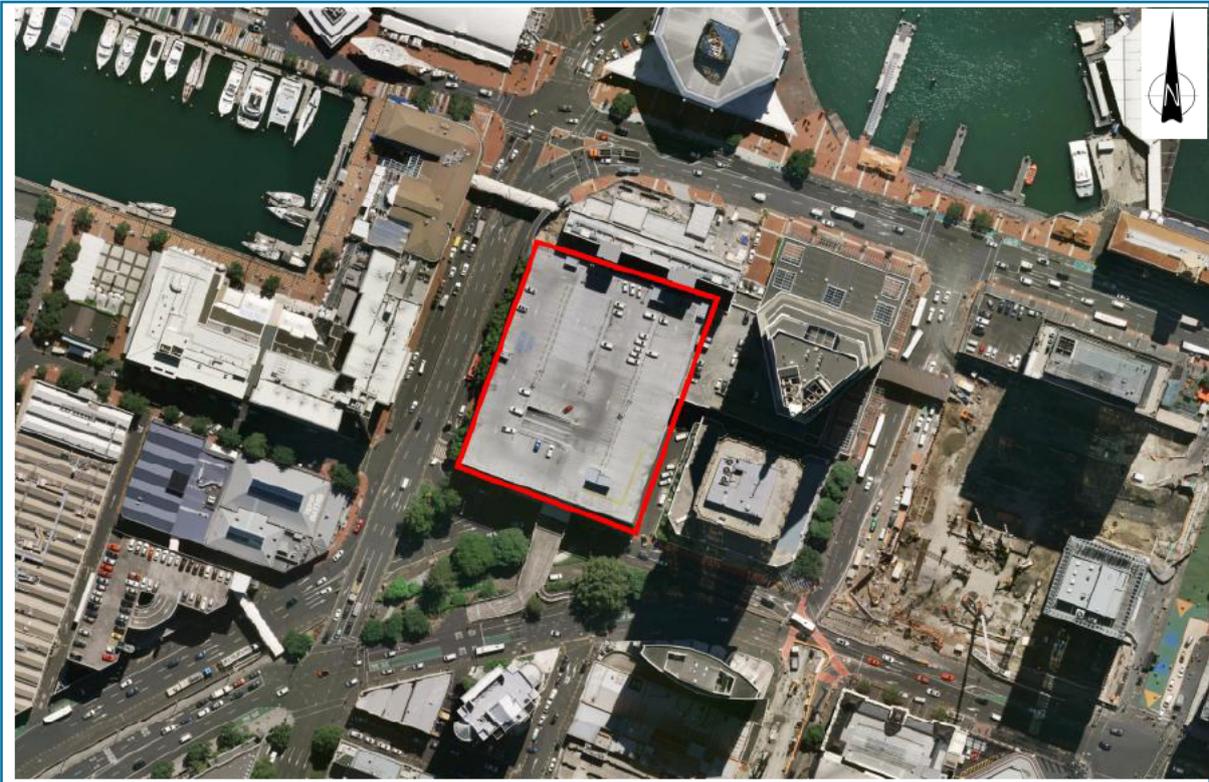
2017, Auckland Council GeoMaps

Site: No significant changes are evident.

Surrounding land features: Former Downtown Shopping Centre has been removed and redevelopment of the site, located to the east, is underway.

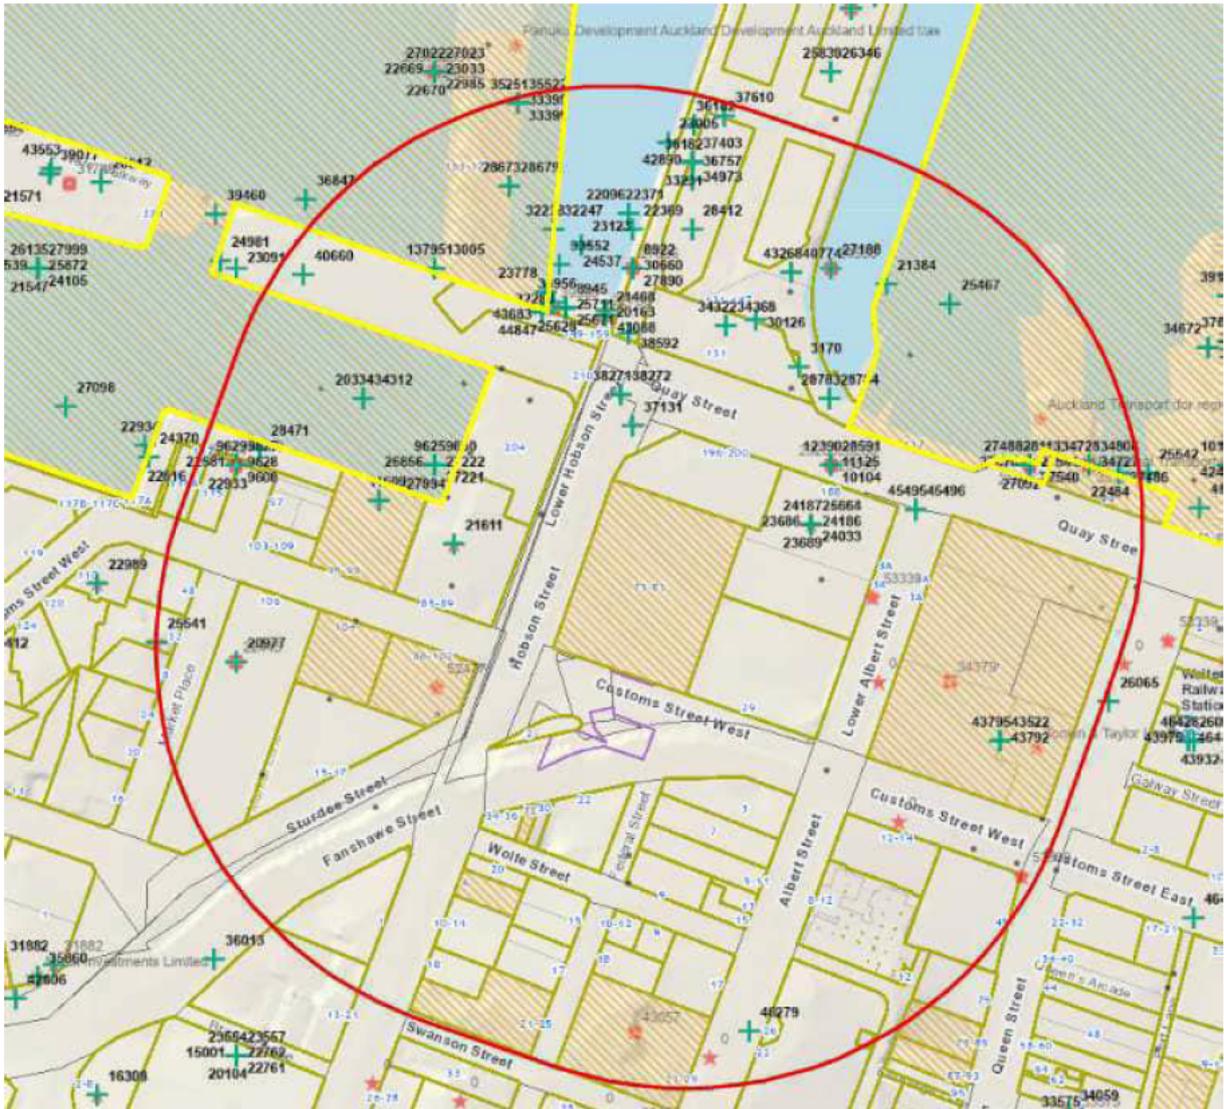
Figure 1: Selected Consents, Incidents and HAIL activities within approximately 200m of the subject site

The Council database was searched for records of the following activities within approximately 200 metres of the site and results are displayed in Figure 1 below:

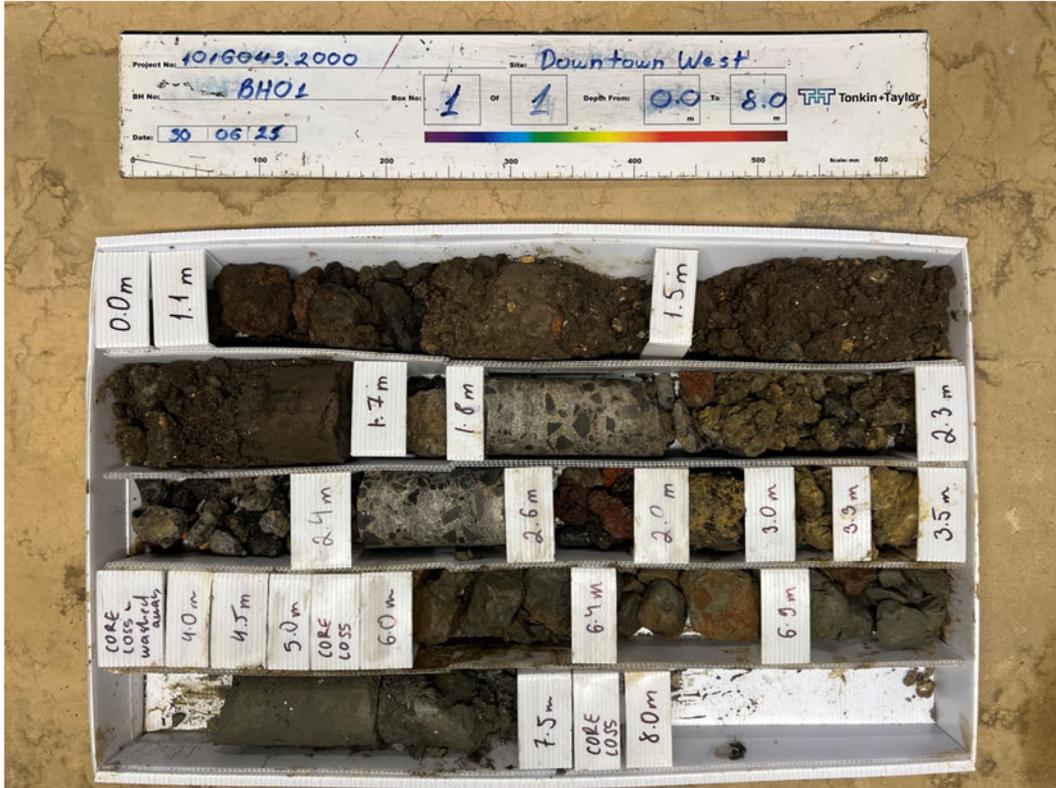
BOREHOLE No.: **BH1**
Hole Location: Downtown Carpark, 31 Customs Street West, Auckland Central, Auckland 1010
 SHEET: 1 OF 1

0.00-8.00m

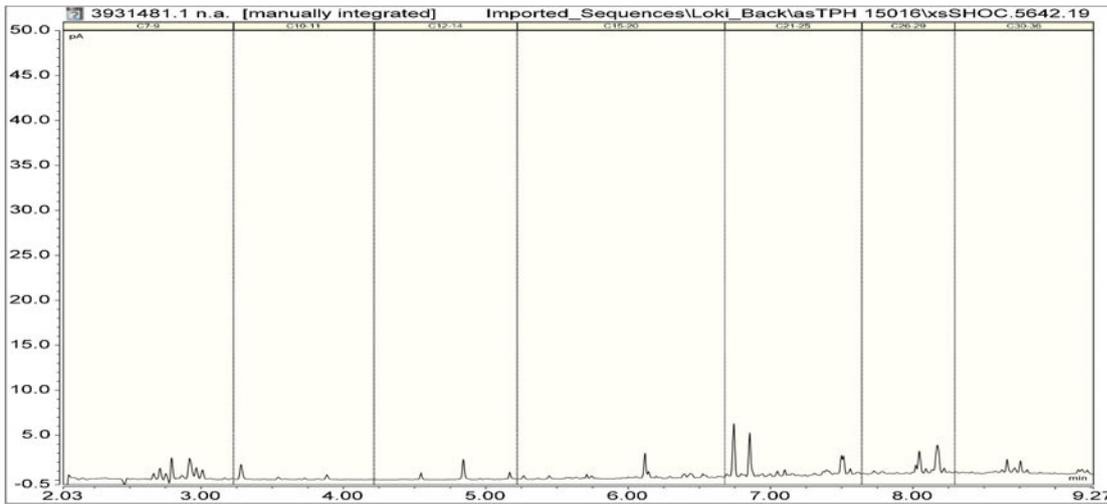
3931481.1
 BH1 1.1-1.5m 30-Jun-2025
 Client Chromatogram for TPH by FID

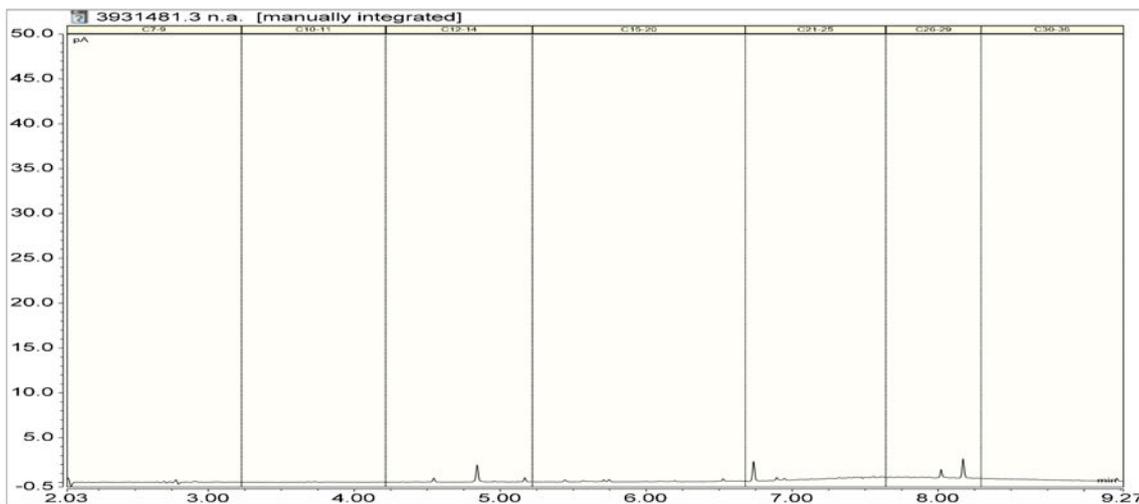
3931481.3
 BH1 4.5-5.0m 30-Jun-2025
 Client Chromatogram for TPH by FID
