**Detailed Site Investigation**

**270 – 292 Dukes Road North  
Mosgiel**

**Southern Link Property Limited**

**April 2026**

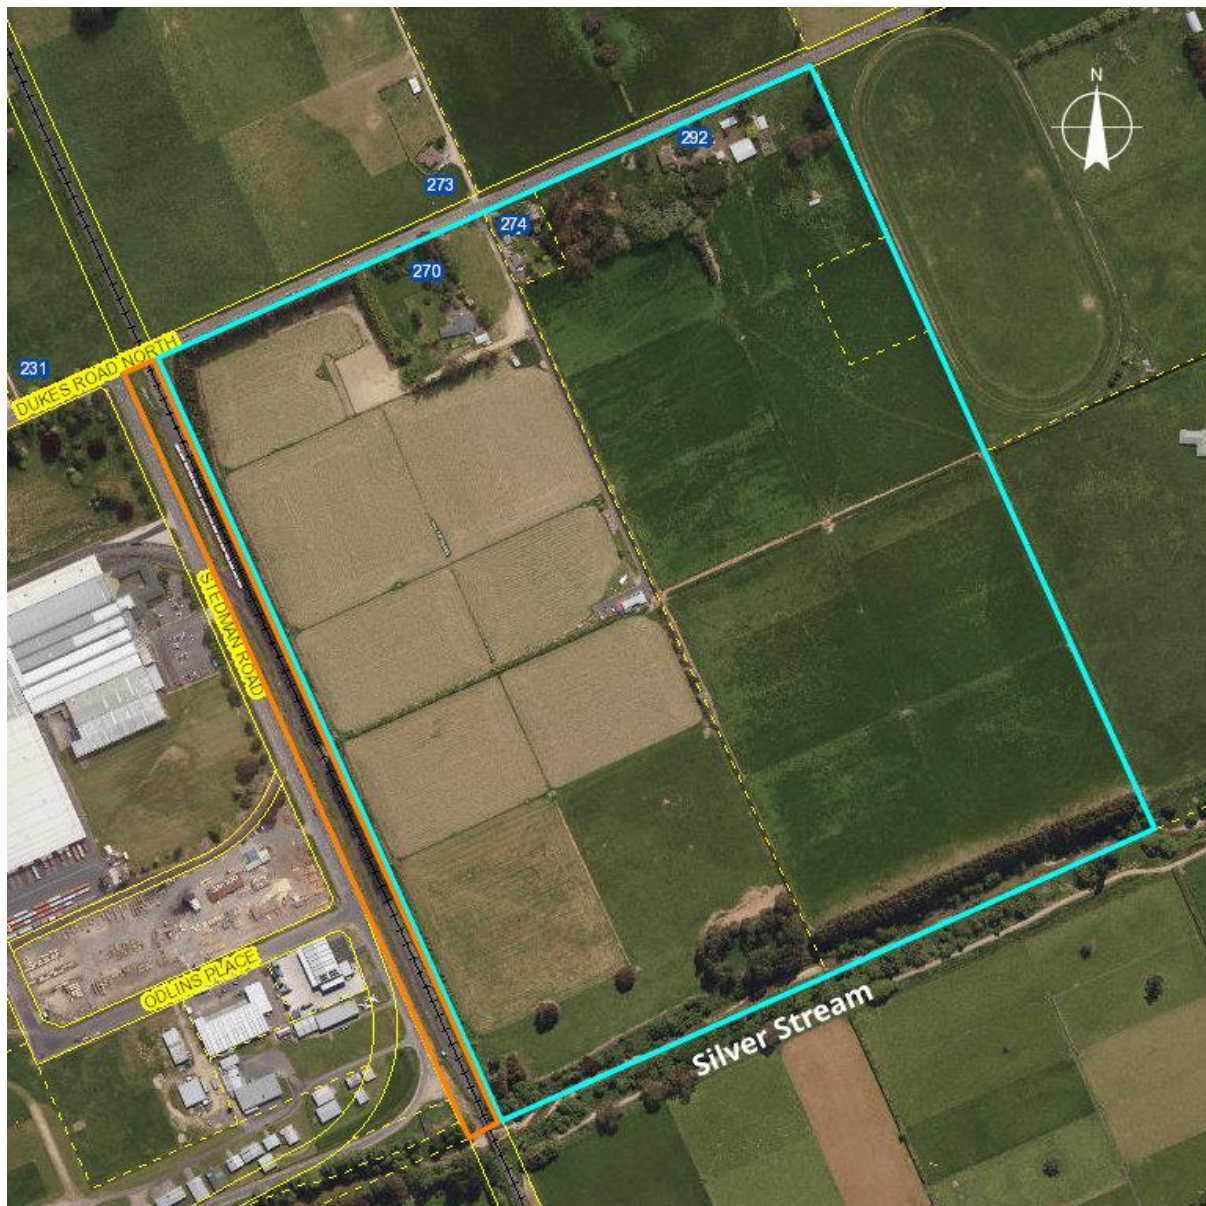
Figure 2: The Site extent at 270 – 292 Dukes Road North outlined in turquoise with the KiwiRail Corridor outlined in orange (DCC GIS | 2023-2024. Copyright DCC/ORC, CC BY 4.0).

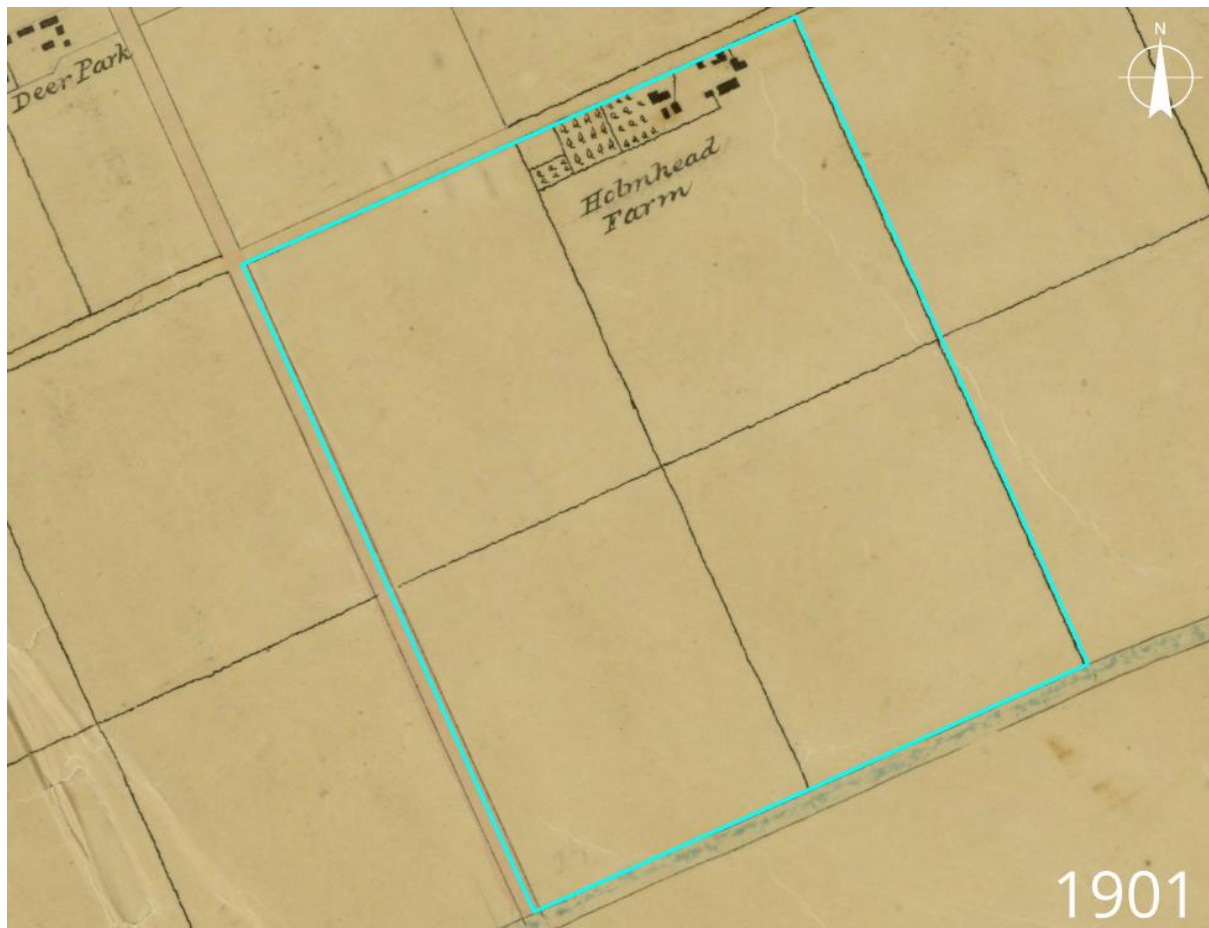
Figure 3: The Site in 1901, with the approximate site boundary outlined in turquoise, showing “Holmhead Farm” to be present on the Site, including various buildings in the northern site corner (extract from W T Neill's Military Topographical Maps dated 1901, [https://ndhadeliver.natlib.govt.nz/delivery/DeliveryManagerServlet?dps\\_pid=IE27293496](https://ndhadeliver.natlib.govt.nz/delivery/DeliveryManagerServlet?dps_pid=IE27293496)).

- Holmhead Farm – a map of the Site from 1901 (Figure 3) identifies the property as “Holmhead Farm” and various buildings can be seen present in the northern site corner (currently 292 Dukes Road North). Subsequent aerial imagery contained within the PSI indicate that the buildings include a dwelling, various sheds, sheep yards and a sheep dip. Comments contained in the PSI indicate that the original dwelling was constructed in the 1860s, with significant renovations conducted in the 1940s.

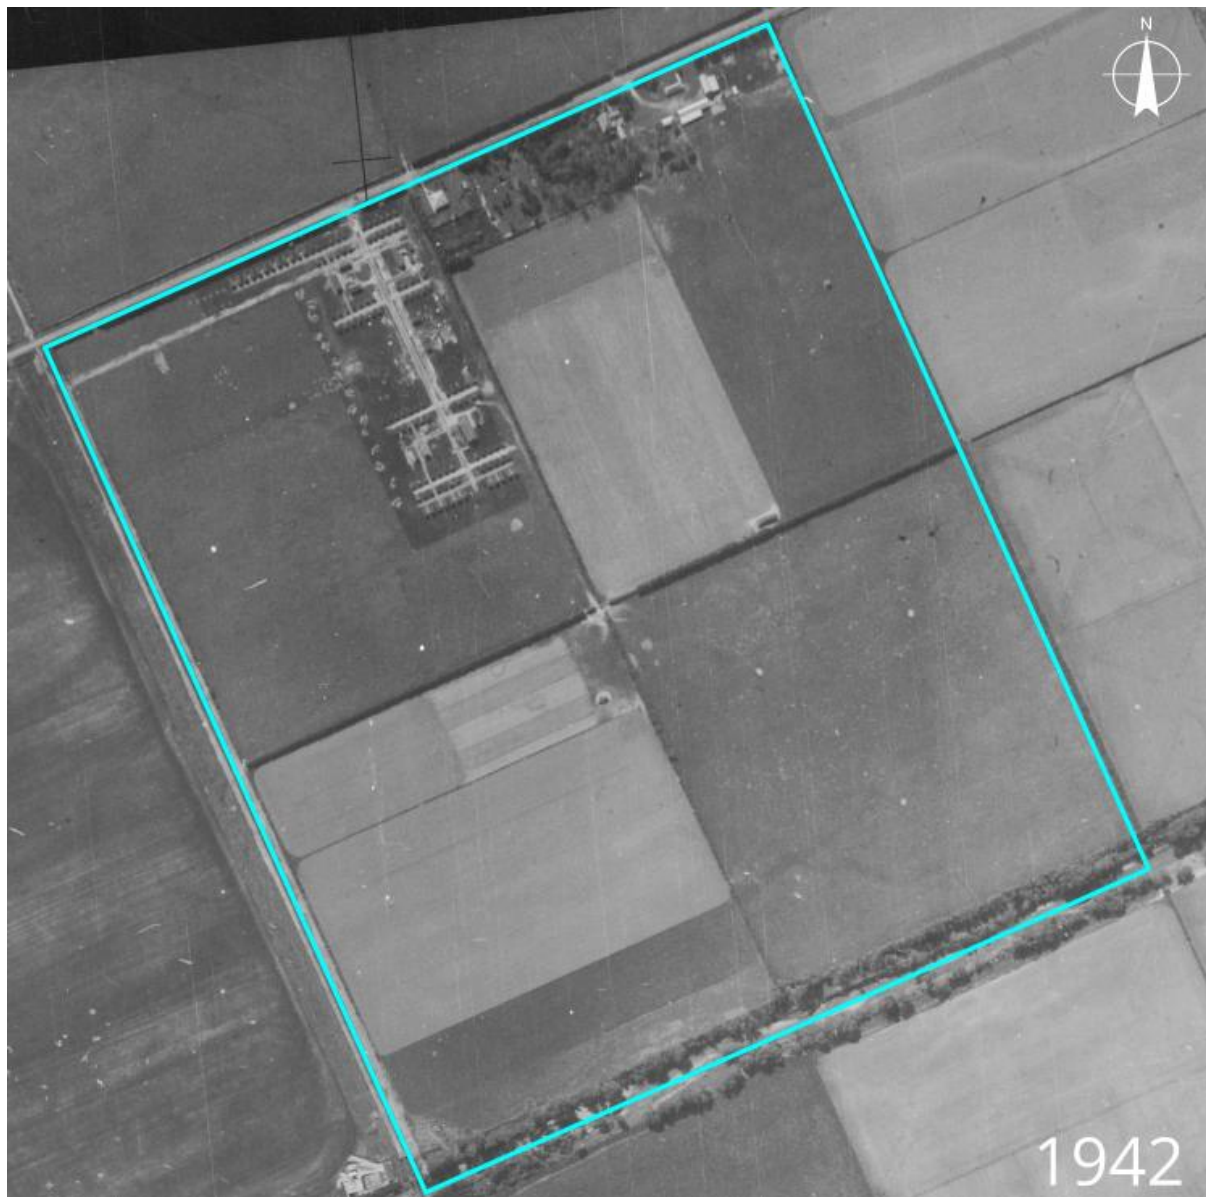
Figure 4: The Site in 1942, with the approximate site boundary outlined in turquoise, showing various buildings including dwellings, farm sheds and the RNZAF barracks present on the Site (sourced from <http://retrolens.nz> and licensed by LINZ CC-BY 3.0).

- RNZAF barracks – RNZAF barracks were constructed on the northern end of 270 Dukes Road North in 1939. Imagery of the Site, including the barracks, is shown in Figure 4 from 1942. Subsequent aerial imagery contained within the PSI show the barracks to have been removed by 1949.

- Dwellings – in addition to the dwelling at 292 Dukes Road North, Figure 4 from 1942 also shows a dwelling to be present at 274 Dukes Road North. The PSI notes that consent records for a coal shed adjacent to the dwelling include polite, a potentially asbestos containing material (ACM). Imagery from 1975 shows the dwelling at 270 Dukes Road North under construction at this time. The PSI notes that consent records for the 1975 dwelling and a garage/workshop *“mention use of Decramastic roof and Hardies Flexiboard, which are both potentially asbestos containing building materials”* along with fibrolite sheeting which may also contain asbestos.

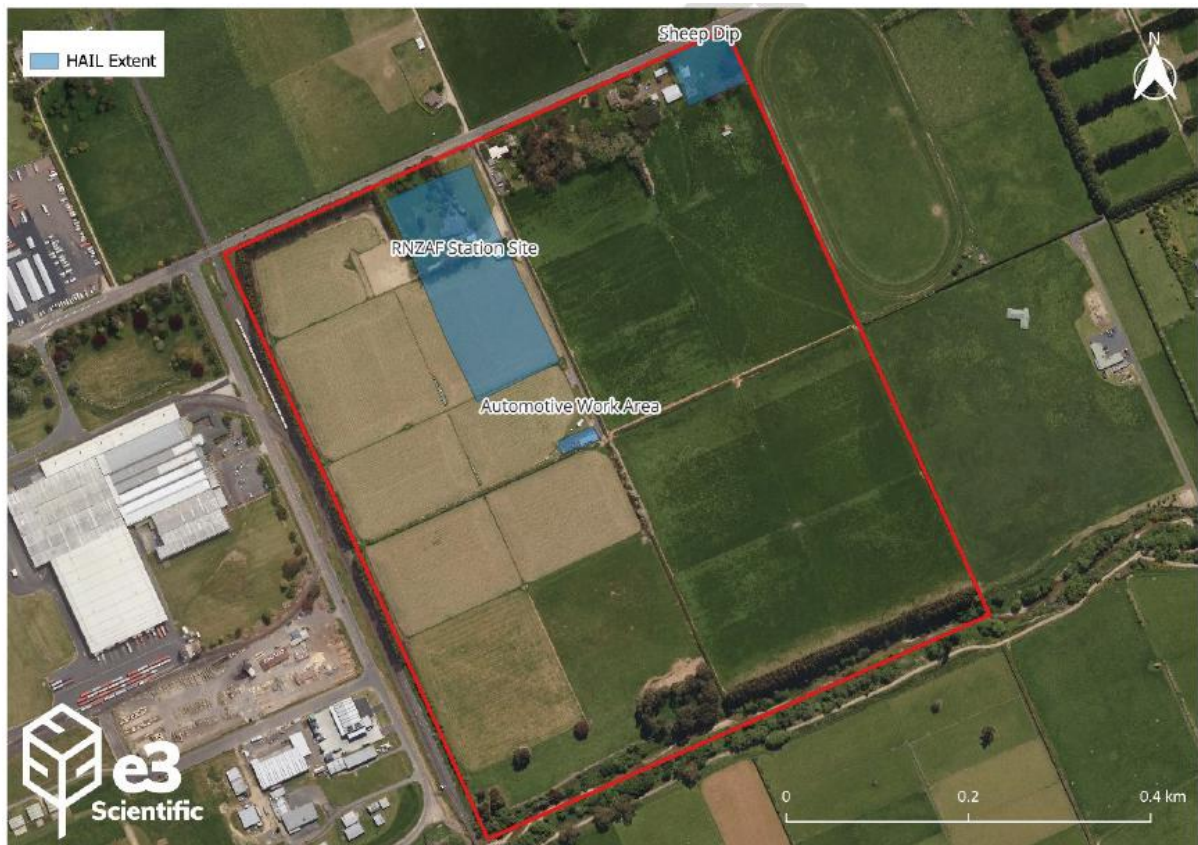
The 2025 PSI found three areas on the Site likely to comprise HAIL sites, as identified in Figure 5. These consist of the sheep dip area in the northern end of the Site (within 292 Dukes Road North), the location of the former RNZAF barracks in the northern end of 270 Dukes Road North, and the workshop in the centre of the Site, also within 270 Dukes Road North.

Figure 5: Three areas of potential HAIL activity on the Site as identified in the 2025 PSI (e3Scientific Limited, 2025. Southern Link Inland Port Preliminary Site Investigation).

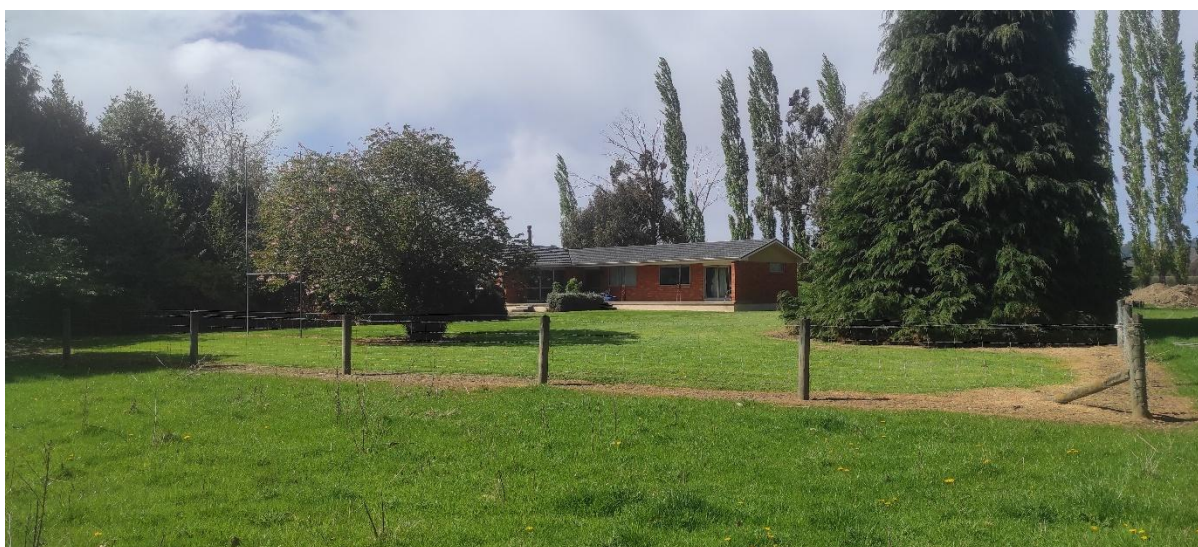
Figure 7: The existing dwelling at 270 Dukes Road North (16 October 2025).

The Site currently contains three existing dwellings, one on each of 270 (Figure 7), 274 (Figure 8) and 292 (Figure 9) Dukes Road North. Various additional garages and sheds are also present adjacent to the dwellings. Numerous garages/sheds (Figures 10 and 11) are present in the northern end of 292 Dukes Road North, along with sheep yards (Figure 12) and a sheep dip (Figure 13). Part of the sheep yards are concreted, including the part of the yards adjacent to the sheep dip. The sheep dip appears to be disused and has been infilled with soil and brick. The adjacent sheds generally appear to be of corrugated metal construction, except for one shed directly to the northwest of the sheep dip (as seen in Figure 13) which appeared to be older than the rest and partially painted timber weatherboard construction.

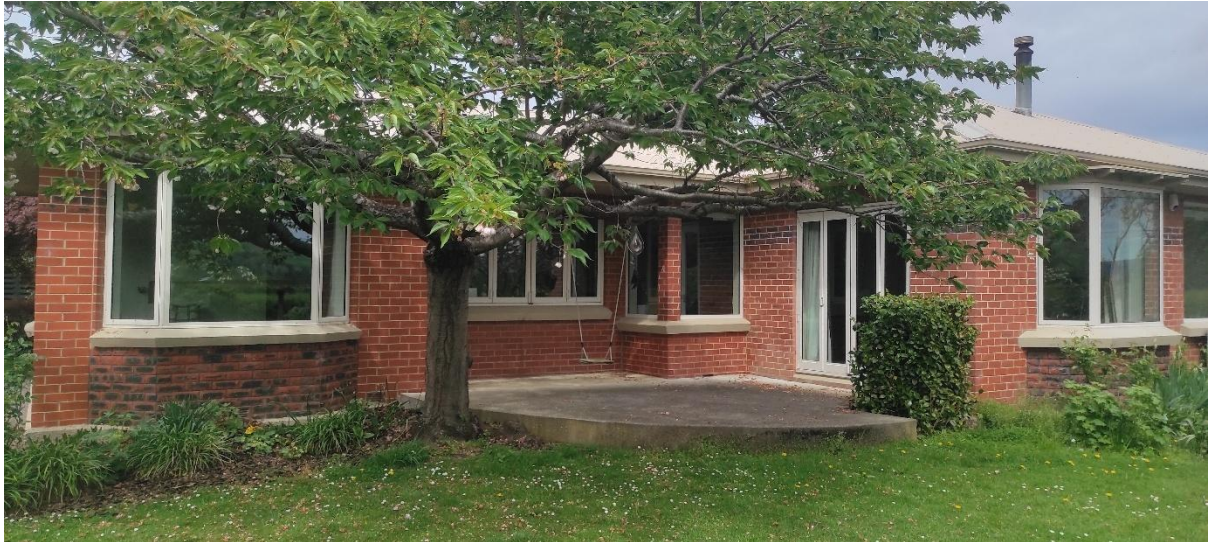
Figure 8: The existing dwelling at 274 Dukes Road North (17 October 2025).

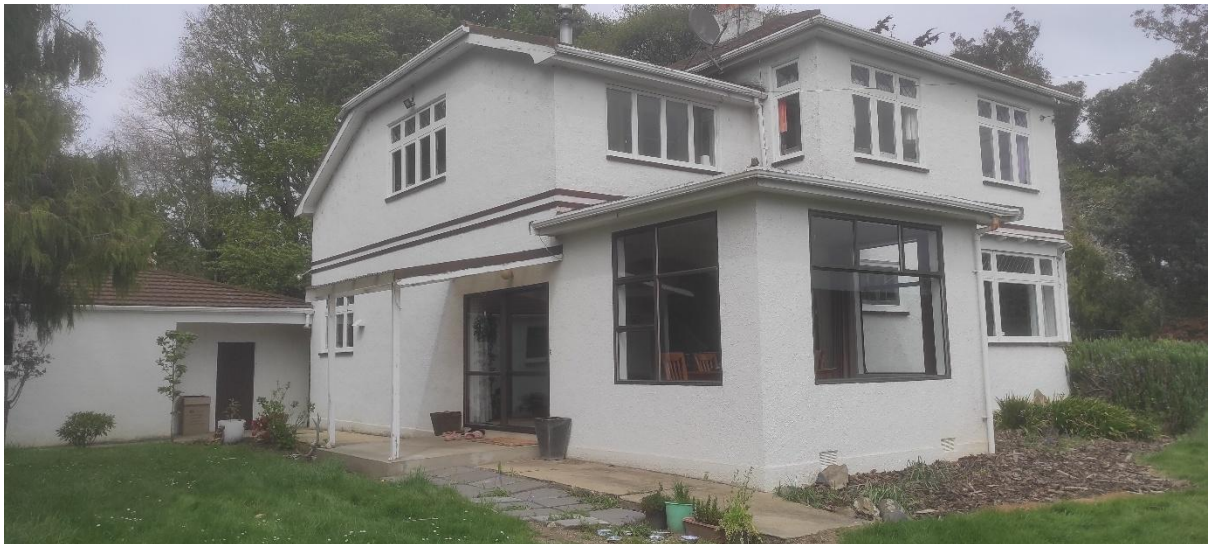
Figure 9: The existing dwelling at 292 Dukes Road North (17 October 2025).

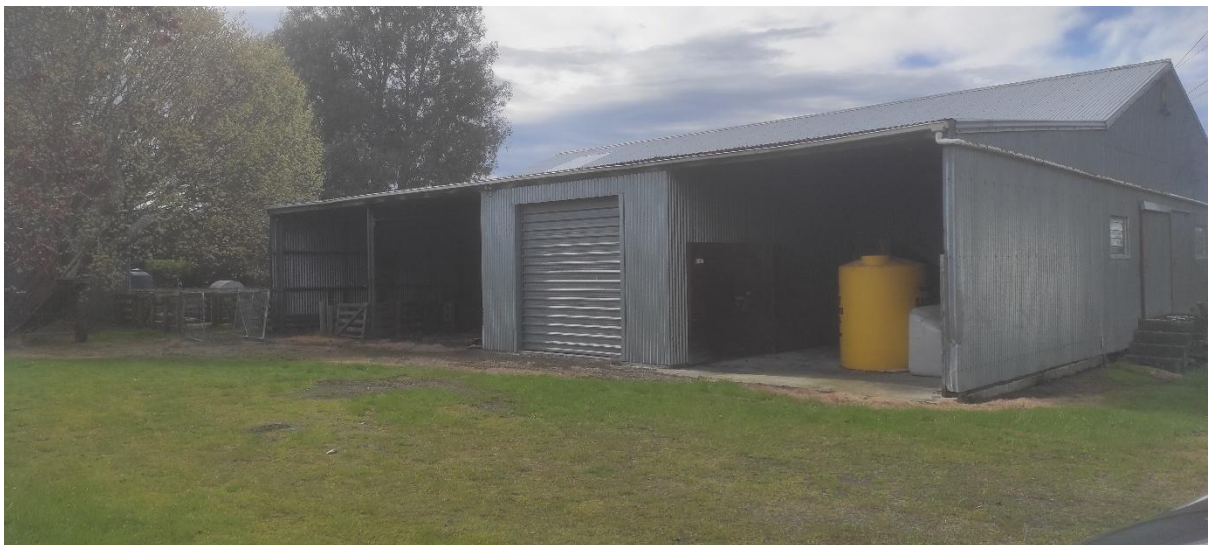
Figure 10: An example of one of the sheds present in the northern corner of the Site (17 October 2025).

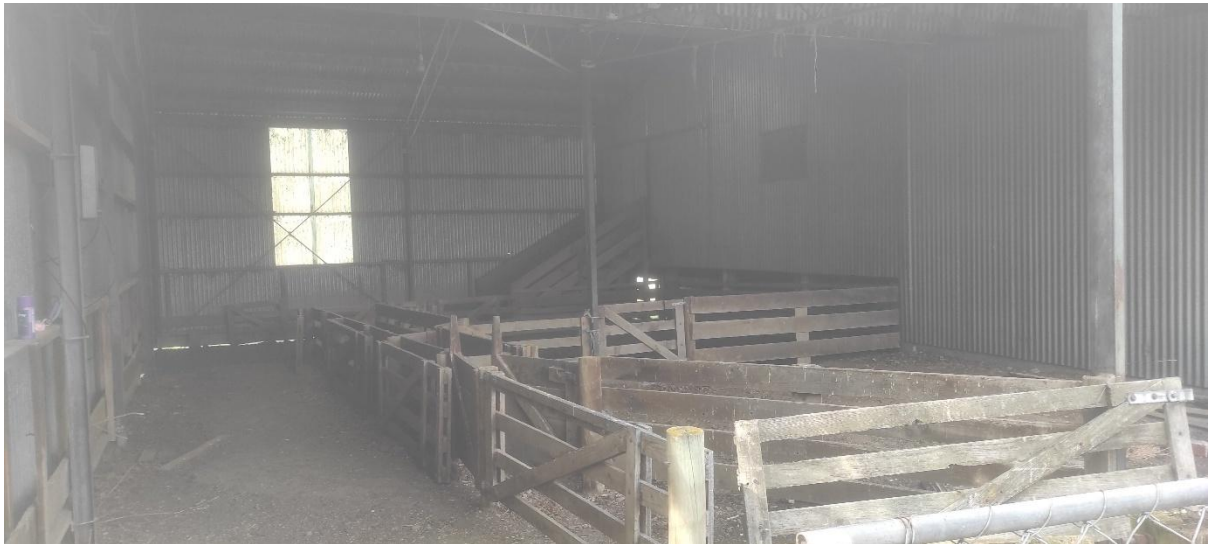
Figure 11: An example of the interior of one of the sheds present in the northern corner of the Site (17 October 2025).

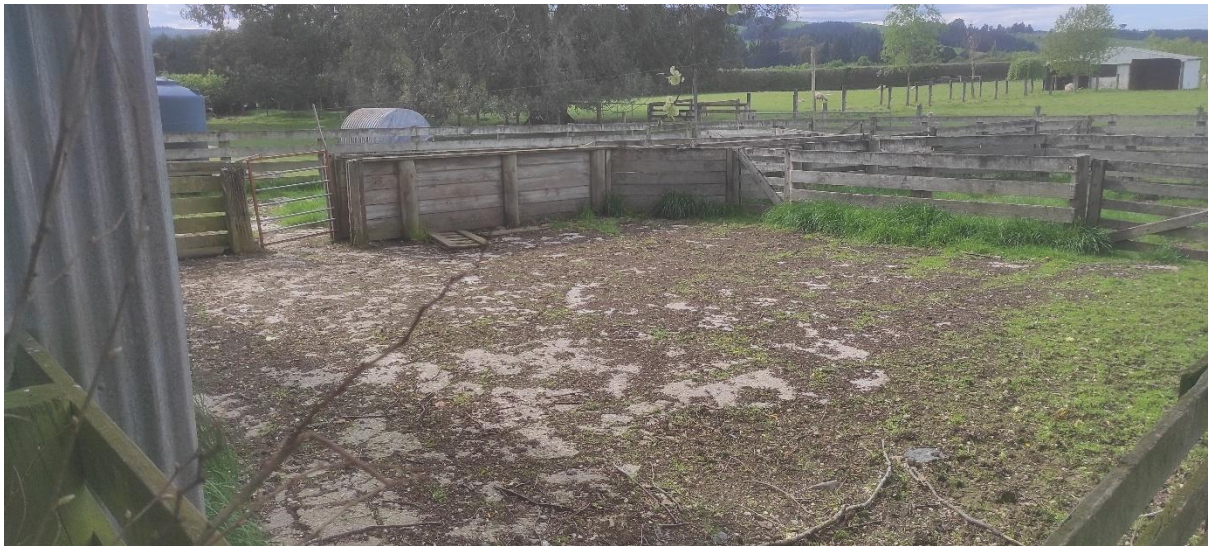
Figure 12: The concreted sheep yards in the northern end of the Site (17 October 2025).

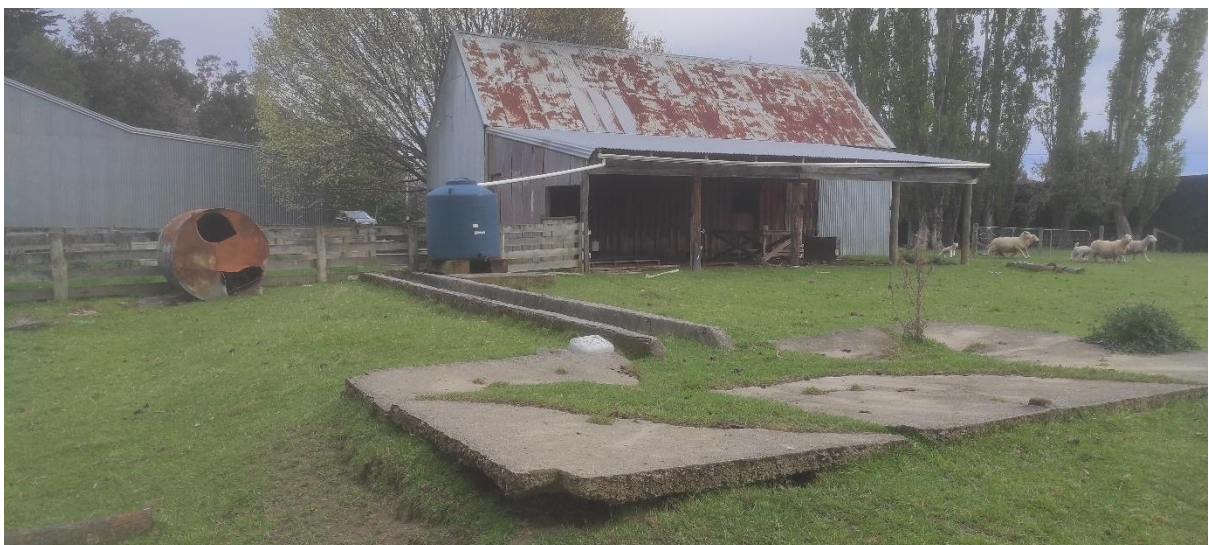
Figure 13: The sheep dip in the northern end of the Site, leading from the yards to a concrete platform (17 October 2025).

As seen in Figure 13 above, a sheep dip is present in the northern end of the Site, which is likely to be a major source of localised contamination on the Site. No obvious signs of contamination, such as phytotoxicity, were observed surrounding the sheep dip. However, fill materials primarily comprising

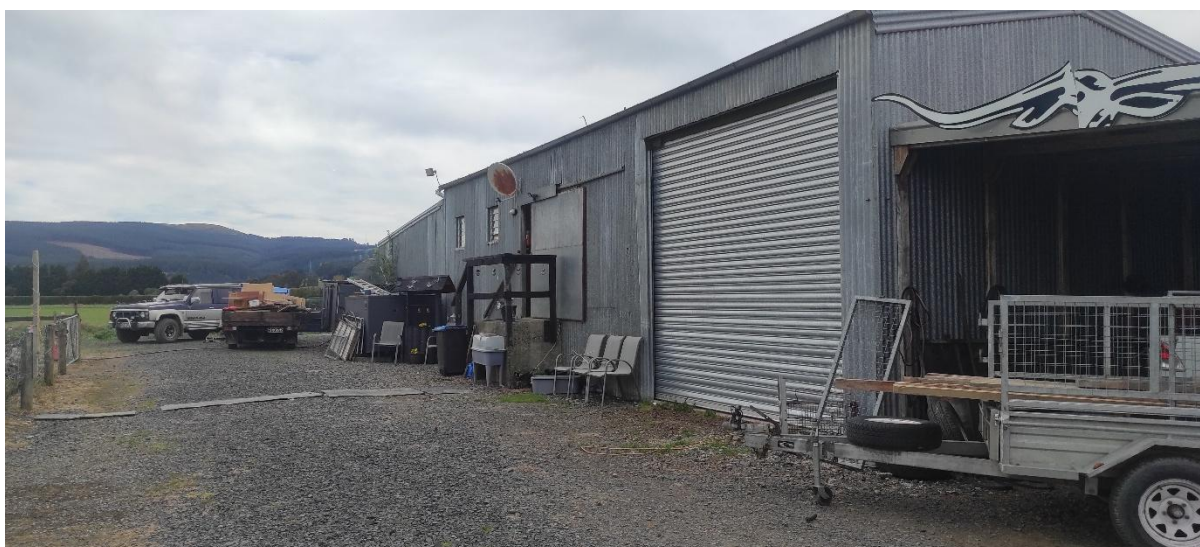
Figure 14: The woolshed in the centre of the Site which has been converted into a workshop (17 October 2025).

In the centre of the Site, a woolshed is present which has been converted into a workshop (Figure 14). The workshop was in active use at the time of the site visit.

As noted in the PSI, minor hydrocarbon staining is present surrounding parts of the former woolshed/current workshop in the centre of the Site. The interior of this building was not inspected, although the active workshop area appears to be at least partially floored with a concrete slab.

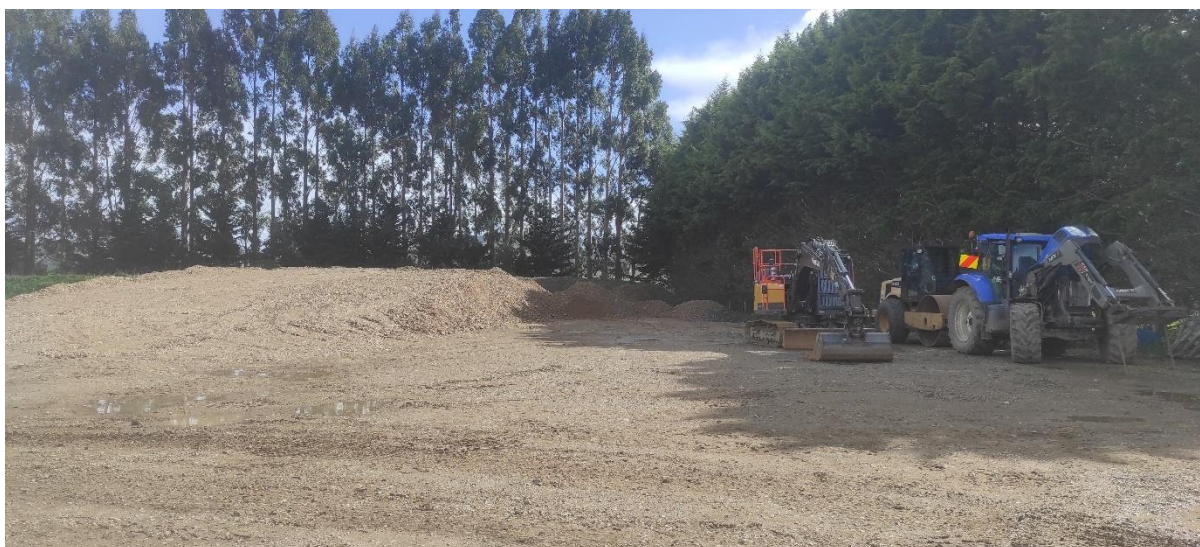
Figure 15: Recent excavation works conducted on the Site to create a gravel platform (16 October 2025).

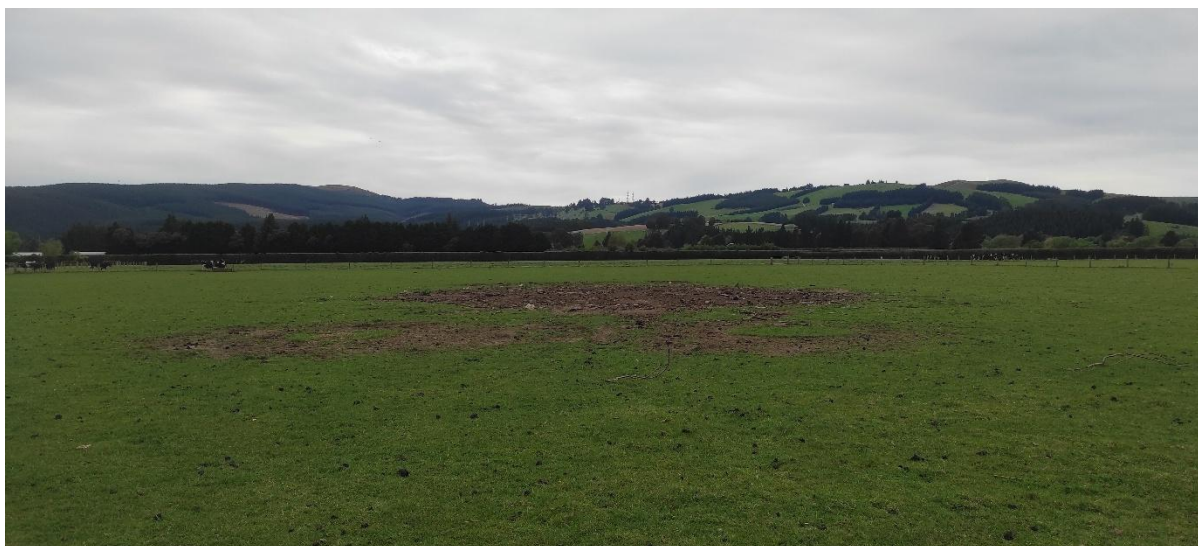
Figure 16: A suspected burn pile area within the northwestern end of 292 Dukes Road North (17 October 2025).

- **Burn Pile:** Concentrations of heavy metals within a suspected burn pile area (location D26) were found to be elevated above predicted background levels. Concentrations of arsenic were reported to exceed the *Commercial/Industrial outdoor worker (unpaved)* SCS and the applicable environmental guidelines, and these soils may present a risk to human and environmental health under the proposed commercial/industrial land use and during development works. This part of the Site must be considered a HAIL site.

In one of the northern paddocks, just to the south of the dwelling at 274 Dukes Road North, a large circular area (Figure 16) was observed that contained charred remains of timber, and this area is likely used for burning waste.

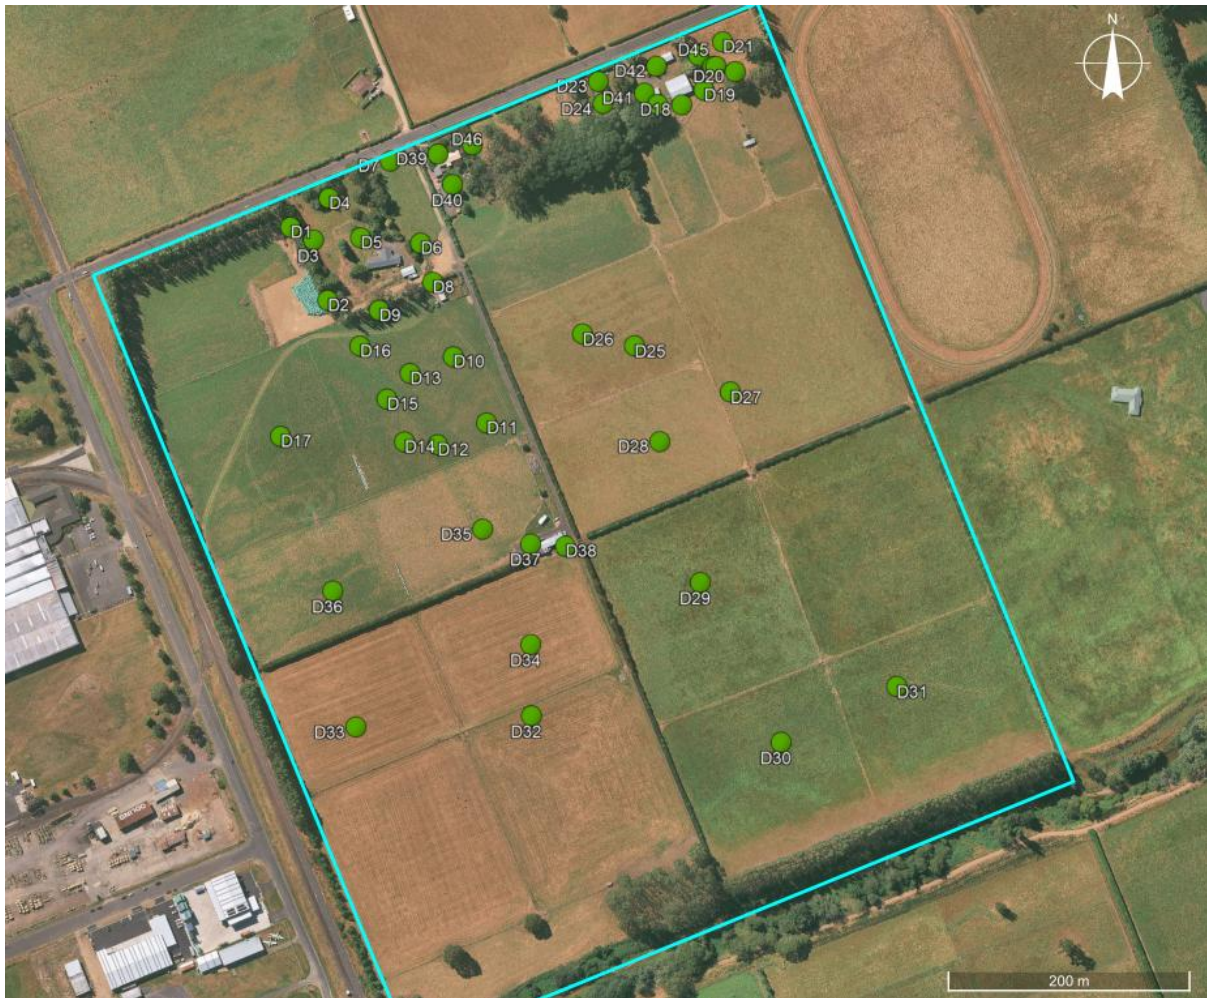
Figure 17: Sampling locations across the Site (Google Earth, Image ©2025 Airbus).

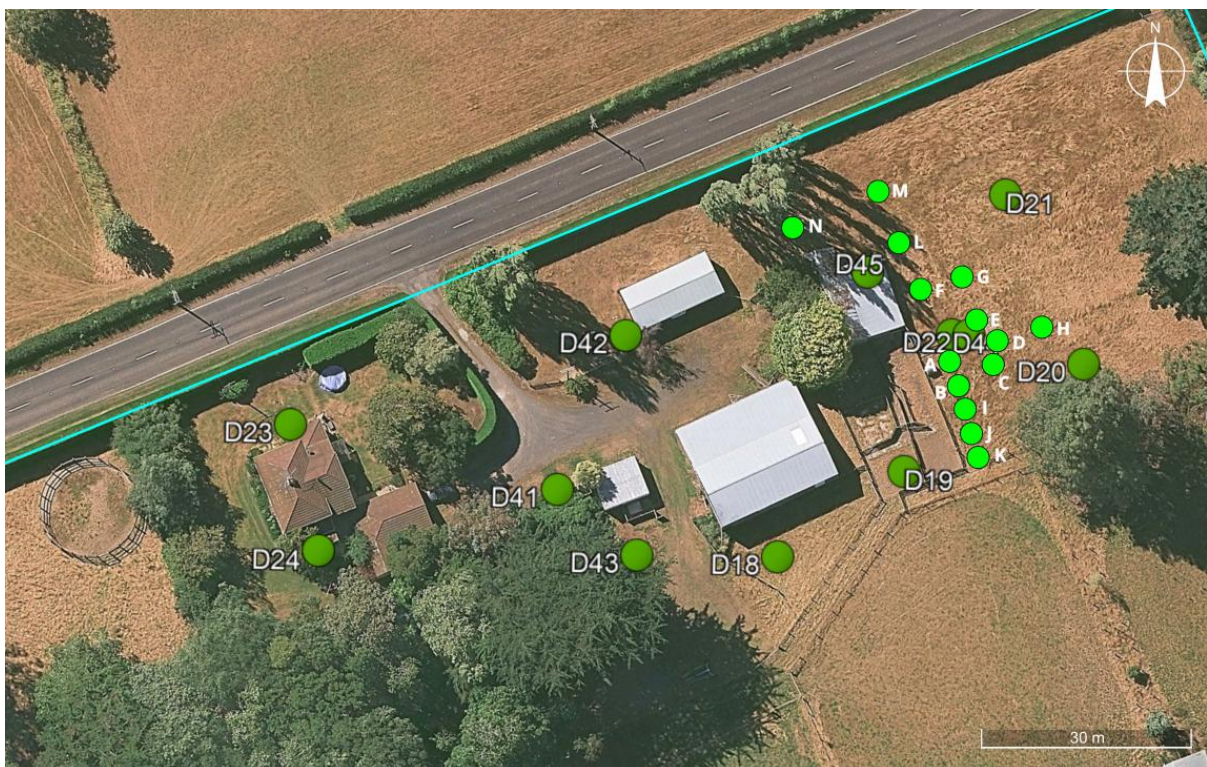
Figure 18: Sampling locations in the northern end of the Site, with samples A-N indicating additional sampling locations analysed via XRF (Google Earth, Image ©2025 Airbus).

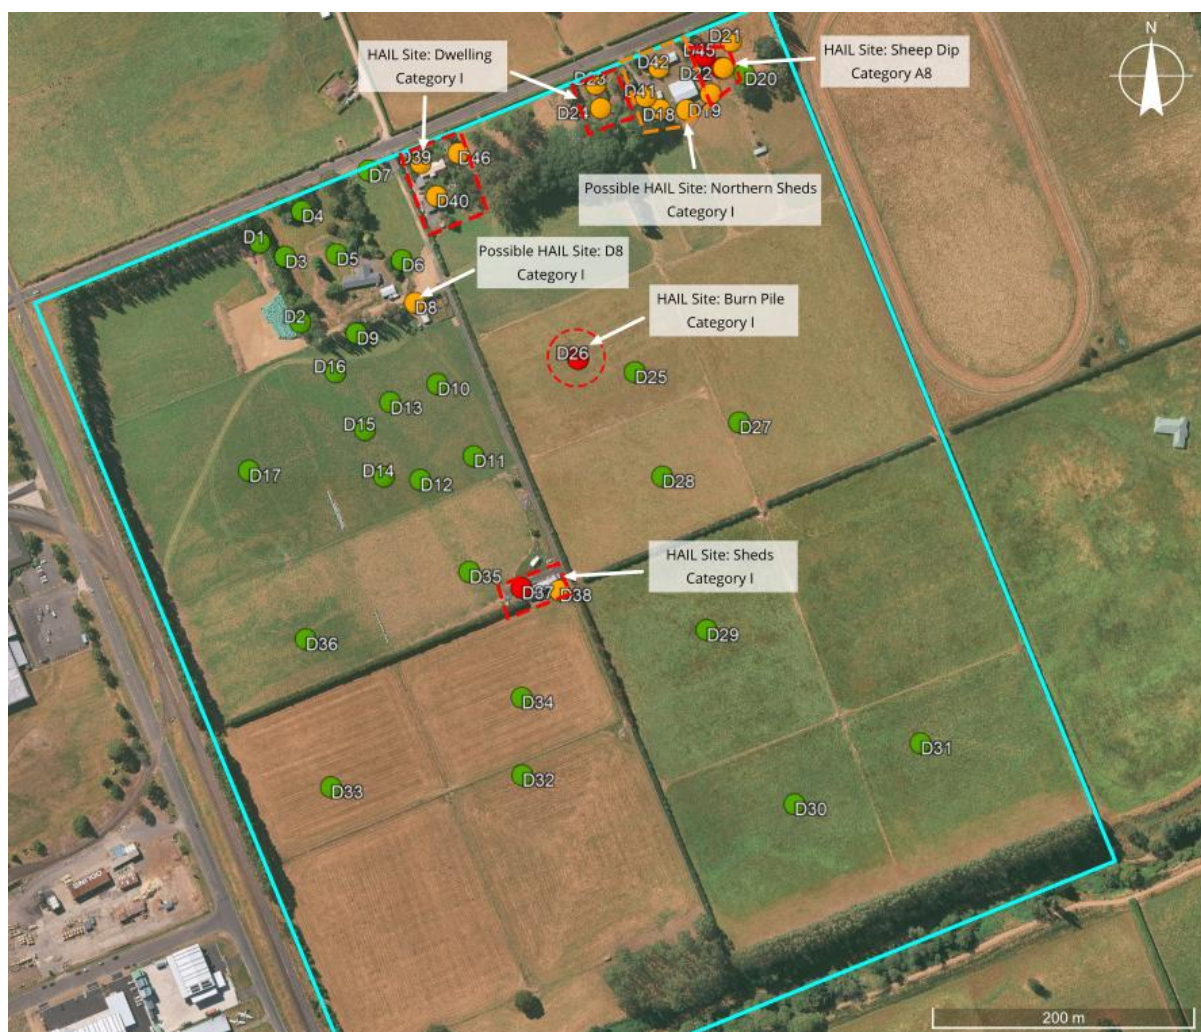
Figure 19: Sampling locations across the Site. Locations denoted in red indicate samples with contaminant concentrations that exceed the Commercial/Industrial SCS/SGV, and locations coloured orange indicate samples with contaminant concentrations above background but below the Commercial/Industrial SCS/SGV. Locations coloured green indicate samples consistent with predicted background. Areas outlined in red indicate verified HAIL sites and areas outlined in orange indicate unverified HAIL sites (Google Earth, Image © 2025 Airbus).

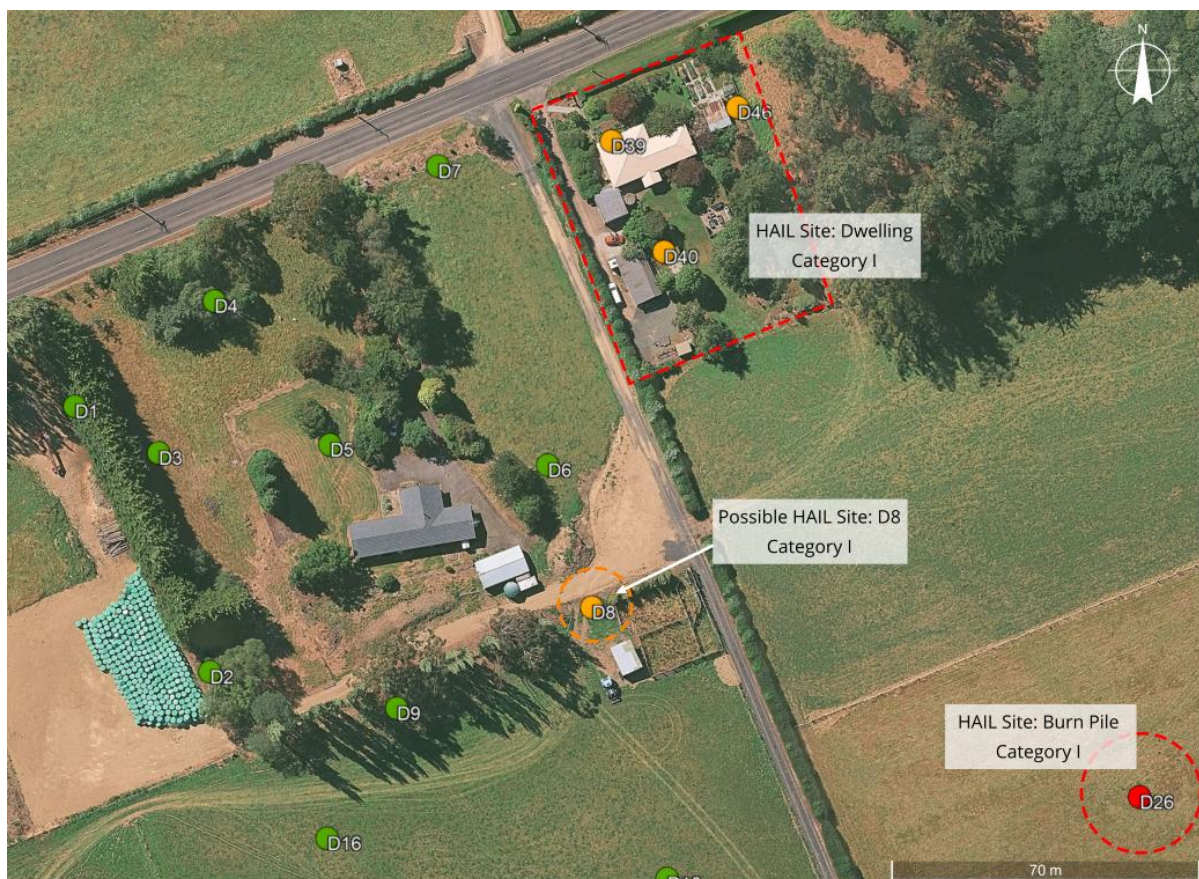
Figure 21: Sampling locations across the northern end of the Site. Locations denoted in red indicate samples with contaminant concentrations that exceed the Commercial/Industrial SCS/SGV, and locations coloured orange indicate samples with contaminant concentrations above background but below the Commercial/Industrial SCS/SGV. Locations coloured green indicate samples consistent with predicted background. Areas outlined in red indicate verified HAIL sites, and areas outlined in orange indicate unverified HAIL sites (Google Earth, Image © 2025 Airbus).
