Project Number: 25086

## PRELIMINARY SITE INVESTIGATION

122 MORVEN FERRY ROAD

Prepared for **Gibbons Development Limited**

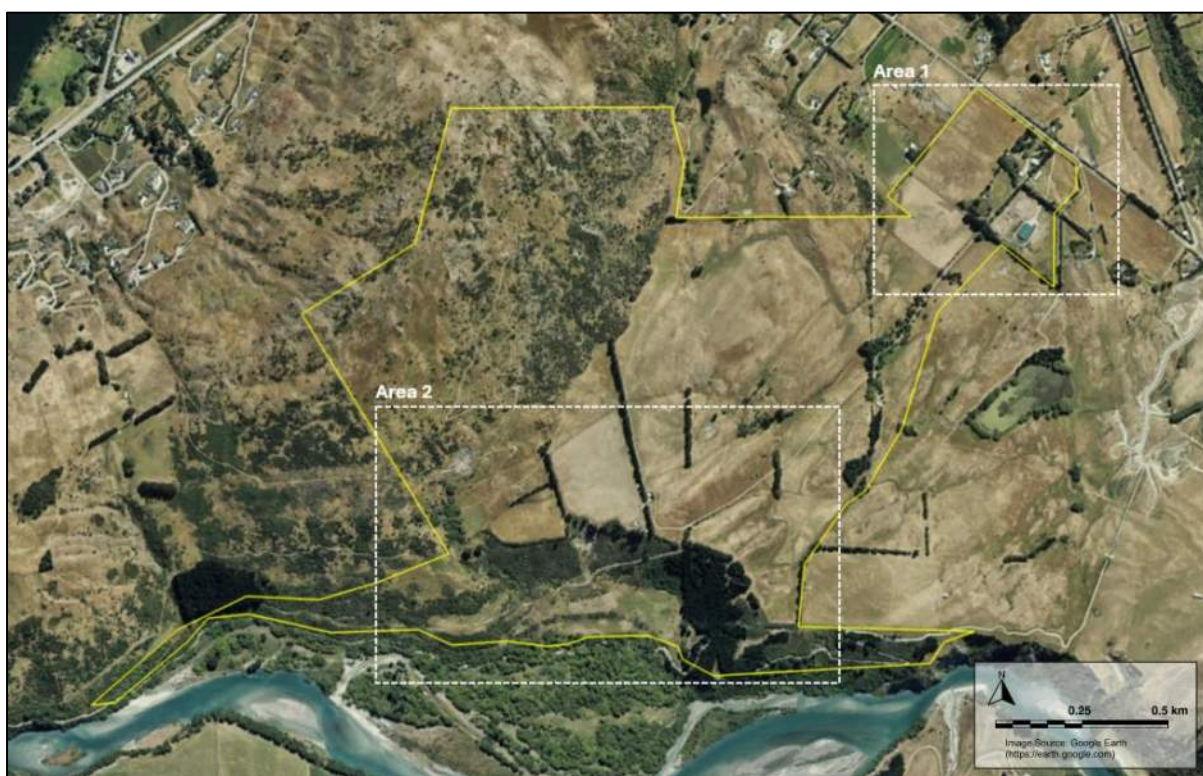
Site location plan, showing the site boundary (yellow) and Area 1 and Area 2 (white boxes) and general surrounds

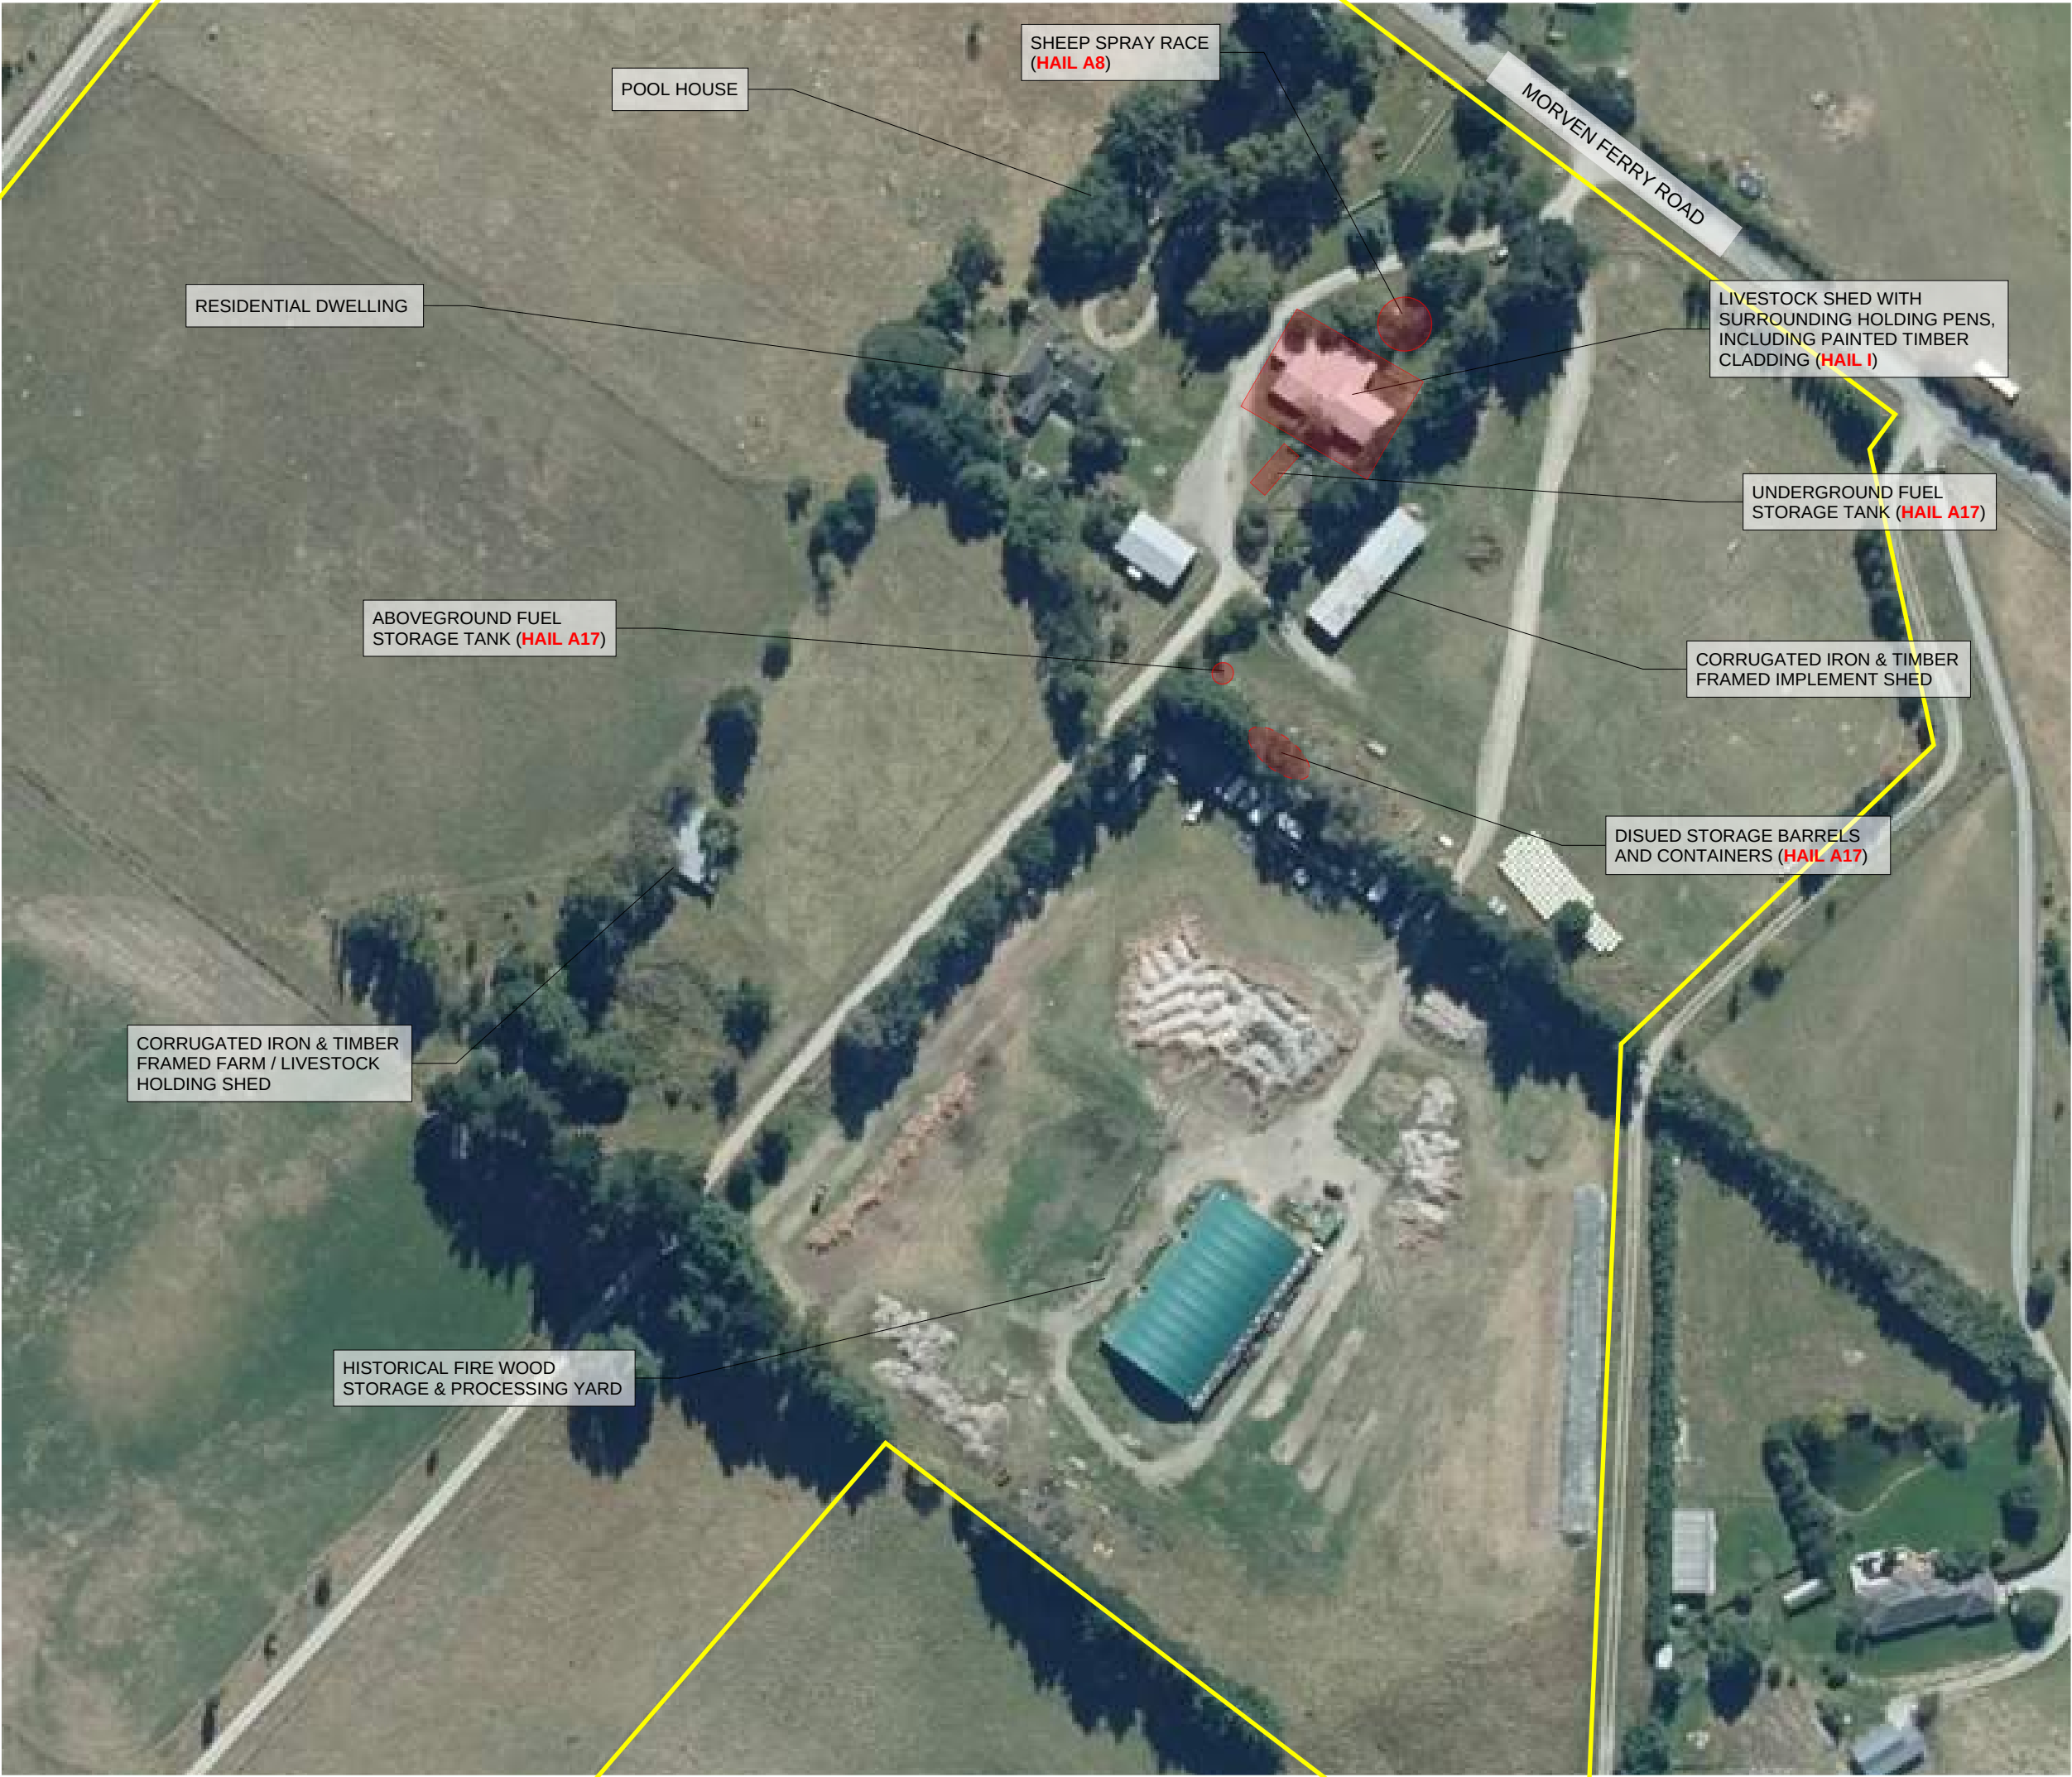
**TITLE**  
Figure 2: Site Plan (Area 1)

A site walkover was undertaken on 9<sup>th</sup> September 2025. Photographs documenting site conditions are provided in Appendix D. All key features described below are marked on Figures 2 – 3 in Appendix B.

Potential sources of contamination identified through the desktop review, site walkover, and landowner interview are summarised in Table 5. The risk ratings relate specifically to HAIL-activities and the likelihood of associated soil contamination exceeding applicable human health assessment criteria; they are not intended to represent the scale, extent, or cost of management, but solely the potential for human health exceedances to occur. All HAIL features requiring further investigation are illustrated in Figures 2 and 3 in Appendix B.

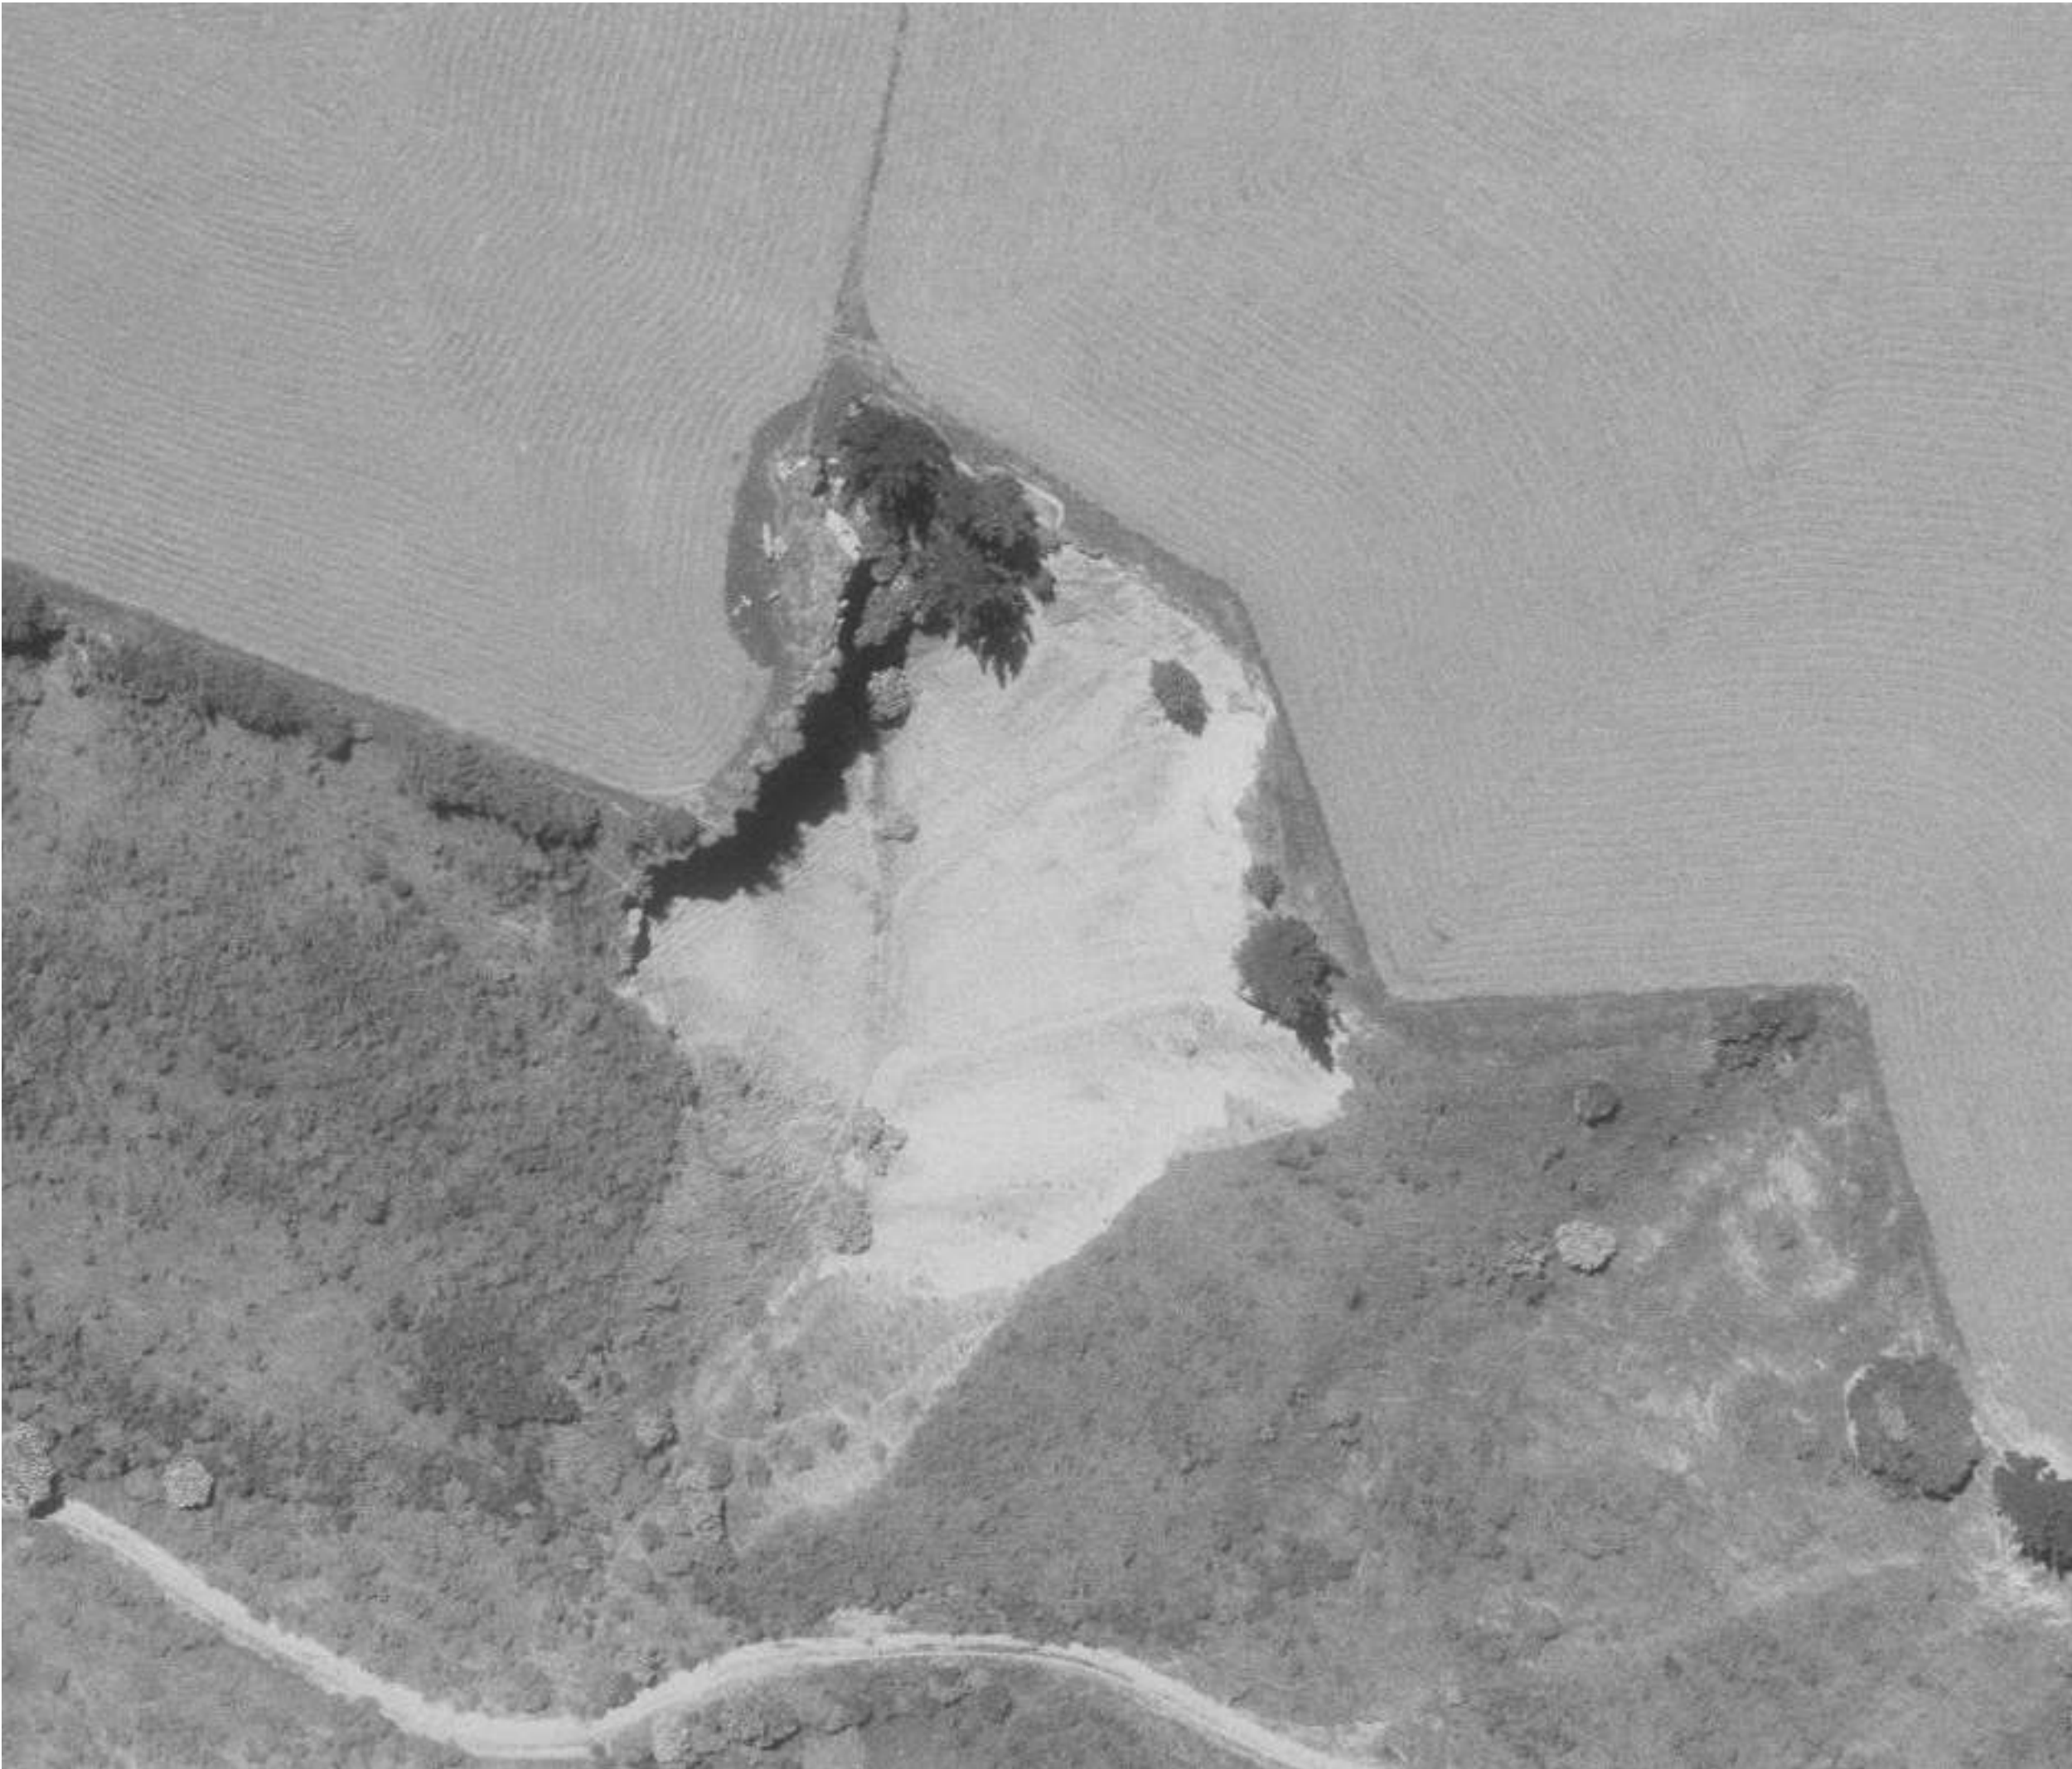
**TITLE**  
Historical Aerial 1978 - potential flytip area

- The prominent gully noted in the aerial photography (Refer to Figure 3, Appendix B) was inspected, and fly-tipped waste was visible within the gully, including plastics, timber, fabric, and other household materials. Waste was confined within the steep gully slopes and was not present on the terrace above. Closer inspection of the waste material was not possible due to steep terrain (Photographs 20 – 21)

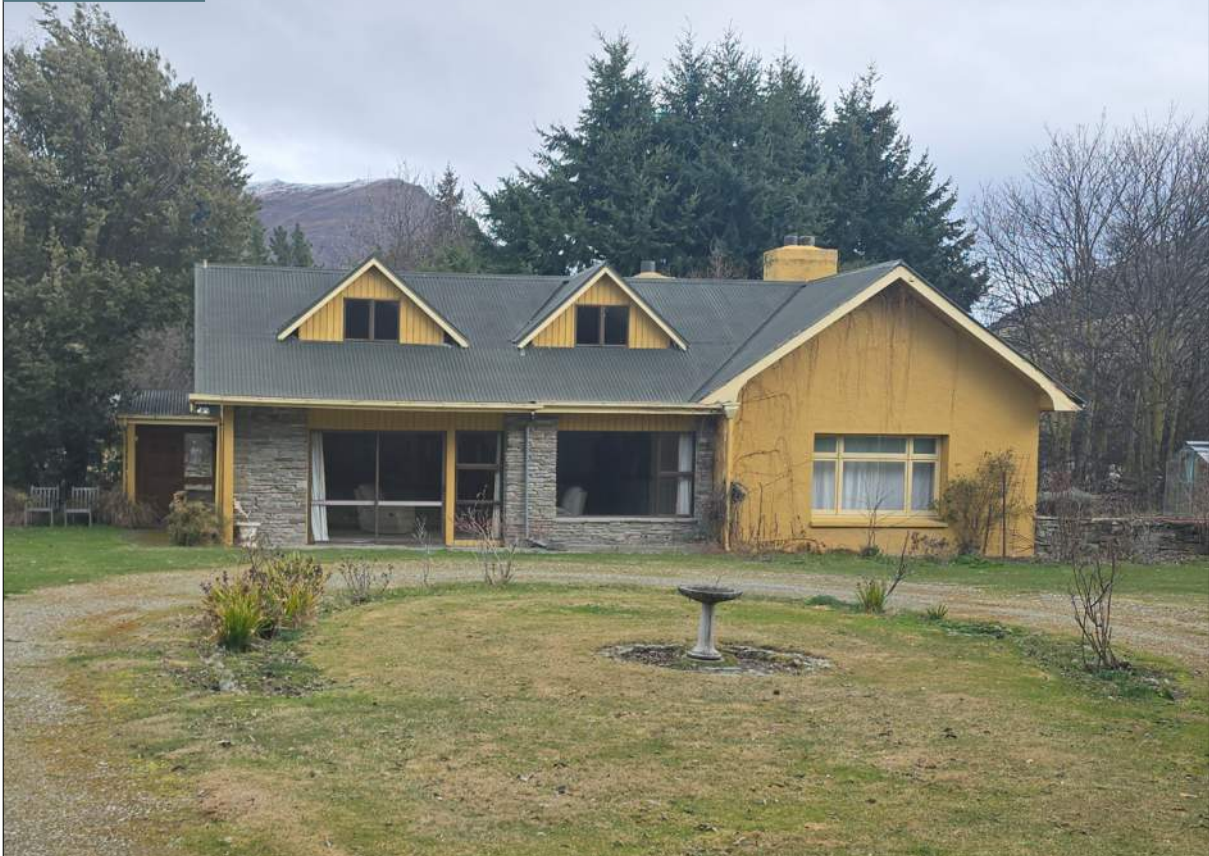
Photograph 1

- A two-storey timber and stone dwelling with corrugated iron roofing is located to the west of the farm sheds and holding pens. The structure was generally in good condition. No potential asbestos-containing materials (PACM) were identified, although painted cladding was present across parts of the exterior (Photograph 1).

Residential dwelling (Area 1)

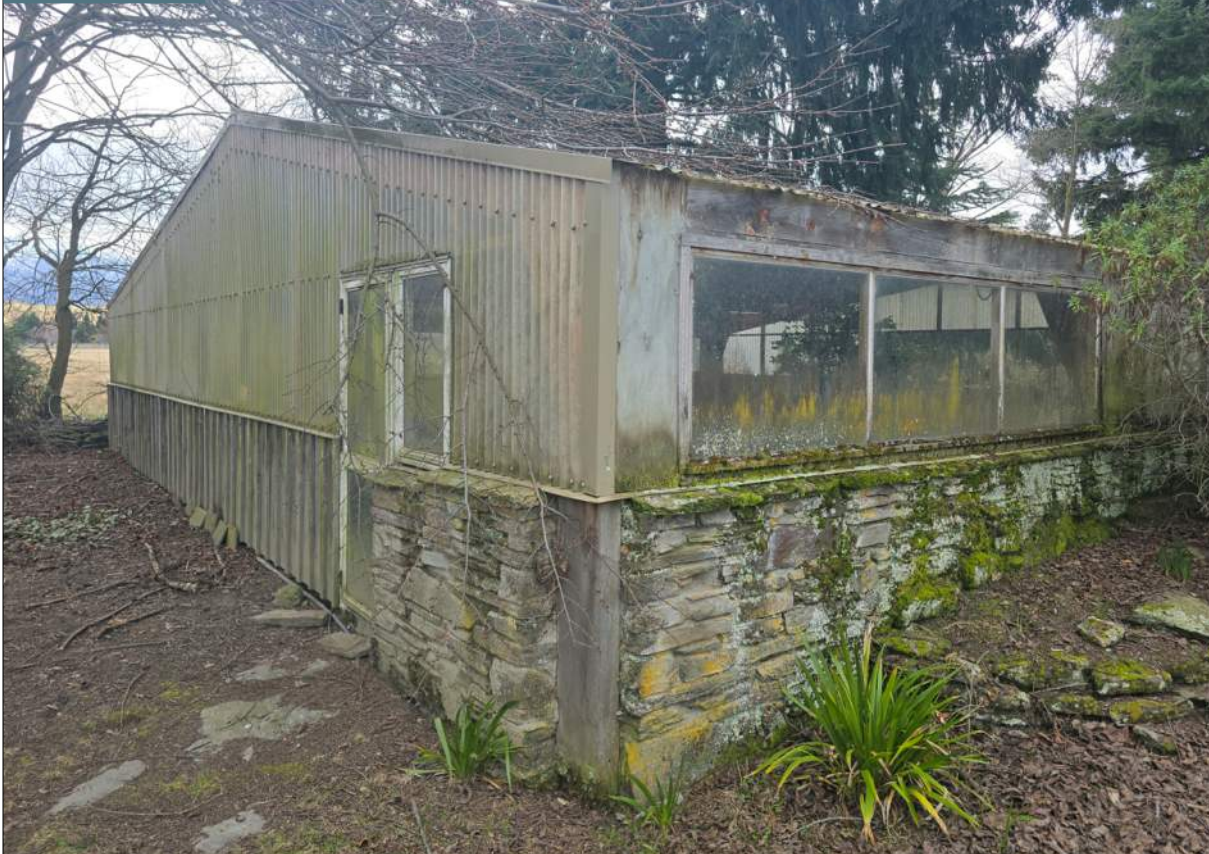
Photograph 2

- North of the dwelling was a dilapidated pool house containing an indoor/inground swimming pool. Construction comprised stone, timber, and corrugated fibre-plastic sheeting. No PACM or painted surfaces were noted (Photograph 2 & 3).

Poolhouse (Area 1)

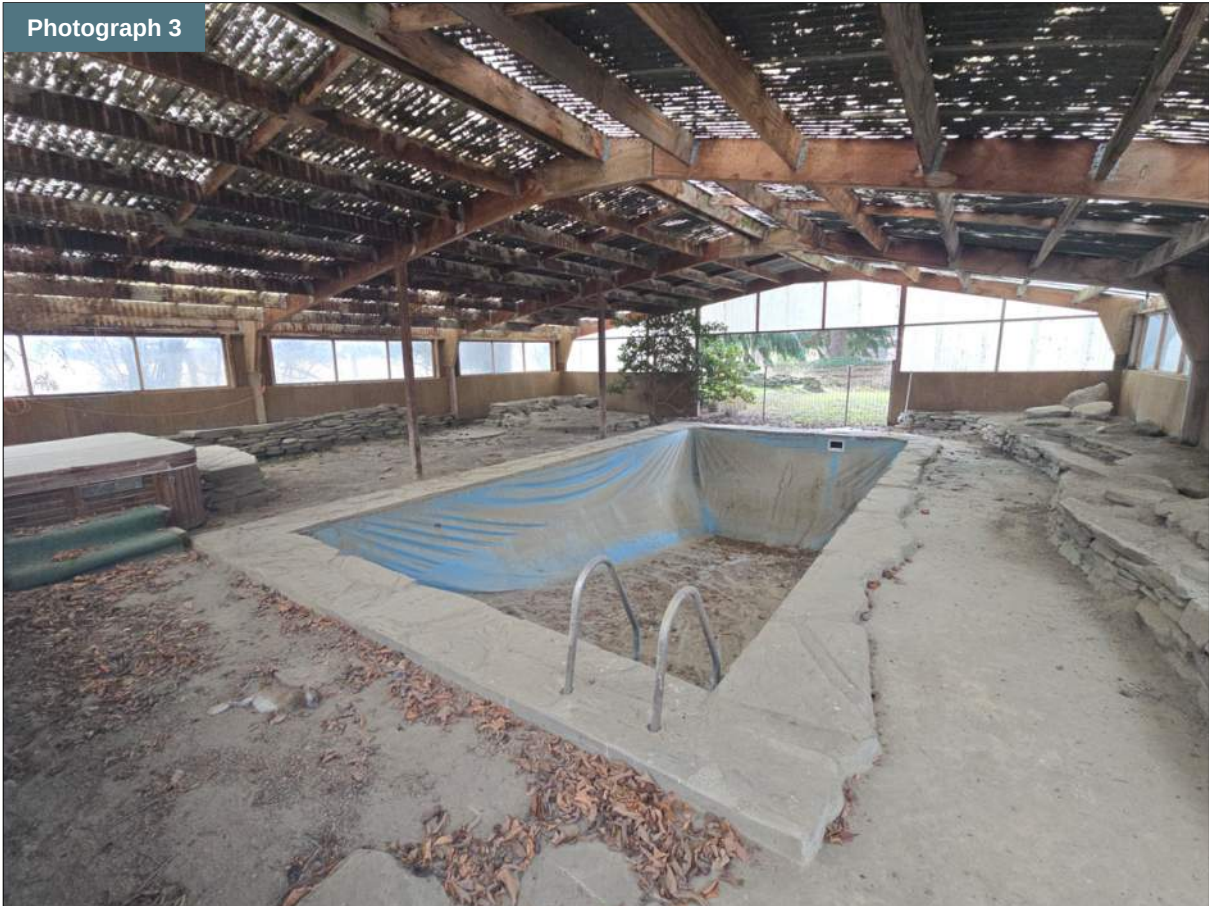
Photograph 3

In-ground swimming pool (Area 1)

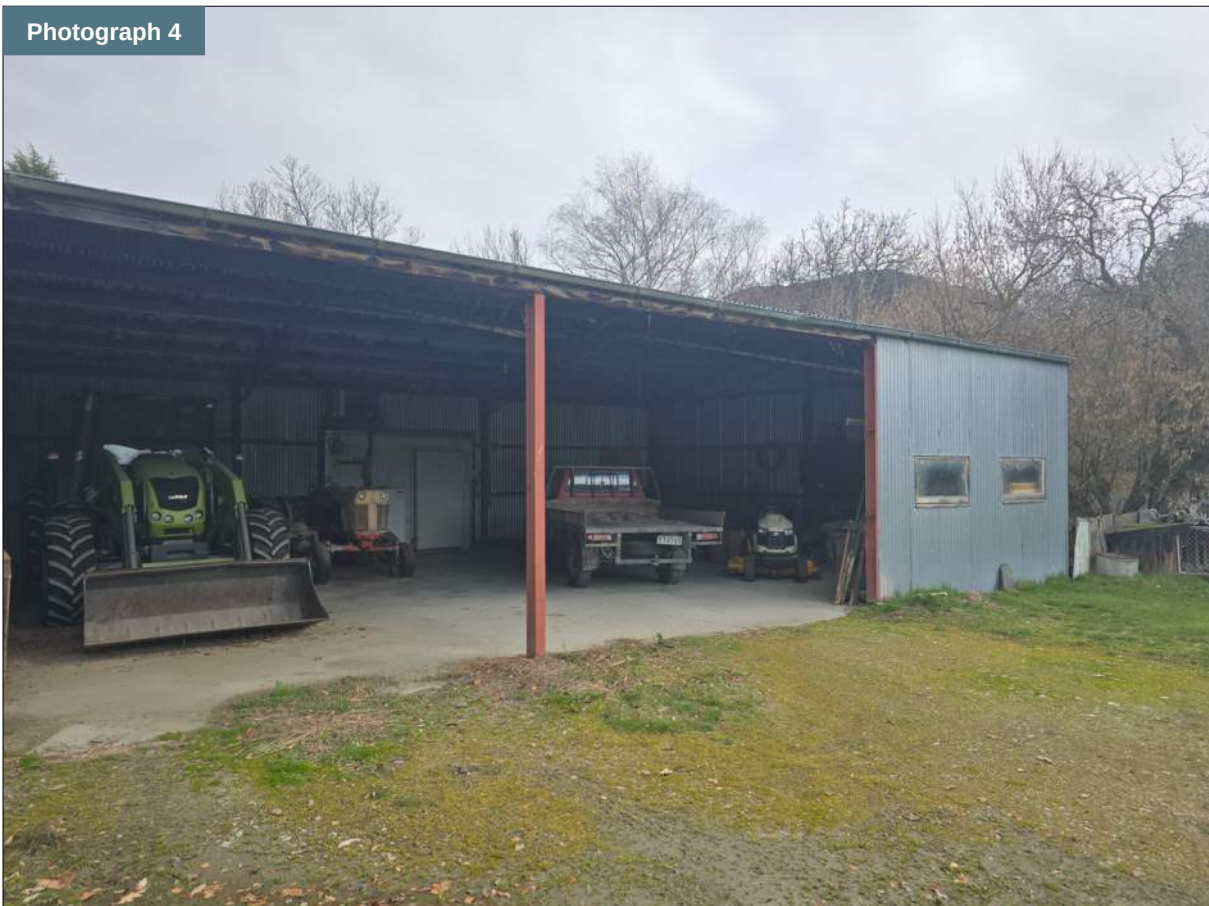
Photograph 4

- Southeast of the dwelling stood the main farm shed, a modern timber and steel structure on a concrete slab, used for storing tractors, vehicles, and agricultural equipment. No PACM or fuel storage was identified (Photograph 4).

Steel and timber implement shed, southeast of the main dwelling (Area 1)

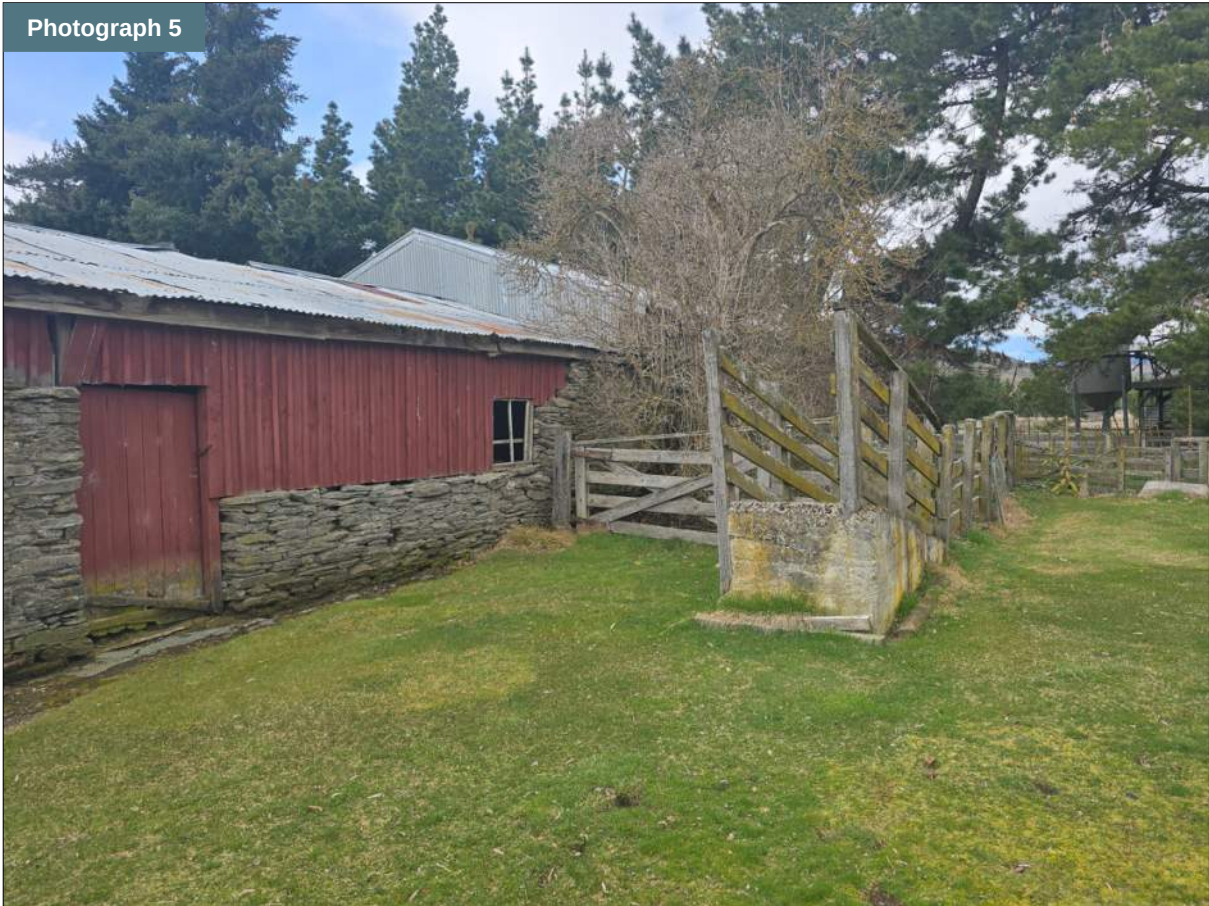
Photograph 5

- East of the dwelling were livestock holding sheds of mixed timber and stone construction. Painted timber cladding was observed in parts, and the structures were in generally poor condition with flaking paint noted. No PACM was observed (Photographs 5 – 8).

Livestock holding shed with surrounding pens and stock races (Area 1)

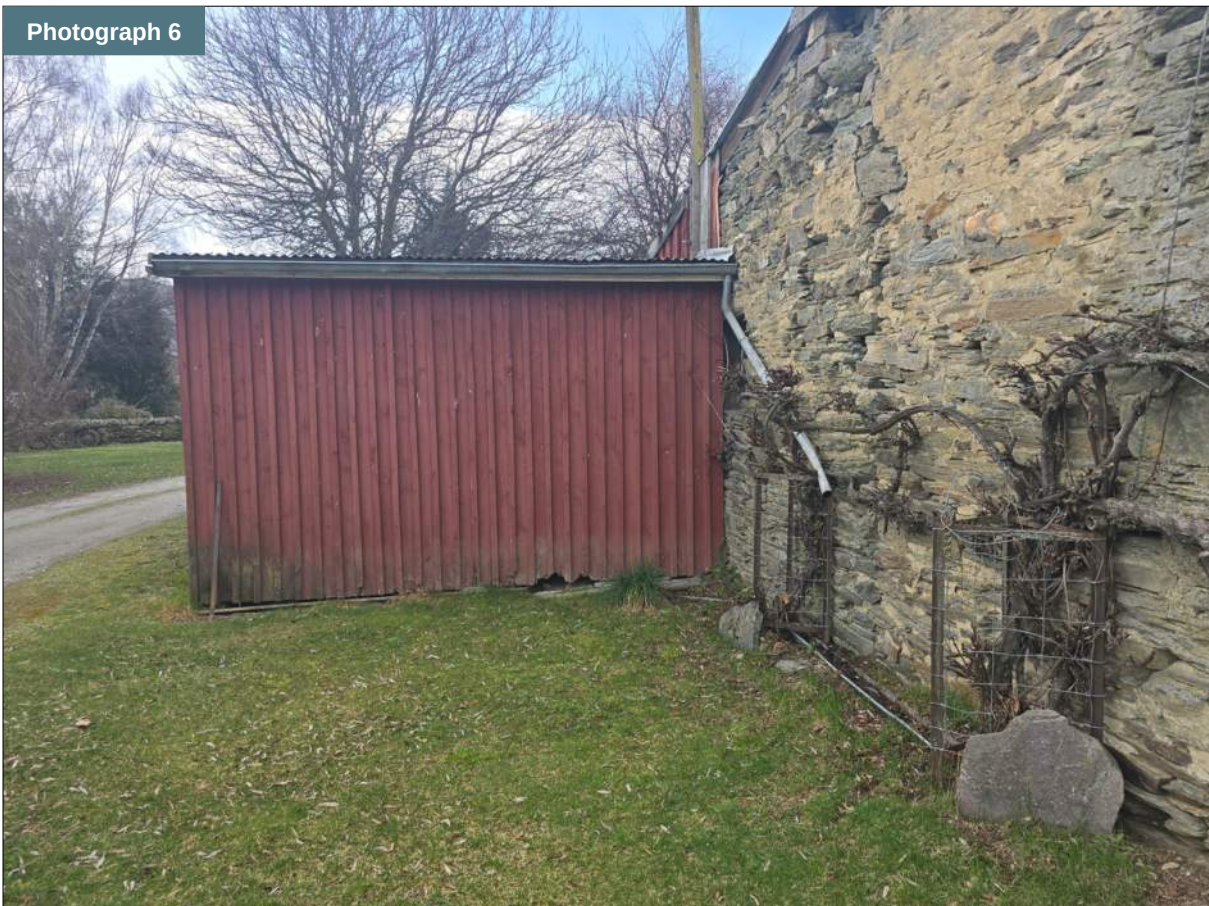
Photograph 6

| | Livestock holding shed and timber clad structures (potential <b>HAIL I</b> ) | The livestock sheds east of the dwelling include sections of deteriorated painted timber with flaking observed. While the likelihood of significant contamination is low, there remains a potential for a shallow “lead-halo” around the structures, compounded by proximity to the former sheep spray race and pens. | Lead, arsenic (from spray race residues), organochlorine pesticides | Moderate | Targeted and systematic soil testing |

Painted exterior, deteriorated and flaking (Area 1)

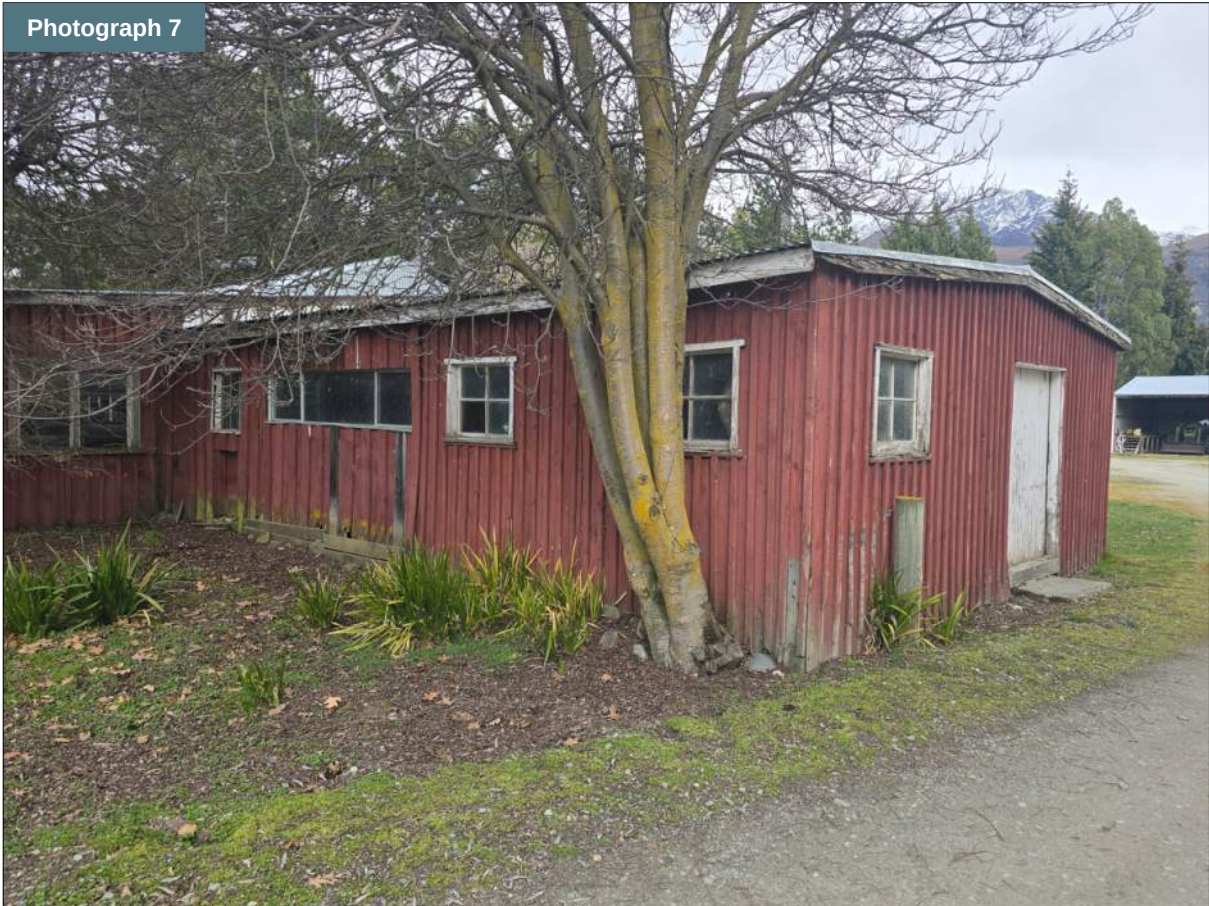
Photograph 7

Painted exterior, deteriorated and flaking (Area 1)

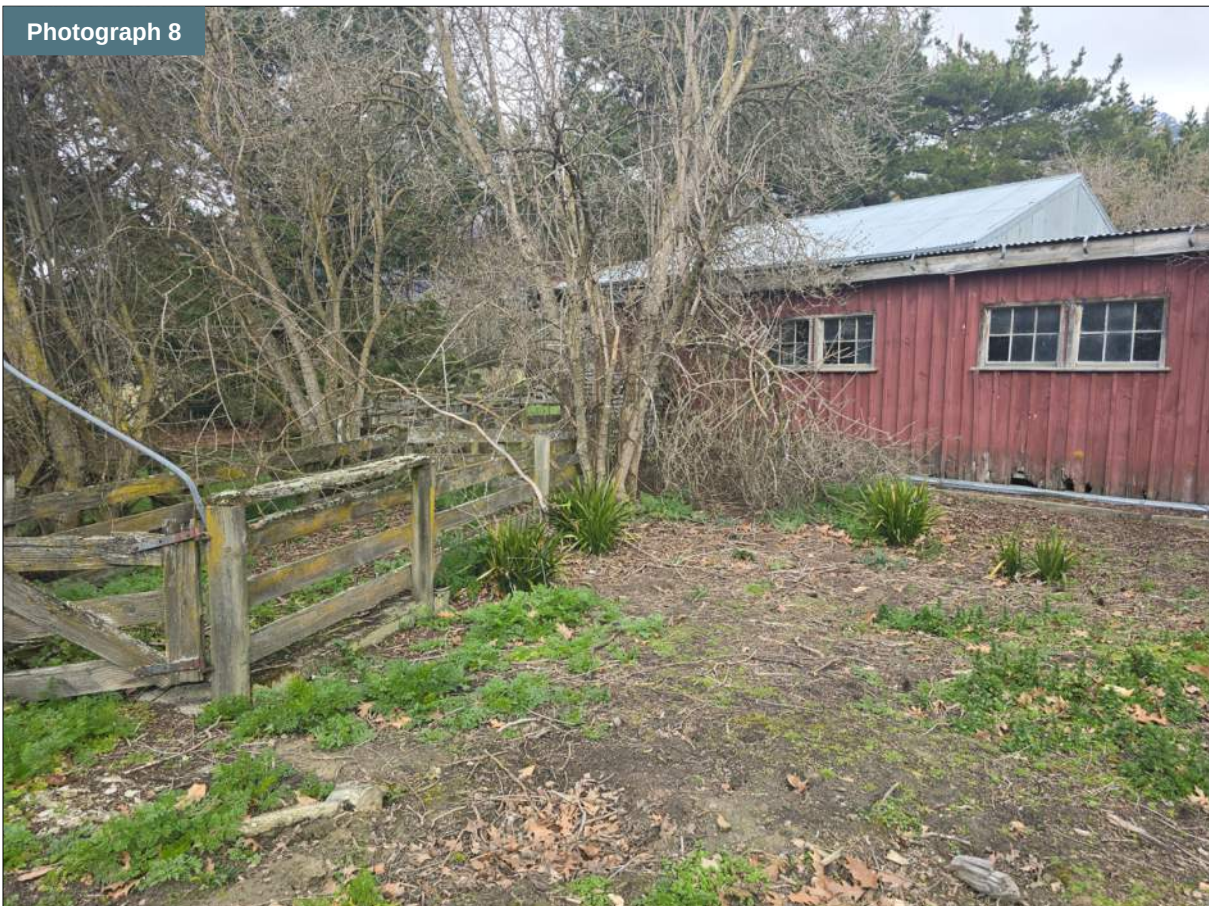
Photograph 8

Livestock holding shed and pens, painted exterior, deteriorated and flaking (Area 1)

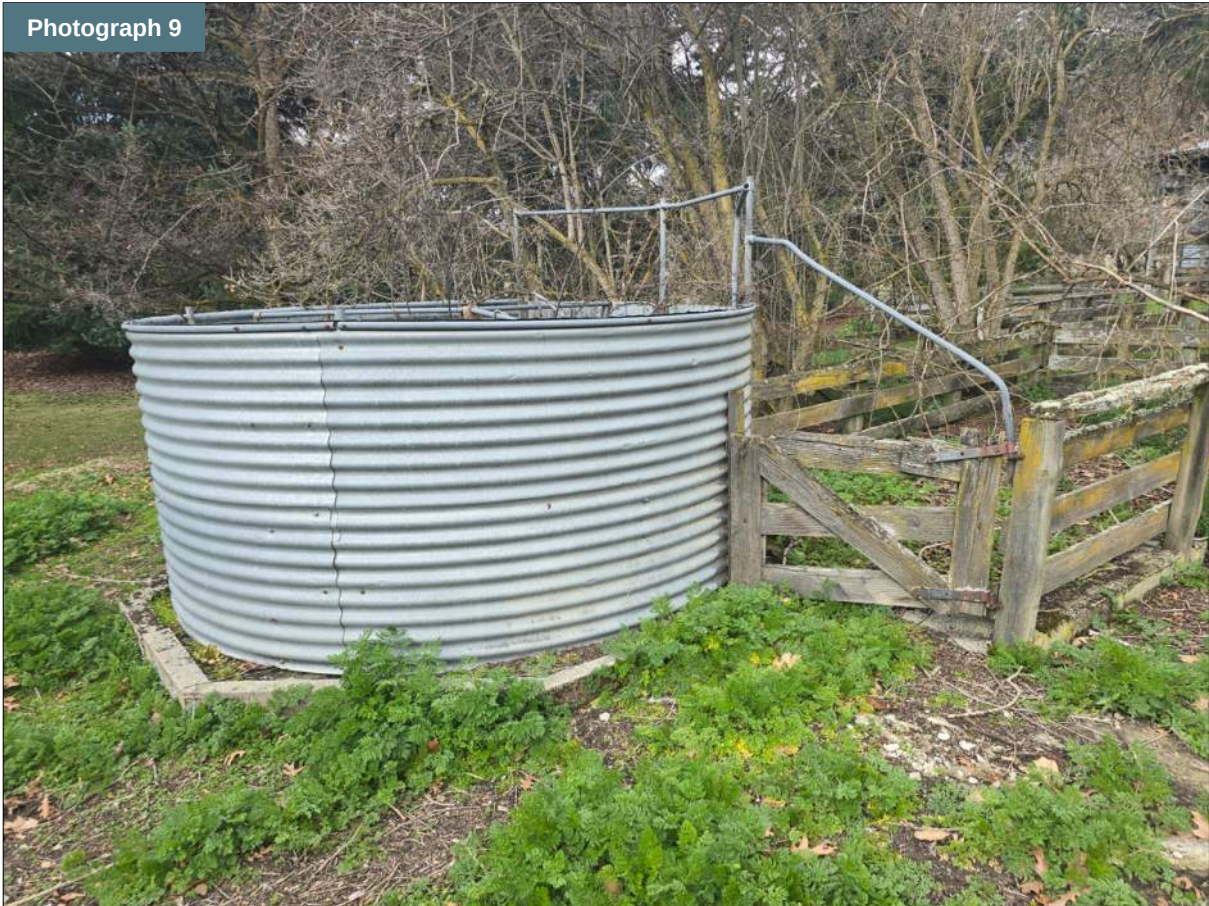
Photograph 9

- A disused sheep spray race was located north of the livestock sheds. The spray chamber was of steel construction, in poor condition, and located on a concrete base. The surrounding stock race surfaces leading to/from the spray chamber were of mixed concrete and bare soil (Photographs 9 – 11).

| Site Area | HAIL / Activity | Comment | Contaminants | Risk | Recommendation |
|---|---|---|---|---|---|
| Area 1 –<br>Farmhouse<br>and farm<br>infrastructure | Sheep Spray race<br>(HAIL A8) and<br>adjacent stock<br>races | A disused sheep spray race is located north of the livestock sheds. Although unused for over 20 years and founded on a concrete base, the structure remains in poor condition, and there is potential for residual contamination in surrounding soils. This risk extends into the adjacent pens and stock races where drip and wash-down may have occurred. | Metal, metalloids and organochlorines | High | Targeted soil investigation around the spray race, extending into pens/races to delineate any drip/run-off |

Sheep spray chamber and adjacent stock pens (Area 1)

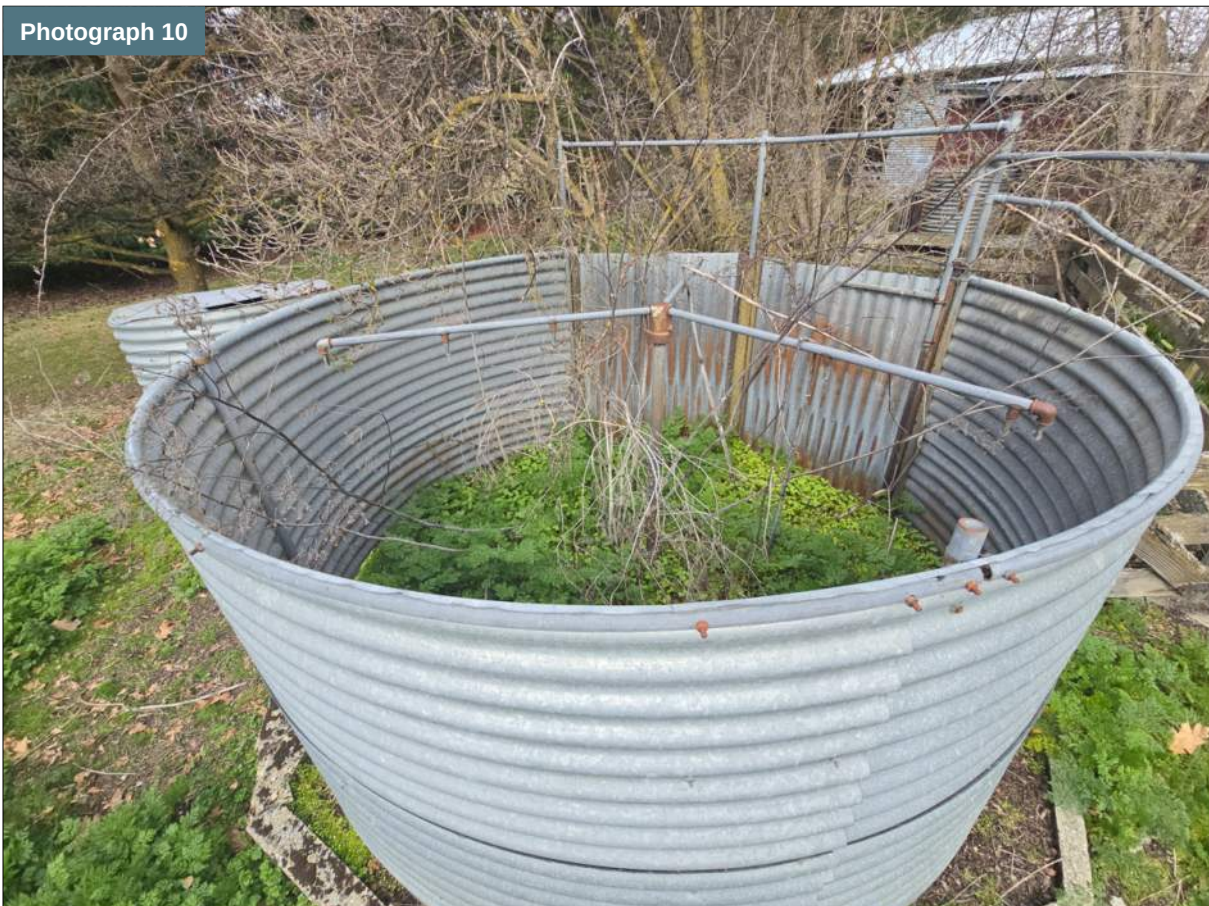
Photograph 10

Sheep spray race operation (Area 1)

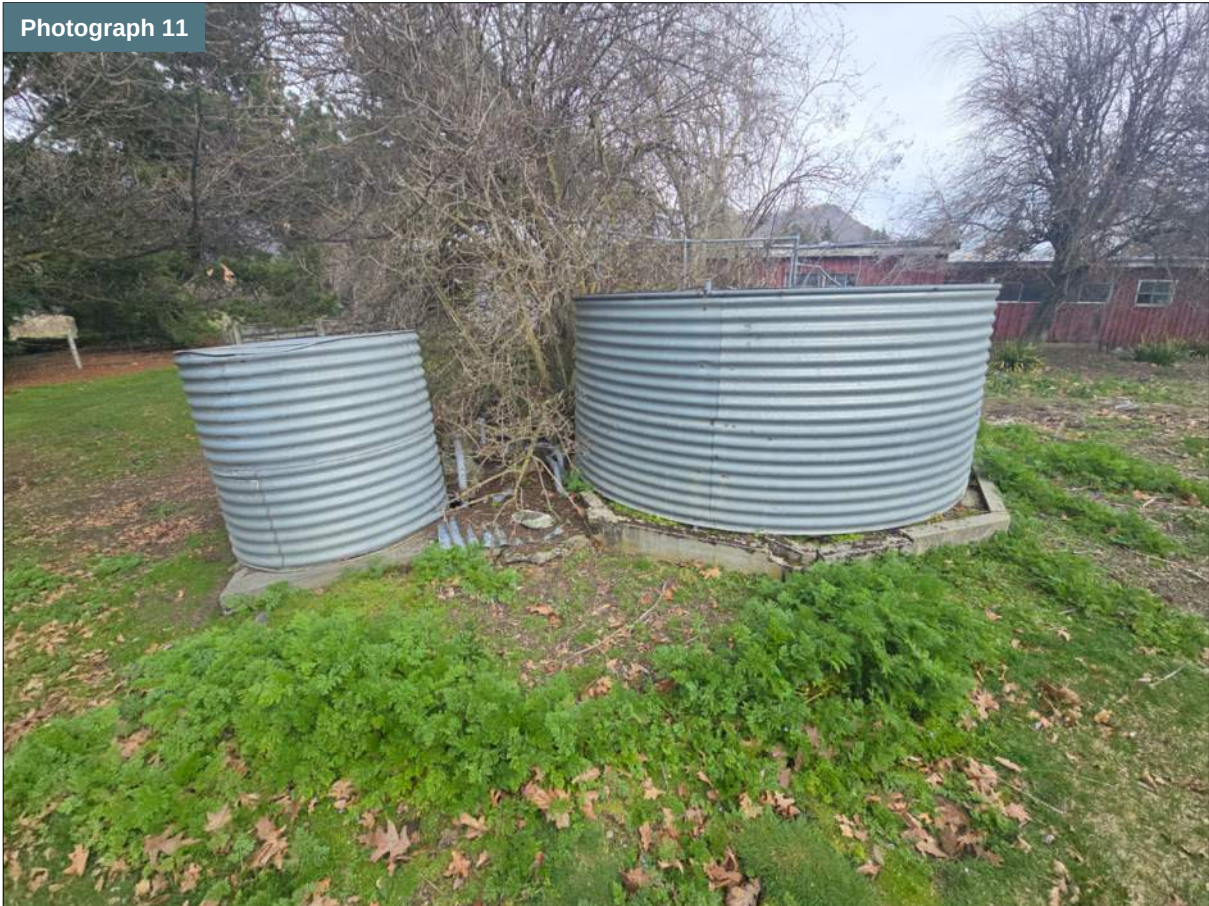
Photograph 11

Sheep spray race operation (Area 1)

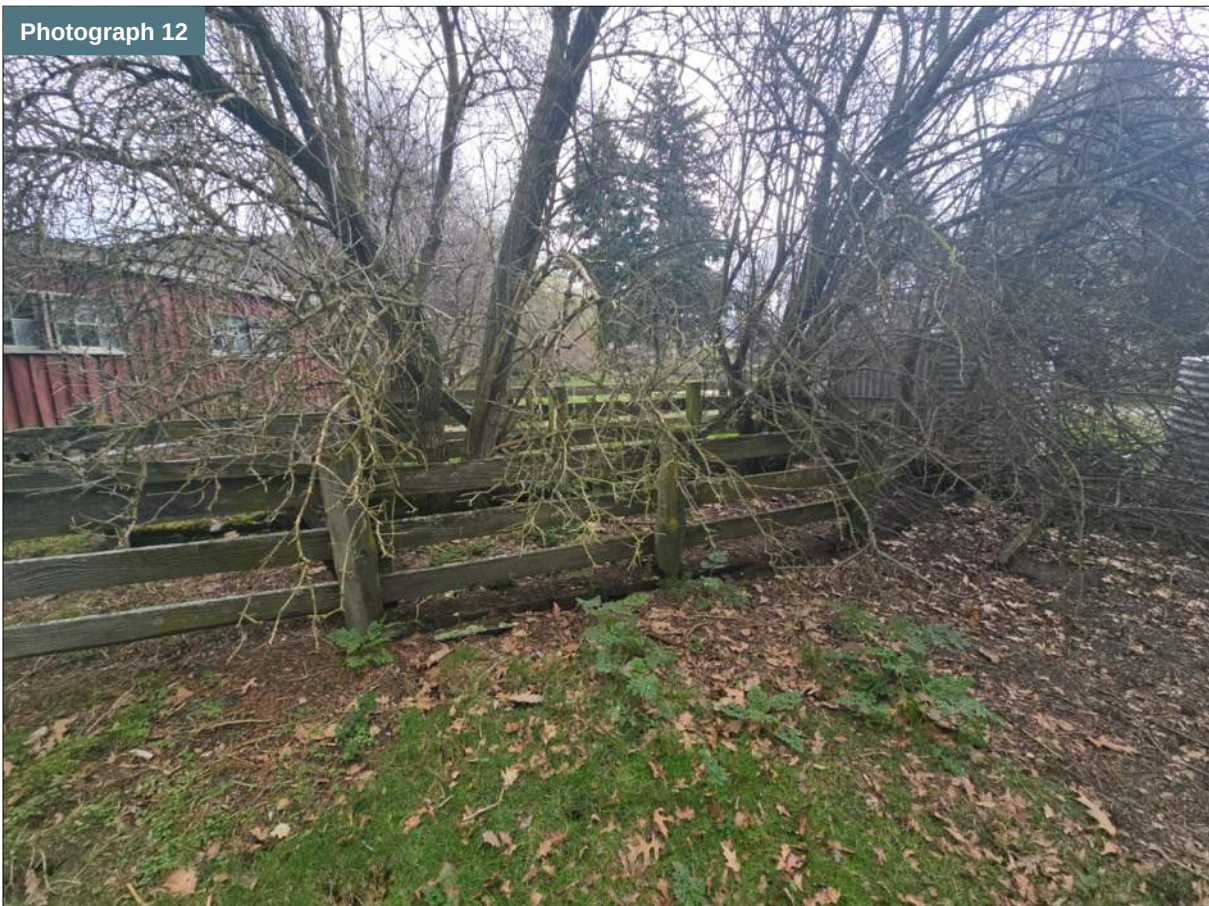
Photograph 12

- Surrounding the livestock holding sheds were a series of outdoor timber pens and fencing, with additional pens located between the sheds and the sheep spray chamber to the north, and further fencing extending south of the sheds (Photographs 12 – 13).

Stock races leading to/from the spray chamber (Area 1)
