Project Number: 25086

## PRELIMINARY SITE INVESTIGATION

122 MORVEN FERRY ROAD

Prepared for **Gibbons Development Limited**

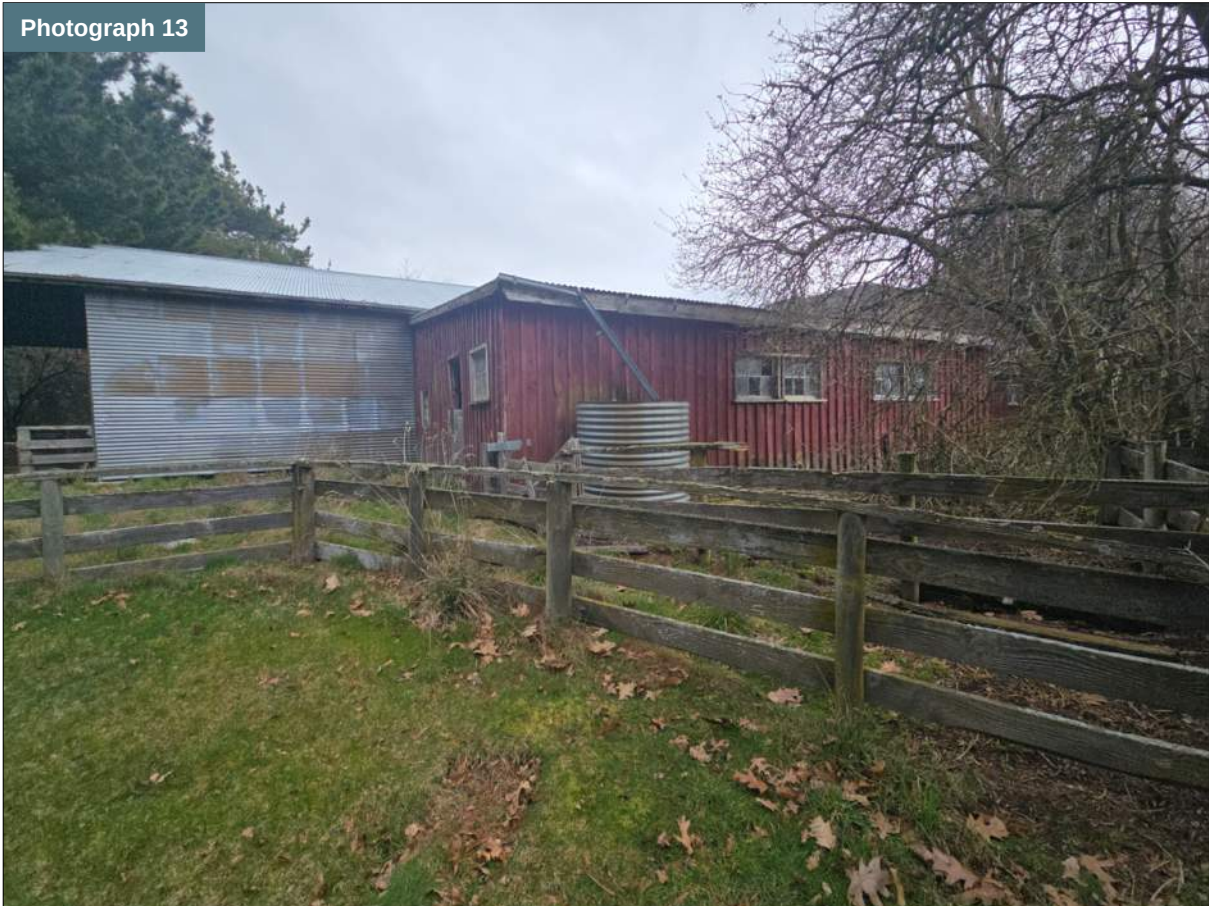
Photograph 13

- Surrounding the livestock holding sheds were a series of outdoor timber pens and fencing, with additional pens located between the sheds and the sheep spray chamber to the north, and further fencing extending south of the sheds (Photographs 12 – 13).

Stock pens between the spray chamber and livestock holding shed (Area 1)

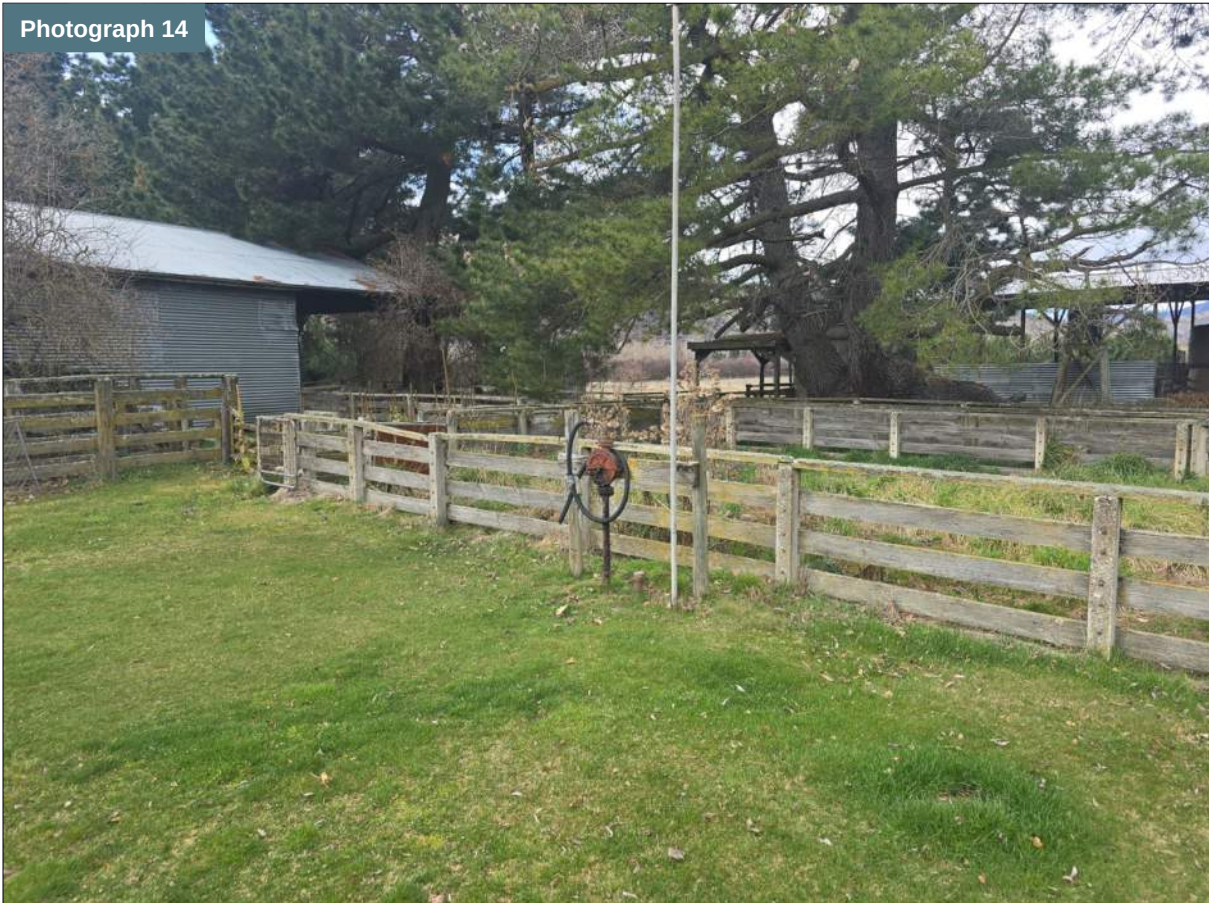
Photograph 14

| Site Area | HAIL / Activity | Comment | Contaminants | Risk | Recommendation |
|---|---|---|---|---|---|
| | Underground<br>storage tank<br>(UST) (HAIL A17) | An in-situ UST is located south of the livestock sheds. The condition of the tank is unknown, and the potential for historical leakage cannot be discounted. | TPH, PAHs, BTEX, heavy metals | Moderate | Remove under SQEP supervision to NES-CS requirements; decommission all associated infrastructure. Undertake verification sampling and remediate if required. |

Area of the underground storage tank, with filling points and vent infrastructure visible. Stock holding pens beyond. (Area 1)

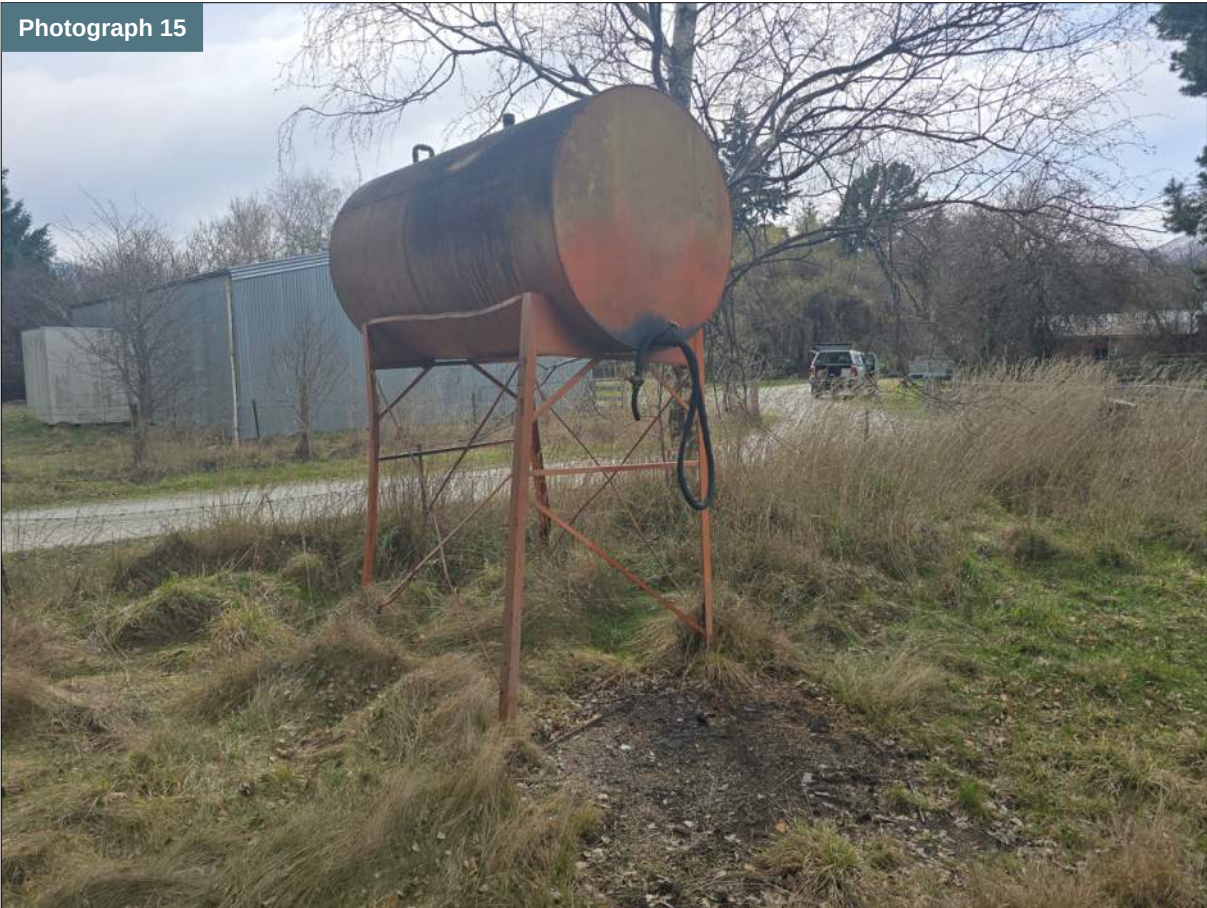
Photograph 15

- An aboveground storage tank (AST) was observed southeast of the residence. The tank was not banded, and surface staining was noted beneath it, confined to a small area (Photograph 15).

| Site Area | HAIL / Activity | Comment | Contaminants | Risk | Recommendation |
|---|---|---|---|---|---|
| | Aboveground<br>storage tank (AST)<br>(HAIL A17) | An AST is located southeast of the residence, with surface staining visible beneath it. While the staining appears localised, direct contact with soil suggests potential for contamination. | Total petroleum hydrocarbons (TPH), polycyclic aromatic hydrocarbons (PAHs), benzene, toluene, ethylbenzene, xylene (BTEX), volatile organic compounds (VOCs), heavy metals | High | Targeted shallow soil testing beneath/surrounding the AST |

Aboveground storage tank with ground surface staining visible (Area 1)

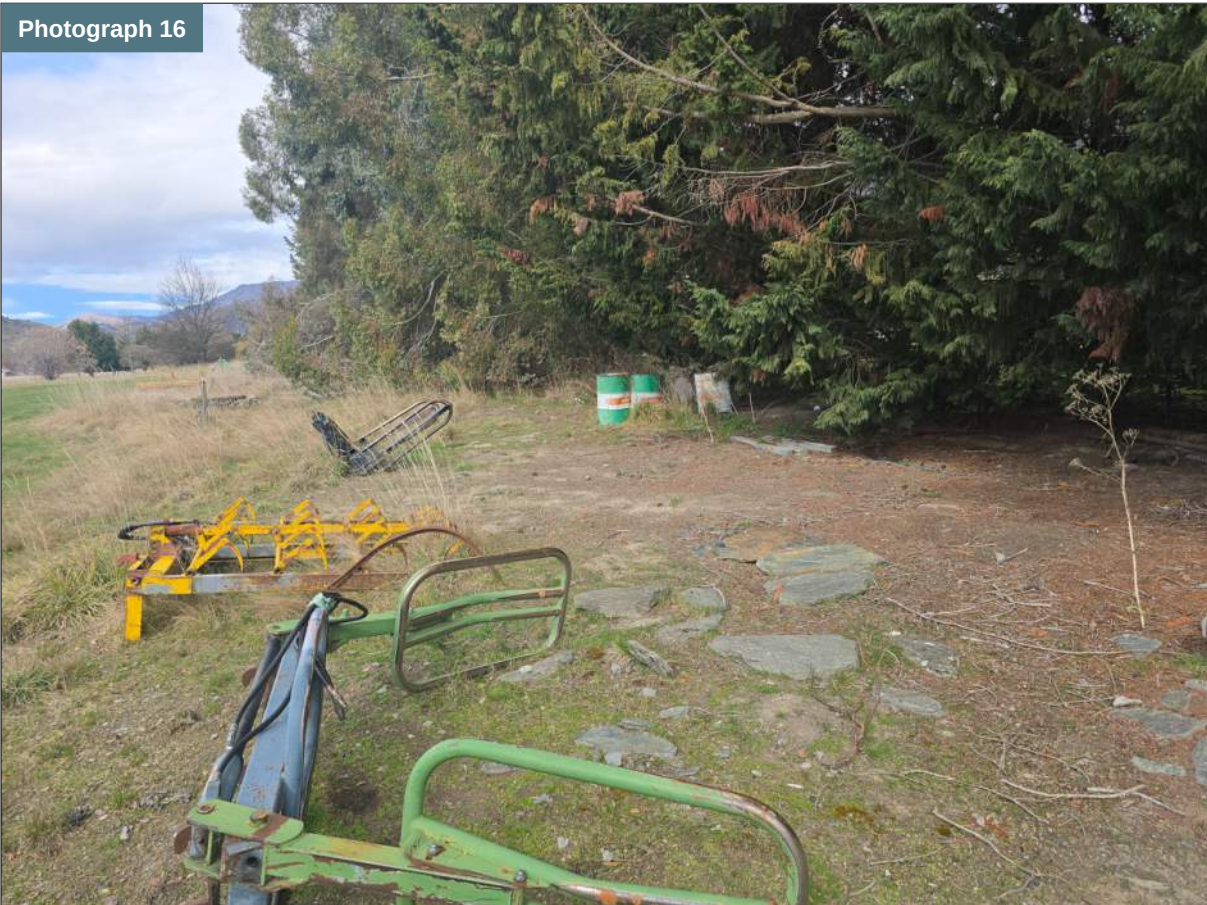
Photograph 16

- Several empty fuel barrels were stored nearby in the same paddock as the AST. The area was also used for general farm equipment and material storage. No staining was observed, though bare soil and reduced grass cover were evident around the barrels (Photograph 16).

| Site Area | HAIL / Activity | Comment | Contaminants | Risk | Recommendation |
|---|---|---|---|---|---|
| | Fuel storage<br>barrels and<br>general storage<br>area (HAIL A17) | Several empty fuel barrels were stored near the AST. No staining was visible, although bare soil and reduced grass cover were noted in the immediate area. The historical use of the area for fuel storage indicates potential for minor impacts. | TPH, PAHs, BTEX, VOCs, heavy metals | Moderate | Judgemental soil testing beneath and around the storage area |

Area of fuel container barrels and machinery storage, adjacent to the AST (Area 1)

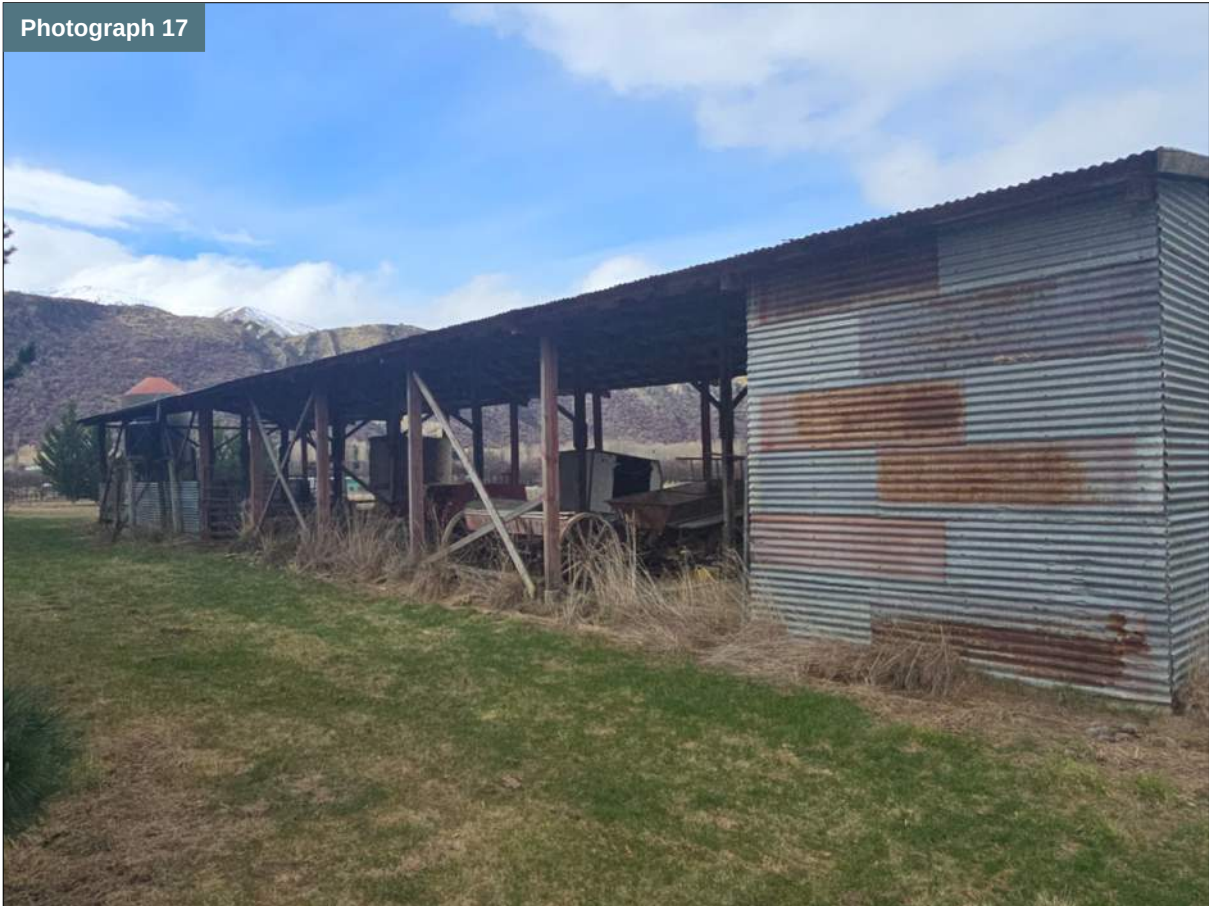
Photograph 17

- East of the dwelling was a dilapidated corrugated iron and timber-framed implement shed, used to store tractors, equipment, hay bales, and firewood. No PACM or fuel storage was observed (Photograph 17).

Farm implement shed east of the livestock holding sheds, of steel and timber construction, in poor condition. (Area 1)

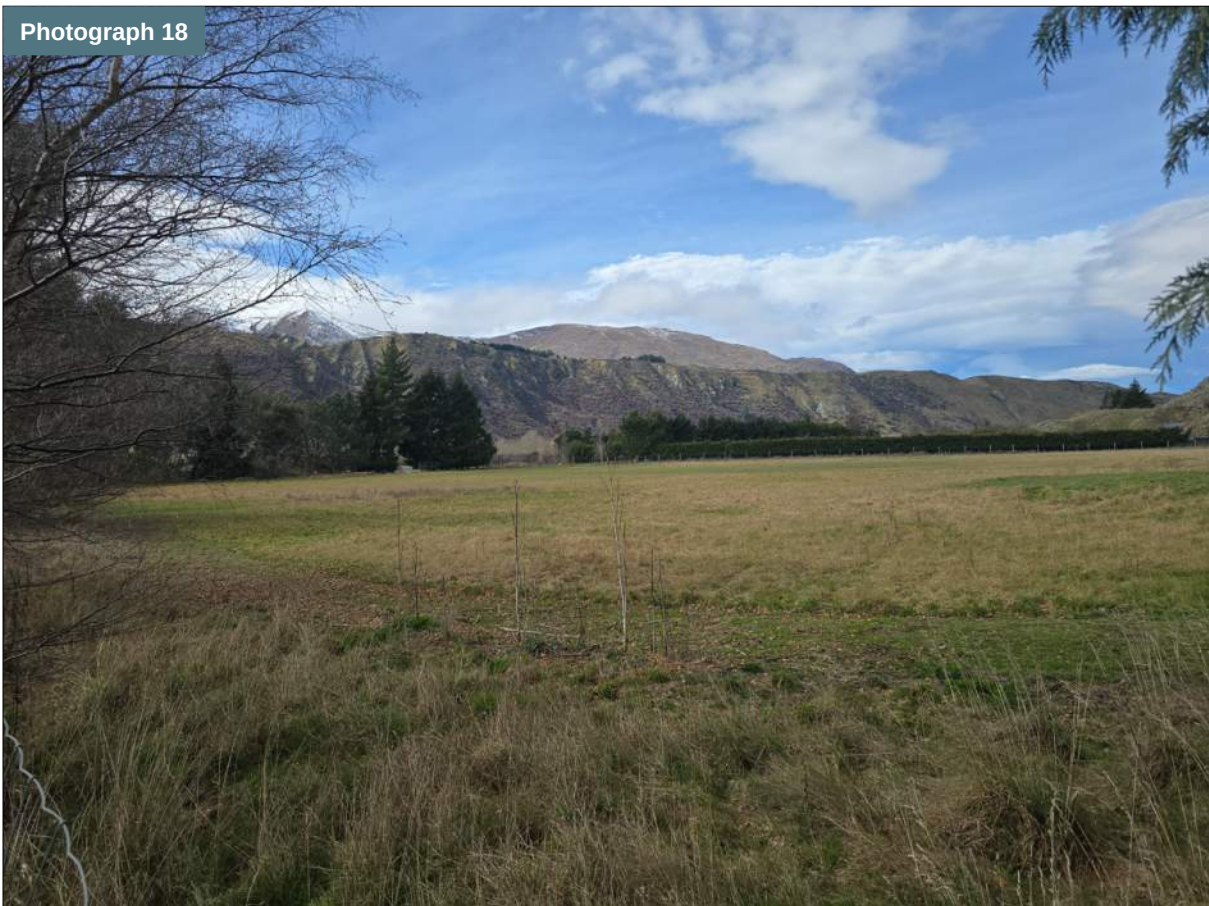
Photograph 18

- The former firewood yard, located nearby, was now a flat grassed paddock with no evidence of fill or residual materials (Photograph 18).
- West of the residence was another corrugated iron and timber-framed farm shed, which was locked at the time of inspection. No external evidence of fuel storage or PACM was observed (Photograph 19).

Paddock of the former firewood storage facility (Area 1)

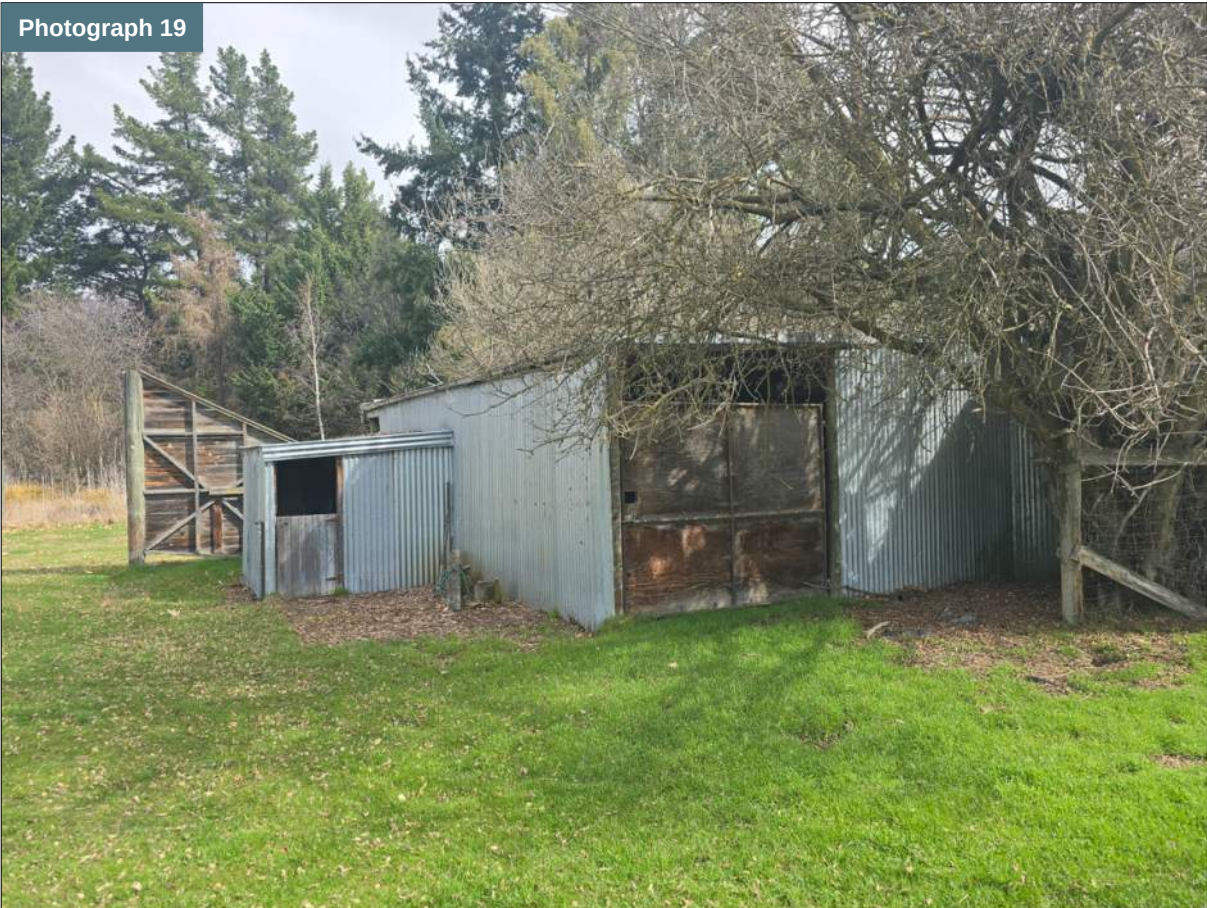
Photograph 19

Livestock holding sheds in the paddocks south of the residence and farm infrastructure (Area 1)

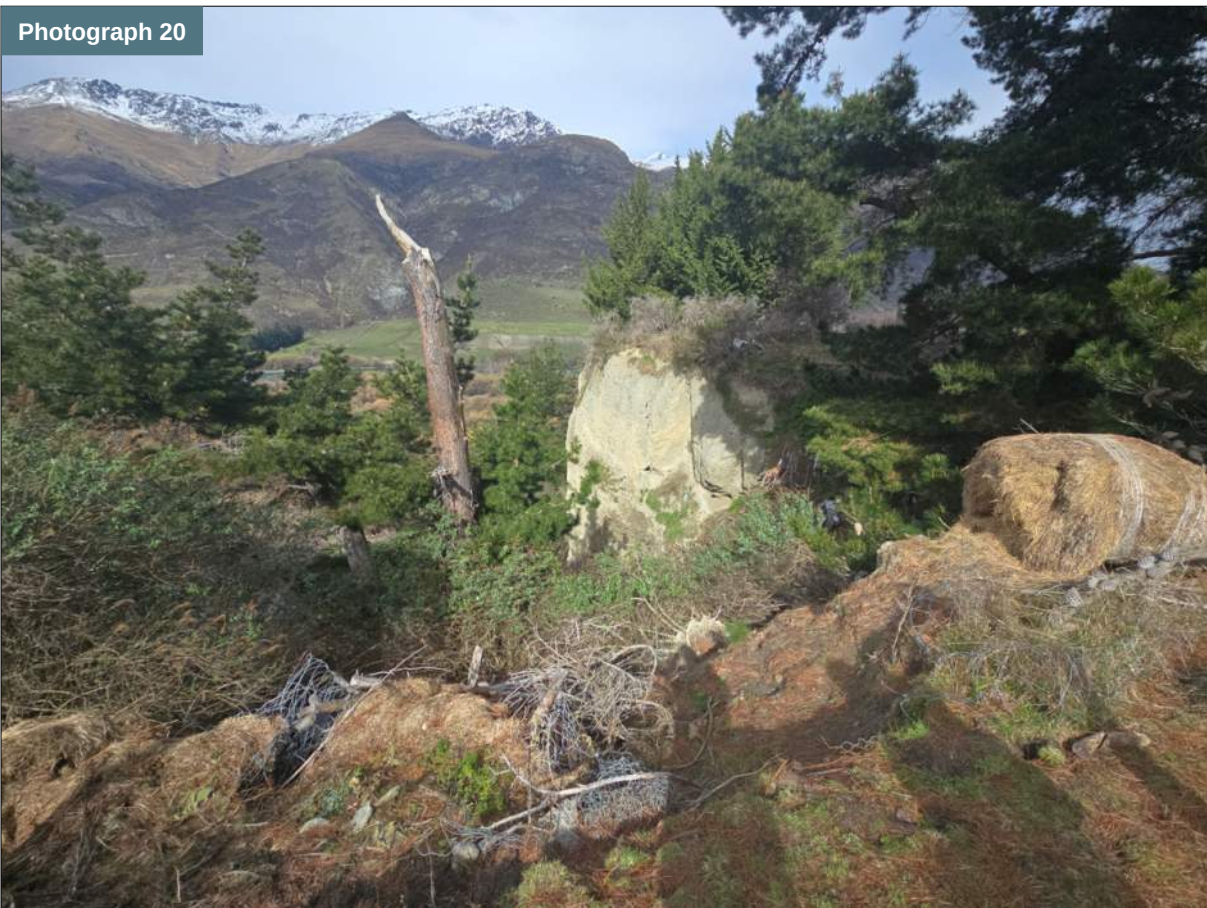
Photograph 20

- The prominent gully noted in the aerial photography (Refer to Figure 3, Appendix B) was inspected, and fly-tipped waste was visible within the gully, including plastics, timber, fabric, and other household materials. Waste was confined within the steep gully slopes and was not present on the terrace above. Closer inspection of the waste material was not possible due to steep terrain (Photographs 20 – 21)

- The landowner also confirmed historic fly-tipping within the prominent gully leading to the Kaware River. This material largely comprised general household waste and rubbish, with no knowledge of hazardous substances or fuels having been disposed of.

Gully in 'Area 2' with fly-tipping activities (Area 2)

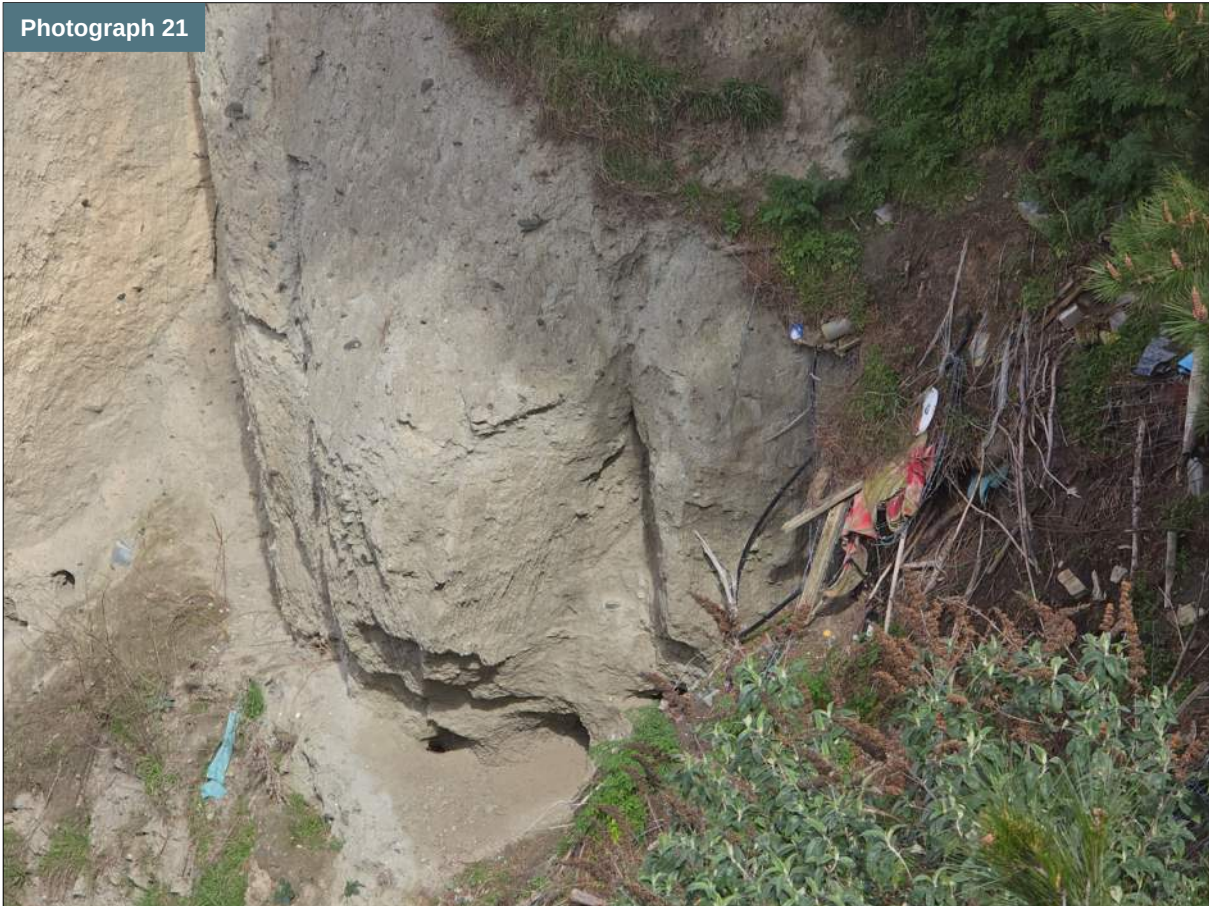
Photograph 21

Fly-tipping waste comprising plastics and household waste (Area 2)

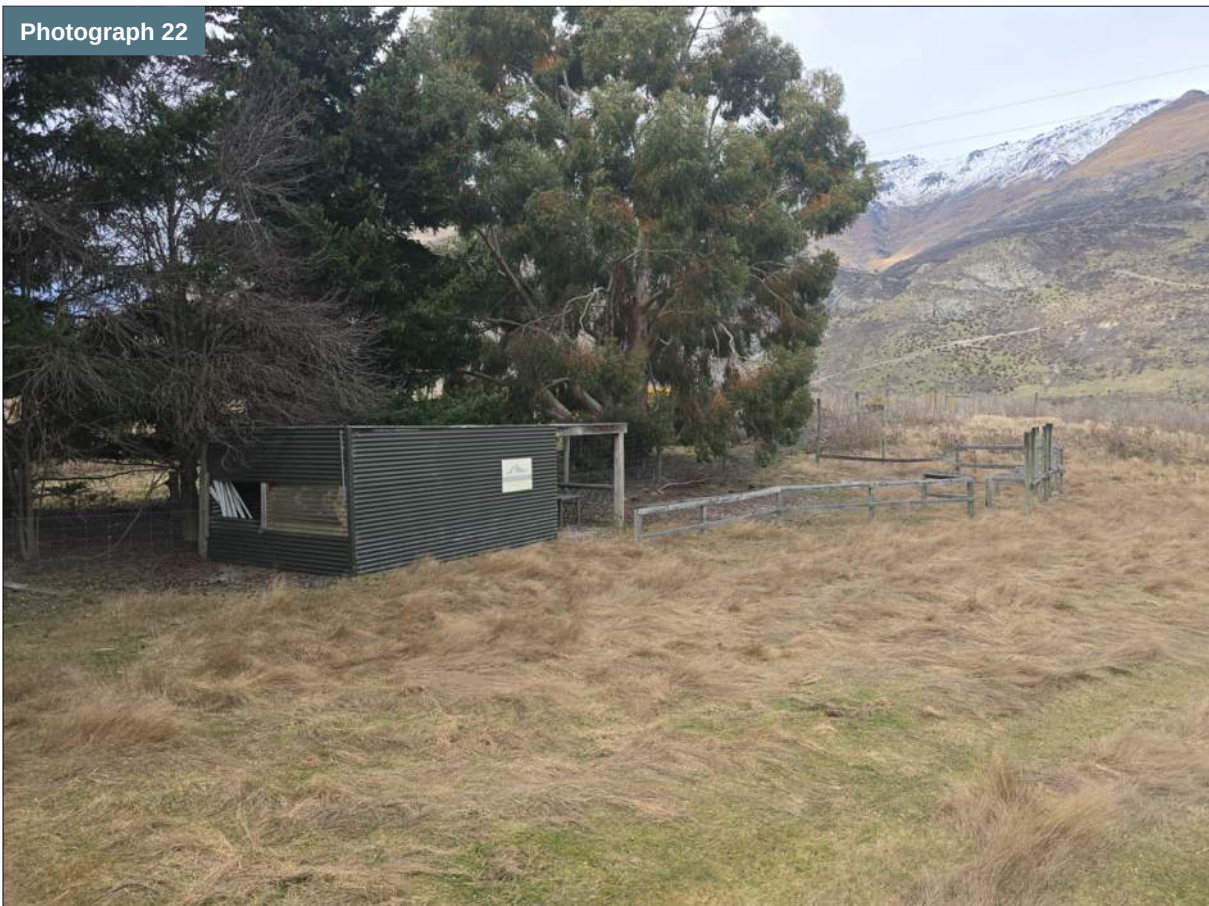
Photograph 22

- A small timber-framed, open-fronted shed was identified as a clay pigeon shooting range situated in the southeastern area of the Area 2, immediately adjacent to the river terrace. The firing line directed towards a southwest-facing slope. Clay target fragments and pellets were observed scattered across the slope surface, extending up to at least 30 – 40 m from the firing range structure (Photographs 22 – 25).

Clay pigeon shooting range / facility (Area 2)

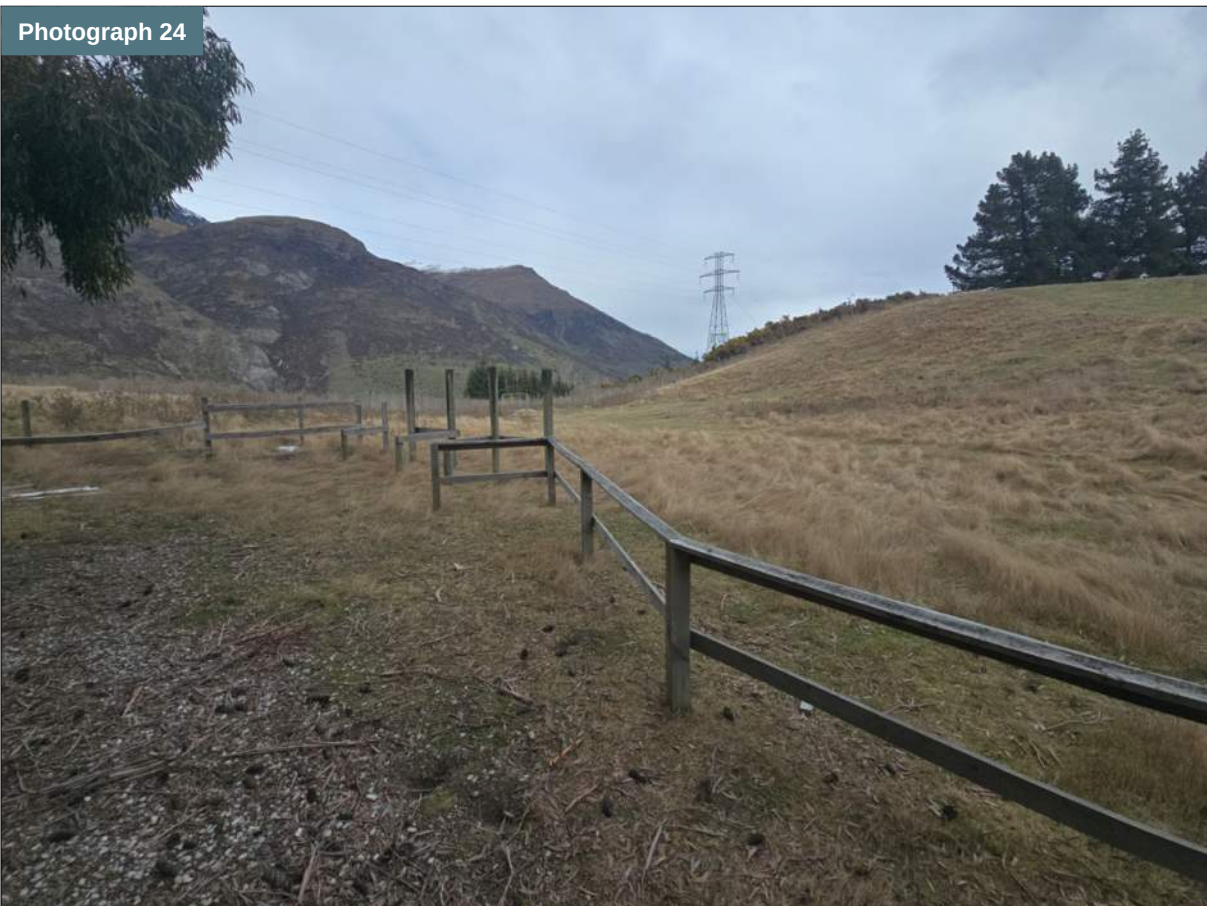
Photograph 24

Clay pigeon shooting range / facility, showing hillside in the background exposed to fall-out (Area 2)

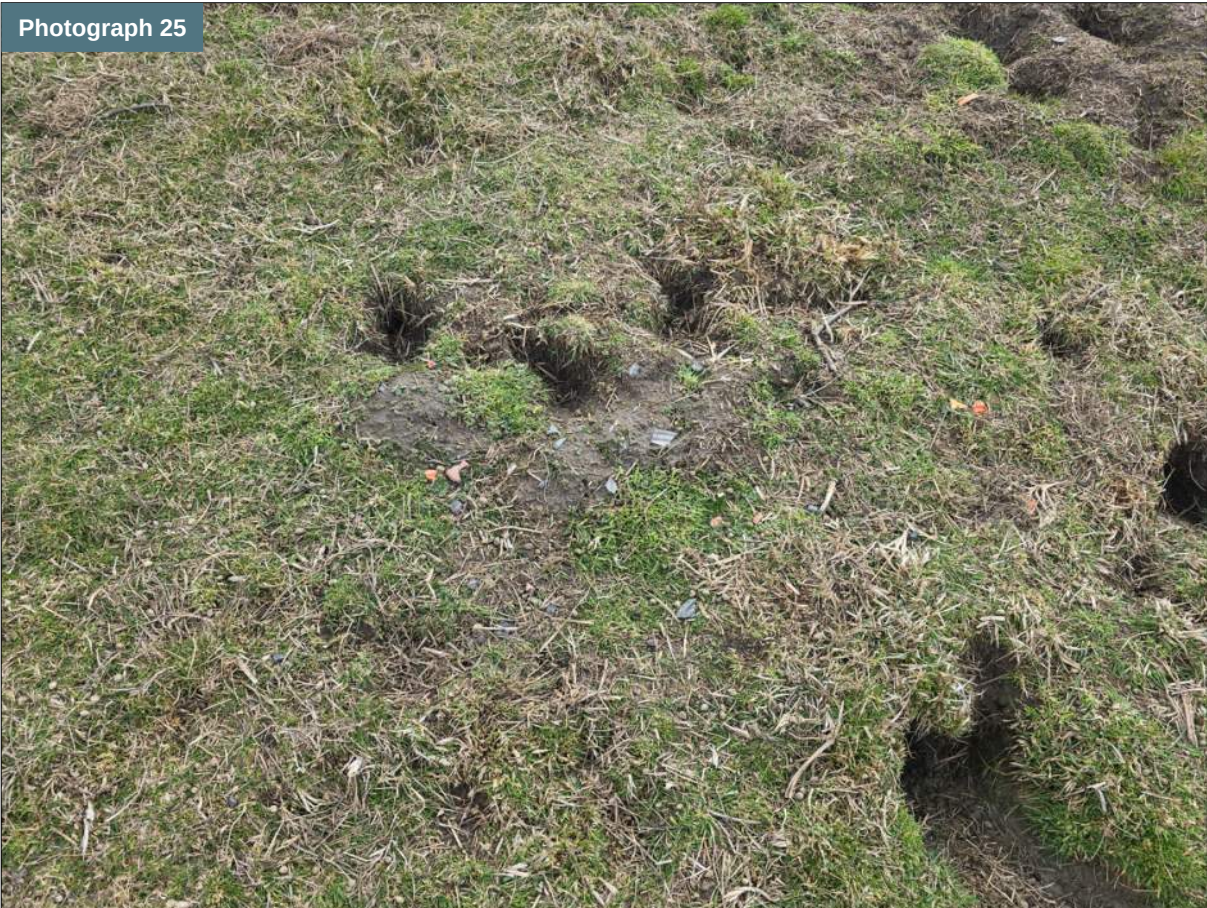
Photograph 25

| <b>Area 2 – Southern river terrace and escarpment</b> | Clay target shooting area ( <b>HAIL C2</b> ) | A small firing range was identified on the southern terrace, consisting of an open shed oriented toward a southwest-facing slope. Clay target fragments and lead shot were observed scattered across the slope for 30–40 m. Such ranges typically result in accumulations of lead pellets in surface soils. Contamination is most likely within the shot-fall zone, where pellets degrade over time and may leach metals into soil. | Lead, antimony | Moderate | Targeted and systematic surface-soil grid across the shot-fall zone for total Pb (with confirmatory leachability if required) |

Soil surface on the hillside facing the firing range with visible clay fragments and lead pellets. (Area 2)

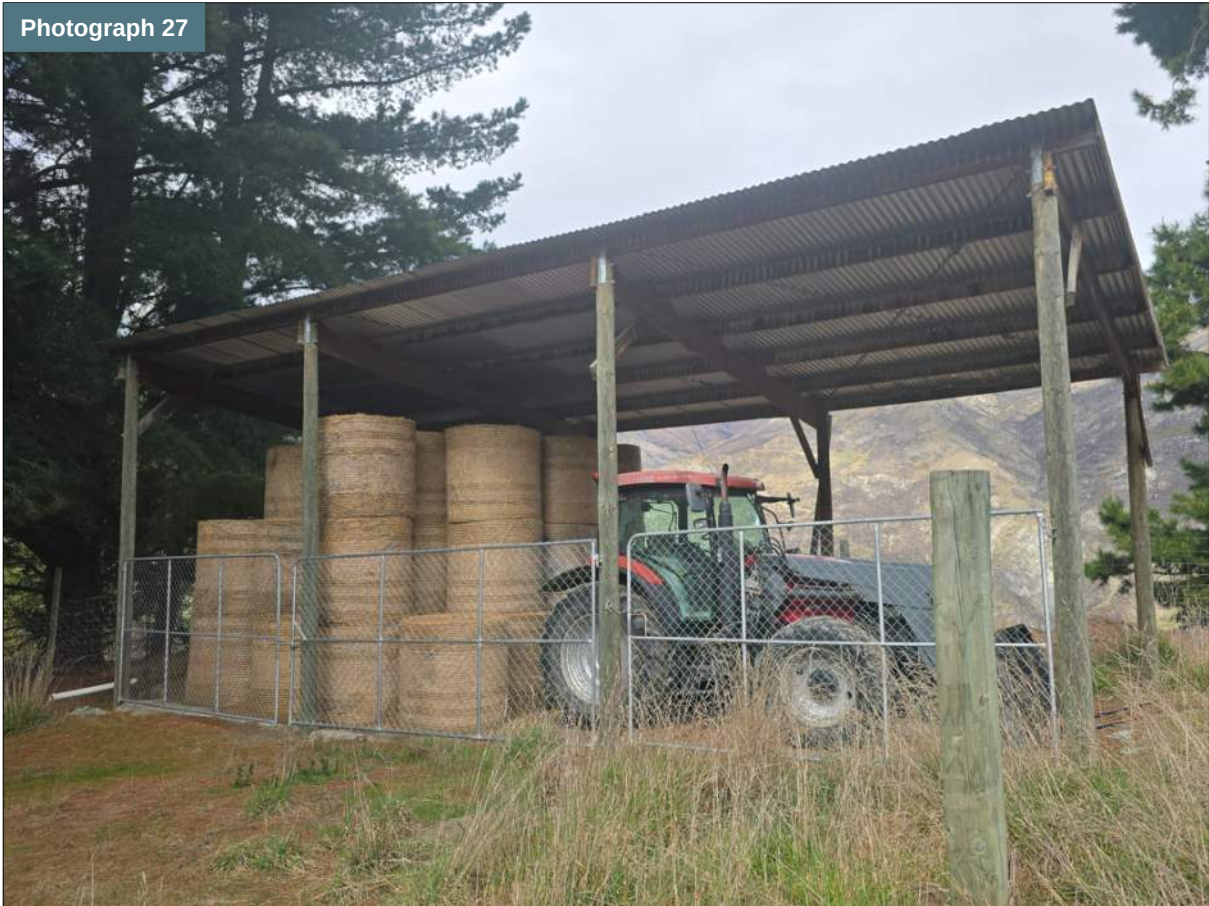
Photograph 27

Hay storage in the southernmost paddock, adjacent to the river terrace (Area 2)

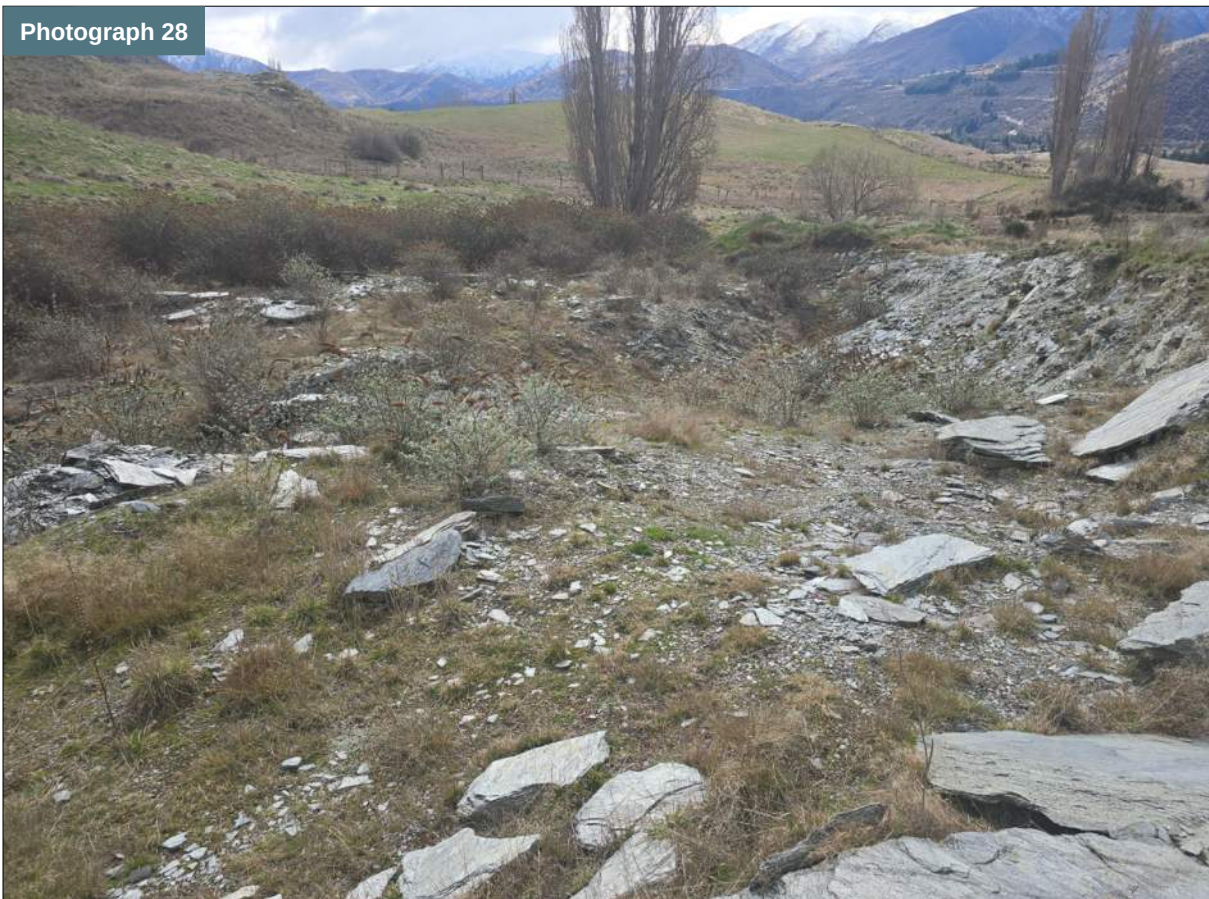
Photograph 28

- An open schist quarry was observed along the Morven Hill track. No evidence of backfilling or imported material was present. Two smaller open quarry faces were also identified within the rolling paddocks within the farmland, similarly, showing exposed schist with no infill (Photographs 28 – 29).

Former quarrying site (Area 2)

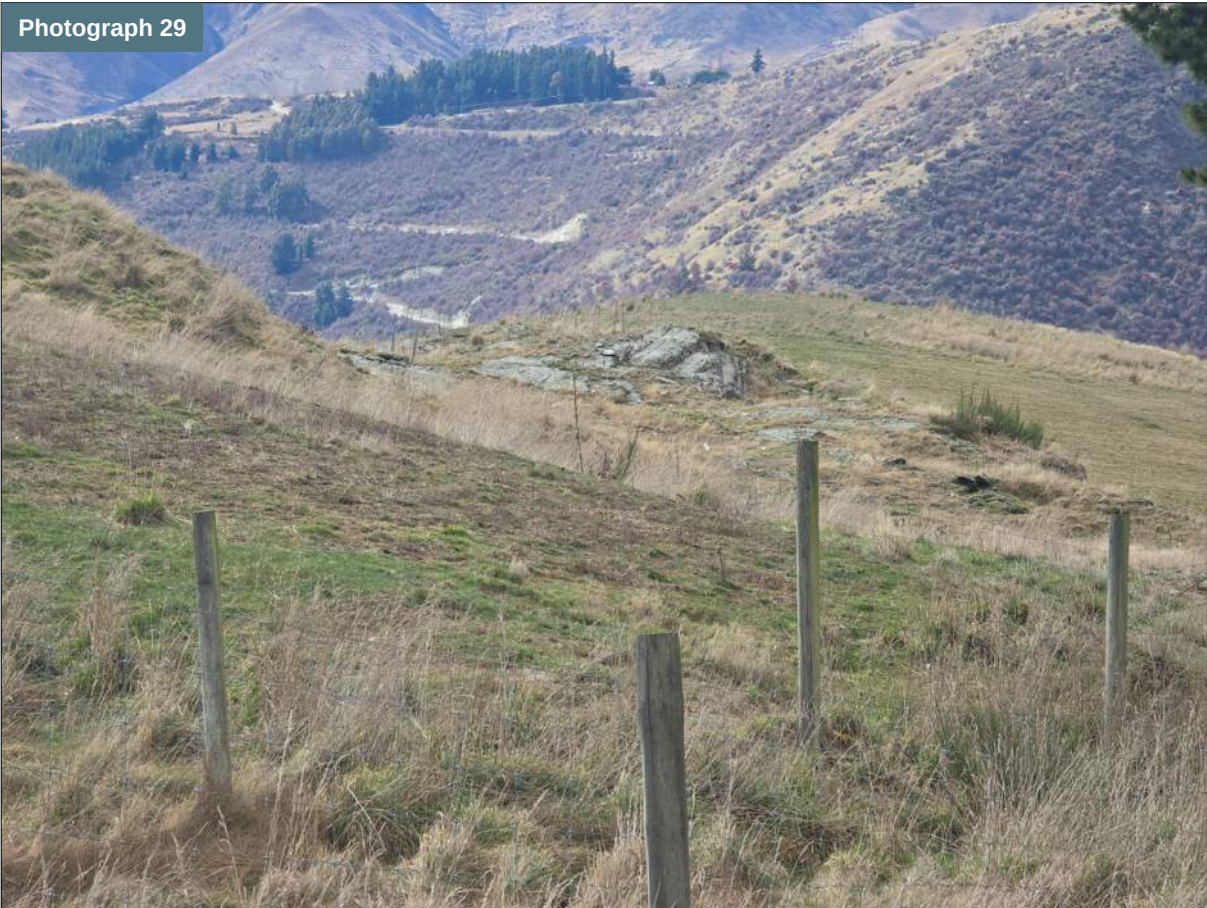
Photograph 29

Former quarrying site (Area 2)

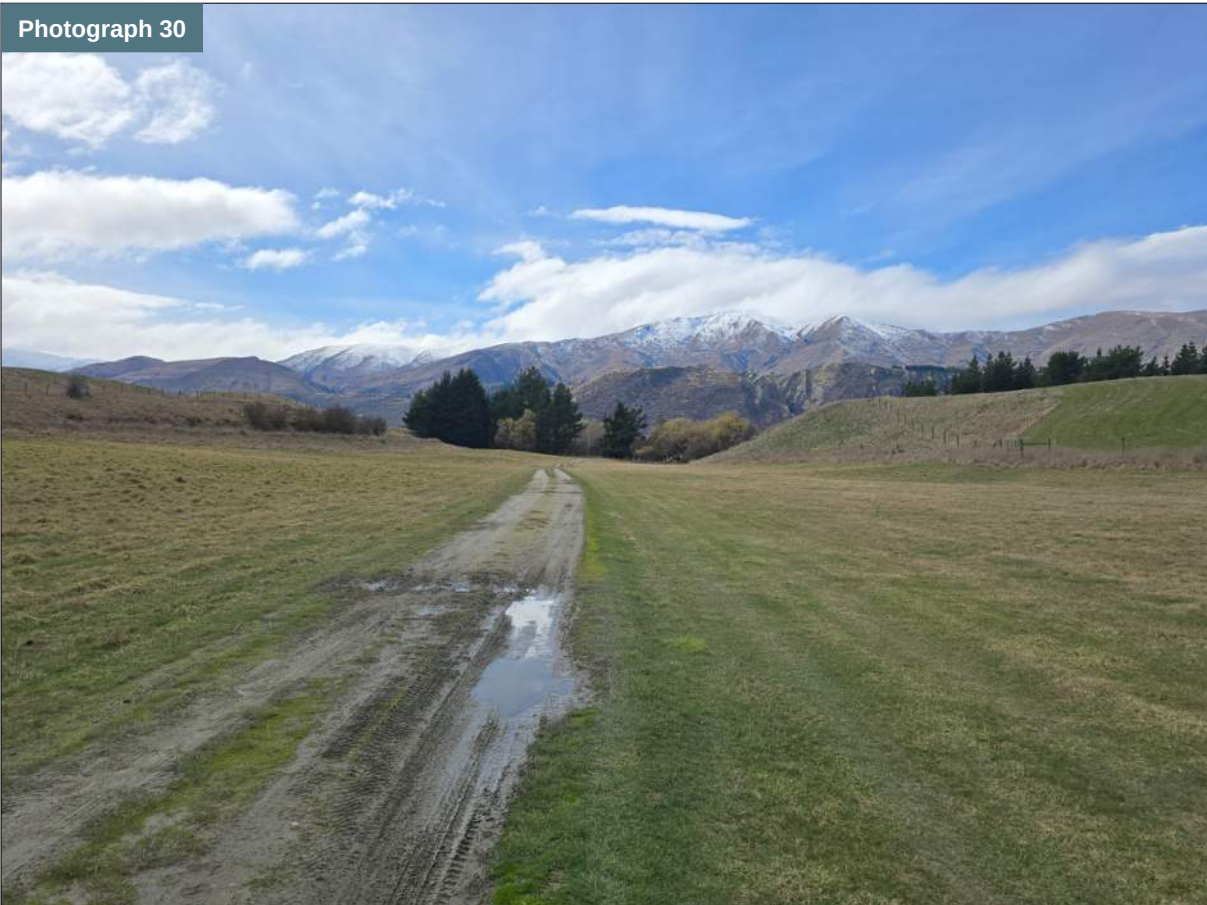
Photograph 30

Image showing typical site conditions in the central area (wider site)
