Auckland Surf Park: Stage 2

Preliminary and Detailed Site Investigation (Ground Contamination)

AW HOLDINGS 2021 (LP) PARTNERSHIP

WWLA1368 | Rev. 1

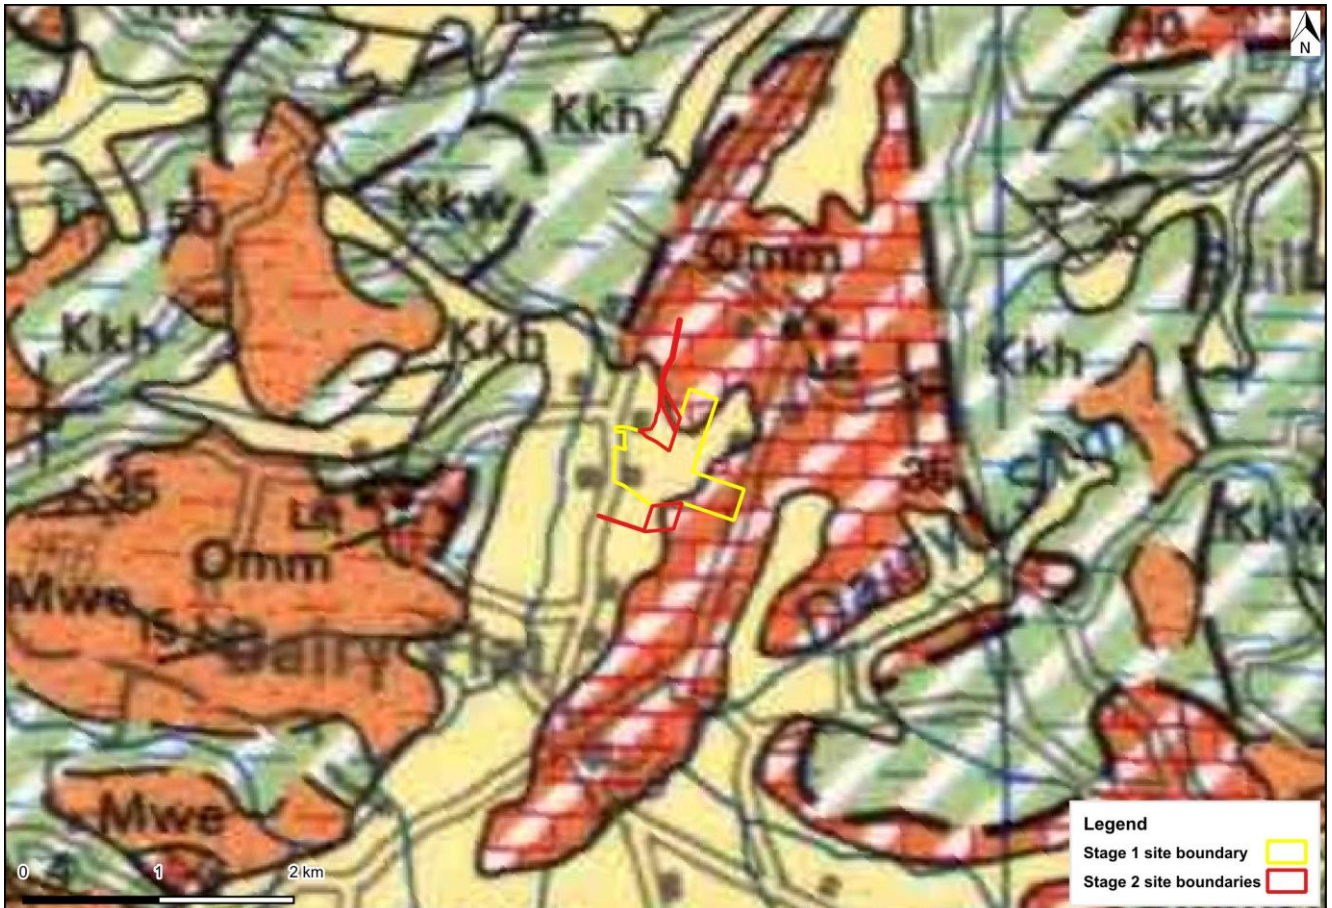
Figure 2. Published geology with site boundary in red (Source: Kermode, L.O., 1992).

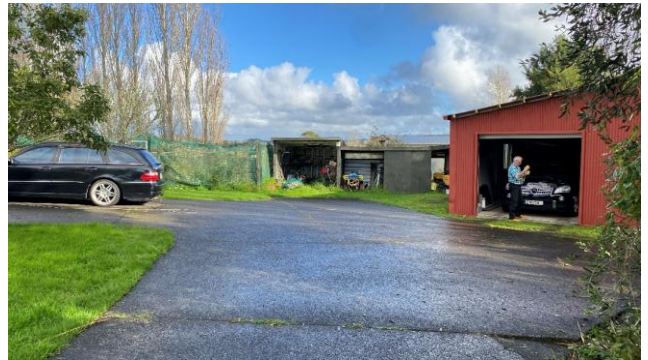
Photograph 6. View of the garage (right), garden sheds (middle) and vegetable garden (left), facing south.

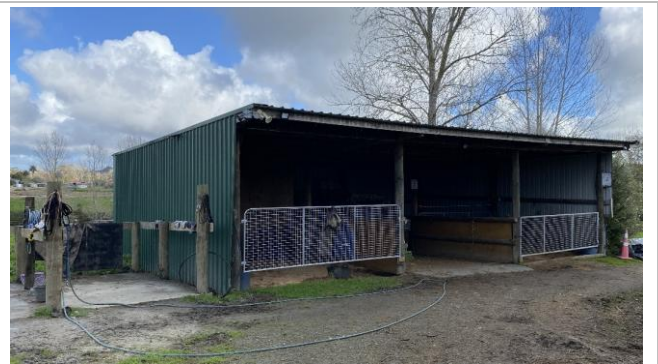
Photograph 14. View of the barn and stables (green building) and the horse washbay (concrete pad to left of image), facing southwest.

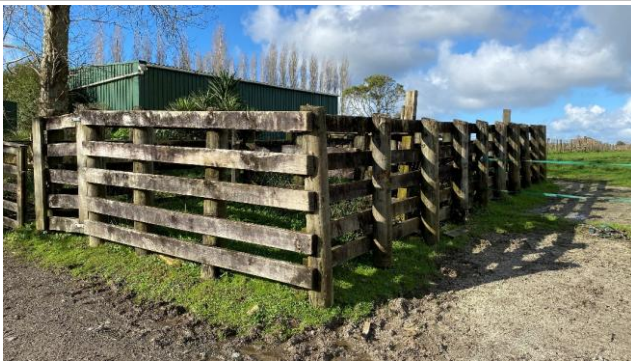
Photograph 15. Old wooden stockyards behind barn/stables.

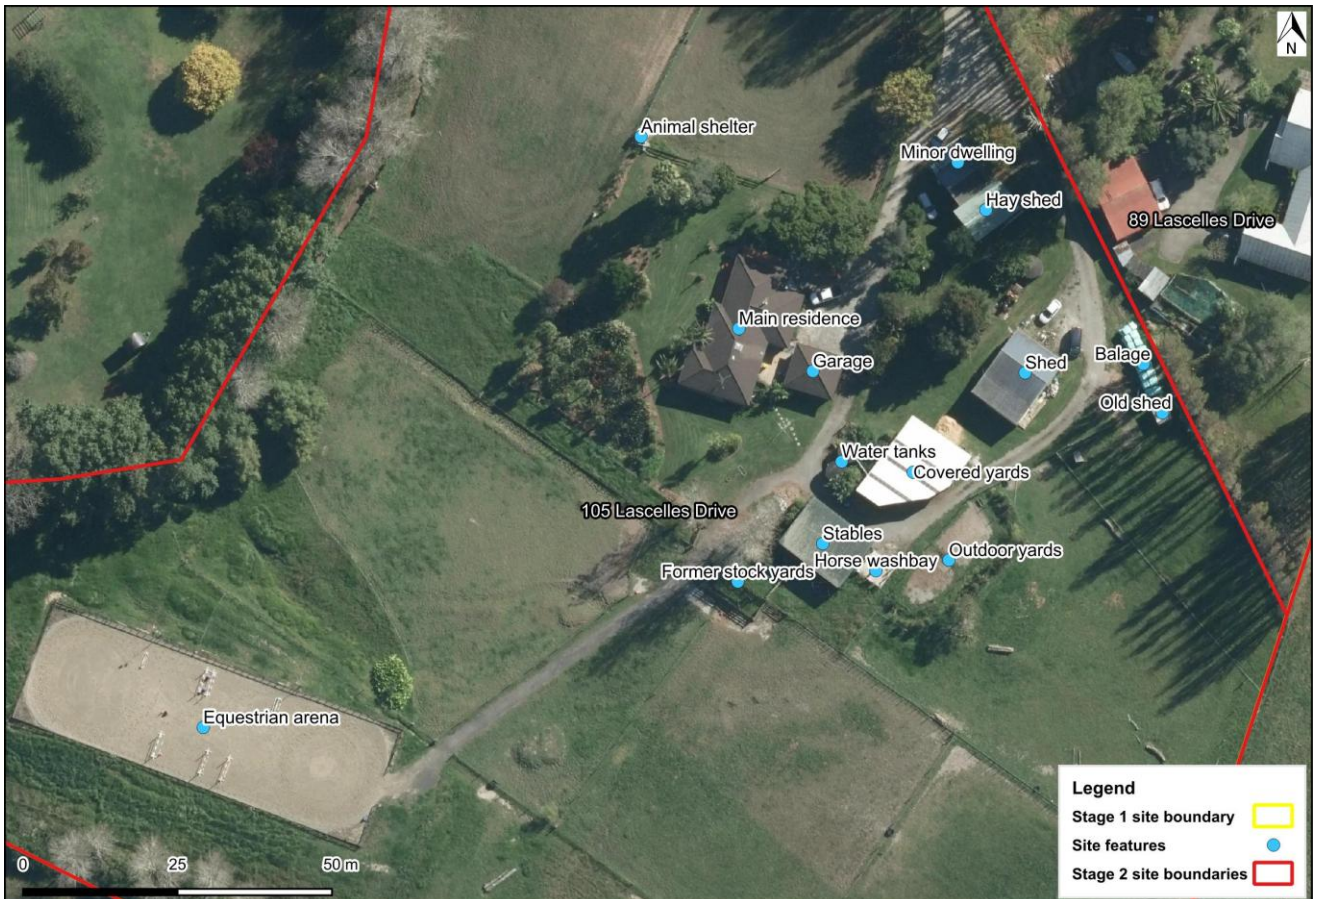
<p>105 Lascelles Drive</p>	<p>This property is an equestrian lifestyle block with the following features:</p> <ul style="list-style-type: none"> • A modern main residence is located in the central and eastern of the property along with a garage, minor dwelling, and sheds. <ul style="list-style-type: none"> - The main residence is constructed of brick and hardboard cladding with a tile roof and timber deck (Photograph 9). - The garage is also constructed from brick and hardboard cladding with a tile roof (Photograph 10). - To the northeast of the main residence is a minor dwelling constructed with weatherboard cladding, a corrugated metal roof and a timber deck (Photograph 11). - On the immediate southeastern side of the minor dwelling is a hay shed constructed from metal framing with corrugated plastic cladding and corrugated metal roofing (Photograph 11). - Another larger farm shed is constructed of corrugated metal cladding and roofing with metal roller doors (Photograph 12). • South and northwest of the main residence and sheds complex are the equestrian facilities: <ul style="list-style-type: none"> - To the southeast of the main residence is a block of covered horse yards constructed from corrugated plastic and metal roofing (Photograph 13). - Southwest of the covered yards is a barn/ stable block constructed from timber with corrugated metal cladding and roofing, with a concreted outdoor space on the eastern side for washing horses (Photograph 14). - To the immediate south of the barn/stables are old wooden stockyards (likely for sheep) (Photograph 15). - To the east of the stables and the covered yards are two large outdoor wooden yards (also for the horses). - The remainder of the site is paddocks surrounding the complex of buildings to the southeast, south, west and northwest, with a sand horse arena located near the southwestern corner (Photograph 16). The area around the arena appears to have been earthworked to create a flat platform.

Figure 5. 105 Lascelles Drive, site features and layout (source: LINZ, 2024-2025)
