# *technical memorandum*

TO William Dorset FROM Katy Grant  
Pukerua Property Group LP DATE 6 August 2026  
RE Mount Welcome Fast Track – Response to reviewer comments

Classic Developments Limited on behalf of Pukerua Property Group LP (the Applicant) are seeking to obtain fast-track consent for the development of a residential subdivision near Pukerua Bay in an area known as Mount Welcome. The fast-track panel has provided reviewer comments on the application. This memorandum responds to Greater Wellington Regional Council (GWRC), Porirua City Council (PCC) and Ngāti Toa Rangatira comments relevant to the assessments provided by PDP including wetland and stream hydrology, water quality and contaminated land.

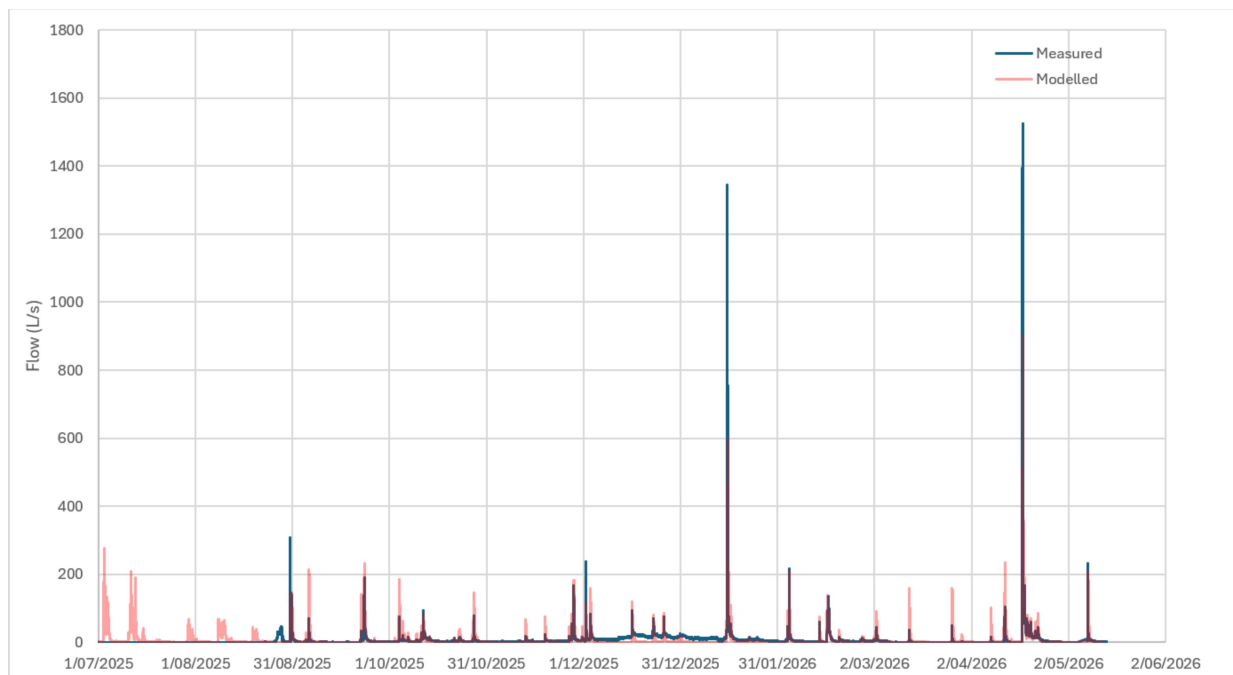
**Figure 1: Flow from T1 catchment (SW02)**

The results indicate a good fit to flow in all three monitored catchments, although the model does underestimate the groundwater baseflow into the streams during winter periods in the Taupō Catchments and year-round in the Kakaho Catchment. The modelled wetland water levels exhibit less variability than the observed water levels, reflecting the model structure, which represent each wetland as a storage bucket with inflows and outflows, rather than a dynamic system with internal flow processes. This difference is particularly apparent in the T3 catchment, where the baseline monitoring results indicate that the wetlands can accommodate substantial water level fluctuations without adverse effects.

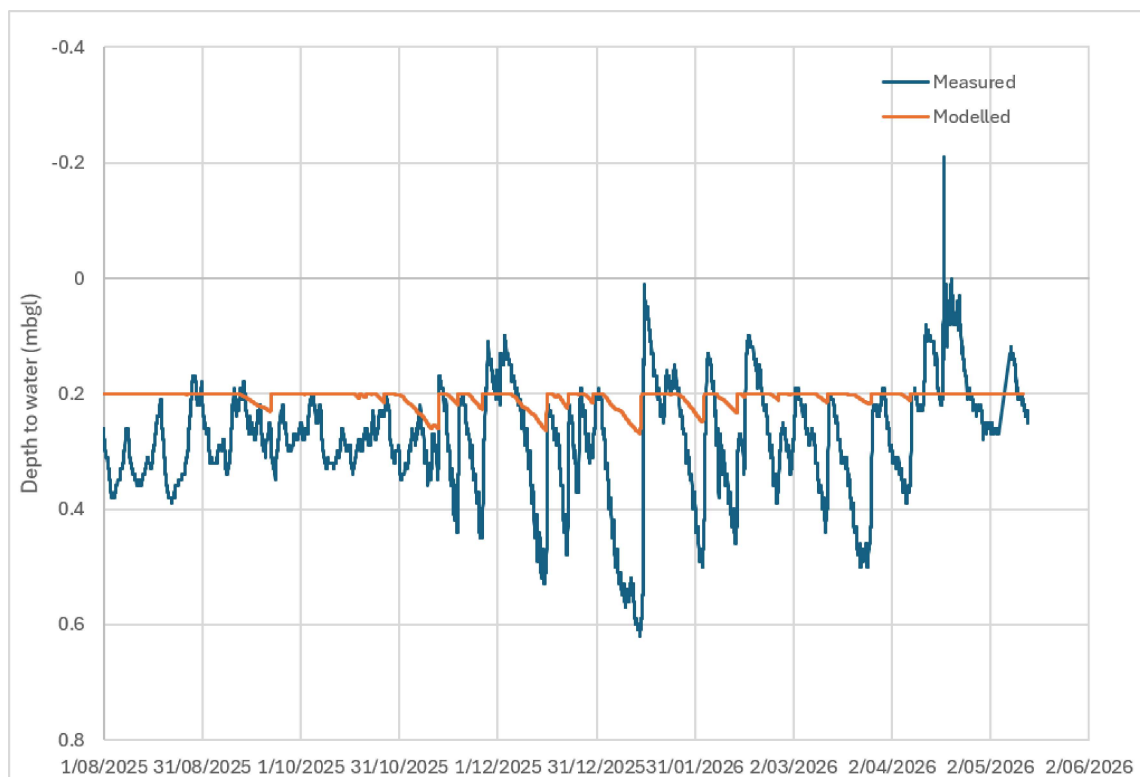
Figure 4: Water levels in T3W1 (BH01)

Furthermore, the monitoring points were not located within the centre of the wetland (to allow for long-term monitoring during and post development) so are likely to show more variation than would be measured centrally. Whilst the fit is not perfect, it is considered that the model provides a reasonable approximation of changes to the entire wetland, albeit not exactly matching localised variations.

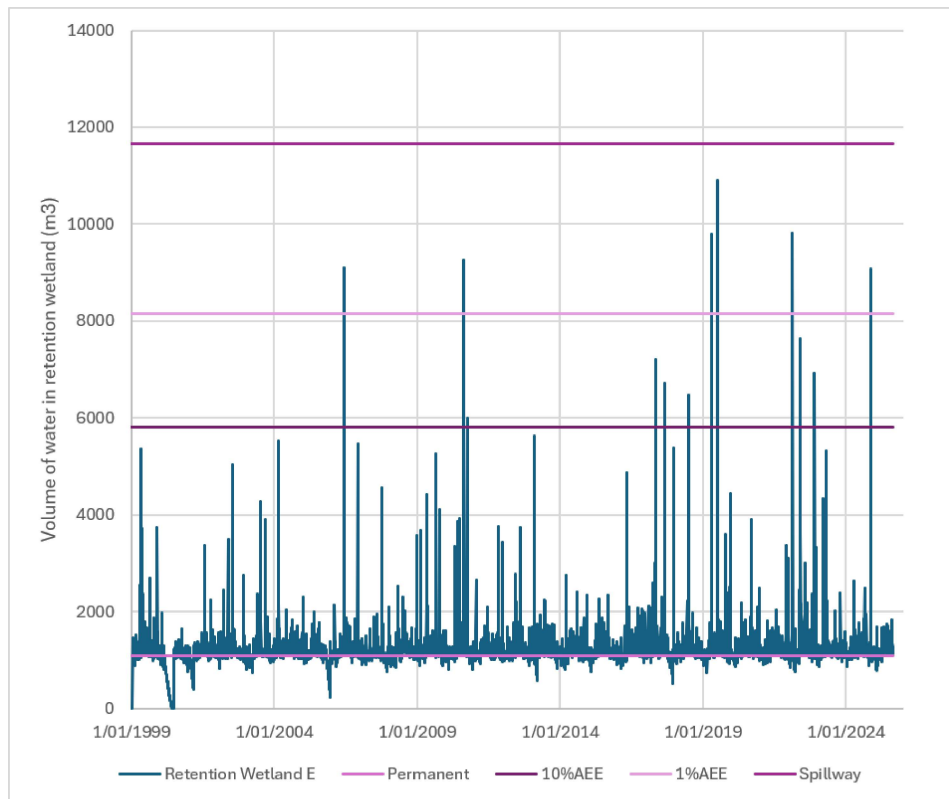
**Figure 10: Modelled pond volumes at Retention Wetland E**

Regarding concerns around the periods of no flow through culvert outlets (point D), Figure 10 below indicates that there may be periods when the water level in Retention Wetland E (K1W4) will be lower than the culvert inlet (line marked permanent in figure). This is also true to a lesser extent for the retention wetlands (A, B and C) in the Taupō Catchment. The duration and extent of water level fluctuation is very sensitive to the hydraulic conductivity of soils downstream of the wetland, which are higher in the Kakaho Catchment due to the alluvial deposits present in this area.

It should be noted that this assessment is considered to be conservative as it underestimates the inflow of groundwater into the wetland and stream, see baseline calibration above. However, based on the modelling results, there may be periods when water does not flow through the culvert at Retention Wetland E. These periods are mostly concentrated in the summer months when it is understood from the project ecologist that fish passage is less critical. During winter months it is considered likely that higher groundwater levels will mean flow is more consistent, but based on the conservative model results, periods of no fish passage are usually less than 8 consecutive days.

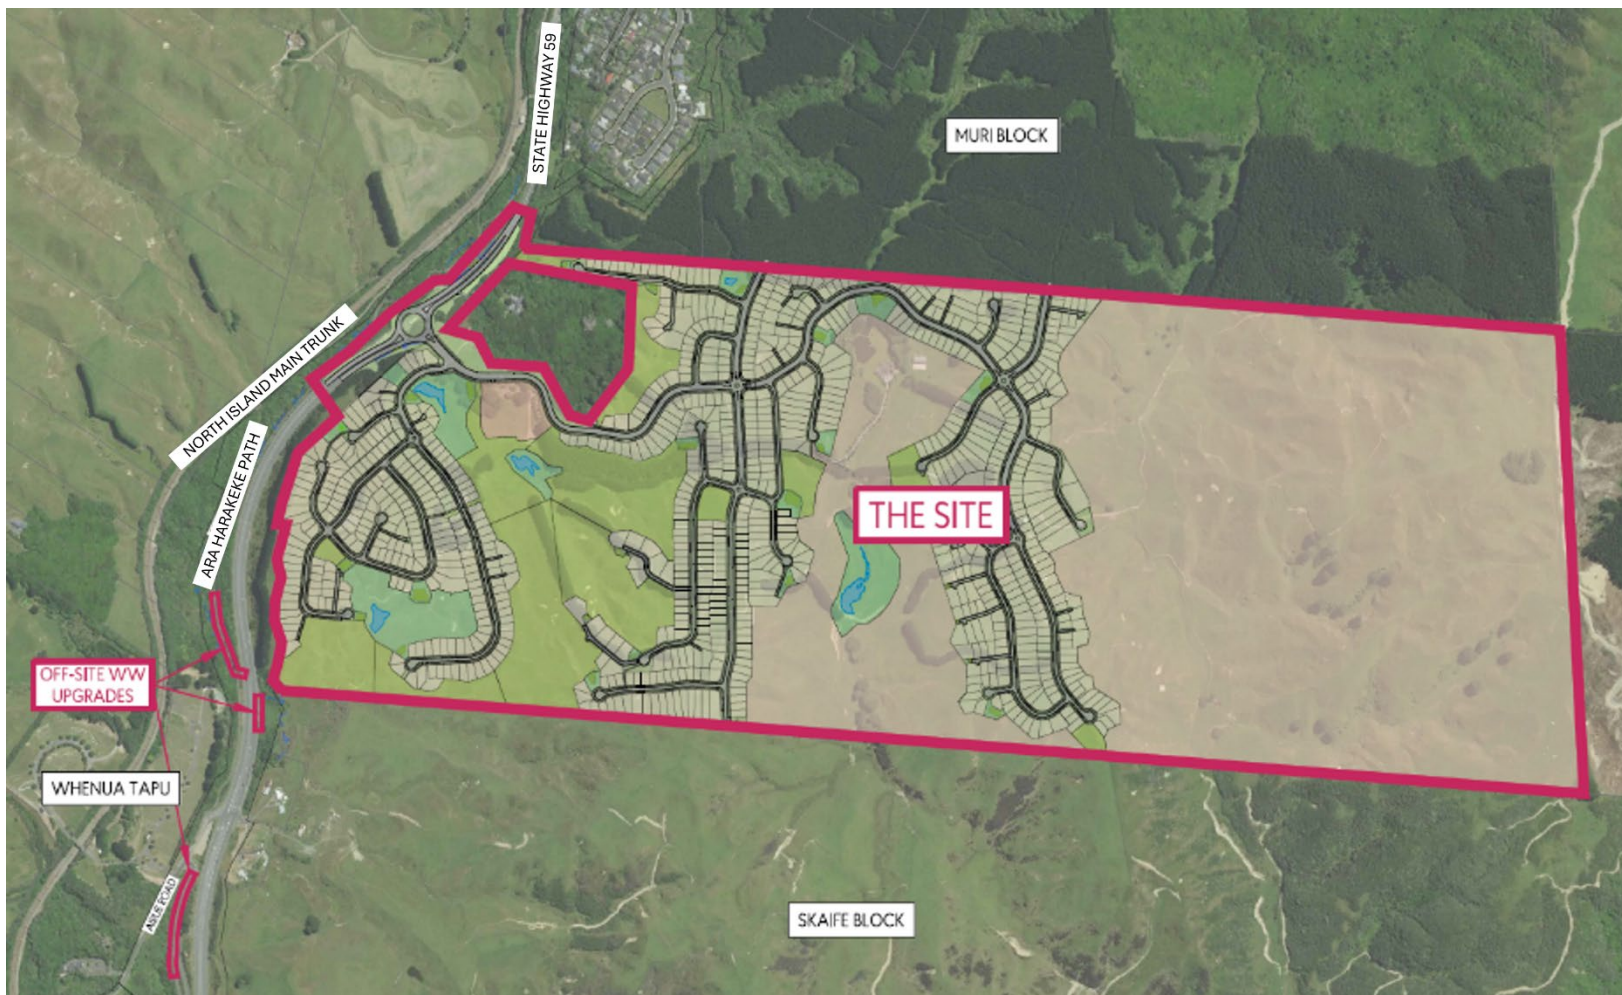
Figure 2: Proposed Site Layout (provided by Envelope Engineering)

The site is bounded to the west by State Highway 59 (formerly SH1), and to the north by the Muri Road block, which is currently undergoing development. The land to the south and east is pasture and used for farming. Figure 2 shows the areas of the site which will be developed under the current application.
