## Appendix H: Parkburn soil permeability testing report

## Re: Soil Permeability Testing, Parkburn Quarry

**Geotechnical and Earthworks  
Assessment for Proposed Residential  
Subdivision at Parkburn Quarry, 922  
Luggate-Cromwell Road (SH6),  
Cromwell**

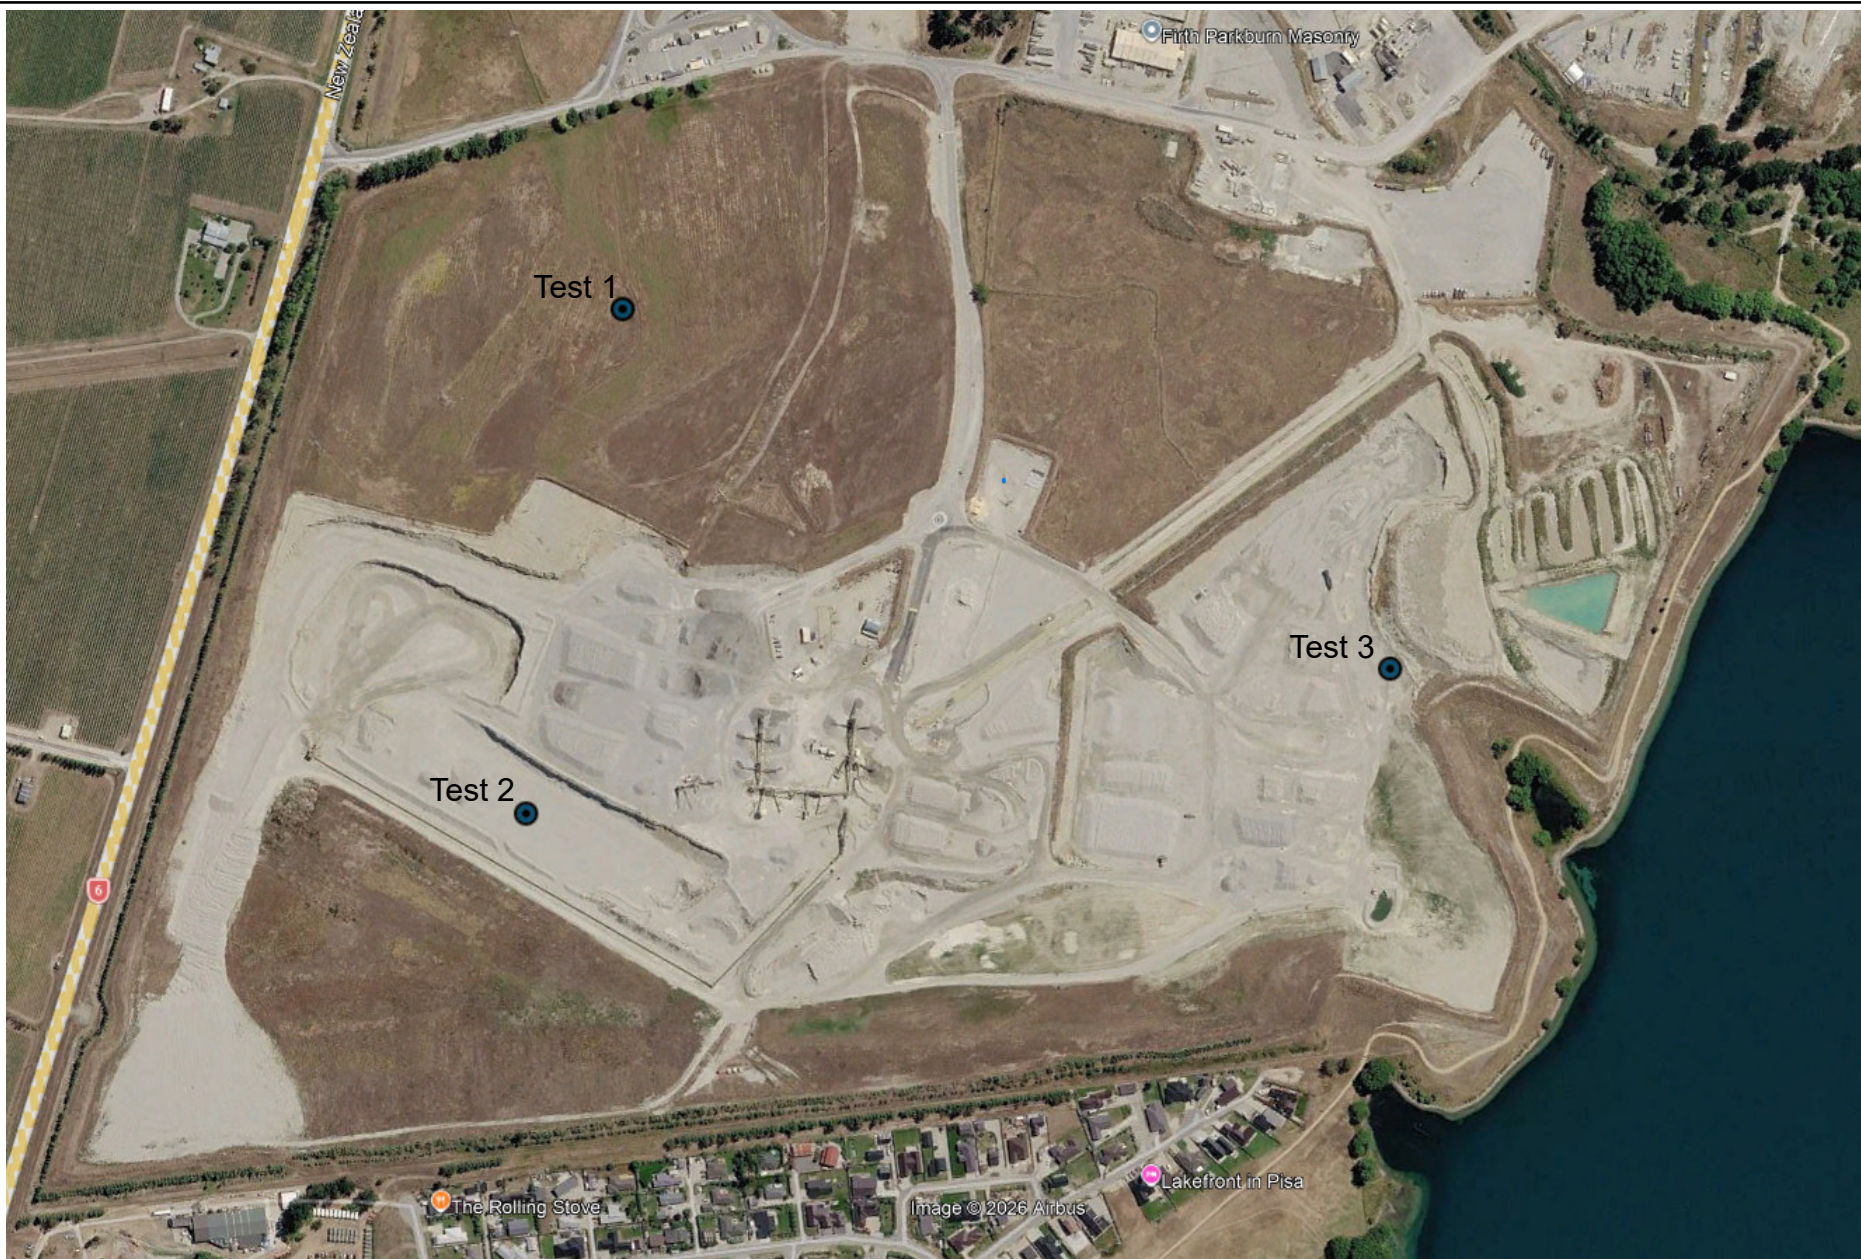
### Test Location Plan

The locations of the three test pits are shown on the attached plan.

| Description | Soil Permeability Test Locations (Not to scale, for information only) | | |

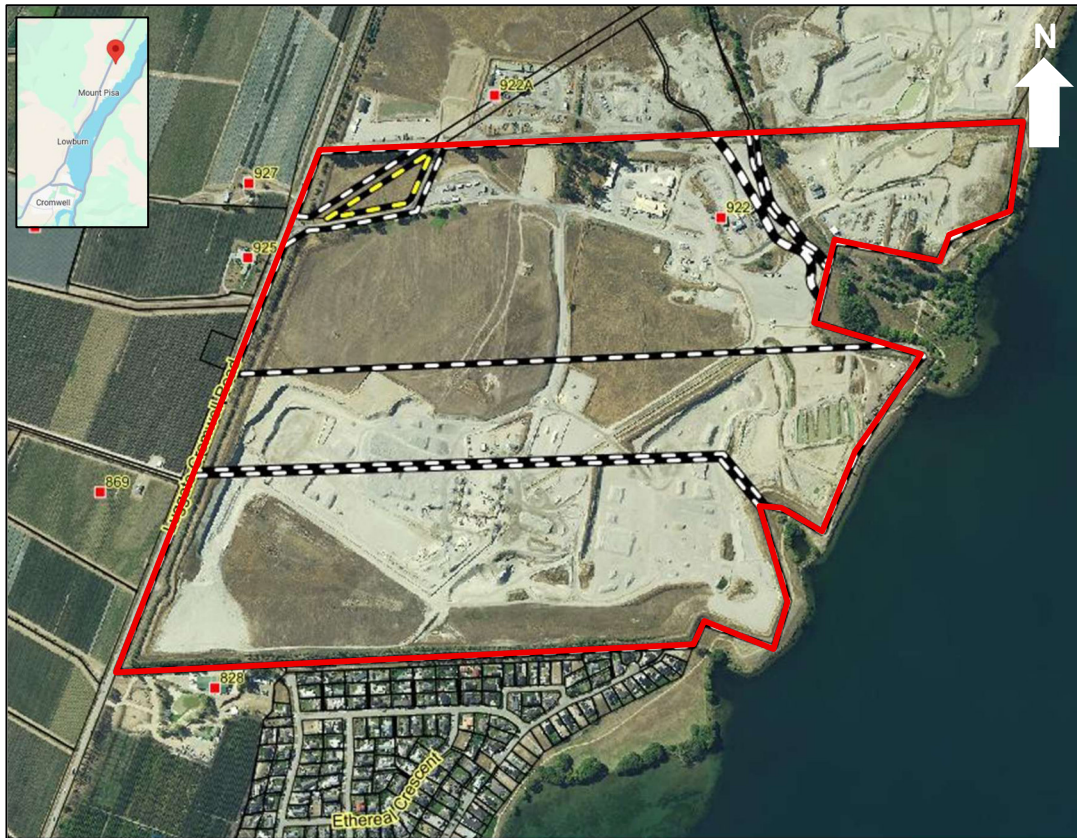
Figure 1: Site Location Plan (not to scale)

The site is located at 922 Luggate-Cromwell Road (SH6), Cromwell (legal description PT SEC 63 BLK IV WAKEFIELD SD). Figure 1 below shows the site outlined in red.

The site location and general site layout are presented as Figures 1 and 2 below.

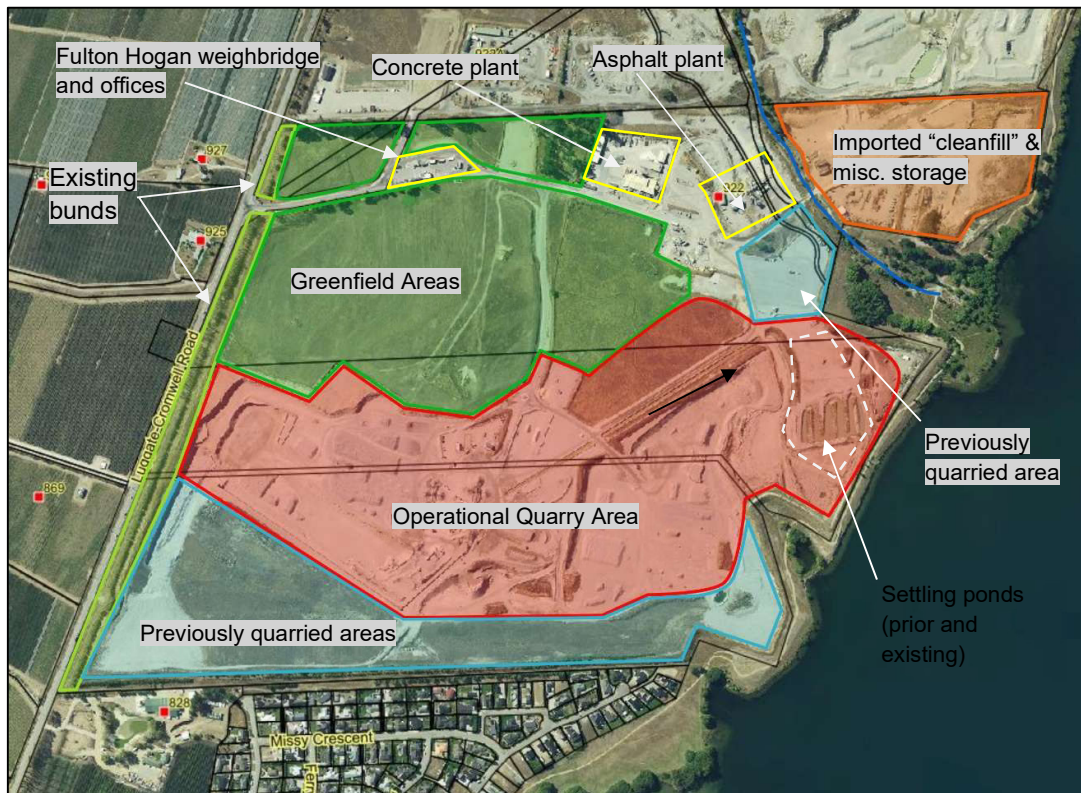
Figure 2: Simplified Site Layout (at time of writing)

The Parkburn Quarry, which was established in the 1980s and is still operational at the time of writing, currently occupies about half of the site area. Also, present are offices and yards for the quarry operators (Fulton Hogan Ltd), a concrete plant, and an asphalt plant. The area to the east of the Park Burn is used as a “cleanfill” disposal area (for imported materials), and general materials and machinery storage.

It should be noted that some areas within the operational quarry area shown on Figure 2 have been previously quarried and backfilled with pea gravel, however currently contain ponds or are otherwise used by the quarry operator. The “cleanfill” area at the north-eastern end was also previously quarried and backfilled with pea gravel to varying extents, with uncontrolled imported fill overlying the pea gravel.

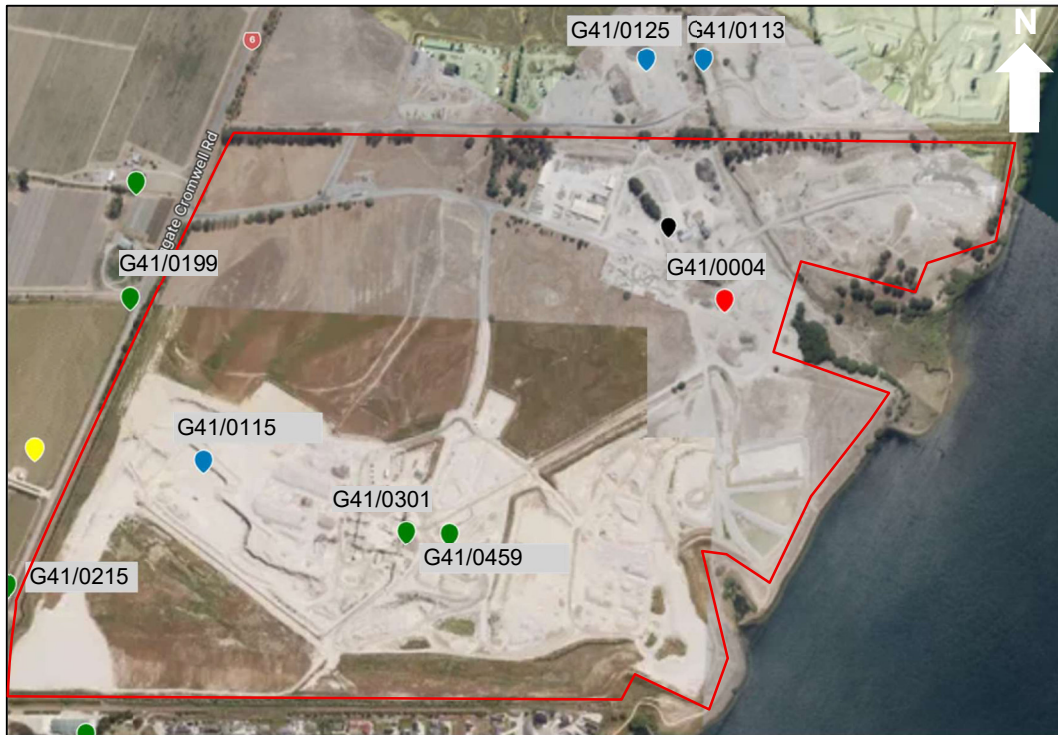
Figure 5: Well Locations

Lithology records for seven wells are available and are presented as Appendix 1 of this report.

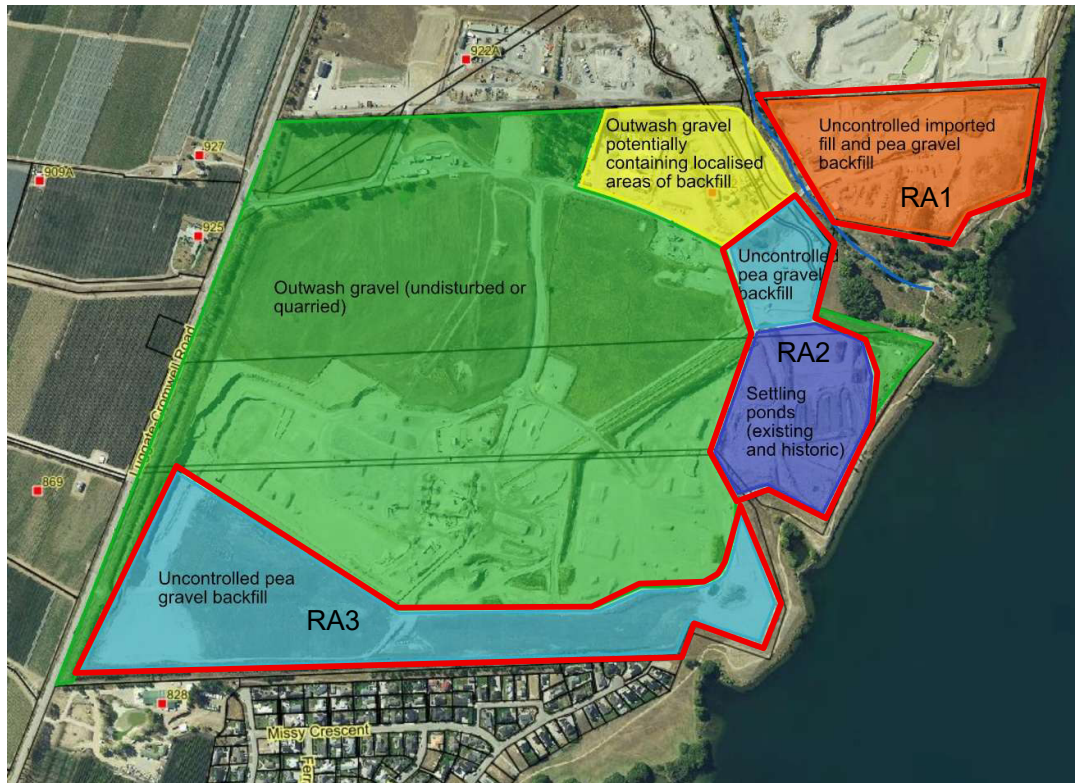
Figure 6: Summary of Preliminary Ground Model

Groundwater depths based on published information show a static water level between 186 mRL to 198mRL. We expect that groundwater level will on average be in keeping with and approximately conform to lake levels (~194 mRL), although some variations could exist from time to time.

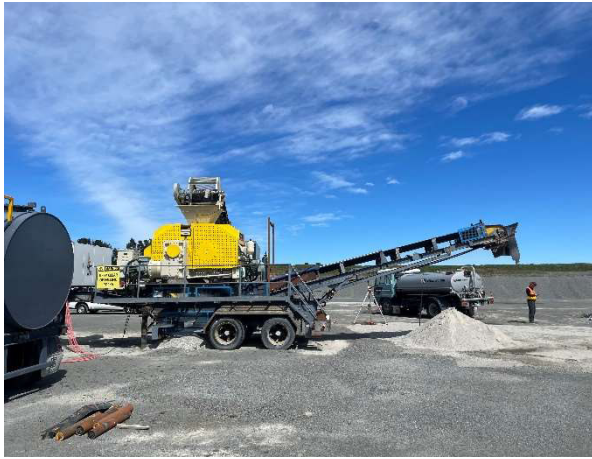
Photograph 1: View of the HRC™800 crushing plant and showing a small stockpile of crushed gravel.

The crushed gravel was generally dry to moist when taken from the stockpile, and water had to be added prior to compacting. Water was sprayed from a water truck for around 5-10 seconds for each trial hardfill pad.

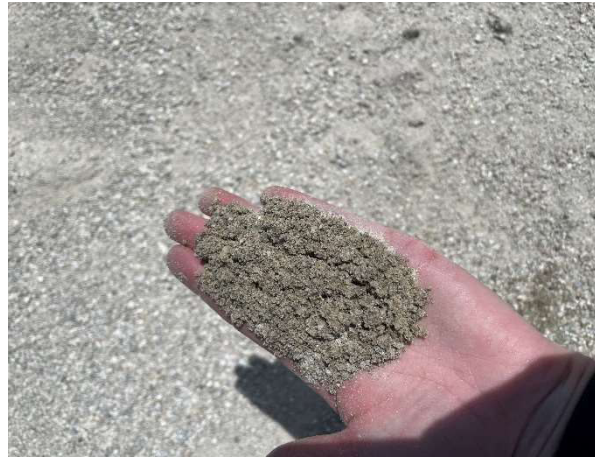
Photograph 2: View of a sample of crushed gravel

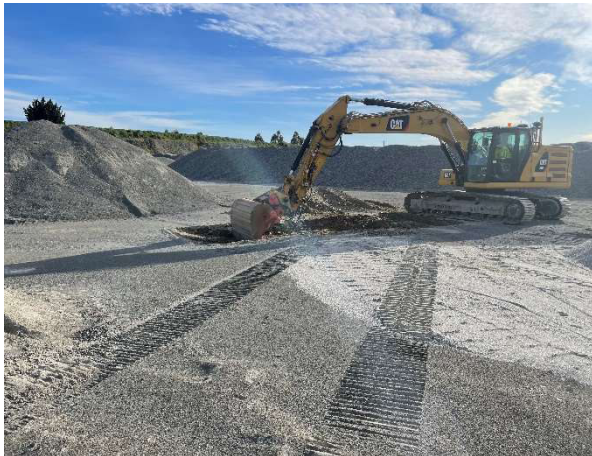
Photograph 3: Over-excavation of the base.

This resulted in a relatively firm base with a dry density of 1.64 t/m<sup>3</sup>.

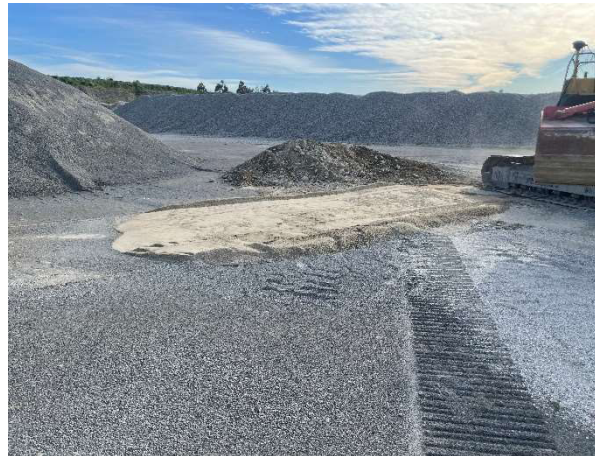
Photograph 4: View of the prepared base prior to formation of the trial hardfill pads.

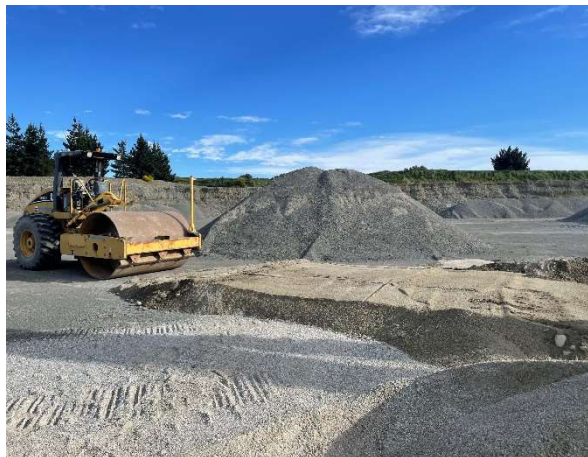
Photograph 5: Trial pad 1 prior to compaction.
