CONSOLIDATED UNDRAINED TRIAXIAL COMPRESSION (CIU)

Test Report - Result Summary

Project: Ground Investigation for Northland Corridor  
 Location : Section 2 Te Hana to Port Marsden Highway, Section 2B GI  
 Client : NZTA c/- Aurecon & WSP NZ Ltd  
 Borehole No: BH2B-1101  
 Sampled by: NC Site Team  
 Sampling Method: Pushtube  
 Sample Description: Clayey SILT; grey  
 Depth (m): 6.00-6.50  
 Date sampled: 14/10/25

Project No: 1-C2466.16  
 Lab Ref No: WL4708/151-TXL-CUM  
 Client Ref: -

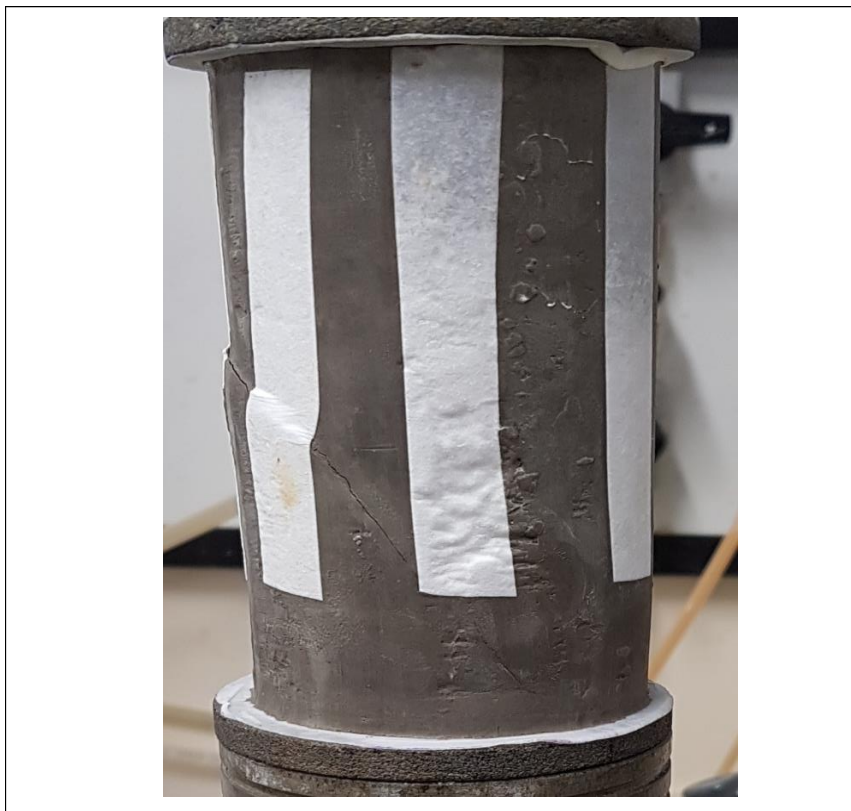
Photo of failure type
