# Ardgour Rise Road Safety Review

## Alternate Alignment Safety Review

Prepared for:  
Santana Minerals Ltd

Project/File:  
310206156

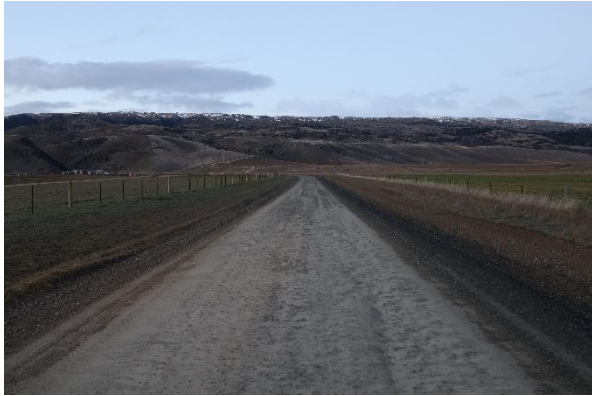
At the time of the inspection (22 July 2026), the initial section of Thomson Gorge Road, from the site access gate (CH0), through to the descent down to the pond (CH6.34), had been modified to a wide gravel surface generally 7-8 metres in width, and well formed with a silty gravel surfacing.

*Figure 3: Initial road section – Thomson Gorge Road*

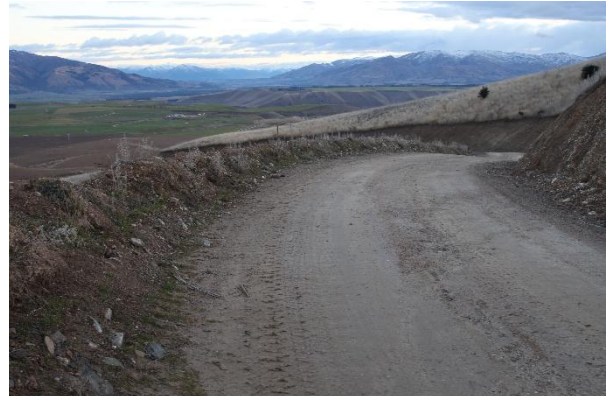
*Figure 4: Example of modified road section with windrow outer edge of road as protection.*

Gradients along this section are typically around 8%, with isolated sections of 12-16% and a maximum recorded gradient of 20%. A large portion of the new formation has a windrow of silt bound material along the outside of the new road formation. This serves as a definition of the edge of road during daylight hours. The windrow also retains any surface water within the road pavement, channelling this along the road rather than off the road.

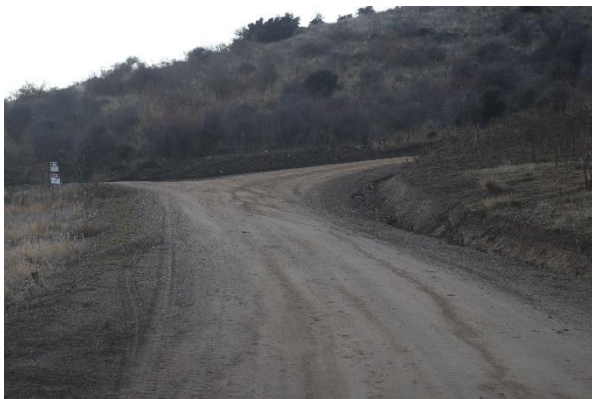
At the time of the inspection there was evidence of water paths showing in the pavement surface, indicating surface water was travelling along the road alignment, and not shedding directly to the road edge. There were isolated sections where the water channel on the road edge was incised due to water scour, typically because of high velocity, and the lack of culverts to shed the water effectively to a suitable watercourse or gully.

*Figure 5: Tight alignment with surface rilling<sup>1</sup>*

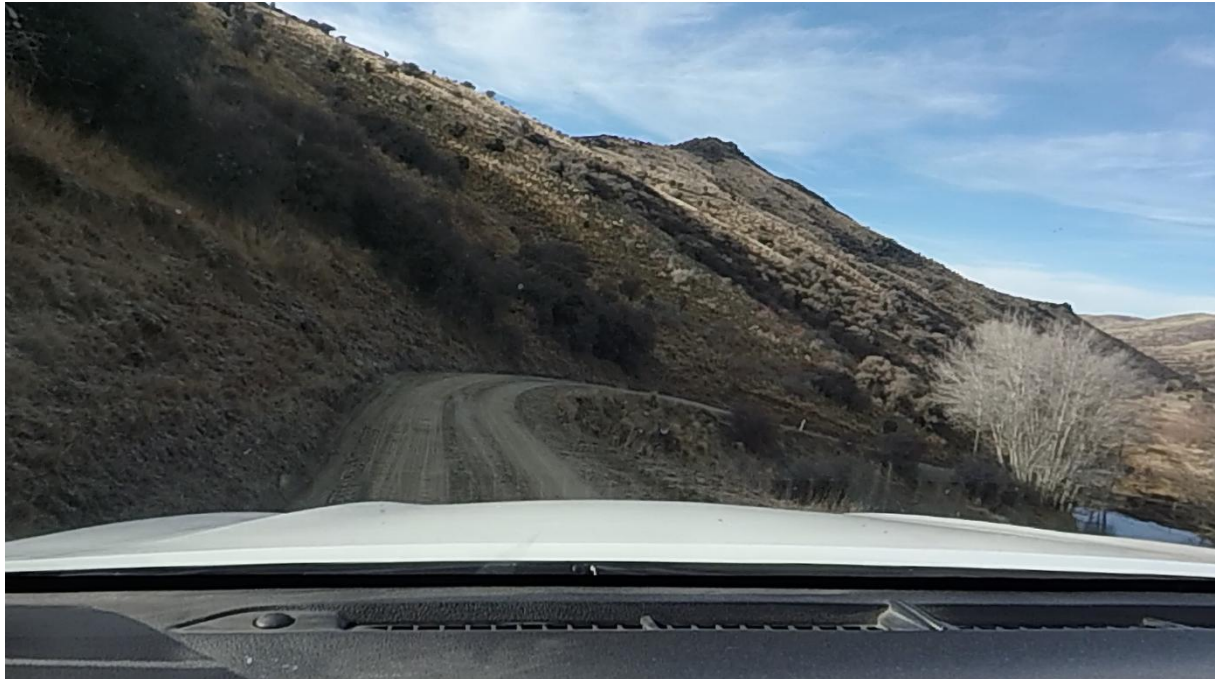
*Figure 7: Example of current Thomson Gorge Road alignment<sup>2</sup>*

A characteristic of the current alignment is that the majority of the route is on the north flank of the mountain slopes and is typically in sunlight from mid-morning through to late afternoon during the winter months. At the time of the inspection snow and ice was present around the summit area. Shaded portions around the pond were extensively covered in ice, and in shade a high proportion of the day.

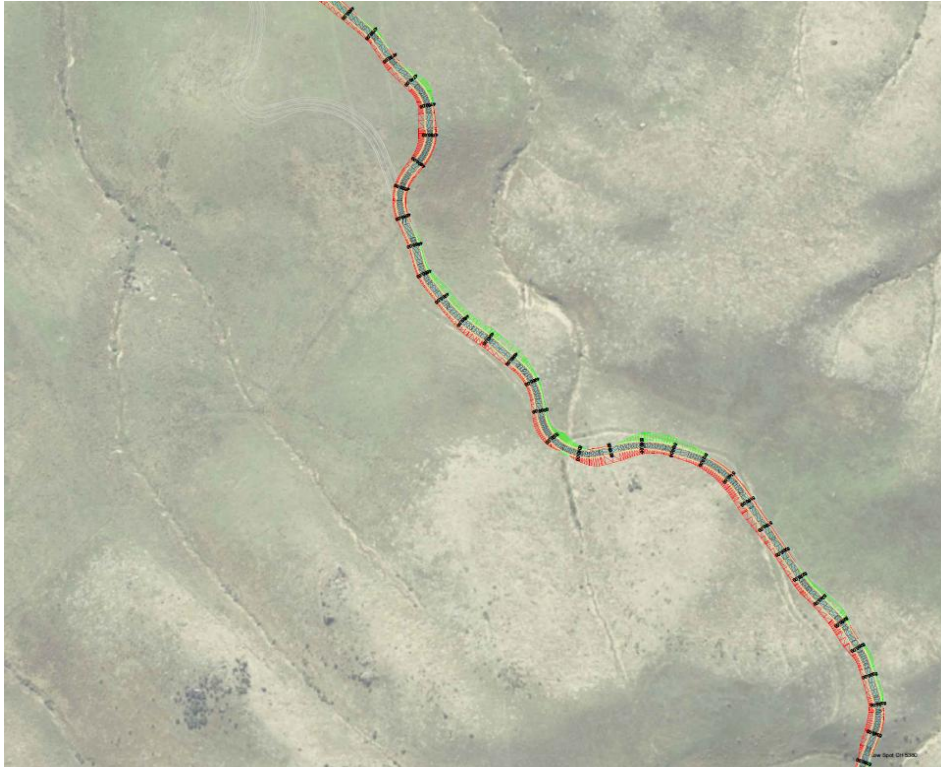
*Figure 9: Example of original design*

Through an analysis of the proposed design, and following observations on site, discussions were held with the project team on potential changes within the design to address the length of steep grades, with an aim to reduce the general gradient below 14%.

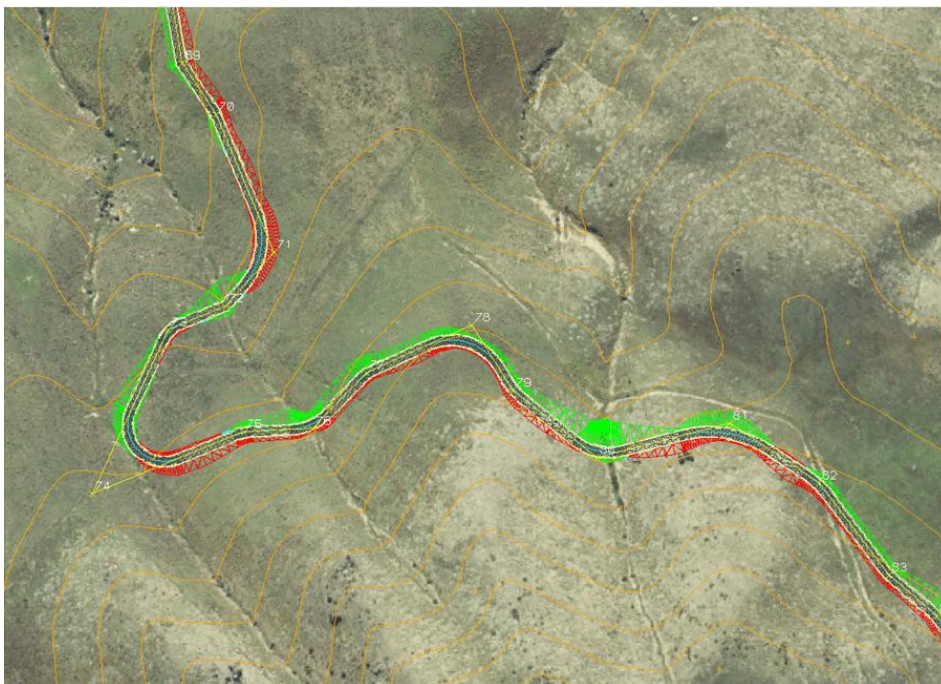
*Figure 10: Example of revised design*

A revised design was submitted on Monday 27<sup>th</sup> July 2026, with further discussions with the designer that same day. This revised design revealed an alignment from CH 4880 to CH 5440 with a gradient on average of below 12.5%. This was achieved through traversing further into gullies, and a general shift utilising a longer distance for the grade change. It is considered that this style of change is demonstration that a redesign of the alignment further in detailed design would result in a more suitable gradient.

A modified design has been undertaken that results in the general elimination of grades above 13%, from CH 3960 through to above CH 8580. This is discussed further in Section 3.3 below.

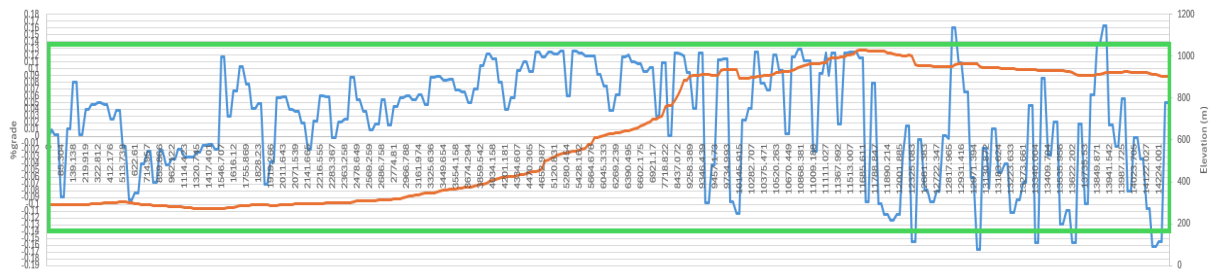
Figure 11: Alignment height / Grade comparison graph.

Figure 11 below details the new road profile (orange), with gradient (blue). The boundary box (green) is the bounds of 12.5% gradient. As demonstrated, there remains isolated sections of road above 12.5%, being the alignment along the highest portion of the proposed road.

For the purpose of this assessment, the vertical scale has been exaggerated to clearly define the changes.

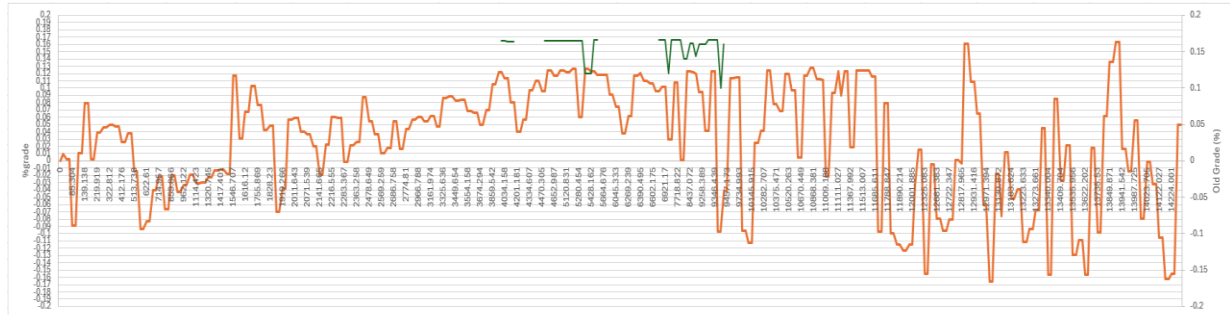
Figure 12: Grade comparison graph.

Figure 12 demonstrates areas where the Revision 4 design steep grade sections (green) have been reduced, resulting in a less steep alignment in Revision 5 (orange). It is acknowledged that there are short sections of steep grade (16%) along the tops, however these are isolated in length, with recovery grades between.

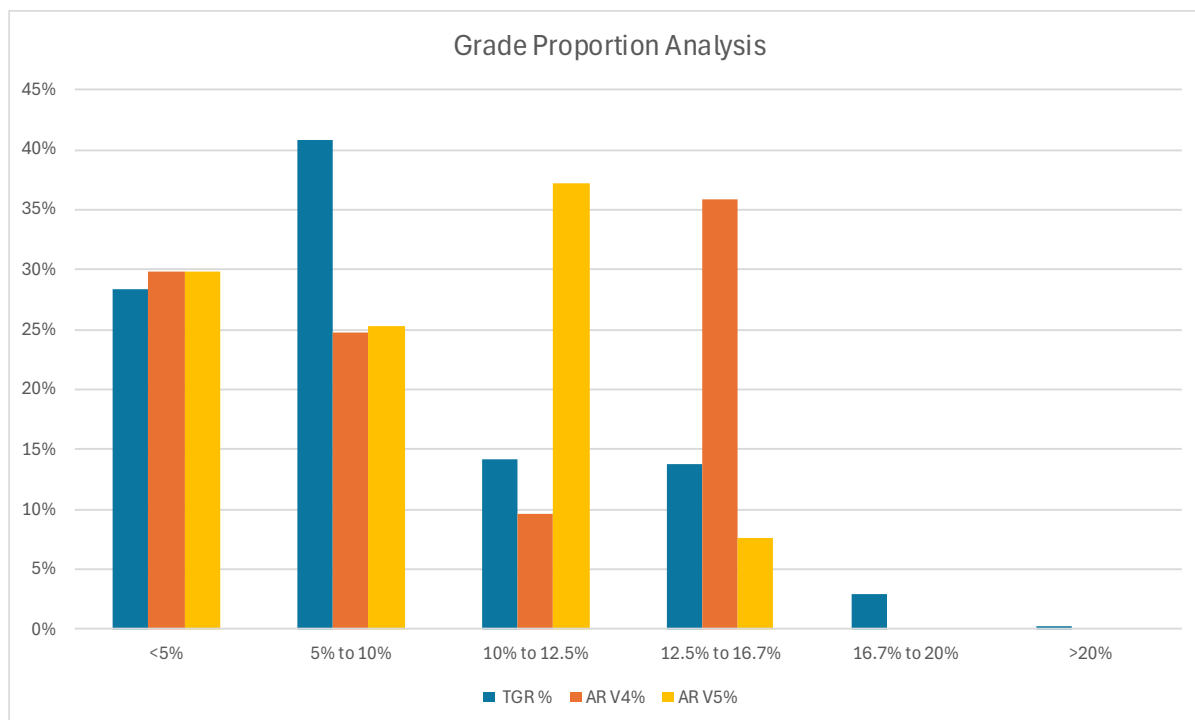
*Figure 13: Grade Summary Analysis*

In undertaking this review, the design data was analysed to understand how the nett effects of the grades compared between all options. The analysis has been undertaken using the absolute value for grade, that it combines positive and negative grades into the same bin ranges.

The length of both the Ardgour Rise V4 and V5 designs is 13.6 km and 14.3 km respectively. Analysis of the grade data has been undertaken from a start point at the entrance to the mine site, commencing at Thomson Gorge Road, and traversing through to rejoining Thomson Gorge Road at CH 12.1 km.

An analysis of the V4 design as submitted to the hearing had a higher proportion of grades in the 12.5% to 16.7%. The version 5 design has reduced this.

This analysis reveals that the Ardgour Rise alignment (V5) results in a lower percentage of length at the higher grades, with no grades exceeding 16.7%. This is achieved through utilising a higher proportion of mid-range grades (10 to 12.5%).

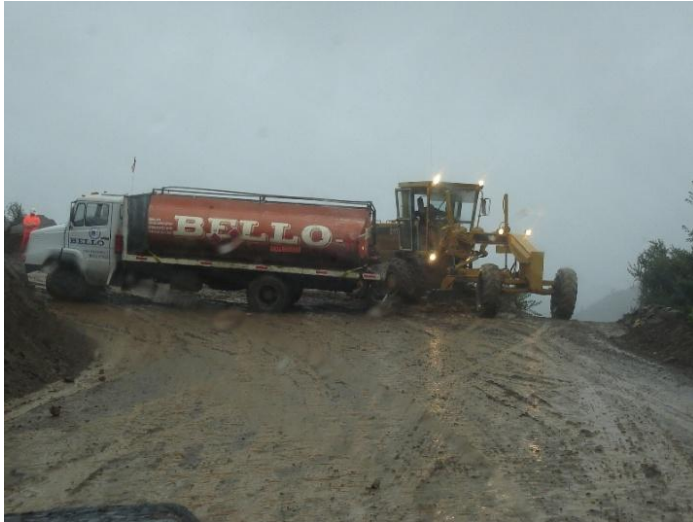
A typical NZTA M-Spec material has a low proportion of fines, resulting in a surface material that could unravel under wheel traction and descent. It is acknowledged that regular maintenance would address many of these issues, however a typical road grading programme would feather (fluff) the top surface. More successful road maintenance programmes incorporate a towed roller behind the grader; however, it is considered that the length of steep grade would prevent this as a feasible option.

*Figure 14: Overseas example of silt rich surfacing in winter months*

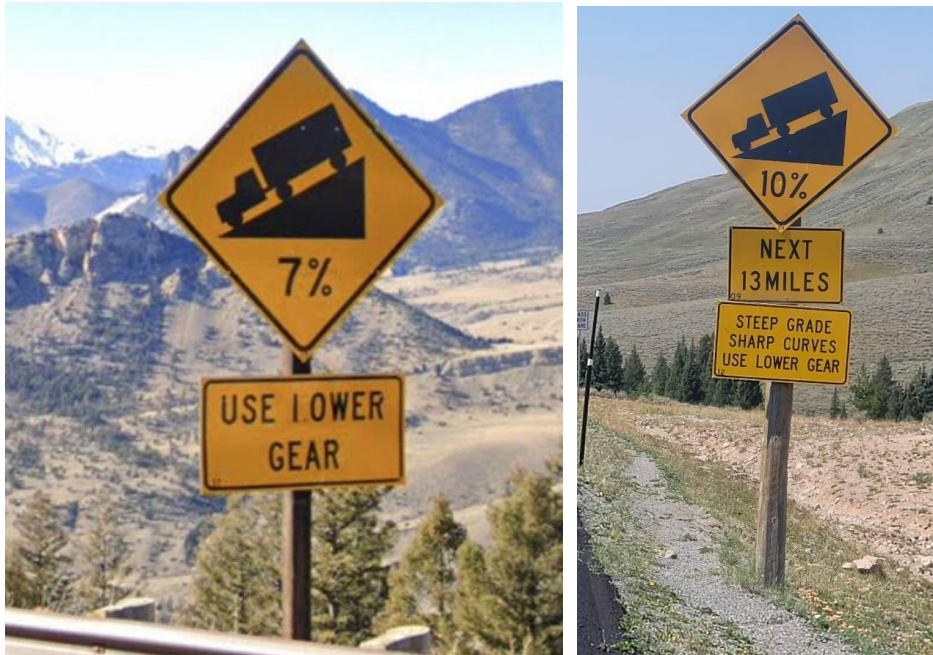
A driver undertaking a descent movement is presented with long steep grades still has a high risk of brake fade and loss of control / loss of traction type events. It is critical that drivers select the correct descent gear at a location prior to encountering the steep grade. This can be notified by appropriate signs for descent advice as demonstrated in Figure 17 below.

*Figure 17: Example of Steep Grade: Use Low Gear signs.*

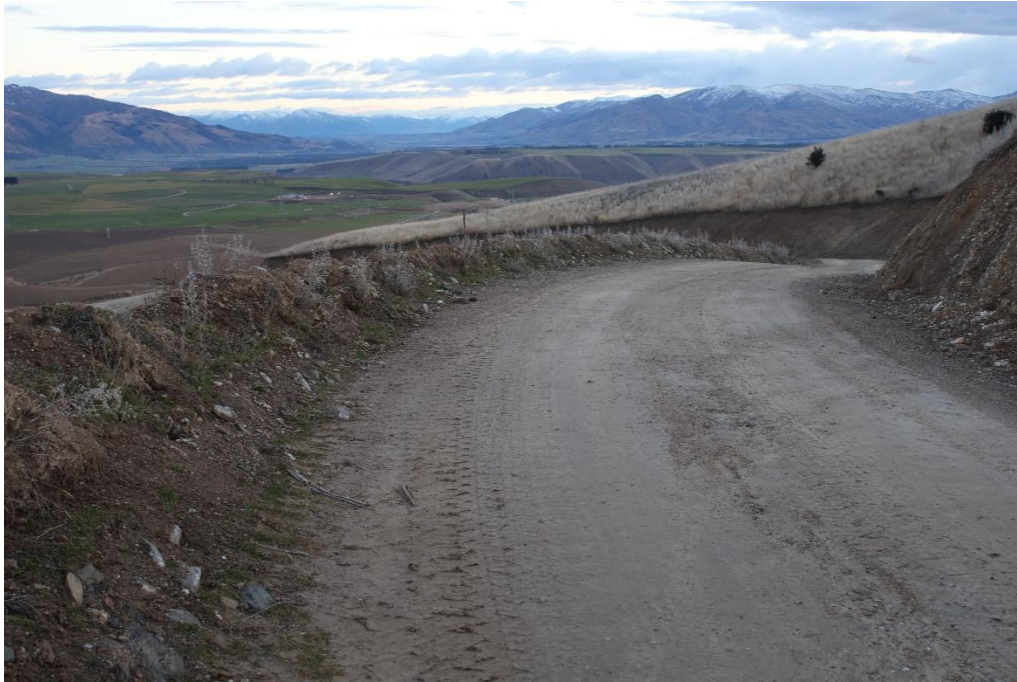
As presented, the modification of the existing Thomson Gorge Road has incorporated a windrow of material on the outside (downslope) side of the road formation. This ensures that an errant light vehicle is generally directed back into the trafficable lane. An example of the applied edge protection is indicated in Figure 18 below.

The existing Thomson Gorge Road, above the modified sections, has minimal downslope edge protection. While the alignment from the pond initially follows the valley floor, it then rises up the mountain slope, with steep downslope grades that have minimal to no edge protection.

*Figure 18: Existing Thomson Gore Road – Edge protection on modified sections*

Considering the proposed road alignment, there will be locations where windrow treatments could be easily established, providing protection for the downslope grade. Tighter sections of alignment, where a wide edge protection could not be formed, could be addressed through the placement of large rocks on the edge. It is acknowledged that panel damage to vehicles may occur if struck, however the vehicle does not penetrate over the road edge, minimising the risk of severe to fatal injury.

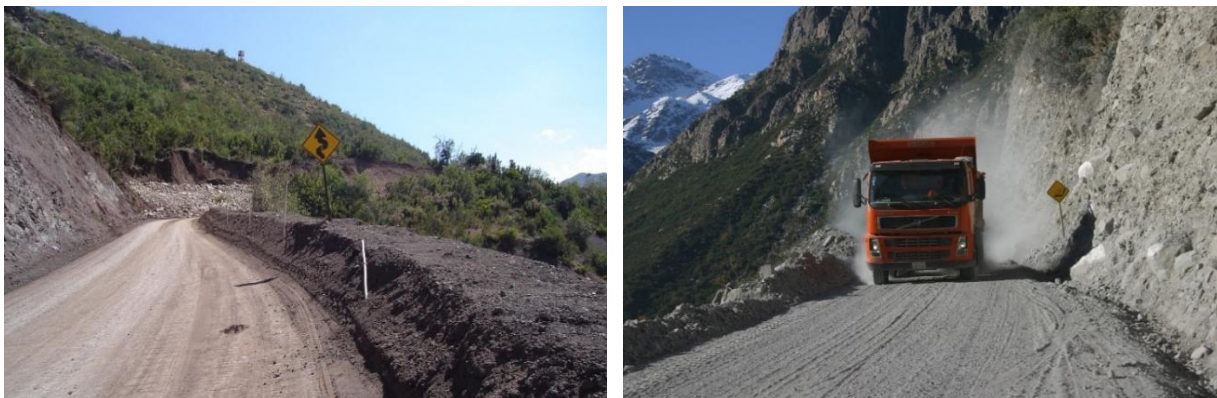
My experience in mountainous roads around the world has indicated that safe and effective edge protection can be achieved through use of appropriate treatments. In Figure 19 below, I give examples of high-level edge protection (left image), along with use of large boulders in more confined locations (right image)

*Figure 19: Examples of edge protection, Chile, elevation 2850 m*

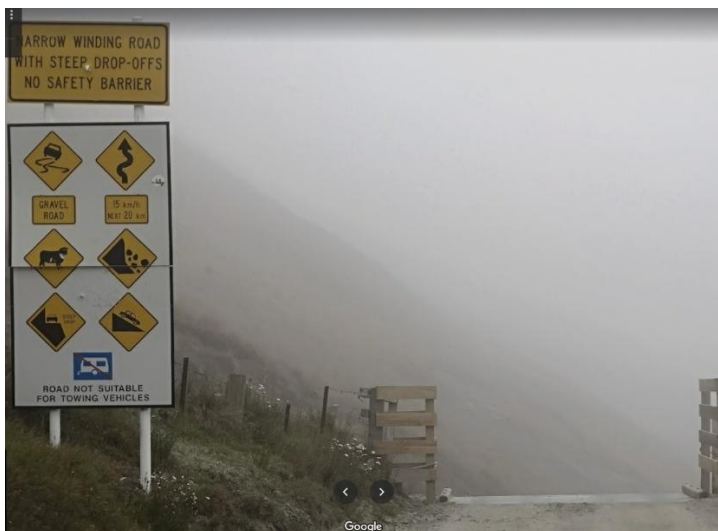
It is essential that a driver is fully aware of the conditions ahead. This is typically achieved through the installation of road condition warning signs at the point of entry onto the road. An example of this style of warning is given in Figure 20 below. This sign grouping is installed at the commencement of the Skippers Canyon Road, Queenstown.

*Figure 20: Example of Skippers Canyon Road*

Through the use of appropriate signs, along with repeat signs at changes within the alignment, ensures that the driver is made fully aware of the road conditions and hazards ahead. These signs can often deter inappropriate use by strangers unfamiliar with the conditions ahead.

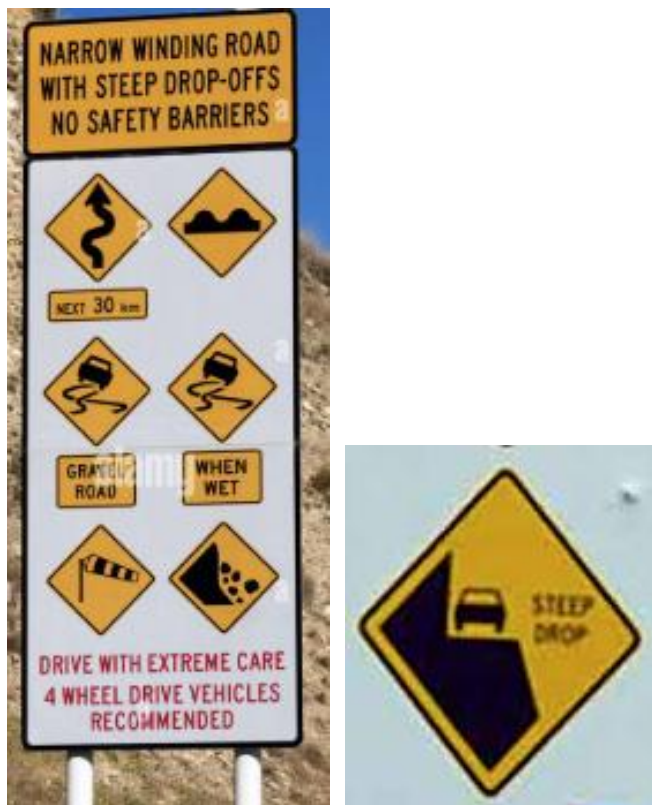
It is acknowledged that not all sections of the road can have edge protection applied. In these locations appropriate signs and alternate treatments should be implemented. At the lowest form of control is road signs advising of unprotected drop-offs. An example of a sign is given in Figure 21 below.

*Figure 21: Road Hazard Sign – French Pass, Marlborough.*

It is considered that the style of sign installed on Skippers Canyon Road and French Pass Road is appropriate for the new road alignment.
