Milldale Temporary Wastewater Treatment Facility

# GEOTECHNICAL INVESTIGATION REPORT

Fulton Hogan Land Development Limited

Job No. AKL2024-0185AC | Version 1

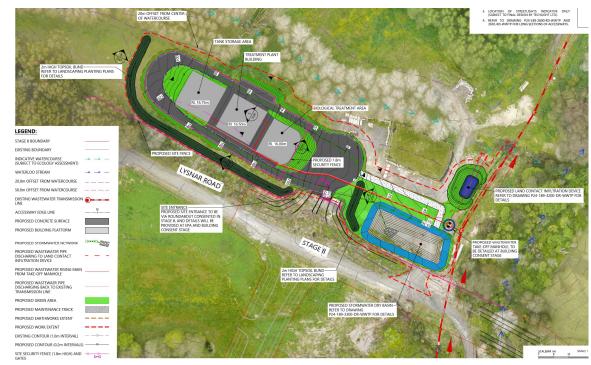
Figure 3.2: Overall Proposed Site Plan (Reference Woods P24-189-2000-RD-WWTP)

- Consent drawings prepared by Woods (Reference: P24-189-2000-RD-WWTP Rev 1 dated February 2025) shows the indicative location of the proposed treatment plant and artificial wetland.
- The treatment plant would comprise a building and several liquid containing tanks. As of writing this report, detailed design is ongoing by others; as such, details of proposed structures have yet to be provided to CMW.
- The proposed structures are to be located outside of the 20 m offset from watercourse and wetland.

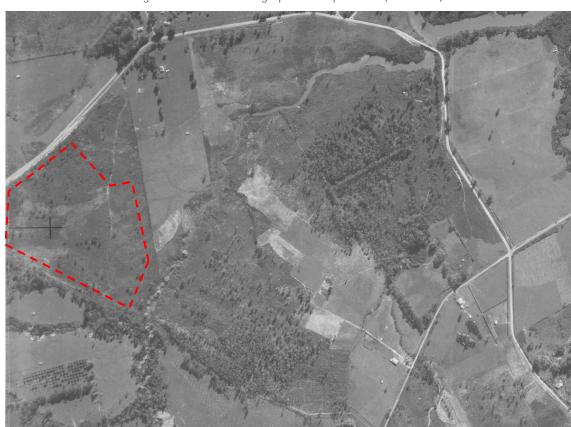
Figure 4.1: Aerial Photograph from April 1940 (Retrolens)

- The site has been used as farmland since the earliest available photographs were taken in 1940 (*Figure 4.1* and *Figure 4.2*).
- No development has been observed on the proposed plant location based on available photographs up to 2017. It is noted that two areas of wetland have been built within the property (*Figure 4.3*).
- Sometime in 2022, the eastern portion of the site near Waterloo Creek has been filled with hardfill to be used as laydown area for Milldale construction (*Figure 4.4*).

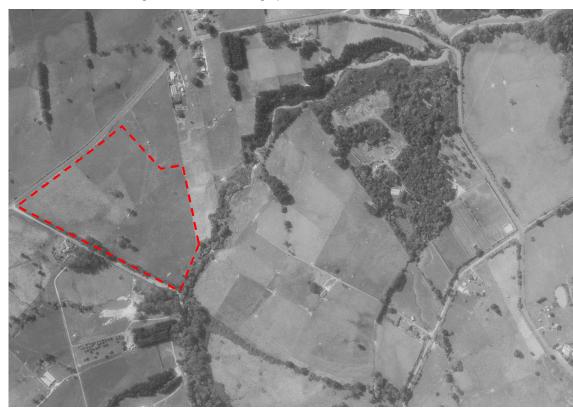
Figure 4.2: Aerial Photograph from March 1988 (Retrolens)

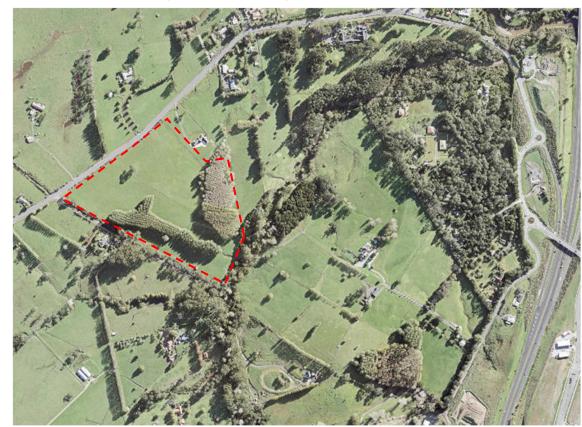
Figure 4.3: Aerial Photograph from 2017 (GeoMaps)

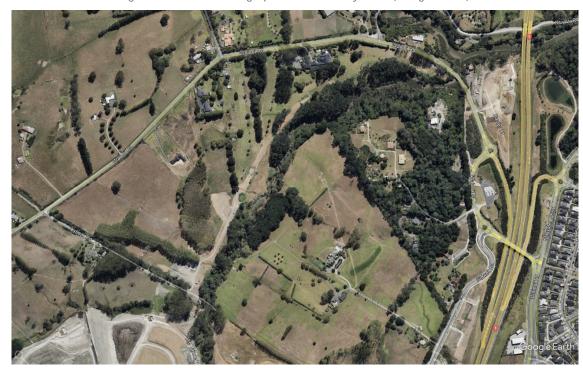
Figure 4.4: Aerial Photograph from February 2022 (Google Earth)

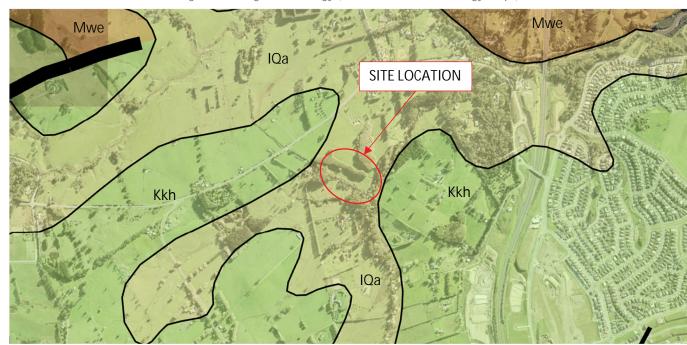
Figure 6.1: Regional Geology (GNS Science Web Geology Map<sup>2</sup>)

Published geological maps<sup>1</sup> for the area depict the regional geology as comprising Mangakahia Complex (Kk) of the Northland Allochthon as illustrated in Figure 6.1. These strata are part of an allochthonous (meaning removed from its formation location) mass of continental crust that was peeled from the subduction zone north of New Zealand and emplaced through low angle thrust faulting onto areas of Northland and the Silverdale area. Due to the nature of emplacement, materials are typically highly fractured or even shattered and variably weathered.

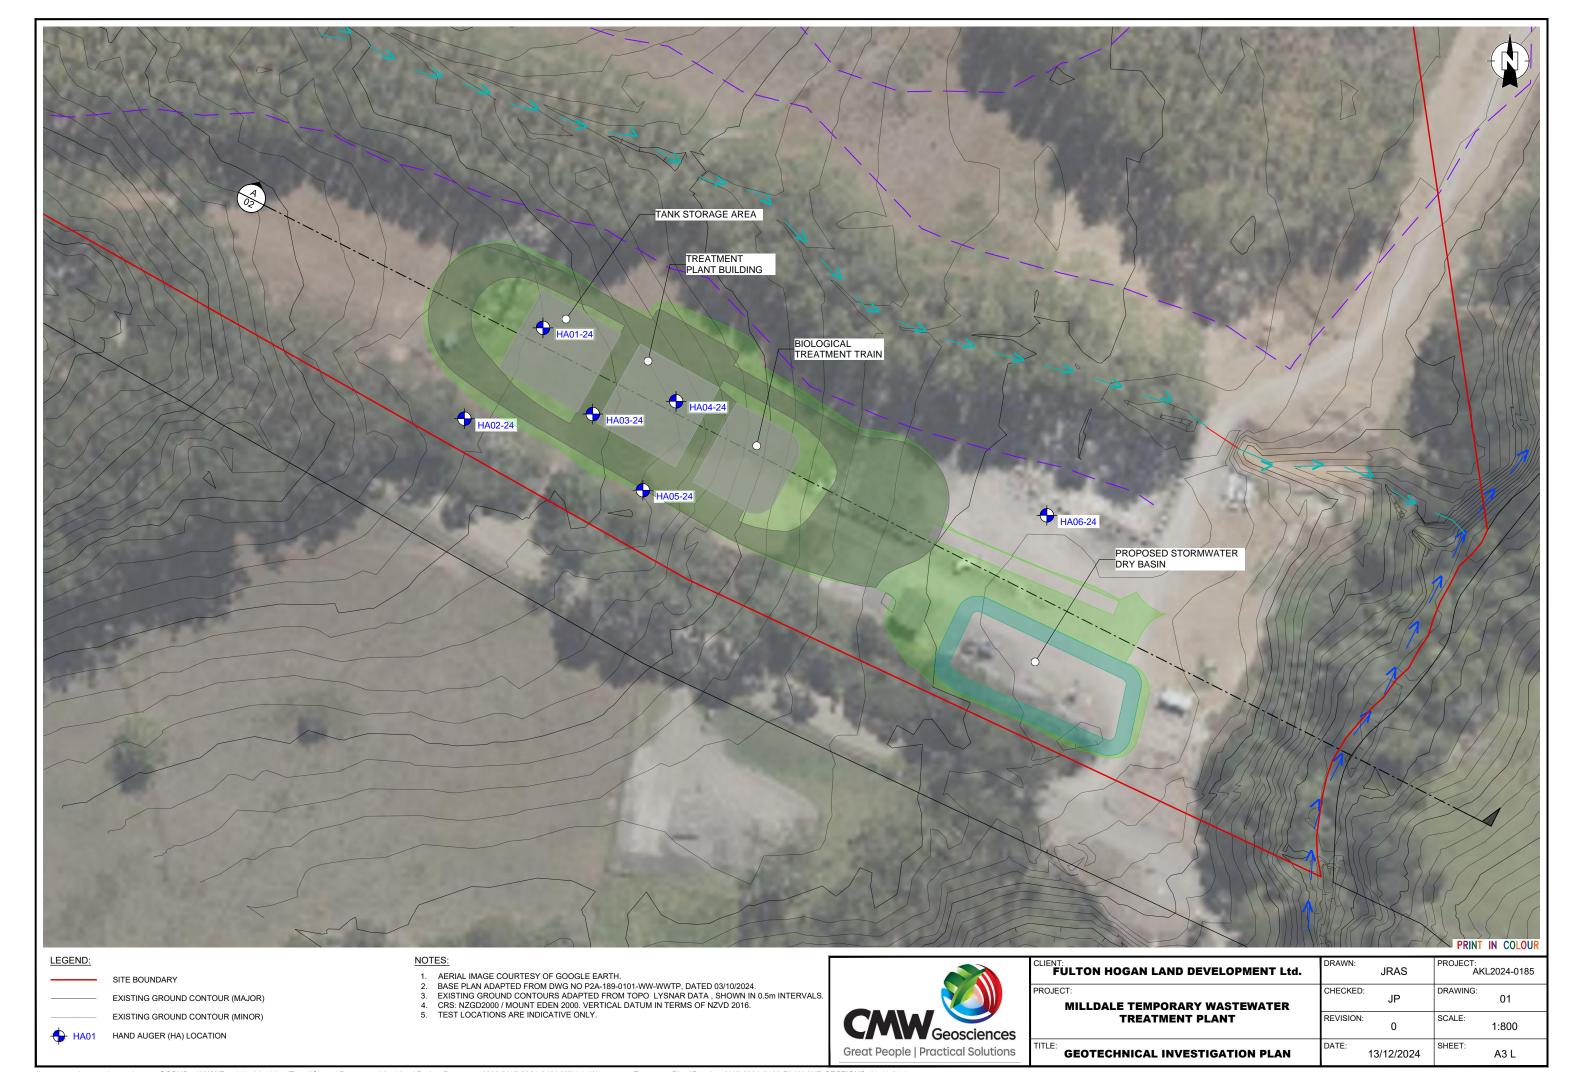
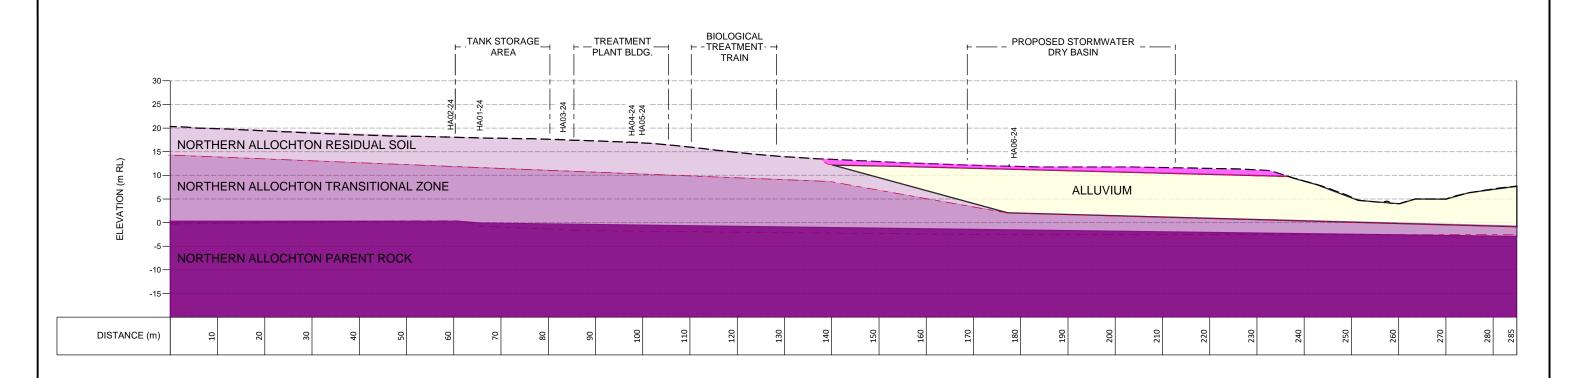
#### CROSS SECTION A

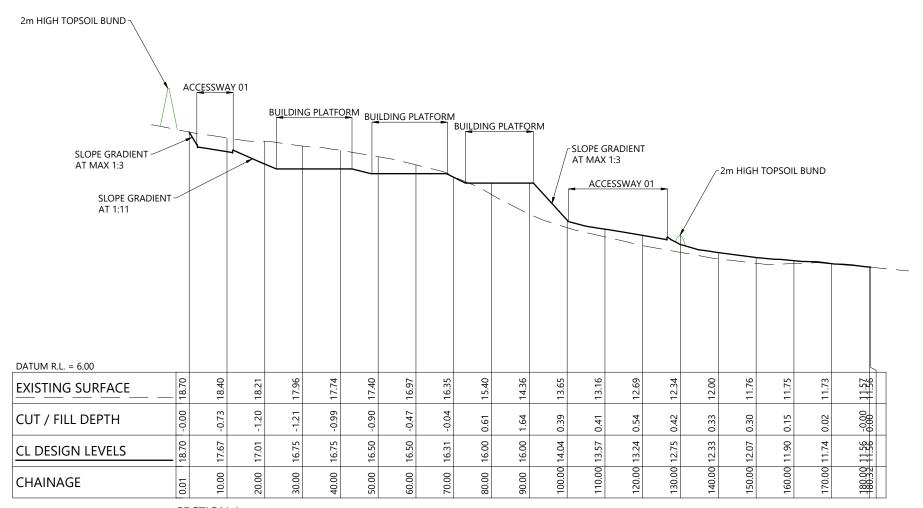
SECTION 1 HORZ 1:1000 @A3 VERT 1:200 @A3

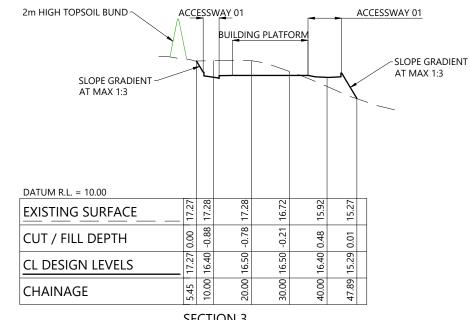
SECTION 3 HORZ 1:1000 @A3 VERT 1:200 @A3

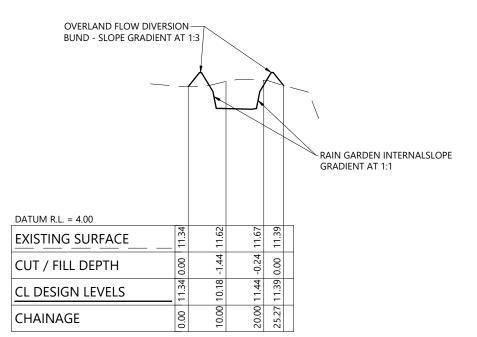
SECTION 6 HORZ 1:1000 @A3 VERT 1:200 @A3

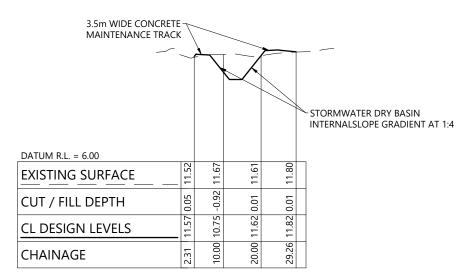
SECTION 8 HORZ 1:1000 @A3 VERT 1:200 @A3

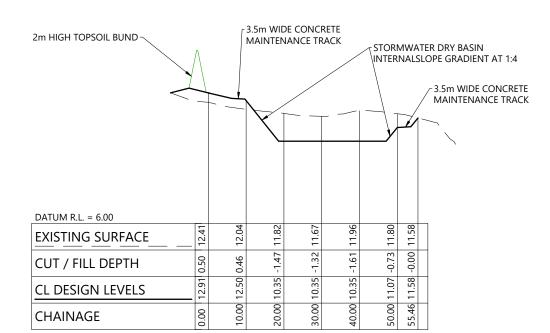
SECTION 7 HORZ 1:1000 @A3 VERT 1:200 @A3

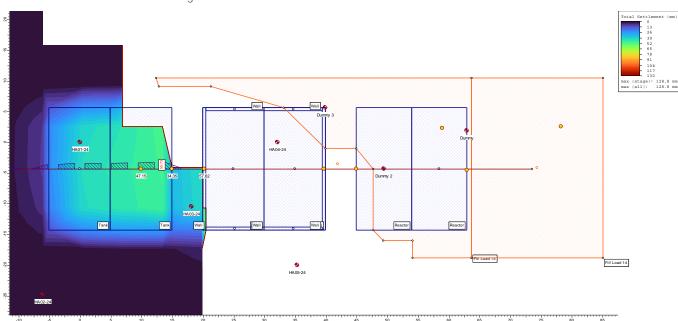
Figure 2: Post-construction settlement contours at RL 16.5 m

The post-construction differential settlement estimated between the structures are within 25mm given the maximum bearing pressures in Table 2. It should be noted that the magnitude of the exterior wall loads have been back-analysed to achieve the 25mm maximum settlement threshold. If these bearing pressures were to be exceeded, CMW must be advised for further analysis.

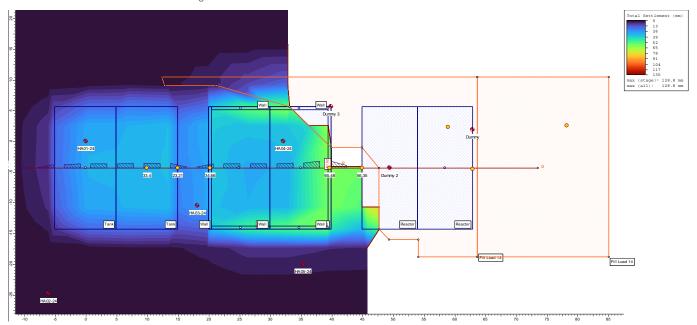
Figure 3: Post-construction settlement contours at RL 16 m

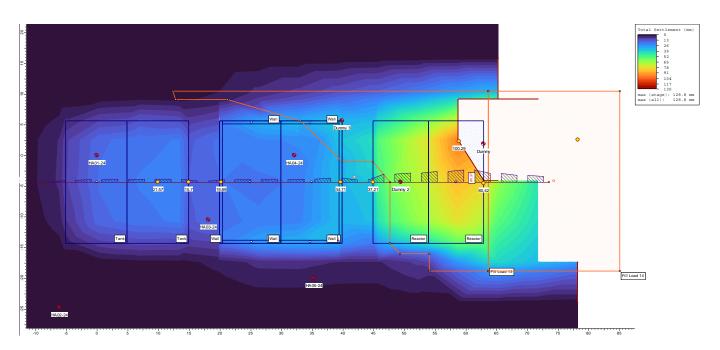
Figure 4: Post-construction settlement contours at RL 15.1 m
