17.0 Revised Conceptual Model of Exposure Pathways

Table 17: Revised Conceptual Site Model: 508 Old Wairoa Road, Ardmore.

***DETAILED SITE INVESTIGATION,
REMEDIAL ACTION PLAN
&
ASSESSMENT OF ENVIRONMENTAL EFFECTS
80 HAMLIN ROAD,
ARDMORE
AUCKLAND***

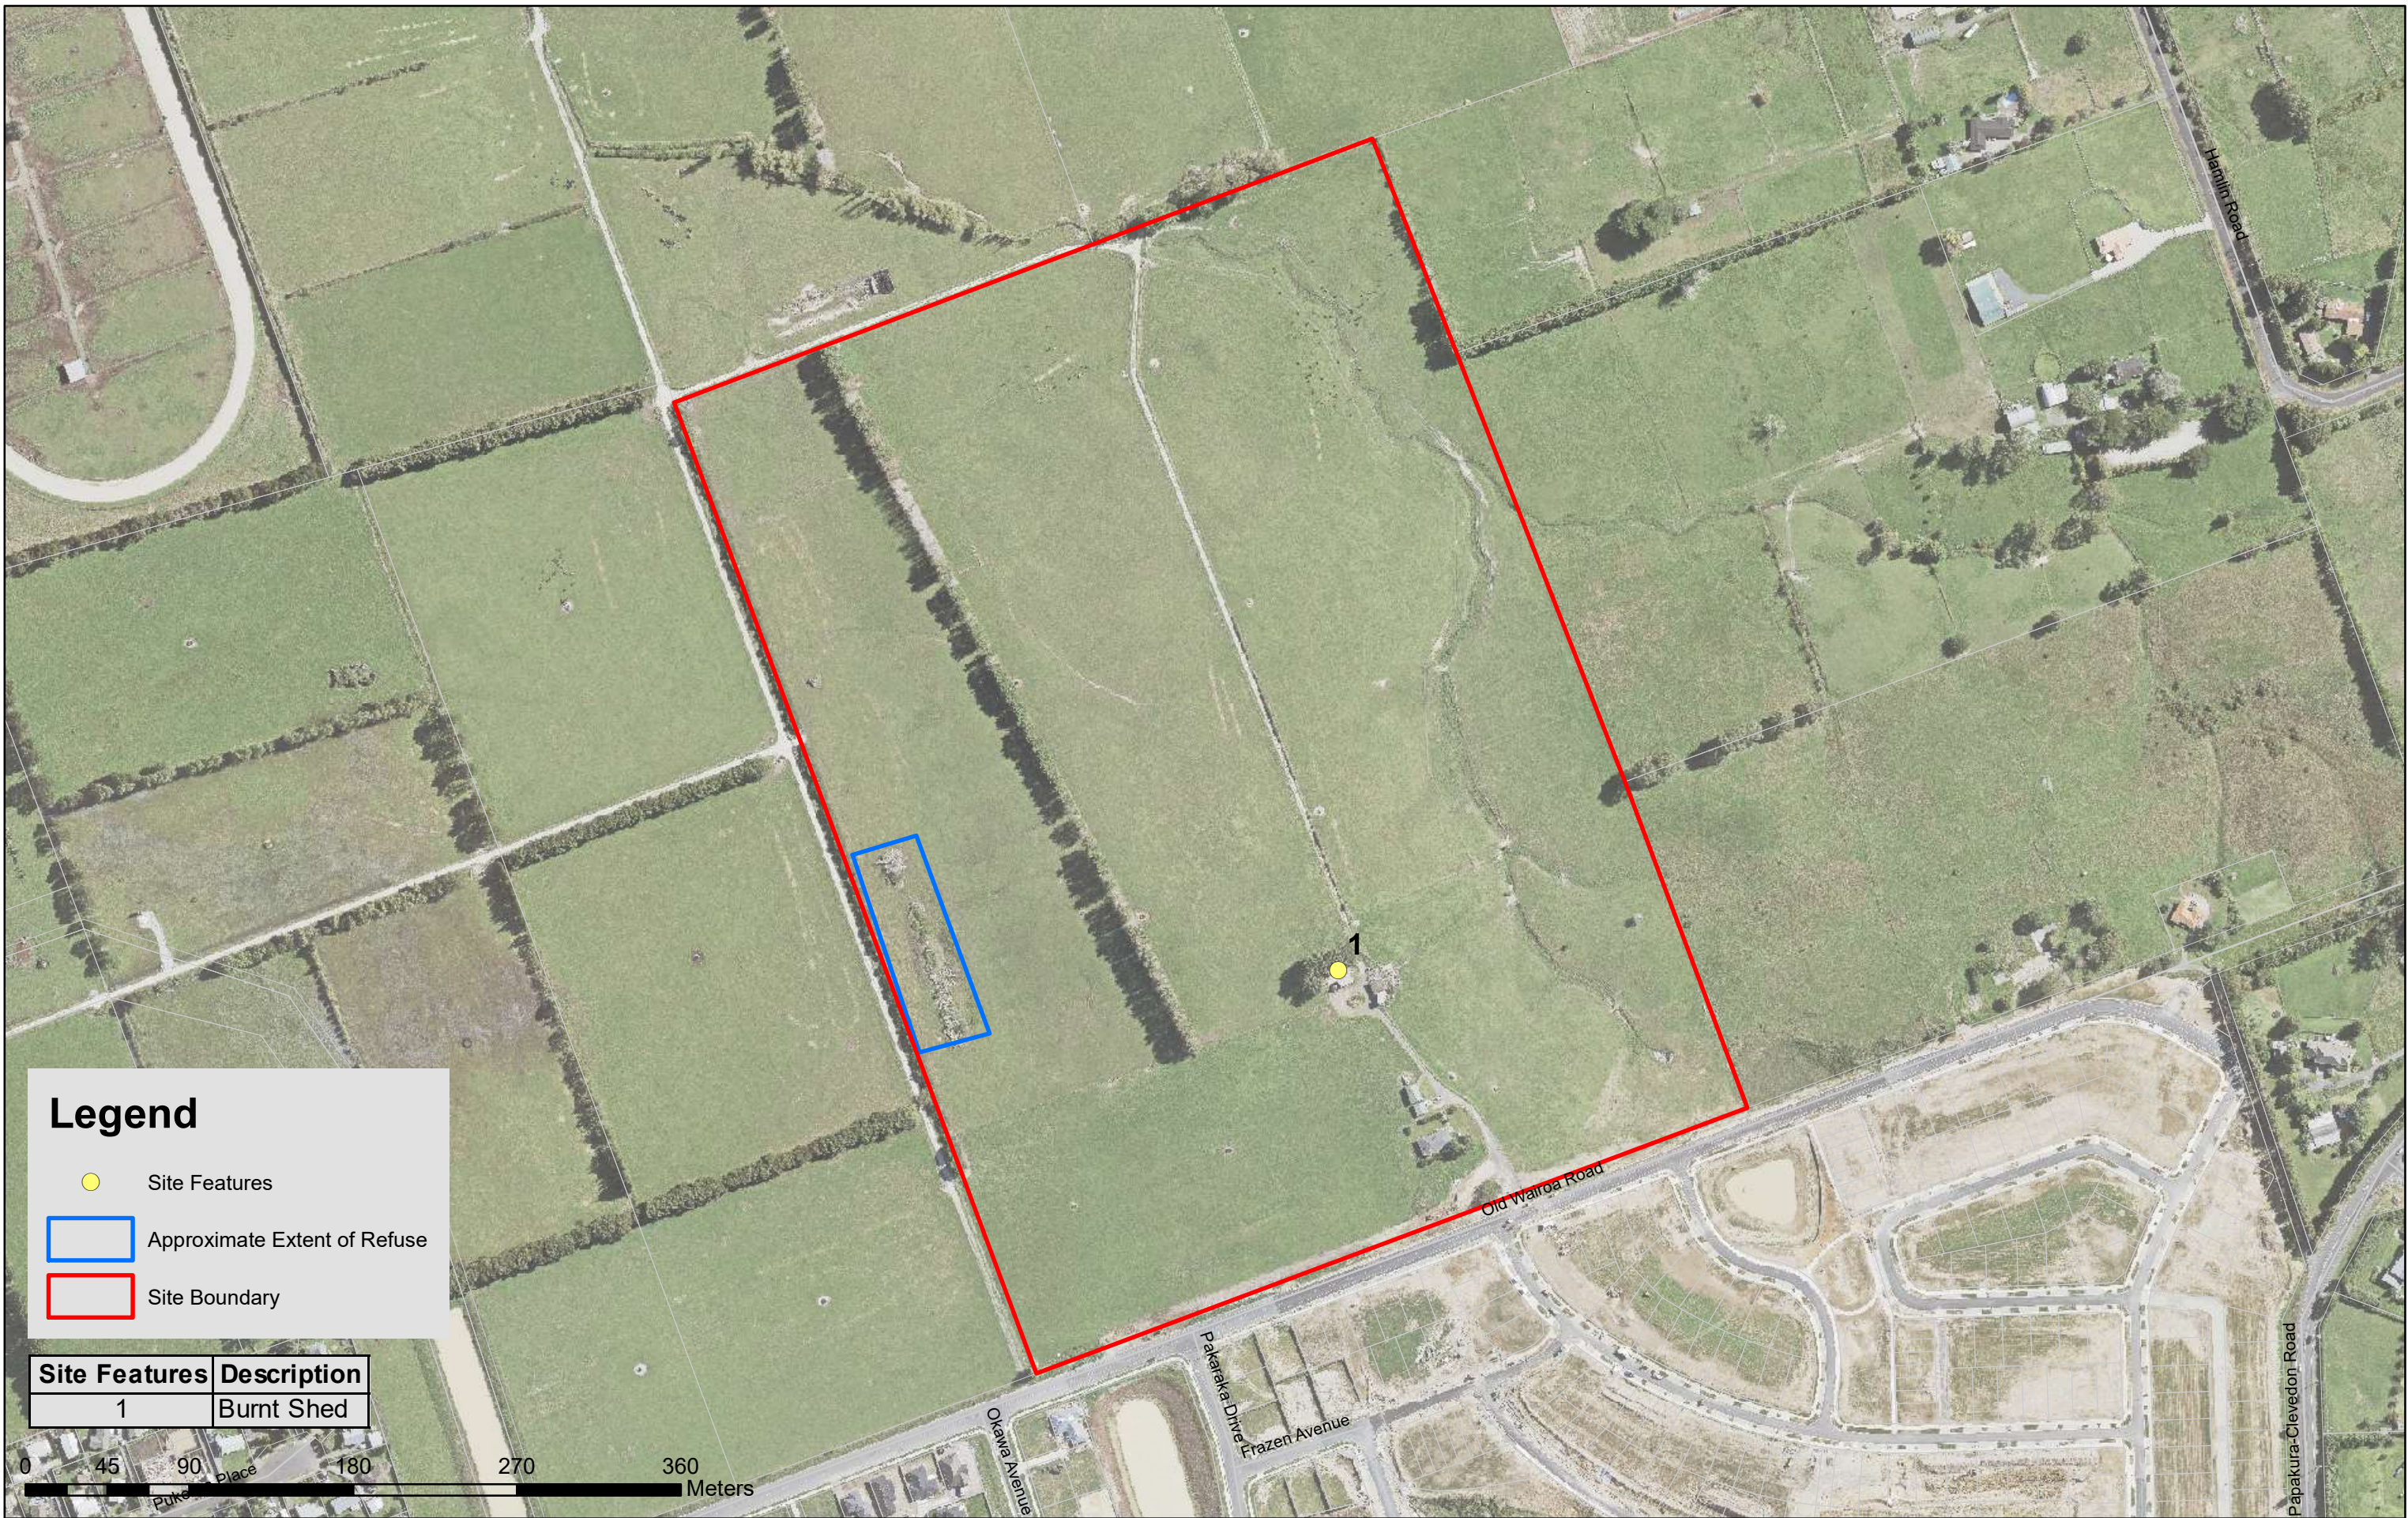
Figure 5 - Inferred Extent of Areas Requiring Management

Site Features	Description
1	Burnt Shed

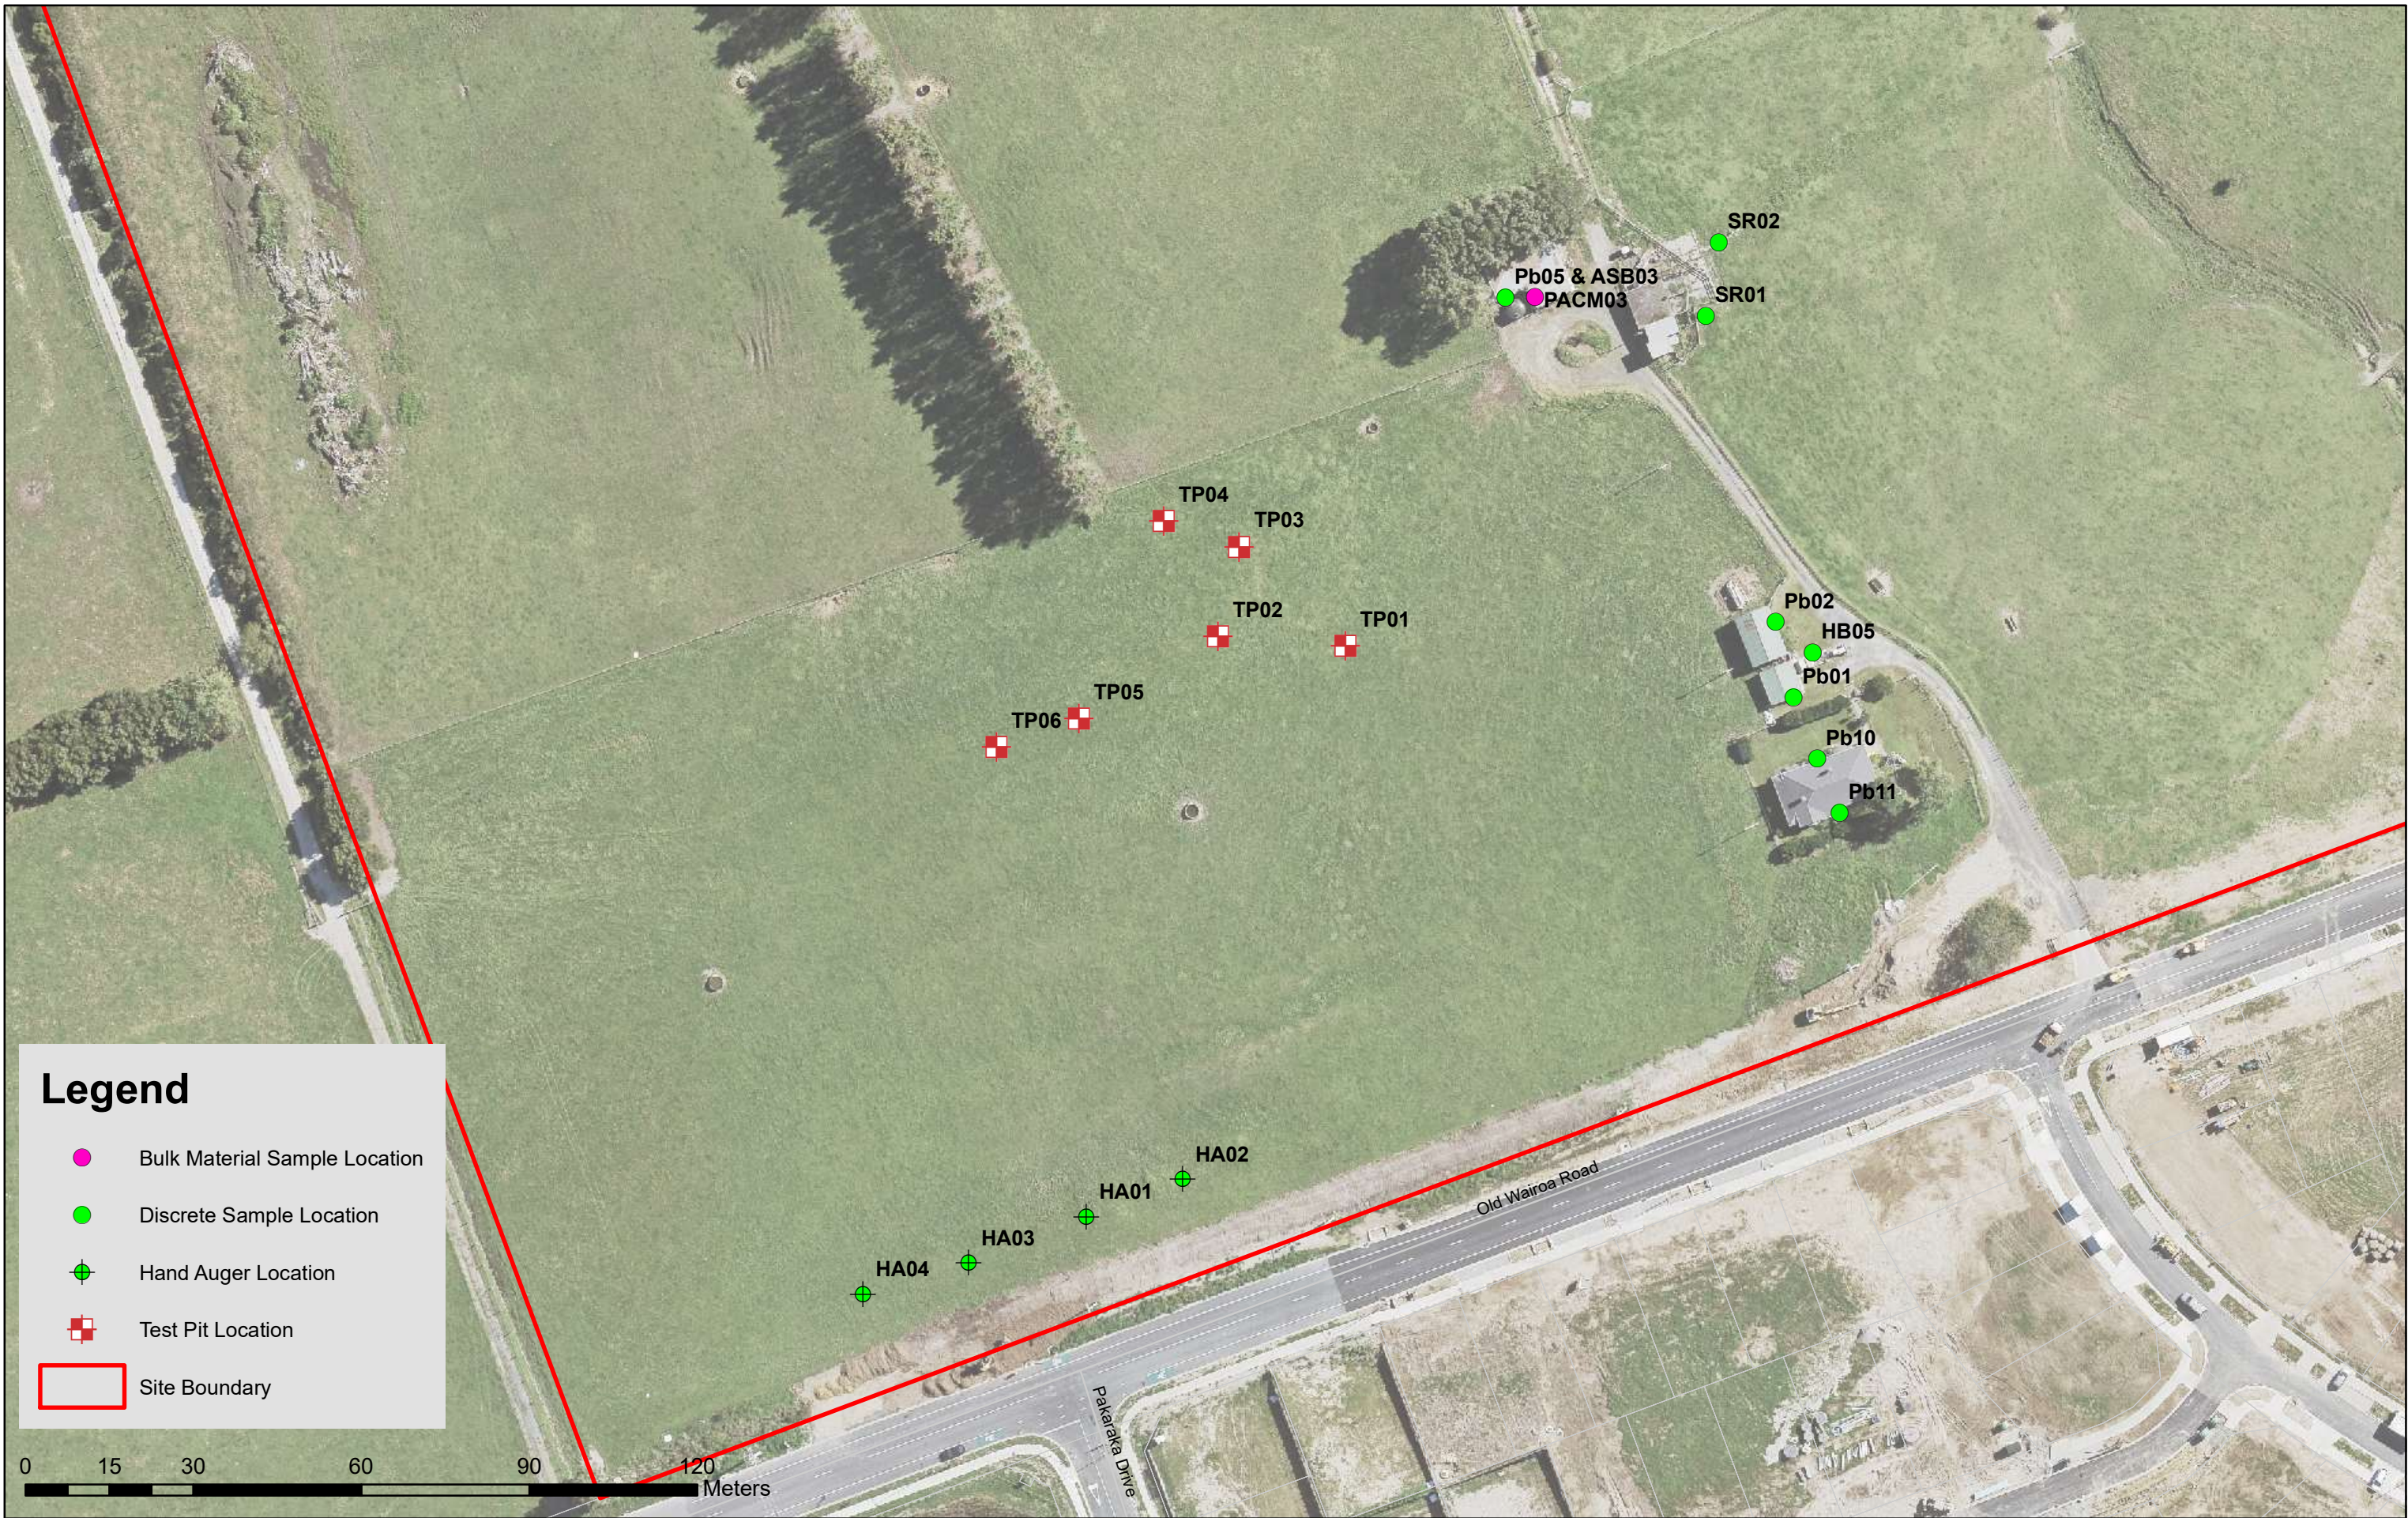
Drawing Number: 1443.010.03
				Drawn By: MT
				Checked By: DO'R
				Date: 20/12/2023

- Bulk Material Sample Location
- Discrete Sample Location
- ⊕ Hand Auger Location
- ⊠ Test Pit Location
- Site Boundary

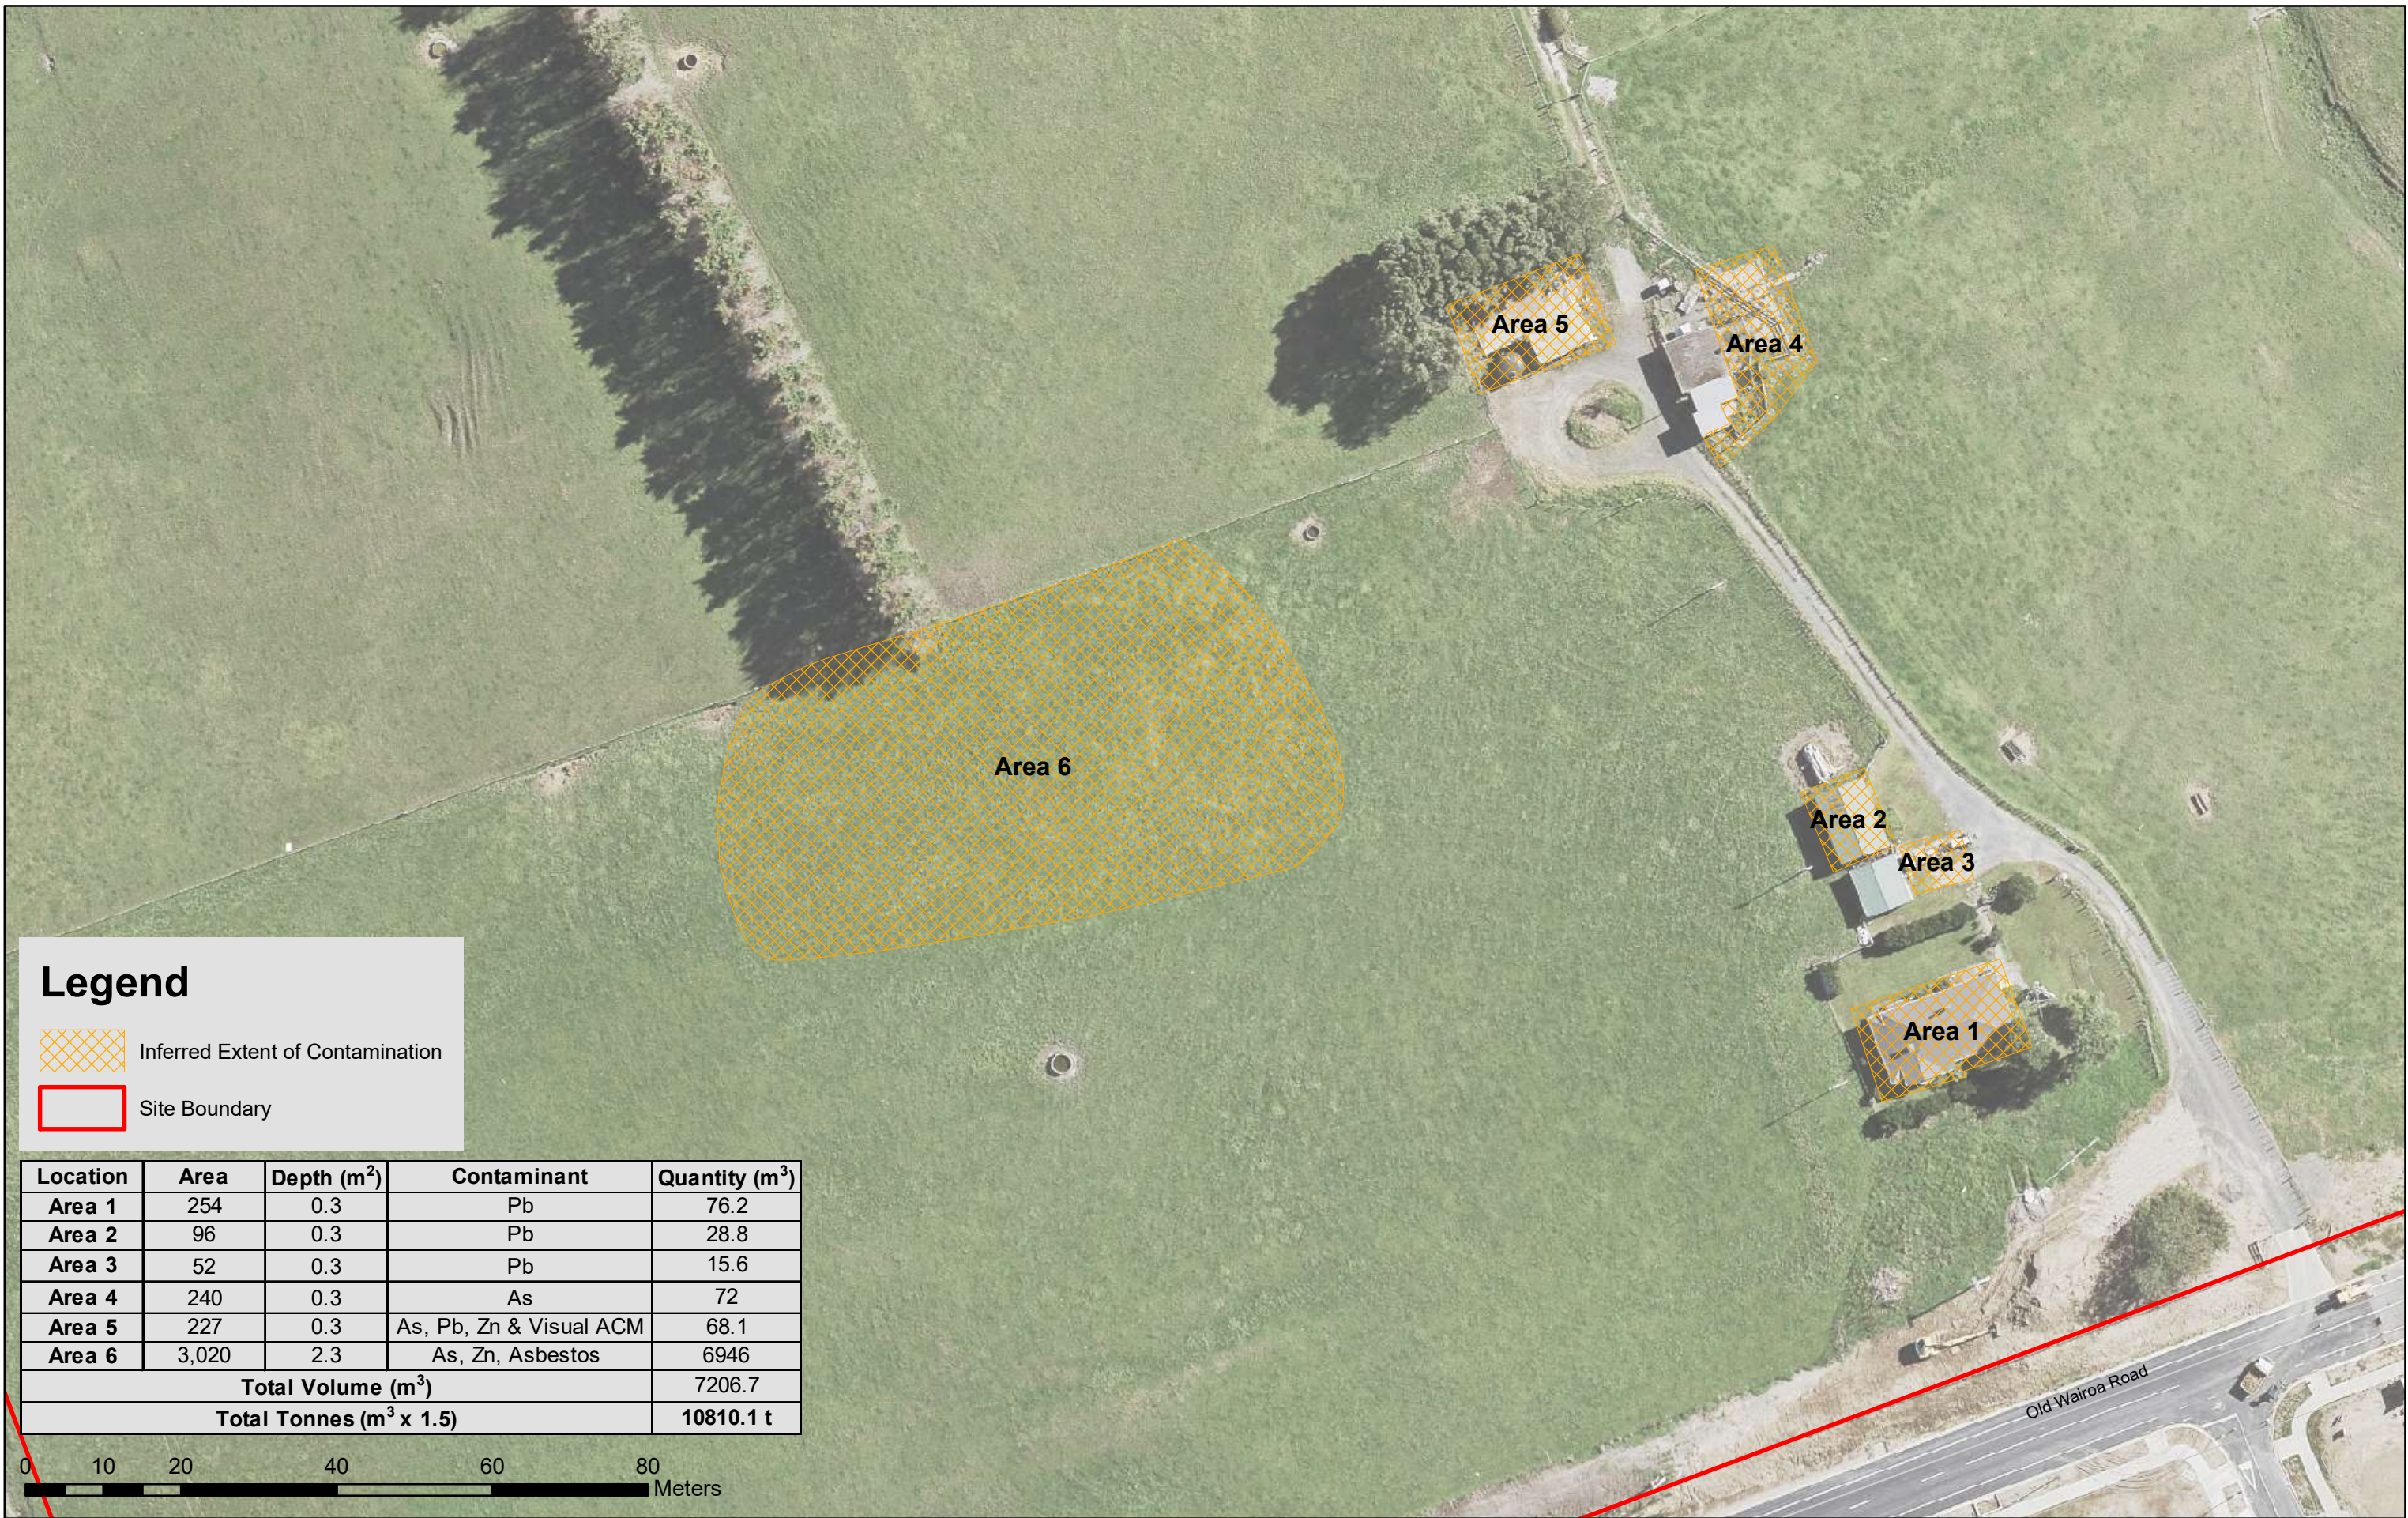
Location	Area	Depth (m ²)	Contaminant	Quantity (m ³)
Area 1	254	0.3	Pb	76.2
Area 2	96	0.3	Pb	28.8
Area 3	52	0.3	Pb	15.6
Area 4	240	0.3	As	72
Area 5	227	0.3	As, Pb, Zn & Visual ACM	68.1
Area 6	3,020	2.3	As, Zn, Asbestos	6946
Total Volume (m ³)				7206.7
Total Tonnes (m ³ x 1.5)				10810.1 t

Due to the elevated levels of contaminants detected, the site at 508 Old Wairoa Road, Ardmore will require remediation of the affected soils prior to being redeveloped. The estimated volume of soil requiring remediation is 7,206.7m³. It should be noted that this volume may change during the remedial process.

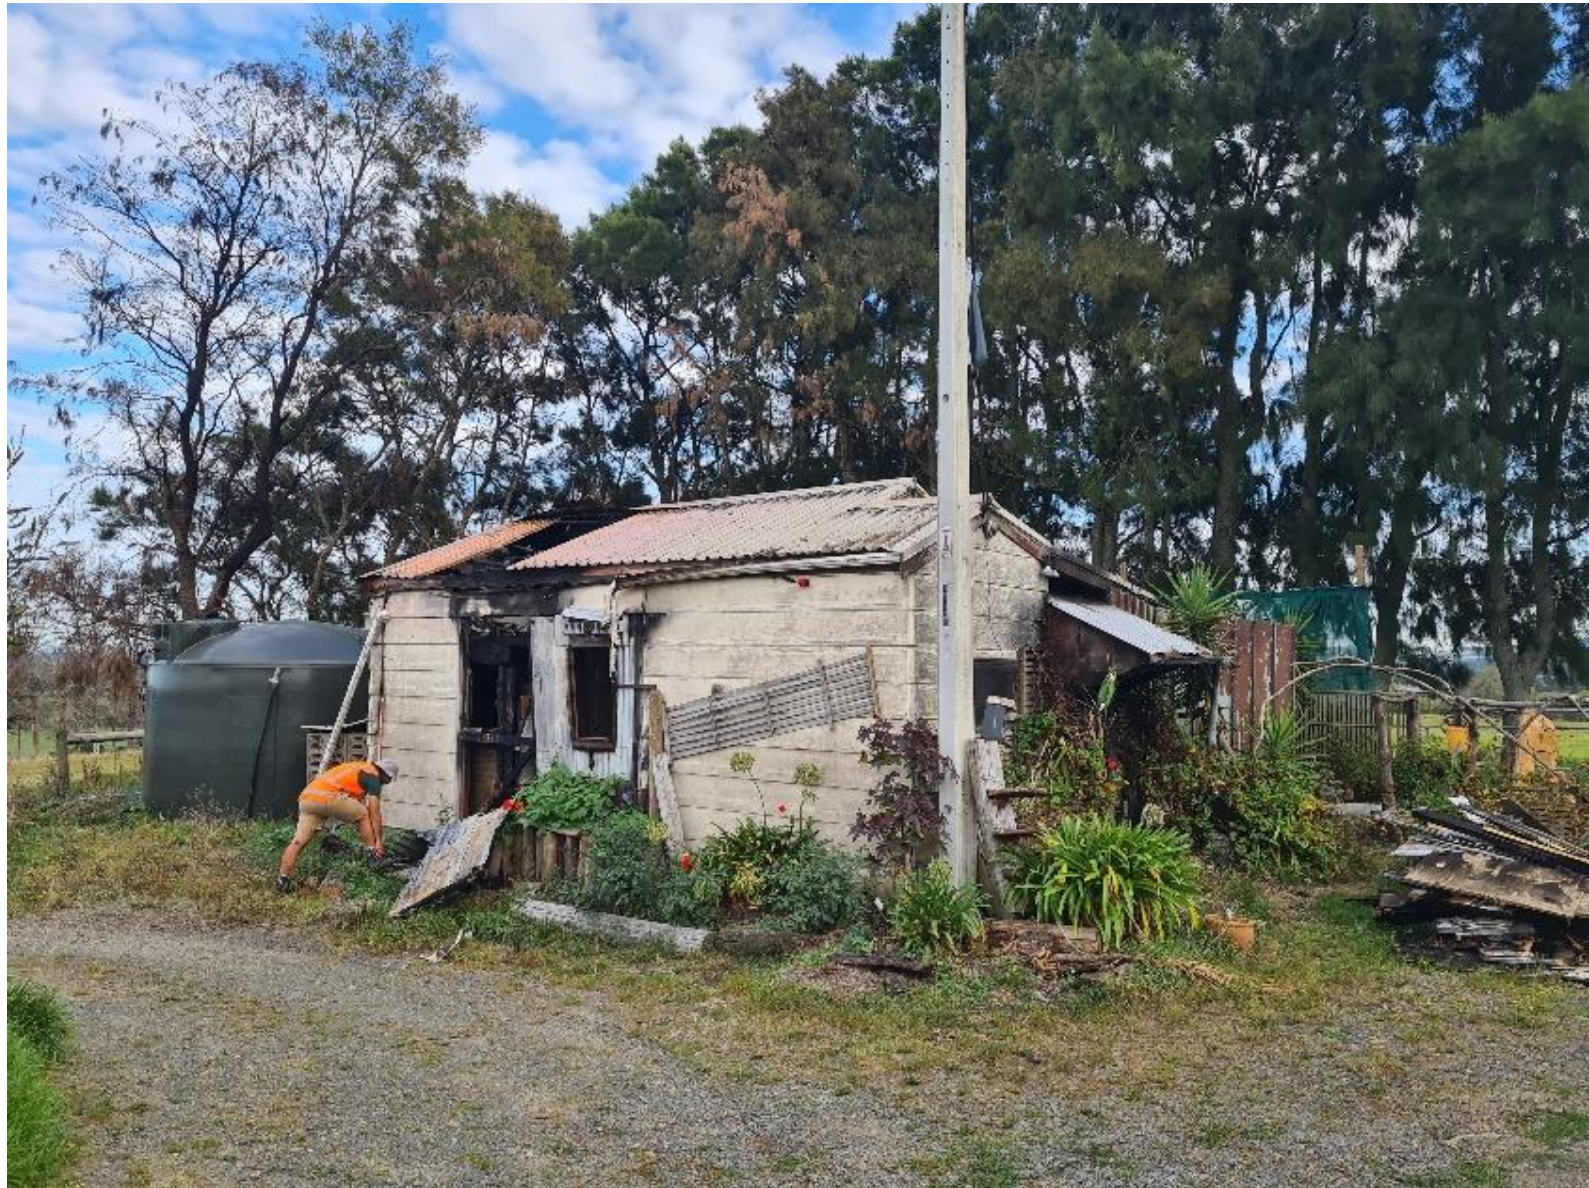
Burnt Shed

During the site inspection and walkover, visual evidence of PACM was observed intermixed with the site soils at what is now 85 Hamlin Road, and a structure was observed with extensive fire damage at the site. The soils in the areas of potential refuse burning identified as part of the PSI were inspected, however no evidence of burning was identified.

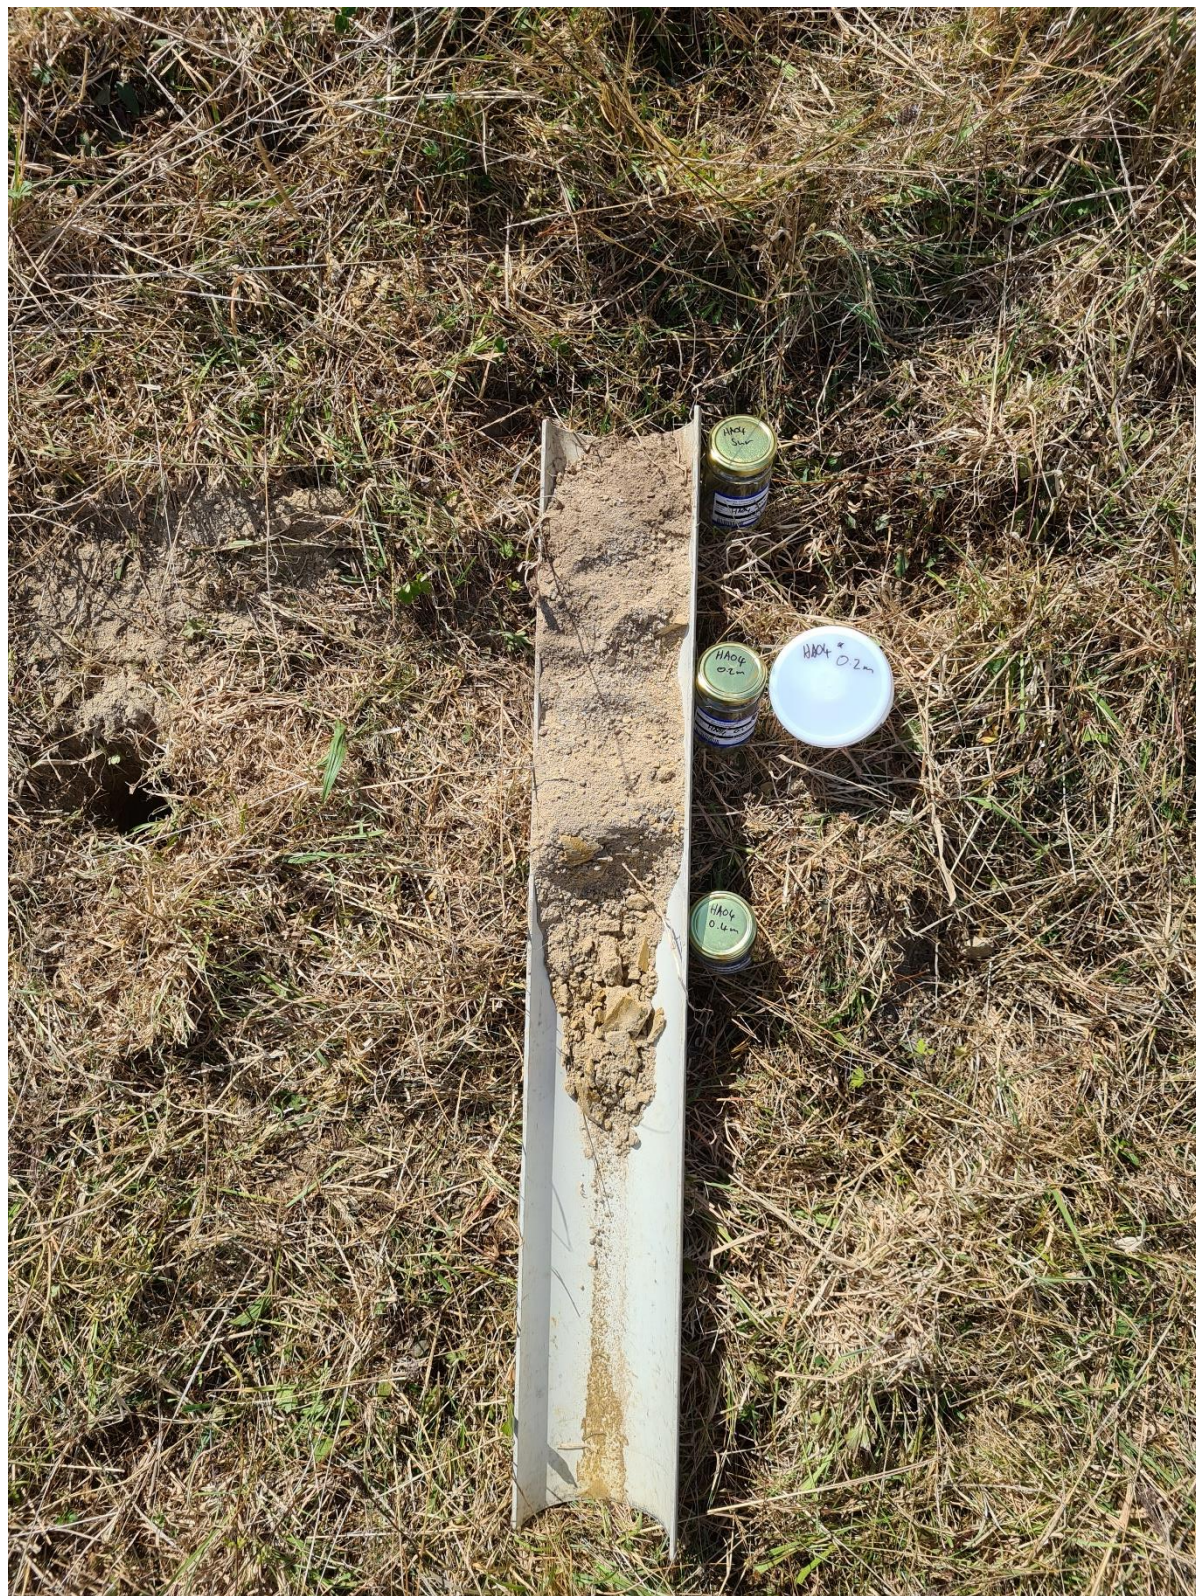
Sample Name:	HA04 0.2m 25-Mar-2021
Lab Number:	2570280.11
Asbestos Presence / Absence	Asbestos NOT detected.
Description of Asbestos Form	-
Asbestos in ACM as % of Total Sample*	% w/w < 0.001
Combined Fibrous Asbestos + Asbestos Fines as % of Total Sample*	% w/w < 0.001
Asbestos as Fibrous Asbestos as % of Total Sample*	% w/w < 0.001
Asbestos as Asbestos Fines as % of Total Sample*	% w/w < 0.001
As Received Weight	g 753.7
Dry Weight	g 676.9
Moisture	% 10
Sample Fraction >10mm	g dry wt < 0.1

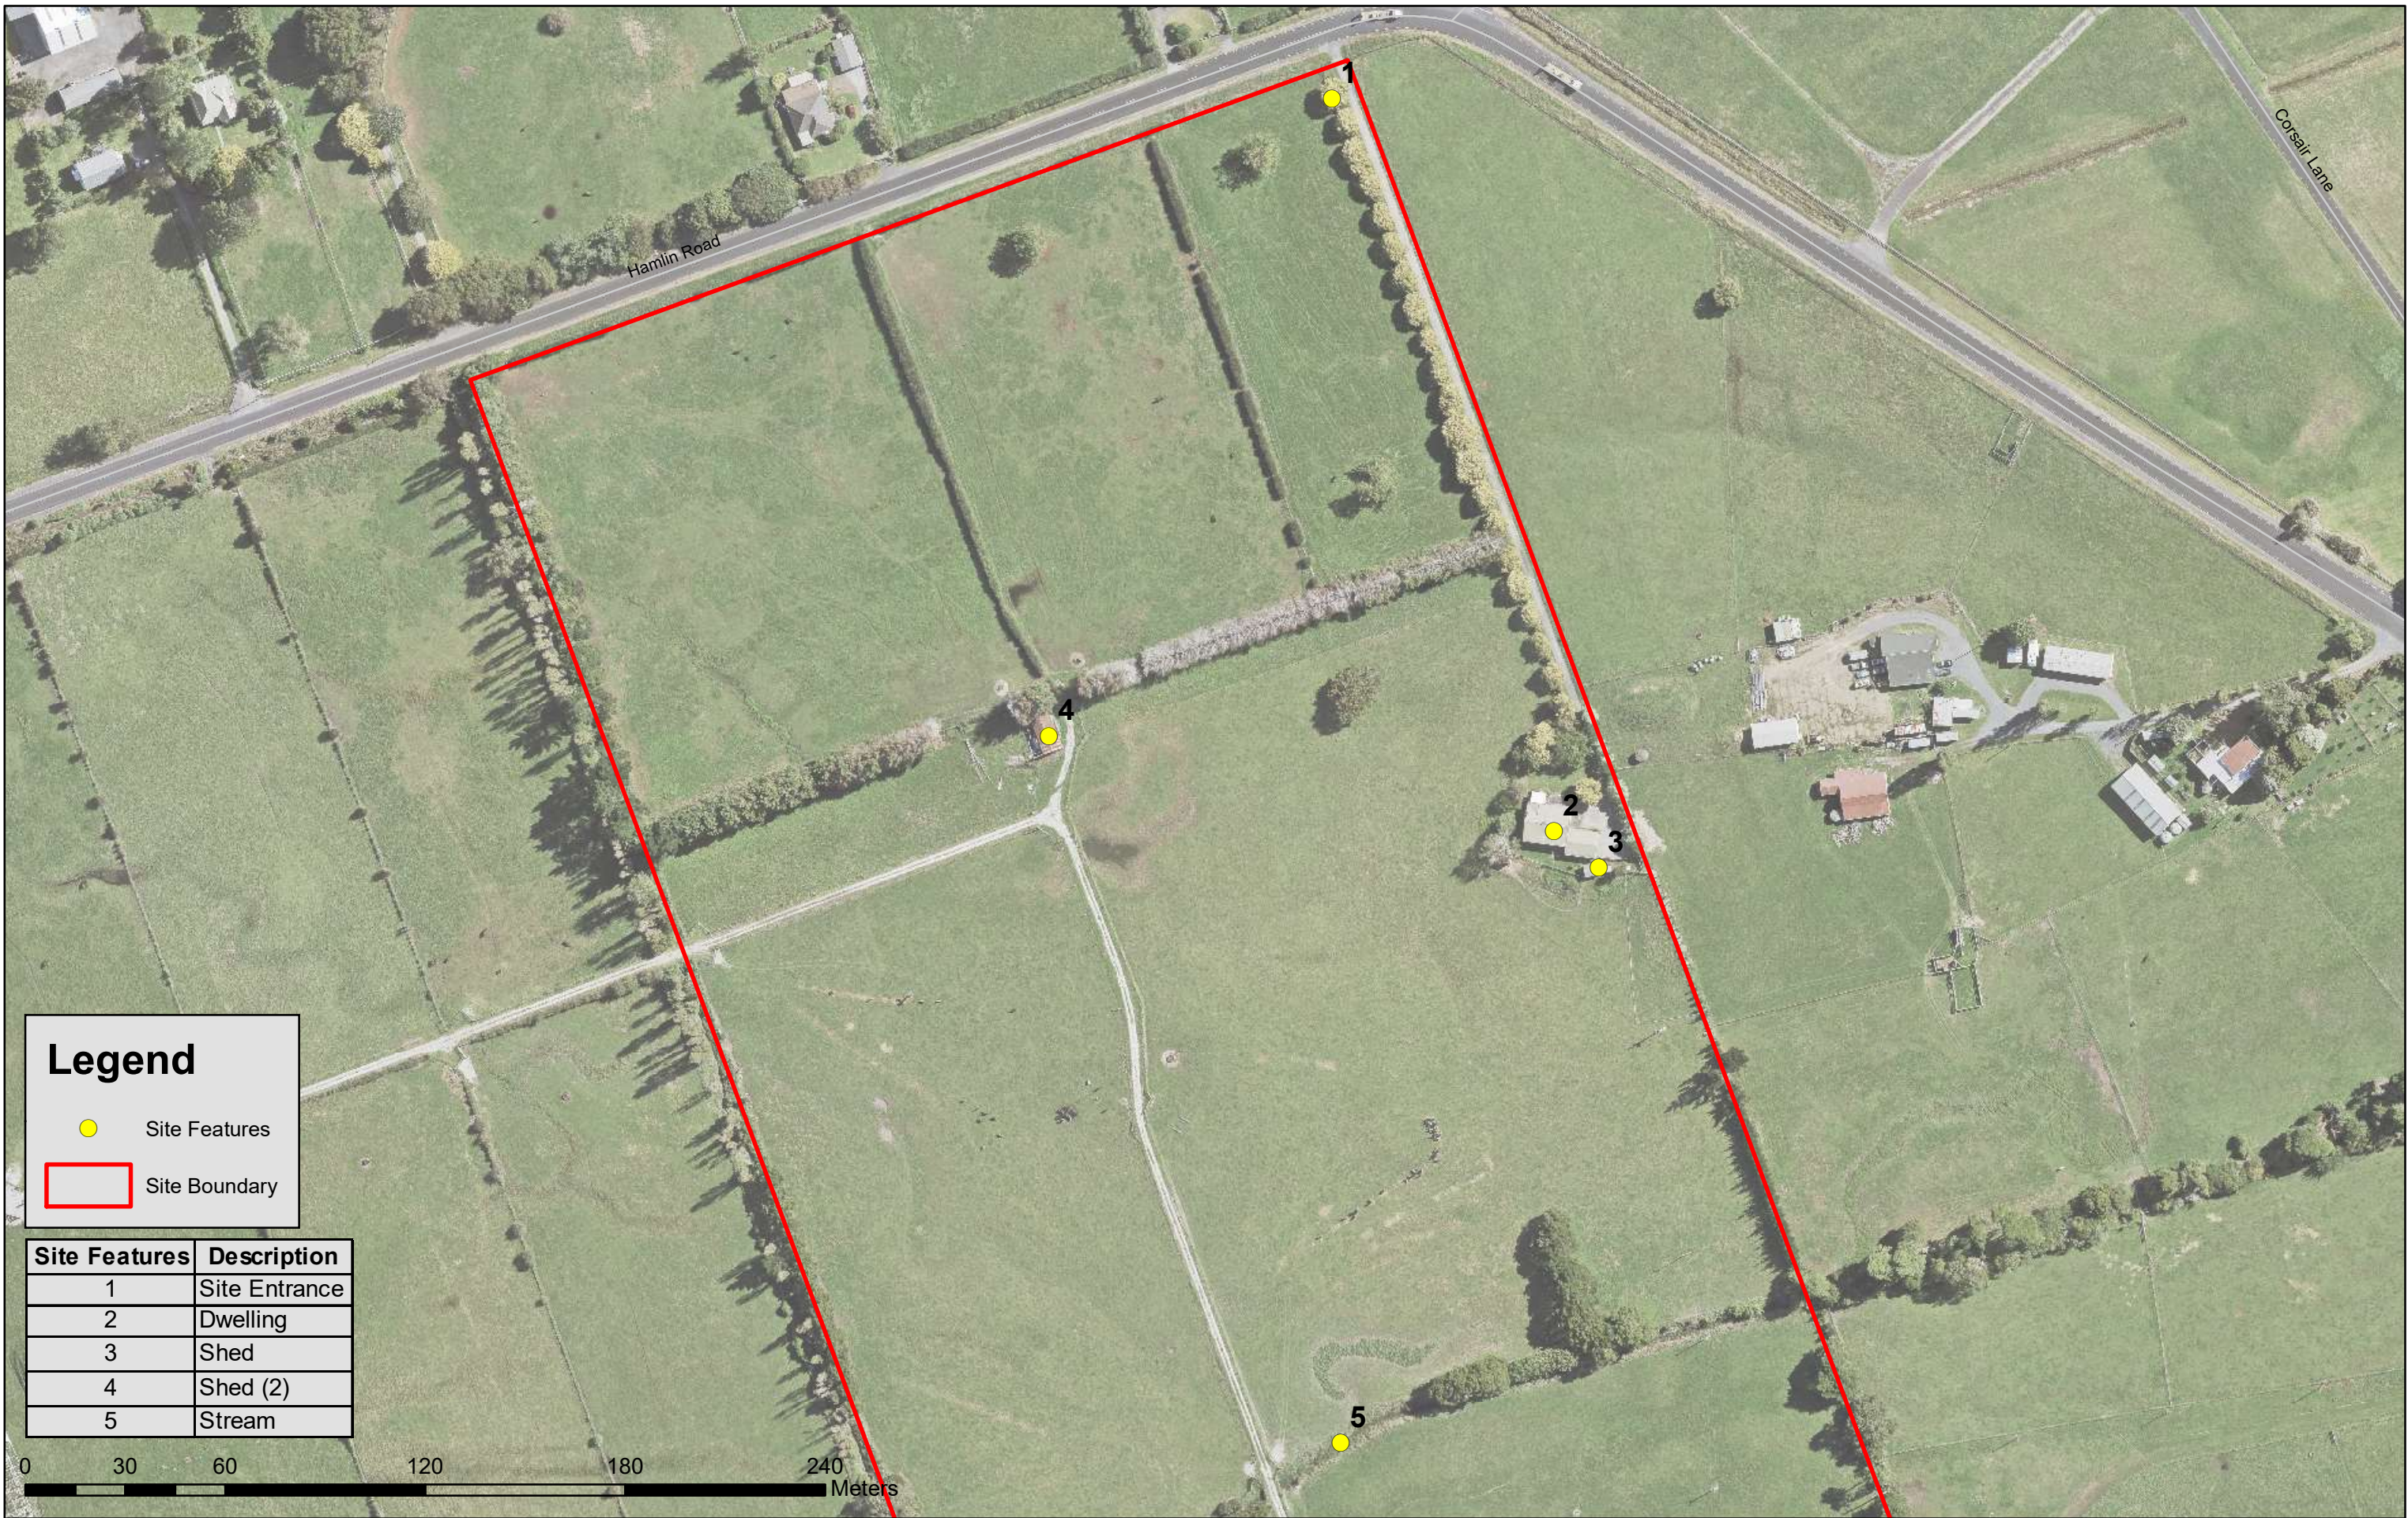
Figure 2 – Site Features Plan

Site Features	Description
1	Site Entrance
2	Dwelling
3	Shed
4	Shed (2)
5	Stream

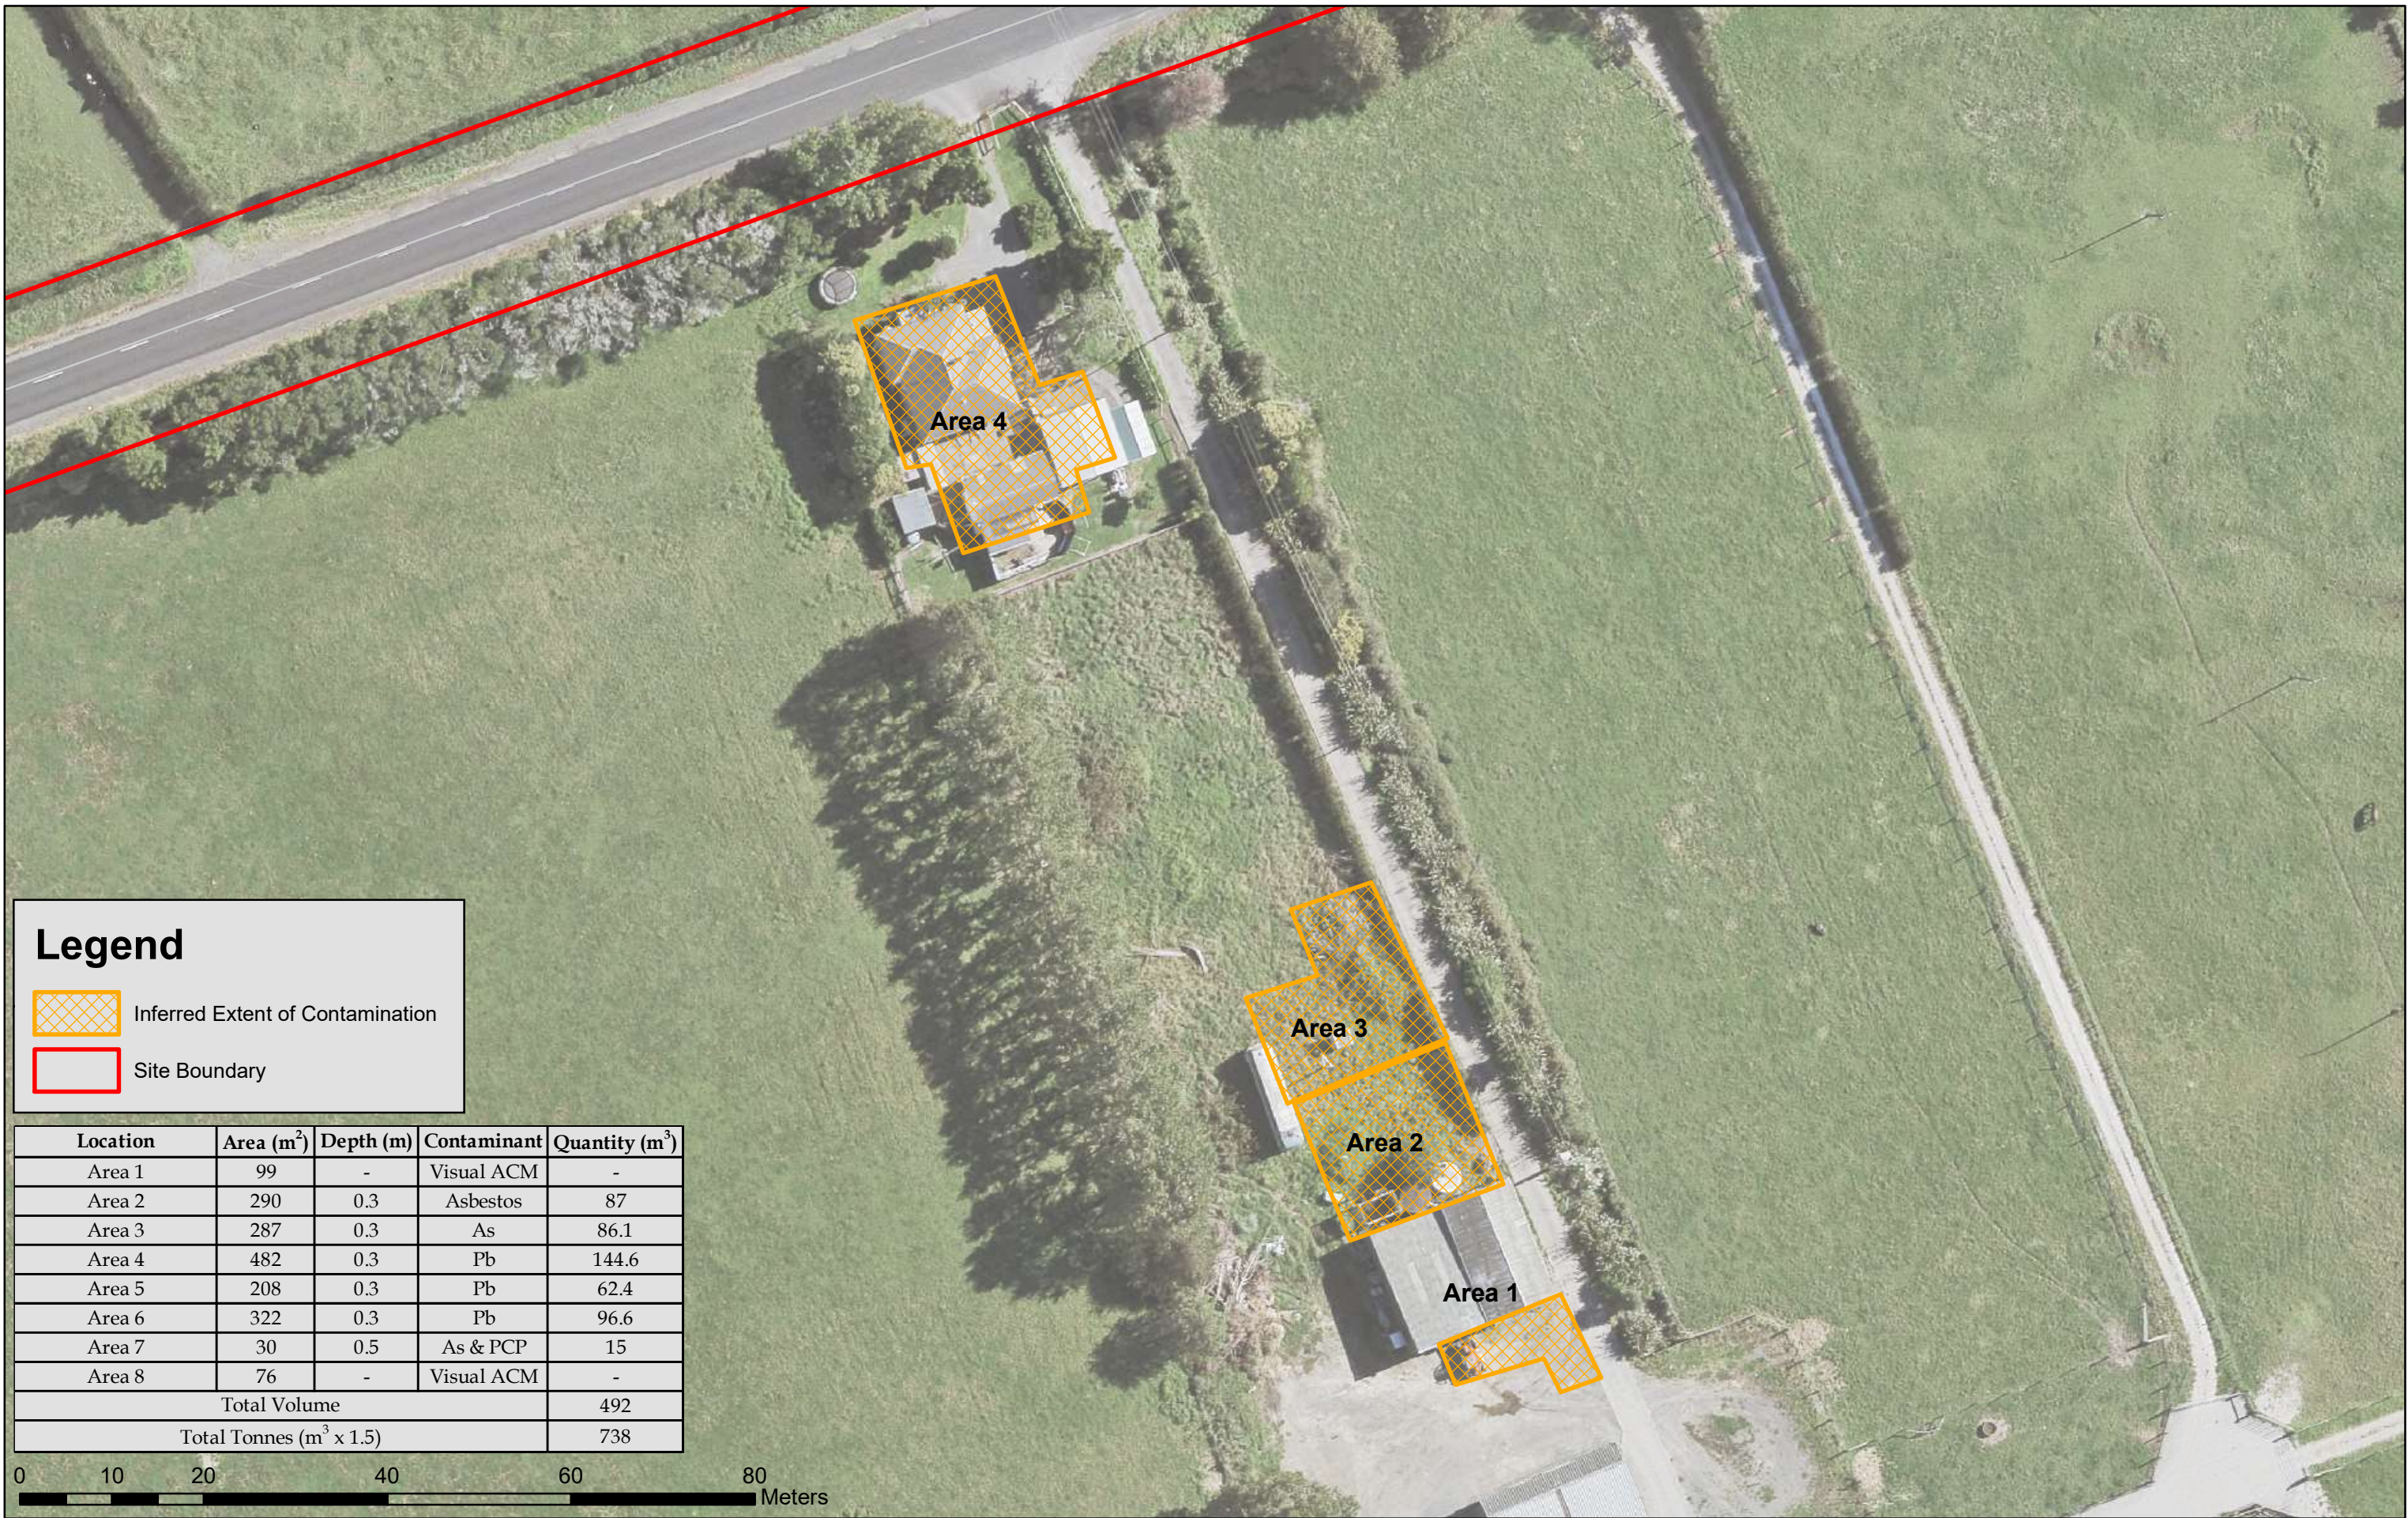
Drawing Number: 1443.009.04
Drawn By: MT
Checked By: DO'R
Date: 20/12/2023

Location	Area (m ²)	Depth (m)	Contaminant	Quantity (m ³)
Area 1	99	-	Visual ACM	-
Area 2	290	0.3	Asbestos	87
Area 3	287	0.3	As	86.1
Area 4	482	0.3	Pb	144.6
Area 5	208	0.3	Pb	62.4
Area 6	322	0.3	Pb	96.6
Area 7	30	0.5	As & PCP	15
Area 8	76	-	Visual ACM	-
Total Volume				492
Total Tonnes (m ³ x 1.5)				738
