17.0 Revised Conceptual Model of Exposure Pathways

Table 17: Revised Conceptual Site Model: 508 Old Wairoa Road, Ardmore.

***DETAILED SITE INVESTIGATION,
REMEDIAL ACTION PLAN
&
ASSESSMENT OF ENVIRONMENTAL EFFECTS
80 HAMLIN ROAD,
ARDMORE
AUCKLAND***

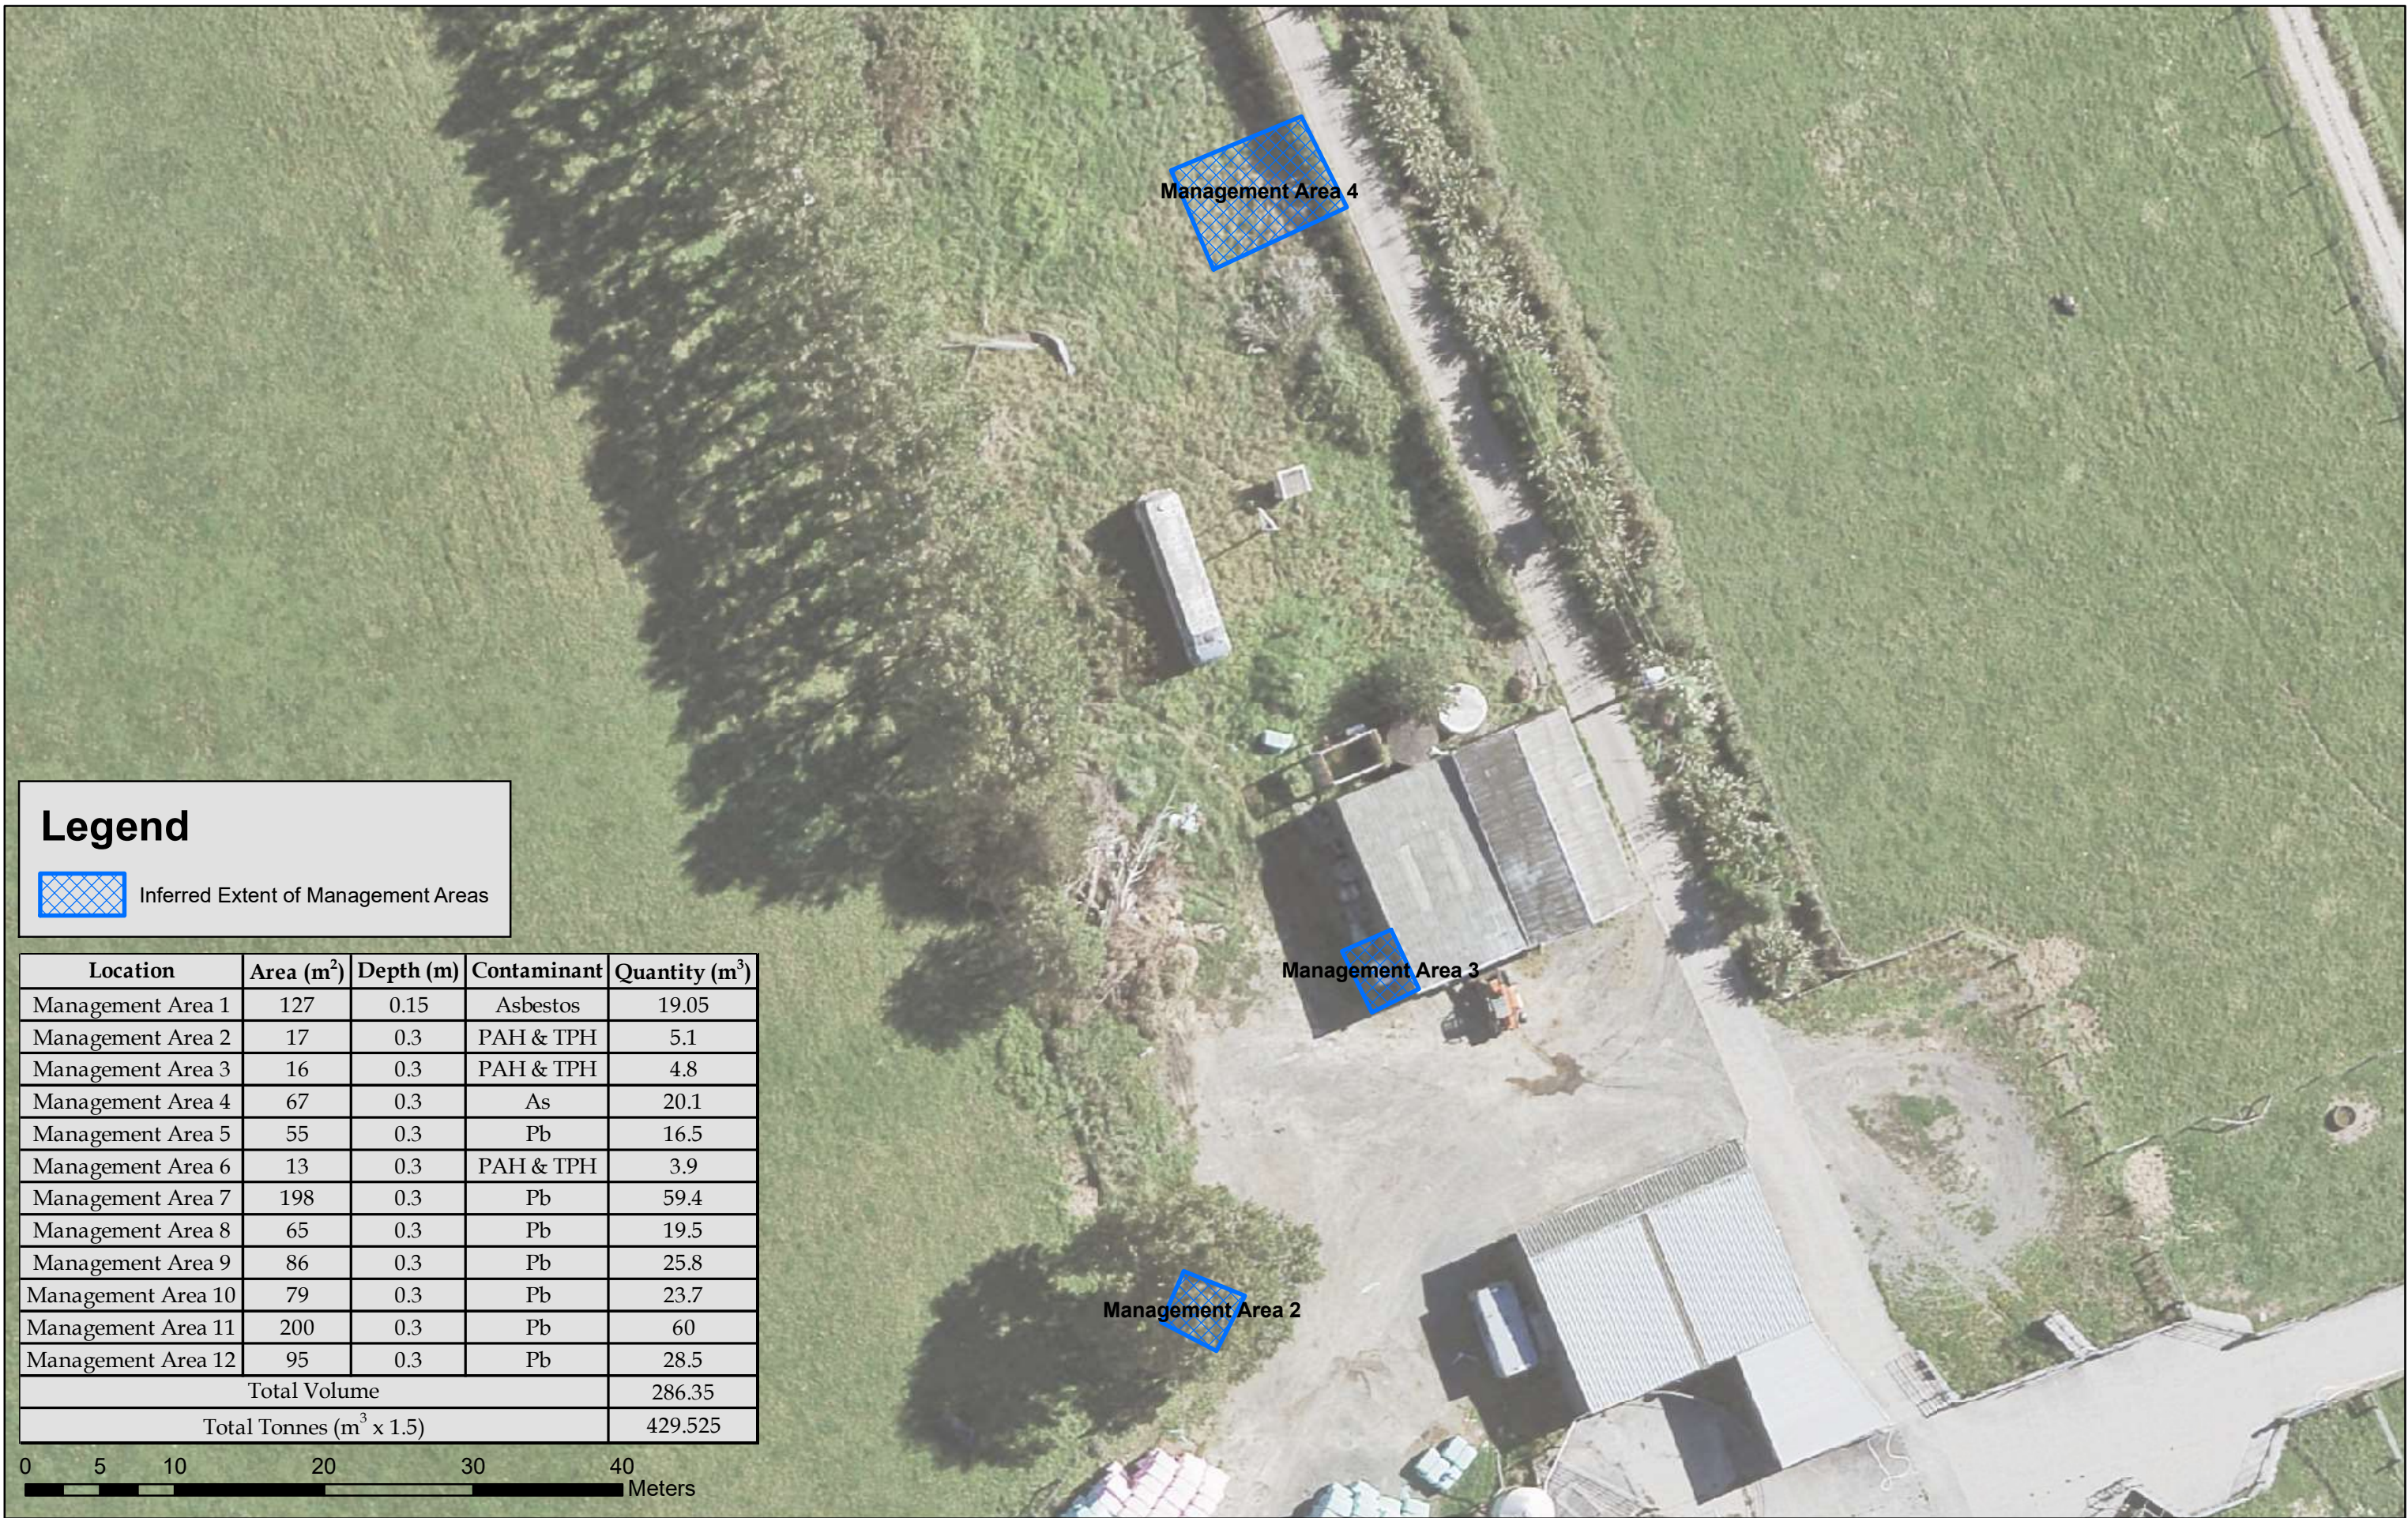
Drawing Number: 1443.009.05-1
Drawn By: MT
Checked By: DO'R
Date: 20/12/2023

Location	Area (m ²)	Depth (m)	Contaminant	Quantity (m ³)
Management Area 1	127	0.15	Asbestos	19.05
Management Area 2	17	0.3	PAH & TPH	5.1
Management Area 3	16	0.3	PAH & TPH	4.8
Management Area 4	67	0.3	As	20.1
Management Area 5	55	0.3	Pb	16.5
Management Area 6	13	0.3	PAH & TPH	3.9
Management Area 7	198	0.3	Pb	59.4
Management Area 8	65	0.3	Pb	19.5
Management Area 9	86	0.3	Pb	25.8
Management Area 10	79	0.3	Pb	23.7
Management Area 11	200	0.3	Pb	60
Management Area 12	95	0.3	Pb	28.5
Total Volume				286.35
Total Tonnes (m ³ x 1.5)				429.525
