**Proposed Screen Hub (including accommodation) - Ayrburn
Contaminated Site Considerations**

A screen hub (including accommodation) facility is being proposed to be constructed on part of the property at 1 Ayr Avenue (Lot 4 DP 540788) near Arrowtown. The proposed development is located to the west of Mill Creek, as shown in Figure 1. The land is part of Ayrburn Farm which operated from the 1860's and contained a sheep dip, woolshed and yards, a farm landfill and underground and above-ground fuel storage tanks. These are activities on the Hazardous Activities and Industries List (HAIL), due to the potential to cause soil contamination. The proposed activity constitutes a change of use of the land.

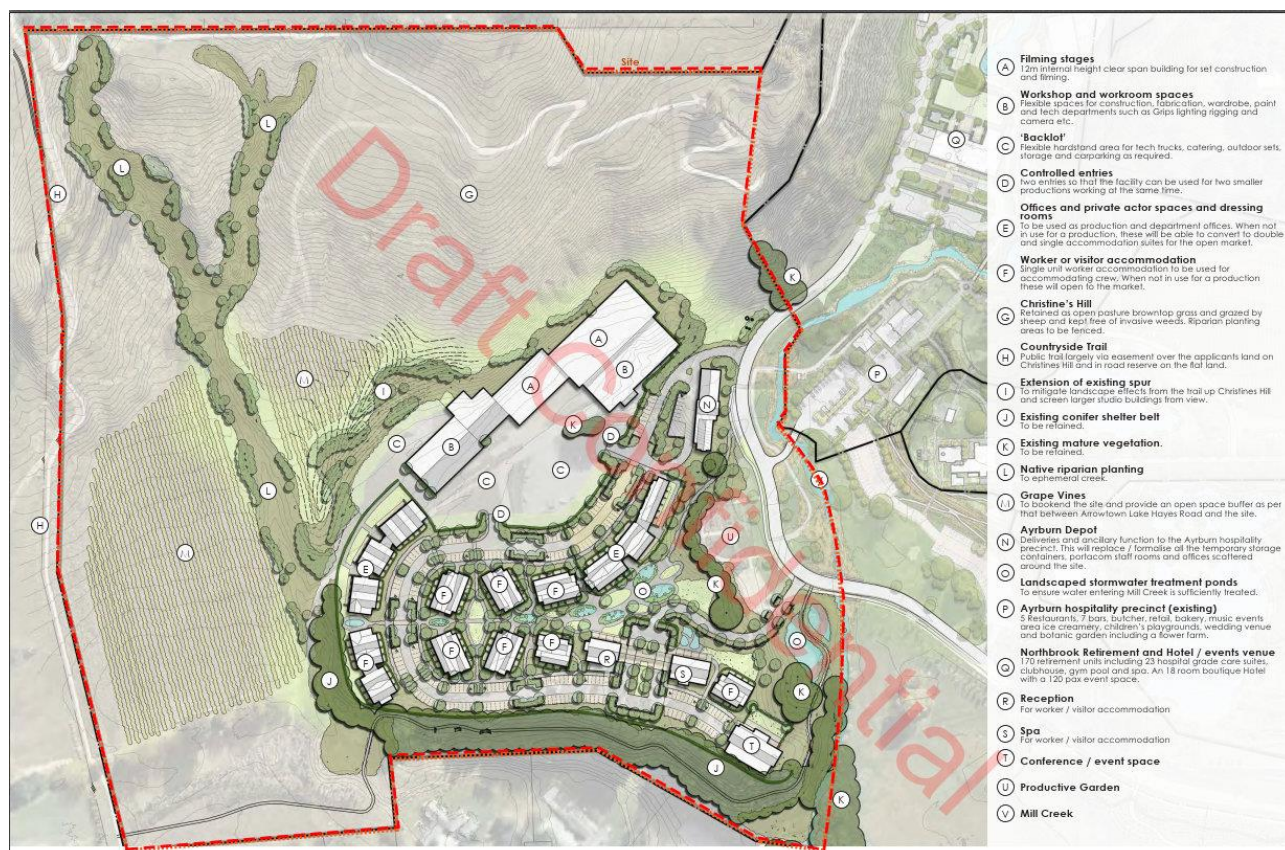
Figure 1: Site plan for the proposed screen hub facility outlined in red.

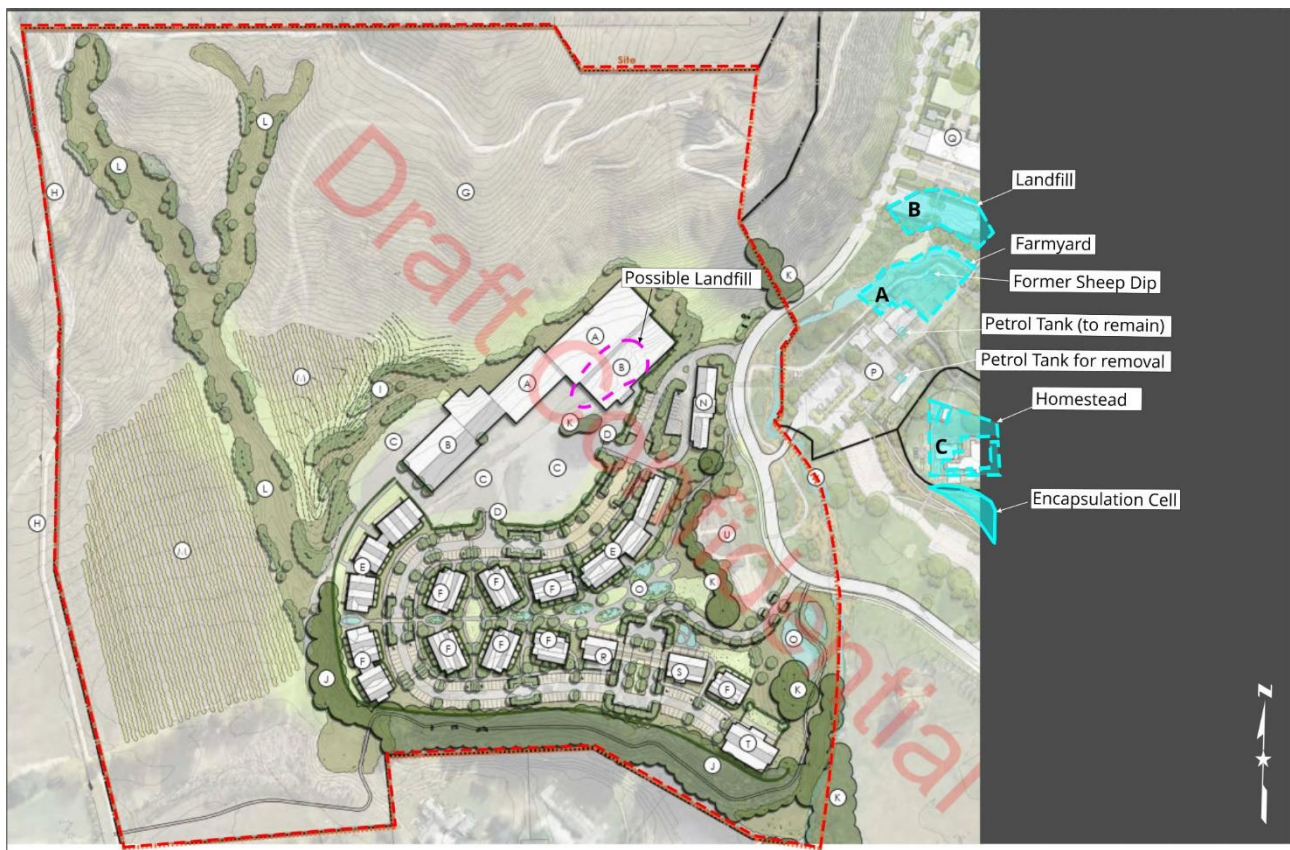
Figure 2: Site layout showing the locations of the contaminated sites (A, B and C) and the Encapsulation Cell in turquoise, and the area originally considered a possible landfill outlined in pink. The site is outlined in red.

Remedial earthworks have subsequently been undertaken under consents RM181597 and RM18.426.01-03, with contaminated soils removed from the sites being placed into a purpose designed encapsulation cell to isolate contaminants and prevent remobilisation. The location and extent of the three sites and the Encapsulation Cell is shown in Figure 2 in turquoise. These areas are all located outside of the proposed development area.

Based on the findings of the PSI and DSI, and the subsequent remedial works, only the areas shown in Figure 2 should be considered HAIL sites. Following the remedial works, Sites B and C are fully remediated and Site A is capped and contained. Site A and the Encapsulation Cell have long-term management plans in place. The contaminated soil is contained and not anticipated to affect the proposed development which is located to the west of these areas, separated by a creek and road infrastructure and with buildings located at a higher elevation. A flood assessment previously undertaken found flooding associated with 20- and 100-year average recurrence interval flood flows affected land to the east of Mill Creek not the west, indicating that in the unlikely event containment is breached the contamination is unlikely to affect the facility buildings.

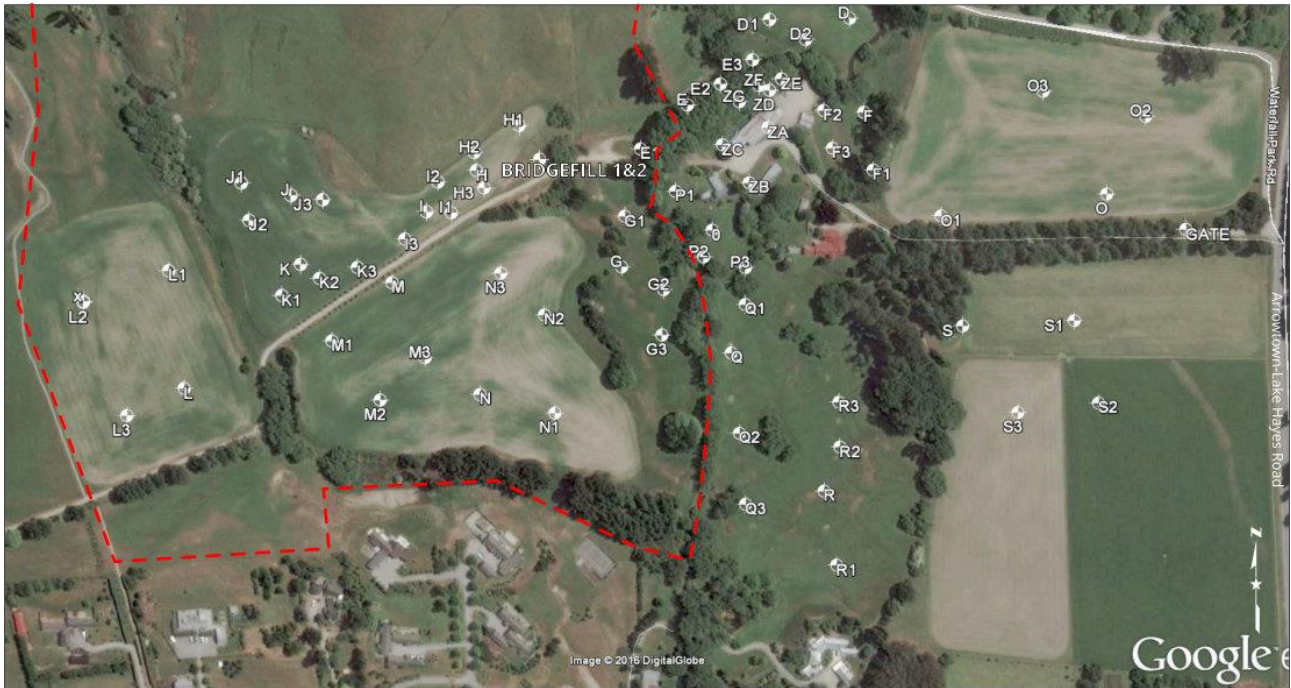
Figure 3: Sampling locations from the PSI undertaken in 2016, with the site outlined in red.

The PSI found that across the greater part of the property contaminants were present at concentrations that are likely to be the natural background levels. The sampling locations that encompassed the area proposed to be developed as the screen hub are shown in Figure 3 and the results are summarised in Table 1. Samples were collected in groups of 4, with one sample analysed as an individual and three analysed as a composite to increase the sampling density while controlling analysis costs. The individual results are consistent with the composites.
