Tekapo Power Scheme re-consenting: Lakeshore geomorphology and processes Existing environment and future effects

Genesis Energy Limited

November 2022

Shore Processes and Management Ltd

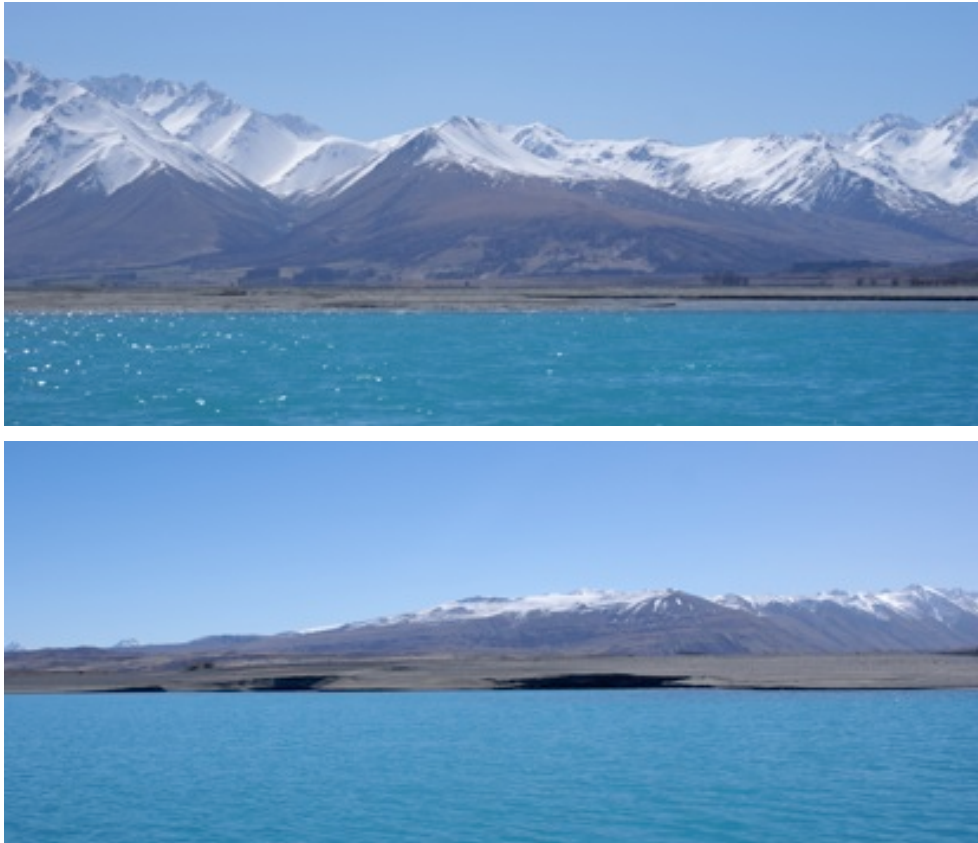
Figure 2.5 Fluvial deposits of the Godley and Cass Rivers.

- Fluvial deposits at the main river mouths, forming large fans or deltas (Figure 2.5),
- Moraine deposits, comprised of a mixture of sediment sizes from fine loess to large boulders (Figure 2.6) eroding in some areas and stable in some areas,
- Hillslope deposits, comprised of reworked colluvium, sands, gravels and small boulders (Figure 2.7) – mainly eroding,
- Linear barrier beaches of gravel formed by alongshore transport of sediments infilling embayments along the shore (Figure 2.8),
- Pocket beaches of coarse sand to gravel sized sediment (Figure 2.9), and
- Hard rock shores where overlying sediments have been removed to expose the underlying basement rock (Figure 2.10).

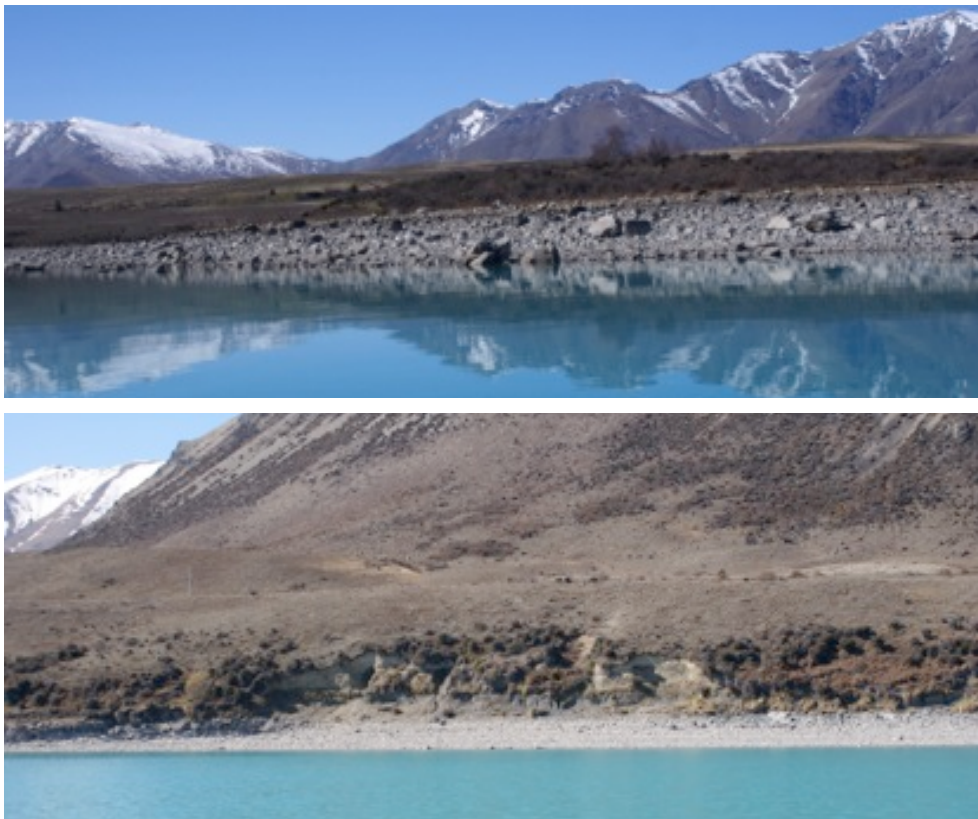
Figure 2.6 Examples of eroding moraine and glacial edge deposits.

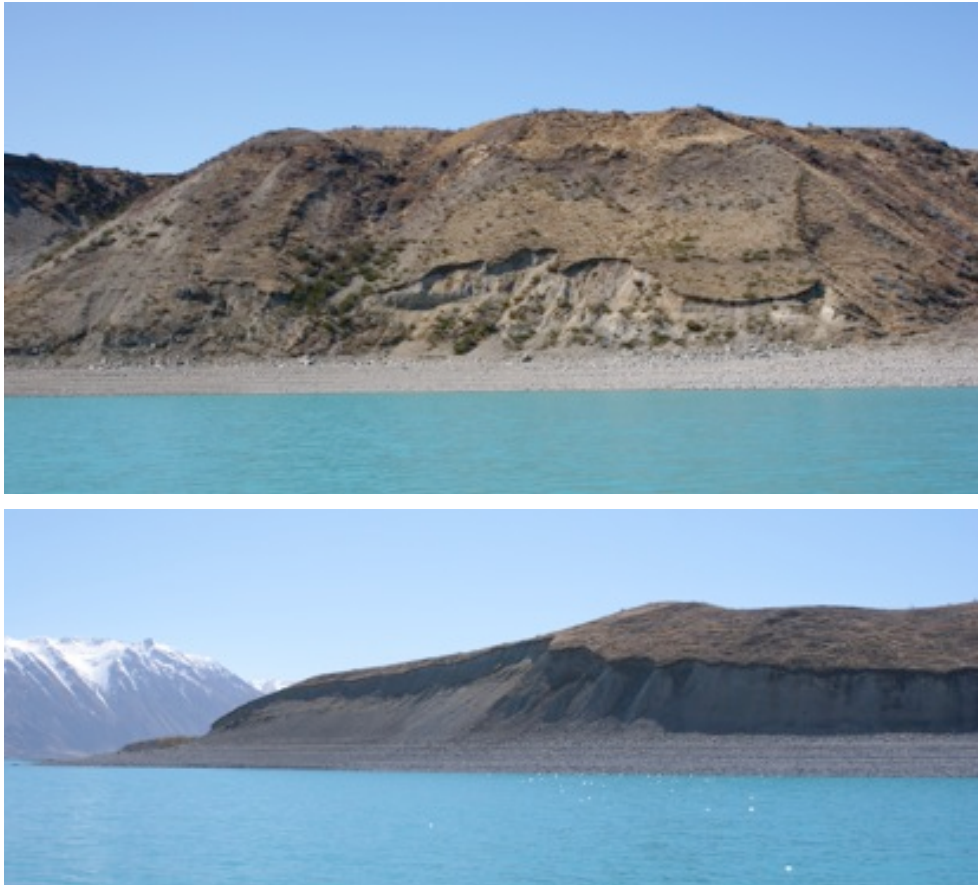
Figure 2.7 Examples of eroding hillslope deposits on the eastern shore.

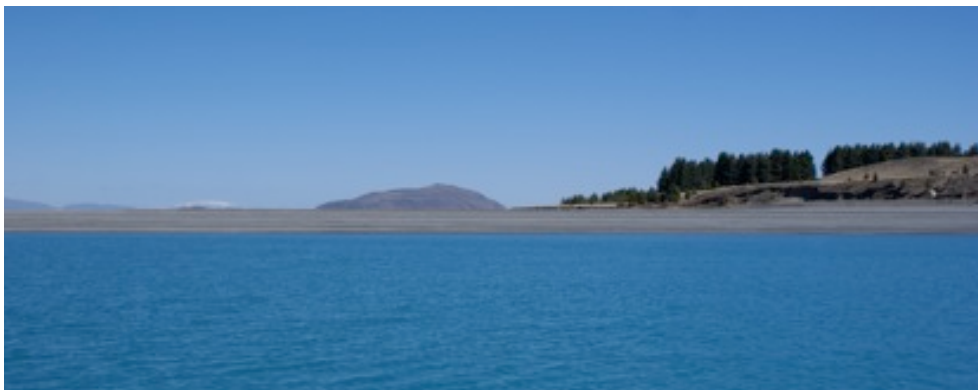
Figure 2.8 Linear gravel beach showing beach ridges, located on the western shore.

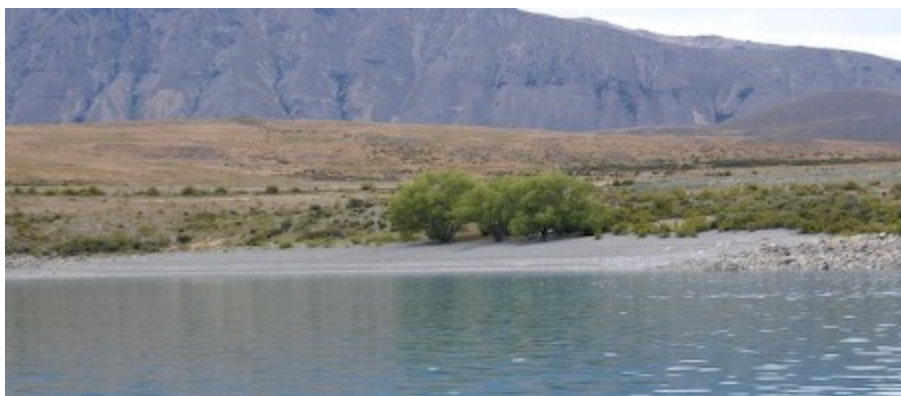
Figure 2.9 Pocket beach on eastern shore with a northerly aspect.

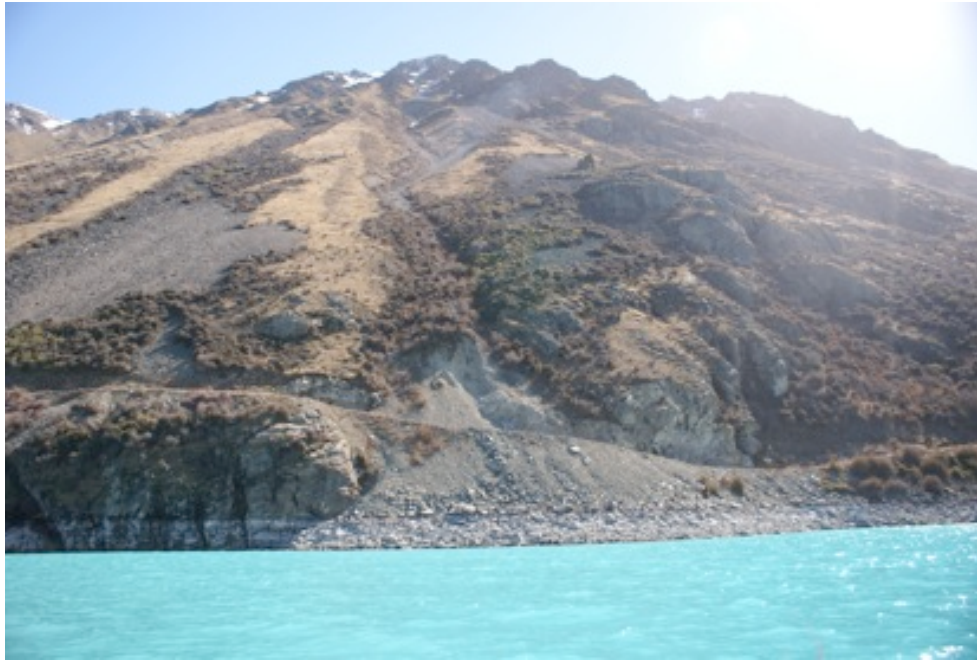
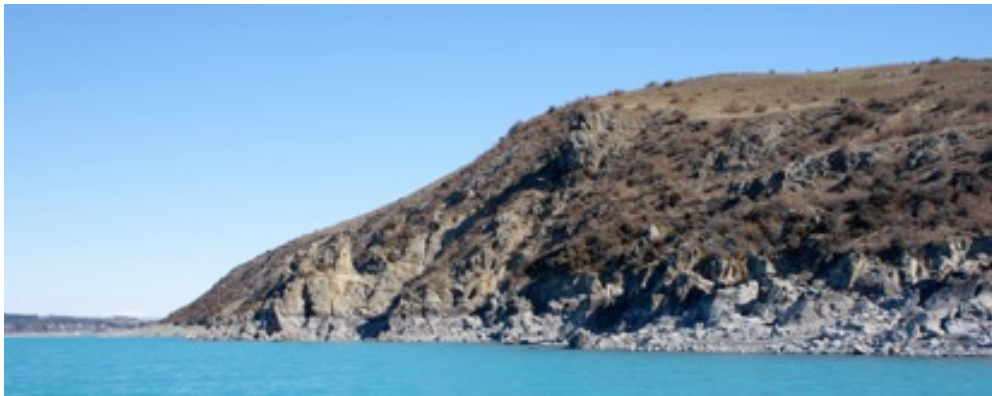
Figure 2.10 Examples of sections of hard rock shores. A) Northern section of Godley Peaks Road. B) Northern section of base of Mt John.

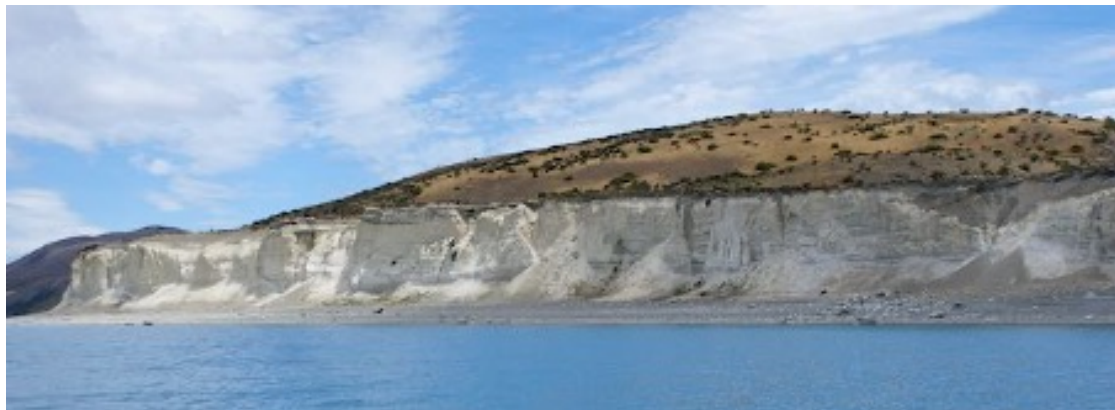
Figure 3.1 Eroding moraine / glacial deposit cliff north of Mt John

Figures 2.3 to 2.10 show how the base geomorphology and overall character of the shore reflects this developing geomorphology. Figures 3.1 and 3.2 show examples where historical shore retreat and areas of construction of linear beaches are evident in the form of the beach and backshore.

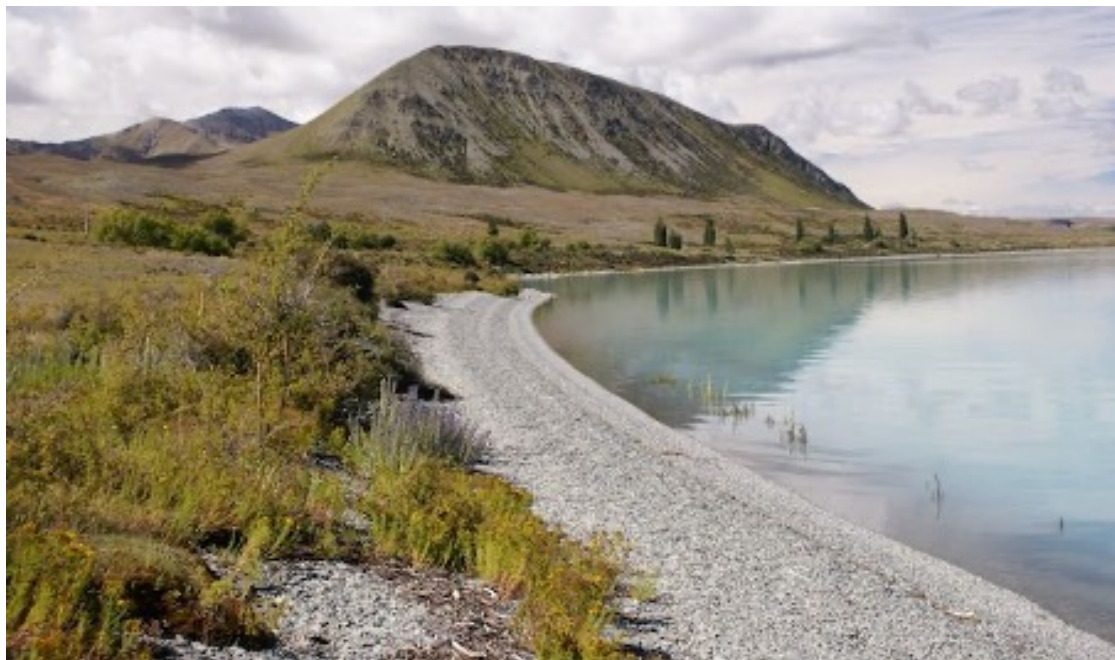
Figure 3.2 Linear beach along the eastern shore

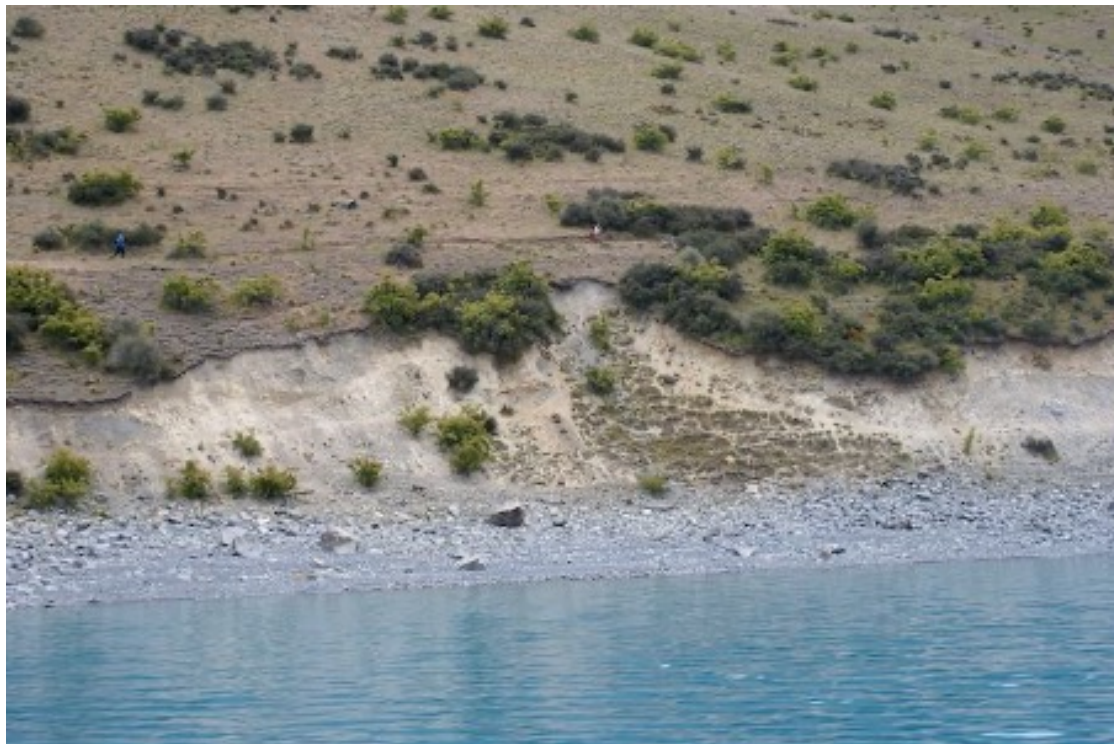
Figure 3.3 Eroded scarp below the northern Mt John walking track (location is the upper part of Figure 3.5)

As shown in Figure 3.3, vegetation at the base and on the face of some cliff and scarped areas is indicative of recent periods of stability to the shore. However, there are also fresh erosion scars that indicate localised processes that could be a result of the effects of waves, currents, terrestrial hill-slope instability brought on by groundwater through-flows, animal movement on the face, earthquakes or gravity induced slumping, or a combination of these processes.

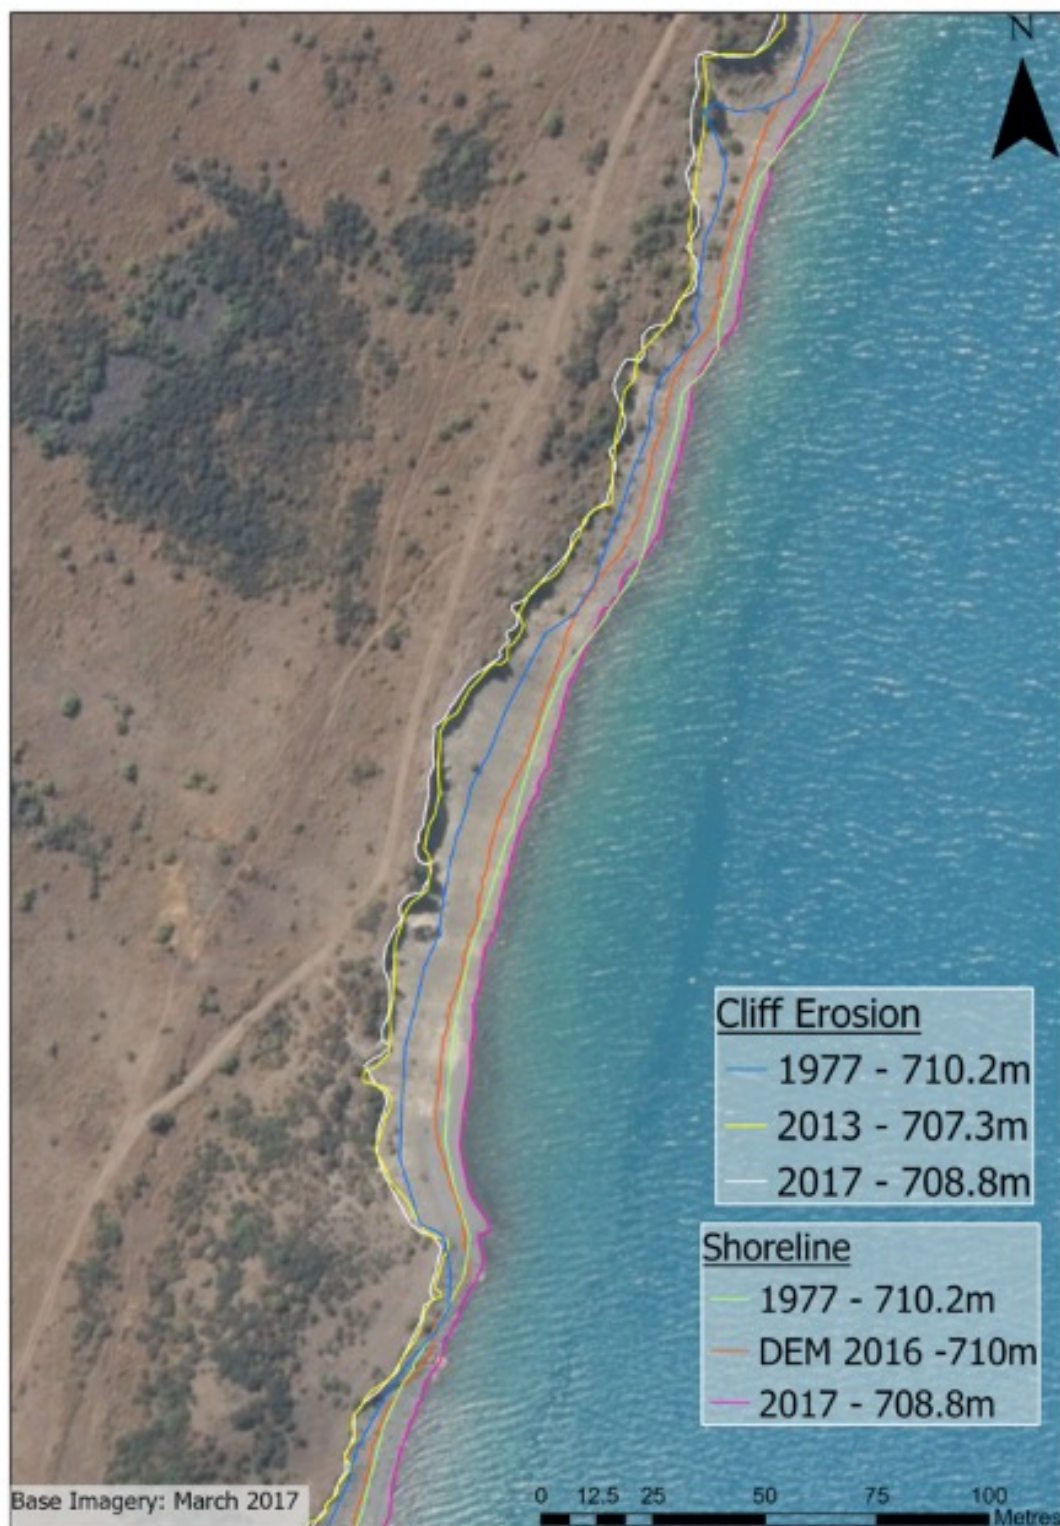
Figure 3.5 Changes in scarp top and shoreline position adjacent to the northern Mt John walkway

Figures 3.4 and 3.5 show changes in the position of the top of the eroded scarp adjacent to two sections of the northern Mt John walking track. Major retreat of the scarp top occurred over time between 1977 and 2006. Available aerial photographs do not provide adequate information to pinpoint a specific event or series of erosion episodes. The base of the cliff is within the effect of potential wave action during the high lake levels of 1984 and 1996 and may have become unsupported due to erosion of the backshore at either or both of those

Figures 3.4 and 3.5 show examples of the cliff slope development. Subaerial, or top down erosion is prevalent in erosion of the cliff shown in Figure 3.4, while the steeper slope in Figure 3.5 shows evidence of a combination of subaerial causes and lacustrine processes resulting in the slope development and landward movement of the shoreline. These sections of shore are within a 500 m stretch of the shore (near site number 29 on Figure 5.2) and are typical of the variability of the backshore slope development around the lake due to the complex composition of moraine and hillslope deposits in which the shore has formed.

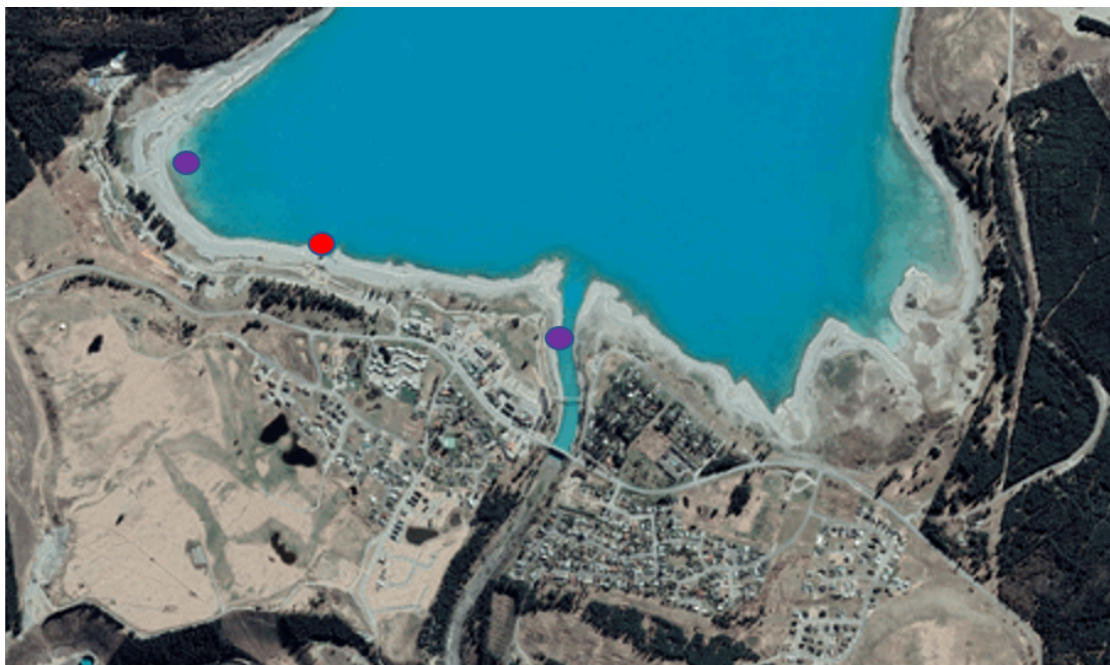
Figure 4.1 Southern shore of Lake Tekapo, showing locations of the boat ramps (purple markers) and the Tekapo HS intake (red marker) (image from GoogleEarth, dated 20 September 2019)

Intensive shoreline resource use is concentrated along the southern shore as shown in Figure 4.1. There are two paved boat ramps. One located near the camping ground and hot pools at the western side of the embayment (Figure 4.2), and one located on the right flank of the outlet channel. A walkway extends along most of the shoreline in front of the village but is well above the maximum lake level. A picnic area is located on the eastern side of the embayment. This area is low-lying relative to the water level operating range and is subject to inundation at high levels. All of the buildings and roads along the southern shore are above the maximum operating level. Any increase in use of the foreshore (for example for recreational purposes) and the lakeshore hinterland within the operating easement will require consideration of the operational water level range and potential ongoing development of the shore geomorphology.

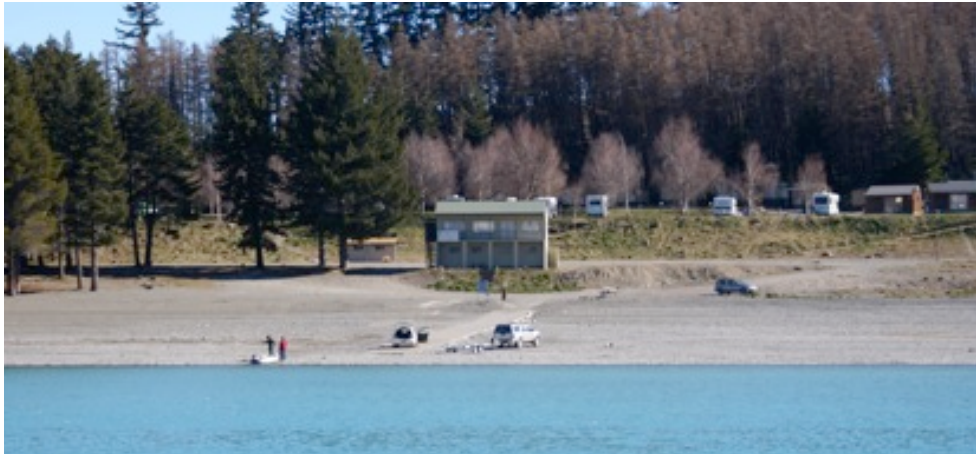
Figure 4.2 Boat ramp and western end of the southern shore, showing the main recreational beach

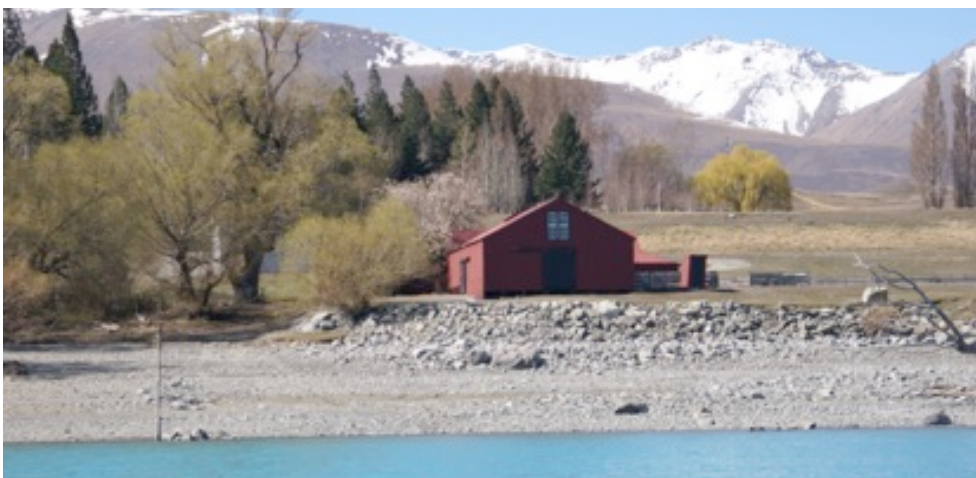
Figure 4.3 The shore in the vicinity of Richmond Station on the eastern shore of Lake Tekapo. A large farm building has rock apparently placed around the shore next to an old stream channel

Rock placement lakeward of farm buildings at Richmond Station indicate a possible historical lakeshore or fluvial erosion hazard. It is the one area around the lakeshore where farm

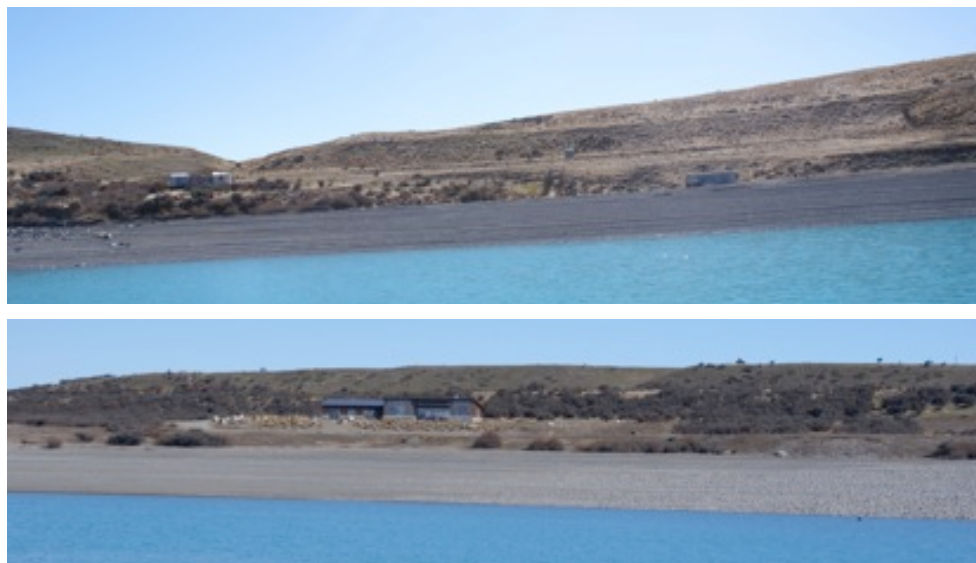
Figure 4.4 Residential buildings along the western shore of the lake near, and north of Lake McGregor

Two residential buildings (Figure 4.4) are sited on a raised beach, approximately 5 m above the highest lake level between Pierce Pond and Lake McGregor. An older, derelict farm building is located on the backshore north of the northern building.

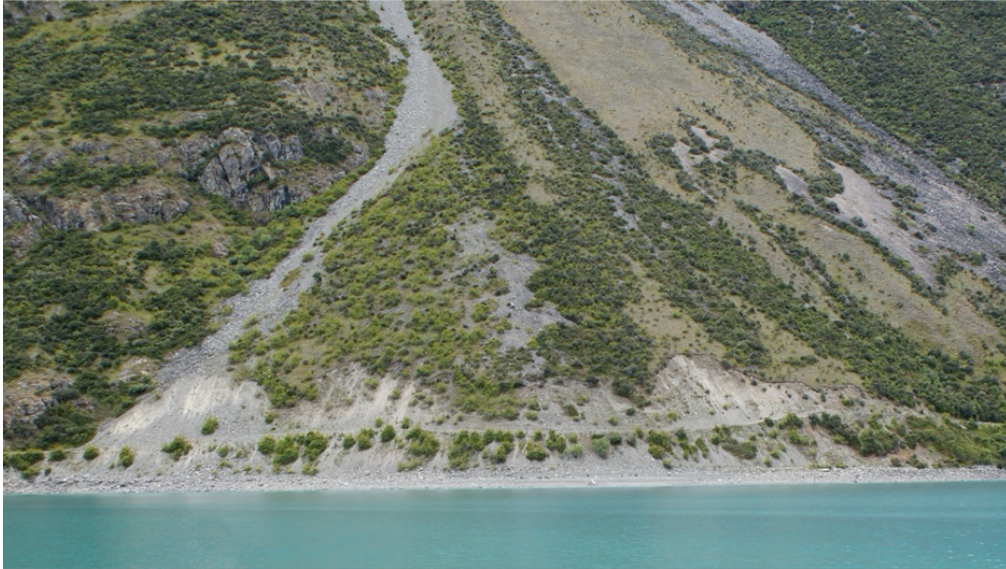
Figure 4.5 Erosion of the base of an active hillslope slip along Godley Peak Road below Mt Mistake

Erosion of the vehicle track along Mt Mistake appears to be predominantly an effect of hillslope erosion processes. However, there are short lengths of shore where wave-induced erosion has destabilised the base of talus deposits of erosion slips. An example is shown in Figure 4.5.

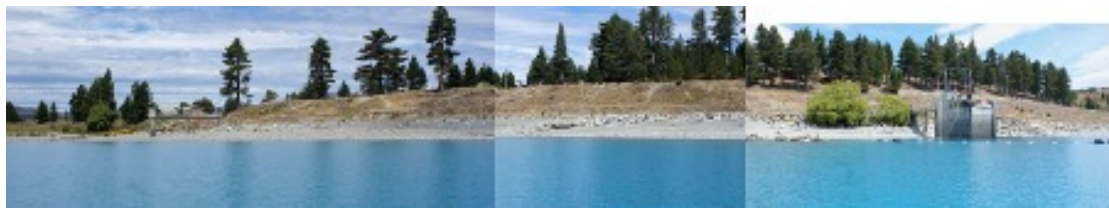
Figure 5.3 TekPS structures and shore protection along the southern shore of Lake Tekapo (lake level approximately 707 m amsl)

There are two sites where shore protection has been constructed. One site is along the southern shore adjacent to the TekPS intake structure (site number 33 on Figure 5.2). The shore protection is a rock revetment extending approximately 100 m to the west and 250 m to the east from the intake. The western part of the revetment covers the active beach to above the limit of wave run-up at the maximum operating level. The eastern part of the revetment is visible only on the upper shore but is present along the shore from the intake structure to a secondary structure to the east as shown in Figure 5.3.

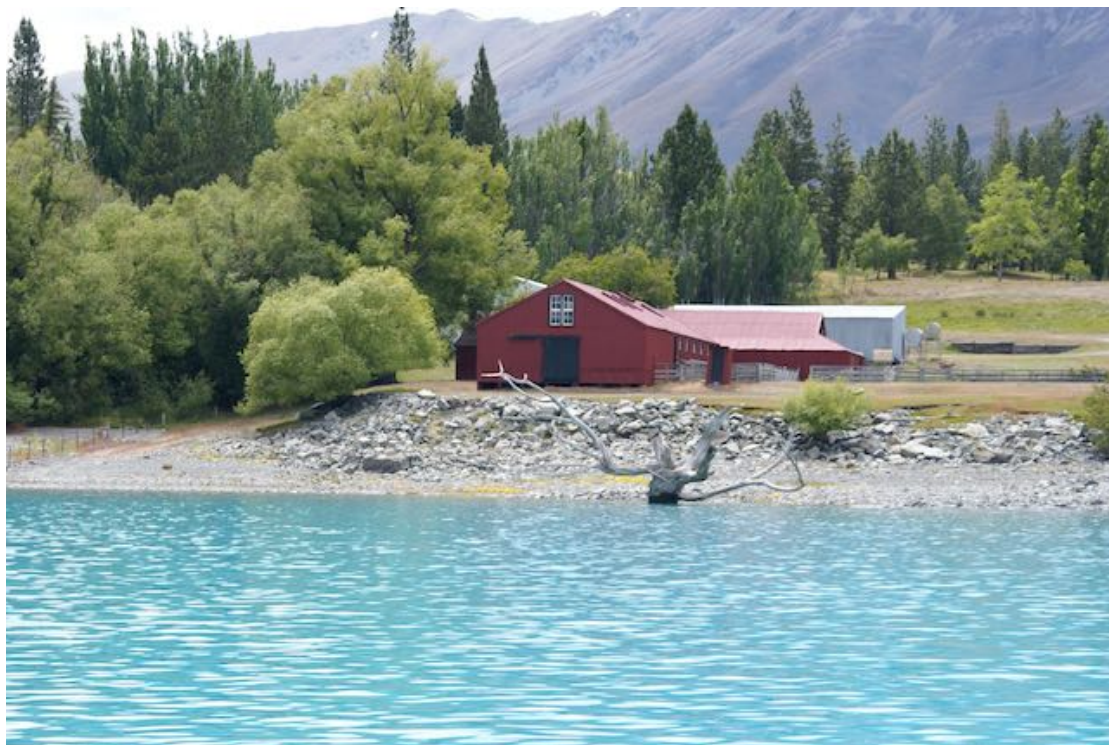
Figure 5.4 Shore protection at Richmond Station (lake level approximately 707 m amsl)

The second location of shore protection is at Richmond Station on the eastern shore of the lake (site number 15 on Figure 5.1) shown in Figure 5.4. The shore protection is a revetment of loose rock. A farm building is present in this location on an aerial photograph from 1954. Although the date of construction of the revetment is unknown, aerial photograph analysis shows erosion of the shore in this vicinity between 1986 and 2006, but no change since 2006.
