K240545-2

30 June 2025

**Geotechnical Engineering Investigation
Pound Road Industrial Development
2-94 Barters Road, 111 & 173 Pound Road,
4, 22 - 48 Hasketts Road, 570 & 578 Waterloo Road,
Islington
Canterbury**

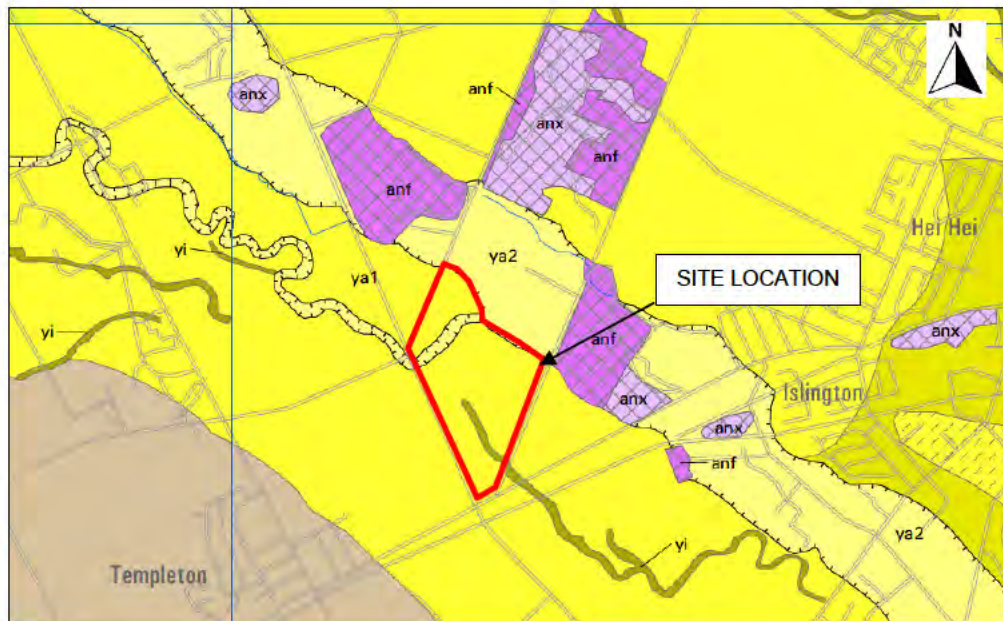
Figure 2: Geomorphological Map of Eastern Canterbury (2015)

Further to the above, we have made reference to the published Geomorphological Map of Eastern Canterbury (2015) which indicates that the site is underlain by a river plain or channel deposits, and localised incised channel deposits below the southeastern portion (see Figure 2). We also have reviewed the original and digitised versions of the mid 1800s Canterbury Black Maps as per the ECan online database. The original maps indicate that the site is underlain by plain deposits with a stream channel/paleochannel aligned northwest to southeast located along the northern boundary.

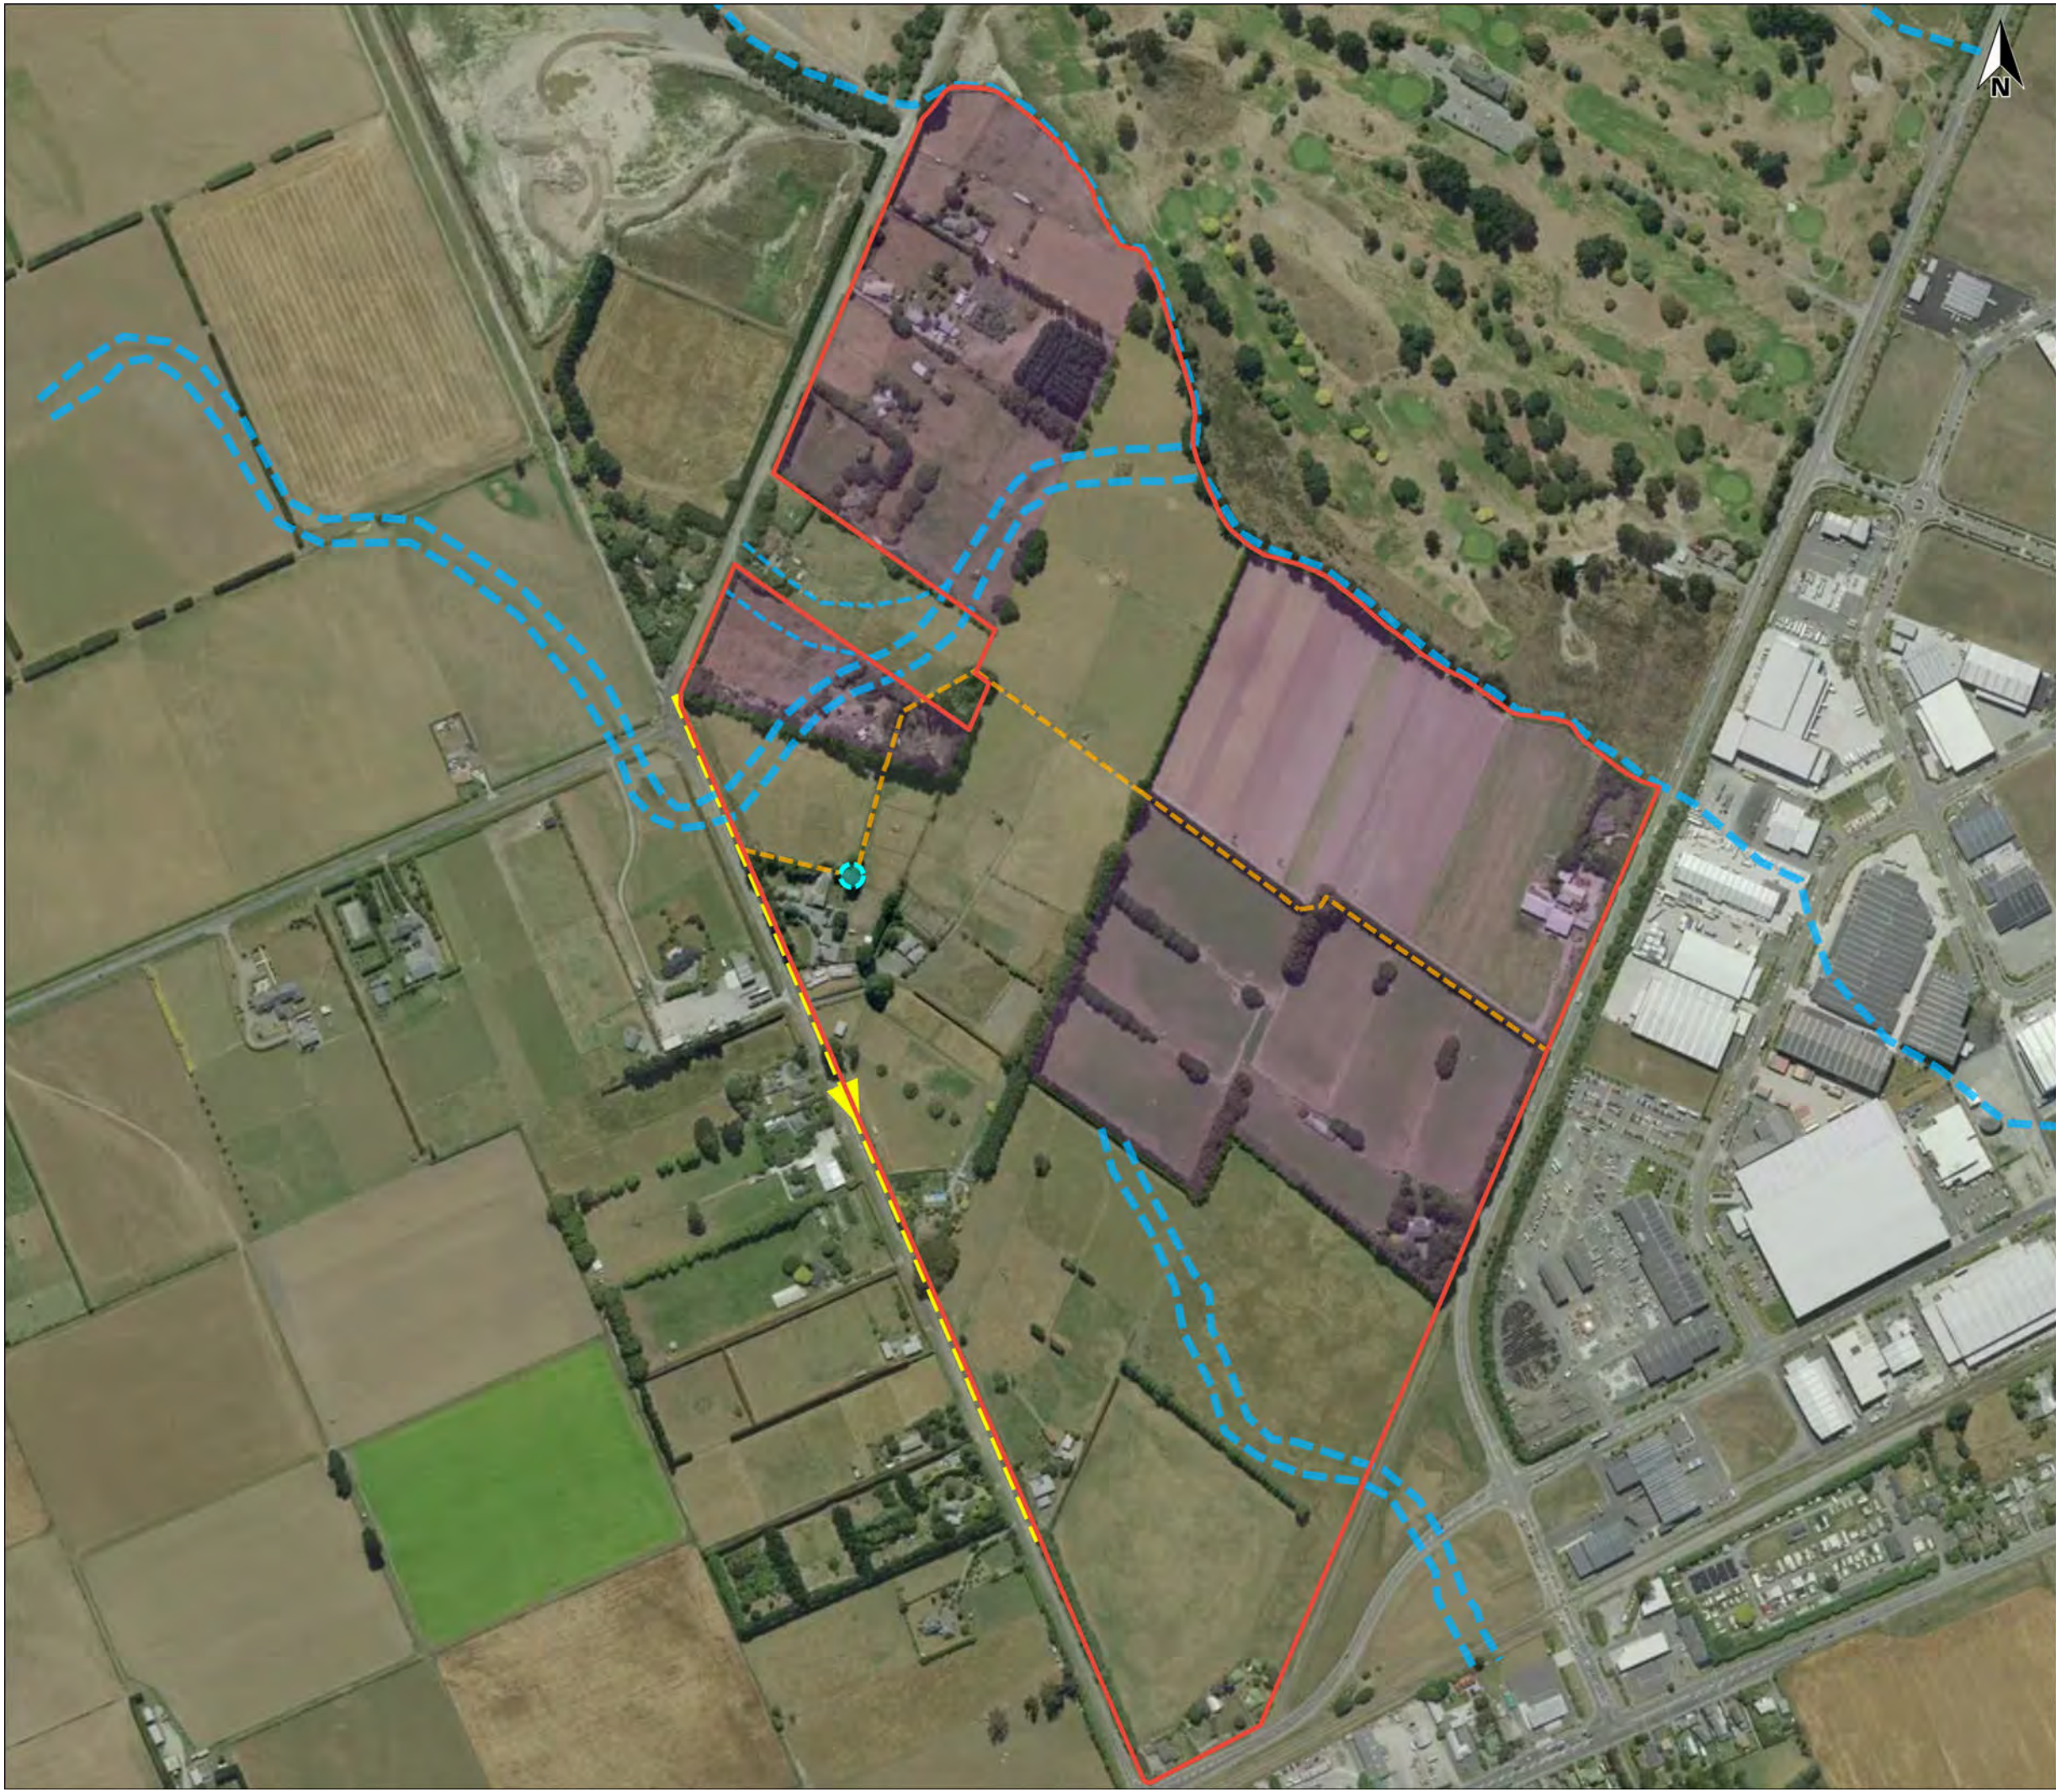
- Site Boundary
- Main inferred paleochannel features (approximately 1m to 2m depth) intersecting or adjacent to the site
- Minor drainage channels (<1m depth)
- Barter's Drain (<1m depth)
- Pond feature (<1m depth)
- No observations during recent site visit (dated: 03 September 2024) due to contractual restrictions; geomorphological features therefore inferred from publicly available aerial photographs

- Formation of area wide road infrastructure circa 1940.
- Establishment of first dwelling circa 1940, with most constructed circa 1990. Minor variations observed between 1990 to present.
- Historic paleochannels extend across the site and the wider region (refer to KGA Drawing 1.1)

- Existing dwellings appear in good condition, with no obvious external damage, though detailed assessments of each dwelling were not completed.
- Historic paleochannel features extend across the site with approximate locations presented on KGA Drawing 1.1. Paleochannel features vary in scale but generally have an elevation difference of 1m to 2m depth below adjacent ground level. The lateral continuity of these features was difficult to track onsite, though it appears these continue into neighbouring properties across the wider region.
- Embankments of paleochannel features are gently to moderately inclined (slope angles between 5° to 20°).
- Barters drain, roughly 1m deep and up to 1.5m wide, extends along the southwestern boundary of site. Approximately 200mm of standing water was observed within the drain.

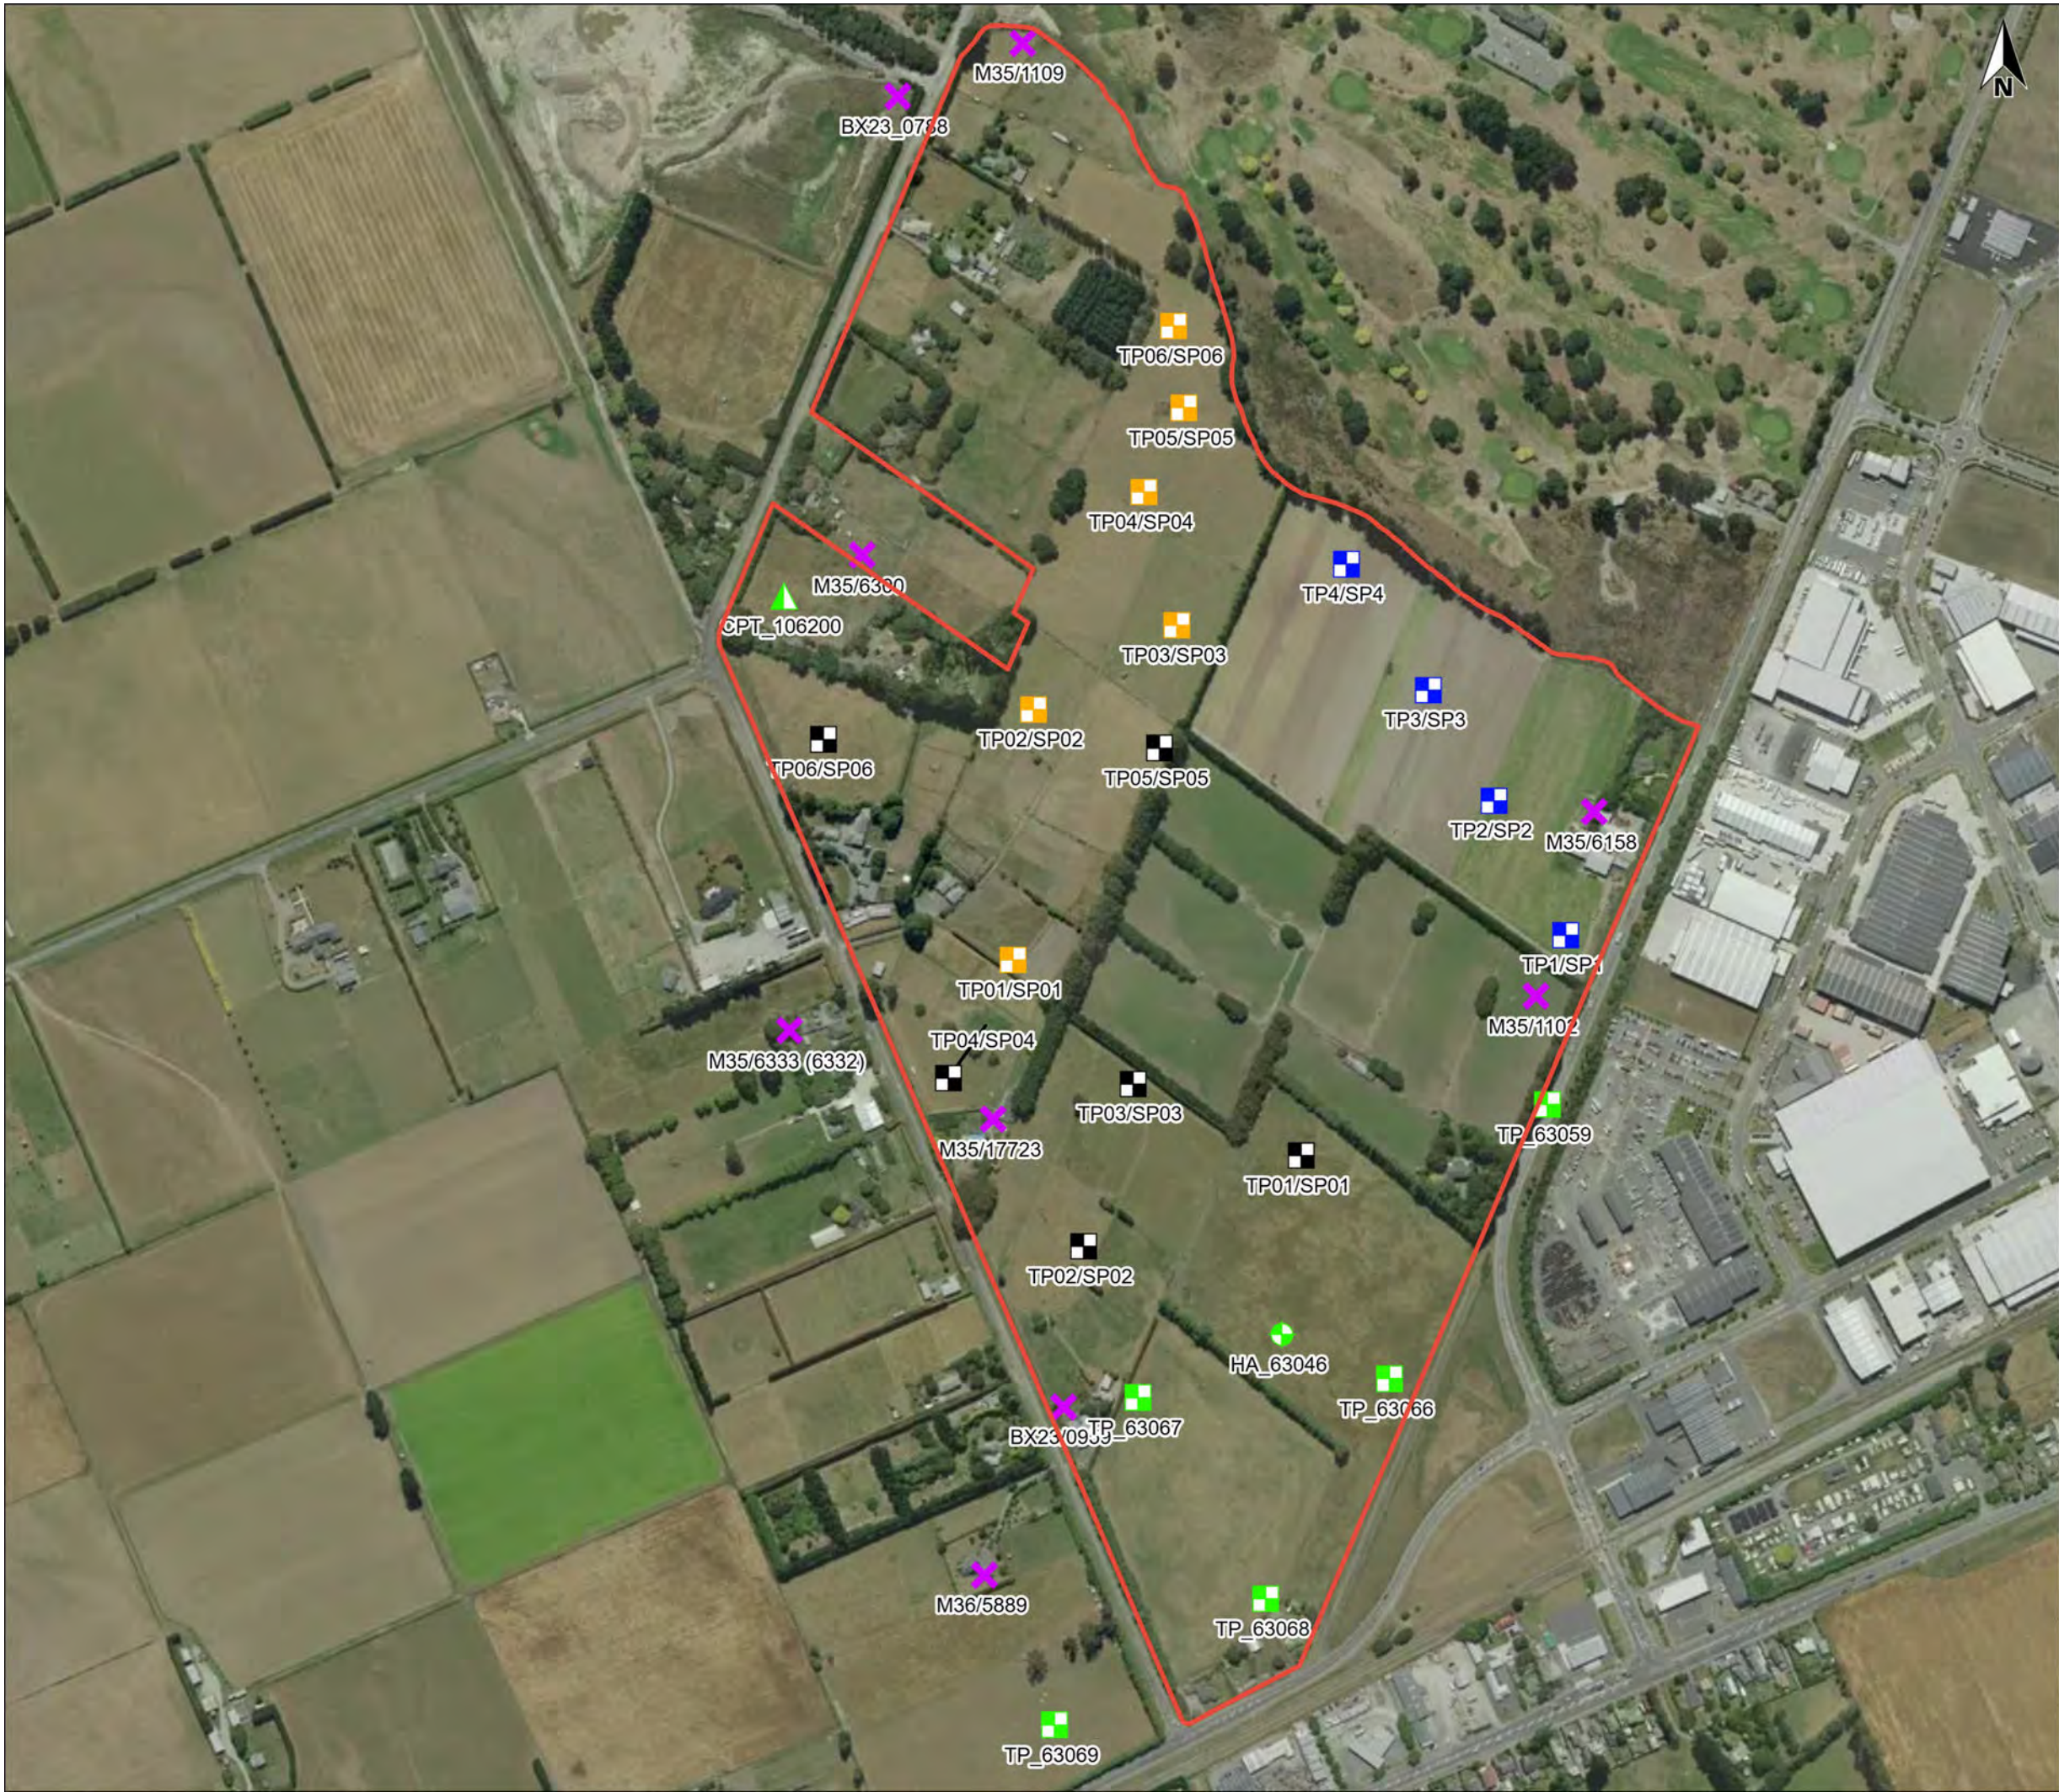
Title: Test Location Plan		
Client: NTP Development Holdings Ltd		Size: A3
Project: Pound Road Industrial Development	Drawn: JB	Drawing: 1.2
Date: 29-05-2025	Checked: RK	
Proj No: K240545	Scale: 1:5500	Version: 0

- Legend**
- Site Boundary
 - KGA machine excavated test pit (Ref: K220216, dated: 12 April 2022)
 - KGA machine excavated test pit (Ref: K230858-1, dated: 05 December 2023)
 - KGA machine excavated test pit (dated: 03 September 2024)
 - NZGD sourced hand auger borehole test
 - NZGD sourced machine excavated test pit
 - NZGD sourced Cone Penetrometer Test (CPT)
 - ECan Well data sourced from Canterbury Maps

The test pit locations were selected to provide representative indications of the subsurface ground conditions within the area being assessed. The locations of the test pits are indicated on our site plan, attached as KGA Drawing 1.2.

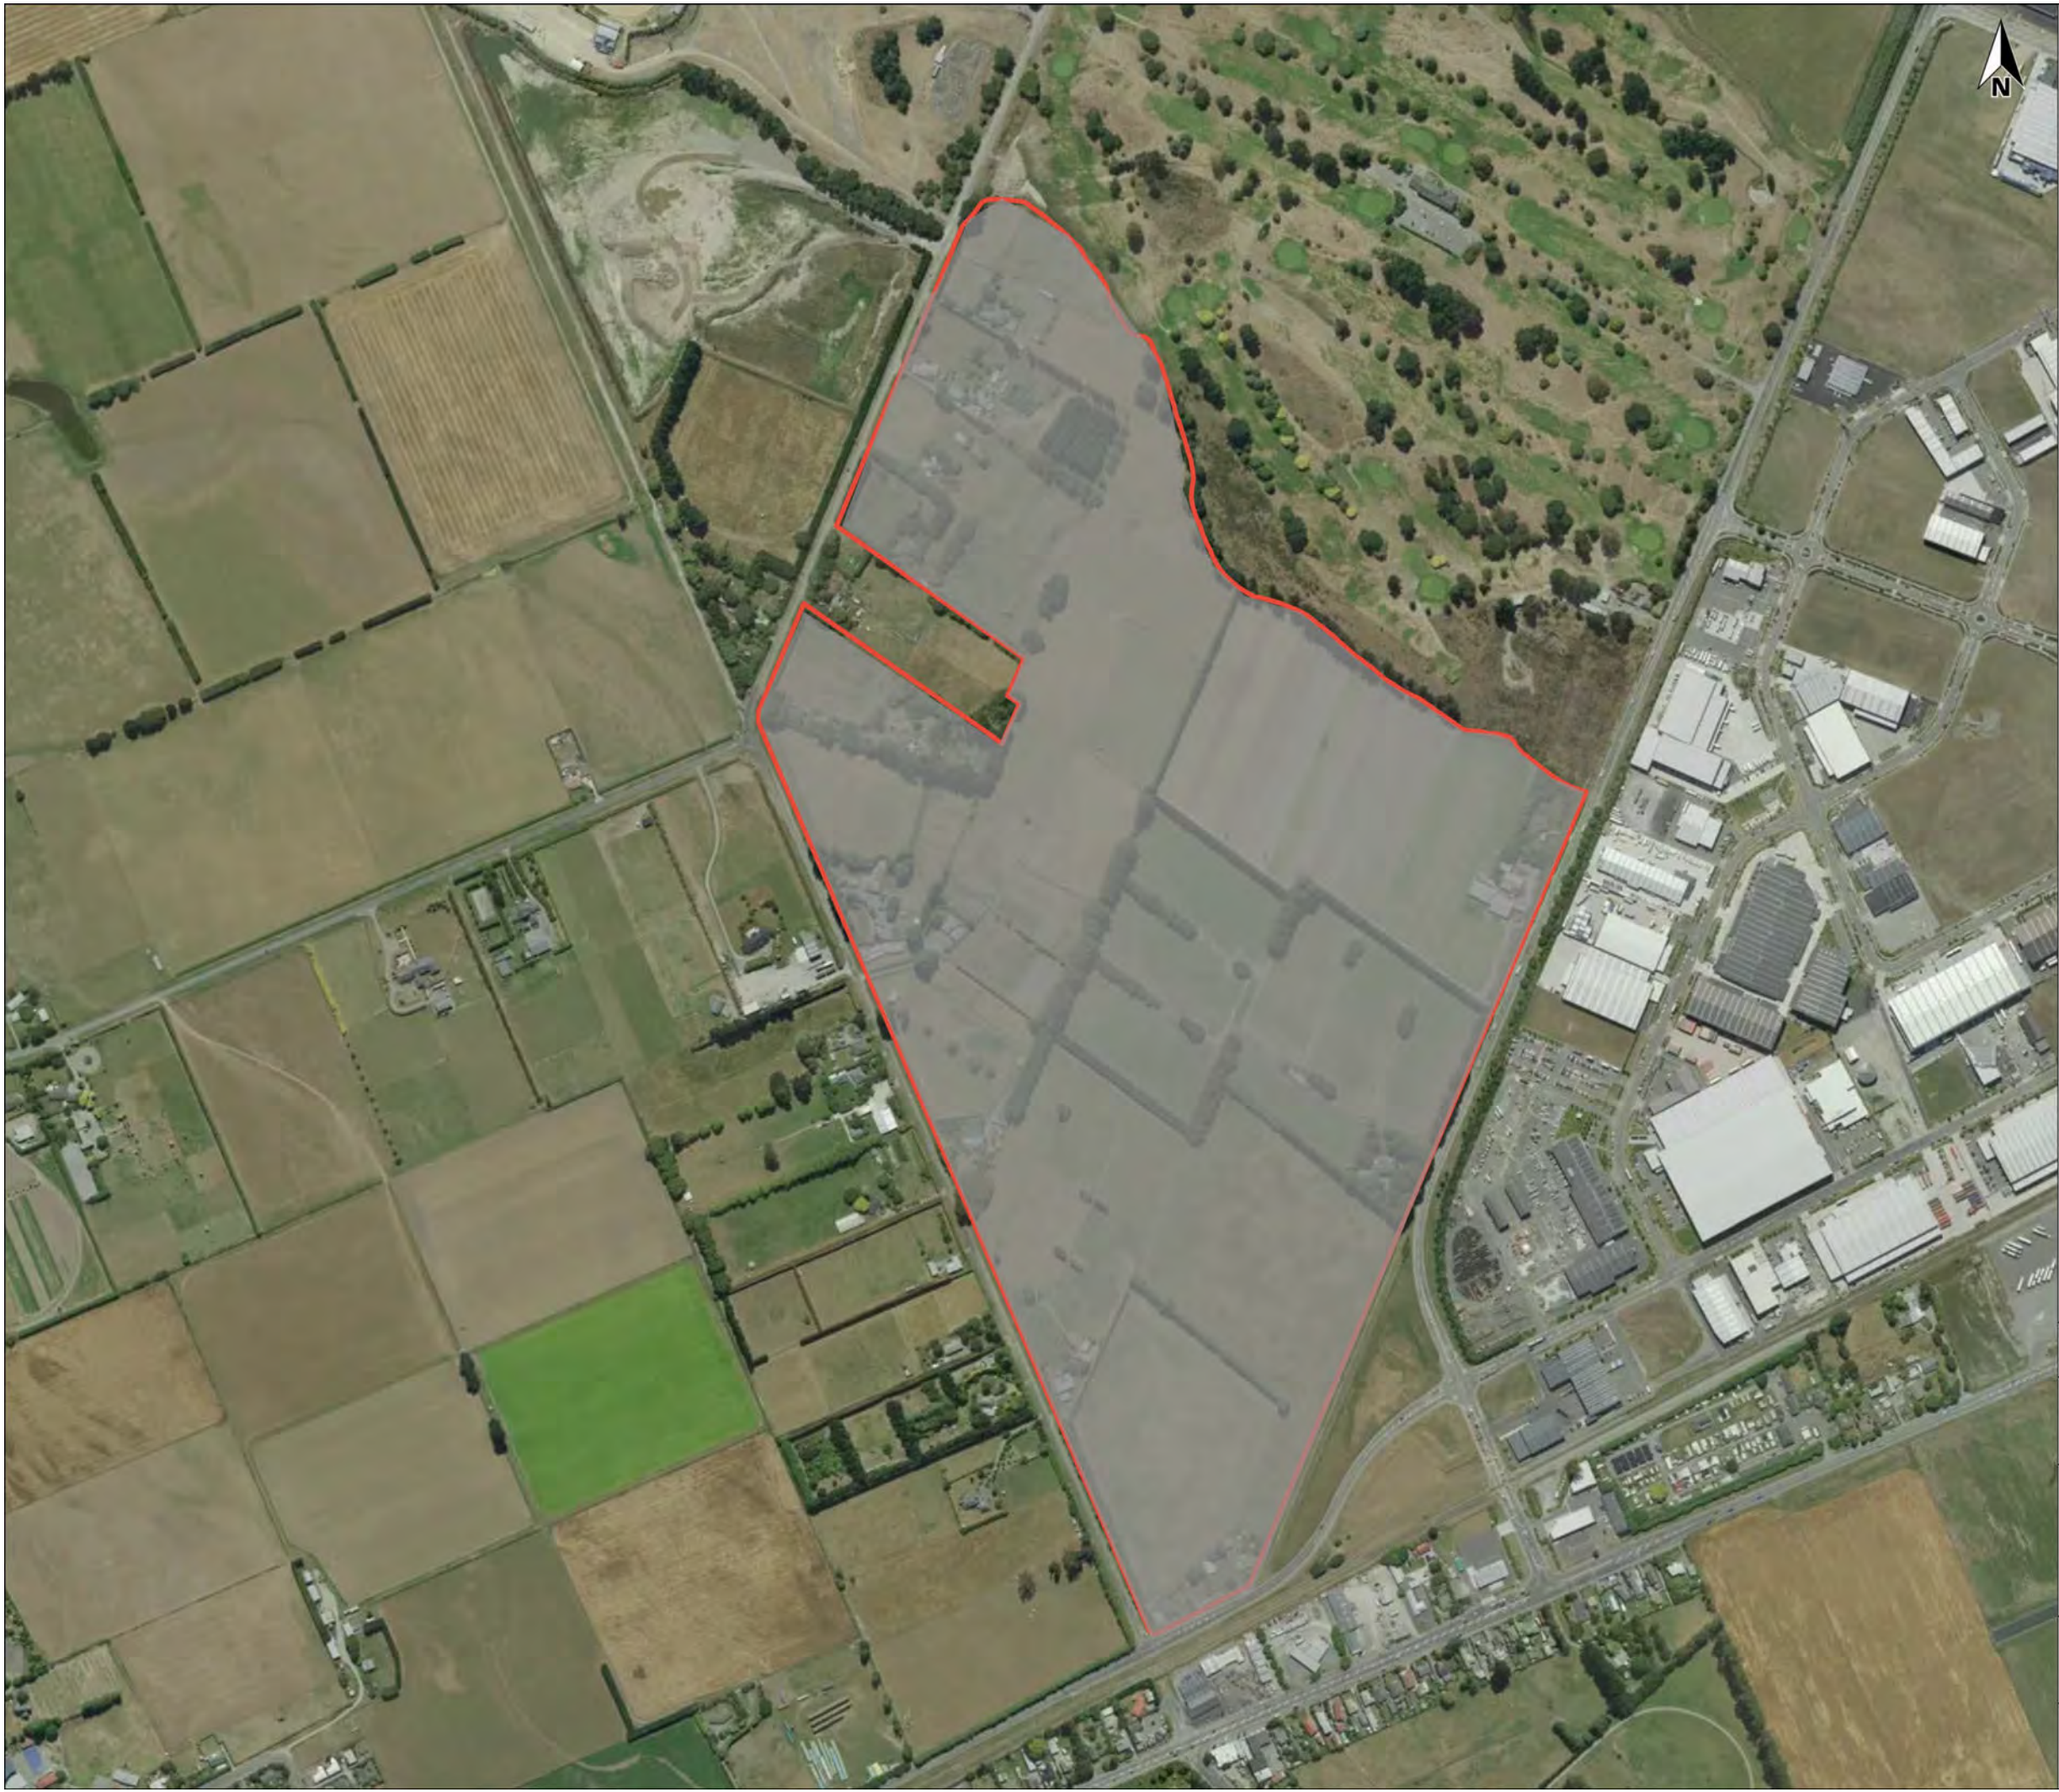
Title: Technical Categorisation Plan		
Client: NTP Development Holdings Ltd		Size: A3
Project: Pound Road Industrial Development	Drawn: JB	Drawing: 1.4
Date: 29-05-2025	Checked: RK	
Proj No: K240545	Scale: 1:6500	Version: 0

Technical Category 1 (TC1) equivalent land as defined by the MBIE Guidance for residential sites

The site is situated in a N/A – Rural and unmapped area as per MBIE mapping available on the NZGD, and indicated as “liquefaction damage is unlikely” in the ECan mapping. Based on the ground conditions encountered onsite and depth to groundwater, we consider that the site has a negligible risk of liquefaction equivalent to a TC1 site if the site was residential.

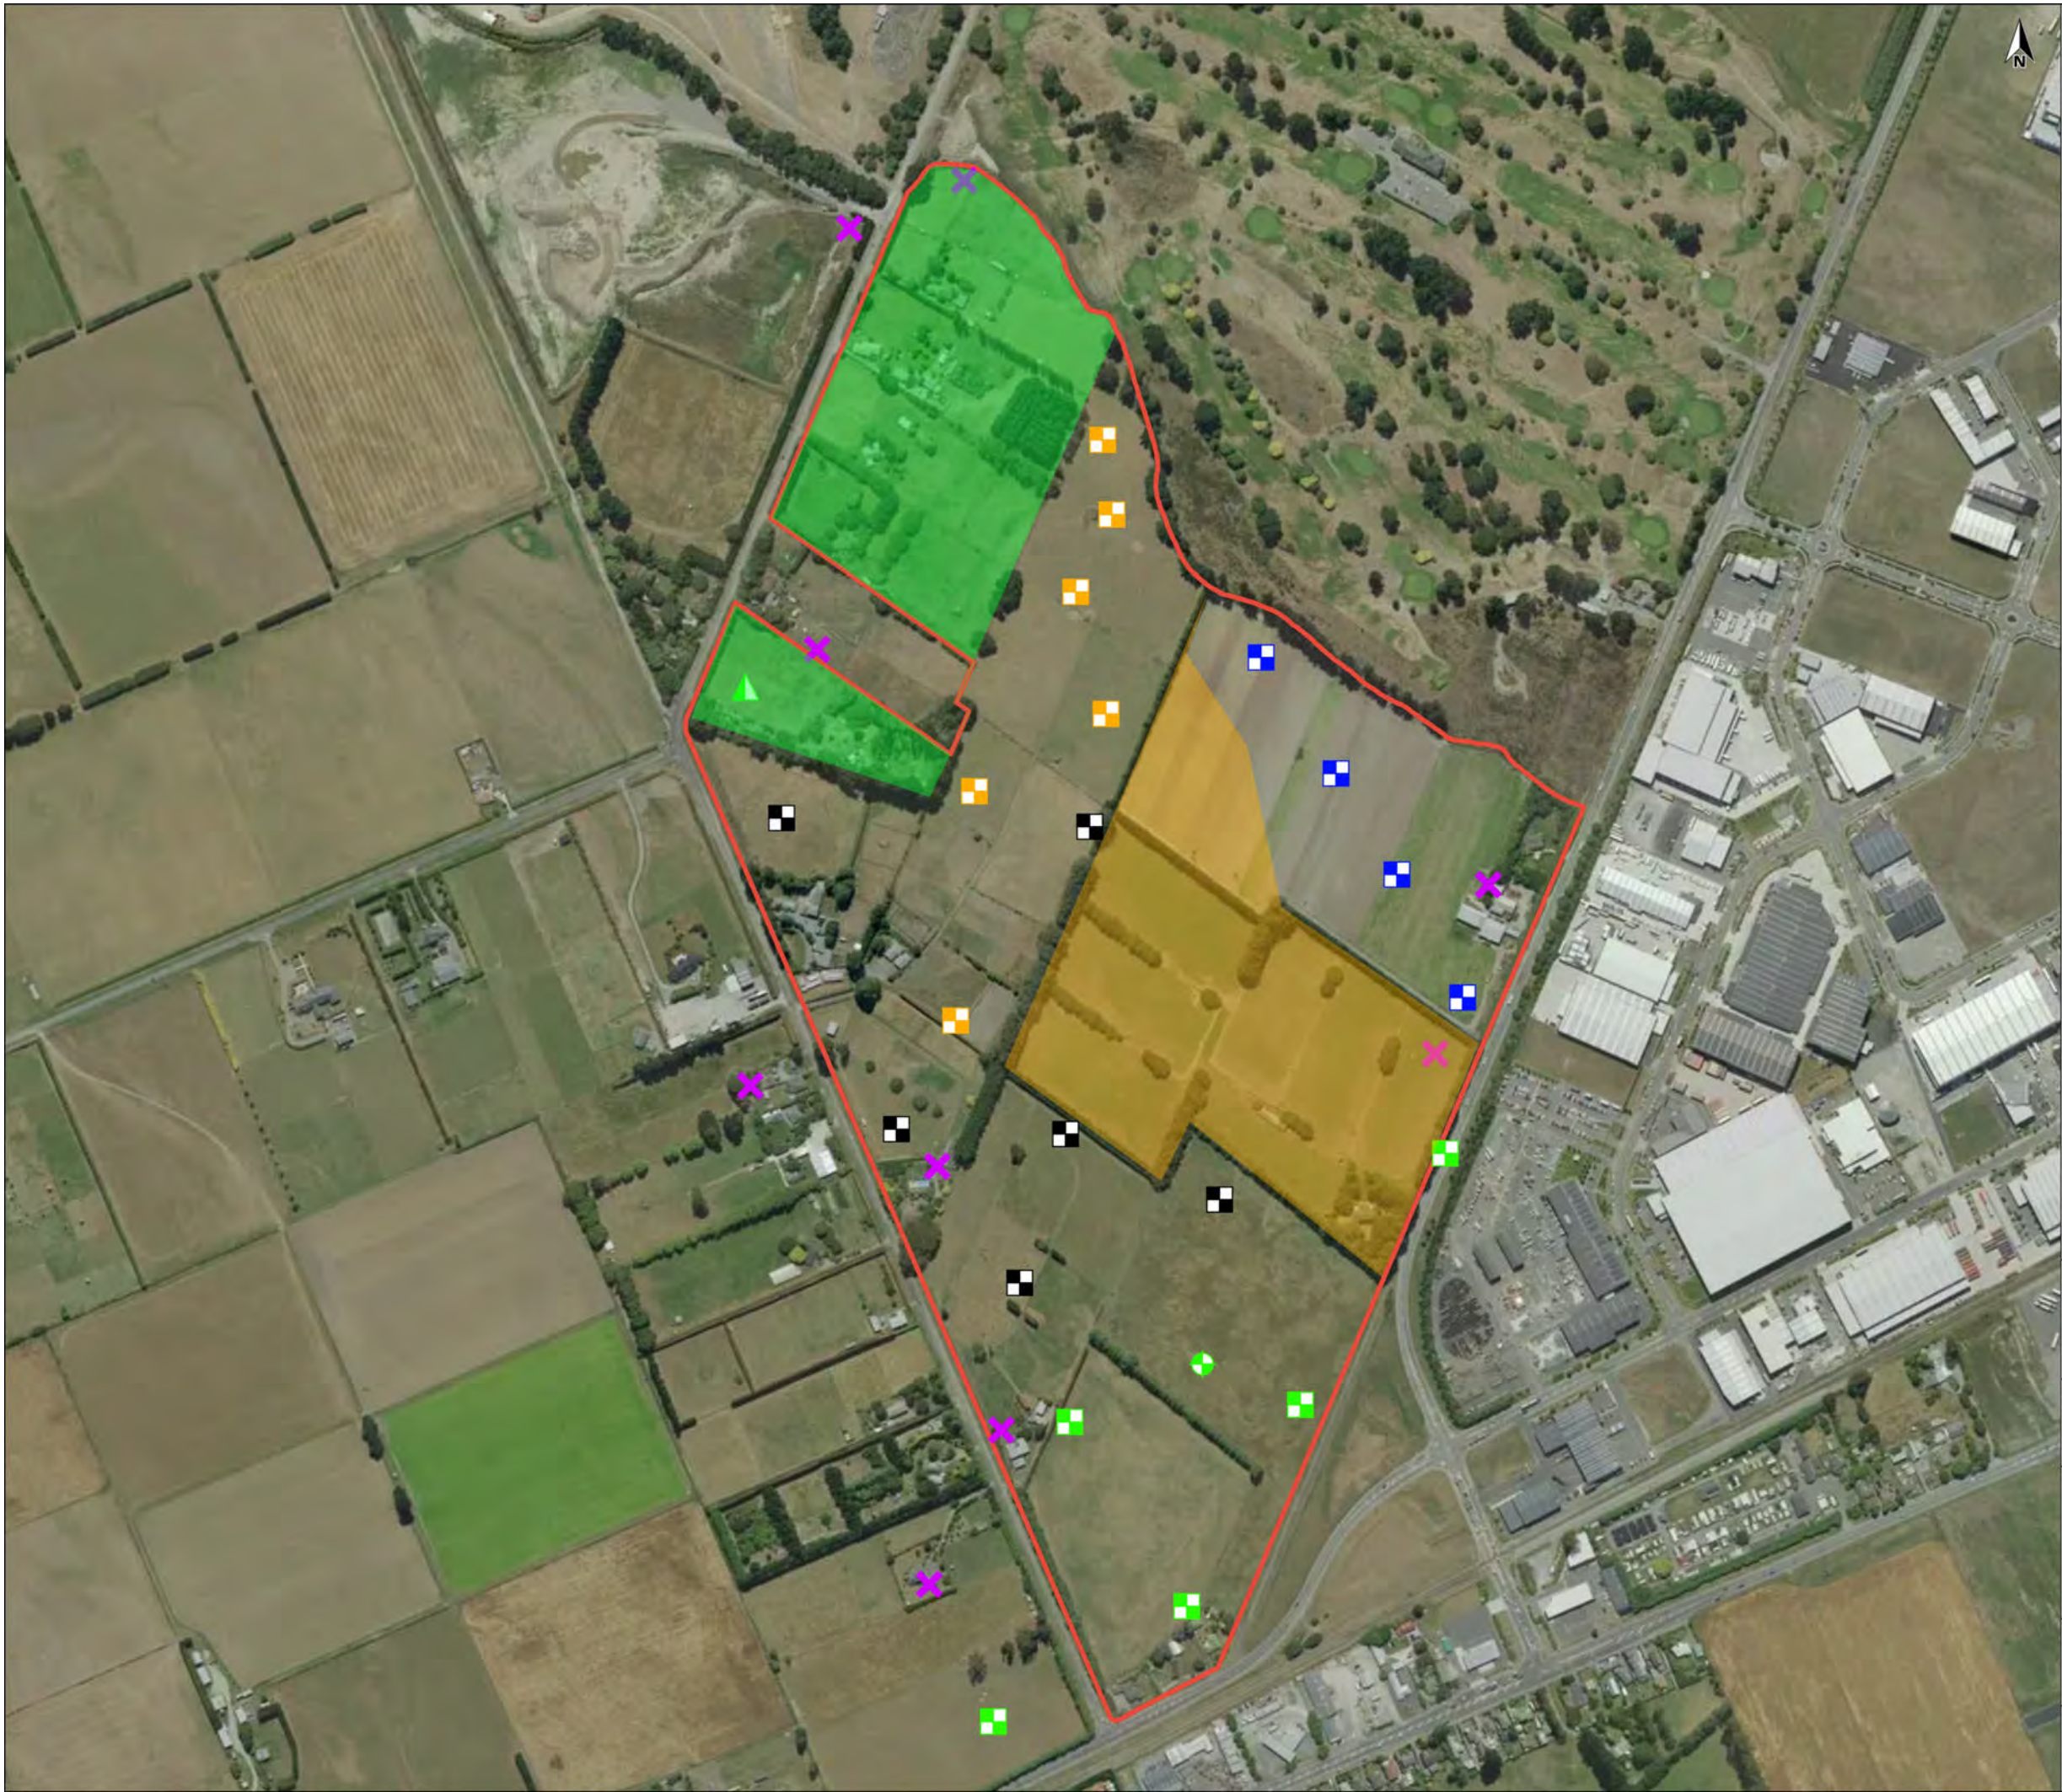
- Area where additional geotechnical investigations will be required prior to the start of Stage 2 subdivision earthworks
- Additional tests required for subdivision
- KGA machine excavated test pit (Ref: K220216, dated: 12 April 2022)
- KGA machine excavated test pit (Ref: K230858-1, dated: 05 December 2023)
- KGA machine excavated test pit (dated: 03 September 2024)
- NZGD sourced hand auger borehole test
- NZGD sourced machine excavated test pit
- NZGD sourced Cone Penetrometer Test (CPT)
- ECan Well data sourced from Canterbury Maps
- Site Boundary

We note that we were unable to test/access Lots 63 to 67 and 73 due to sensitive livestock in these paddocks. We recommend a condition requiring additional testing be undertaken prior to the start of Stage 2 subdivision earthworks. We also note that Lot 74 was not accessible due to contractual obligations and further testing will be required to confirm ground conditions across the entire lot. A supplementary geotechnical report will be required to confirm that conclusions of this report are applicable to Lot 74.

We note that certain areas were not accessible at the time of our investigations. Additional investigations will be required to confirm that the ground conditions and to ensure our recommendations remain valid across these areas prior to the start of Stage 2 subdivision earthworks. Additional testing will also be required on Lot 74. These areas are shown on KGA Drawing 1.5.

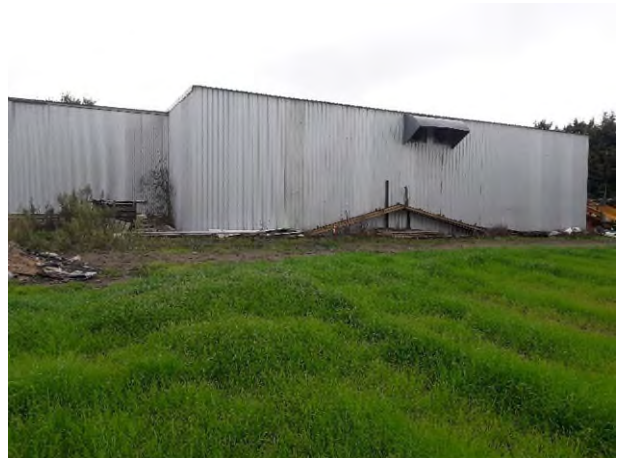
Existing ancillary structure

Concrete pavements supporting ancillary structure

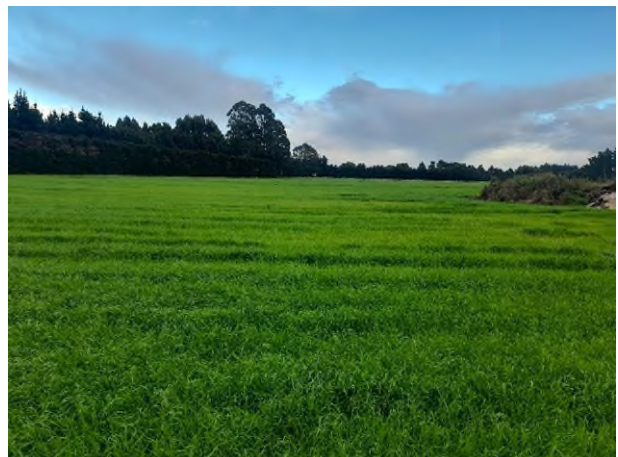
Agricultural paddocks across the W portion of site

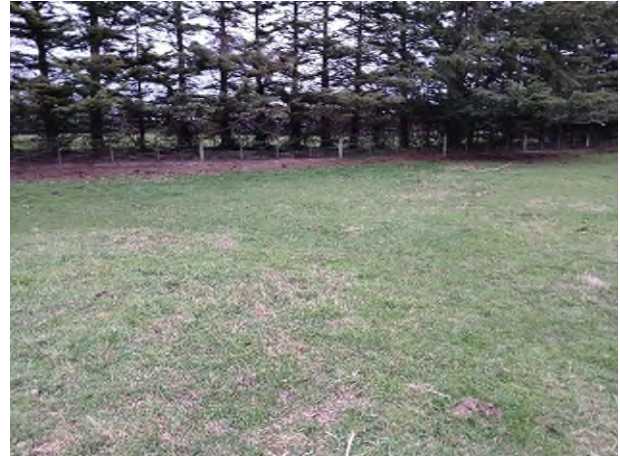
Minor paleochannel feature near N boundary

Paleochannel extending through E paddock

- Paleochannel features and existing drainage channels must also be appropriately backfilled in accordance with the above recommendations and standard. Any filling should be undertaken under supervision of a geotechnical engineer and after their confirmation that remnant subgrade is acceptable with all unsuitable material removed from the base and sides.

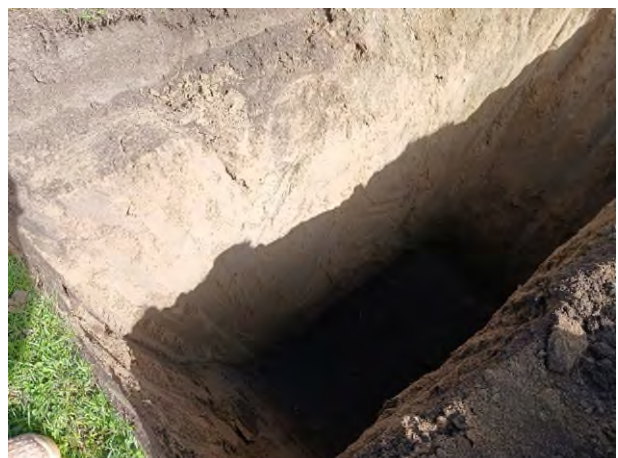
Typical ground conditions (TP04)

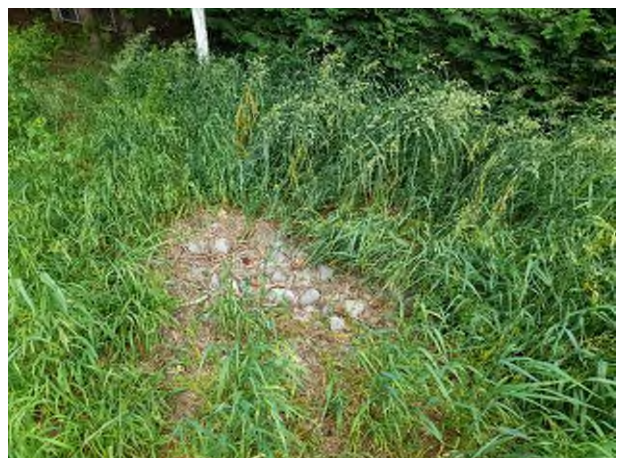
Potential soakage pit S of equestrian facility

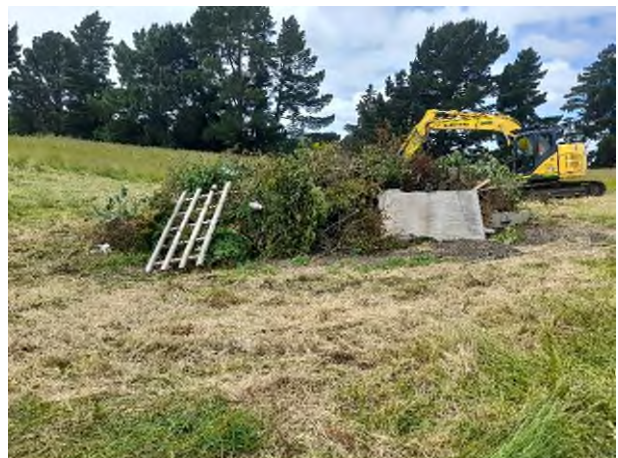
Burn pit within paleochannel

We also recommend that the backfilling and infilling of drains/open channels and historic paleochannels is completed under geotechnical supervision.

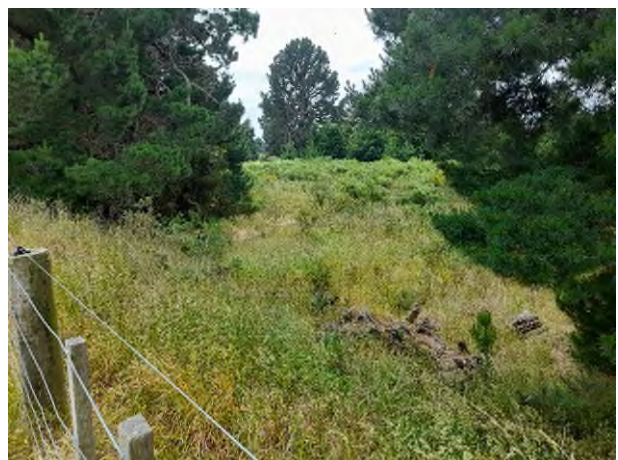
Slope adjacent to N boundary

Details of proposed stormwater basins were not available at the time of preparing this report although we understand that they will be less than 1.5m deep and likely to have gentle slopes. There are also minor slopes and bunds along the north elevation of the site and along Barbers Road. The impact of any stormwater infrastructure and any existing/permanent slopes around the site should be considered at the time of lot-specific investigations. However, this would be to provide recommendations for good engineering practice based on proposed development adjacent to the slopes and building specific foundation design.

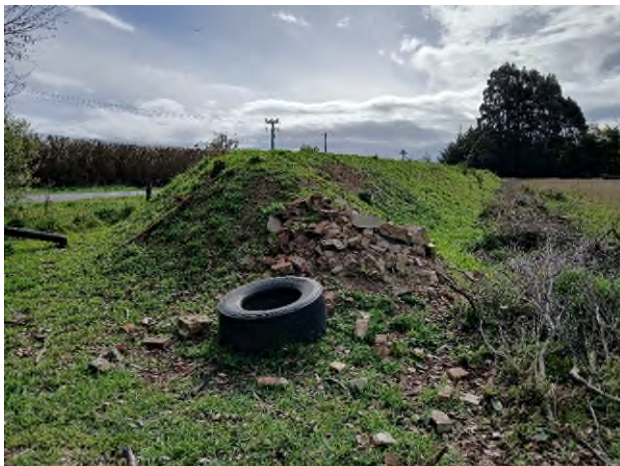
Soil bund along S boundary, comprising construction debris/non-engineered fill

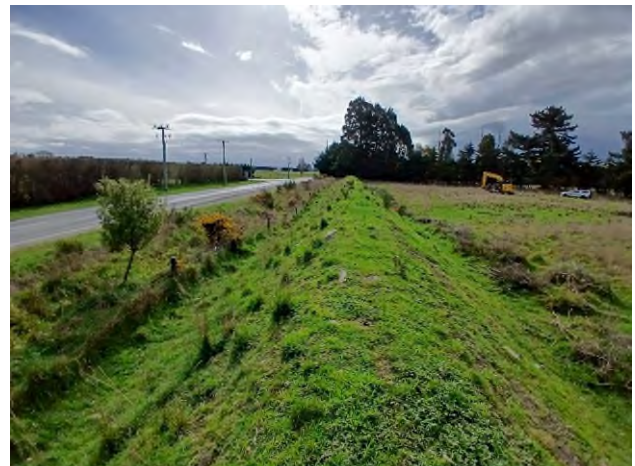
Soil bund along S boundary, comprising construction debris/non-engineered fill

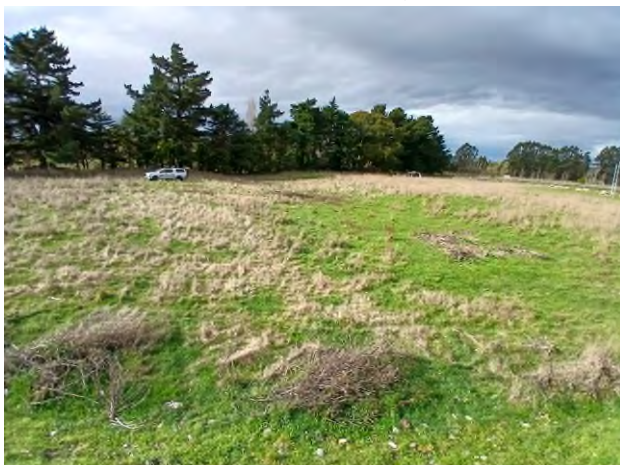
Paleochannel extending through W portion

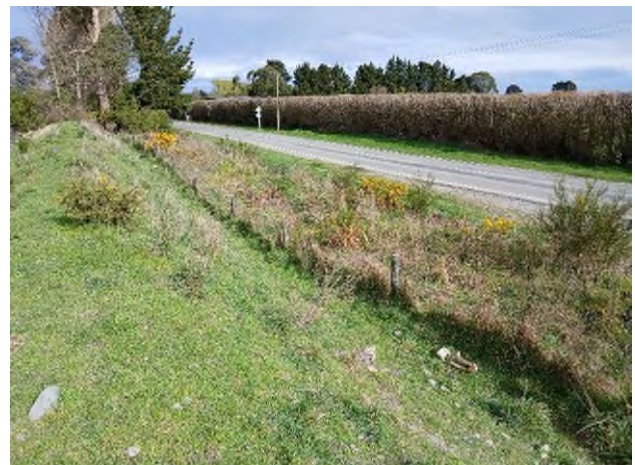
Overview of Barbers Drain adjacent to S boundary.
