20 May 2025 Project Ref: 2555087

Rev.: 02

### Geotechnical Review for Proposed Development at Morven Ferry Road, Queenstown

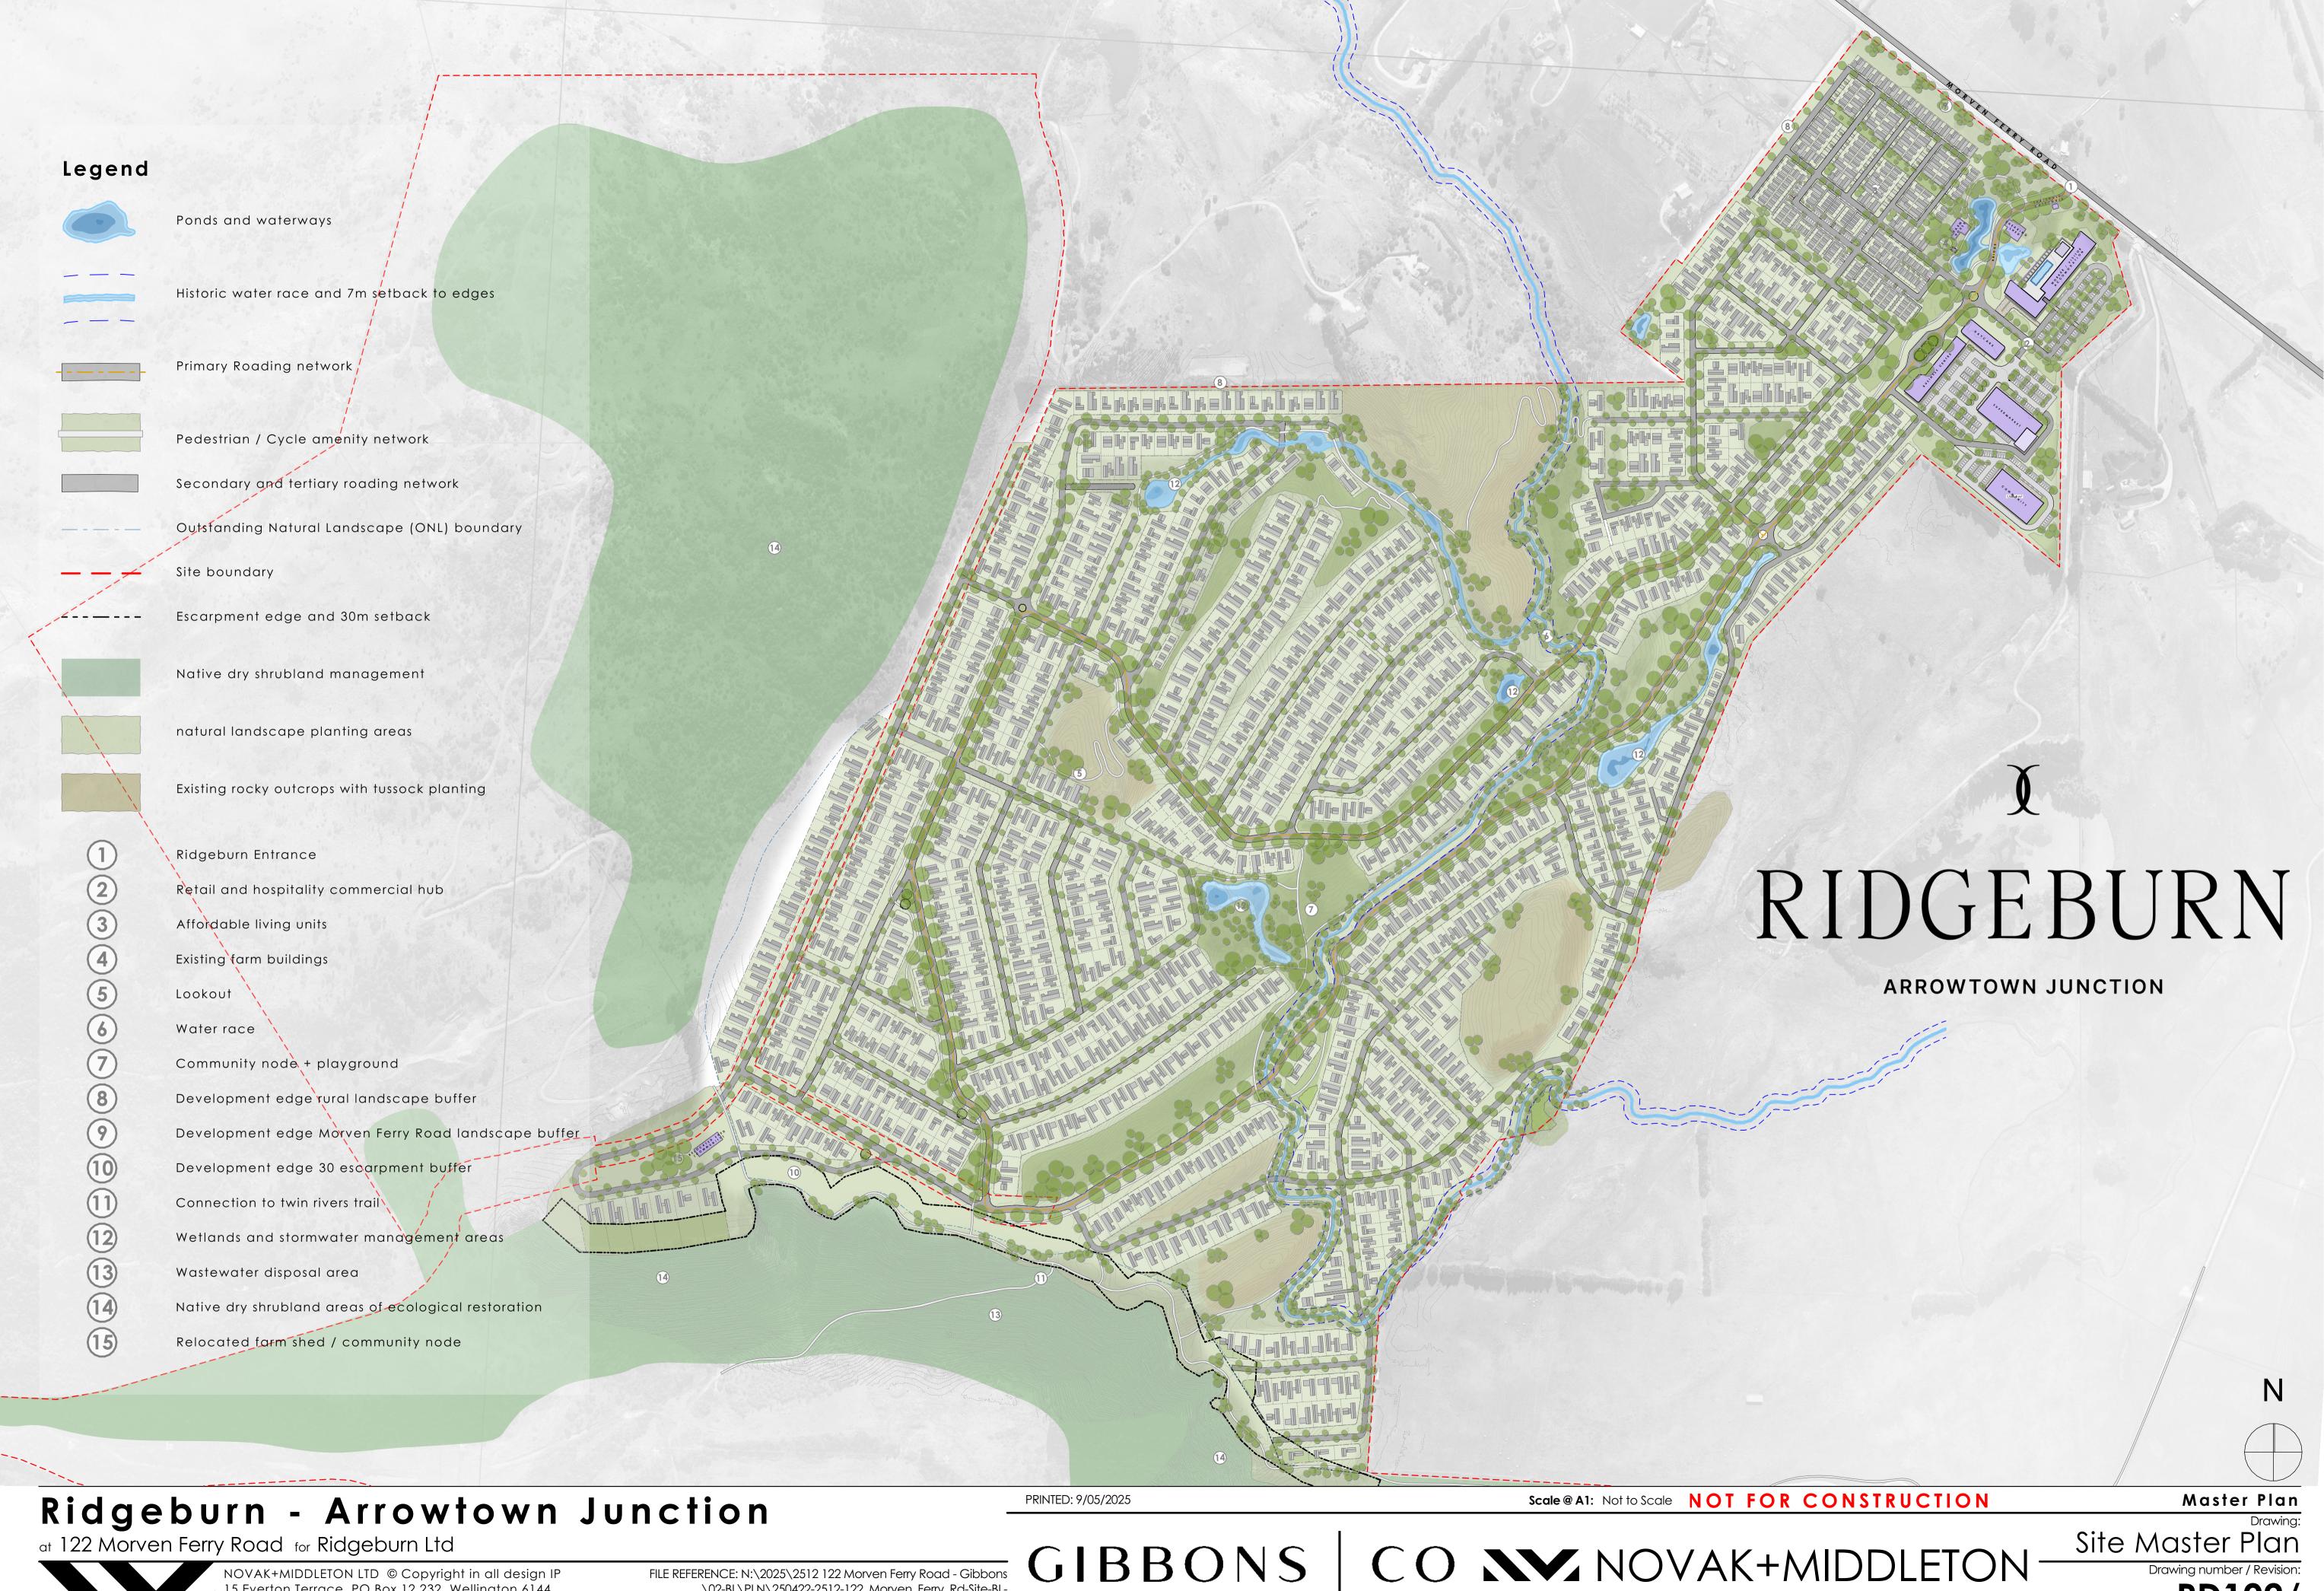
Attachment 2 : Proposed Development Plans

Kirk Roberts has been provided with a proposed development plan<sup>2</sup> (Master Plan) showing the development of 1,242 residential lots. The existing dwelling and ancillary buildings will be demolished and removed from the site. The proposed development plans are included in Attachment 2.
