Hastings & Napier Future Development Strategy

Re: *Draft Napier Hastings Future Development Strategy – Submission re
Inclusion of land at 174 & 176 Brookvale Road, Havelock North*

Soil and Resource Report for 174 Brookvale Road, Havelock North.

REVIEW OF LAND CLASS:
TE MATA MUSHROOMS
BROOKVALE ROAD SITE

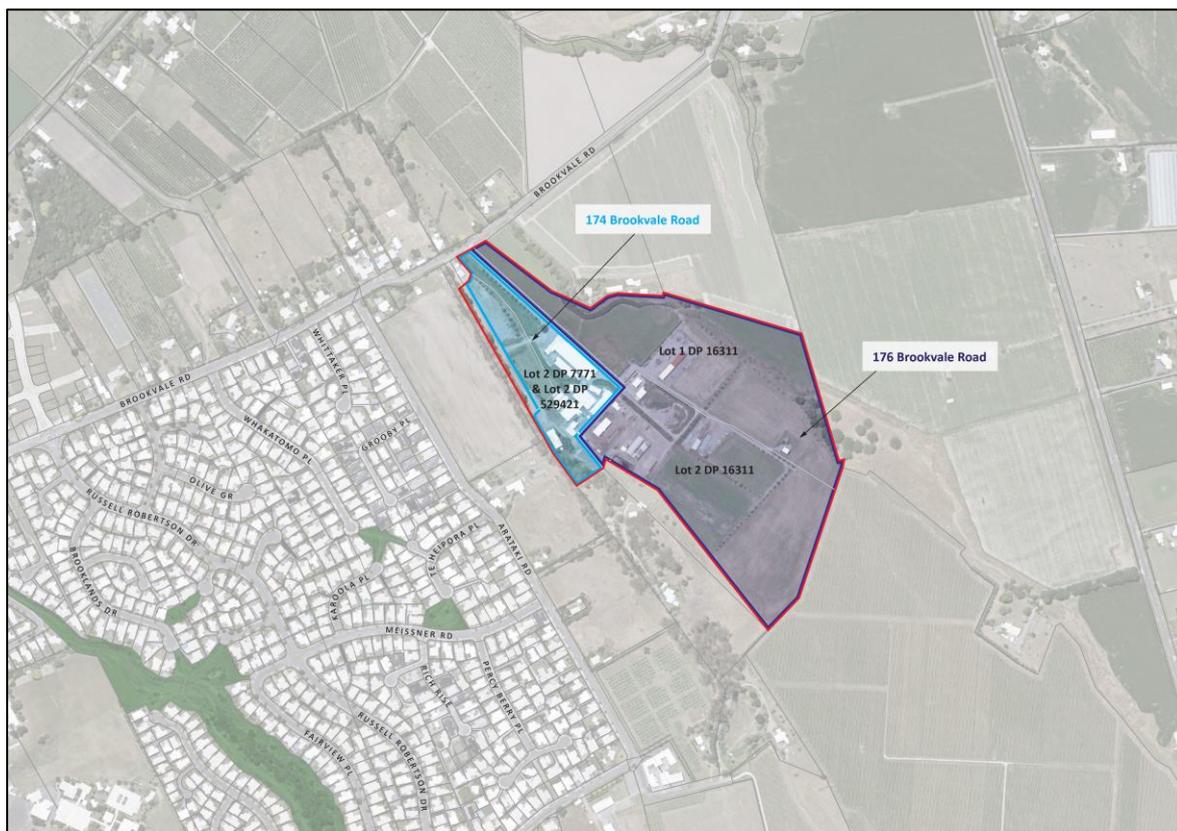
Figure 1 – 174 and 176 Brookvale Road, Havelock North

174 & 176 Brookvale Road (**subject site**) comprise three titles containing approximately 22.26 hectares of land, on a prime location on the north eastern edge of Havelock North, approximately 6km from Hastings Central, and 2.8km from the Havelock North commercial centre – see image below in **Figure 1**.

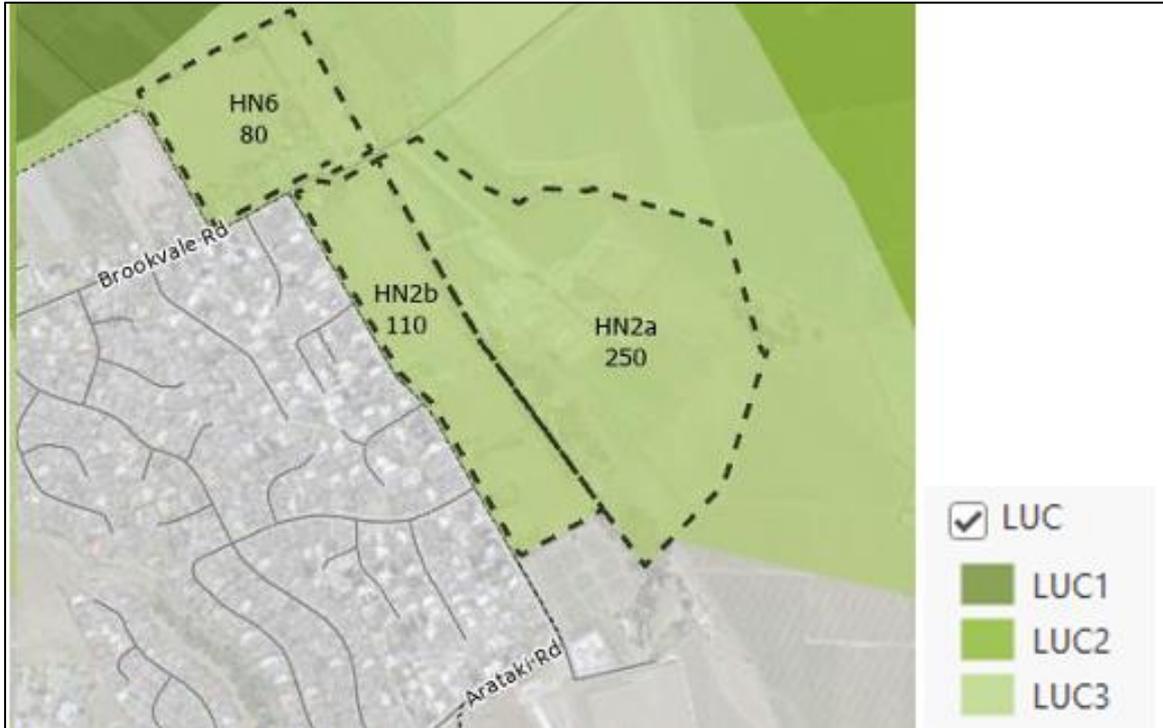
Figure 2 – NZLRI LUC3 mapping as it applies to the subject site / HN2a

to the generic use of the NZLRI mapping of LUC 1 – 3 soils.

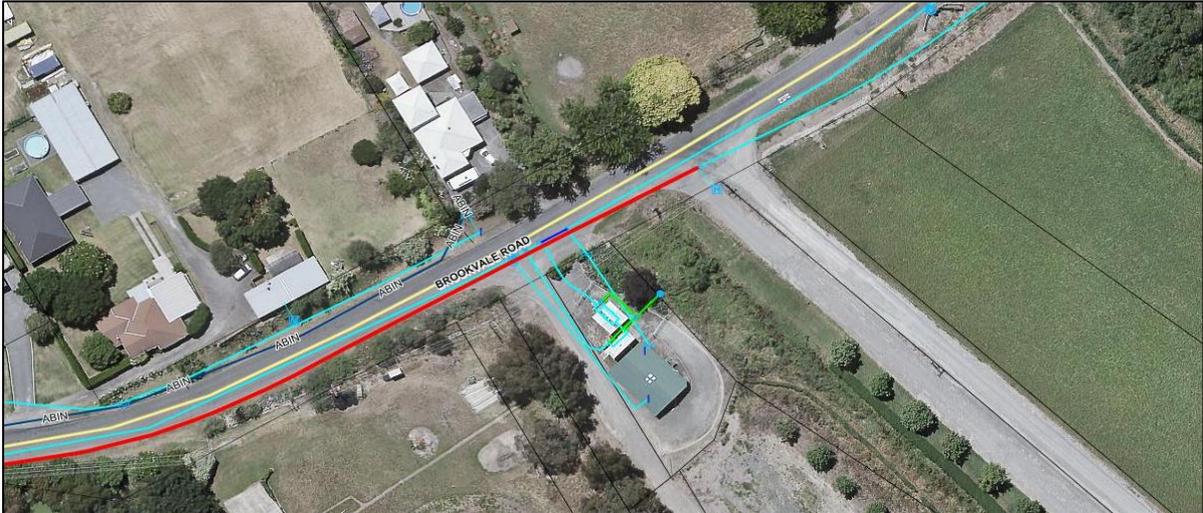
Figure 3: image showing existing water infrastructure in proximity to the subject site

In terms of wastewater supply, a 375mm gravity trunk main terminates in a manhole at the Brookvale Road / Arataki Road intersection to the west of the subject site, with a 150mm line coming down Arataki Road – see **Figure 4** below. Therefore, extension of wastewater infrastructure to service urban expansion on the subject site should not be an issue, noting that there is already a programme in place to enable this to occur as signalled in the FDS documentation.

VSP understand that it will be straight forward to expand existing reticulated water and wastewater networks to service urban development on the subject site. This is consistent with the findings of the Draft FDS MCA Matrix for the Te Mata Mushroom site which does not identify any constraints for reticulated water supply and wastewater services.

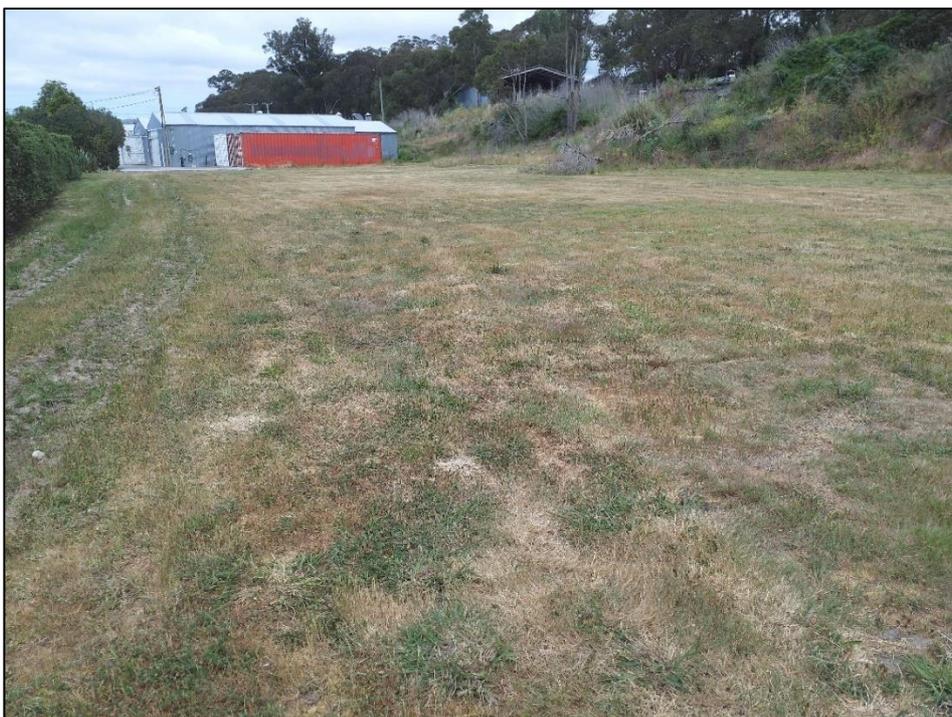
The area of anthropic soil is located on an excavated area of the site where the slope from the terrace above has been removed to create a flat area. The soil at this site consists of very stony subsoil a number of metres below the surface of the original soil profile. Figure 1 below shows the area including the bank cutting on the right while figure 2 shows the shallow, stony soil surface that exists below the grass cover.

Figure 1. Excavated site with anthropic soil

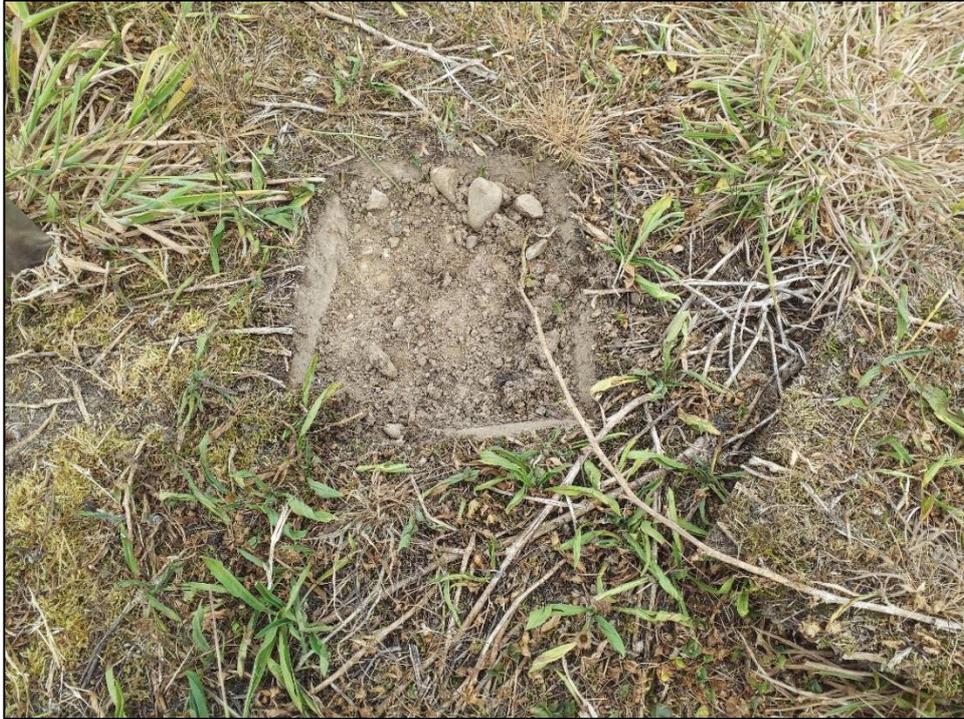
Figure 2. Very shallow soil over gravel at the excavated site.

The soil at this site cannot be dug manually with a spade due to the degree of stoniness and only has a very thin layer of soil material overlaying the stony profile.

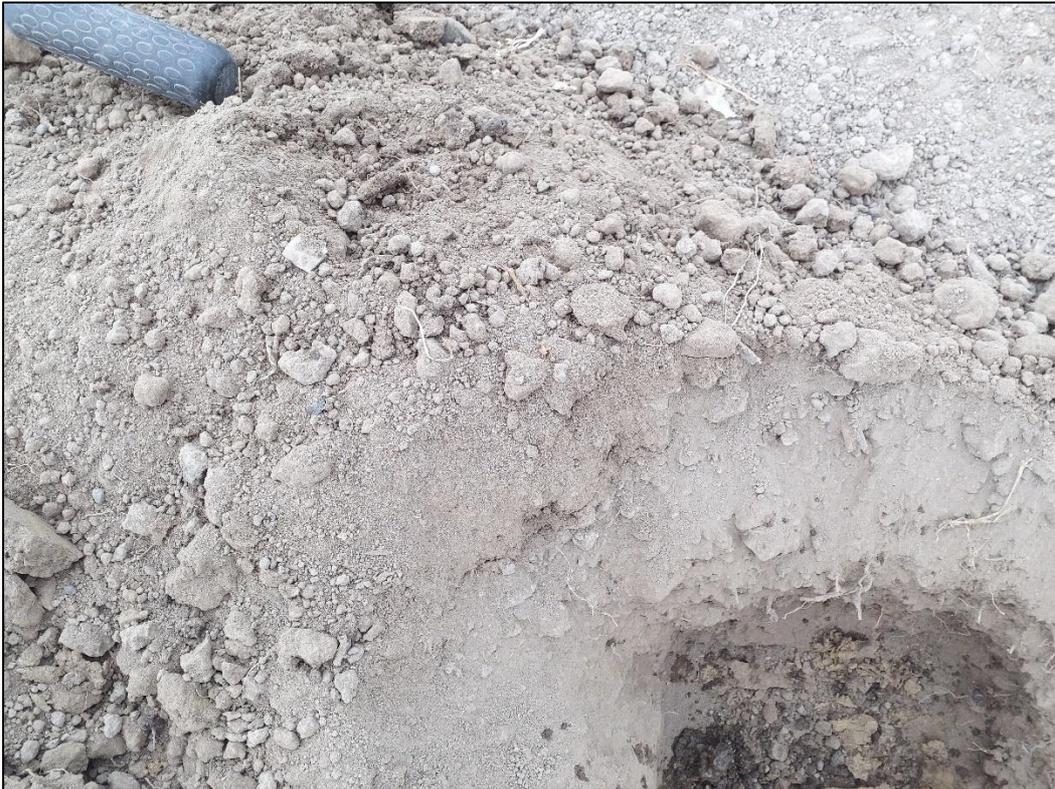
In general, the condition of the soil on Title 2 was found to be slightly to significantly degraded due to compaction and a loss of soil structure. Figure 3 below shows the degraded topsoil of a recently cultivated area of the site with structure almost total lost leaving a powdery texture topsoil containing small, compacted clods of subsoil

Figure 3. Soil degradation at the site from a loss of structure likely due to over cultivation.

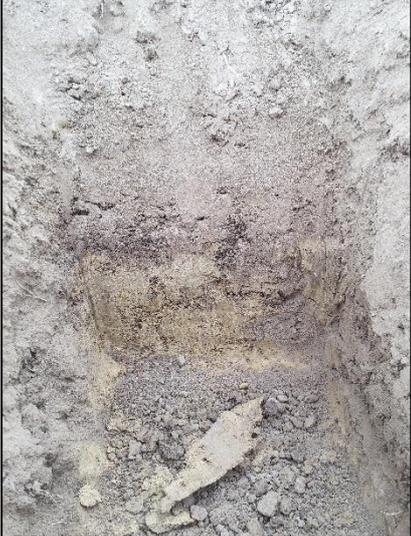
<p>Soil Name: Hinds_25a.1.</p> <p>Soil classification: Mottled fluvial recent soil.</p> <p>Parent material: Alluvium</p> <p>Soil description:</p> <p>0-200 Loss of soil structure and organic matter, becoming powdery with compacted lumps</p> <p>200-400mm: Firm, massive, sticky plastic, light yellowish brown (2.5y6/3) to light brownish grey (2.5y6/2) sandy clay with black (10yr 2/1) iron staining and yellowish red (5yr 5/8) mottling.</p> <p>400mm+ – clay to firm to auger</p> <p>Overall drainage: Imperfectly drained</p>

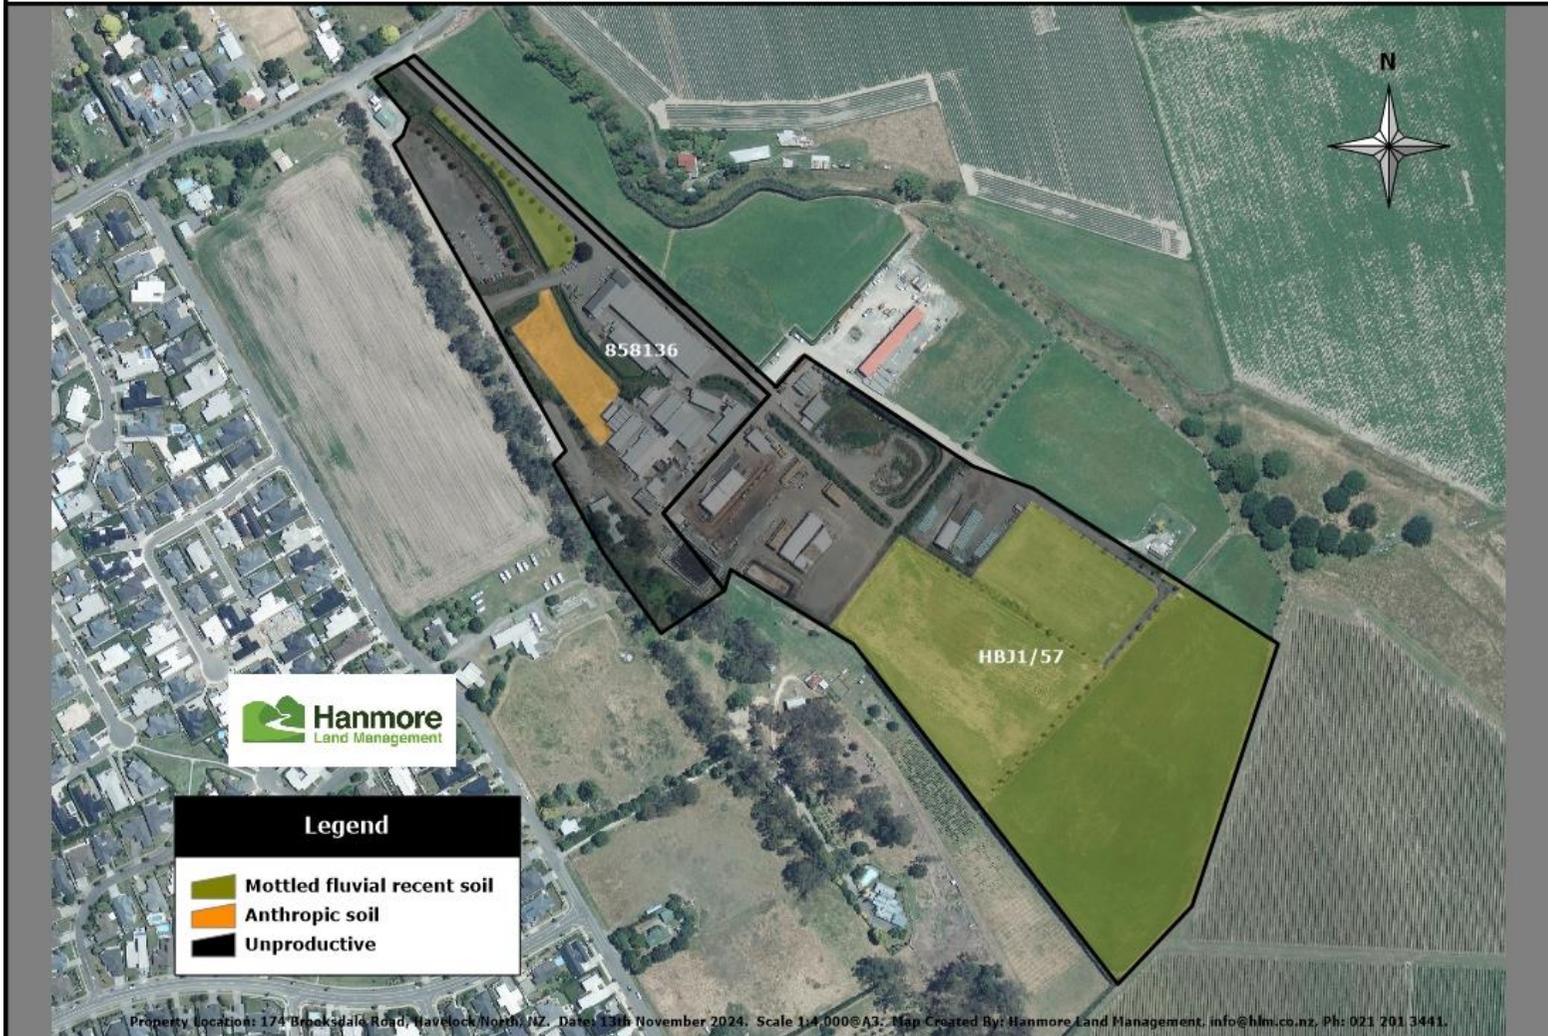
174 Brooksdale Road Soil Map

On Title 1 there are only two notable flat grassed areas. These are shown on the soil map in Section 7 of this report as anthropic or manmade soil and mottled fluvial recent soil (recorded as Hinds_25a.1 in S-map). A third area has not been highlighted as it covers only 400m² adjacent to a building and as such a negligible production potential.

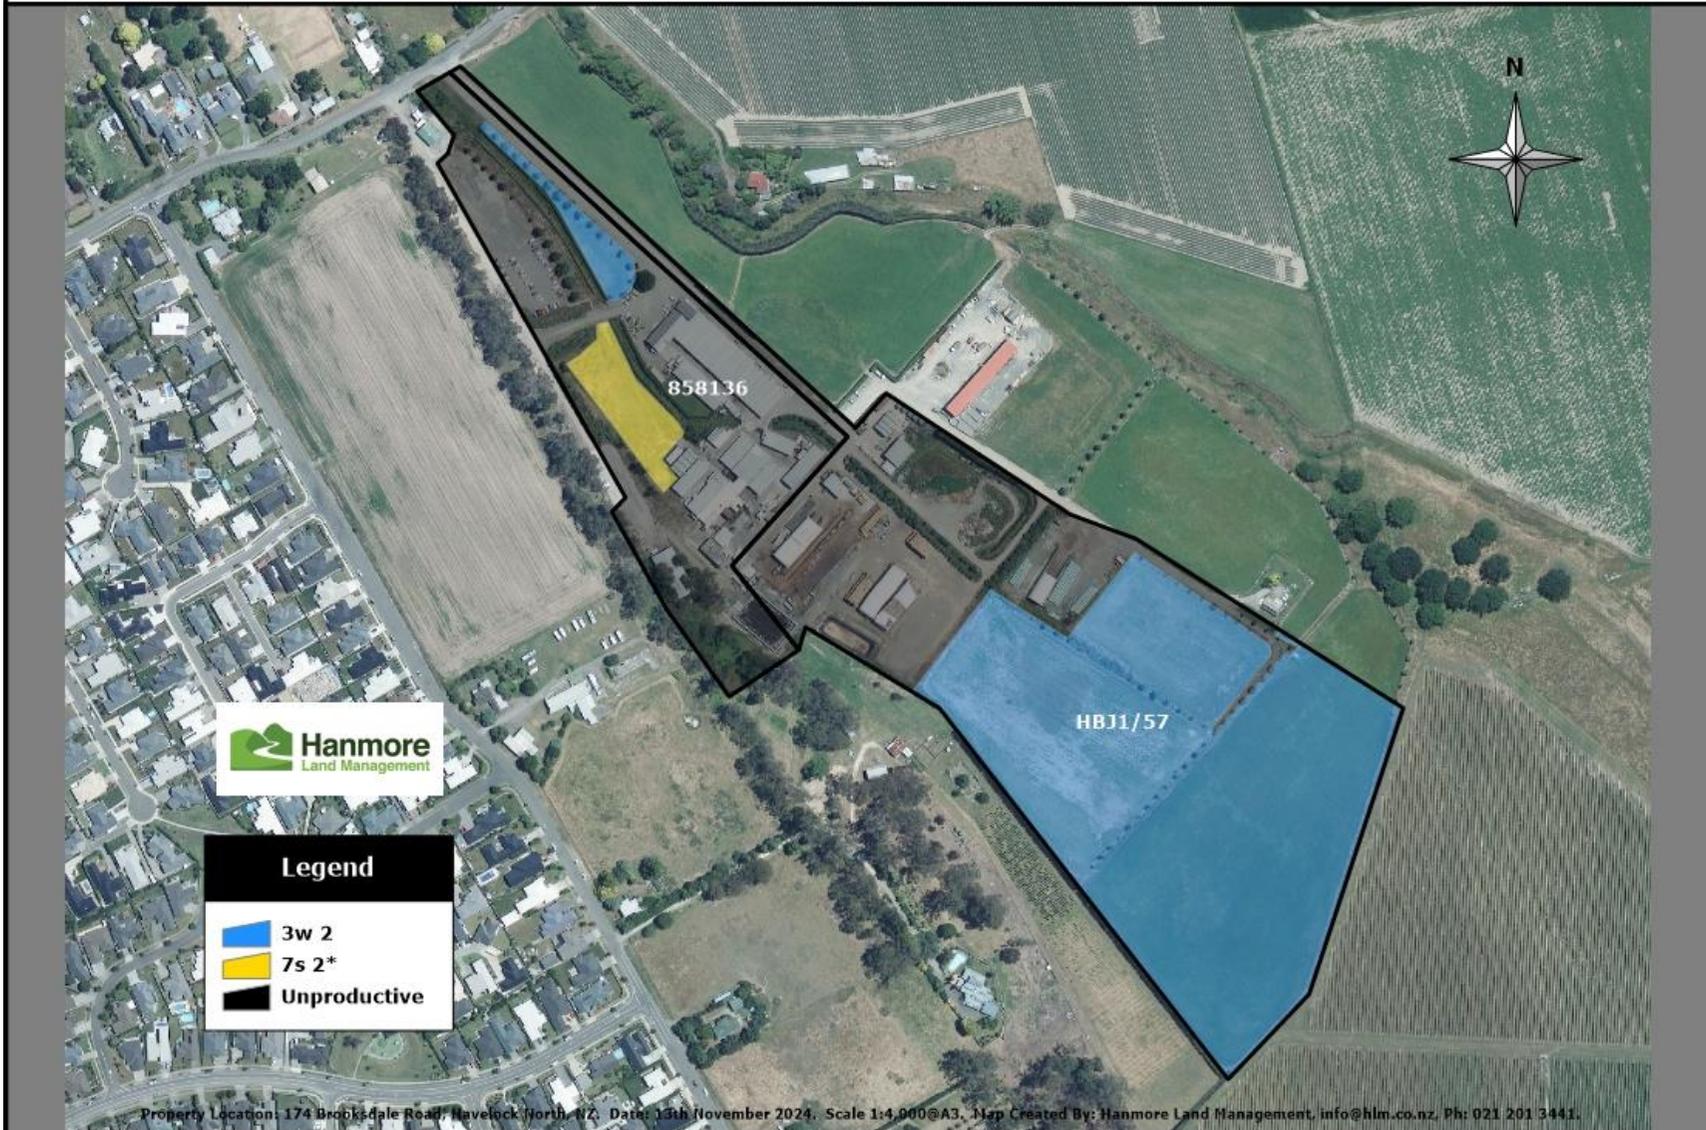
174 Brooksdale Road Land Use Capability Classifications

As can be seen in the soil and LUC maps a significant area of this title is also occupied by buildings, accessways and hardstand areas. These areas have no productive potential and therefore cannot be given a LUC classification. The balance of the site is classified as LUC unit 3w 2 includes and productive land but with degraded soil structure likely due to over cultivation.

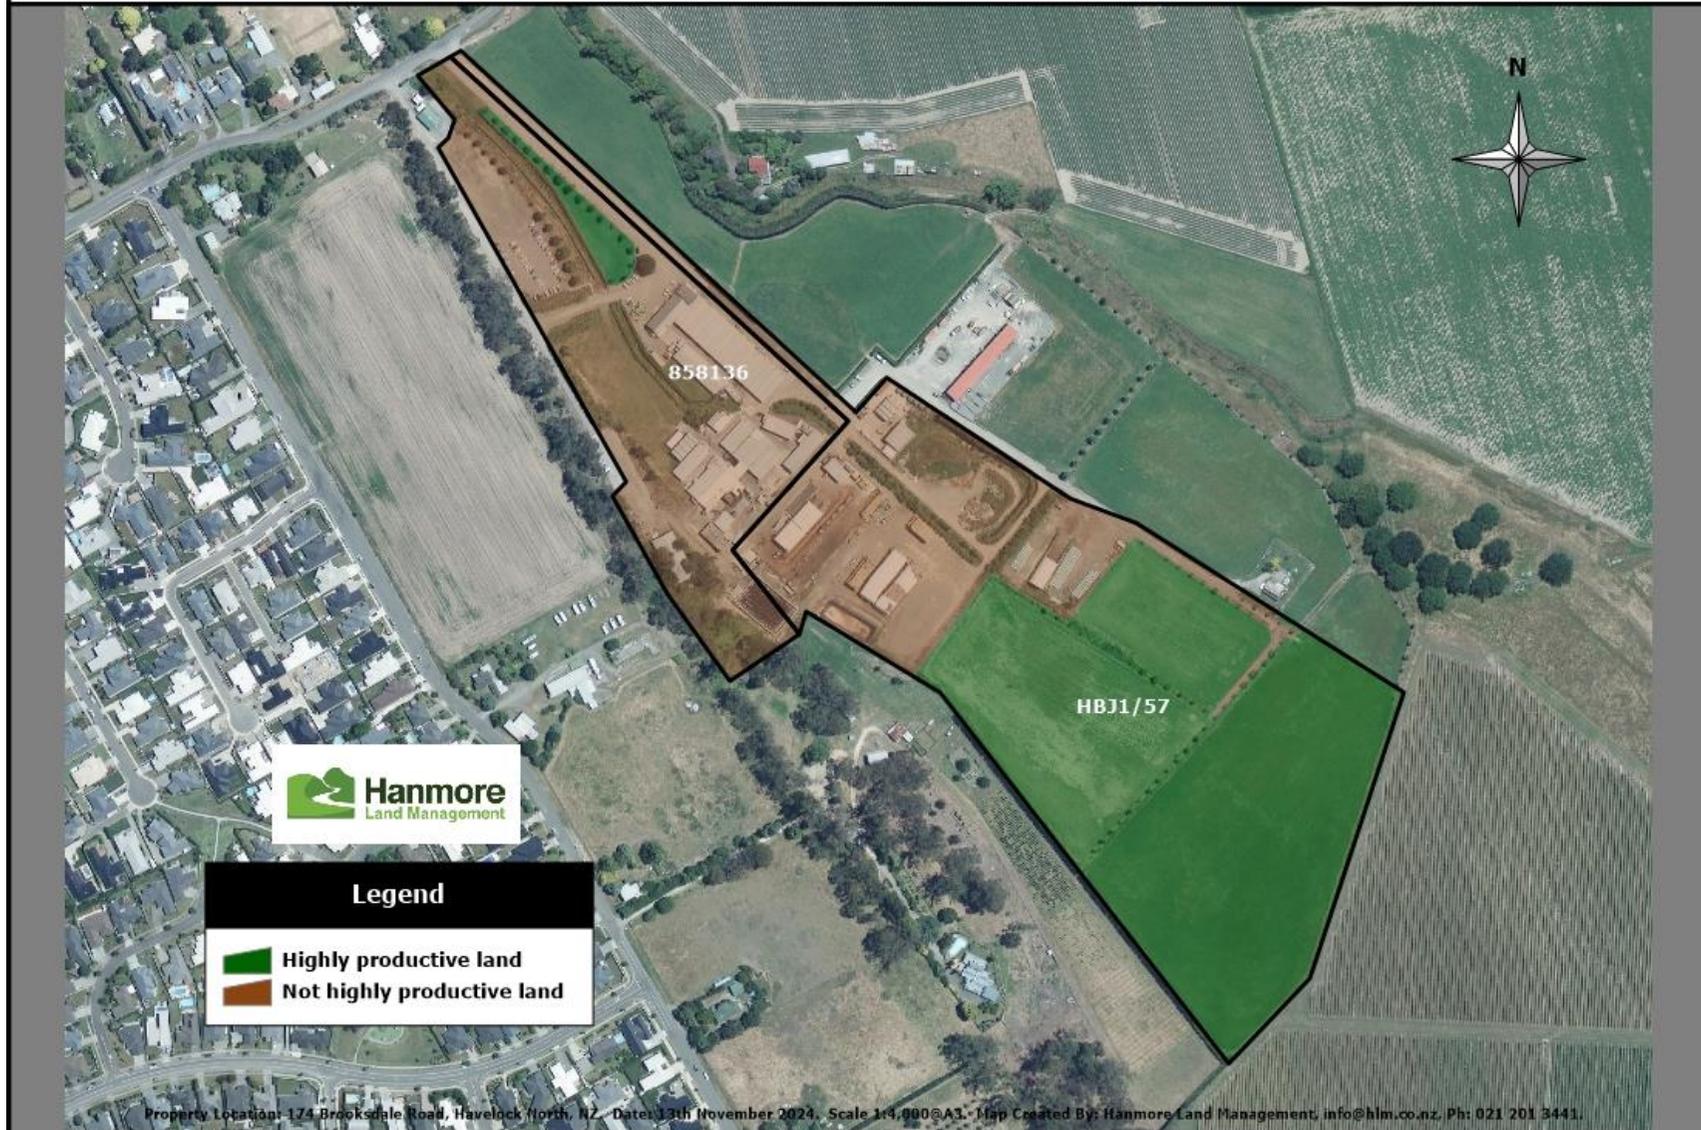
174 Brooksdale Road Highly Productive Land Classifications

- Productive soils at the site have been degraded due to compaction and loss of soil structure and require remedial action to return them to their natural level of productivity.

- The current land use appears to be unsustainable due to the soil profile degradation observed.
- The lack of land use options or site versatility mean this site would not be classified as a highly productive site.

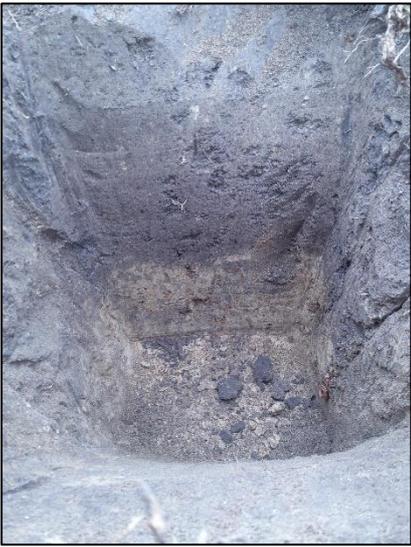
<p>Soil Name: Hinds_25a.1.</p> <p>Soil classification: Mottled fluvial recent soil.</p> <p>Parent material: Alluvium</p> <p>Soil description:</p> <p>0-260mm: Friable, weakly developed, 2-3mm nut, some compaction evident, very dark greyish brown (10yr 3/2), sticky, plastic, silt loam.</p> <p>260-400mm Very firm, massive, breaks to weakly developed 2-3mm nut, light brownish grey (10yr 6/2), sticky, plastic, gravelly clay with dark yellowish brown (5yr 4/6) iron deposits.</p> <p>Overall drainage: Imperfectly drained</p>

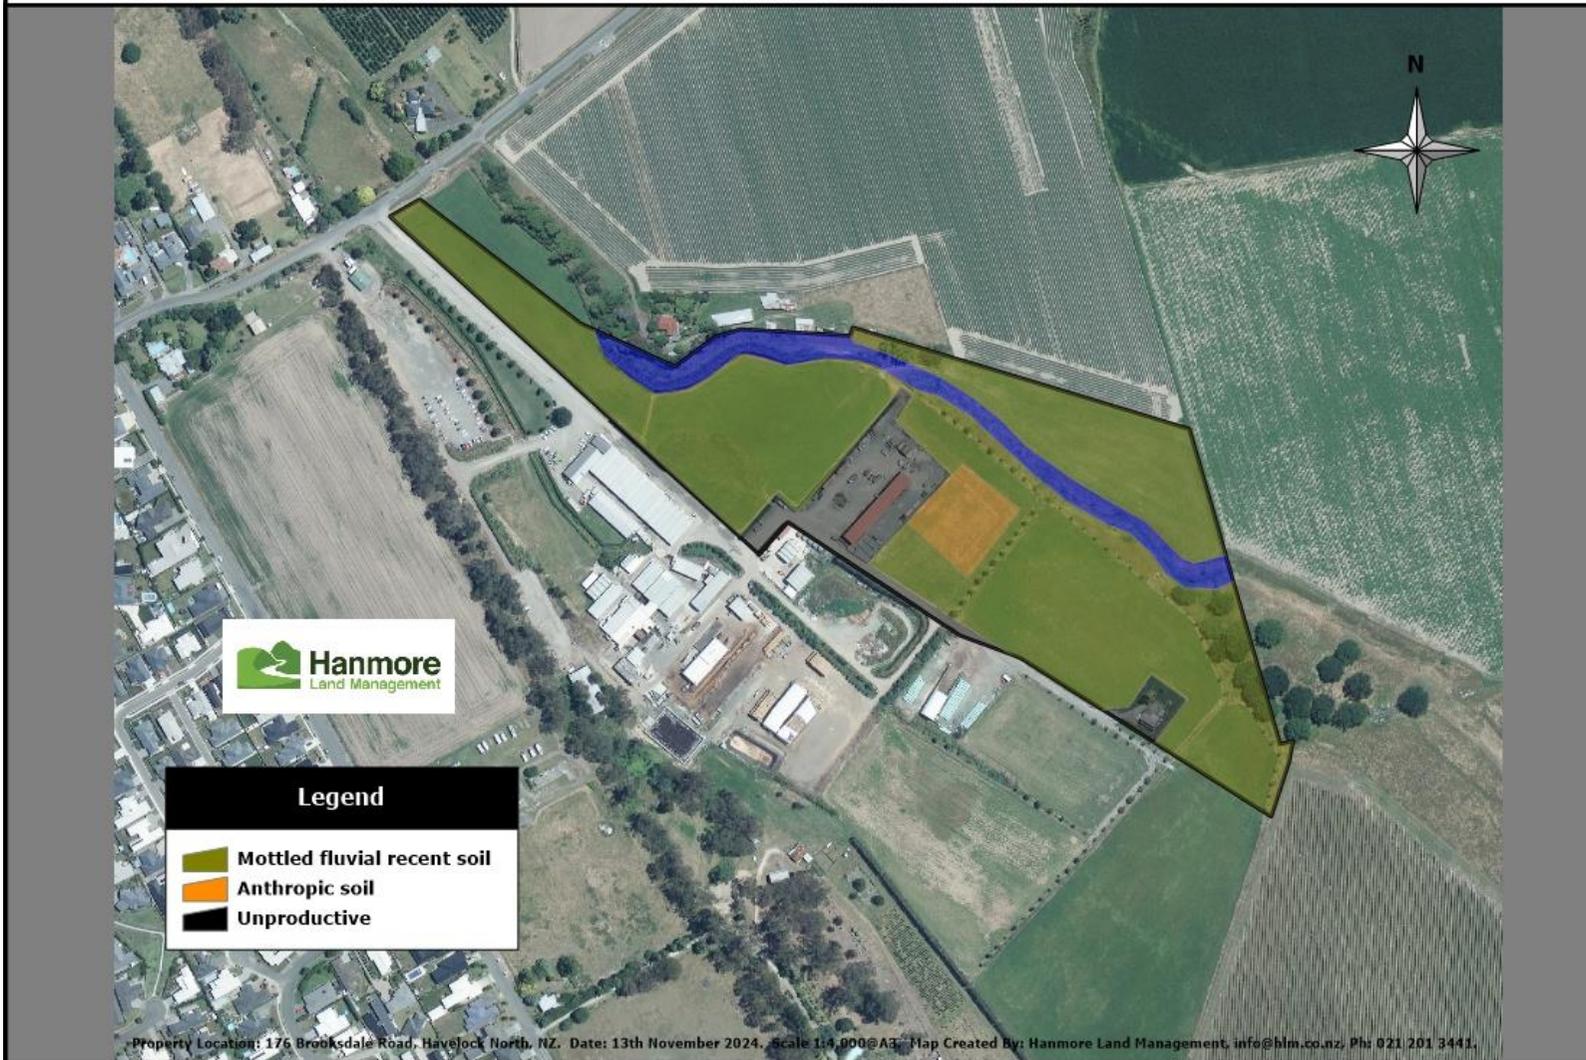
176 Brooksdale Road Soil Map

Also of note at the site is an old settlement pond that has been filled in. The area of the site has Anthropogenic or a manmade soil profile. Based on the report by the Land and Water People in which trenches were dug and soil auger samples taken this area was found to be a mix of topsoil and subsoil along with sand, gravel and rubbish.

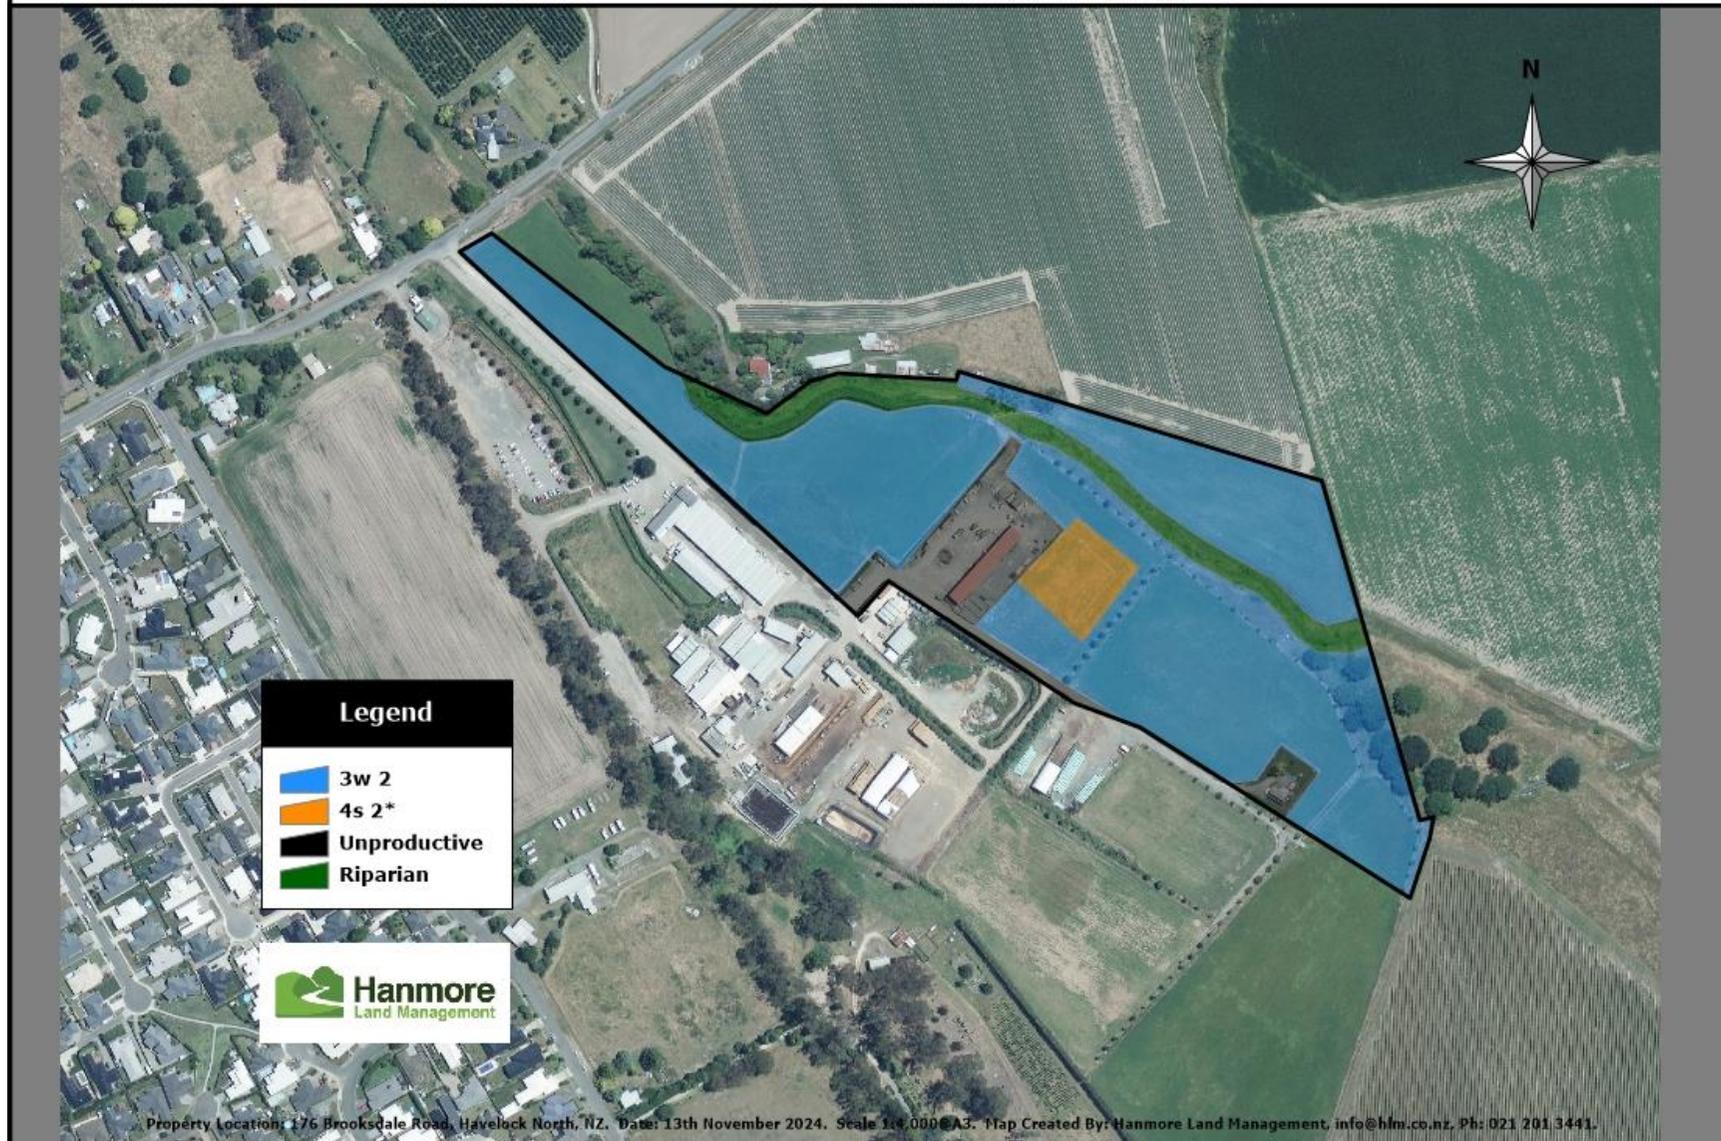
176 Brooksdale Road Land Use Capability Classifications

Due to the alteration of the soil profile at the site of the old settling pond this area has been given a 4s 2* classification reflecting the degradation of the natural soil profile. The remaining area of the site, apart from the riparian zone, retains its 3w 2 classification.

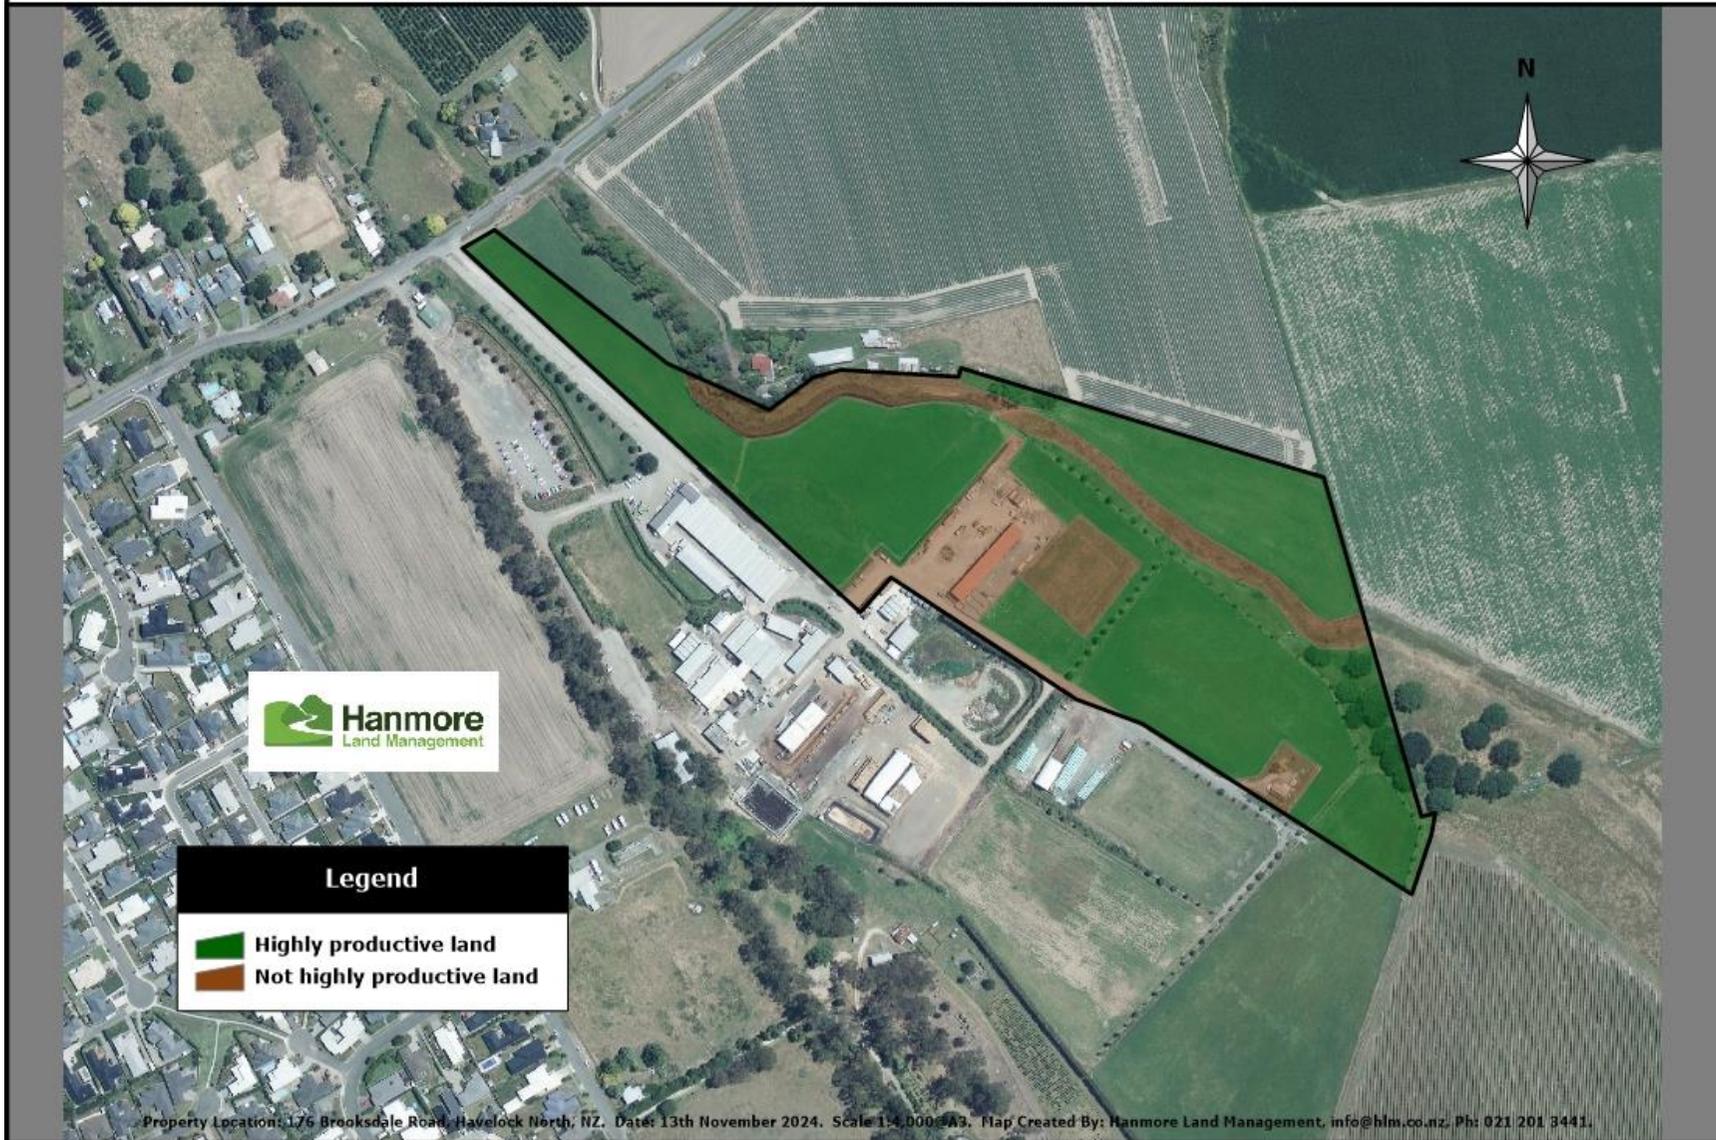
176 Brooksdale Road Highly Productive Land Classifications

- The entire site is technically classified as HPL under the NPS-HPL but in reality significant areas of the site have been developed and have no productive potential.
- The site is currently operated in conjunction with 174 Brookvale Road but needs to be considered separately in its productive capacity rather than as one block.
- Impeded soil drainage and stony soil profiles limit the productive potential of the site making it more suited to intensive grazing than cropping.
- Soils at the site have been degraded due to compaction and loss of soil structure and require remedial action to return them to their natural level of productivity.
- The current land use appears to be unsustainable due to the soil profile degradation observed.
- The lack of land use options or site versatility mean this site would not be classified as a highly productive site.

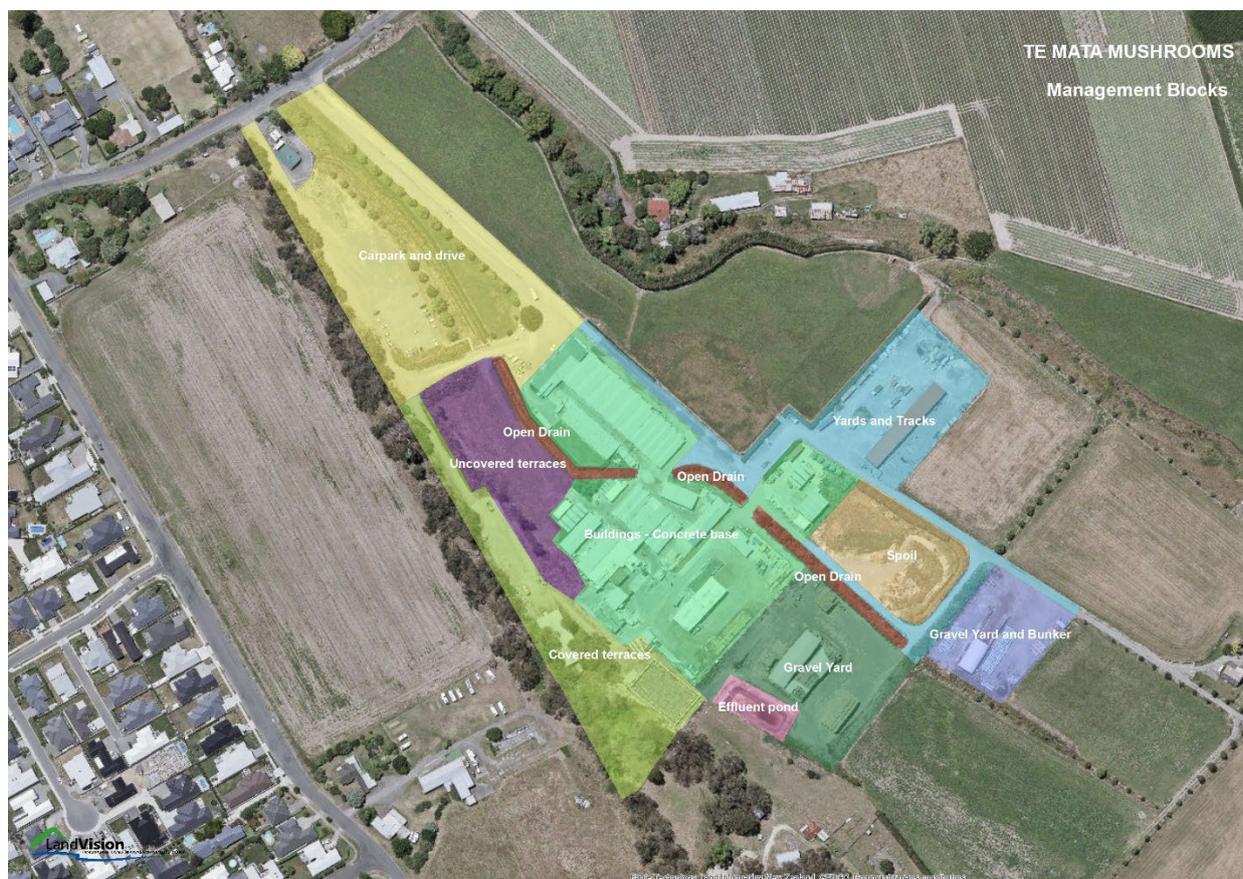
Figure 1: Management blocks on Te Mata site - Management blocks are essentially areas of difference that are separately assessed in Table 1 below. Total area of blocks is 8.54ha

Table 1: Table of respective management blocks and characteristics as they relate to LUC

Management Block	Area (Ha)	Description	LUC
Carpark and drive	1.81	Excavated site (carpark) drain, and drive. No soil within this block apart from a very small area of grass adjacent to drive. The soils on this area are structureless and most likely introduced. Soil on the rest of the block has been removed and replaced with gravel 200-300mm deep. Carpark is excavated from a terrace rise which has	Non-Productive

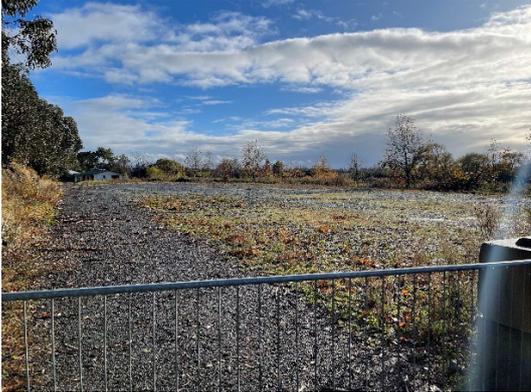
<p>also had sub soil removed.</p>

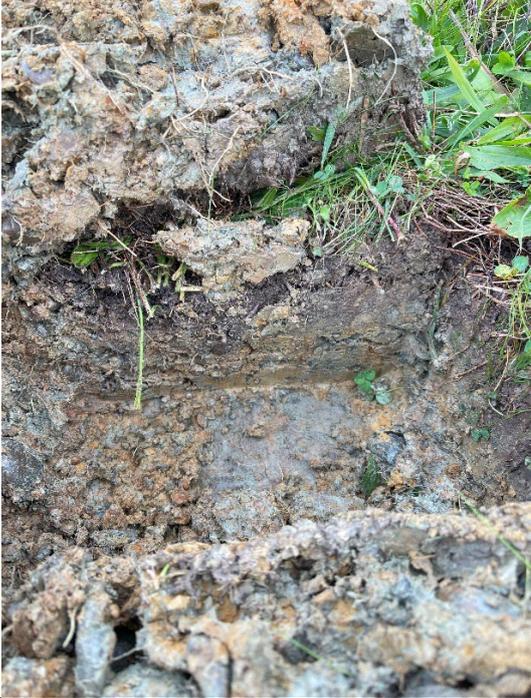
Uncovered terraces	0.59	<p>Excavated site. No soil or sub soil present.</p>

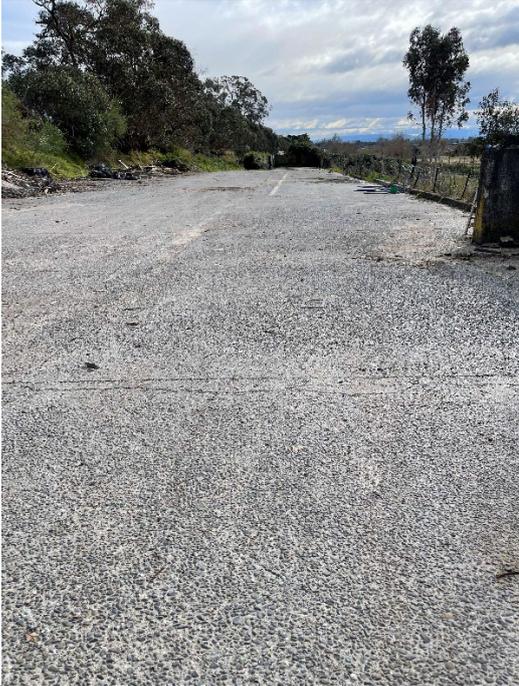
Non-Productive
Covered terraces	0.96	<p>Excavated site. No soil present. Approx. 100mm gravel under 100mm concrete. Small area of original terrace rise included in this block. This area is best mapped as unit IVs2 (Rolling to strongly rolling ridges of loess overlying red metal seams).</p>	Non-Productive apart from very small area (approx. 3000m ²) of IVs2.

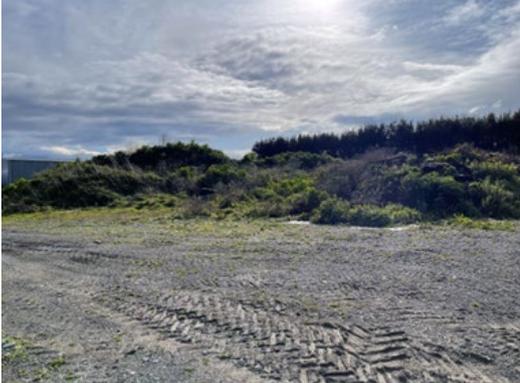
Non-Productive
Spoil	0.48	<p>Various spoil material placed on top of soil surface. Very poorly drained and gleyed .</p>	Non-Productive

<p>Not suitable for production.</p>

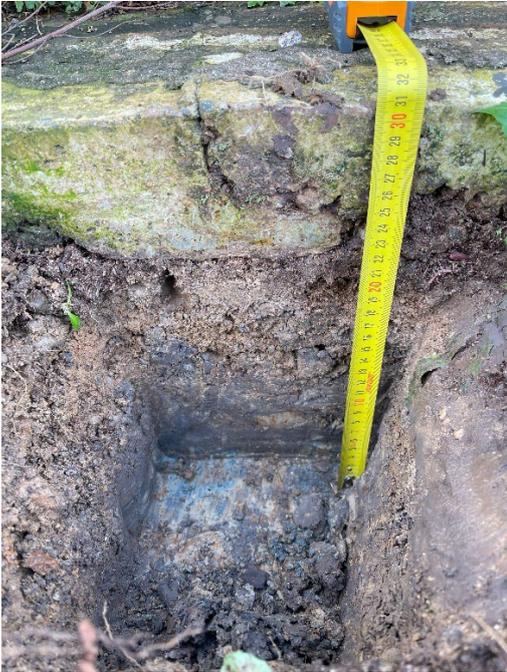
Buildings - Concrete base	2.06	<p>Oldest part of site where main buildings are situated on a concrete base. No soil present. Concrete over gravel over very gleyed sub soil.</p>

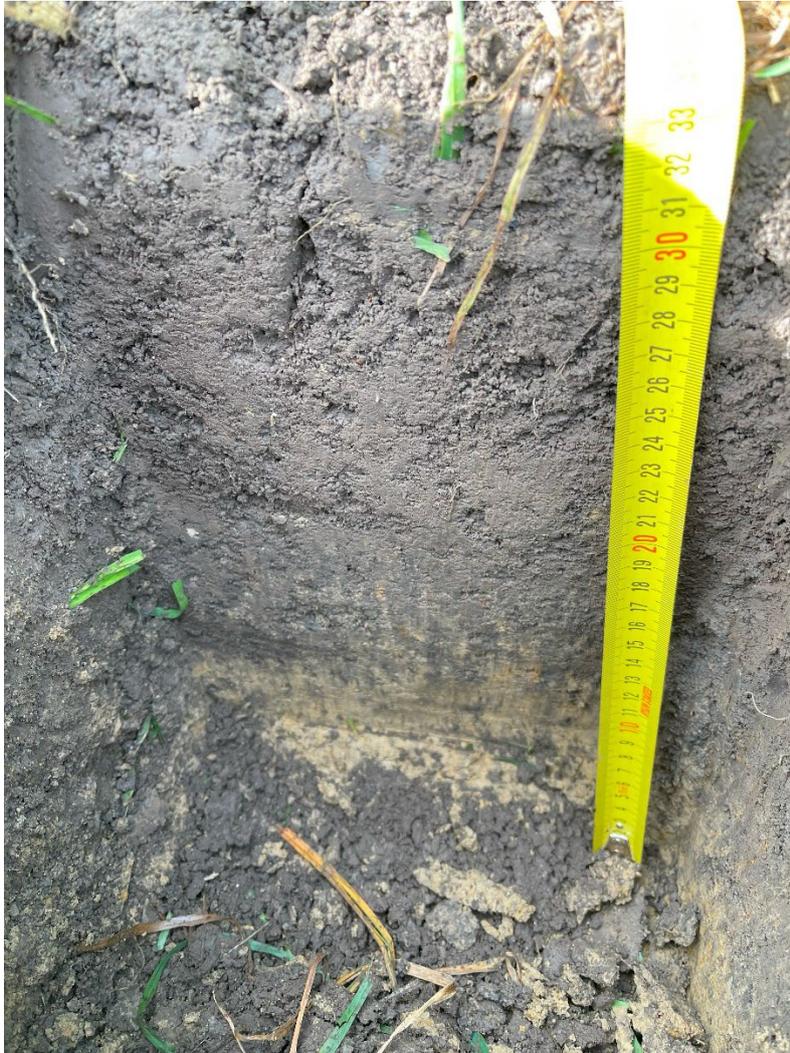
As a comparison the soil profile in the adjacent paddocks was inspected in three locations. While there were differences in soil characteristics between these three points in general the soils in the adjacent paddocks were as expected.

Figure 2: productive soil in adjacent paddock
