REFERRAL APPLICATION FOR RESOURCE CONSENT UNDER THE
FAST TRACK APPROVAL ACT 2024

1080 STATE HIGHWAY 16

GEOTECHNICAL APPRAISAL REPORT

Job No. AKL2025-0012AB | Version Rev. 3

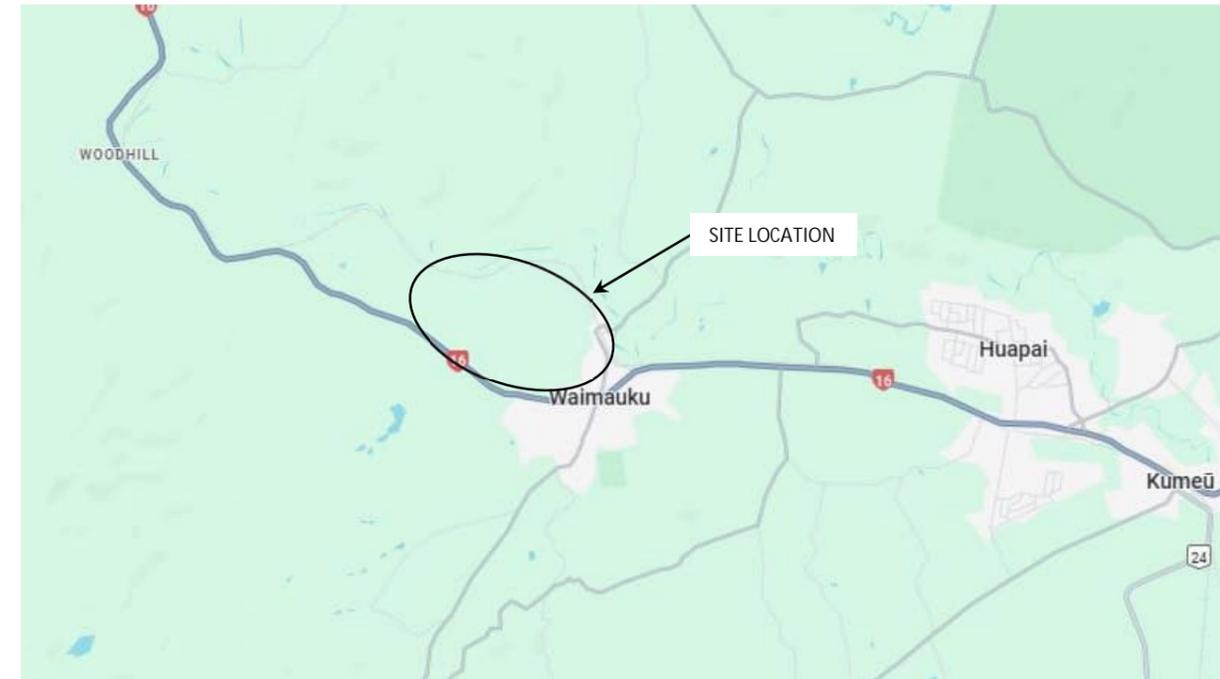
Figure 1: Site Location Plan (Google Maps)

The site encompassing the proposed resource consent area, comprises an area of approximately 200 ha and is located in the southern portion of 1080 State Highway 16, Waimauku, Auckland as shown on *Figure 1* and *Figure 2*.

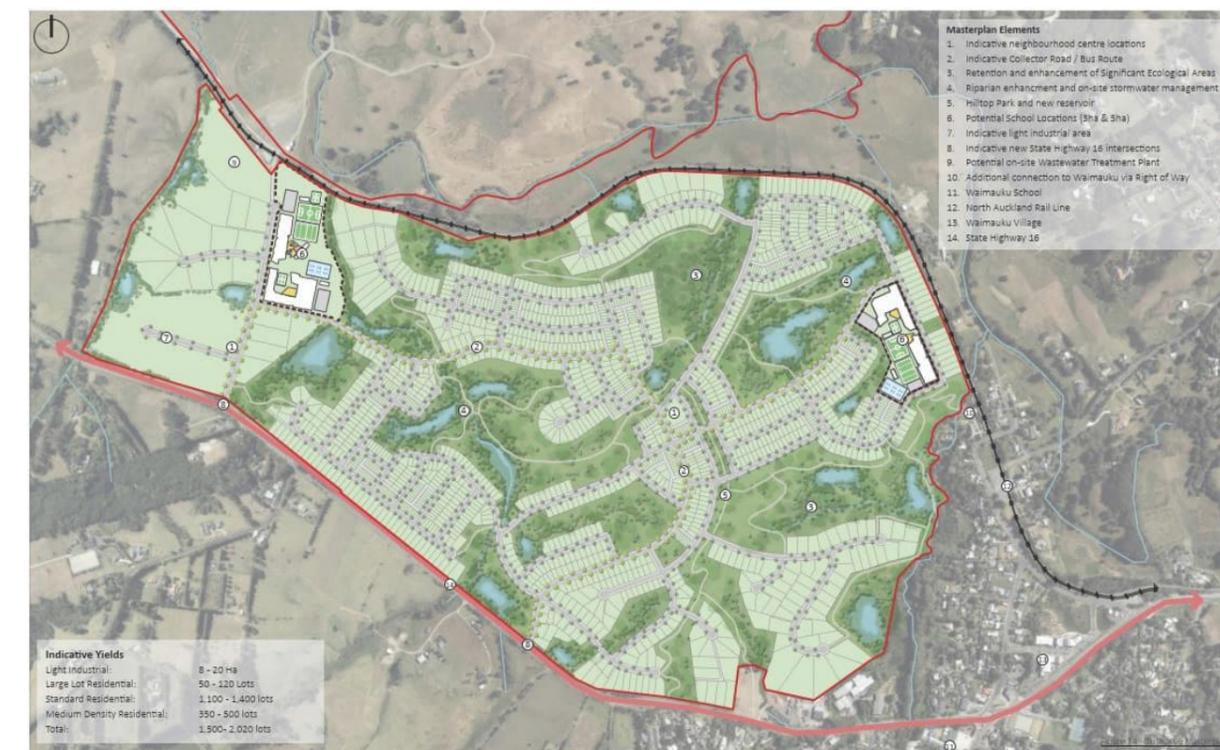
Figure 2: Site Masterplan (Barker Associates)

CMW has been provided with an initial masterplan which shows the site subdivided into 1596 residential lots across a range of lot sizes, A neighbourhood centre, a light industrial area, 22 open spaces and a wastewater treatment plant. This plan currently shows that the lowest density development areas are located in the western and southeastern areas of the site with higher density areas filling in the centre. The updated masterplan is presented in *Appendix A* and in *Figure 2*.

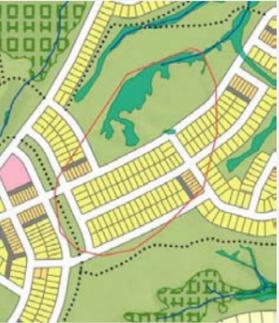
Masterplan Comments			
Hazard	Description of Hazard on Development	Remediation Options	Photograph of Area
Deep-Seated Slope Instability	A large deep-seated landslide is inferred to be within the area shown by the red outline in the attached photograph.	It has been made aware to CMW that large cuts are proposed to the more elevated areas of the site which includes the southern half of this landslide. Head unloading through earthworks, along with construction of a shear key at the base of the landslide and reworking or removal of unsuitable material should be sufficient to reduce the risk for this area of the development to acceptable levels. Low to moderate height retaining walls are likely to be required between lots within this area.

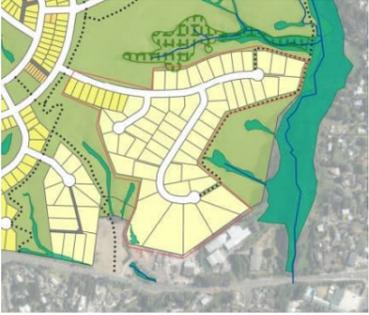
Deep-Seated Slope Instability	Multiple large deep-seated landslides are inferred to affect the development area shown by the red outline in the attached photograph.	It has been made aware to CMW that large cuts are proposed to the more elevated areas of the site which includes head scarps of the inferred landslides to the northwest of this development area. Head unloading through earthworks, along with construction of a shear key at the base of the landslide and reworking or removal of unsuitable material should be sufficient to reduce the

Masterplan Comments			
Hazard	Description of Hazard on Development	Remediation Options	Photograph of Area
		risk for this area of the development to acceptable levels. Low to moderate height retaining walls are likely to be required between lots on steeper portions of this area.	
Deep-Seated Slope Instability	Multiple deep-seated landslides are inferred to affect the development area shown by the red outline in the attached photograph.	It has been made aware to CMW that large cuts are proposed to the more elevated areas of the site which includes head scarps of the inferred landslides to the northwest of this development area. Head unloading through earthworks, along with construction of a shear key at the base of the landslide should be sufficient to reduce the risk for this area of the development to acceptable levels. Low to moderate height retaining walls are likely to be required between lots in this area.

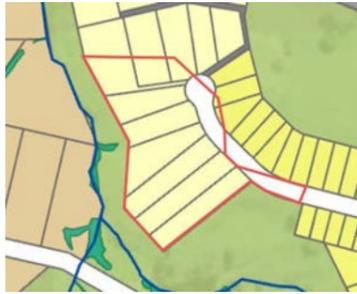
Deep-Seated Slope Instability	Multiple deep-seated landslides are inferred to affect the development area shown by the red outline in the attached photograph.	Given the relatively small size of these landslides in comparison with other landslides referred to in the rows above, these landslides should be considered remediable through earthworks. These earthworks are likely to include construction of a shear key.

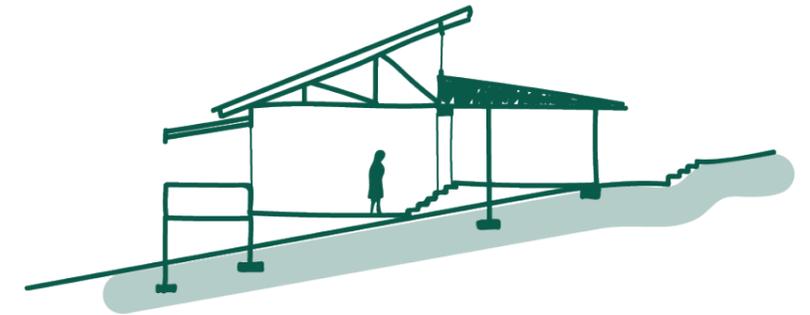
Stepped floor levels -
approximate 15% slope
(south facing slope)

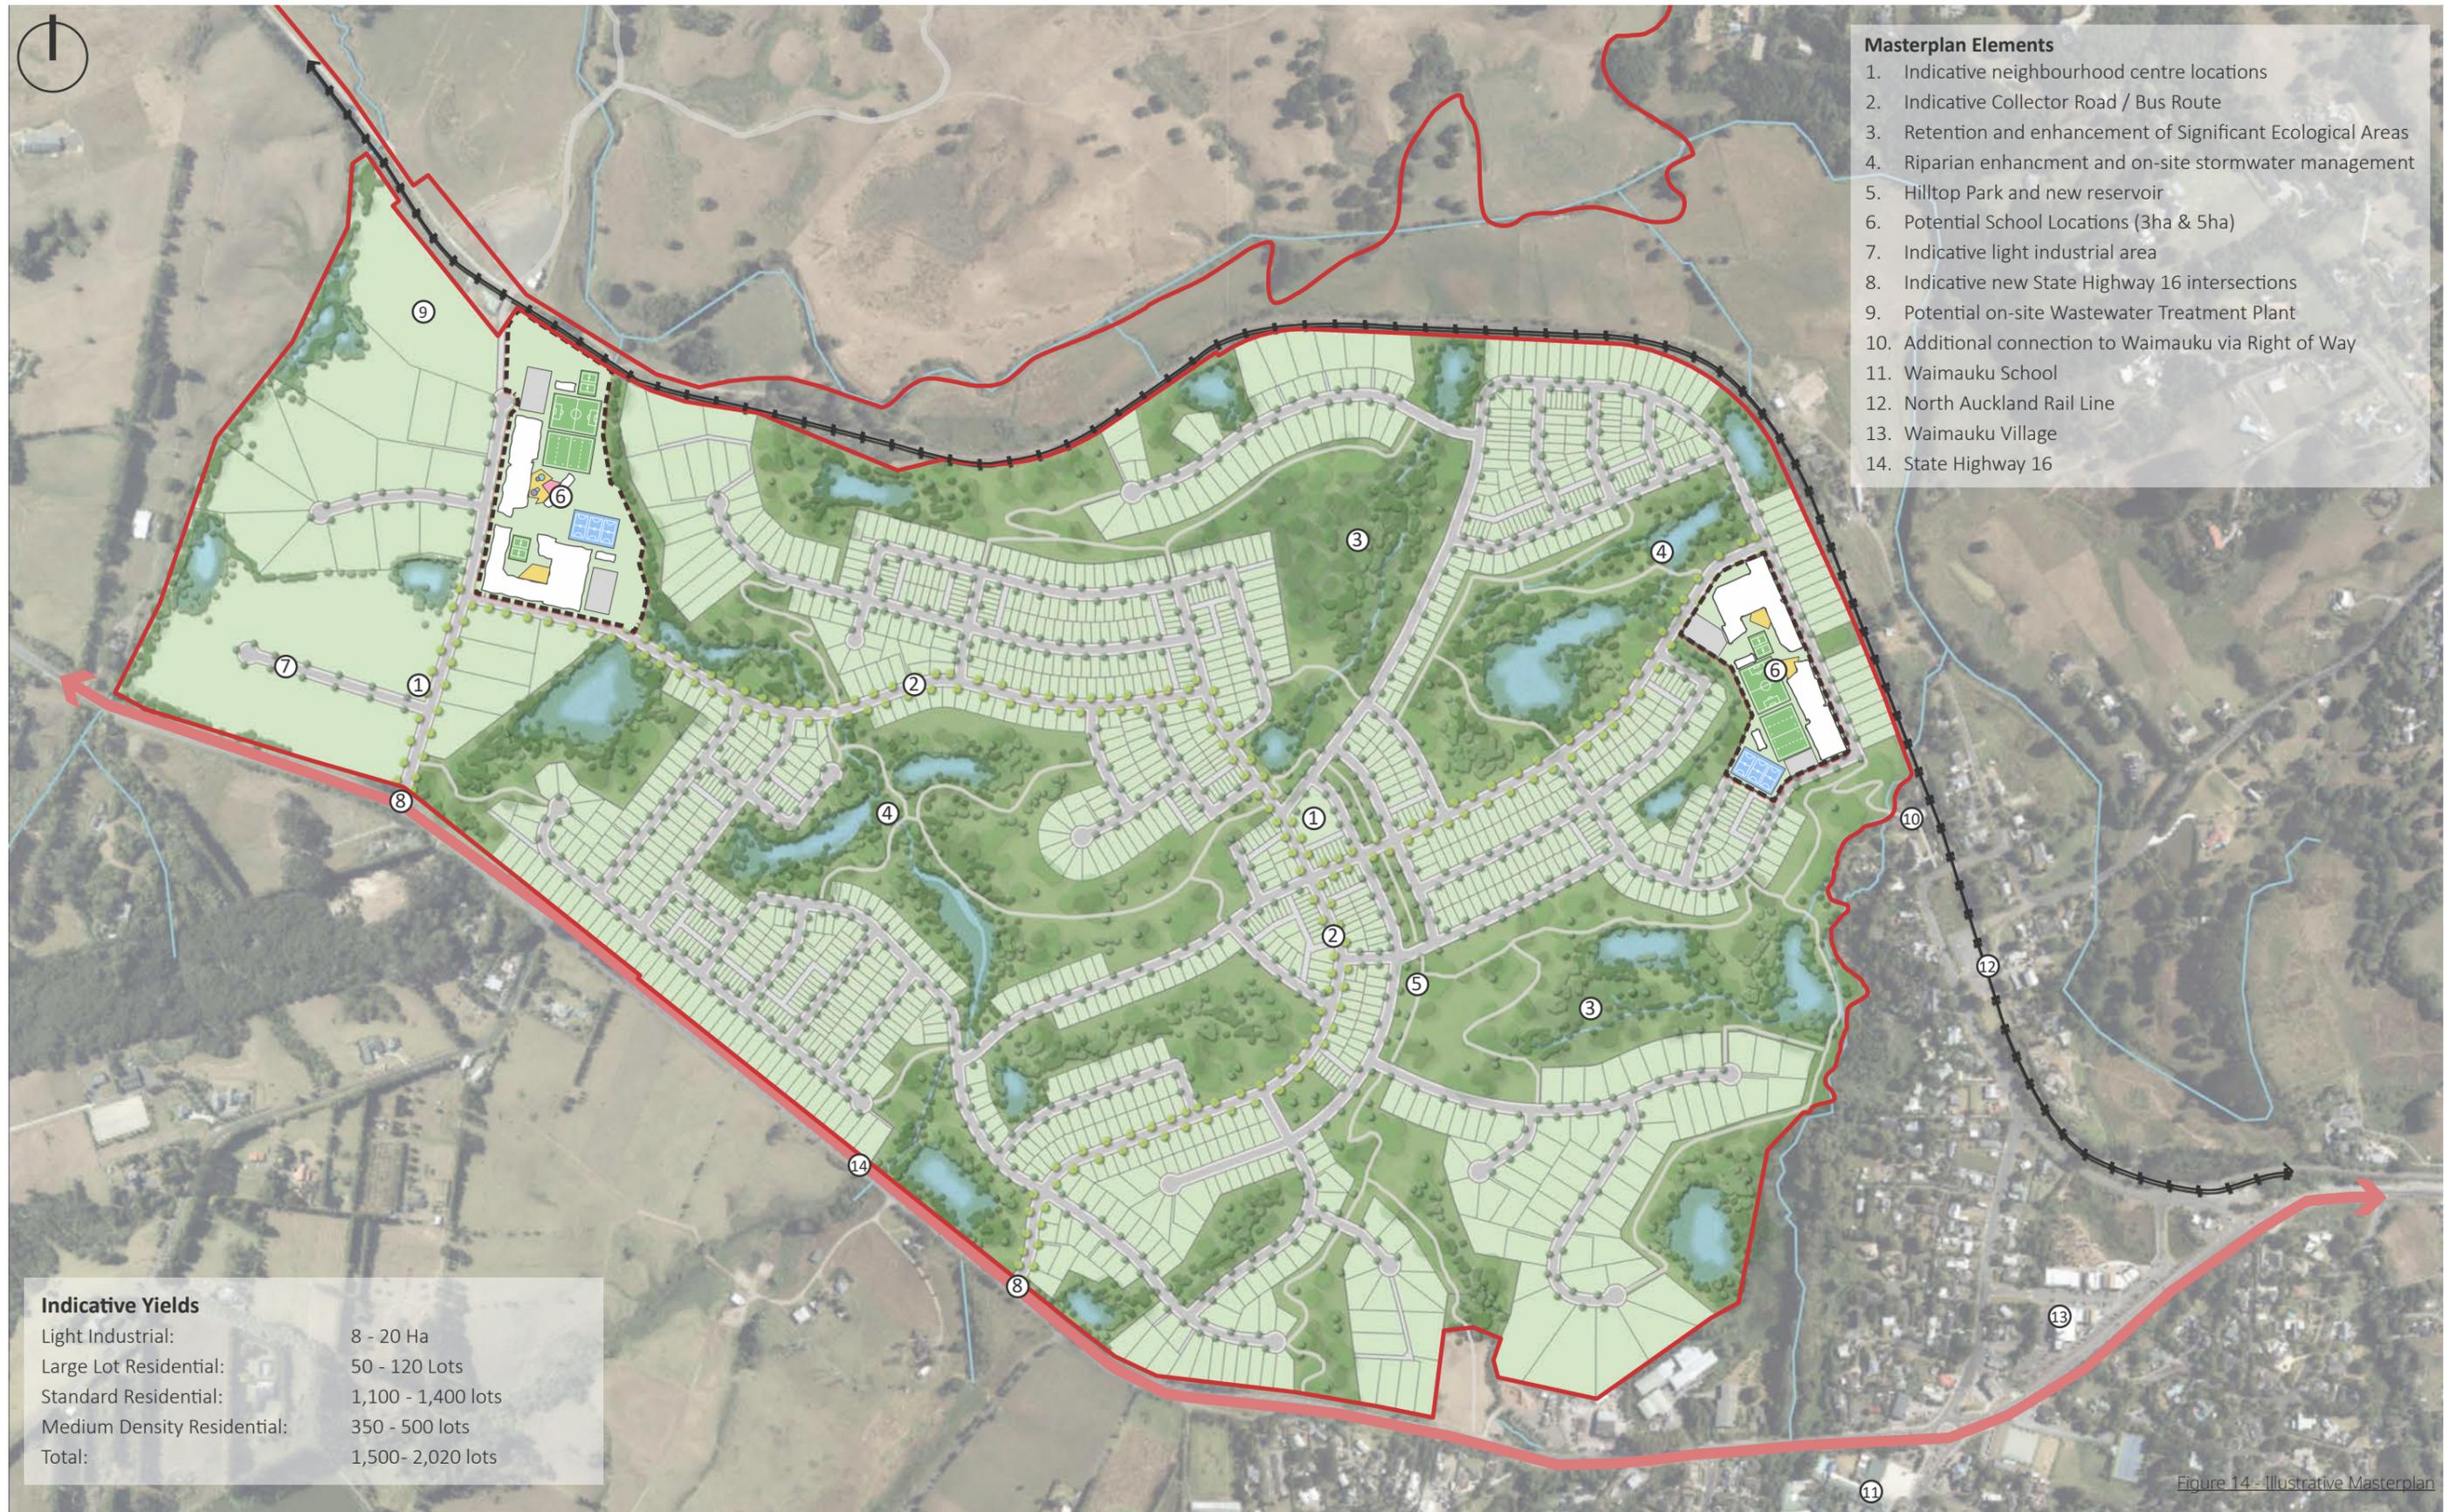
2.4 Illustrative Masterplan

The Illustrative Masterplan presents a vision for urban development of the site. Key landscape and ecological features of the site are maintained whilst facilitating a variety of residential typologies that respond to the market. Depending on detailed design it is estimated that the site could accommodate between 1,500 and 2,020 new residential dwellings.

Provision has also been made for two potential school sites (subject to further discussion with MoE), a neighbourhood centres and parks, land for business uses, stormwater management, and recreational trails.
