## **Appendix J      Technical Memo**

# Memo

| <b>Subject:</b> | <b>Redvale Landfill : Project Rex<br/>Task C2 : Stability Review Technical Memo</b> | | |

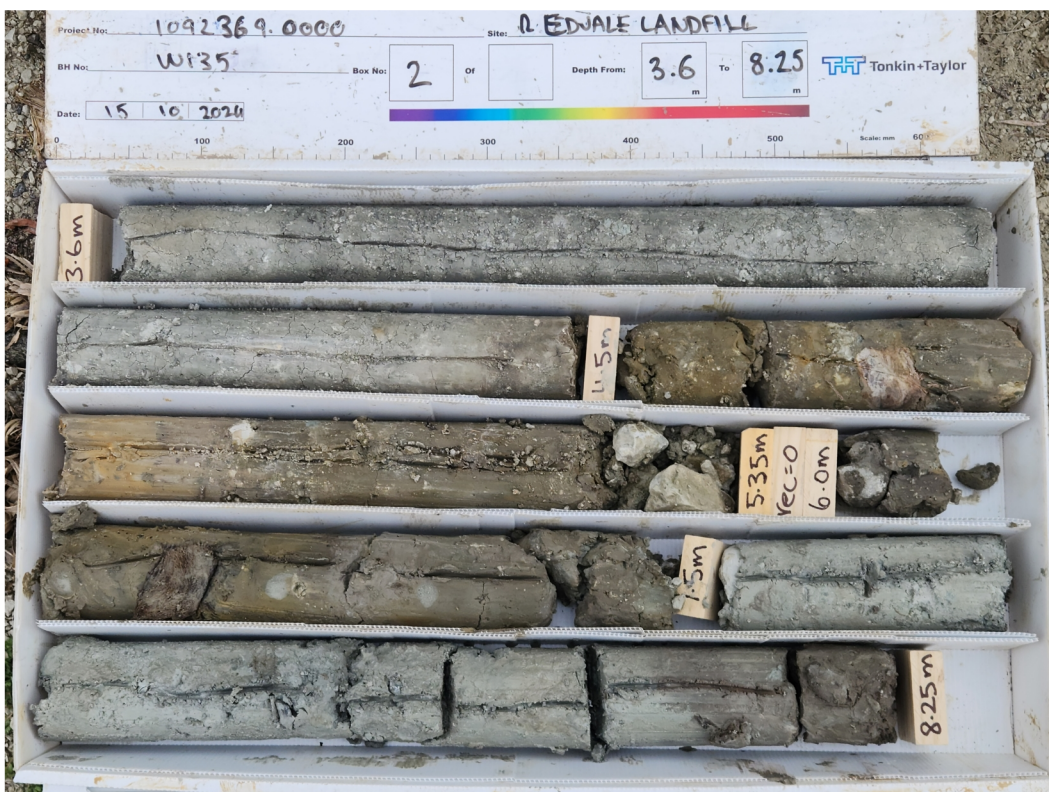
3.60-8.25m

| GEOLOGICAL UNIT | MATERIAL DESCRIPTION | Rock Weathering | Rock Strength | Sampling Method | Core Recovery (%) | Testing | RL (m) | Depth (m) | Graphic Log | ROCK MASS DISCONTINUITIES | | | | Water Level (Ref #) /<br>Fluid Loss (%) | Casing | Installation | Core Box No |
|---|---|---|---|---|---|---|---|---|---|---|---|---|---|---|---|---|---|
| | 5.35m: CORE LOSS - Suspect loose granular material dropped out of barrel | | | | | | | 6 | | | | | | | | | |
| | 6.00m: CLAY, some organic, minor cobbles; grey with streaked orange. Stiff to very stiff, moist to wet, medium to high plasticity wood fragments (partially decomposed) (fill - embankment) | | | | | | | 73 | | | | | | | | | |
| | 7.50m: Gravelly SILT, some organic, minor clay; light grey. Very stiff to hard, moist to wet, non-plastic to low plasticity; organics, rootlets rootlets (fill - embankment) | | | | | | | 72 | | | | | | | | | |
