## 8 Golden Bar Pit and Waste Rock Stack

### 8.1 Proposed Works and Project Area

#### 8.1.1 Pit Extension and Waste Rock Stack

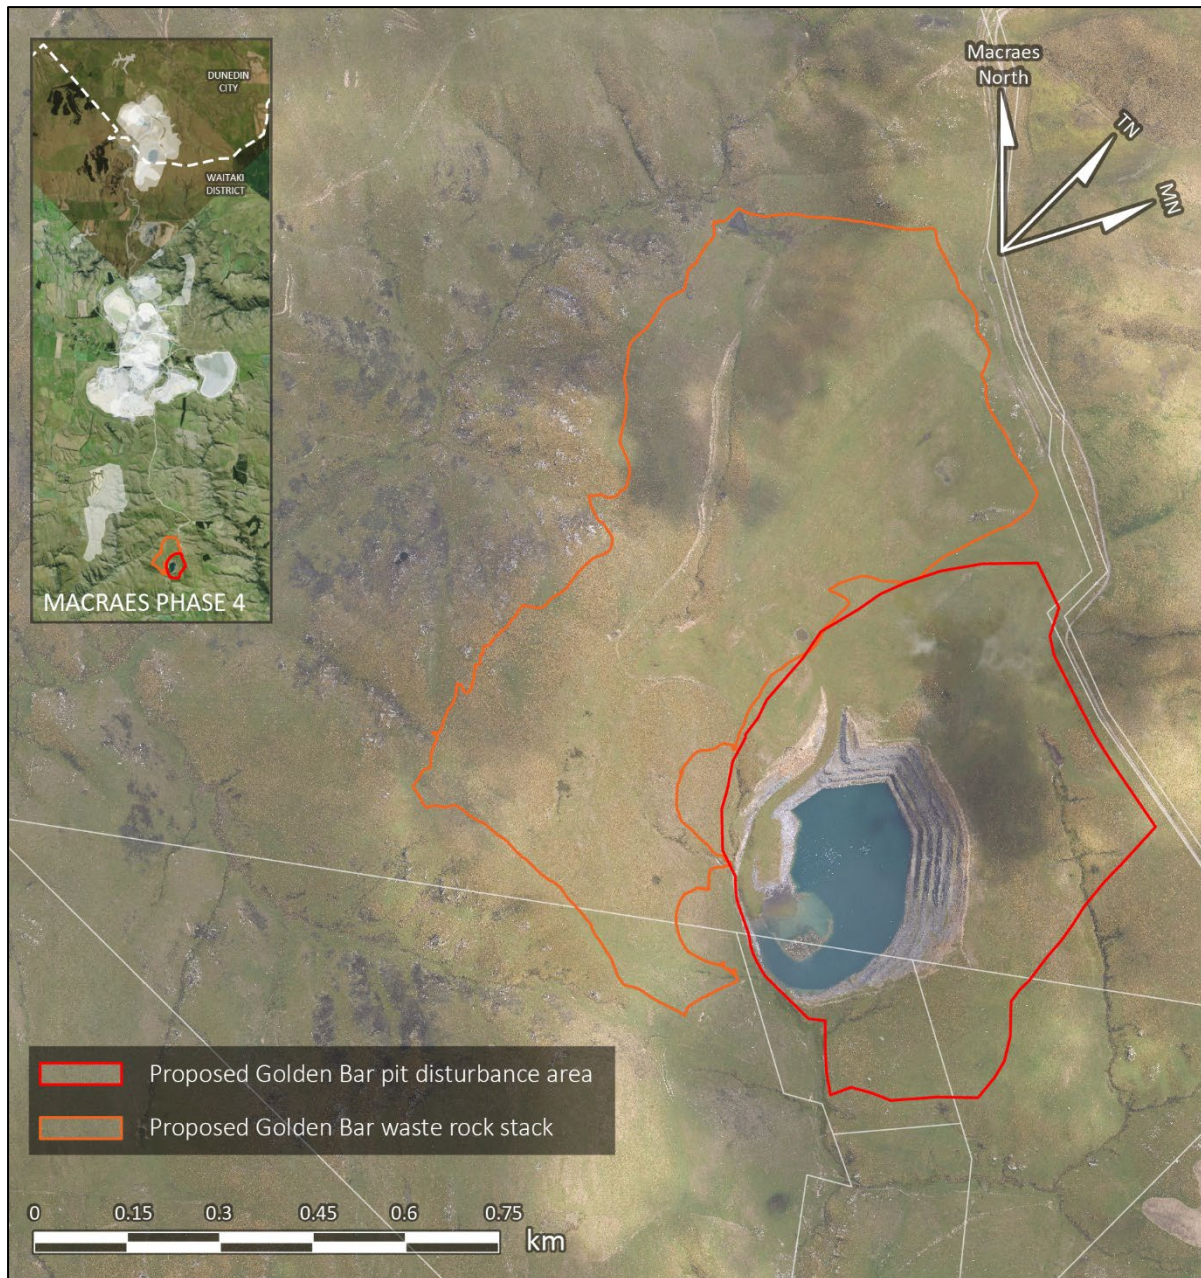
Figure 60. Pit disturbance area, pit shell, and waste rock stack footprints (2025 OGNZL aerial photography).

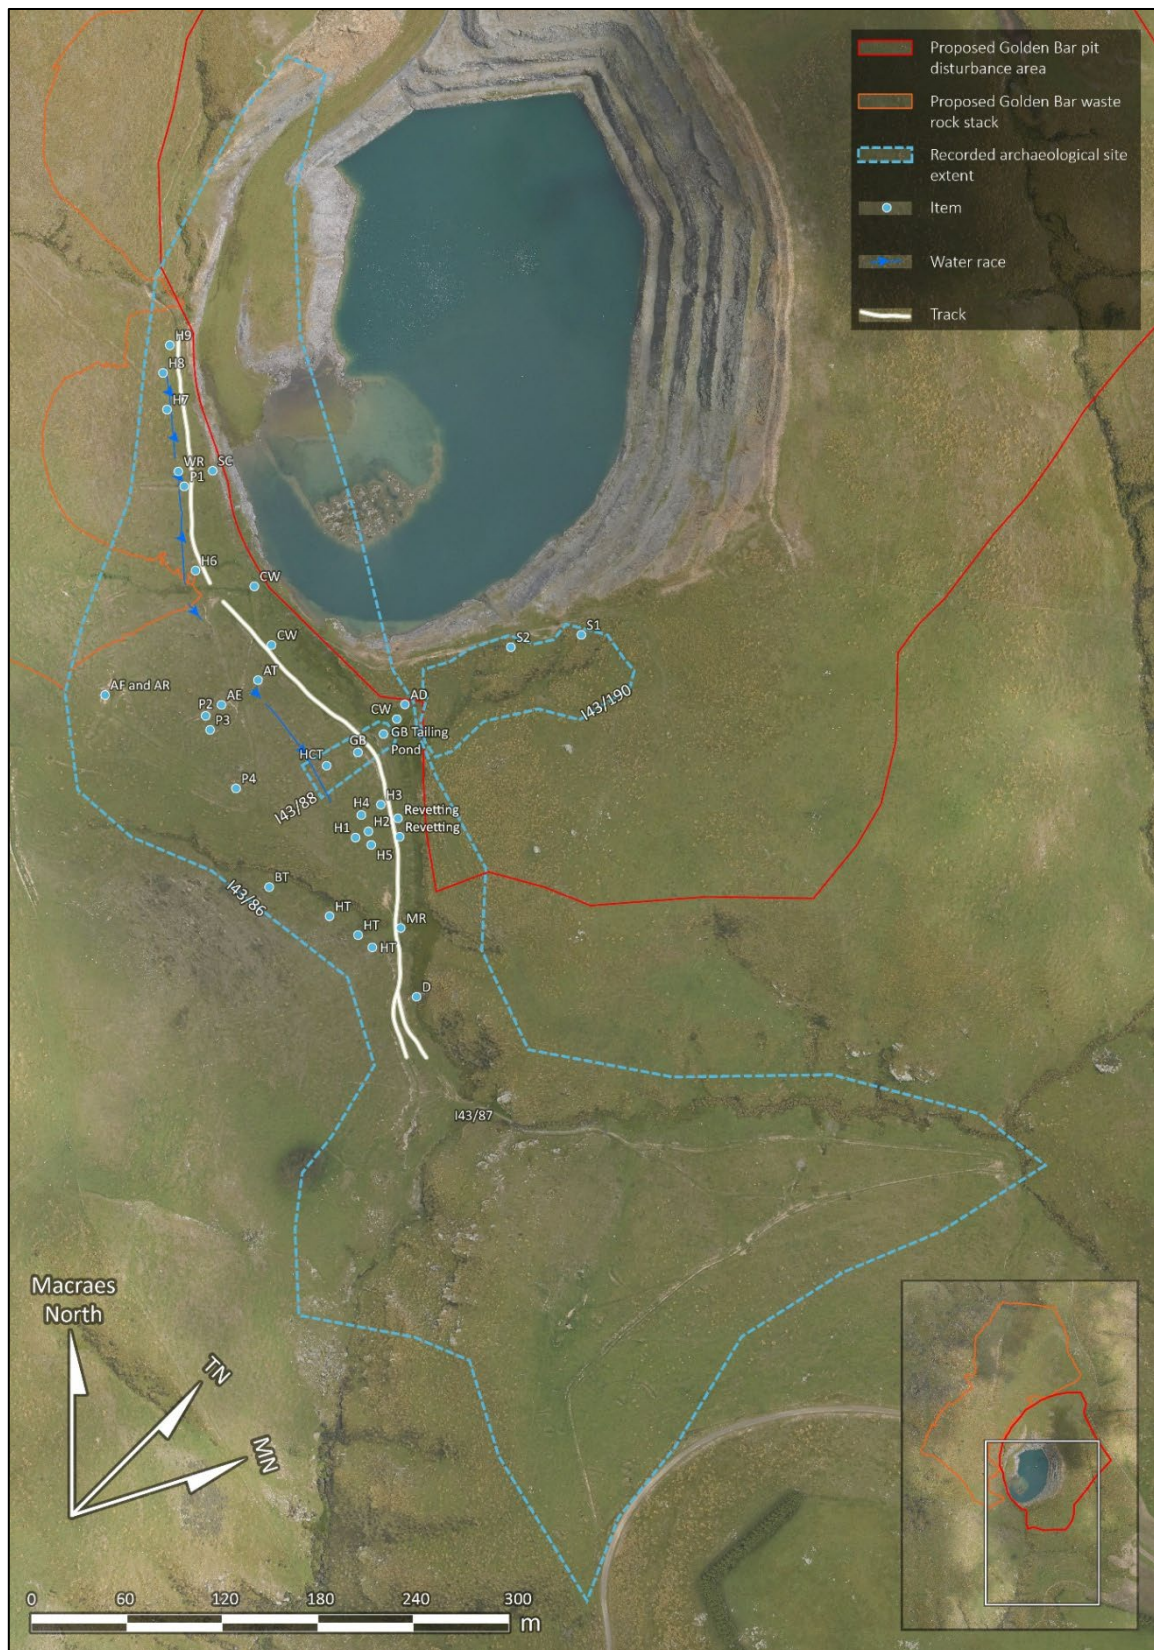
The Golden Bar mining site (I43/86) encompasses several features associated with the 19<sup>th</sup> and 20<sup>th</sup> century mining system as outlined in Figure 66 and Table 18, and includes two battery sites (archaeological sites I43/87 and I43/88). The 1901 gold battery (I43/87) is outside the pit disturbance area and was not included in the survey. Likewise features of site I43/86 which are located outside of the disturbance area, to the south of the surveyed dam (D), were not included as part of the survey.

Figure 66. Golden Bar Mine and Battery recorded items. Overall site extent of I43/86 is based on Petchey's 1990s survey (2025 OGNZL aerial photography).

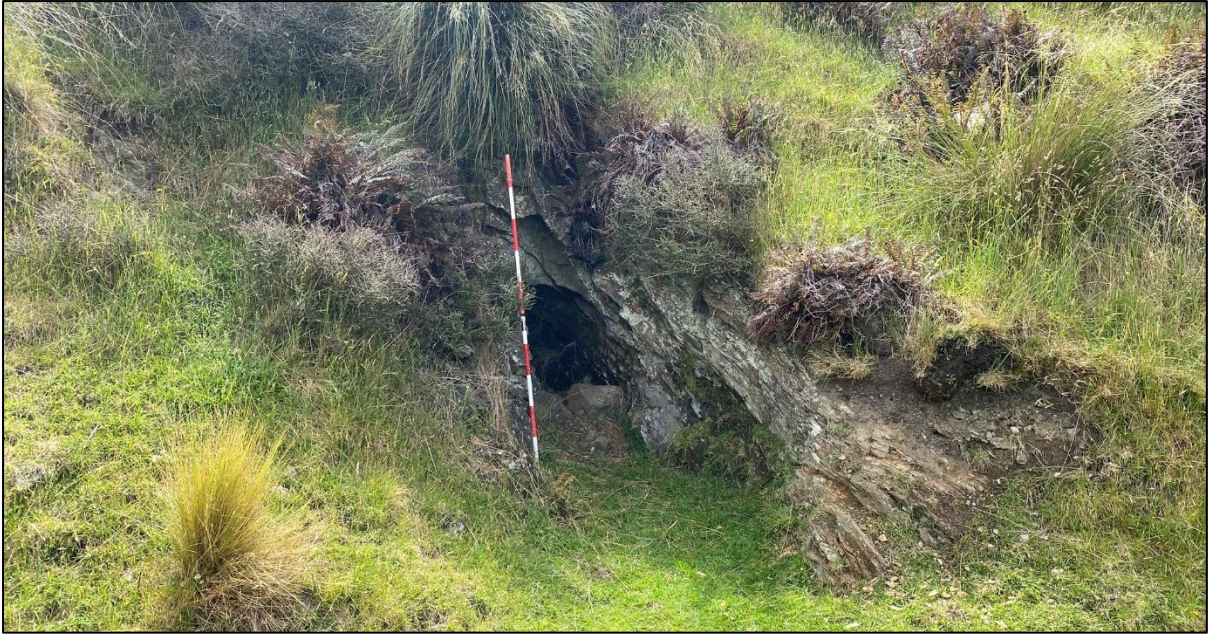
| Ref | Item | Details |
|---|---|---|
| AD | Adit | Adit identified as 'Adit D' by Petchey. Adjacent to tramway on the northern side of the creek, located north of 1927 battery (GB). Opening approximately 800mm tall and easily visible (Figure 67). |

Figure 67. Adit feature (AD) adjacent to tramway, looking north-west.

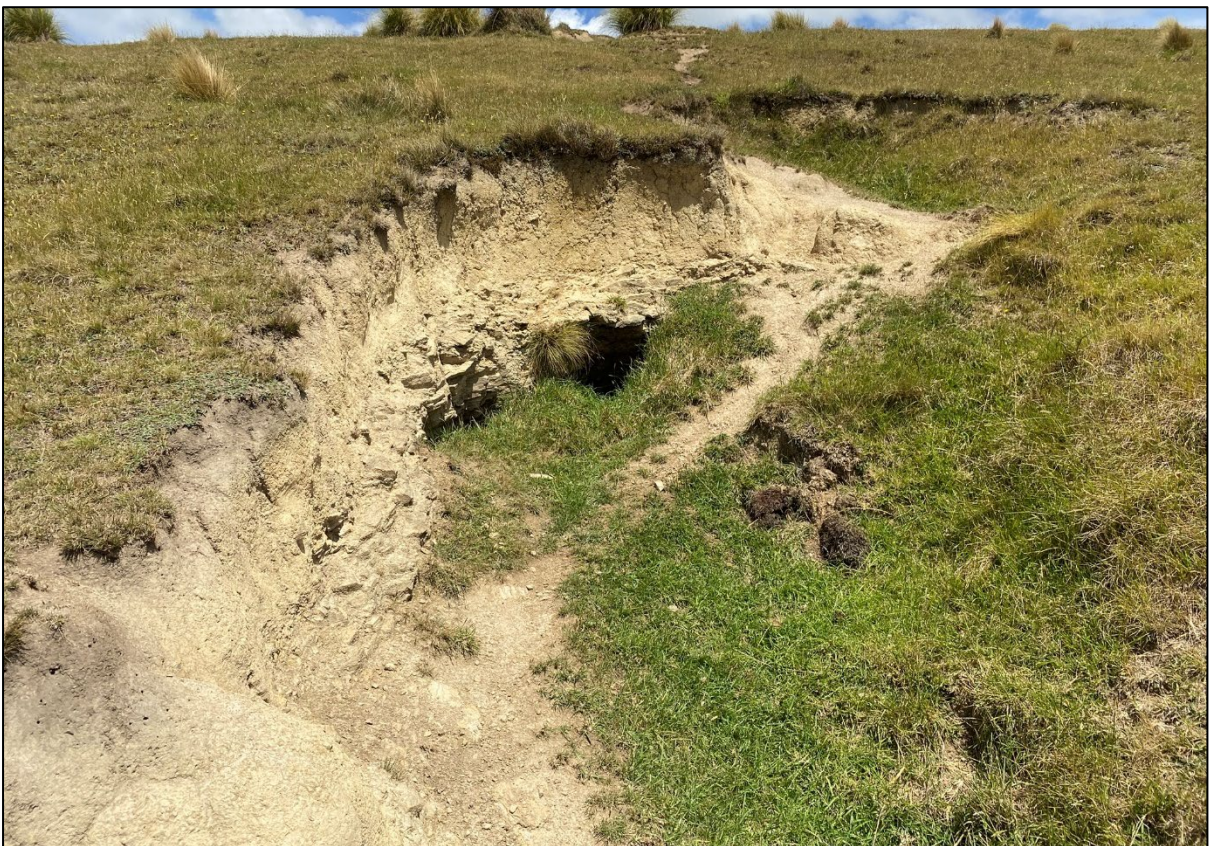
Figure 68. Adit feature (AE), looking south.

| Ref | Item | Details |
|---|---|---|
| AE | Adit | Adit identified as 'Adit E' by Petchey. Located south of Adit T. Surrounding area eroding due to loss of vegetation caused by old mine workings (Figure 68). |

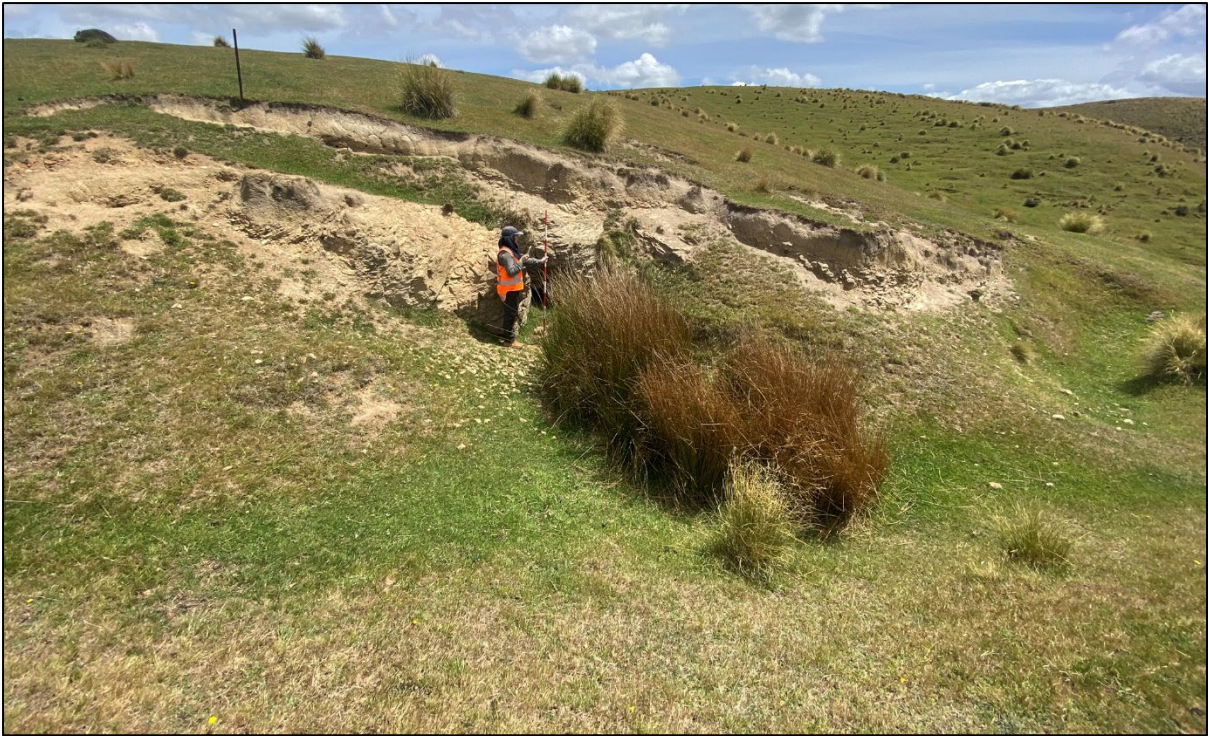
| Ref | Item | Details |
|---|---|---|
| AF | Adit | Adit to the south of adjacent Adit R. Identified as 'Adit F' by Petchey. Surrounding mine workings causing erosion due to vegetation loss. Adit opening has been partially closed off (Figure 69-Figure 70). |
| AR | Adit | Adit identified as 'Adit R' by Petchey, adjacent to Adit F (AF) located to the south (Figure 69). |

Figure 69. Adits R and F (AF and AR). Ranging pole nearest Adit F, looking south-west.

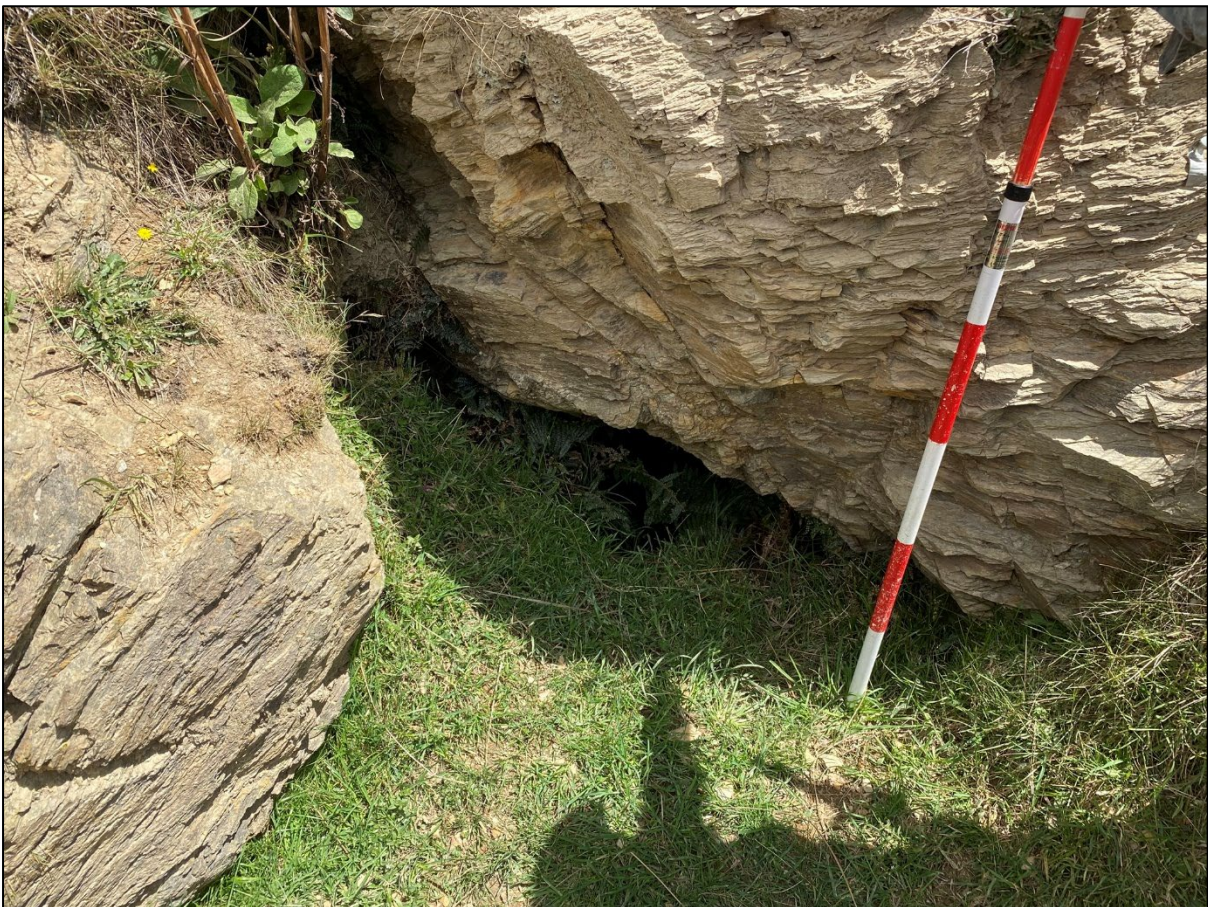
Figure 70. Detail of Adit F (AF) shown in previous photo, looking south.

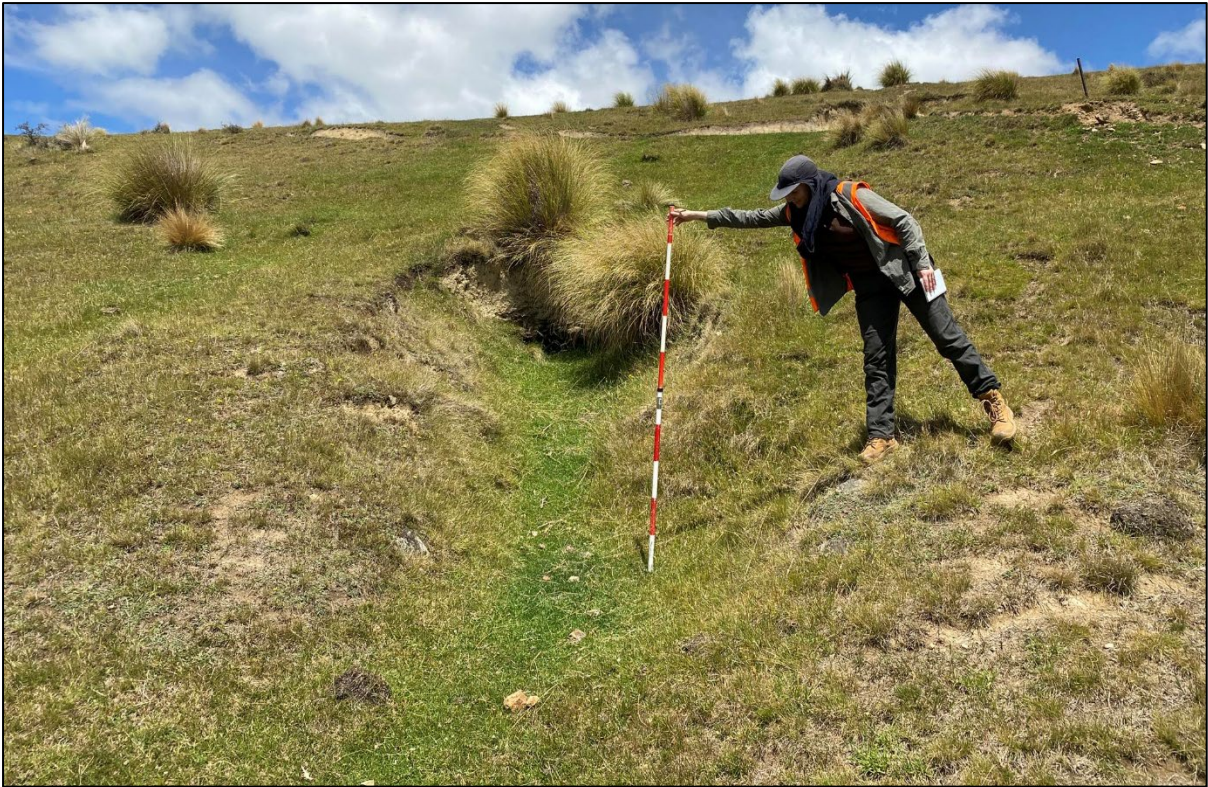
| Ref | Item | Details |
|---|---|---|
| AT | Adit | Adit recorded as Adit T by Petchey. Located north of Adit E. Opening is obscured by tussock growth (Figure 71). |

Figure 71. Adit T (AT), looking south-east.

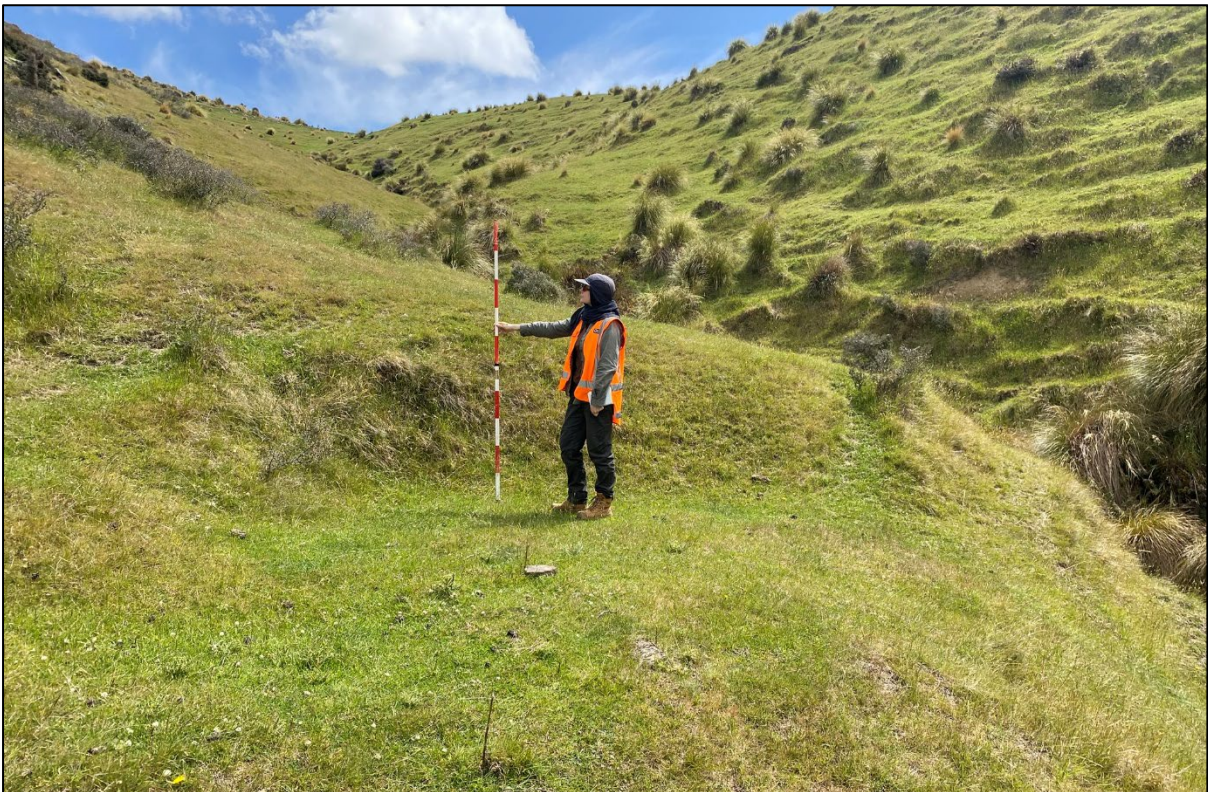
Figure 72. Interpreted as building site (not specifically identified on Petchey map). Sits within a probable sluiced area, looking south-west.

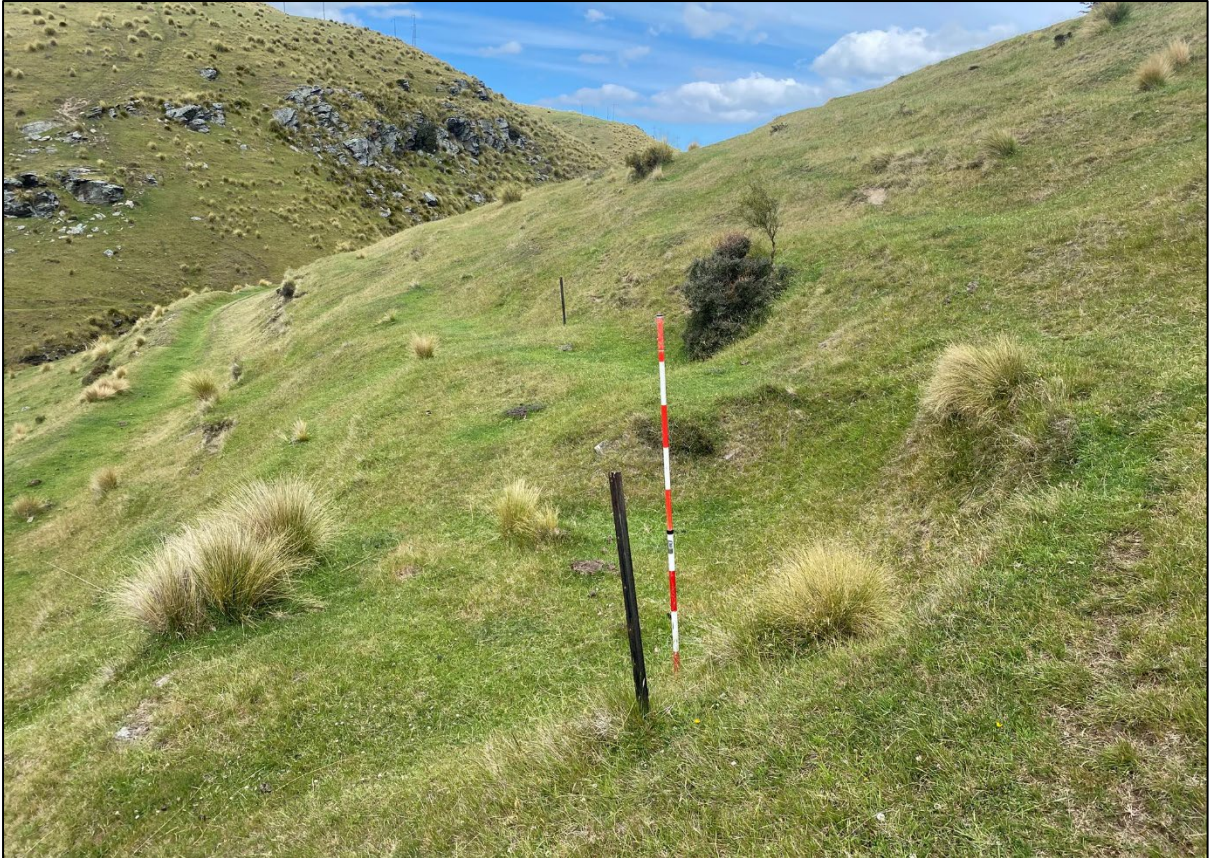
Figure 73. Two building sites marked with waratahs, BT2 in the foreground and BT3 in the background, looking east.

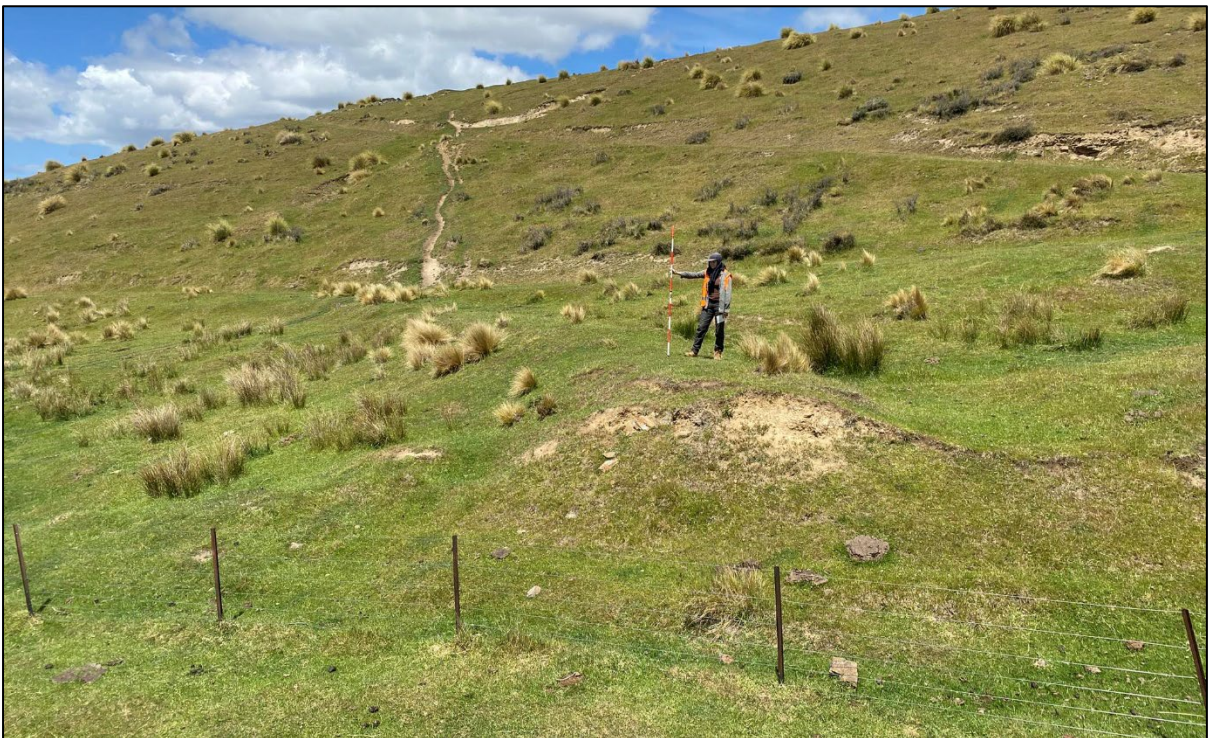
Figure 74. Tram causeway (CW) embankment, looking south-east.

| Ref | Item | Details |
|---|---|---|
| CW | Causeway | Remains of a tram causeway running north-west to south-east. Identified by earthen embankments (Figure 74-Figure 75), cuts (Figure 76), and steel tramway line (Figure 77). Partially destroyed by the current Golden Bar Pit. |

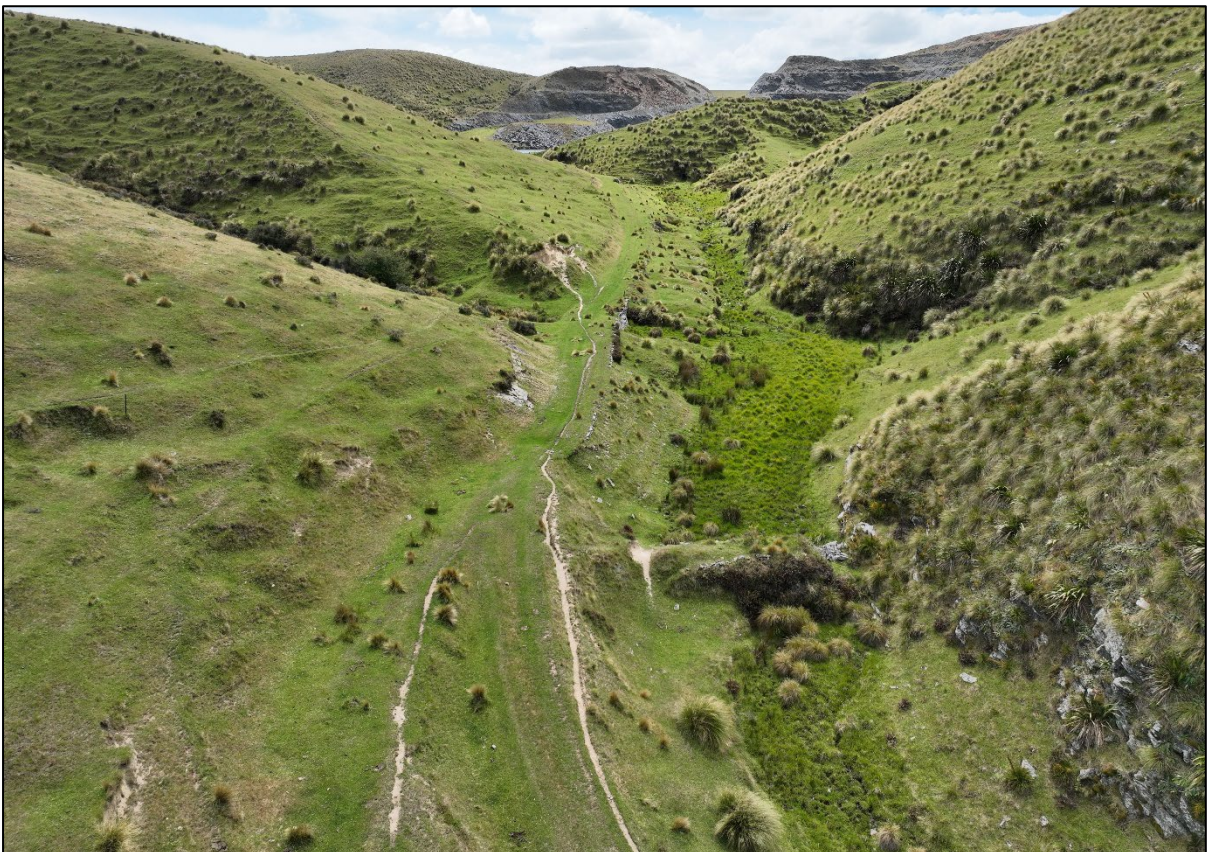
| Ref | Item | Details |
|---|---|---|
| <b>D</b> | Dam | A dam constructed of dry stacked stone over an earthen embankment, located along the creek approximately 160m south-east of the 1927 battery (Figure 78-Figure 82). Partial collapse of stone wall at northern and southern ends (Figure 79), condition degraded since previous recording by Petchey. Likely related to post-1900 operation of the 1901 battery and/or cyanide plant located approximately 100m downstream (south-east). A license for a dam on the section was granted in 1902. <sup>189</sup> |

Figure 78. Dam (D) in relation to revetted track (ST), looking north-west.

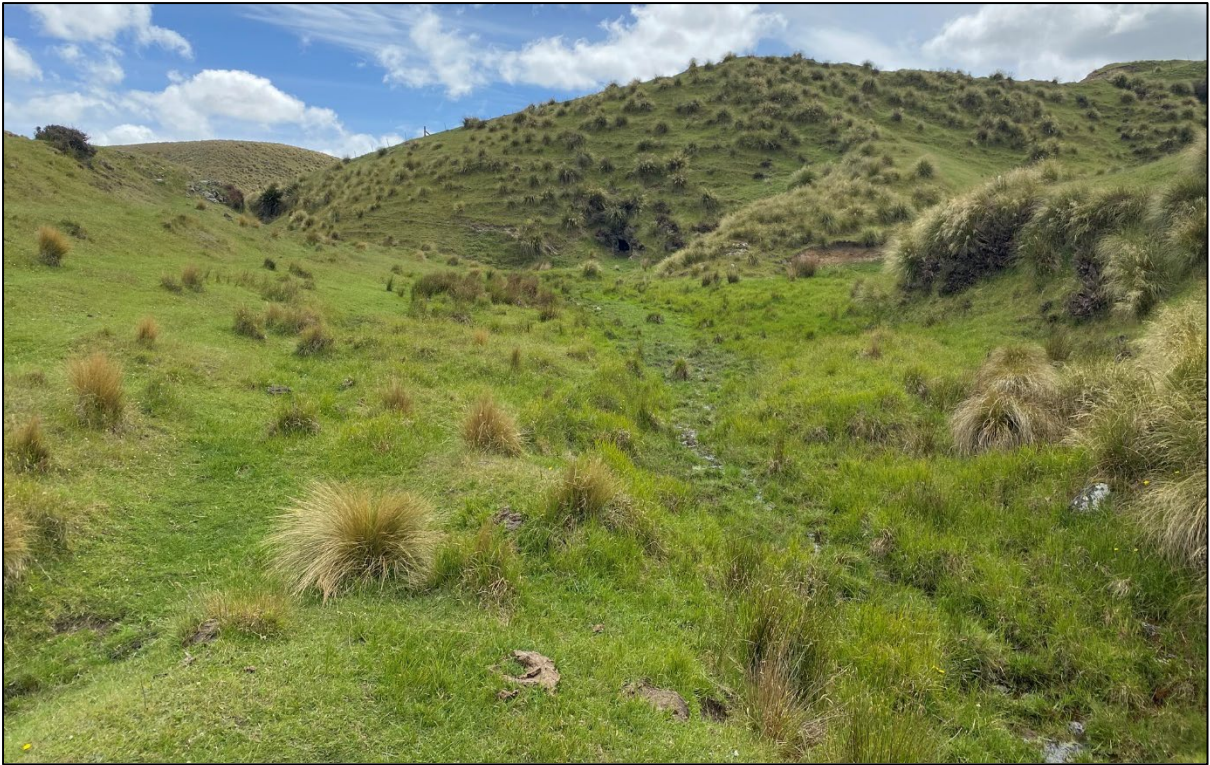
Figure 81. Creek, looking upstream towards adit (AD) and pit lake, looking north-west.

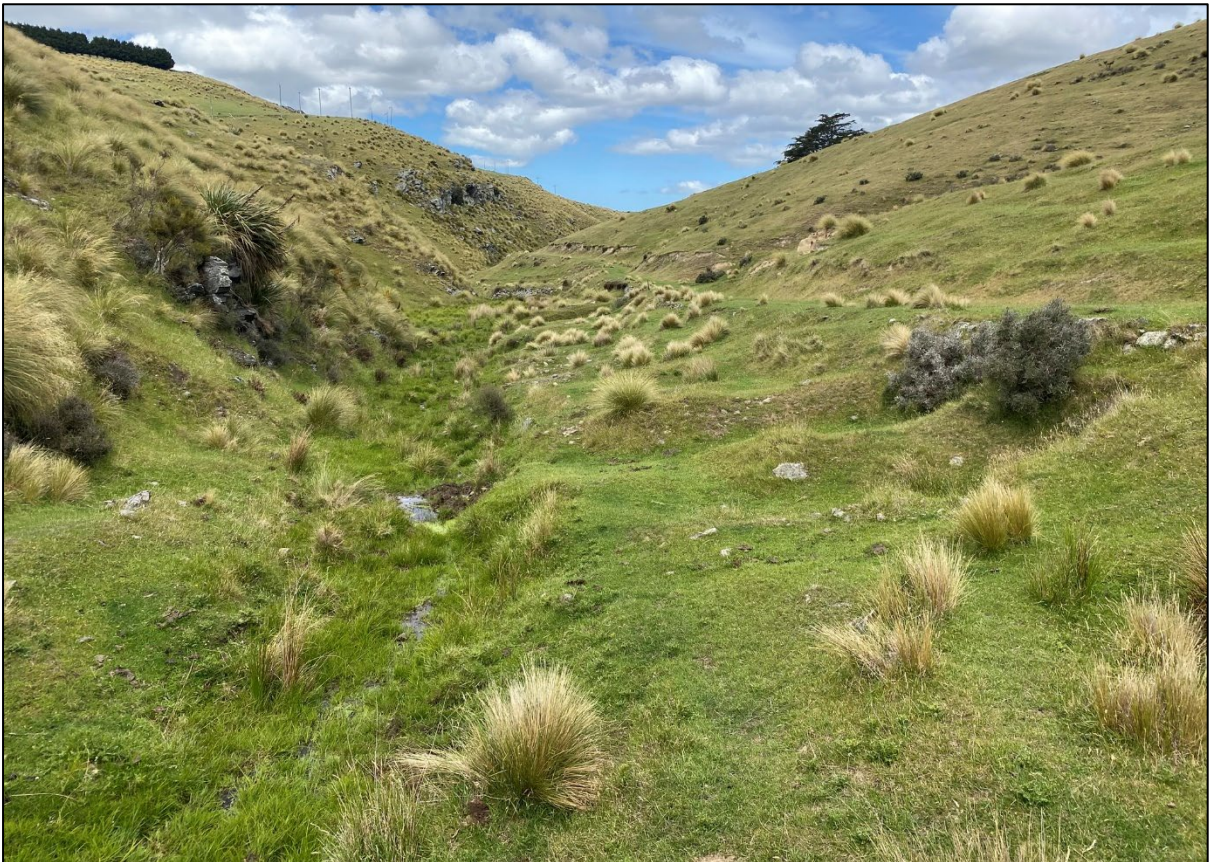
Figure 82. Creek workings, looking south-east towards dam.

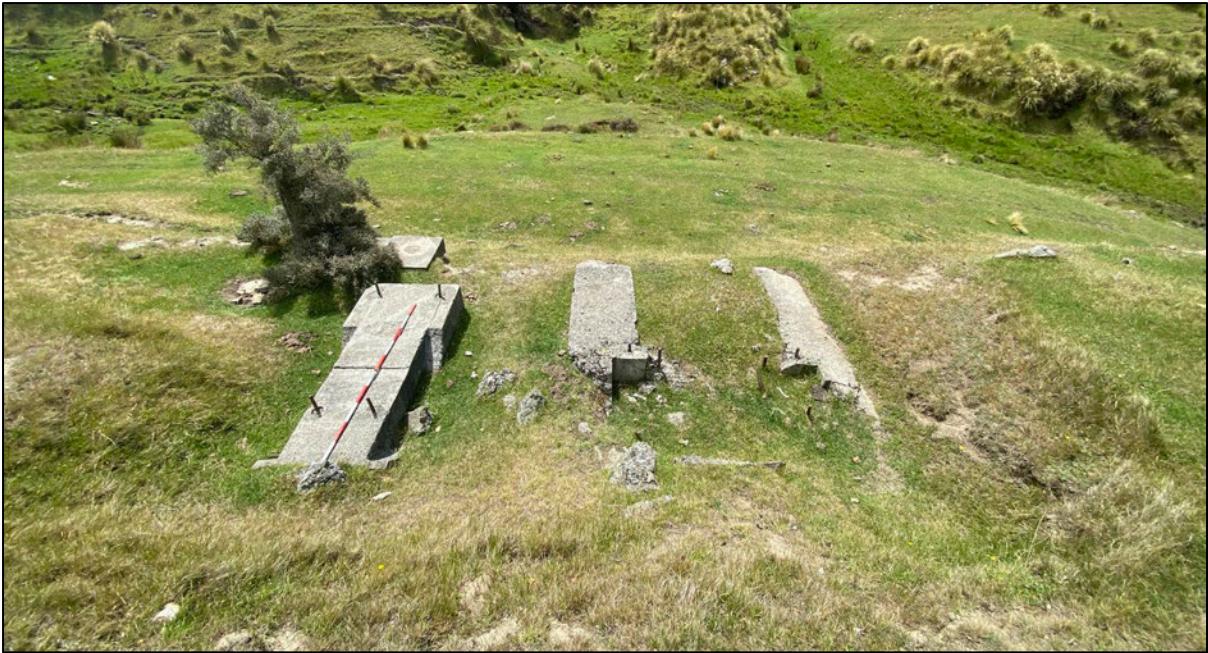
Figure 83. Battery foundations (GB) (I43/88), looking north.

| Ref | Item | Details |
|---|---|---|
| <b>GB</b> | Gold battery (I43/88) | Constructed in 1927, excavated 2003-2004 by Petchey. Concrete foundations supported plant relocated from the Deep Dell Battery at Horse Flat. Foundations of battery and generator have been clearly defined by previous archaeological investigation (Figure 83-Figure 84). Firebricks associated with the gas producer located on surface in a pile to the north-west of the battery foundations, not in-situ (Figure 85). Clearly defined platform of the tailing pond was located below the road level to the north-east of the battery (Figure 86). <sup>190</sup> |

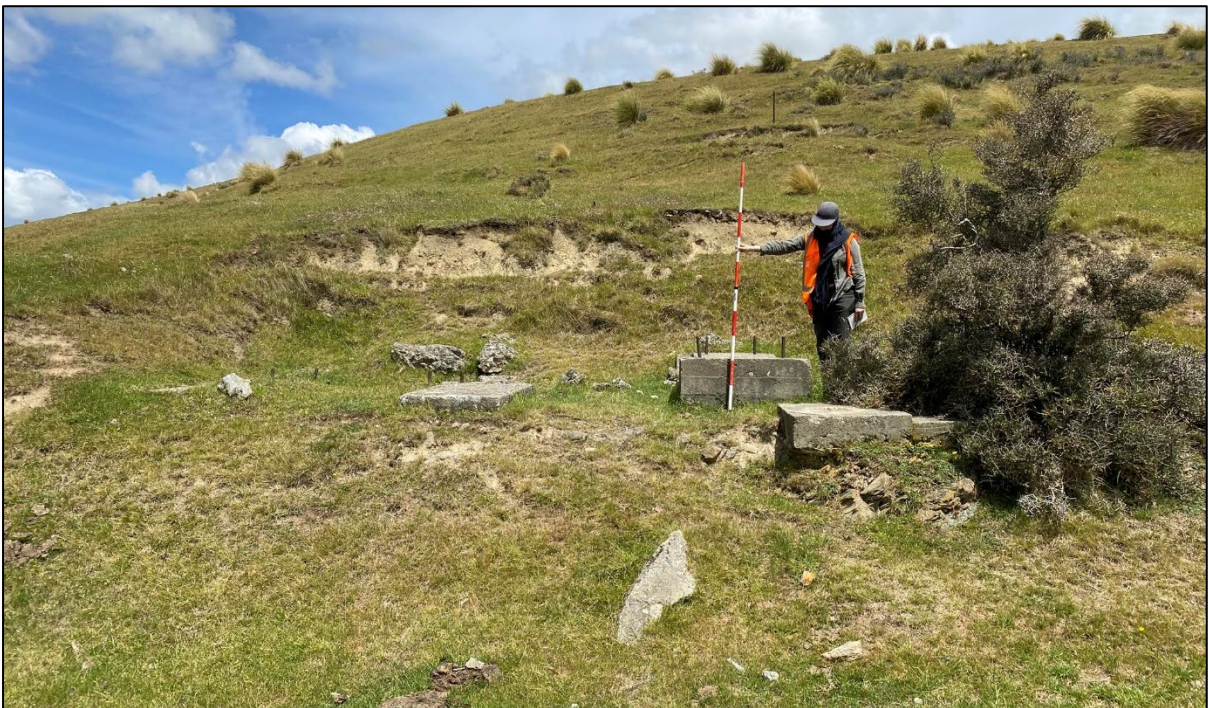
Figure 84. Battery foundations (GB) (I43/88), possible aerial terminus (HCT) marked with steel waratah in the background, looking south.

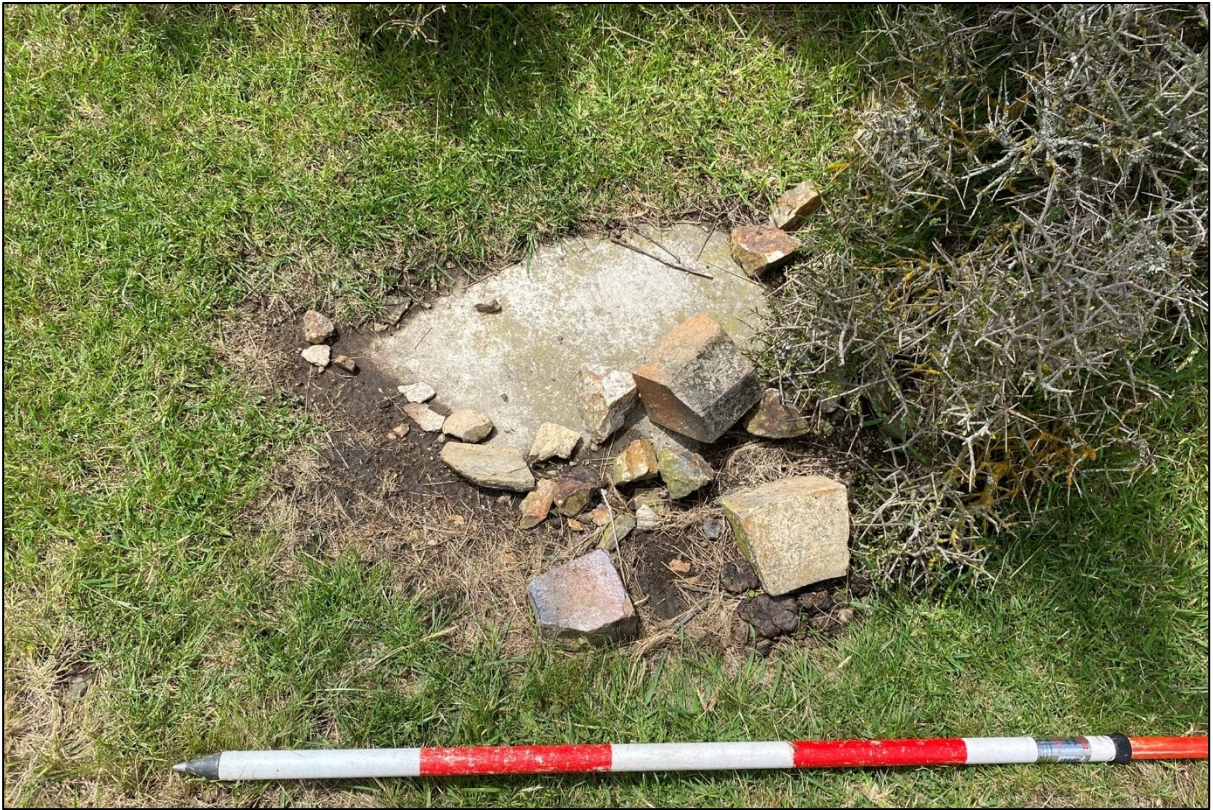
Figure 85. Firebricks piled to the west of battery, looking north.

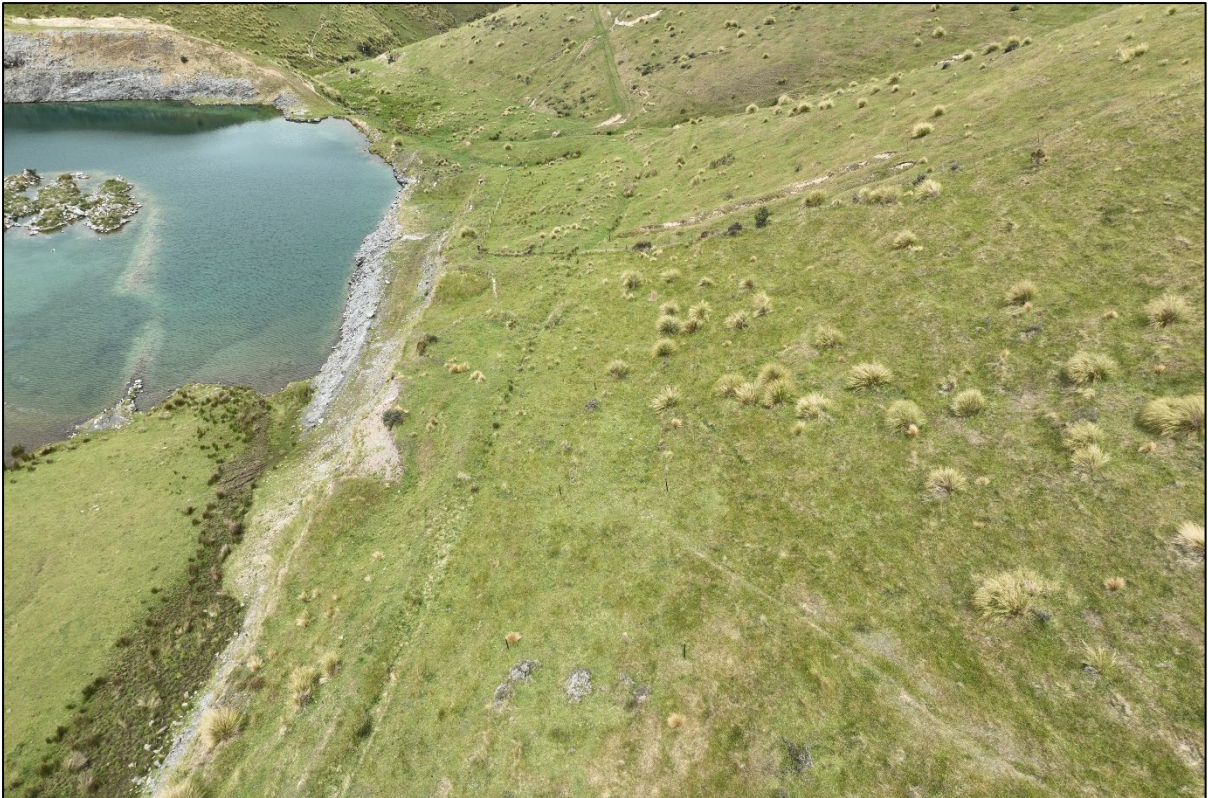
Figure 87. Building/hut terraces (huts 7 and 8) north-west of the 1927 battery site, extents marked with waratahs, looking south-east.

Terraces were located on slopes north-west and south-east of the 1927 gold battery (Figure 87-Figure 88; 143/88). Some terraces were marked with modern steel waratahs, presumably to aid their re-location. Of the 11 building/hut sites identified during this survey, seven were sites previously excavated in 2003-2004<sup>186</sup> including a building terrace above the 1927 battery site (Figure 95) and Huts 1, 3, 4, 6, 7, and 8 (Figure 89-Figure 116). Huts 5 and 9 were not able observed on the ground but their location has been approximated from previous survey maps and LiDAR data. One previously unrecorded terrace was also identified as a possible hut/building site adjacent to the locations of the huts marked on the 1897 survey plan<sup>187</sup> (Figure 72-Figure 73). Two of the previously unrecorded terraces were located adjacent to one another on the hillside south-east of the stone dam. The third previously unrecorded terrace was located to the south-west of the area labelled by Petchey as hut terraces.<sup>188</sup>

| Ref | Item | Details |
|---|---|---|
| <b>H8</b> | Building/hut terrace | Building terrace, identified by Petchey as Hut 8, excavated 2003-2004. Possible location of a domestic residence, previous excavation identified artefactual material related to domestic activity. Stonework scatter and fibrolite found during excavation. Adjacent to Hut 7 (H7). Terrace was clearly defined, and its extent marked with steel waratahs (Figure 87 and Figure 94). |

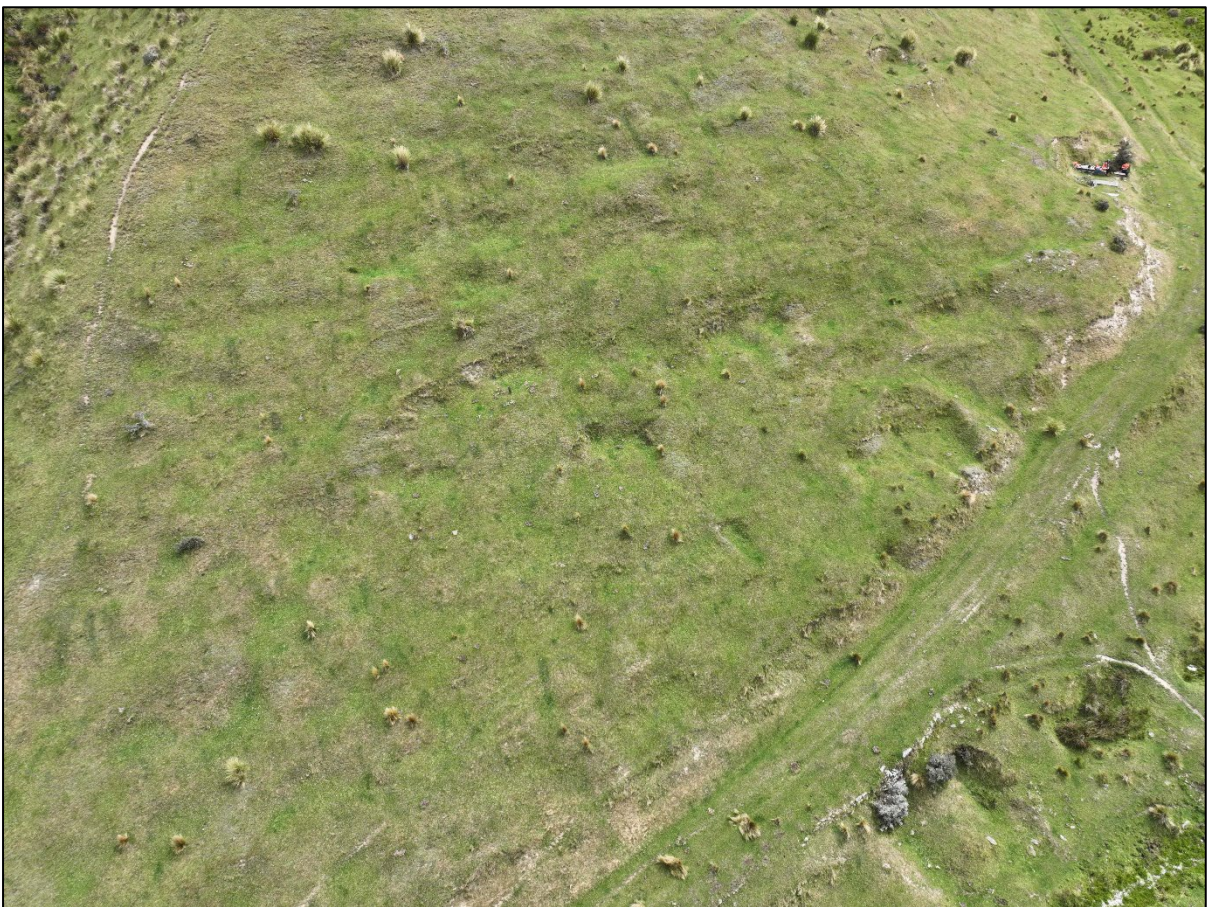
Figure 88. Plan shot of hut/building sites to the south-east of the battery site, looking west.

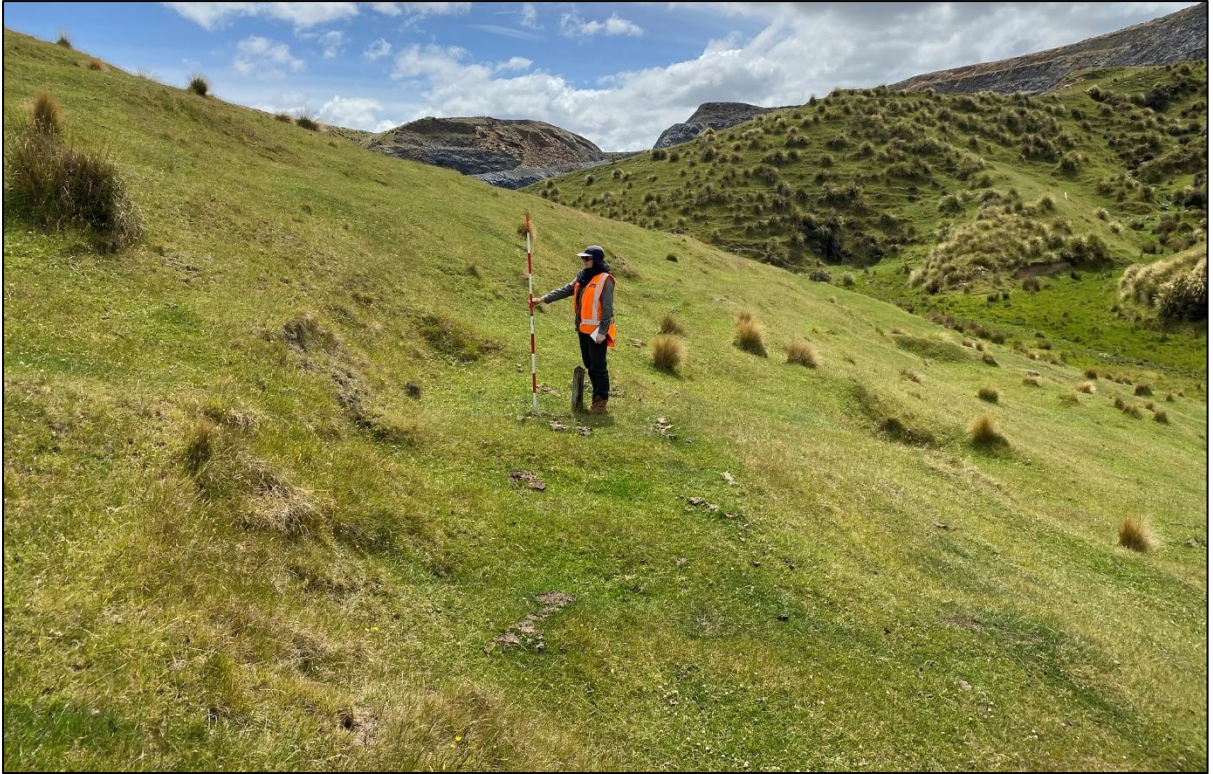
| Ref | Item | Details |
|---|---|---|
| <b>H1</b> | Building/hut terrace | Building terrace identified by Petchey as Hut 1. Partially excavated 2003-2004. Likely location of a small timber hut. Terrace and excavated timber post were easily located (Figure 89). |

Figure 89. Building site with wood post (H1), looking north-west.

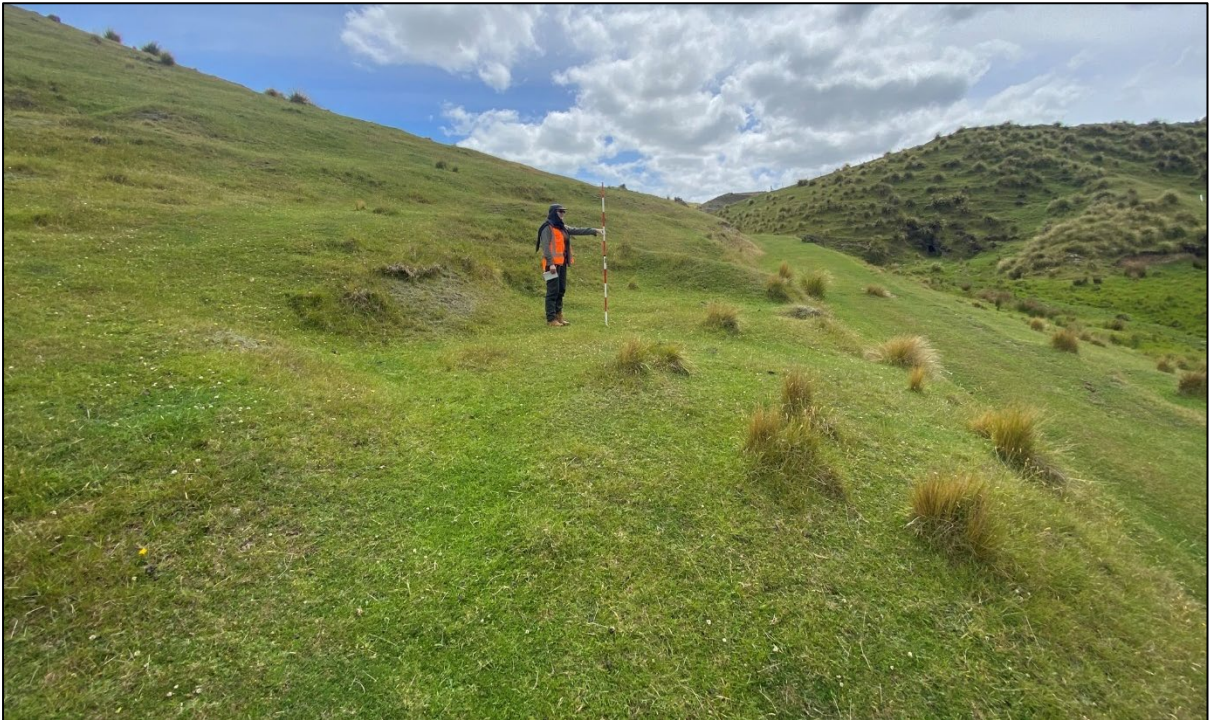
| Ref | Item | Details |
|---|---|---|
| <b>H3</b> | Building/hut terrace | Possible building terrace located immediately above the old mine road. Identified by Petchey as Hut 3, partially excavated 2003-2004. No above ground structural evidence, terrace clearly defined (Figure 90). |

Figure 90. Building site (H3), looking west.
