## 8 Golden Bar Pit and Waste Rock Stack

### 8.1 Proposed Works and Project Area

#### 8.1.1 Pit Extension and Waste Rock Stack

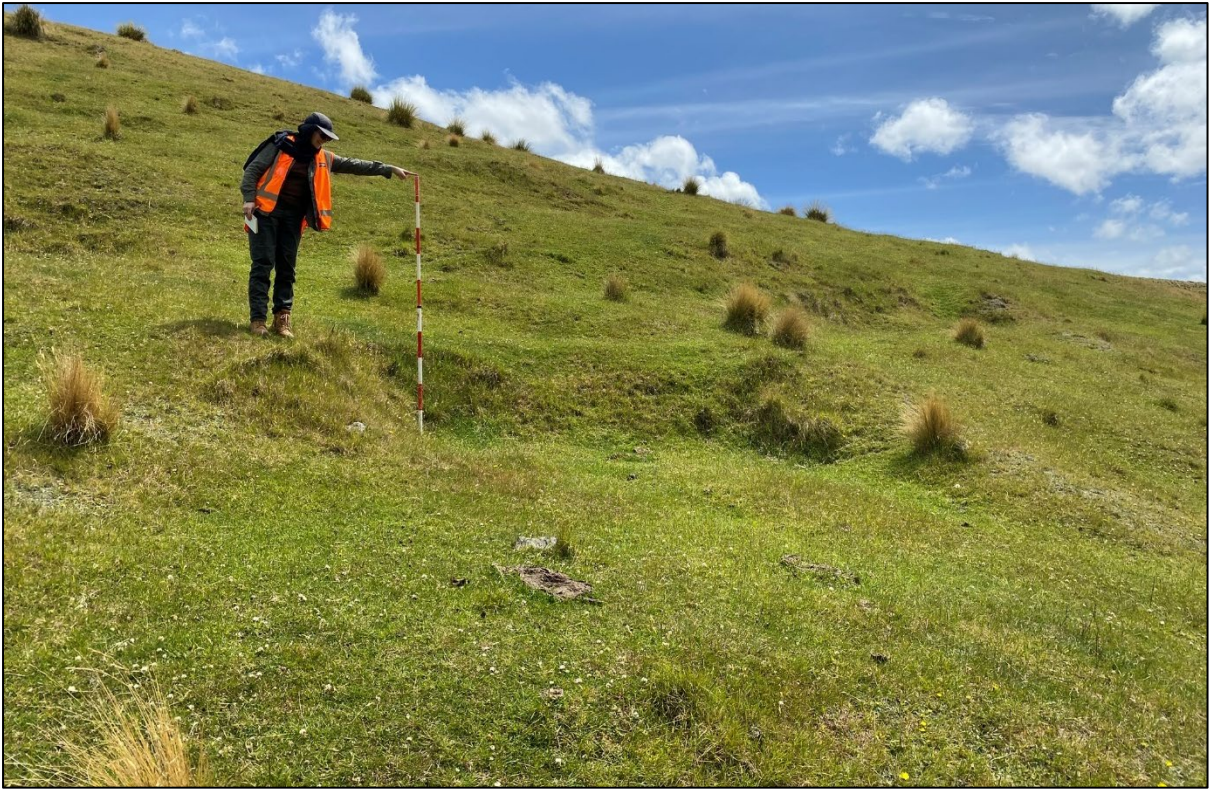
| Ref | Item | Details |
|---|---|---|
| <b>H4</b> | Building/hut terrace | Building terrace, identified by Petchey as Hut 4 partially excavated 2003-2004. Possibly occupied by a small hut. No above ground structural evidence, terrace is well defined (Figure 91). |

Figure 91. Building terrace (H2), looking south-west.

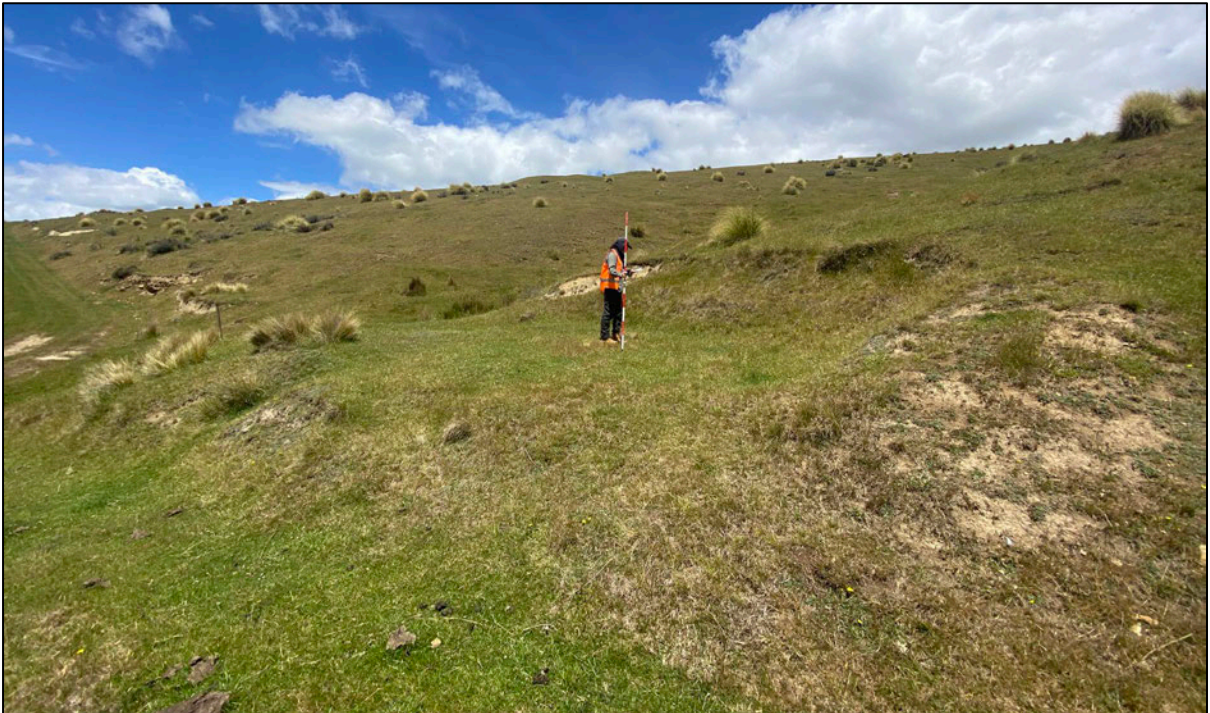
| Ref | Item | Details |
|---|---|---|
| <b>H6</b> | Building/hut terrace | Large building terrace, identified by Petchey as Hut 6 partially excavated 2003-2004. Possibly related to mining operation rather than domestic residence. "The lines of several drains... partially visible on the surface..." could not be located during the survey. Terrace itself is well defined (Figure 92). |

Figure 92. Building site (H6), looking south-east.

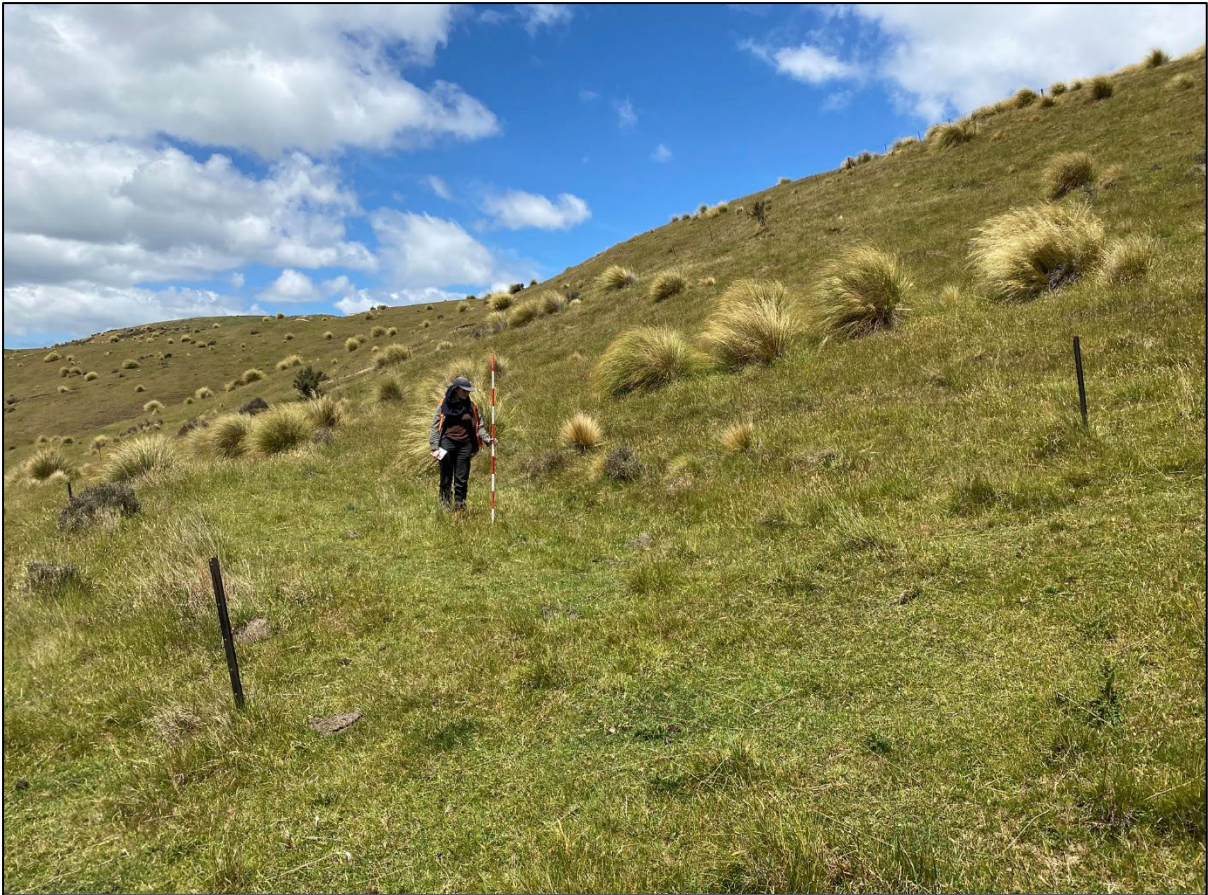
| Ref | Item | Details |
|---|---|---|
| <b>H7</b> | Building/hut terrace | Building terrace identified by Petchey as Hut 7, excavated 2003-2004. Possible location of a timber framed mining building. Located to the south-west of the Golden Bar Pit. Adjacent to Hut 8 (H8). Terrace was clearly defined, and its extent marked with steel waratahs (Figure 87 and Figure 93-Figure 94). |

Figure 93. Building site (H7), looking south-east.

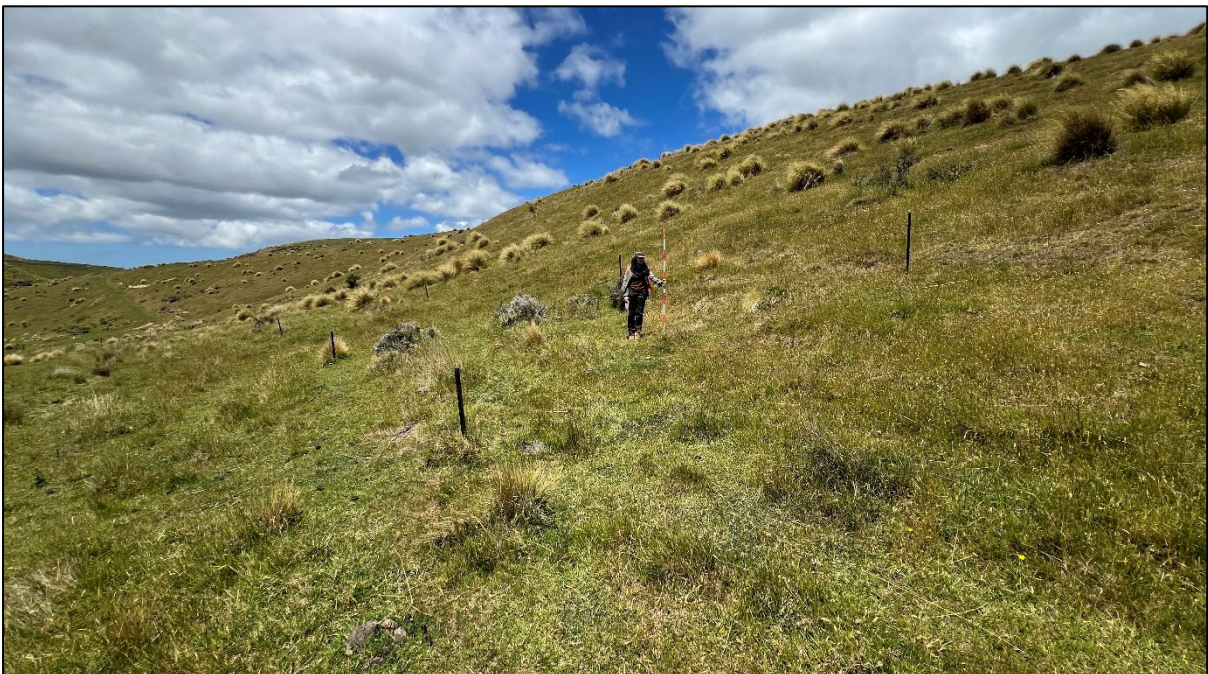
| Ref | Item | Details |
|---|---|---|
| <b>H8</b> | Building/hut terrace | Building terrace, identified by Petchey as Hut 8, excavated 2003-2004. Possible location of a domestic residence, previous excavation identified artefactual material related to domestic activity. Stonework scatter and fibrolite found during excavation. Adjacent to Hut 7 (H7). Terrace was clearly defined, and its extent marked with steel waratahs (Figure 87 and Figure 94). |

Figure 94. Building sites (H7 in the background and H8 in the foreground). Extents marked with waratahs, looking south-east.

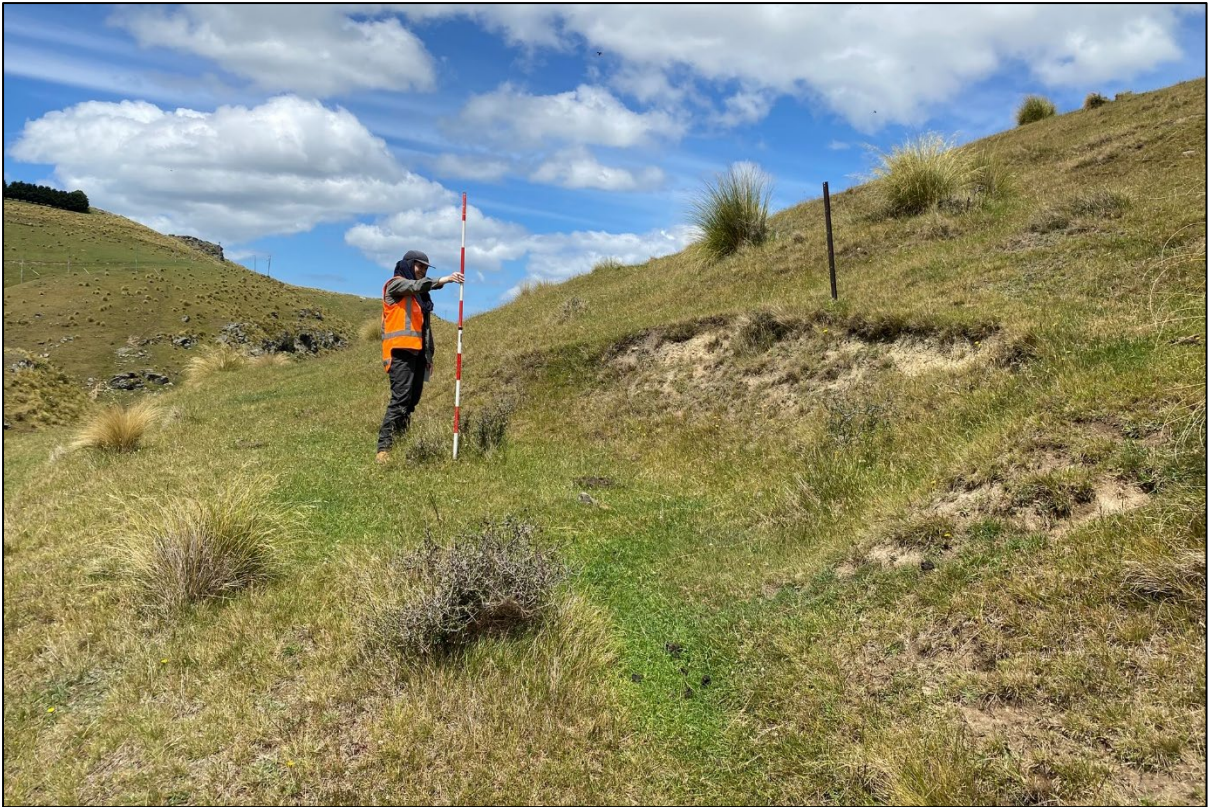
Figure 95. Aerial cableway terminus (HCT) to the south of 1927 Gold Battery site, looking south-east.

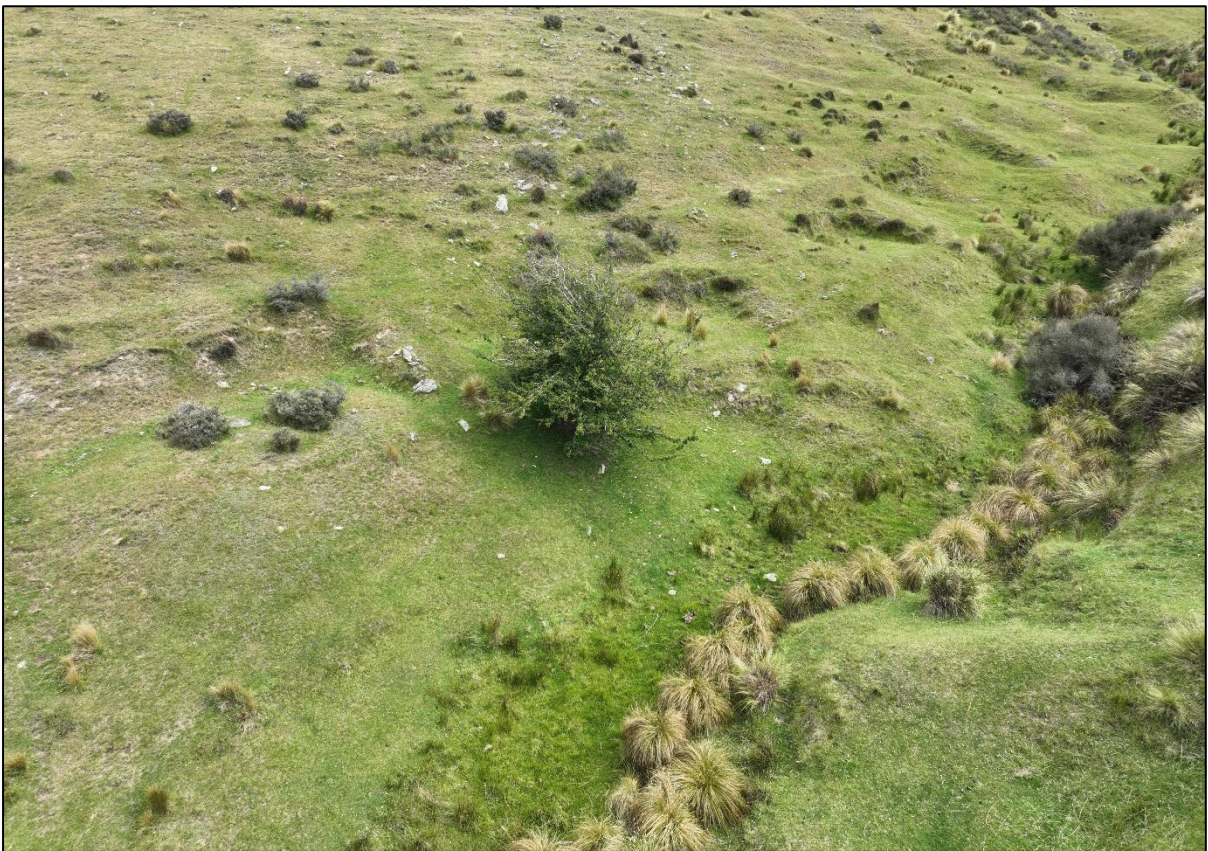
Figure 96. Possible building terraces (see above) next to sluced area, looking south.

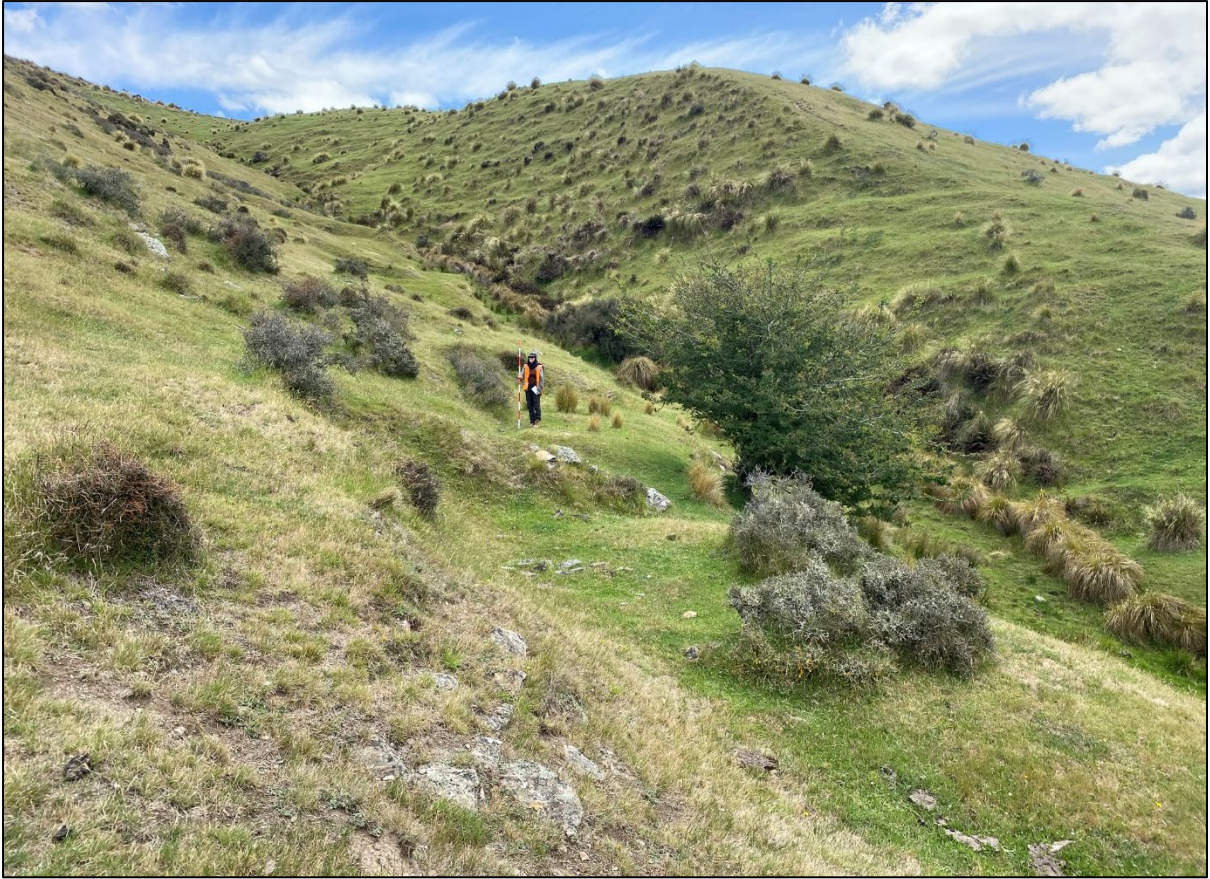
| Ref | Item | Details |
|---|---|---|
| <b>HT</b> | Building/hut terraces | 'Three hut terraces' identified by Petchey. Recorded on 1897 survey. Terraces are clearly defined (Figure 97). No above ground structural remains. |

Figure 97. Building site (HT), looking south-west.

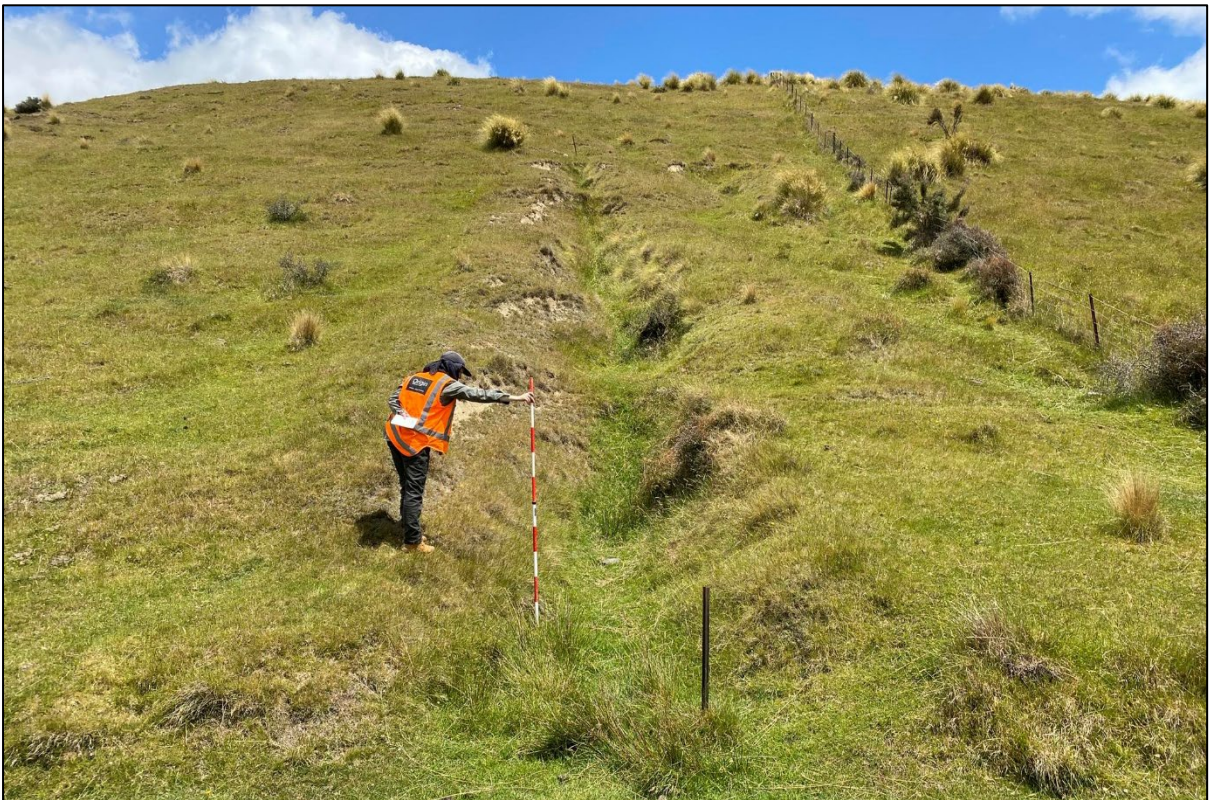
Figure 98. Bottom of P1, looking south.

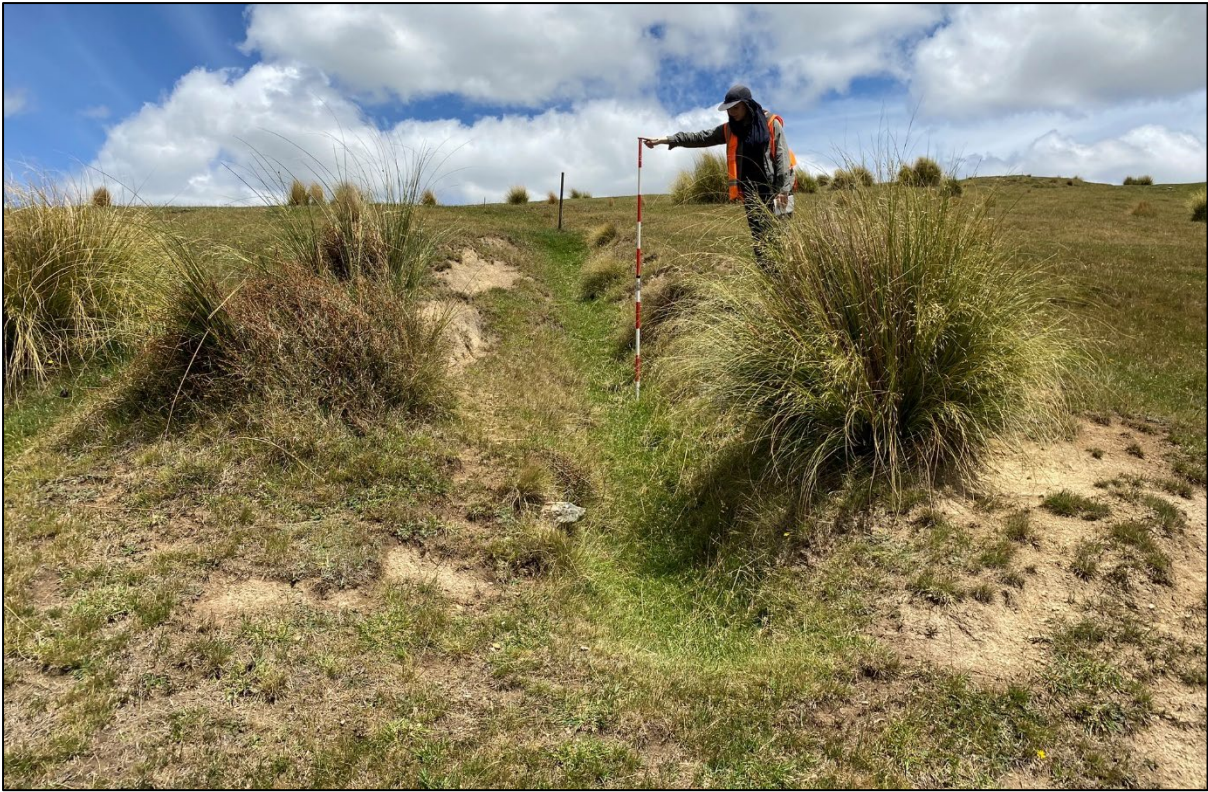
Figure 99. Bottom of prospecting trench (P2), looking south.

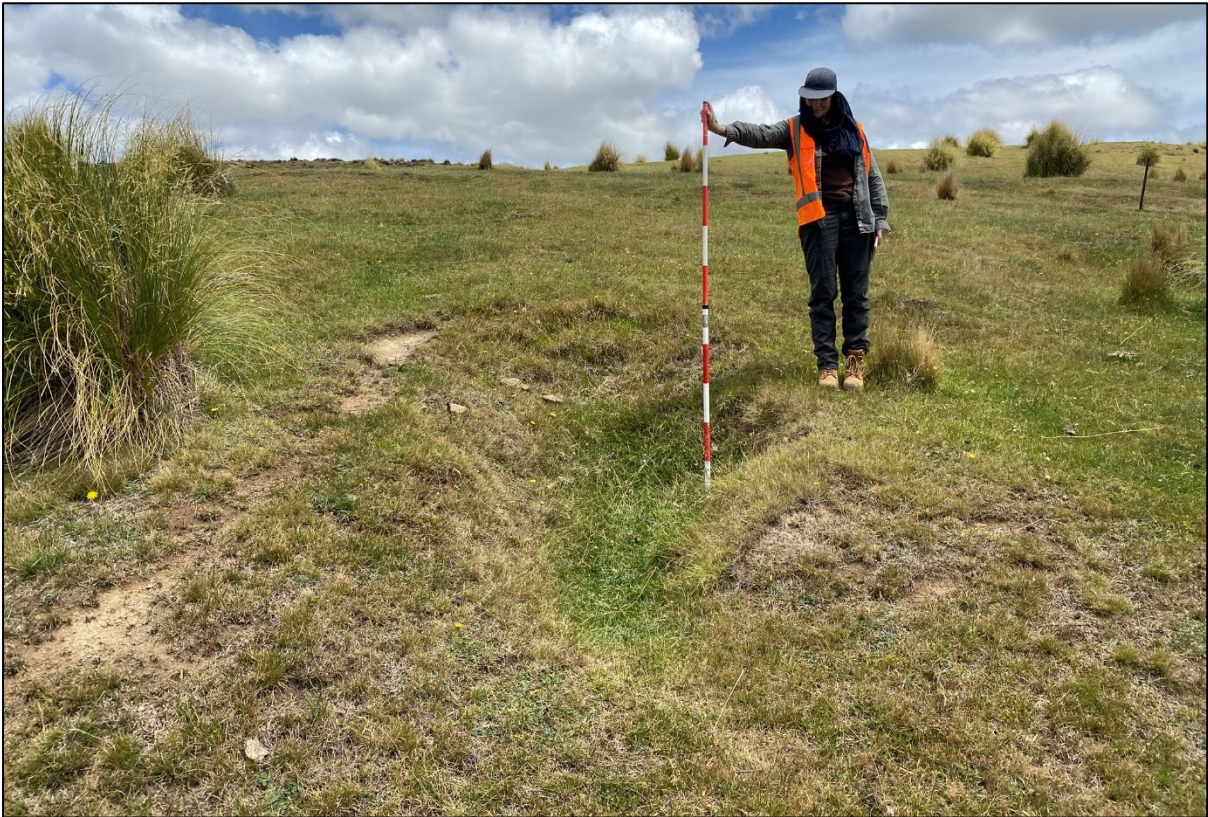
Figure 100. Prospecting trench (P3), looking south.

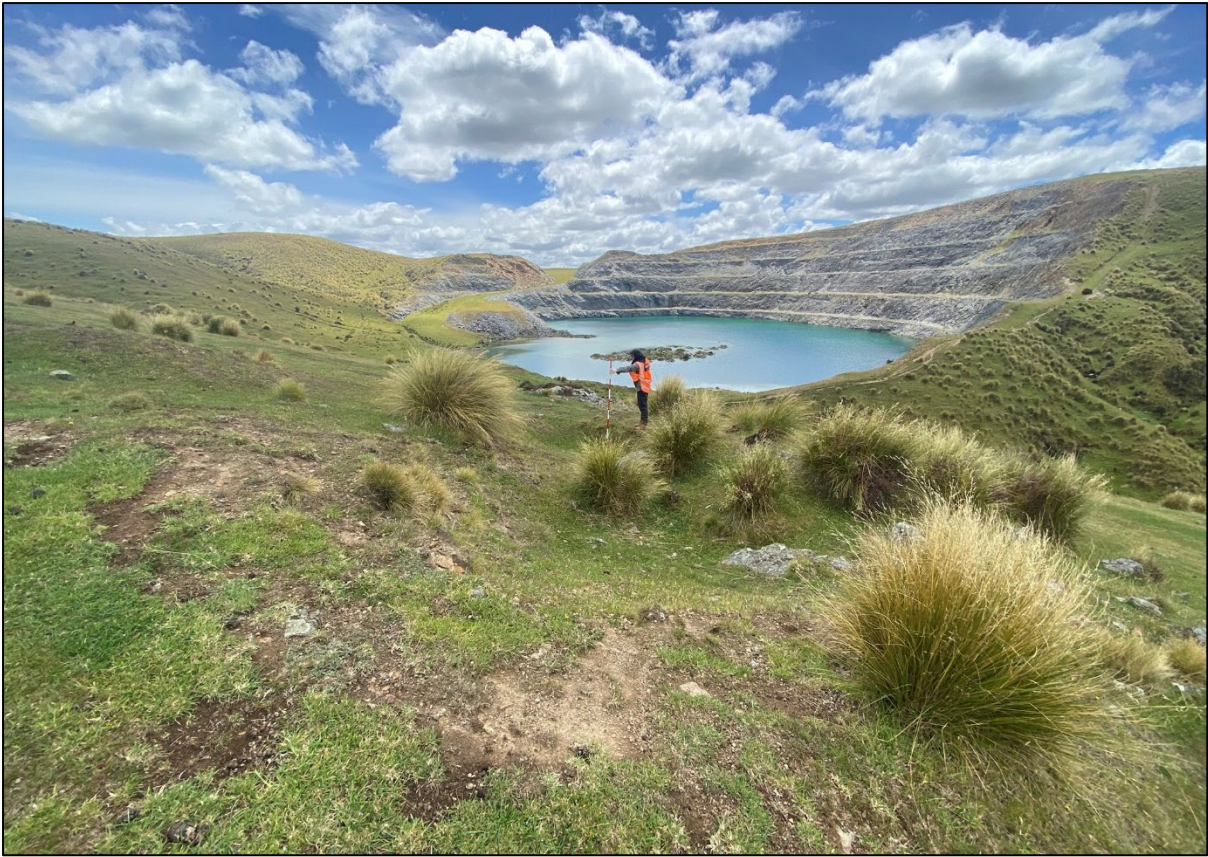
Figure 101. Prospecting pit (P4), looking north-west.

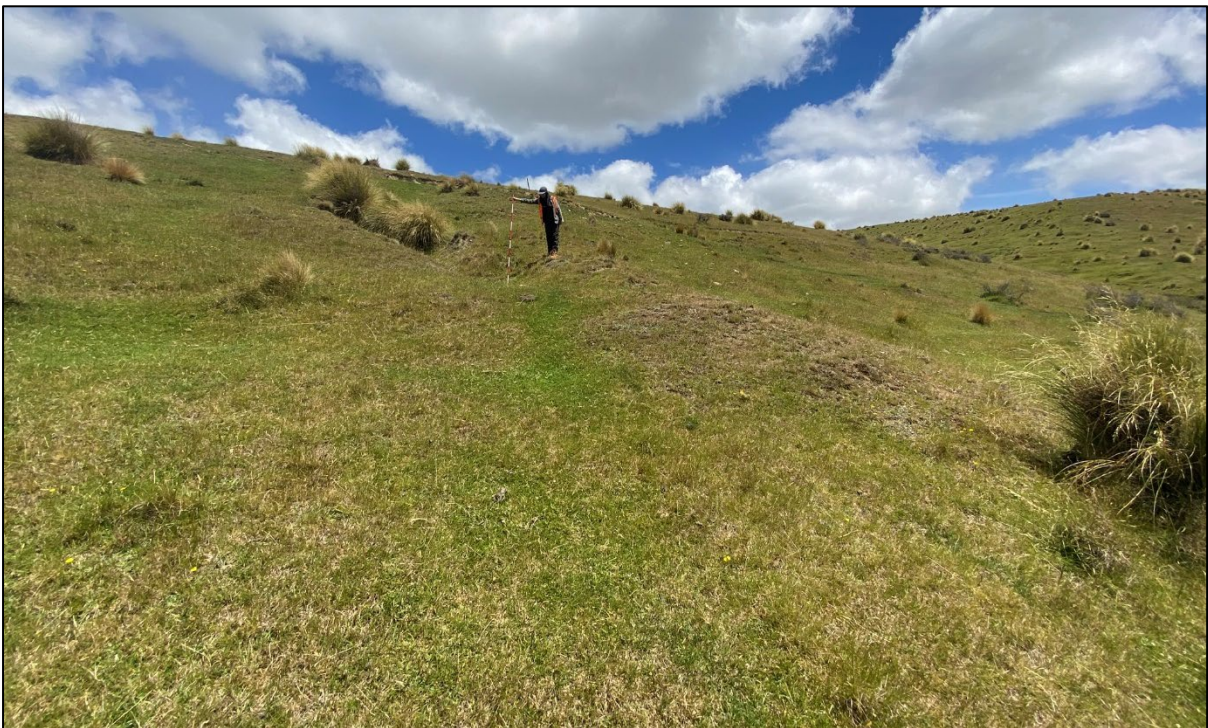
Figure 102. Mullock heap (S2), looking south-west.

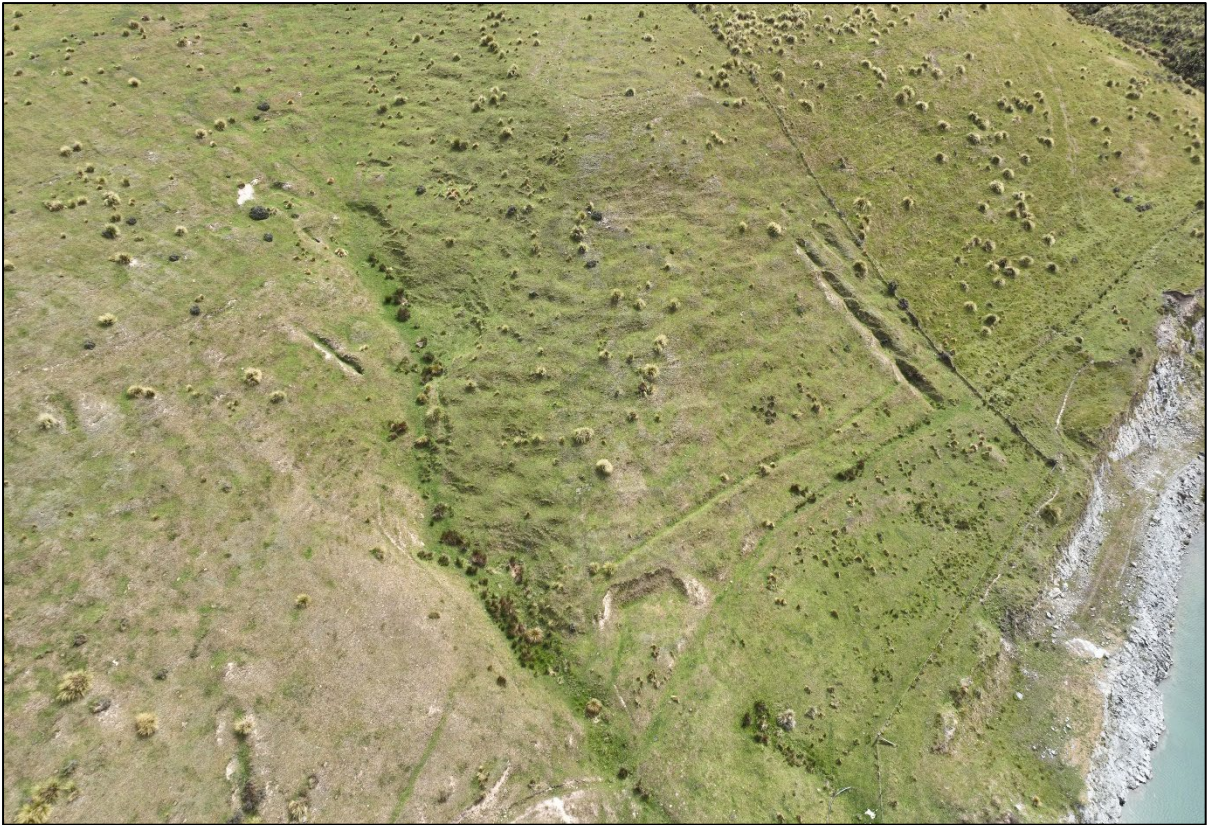
Figure 103. Mine workings to the west of pit lake and hut 6 (H6), looking west.

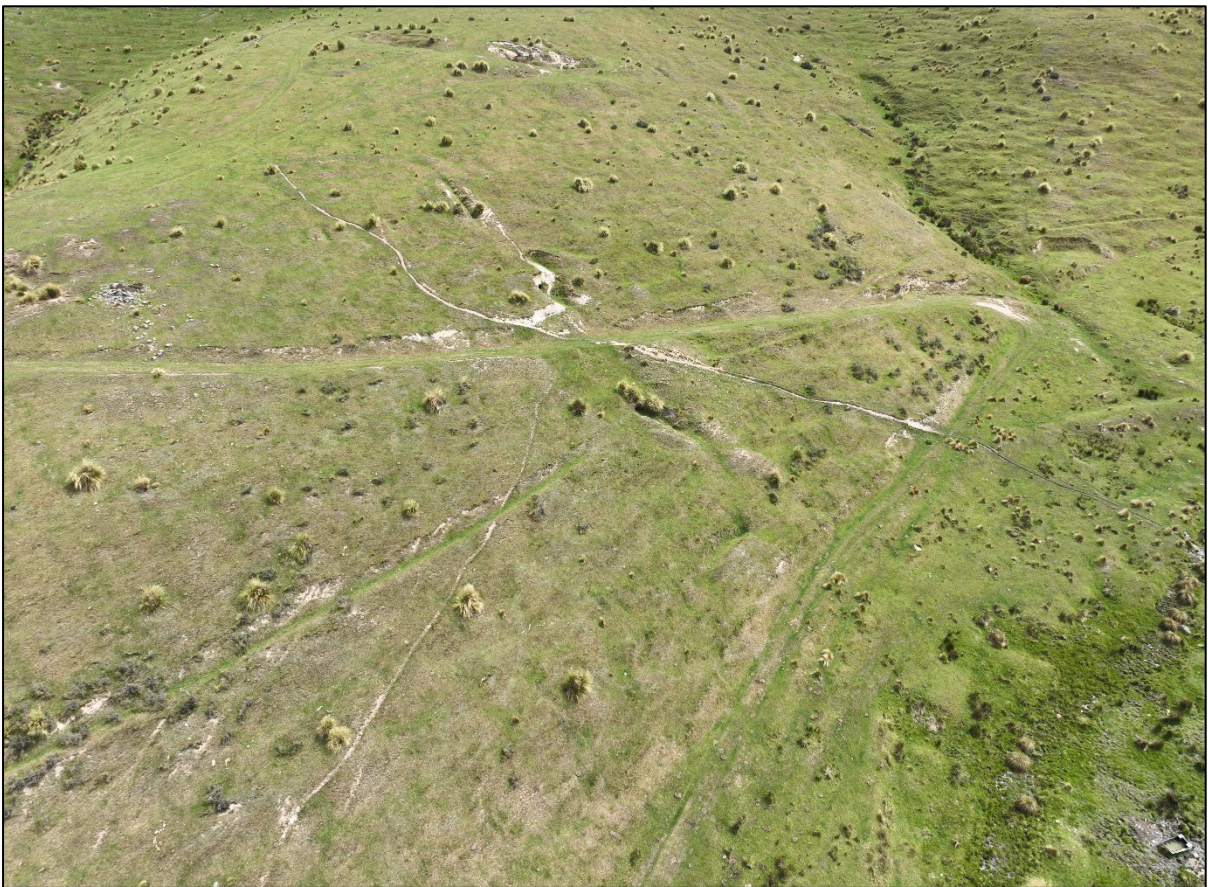
Figure 104. Mine workings to the west of pit lake, looking west.

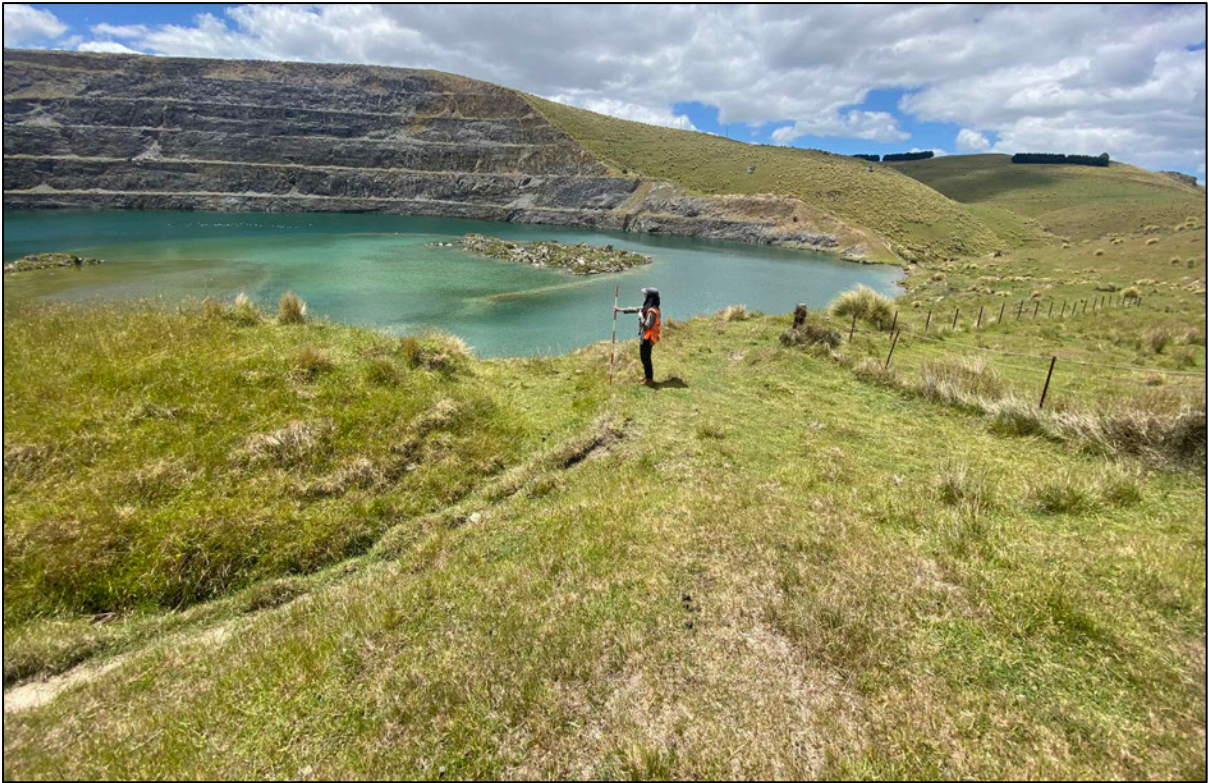
Figure 105. Scarp/terrace (S3), looking east. Former location of Adit I (AI) to the left of the scarp/terrace.

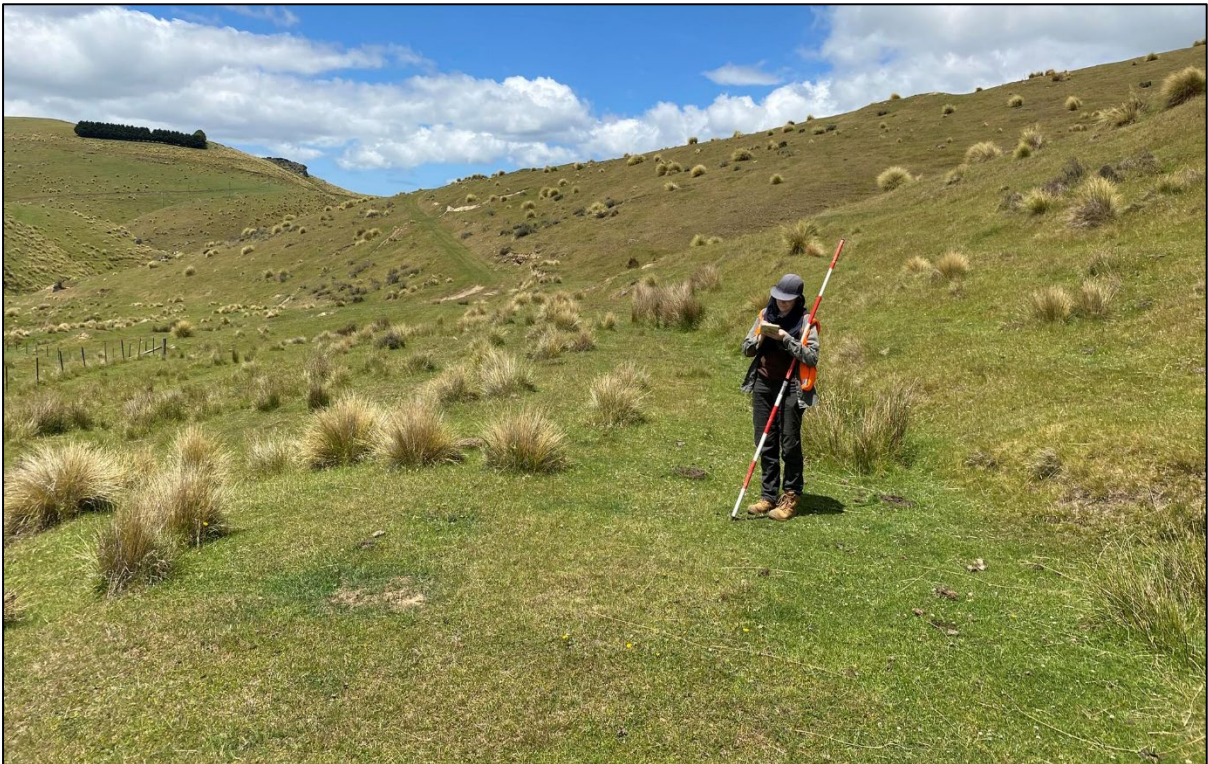
| Ref | Item | Details |
|---|---|---|
| <b>ST</b> | Stone revetted track | Portions constructed in 1901 and 1912. A track/road, partially supported by stone revetment, is located above the stream level and runs north-west to south-east along the Golden Bar Mine site (Figure 106-Figure 110). Revetment occurs on the north-east facing side of the road. Track widens directly in front of the 1927 Gold Battery. |

Figure 106. Widening of track at northern end below bottom of prospecting trench (ST), looking south-east.

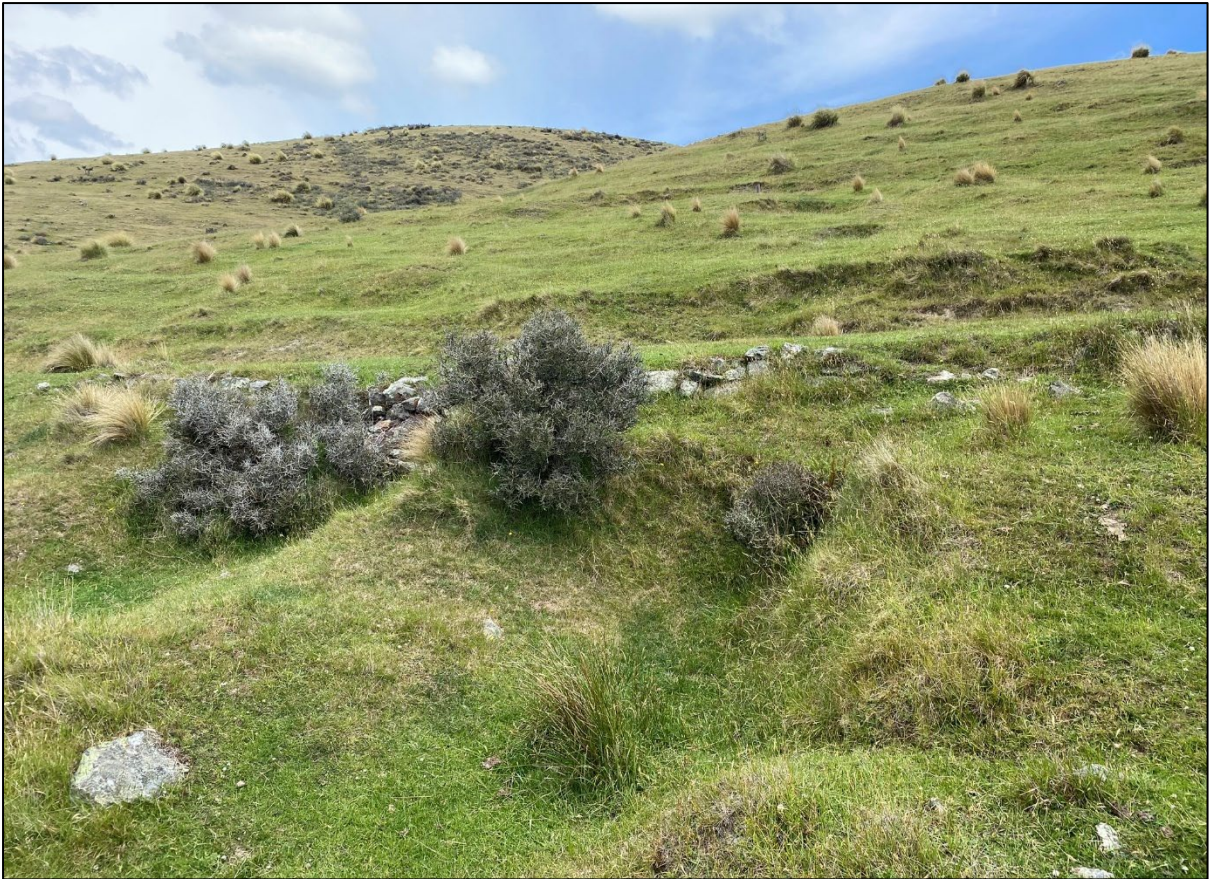
Figure 107. Stone revetting along track (ST), looking south-west.

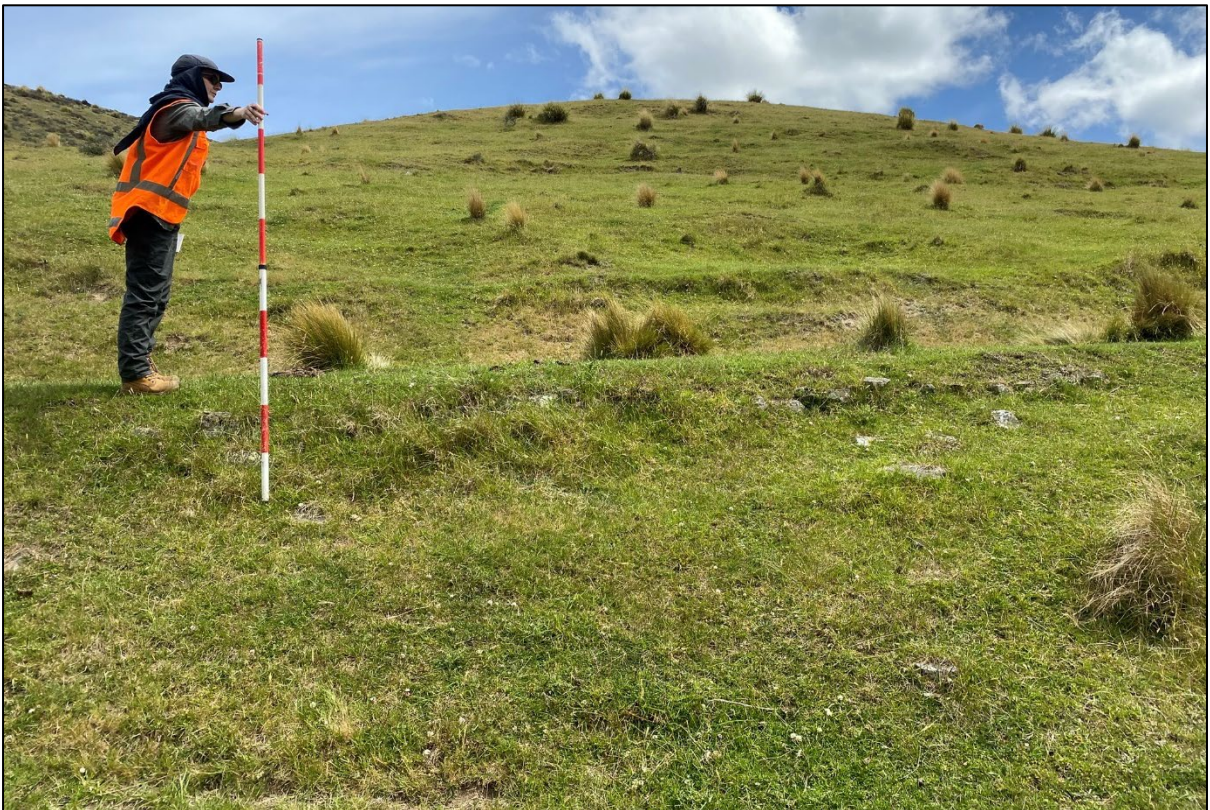
Figure 108. Stone revetting along track (ST), looking south-west.

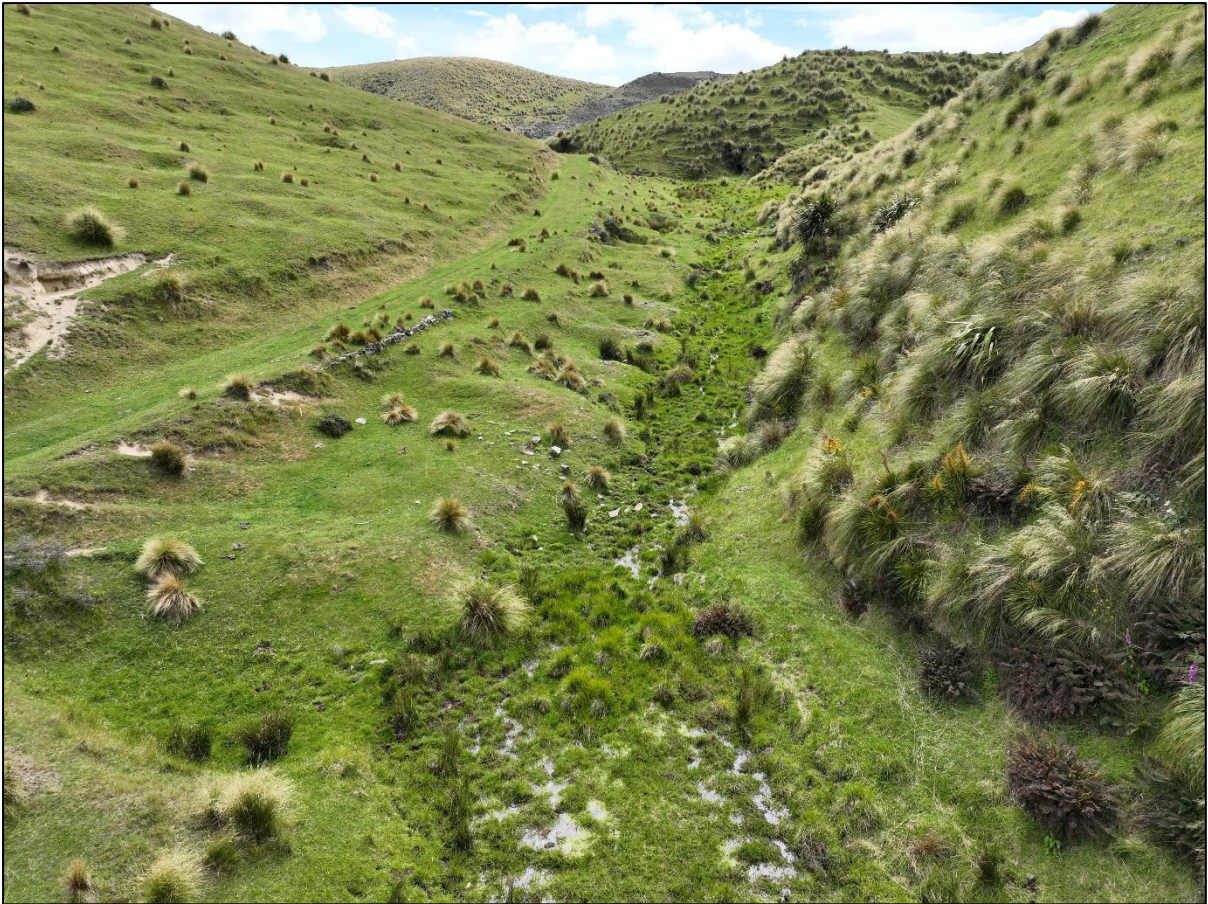
Figure 109. Revetment along track, looking north-west.

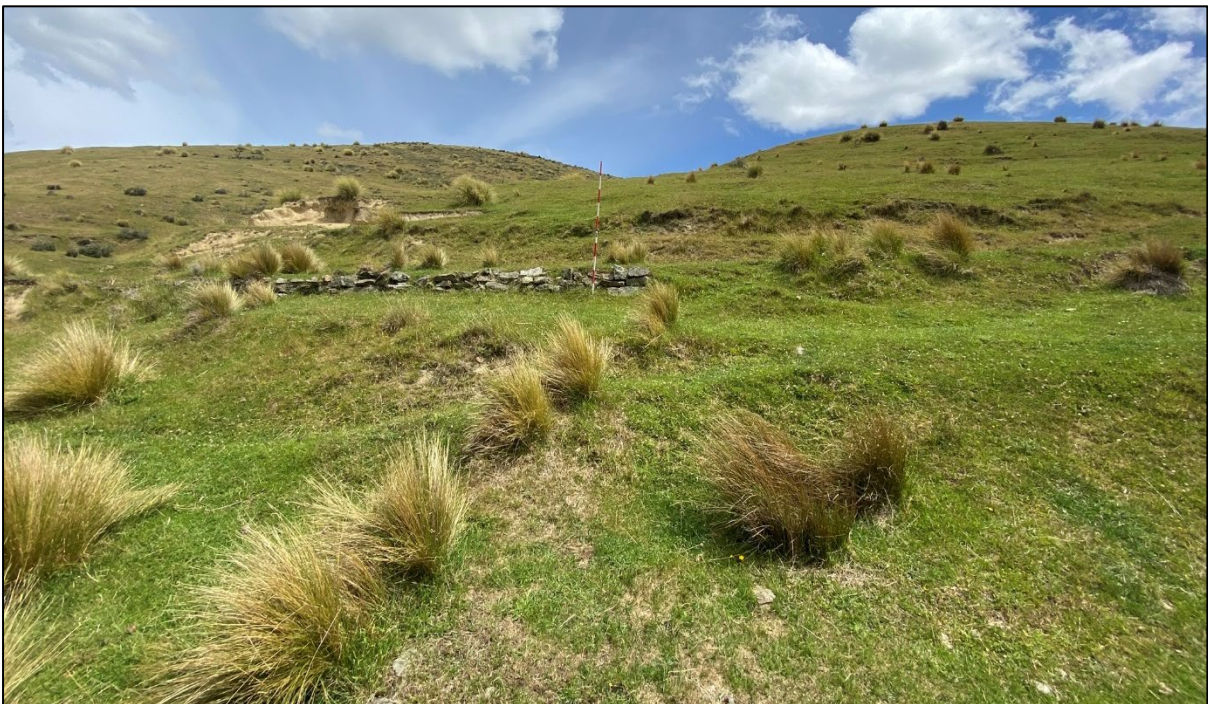
Figure 110. Detail of stone revetted track as shown above, looking south.

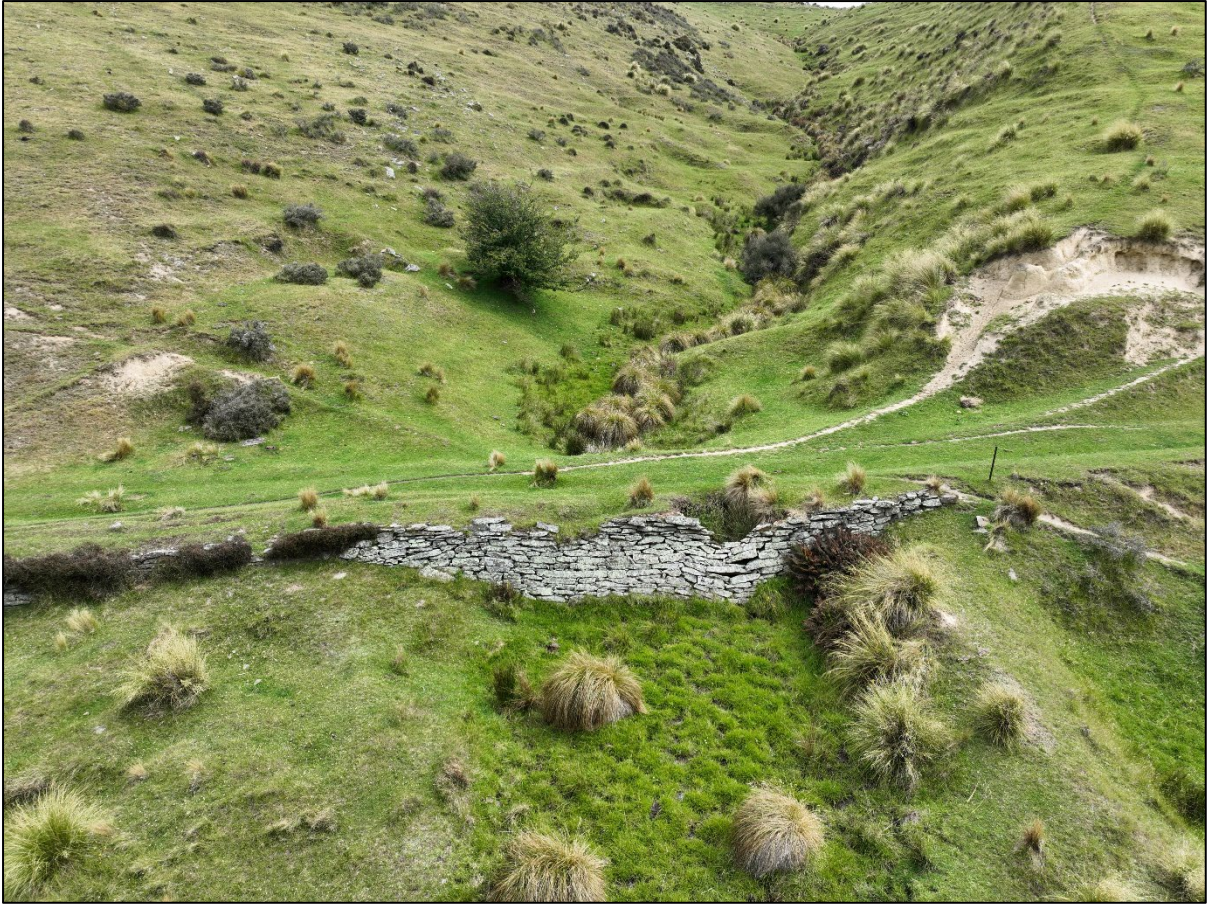
Figure 111. Major revetment, looking south-west.

| Ref | Item | Details |
|---|---|---|
| <b>MR</b> | Stone revetment (culvert) | Area of major revetment is located approximately 50m north-west of dam (D) (Figure 111-Figure 115). This appears to be a culvert, but the inlet and outlet are not evident. Collapse of earth embankment on northern end has caused partial collapse of stone revetting. |

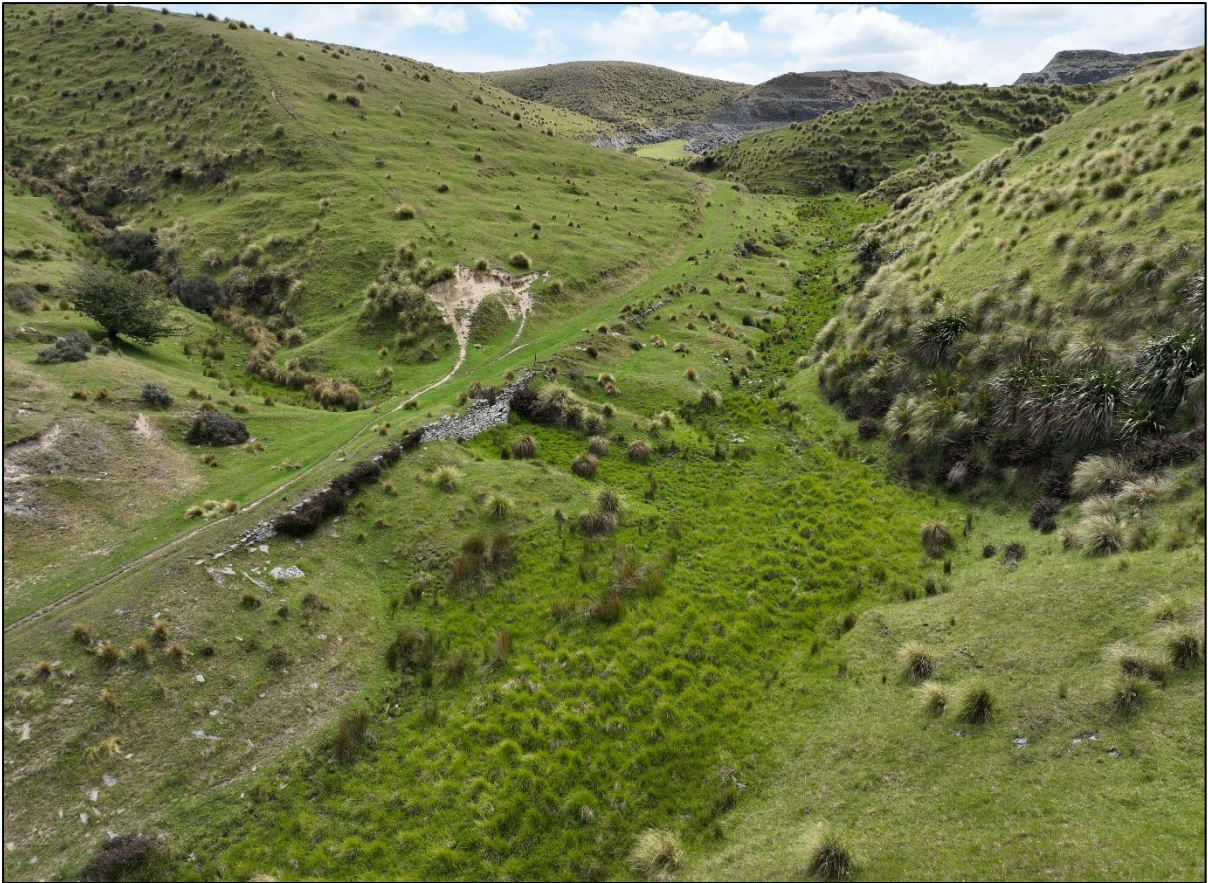
Figure 112. Showing the major revetment along the track in relation to the creek, looking north-west.
