## 8 Golden Bar Pit and Waste Rock Stack

### 8.1 Proposed Works and Project Area

#### 8.1.1 Pit Extension and Waste Rock Stack

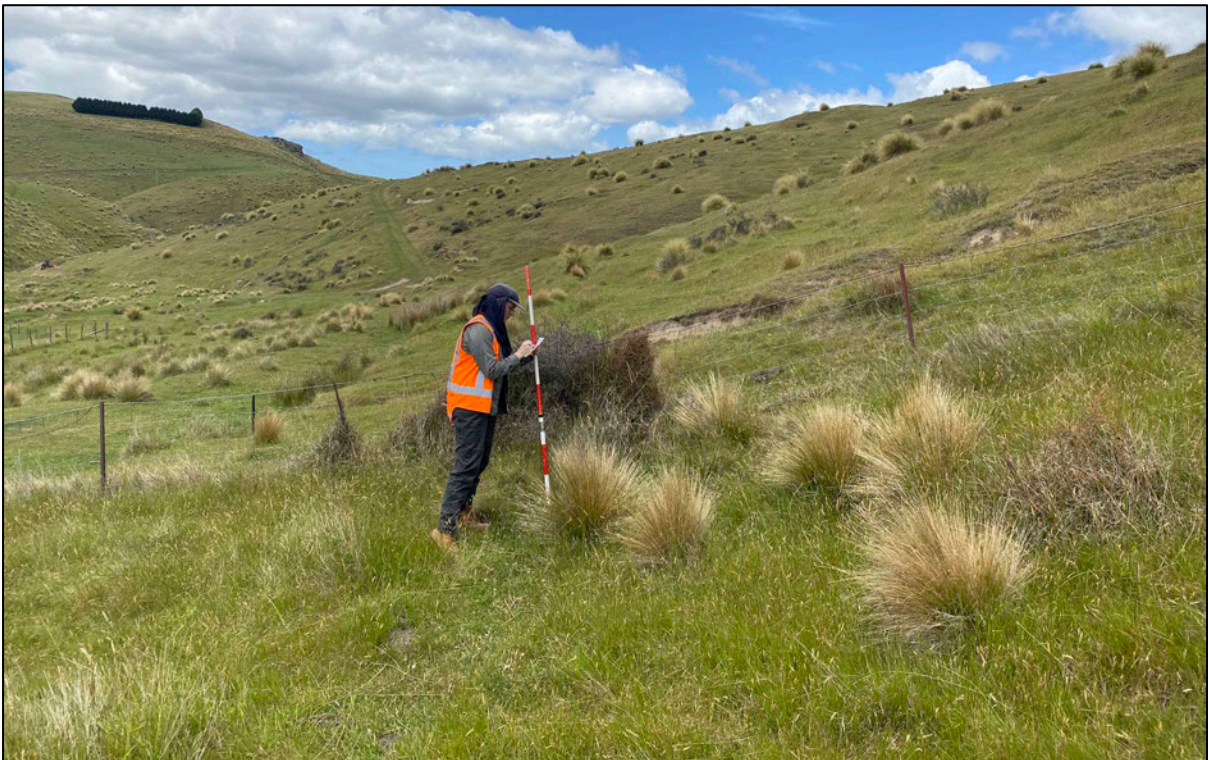
| Ref | Item | Details |
|---|---|---|
| <b>WR</b> | Water race | Shallow cut earth water race running north-west to south-east (Figure 116-Figure 118). Located to the west of the stone revetted track. Possibly constructed in 1924 in connection with the gold battery (GB), application for water race on Section 8 was granted in 1924. |

Figure 117. Looking along water race (WR), looking south-east.

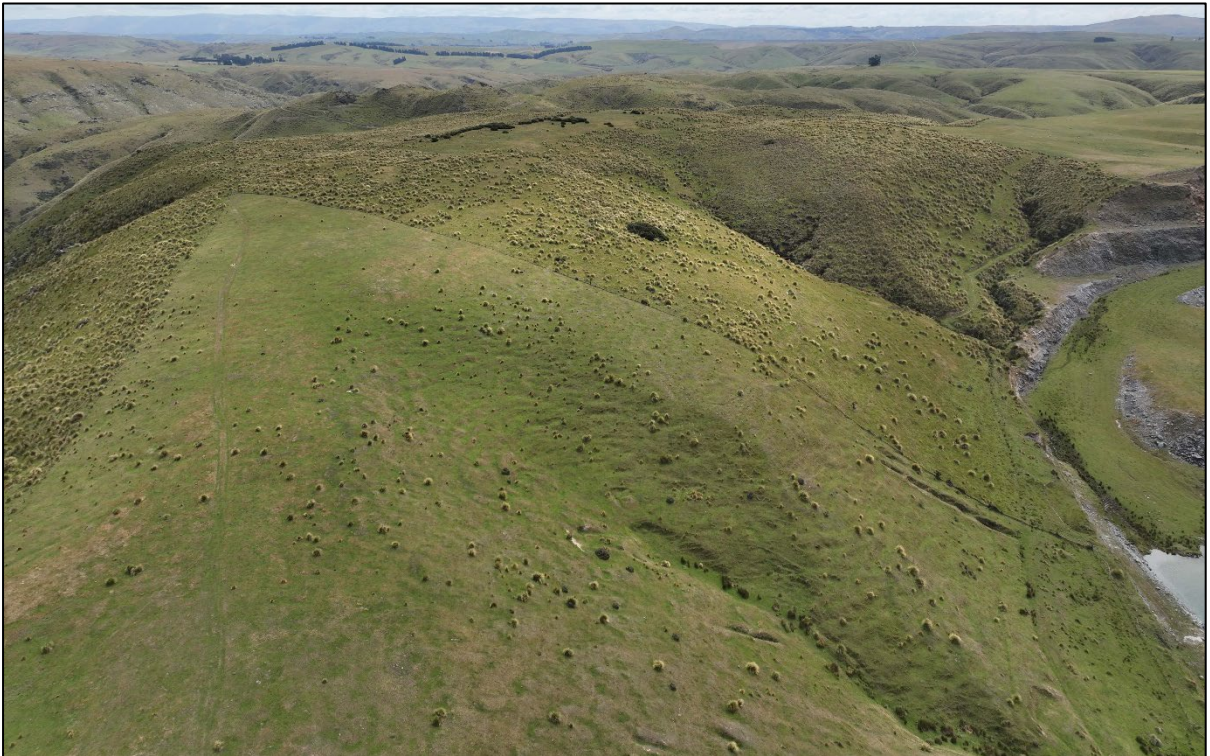
Figure 123. Area of proposed waste rock stack, looking west.

The Golden Bar Waste Rock Stack largely covers open paddocks (Figure 123-Figure 124). One area of interest was identified, consisting of an area of disturbed ground (potentially indicating historic mining) within the proposed footprint. This was surveyed on 2 March 2026 by Jeremy Moyle and Renée Sadlier. The ground disturbance appeared to be an area affected by natural slumping (Figure 125).

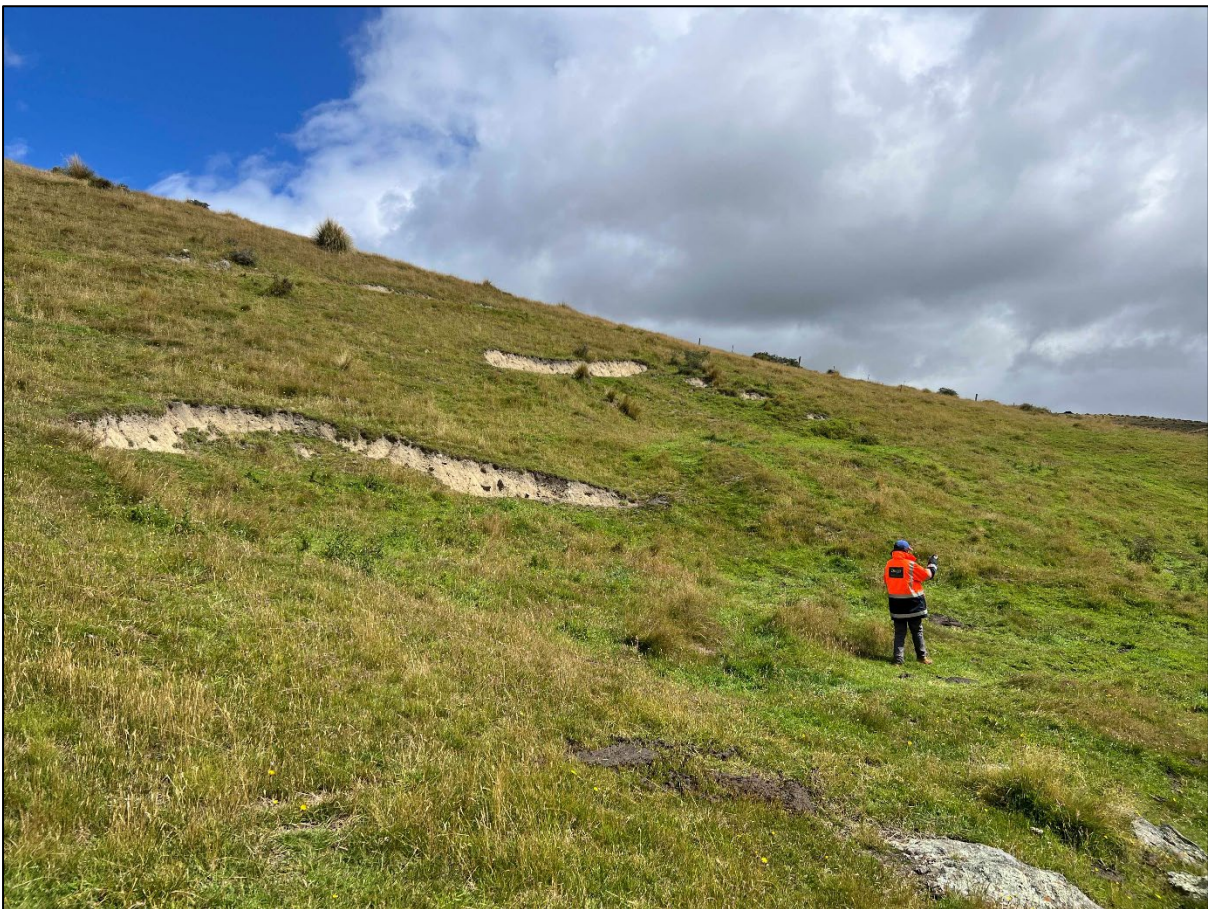
Figure 125. Slumped ground in the proposed waste rock stack area, looking south-west.

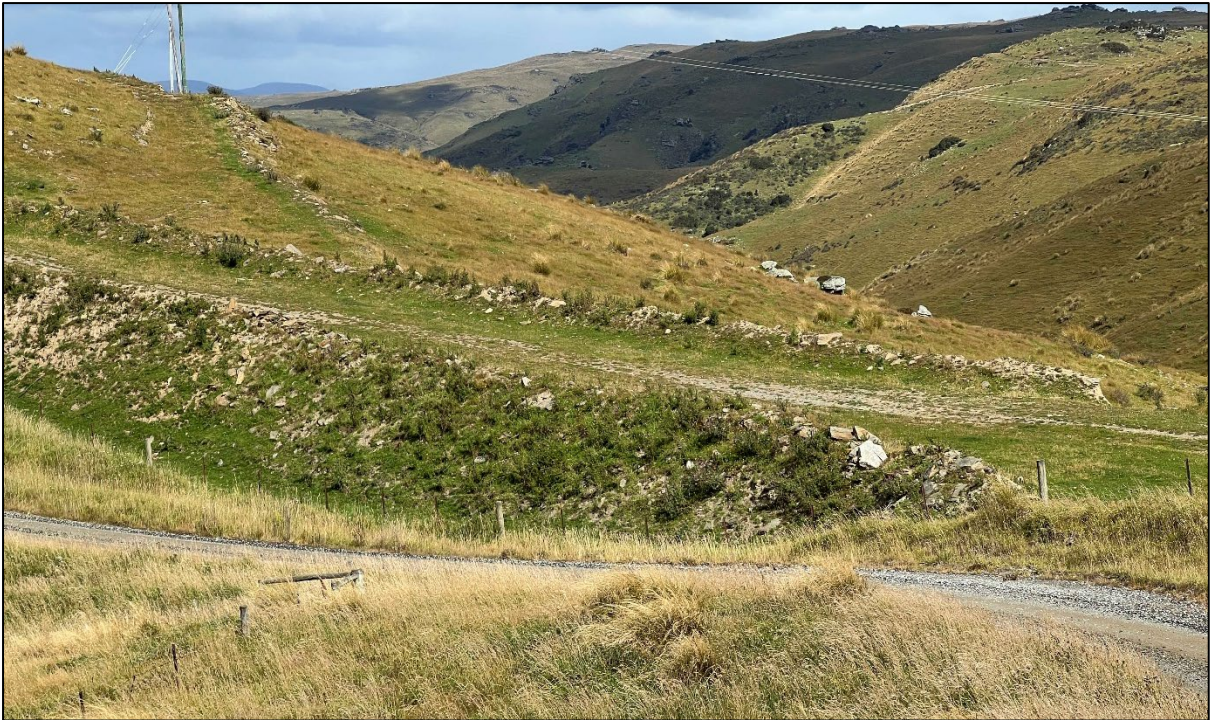
Figure 133. Example of the existing haul road formation, with Golden Bar Road in the foreground.

A survey of the project area was undertaken by Jeremy Moyle and Chris Jennings on 24 November 2025 with a return visit to I42/33 by Jeremy Moyle on 2 March 2026.<sup>211</sup> Figure 132 shows the general areas that were visited based on the identification of archaeological features or areas with archaeological potential during the desktop review. The area around the haul road route consists of vacant pastureland along the ridgeline between Tipperary/McCormicks Creek and Murphys Creek. The haul road project area runs immediately adjacent to Golden Bar Road. Given the history of this road, the potential for historic stone culverts was anticipated in the targeted survey, but none were identified on the ground. The length of Golden Bar Road was driven in addition to the targeted survey areas. No additional archaeological sites were identified beyond the two previously recorded sites discussed below. On site it was evident that almost all the Haul Road project area has already been significantly disturbed by past road formation (Figure 133).

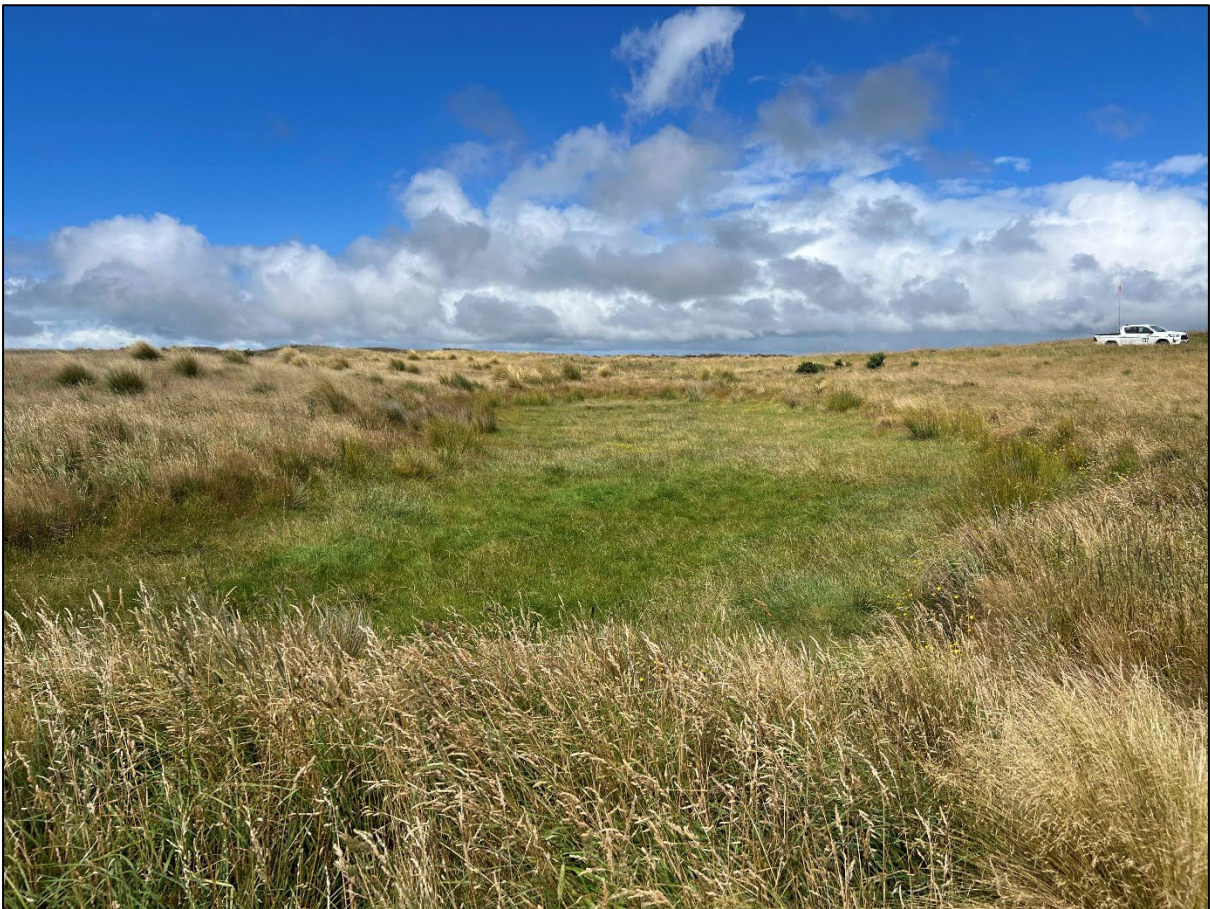
Figure 136. I42/33, looking south-east.

Her diagram of the site indicates a spoil heap adjacent to the deepened pit (Figure 134). At the time of the site visit there was no clear evidence of the excavated area or spoil heap, though a patch of greener grass may indicate the former (Figure 136). A kidney-shaped depression is indicated on Hamel's site record, though it appears she did not interpret this as archaeological. It is now surrounded by earthworks associated with modern mining activities (Figure 135 and Figure 137). A road passes between this depression and the dug-out pit.

- Site I42/33 (prospecting pit) is flanked by two branches of the proposed haul road; a post and wire fence should be erected around this site – at least while the haul road is in use – to make its location apparent and protect it from any accidental damage.

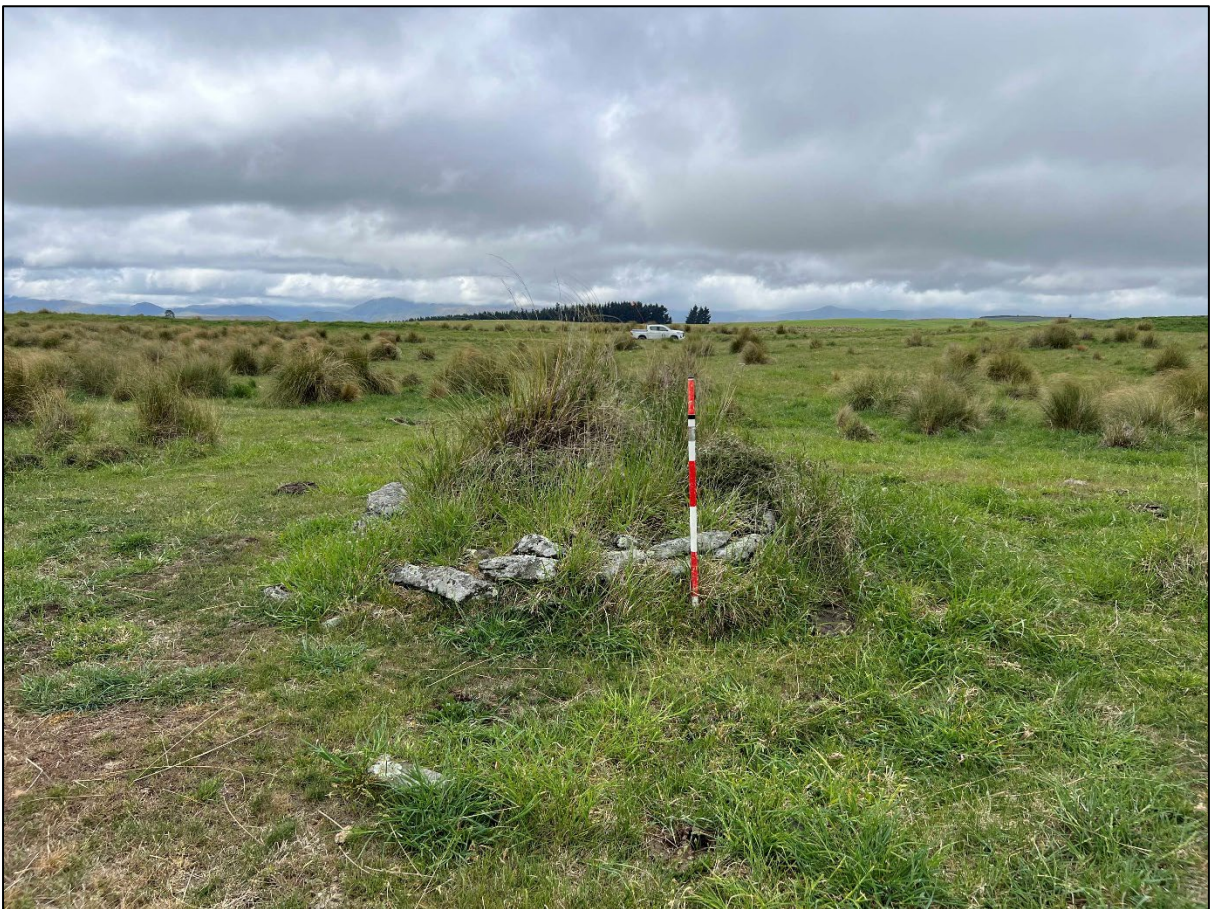
Figure 138. I42/41 (Trig D), looking north-east towards a truck on Golden Bar Road in the background.

The historic Trig D survey mark consists of an approximately 200mm high circular plinth, walled with schist boulders, surmounted with an iron 'bayonet' type marker (Figure 138-Figure 139).<sup>213</sup> The item is overgrown with grass. Hamel<sup>214</sup> interpreted this as a 19<sup>th</sup> century feature, and it possibly dates to the establishment of the mark at some point prior to 1867.<sup>215</sup>

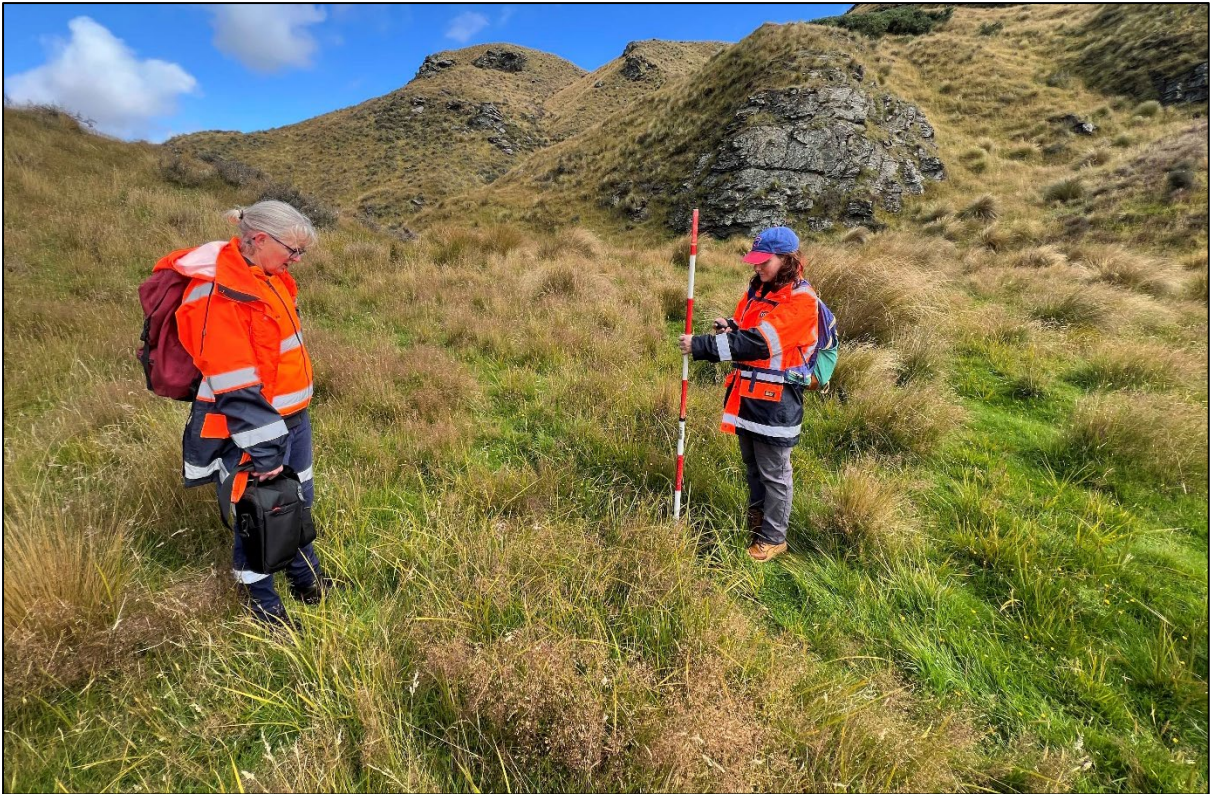
Figure 149. Prospecting pit (A), looking west.

| Ref | Item | Site | Details |
|---|---|---|---|
| A | Prospecting pit | I43/193 | Heavily overgrown pit adjacent to MEEA Creek, approximately 160m upstream of the junction with Murphy's Creek, within the MEEA (Figure 149). |

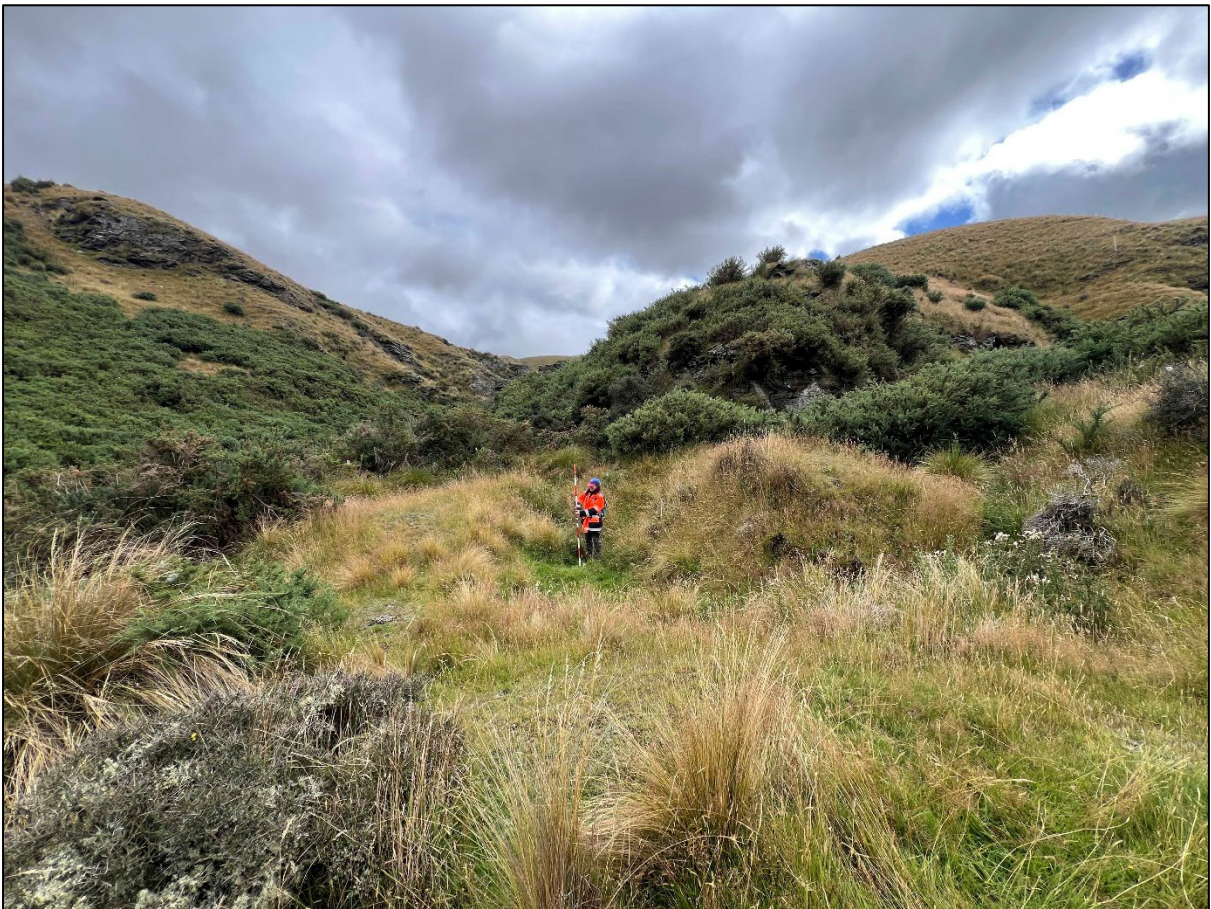
Figure 150. Possible dam/tailings mounds (B), looking north.

| Ref | Item | Site | Details |
|---|---|---|---|
| B | Possible dam/tailings mounds | I43/191 | Earthen embankments adjacent to Murphy's Creek (Figure 150). May be either a dam or overgrown tailings piles. |

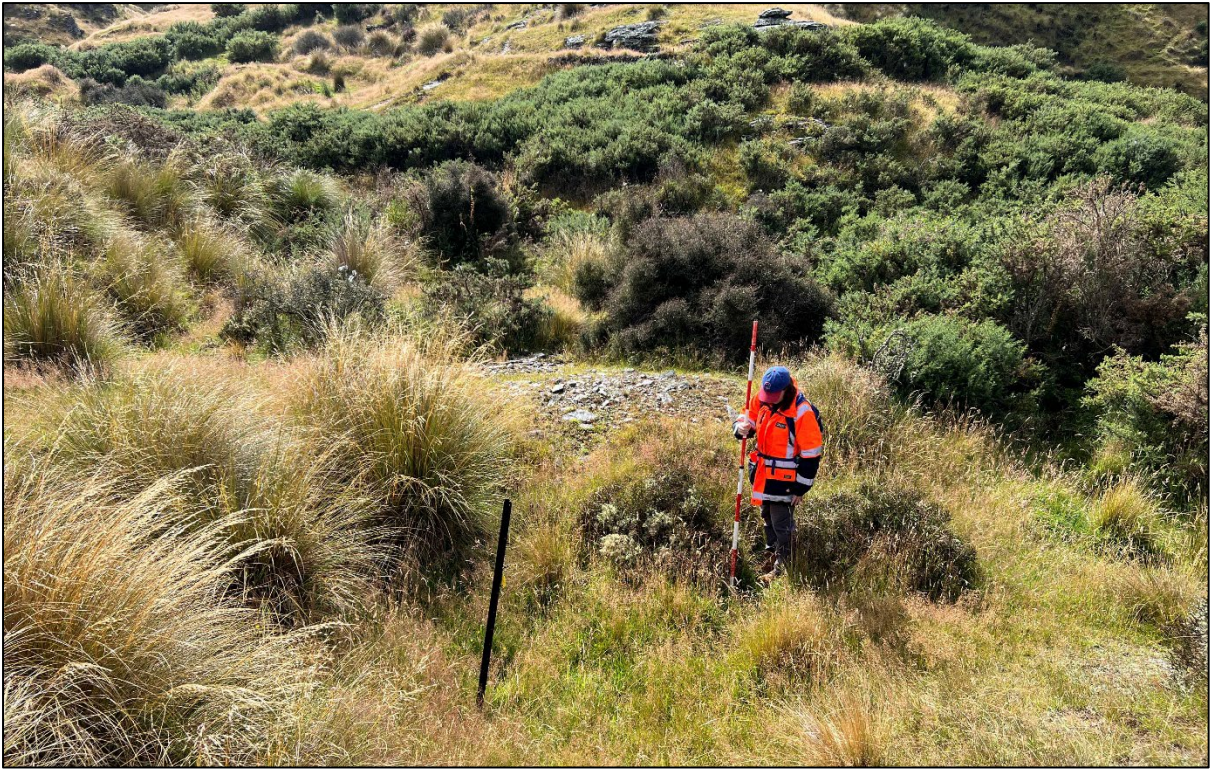
Figure 151. Tailings and sluiced ground (C), looking north-east. The waratah marks an ecological monitoring site.

| Ref | Item | Site | Details |
|---|---|---|---|
| C | Tailings and sluiced ground | I43/191 | Exposed tailings piles within sluicing scar adjacent to Murphy's Creek (Figure 151). |

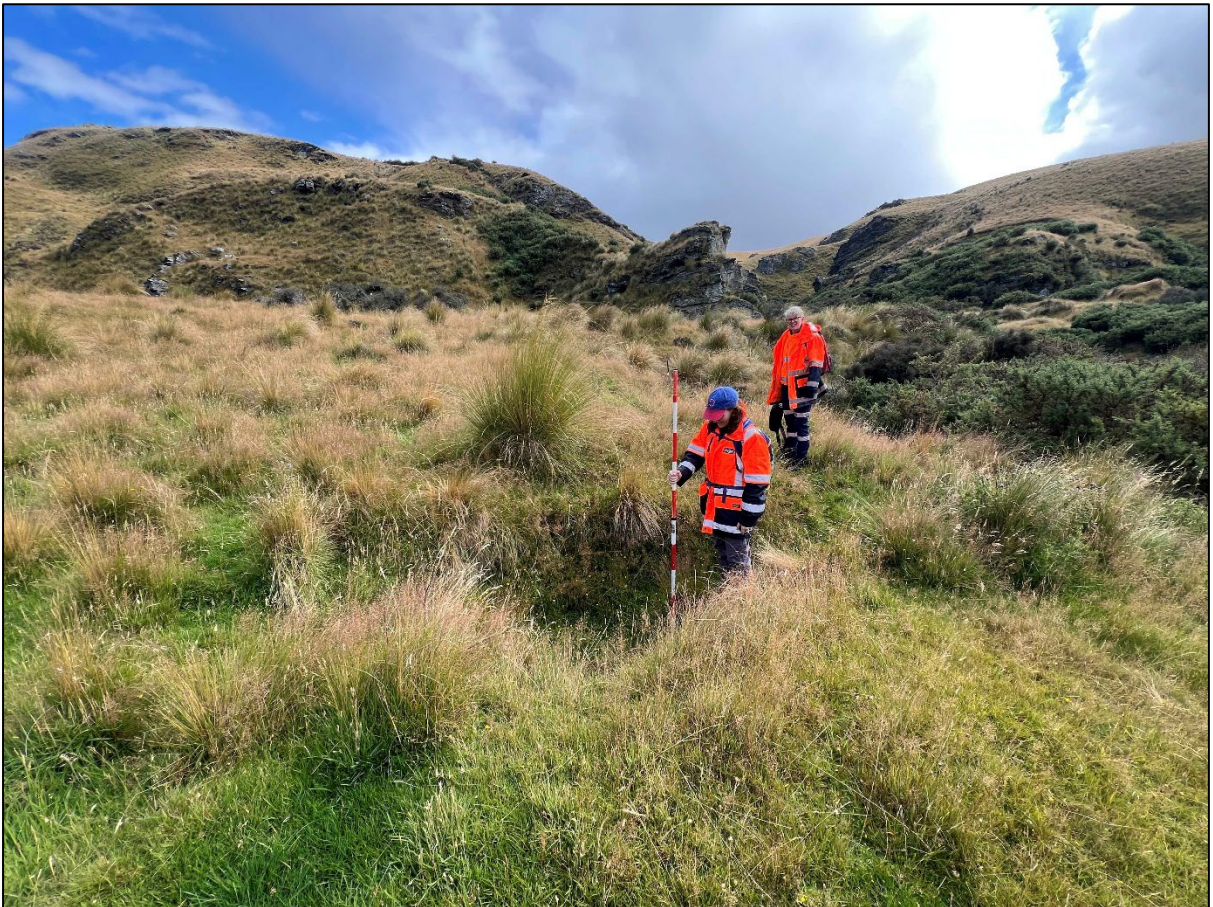
Figure 152. Prospecting pit (D), looking north.

| Ref | Item | Site | Details |
|---|---|---|---|
| D | Prospecting pit | I43/191 | Overgrown pit adjacent to sluiced area (Figure 152). |

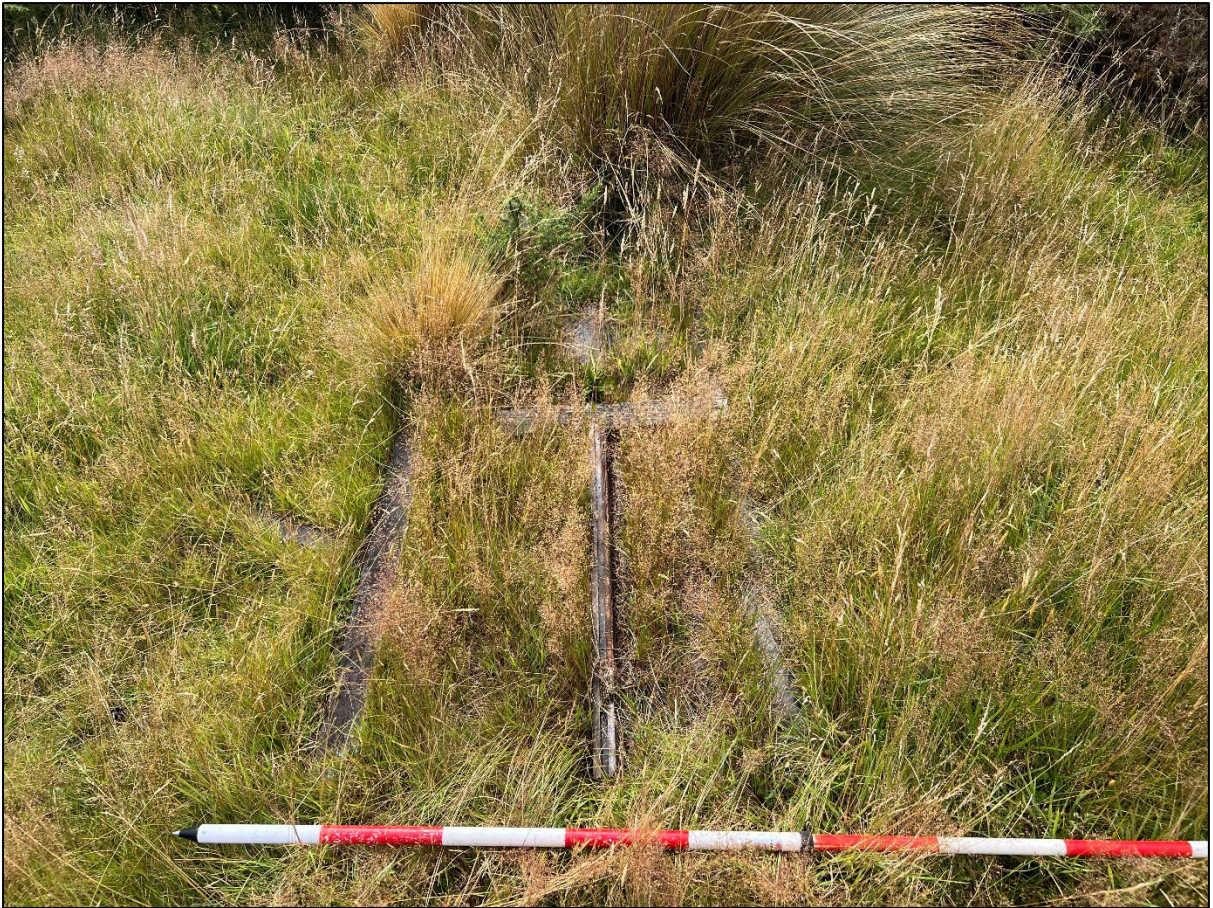
Figure 153. Timber door (E), looking east.

| Ref | Item | Site | Details |
|---|---|---|---|
| E | Timber door | I43/191 | Remains of a panelled timber door (Figure 153). |

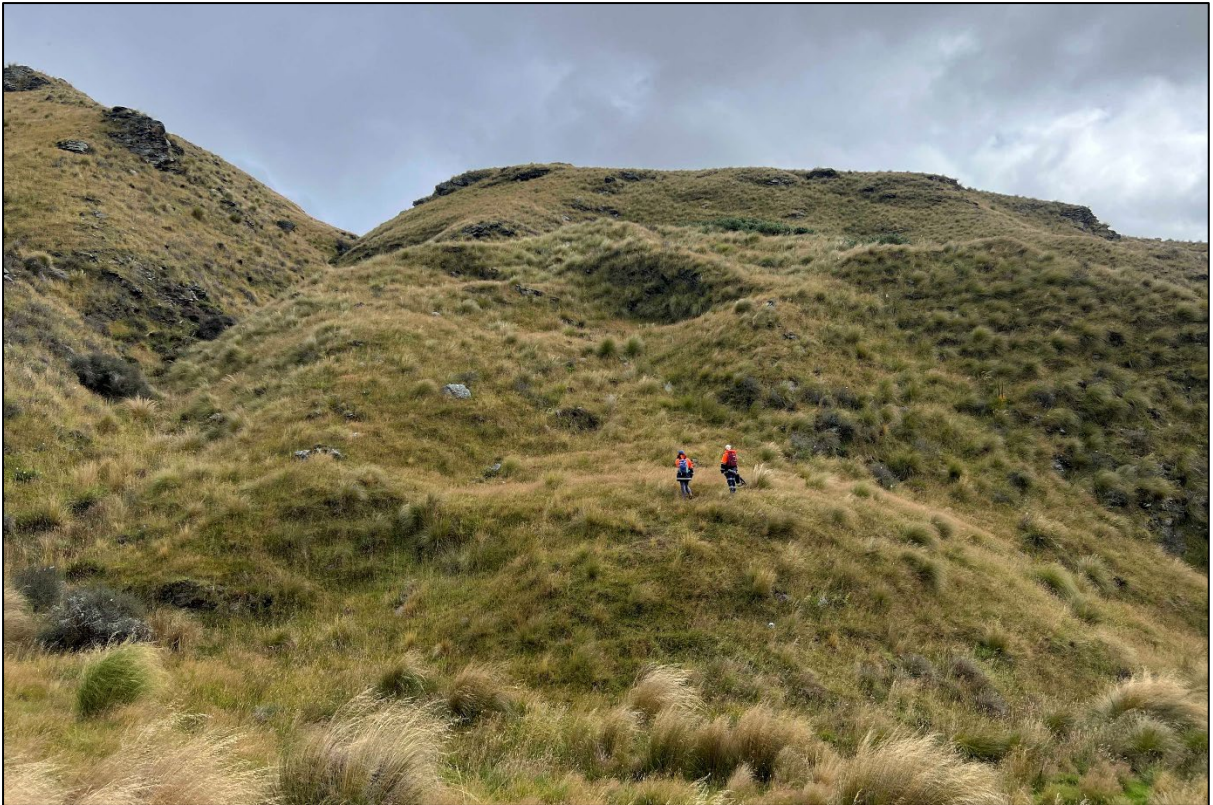
An area of broken ground close to the prospecting pit in the MEEA was inspected as potential workings (Figure 157). This was interpreted as natural land slumping. No other archaeological evidence was identified along MEEA Creek (Figure 158).

Figure 157. Broken ground interpreted as natural land slumping in Grid 157, looking north.

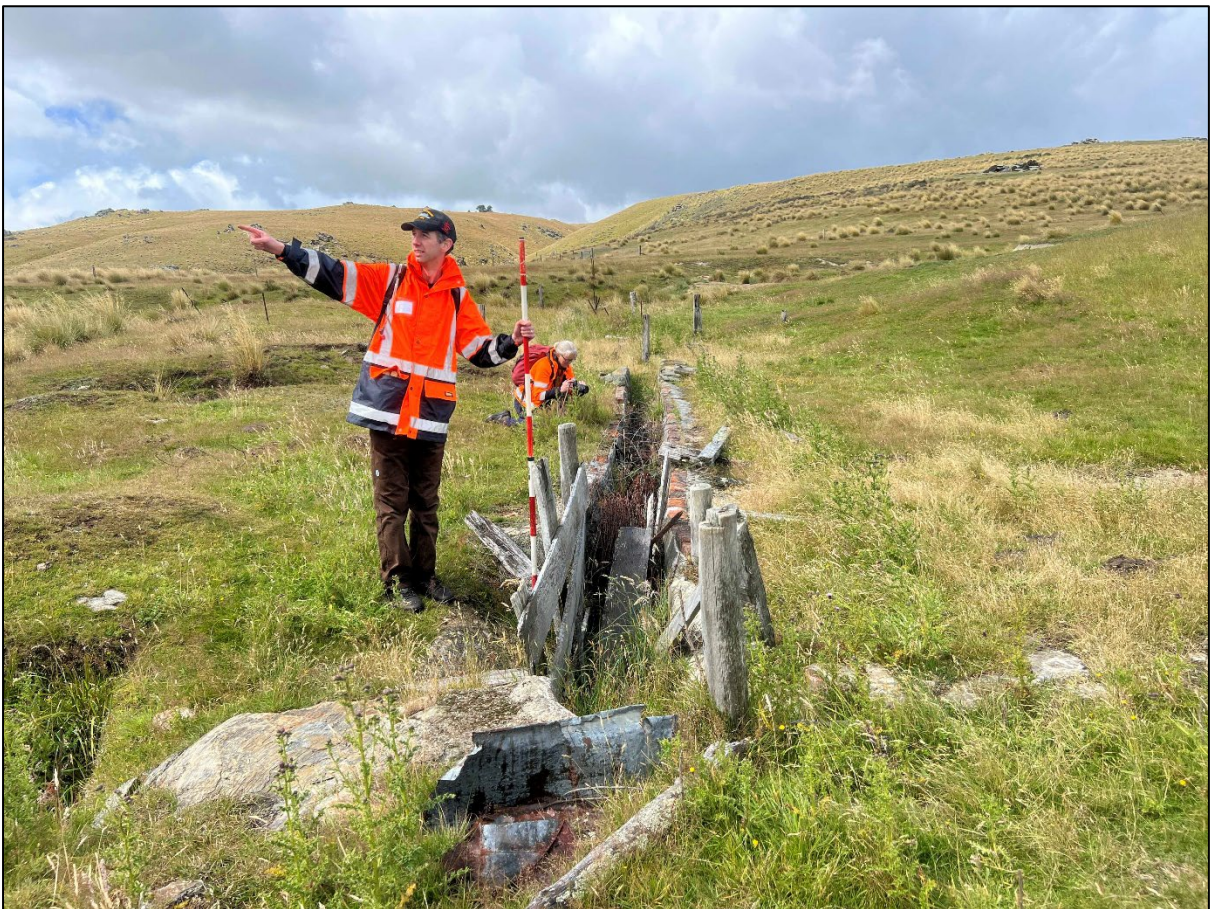
Figure 161. Sheep dip, looking south-east. Note exposed areas of paving at the lower right of the image.

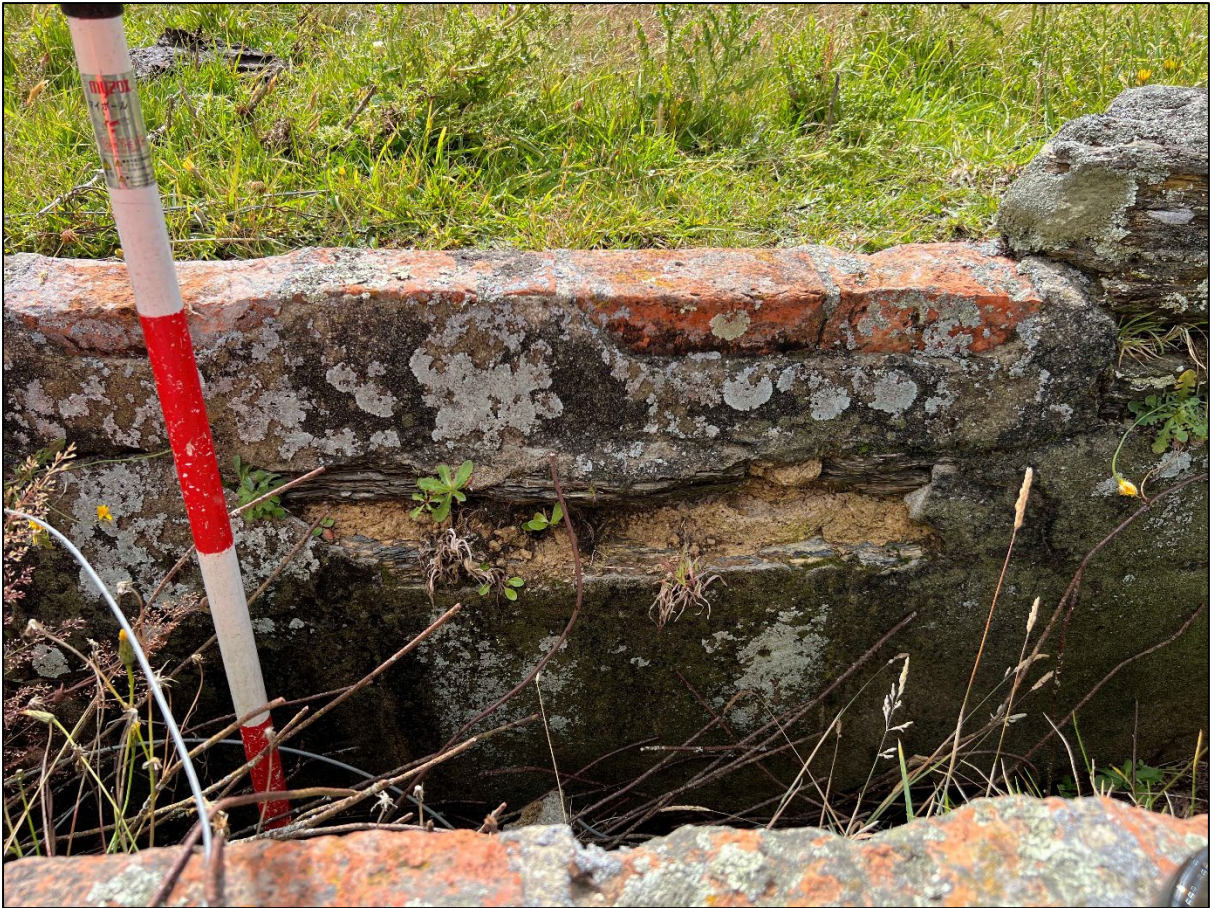
Figure 162. Detail of sheep dip showing mortared stone construction and brick top course.

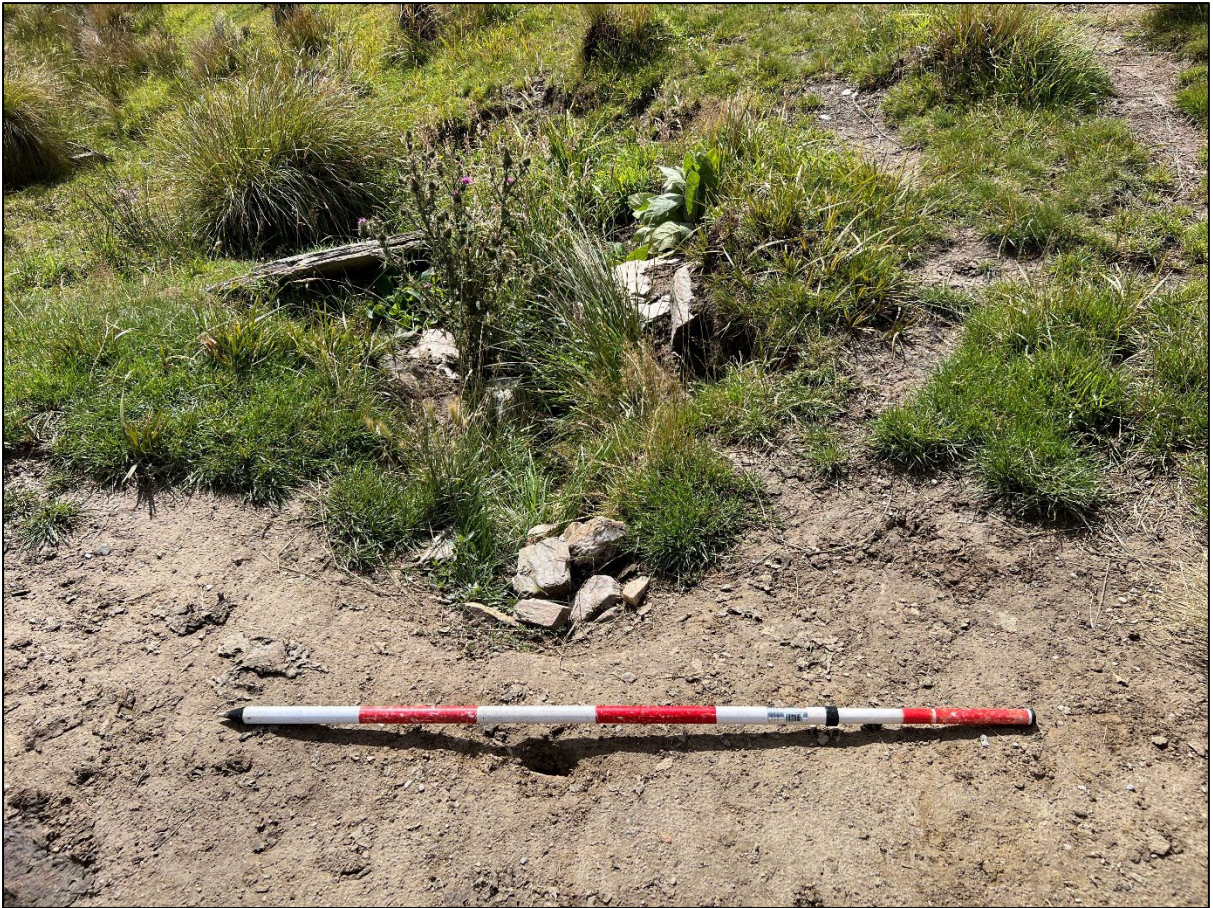
Figure 164. Stone-lined dam outlet, looking north-east.

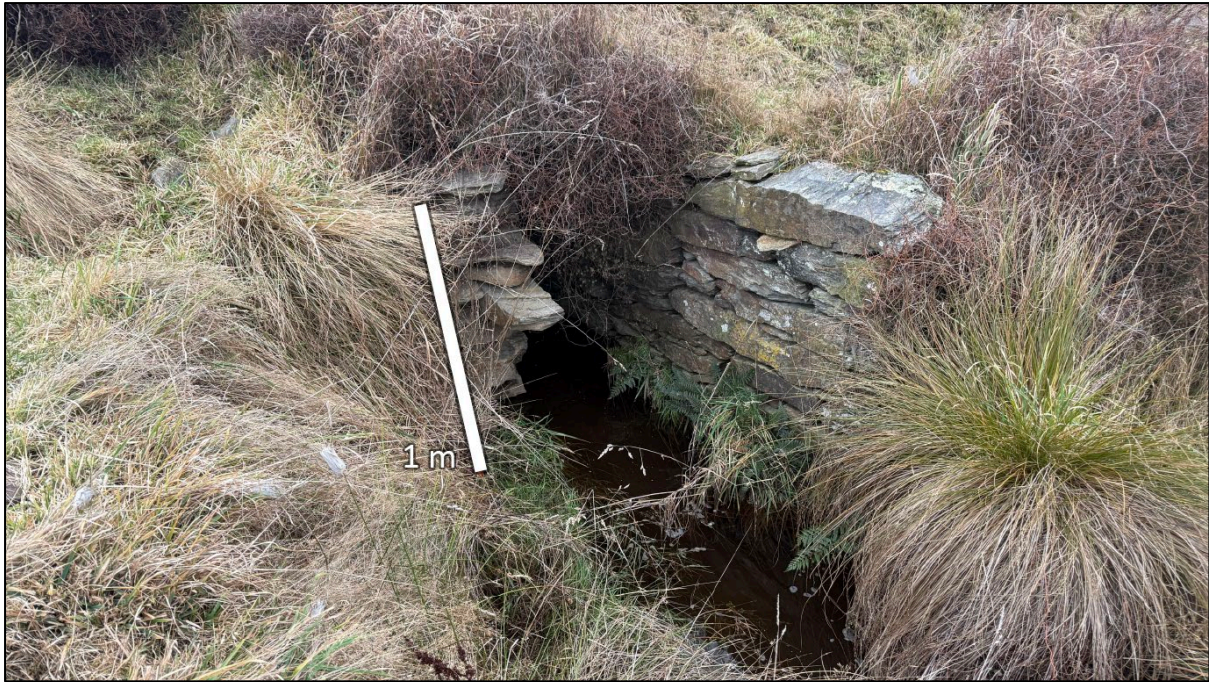
Figure 170. View of culvert outlet.

The eastern outlet of the culvert is asymmetrical (Figure 170), with its northern side protruding further out of the road embankment. No indication of collapse was observed on its southern side. The roof of the culvert on this side was unable to be properly observed as it was obscured by scrub, which made measurement difficult.

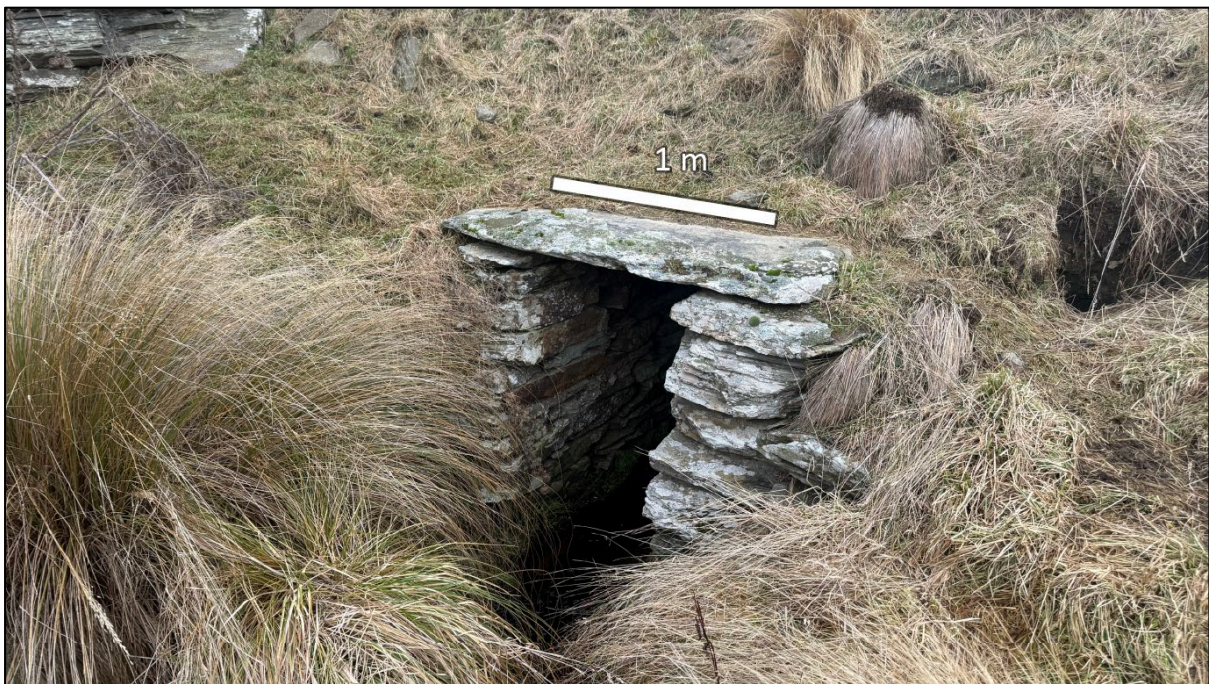
Figure 171. View of Culvert intake.

The western intake of the culvert was capped by an exposed schist slab approximately 1.85 m long by 60 cm wide (Figure 171). The site has been recorded on ArchSite as I42/256.

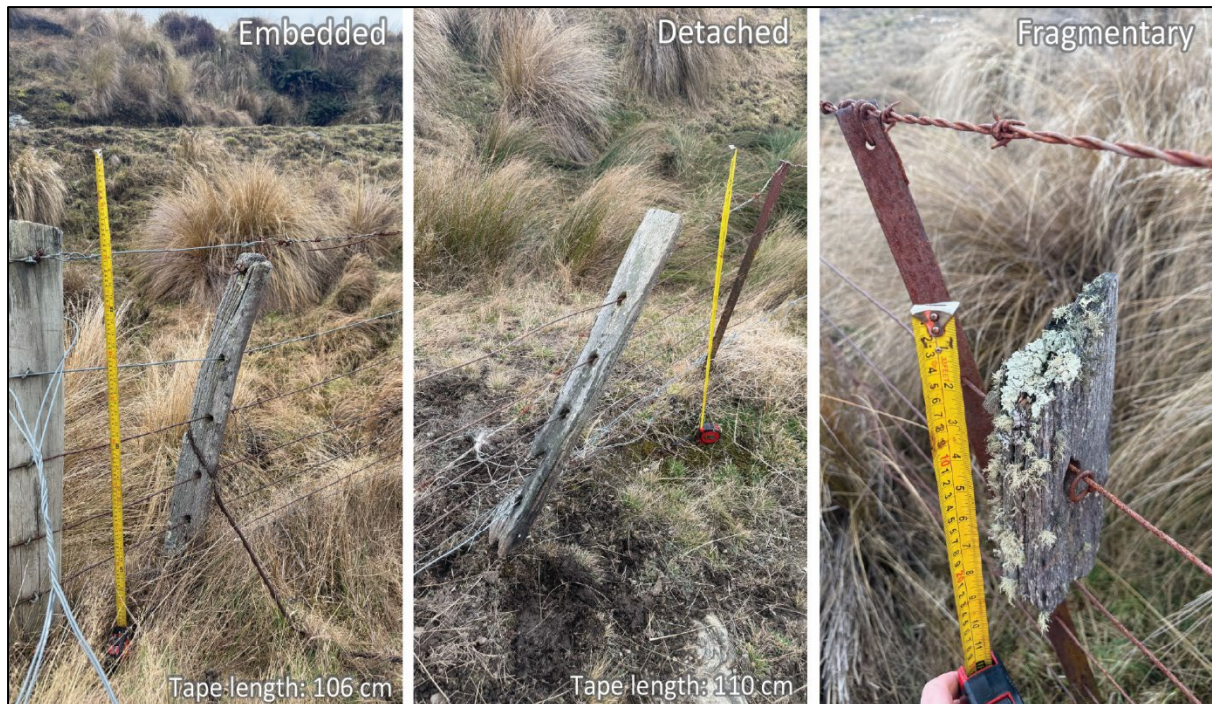
Figure 173. Different states of fence posts along fence line I42/257.

A fenceline runs along the southern side of the farm road that passes over Culvert I42/256 for a length of approximately 507 metres (Figure 172). The fenceline is consistent with the edge of the road reserve as shown on the 1891 SO 421 and is likely to be pre-1900 in origin. The site consists of a No. 8 wire fence with 5 wires, a barbed top-wire and deteriorating wooden posts. It runs alongside a road reserve, although mostly offset from the surveyed boundary. Most of the posts are flat triangular in cross section, potentially to make the number of posts go further. The remaining posts consist of metal standards. Several of the posts are still in embedded in

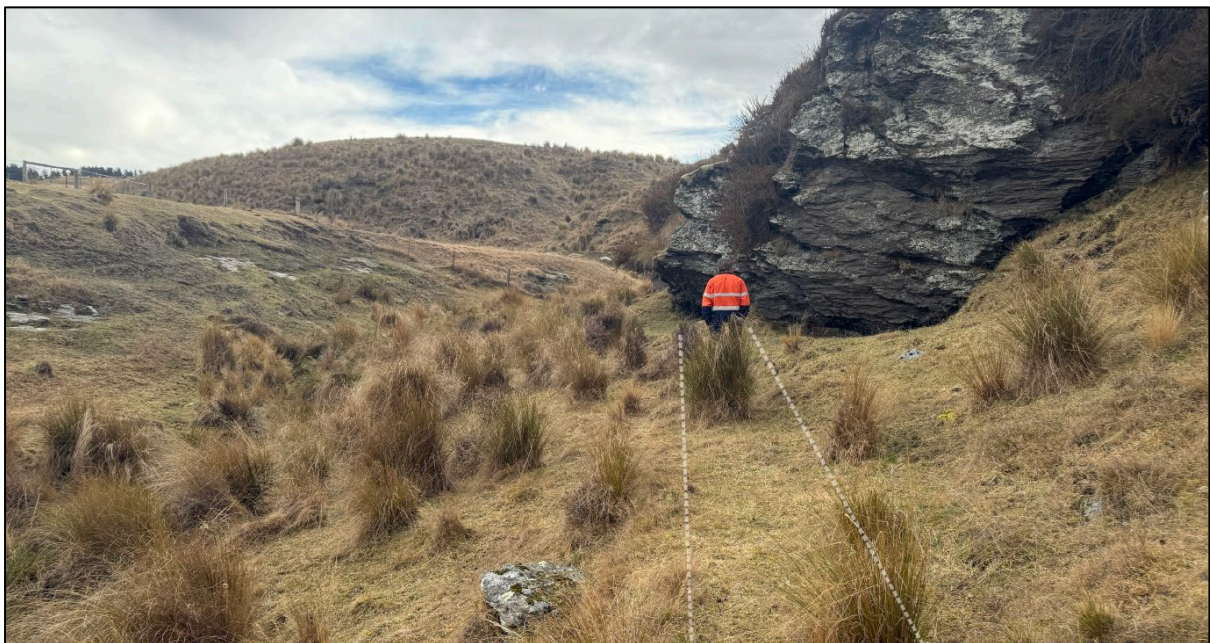
Figure 176. View of I42/258 track (indicated by white dashed lines) towards northeast rock outcrop.

Inside the MEEA boundary, southeast of the stone culvert I42/256, was a small goldmining area including partially revetted benched track, a prospecting pit, and potential tailings (Figure 175). The area was heavily covered in tussock and thick grass, obscuring many of the features. The track appears to be formed in two parts. One, is a flattened path between two large schist outcrops (Figure 176); the second part of the track is a revetted section that carried on approximately 14m before it either terminated or deteriorated (Figure 177).

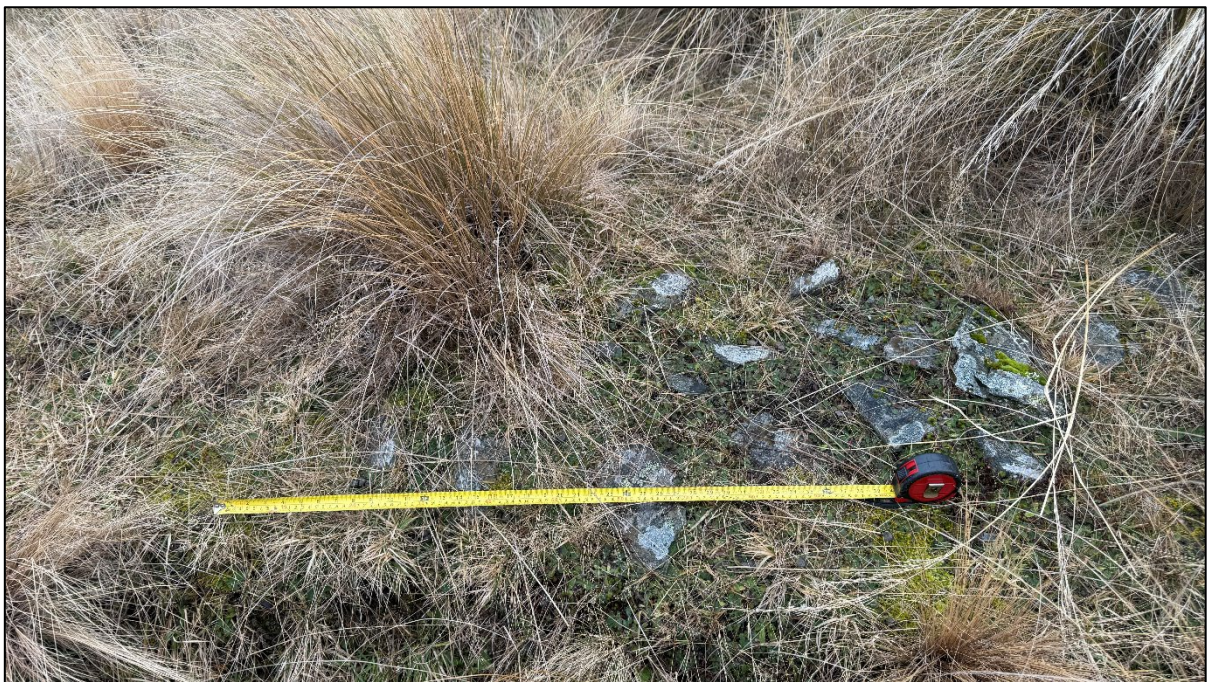
Figure 178. View of probable tailings south of revetted section of I42/258) path. Tape extended to 100cm.

South of the revetted section were partially buried schist rocks that were likely indicated of tailings (Figure 178). As much of the site area was obscured by tussock, and the rocks were only partially exposed, it was difficult to determine the extent of the feature. Downslope to the south of the flattened path section was a prospecting pit, approximately 180cm long, 140cm wide, and 40m deep (Figure 179).
