Auckland Council Model Review

Section 3 Review Details

Appendix - FIGURES

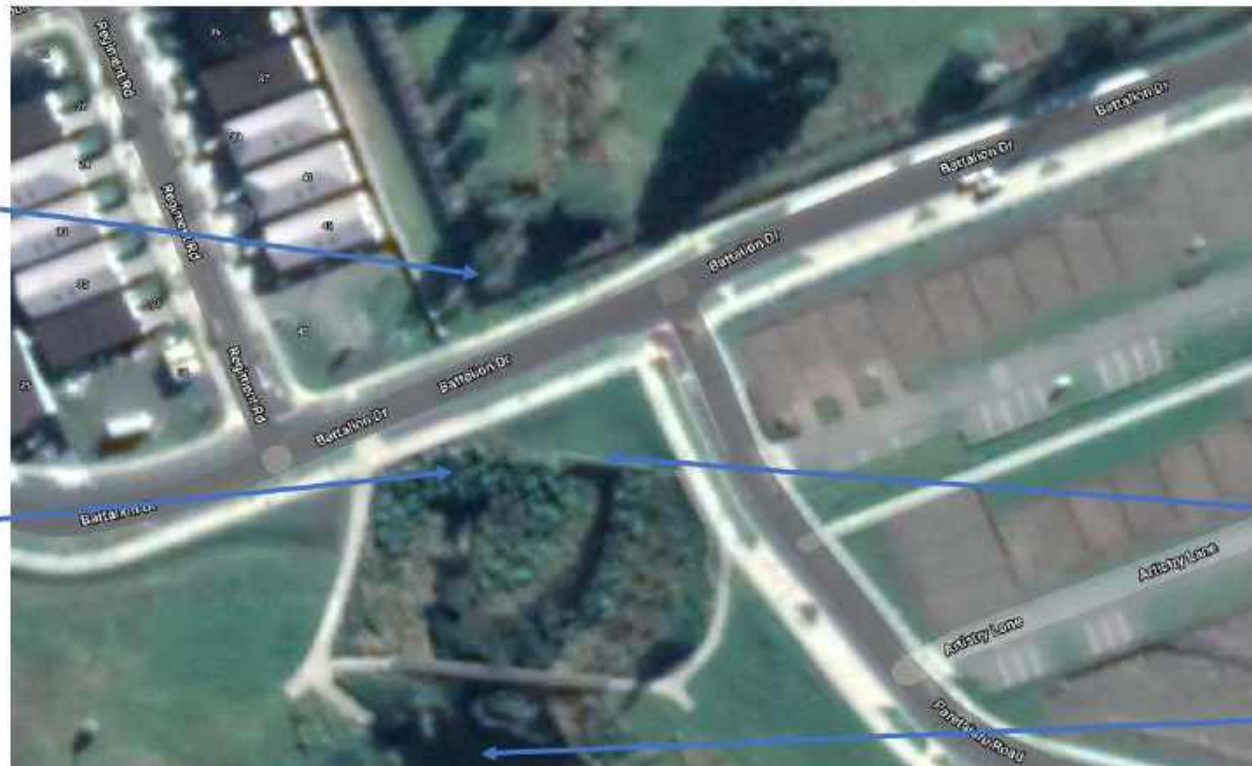
asset data required for culvert/pipe discharging to wetland from Military camp

UPDATE: Data received and structures have been added to the model

Appears to be a culvert under Battalion Drive from Military camp to wetland (potentially a private asset). Geomaps shows a 1050 pipe in the vicinity of this area but not clear if this is same asset/latest configuration

Flow from this subcatchment is currently loaded downstream of the asset which is not in the model. Meaning backwater effects through this pipe are not currently included.

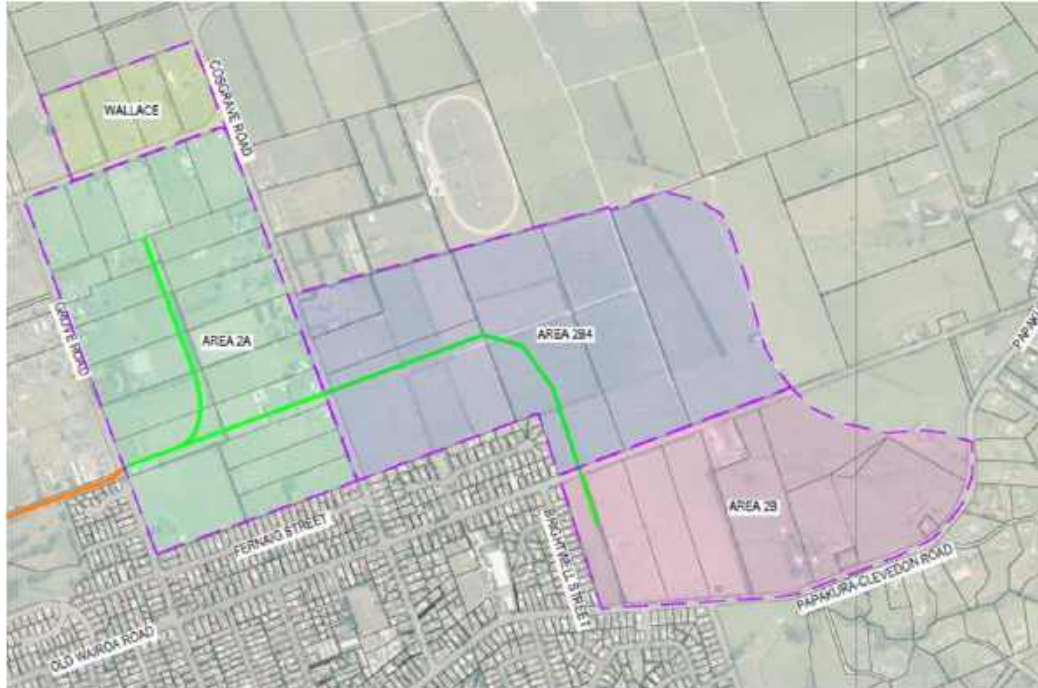
Figure 1 Takanini 2A2B catchment

The area is approximately 155 hectares (ha) and consists of areas 2A (50.3 ha), 'Wallace' (9.1 ha), 2B4 (57.3 ha), 2B (38.0 ha) as shown as a dotted purple line in Figure 1 (referred to as the Takanini 2A2B catchment herein).

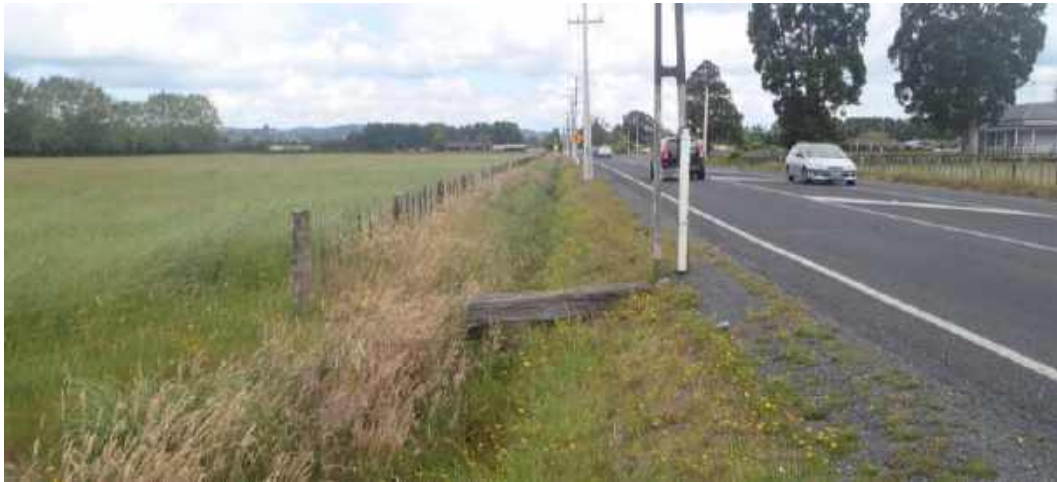
Figure 2 Cosgrave Road table drain

The roadside table drains along Cosgrave Road collect overland flow and have limited conveyance capability. These roadside drains are deeply incised, up to about 2 to 2.5 m in depth. Generally, the roadside drains store water and discharge to ground soakage when water tables are low over summer. Figure 2 shows the table drain on Cosgrave Road.

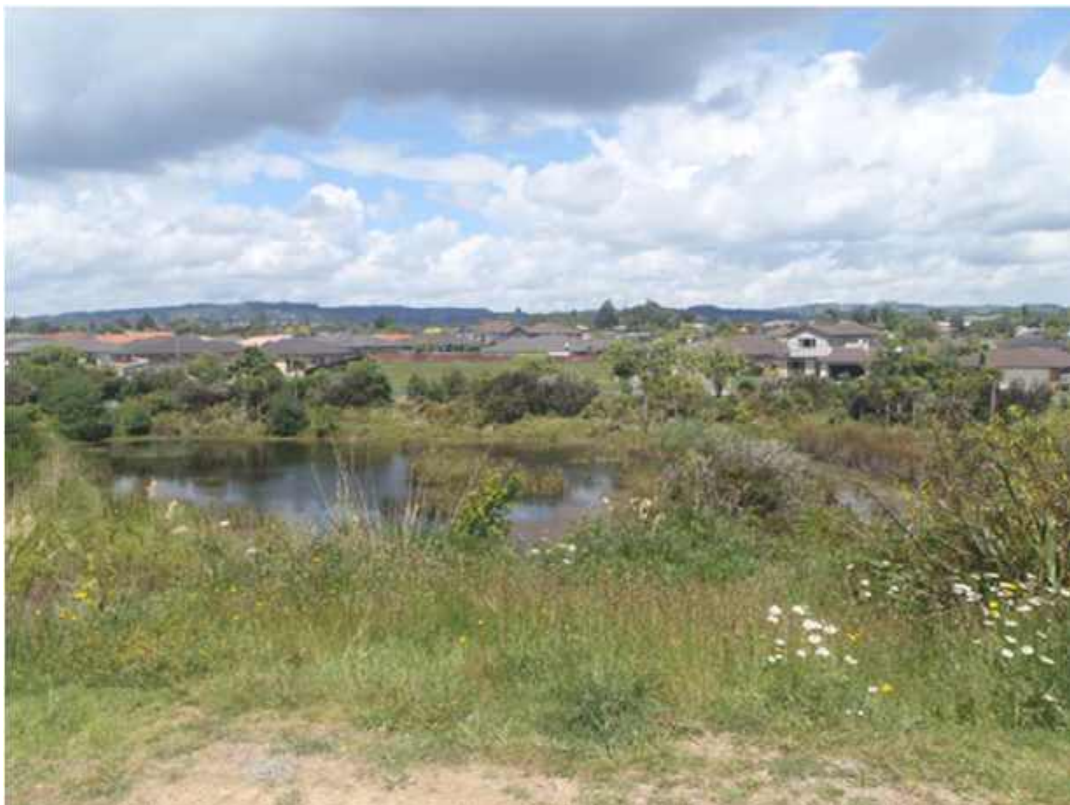
Figure 3 McLennan wetland

To the west of Grove Road and south of Fernaig Street and Pukeroa Place stormwater is reticulated. Most of these flows are directed to the wetland located in McLennan Park. This wetland (the McLennan wetland) is designed to attenuate and treat flows from the Old Wairoa Road catchment before discharge via Gills Pond to the Pahurehure Inlet and is discussed further in Section 5.4.

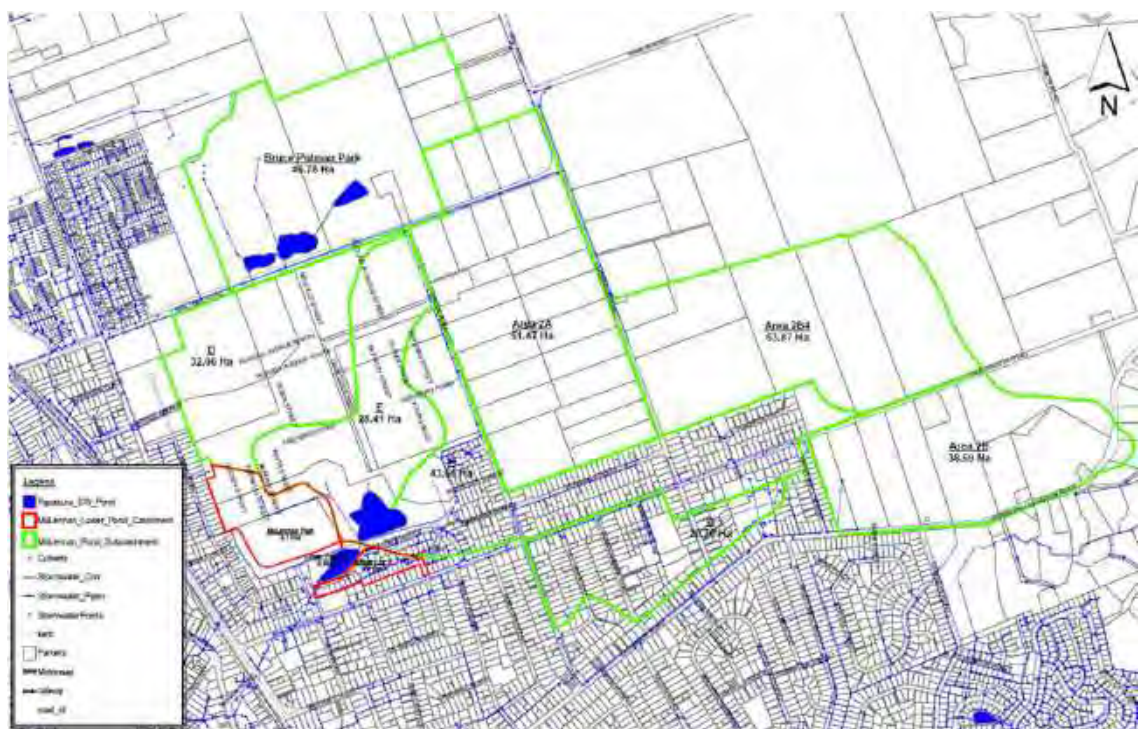
Figure 4 McLennan wetland sub-catchment map (Old Wairoa Road CMP Variations, 2009)

The McLennan wetland was constructed in 2002, this wetland already receives stormwater from the Housing New Zealand development and Papakura Military Camp through to Bruce Pulman Park in the north; and Willis Road and Clevedon Road to the south. The wetland provides attenuation and treatment for of the Old Wairoa Road catchment as per Figure 4.

The wetland currently has an embankment top level of RL 16.00 m and an emergency spillway level of RL 15.1 m.

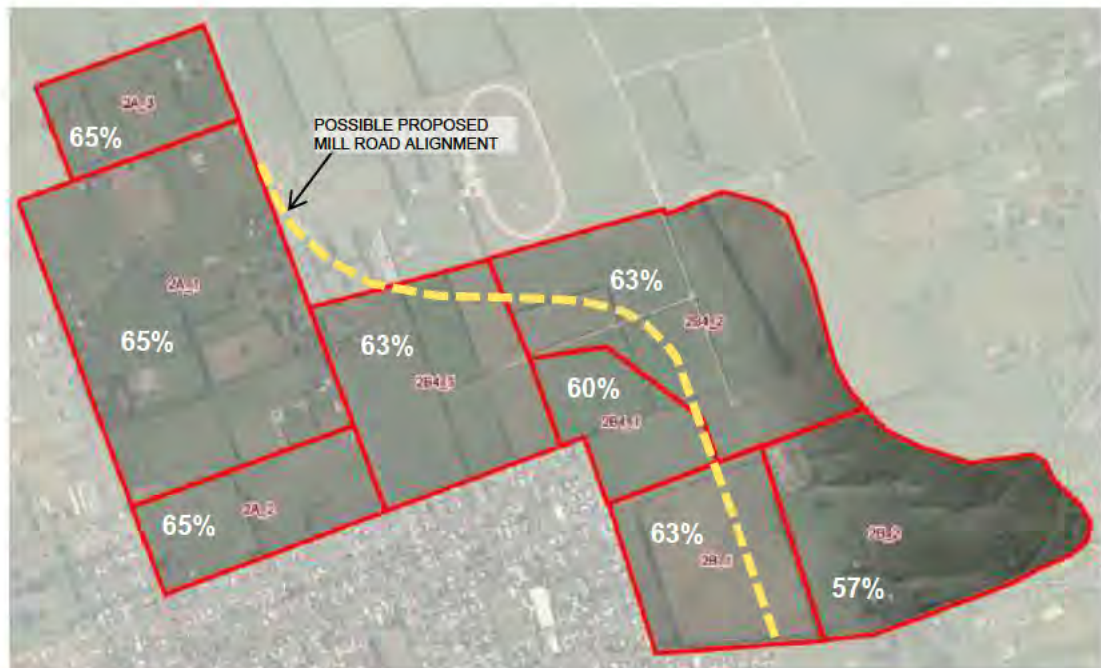
Figure 5 Impervious areas

The Mill Road Corridor is proposed to run through areas 2B and 2B4, as shown in Figure 5. The alignment and size of the Mill Road Corridor has not been confirmed; however, for the purpose of this report, a possible route has been assumed which allows for a corridor approximately 1 km long, 20 m wide and 100% impervious. This additional impervious area will slightly increase the maximum impervious area (MPD) scenario as per the values in Figure 5. The three sub-catchments that Mill Road runs through will have impervious areas increased from 60% to 63%.

A sensitivity analysis was carried out on the impervious area assumptions for the catchment. The 1% AEP model was run using a base of 70% impervious area for each sub-catchment, adjusted further as above for the Mill Road Corridor (+3% for the three sub-catchments that Mill Road runs through). This resulted in an increase in flow of approximately 1 m³/s for the 1% AEP event (37.9 m³/s). This is expected to have a negligible effect on the water level in the channel, and therefore the values in Figure 5 are considered reasonable.

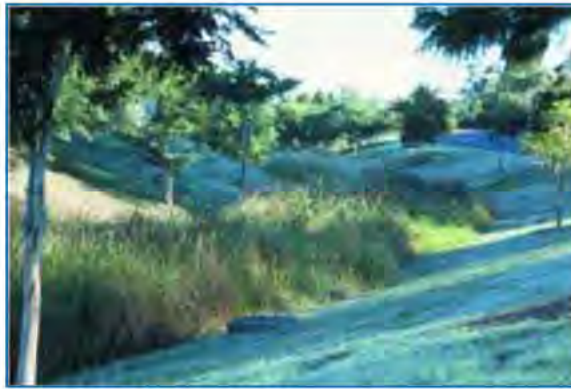
Figure 9 Similar channel with an average bankfull $n = 0.035$

The adopted Manning's numbers for the Takanini Stormwater Conveyance Channel align with the recommended values in *Christchurch City Council's Waterways, Wetlands and Drainage Guide* (Christchurch City Council, 2003). The above publication was used as it contains Manning's numbers for stream surfaces that are similar to the proposed vegetation and channel profiles of the proposed Takanini Stormwater Conveyance Channel. No local (Auckland) publications were found with Manning's numbers for similar surface types.

No channel example case studies with assessment Manning's numbers were found in local (Auckland or New Zealand) publications, however, example case studies are given in the *Natural Channel Design Guidelines* (Brisbane City Council, 2003). Figure 9 outlines a channel with similar features to the proposed stormwater channel.

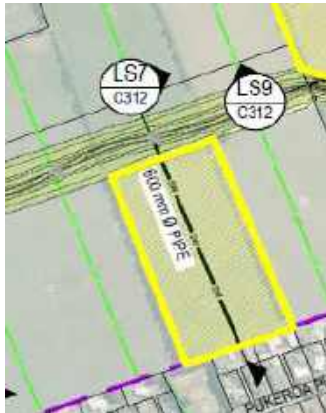
Roughness Coefficient: 0.013	Flow Area: 0.28 m ²
Channel Slope: 0.4500%	Wetted Perimeter: 1.91 m
Normal Depth: 0.61 m	Hydraulic Radius: 0.15 m
Diameter: 0.61 m	Top Width: 0.00 m
Discharge: 0.51 m ³ /s	Critical Depth: 0.47 m
	Percent Full: 100.0%
	Critical Slope: 0.00730 m/m
	Velocity: 1.76 m/s
	Velocity Head: 0.16 m
	Specific Energy: 0.27 m
	Froude Number: 0.60
	Maximum Discharge: 0.58 m ³ /s
	Discharge Full: 0.51 m ³ /s
	Slope Full: 0.00650 m/m
	Flow Type: Subcritical

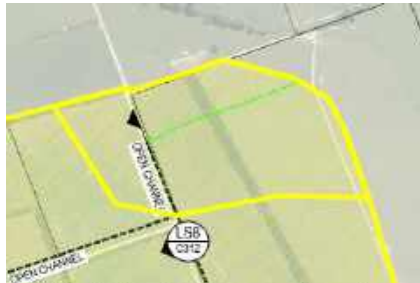
Roughness Coefficient:	0.035	Flow Area:	1.18	m ²	
Channel Slope:	2.30000	%	Wetted Perimeter:	4.86	m
Normal Depth:	0.35	m	Hydraulic Radius:	0.24	m
Left Side Slope:	4.00	m/m (H/V)	Top Width:	4.78	m
Right Side Slope:	4.00	m/m (H/V)	Critical Depth:	0.39	m
Bottom Width:	2.00	m	Critical Slope:	0.01394	m/m
Discharge:	2.31	m ³ /s	Velocity:	1.98	m/s
			Velocity Head:	0.20	m
			Specific Energy:	0.54	m
			Froude Number:	1.28	
			Flow Type:	Supercritical

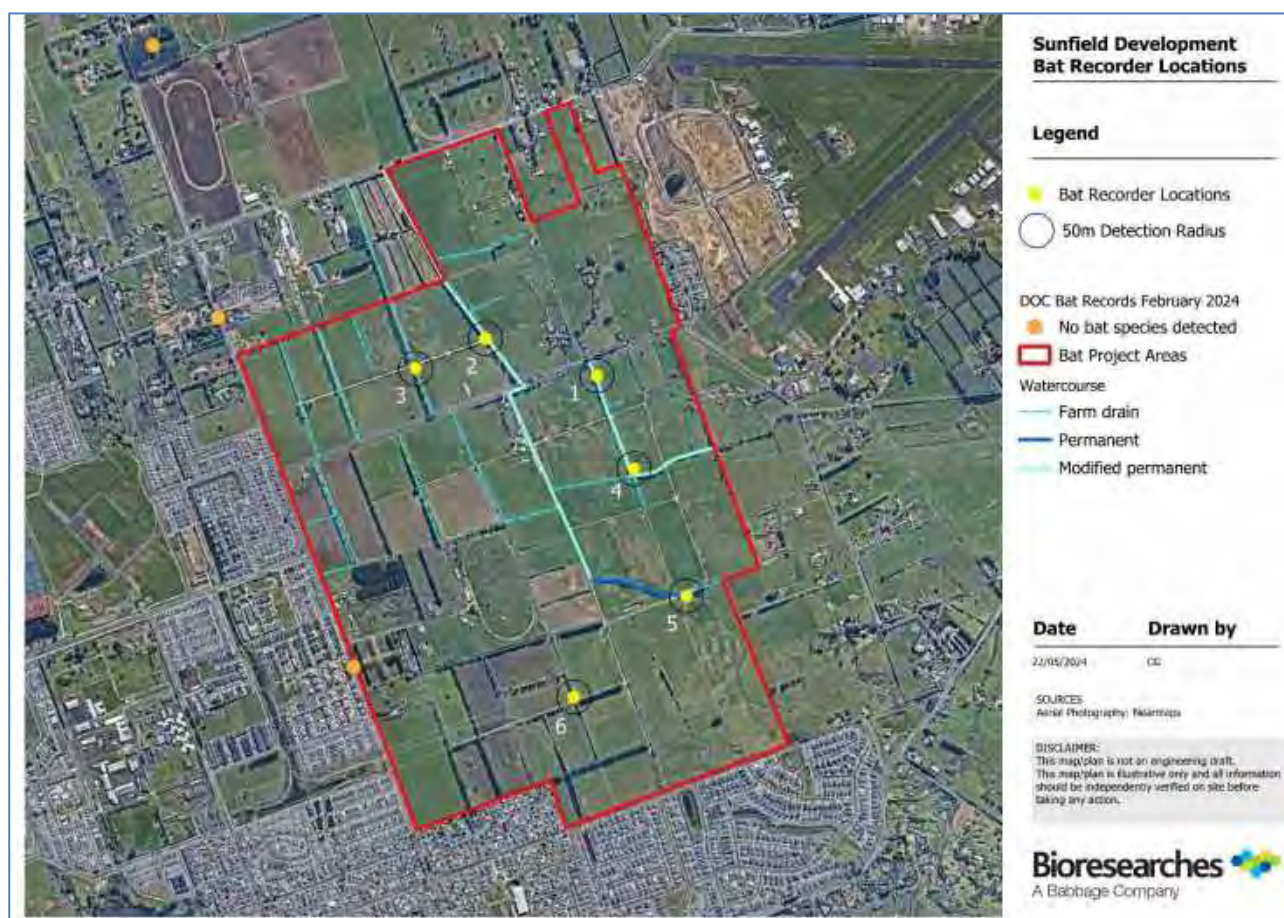
Figure 5. April 2024 bat survey ABM locations

A survey using Automatic Bat Monitors (ABMs; DOC AR4s) was conducted with 6 units from 4/4/24 – 19/4/24 across the Sunfield North and South sites, with placement targeting linear features such as tree rows which might be used as flyways and waterways which could support drinking/ foraging habitat for bats (Figure 5). One ABM failed (Unit 6), and no bats were detected with the remaining five units during the total 67 valid survey nights (Table 6).

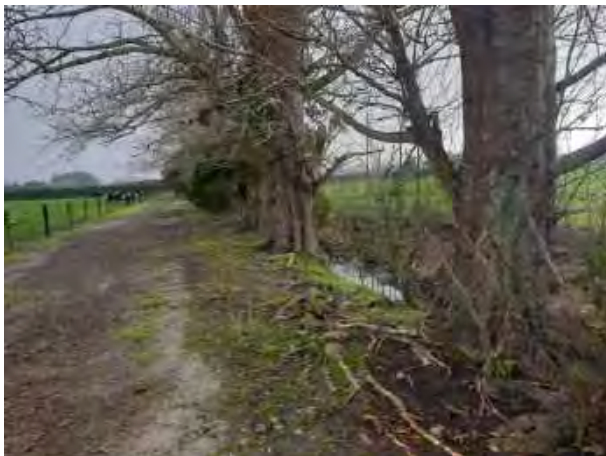
Watercourse 1 is a **permanent stream** which has been historically modified through straightening and deepening, and potentially diversion (Photo 10). Watercourse 1 is visible on historic aerials from 1960, and it is likely the natural stream channel has been modified for over 80 years. Watercourse 1 was considered to be a modified permanent stream, rather than artificial due to the connectivity to the wider freshwater catchment on the upstream and downstream reaches. Watercourse 1 enters the site through a roadside drain on the southern portion of the site, and flows in a northern direction through an unnaturally straight and deep channel (Photo 11) for approximately 400 m before discharging from the site.

Photo 10. Watercourse 1 consisted of a modified permanent channel.

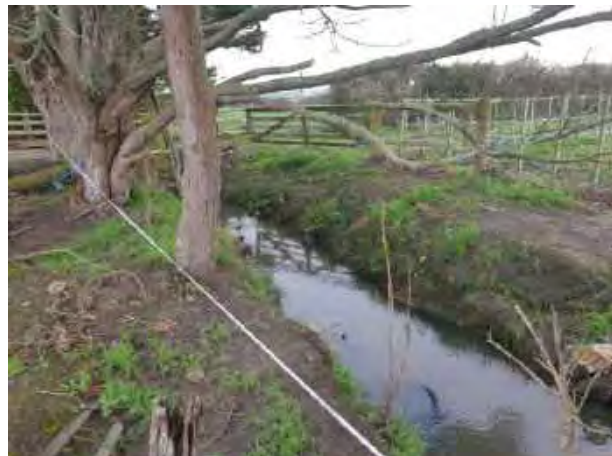
Photo 11. Watercourse 1 was unnaturally straight and deep.

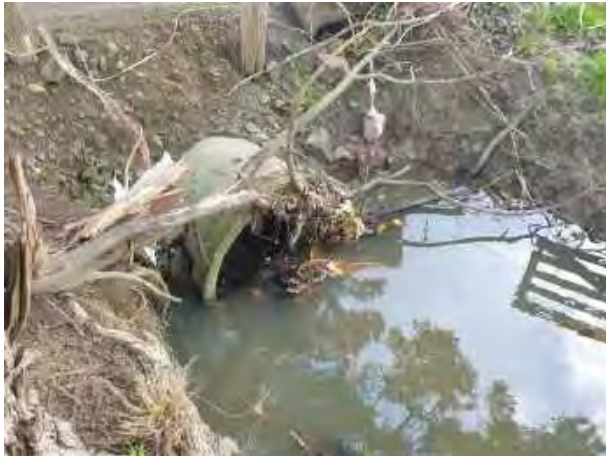
Watercourse 1 was wide and deep, with the channel approximately one metre in width and surface water approximately 0.5 m deep. An embedded culvert is present in the stream channel resulting in a drop-in stream bed levels by approximately 0.3 m (Photo 12). The channel banks were incised and steep, approximately 0.6 m, restricting connectivity to the floodplain. Substrate throughout Watercourse 1 was predominantly soft with the channel bed consisting of compacted earth and a layer of fine sediments (Photo 13). A high degree of organic matter is present within the stream channel with leaf litter and woody debris established throughout. Hydrological variation within the stream reach is low, with the channel predominantly consisting of a straight run and shallow pools, however some woody debris dams have resulted in minor riffle habitat.

Photo 12. An embedded culvert is present within the stream channel

There was a low degree of aquatic habitat and diversity throughout the reach, with available habitat consisting of runs, occasional pools and debris (including rubbish and wood) ([Photo 15](#)). An embedded culvert is present within Watercourse 1, with the culvert pipe below the stream bed resulting in a “drop” which likely acts as a partial barrier to fish passage. Shortfin eel and banded kōkopu have been recorded within 2 km of the site, within similar freshwater environments (i.e. highly modified farm drains and artificial channels), and are likely to access and reside within Watercourse 1.

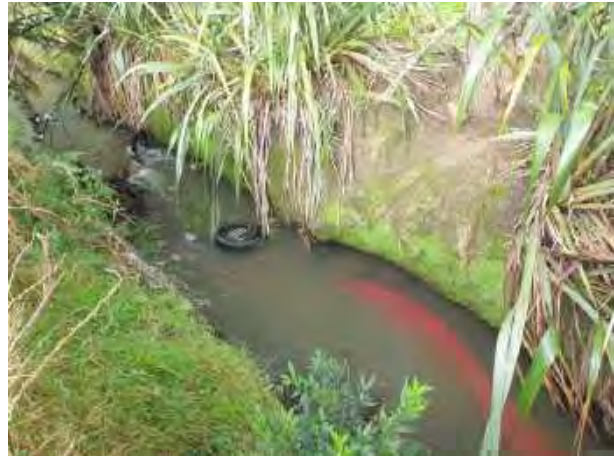
Photo 13. Watercourse 1 contained incised banks and soft substrates.

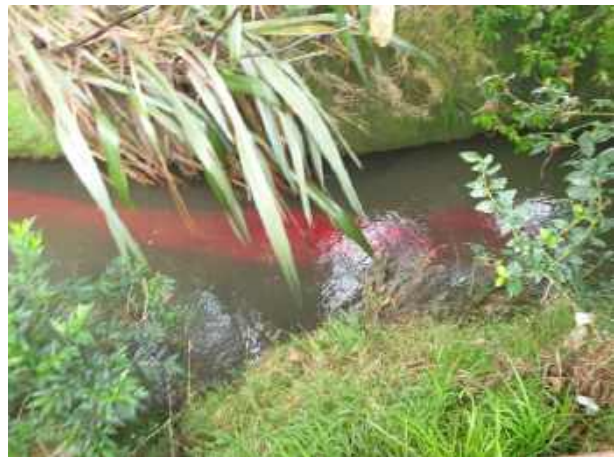
Photo 15. Aquatic habitat was low and limited to runs and occasional pools.

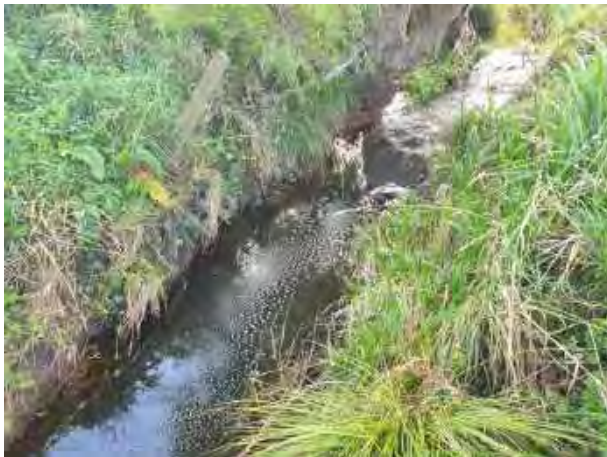
Watercourse 2 was present within the lower half of Sunfield South, forming the headwater of the tributary and flowed through a natural flow path (*Photo 26*) for approximately 750 m before being diverted and deepened into a farm drain (*Photo 27*). Watercourse 2 was classified as a **permanent stream** which has been modified through historic straightening and deepening. The upper reach and headwater of Watercourse 2 flowed through a natural inland wetland, further described in Section 5.3.4. Watercourse 2 had an average width, including the modified reach, of approximately 1 m, with an average depth of 0.5 m. The bank morphology throughout the reach was variable, with some sections containing highly incised, near vertical banks up to 0.5 m high or relatively low sloping banks with connectivity to the floodplain.

Photo 26. Upstream reach of Watercourse 2

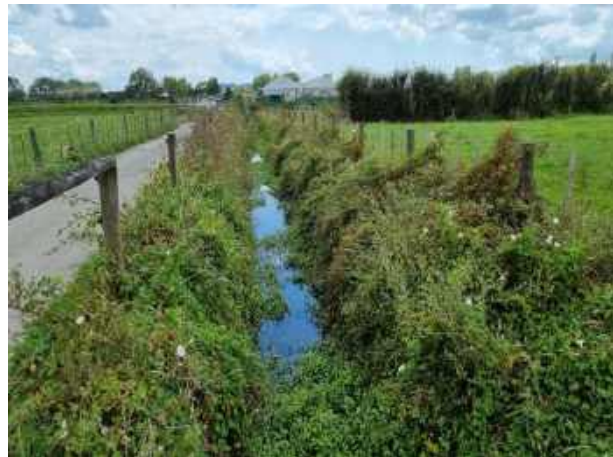
Photo 27. Downstream reach of Watercourse 2

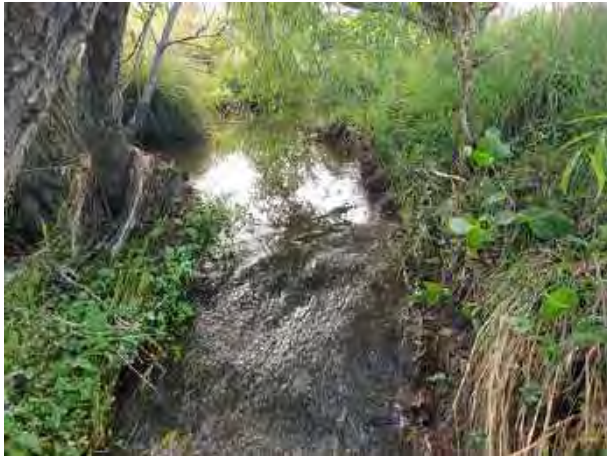
Flow was generally slow through Watercourse 2, with hydrological variation relatively low and consisting of runs and pools, with the uneven channel bed around tree roots creating occasional shallow cascades (*Photo 28*). The dominant substrate throughout the reach was soft with a layer of fine silt present on the stream bed (*Photo 29*). Macrophytes growing within the stream reach consisted of water celery (*Helosciadium nodiflorum*), and willow weed, with the density of these macrophytes dependant on shade provided by the riparian yard (*Photo 30*). The riparian yard was fenced, extending approximately one metre from the edge of the stream. Vegetation observed within the riparian yard consisted of occasional willow, poplars and Chinese privet, with understory vegetation consisting of rank pasture grasses (*Photo 31*). Shade was variable and ranged between high to very low, due to the lack of evergreen trees throughout the entire reach.

Photo 28. Root mats present in the upper reach

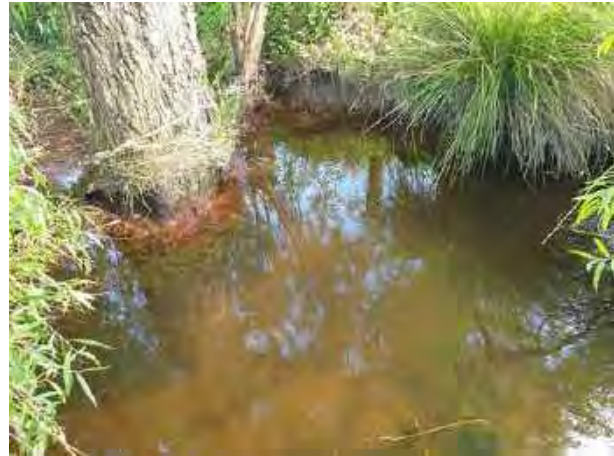
Photo 29. Watercourse 2 was soft bottomed with a fine layer of silt.

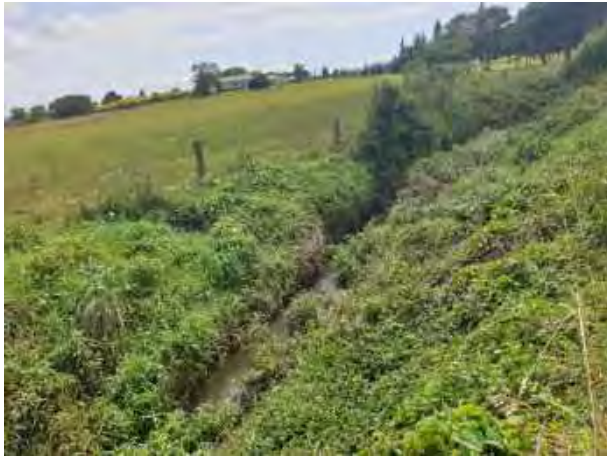
Watercourse 3 was located on the eastern side of Sunfield South, and was classified as a **permanent stream**, which has largely been modified through straightening and deepening (*Photo 32*). Watercourse 3 flowed in an east to west direction for 208 m before forming a confluence with Watercourse 4. Watercourse 3 had an average width of 0.4 m and an average depth of 0.35 m with a relatively consistent channel morphology. The channel banks throughout the reach were steep and incised restricting the connectivity to the floodplain. Hydrological variation throughout Watercourse 3 was low, with the stream reach predominantly consisting of a single slow run and small pools present (*Photo 33*). The dominant substrate throughout Watercourse 3 was soft with fine sediments overlaying the compacted clay bed, and with suspended sediments present within the water column increasing the turbidity.

Photo 32. Watercourse 3 had been modified through straightening and deepening.

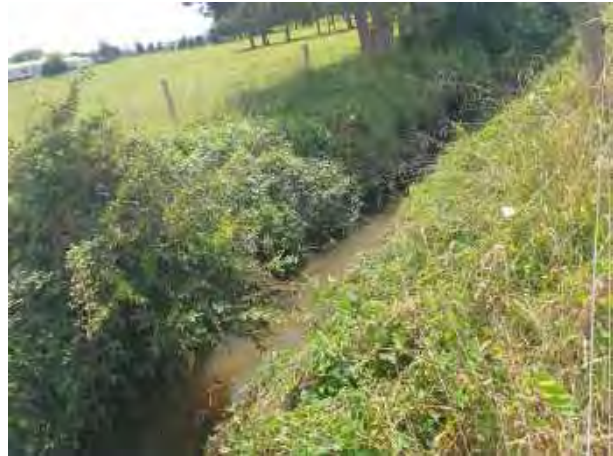
Photo 33. The reach consisted of a straight run with little variation.

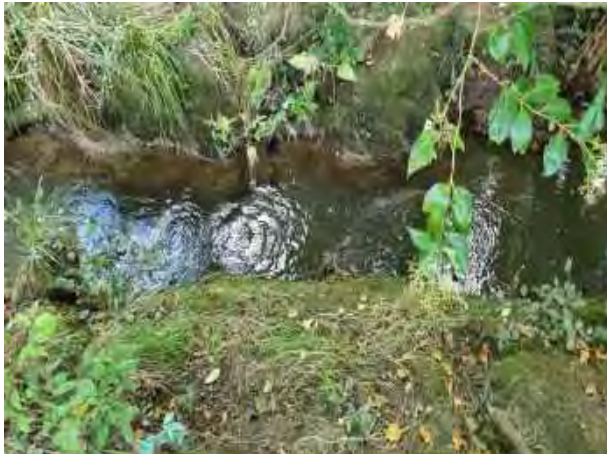
Watercourse 4 flowed in a general south to north direction for approximately 400 m and discharges from the site to a roadside drain. Watercourse 4 had been modified through straightening and deepening with some variation in terms of depth, width, meanders and channel shape than the remaining modified watercourses within the site. Watercourse 4 was more reflective of a natural stream channel (Photo 36) and had an average width of 0.3 m and an average water depth of 0.25 m, with the downstream reach

Photo 36. Watercourse 4 was more reflective of a natural stream channel.

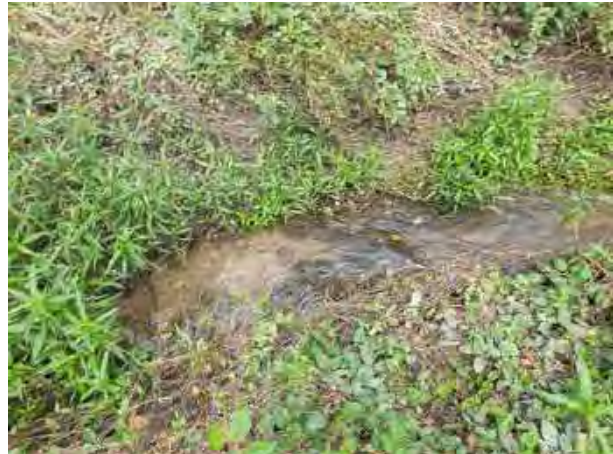
widening to approximately 0.6 m in width and deeper water. Channel banks throughout Watercourse 4 were variable with some incision occurring and some relatively low bank profiles providing some connectivity to the floodplain (*Photo 37*).

Photo 37. Some sections of the stream bank contained connectivity to the floodplain.

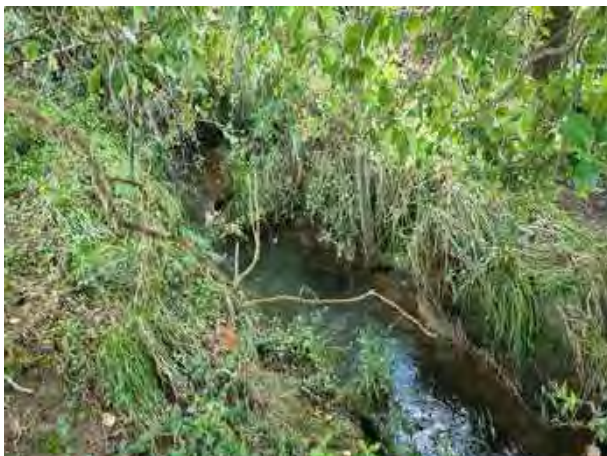
Photo 38. Hydrological variation was low and consisted of runs and occasional pools.

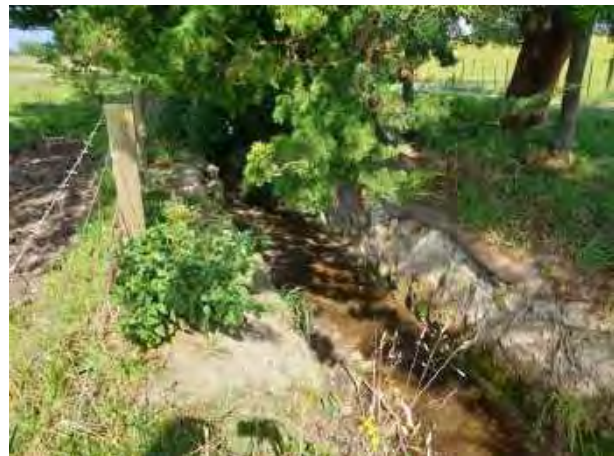
Photo 43. Drain m

The drains were approximately 0.6 m in width and water depth between 0.1 m to 0.2 m, with the banks steep and incised. Each drain consisted of a single run, with the substrate soft and consisting of compacted clay bed and banks with willow weed growing within the drain channel. Riparian vegetation lining the artificial drains consisted of shelter belts, with the vegetation observed mixed exotic and native. The

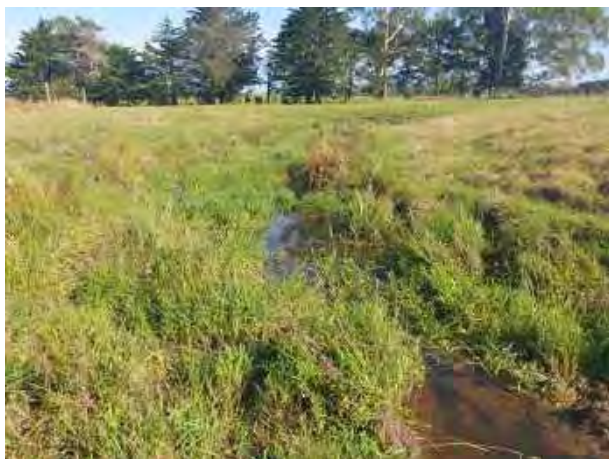
Photo 46. Deep standing water was present throughout the wetland.

At the time of assessment, the wetland contained boggy ground and standing water outside of the flow path, with deep standing water in the stream channel (Photo 46). The wetland was severely pugged, with areas not subject to stock impacts within the neighbouring property consisting of a grassed swale. Multiple undersized culverts supporting farm crossings extend over the flow path and wetland. Riparian vegetation established around the natural inland wetland consisted of grazed pasture grasses, with sparse barberry, and privet. The upper 30 m of flow path which contained dense stands of gorse and some fencing. Aquatic habitat was low throughout the wetland and solely consisted of the defined flow path through the centre, however the thick rhizomes and root mats of the reed-sweet grass likely restricts fish passage through the area. The natural inland wetland discharges into the stream reach of Watercourse 1 through an undersized culvert (Photo 47).

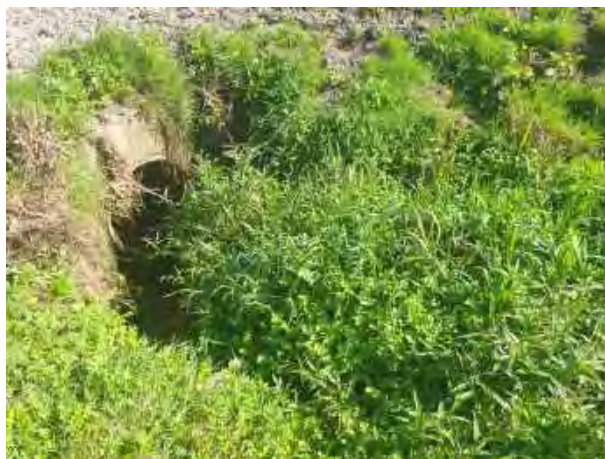
Photo 47. The natural inland wetland discharged to Watercourse 2 through an undersized culvert.

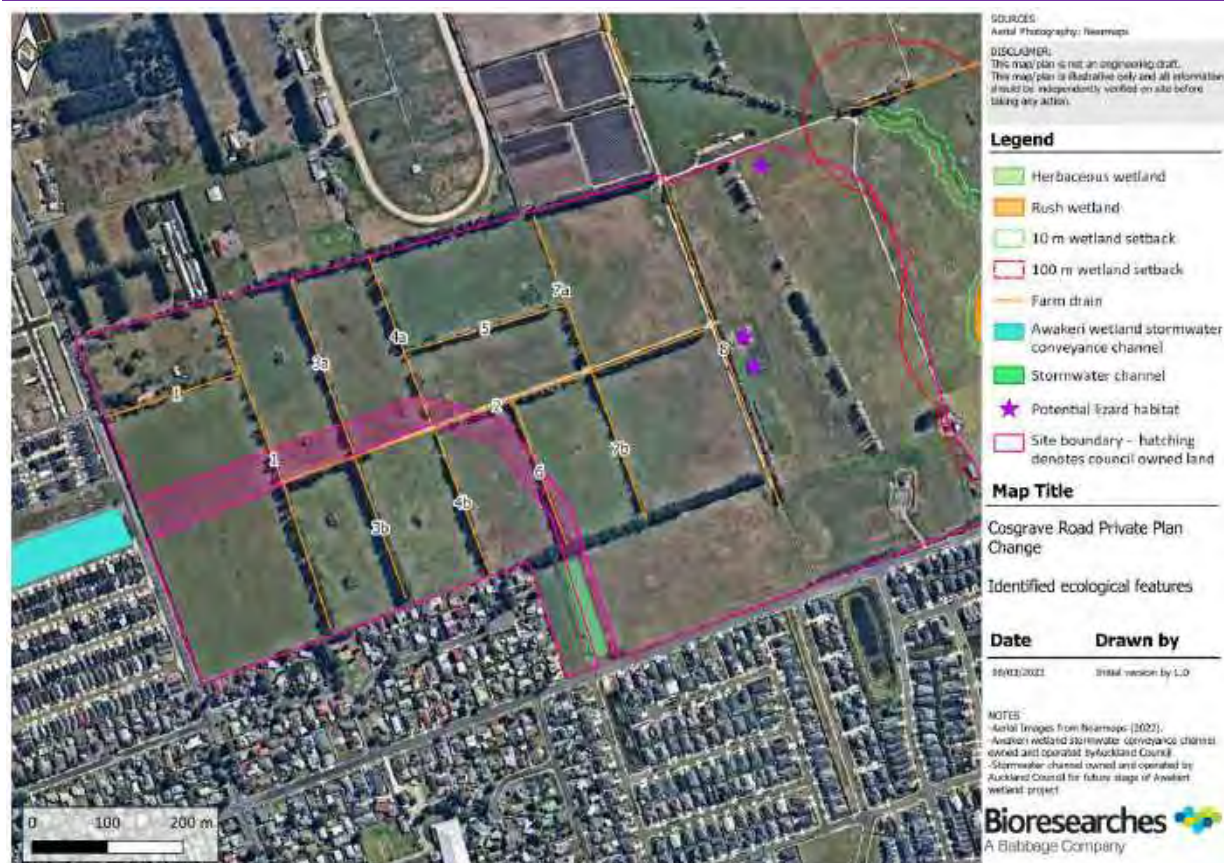
Figure 10. Identified ecological features within the Cosgrave Block. Note pink hashed polygon represents land owned by Auckland Council

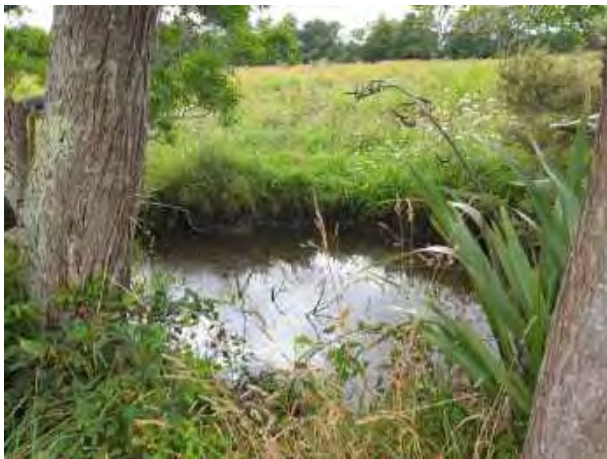
The watercourse contained slow flowing run habitat between 0.2 m to 1 m in depth, with surface scums present (Photo 56). No variation on hydrological heterogeneity was observed. Water clarity was poor and opaque indicating a high degree of suspended sediments present throughout and a very high level of turbidity (Photo 57). Silt substrates dominated the watercourse, with willow weed (*Persicaria maculosa*)

Photo 56. Drain 1 was wide and deep.

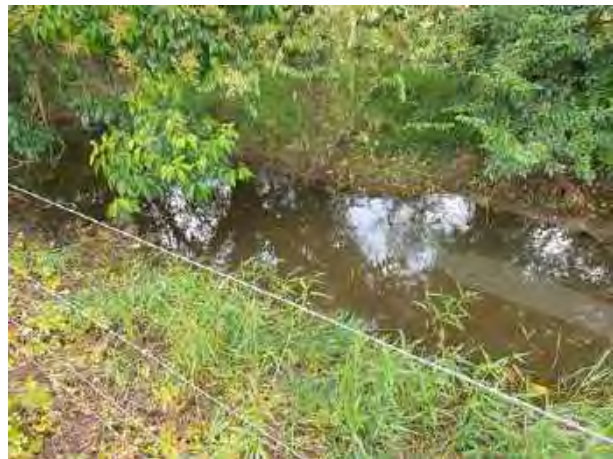
Photo 57. Water clarity was poor.

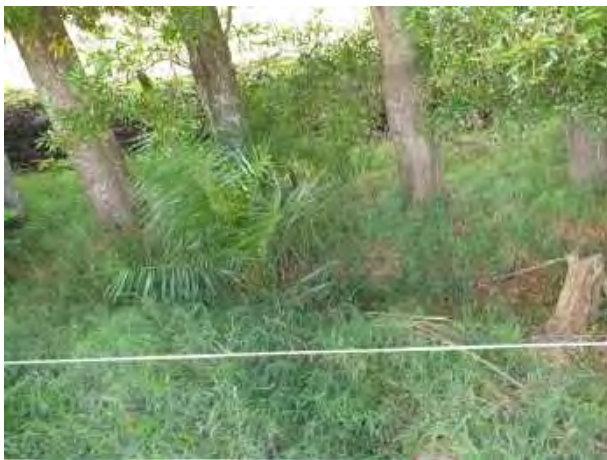
The flow path of Drain 2 was straight and uniform, approximately 1.5 m in width. Water depth was highly variable at the time of assessment, with the upper reaches completely dry (Photo 60) and the lower reaches of Drain 2 containing slow flowing water, which overtopped the channel banks in some locations (Photo 61 and Photo 62). The drain is likely dominated by silt substrates with heavy loading of fine sediments and turbidity present within the water column where water is present.

Photo 60. The upper section of Drain 2 was dry.

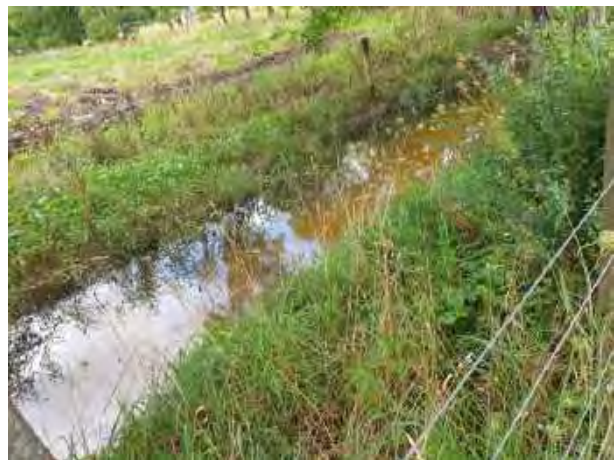
Photo 61. The downstream reach contained standing water.

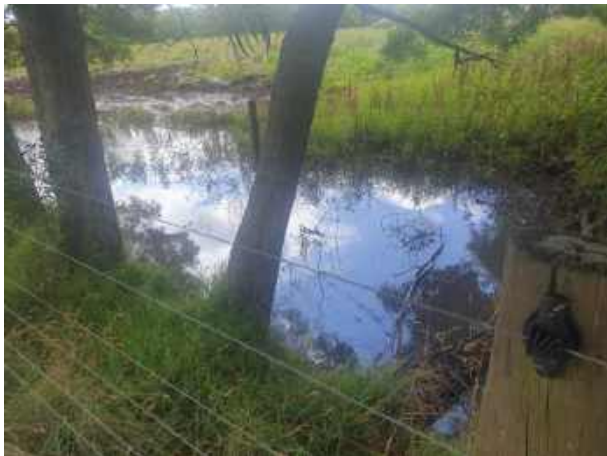
Photo 62. Sections of Drain 2 overtopped the banks.

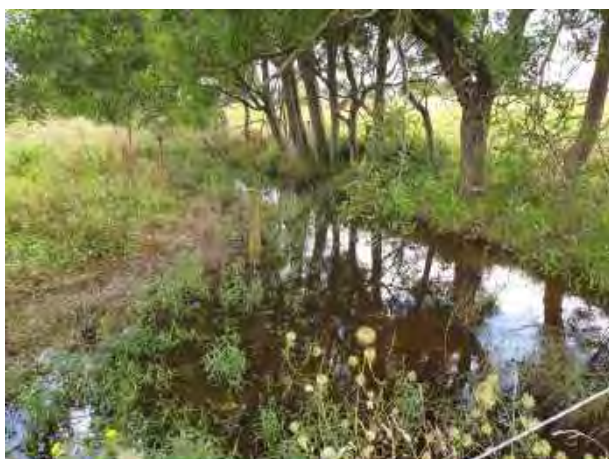
Photo 64. Drain 3.

Drain 3, Drain 4 and Drain 7 have been grouped as they contain similar channel characteristics (Photo 64, Photo 65 and Photo 66). The entirety of the three drains is approximately 450 m in length with Drain 2 dividing the drains in the centre. The drains are each formed by two channel segments; one channel flowing from north to south and entering Drain 2 (Drain 3a, Drain 4a and Drain 7a), and the second section

Standing water was present throughout the three drains, approximately 0.10 m to 0.60 m in depth and 0.60 m in width. No discernible flow was observed throughout the two drains and water was highly turbid with water murky and dirty in colour. The drains are entirely soft bottomed and there is heavy loading of fine sediments throughout. The drains were lined by shelter belts, with exotic vegetation such as sweetgum (*Liquidambar styraciflua*), wattles, willow, Japanese cedar, and bald cypress. Shade throughout the drain is variable, and as a result, willow weed has clogged over 60% of Drain 4. Aquatic habitat was very low, with the dense macrophyte growth limiting the abundance of habitat, and it is expected only shortfin eel would be present.

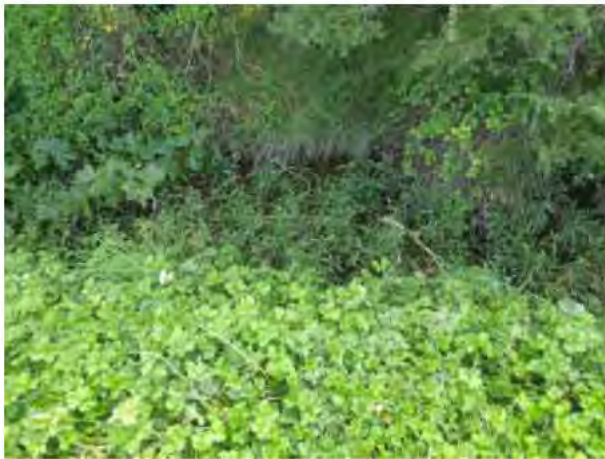
Standing water was present throughout the entire length of Drain 8 and was approximately 0.3 m deep at the time of assessment (Photo 67). The dominant substrate throughout the reach was silt, with a high loading of suspended sediment present within the water column, made evident by the murky and opaque colouration. Duck weed (*Lemna minor*), and willow weed were abundant throughout the reach, covering approximately 60% of the channel (Photo 68), with hydrological heterogeneity limited to a single slow run. The drain banks were steep, approximately 0.5 m to 0.7 m high, however no bank incision or collapse was observed, and the bank height was likely created when the drain was constructed (Photo 69).

Photo 67. Drain 8 contained slow flowing water and was relatively straight and uniform.

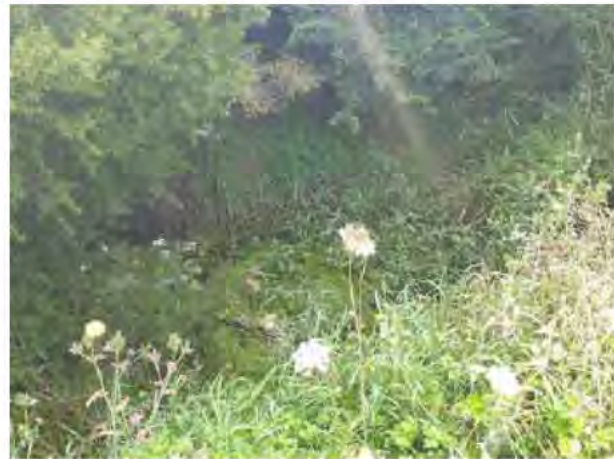
Photo 68. Macrophytes covered the surface of Drain 8.

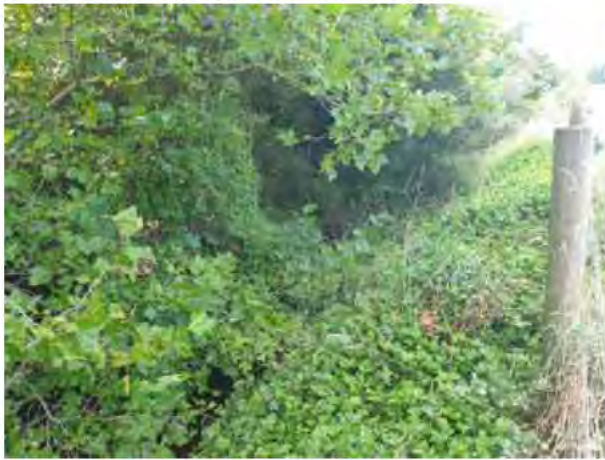
Photo 69. The banks of Drain 8 were relatively steep.

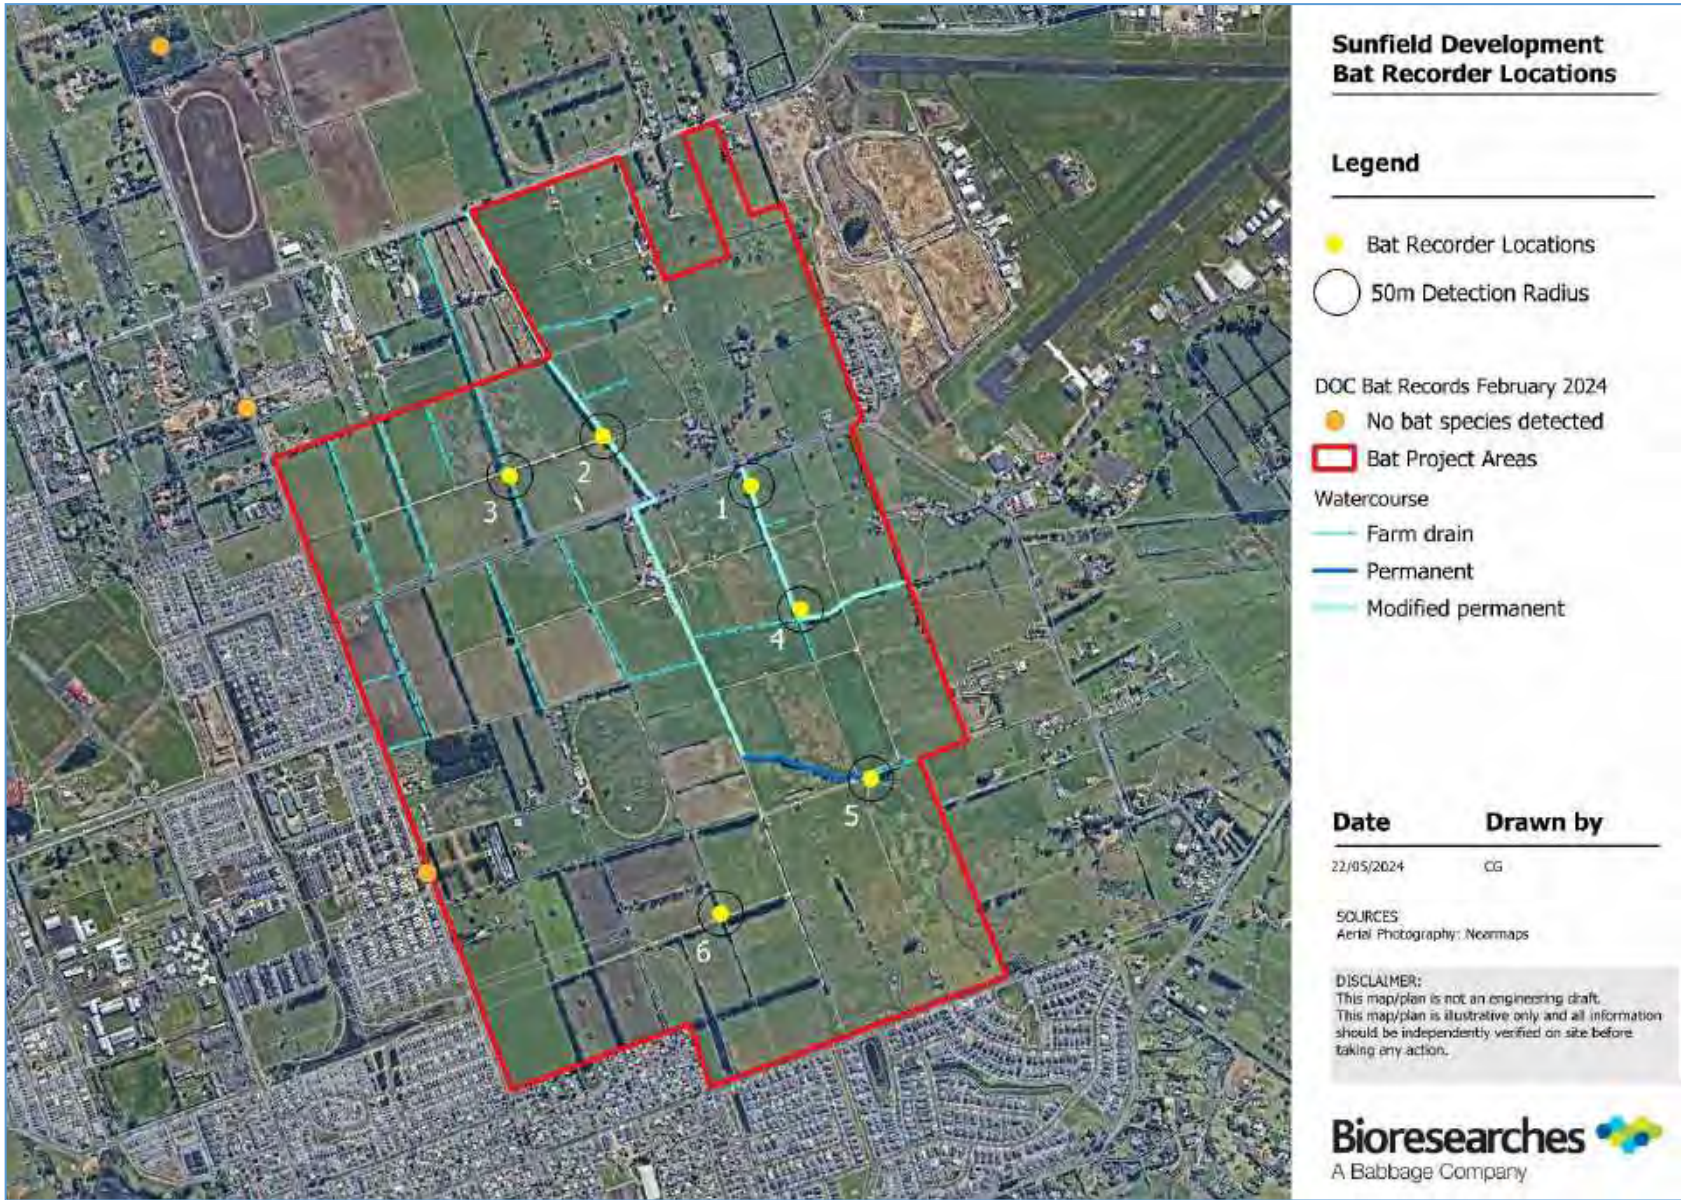
Figure 11: Map showing location of recorders within the Sunfield site, as well as local DOC records of previous bat survey work

No bat recorders detected any bats. One recorder (Recorder 6) failed.
