Auckland Council Model Review

Section 3 Review Details

Appendix - FIGURES

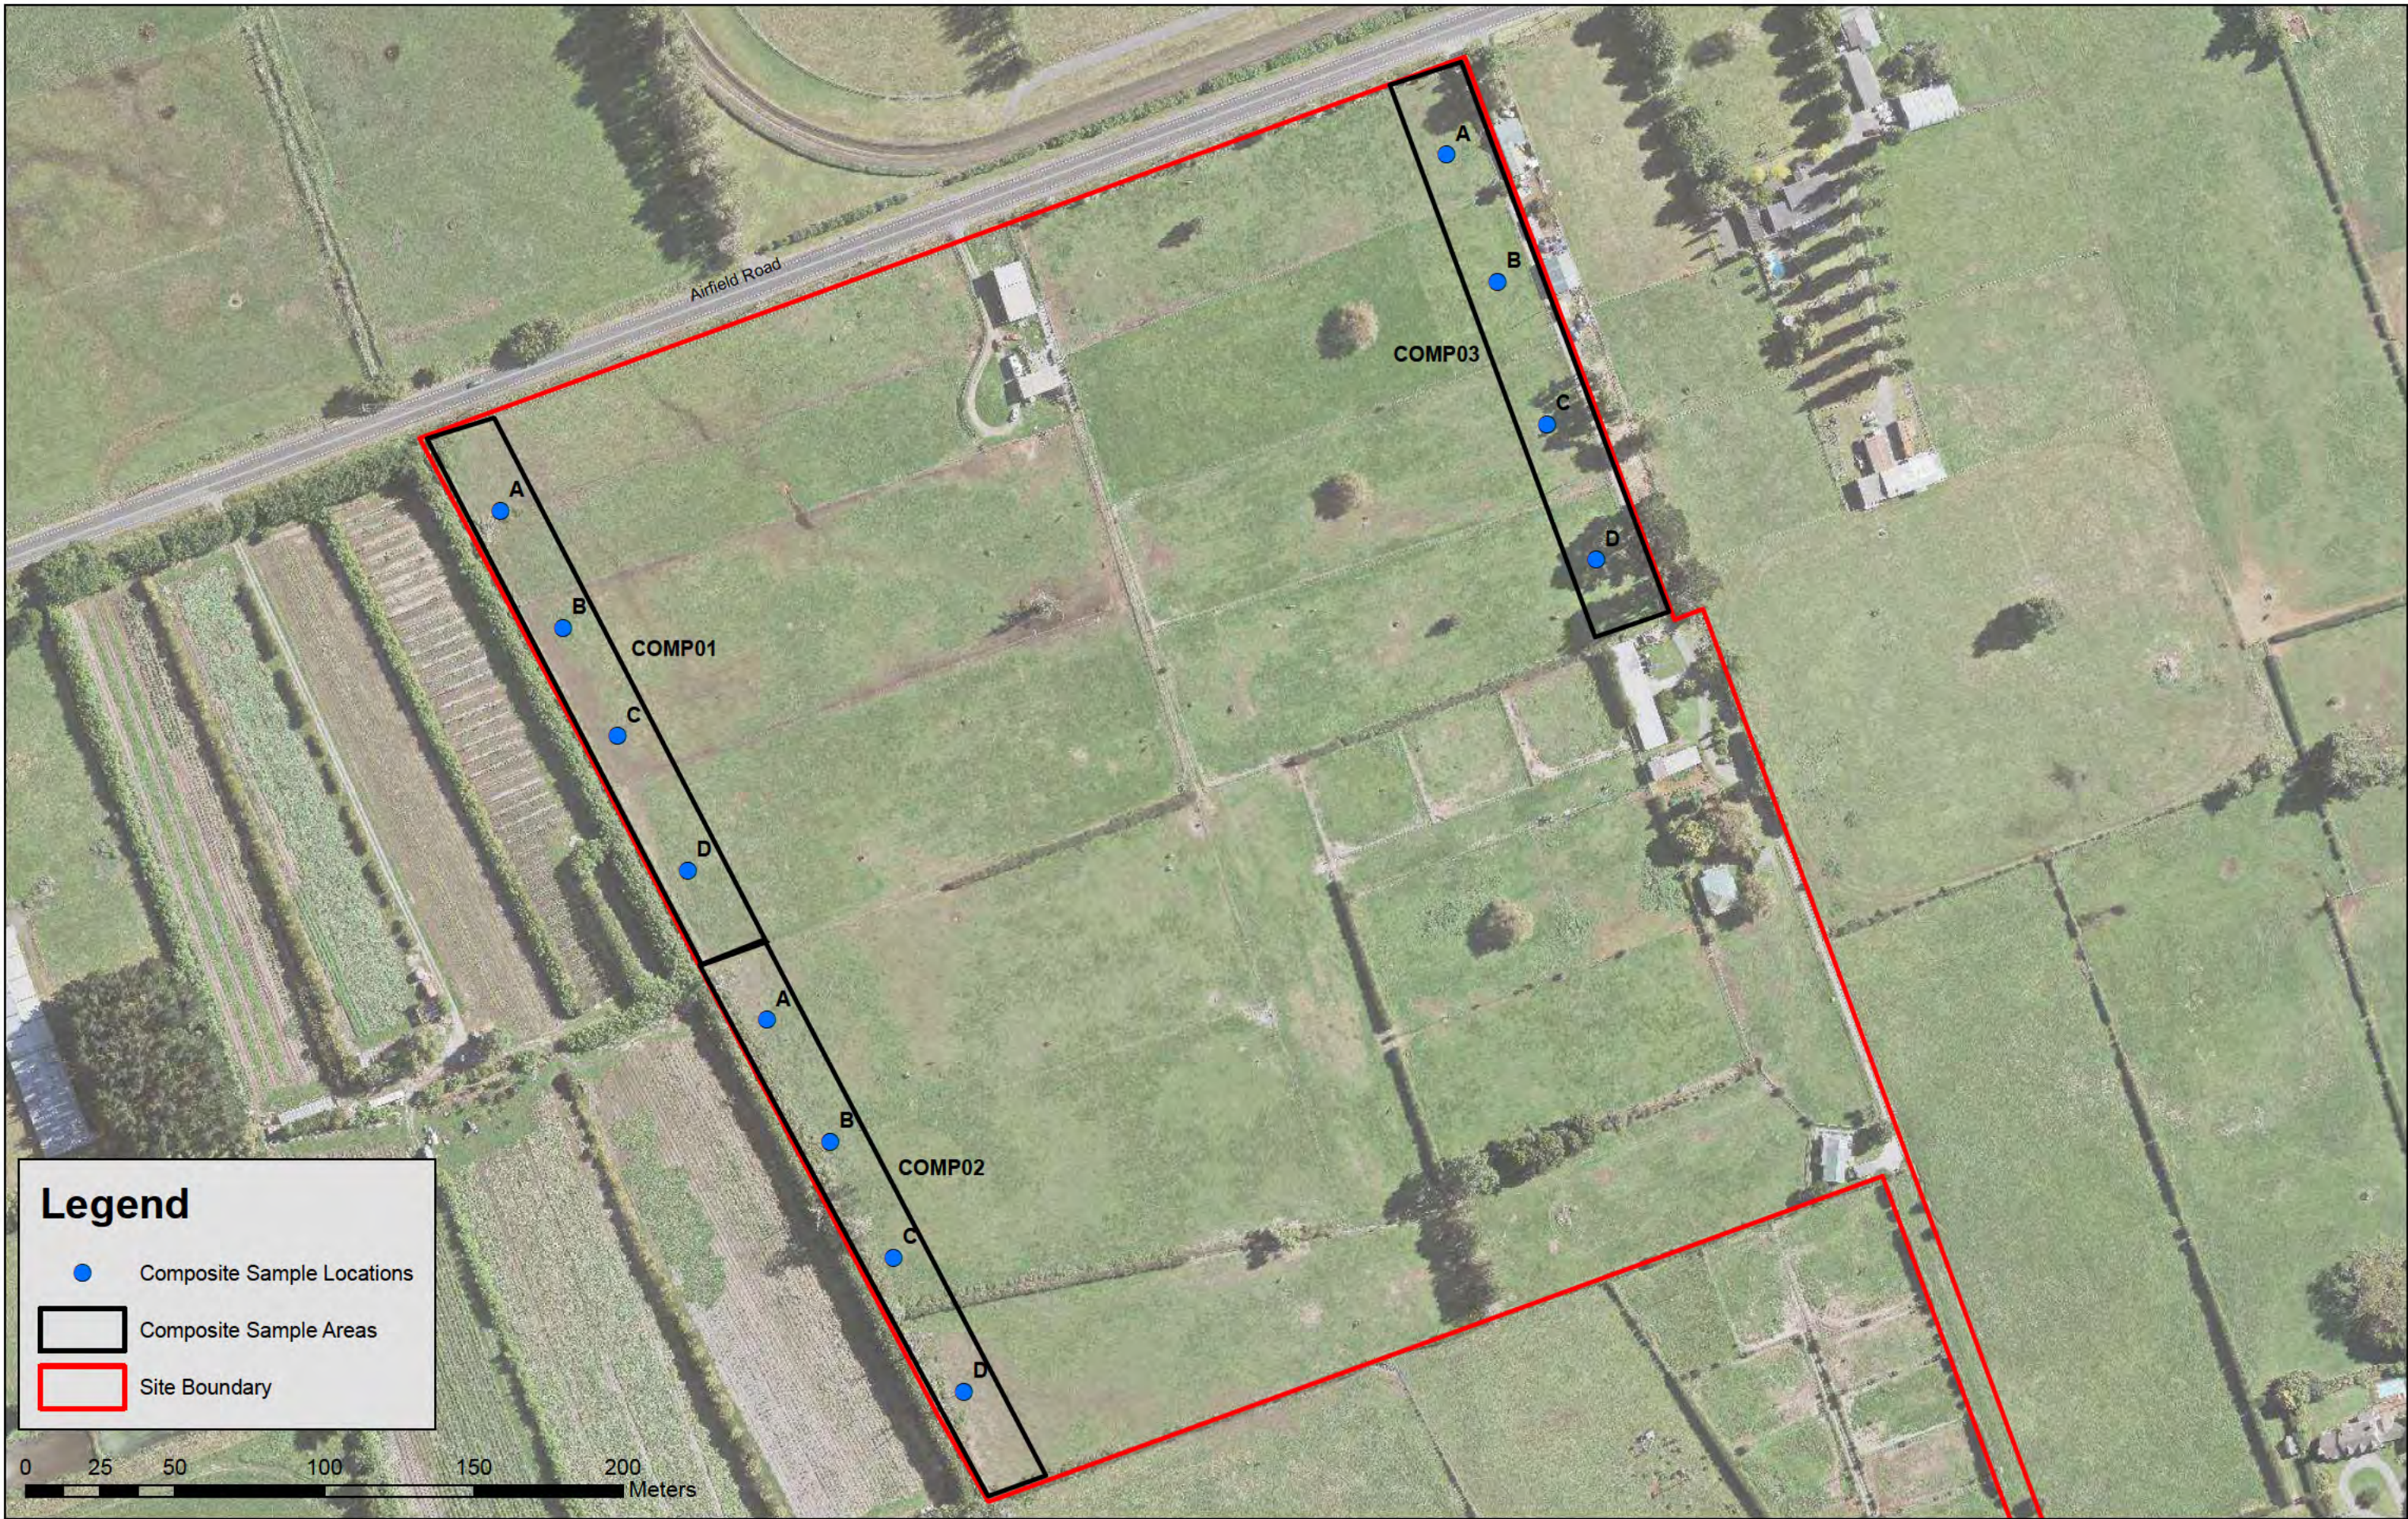
Drawing Number: 1686.001.04-3
Drawn By: MT
Checked By: DO'R
Date: 20/12/2023

Legend

- Composite Sample Locations
- Composite Sample Areas
- Site Boundary

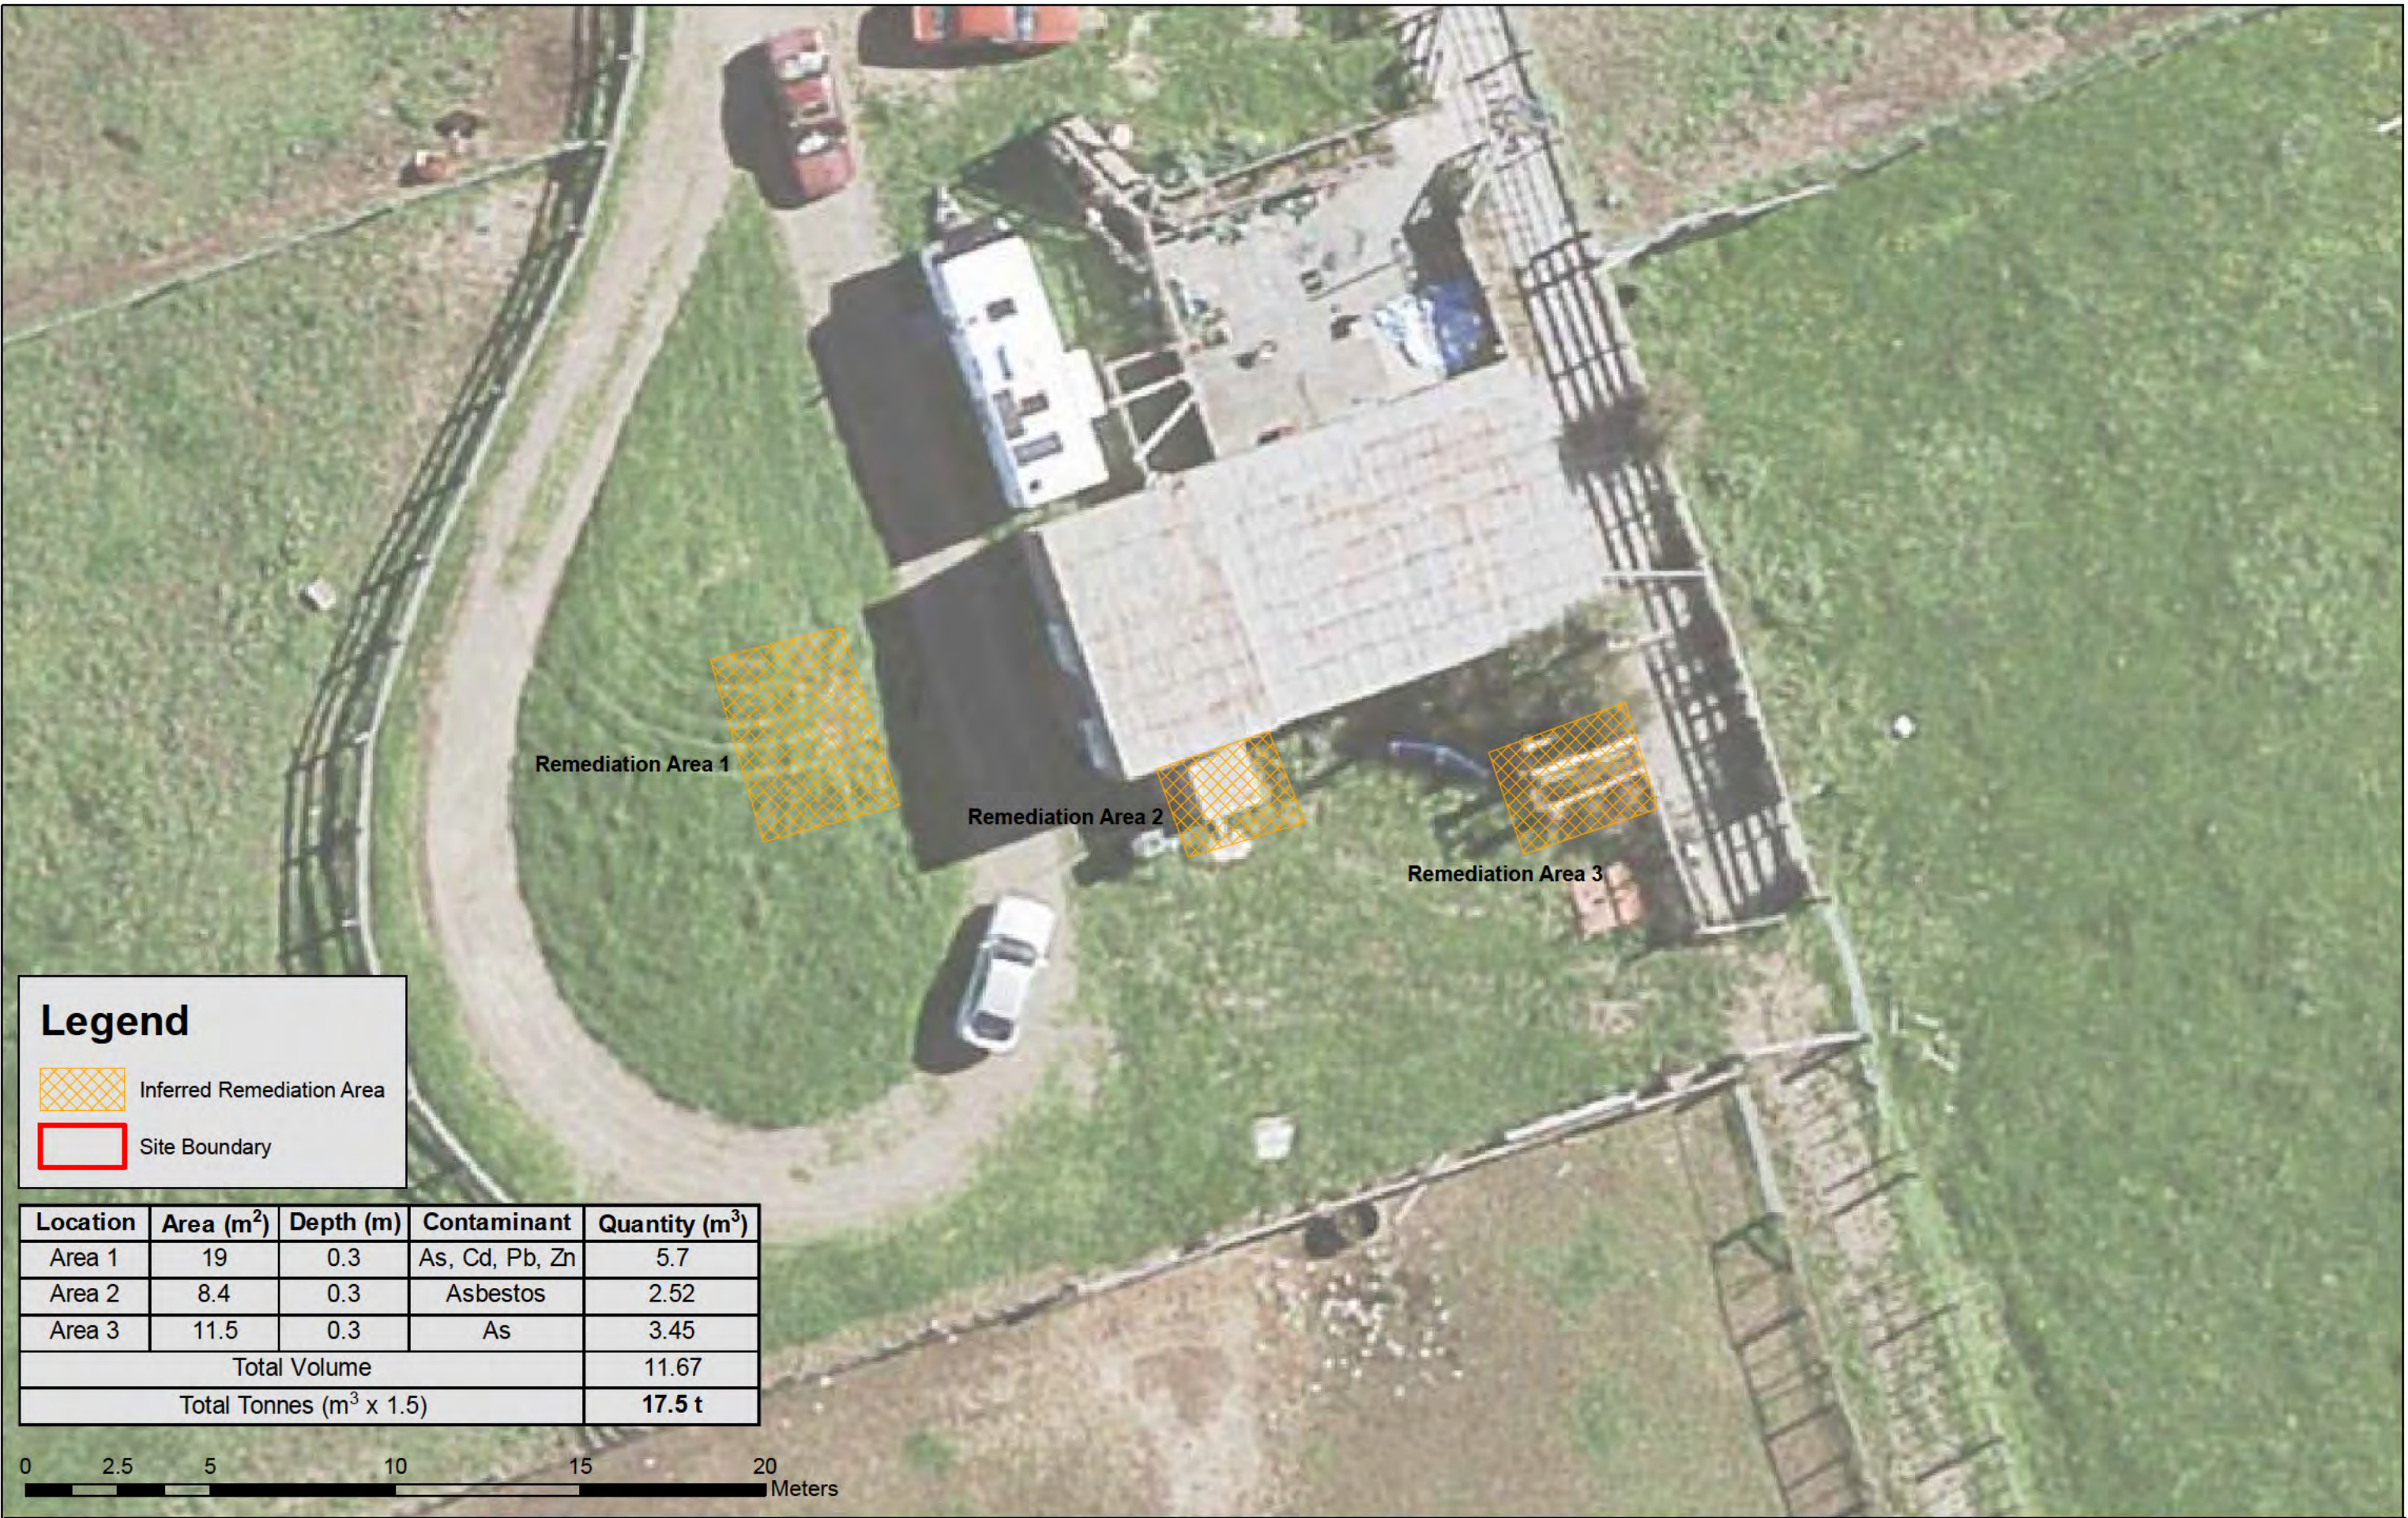
Location	Area (m ²)	Depth (m)	Contaminant	Quantity (m ³)
Area 4	10.8	-	Visual ACM	-
Area 5	54.9	0.3	Pb	16.47
Area 6	3.1	0.3	As, Cd, Pb, Zn	0.93
Area 7	97.7	0.3	Pb	29.31
Total Volume				46.71
Total Tonnes (m ³ x 1.5)				70.1 t

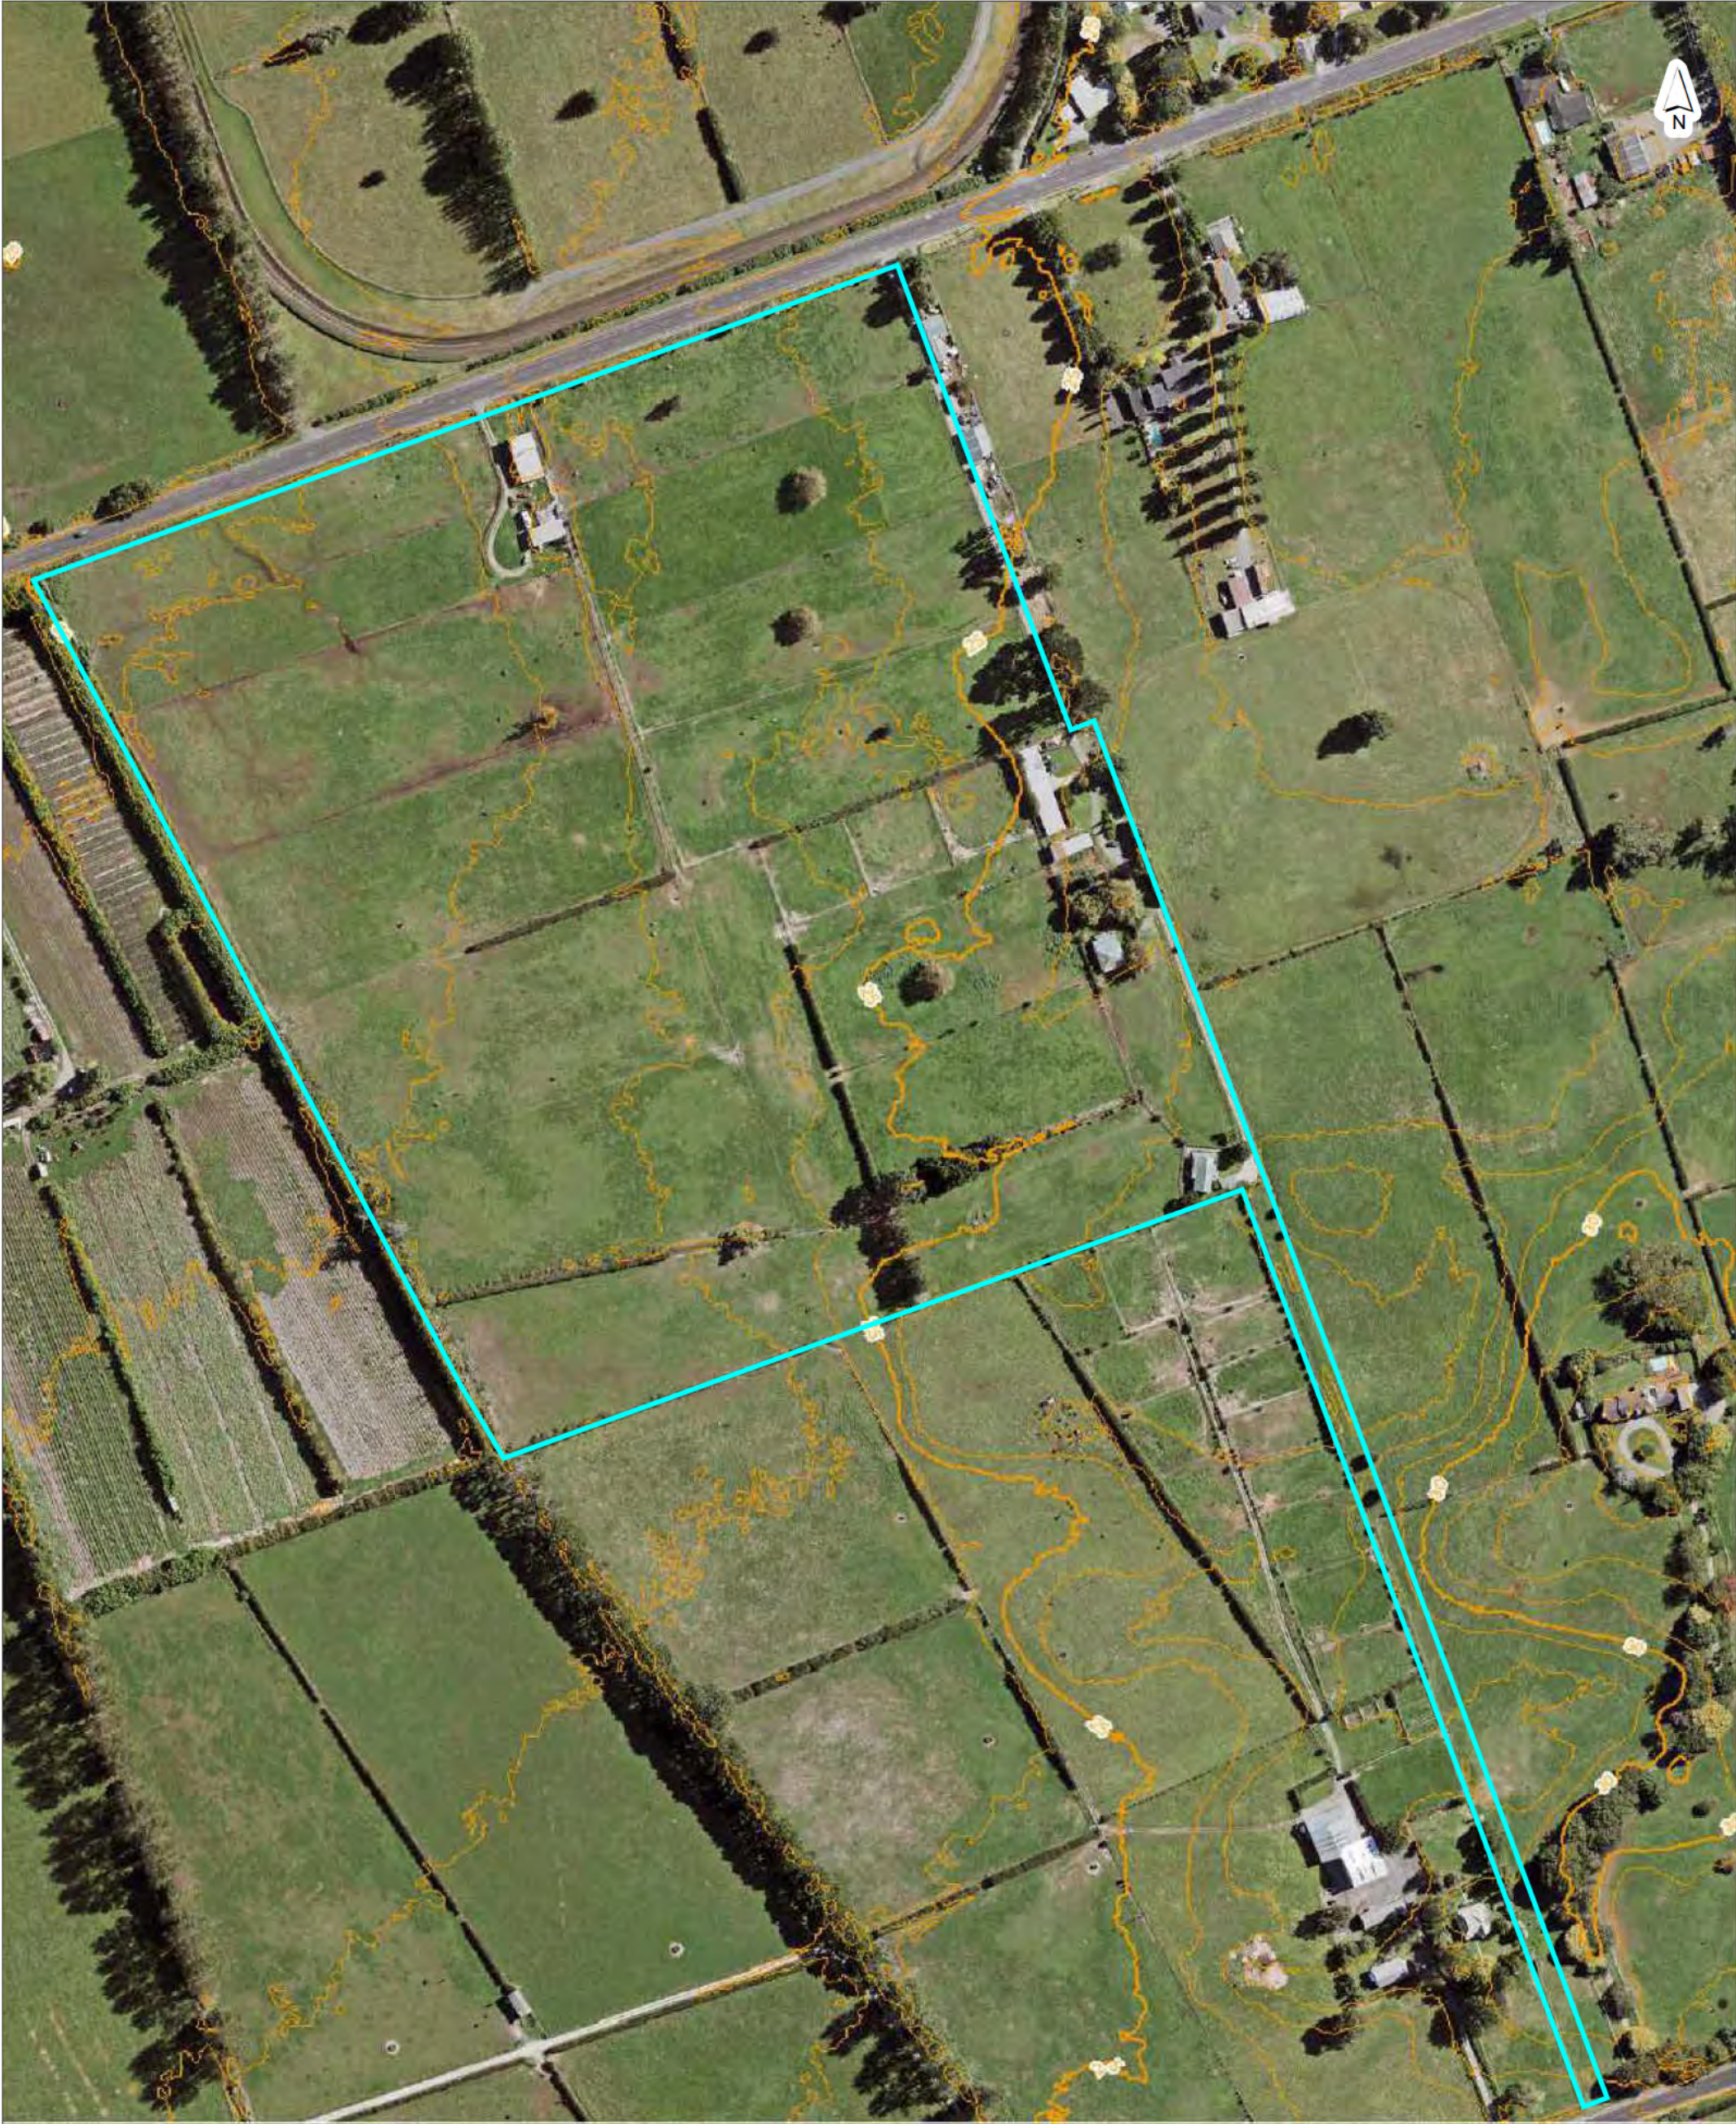
Appendix B – Site Contour Plan

Site Contour Plan
