Kings Quarry Stage 2 Expansion

## **Freshwater Ecology Residual Effects Analysis Report**

for: Kings Quarry Limited

**Version: Draft A**

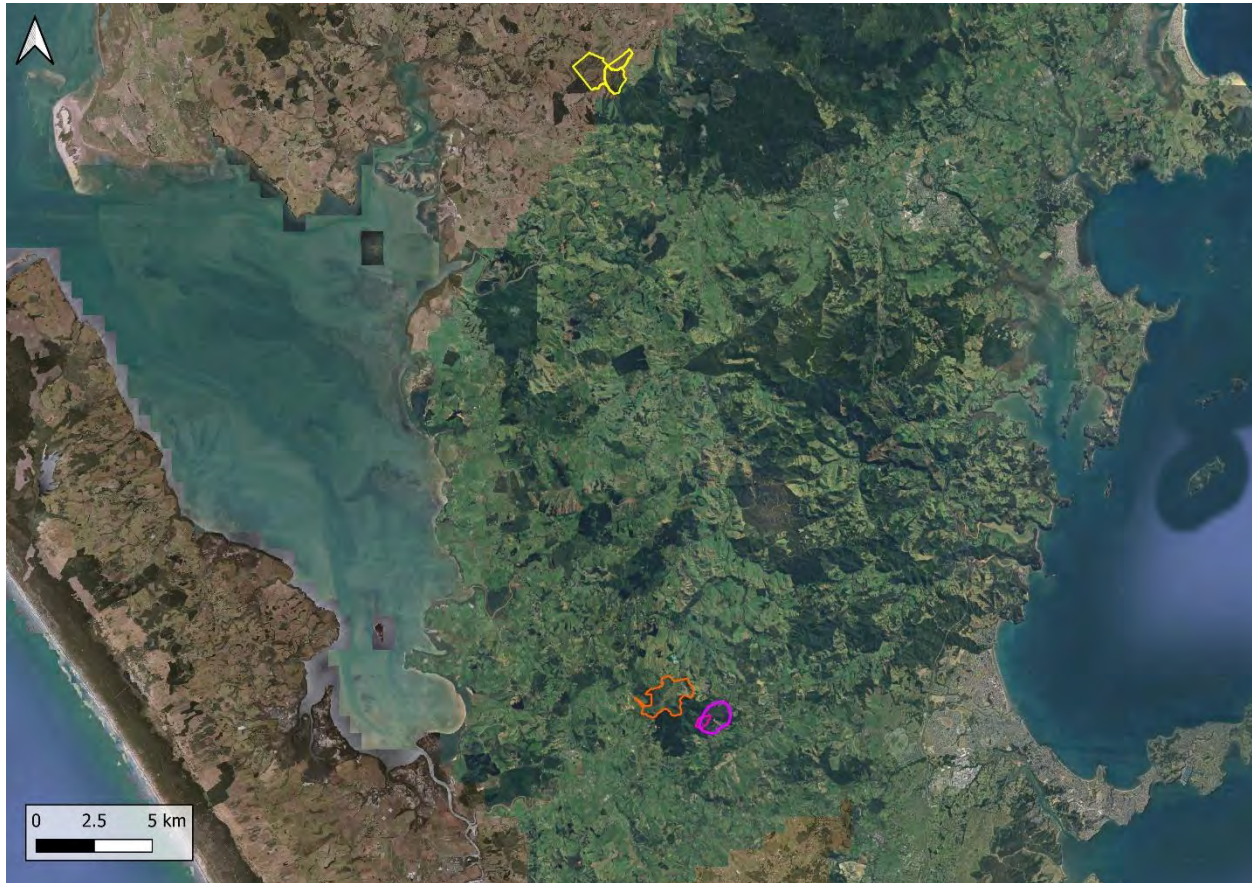
**Figure 2. Offset site locations, 142 Old Field Road (yellow polygon) and 158 Hellyer Road (orange polygon) and their proximity to Kings Quarry (pink polygon)**

147 Oldfield Road, Wellsford, is located 26 km north of the Project area. The stream habitats are located within farmland with stock able to access the streams. The site has an elevation of 80 – 190 m above sea level, and is topographically steep and hilly resulting in a greater proportion of intermittent headwater streams, with a pastoral catchment. This is similar to Kings Quarry, (Stage 2 is approximately 70 m to 170 m above sea level), with streams within the Stage 2 area consisting of small intermittent headwater streams.

158 Hellyer Road is located 1.5 km north-west of the Project Area. The site is less topographically steep and hilly than Kings Quarry, with lower topography resulting in a greater proportion of permanent streams with the historic land use pastoral farming.

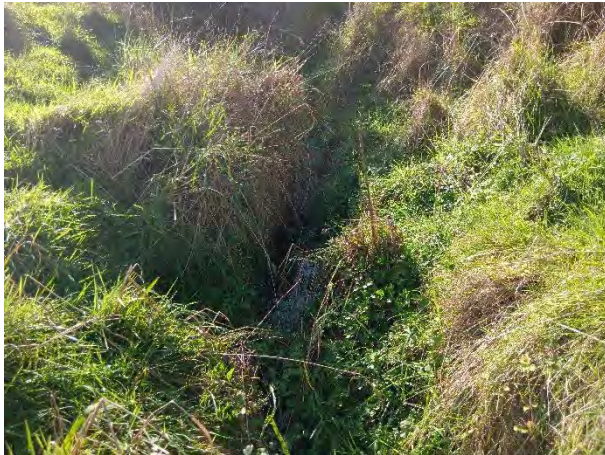
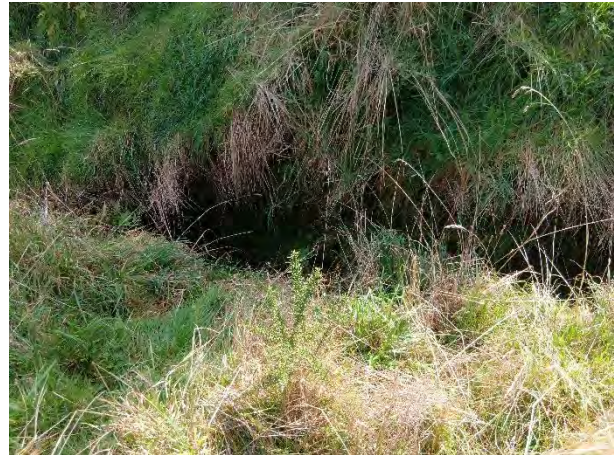
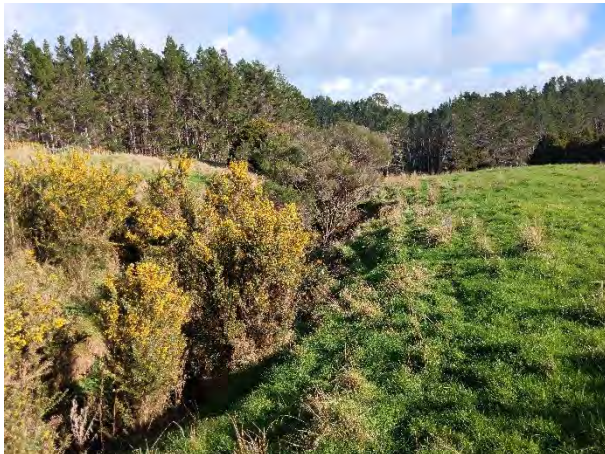
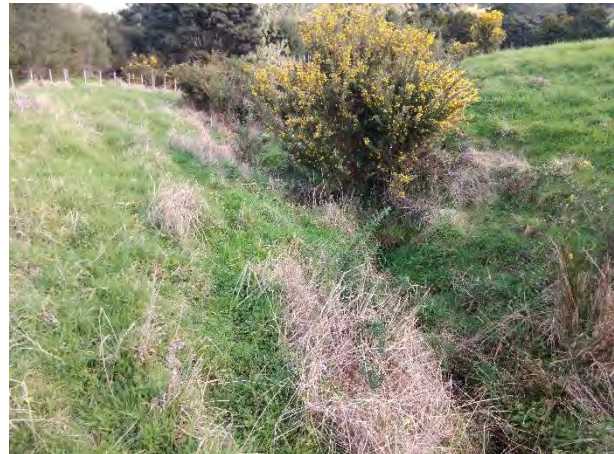
**Photo 1. Stream 1a**

Stream 1a and Stream 1b were located on the western portion of the site, and flowed in an east to west direction, draining into areas of indigenous bush. An SEV (SEV1) was undertaken on Stream 1a, and is

representative of Stream 1b as the watercourses were similar in regard to the channel characteristics, stream classification and land use practices (Photo 1 to Photo 4).

The intermittent streams had an average width of 0.57m (0.24 m – 0.83 m) and an average depth of 0.08 m (0.01 m – 0.17m), with water slow flowing. The banks were highly incised throughout the entirety of both reaches restricting connectivity to the floodplain, with the exception of the headwaters which showed evidence of bank collapse due to stock access.

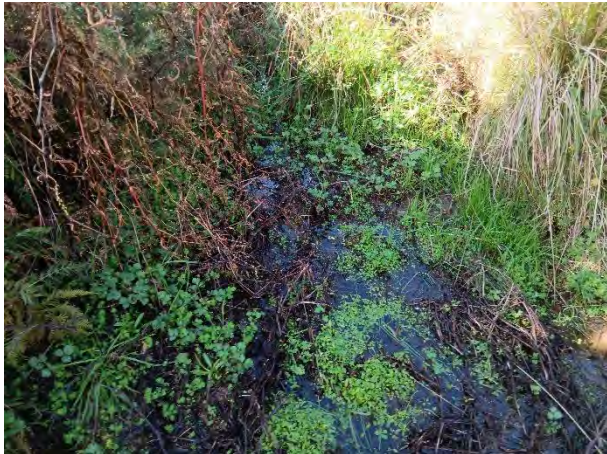
Hydrological heterogeneity was considered to be low and consisted of a slow run with the occasional shallow pool. Oxygen reducing process were sub-optimal. The dominant substrate throughout the reaches were silts, with occasional small gravels present and a high loading of fine sediment. Organic matter observed included woody debris, leaf litter and some root mats with the macrophytes watercress (*Nasturtium officinale*), starwort (*Callitriche stagnalis*) and water forget-me-not (*Myosotis laxa* subsp. *caespitosa*) present (Photo 5).

**Photo 5. Macrophyte cover**

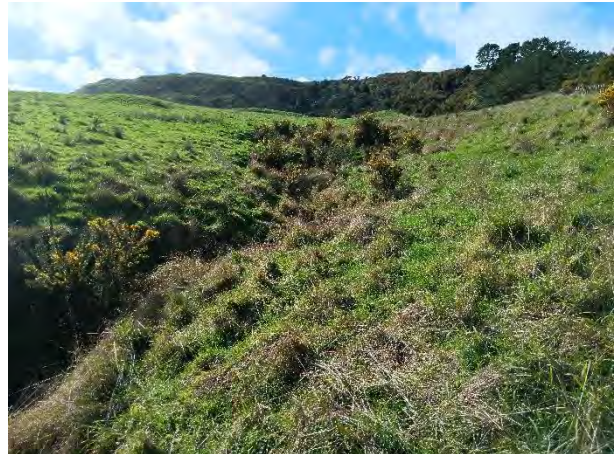
yard provided very low riparian yard functions such as filtration and bank stability. However, the topography of the site and channel incision provided good shade to the length of the reach (Photo 6).

**Photo 6. Topography and bank incision provided good shade.**

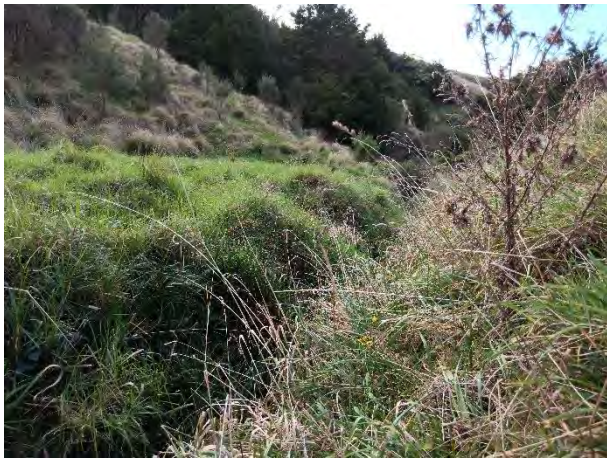
Stream 4 was located on the northern portion of the site and flows in a south to north direction, where it flows for 190 m before entering a planted wetland. The stream had an average width of 0.6 m (0.34 m – 1.52 m), and an average depth of 0.08 m (0.01 – 0.28 m). Stream 4 was classified as a permanent stream, and was flowing well at the time of assessment, with a variety of hydrology including runs, pools, chutes and waterfalls, however areas of still pools were present.

**Photo 7. Incised channel**

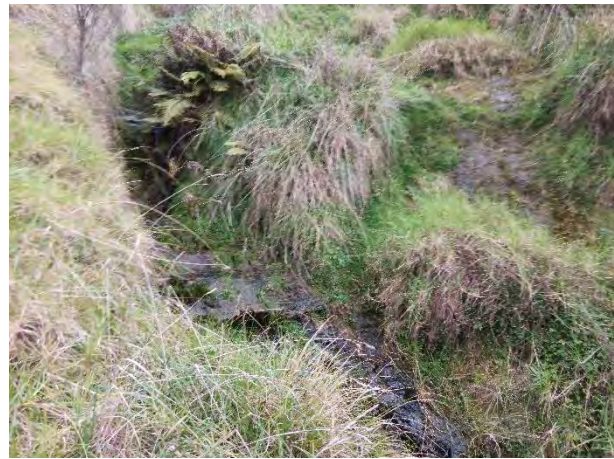
**Photo 8. Waterfall system.**

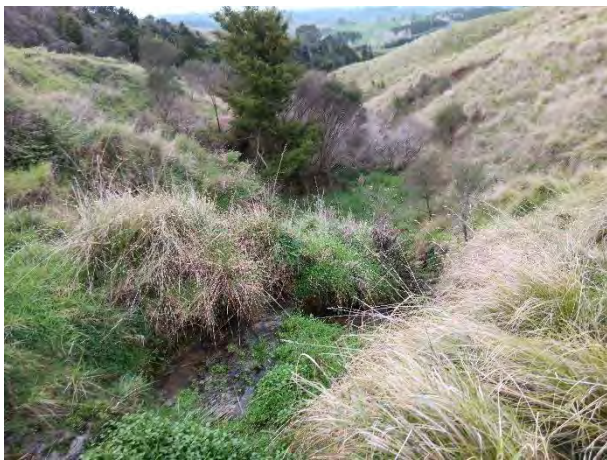
Riparian vegetation throughout Stream 4 predominantly consisted of grazed grasses with discrete patches of indigenous vegetation such as red matipo (*Myrsine australis*), kānuka, and ponga. Whilst canopy cover through the reach was low, shade was high due to the topography of the area (Photo 9 and Photo 10). Riparian yard functions such as filtration and bank stability were considered to be low due to the prevalence of grazed pasture grasses.

**Photo 9. Upper portion riparian yard.**

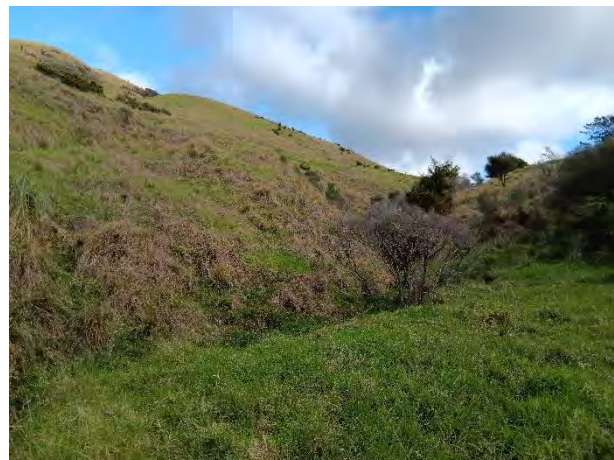
**Photo 10. Lower portion with banks.**

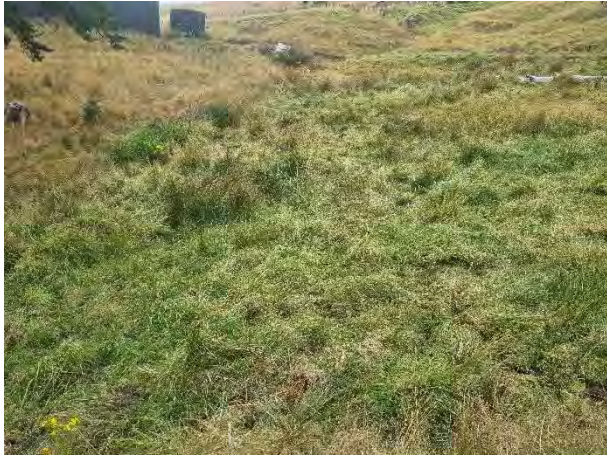
The upper headwaters portion of the wetland was 3,783 m<sup>2</sup> in size and contained within a wide vale. The vegetation consisted of mixed exotic and indigenous wetland plants including; sharp-spike sedge (*Eleocharis acuta*), tall fescue (*Lolium arundinaceum*), lotus (*Lotus pedunculatus*), jointed rush (*Juncus articulatus*), soft rush (*Juncus effusus*) and fan-flowered rush (*Juncus sarophorus*) (Photo 11). The lower portion of Wetland 1 was 2,067m<sup>2</sup> in size and laid within wide gully floor with steeper sloping banks. The vegetation within this lower portion was largely a reed-sweet grass monoculture with some water cress and water pepper (Photo 13).

**Photo 11. Upper portion of Wetland 1 vegetation**

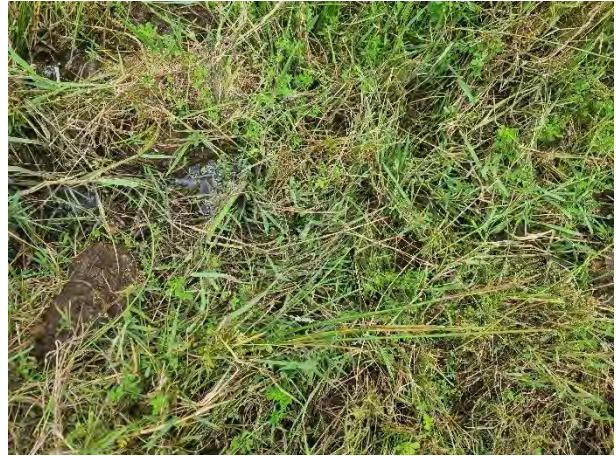
The entirety of Wetland 1 was unfenced and severely impacted by stock access, with extensive pugging and grazing observed, especially throughout the lower portion. The wetland was permanently saturated with one hydrological unit, where non-channelised water flows through vegetation (Photo 12). No open water or areas of pools were present, with the exception of the pugging holes (Photo 14). The wetland buffer is limited in how it can form protective services to the wetland, with the vegetation consisting of rank pasture grasses or gorse.

**Photo 12. Bed conditions in upper portion**

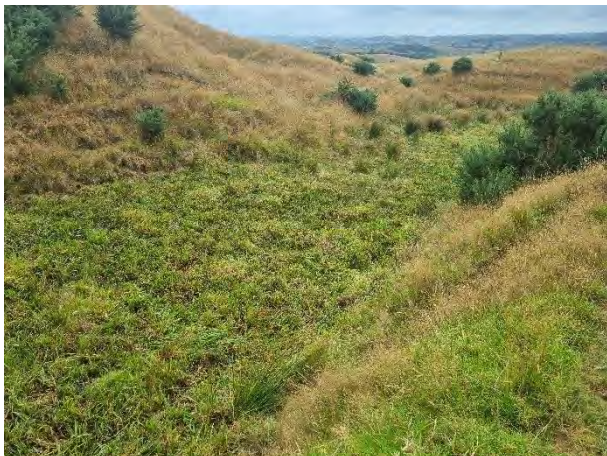
**Photo 13. Monoculture in lower portion**

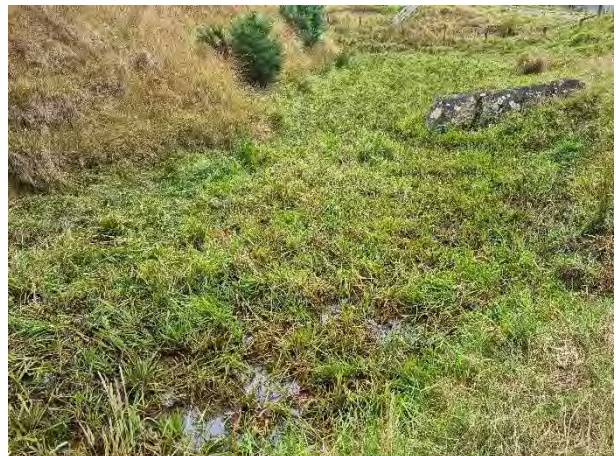
**Photo 14. Bed condition in lower portion.**

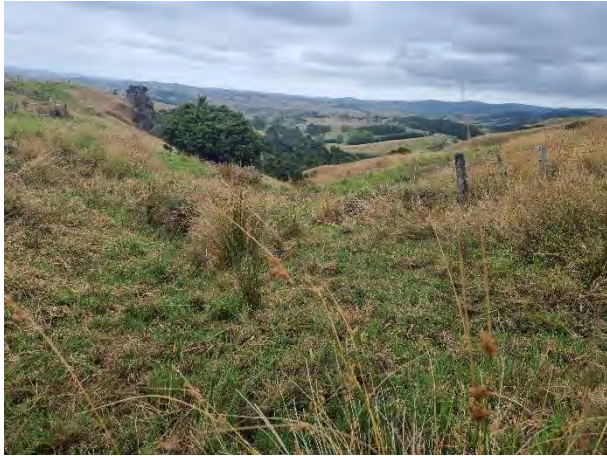
Wetland 2 is a small wetland located at the headwaters of Stream 4, and is a palustrine swamp of low ecological value. The wetland is hydrologically connected to Stream 4 and its downstream reach. Wetland 2 was located within a vale with steep gully's immediately upstream and downstream of the wetland, which was 570 m<sup>2</sup> in size. Wetland 2 consists of a monoculture of grazed reed-sweet grass with sparse fan-flowered rush, lotus and buttercup (*Ranunculus sp.*) present (Photo 15).

***Photo 15. Wetland 2 vegetation.***

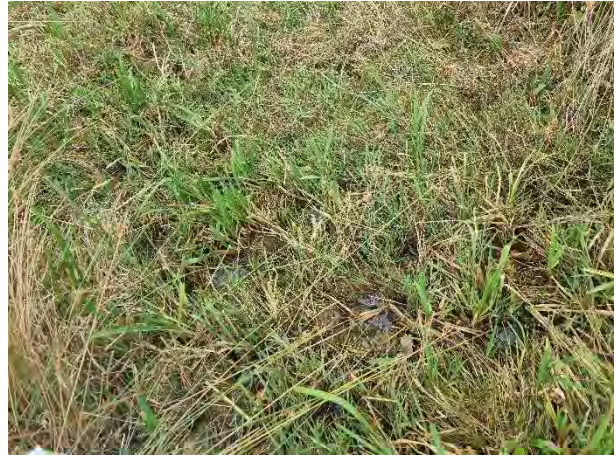
The wetland was not fenced and impacted by livestock through pugging and grazing. Standing water and saturated soils were present throughout the wetland, however the bed damage from livestock has likely restricted water flows through the wetland to be still or very slow flowing (Photo 16). Like Wetland 1, the wetland buffers were poor and did not provide any protective services and consisted of grazed pasture grasses.

***Photo 16. Bed condition of Wetland 2.***

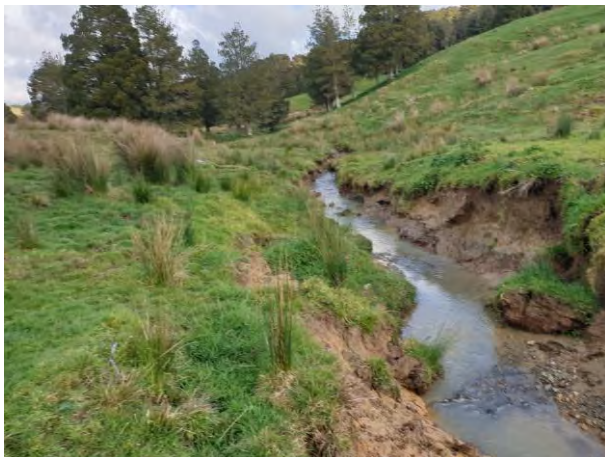
**Photo 17. The Central Upper reach contained deep and flow flowing water.**

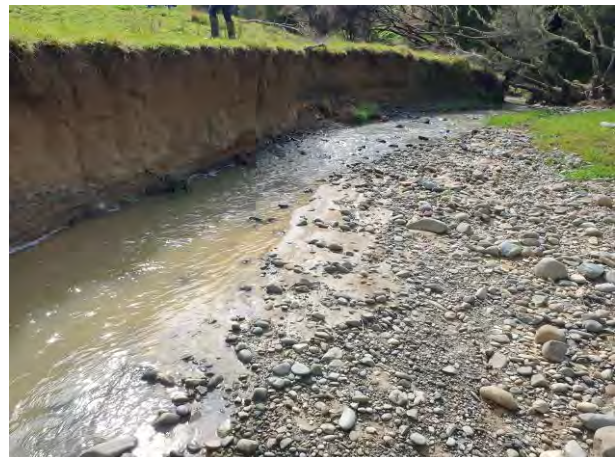
**Photo 18. Riffle habitat with significant scour on the banks**

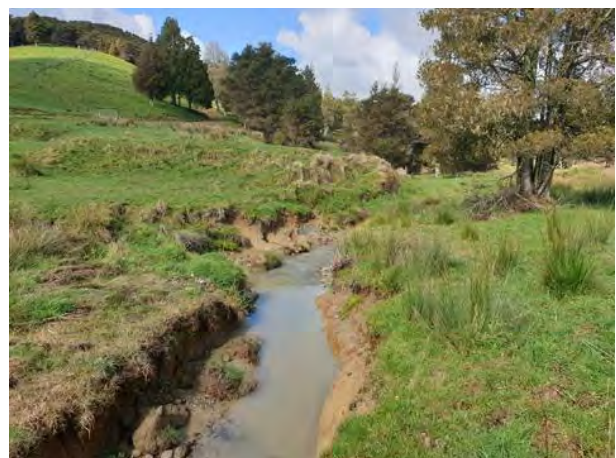
**Photo 20. Some riparian yard provided very low functions to the stream.**

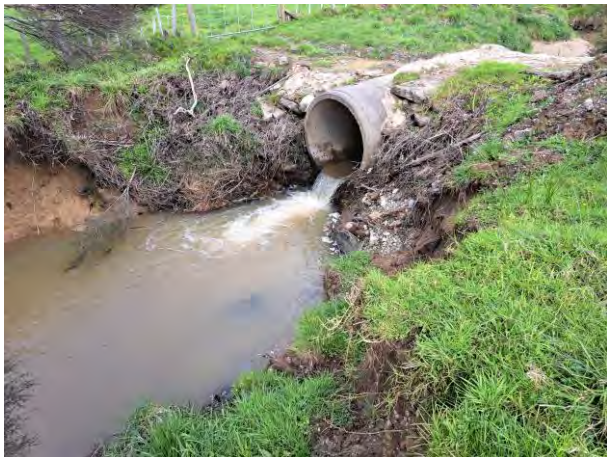
***Photo 21. A perched culvert was located on the Central Lower Reach***

Aquatic habitat and diversity throughout Lower Tributary were considered to be low with habitat available for indigenous fish and macroinvertebrates consisting of woody debris, riffles and undercut banks (Photo 24). Furthermore, the undersized culvert within the reach would act as a total barrier to fish passage, and restrict species moving upstream.

At 153 Hellyer Road, the removal and replacement of fish barriers, including the perched culverts will be undertaken, restoring fish passage through the reach.

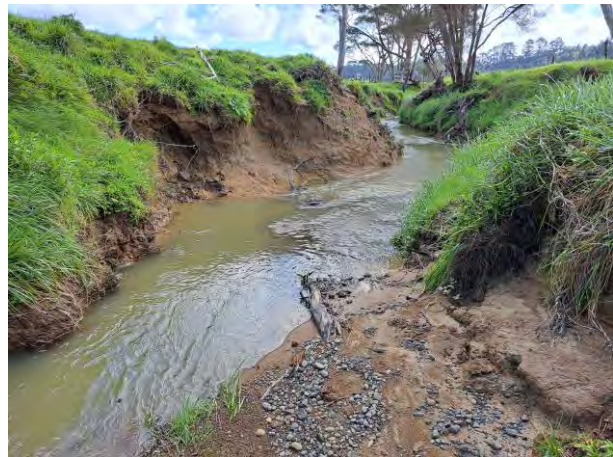
***Photo 22. Bank incision was severe throughout the Central Lower Reach***

The Central Lower was the lower section of the Te Kuru Stream tributary draining from the west of the property. The Lower Tributary SEV reach was assessed between two tributaries to the Te Kuru Stream. The Lower Tributary reach flowed from the east to west direction. The Lower Tributary had an average water depth of 0.14 m (0.03m – 0.47 m) and an average width of 2.09 m (0.99 m – 2.54 m). One farm crossing intersects the stream with an undersized and perched culvert, acting as a total barrier to fish passage (Photo 21). Much the stream channel is modified through bank incision restricting the connectivity to the floodplain.

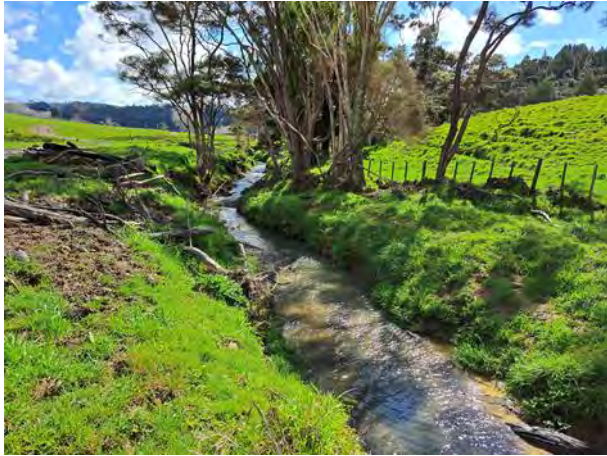
**Photo 23. The riparian yard was restricted to grass with small bands of evergreen vegetation**

Riparian vegetation largely consisted of pasture grass, with sparse grazed wetland vegetation contributing the ground cover. Tall trees present within the riparian yard largely consisted of mature exotic trees such as macrocarpa (*Cupressus macrocarpa*), kānuka, and kahikateas (Photo 23). Shade and organic matter input were considered to be low-moderate due to the occasional presence of mature exotic trees, however as the riparian yard predominantly consisted of pasture grass, filtration function and bank stability were considered to be low.

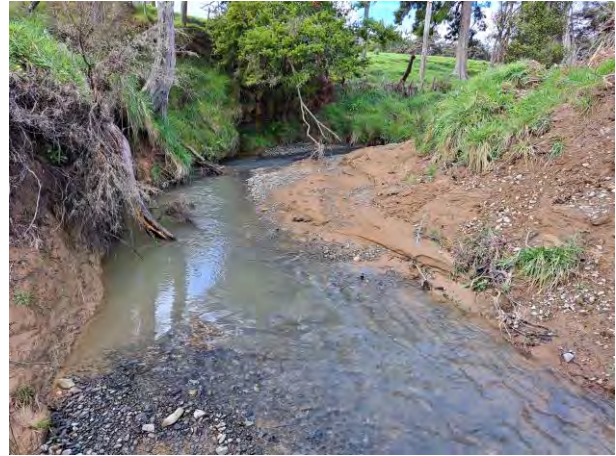
**Photo 24. Aquatic habitat within Central Lower was low.**

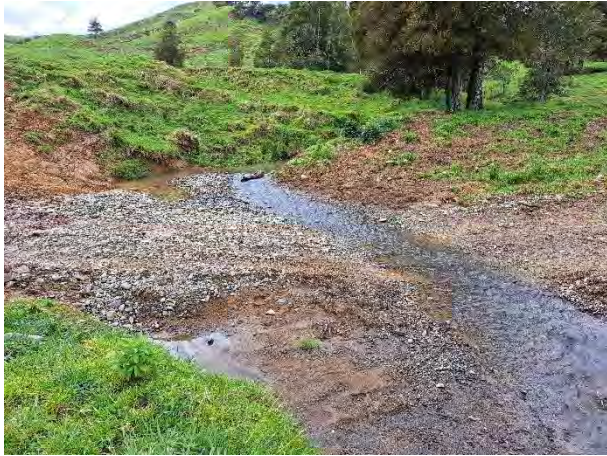
***Photo 25. Low profile ford crossing in the centre of Tributary 1.***

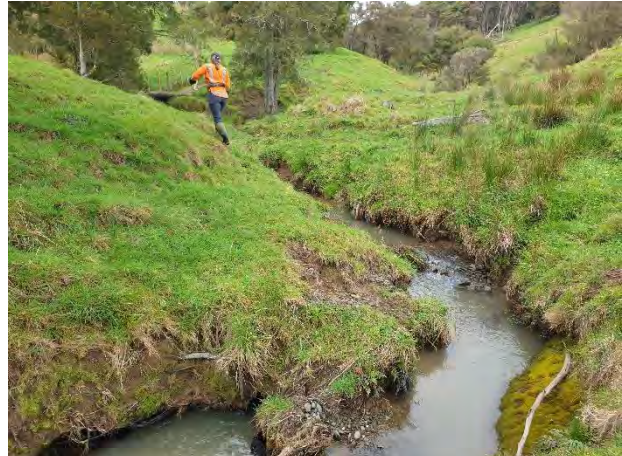
***Photo 26. The riparian yard was restricted to short grasses with some mature trees.***

The riparian yard largely consisted of grazed and sparse soft rush (*Juncus effusus*) pasture and some mature deciduous trees such as kānuka, kahikatea and tōtara. No understory was present with groundcover solely consisting of pasture and bare ground (Photo 26). Due to the lack of established riparian vegetation, the riparian yard services such as shading, bank stability and ground filtration function to the stream were considered to be low, however oxygen reducing process were considered to be optimal due to the lack of macrophyte growth, and no anaerobic sediments or bubbling was observed.
