Preliminary Geotechnical Assessment Report

61 Hampton Downs Road, Hampton Downs

Prepared for National Green Steel Limited

Reference: R4392-2

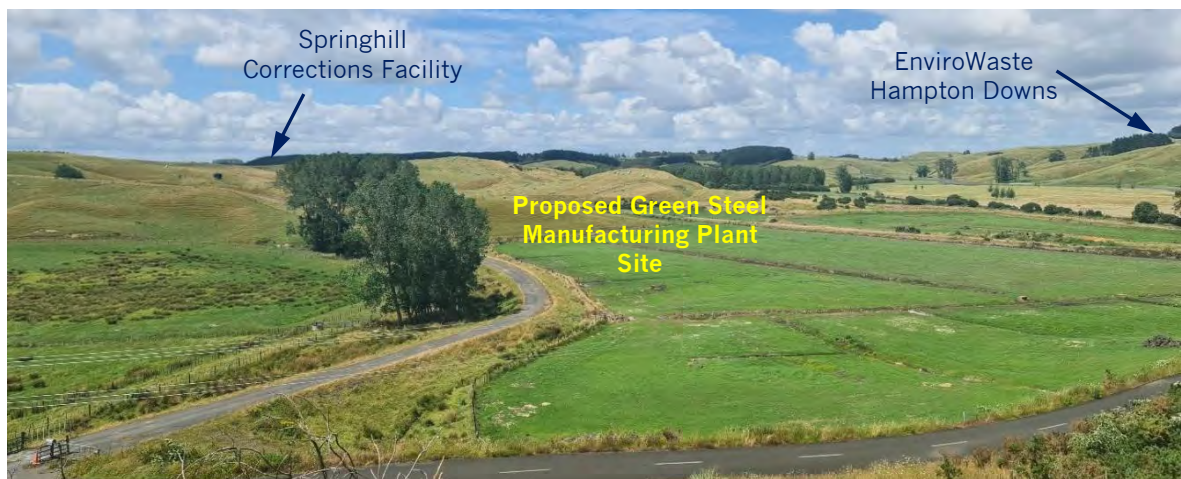
Figure A: The site at 61 Hampton Downs Road, Hampton Downs, Waikato, viewing southwards from the hillside on the northern side of Harness Road.

The Hampton Downs Motorsport Park is located immediately north of the property, and the operational Hampton Downs Landfill site is situated to the west (Figure A below) – both are accessed from Hampton Downs Road. The Hampton Downs Landfill site serves the solid waste disposal needs of the cities of Auckland and Hamilton, as well as several other areas of North Island. The Spring Hill Corrections Facility is situated to the south, as shown in Figure A below. A site location plan is presented in Figure 1.1.

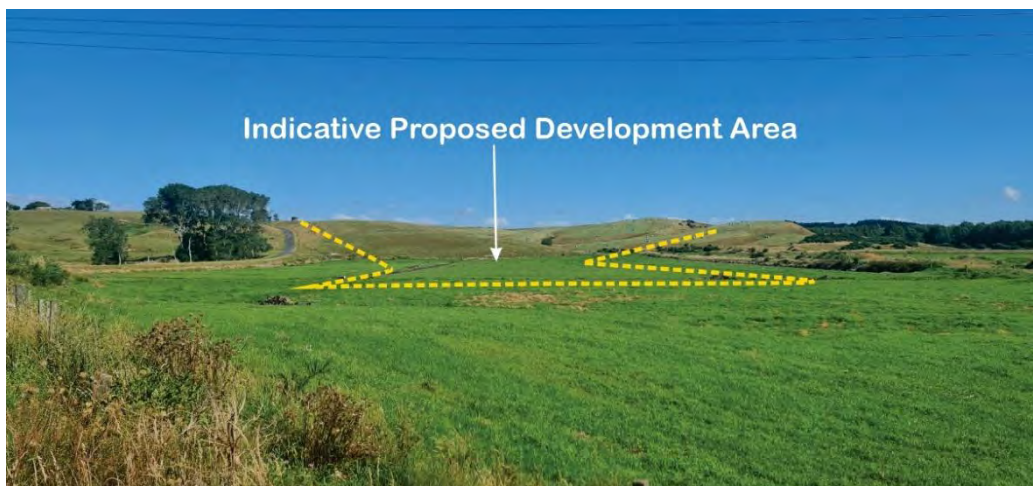
Figure A: Viewing southwards from Hampton Downs Road

The proposed development comprises the construction of building platforms and linking embankments, as shown in the layout plan Figure 2.2, long section Figure PD5.1 and cross-sections Figure PD5.2. It is currently envisaged that a large single-level building platform (*main platform*) is to be constructed at the finished platform level of RL14m. Several *perimeter platforms* are to be constructed at provisionally proposed elevations RL14m, RL35m and RL45m, as shown in Figure 2.3, and the long section and cross sections in Figure PD5.1 and Figure PD5.2, respectively. Figures A, B and C below illustrate the proposed development area.

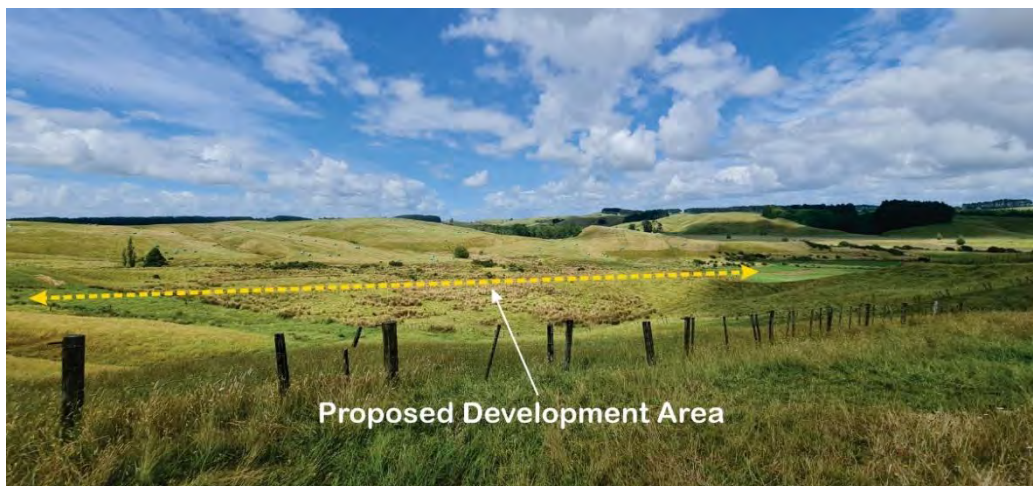
Figure B: Viewing westwards from the peripheral access road

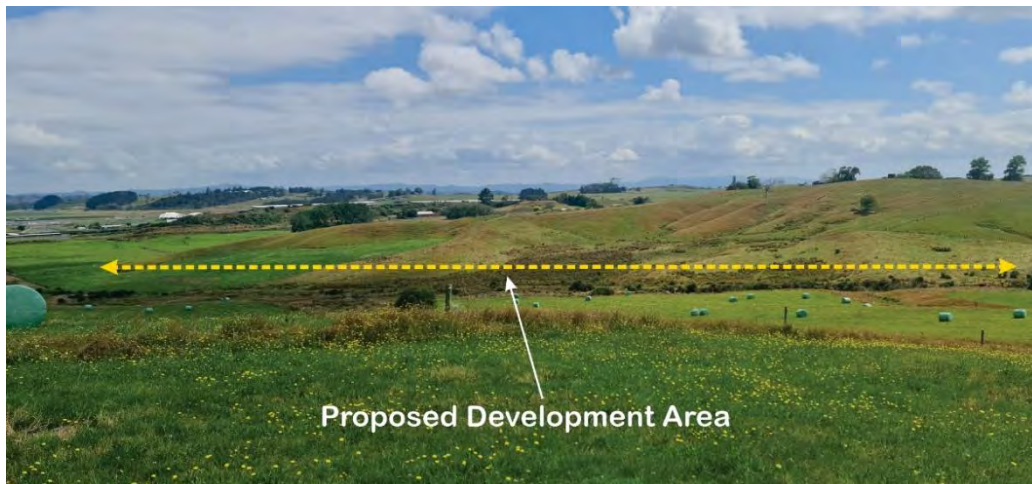
Figure C: Viewing eastwards from the hilltop in Lot 5

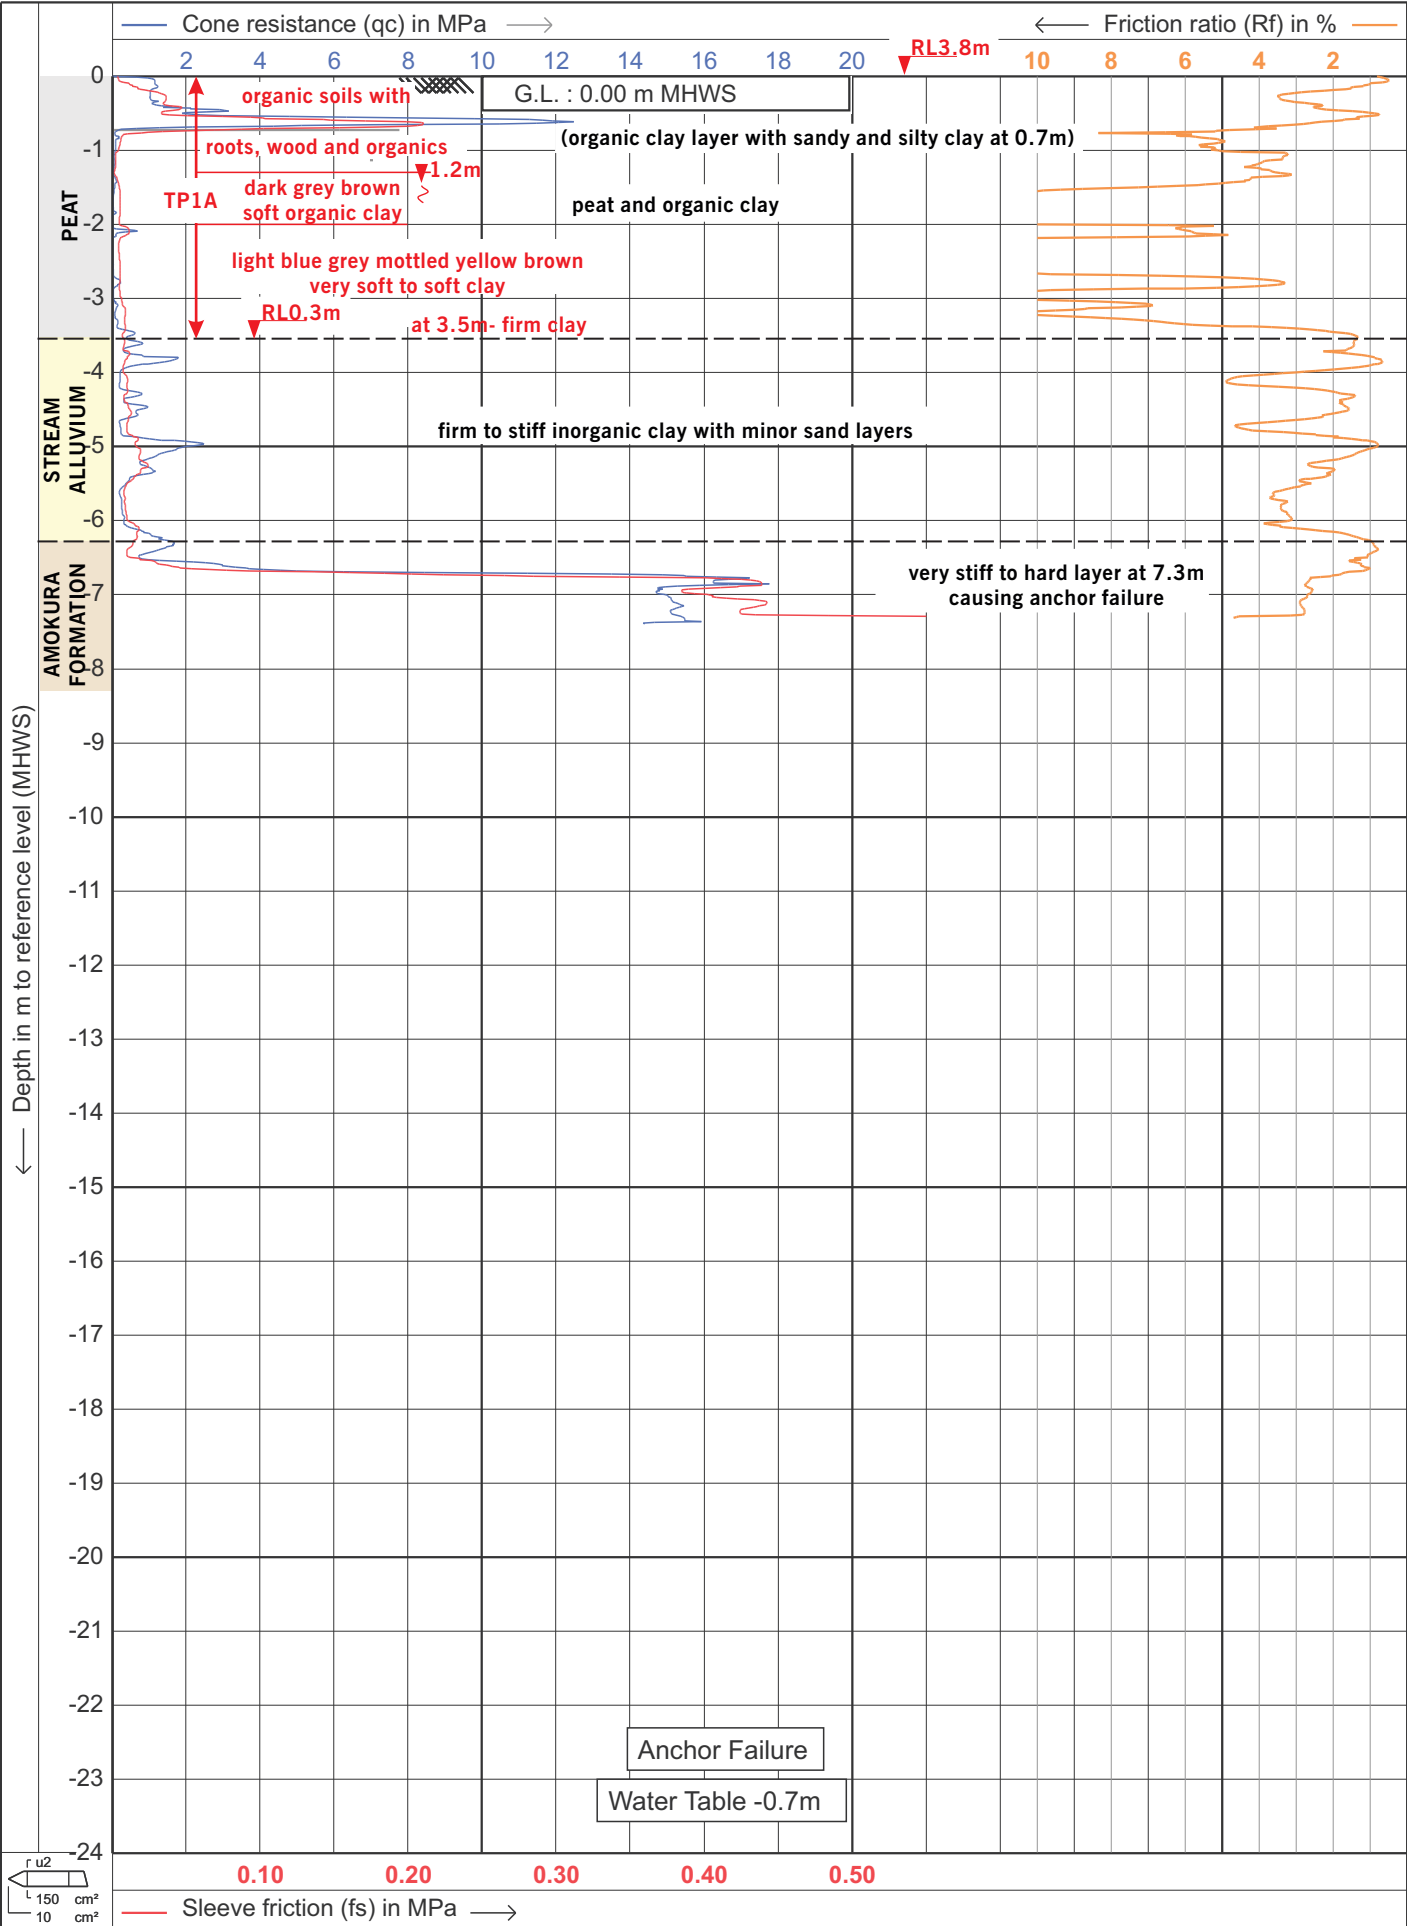
TEST RIGHT • BUILD RIGHT NORTHLAND • WELLINGTON • CANTERBURY • OTAGO	Test performed in accordance with ASTM D5778-12		Date : 25-1-2024
	Project : EARTHTECH		Cone no. : C10CFIIP.C21103
	Location: Hampton Downs		Project no. : 8736-010
	Position : 175.077455, -37.361146 WGS84		CPT no. : CPT01a 1/4

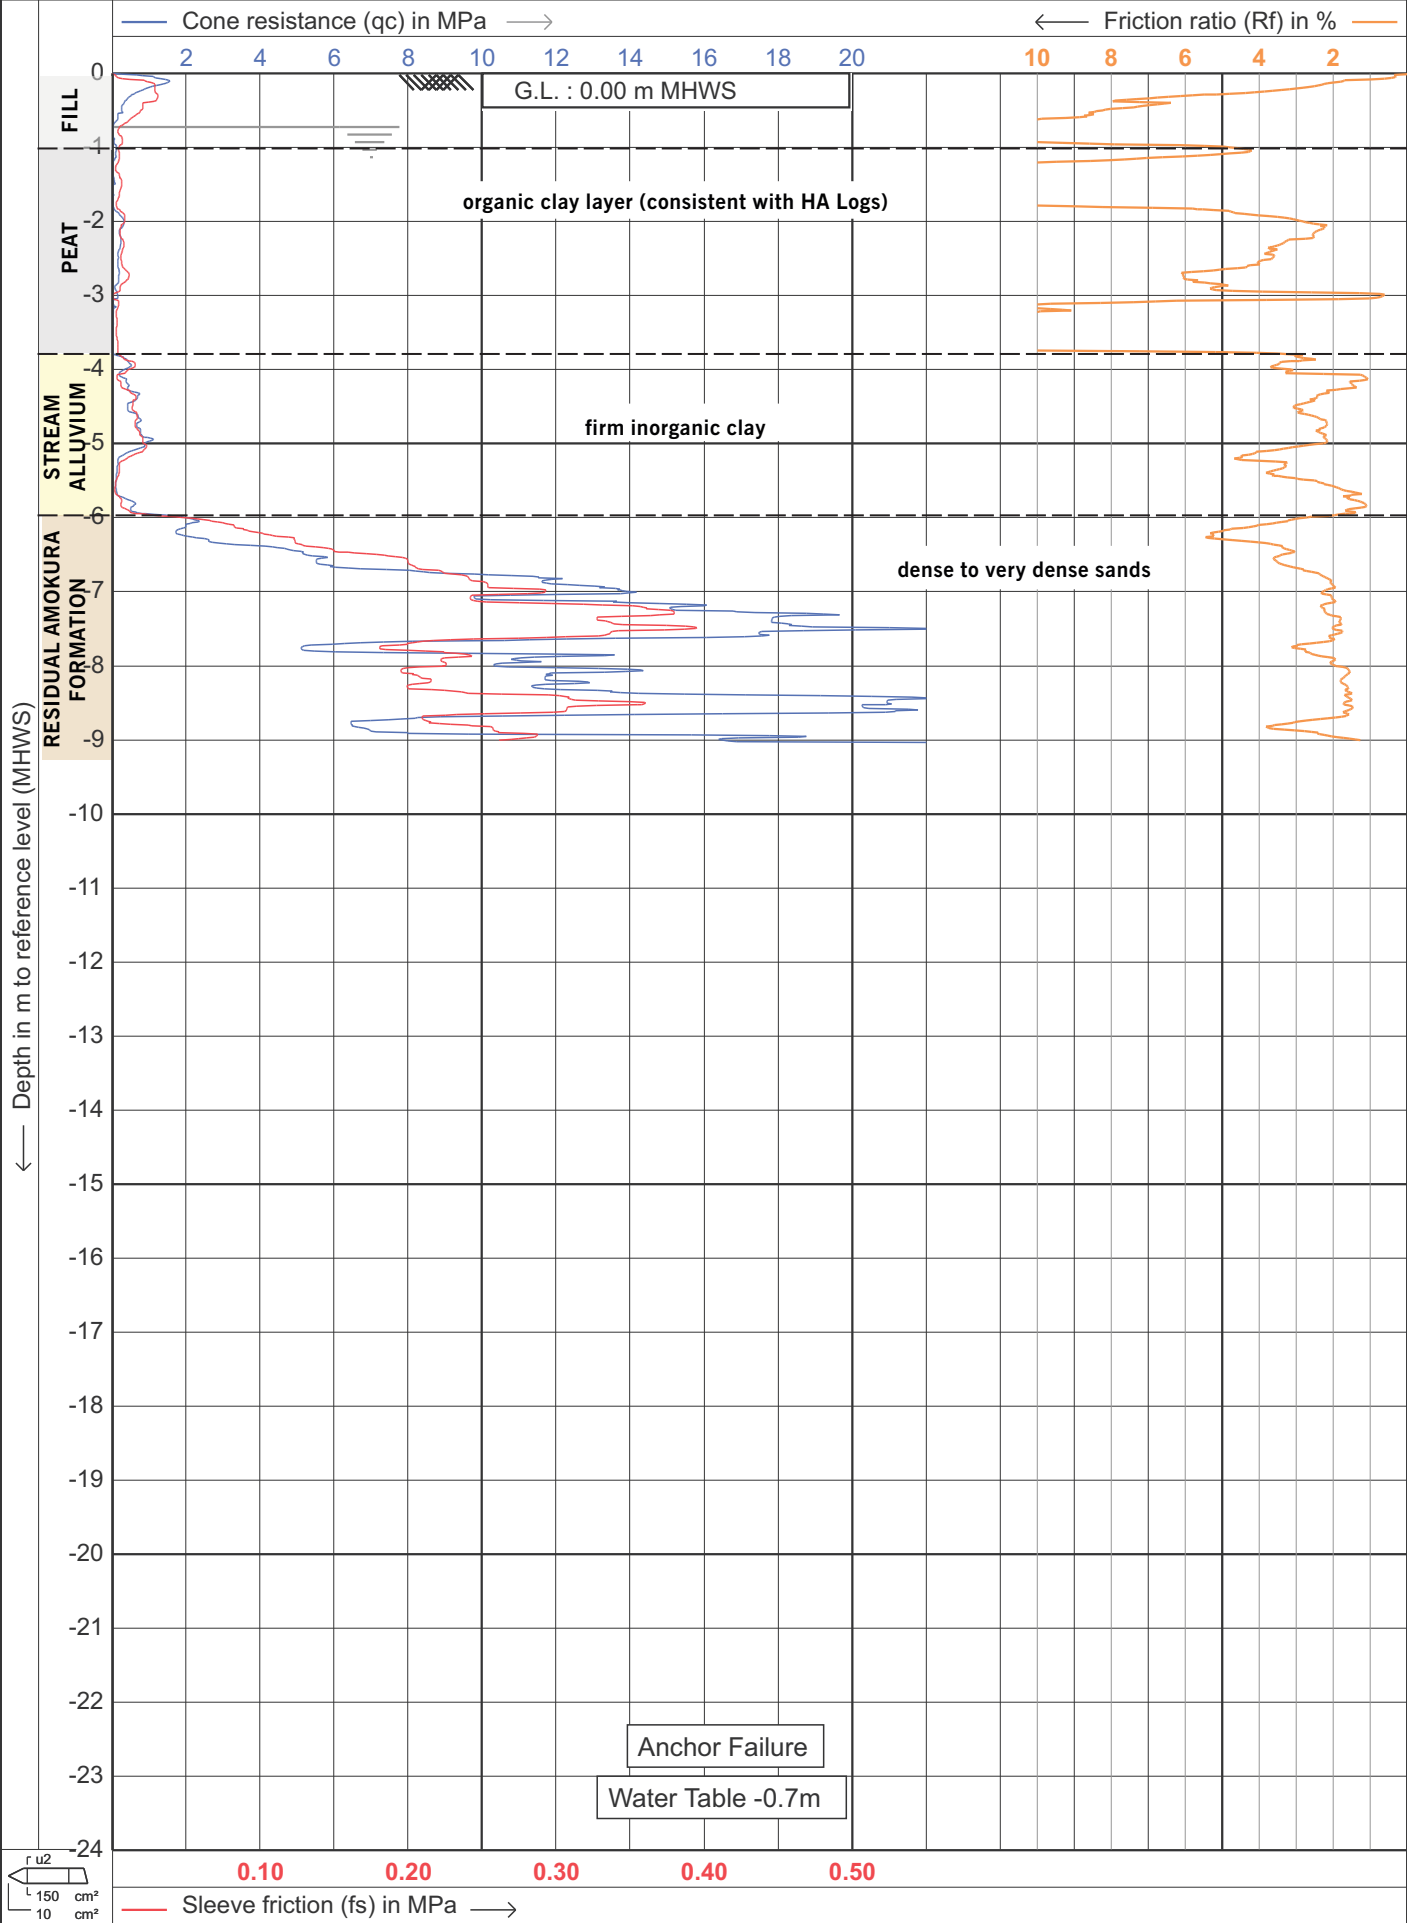
TEST RIGHT • BUILD RIGHT NORTHLAND • WELLINGTON • CANTERBURY • OTAGO	Test performed in accordance with ASTM D5778-12		Date : 25-1-2024
	Project : EARTHTECH		Cone no. : C10CFIIP.C21098
	Location: Hampton Downs		Project no. : 8736-010
	Position : 175.077173, -37.361991 WGS84		CPT no. : CPT02 1/4

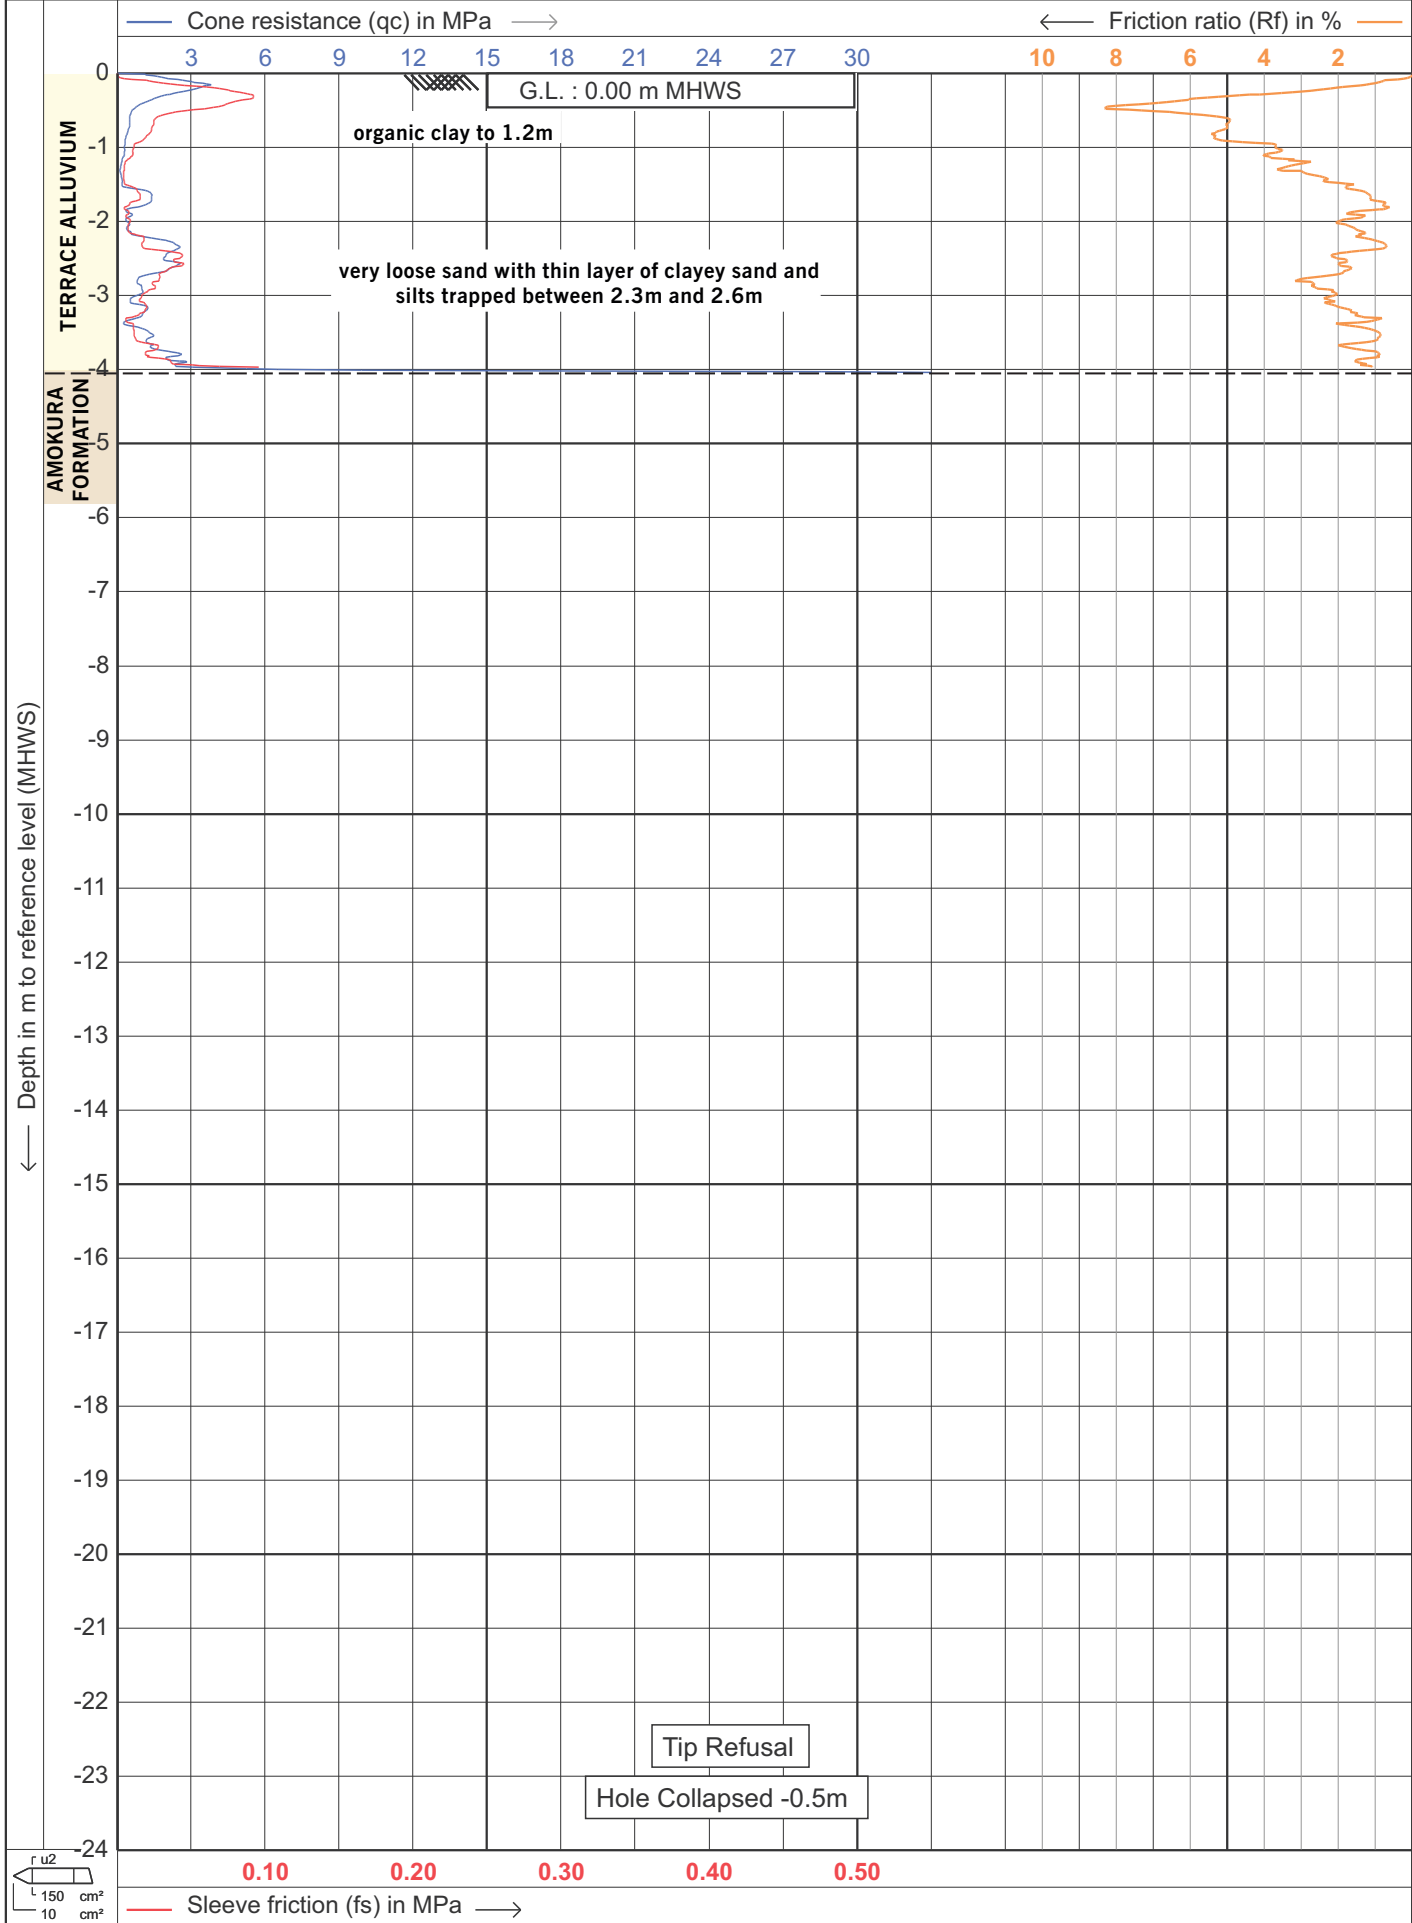
TEST RIGHT • BUILD RIGHT NORTHLAND - WELLINGTON - CANTERBURY - OTAGO	Test performed in accordance with ASTM D5778-12		Date : 26-1-2024
	Project : EARTHTECH		Cone no. : C10CFIIP.C21103
	Location: Hampton Downs		Project no. : 8736-010
	Position : 175.080474, -37.363137 WGS84		CPT no. : CPT10 1/4

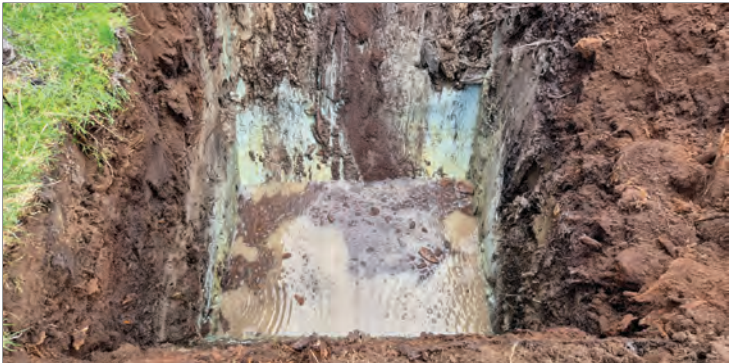
1.2m: Water ingress.		1.0			
	CLAY; dark brown grey. Soft; saturated; highly plastic. Pockets of organic clays.		1.5		25/19kPa	
	2.0m: CLAY; light blue grey with yellow brown staining. Soft to firm; saturated; highly plastic.		2.0

2.5			
			3.0		29/22kPa	
			3.5			
			4.0			
<div>EXCAVATOR TYPE: 13t</div> <div>OPERATOR: Grant Fitzgerald</div> <div>TEST PIT TERMINATED AT: 3.5m</div> <div>Target Depth <input checked="" type="checkbox"/> Refusal <input type="checkbox"/></div> <div>Near Refusal <input type="checkbox"/> Flooding <input type="checkbox"/></div> <div>SAMPLE TYPE:</div> <div>bulk sample <input type="checkbox"/> Shear vane <input checked="" type="checkbox"/></div> <div>tube sample <input type="checkbox"/> Hand penetrometer <input type="checkbox"/></div> <div>disturbed profile sample <input checked="" type="checkbox"/> Estimate only <input type="checkbox"/></div> <div>FIELD SHEAR STRENGTH:</div> <div>Remarks: This TP log has been profiled with focus on earthworks for the Green Steel Project. As such, notes are provided here in regard to soil material quality for potential use as engineered fill or as general landscaping fill, or to be spoiled.</div>					<div>TEST PIT PHOTO</div> <div>SCALE: NTS</div> <div>

- Organic and poor materials were observed in:
 - TP1A: organic clays and peat-like material encountered at shallow depths with high plasticity and moisture content, unsuitable for engineered fill material. Note: the existing surface was found to be firm in-situ, displaying very little penetration of the tracks of the 13t excavator. We suggest placing the fill material directly on this surface.

- Groundwater and Moisture Observations:
 - Water ingress was noted at 1.2m depth (~RL2.6m) in TP1A and 4.5m depth (~RL9.7m) in TP7. Groundwater was not observed in other test pit locations.
