Geotechnical Assessment for Resource Consent

Southland Wind Farm, Southland

Report prepared for: Contact Energy Limited

Report reference: 220372-B (Issue 4.0)

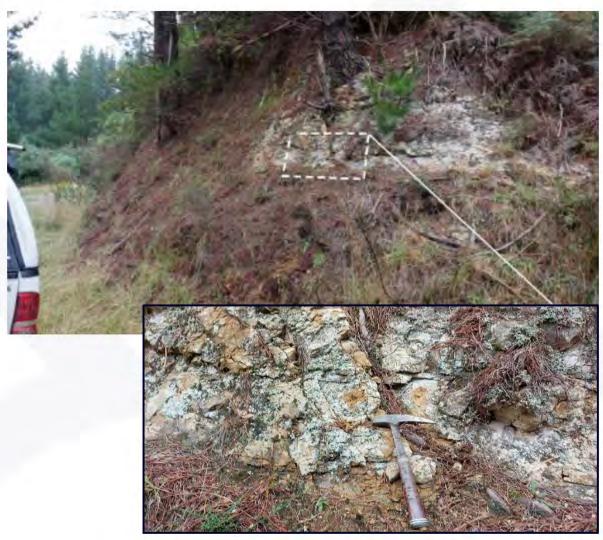
Figure 8: Photo of Venlaw Forest road cut, waypoint 'OC-X2'. Exposure of 'lower-strength' bedrock consisting of very weak to weak sandstone with closely to very closely spaced joint sets – exposed in an over 4m high, moderately inclined cut slope (dashed area showing enlargement photo below).

In general, the near-surface soils are underlain by a mantle of lower-strength, and more-weathered, bedrock. This rock is typically very weak to weak, but locally extremely weak⁷ (TP104 to TP106) and moderately strong examples are encountered. Figure 8 shows an approximately +4m thick exposure of lower-strength bedrock in a Venlaw Forest road cut.

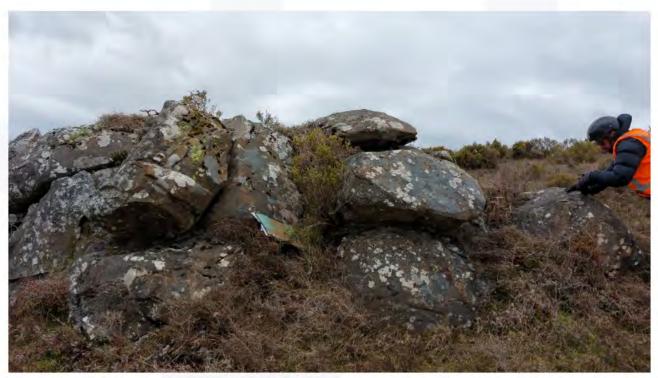
Figure 9: Photo of natural exposure of moderately strong to strong sandstone boulders ('blue-rock') on the strike-ridge at the south end of Jedburgh Station (just north of WTG JED-28) (Oct. 2022).

Rock mass and defects are like those for the 'lower strength' bedrock. However, in general wider-spaced joints, producing approximately 300mm to 1m-diameter blocks, are anticipated in the higher-strength bedrock (Figure 9 to Figure 11).

There are limited natural exposures of the higher-strength bedrock. It was observed, in the invert of the Mimihau Stream (South Branch) from Venlaw Road, and in the base of tributary gullies near the main Mimihau Stream valley. It was also observed locally on the margin of the high elevation plateau-like area at the Jedburgh Station (Figure 9, just north of WTG JED-28).

ROCK MASS AND DEFECTS ARE SIMILAR TO THAT 'LOWER STRENGTH' BEDROCK. HOWEVER, IN GENERAL WIDER-SPACED OF JOINTS, PRODUCING APPROXIMATELY 300mm TO 1m DIAMETER BLOCKS, ARE ANTICIPATED IN THE HIGHER-STRENGTH BEDROCK (REFER FIGURE 9 TO FIGURE 10).

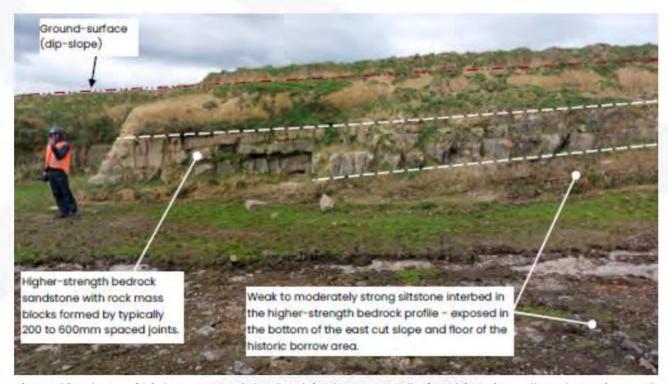
Figure 10: Photo of higher-strength bedrock in the east wall of an historic Jedburgh Station rock borrow area (silage pit), underlying approx. 1.5m of soil. Note bedding dipping approx. 10° to north subparallel to general dip-slope (waypoint ID 'OC-V') (Oct. 2022).

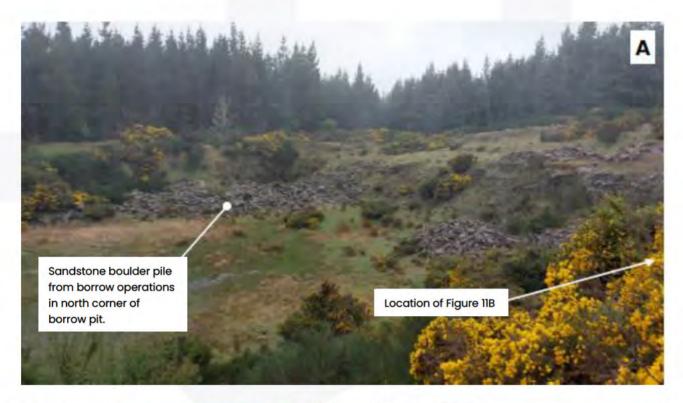
Figure 11A and 11B: Photos of historic rock borrow in Venlaw Forest (waypoint ID 'OC-R') exposing higher-strength bedrock. The borrow is approximately 60m x 80m and 4 to 5m deep (Figure 11A). Approximately 2m of lower-strength soil or bedrock was stripped to expose the top of higher-strength bedrock. Figures 11A and 11B were taken on 20 October 2022 and 21 February 2023, respectively.

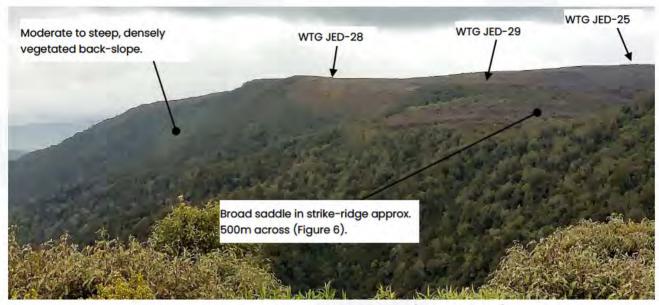
Figure 12: Photo looking south-west along the back-slope (left of frame) at Jedburgh Station. Taken from near to WTG MAT-01. WTG positions are approximate (Oct. 2022).

One possible deeper-seated landslide (ID 'G') is noted along the back-slope of Jedburgh Station between WTG JED-27 and JED-17. This inferred feature is approximately 500m wide (subparallel to the strike-ridge), with an estimated debris volume of a few thousand cubic metres. The inferred debris lobe is only partially displaced (i.e. not completely evacuated from the source area). The headscarp is a few tens of metres from the nearest road or WTG. No ground-cracks or evidence of recent ground movement was observed in this area, or north along the strike-ridge to WTG JED- 29.

No evidence has been encountered to preclude the proposed access road or WTG's near to the strike-ridge. However, it would be prudent, during detailed geometric design and layout, to set the works as far back from the lip of the back-slope (considering other environmental and civil engineering constraints etc.). Selected deep investigations should be considered during detailed design as part of confirming the degree of hazard and consideration slope stability is to the proposed development and develop appropriate mitigation measures (if any).

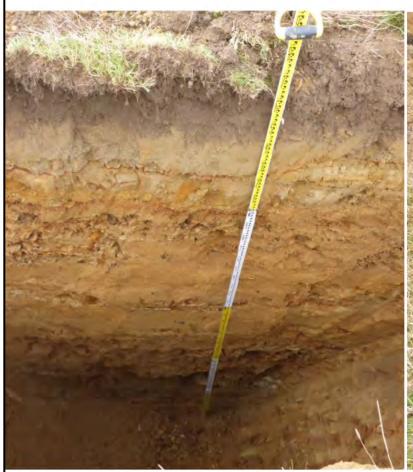
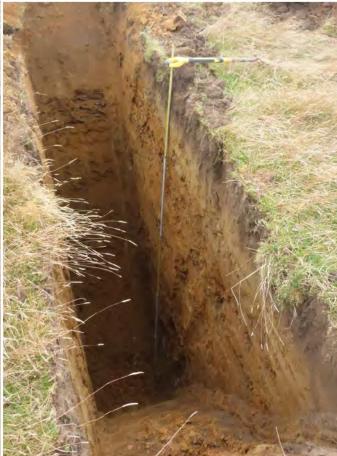
Client Project Title	ROARING40'S LTD SOUTHLAND WIND FARM 100-SERIES - MACHINE INSPECTION PIT PHOTOS	Pit ID:		TP101	
		Date:		22-Feb-2023	
Notes:	1) Stable on all sides.	Plant:	16t exc. Toothed Buck		
	No groundwater encountered.	Pit Toe Depth (m):	4.75		
Project No.	220372	Terminated Due To:		Target Depth

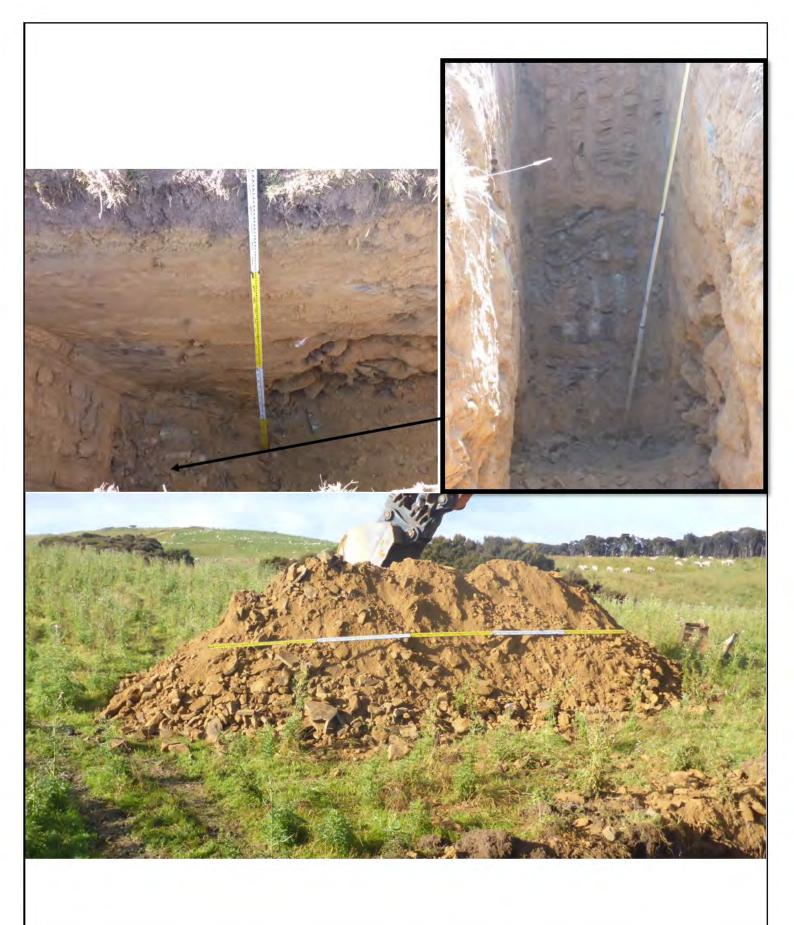
Client Project	ROARING40'S LTD SOUTHLAND WIND FARM	Pit ID: TP1		TP102
Title	100-SERIES - MACHINE INSPECTION PIT PHOTOS	Date:	2	23-Feb-2023
Notes:	Local pit wall collapse below 2.50m depth.	Plant:	16t exc. Toothed Buck	
	No groundwater encountered.	Pit Toe (m):	oe Depth 5.50	
Project No.	220372	Terminated Due To:		Practicable Refusal

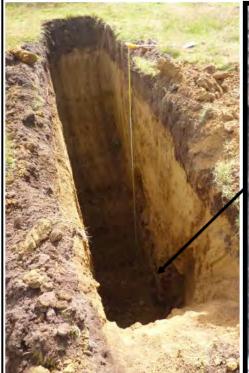
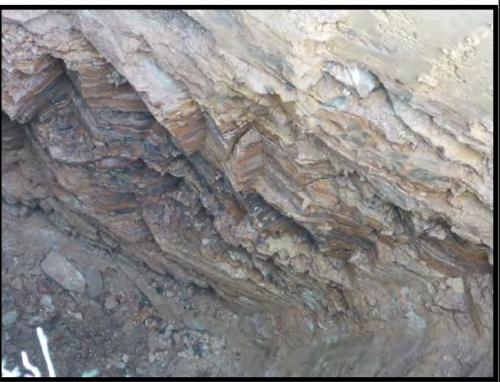
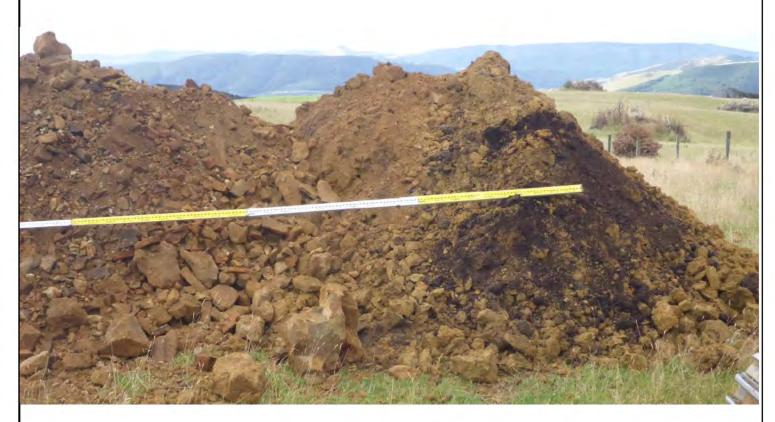
Client Project	ROARING40'S LTD SOUTHLAND WIND FARM	Pit ID:		TP103	
Title	100-SERIES - MACHINE INSPECTION PIT PHOTOS	Date:		22-Feb-2023	
Notes:	1) Stable on all sides.	Plant:	16t exc	. Toothed Bucket	ket
	2) No groundwater encountered.	Pit Toe (m):	Depth	4.90	
CLA C/-1184		Terminated		Target Depth	
Project No.	1220372	Due To		raiget Deptil	ı

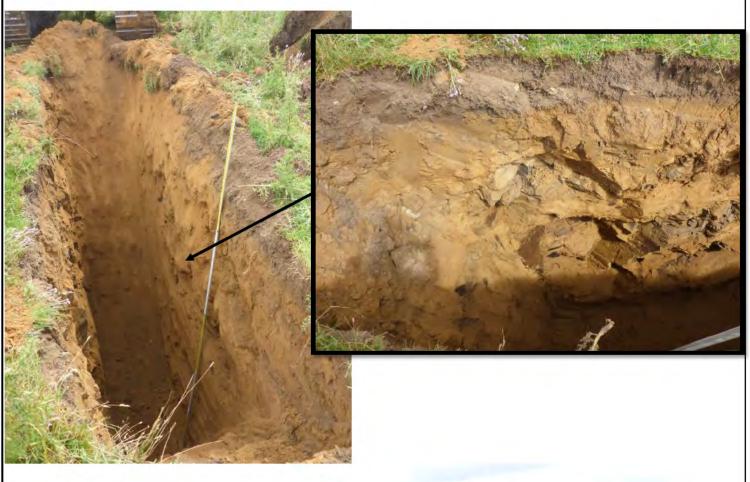
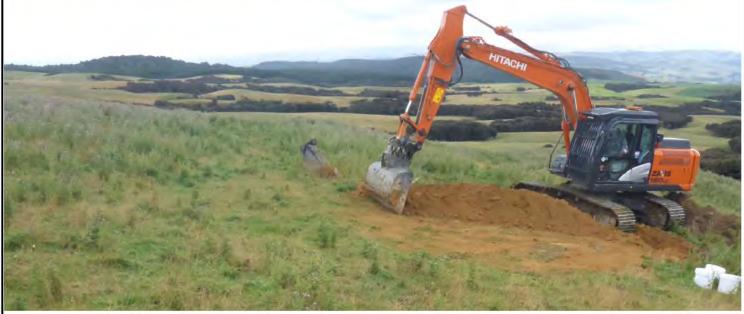
Client Project Title	ROARING40'S LTD SOUTHLAND WIND FARM	Pit ID:	TP104		
	100-SERIES - MACHINE INSPECTION PIT PHOTOS	Date:		22-Feb-2023	
Notes:	1) Stable on all sides.	Plant:	16t exc. Toothed Bu		
	2) No groundwater encountered.	Pit Toe Depth (m):	4.50		
Project No.	220372	Terminated Due To:		Target Depth

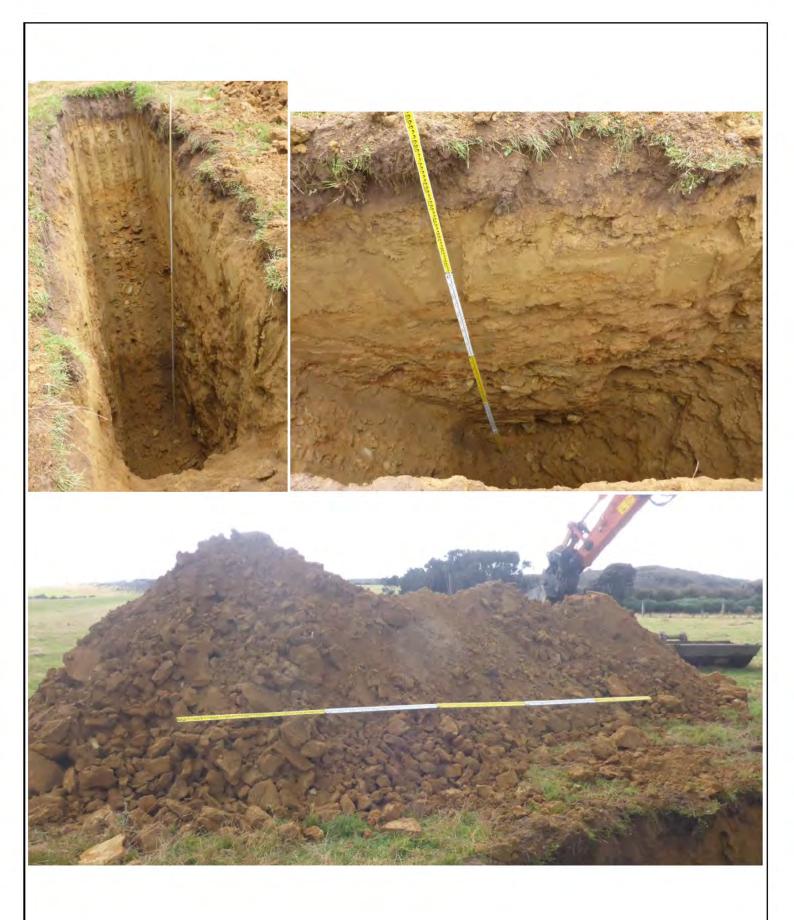
Client Project Title	ROARING40'S LTD SOUTHLAND WIND FARM	Pit ID:	TP105	
	100-SERIES - MACHINE INSPECTION PIT PHOTOS	Date:		22-Feb-2023
Notes:	Local pit wall collapse below 2.0m depth.	Plant:	16t exc. Toothed Buck	
	2) No groundwater encountered.	Pit Toe Depth (m):	4.8	
Project No.	220372	Terminated Due To:		Target Depth

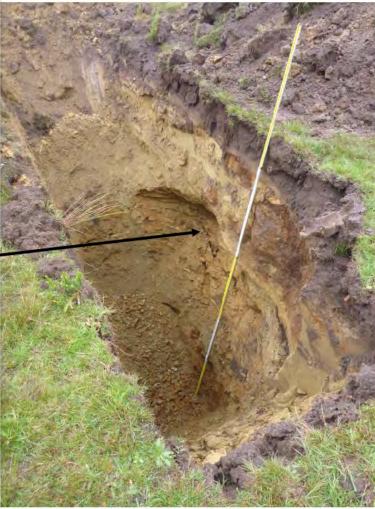
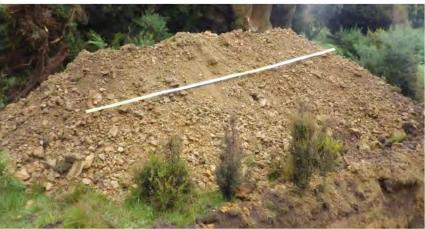
Client Project	ROARING40'S LTD SOUTHLAND WIND FARM	Pit ID:		TP106	
Title	100-SERIES - MACHINE INSPECTION PIT PHOTOS	Date:		23-Feb-2023	
Notes:	1) Pit wall collapse below 1.0m depth.	Plant:	16t exc. Toothed Buck		
	No groundwater encountered.	Pit Toe (m):	Depth 4.30		
Project No.	220372	Terminated Due To:		Pit Collapse

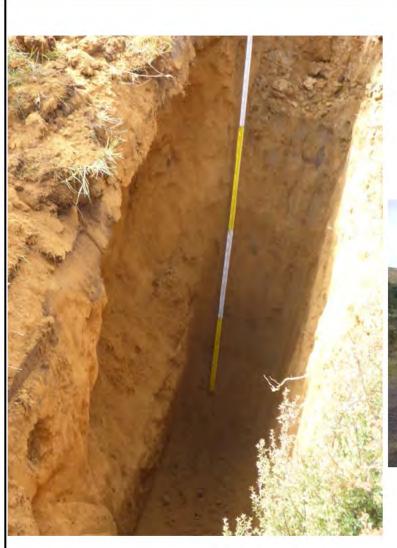
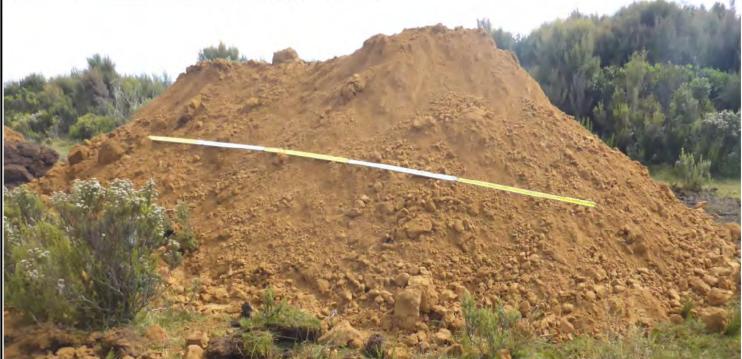
Client Project Title Notes:	ROARING40'S LTD SOUTHLAND WIND FARM			TP107
	100-SERIES - MACHINE INSPECTION PIT PHOTOS	Date:		23-Feb-2023
	1) Local pit wall collapse between 0.3m to 3.50m.	Plant:	16t exc. Toothed Bu	
	Slow groundwater seep at 0.3m depth along northern pit wall.	Pit Toe Depth (m):		5.50
Project No.	220372	Terminated Due To:		Target Depth

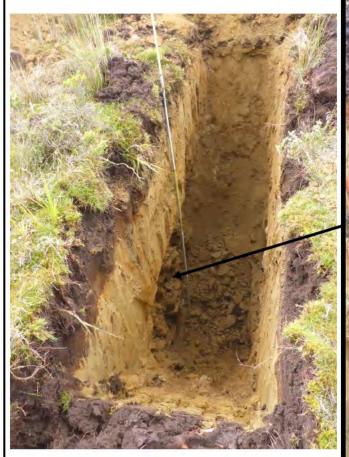
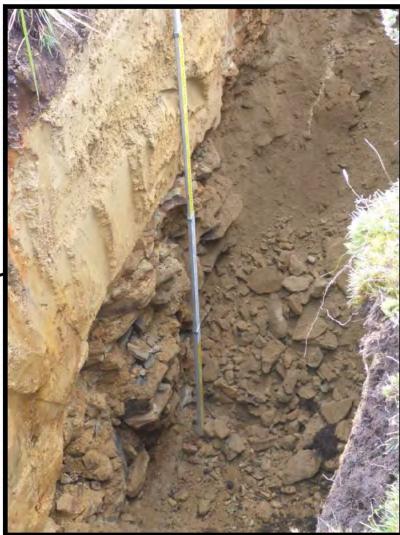
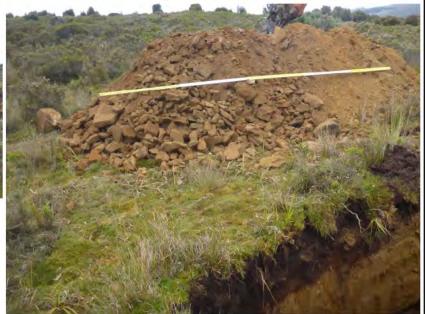
Client Project Title	ROARING40'S LTD SOUTHLAND WIND FARM	Pit ID:		TP108	
	100-SERIES - MACHINE INSPECTION PIT PHOTOS	Date:		23-Feb-2023	
Notes:	1) Stable on all sides.	Plant:	16t exc. Toothed Buck		
	No groundwater encountered.	Pit Toe (m):	Depth	3.80	
Project No.	220372	Termina Due To		Target Depth

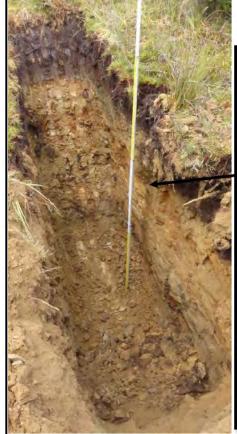
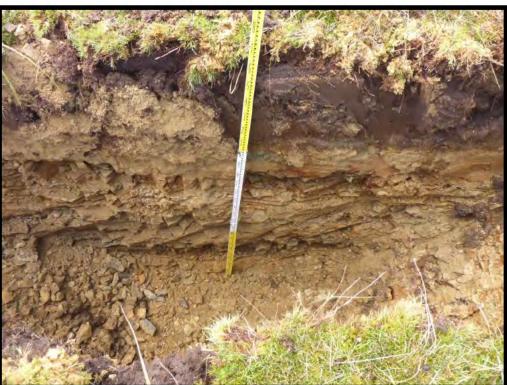
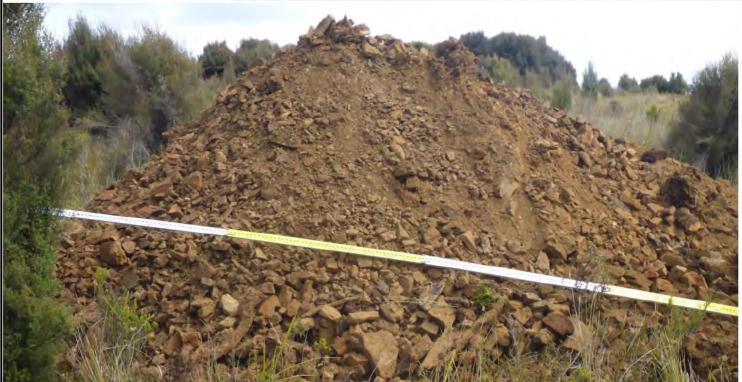
Client Project Title	ROARING40'S LTD SOUTHLAND WIND FARM			TP109	
	100-SERIES - MACHINE INSPECTION PIT PHOTOS	Date:	:	23-Feb-2023	
Notes:	1) Stable on all sides.	Plant:	16t exc. Toothed Buck		
	Slow groundwater seep encountered at 0.3m depth.	Pit Toe Depth (m): 2.	2.75		
Project No.	220372	Terminated Due To:		Practicable Refusal

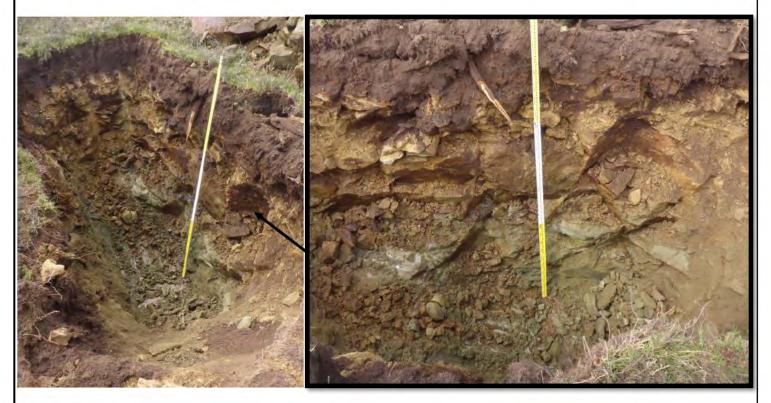
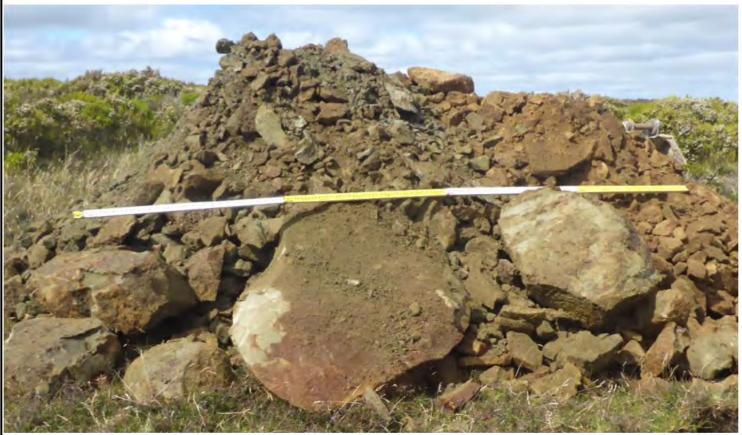
Client Project Title	ROARING40'S LTD SOUTHLAND WIND FARM	Pit ID:	rit ID: TP111	
	100-SERIES - MACHINE INSPECTION PIT PHOTOS	Date:	2	24-Feb-2023
Notes:	1) Stable on all sides.	Plant:	16t exc	. Toothed Bucket
	2) Slow groundwater seep at 0.45m depth.	Pit Toe (m):	Pit Toe Depth (m): 2.6	2.60
Project No.	220372	Terminated Due To:		Practicable Refusal

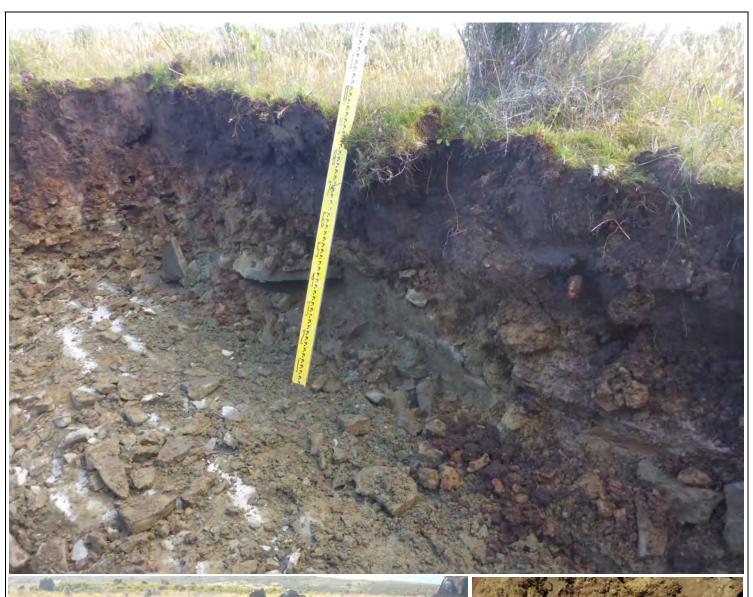
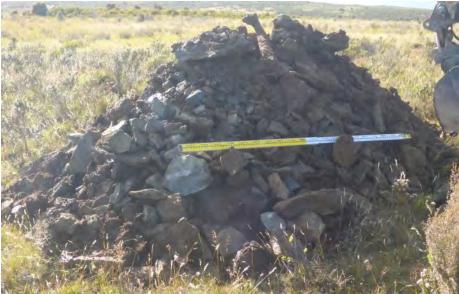
Client Project Title	ROARING40'S LTD SOUTHLAND WIND FARM 100-SERIES - MACHINE INSPECTION PIT PHOTOS	Pit ID:		TP112	
		Date:	:	24-Feb-2023	
Notes:	1) Stable on all sides.	Plant:	16t exc. Toothed Bucl		
	2) Slow groundwater seep at 0.4m depth.	Pit Toe Depth (m):	1.10		
Project No.	220372	Terminated Due To:		Practicable Refusal

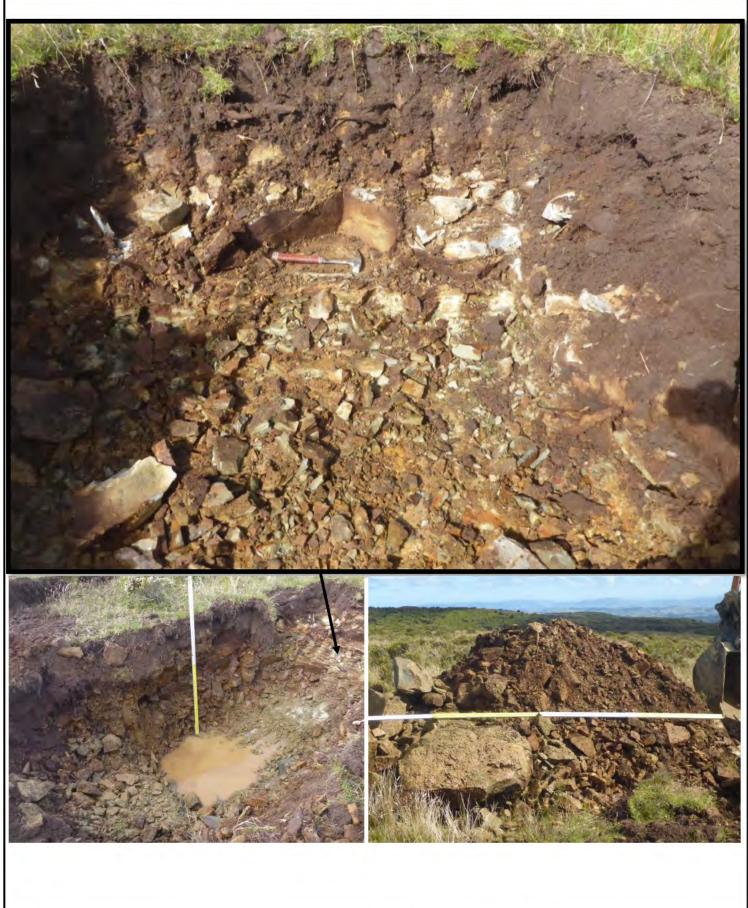
Client Project	ROARING40'S LTD SOUTHLAND WIND FARM	Pit ID:		TP113
Title	100-SERIES - MACHINE INSPECTION PIT PHOTOS	Date:	2	24-Feb-2023
Notes:			16t exc	. Toothed Bucket
	2) Slow groundwater seep at 0.2m depth.	Pit Toe (m):	Depth	1.60
Project No.	220372	Termina Due To	71 77 77	Practicable Refusal

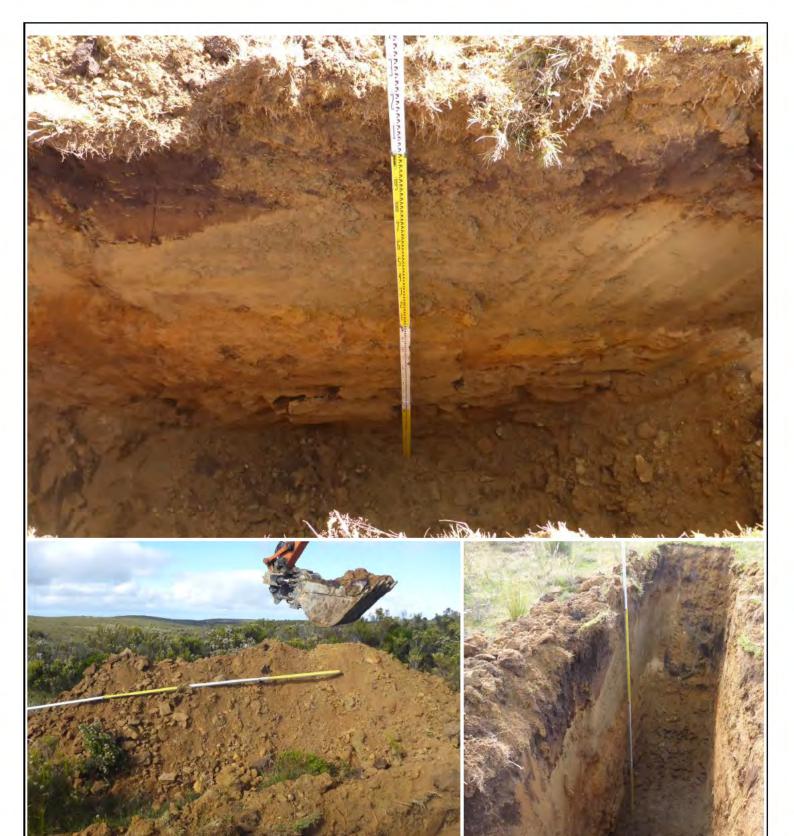
Notes:	1) Stable on all sides. 2) Slow groundwater seep at 2.55m depth.	Date: Plant:	16t exc	24-Feb-2023 . Toothed Bucket
		Pit Toe (m):	Depth	3.20
Project No.	220372	Termin		Target Depth
