# RCL Homestead Bay Limited

## **Detailed Site Investigation**

786 Kingston Road, Queenstown

6-XZ762.00

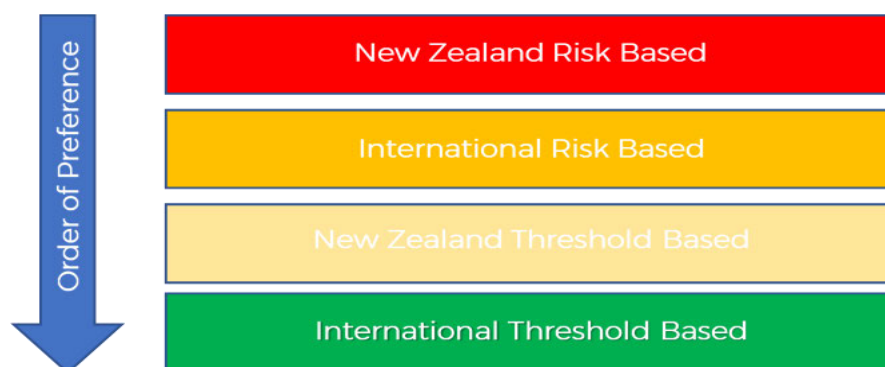
Diagram 1: Hierarchy of guideline values

This section summarises the guideline values that have been adopted for the proposed assessment of the site, considering future continued use as a reserve. The selected guidelines have been based on the *Contaminated Land Management Guidelines No. 2: Hierarchy and Application in New Zealand of Environmental Guideline Values (Revised 2011)* (CLMG No. 2) (MfE, 2011a) as detailed in Diagram 1.

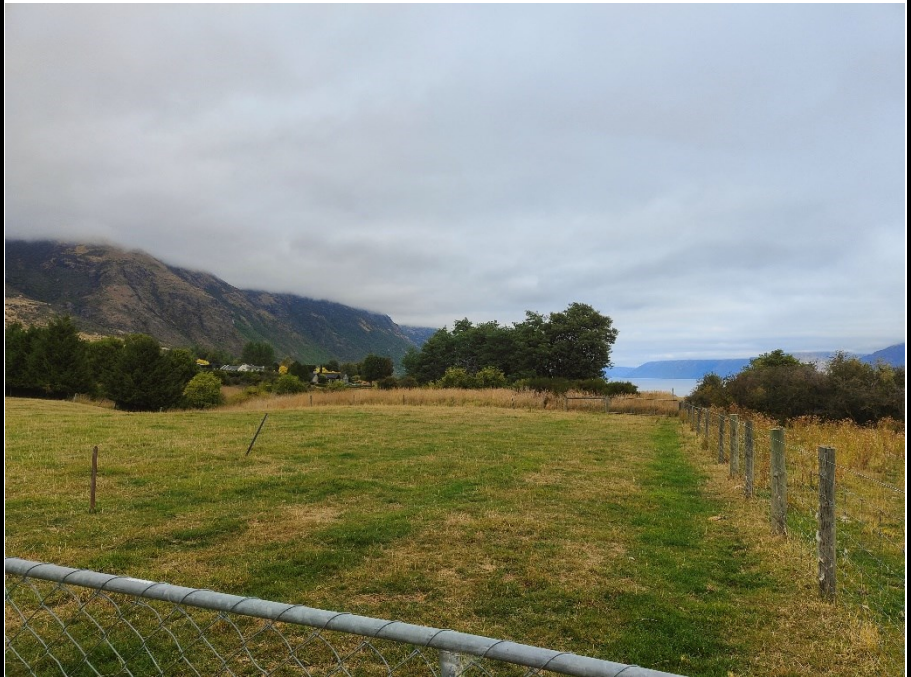
| Photo No. | Date | |
|---|---|---|
| 1. | 1/04/2025 | |

| Photo No. | Date | |
|---|---|---|
| <b>Description</b><br>Location of sample Sheep Dip 1 (SD1) looking south. | | |

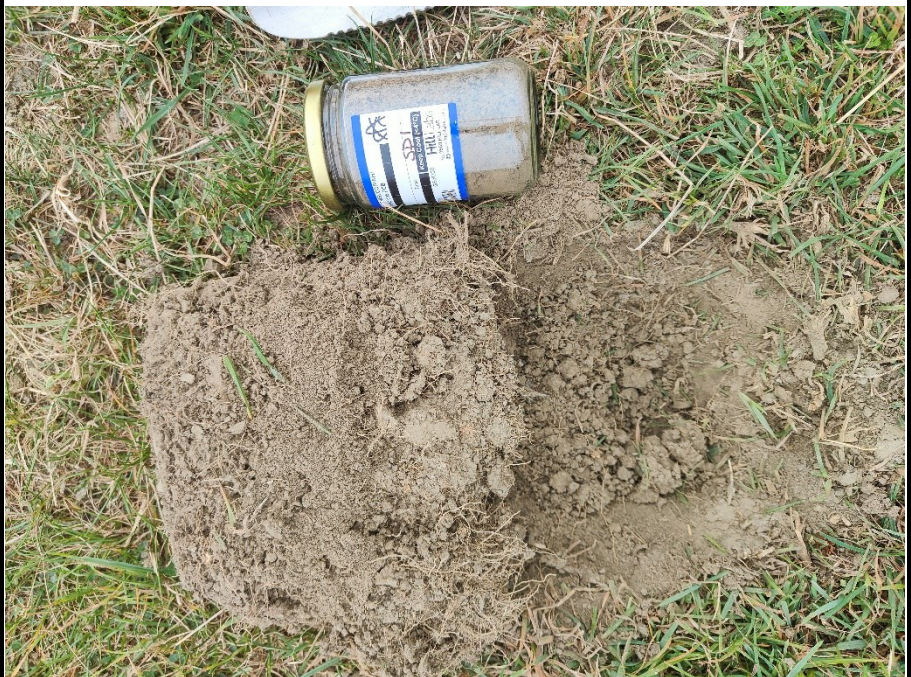
| Photo No. | Date | |
|---|---|---|
| 2. | 1/04/2025 | |

| Photo No. | Date | |
|---|---|---|
| <b>Description</b><br>Closeup of sample collected for SD1. | | |

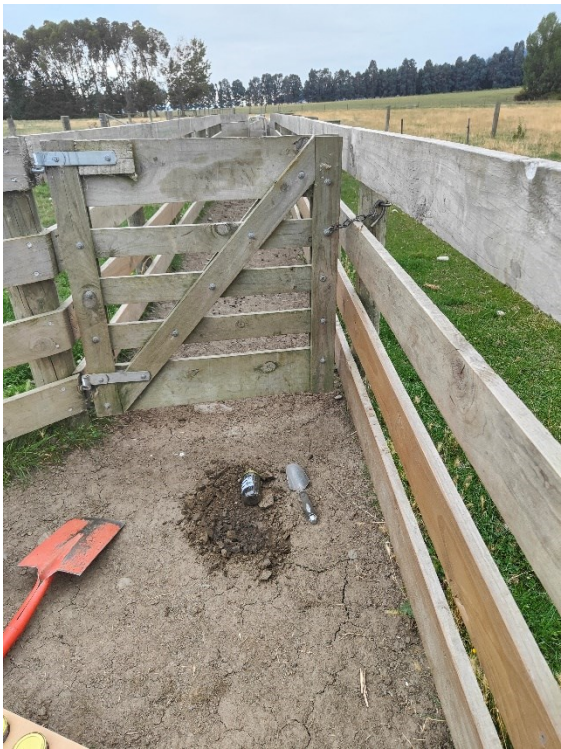
| Photo No. | Date | |
|---|---|---|
| 3. | 1/04/2025 | |

| Photo No. | Date | |
|---|---|---|
| <b>Description</b><br>Location of sample SD2 looking north. | | |

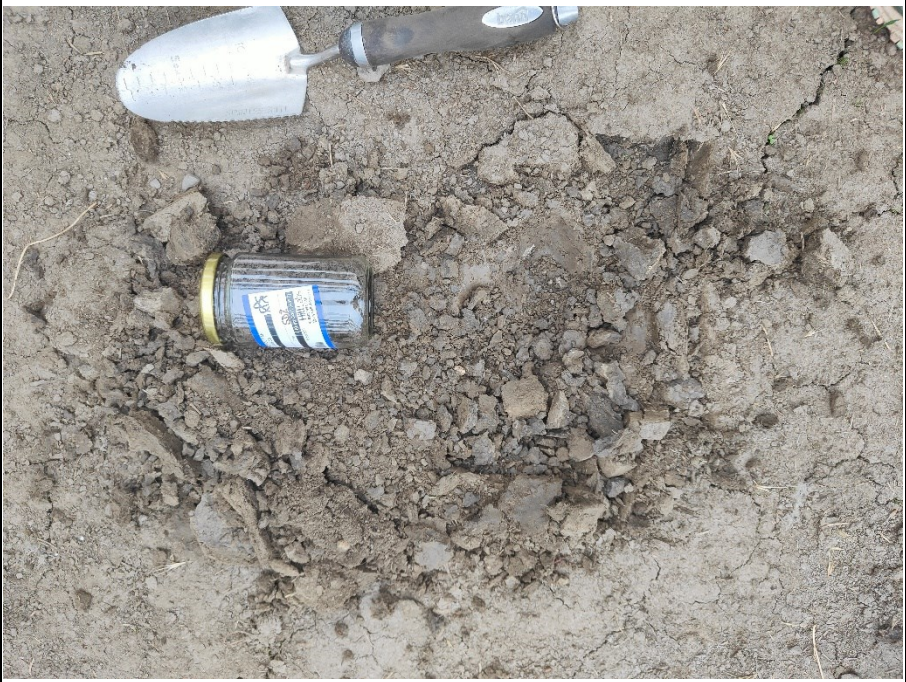
| Photo No. | Date | |
|---|---|---|
| 4. | 1/04/2025 | |

| Photo No. | Date | |
|---|---|---|
| <b>Description</b><br>Closeup of sample collected for SD2. | | |

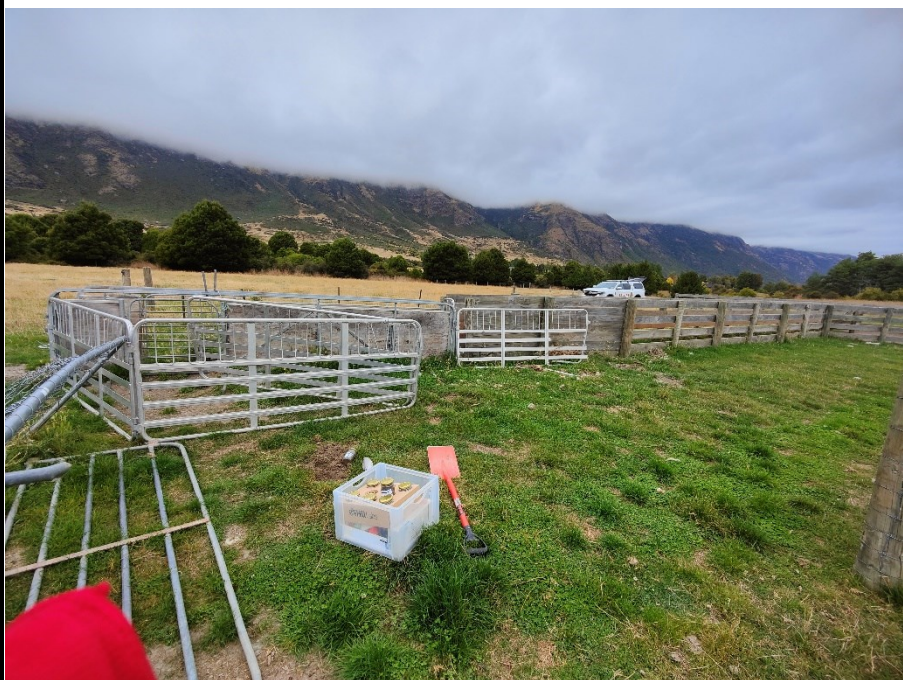
| Photo No | Date | |
|---|---|--|
| Location of sample SD3 looking southeast. | | |

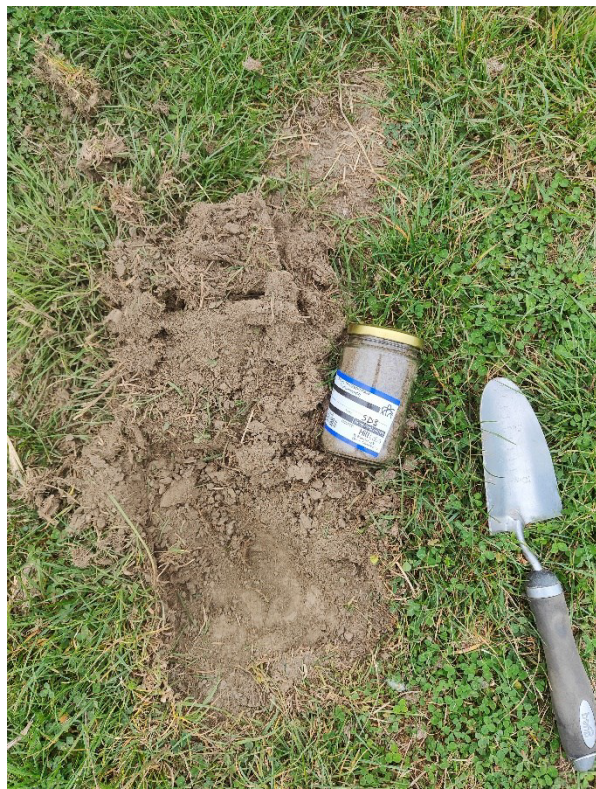
| Photo No. | Date | |
|---|---|---|
| 6. | 1/04/2025 | |

| Photo No. | Date | |
|---|---|---|
| <b>Description</b><br>Closeup of sample collected for SD3. | | |

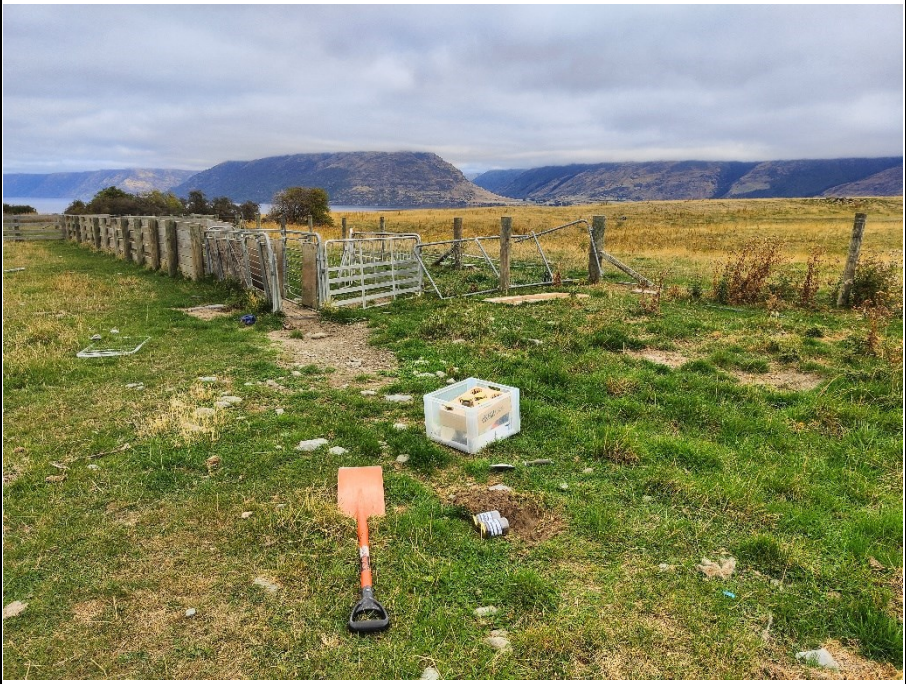
| Photo No | Date | |
|---|---|---|
| 7. | 1/04/2025 | |

| Photo No | Date | |
|---|---|---|
| <b>Description</b><br>Location of sample SD4 looking southwest. | | |

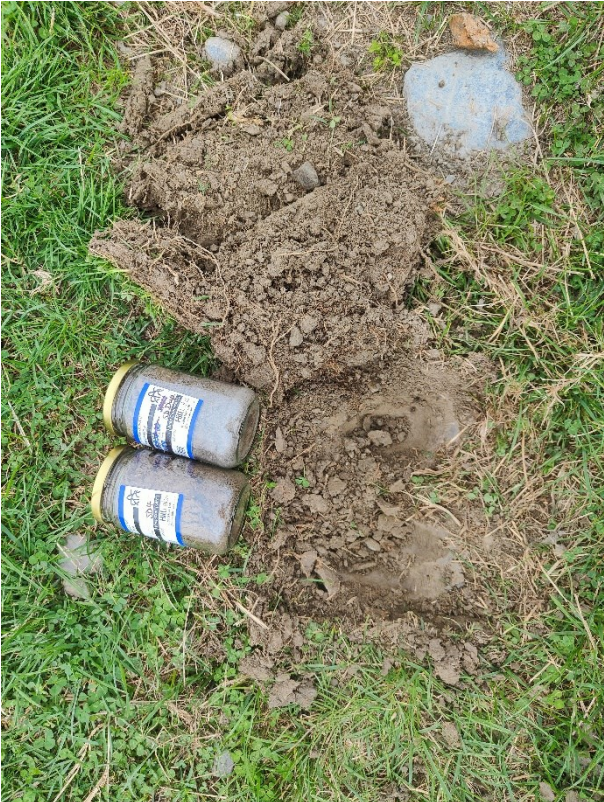
| Photo No. | Date | |
|---|---|---|
| 8. | 1/04/2025 | |

| Photo No. | Date | |
|---|---|---|
| <b>Description</b><br>Closeup of sample collected for SD4 & field duplicate. | | |

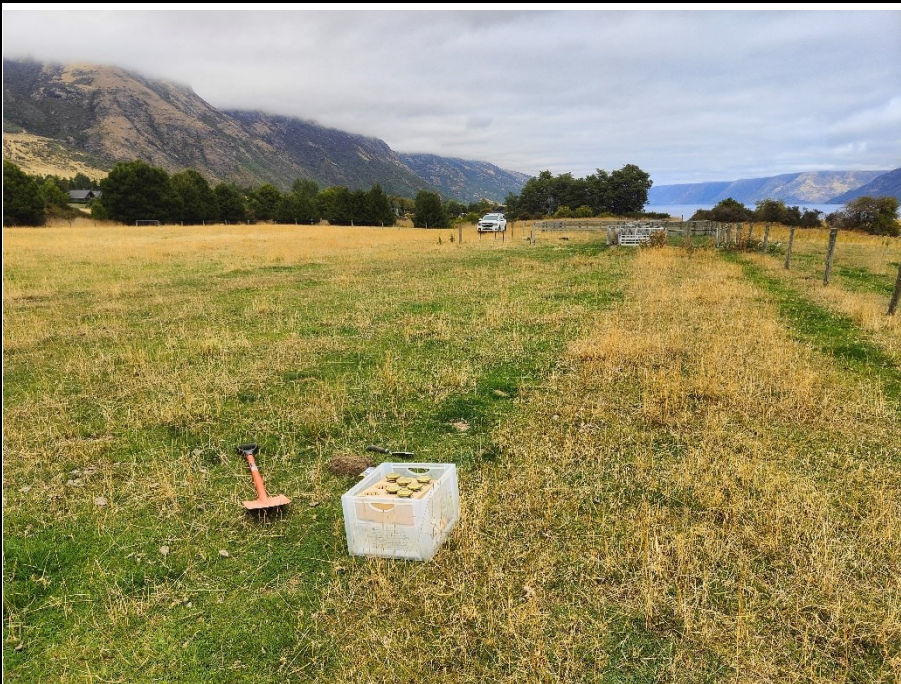
| Photo No | Date | |
|---|---|---|
| 9. | 1/04/2025 | |

| Photo No | Date | |
|---|---|---|
| <b>Description</b><br>Location of sample SD5 looking south. | | |

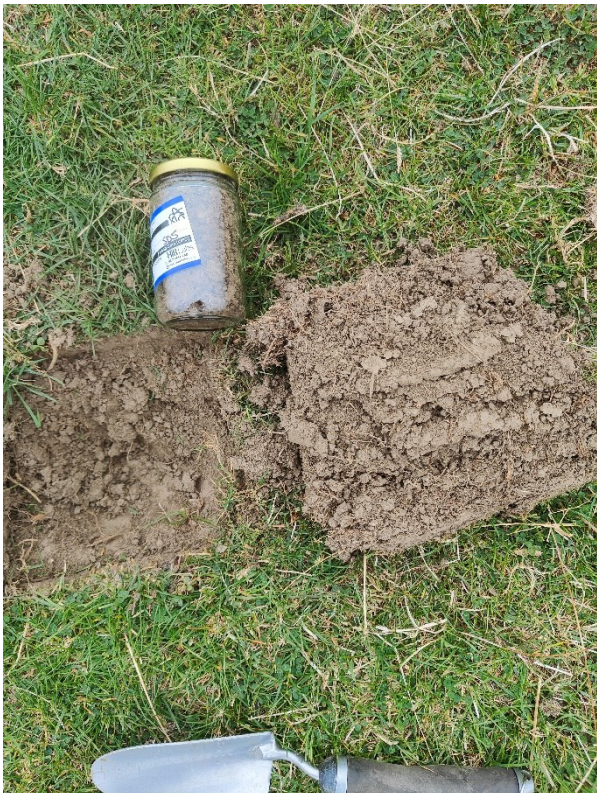
| Photo No. | Date | |
|---|---|---|
| 10. | 1/04/2025 | |

| Photo No. | Date | |
|---|---|---|
| <b>Description</b><br>Closeup of sample collected for SD5. | | |

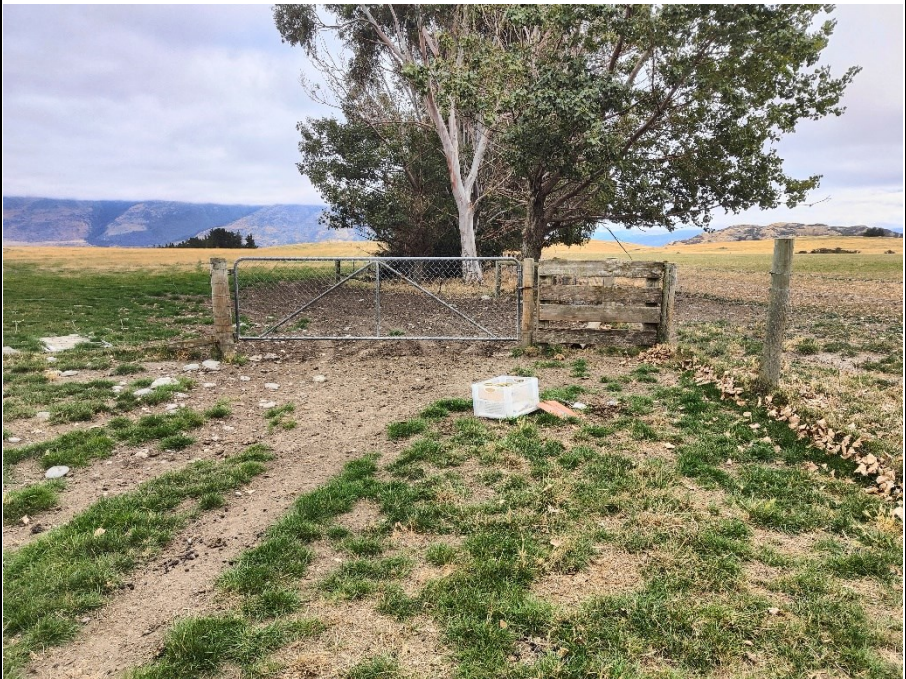
| Photo No | Date | |
|---|---|---|
| 11. | 1/04/2025 | |

| Photo No | Date | |
|---|---|---|
| <b>Description</b><br>Location of sample SD6 looking west. | | |

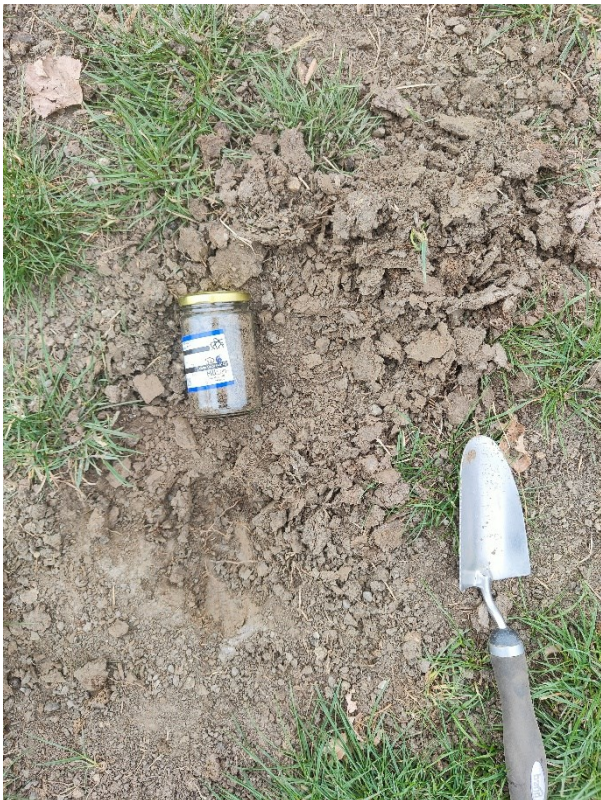
| Photo No. | Date | |
|---|---|---|
| 12. | 1/04/2025 | |

| Photo No. | Date | |
|---|---|---|
| <b>Description</b><br>Closeup of sample collected for SD6. | | |

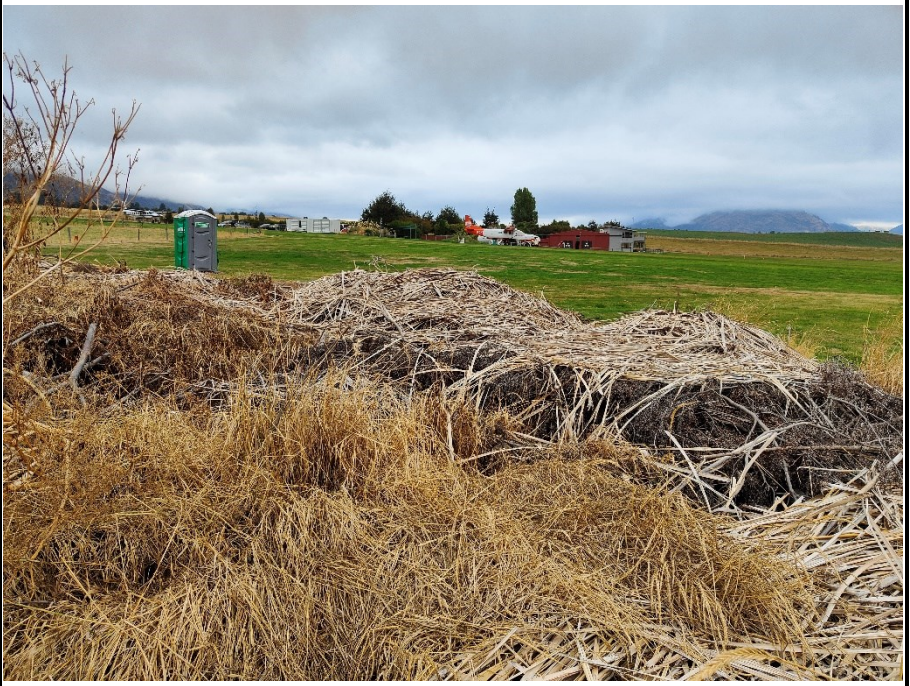
| Photo No | Date | |
|---|---|---|
| 13. | 1/04/2025 | |

| Photo No | Date | |
|---|---|---|
| <b>Description</b><br>Location of landfilling looking south. | | |

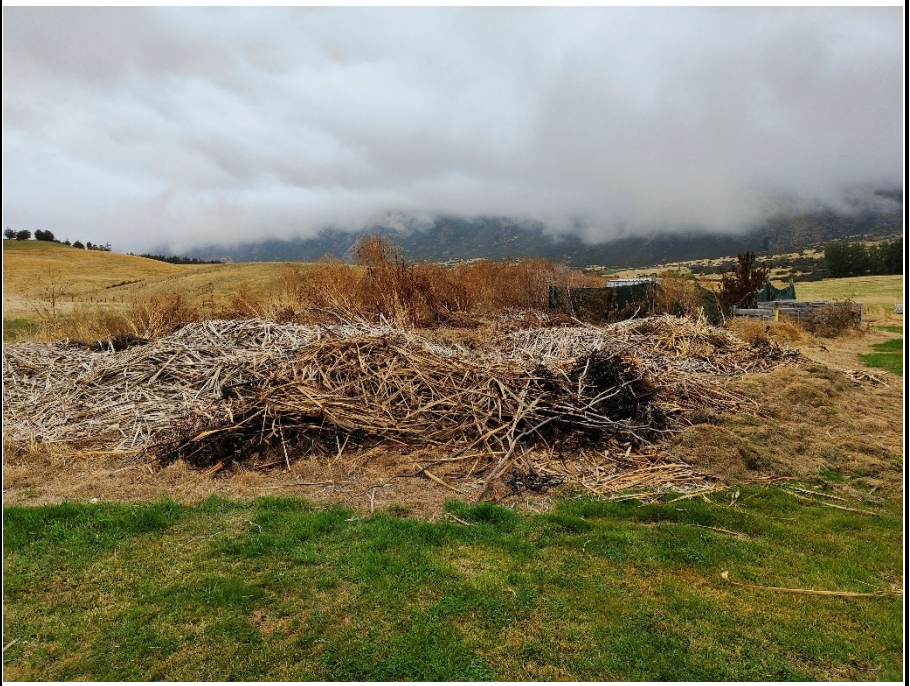
| Photo No. | Date | |
|---|---|---|
| 14. | 1/04/2025 | |

| Photo No. | Date | |
|---|---|---|
| <b>Description</b><br>Landfill stockpile comprising organic material, mainly flax leaves. | | |

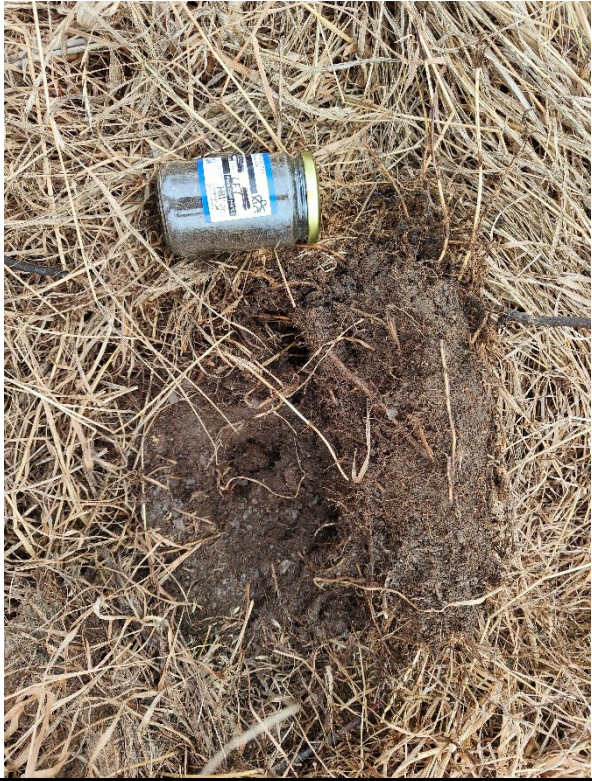
| Photo No | Date | |
|---|---|---|
| 15. | 1/04/2025 | |

| Photo No | Date | |
|---|---|---|
| <b>Description</b><br>Closeup of sample collected for Landfill 1 (LF1). | | |

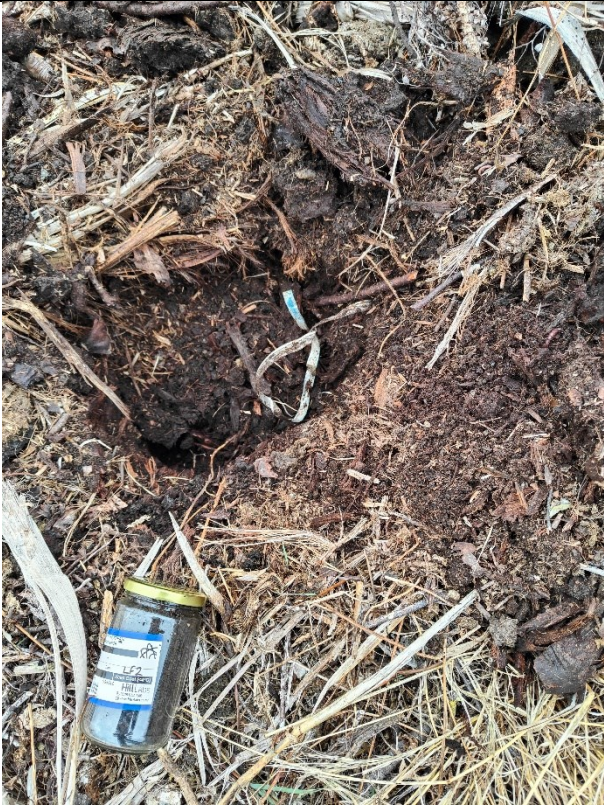
| Photo No. | Date | |
|---|---|---|
| 16. | 1/04/2025 | |

| Photo No. | Date | |
|---|---|---|
| <b>Description</b><br>Closeup of sample collected for LF2. | | |

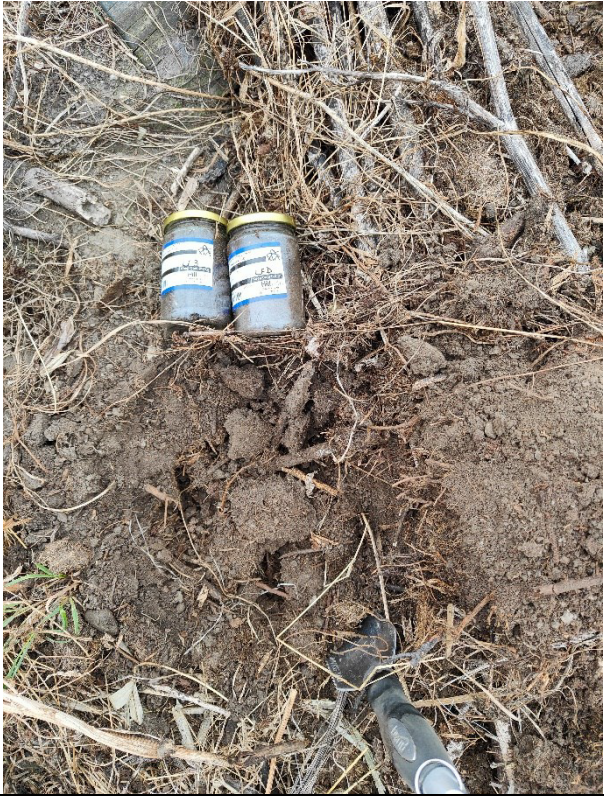
| Photo No | Date | |
|---|---|---|
| 17. | 1/04/2025 | |

| Photo No | Date | |
|---|---|---|
| <b>Description</b><br>Closeup of sample collected for LF3 with field duplicate. | | |

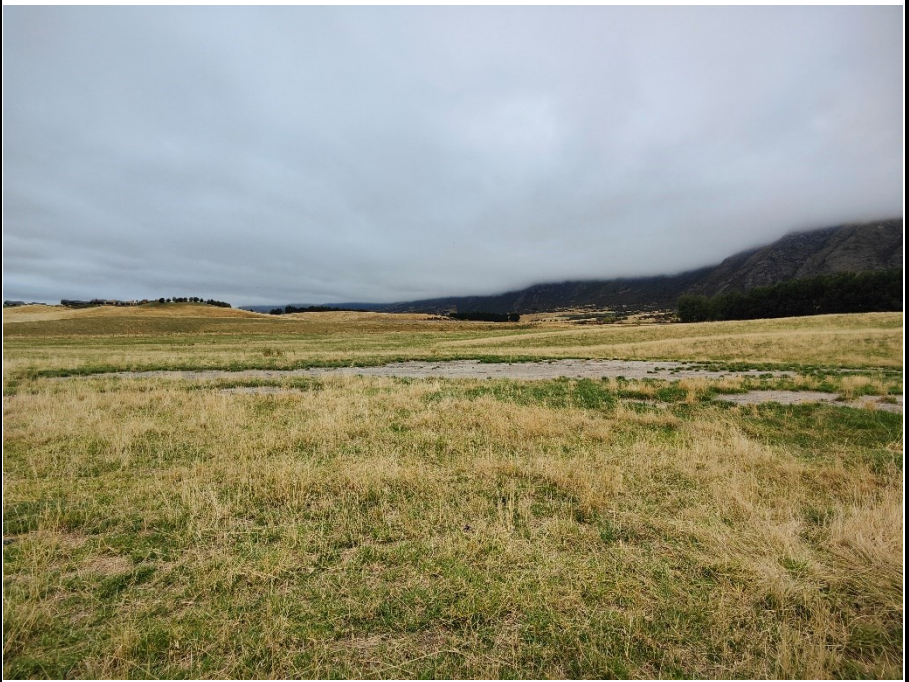
| Photo No. | Date | |
|---|---|---|
| 18. | 1/04/2025 | |

| Photo No. | Date | |
|---|---|---|
| <b>Description</b><br>Location of Fertilizer Storage looking north. | | |

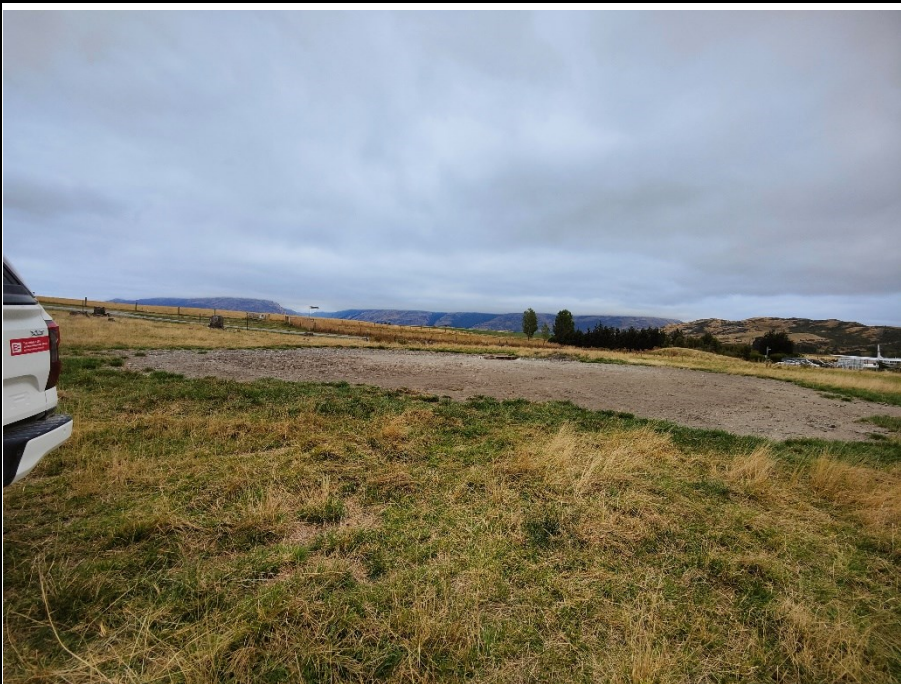
| Photo No | Date | |
|---|---|---|
| 19. | 1/04/2025 | |

| Photo No | Date | |
|---|---|---|
| <b>Description</b><br>Location of Fertilizer Storage looking southwest. | | |

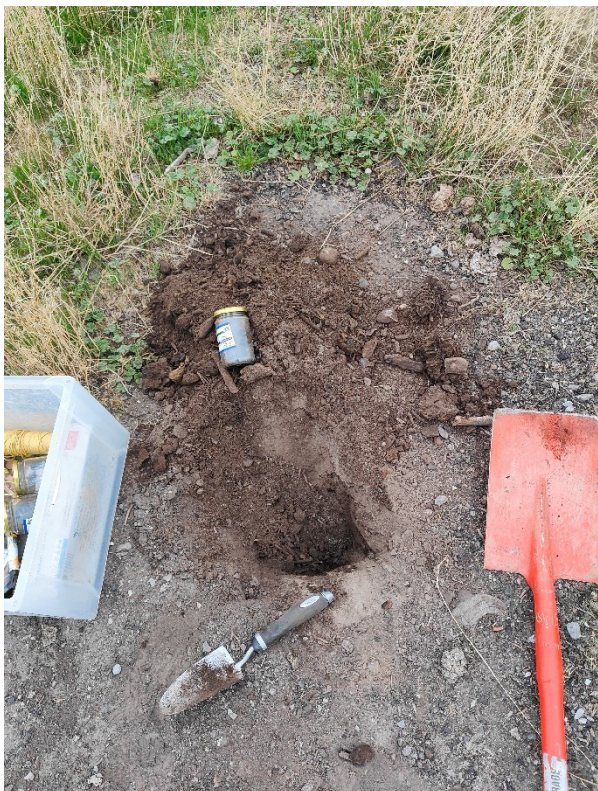
| Photo No. | Date | |
|---|---|---|
| 20. | 1/04/2025 | |

| Location | Sample ID | Depth (m bgl) | Soil Description | Notes |
|---|---|---|---|---|
| Fertiliser Storage | FZ1 | 0.3 | Sandy SILT, dark brown, with lots of wood chips, pinecones and organic material | Sample collected from elevated burn pile. |

| Photo No. | Date | |
|---|---|---|
| <b>Description</b><br>Closeup of sample collected for Fertilizer Storage 1 (FZ1). | | |

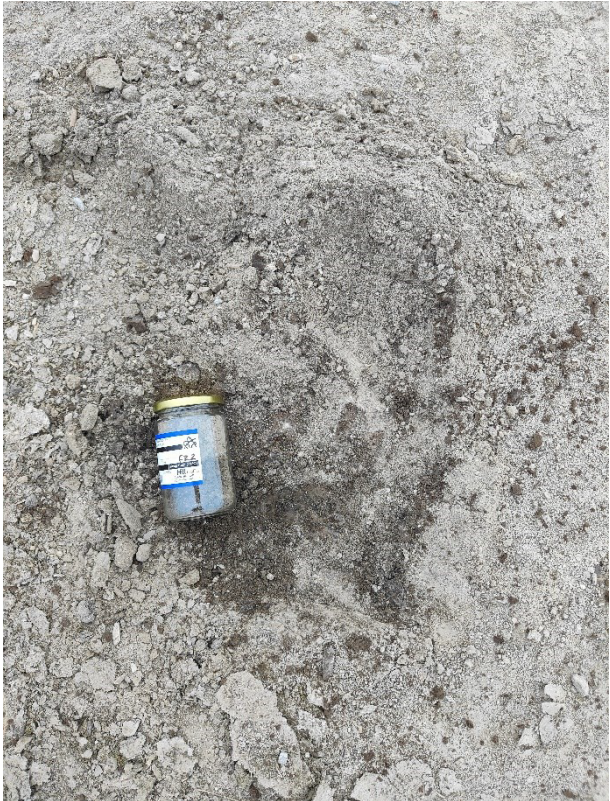
| Photo No | Date | |
|---|---|---|
| 21. | 1/04/2025 | |

One marginally elevated cadmium concentration (FZ2) was noted within the Fertiliser area. This concentration exceeds both human health and ecological criteria

| Photo No | Date | |
|---|---|---|
| <b>Description</b><br>Closeup of sample collected for FZ2. | | |

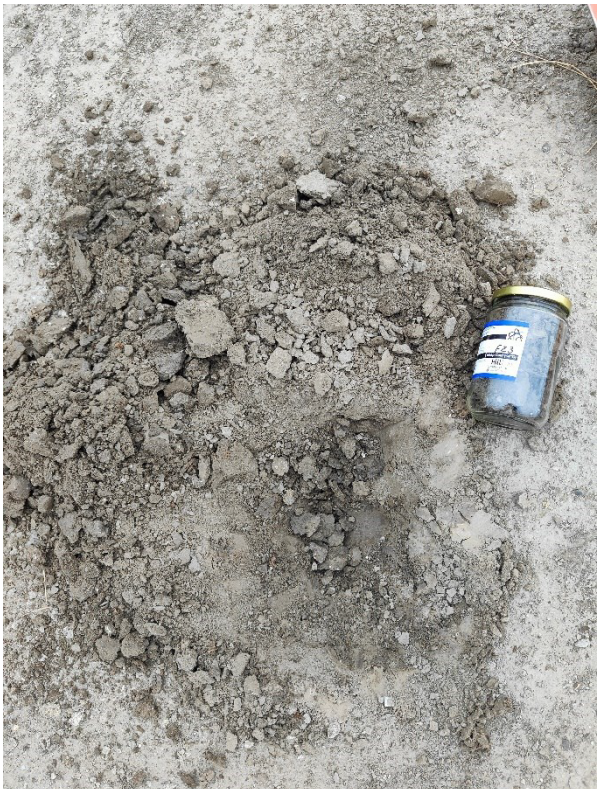
| Photo No. | Date | |
|---|---|---|
| 22. | 1/04/2025 | |

| Photo No. | Date | |
|---|---|---|
| <b>Description</b><br>Closeup of sample collected for FZ3. | | |

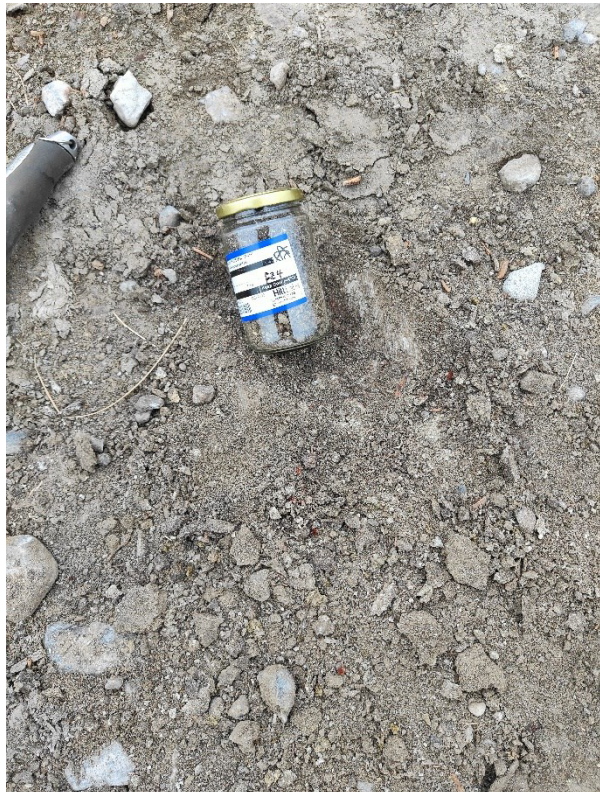
| Photo No | Date | |
|---|---|---|
| 23. | 1/04/2025 | |

| Photo No | Date | |
|---|---|---|
| <b>Description</b><br>Closeup of sample collected for FZ4. | | |

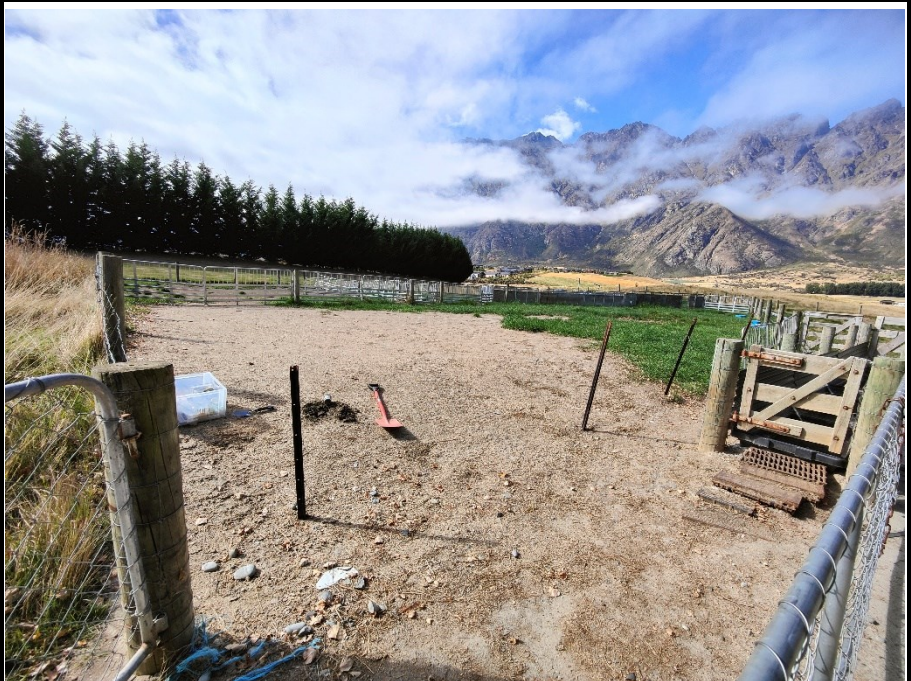
| Photo No. | Date | |
|---|---|---|
| 24. | 1/04/2025 | |

| Photo No. | Date | |
|---|---|---|
| Location of Homestead Bay Road Sheep Pens looking east. | | |

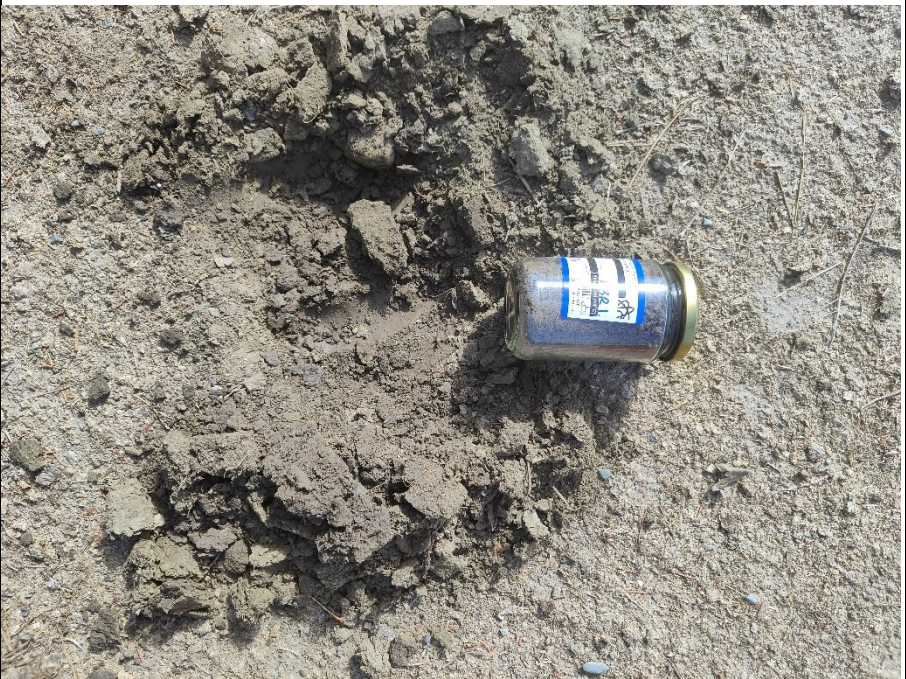
| Photo No | Date | |
|---|---|---|
| 25. | 1/04/2025 | |

Two exceedances of the Eco-SGV 'Target Limit' for 95% species protection were reported for heavy metals which were also above local background concentrations. Zinc was noted in two samples to exceed both criteria in HBR1 and HBR4, with HBR being significantly elevated.

| Photo No | Date | |
|---|---|---|
| <b>Description</b><br>Closeup of sample collected for Homestead Bay Road Sheep Pens 1 (HBR1). | | |

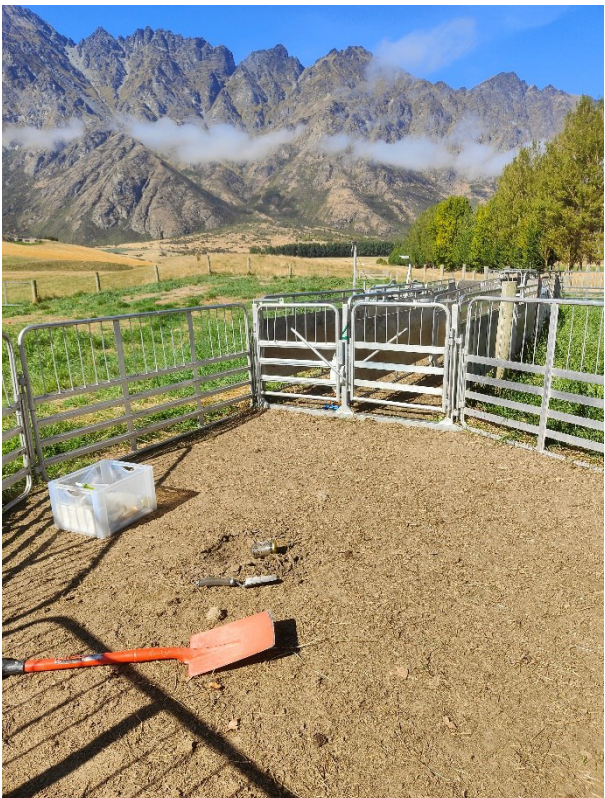
| Photo No. | Date | |
|---|---|---|
| 26. | 1/04/2025 | |

| Photo No. | Date | |
|---|---|---|
| <b>Description</b><br>Location of sample HBR2 looking east. | | |

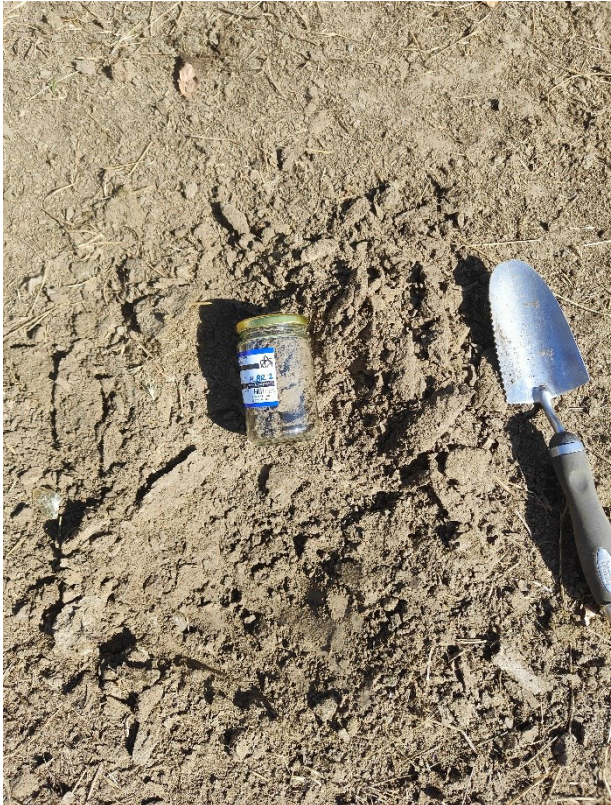
| Photo No | Date | |
|---|---|---|
| 27. | 1/04/2025 | |

| Photo No | Date | |
|---|---|---|
| <b>Description</b><br>Closeup of sample collected for HBR2. | | |

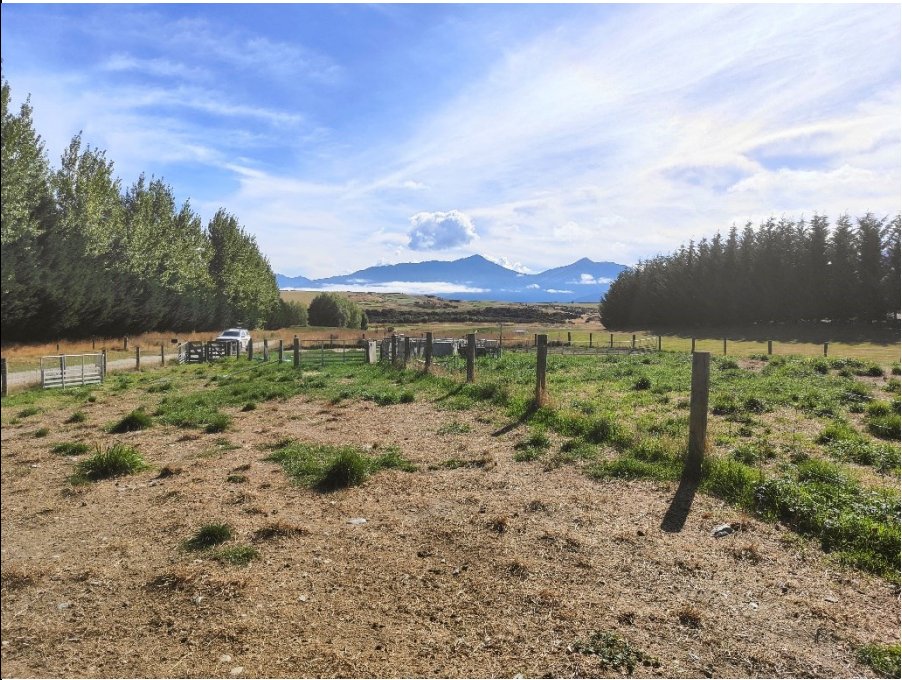
| Photo No. | Date | |
|---|---|---|
| 28. | 1/04/2025 | |

| Photo No. | Date | |
|---|---|---|
| <b>Description</b><br>Location of sample HBR3 looking northwest. | | |

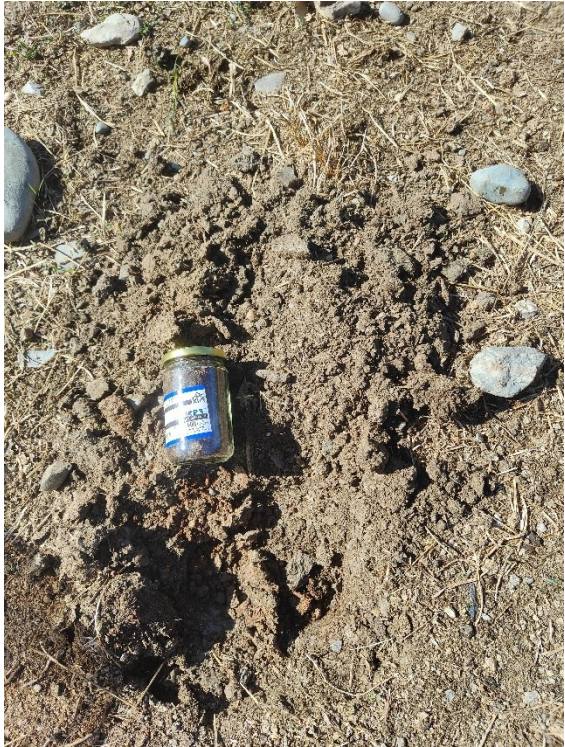
| Photo No | Date | |
|---|---|---|
| 29. | 1/04/2025 | |

| Photo No | Date | |
|---|---|---|
| <b>Description</b><br>Closeup of sample collected for HBR3. | | |

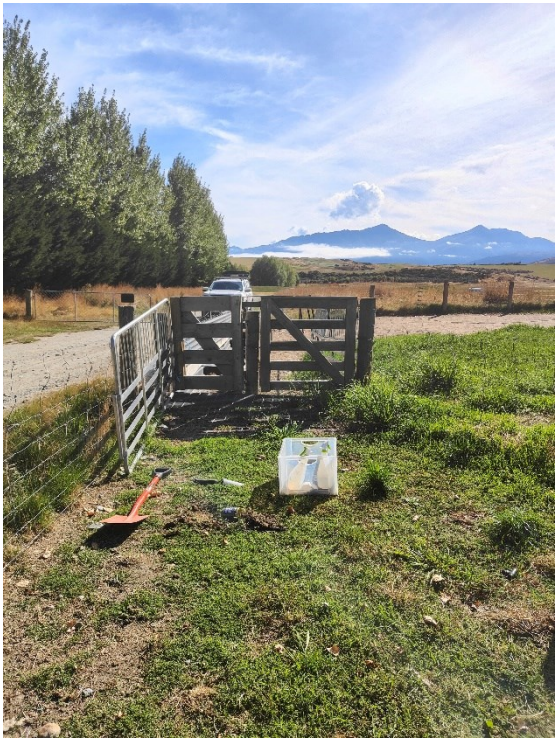
| Photo No. | Date | |
|---|---|---|
| 30. | 1/04/2025 | |

| Photo No. | Date | |
|---|---|---|
| <b>Description</b><br>Location of sample HBR4 looking northwest. | | |

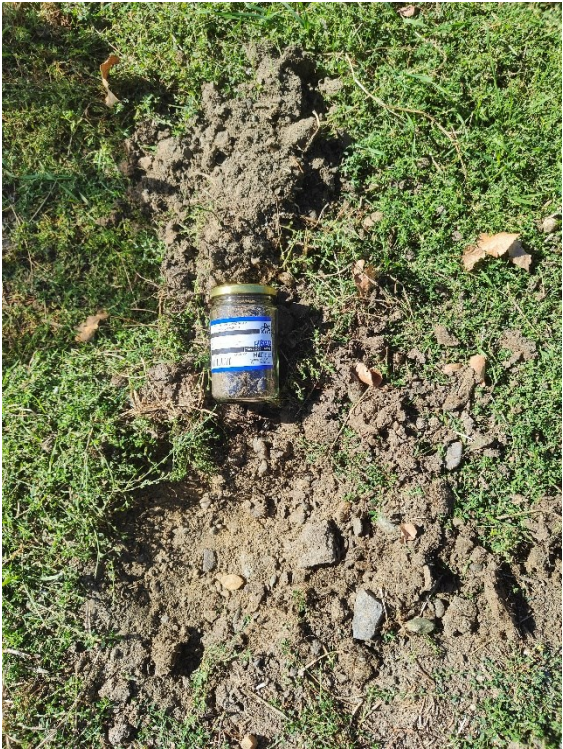
| Photo No | Date | | |
|---|---|---|--|
| 31. | 1/04/2025 | | |

| Photo No | Date | | |
|---|---|---|--|
| <b>Description</b><br>Closeup of sample collected for HBR4. | | | |

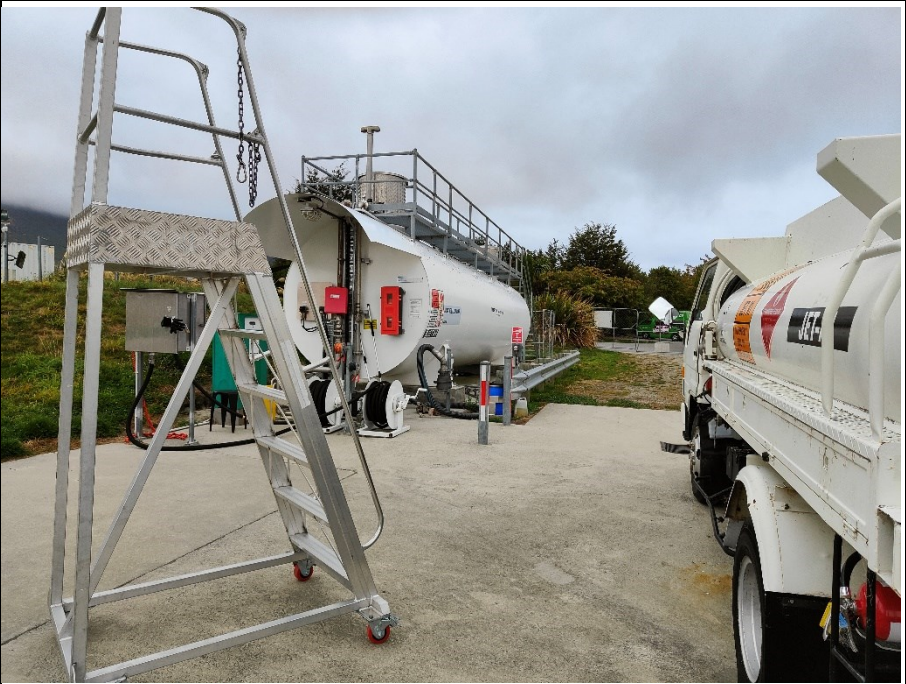
| Photo No. | Date | |
|---|---|---|
| 32. | 1/04/2025 | |

A review of the airstrip and fuel storage tank during the site investigation revealed that refuelling Fuelhas occurred solely on a well-maintained concrete pad which contains adequate drainage to a sump with interceptor. The fuel tank is also located on a well-maintained concrete slab and comprises a double skinned container with no evidence of spills noted. As operations are still ongoing at the NZone site, ground disturbance of the concrete pads and grassed runway was not completed as part of this DSI. Discussions with owners and operators of the site revealed that PFAS chemicals (or similar) have never been used on site. The airfield has therefore been excluded from the DSI at this time, however investigations are advised during decommissioning of this area prior to development for completeness.

| Photo No. | Date | |
|---|---|---|
| <b>Description</b><br>Fuel tank and tanker at NZONE Skydive. | | |

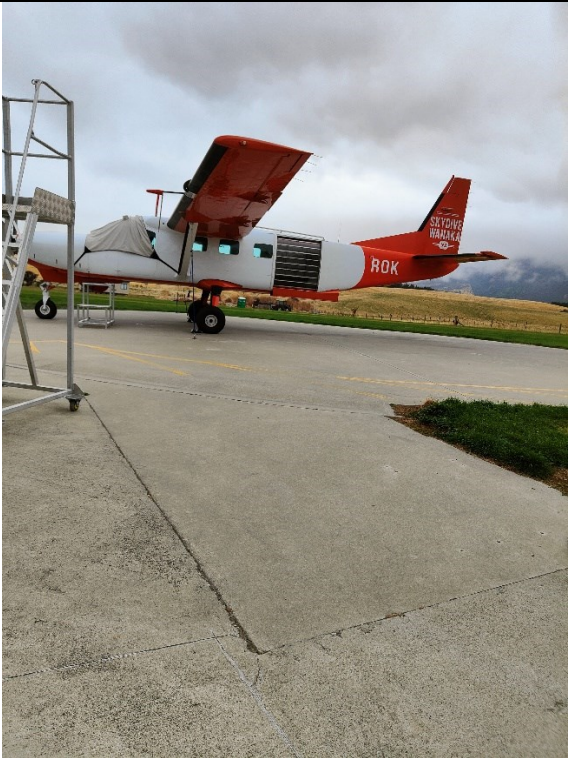
| Photo No. | Date | |
|---|---|---|
| 33. | 1/04/2025 | |

| Photo No. | Date | |
|---|---|---|
| <b>Description</b><br>Airplane on refueling pad – NZone Skydiving. | | |

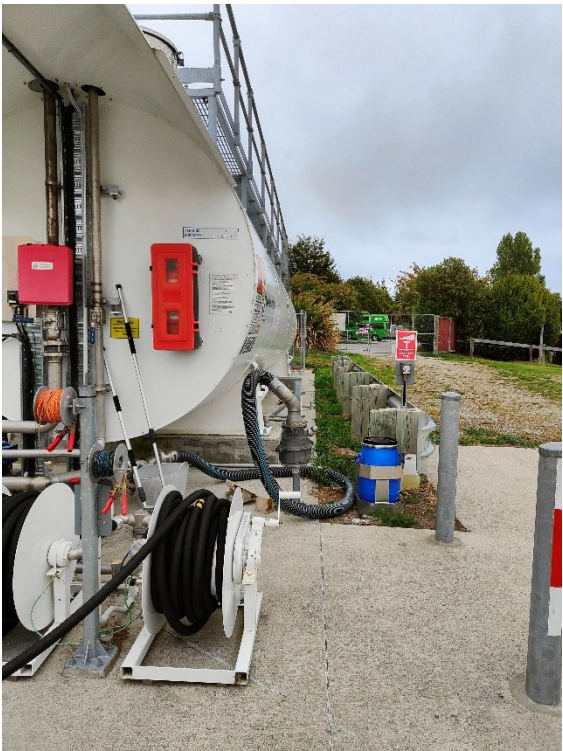
| Photo No. | Date | |
|---|---|---|
| 34. | 1/04/2025 | |

| Photo No. | Date | |
|---|---|---|
| <b>Description</b><br>Fuel tank at NZONE Skydive. | | |

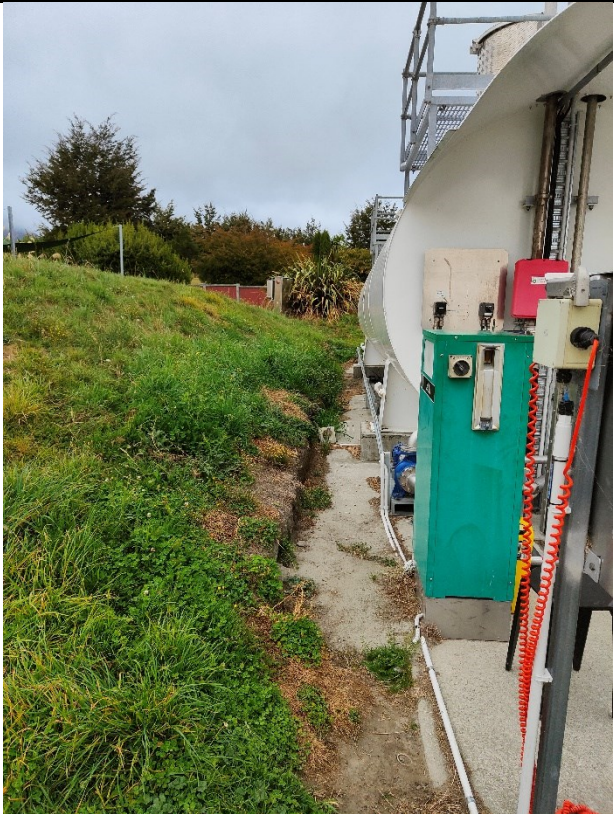
| Photo No. | Date | |
|---|---|---|
| 35. | 1/04/2025 | |

| Photo No. | Date | |
|---|---|---|
| <b>Description</b><br>Fuel tank at NZONE Skydive. | | |
