Appendix A

Field Investigation Data

GEOTECHNICAL AND **GEOLOGICAL INFORMATION**

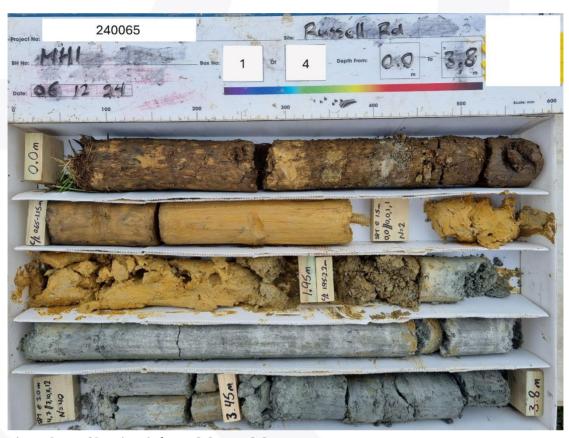
Photo 1: MH01 - depth from 0.0m to 3.8m

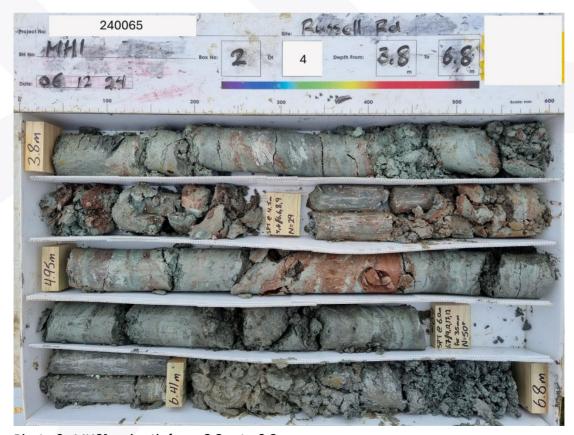
Photo 2: MH01 – depth from 3.8m to 6.8m

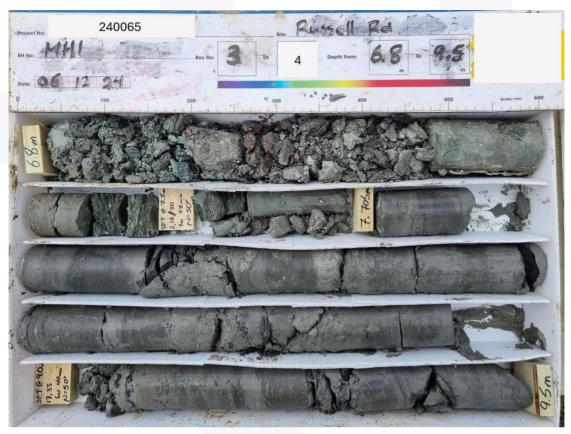
Photo 3: MH01 – depth from 6.8m to 9.5m

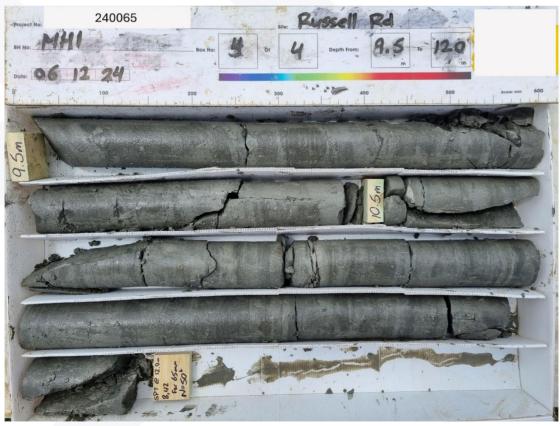
Photo 4: MH01 – depth from 9.5m to 12.0m

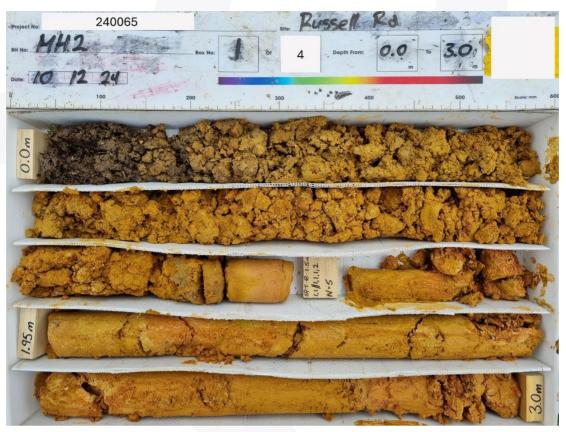
Photo 5: MH02 – depth from 0.0m to 3.0m

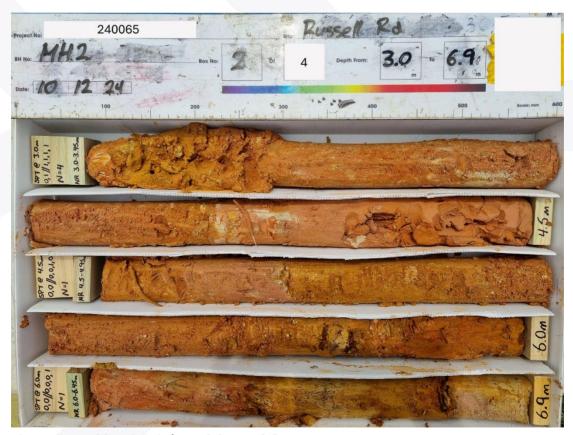
Photo 6: MH02 – depth from 3.0m to 6.9m

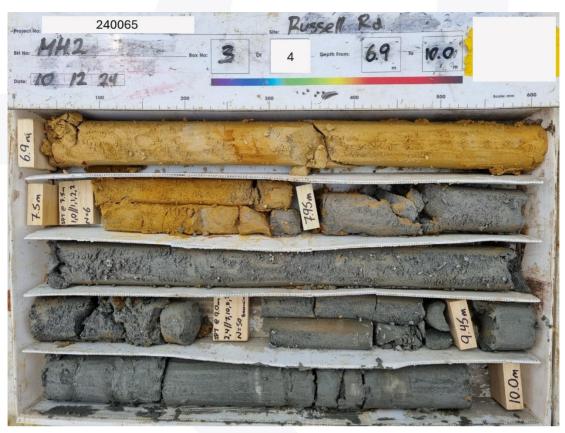
Photo 7: MH02 – depth from 6.9m to 10.0m

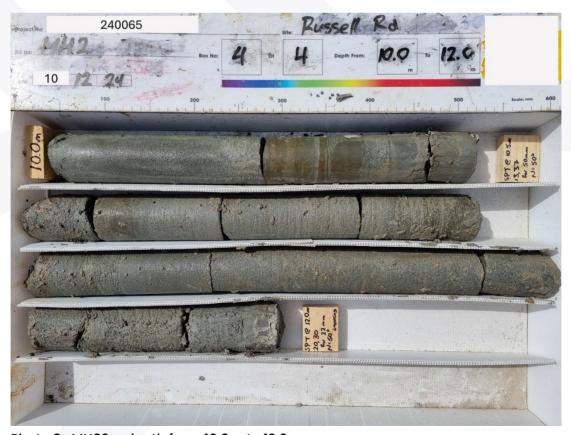
Photo 8: MH02 – depth from 10.0m to 12.0m

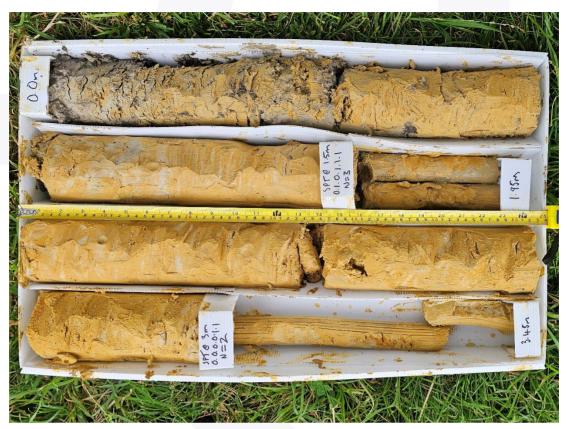
Photo 9: MH03 - depth from 0.0m to 3.45m

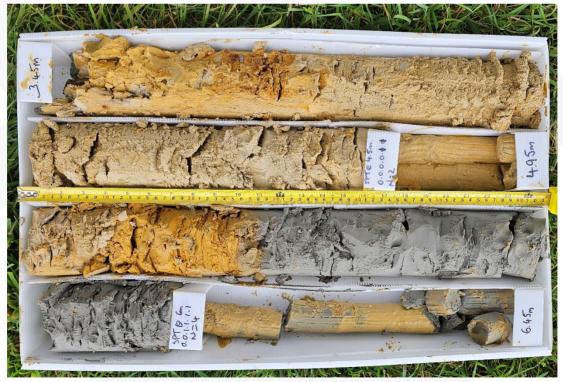
Photo 10: MH03 - depth from 3.45m to 6.45m

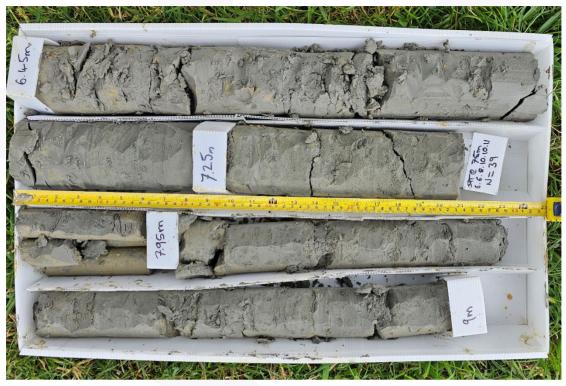
Photo 11: MH03 - depth from 6.45m to 9.0m

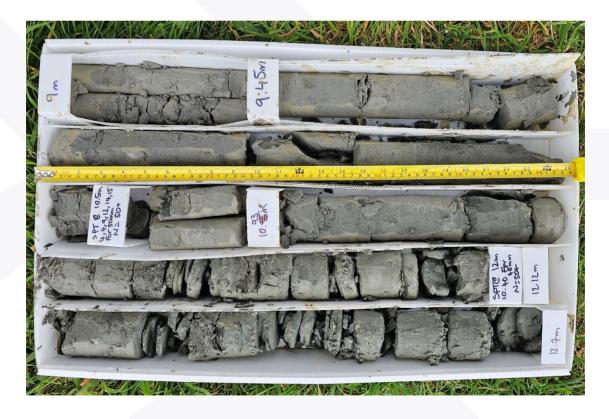
Photo 12: MH03 – depth from 9.0m to 12.7m

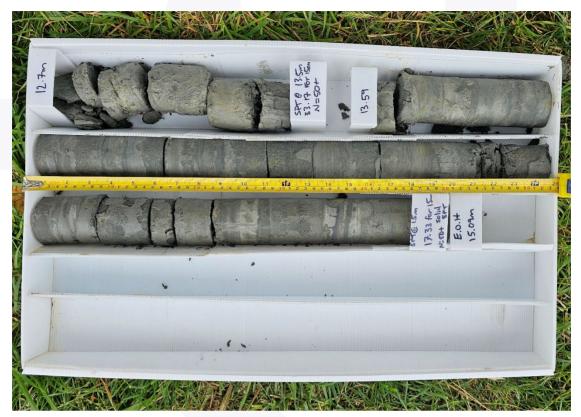
Photo 13: MH03 – depth from 12.7m to 15.09m

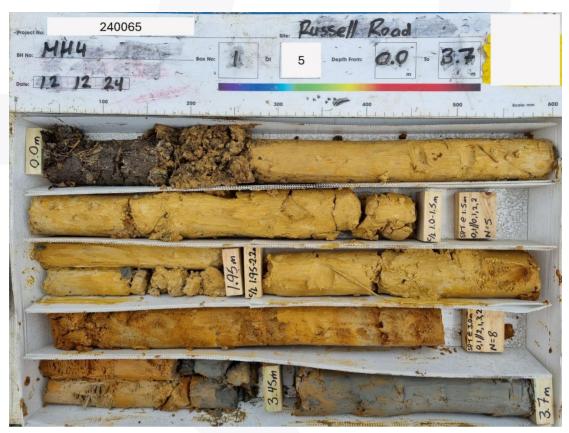
Photo 14: MH04 - depth from 0.0m to 3.7m

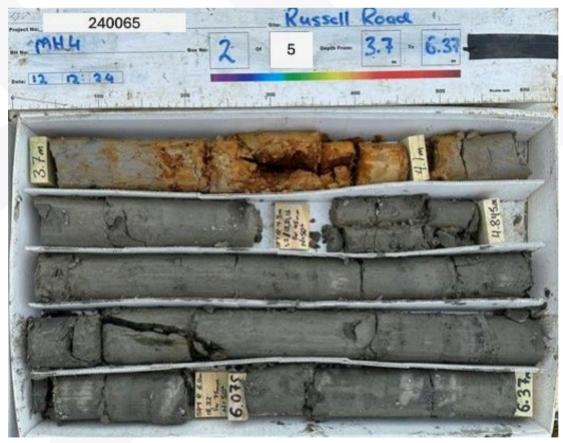
Photo 15: MH04 – depth from 3.7m to 6.37m

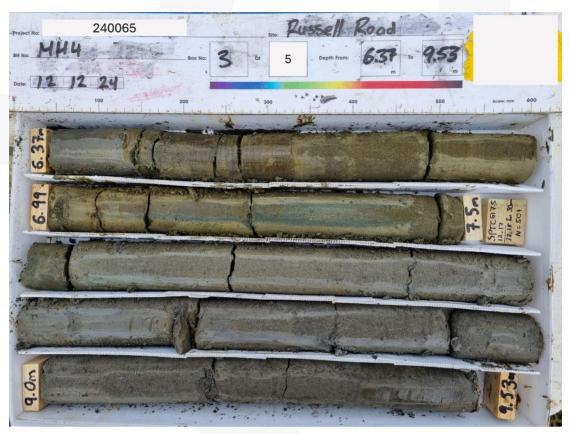
Photo 16: MH04 - depth from 6.37m to 9.53m

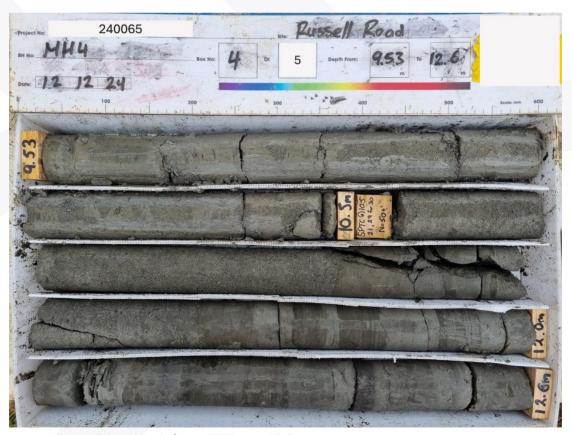
Photo 17: MH04 - depth from 9.53m to 12.6m

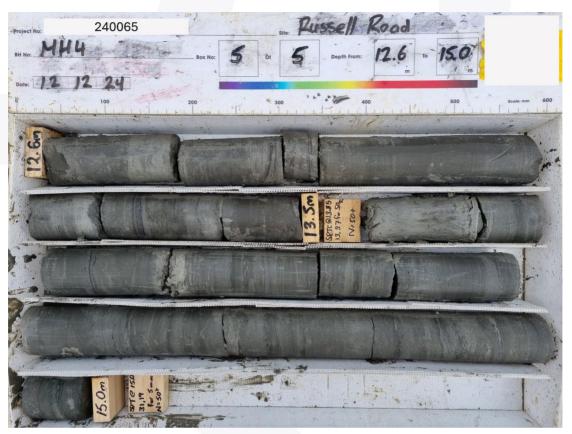
Photo 18: MH04 - depth from 12.6m to 15.0m

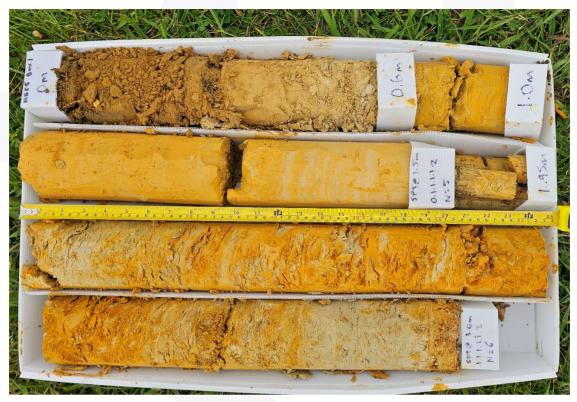
Photo 19: MH05 - depth from 0.0m to 3.0m

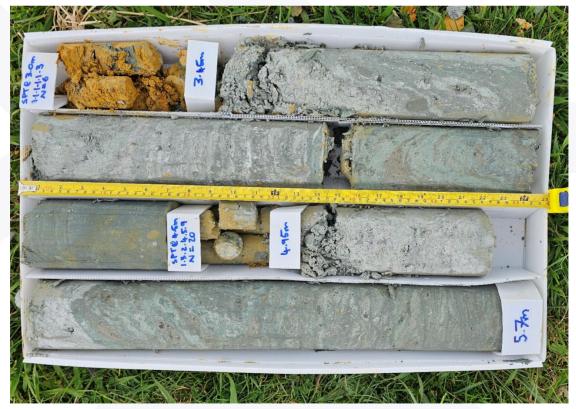
Photo 20: MH05 – depth from 3.0m to 5.7m

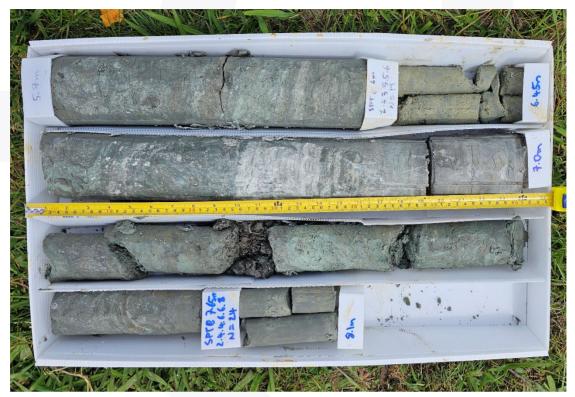
Photo 21: MH05 - depth from 5.7m to 8.1m

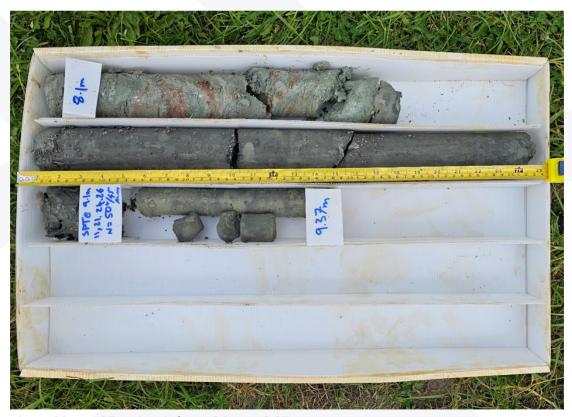
Photo 22: MH05 – depth from 8.1m to 9.37m

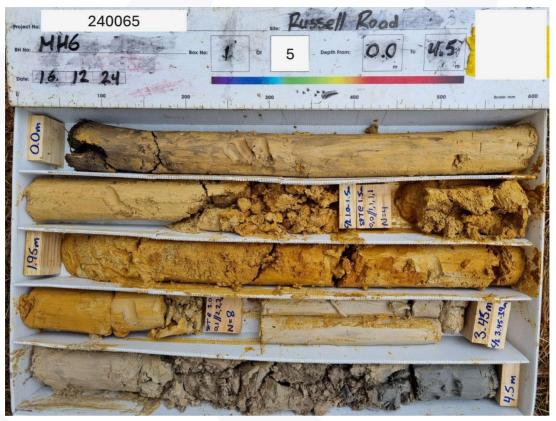
Photo 23: MH06 - depth from 0.0m to 4.5m

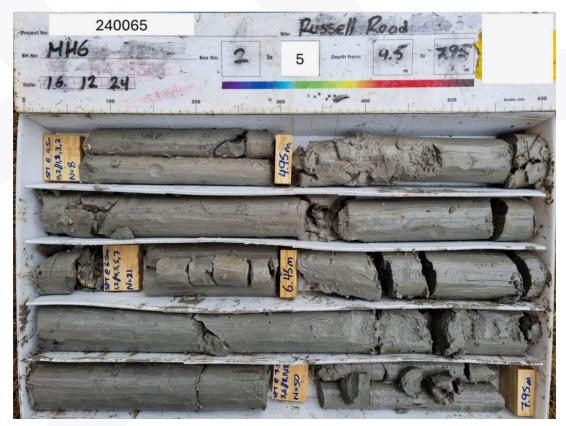
Photo 24: MH03 – depth from 4.5m to 7.95m

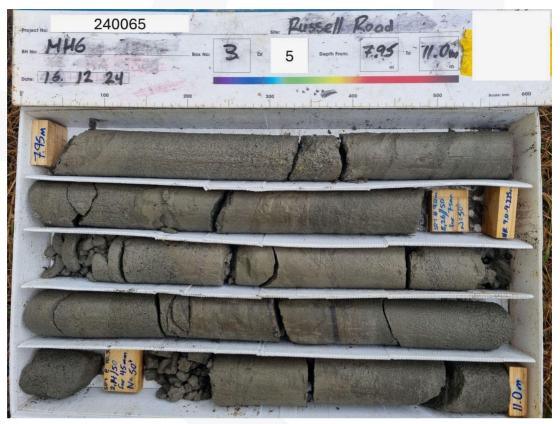
Photo 25: MH06 - depth from 7.95m to 11.0m

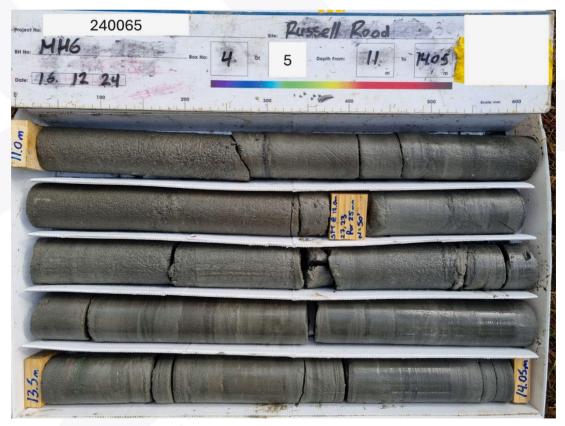
Photo 26: MH06 - depth from 11.0m to 14.05m

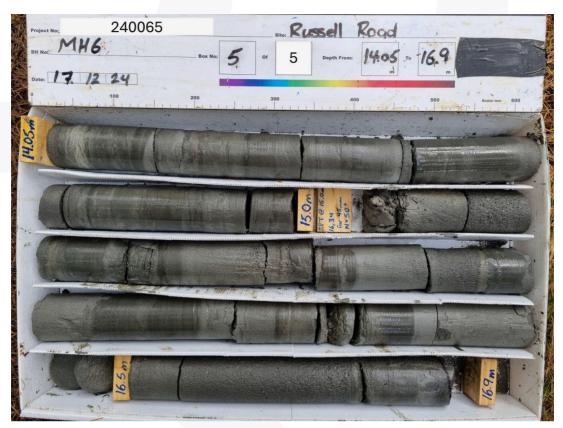
Photo 27: MH06 - depth from 14.05m to 16.9m

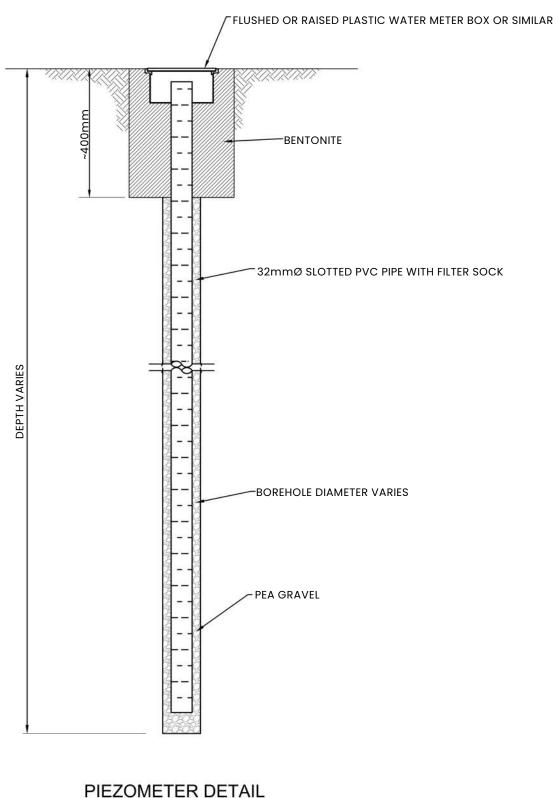
PIEZOMETER DETAIL

1. Do not scale from drawing 2. Refer to borehole logs in Riley report ref. 240065-F Appendix A for piezometer construction at specific locations

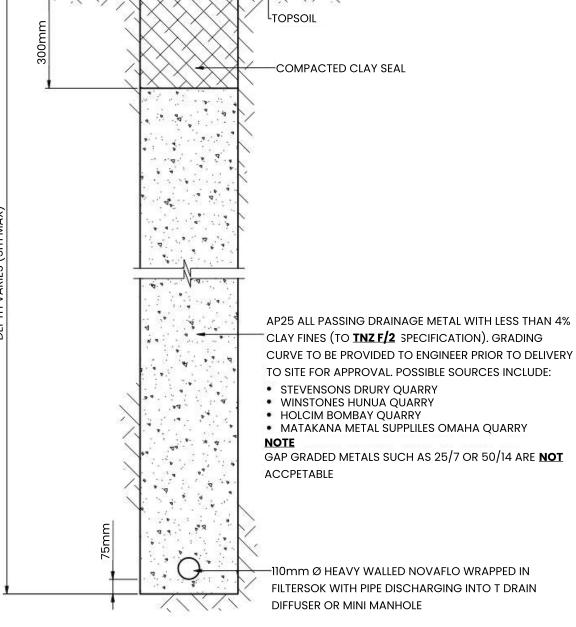
TYPICAL MAINTENANCE CONNECTION DETAIL SCALE 1:20

THUMES VALVE BOX HEAVY DUTY (W300xL335xH140) OR APPROVED EQUIVALENT. SURFACE BOX CAST INTO CONCRETE SURROUND (TYP. 100mm GAP ALL AROUND CAP) uPVC SCREWCAP 100 TOPSOIL GROUND LEVEL 400x400x100 CONCRETE SURROUND 300 CLAY SEAL COUNTERFORT DRAIN 110Ø HEAVY WALL PERFORATED DRAIN COIL PIPE **EXTENDS TO GROUND LEVEL**

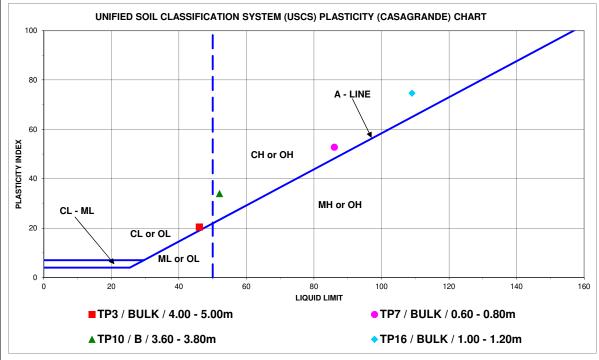
The chart below & soil classification terminology is taken from ASTM D2487-17^{e1} "Standard Practice for Classification of Soils for Engineering Purposes (Unified Soil Classification System)", April 2020, & is based on the classification scheme developed by A. Casagrande in the 1940's (Casagrande, A., 1948: Classification and identification of soil. Transactions of the American Society of Civil Engineers, v. 113, p. 901-930). The chart below & the soil classification given in the table above are included for your information only, and are not included in the IANZ endorsement for this report.

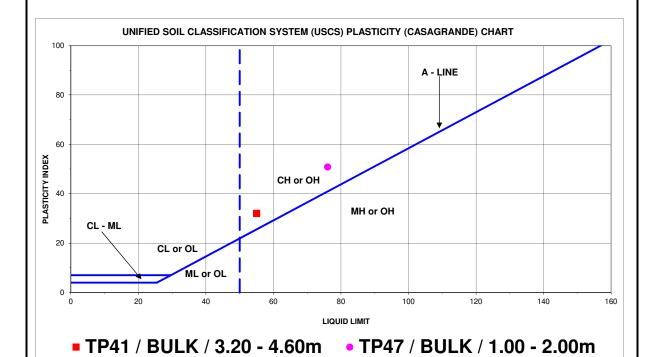
The chart below & soil classification terminology is taken from ASTM D2487-17^{e1} "Standard Practice for Classification of Soils for Engineering Purposes (Unified Soil Classification System)", April 2020, & is based on the classification scheme developed by A. Casagrande in the 1940's (Casagrande, A., 1948: Classification and identification of soil. Transactions of the American Society of Civil Engineers, v. 113, p. 901-930). The chart below & the soil classification given in the table above are included for your information only, and are not included in the IANZ endorsement for this report.

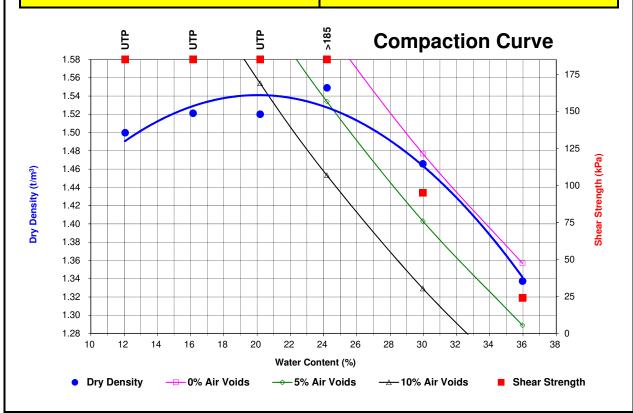
Maximum Dry Density: 1.54 t/m³ Optimum Water Content: 20 %

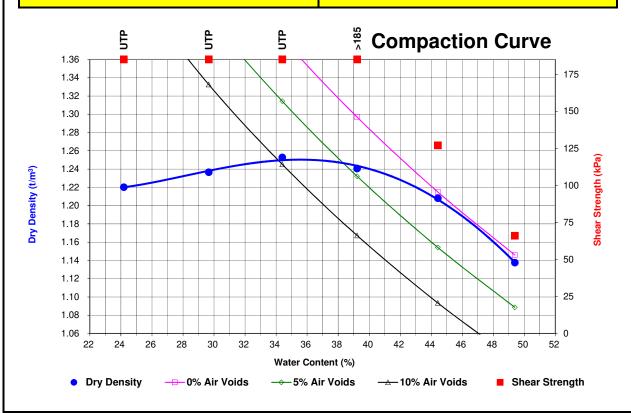
Maximum Dry Density: 1.25 t/m³ Optimum Water Content: 36 %

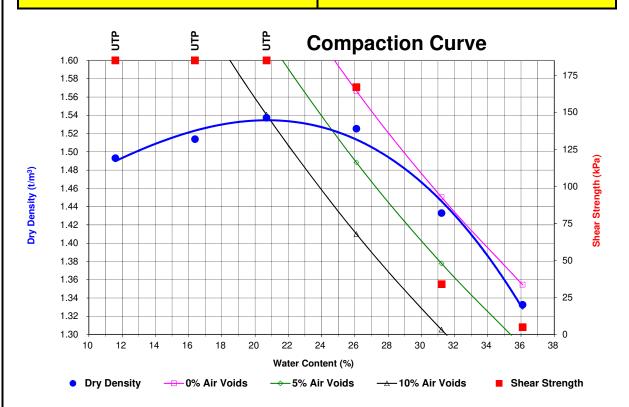
Maximum Dry Density: 1.53 t/m³ Optimum Water Content: 21 %

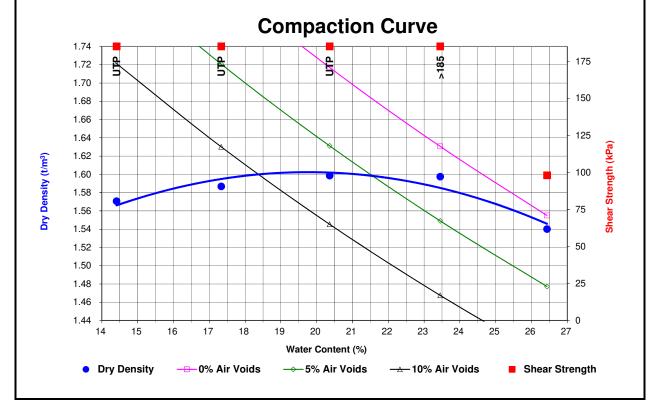
Maximum Dry Density: 1.60 t/m³ Optimum Water Content: 20 %

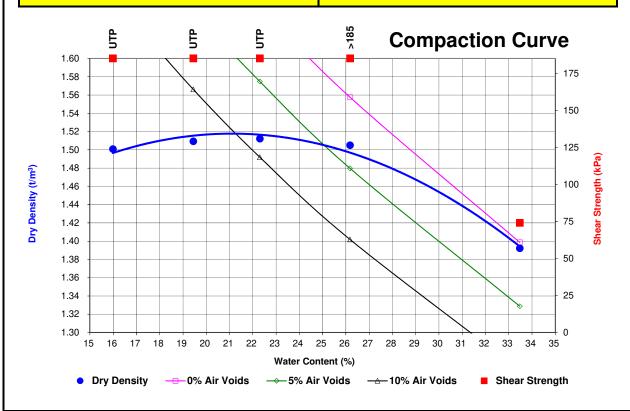
Maximum Dry Density: 1.52 t/m³ Optimum Water Content: 21 %

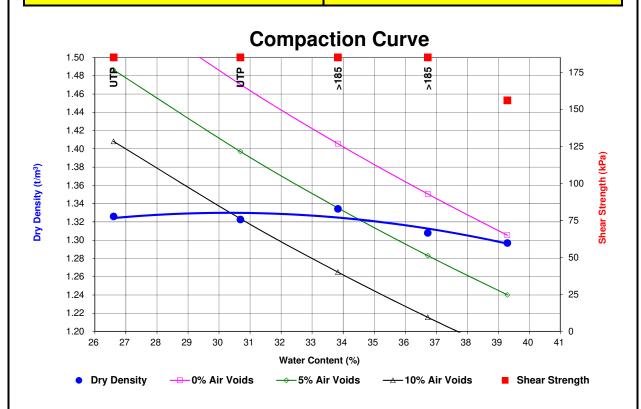
Maximum Dry Density: 1.33 t/m³ Optimum Water Content: 31 %

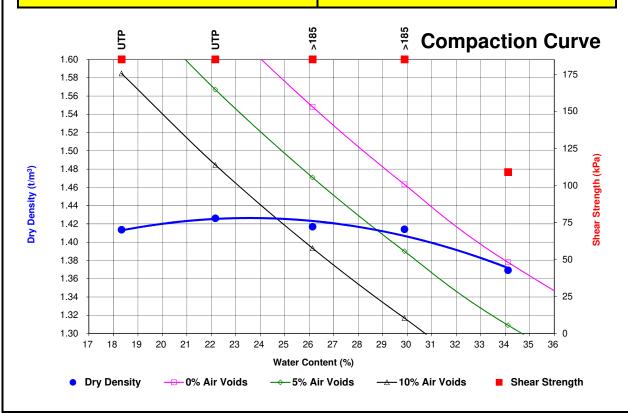
Maximum Dry Density: 1.43 t/m³ Optimum Water Content: 25 %

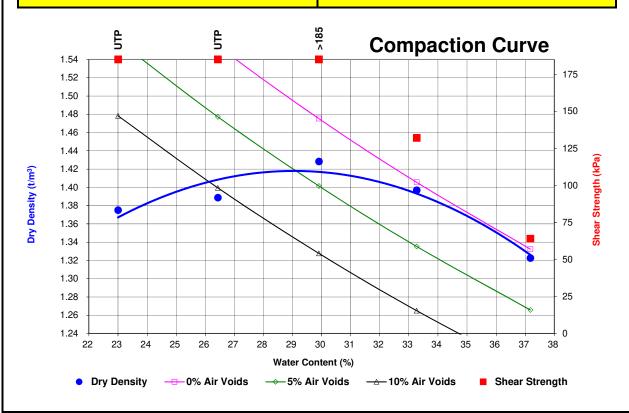
1.42 t/m³ **Maximum Dry Density: Optimum Water Content:** 29 %
