**TE ARA HAUĀURU
NORTHWEST RAPID TRANSIT
ASSESSMENT OF GROUNDWATER AND
SETTLEMENT EFFECTS**

GREG SHEPPARD

15 DECEMBER 2025

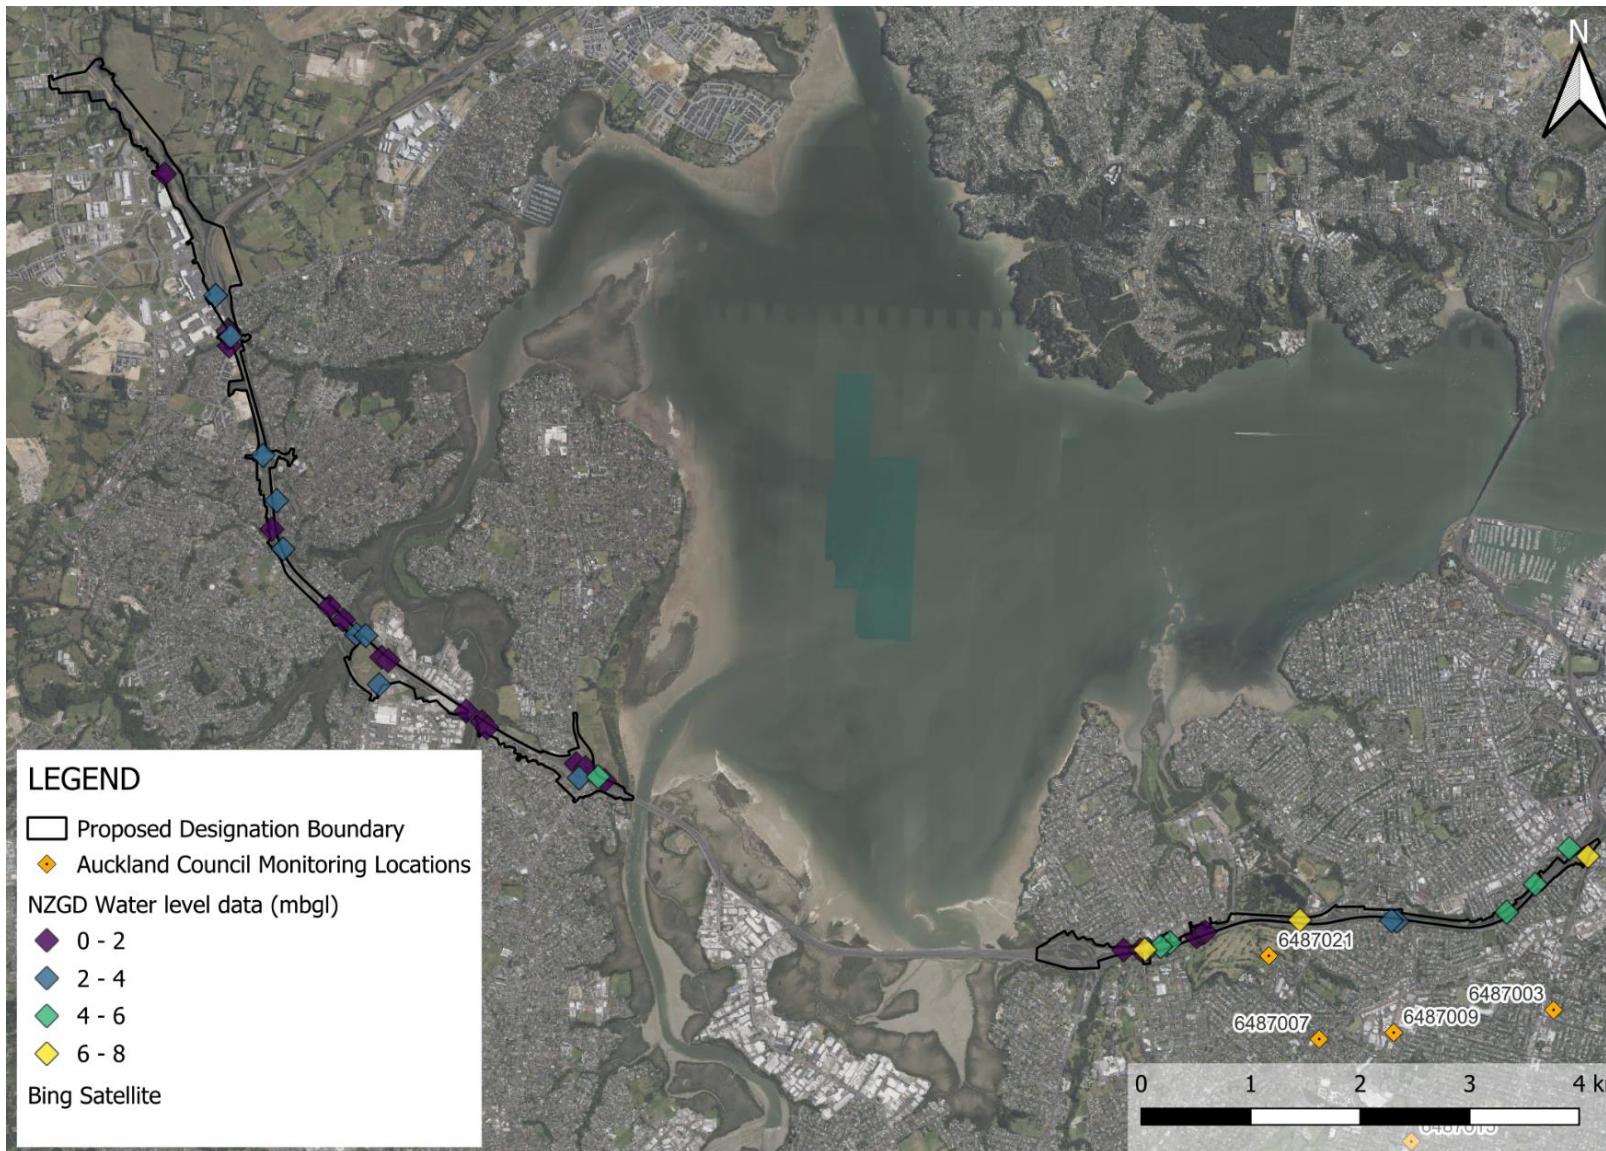
Figure 3-3: Groundwater level data

Boreholes from the New Zealand Geotechnical Database¹ (NZGD) in the vicinity of the Project Area and with available water level data are shown in Figure 3-3 in green.

Auckland Council manage a number of groundwater monitoring bores in the vicinity of the Project Area with data available through the Environmental Data Portal.² The nearest bores with complete data records are located approximately 1km south of the Indicative Design and are located in the Western Springs – Three Kings Volcanic aquifer. These bore locations are shown in Figure 3-3 in orange.
