Preliminary Site Investigation

1080 State Highway 16, Waimauku

SLR Project No.: 810.031375.00001

12 August 2025

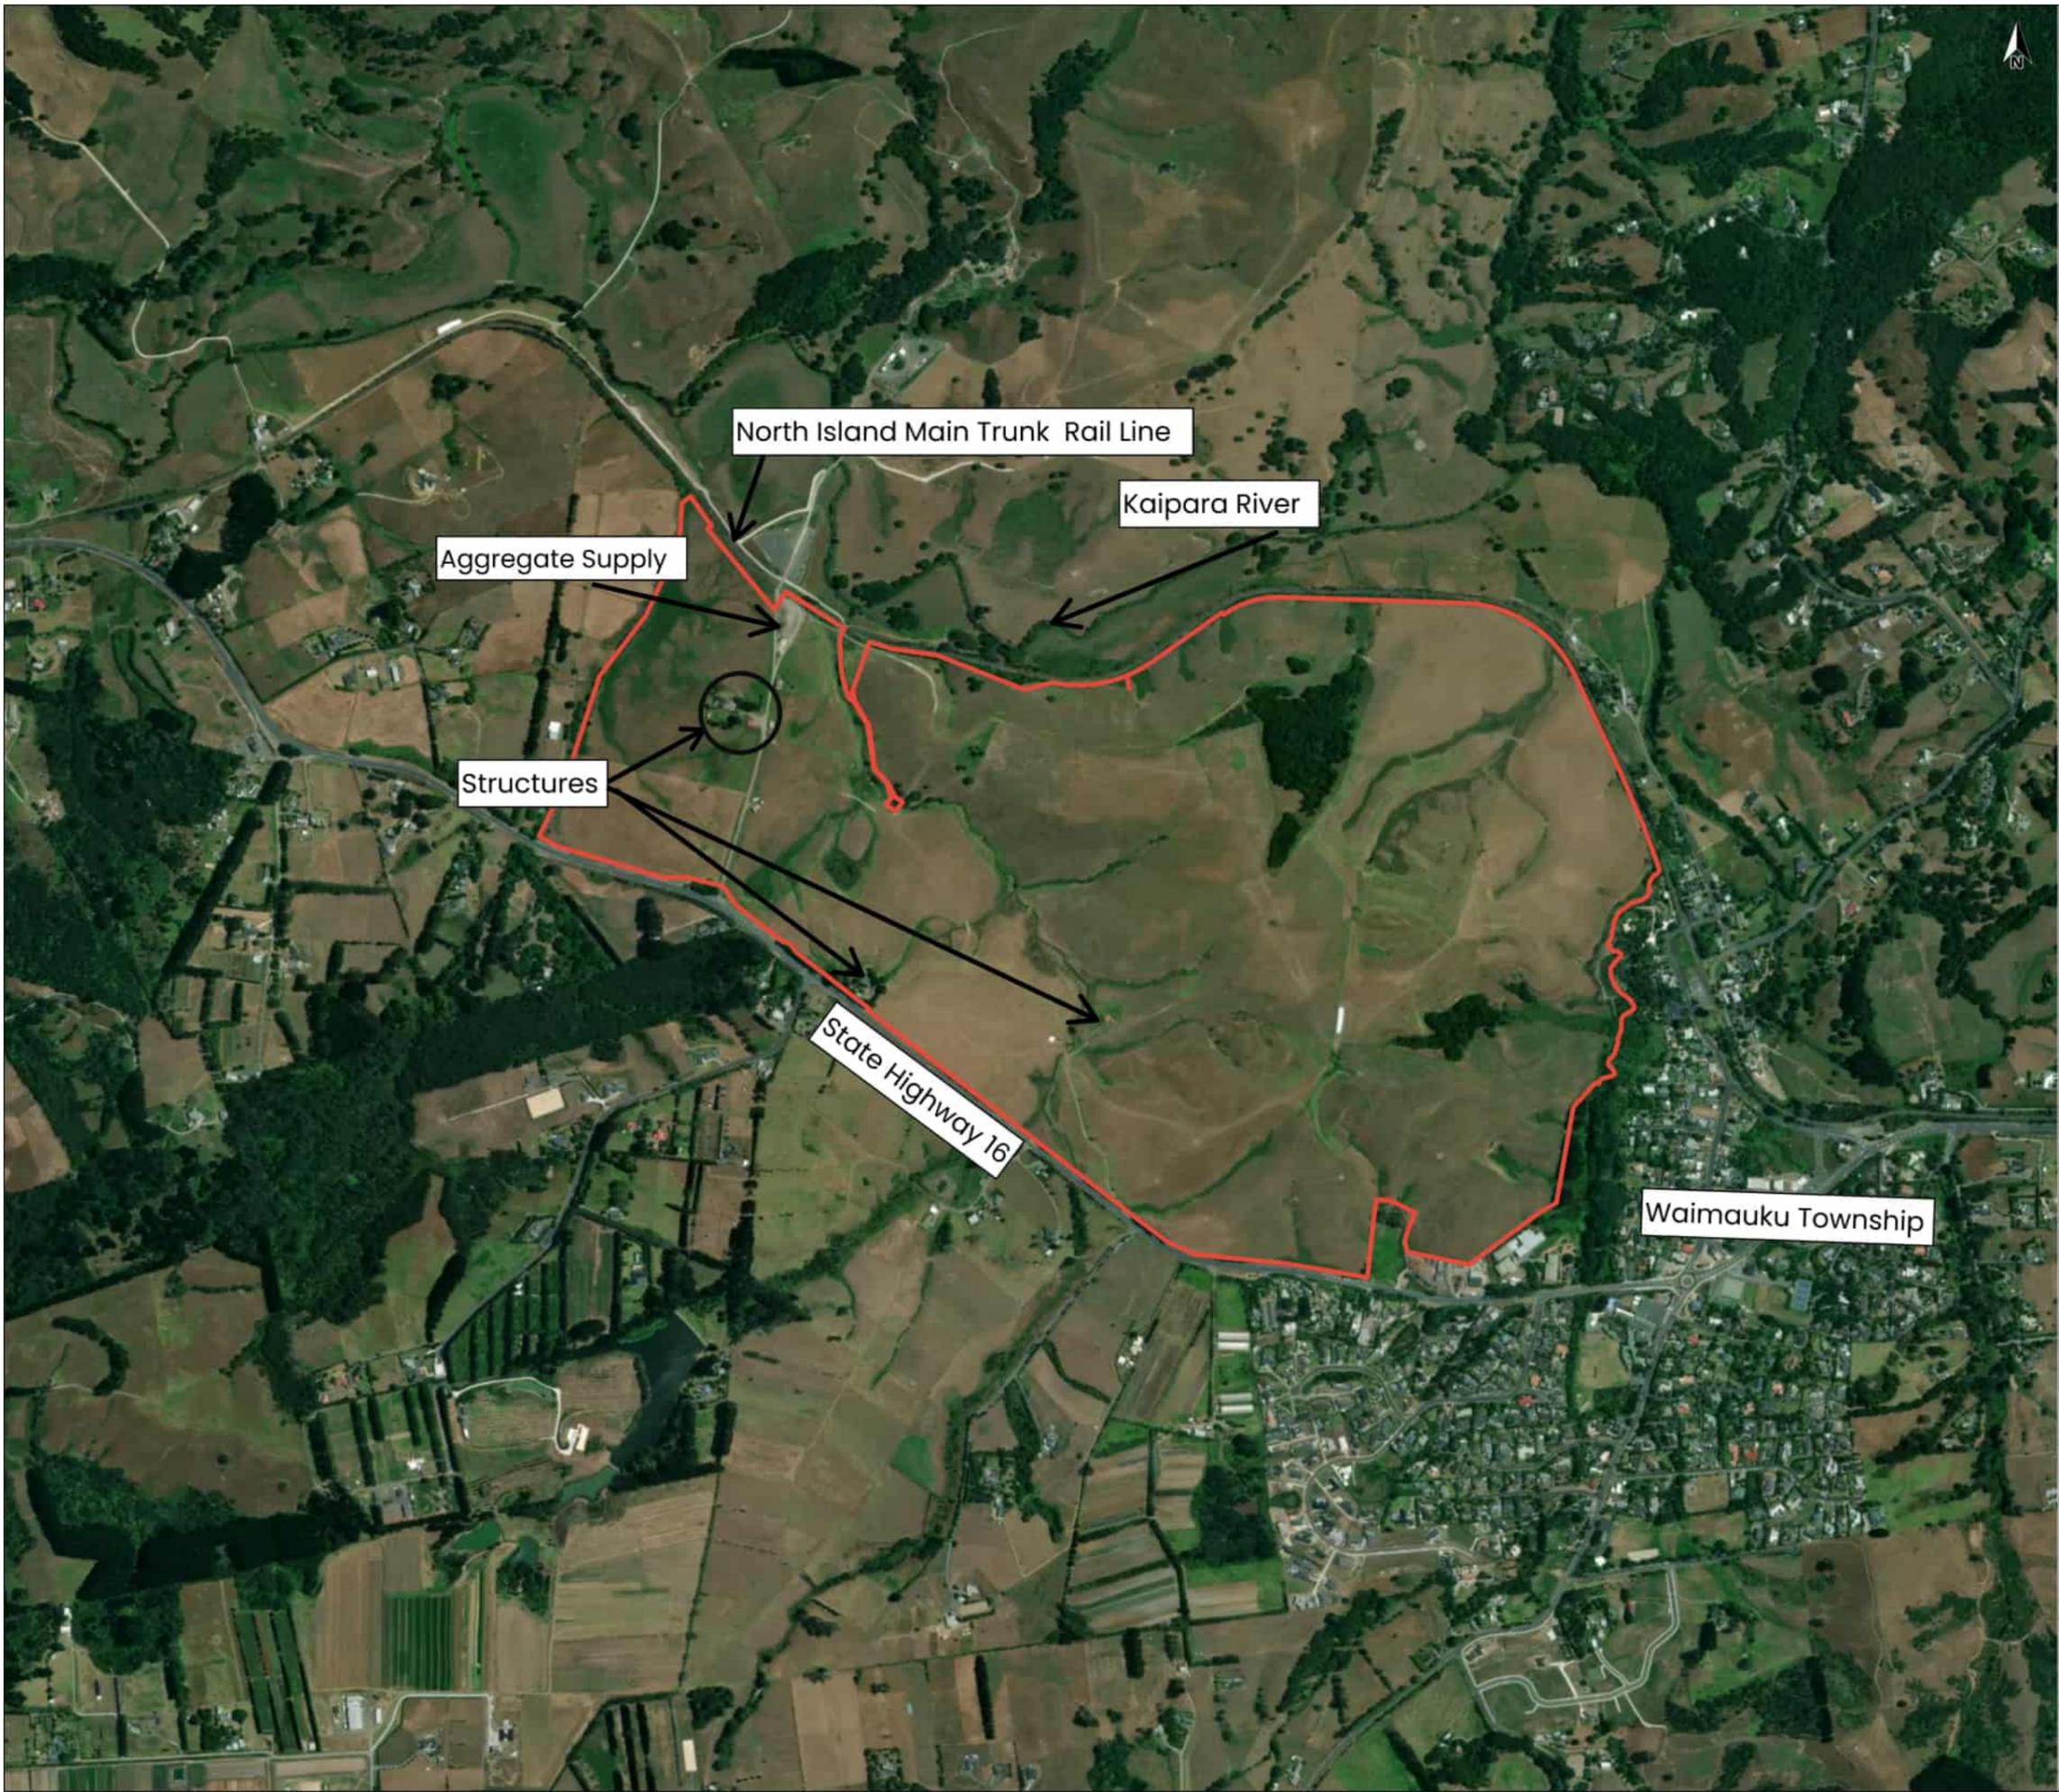
Title: Surrounding Environment

Site identification details are presented in **Table 2**. An image of the surrounding environment is provided as **Figure 2**.

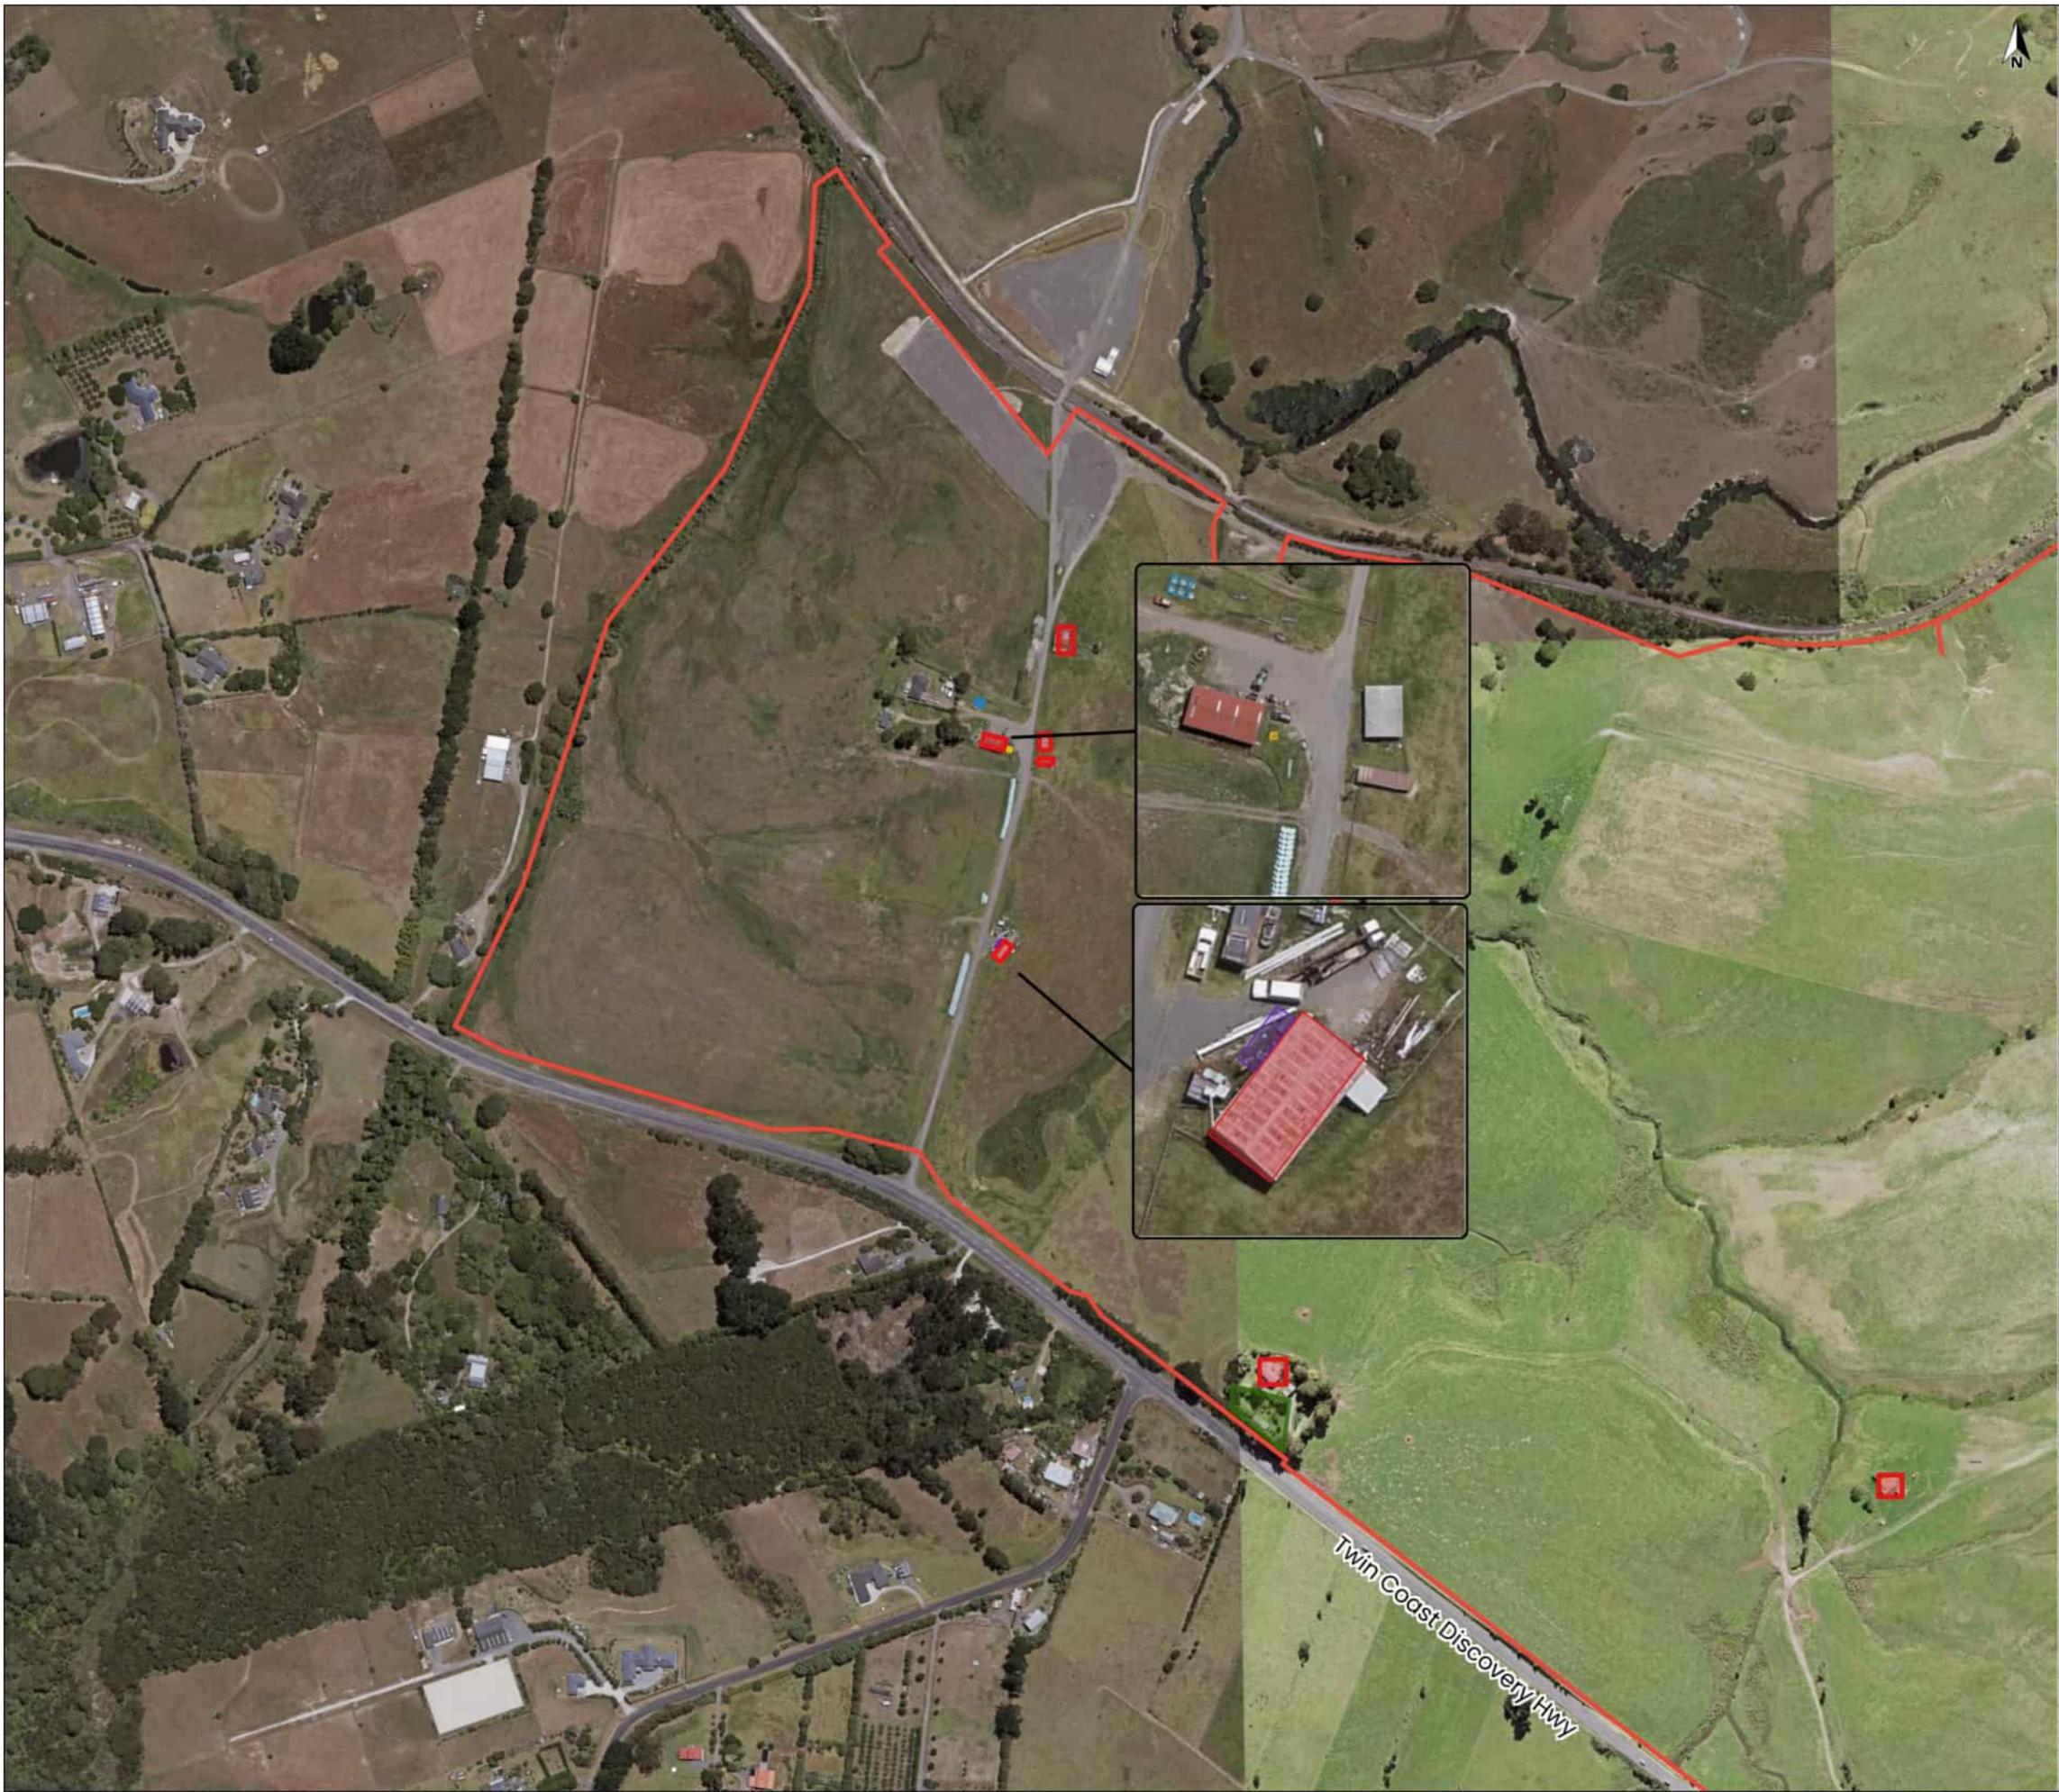
The site walkover identified a fence post storage area, drum storage area and burn pit near the sheds in the western side of the site. In addition, two of the sheds were observed to be used for storage of farm equipment and tools.

- *I: Any other land that has been subject to the intentional or accidental release of a hazardous substance in sufficient quantity that it could be a risk to human health or the environment* – associated with:
 - The fence post storage, and the potential for discharge of timber treatment chemicals to shallow soil.
 - Burn pit, and discharge of contaminants (metals, hydrocarbons) to ground.

- Deteriorated buildings, specifically potential for discharge of lead from lead-based paint to soil.

It is recommended that a detailed site investigation (DSI) involving a targeted soil sampling is undertaken at the site in support of any future residential land development project. This should be conducted to support the resource application. The results of DSI will:

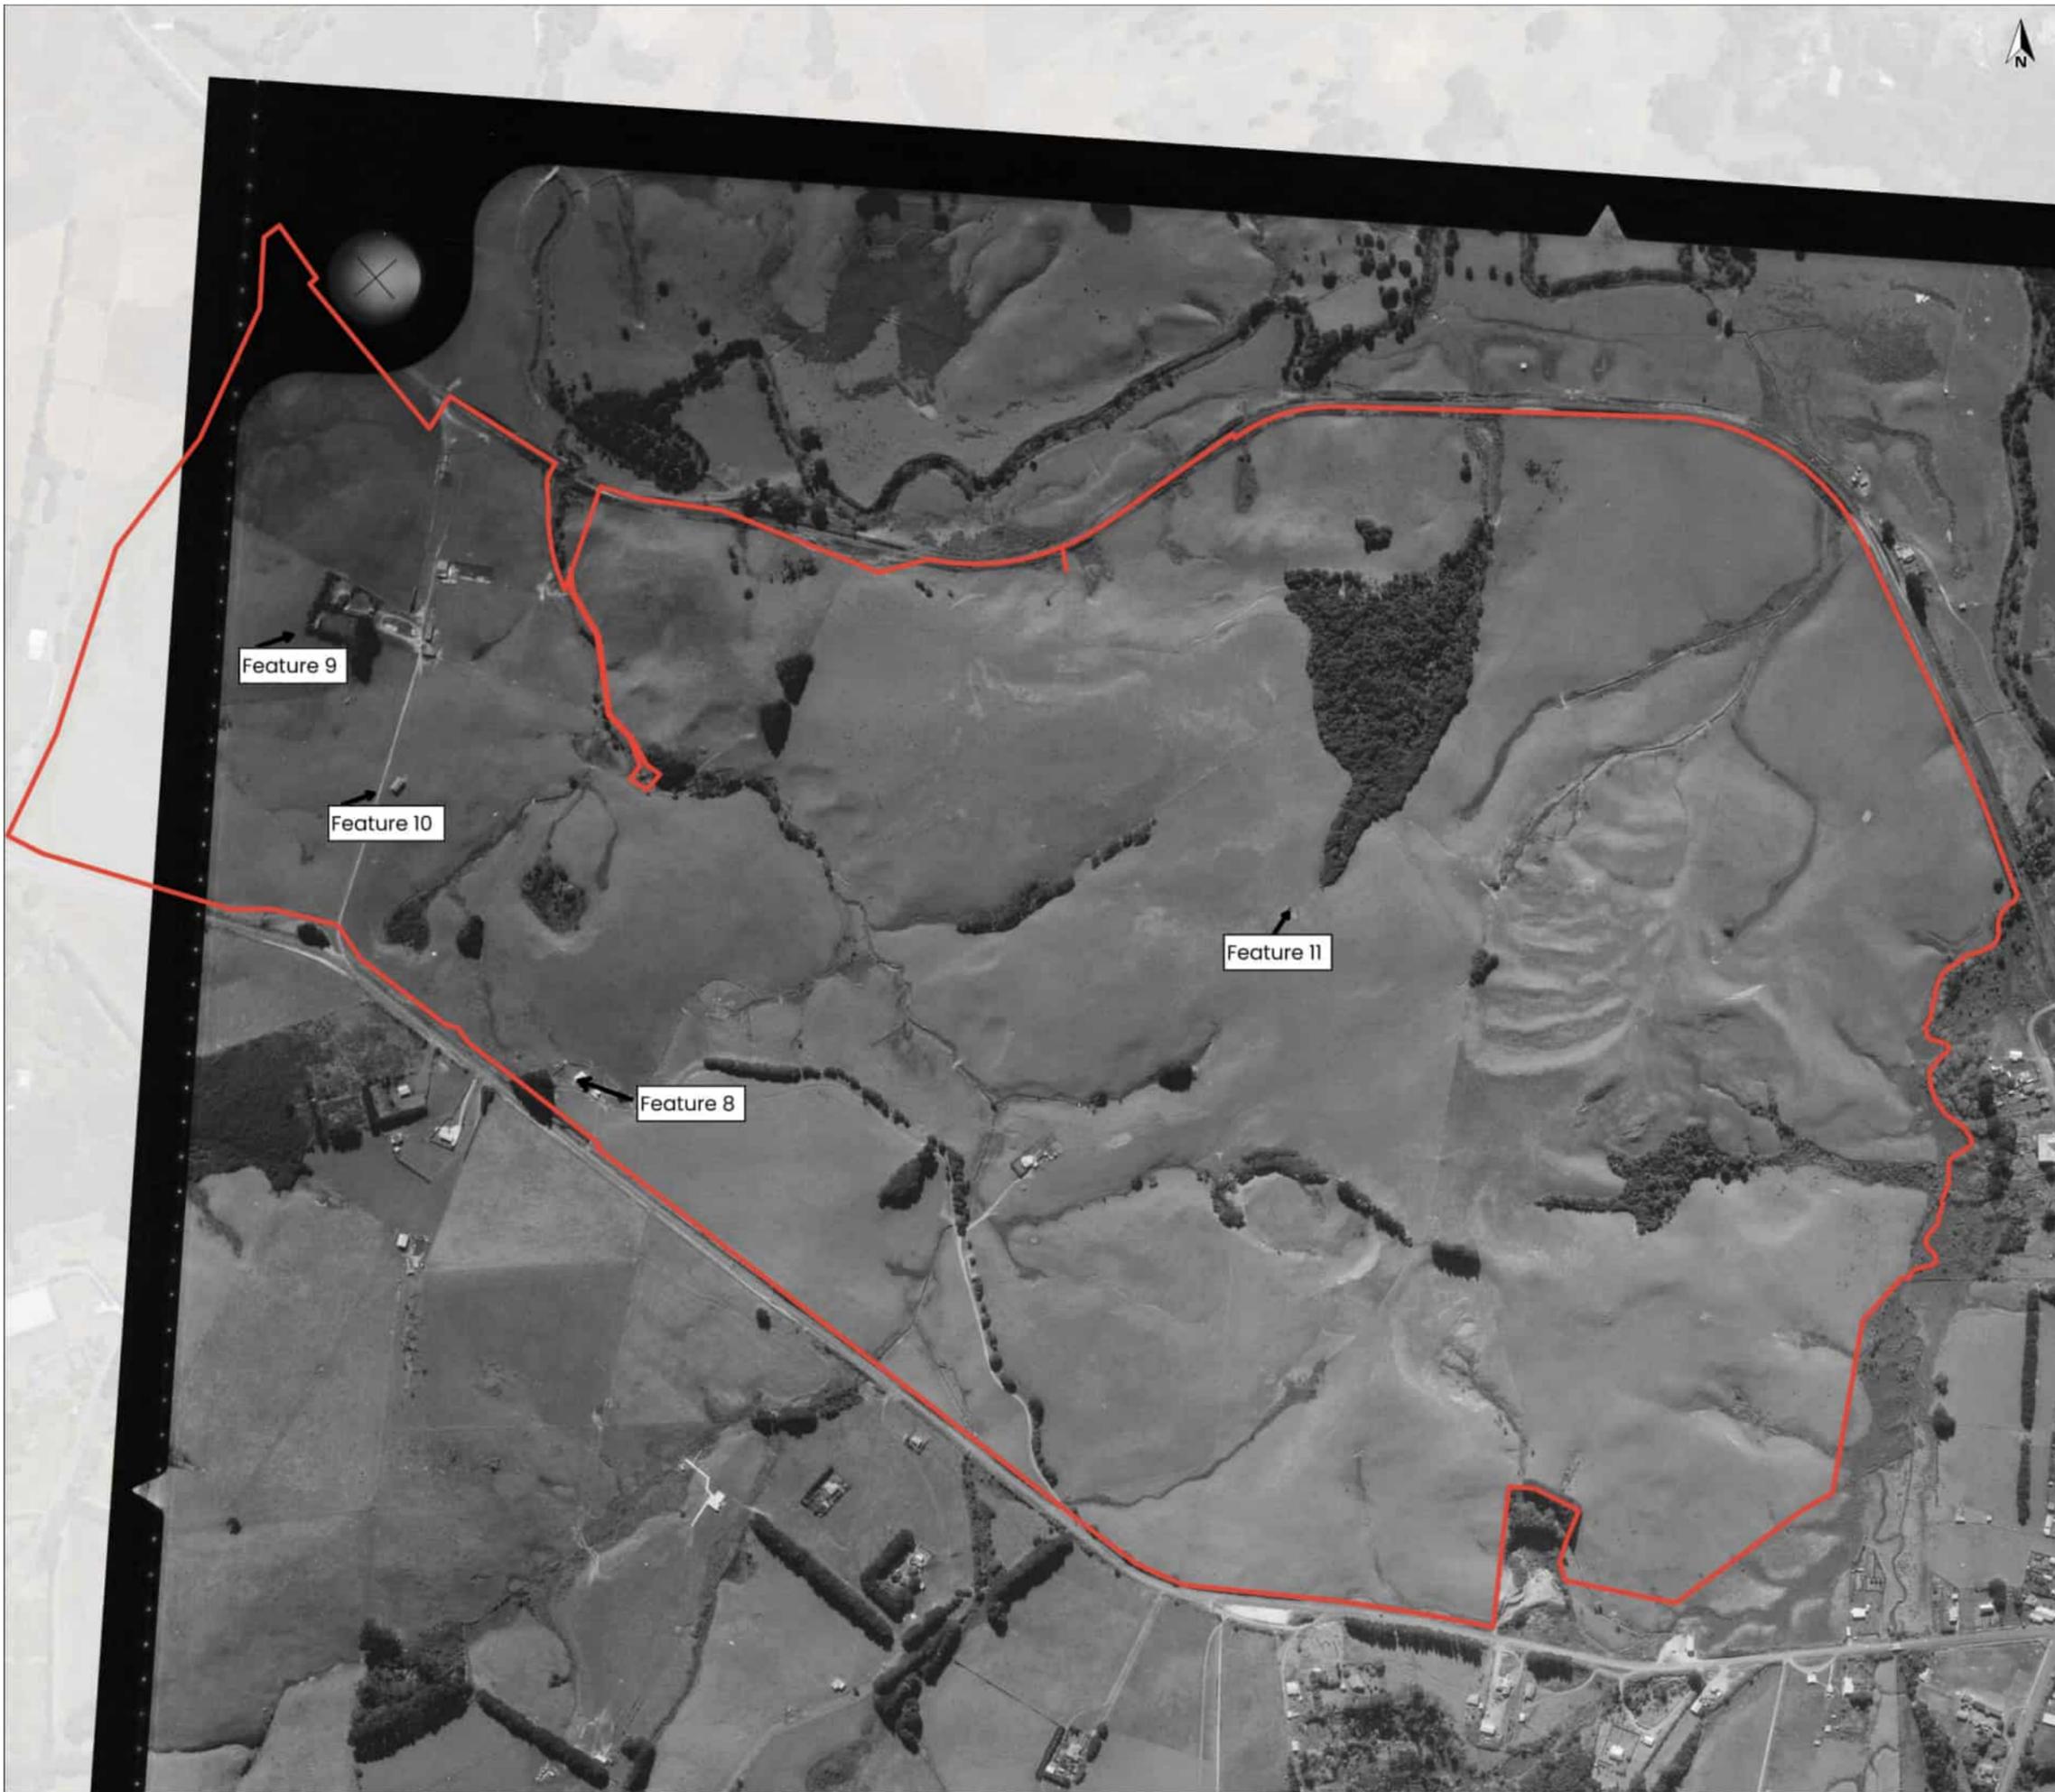
Title: Historical Aerial - 1975		
Client: CMW Geosciences		Size: A3
Project: Waimauku West PSI	Drawn: SH	Appendix: A
Date: 28-05-2025	Checked: SE	
Proj No: 810.031375.00001	Scale: 1:7000	Version: 2.0

Year	Reference	Observations
		<p>Surrounding area: There has been further development of Waimauku township east of the site. No other significant changes are observed.</p>
1975	Retrolens (Black & white)	<p>Site: No significant changes observed.</p> <p>Surrounding area: No significant changes are observed.</p>
1981	Retrolens (Black & white)	<p>Site: The farm structures located in the northwest of the site have expanded (<i>Feature 12</i>). Multiple water troughs are evident across the Site (<i>Feature 13</i>). A pond has been constructed in the western portion (<i>Feature 14</i>). Storage of materials is observed north of the farm structures (<i>Feature 15</i>). Small scale orchard has been established adjacent to dwelling located in the south of the Site (<i>Feature 16</i>).</p> <p>Surrounding area: Residential development to the east has increased. Horticultural activities on adjacent properties to south and southwest have extended with glass houses and orchards present.</p>

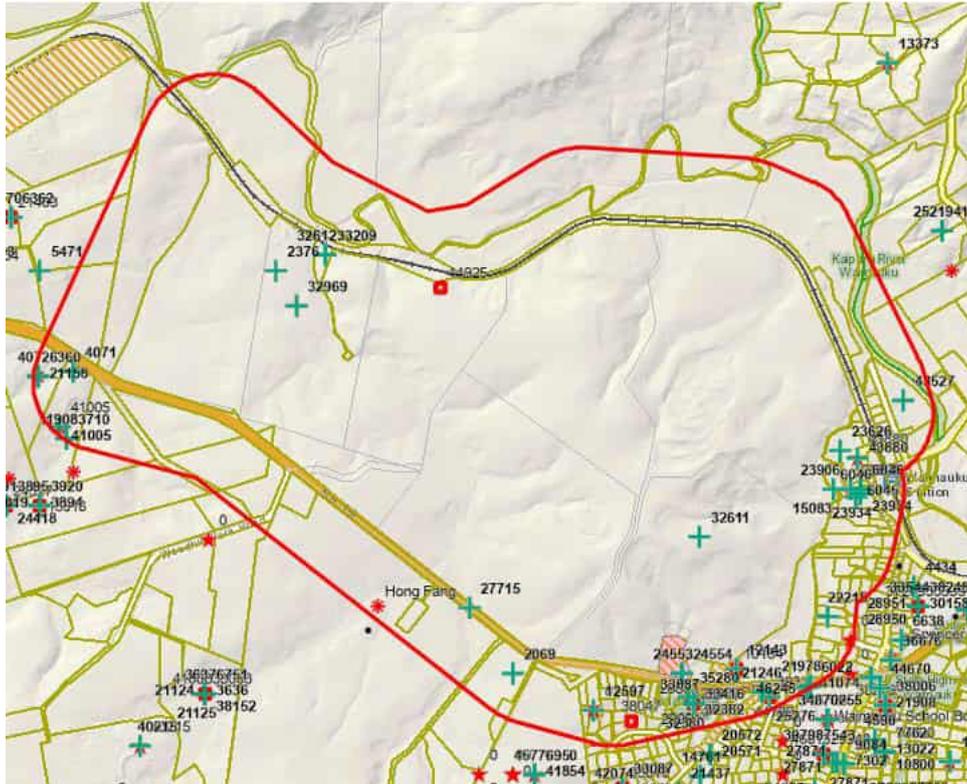
Figure 1: Selected Consents, Incidents and HAIL activities within approximately 200m of the subject site

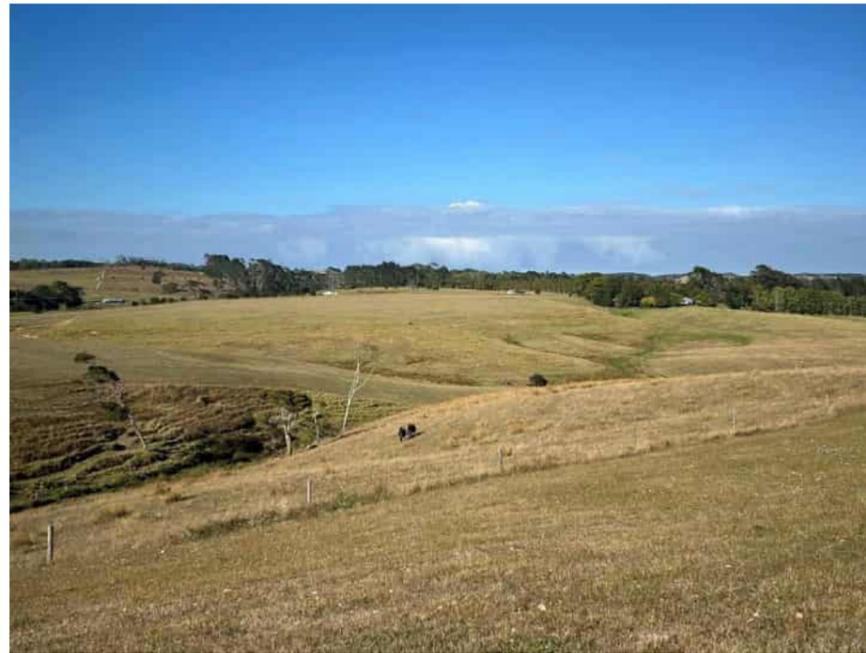
- The walkover confirmed the topography of the site as undulating land with a number of gullies dissecting the site. Water was observed in the stream running from southeast to northwest (*photos 1-2*).

Photo 2: General topography of the Site, looking north east (25 February 2025).

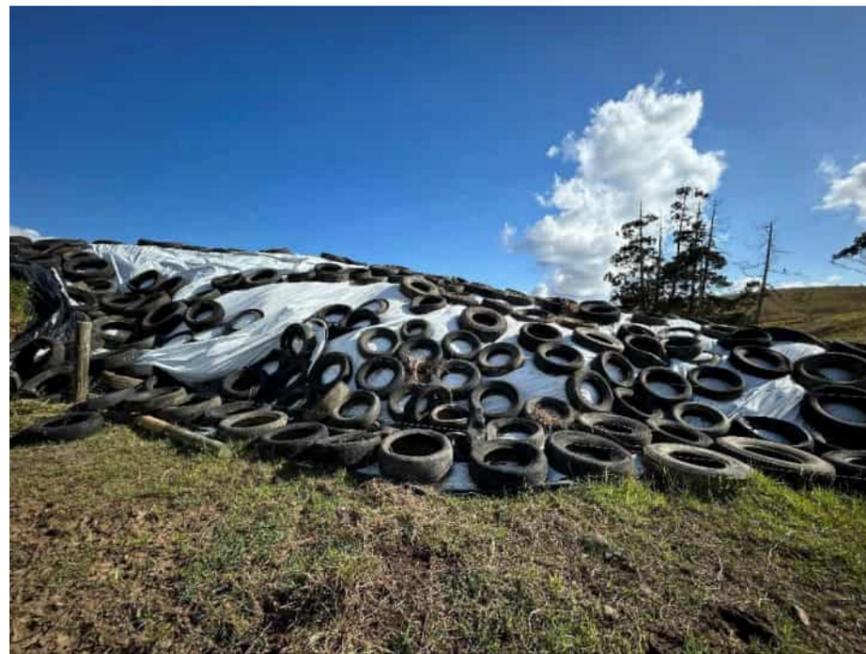
- A dwelling located south of the site and identified in the 1963 aerial imagery (*Feature 8*) was observed to be vacated and in good condition. The dwelling is constructed of timber (*photo 8*).

Photo 8: Dwelling located south of the Site and identified on the aerial image as Feature 8. Looking towards south. (25 February 2025)

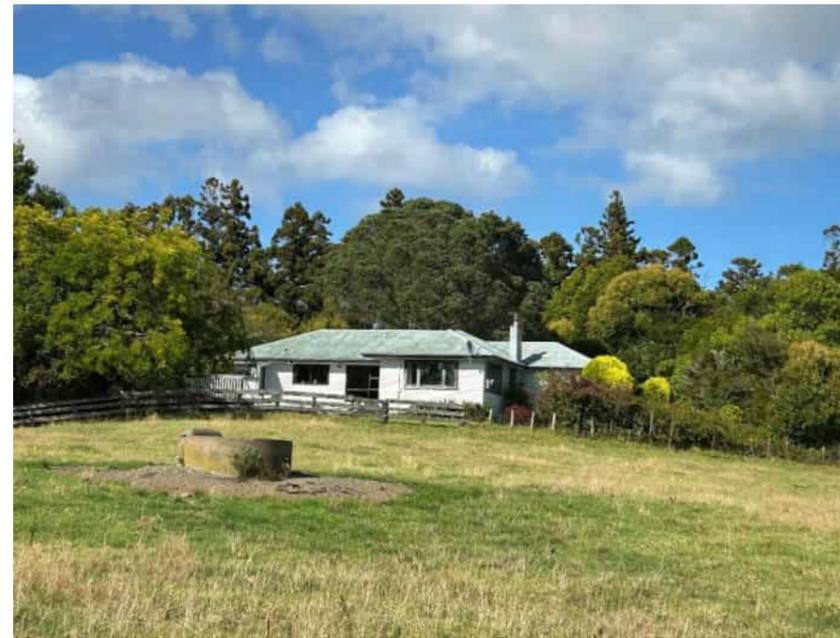
- A farm structure identified in the 1950 aerial image (*Feature 7*) is in a deteriorated condition (*photos 9 and 10*). The shed is constructed of timber.

Photo 9: Former farm structure located along metalled driveway and identified on aerial image as Feature 7. Looking towards north (25 February 2025)

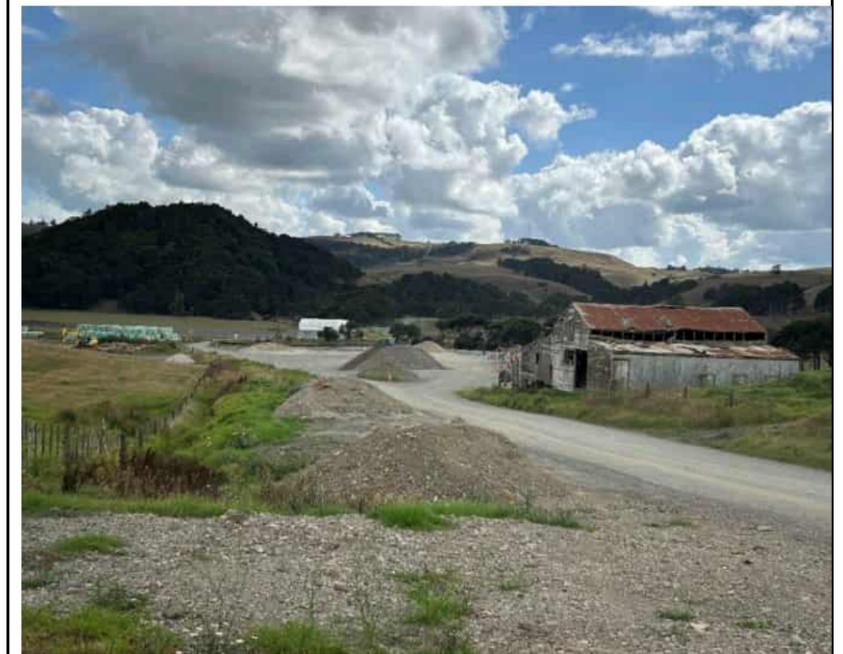
Photo 10: Former farm shed (Feature 7; 25 February 2025)

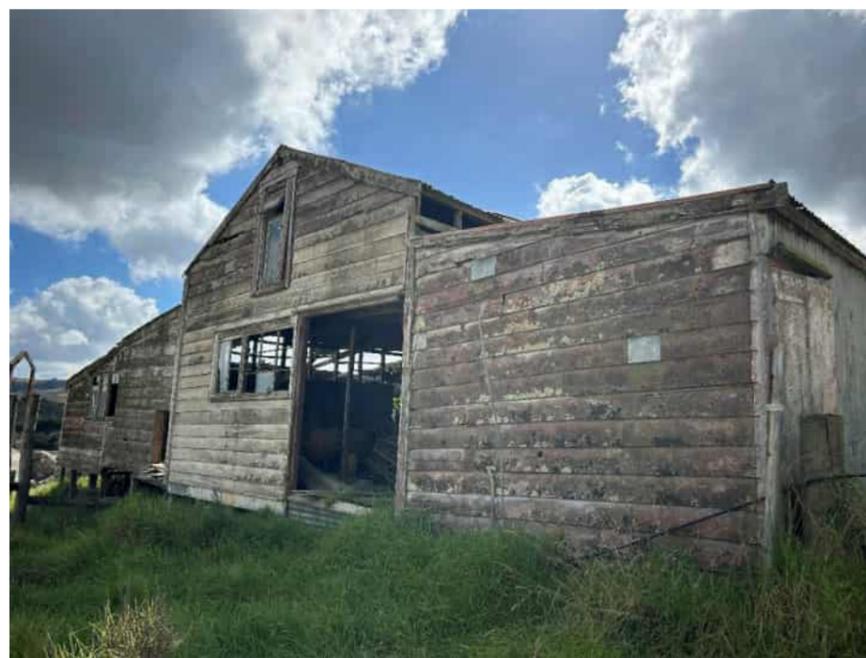
- Four sheds are situated along the metal driveway which extends from SH16 to the northern boundary of the site (*photo 11 and 12*):
 - Three sheds are constructed from corrugated metal and are in a deteriorated state.

Photo 11: Sheds along metalled driveway, looking towards west (25 February 2025)

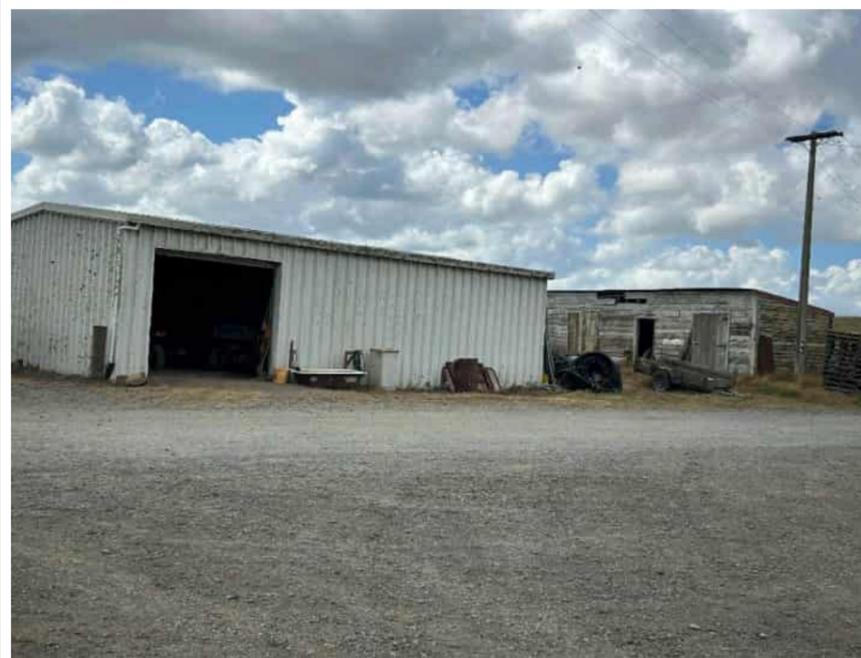
- One shed is made of timber and is also in a deteriorated condition.
 - Two sheds are currently used for equipment, tools, fencing materials, and building supplies storage. The sheds were noted to have an unsealed floor.

Photo 12: Shed along metalled driveway (25 February 2025)

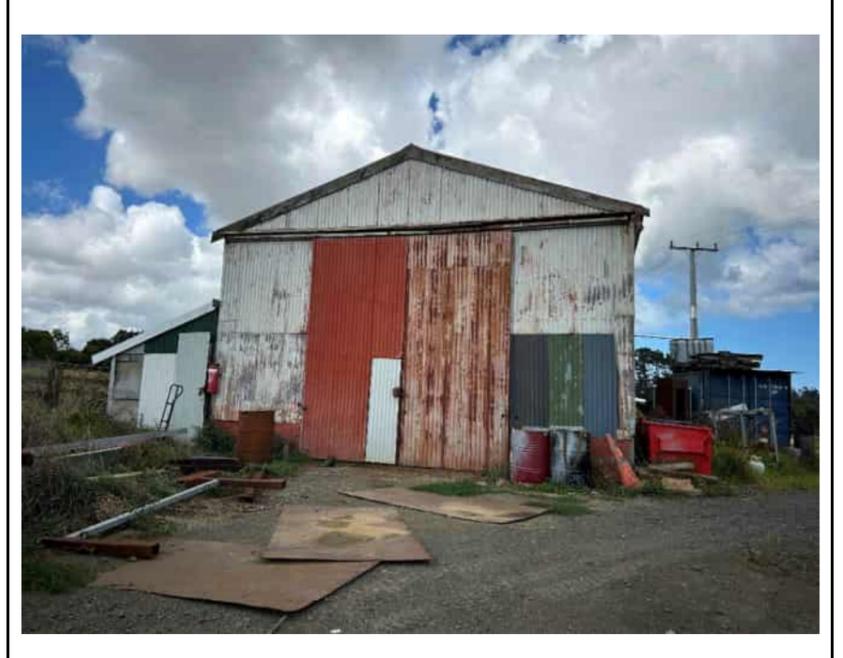
- The remaining two sheds were locked and could not be inspected.
- Various farm items and pieces of equipment were scattered around the sheds, including metal sheets, farm equipment, pallets, storage containers, barrels, and construction materials. Multiple empty and full drums (labelled as containing Glycol) were observed adjacent to sheds, however, no evidence of spills associated with these drums or soil staining was observed (*Photo 12-15*).

Photo 13: Storage of farm equipment (25 February 2025)

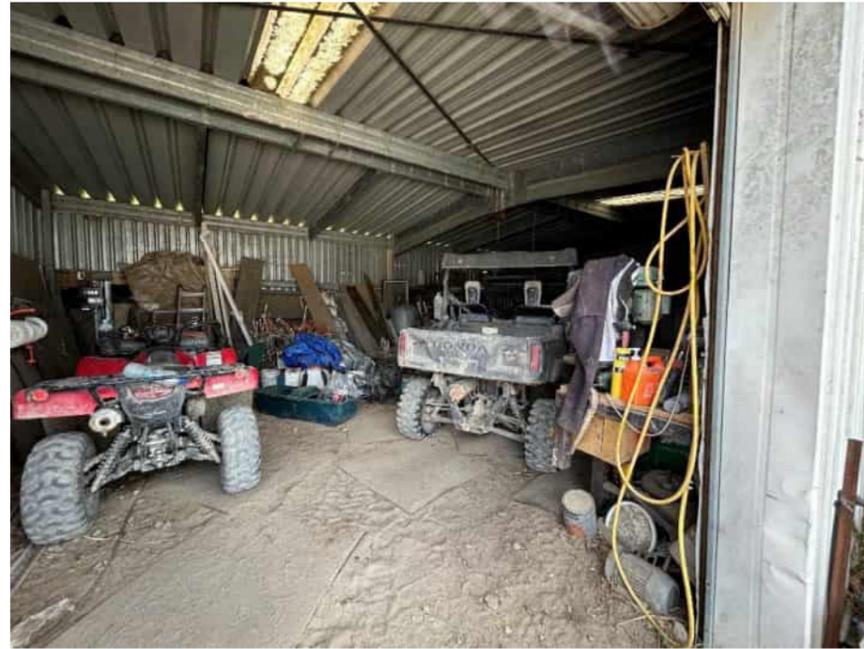
Photo 14: Storage of fences (25 February 2025)

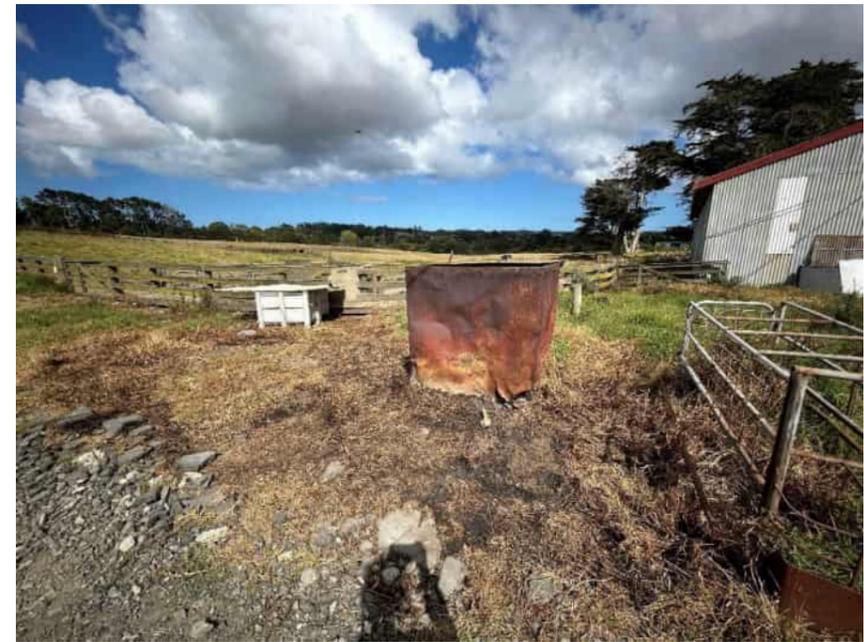
- A metal bin was located adjacent to a shed on the metal driveway which extends from SH16 to the northern boundary of the site. This bin is used to burn rubbish, and has a small (< 2 m²) burned halo surrounding it (Photo 16 and 17).
- Fence posts were observed to be stored on the ground near the sheds (photo 18).
- The two dwellings located to the west of the Site and identified in the 1940 aerial imagery (Feature 1) appeared to be in good condition.
- Hay storage is located at the end of the metalled driveway, north of the Site (photo 19).
- An aggregate landscape supplier operates a yard out of the northwestern corner of the site, with visible stockpiles of gravel materials and a large metalled parking area (photo 20).
- A composting system is located adjacent to sheds (photo 21).

Photo 17: Burn pit drum (25 February 2025)

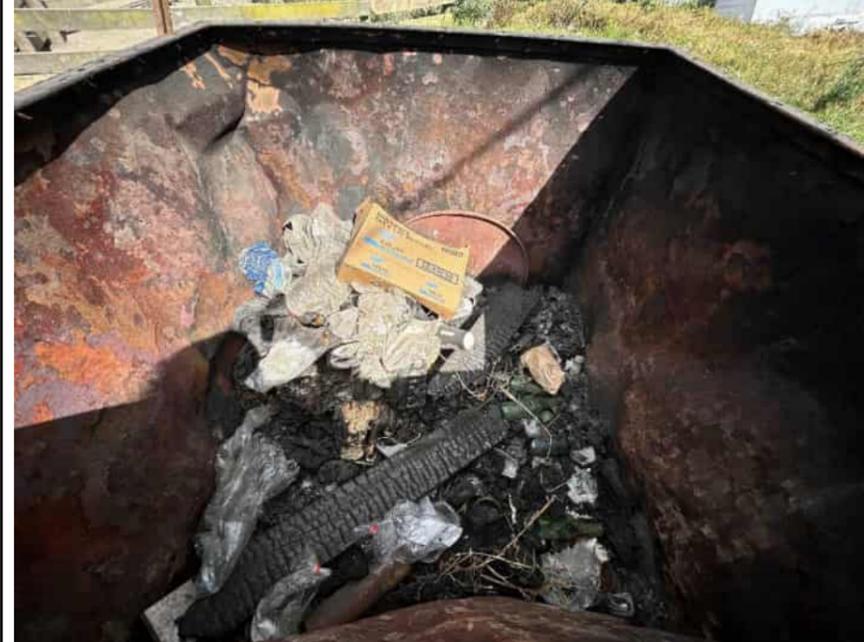
Photo 18: Fence post storage, looking towards west (25 February 2025)

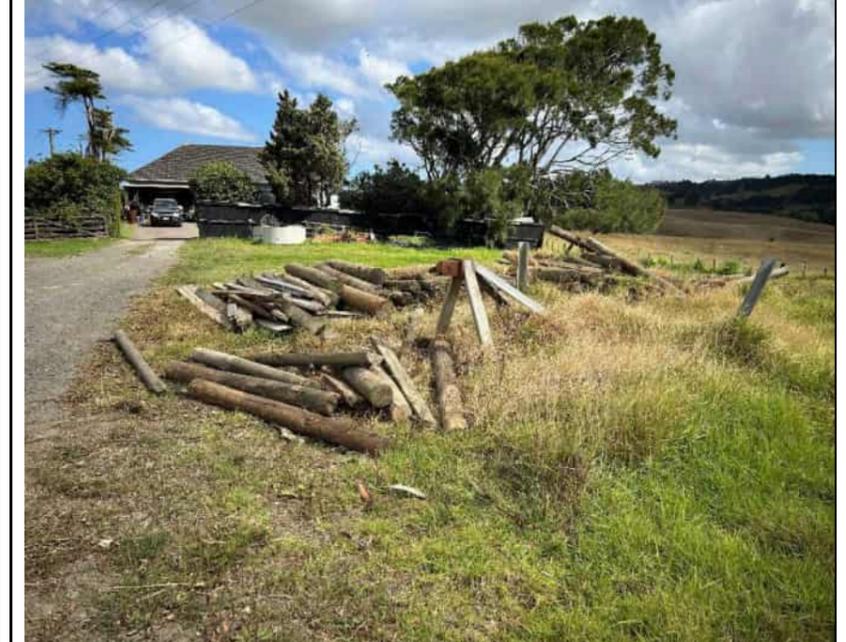
Photo 19: Hay storage located north of the site, looking towards north (25 February 2025)

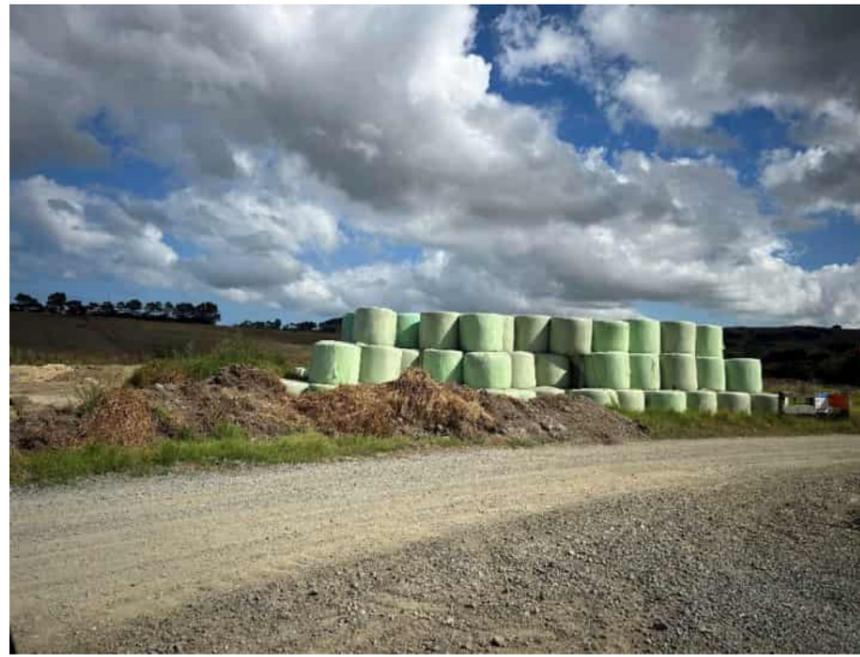
Photo 20: Aggregate supply, looking towards north (25 February 2025).
