# Ohoka Development

## Geotechnical Assessment Report - Fast-track Application

Carter Group Limited

**Reference: 773-CHCGE288040AB**

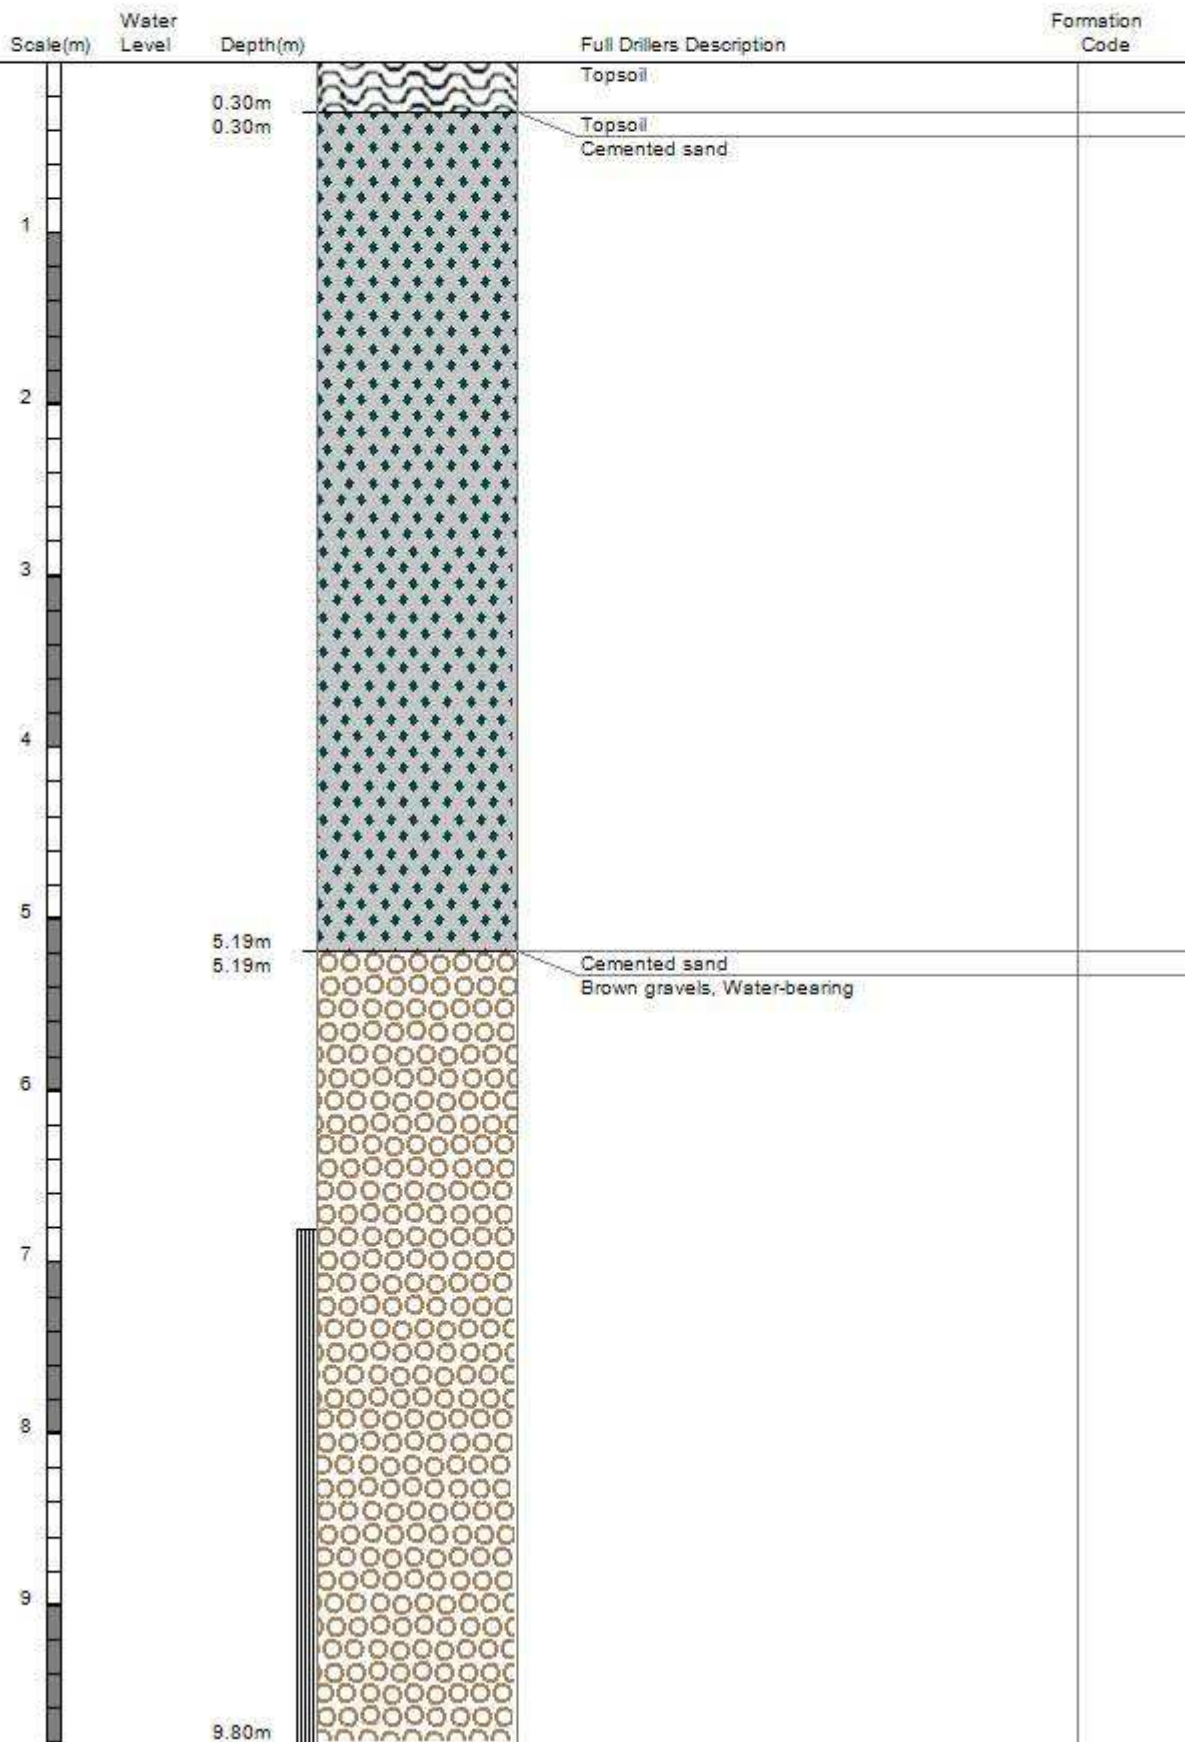
# Borelog for well M35/4428

Grid Reference (NZTM): 1564502 mE, 5197382 mN
