# Ecological Assessment Report

Brookvale Green, 174 & 176 Brookvale Road,  
Havelock North

Prepared for  
Vermont Street Partners No. 4 Ltd

July 2026

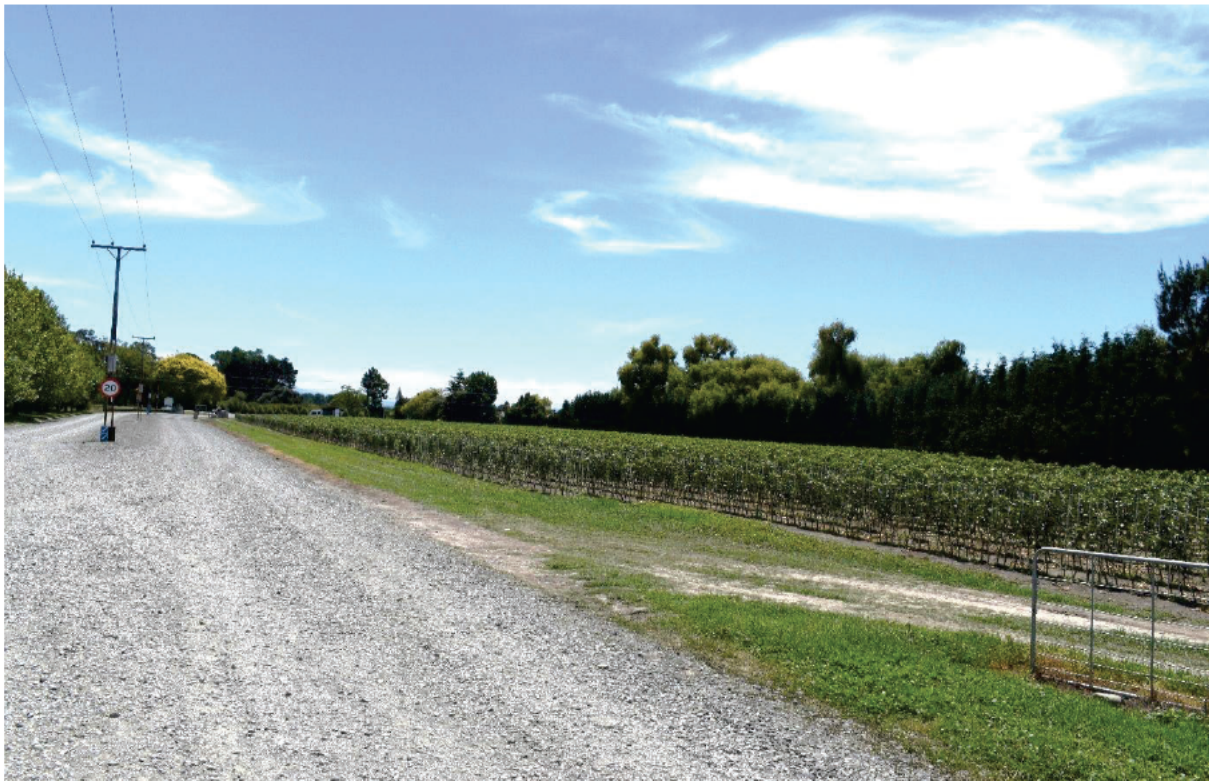
Figure 2: Showing the general characteristics of the site – primarily comprised in orchard areas, exotic pasture and outbuildings

The site is located on the residential fringes of Havelock North, approximately 3km north-east of central Havelock North. The site currently supports (Figure 2 and Figure 3) one residential dwelling unit, and several outbuildings, including growing and picking sheds, packhouses, warehouses and carparking areas associated with the current business located onsite; Te Mata Mushrooms, which is a commercial mushroom farm. The remainder of the site is a horticultural orchard, exotic pasture, and most terrestrial and aquatic habitats within the site are highly degraded.

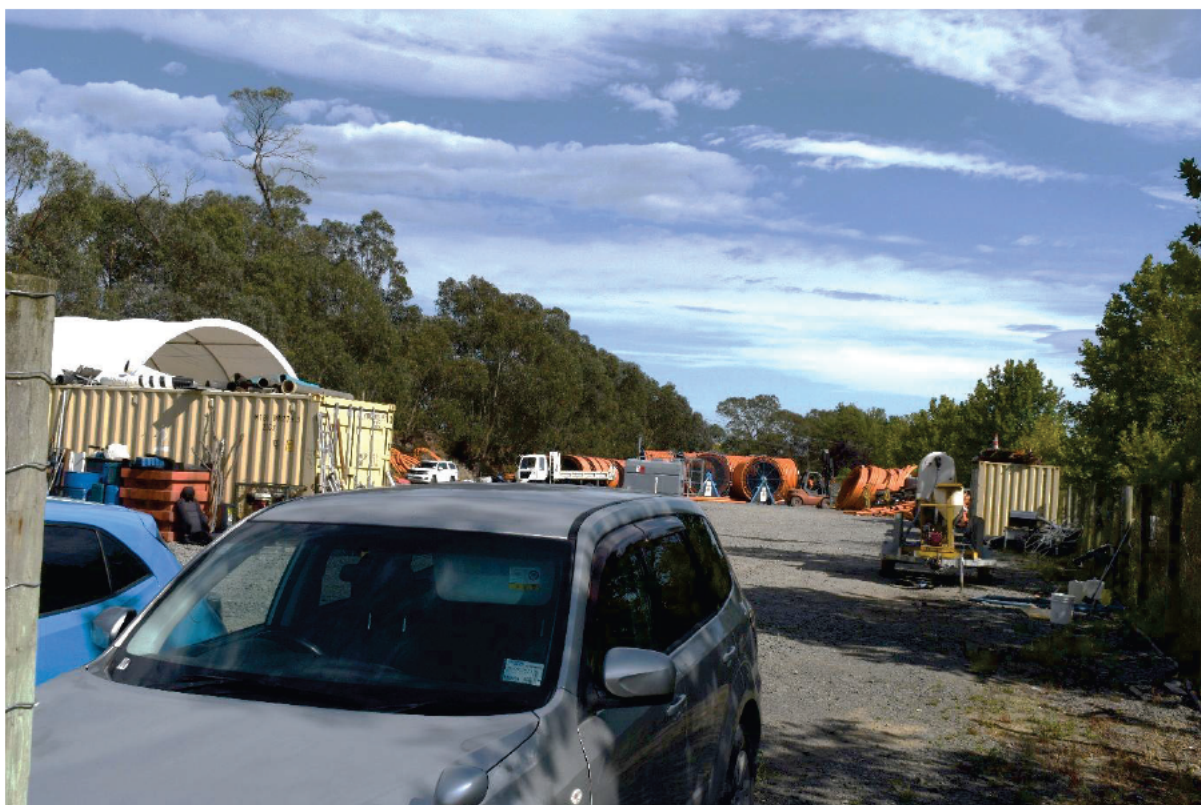
Figure 3: Much of the site comprises commercial buildings, yard areas, and accessways

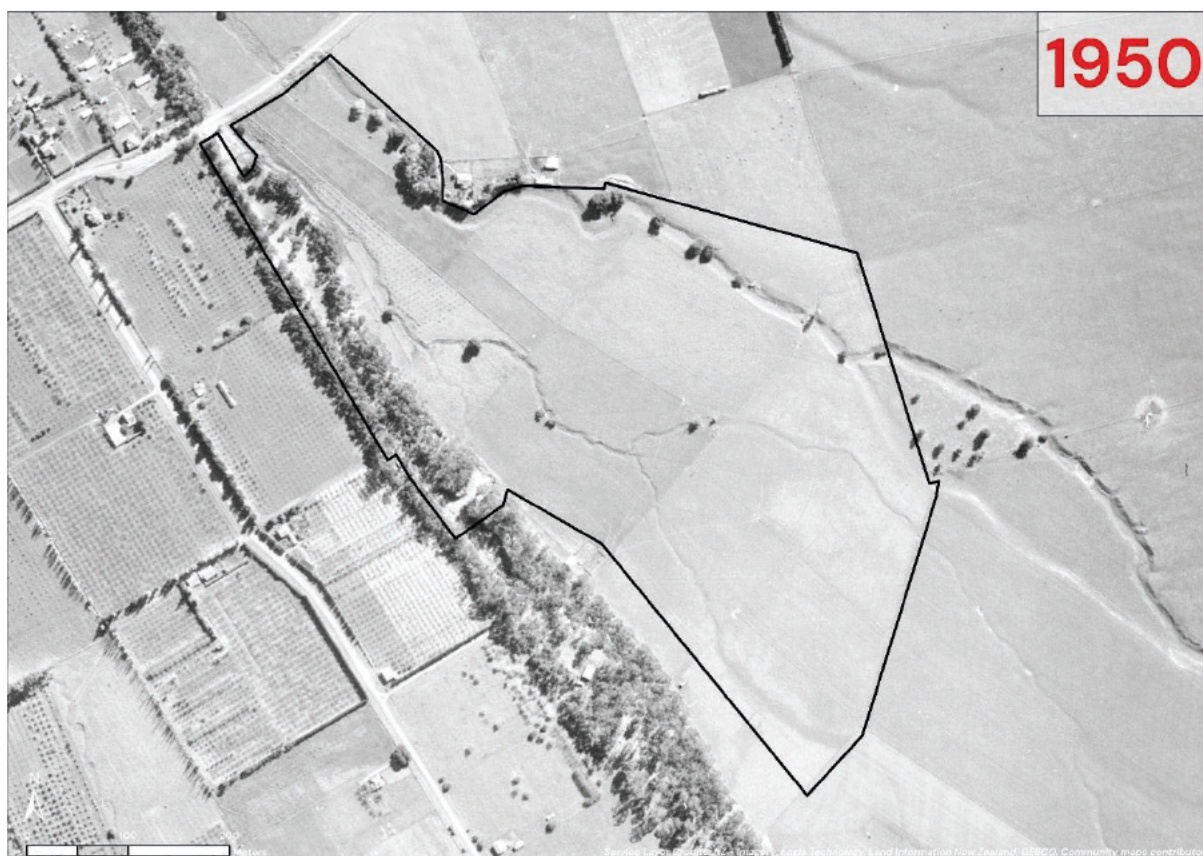
Figure 4: Showing the site and surrounds in 1950 (Source: Retrolens)

Following a review of historical imagery from 1950 and the most recent aerial photography from 2022–2023, it is evident that the waterbodies on site have undergone significant modification from their original alignment. By the 1950s, the majority of the site's vegetation had been cleared, with only a few scattered trees remaining (Figure 4). Natural watercourses appeared to extend across the northern and central parts of the site at this time, which is presumed to represent their original configuration.

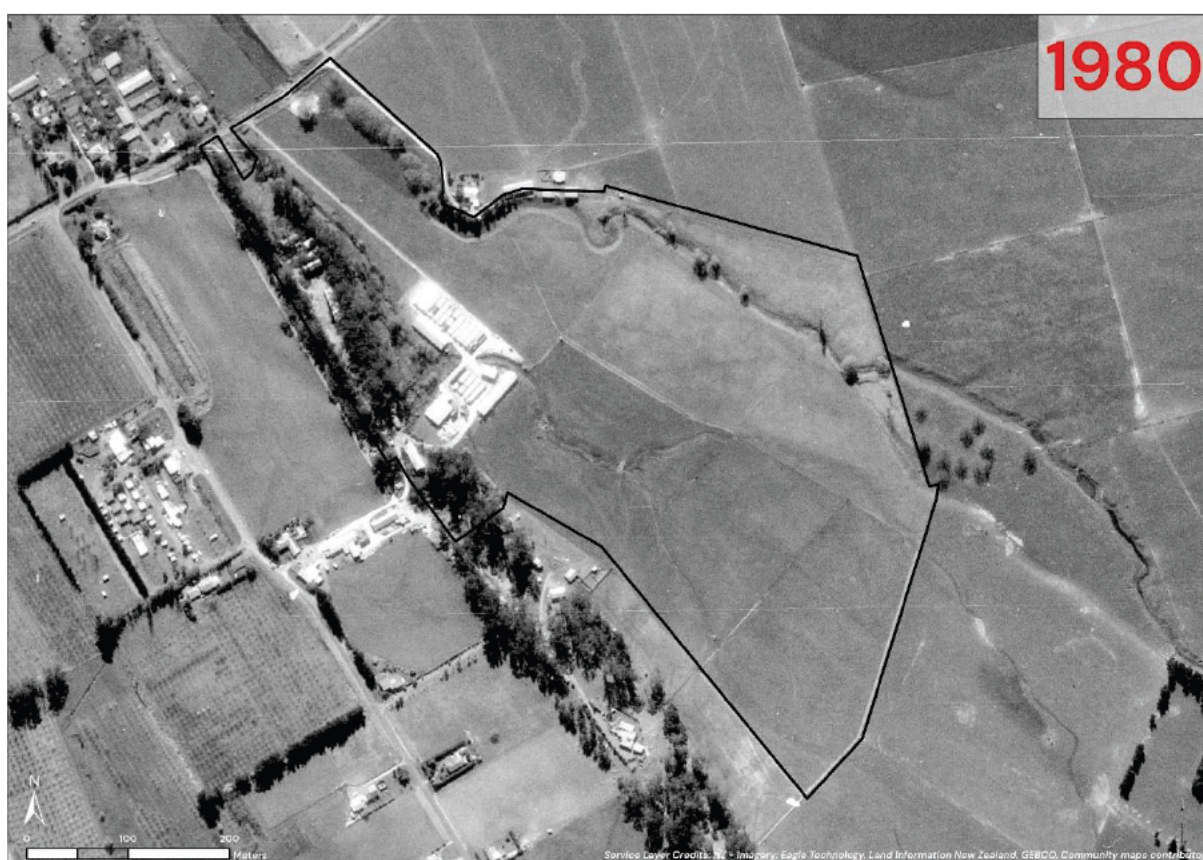
Figure 5: Showing the site and surrounds in 1980 (Source: Retrolens)

By the 1980s, commercial operations and development had been established on the site (Figure 5), including buildings located in the northwestern portion that appear to have been constructed over the central stream catchment. These activities continued into the 1990s (Figure 6), during which time the central stream appears to have been channelised and straightened—likely in preparation for piping or infilling to allow for increased land utilisation.

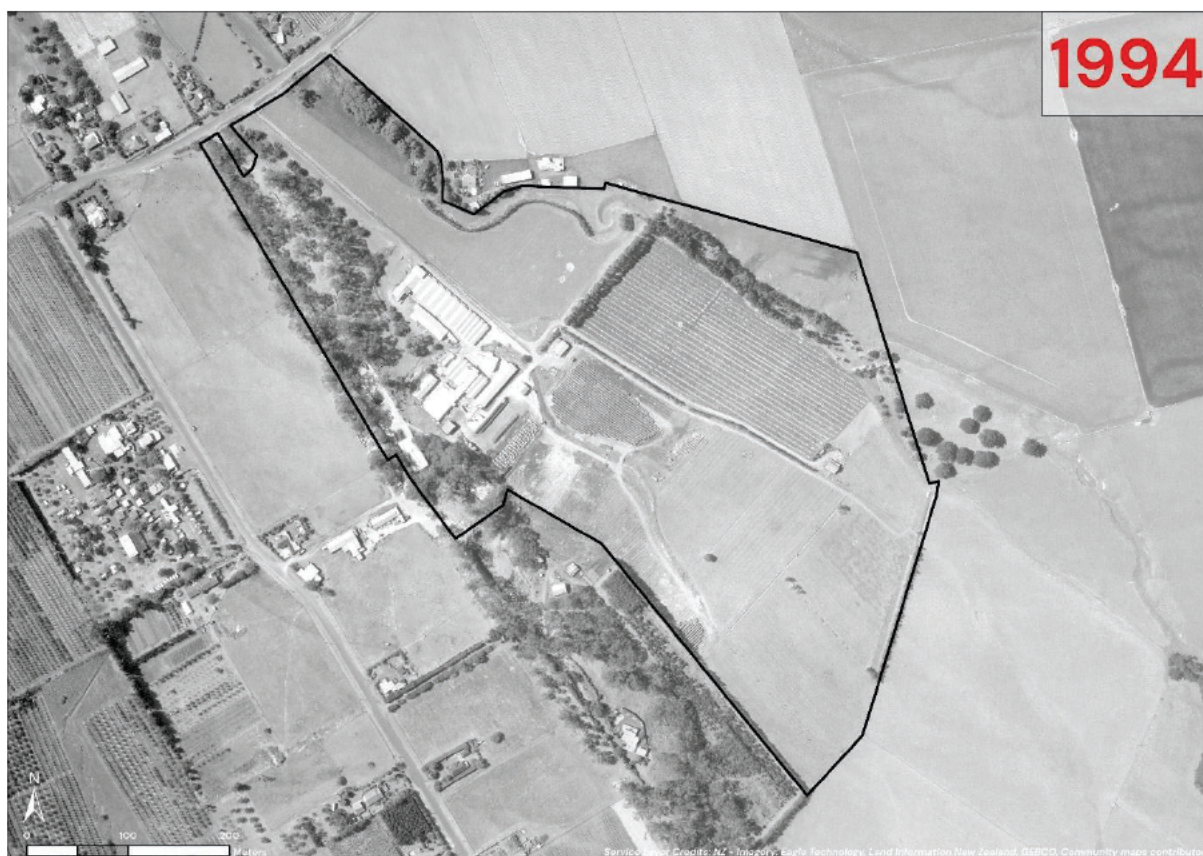
Figure 6: Showing the site and surrounds in 1994 (Source: Retrolens)

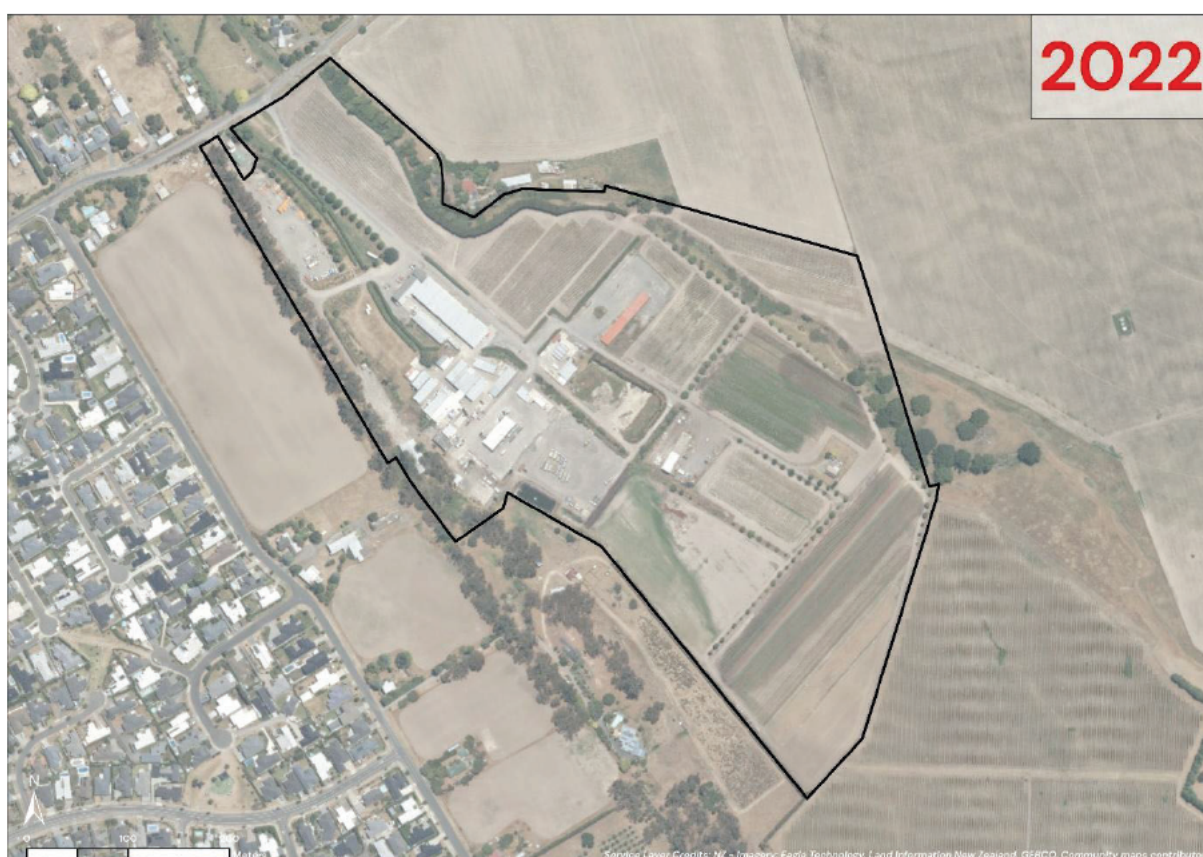
Figure 7: Showing the site and surrounds in 2022 (Source: LINZ)

Natural meanders within the northern stream catchment were also straightened to create a more linear corridor for water conveyance. From 1994 onwards until 2022 (Figure 7), the upper sections of the central stream catchment appear to have been removed entirely, likely either infilled or piped underground as part of ongoing horticultural land development. There is no evidence of this upper catchment area remaining on site today.

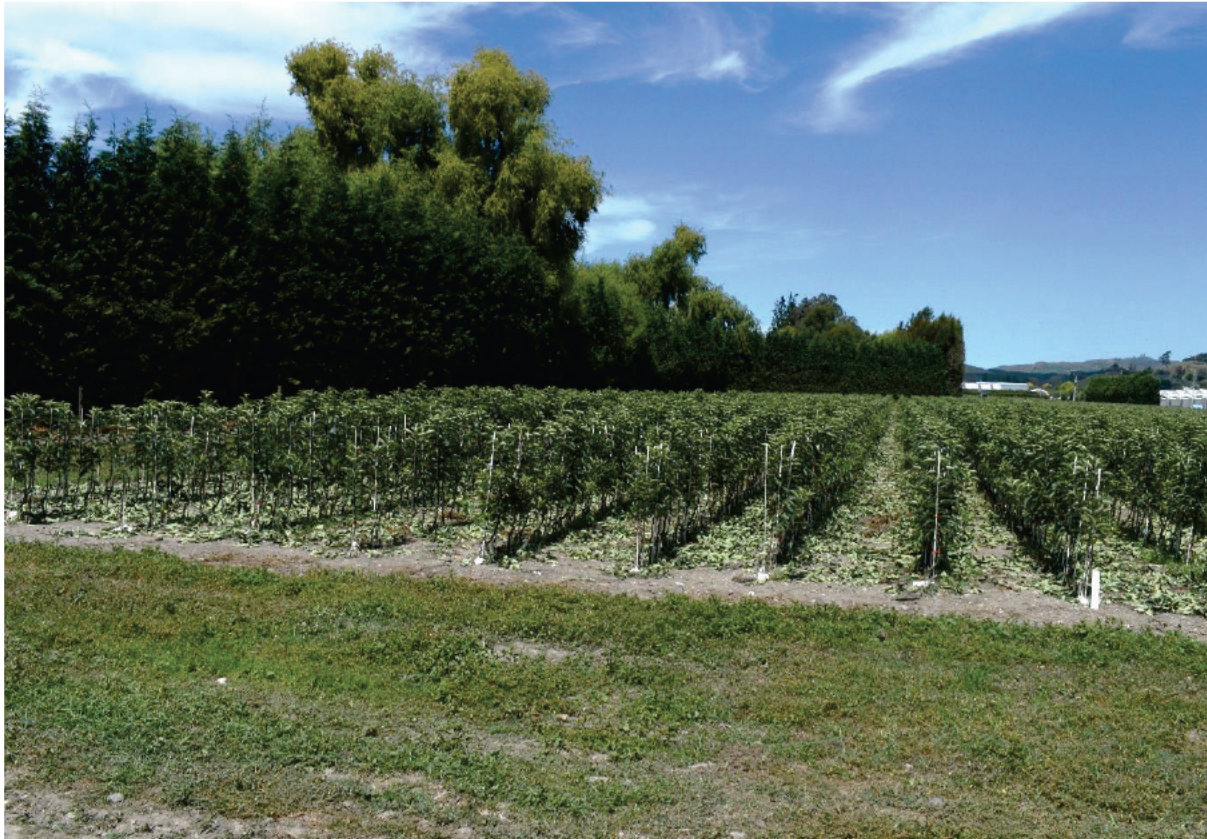
Figure 8: Looking east from the main accessway into the site

The site generally has a flat to gently sloping topography (Figure 8). Much of the site is utilised as a commercial growing unit/orchard. Several outbuildings, including growing and picking sheds, packhouses, warehouses and carparking areas are also present on site.

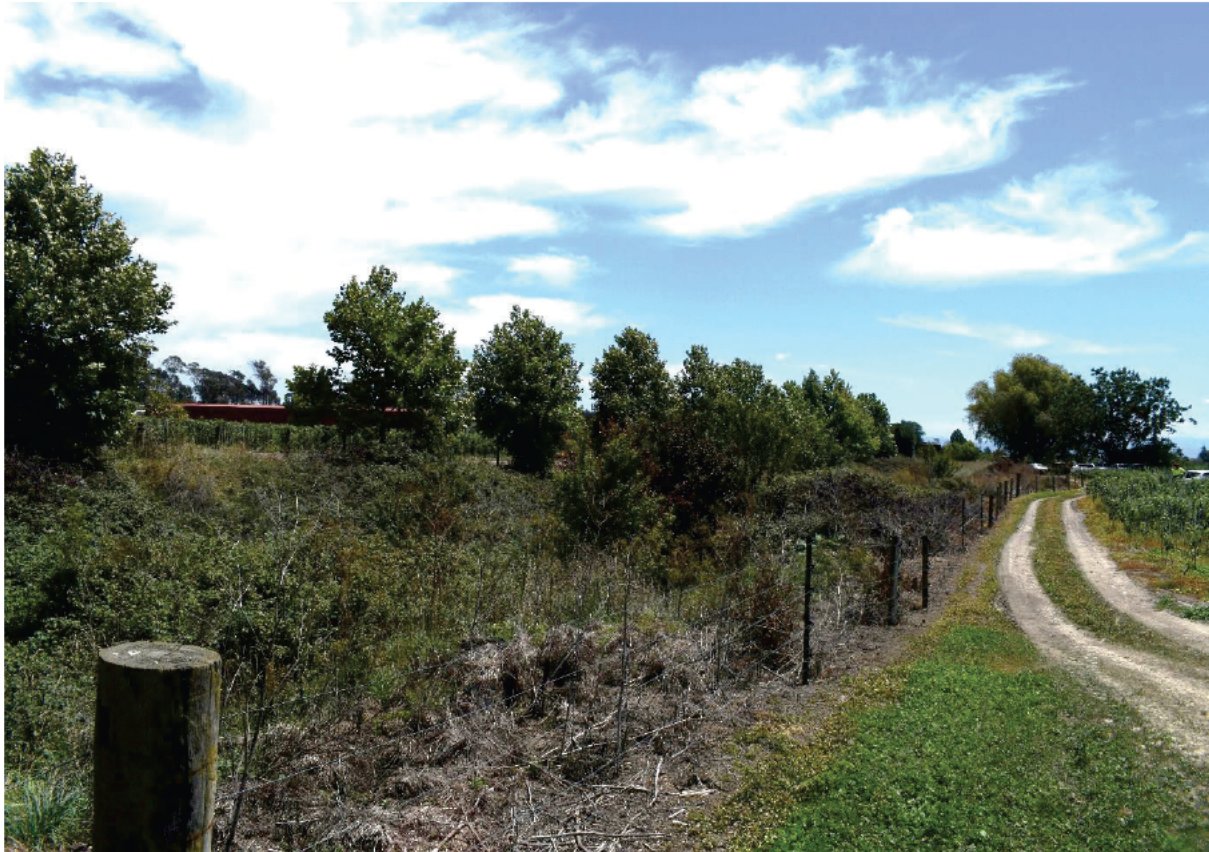
Figure 10: Showing the existing scattered terrestrial vegetation limited to exotic ornamental trees

With regard to terrestrial habitats, the site currently contains no naturally occurring indigenous vegetation. The only indigenous vegetation present consists of planted harakeke (New Zealand flax, *Phormium tenax*), which is located along bunds and shelterbelts. The remainder of the vegetation on site is comprised of exotic species, including Casuarina (*Casuarina spp.*), European oak (*Quercus robur*), walnut (*Juglans regia*), tortured willow (*Salix matsudana* 'Tortuosa'), crack willow (*Salix fragilis*), Japanese privet hedge (*Ligustrum japonicum*), plane trees (*Platanus spp.*), gum (*Eucalyptus spp.*), and a variety of other exotic shelterbelt plantings (Figure 10).

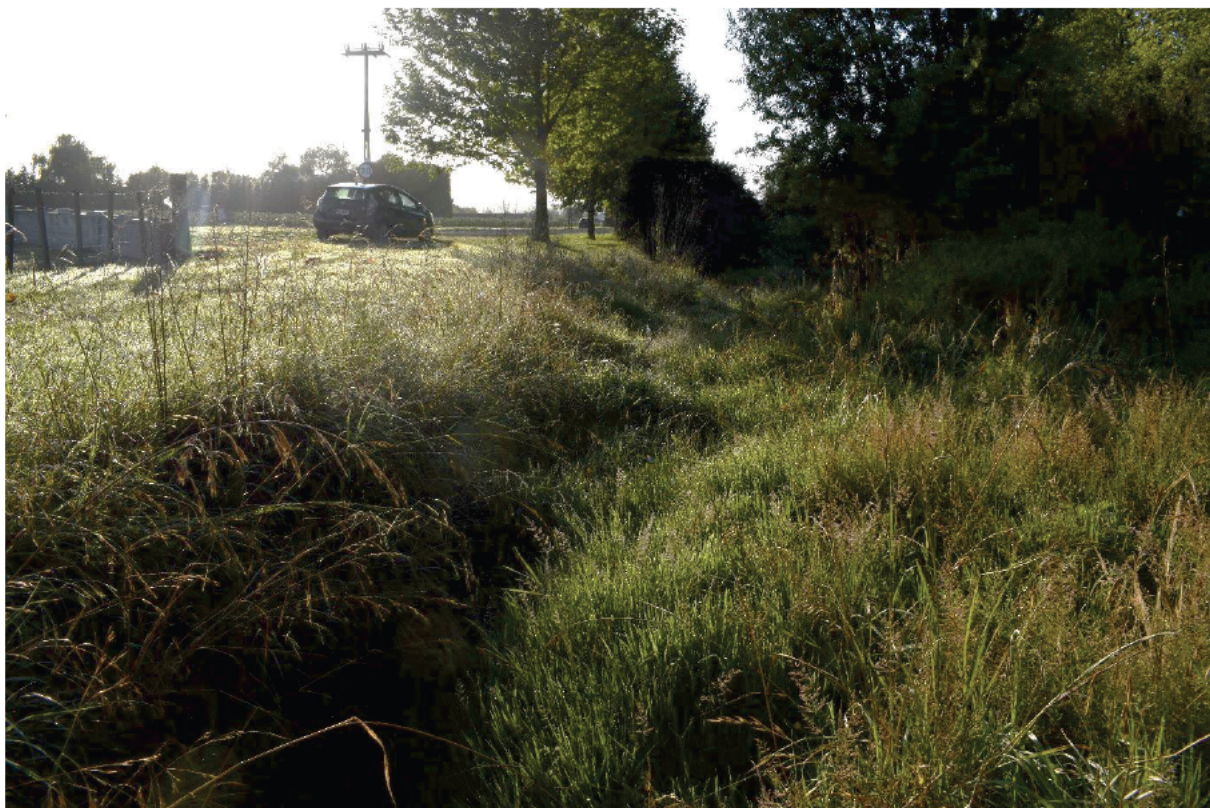
Figure 13: Wetland area W1 associated with watercourse 2 stream channel

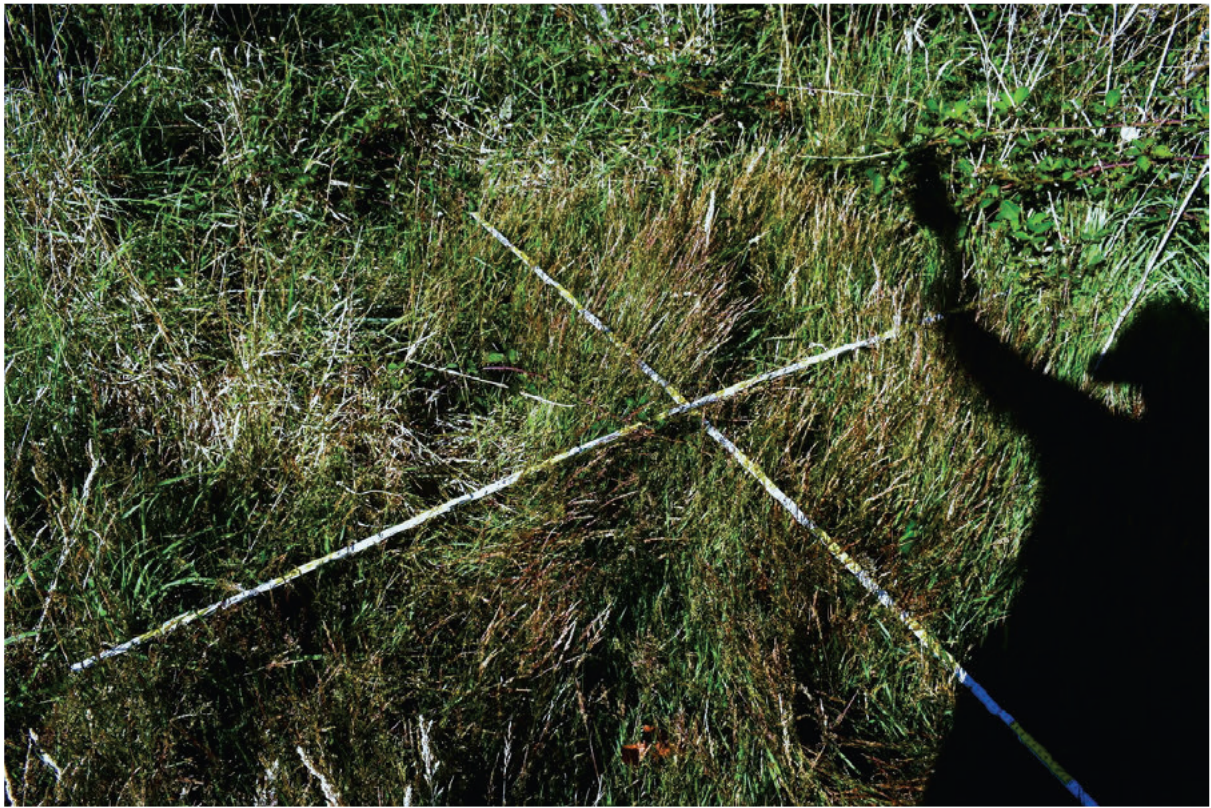
Figure 14: Wetland W3 — survey quadrat on the modified streambed of Watercourse 1: an exotic-dominated ephemeral feature rather than a self-sustaining wetland

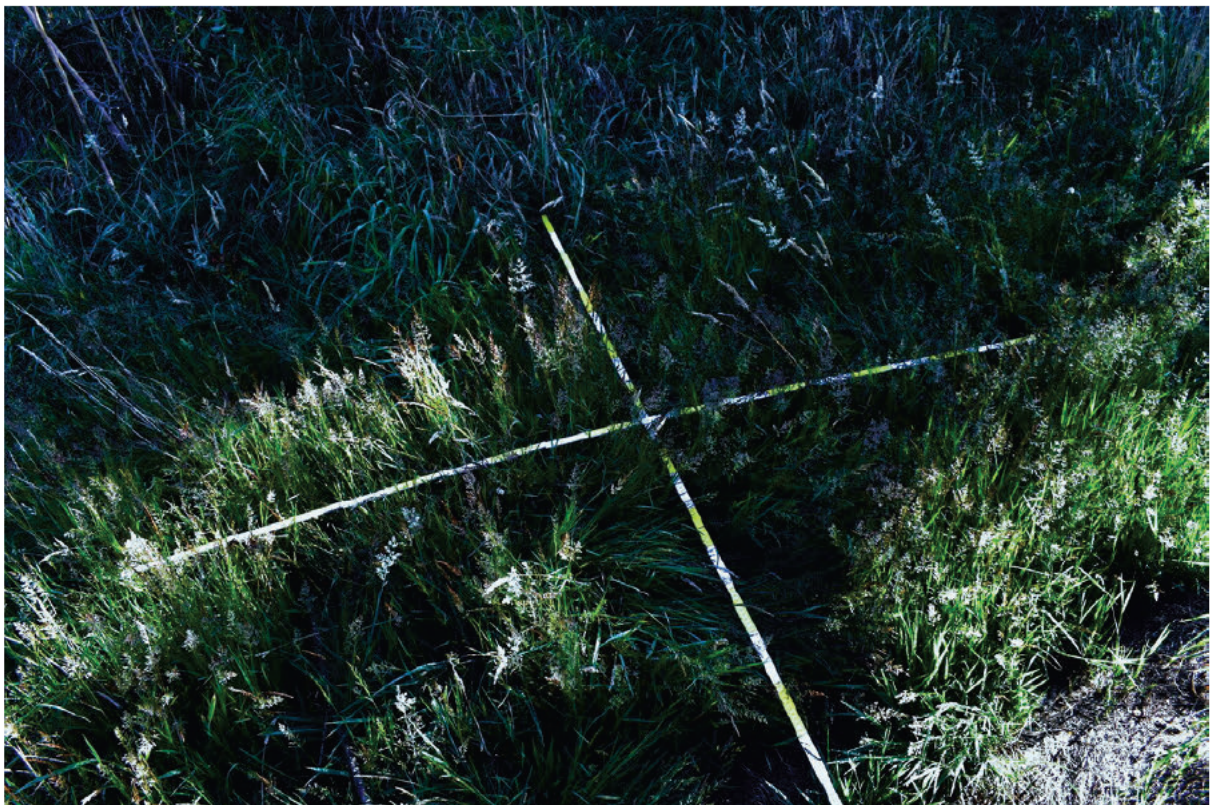
Figure 15: Wetland W4 — survey quadrat showing the exotic-dominated ephemeral feature on the Watercourse 1 channel bed

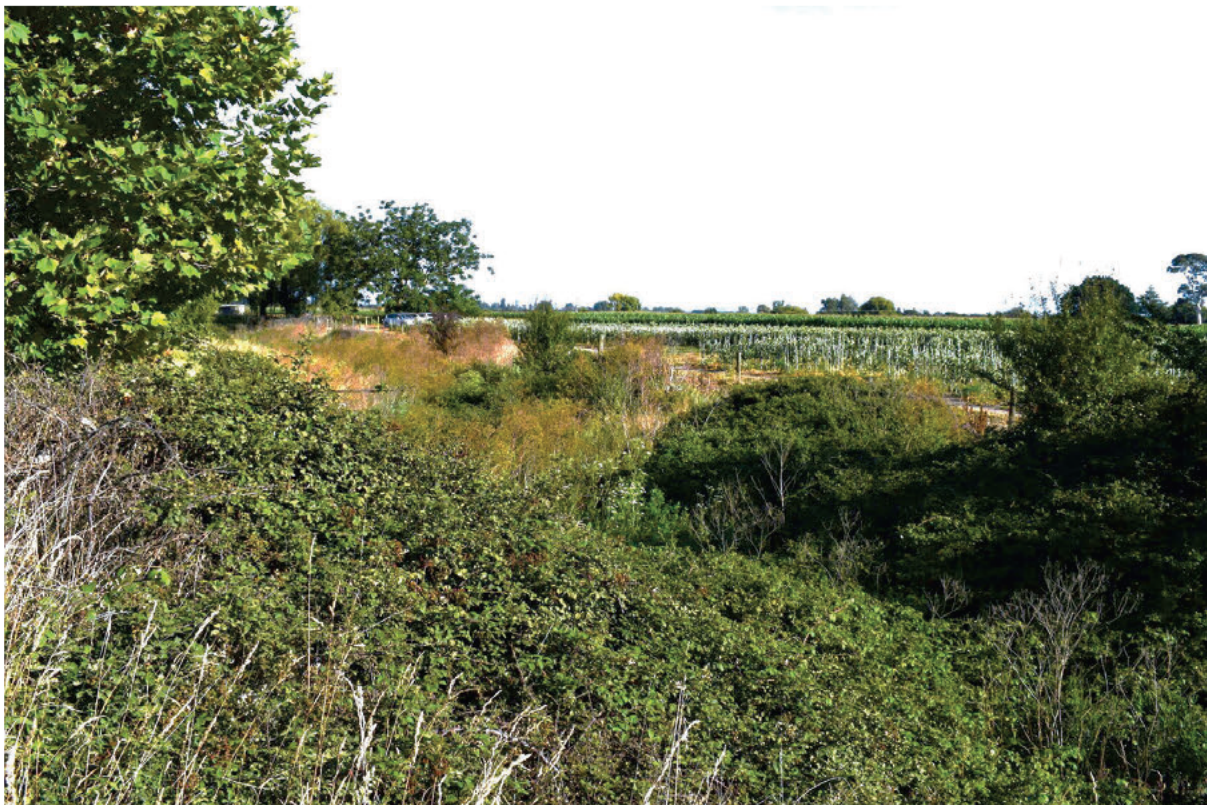
Figure 16: Watercourse 1 — representative channel cross-section recorded during the January 2025 survey: the bed and banks are vegetated, with no defined low-flow channel and no surface water

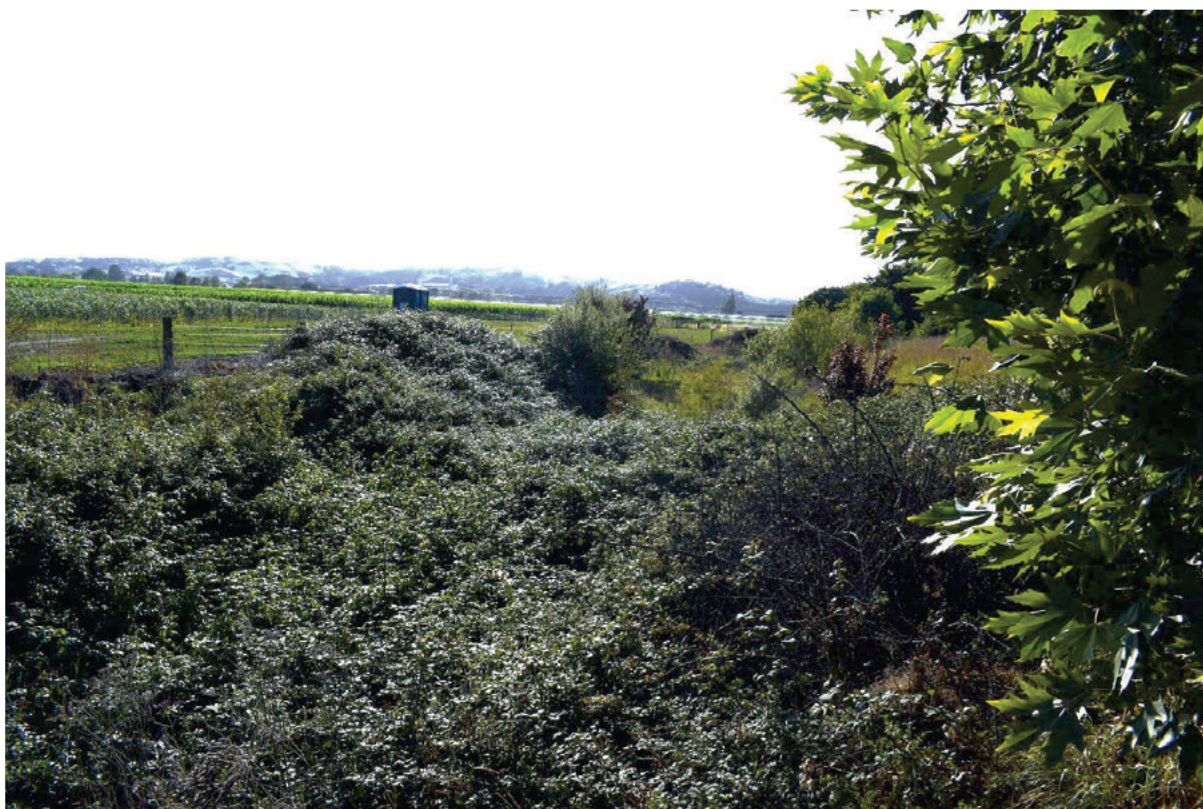
Figure 17: Watercourse 1 — channel overgrown with rank grasses and blackberry and no wetted channel, typical of conditions from the upper catchment to Brookvale Road

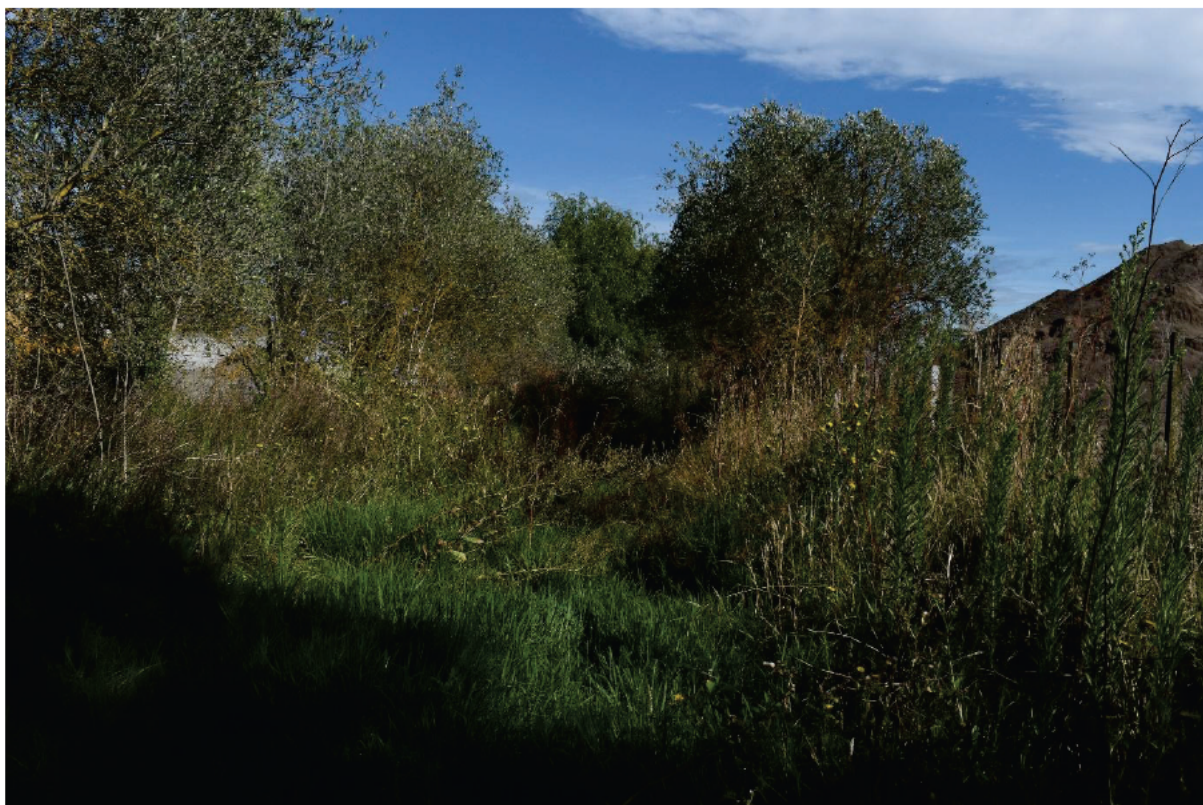
Figure 18: Watercourse 2 – channel largely overgrown blackberry and no wetted channel, typical of conditions from the upper catchment to Brookvale Road

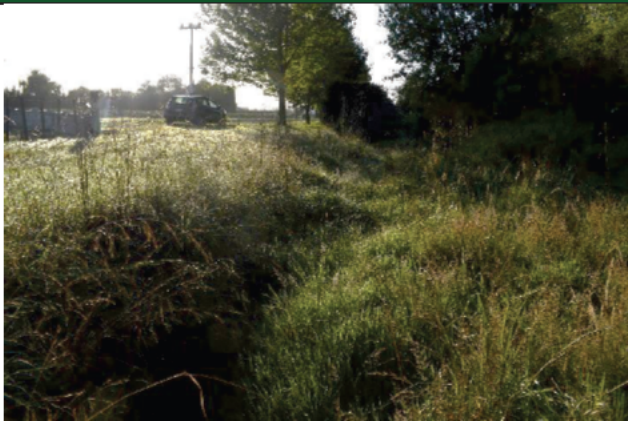
| ID | Technical definition | Reasoning | Stream length within site boundaries | Characteristics | Ecological value | Representative photo |
|---|---|---|---|---|---|---|
| 2 | Intermittent stream | Stream bed can be identified, some evidence of historic water flows. Mostly dry during site visit in January 2025 | 484 m | A linear watercourse runs through the central portion of the site, with clearly identifiable bed and banks, suggesting it is likely subject to regular maintenance. Surface water was observed only along the northern section, likely caused by a backwater effect due to an undersized culvert beneath Brookvale Road. The remainder of the watercourse is heavily modified, with multiple stormwater pipe outlets directing runoff into the stream. Shortfin eel ( <i>Anguilla australis</i> ) were recorded within this watercourse. The average bankfull width is approximately 2 meters; however, this measurement reflects the modified, artificially created channel rather than the original natural stream dimensions. | Very low | |

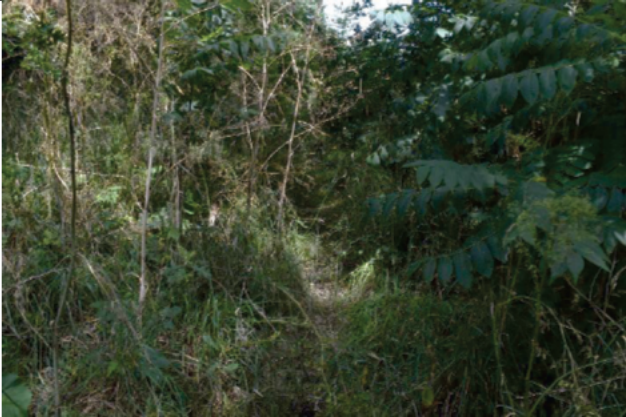
| ID | Technical definition | Reasoning | Stream length within site boundaries | Characteristics | Ecological value | Representative photo |
|---|---|---|---|---|---|---|
| 4 | Intermittent stream | Stream bed can be identified, some evidence of historic water flows. Dry during site visit in January 2025 | 93 m | This watercourse likely conveys channelised flows from artificial waterways that have been diverted toward Watercourse 1. The majority of its length is overgrown with common exotic pasture species, with no riparian vegetation present aside from pastoral grasses. While some sections are wet underfoot, the stream is largely dry. The average bankfull width is approximately 1.1 meters. Given its condition, it is unlikely to provide suitable habitat for fish species. | Very low | |

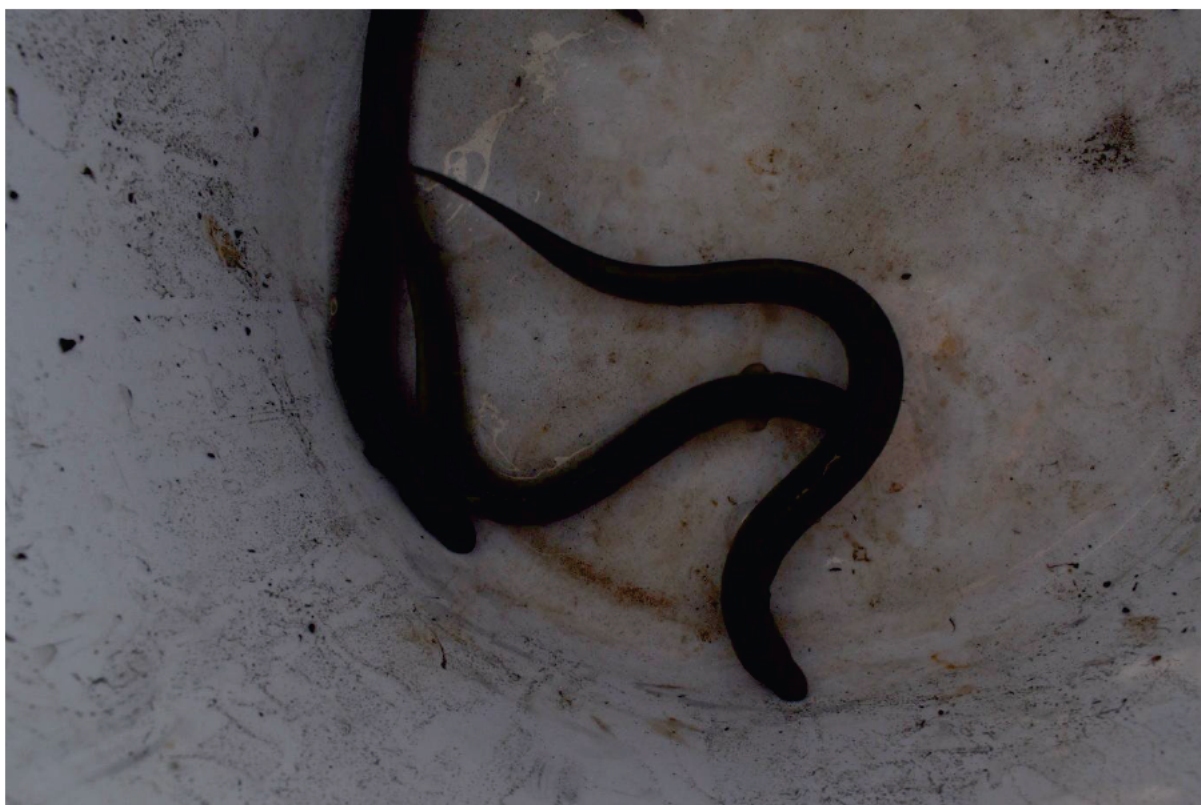
Figure 20: Only a low number of shortfin eel were recorded within stream catchment 2

It is noted that the only fish species recorded on site during field surveys were shortfin eel (*Anguilla australis*) (see Figure 20). These species are disturbance tolerant and have adapted to various forms of environmental disturbance, such as changes in water flow, ongoing dredging or habitat degradation. It is likely that following cessation of the sites horticultural use, and watercourse ongoing maintenance, and re-naturalising of the watercourses on site, a wider range of indigenous fish species may inhabit the site.
