## APPENDIX E – Insight Engineering Contaminated Land Report

## **Remediation Action Plan for the Parkburn Quarry at 922 Luggate- Cromwell Road (SH6), Cromwell**

**Prepared for:** Fulton Hogan Land  
Development

**Date:** 16/07/2026

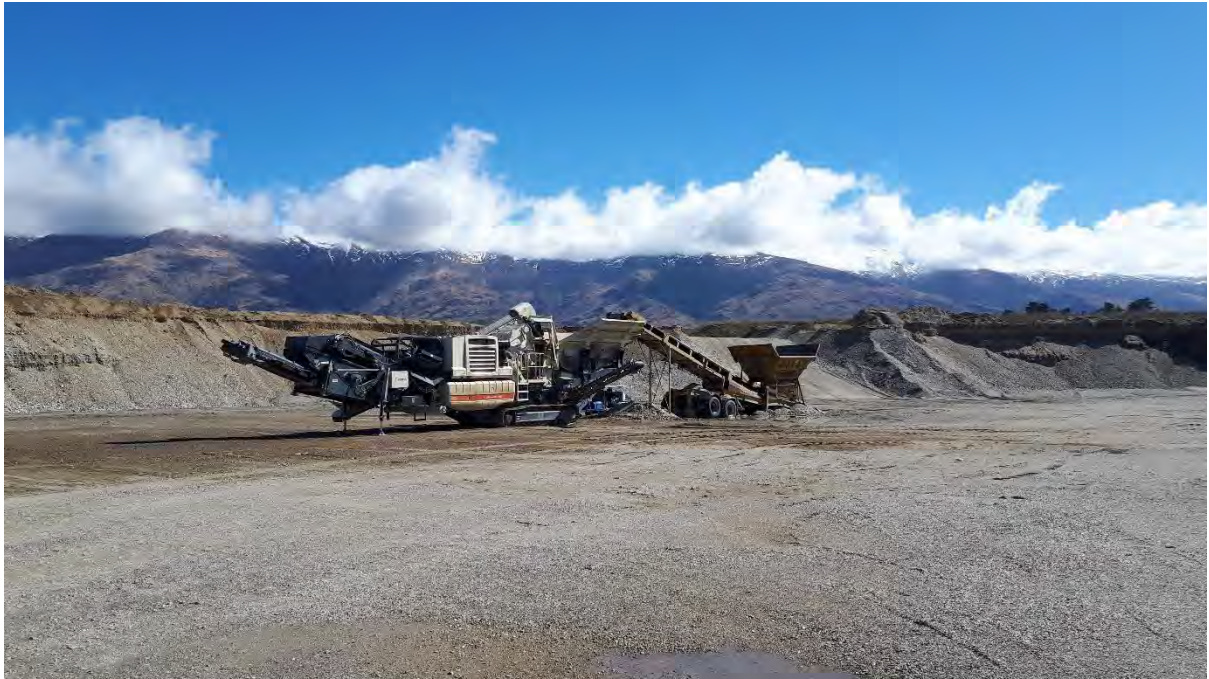
**Figure 5: Mobile crusher within Schedule Activity portion of quarry.**

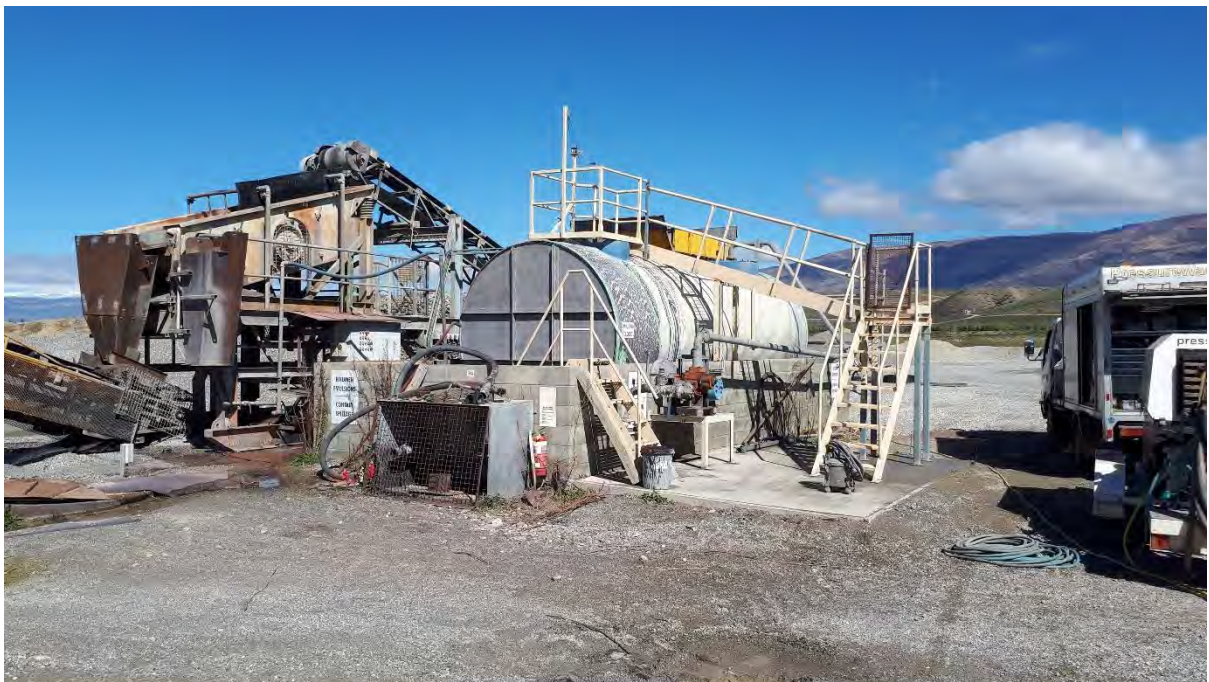
**Figure 6: Bitumen spray plant within quarry.**

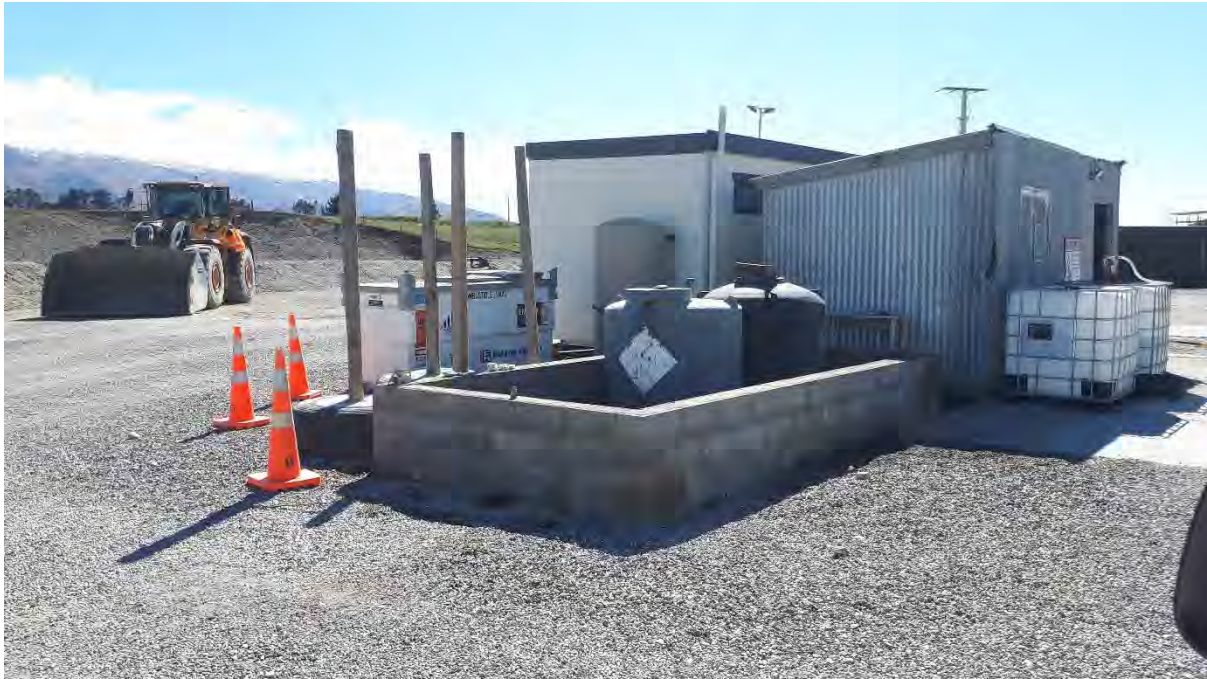
Figure 7: Fuel and waste oil storage within quarry.

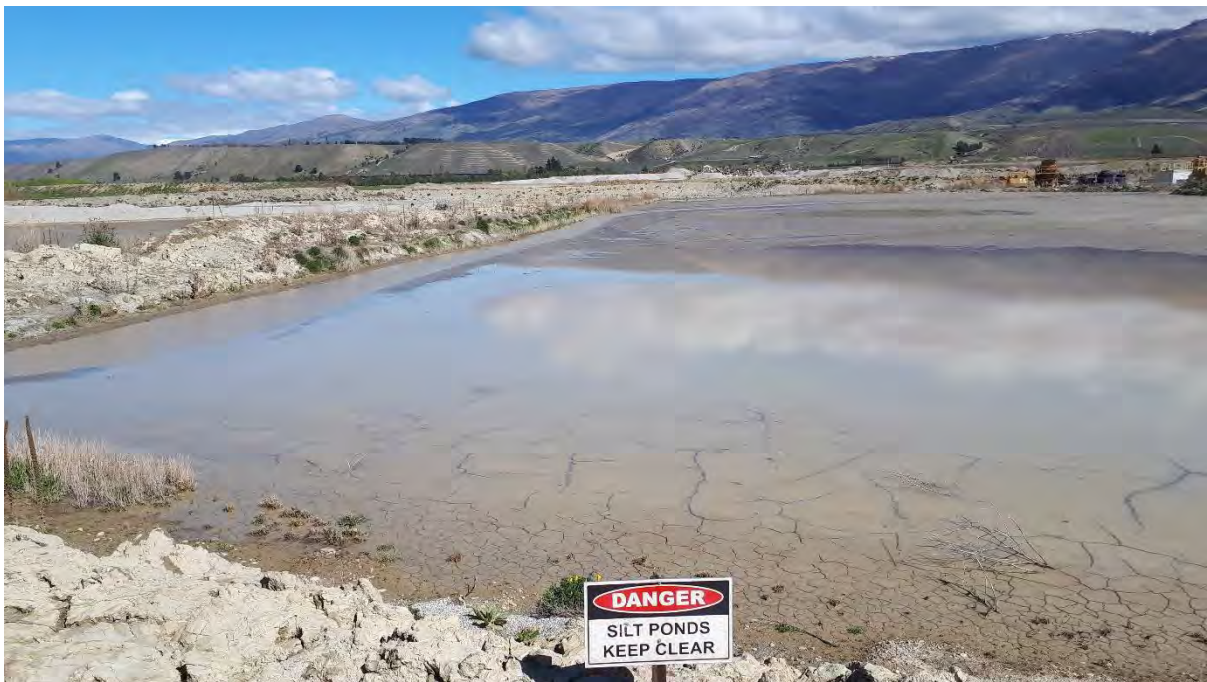
Figure 8: Silt ponds for treatment and disposal of quarry plant wash water.

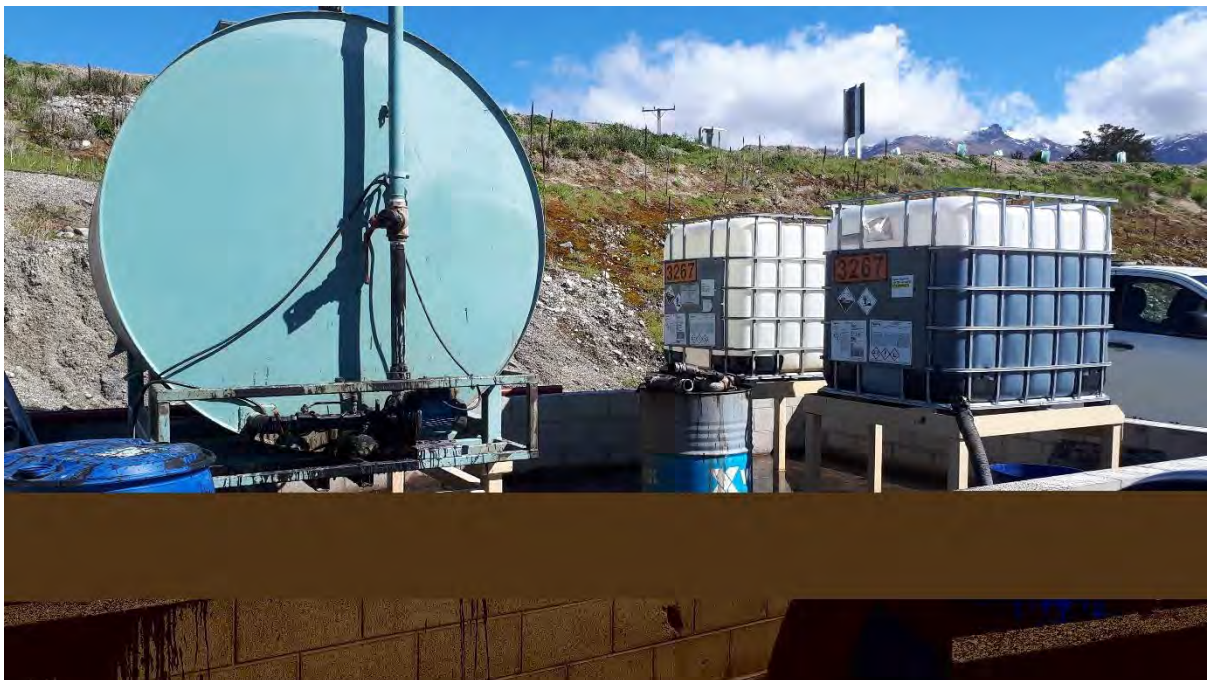
**Figure 10: Bitumen storage at the asphalt plant.**

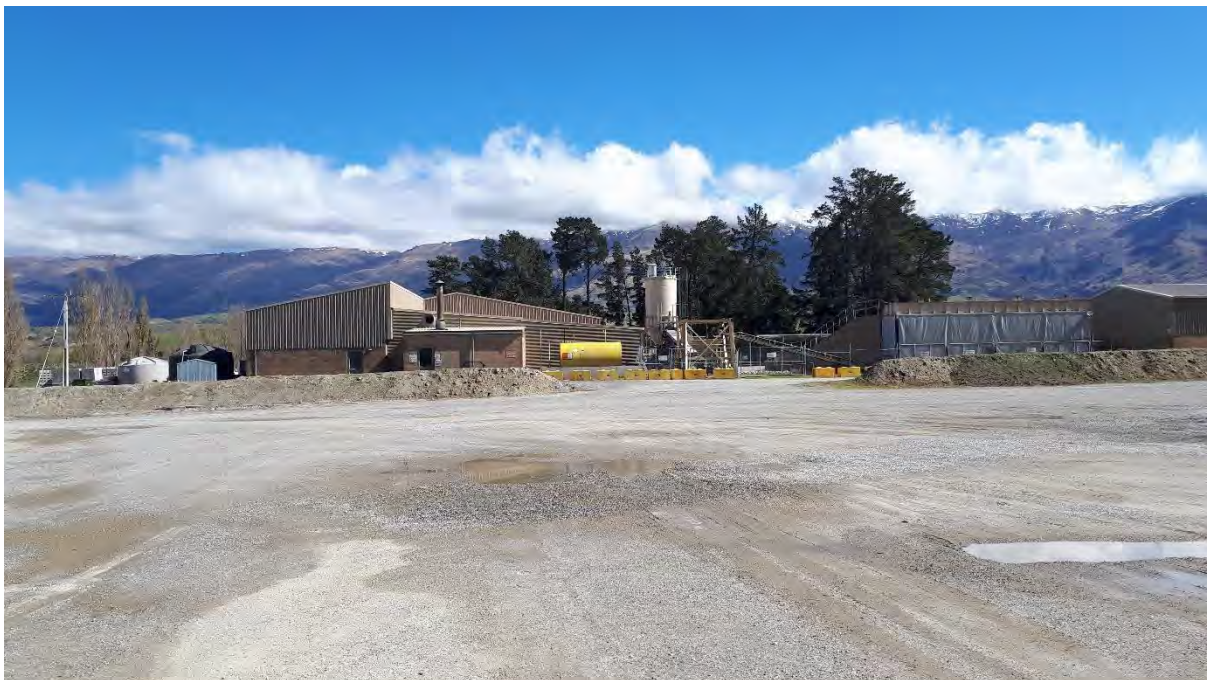
**Figure 12: Firth concrete block plant, with concrete silo (white) and diesel tank (yellow) in background.**

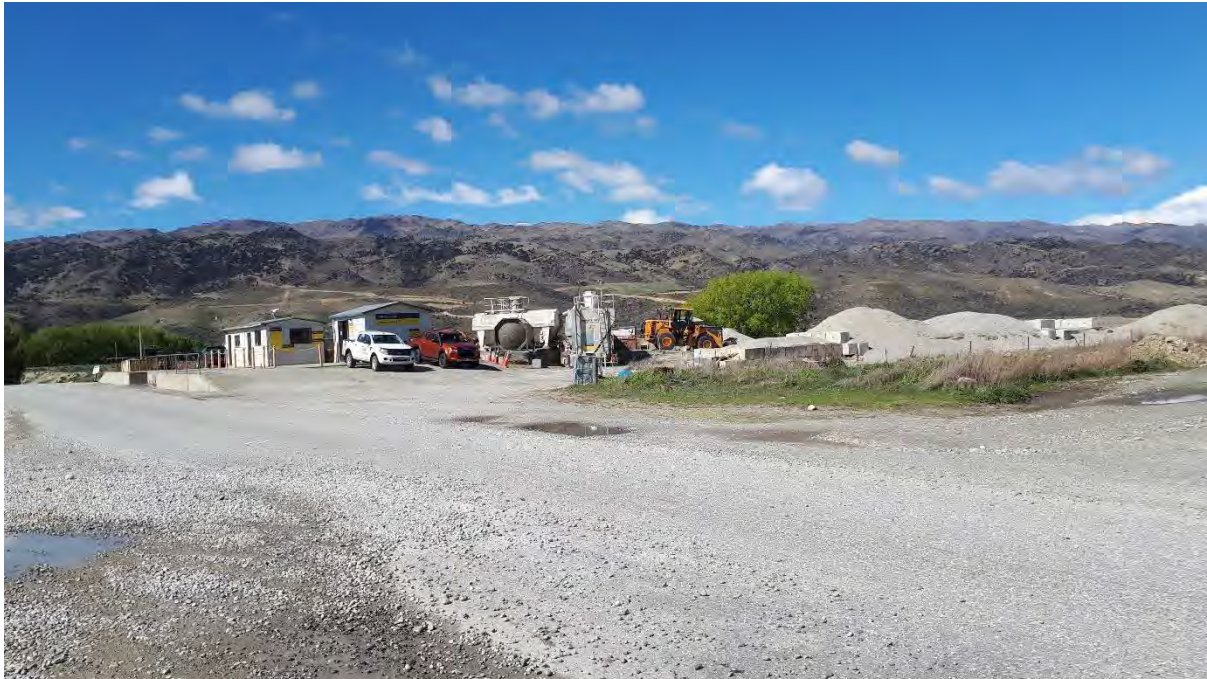
**Figure 13: Allied concrete batching plant.**

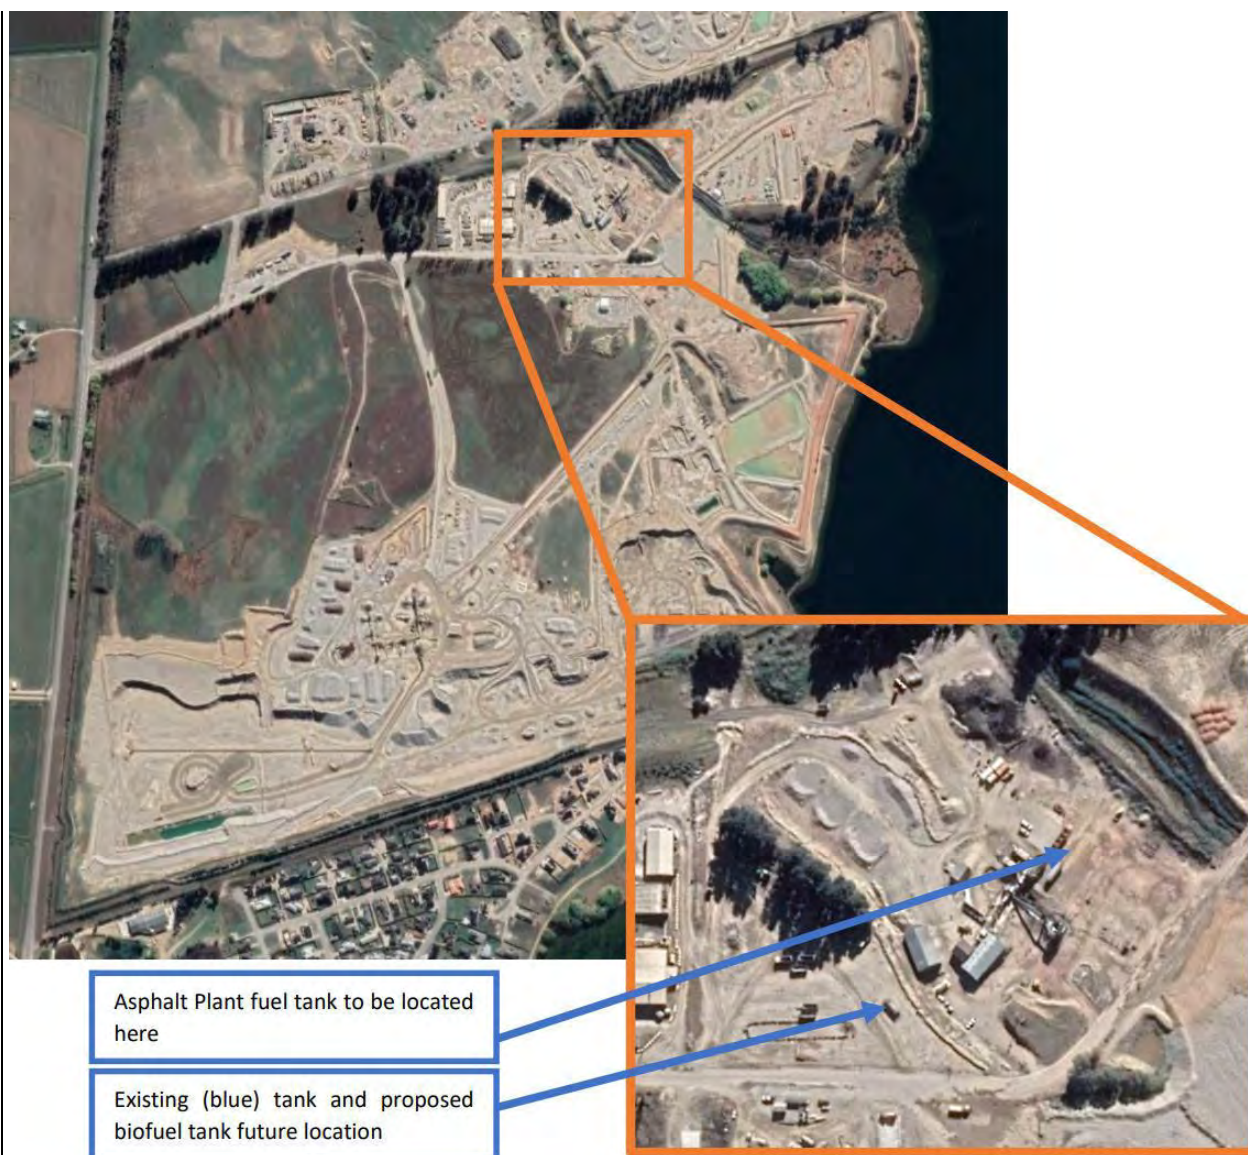
Figure One: Extract from application for RC 210129 showing location of pre-existing and proposed fuel tanks.

- 16/08/2021 RC 210129: Land use consent to install two 20,000L diesel fuel tanks to replace one diesel tank which is to be removed
- Information provided with the application indicates the presence of fuel storage tanks, and an asphalt plant. Fuel storage and asphalt manufacture and bulk storage are items A17 and E2 on the HAIL and may trigger NES-CS requirements.*
