# Belmont Quarry Development – Part B

Substantive Application  
Appendix B.3 – Contamination Reports  
Winstone Aggregates

Substantive Application  
Appendix B.3.A – PSI/DSI – OBDA  
Winstone Aggregates

## **PRELIMINARY AND DETAILED SITE INVESTIGATION - BELMONT QUARRY – PROPOSED OVERBURDEN DISPOSAL AREA**

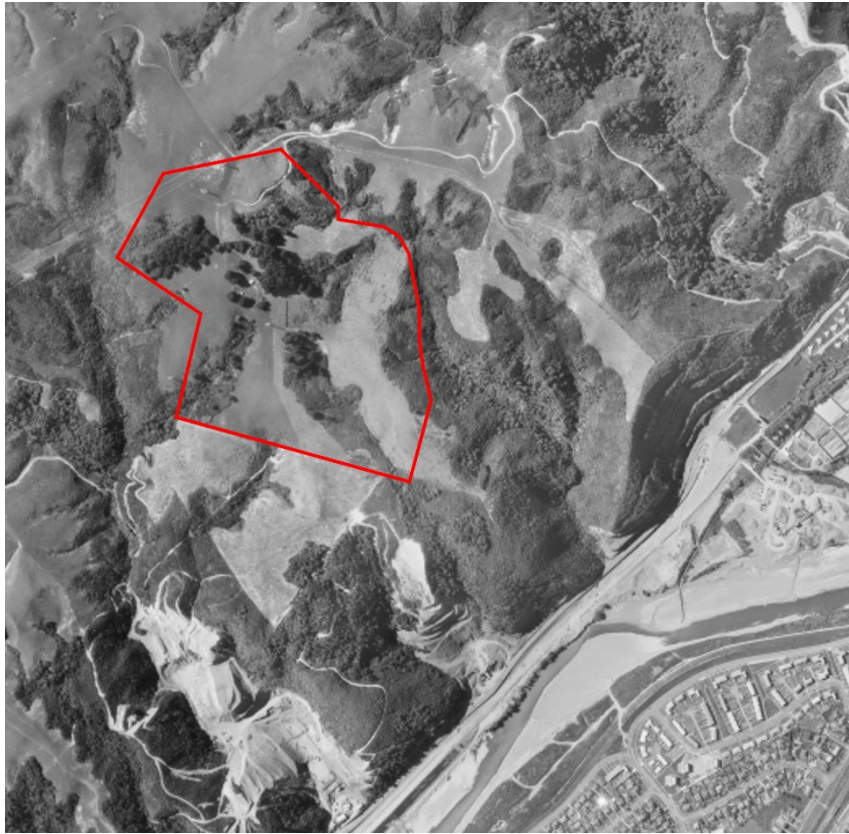
| Date | Description |
|---|---|
| 1957 | Dense vegetation cover is present across most of the site. Three pylons are visible in the north-western, central and south-western areas of the site. No other significant changes were observed. |

**Historical Aerial Photograph 3: 1966 (Retrolens)**

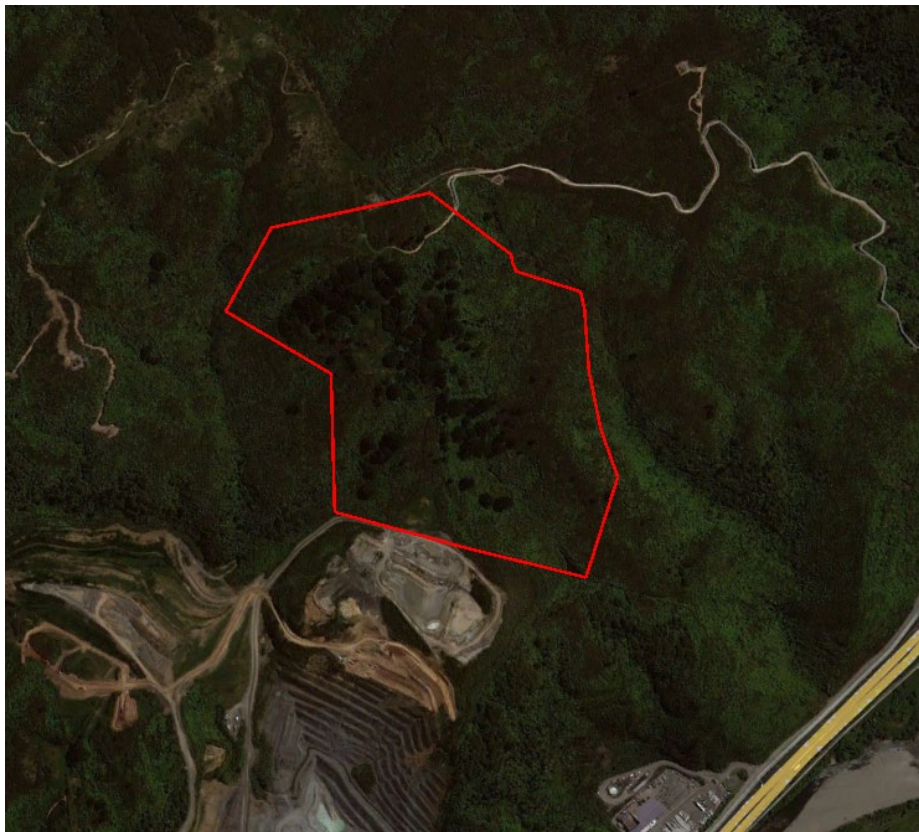
| 2009 | The minor ground disturbance previously observed has been revegetated. No other significant changes were observed. |

**Historical Aerial Photograph 7: 2009 (Google Earth Pro)**

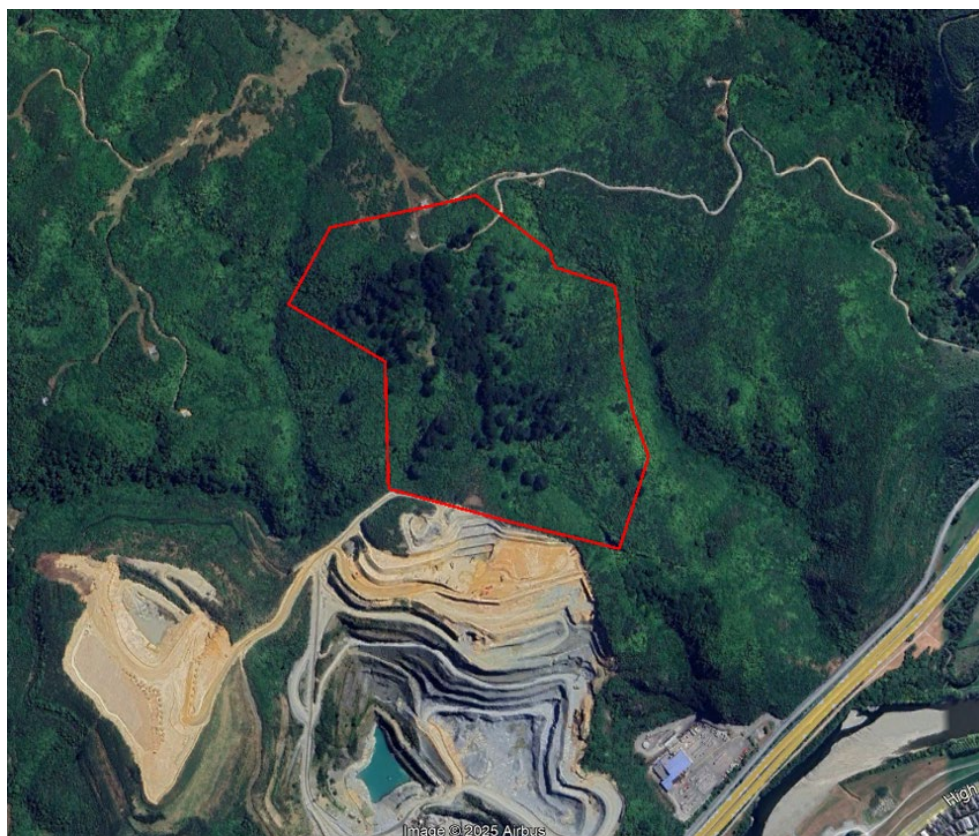
| 2024 | No significant changes observed from the 2009 aerial image. |

**Historical Aerial Photograph 10: 2024 (Google Earth Pro)**

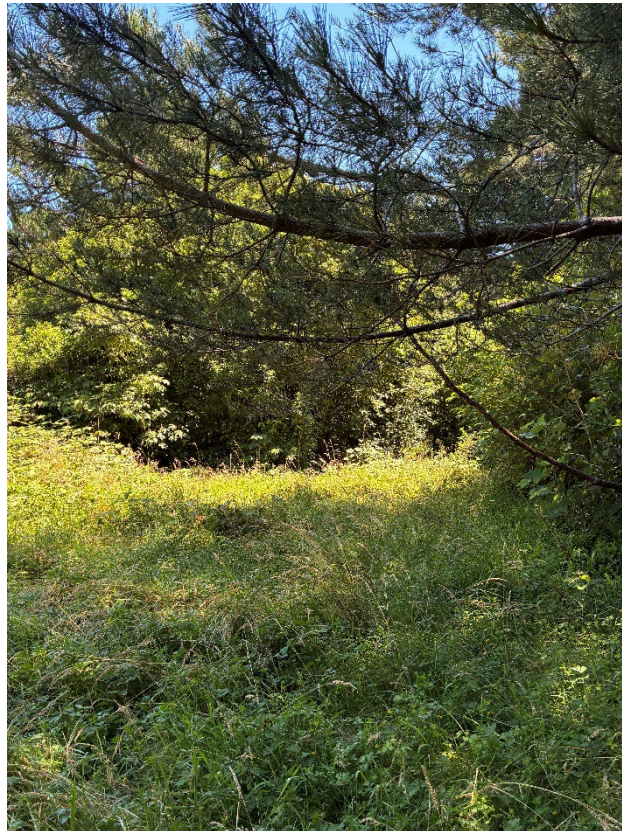
**Photograph 2: General overview of cleared area.**

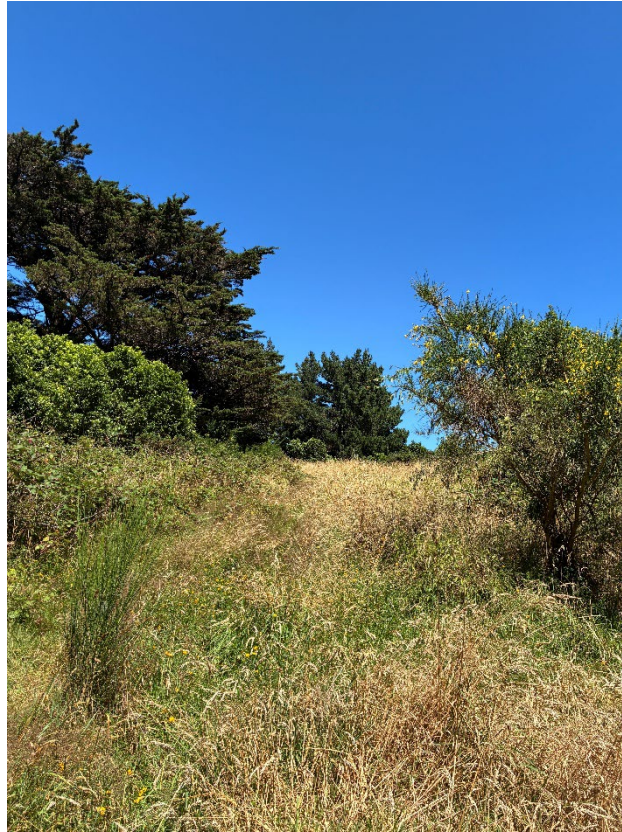
**Photograph 3: General overview of shorter vegetation, looking south.**

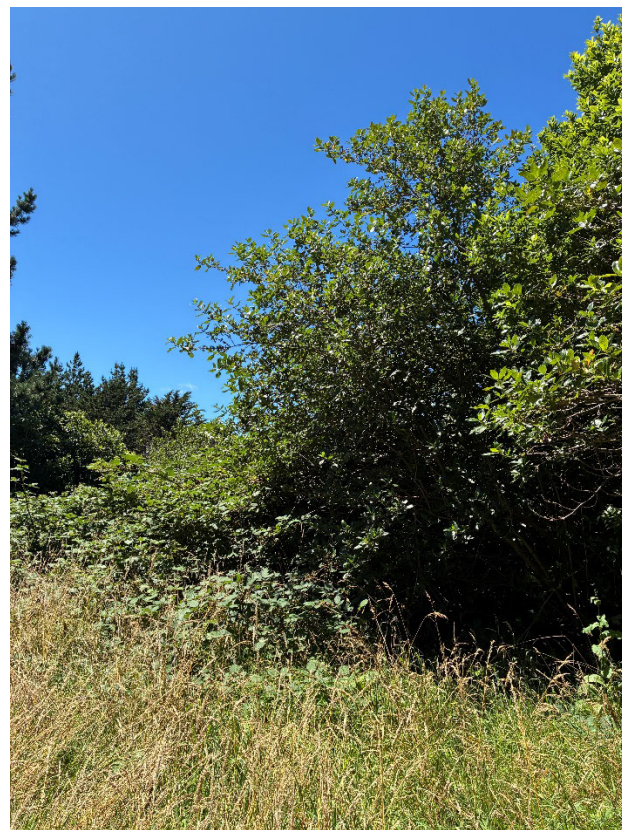
**Photograph 4: General overview of dense vegetation, looking southwest.**

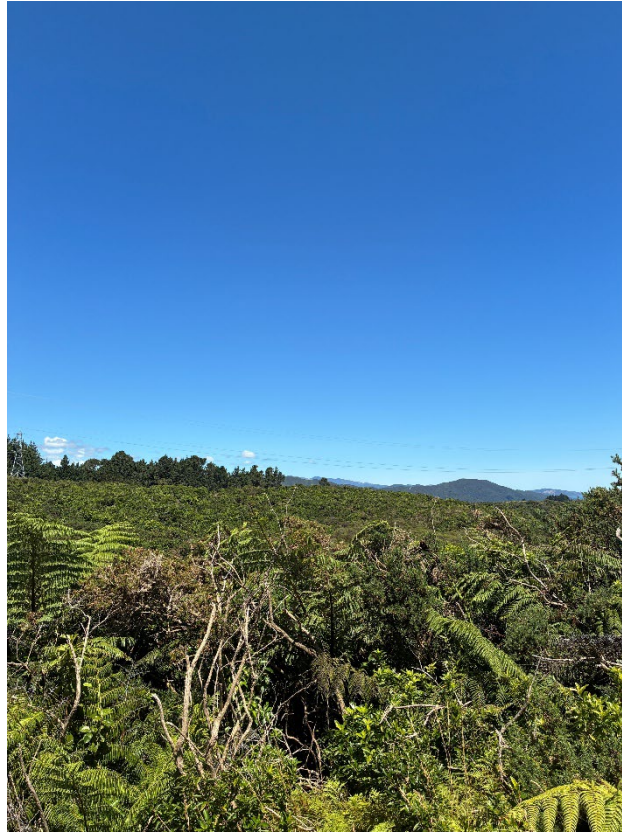
**Photograph 5: General overview of dense bush looking southeast.**

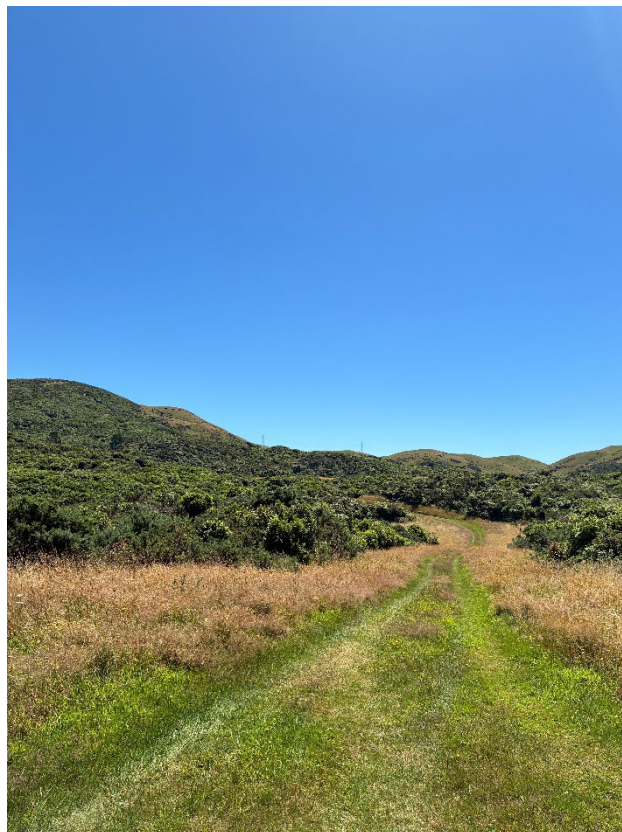
**Photograph 6: Access track to the north of the site, looking north.**

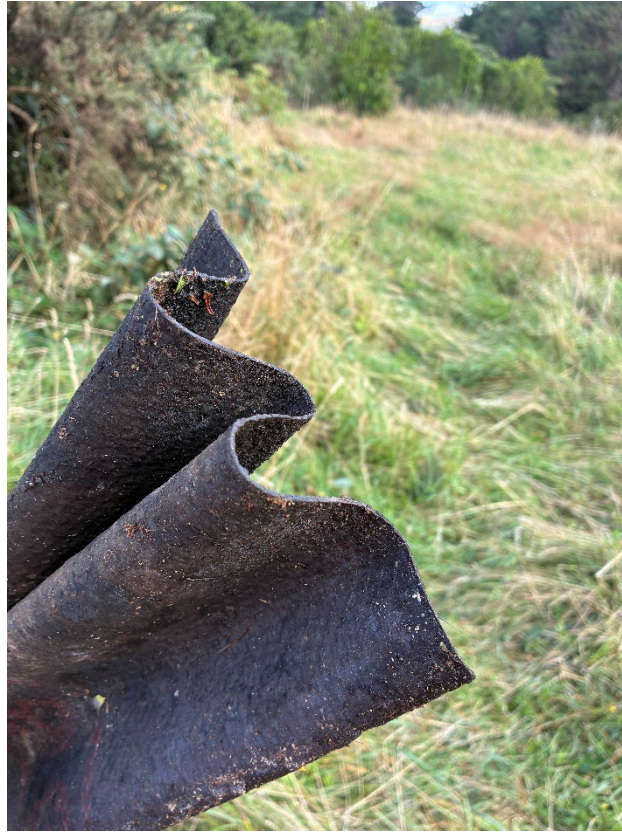
Initial soil sampling was undertaken on 18 February 2026 at six targeted locations (SS01 – SS06), with soil collected at the near-surface (0.0 m bgl) and at 0.3 m bgl to characterise soil conditions and to assess the presence of potential contaminants. Select samples were analysed for key contaminants of concern (see Table 3). Following a review of the initial analytical results (refer to Section 12), delineation sampling was undertaken 4 March 2026 at a further 16 locations positioned at regular intervals (1 m, 2 m, 5 m, and 10 m) from the original source areas. Delineation samples were collected at depths of 0.05 m bgl, 0.3 m bgl and 0.5 m bgl. Furthermore, sampling was completed at one additional location (SS07) adjacent to the former dwelling and one location adjacent to metal sheeting (SS08) at depths of 0.05 m bgl, 0.3 m bgl and 0.5 m bgl, and an additional deeper sample was collected at the original SS03 location at a depth of 0.5 m bgl. Additionally, one bulk material sample comprising corrugated roofing material recovered from at SS01 was collected.

**Photograph 7: Photo of potential asbestos at SS01.**

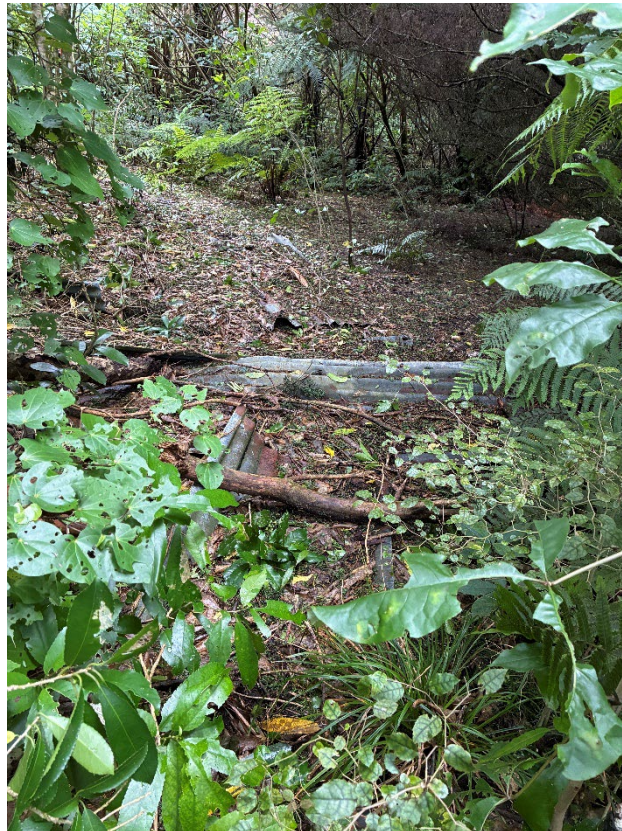
| Target Area Observations | Sample Location | Site Walkover Photograph Reference | Sampling Rationale |
|---|---|---|---|
| Degraded metal sheeting | SS03 | Photograph 8 | Heavy metals and potential asbestos associated with historical onsite structures and activities. |

Surface samples within the vicinity of exposed metal sheeting and the roof structure (SS03, SS04 and SS05) all contained elevated zinc and cadmium within shallow soils, with the greatest concentrations noted to be 4,100 mg/kg (SS03\_0.0) and 9.1 mg/kg (SS03\_0.0) respectively. Zinc concentrations generally decreased

**Photograph 8: Example of metal sheeting at SS03 and SS04.**

Out of the 22 samples, a total of four samples exceed the Class 3 criteria for zinc (1,200 mg/kg) with concentrations ranging from 1,210 mg/kg to 4,100 mg/kg. However, given the observed localised sources of this contamination it is considered that these exceedances are likely to be isolated hotspots associated with the degradation of metal sheeting.

- The results of the intrusive investigation indicate zinc concentrations in the delineated, immediate surrounds of the degraded metal may pose a risk to the ephemeral streams onsite if not managed and as such meet the threshold for HAIL category I. As such, it is considered that in relation to soil disturbance, the HAIL 'piece of land' as described by the NESCS, pertains to a minimum 2 m radius area surrounding the metal and machinery and a minimum 3 m radius at SS08. This soil will require offsite disposal at a Class A landfill. Additional delineation sampling will be required during remedial excavation work at the site to confirm the extent of the "hotspot" areas. Additional sampling will be completed during remedial works in the vicinity of the secondary piece of machinery that was unable to be sampled during the PSI/DSI. The results will be used to determine contaminant concentrations and guide the appropriate remedial management of any identified contamination.

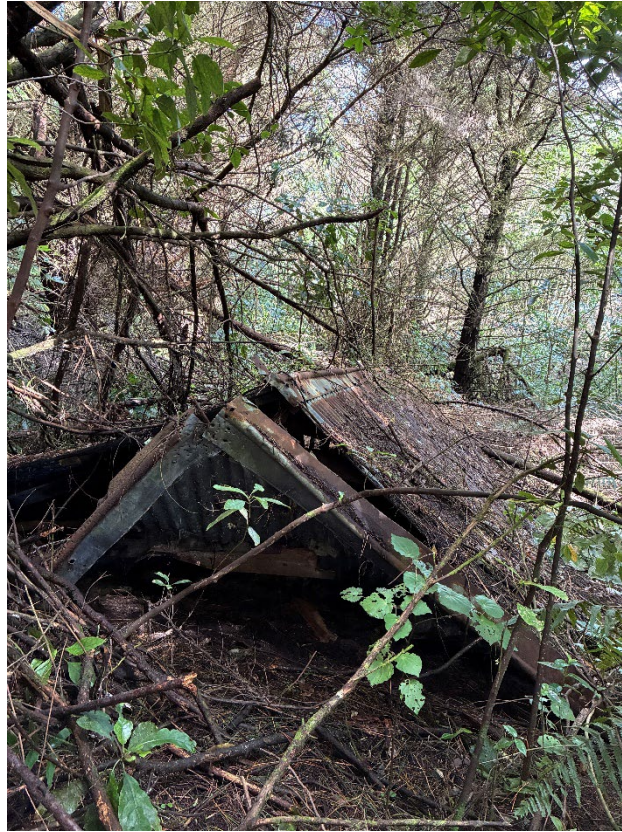
Slightly elevated lead was observed in SS03a\_0.05, SS03b\_0.05, SS05a\_0.05 and SS05a\_0.3 at concentrations between 210 mg/kg (SS05a\_0.05) and 370 mg/kg (SS05a\_0.3).

**Photograph 9: Roof structure at former dwelling (SS05).**

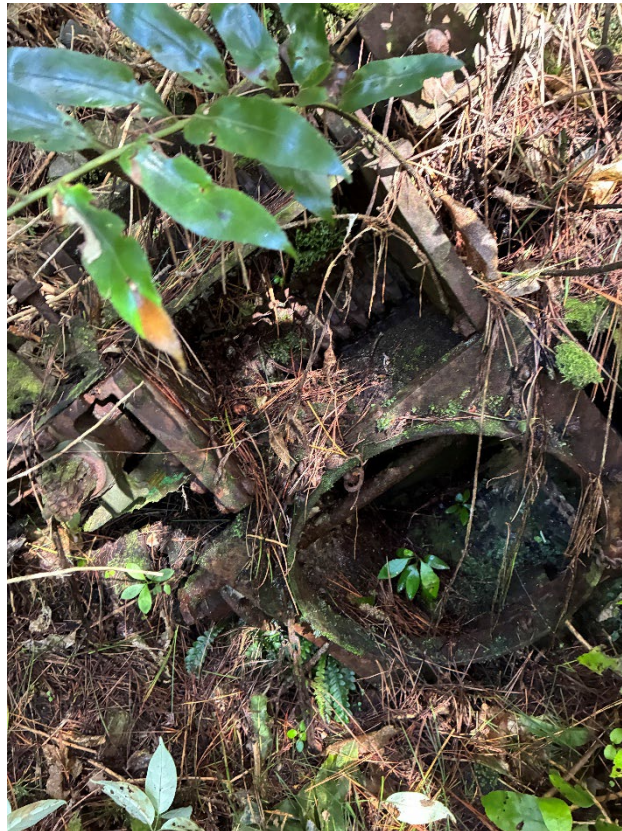
- ✧ Abandoned farm machinery was observed in two locations, at the head of a gully and near the stream, both in the north-eastern part of the site.
- ✧ A pile of corrugated roofing material was observed in the south-western portion of the site.

- ✧ Eight soil samples collected at 0.05 m bgl and 0.3 m bgl immediately adjacent to the degrading metal sheeting (SS03 and SS04), the former roof structure (SS05), and the abandoned farm equipment (SS06) were analysed for a suite of heavy metals (arsenic, cadmium, chromium, copper, lead, nickel and zinc).

**Photograph 10: Example of abandoned machinery at SS06.**

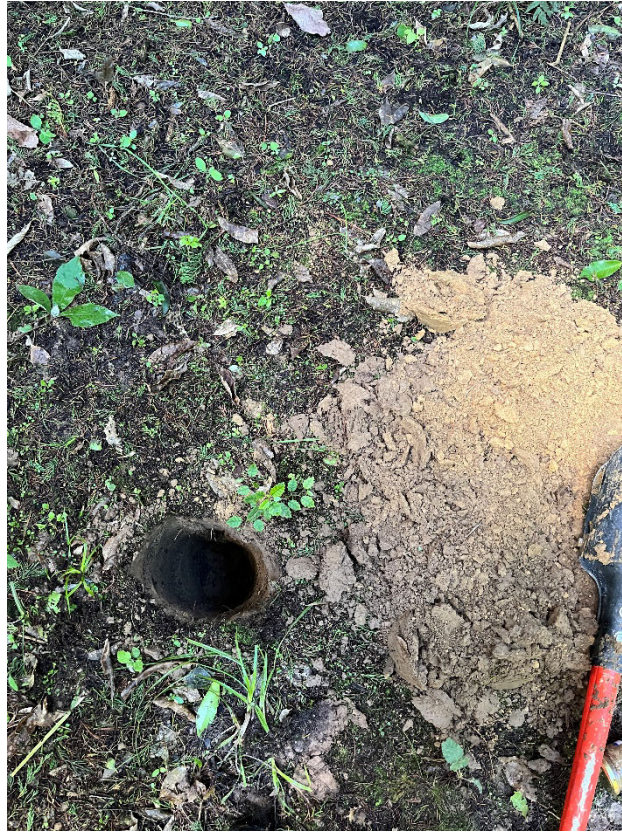
The lithology across the site was generally comparable. During soil sampling, the following was observed:

- ✧ Glass fragments were observed at the surface at SS03 and SS04.
- ✧ The surface samples comprised a brown silty leaf litter, underlain by a medium brown sand at SS01 and a brown silty clay across the other sampling locations.
- ✧ Water was encountered at 0.3 m bgl in SS03 and at 0.2 m bgl in SS06. This water is interpreted to be perched surface water, likely resulting from recent rainfall, with infiltration restricted by the underlying clayey soil matrix.
- ✧ Corrugated roofing material, suspected to comprise ACM, were observed at sampling location SS01. No other suspected ACM was observed.
- ✧ No staining or olfactory evidence of contamination was noted on any soil material.

**Photograph 11: General overview of lithology encountered.**

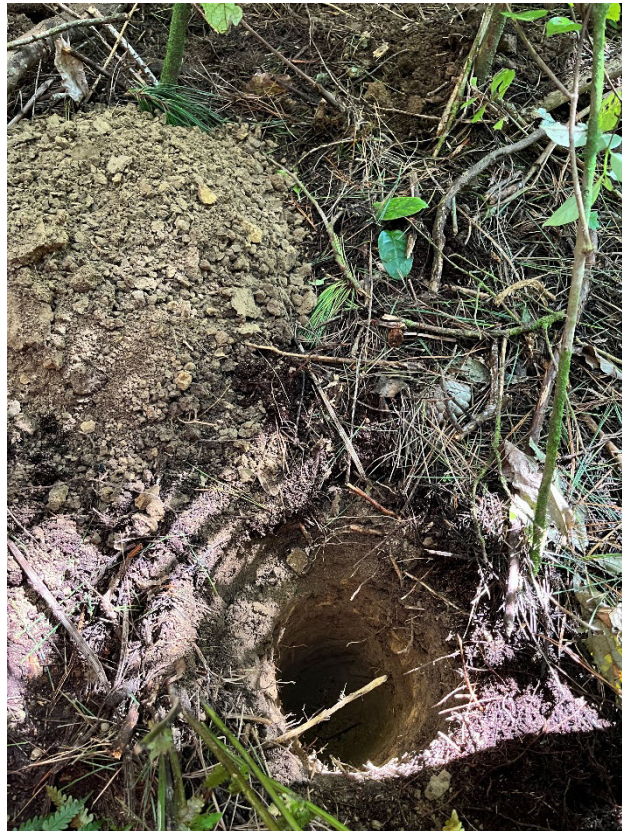
**Photograph 12: General overview of lithology encountered.**

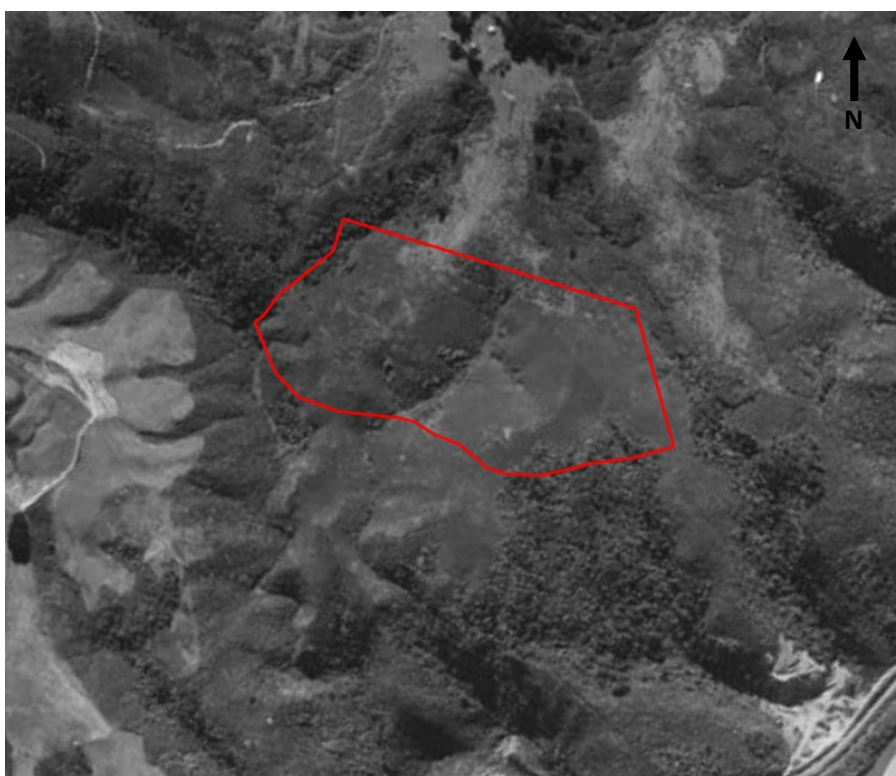
**Photograph 2: 1957 sourced from Retrolens**

| Date | Reference | Description |
|---|---|---|
| 1957 | Photograph 2 | The site appears to have obtained more bush/vegetative cover. |

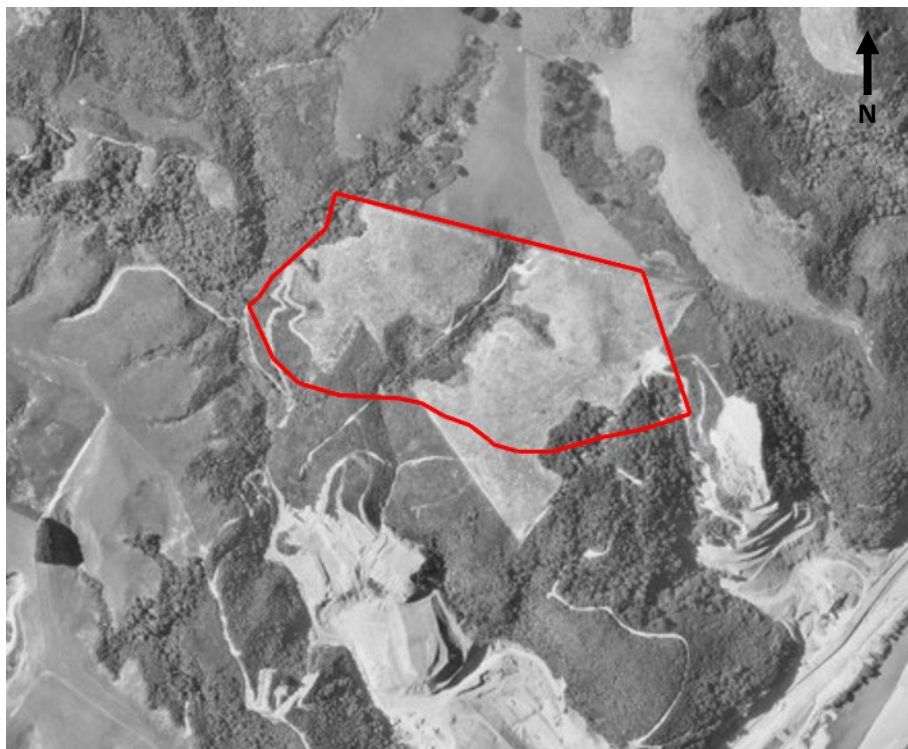
**Photograph 3: 1966 sourced from Retrolens**

| Date | Reference | Description |
|---|---|---|
| 1966 | Photograph 3 | The site appears to have been developed into farmland with some areas of bush remaining centrally and to the west and southeast of the site. Multiple tracks are observed through the central, eastern and western areas of the site, with the far eastern area of the site. Belmont Quarry is located offsite and is now visible to the south of the site. |

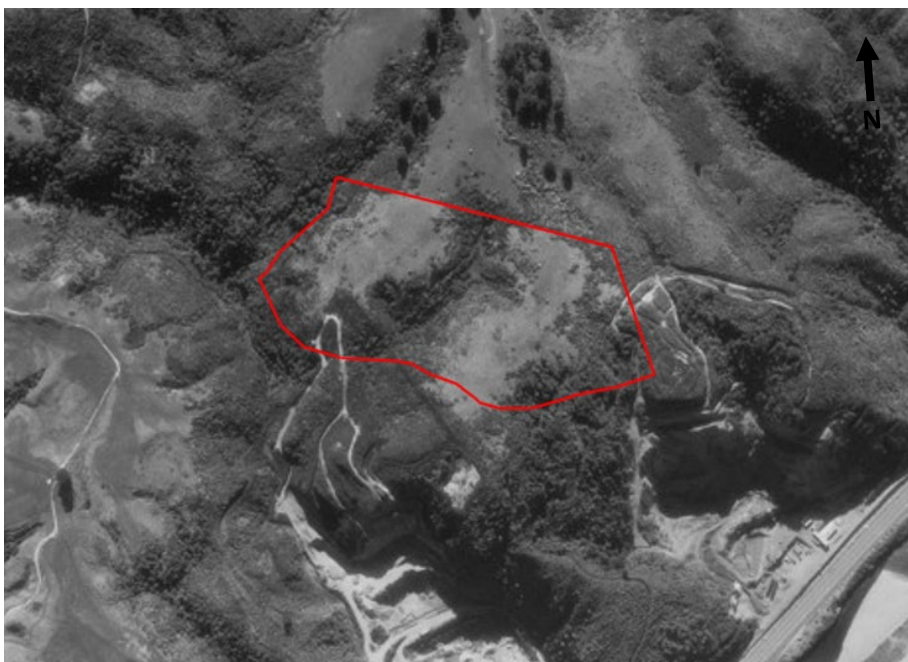
**Photograph 4: 1984 sourced from Retrolens**

| Date | Reference | Description |
|---|---|---|
| 1984 | Photograph 4 | The site appears to have more vegetative cover, and a track, connected to Belmont Quarry, intersects the southwestern area of the site. |

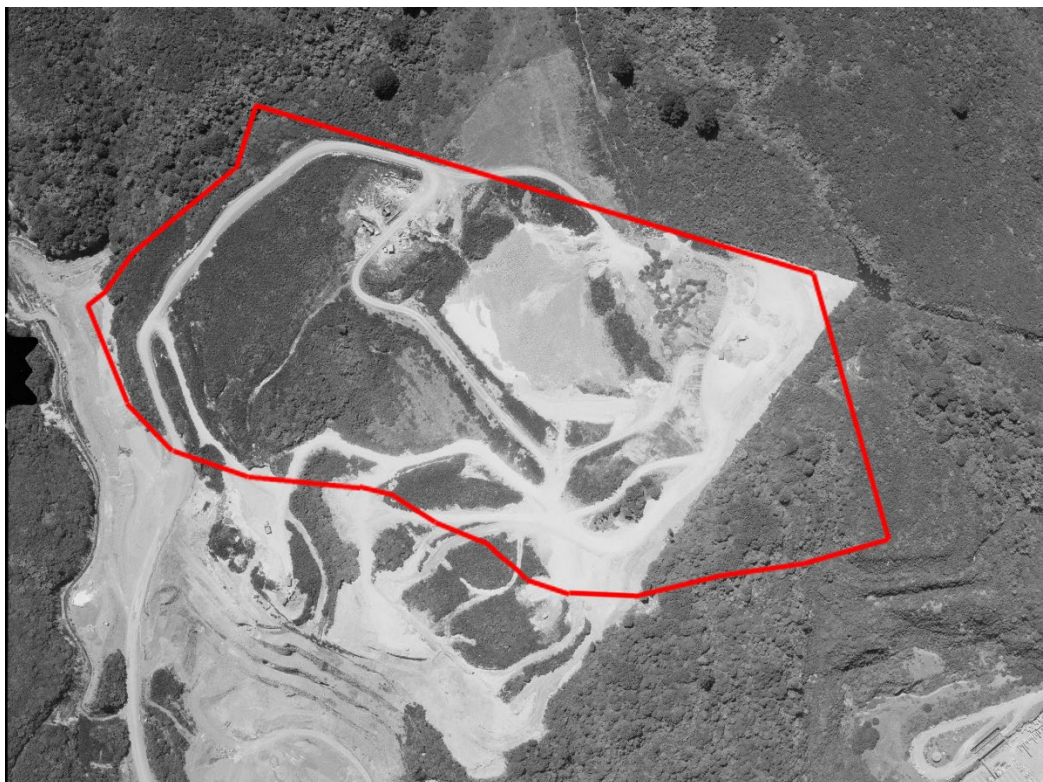
**Photograph 6: 1996 sourced from Retrolens**

| Date | Reference | Description |
|---|---|---|
| 1996 | Photograph 6 | The quarry area has been further developed to the east of the site. Further miscellaneous items, equipment and tyres are observed in the northern area of the site. A small cleared area is present offsite to the northeast. |

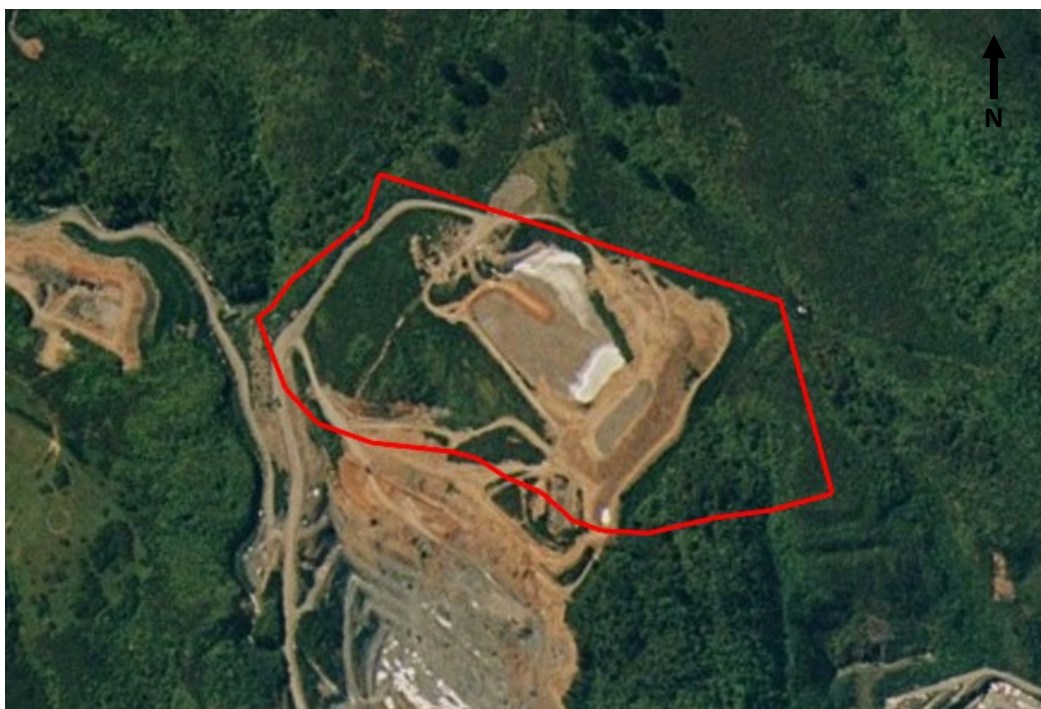
**Photograph 7: 2000 sourced from Retrolens**

| Date | Reference | Description |
|---|---|---|
| 2000 | Photograph 7 | The quarry area has been further developed across the site and vegetation cover can be observed in the eastern area of the site where a quarried area had been previously, as observed in the 1996 historical photograph.<br><br>Externally to the site, a track and earth disturbance area is visible north of the site's northern boundary. |

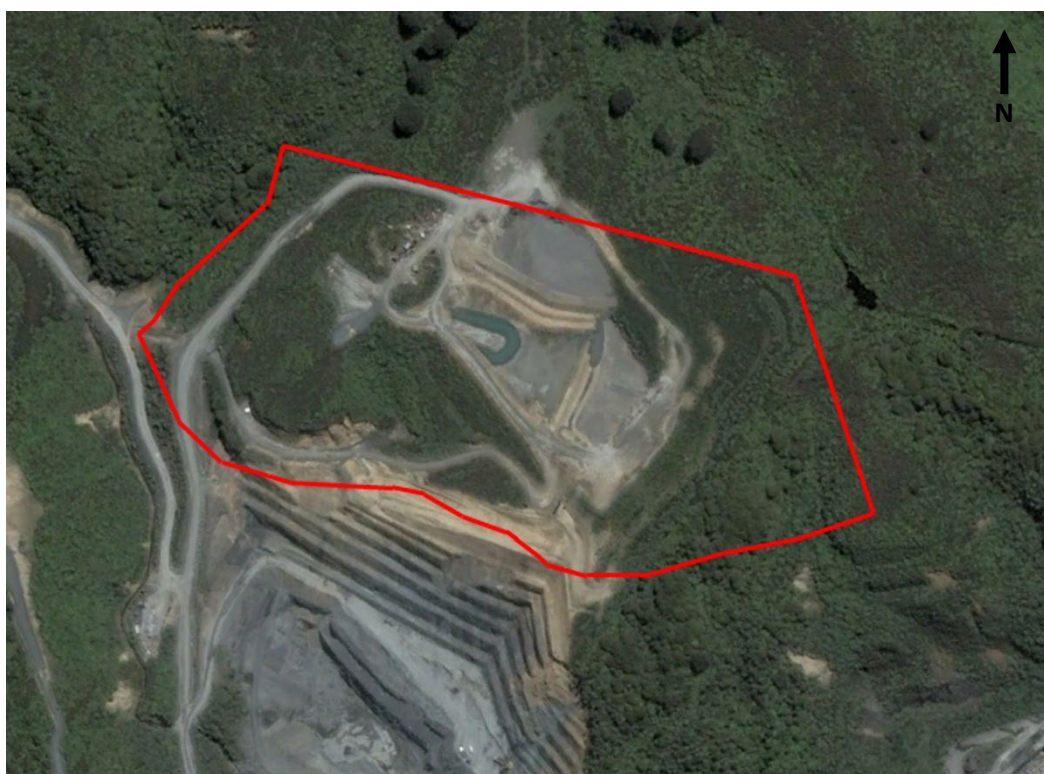
**Photograph 8: 2004 sourced from Google Earth Pro**

| Date | Reference | Description |
|---|---|---|
| 2004 | Photograph 8 | The quarry area has been further developed across the site. Miscellaneous items are observed across the northern area of the site. |

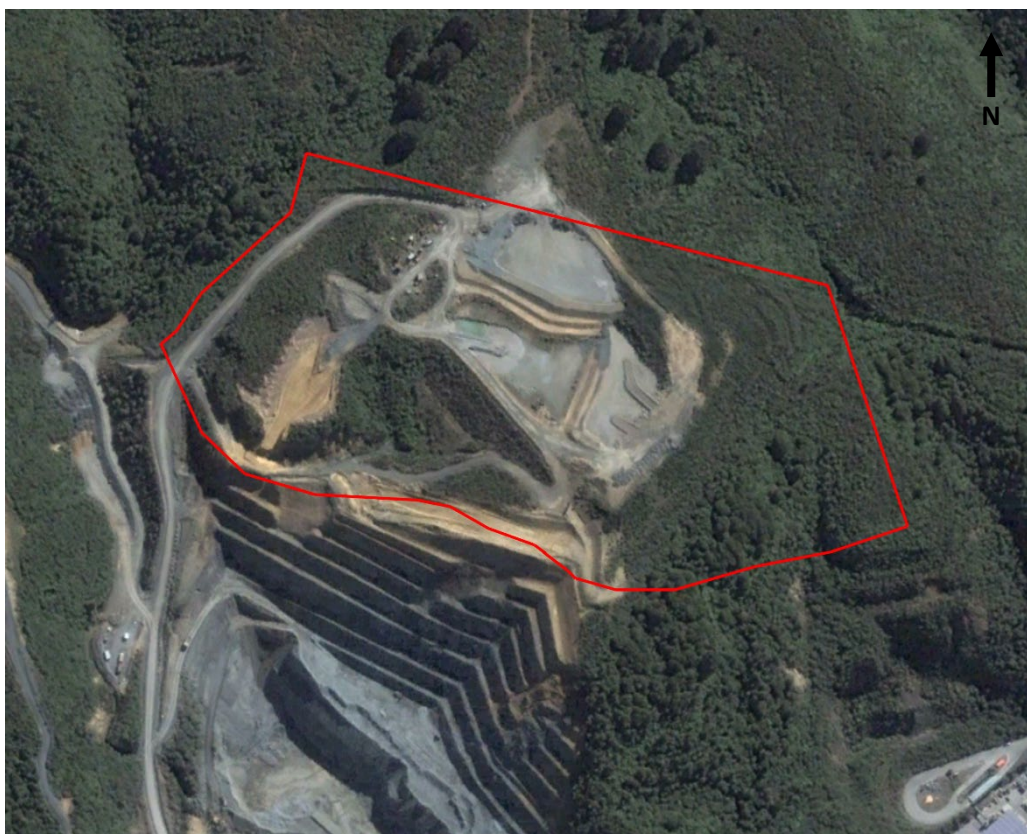
**Photograph 9: 2005 sourced from Google Earth Pro**

| Date | Reference | Description |
|---|---|---|
| 2005 | Photograph 9 | The quarry area to the east and west of the site has been further developed. |

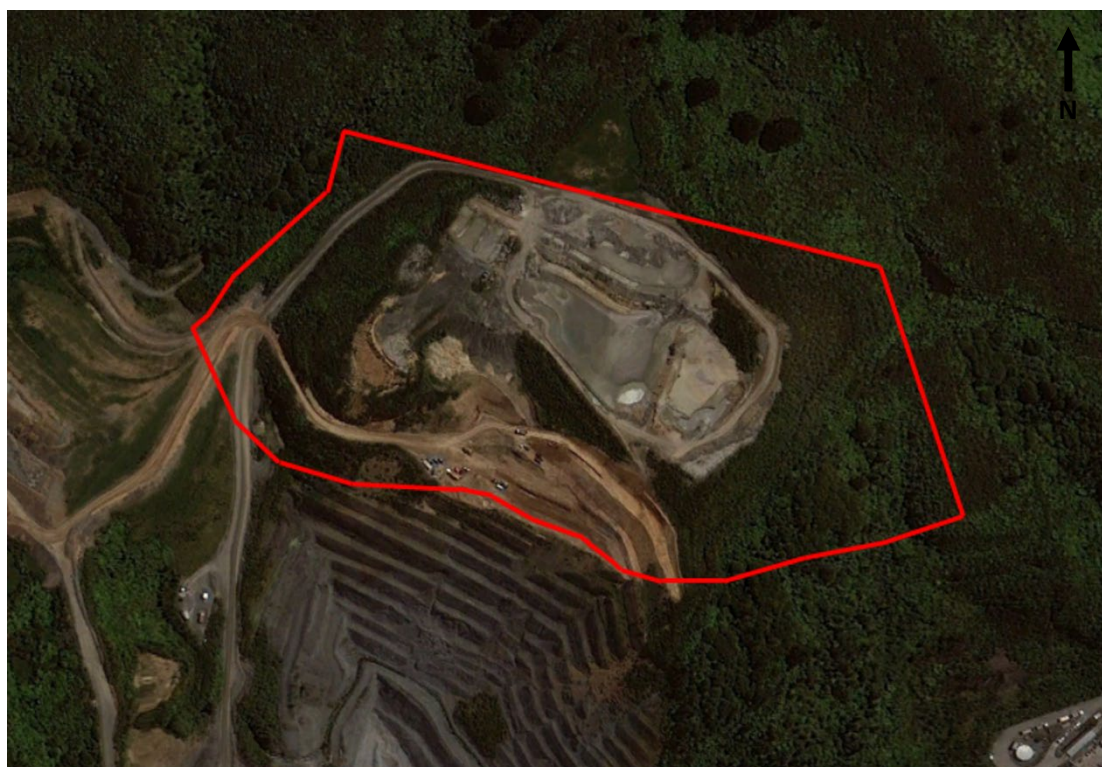
**Photograph 10: 2009 sourced from Google Earth Pro**

| Date | Reference | Description |
|---|---|---|
| 2009 | Photograph 10 | The quarry area has extended into the central area of the site, the terraced area along the southern boundary has been further developed and extends offsite. The small portico structure is no longer present onsite.<br><br>Externally to the site, the quarried area to the north is now covered by vegetation. |

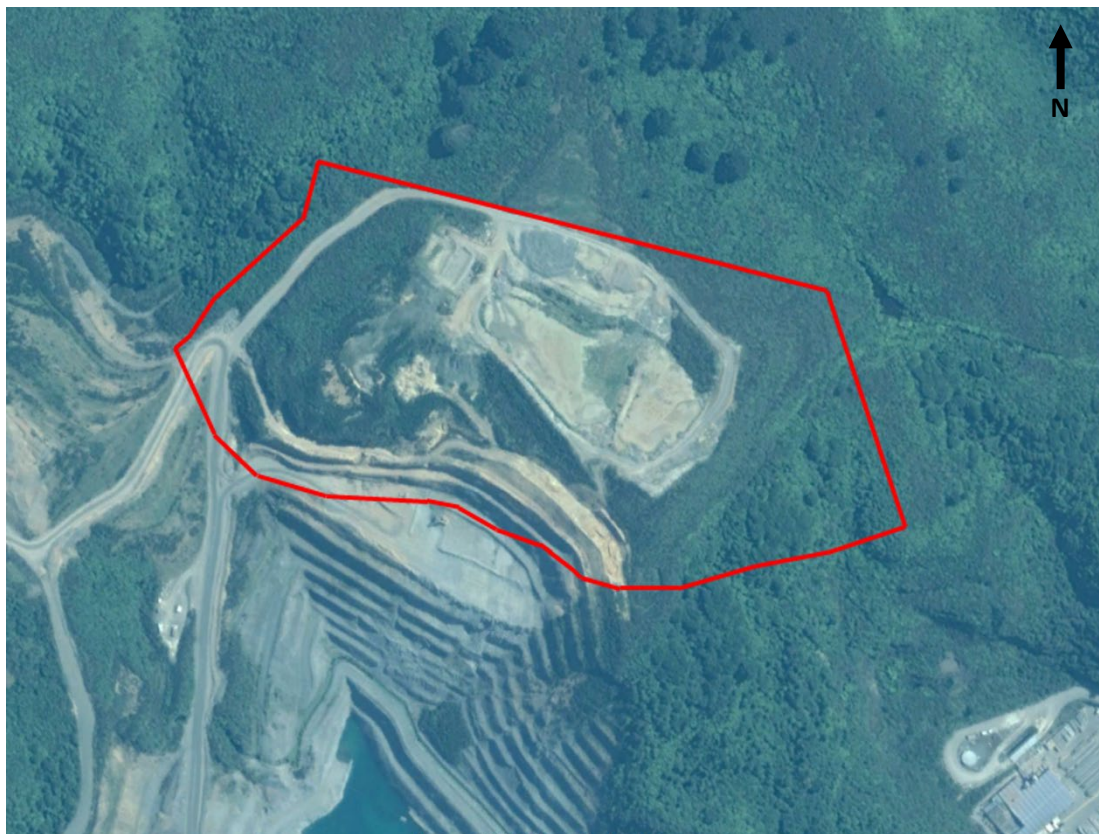
**Photograph 11: 2011 sourced from Google Earth Pro**

| Date | Reference | Description |
|---|---|---|
| 2011 | Photograph 11 | No significant changes have been made to the site. |

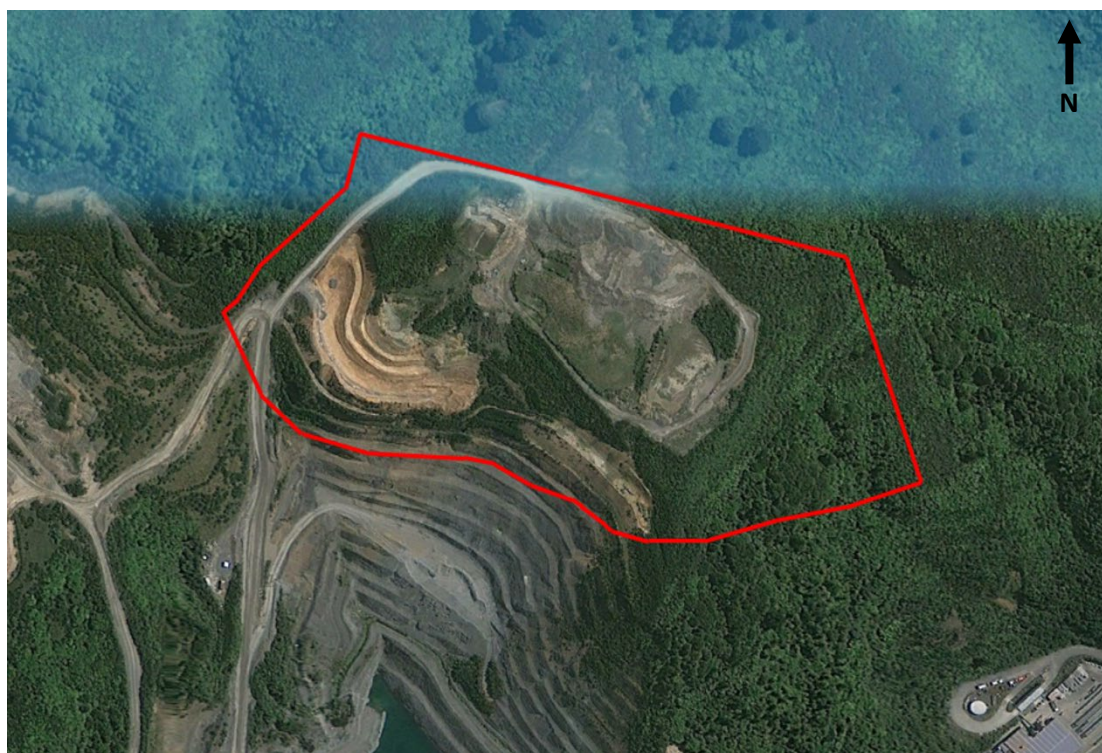
**Photograph 12: 2012 sourced from Google Earth Pro**

| Date | Reference | Description |
|---|---|---|
| 2012 | Photograph 12 | The central-eastern area of the site has been further developed into a quarry. Miscellaneous items appear to be stored in the central northern area of the site. |

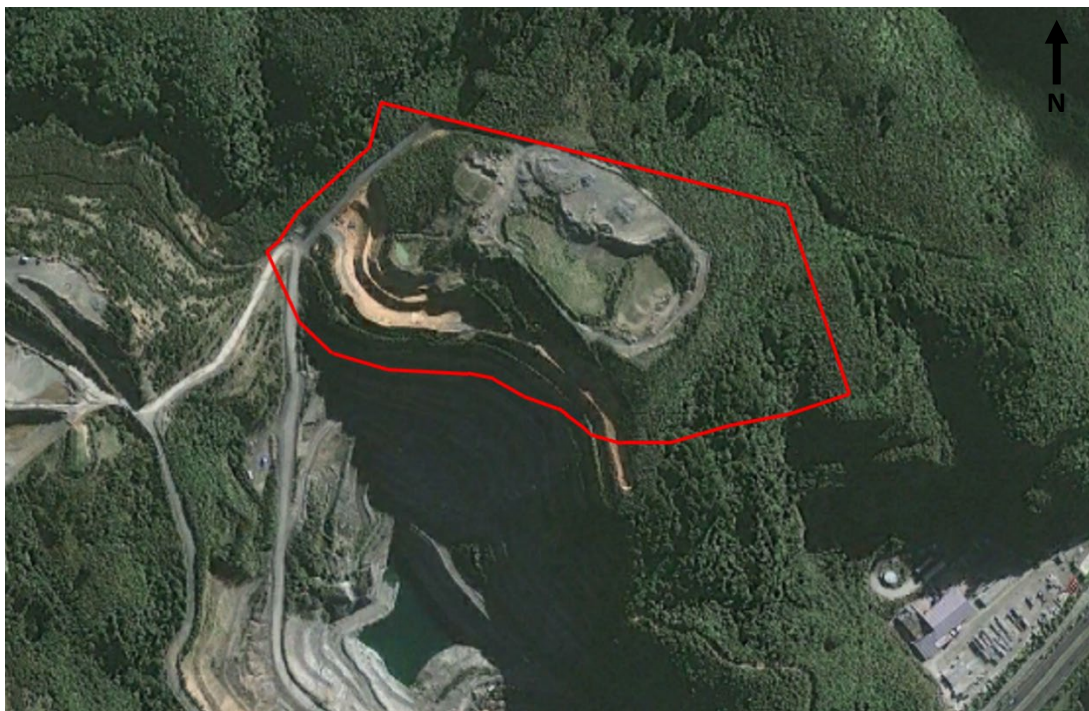
**Photograph 13: 2013 sourced from Google Earth Pro**

| Date | Reference | Description |
|---|---|---|
| 2013 | Photograph 13 | The quarried terrace to the southeast of the site has been further developed and extends offsite. Miscellaneous items including spare pieces of culvert pipe are visible in the central area of the site. |

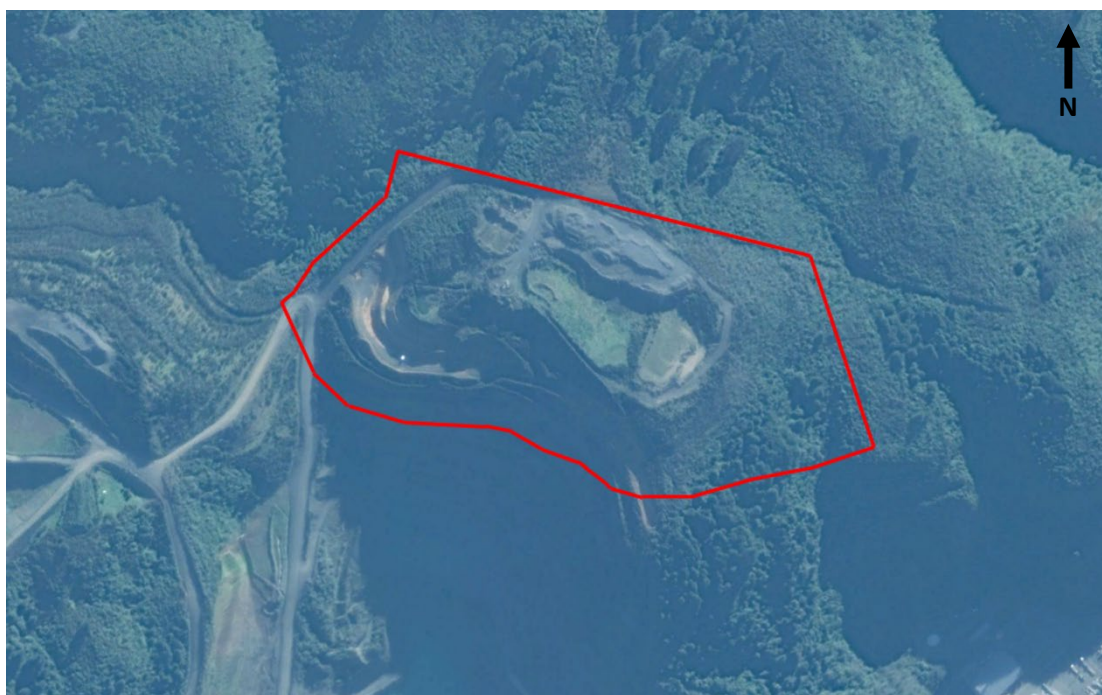
**Photograph 14: 2014 sourced from Google Earth Pro**

| Date | Reference | Description |
|---|---|---|
| 2014 | Photograph 14 | Stockpiled aggregate material is visible in the central and western areas of the site. |

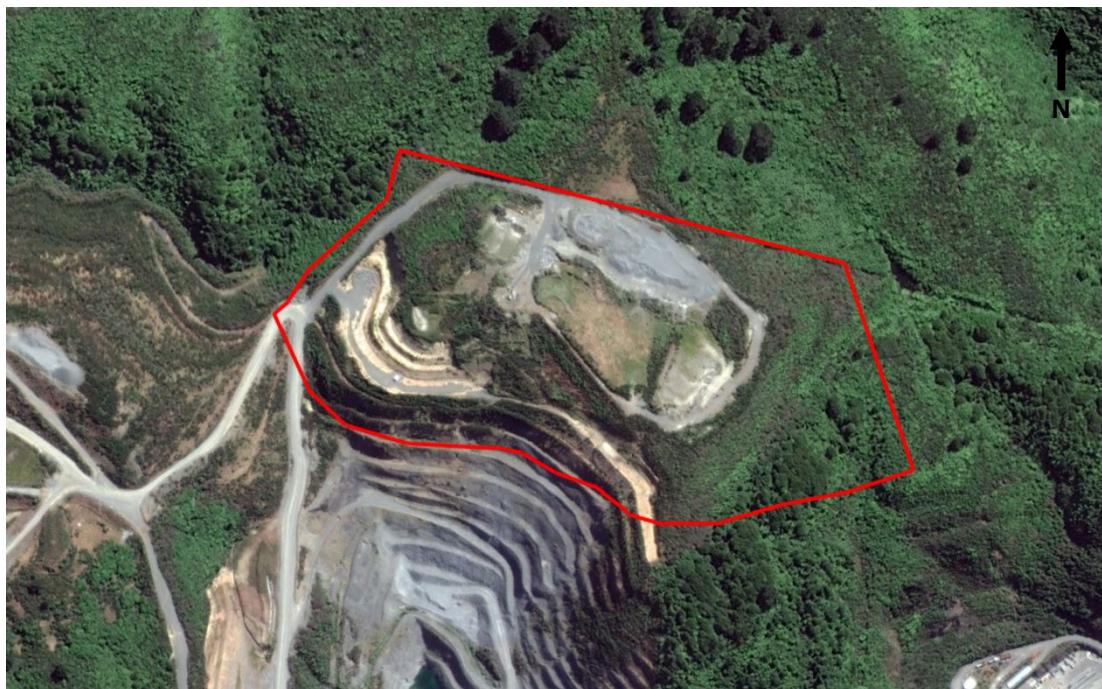
**Photograph 15: January 2015 sourced from Google Earth Pro**

| Date | Reference | Description |
|---|---|---|
| January 2015 | Photograph 15 | The stockpiled aggregate material is more clearly visible. Tyres are visible in the northern area of the site. |

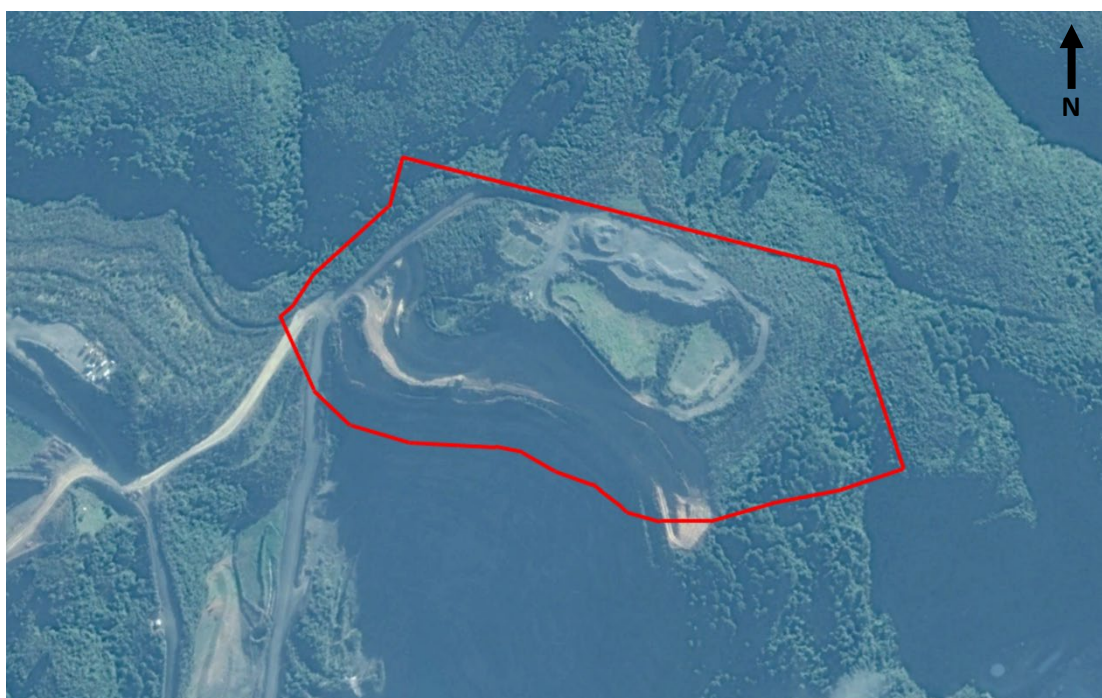
**Photograph 16: May 2015 sourced from Google Earth Pro**

| Date | Reference | Description |
|---|---|---|
| May 2015 | Photograph 16 | The aggregate stockpiles are no longer present on the site and further expansion of the quarry is visible to the south of the site. |

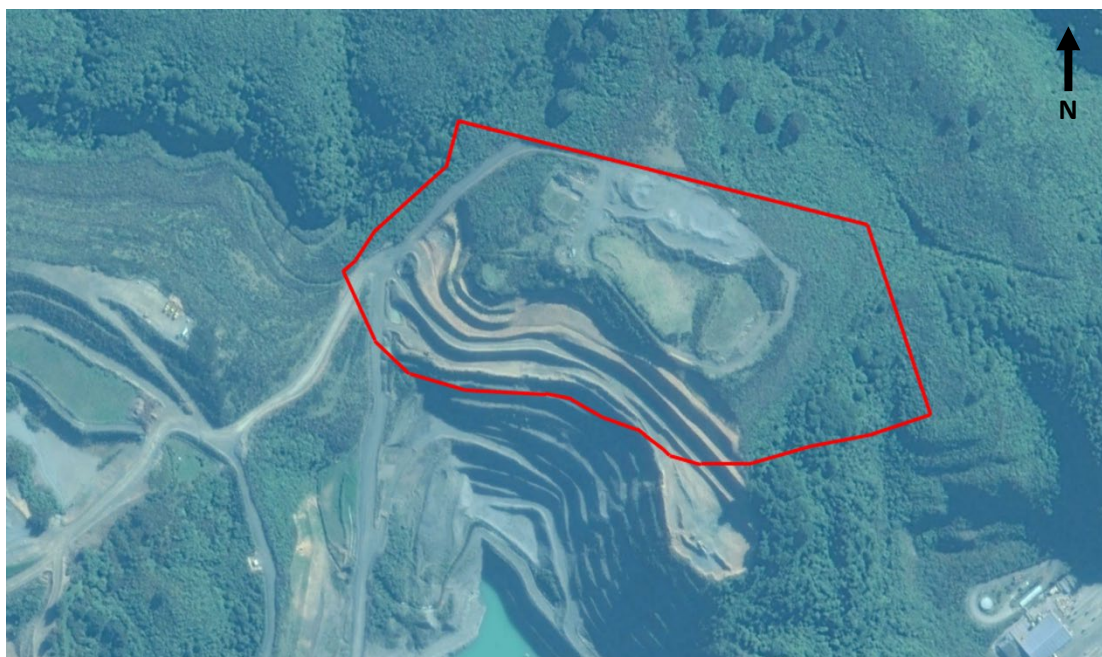
**Photograph 17: September 2015 sourced from Google Earth Pro**

| Date | Reference | Description |
|---|---|---|
| September 2015 | Photograph 17 | Further benching is observed in the quarry area to the south of the site. |
