# Belmont Quarry Development – Part B

Substantive Application  
Appendix B.3 – Contamination Reports  
Winstone Aggregates

Substantive Application  
Appendix B.3.A – PSI/DSI – OBDA  
Winstone Aggregates

## **PRELIMINARY AND DETAILED SITE INVESTIGATION - BELMONT QUARRY – PROPOSED OVERBURDEN DISPOSAL AREA**

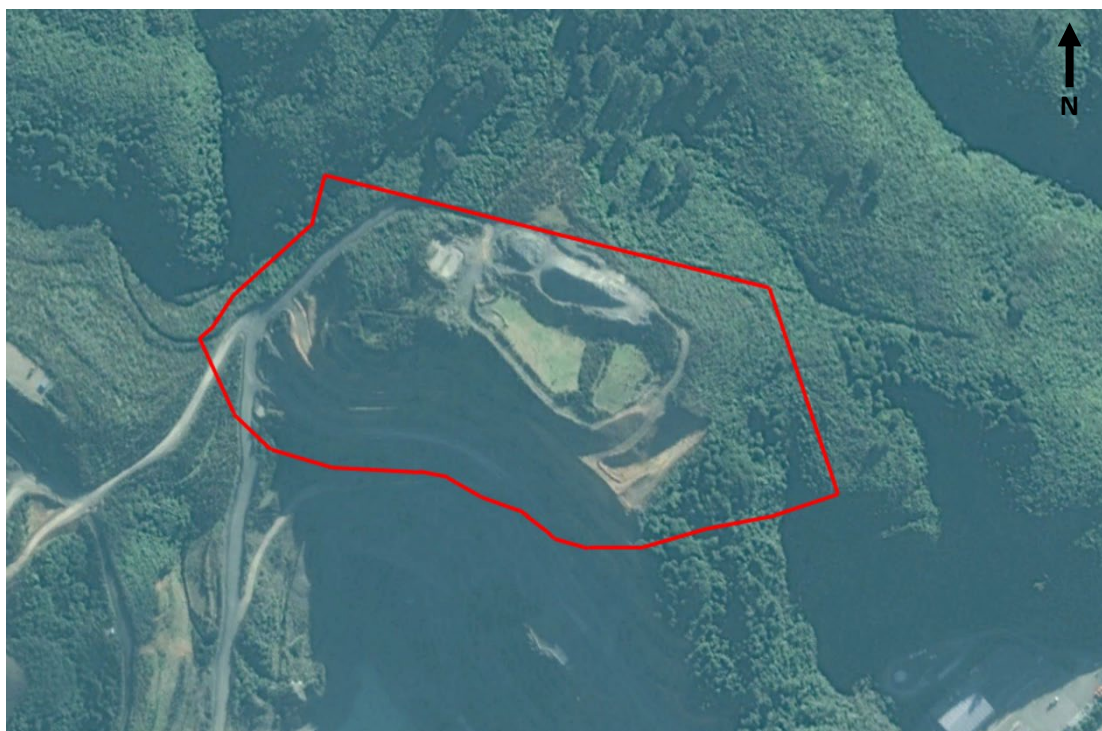
**Photograph 18: 2017 sourced from Google Earth Pro**

| Date | Reference | Description |
|---|---|---|
| 2017 | Photograph 18 | The quarry area has expanded to the southeast of the site, and a large stockpile of what appears to be quarried material is visible in the north of the site. |

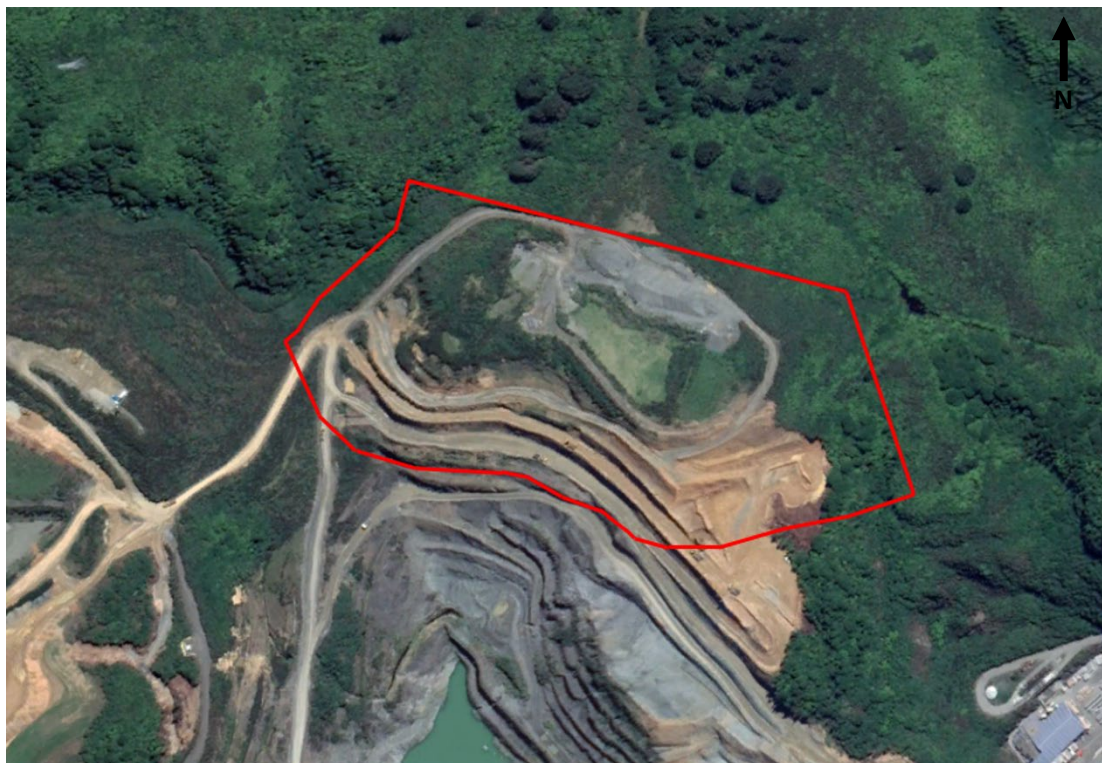
**Photograph 19: February 2018 sourced from Google Earth Pro**

| Date | Reference | Description |
|---|---|---|
| February 2018 | Photograph 19 | Further expansion of the quarry area to the southeast of the site is observed and the amount of material to the north of the site has increased. |

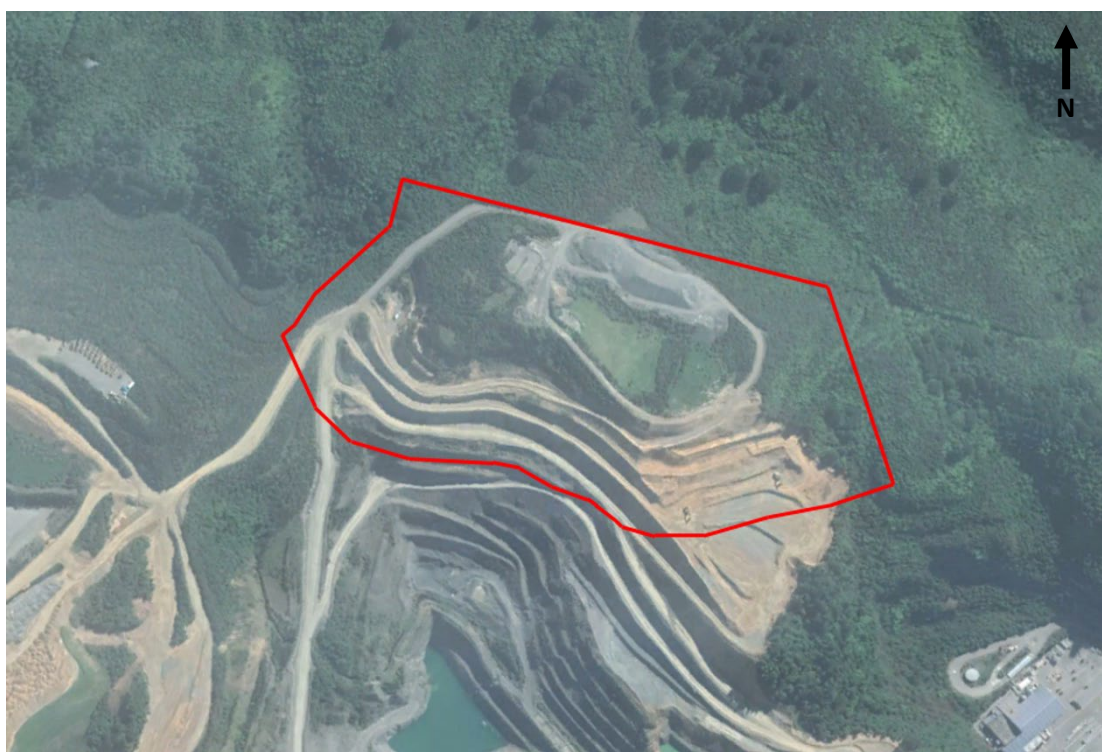
**Photograph 20: March 2018 sourced from Google Earth Pro**

| Date | Reference | Description |
|---|---|---|
| March 2018 | Photograph 20 | Further expansion of the quarry area to the southeast of the site is observed. A small white shed is situated in the west of the site. |

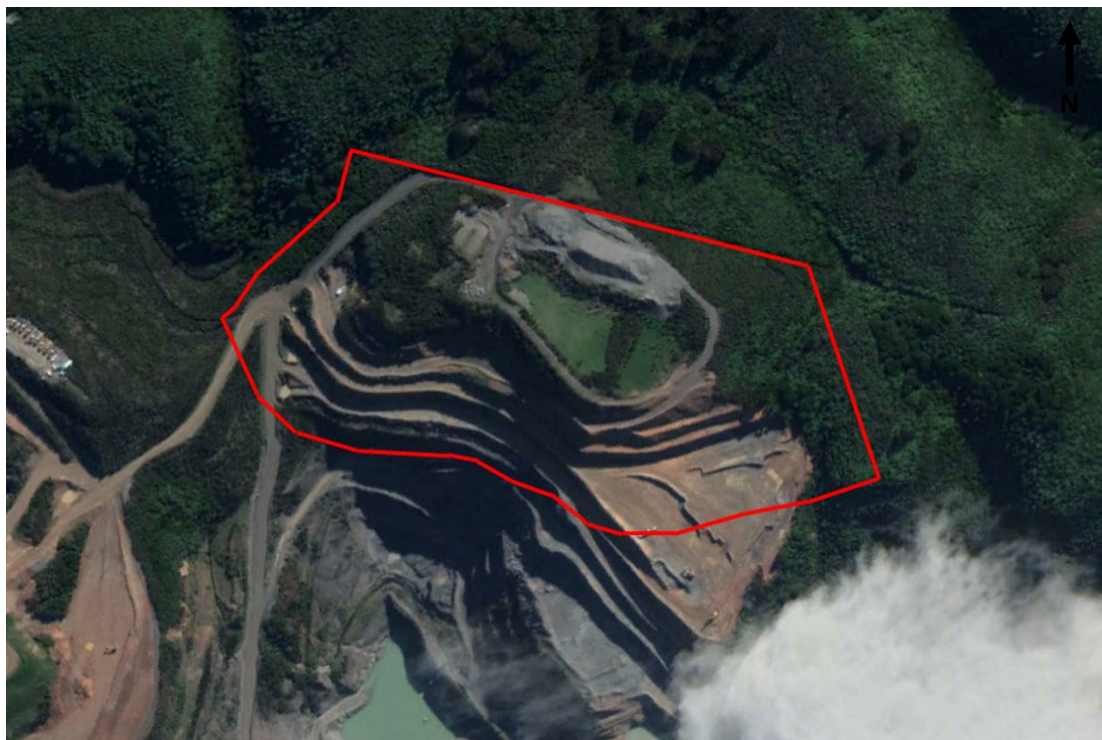
**Photograph 21: April 2018 sourced from Google Earth Pro**

| Date | Reference | Description |
|---|---|---|
| April 2018 | Photograph 21 | Further expansion of the quarry area to the southeast of the site is observed. |

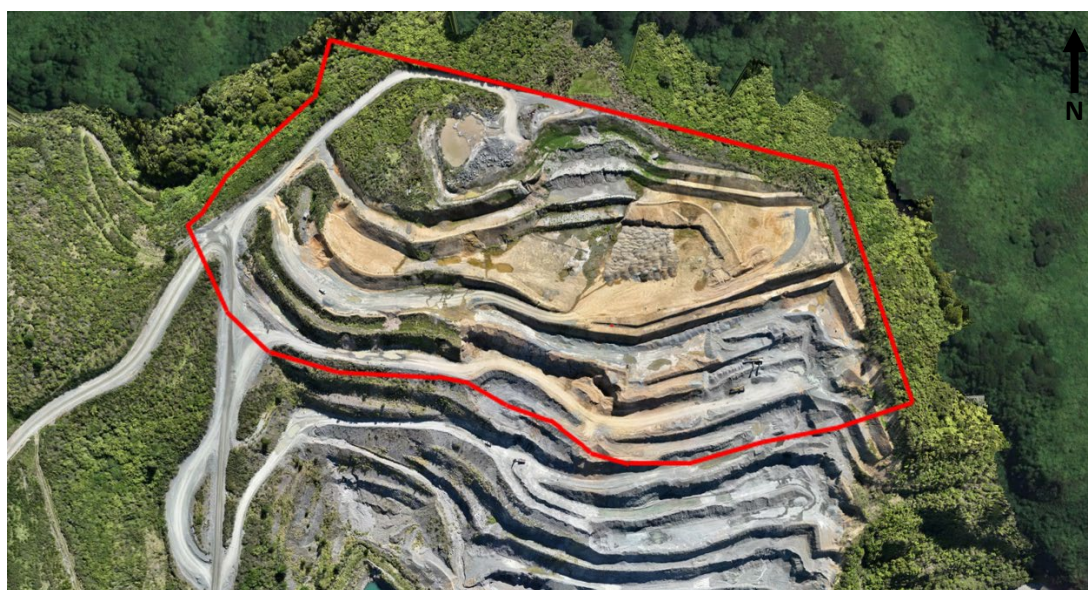
**Photograph 28: 2026 sourced from Belmont Quarry**

| Date | Reference | Description |
|---|---|---|
| 2026 | Photograph 28 | Minimal changes have been made to the site. |

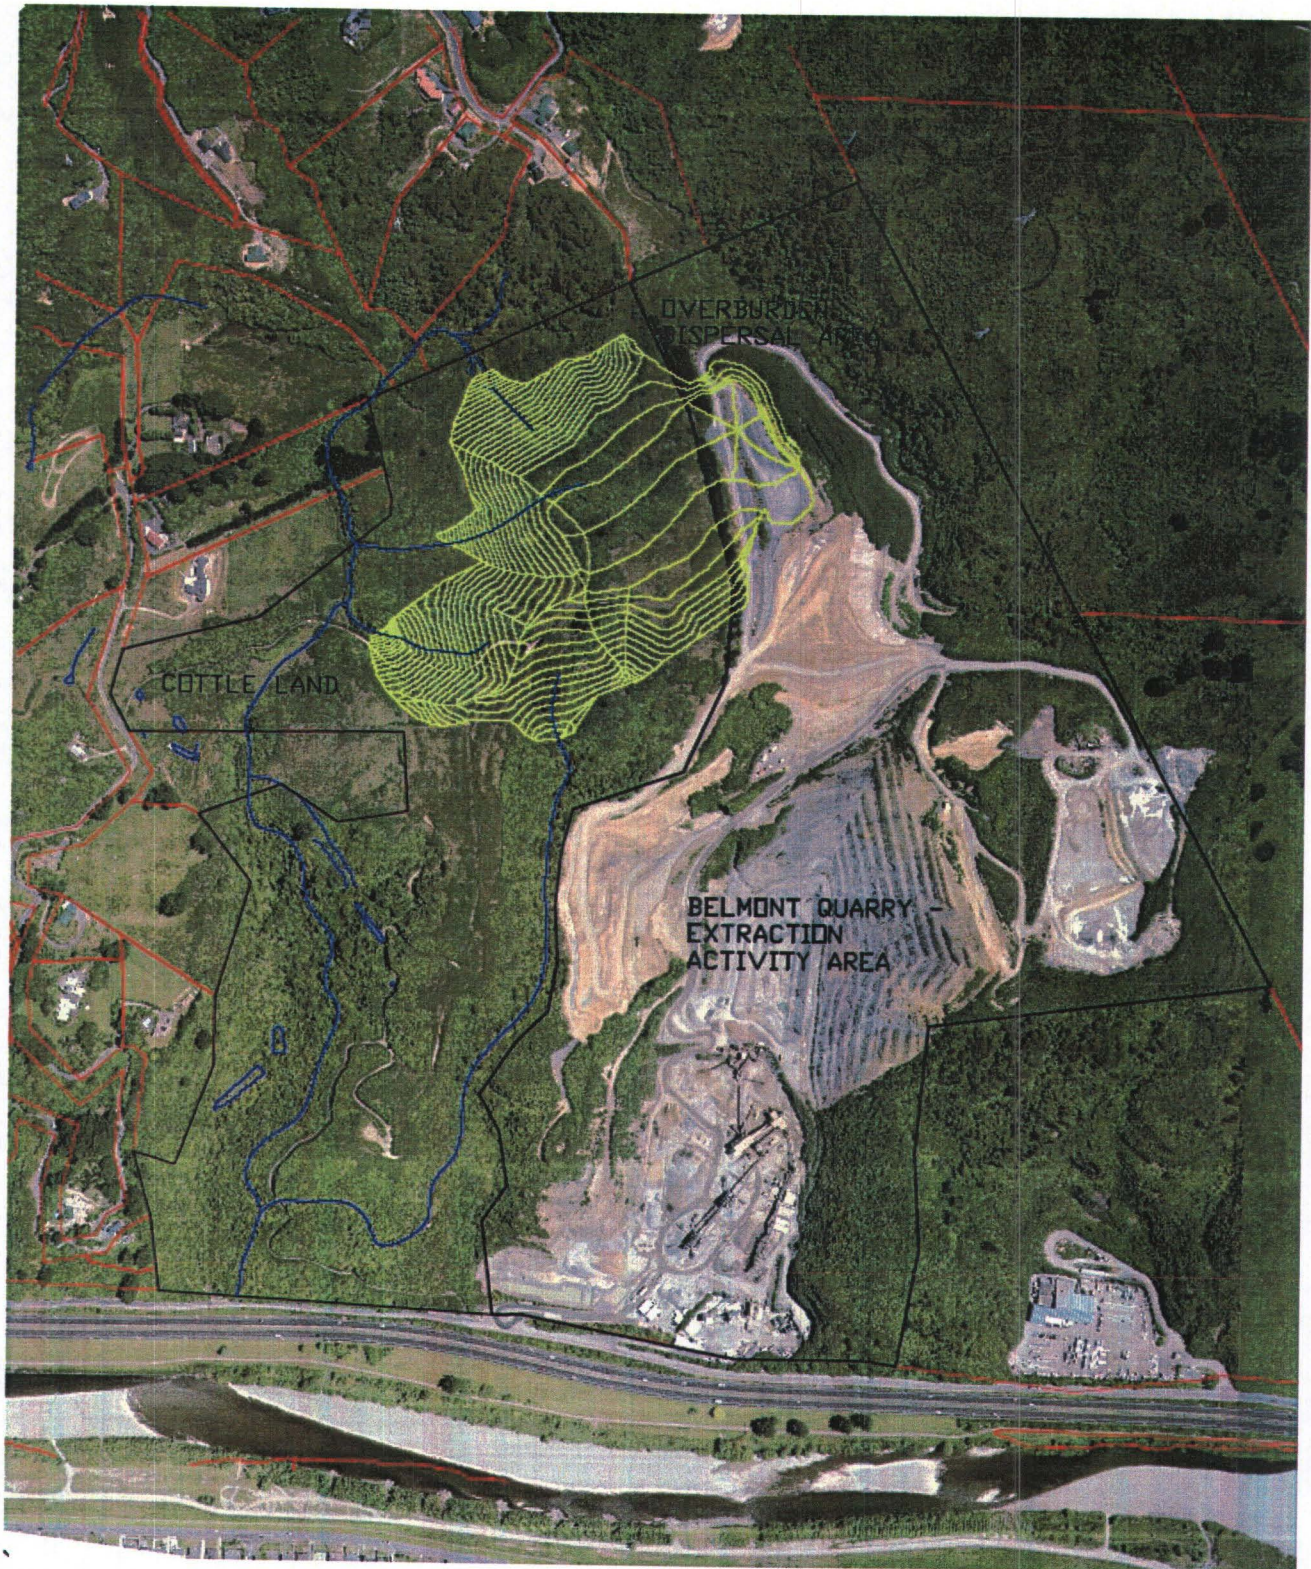
**Figure 1:** Location of Cottle Land and the proposed overburden disposal area.

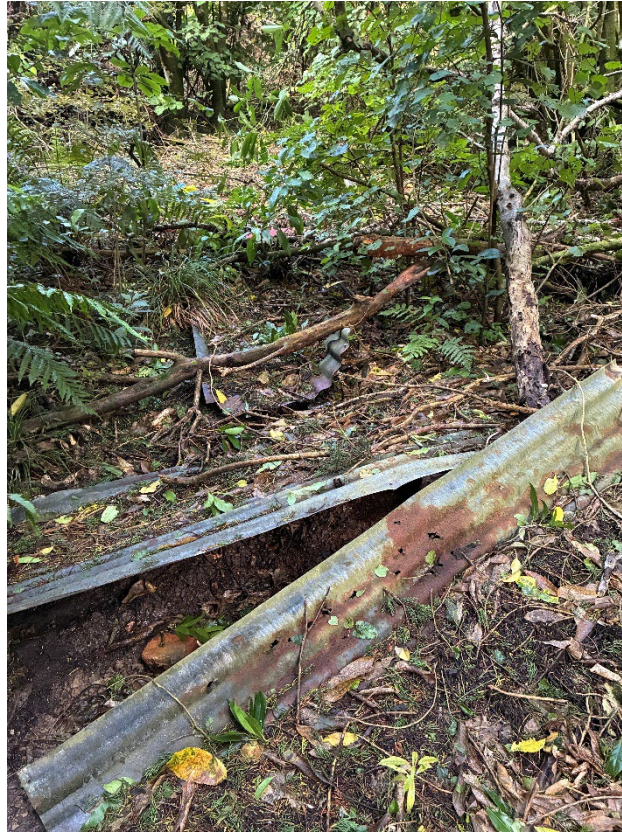
**Photograph 1: Example of sheeting which may be found.**

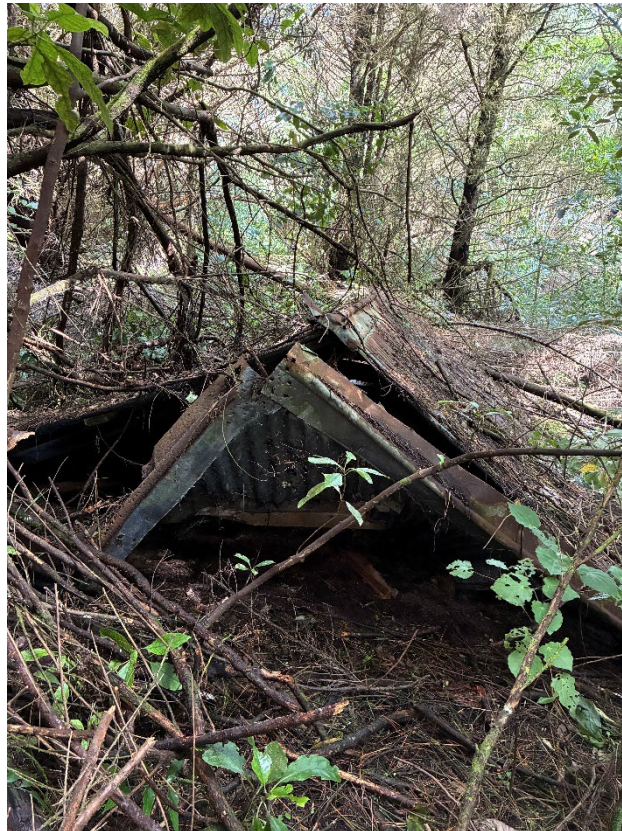
**Photograph 2: Example of roof structure.**

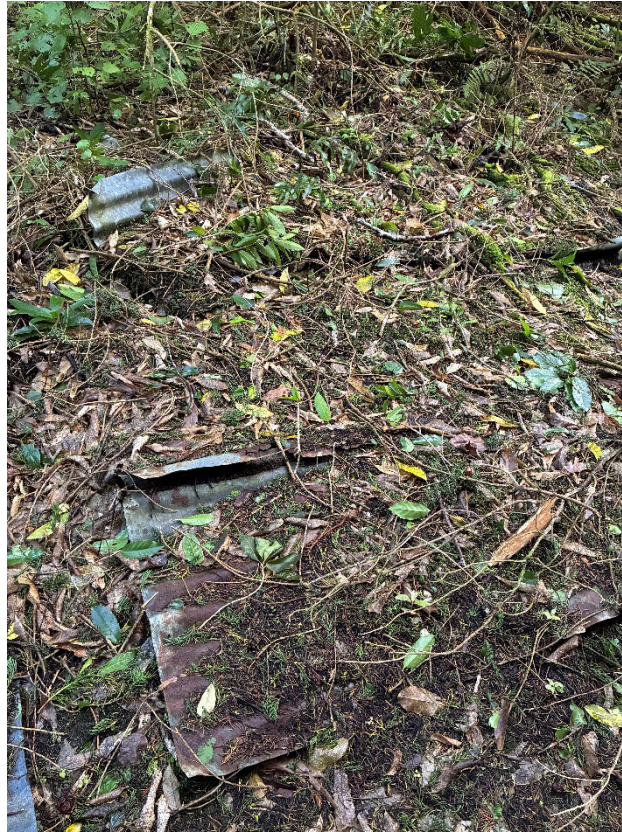
**Photograph 3: Example of covered metal which may be found.**

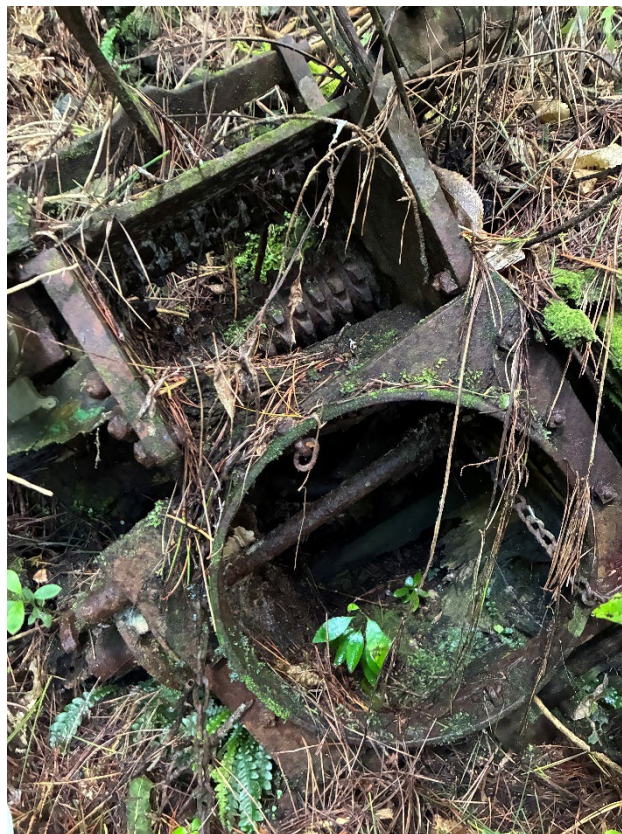
**Photograph 4: Example of machinery which may be found.**
