# Comments on DRAFT Report on land exchange: Tukituki Water Security Project – Land Exchange Application (FTAA-2603- Loo3).

Thank you for inviting me to make a comment on the Draft Report on the land exchange: Tukituki Water Security Project – Land exchange Application (FTAA-2603- Loo3)'. In this submission I will make comments on survey gaps and effort given, the subjectivity of assessment criteria and weighting, and corrections to vegetation assessment and threatened flora and fauna assumptions made.

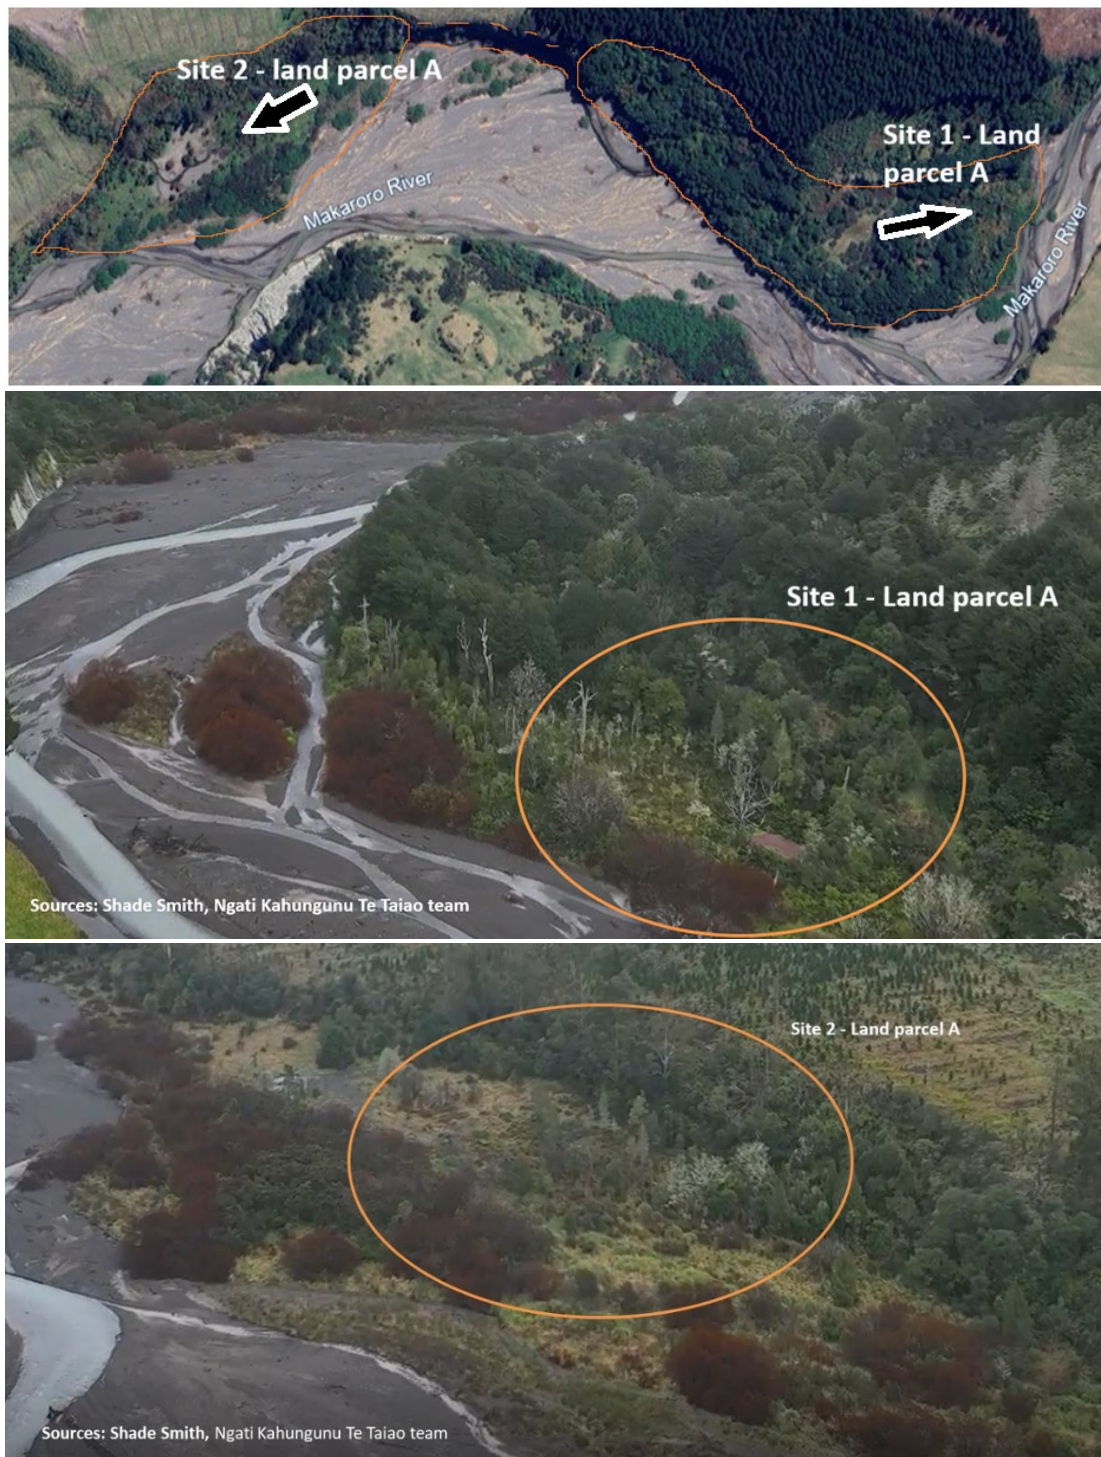
Figure1: Drone footage of Doc land parcel A, showing river terrace, a swamp and other ‘wetland’ areas.

- 1) River terraces, Swamp and wetland areas in Parcel A – See drone footage of areas of interest below.

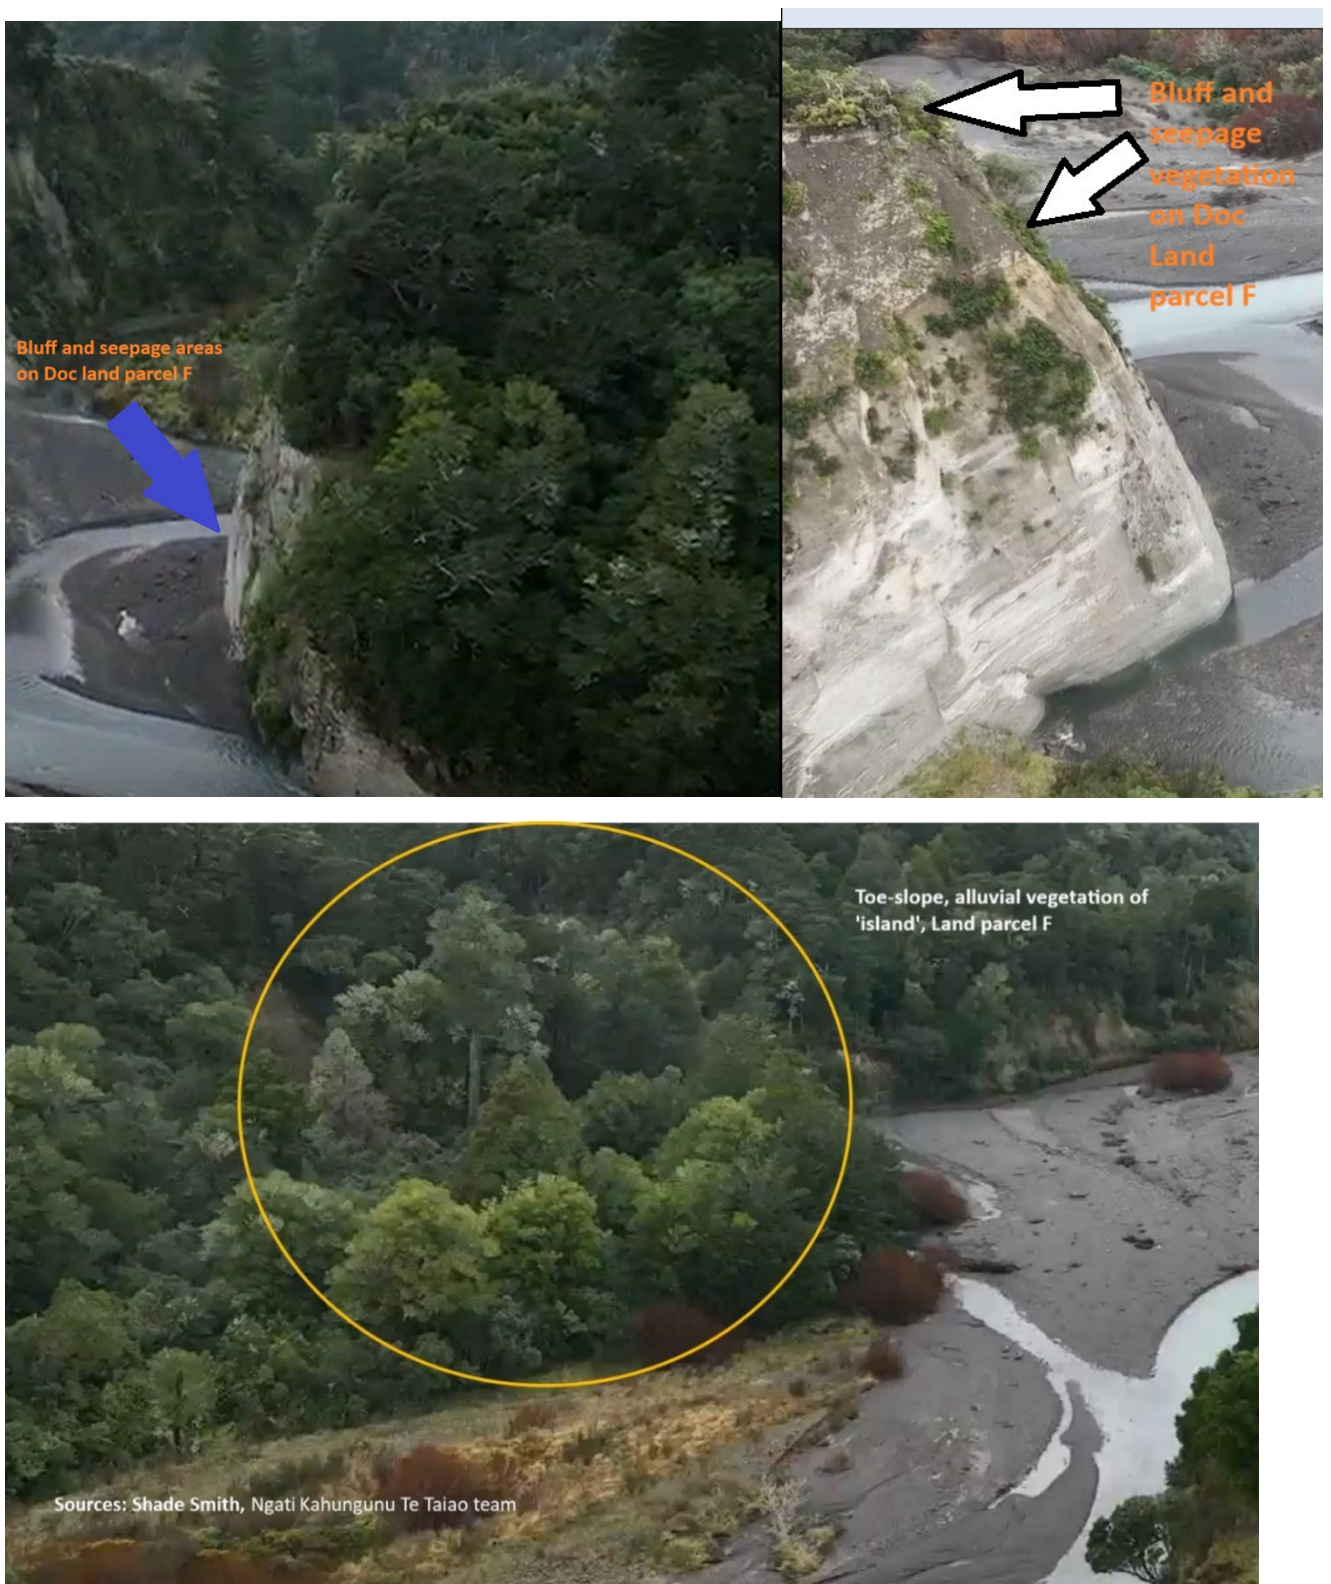
Figure 2: Drone footage of Doc land parcel F 'island', showing bluff and seepage vegetation communities and alluvial 'toe slope' with emergent and juvenile Kahikatea adjacent to the Makaroro river

2) Bluff vegetation, alluvial and toes slopes forest in land parcel F – See drone footage of areas of interest below.

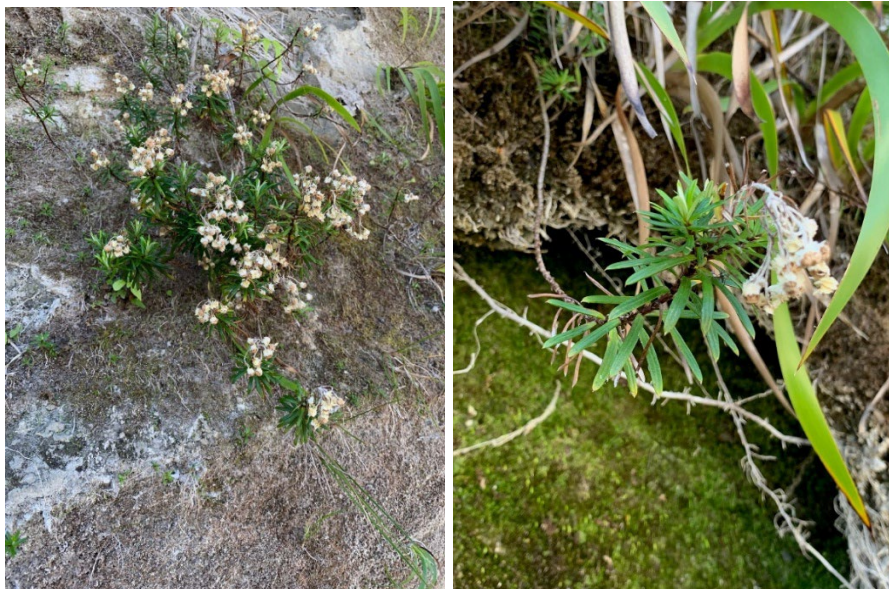
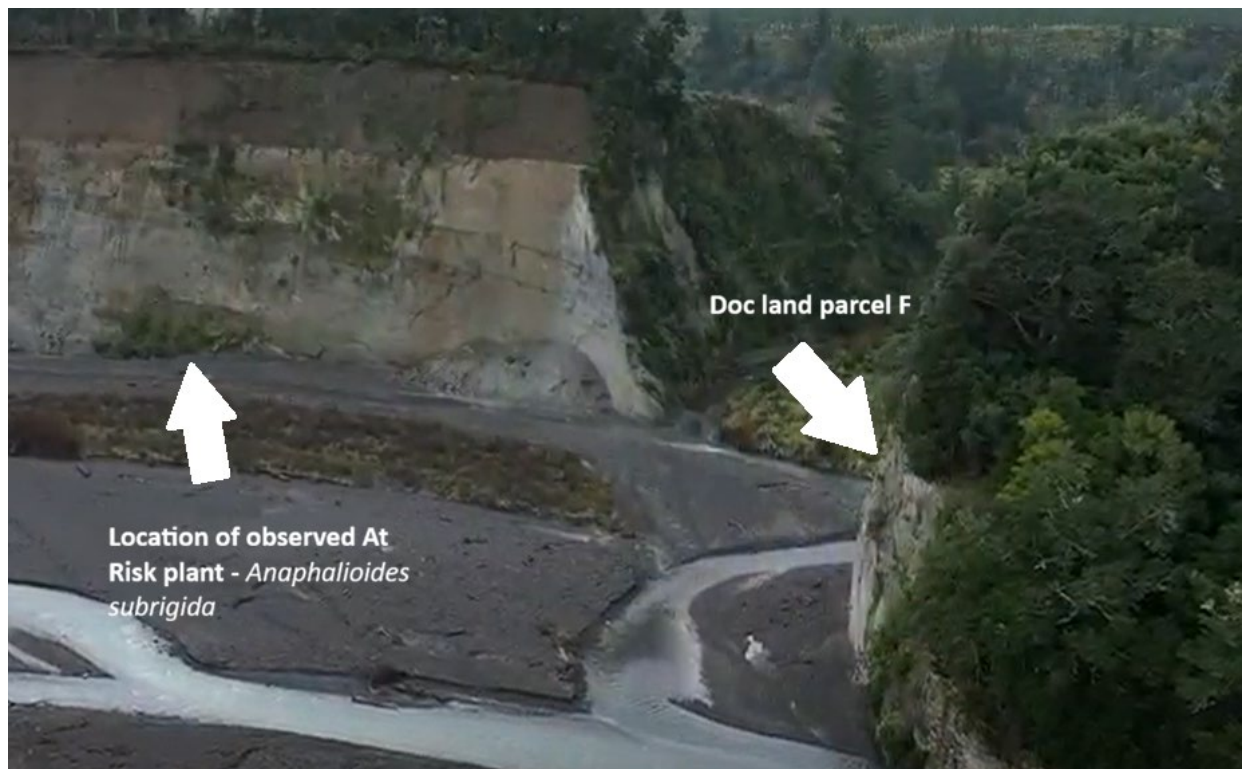
Figure 3: Large plants of *Anaphalioides subrigida* present on mudstone seepages, location: Lat -39.743943, Long. 176.266099.

| Species | Doc land parcels (Doc-give) | | Smedley Exchange Block (Doc -get) | | Comments |
|---|---|---|---|---|---|
| <i>Anaphalioides subrigida</i> | ? | × | - | - | <p><i>Anaphalioides subrigida</i> is Threatened – At Risk (Naturally uncommon). This plant is found in mudstone seepage approximately 15 meters away from Doc land parcel F. Search of mudstone / bluff areas on Doc land parcel F is required to confirm any presence.</p> <p><b>However, <i>Anaphalioides subrigida</i> highly likely to be present at this Doc Land parcel F. No mudstone, seepage, bluff habitat is found within the SEB.</b></p> |

It is important to acknowledge that if threatened plants are not seen during brief surveys, it does not mean they are not present. It is highly likely that there will be threatened plants present, indeed I observed the Threatened - At Risk plant *Anaphalioides subrigida* on seepage cliffs every close to the Doc Land parcel F (see Figure 3). It is reasonable to include this At Risk species and others as a ‘potentially’ present within Doc land parcel F / Doc-give land (see Table 2B).
