DRURY QUARRY EXTENSION, SUTTON PROJECT, DRURY, AUCKLAND: ARCHAEOLOGICAL ASSESSMENT (APPENDICES)

Prepared for Stevenson Aggregates Ltd

March 2025

APPENDIX 1: SITE RECORD FORMS

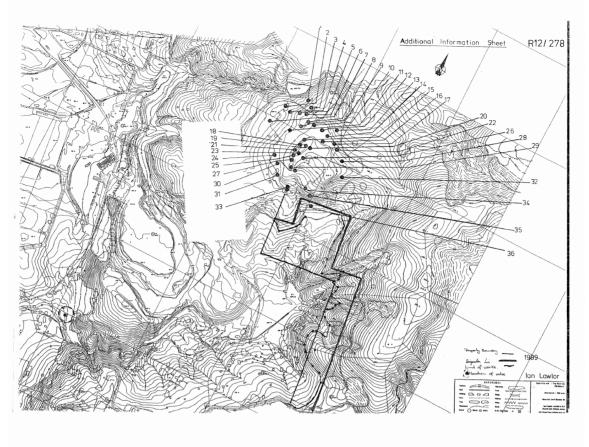
The following were observed while carrying out the reconnaissance survey. The numbers below refer to specific points around the volcanic rock outcrop and they are located on the attached contour plan (from N to S):

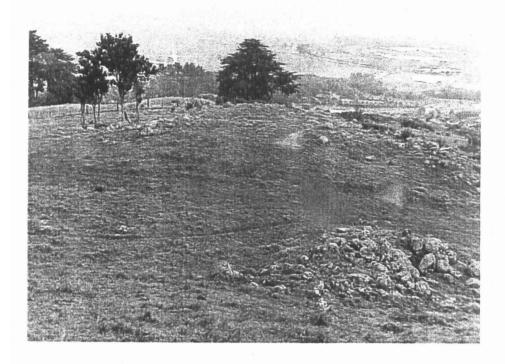
R12/723. 29 May 2002. Looking from the north downslope to the site.

NZAA Condition partly damaged, no information on danger (2002) indistinct, in vicinity of buildozed farm track, in sheep pasture

Additional information May 2002 by Matt Felgate, Greg Walter, Vanessa Tanner Uncertain whether the observed features were those recorded by Lawlor A pair of indistinct pit-like features with some boulders around on the spur at this grid reference, with the other more northerly features of R12/723 not relocated

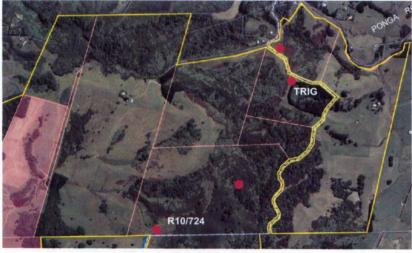
Locations of Mrs Priestley's occupation sites, 1920s
