Assessment of Environmental Effects for the Discharge of Wastewater to Land

RCL Homestead Bay Limited

Resource Consent Application and Assessment of Environmental Effects for the Discharge of Wastewater to Land

10934-RCL WW AEE-250409-final

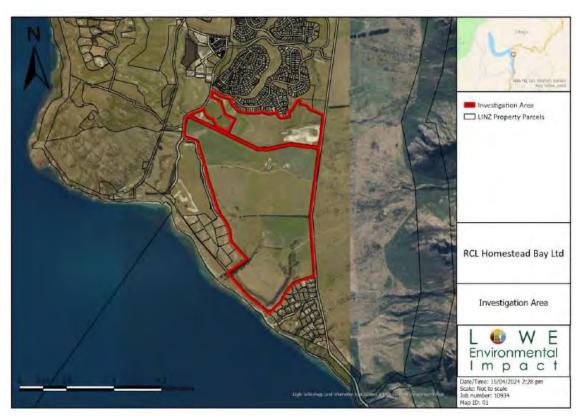
Figure 1.1: RCL Homestead Bay Limited Development Area

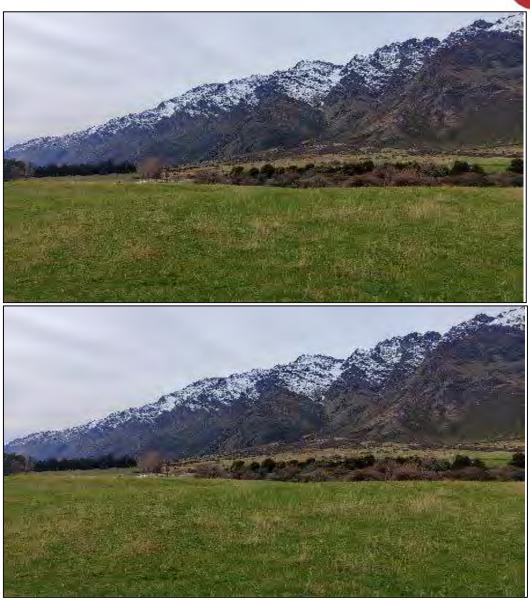
Figure 2.6: A-Alluvial Fan Looking East Towards the Remarkable Range and the Head of the Fan

The eastern and southern portion of the site is located on an elevated, gently inclined slope comprising distal fan alluvium (Figure 2.6). The fan alluvium originates from the western slopes of the Remarkables Mountain Range, and immediate area.

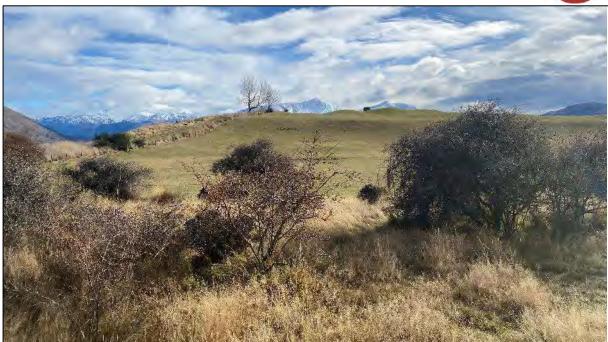
Figure 2.7: Zone C Characterised by Locally Elevated Irregular and Undulating Hummocky Topography

Zone C runs along the elevated western portion of the site with surface topography comprising of undulating, irregular hummocky features (see Figure 2.7 below). The deposition environment and geomorphology are glacial in origin.

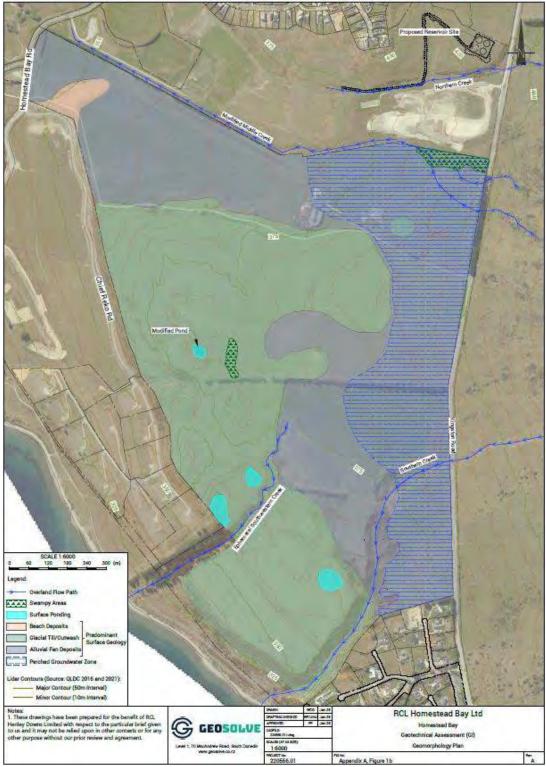
Figure 2.8: Indicative Hydrogeology (Details in Appendix B)

From Figure 2.8, the investigations indicate that a part of the site comprises perched groundwater zones and unconfined aquifers due to the presence of the deposited materials, such as Alluvial Fan Deposits and Beach Deposits. Additional information is available in the attached Geotechnical Report 2025 (Appendix B).

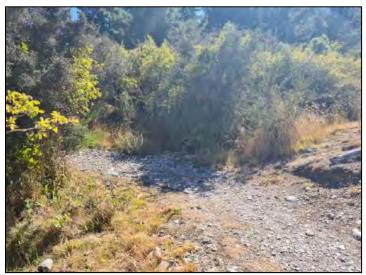
Figure 2.12: Water Course 1

Waterways Consulting completed a site visit in March 2023 and provided an aquatic assessment for the Homestead Bay Development. The channels were found to be generally well vegetated with terrestrial shrubbery. Stream 1 had minimal wetted habitat and it is expected that the stream only flows during and after heavy rainfall and dries again very quickly. Stream 2 had no evidence of any permanent water but does experience high flow events that have scoured an obvious and deep channel along the canyon valley floor. Neither of the streams support any fish or stream macroinvertebrates. Therefore, neither stream has aquatic ecological value.

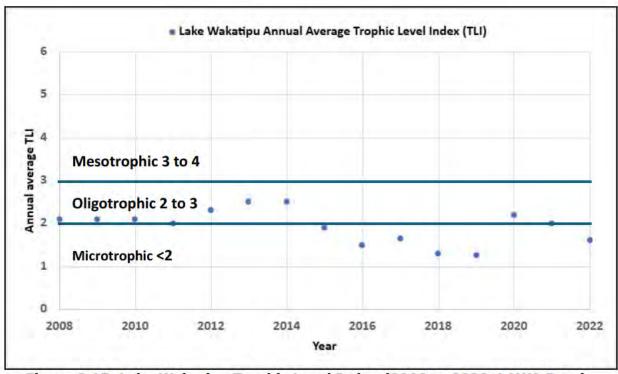
Figure 2.15: Lake Wakatipu Trophic Level Index (2008 to 2022, LAWA Data)

The current TLI of the Lake Wakatipu in 2022 is microtrophic (LAWA data, 2022). It appears that the TLI of Lake Wakatipu is in a stable state near the microtrophic- oligotrophic boundary. Figure 2.15 presents the annual average TLI using TN, TP and Chlorophyll 'a' data from the lake outlet data. Minor variation of TLI from year to year is expected due to the slight variation of weather conditions from year to year.

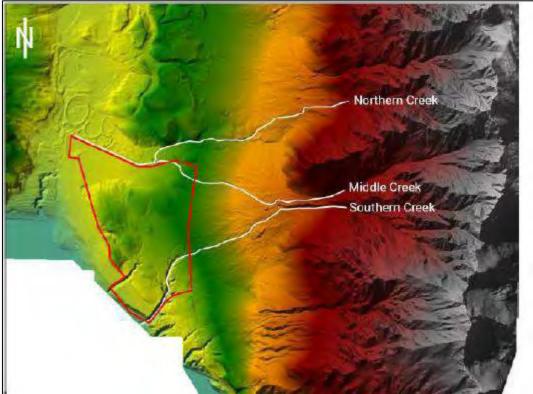
Figure 2.16: Northern, Middle, and Southern Drainage Channels that Dissect the Site (Geosolve 2025)

There are three significant drainage channels present on the site, as shown in Figure 2.16 below from Geosolve 2025. All three channels, along with an additional south-western channel, ultimately discharge into Lake Wakatipu.

The principal routes for stormwater discharge from the development will be through existing drainage channels leading into Lake Wakatipu. Flood and stormwater treatment systems will be designed to control flows and maintain water quality.

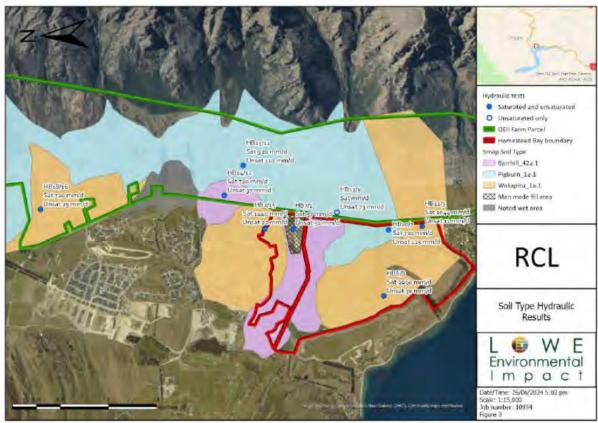
Figure 2.20: Soil Hydraulic Distribution

The hydraulic results based on soil distribution are shown below in Figure 2.20. The distribution of these rates support the proposal to irrigate based on soil type.

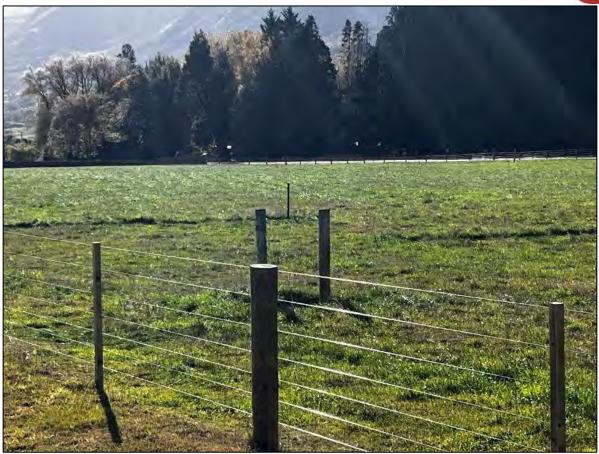
Figure 7.2: LTA Example Subsurface Drip Fields

This is similar to the existing LTA areas within the neighbouring Jacks Point Residential area which does not have any notable visual effects and could be considered as a practical example of the negligible visual effects of managing wastewater in LTAs. Figure 7.2 and Figure 7.3 below are examples of typical LTA scenery. In these areas the dripper lines are buried as is proposed for the Homestead Bay scheme.

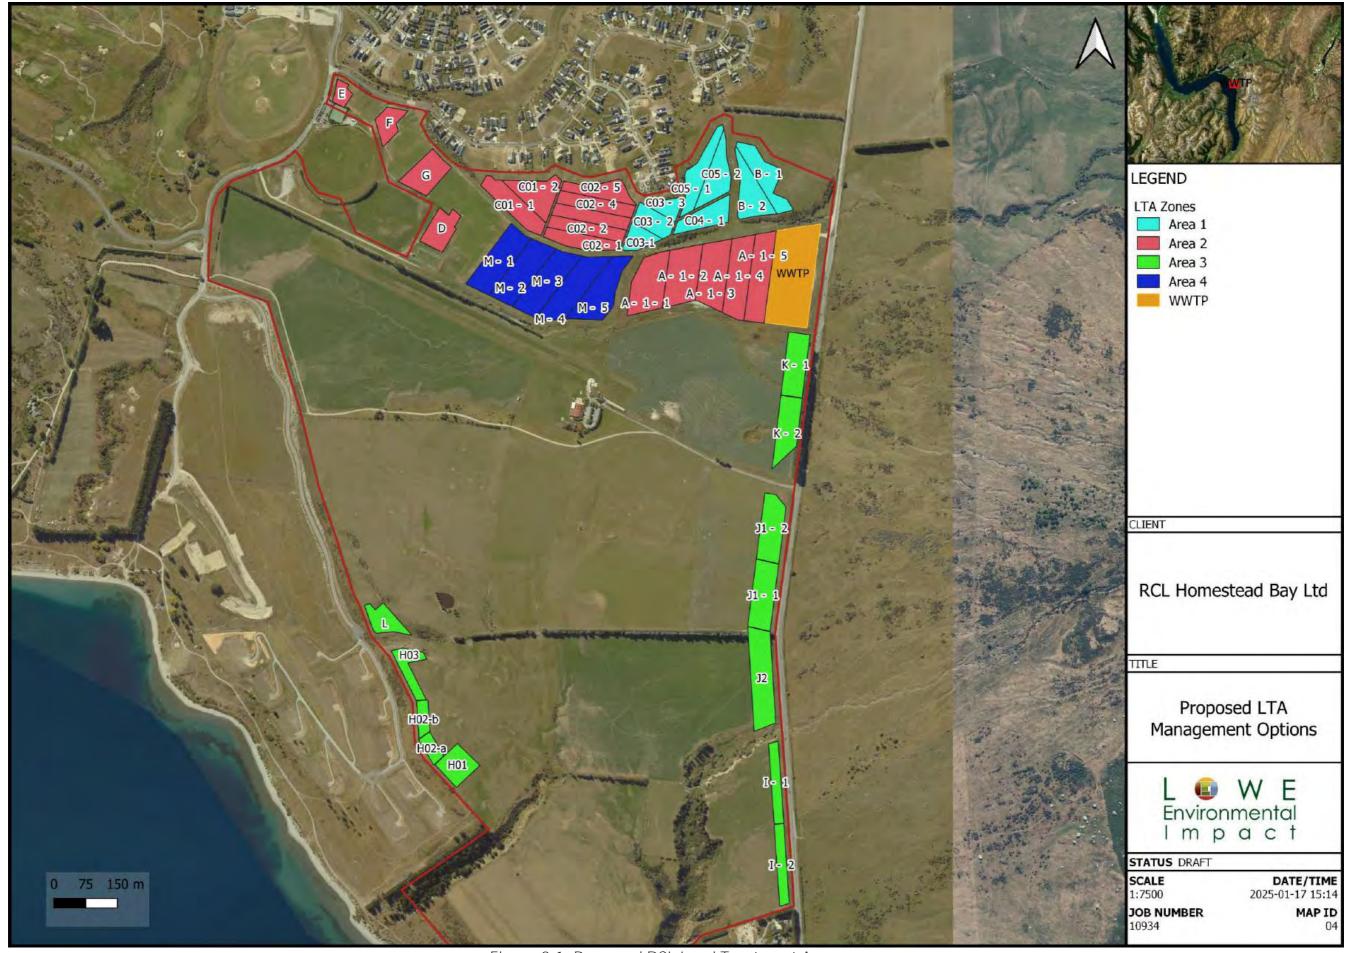
Figure 3.1: Proposed RCL Land Treatment Areas

The average discharge rate for the LTA sites are derived from the LEI's soil assessment report (Appendix A), and the proposed LTA's ability to remove nutrients.

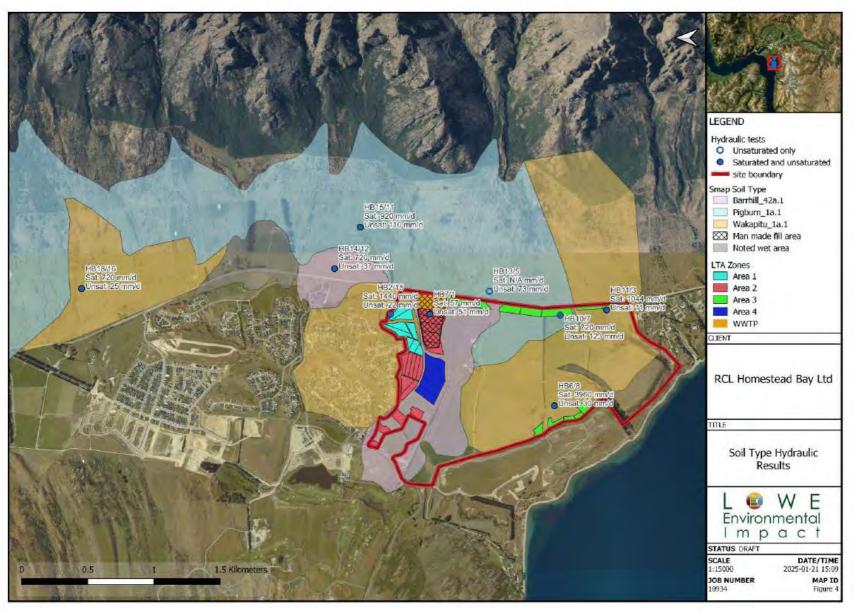
Figure 4.1: Soil Hydraulic Testing

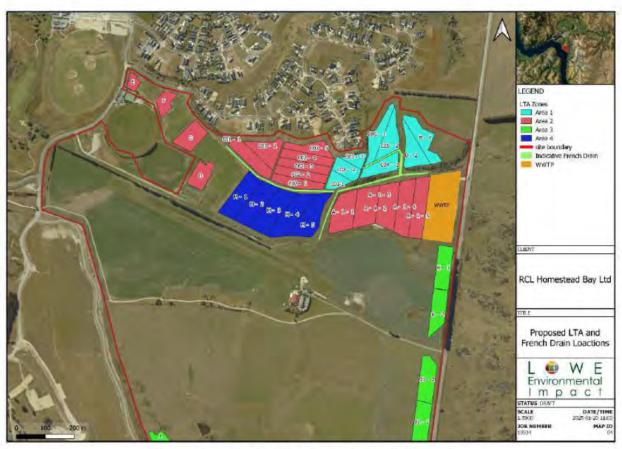
Figure 6.2: Indicative French Drain Location

The recommended LTAs include some sloping sites. As an extra assurance, on the more highly sloped land associated with Area 1 irrigation zones and along the hill slope toe for Area 2, the proposal is to include subsurface French drains (Figure 6.1) to intercept any lateral flow and allow for this to infiltrate into the deep subsoil or to be collected for discharge into a wetland system. The conceptual location of the drains is shown in Figure 6.2.

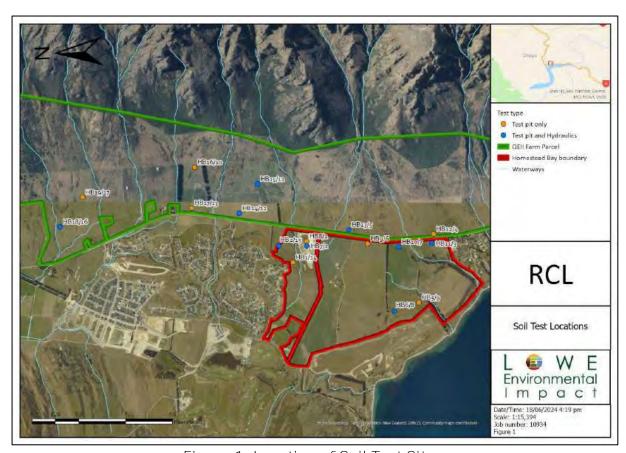
Figure 1: Location of Soil Test Sites

A comprehensive soil investigation was undertaken by LEI at these two sites on behalf of RCL between 4 to 7 June 2024. It comprised of the machine excavation of 17 test pits, nine of which also included hydraulic testing, as shown in Figure 1. These test pits were excavated down to a depth of approximately 2 m, with hydraulic testing completed at a depth of 0.2 m.

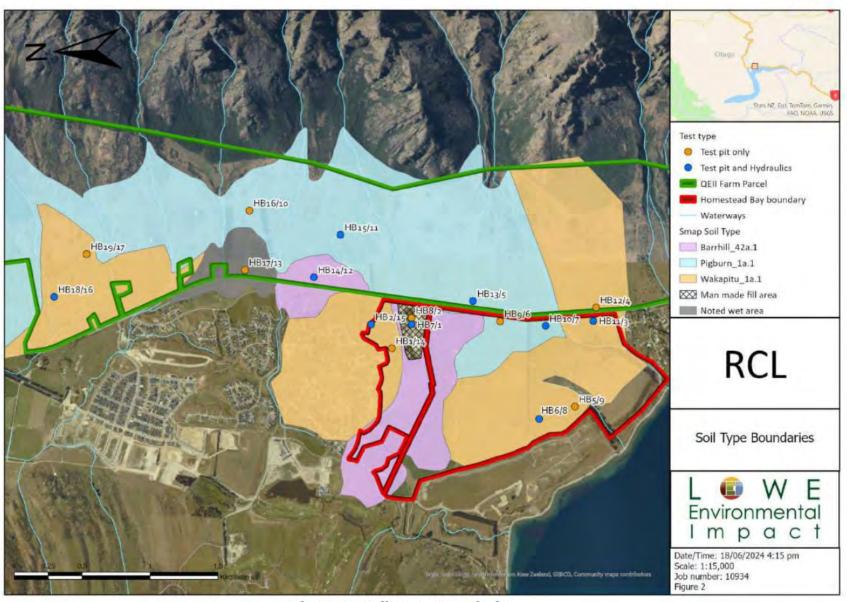
Figure 2: Soil Type Boundaries

The RCL and QEII sites both contain a mixture of all three soil types, Barrhill, Pigburn, and Wakatipu, as noted in Error! Reference source not found. The area of sites HB7/1 and HB8/2 is the clean fill site of the nearby Jacks Point subdivision, so it is classed differently due to this human interfered soil profile. The area of HB17/13 is also classed differently due to the note from the farmer of the presence of groundwater springs during wet periods, as well as the appearance of mottling in the profile, despite the Barrhill classification.

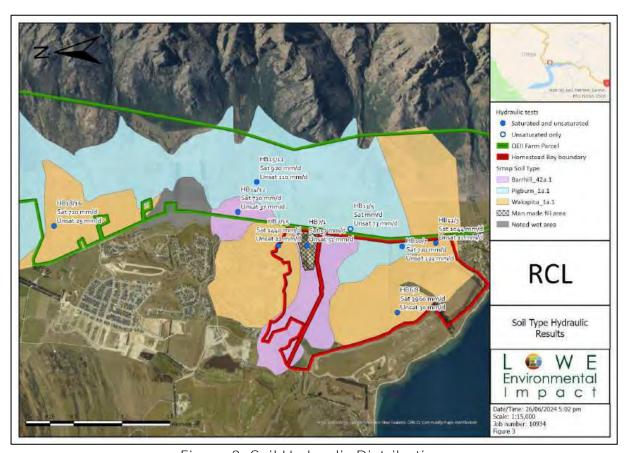
Figure 3: Soil Hydraulic Distribution

The hydraulic results based on soil distribution are shown below in Error! Reference source not found. The distribution of these rates supports the proposal to irrigate based on soil type.

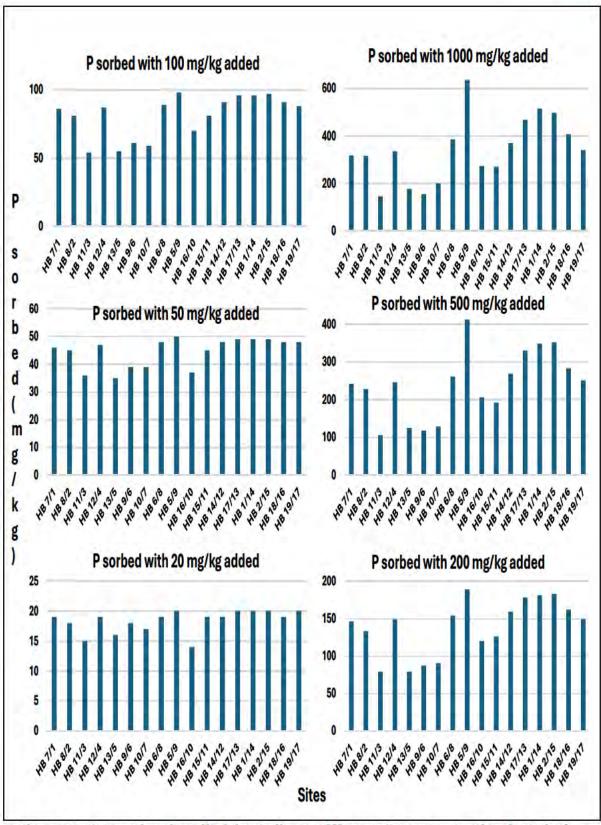
Figure 4: P sorption (mg/kg) by Soils at Different P Concentration in Solution (mg/kg)

Phosphorus (P) sorption in soils (Error! Reference source not found.) is a critical factor in determining the availability of this essential nutrient for plant uptake and its potential impact on the environment. Phosphorus plays a crucial role in plant growth, contributing to processes like energy transfer, photosynthesis, and the synthesis of nucleic acids. However, phosphorus is often a limiting nutrient in soils due to its strong tendency to bind to soil particles, making it less available to plants. Understanding phosphorus sorption dynamics is vital for effective soil management, optimizing fertilization practices, and preventing environmental issues like eutrophication.

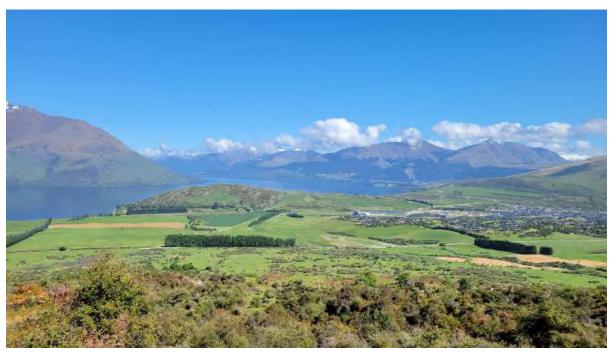
Photograph 2.1: Looking west over central and northern areas of the proposed development area.

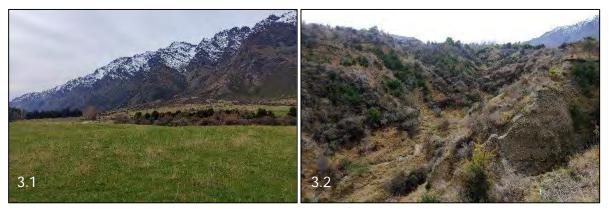
The eastern and southern portion of the site is located on an elevated, gently inclined slope comprising distal fan alluvium, see Photograph 3.1 below. The fan alluvium originates from the western slopes of the Remarkables, and immediate area.

The northern creek flows along the northern boundary of Lot 8 in a modified channel.

Photograph 3.1: Standing on the alluvial fan looking east towards the Remarkable Range and the head of the fan. Photograph 3.2: The deeply incised southern flow channel through the alluvial fan then glacial till deposits.

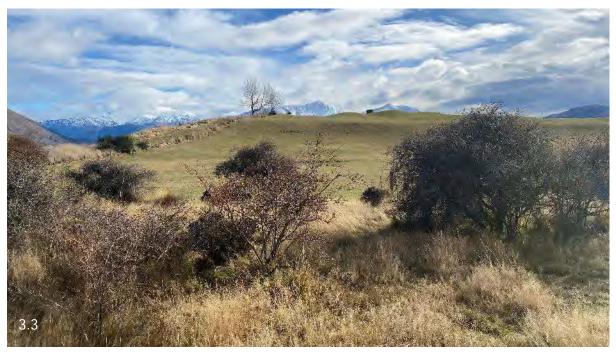
Photograph 3.2: Site photo of Zone C characterised by locally elevated irregular and undulating hummocky topography.

From the western crest of the zone the slope falls moderately towards Lake Wakatipu. A series of beach ridges running parallel to the western boundary of the site represent stranded shorelines associated with the lowering of Lake Wakatipu.

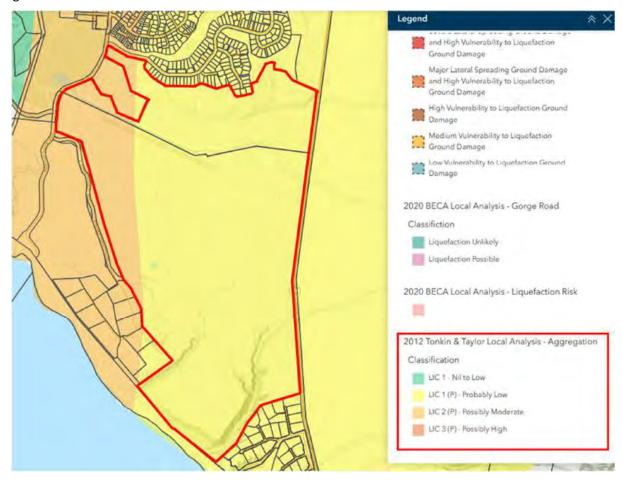
Figure 6.1: Liquefaction hazard mapping. Image retrieved from QLDC GIS Natural Hazards Map on 17th January 2024. The site boundary is shown in red.

Figure 1b, Appendix A, identifies the approximate extent of the eastern perched water zone. Therefore most of the site, where there is no perched groundwater level, will have at least 10 m of dry non liquefiable crust. In these areas the liquefaction risk will be low for a standard shallow foundation structure (i.e. MBIE TC1 equivalent). The perched groundwater level is highly variable with seepages running through more permeable deposits in the alluvial fan. Further geotechnical investigations and assessment can be undertaken to better define the seepage behaviour, however, for this assessment we have undertaken a detailed assessment using the CPTs and assuming different shallow groundwater levels.

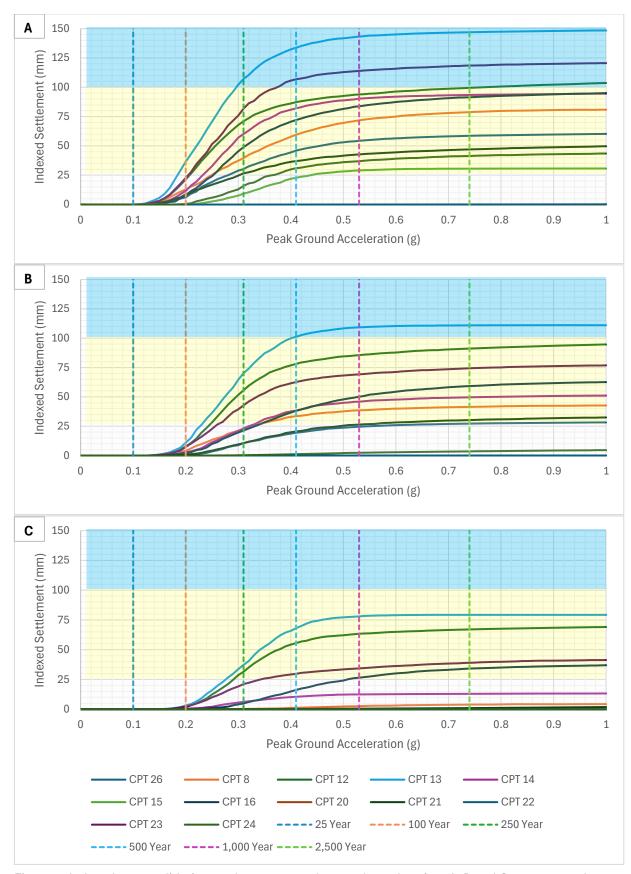
Figure 1: Indexed reconsolidation settlement vs peak ground acceleration. A, B and C are assumed groundwater levels of 2, 4 and 6 m below ground level respectively

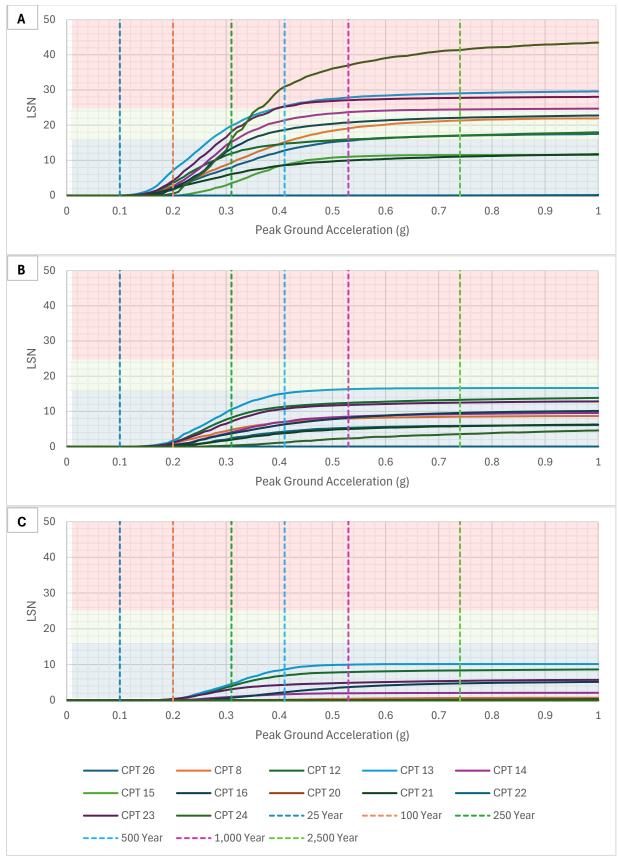
Figure 2: Liquefaction severity number vs peak ground acceleration. A, B and C are assumed groundwater levels of 2, 4 and 6 m below ground level respectively

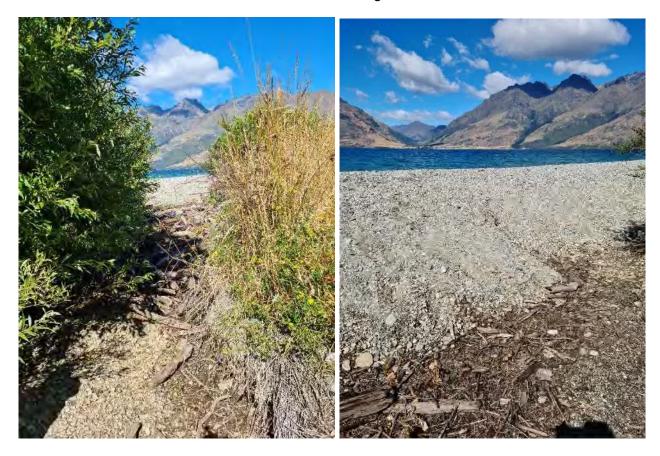
Figure 2: Photos of Māori Jack Stream - Lower section — intermittent and disconnected from the lake by a beach gravel barrier built by wave action. There is no surface water in these photographs. The visible dry driftwood has been left stranded at the bottom of the gravel channel following recession of the last high water level flood event.

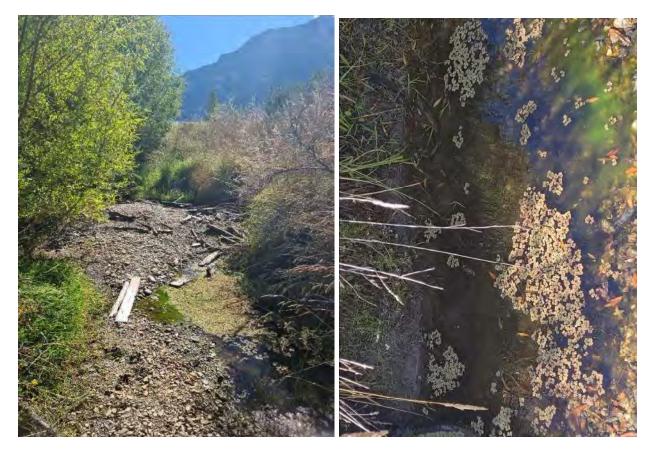
Figure 3: Photos of Māori Jack Stream - Lower section – gravel bed with intermittent stagnant ponds. The most downstream stagnant pond is visible at bottom right of left photo, with close-up shown in right photo.

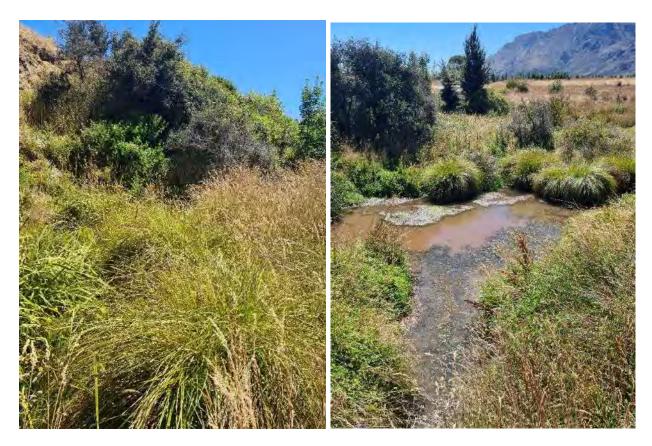
Figure 4a: Photos of Māori Jack Stream – Mid section –wetland areas with narrow meandering obscured channel (left photo) and occasional pools (right photo).

On balance, I think the anaerobic wetland section of Māori Jack Stream is likely to be favourable, because phosphorus can be more easily treated earlier in the wastewater treatment chain and the wetland areas will complement the early-chain engineered removal of nitrogen by removing further nitrogen to the atmosphere via denitrification.

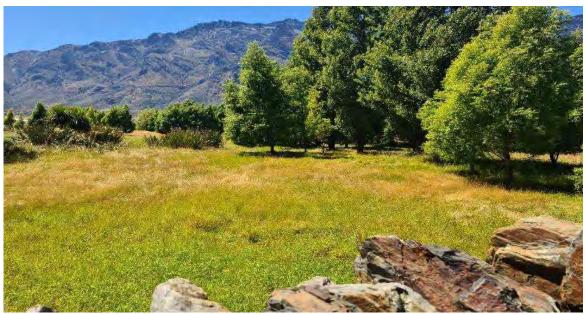
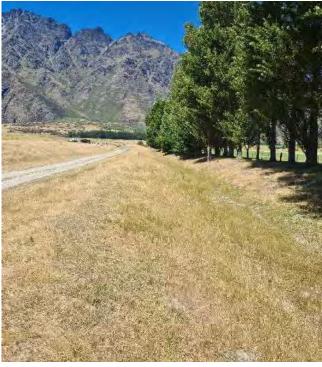
Figure 5a: Photos of Māori Jack Stream – Upper section – swales above Lodge Road.

The upper section of Māori Jack Stream above approximately the bridge at Lodge Road I would describe as essentially two main grassed swale depression channels (both labelled 'Jacks Point Tributary' in Figure 1) with a series of contributing sloping grassed depressions (Figure 5). These grassed swale tributaries are all ephemeral (i.e., only flow temporarily after rainfall) and have absolutely no aquatic ecological value at all (Figures 5a, 5b and 5c).

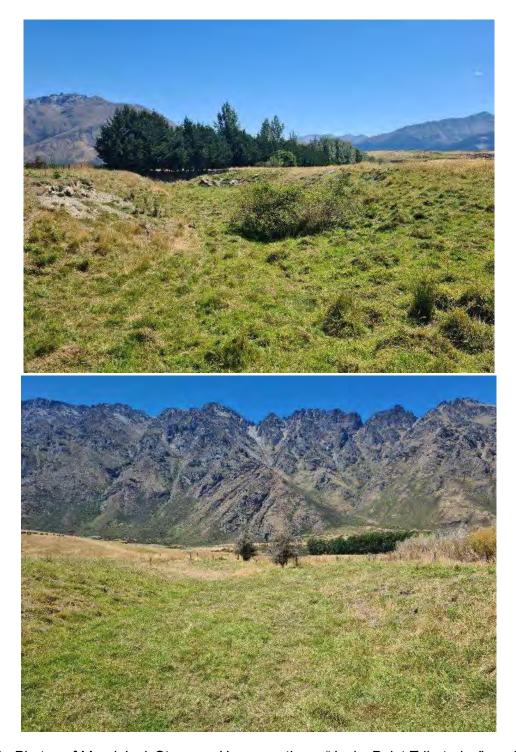
Figure 5b: Photos of Māori Jack Stream – Upper section – "Jacks Point Tributaries" swales.

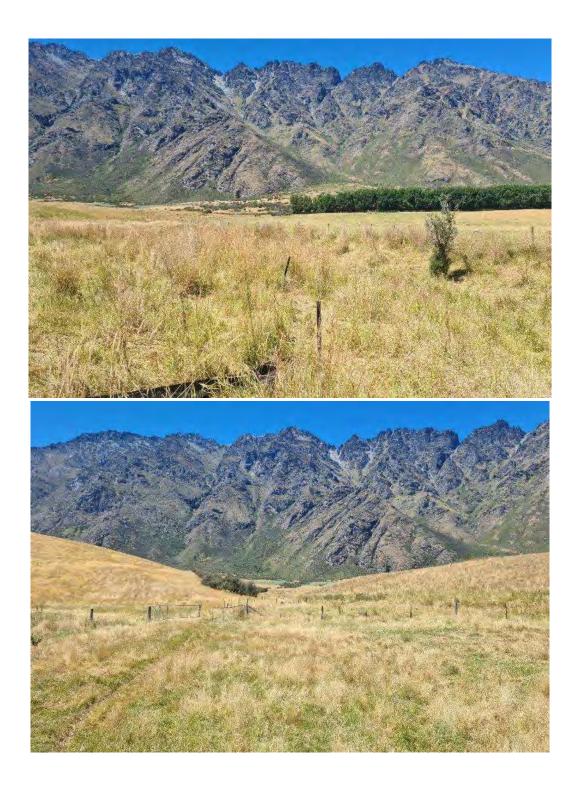
Figure 5c: Photos of Māori Jack Stream – Upper section – "Jacks Point Tributaries" swales.

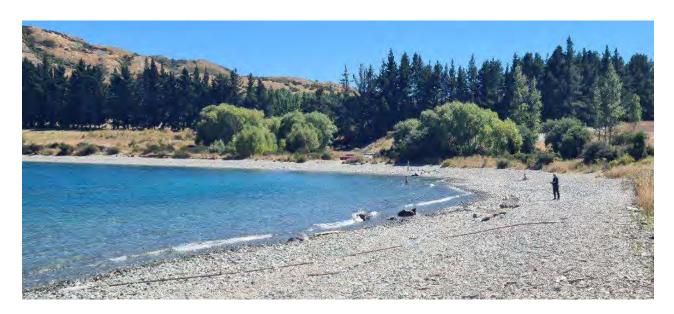
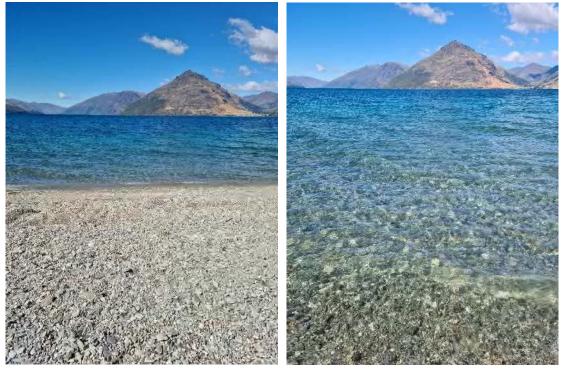
Figure 6: Photos of the embayment in Homestead Bay showing where Māori Jack Stream enters Lake Wakatipu through the left-hand clump of willow trees to the left of the cars visible centre of top image. The three lake water quality sampling sites defined in the existing Jacks Point consent conditions and sampled by e3S (2022) are taken 5 m out from the water edge in this embayment – one sample directly out from Māori Jack Stream, one approximately 200m to the west (left in top image) and one approximately 200m south (bottom foreground in top image). See also Attachment 3 for aerial location plan. Bottom left image is taken with photographer standing on top of the gravel beach barrier at the disconnected Māori Jack Stream outlet. Bottom right image shows very high lake water clarity directly off Māori Jack Stream.

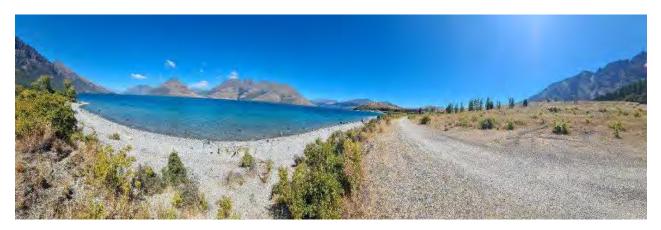
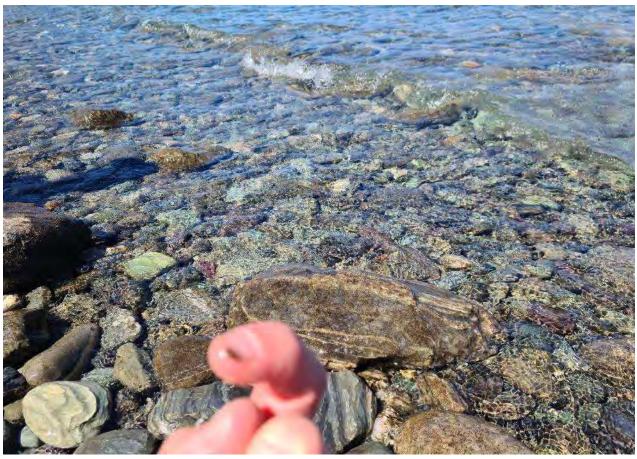
Figure 7: Panorama photo (top) of the whole section of shoreline viewed from just north of the unnamed watercourse 1 which meets the lake at far left of photo. Unnamed watercourse 2 meets the lake out of view around the point to the left. The bottom photo shows that a (healthy) thin brown diatom film can accumulate (scratched under fingernail) where the shallow cobbles are large enough to resist wave action and provide stable substrate, even with the low intensity existing farming landuse - in this case near unnamed watercourse 2 below catchment area RCL D. This is not nuisance or harmful algae. It provides the base of a food chain for invertebrates and fish. (see Figure 1 for location and note the shoreline is in reality fairly straight at this location – the deep curve in the shoreline here is an artefact of the panoramic field of view).

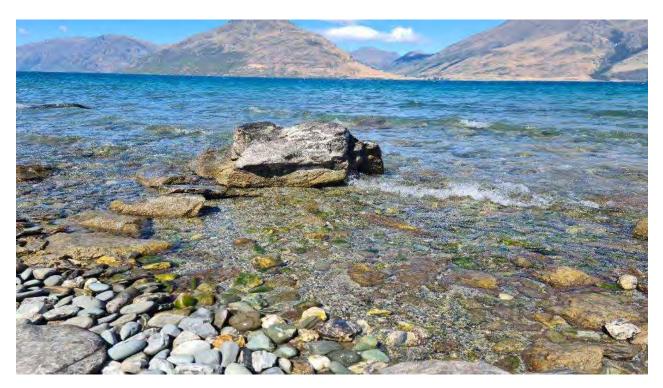
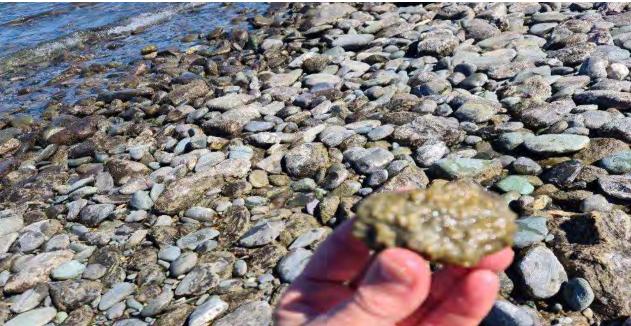
Figure 8: Photos showing two examples where some very localized (3 m wide strip) growth of green filamentous algae (bright green) and didymo (olive-coloured) can currently occur where there is sufficient shelter from the prevailing wave action (i.e., behind the visible boulder) and where apparently a seep of nutrients may be contributing from some unknown source. Such algae growth occurred in only two very small locations on the straight section of shoreline north of unnamed watercourse 1 and approximately 600-800 m south of Māori Jack Stream. No such algae growth occurred in the sampled embayment of Māori Jack Stream shown in Figure 6.

- There were just two locations where very narrow (3 m wide) bands of thicker algae growth were visible near shore. These appear to have been enabled at specific locations where there was localised shelter from wave action behind large boulders and a groundwater seep of additional nutrients which I suspect was coming from some unconfirmed source on the terrace directly above the lakeshore at these locations (Figure 8). These locations were very localized and an exception to the generally clean cobbles or presence of only thin healthy films along the majority of the 1.8 km length of shoreline observed.

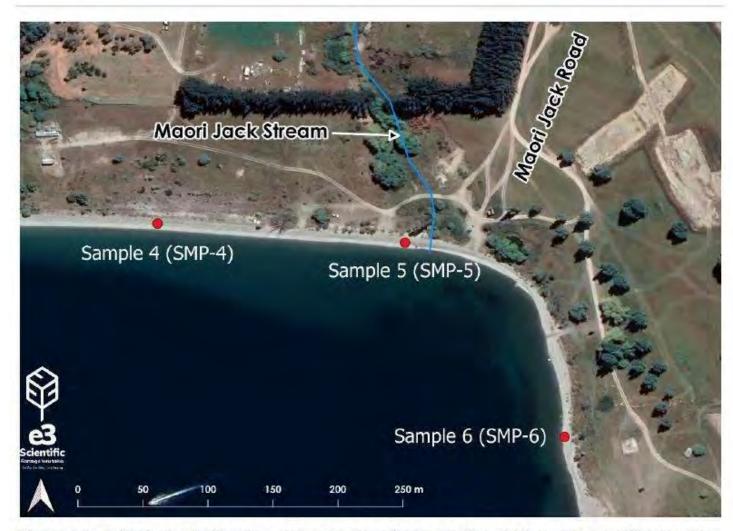
Figure 5: Māori Jack Stream sample locations. Note: GPS point locations were taken onshore. Actual sample locations are 5m offshore (perpendicular to the shoreline).

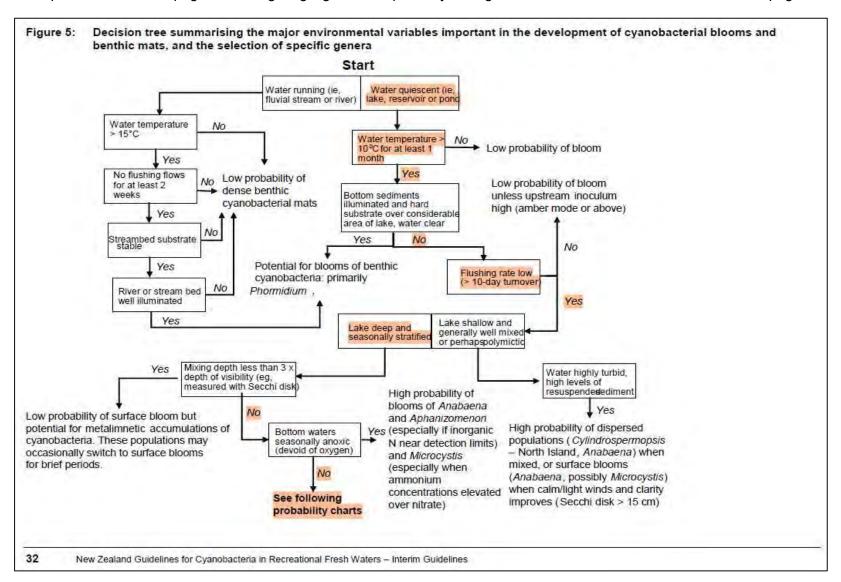
Excerpt from Guidelines page 32: Orange highlights show pathway through the decision tree as detailed on the next page.

The orange highlights show the pathway through the decision tree for Homestead Bay, as evidenced by:

- i) Is water quiescent (i.e., lake, reservoir or pond)? Yes
- ii) Is water temperature >10°C for at least 1 month? Yes (e.g., Borges 2024)
- iii) Are bottom sediments illuminated and hard substrate over considerable area of lake, water clear? Yes for marginal areas only but the risk of benthic blooms near shore in Homestead Bay is considered low due to the frequent wind-driven wave action as evidenced by observation of very clean gravels in that area. The answer is "No" for majority of Homestead Bay area which in the decision tree leads to assessment of risk for planktonic cyanobacterial blooms in the water column or on the lake surface.

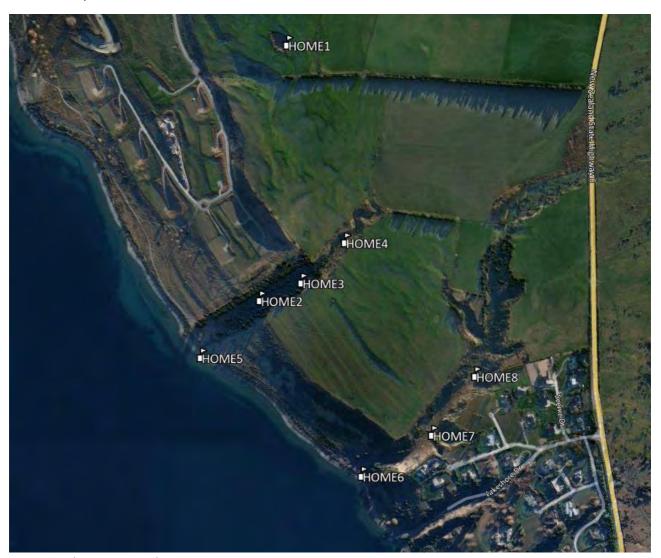
Figure 1: The Homestead Bay aquatic assessment areas.

The Homestead Bay area was visited on the 15 March 2023. The two water courses and a pond on the property were all visited (Figure 1). The habitat at each site and the permanence of water in the water courses was assessed. For wetted sites the potential for fish residence and fish passage was checked and the likely macroinvertebrate communities determined.

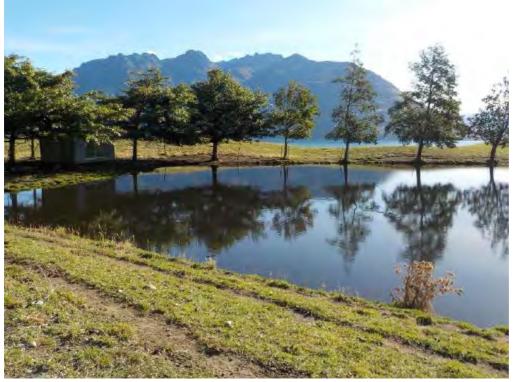
Figure 2: The pond with small hut and oak trees.

The unfenced pond (site HOME1, Figure 1) is situated on a hilltop (altitude 380 m) and has no inflowing tributaries. There is a small hut and oak trees¹ beside the pond (Figure 2), and duck decoys in the pond indicating the pond is used for recreation duck shooting. The pond margin is grazed pasture grass or bare ground.

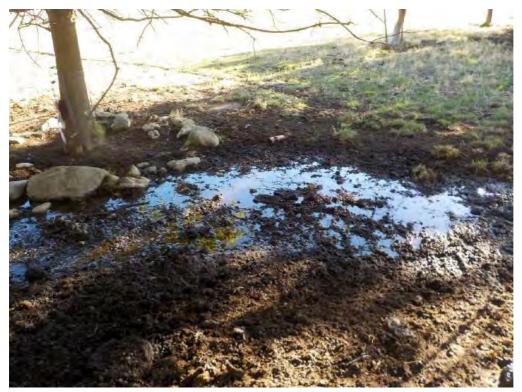
Figure 3: The pond outflow on bare ground that is a sheep resting area.

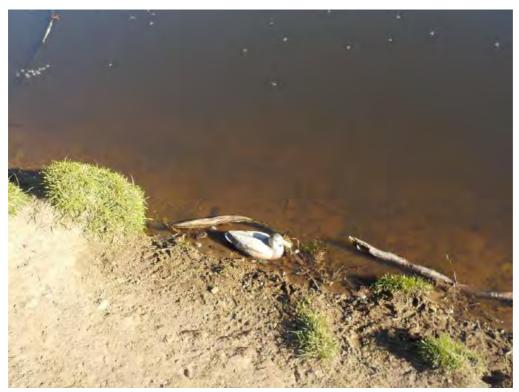
Figure 4: Pond edge and muddy bottom.

With no tributaries and no outflow connection to other water bodies the pond cannot be colonised by fish. Diving beetles, backswimmers and water boatmen were the only macroinvertebrates seen in the pond. For the most part the pond bottom is mud with the occasional stick and rock on the bottom (Figure 4).

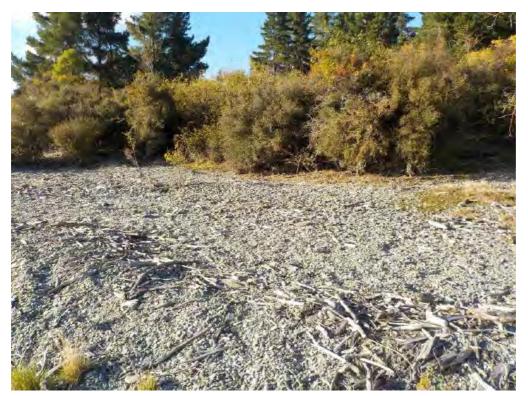
Figure 5: The lakeshore where Water Course 1 discharges into Lake Wakatipu.

across the lake shore and above the gravel lake shore the stream channel is well vegetated with terrestrial shrubbery (Figure 5).

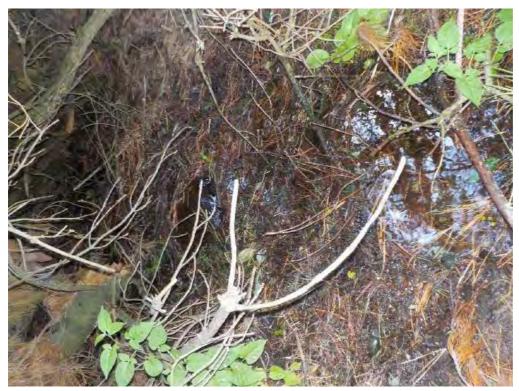
Figure 6: windfall pine and leaf litter creating a dam and ponded water.

Fifty metres upstream from the lake shore the stream emerges from a steep sided valley and pine plantation. At Site Home 2 windfall pines, valley floor vegetation and leaf litter have created a dam and upstream of this a small wet area with well-established weedy terrestrial species (Figure 6).

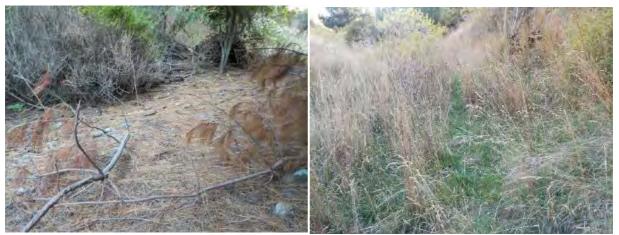
Figure 7: Water Course 1 at (left) top of pine plantation and (right) near site HOME4 with a terrestrial vegetation valley floor.

This wetted area of the valley floor extends for less than 75 m between sites HOME2 and HOME3 and the water is very shallow. At Site HOME3 and upstream to site HOME4 and further the water course is dry and vegetated with terrestrial plants, often grazed grasses (Figure 7).

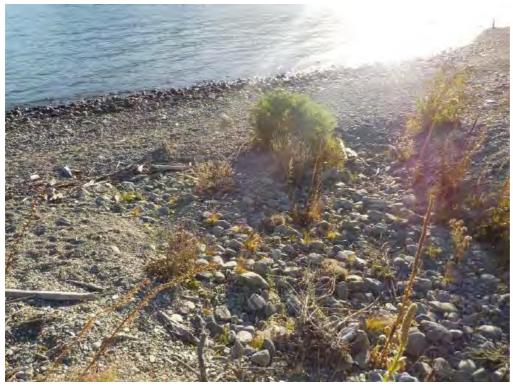
Figure 8: The Lake shore and dry channel of Stream Course 2.

Water Course 2 rises on the flank of the Remarkables Range, flows under State Highway 6 and down slope to Lake Wakatipu. The outflow to Lake Wakatipu across the lake front has a dry stream channel upstream of the lake shore where wave action creates the lake shore gravel/cobble beach zone (Figure 8). The stream flows out of a canyon like valley with a wide valley floor and steep, often vertical sides (Figure 9).

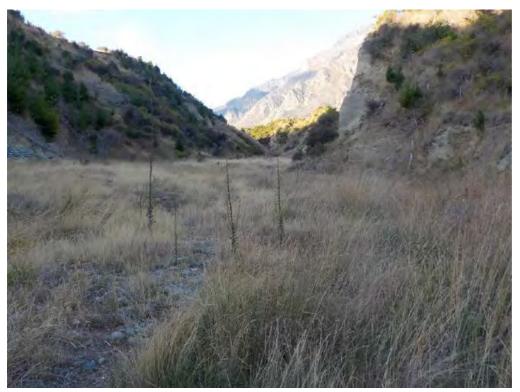
Figure 9: Looking upstream in Stream Course 2.

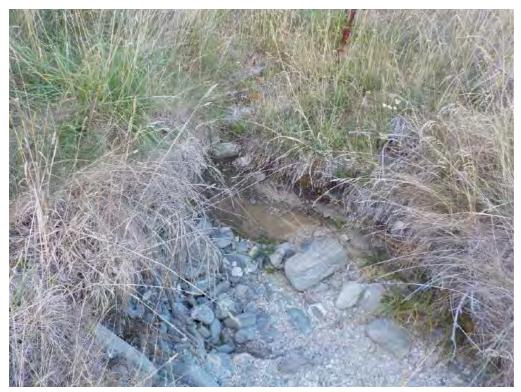
Figure 10: Scour pool in Stream Course 2.

Upstream of the shoreline the stream has a well-established, 1 m wide incised channel with a dry gravel/cobble/boulder bed. This channel extends upstream for nearly 400 m before terrestrial grasses began to establish in the channel. Within this reach there are small boulder waterfall structures with downstream scour pools. While the channel is deep none of the scour pool retained water (Figure 10). The scour pools do indicate that when the stream flows it has the power to move cobble and gravel material downstream. Between 400 m and 500 m upstream from the lake there are a number of tributary inflows, and the channel become progressively smaller and terrestrial grasses and shrubs begin to grow in the channel. The tributaries include scour channel flowing over the canyon walls (Figure 11). Beyond site HOME8 the channel has intermittently exposed rock but is predominately overgrown with terrestrial vegetation.

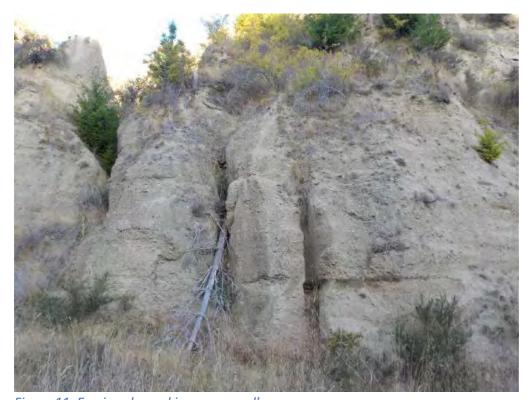
Figure 11: Erosion channel in canyon walls.

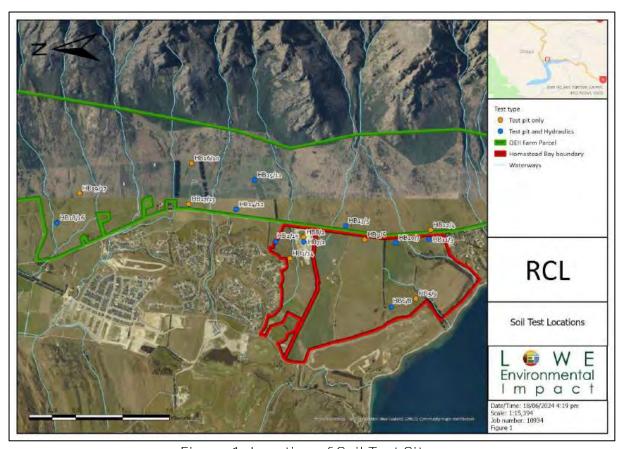
Figure 1: Location of Soil Test Sites

A comprehensive soil investigation was undertaken by LEI at these two sites on behalf of RCL between 4 to 7 June 2024. It comprised of the machine excavation of 17 test pits, nine of which also included hydraulic testing, as shown in Figure 1. These test pits were excavated down to a depth of approximately 2 m, with hydraulic testing completed at a depth of 0.2 m.

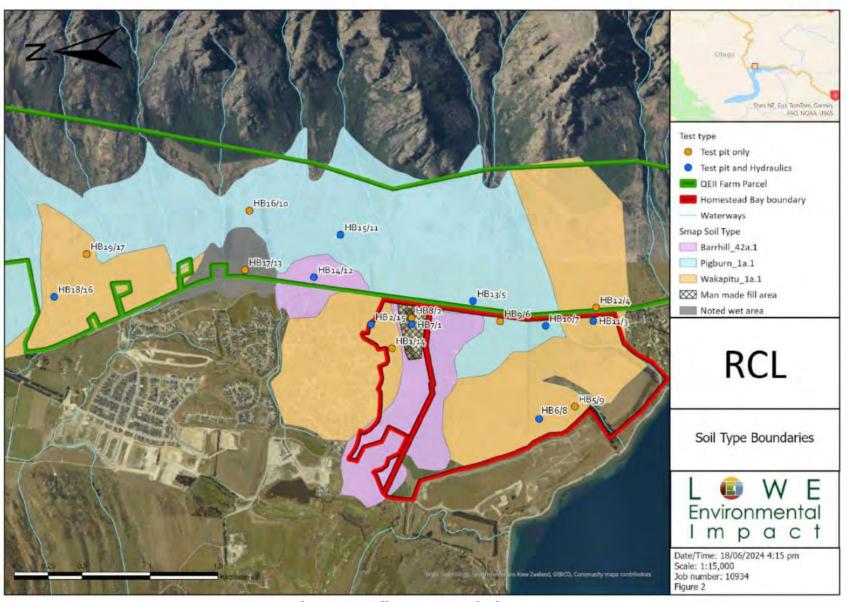
Figure 2: Soil Type Boundaries

The RCL and QEII sites both contain a mixture of all three soil types, Barrhill, Pigburn, and Wakatipu, as noted in Error! Reference source not found. The area of sites HB7/1 and HB8/2 is the clean fill site of the nearby Jacks Point subdivision, so it is classed differently due to this human interfered soil profile. The area of HB17/13 is also classed differently due to the note from the farmer of the presence of groundwater springs during wet periods, as well as the appearance of mottling in the profile, despite the Barrhill classification.

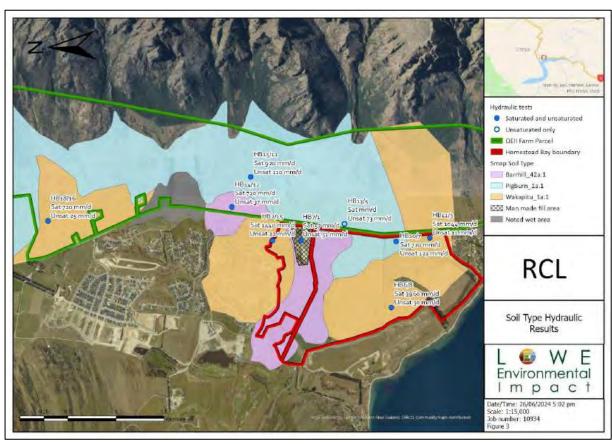
Figure 3: Soil Hydraulic Distribution

The hydraulic results based on soil distribution are shown below in Error! Reference source not found. The distribution of these rates supports the proposal to irrigate based on soil type.

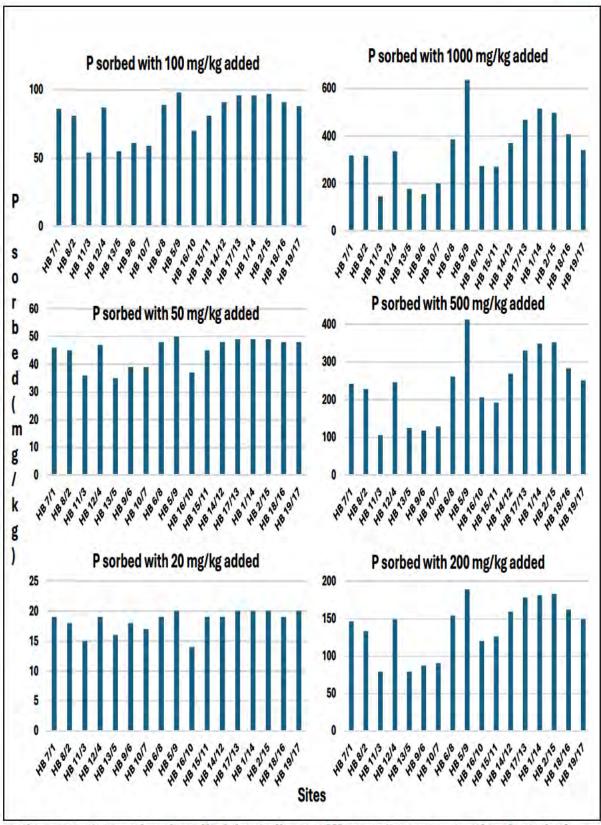
Figure 4: P sorption (mg/kg) by Soils at Different P Concentration in Solution (mg/kg)

Phosphorus (P) sorption in soils (Error! Reference source not found.) is a critical factor in determining the availability of this essential nutrient for plant uptake and its potential impact on the environment. Phosphorus plays a crucial role in plant growth, contributing to processes like energy transfer, photosynthesis, and the synthesis of nucleic acids. However, phosphorus is often a limiting nutrient in soils due to its strong tendency to bind to soil particles, making it less available to plants. Understanding phosphorus sorption dynamics is vital for effective soil management, optimizing fertilization practices, and preventing environmental issues like eutrophication.

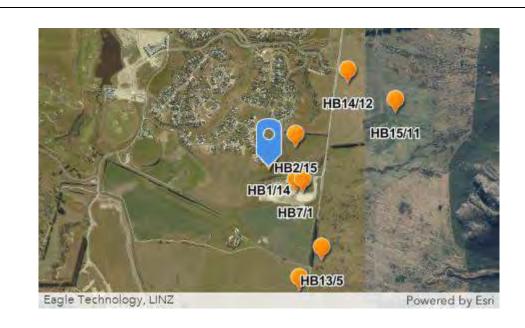
LEI Soil Profile Description			
June 6, 2024 4:28 PM HB2/15			
Millie	Elevated rolling hills closest to highway		
overcast, calm	Much the same as HB1/14 but bigger boulders in b horizon		
Soil Core # (if collected)	Top soil: Sub soil: 832

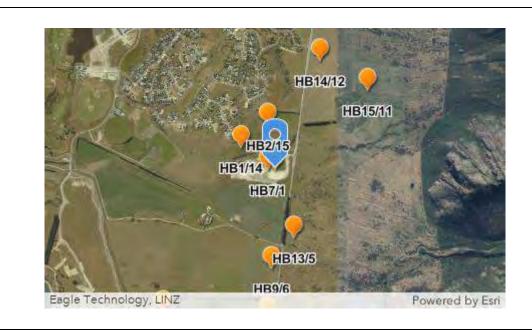
LEI Soil Profile Description			
June 5, 2024 11:15 AM	:15 AM HB9/6		
Millie	Pasture beside airfield		
overcast, calm	Generally homogeneous profile		
Soil Core # (if collected)	Top soil:	Sub soil: 697

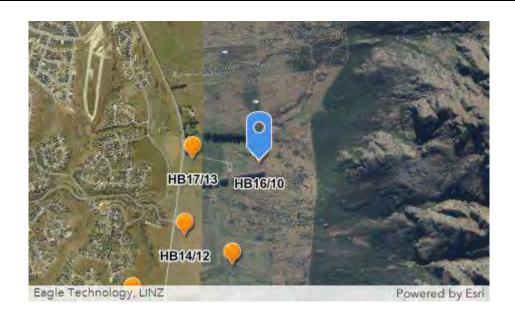
LEI Soil Profile Description			
June 6, 2024 2:21 PM	HB17/13		
Millie	Turnip paddock		
overcast, calm	Farmer mentioned that this paddock experious overflow drainage and springs can pop up winter, this is confirmed with the presence mottles		
Soil Core # (if collected)	Top soil:	Sub soil: 739

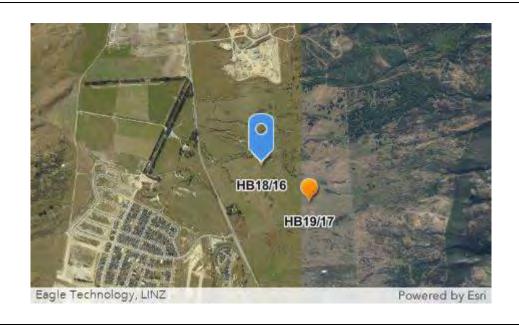
LEI Soil Profile Description			
June 7, 2024 11:16 AM		HB19/17	
Millie	Elevated flats		
fine, calm			
Soil Core # (if collected)	Top soil:	Sub soil: 898
