Assessment of Environmental Effects for the Discharge of Wastewater to Land

RCL Homestead Bay Limited

Resource Consent Application and Assessment of Environmental Effects for the Discharge of Wastewater to Land

10934-RCL WW AEE-250409-final

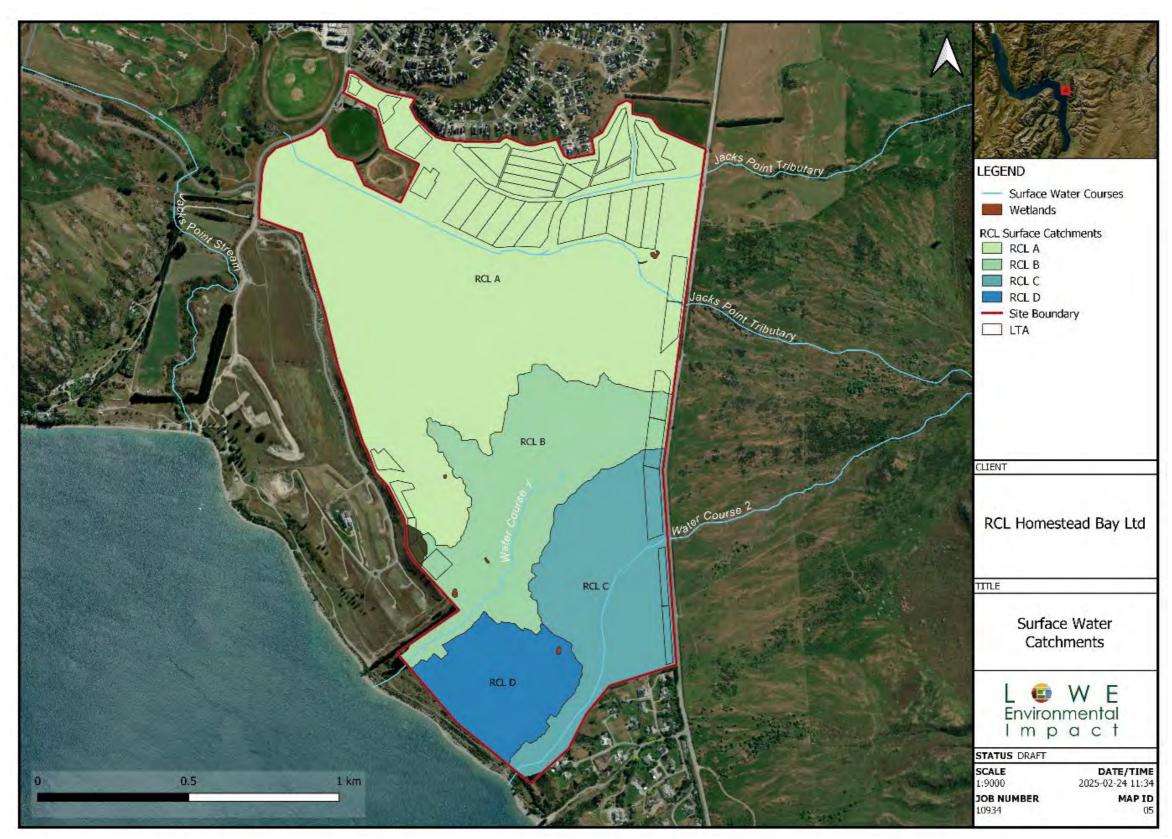
Figure 1: Surface Water Features

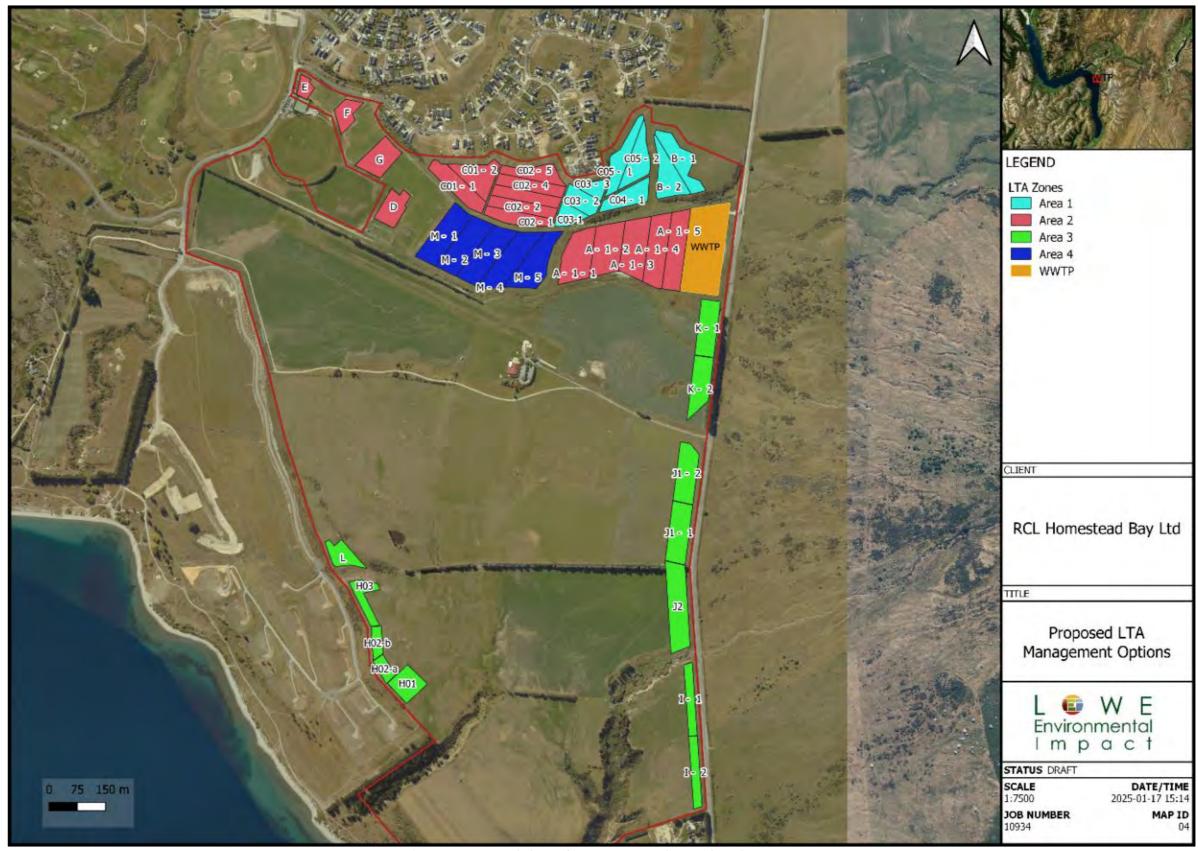
Figure 2: LTA of the RCL Homestead Bay development

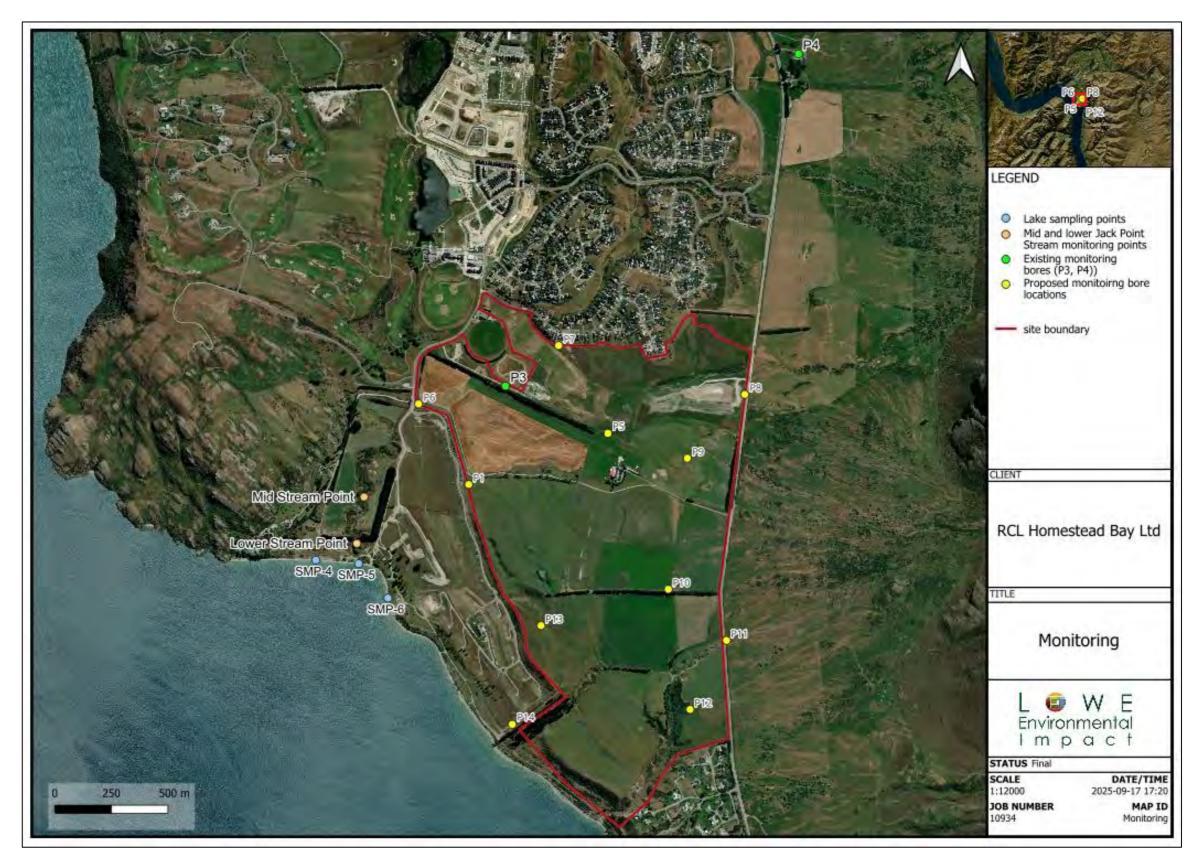
Figure 3: Proposed Location of Sampling Sites for Surface Water and Groundwater Monitoring

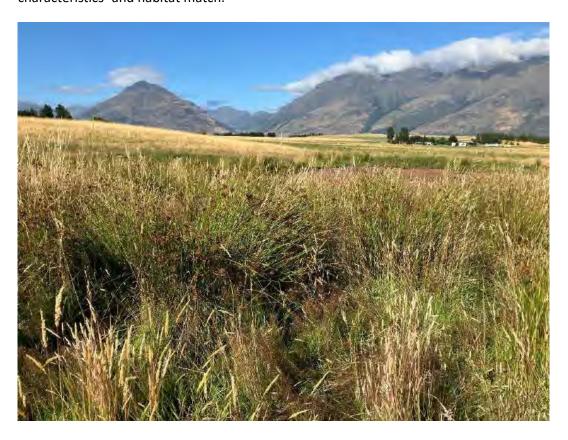
Plate 1 – Rushland marsh wetland above the pond in Wet Area 1 at Homestead Bay. 30 January 2025.

Clusters of soft rush are spread throughout a mosaic of browntop, sharp spike sedge and Yorkshire fog (Plate 1). Other species occasionally present include white clover, wīwī/leafless rush and jointed rush (*Juncus articulatus*). A sedge species is also present in very low abundance. The sedge did not have an inflorescence to confirm identification but is likely Sinclair's sedge (*Carex sinclairii*), due to its leaf characteristics¹ and habitat match.

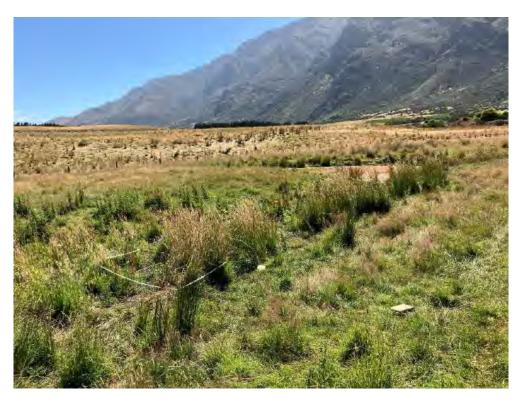
Plate 2 – Rushland swamp wetland below the pond in Wet Area 1 at Homestead Bay. Plot 3 can be seen within the wetland. 30 January 2025.

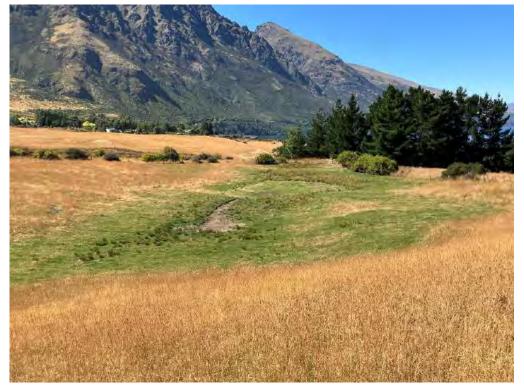
Plate 3 – Ephemeral wetland surrounded by rushlands in the middle of Wet Area 2 at Homestead Bay. 30 January 2025.

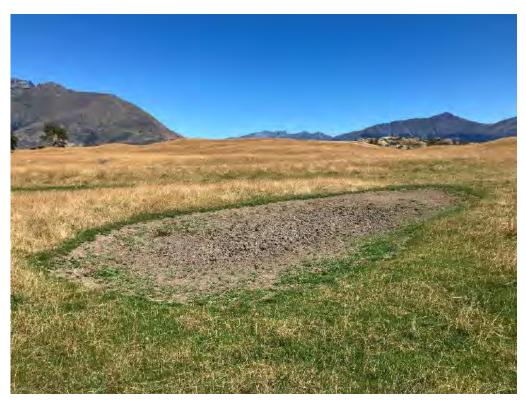
Plate 4 – Ephemeral wetland within the exotic pasture grassland within Wet Area 3 at Homestead Bay. 30 January 2025.

Another ephemeral wetland is located in Wet Area 3. This wetland is within an oval depression and is mostly unvegetated (Plate 4). A few exotic species are scarce and scattered near the edges and include: marsh plantain, ryegrass, nettle and clammy goosefoot.

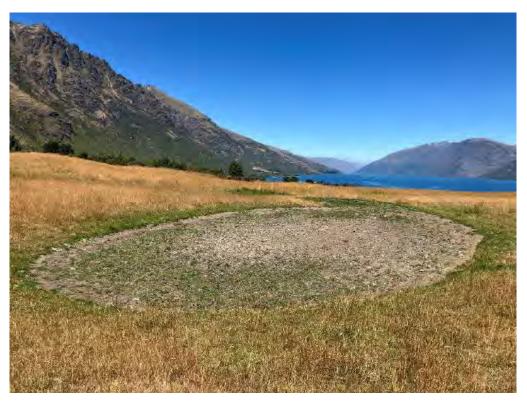
Plate 5 – Ephemeral wetland within the exotic pasture grassland within Wet Area 4 at Homestead Bay. 3 February 2025.

This ephemeral wetland is also within a mostly unvegetated oval depression (Plate 5). Scarce and scattered exotic species located near the edges of the wetland include floating sweetgrass, browntop, clammy goosefoot, white clover, and black nightshade (Solanum nigrum).

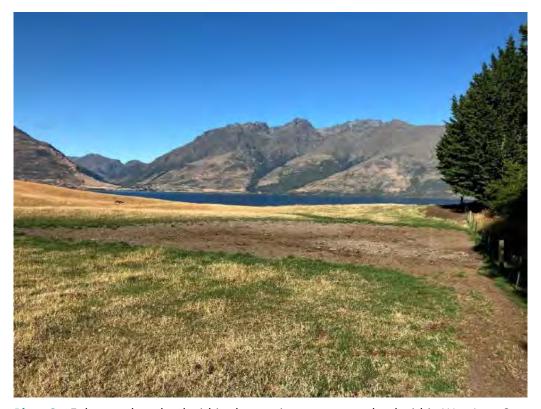
Plate 6 – Ephemeral wetland within the exotic pasture grassland within Wet Area 6 at Homestead Bay. 4 February 2025.

This unvegetated ephemeral wetland is lies in a small depression and is very small in size. This area is likely a recently developed wetland, as suggested by the 'uncertain' soil result in the guidelines (Fraser et al. 2018). The first evidence of water pooling in this wetland on Google Earth can only be seen from 10 February 2010. The ephemeral wetland is at the lowest point (paler soil) of a compacted open soil patch (Plate 6).

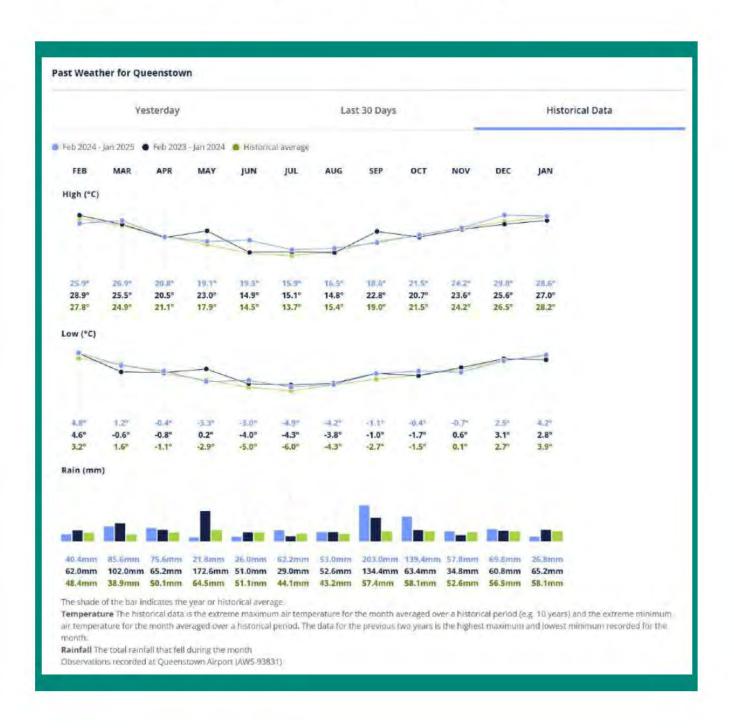
Monthly rainfall data for 2024, 2025 and historical averages
